Flood Control Project Maintenance Levee Inspections

Fall 2022 Levee Maintenance Deficiency Summary Report

San Joaquin River Basin

Reclamation District No. 0524 Middle Roberts Island

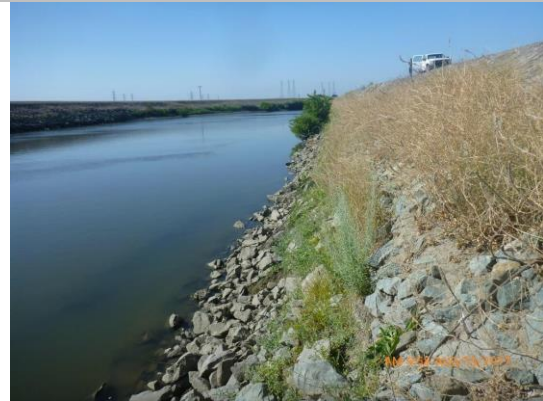
Photo 1 of 1 : LEVAL_FA_2022_523_4217.jpg

LM Start	4.76	Rating **	A/W	Issue No.	236
LM End	4.76	Issue Type +	Ma	Location *	WS
Category	Earthen Levee			GPS Latitude/Longitude	
				Start	End
Item	Erosion / Bank Caving			37.889300 °	37.889300 °
				-121.329800 °	-121.329800 °
DWR ID	DWR_RD0524_01_s_2020_236				
Comment Code					
E1 : Note and monitor erosion site.					
Inspector Comment					
2017 Strom Damage Site, ID No. 523, LMA-429,

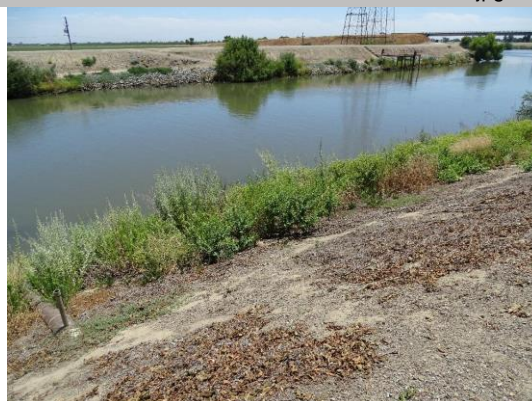
Photo 2 of 3 : UCIP_FA_2022_73986_89485.jpg

Water-Side: view of WS slope.

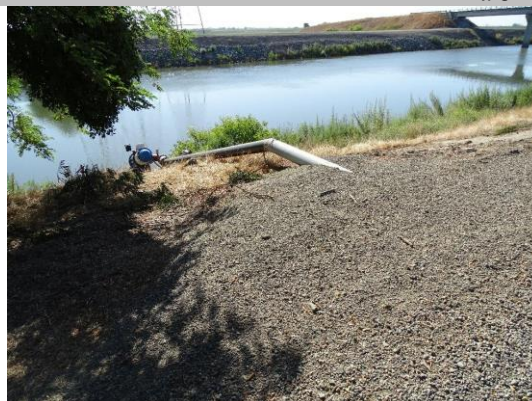
Photo 1 of 3 : UCIP_FA_2022_73997_111031.jpg

LM Start	5.53	Rating **	M	Issue No.	933 (cont)
LM End	5.53	Issue Type +	En	Location *

View of WS slope.

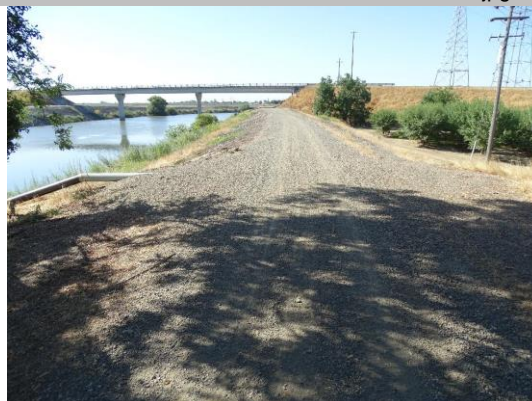
Photo 2 of 3 : UCIP_FA_2022_73997_111032.jpg

View of levee crown.

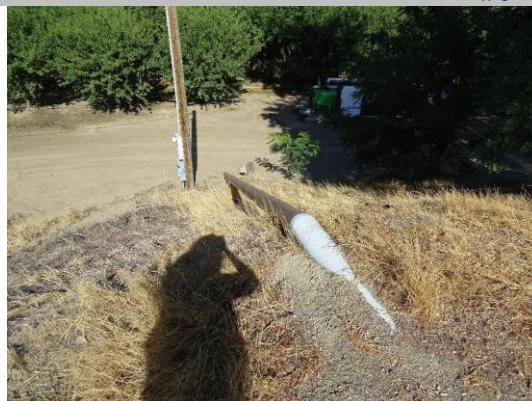
Photo 3 of 3 : UCIP_FA_2022_73997_111030.jpg

LM Start	5.53	Rating **	M	Issue No.	933 (cont)
LM End	5.53	Issue Type +	En	Location *	
Category	Supplemental			GPS Latitude/Longitude	
				Start	End
Item	DWR UCIP Field Study			37.878868 °	37.878868 °
				-121.333136 °	-121.333136 °
DWR ID	25713

View of LS slope.
