Flood Control Project Maintenance Levee Inspections

Fall 2024 Levee Maintenance Deficiency Summary Report

San Joaquin River Basin

Reclamation District No. 0524 Middle Roberts Island

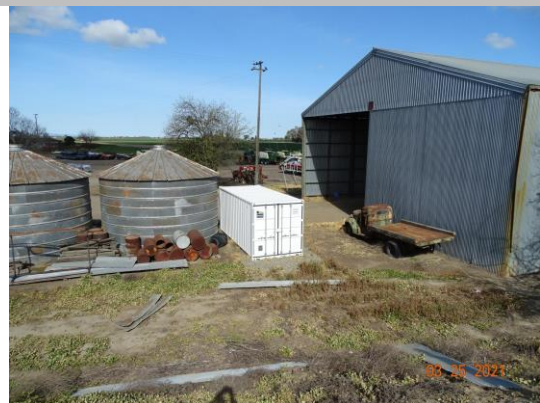
Photo 1 of 1 : FA_2024_RD0524_107_138_20240910_00022.jpg

LM Start	0.00	Rating **	A	Issue No.	138
LM End	0.00	Issue Type +	Ma	Location *	N/A
Category	Earthen Levee			GPS Latitude/Longitude	
				Start	End
Item	Emergency Supplies & Equipment				°
					°
DWR ID	DWR_RD0524_01_s _ 2013_138				
Comment Code					
ES : Emergency Supplies & Equipment					
Inspector Comment					
The LMA has emergency supplies or equipment stored in a shipping container at LM 4.65, (37.890799, -121.32913).

View of container with Districts Flood Fight Materials. Spring 2021

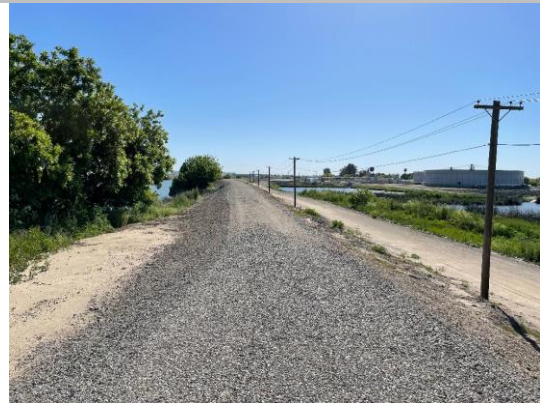
Photo 1 of 3 : UCIP_FA_2024_83419_121986.jpg

Comment Code					
Inspector Comment					
DS_ID:20590 FS_ID:83419 EP_NO: 6035 Repair Type: Non-Urgent EVAL Issue: 6, Levee Damage or Threat for Levee Damage Crossing Status: Not Found UCIP Comments: 04/29/2020 Record updated from No Action Needed to Non-Urgent. Pipe removed under maintenance by KSN according to Aaron Lickingteller. No permit found for removal so pipe status will remain abandoned with permit until documentation can be found for pipe removal. Minor sloughing on LS within 15 feet of levee toe. (J. Taylor - DWR UCIP) 6/23/2020 Record remains No Action Needed. Crossing abandoned under Permit No. 6035. (D.Sanoski - DWR UCIP) FIELD_STRUCT_DESC: *ABANDONED* 14-inch irrigation pipe of an unknown material through the levee, 3 feet below the crown. Plugged with concrete. Concrete pad for pump still exists on the waterside (WS) shoulder. (14-inch abandoned pipe authorized under Permit No. 6035, 1968 - City of Stockton). [Additional Reference(s): DWR Levee Log, 2004 (HLM 0.30). USACE San Joaquin O&M Manual, Unit 7, April 1964, Revised 29 December 2016, (0.27), listed as 14-inch pipe]. FS Date: 4/29/2024 2:36:38 PM

Overview of levee crown looking upstream.

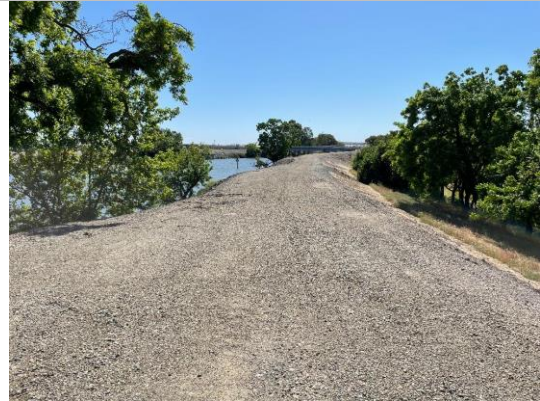
Photo 1 of 3 : UCIP_FA_2024_83469_122088.jpg

Comment Code					
Inspector Comment					
DS_ID:20598 FS_ID:83469 EP_NO: N/A Repair Type: Non-Urgent EVAL Issue: Crossing Status: Found UCIP Comments: 04/29/2024 Record remains Non-Urgent. Pipe is a good candidate for internal pipe inspection. (J. Taylor - DWR UCIP) 06/23/2020 Record updated from No Action Needed to Non-Urgent. System Feature. Crossing appears abandoned. (D.Sanoski - DWR UCIP) FIELD_STRUCT_DESC: 36-inch drainage pipe of an unknown material through the levee, 15 feet below the crown. Landside (LS) end is not visible. Concrete headwall at outlet on the waterside (WS) slope is visible. Pipe appears to be abandoned in place. Slide gate on the WS removed. [Additional Reference(s): DWR Levee Log, 2004 (HLM 0.99). USACE San Joaquin O&M Manual, Unit 7, April 1964, Revised 29 December 2016, (0.99), listed as 36-inch pipe]. FS Date: 4/29/2024 12:26:34 PM

Overview of levee crown looking U/S.

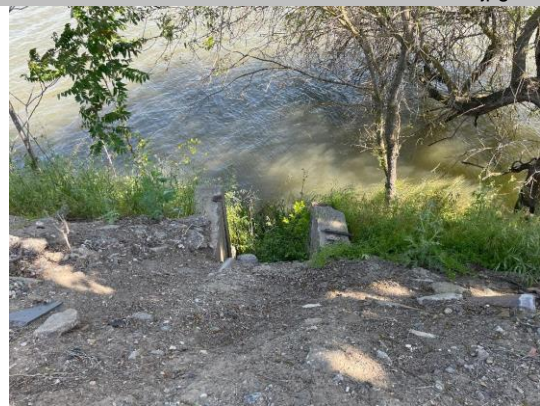
Photo 2 of 3 : UCIP_FA_2024_83469_122089.jpg

WS view: overview of WS slope with the concrete headwall in WS slope.

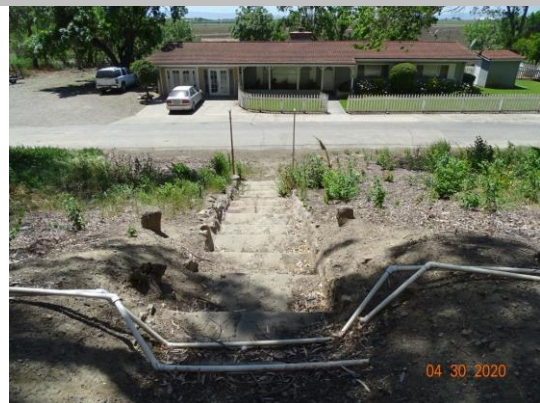
Photo 1 of 1 : FA_2024_RD0524_107_267_20240910_00032.jpg

LM Start	1.67	Rating **	M	Issue No.	267
LM End	1.67	Issue Type +	En	Location *	LS
Category	Earthen Levee			GPS Latitude/Longitude	
				Start	End
Item	Encroachments			37.927014 °	37.927014 °
				-121.326858 °	-121.326858 °
DWR ID	DWR_RD0524_01_s_2020_267				
Comment Code					
ST : Stairway					
Inspector Comment

View of concrete stairs on landside slope. Spring 2020

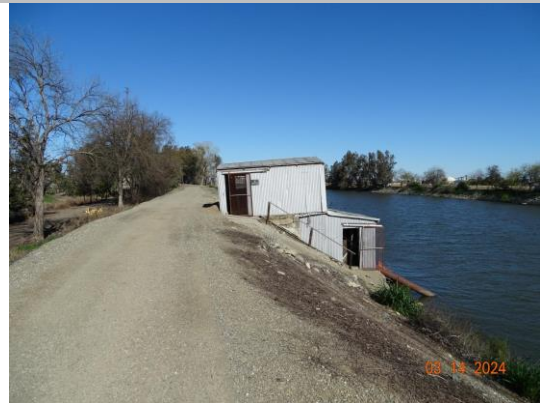
Photo 1 of 1 : FA_2024_RD0524_107_148_20240910_00023.jpg

LM Start	1.81	Rating **	U	Issue No.	148
LM End	1.81	Issue Type +	En	Location *	WS
Category	Earthen Levee			GPS Latitude/Longitude	
				Start	End
Item	Encroachments			37.925457 °	37.925457 °
				-121.325332 °	-121.325332 °
DWR ID	DWR_RD0524_01_f_2019_148				
Comment Code					
BU : Building					
Inspector Comment					
A pump house is located on the waterside shoulder.

View of pump house on waterside shoulder. Spring 2024

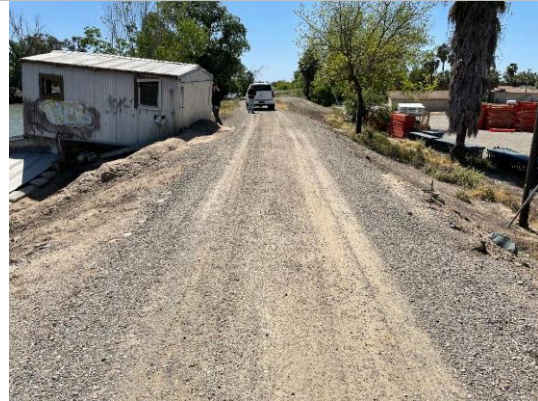
Photo 1 of 3 : UCIP_FA_2024_83639_122624.jpg

Comment Code					
Inspector Comment					
DS_ID:20609 FS_ID:83639 EP_NO: N/A Repair Type: Urgent EVAL Issue: 1, Pipe Integrity Crossing Status: Found UCIP Comments: 04/29/2024 Record updated from Non-Urgent to Urgent. Leaking pipe on both WS and LS. On LS water is coming out of the LS toe and causing significant erosion on LS slope. Leaking on WS is coming from the wrap on the pipe but does not appear to be causing erosion on the levee slope. (J. Taylor - DWR UCIP) 6/23/2020 Record remains Non-Urgent. Unauthorized encroachment recorded in Levee Log prior to 2011. No permit has been identified authorizing pipe. (D.Sanoski - DWR UCIP) FIELD_STRUCT_DESC: 14-inch irrigation pipe of an unknown material through the levee, 20 feet below the crown. 2 pumps and gate valves discharge into surge tank in pump house on the waterside (WS) slope. Concrete distribution box removed from the WS slope. Abandoned 36-inch diameter concrete standpipe on the landside (LS) toe next to service pole. [Additional Reference(s): DWR Levee Log, 2004. USACE San Joaquin O&M Manual 7, April 1964, (HLM 1.83)]. FS Date: 4/29/2024 7:59:42 AM

Overview of levee crown.

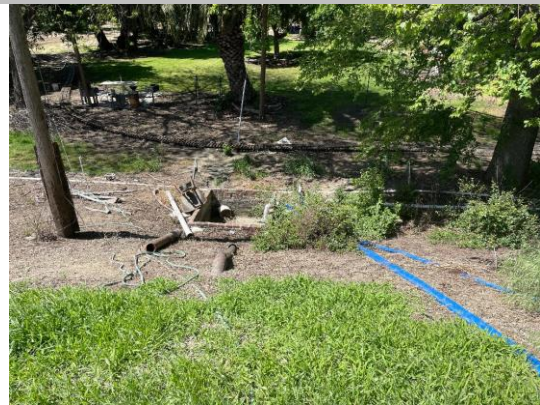
Photo 3 of 3 : UCIP_FA_2024_83659_122686.jpg

Comment Code					
Inspector Comment					
DS_ID:20611 FS_ID:83659 EP_NO: N/A Repair Type: Urgent EVAL Issue: 3b, Flood Risk Crossing Status: Found UCIP Comments: 04/29/2024 Record updated from Non-Urgent to Urgent. Pipe is open on the WS slope where pipe is sleeved approximately 5 feet below levee crown, also open on LS. Because the opening is above the 200-year WSE it received code 3b and is a flood risk during high water events. (J. Taylor - DWR UCIP) 06/23/2020 Record updated from No Action Needed to Non-Urgent. No permit has been identified authorizing pipe. (D.Sanoski - DWR UCIP) FIELD_STRUCT_DESC: 6-inch irrigation pipe of an unknown material through the levee, 3.5 feet below the crown. 4.5-inch irrigation pipe of unknown material sleeved through 6-inch pipe. Pump on concrete slab on the waterside (WS) slope. 6-foot by 6-foot brick distribution box and power pole at the landside (LS) toe. [Additional Reference(s): DWR Levee Log, 2004 (HLM 2.06). USACE San Joaquin O&M Manual, Unit 7, April 1964, Revised 29 December 2016, (2.06), listed as 6-inch pipe]. FS Date: 4/29/2024 12:06:37 PM

LS view: overview of LS slope and pipe on slope along with distribution box outfall.

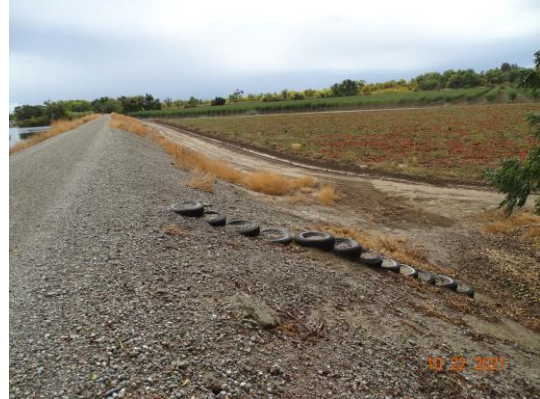
Photo 1 of 1 : FA_2024_RD0524_107_247_20240910_00031.jpg

LM Start	2.12	Rating **	M	Issue No.	247
LM End	2.12	Issue Type +	En	Location *	LS
Category	Earthen Levee			GPS Latitude/Longitude	
				Start	End
Item	Encroachments			37.921664 °	37.921664 °
				-121.322499 °	-121.322499 °
DWR ID	DWR_RD0524_01_f _ 2017_247				
Comment Code					
ST : Stairway					
Inspector Comment					
Landowner installed rubber tires for a stairway on the landside slope.

View of rubber tires being used as stairs on landside slope. Fall 2021

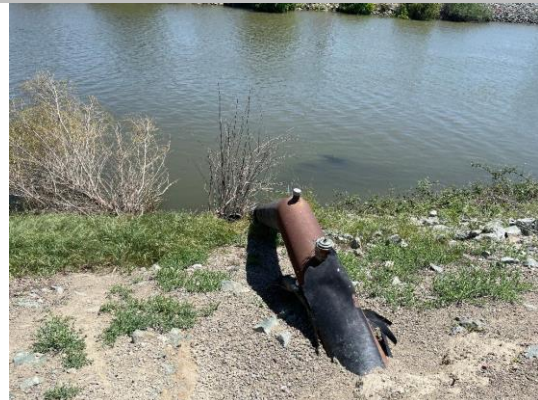
Photo 2 of 3 : UCIP_FA_2024_83695_122790.jpg

WS view: overview of WS slope and channel with pipe visible on slope and entering near WS shoulder.

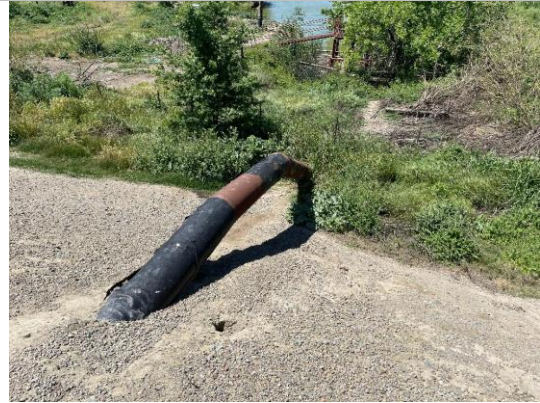
Photo 3 of 3 : UCIP_FA_2024_83695_122791.jpg

LS view: overview of LS slope and toe with pipe visible on slope and entering near LS shoulder.

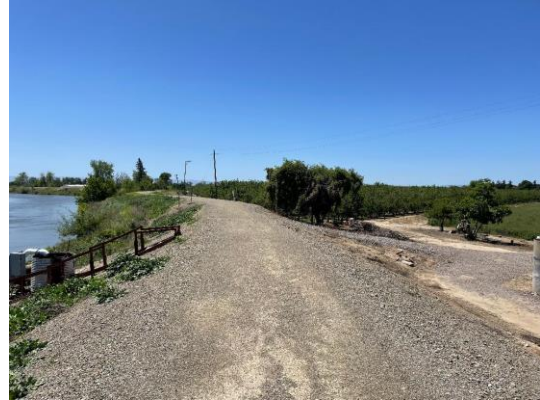
Photo 1 of 3 : UCIP_FA_2024_83755_122822.jpg

Overview of levee crown.

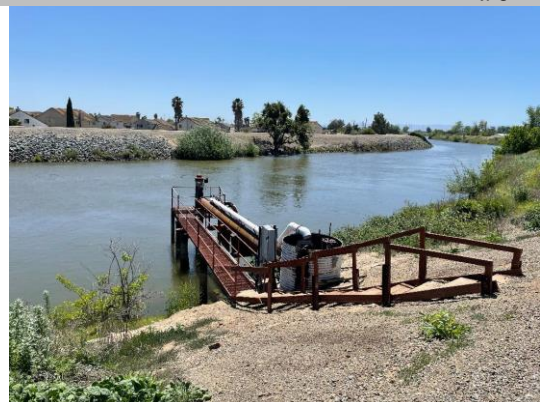
Photo 2 of 3 : UCIP_FA_2024_83755_122823.jpg

WS view: view of metal walkway and pile structure for existing and new pump.

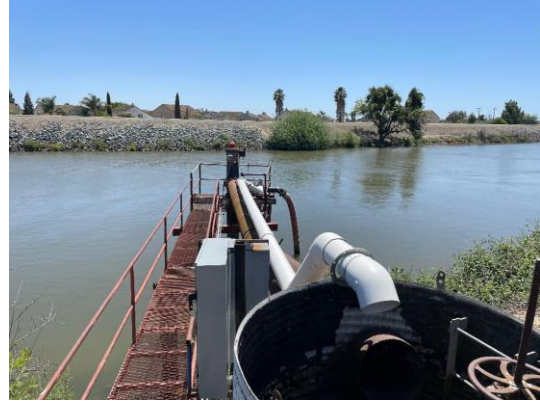
Photo 3 of 3 : UCIP_FA_2024_83755_122824.jpg

WS view: New PVC pipe discharges into the WS CMP riser on WS slope. New electrical box next to riser.

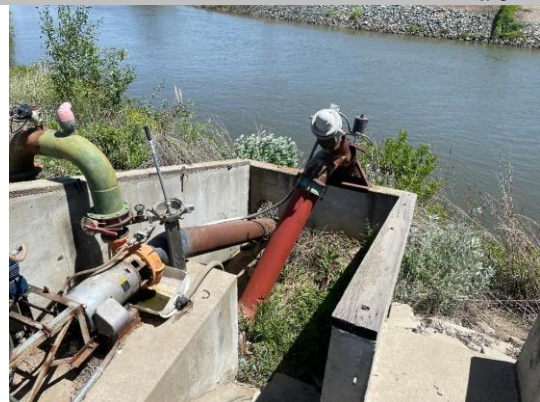
Photo 2 of 3 : UCIP_FA_2024_83717_122859.jpg

WS view: inside concrete foundation with pump and pipe visible going up and over the left and through the concrete towards the channel.

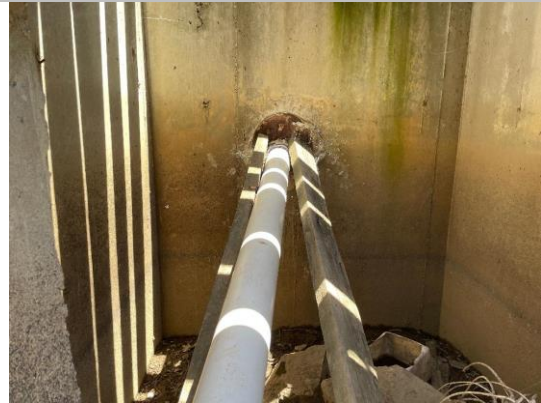
Photo 3 of 3 : UCIP_FA_2024_83720_122870.jpg

LS view: inside distribution box where 4.5-inch pipe has been sleeved through the 12-inch pipe opening.

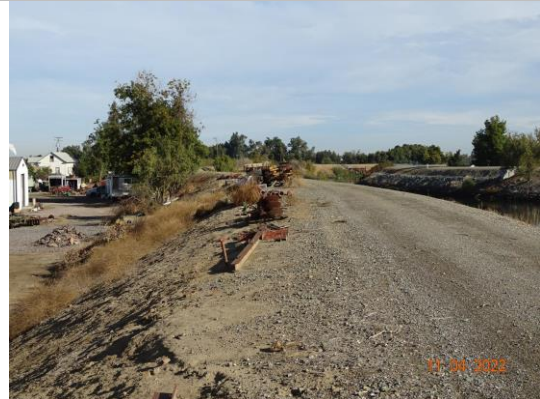
Photo 1 of 1 : FA_2024_RD0524_107_95_20240910_00018.jpg

LM Start	3.86	Rating **	M	Issue No.	95
LM End	3.97	Issue Type +	En	Location *	LS
Category	Earthen Levee			GPS Latitude/Longitude	
				Start	End
Item	Encroachments			37.901354 °	37.899764 °
				-121.326483 °	-121.326589 °
DWR ID	DWR_RD0524_01_f_2013_95				
Comment Code					
EQ : Equipment					
Inspector Comment					
Landowner is storing equipment on the landside shoulder and the landside toe.

View of farm equipment being stored along the landside shoulder. Fall 2022

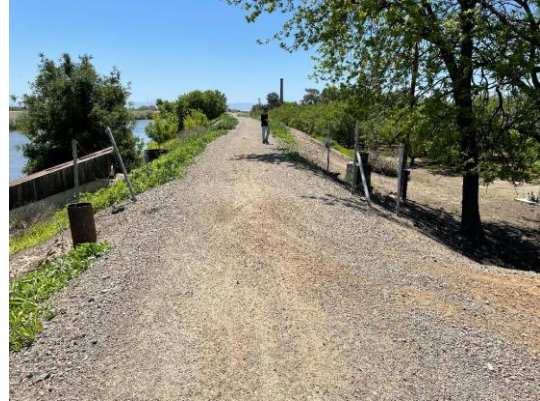
Photo 1 of 3 : UCIP_FA_2024_83727_122887.jpg

Overview of levee crown.

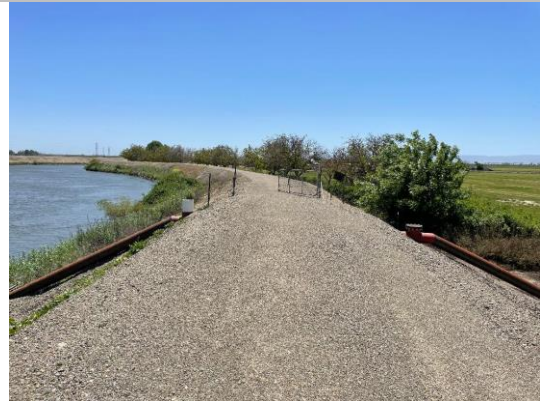
Photo 1 of 3 : UCIP_FA_2024_83760_122906.jpg

Comment Code						
Inspector Comment						
DS_ID:20626 FS_ID:83760 EP_NO: N/A Repair Type: Non-Urgent EVAL Issue: 10, Unauthorized Modification or Non-Compliant Permit Crossing Status: Found UCIP Comments: 04/29/2024 Record remains Non-Urgent. No permit has been identified authorizing pipe. Unable to find a permit for modification. Pipe at entrance and exiting the levee appears to be new. (J. Taylor - DWR UCIP 06/24/2020 Record remains Non-Urgent. Small leak has been repaired. No permit has been identified authorizing pipe. (D.Sanoski - DWR UCIP 08/23/2013 Small leak in pipe on LS slope and pipe slightly crushed on LS toe. (W.Wylie - DWR UCIP FIELD_STRUCT_DESC: 10-inch steel drainage pipe through the levee, 3 feet below the crown. Pump in drainage ditch off the landside (LS) toe. Siphon breaker on the waterside (WS) slope. [Additional Reference(s): DWR Levee Log, 2004 (HLM 4.42, listed as 8-inch pipe). USACE San Joaquin O&M Manual, Unit 7, April 1964, Revised 29 December 2016, (4.42), listed as 8-inch pipe]. FS Date: 4/29/2024 8:00:05 AM

Overview of levee crown with pipe visible going through the levee.

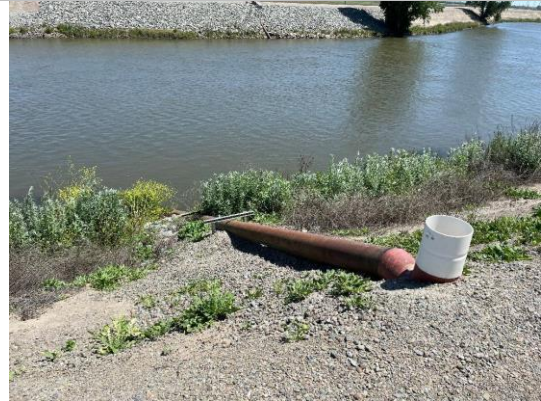
Photo 2 of 3 : UCIP_FA_2024_83760_122907.jpg

WS view: pipe on WS slope and entering channel. Siphon breaker on pipe near where pipe enters levee.

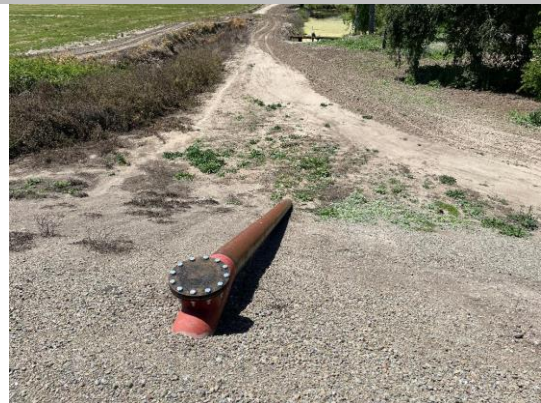
Photo 3 of 3 : UCIP_FA_2024_83760_122908.jpg

LS view: pipe on LS slope with new bolted cap. Pump visible off LS toe in irrigation ditch.

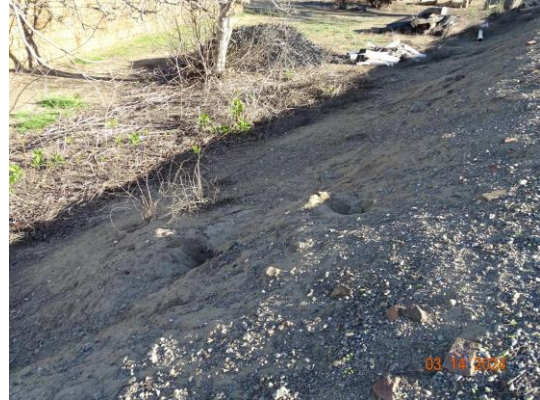
Photo 1 of 1 : FA_2024_RD0524_107_28_20240910_00009.jpg

LM Start	4.63	Rating **	U	Issue No.	28
LM End	4.63	Issue Type +	Ma	Location *	LS
Category	Earthen Levee			GPS Latitude/Longitude	
				Start	End
Item	Animal Control			37.891013 °	37.891013 °
				-121.328949 °	-121.328949 °
DWR ID	DWR_RD0524_01_s_2024_28				
Comment Code					
A3 : No rodents visible, but rodent burrows visible; need to backfill and compact or grout burrows.					
Inspector Comment

View of multiple burrow holes along the landside slope. Spring 2024

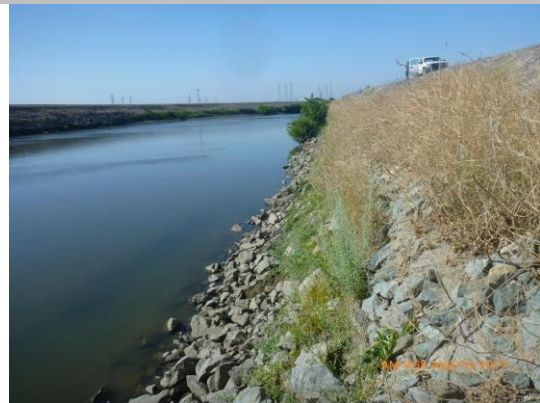
Photo 1 of 2 : LEVAL_FA_2024_523_4217.jpg

LM Start	4.76	Rating **	A/W	Issue No.	236
LM End	4.76	Issue Type +	Ma	Location *	WS
Category	Earthen Levee			GPS Latitude/Longitude	
				Start	End
Item	Erosion / Bank Caving			37.889300 °	37.889300 °
				-121.329800 °	-121.329800 °
DWR ID	DWR_RD0524_01_s_2020_236				
Comment Code					
E1 : Note and monitor erosion site.					
Inspector Comment					
This is a 2017 Strom Damage Site, ID No. 523, LMA-429.

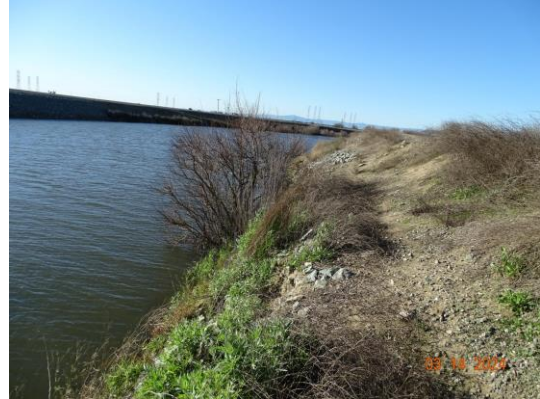
Photo 2 of 2 : FA_2024_RD0524_107_236_20240910_00030.jpg

View of bank erosion looking upstream. Spring 2024

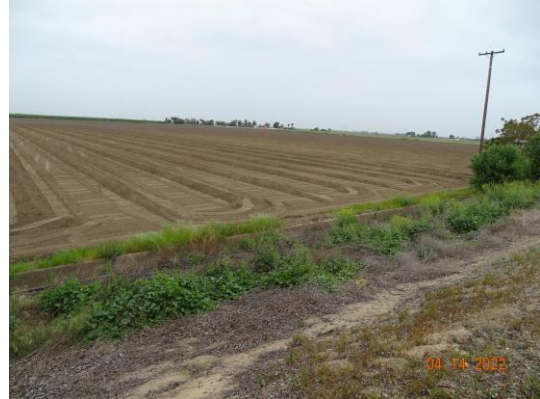
Photo 1 of 1 : FA_2024_RD0524_107_111_20240910_00021.jpg

LM Start	4.89	Rating **	M	Issue No.	111
LM End	5.19	Issue Type +	En	Location *	LS
Category	Earthen Levee			GPS Latitude/Longitude	
				Start	End
Item	Encroachments			37.887708 °	37.883594 °
				-121.331077 °	-121.332140 °
DWR ID	DWR_RD0524_01_s_2022_111				
Comment Code					
DT : Ditch					
Inspector Comment					
There is a concrete lined irrigation ditch within the landside easement.

View of concrete lined irrigation ditch along the landside easement.
Spring 2022

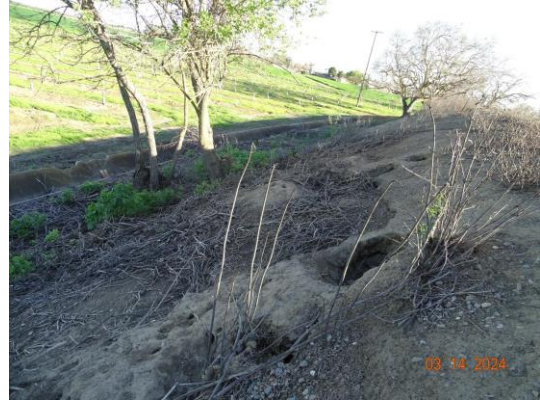
Photo 1 of 1 : FA_2024_RD0524_107_15_20240910_00007.jpg

LM Start	4.94	Rating **	U	Issue No.	15
LM End	4.96	Issue Type +	Ma	Location *	LS
Category	Earthen Levee			GPS Latitude/Longitude	
				Start	End
Item	Animal Control			37.887136°	37.886867°
				-121.331722°	-121.331893°
DWR ID	DWR_RD0524_01_s_2024_15				
Comment Code					
A3 : No rodents visible, but rodent burrows visible; need to backfill and compact or grout burrows.					
Inspector Comment

View of large animal burrow along the landside slope. Spring 2024

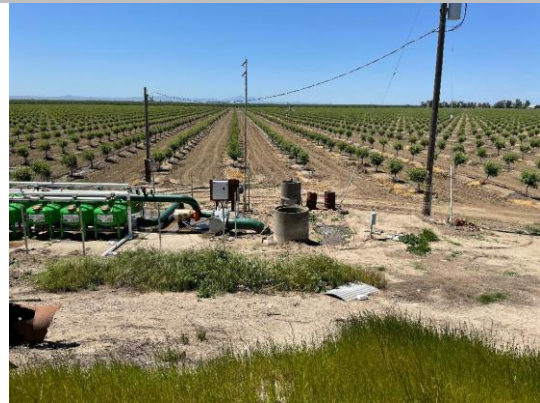
Photo 1 of 2 : UCIP_FA_2024_83779_122987.jpg

Comment Code					
Inspector Comment					
DS_ID:20629 FS_ID:83779 EP_NO: N/A Repair Type: Non-Urgent EVAL Issue: 11, Maintenance Compliance Issue Crossing Status: Found UCIP Comments: 04/29/2024 Record remains Non-Urgent. No permit has been identified authorizing pipe. Minor leak on LS coming from full concrete standpipe. May cause erosion over time. (J. Taylor - DWR UCIP) 06/24/2020 Record updated from No Action Needed to Non-Urgent. No permit has been identified authorizing pipe. (D.Sanoski - DWR UCIP) FIELD_STRUCT_DESC: 14-inch irrigation pipe of an unknown material through the levee, 15 feet below the crown. Pump house foundation on the waterside (WS) slope. 11-foot by 12-foot concrete sump on the WS shoulder. 4-foot diameter concrete standpipe on the landside (LS) toe. [Additional Reference(s): DWR Levee Log, 2004 (HLM 5.26). USACE San Joaquin O&M Manual, Unit 7, April 1964, Revised 29 December 2016, (5.26), listed as 14-inch pipe]. FS Date: 4/29/2024 9:54:44 AM

LS view: overview of LS slope and toe with standpipe and filtration system off LS toe.

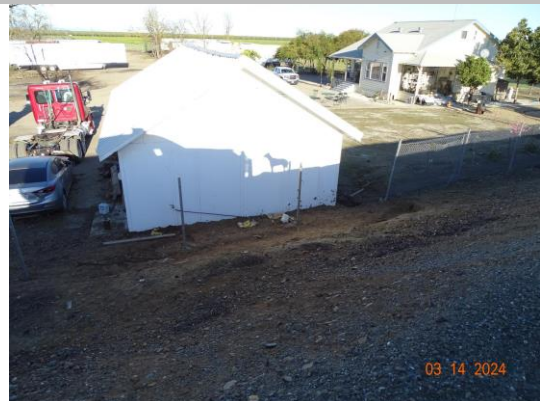
Photo 1 of 1 : FA_2024_RD0524_107_13_20240910_00006.jpg

LM Start	5.34	Rating **	M	Issue No.	13
LM End	5.37	Issue Type +	En	Location *	LS
Category	Earthen Levee			GPS Latitude/Longitude	
				Start	End
Item	Encroachments			37.881583°	37.881162°
				-121.332813°	-121.332840°
DWR ID	DWR_RD0524_01_s_2024_13				
Comment Code					
FE : Fence					
Inspector Comment					
Metal fence along the landside toe.

View of metal fence along the landside easement. Spring 2024

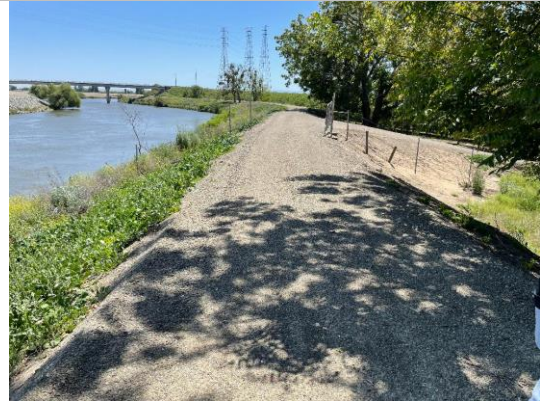
Photo 1 of 3 : UCIP_FA_2024_84030_122993.jpg

Comment Code						
Inspector Comment						
DS_ID:20659 FS_ID:84030 EP_NO: N/A Repair Type: Non-Urgent EVAL Issue: Crossing Status: Not Found UCIP Comments: 04/29/2024 Record remains Non-Urgent. Record is a duplicate of DSID 20630 or vice versa. Either way crossing has been abandoned and grouted in place or removed by KSN according to Aaron Kissingteller. Crossing not found during current inspection. (J. Taylor - DWR UCIP) 06/24/2020 Record updated from No Action Needed to Non-Urgent. Crossing appears to have been removed, but needs to be confirmed. Crossing not found. Limited inspection on LS due to overgrown vegetation. System Feature. (D.Sanoski - DWR UCIP) FIELD_STRUCT_DESC: 10-inch steel drainage pipe through the levee, 6 feet below the crown. Pump on the landside (LS). Flap gate on the waterside (WS) end. [Additional Reference(s): DWR Levee Log, 2004 (HLM 5.48). USACE San Joaquin O&M Manual, Unit 7, April 1964, Revised 29 December 2016, (5.48), listed as 10-inch pipe]. Drawing No. 07-04-1490, Sheet 1490/4, (Station 8+01.3)]. FS Date: 4/29/2024 10:51:21 AM

Overview of levee crown.

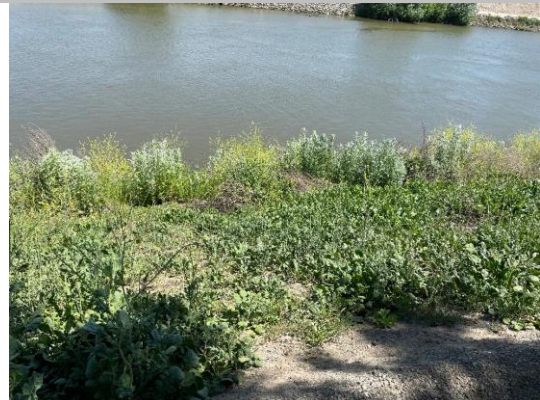
Photo 2 of 3 : UCIP_FA_2024_84030_122994.jpg

WS view: overview of WS slope and channel.

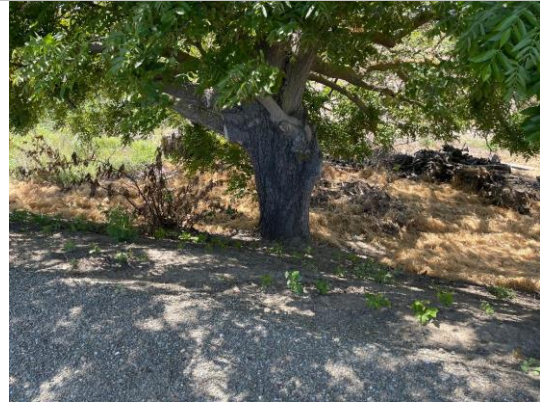
Photo 3 of 3 : UCIP_FA_2024_84030_122995.jpg

LS view: overview of LS slope and toe.

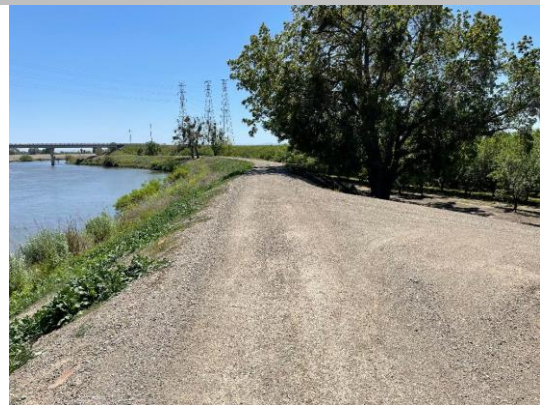
Photo 1 of 3 : UCIP_FA_2024_83784_122996.jpg

DS_ID:20631
FS_ID:83784
EP_NO: N/A
Repair Type: Non-Urgent
EVAL Issue:
Crossing Status: Found
UCIP Comments: 04/29/2024 Record updated from Non-Urgent to No Action Needed. Pipe found in working condition. System feature. (J. Taylor - DWR UCIP 06/25/2020 Record remains Non-Urgent. Limited inspection on LS due to overgrown vegetation. System Feature. (D.Sanoski - DWR UCIP 08/23/2013 Recent work being done on WS slope. Pipe may still be in use. (W.Wylie - DWR UCIP)
FIELD_STRUCT_DESC: 10-inch steel drainage pipe through the levee, 6 feet below the crown. 8-inch pipe sleeved through this pipe.
[Additional Reference(s): DWR Levee Log, 2004 (HLM 5.50). USACE San Joaquin O&M Manual, Unit 7, April 1964, Revised 29 December 2016, (5.50), listed as 10-inch pipe].
FS Date: 4/29/2024 11:11:23 AM

Overview of levee crown.

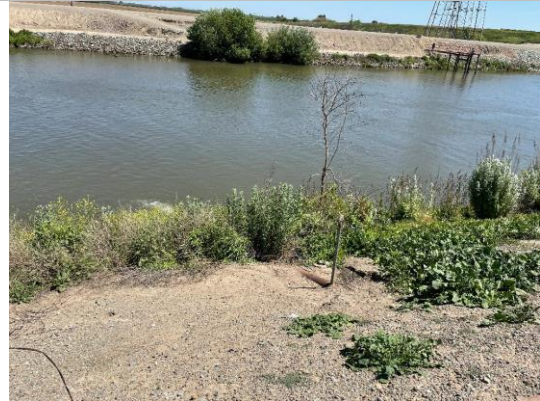
Photo 2 of 3 : UCIP_FA_2024_83784_122997.jpg

WS view: overview of WS slope and channel. Pipe visible on WS shoulder with siphon breaker. Pipe actively discharging into channel.

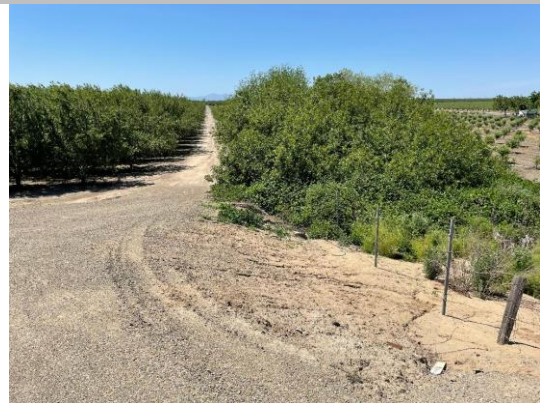
Photo 3 of 3 : UCIP_FA_2024_83784_122998.jpg

LS view: overview of LS slope and toe.

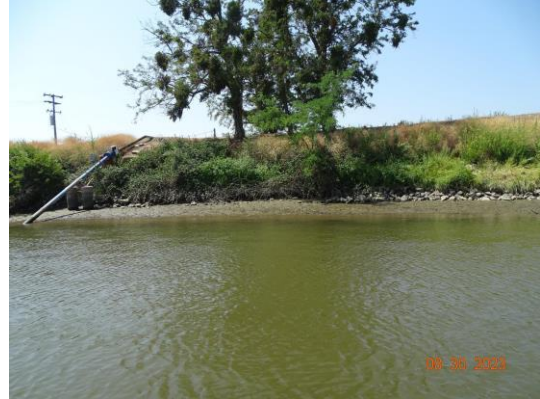
Photo 2 of 2 : SJR2024_RD0524U01RM46.06_7.JPG

LM Start	5.53	Rating **	M	Issue No.	2
LM End	5.54	Issue Type +	Ma	Location *	WS
Category	Supplemental			GPS Latitude/Longitude	
				Start	End
Item	DWR Erosion Survey			37.878798 °	37.878798 °
				-121.333111 °	-121.333111 °
DWR ID	RD0524U01RM46.06				
Comment Code					
Inspector Comment					
Site ID: RD0524U01RM46.06					
8/9/2024: From 2021 to present, no significant changes were observed during the annual survey.					
08/20/2021: During the erosion survey, the erosion length was increased to 75 feet.					
09/24/2020: From 2014 to present, no significant changes were observed during the annual survey. Vegetation is limiting the view but undercutting of the levee toe is still visible.					
08/13/2013: Larger trees are at the levee shoulder, and an irrigation pump station is next to the erosion site.

8/31/2023: View of the erosion immediately downstream of an irrigation pipe.

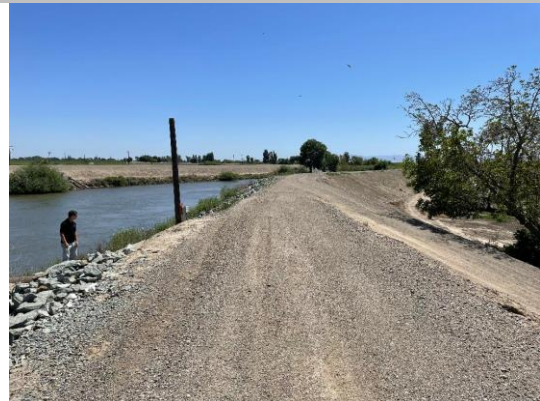
Photo 1 of 3 : UCIP_FA_2024_83790_123008.jpg

DS_ID:20633
FS_ID:83790
EP_NO: N/A
Repair Type: Non-Urgent
EVAL Issue: 6, Levee Damage or Threat for Levee Damage
Crossing Status: Found
UCIP Comments: 04/29/2024 Record remains Non-Urgent. No permit has been identified authorizing pipe. Some minor erosion on WS shoulder indicates small leak in pipe. Couple possibly be burrow activity as well. (J. Taylor - DWR UCIP) 06/25/2020 Record updated from No Action Needed to Non-Urgent. No permit has been identified authorizing pipe. (D.Sanoski - DWR UCIP)
FIELD_STRUCT_DESC: 21-inch steel irrigation pipe through the levee, 7 feet below the crown. Pump on pile structure in stream on the waterside (WS) toe. Timber walkway to the pump. Service pole on the WS shoulder. 5-foot concrete standpipe on the landside (LS) toe.
[Additional Reference(s): DWR Levee Log, 2004 (HLM 5.71, listed as 20-inch pipe). USACE San Joaquin O&M Manual, Unit 7, April 1964, Revised 29 December 2016, (5.71), listed as 20-inch pipe].

Overview of levee crown.

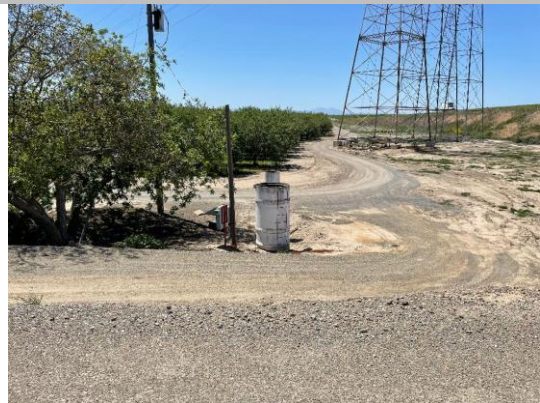
Photo 3 of 3 : UCIP_FA_2024_83790_123010.jpg

LS view: overview of LS slope and toe. Concrete standpipes off LS toe.

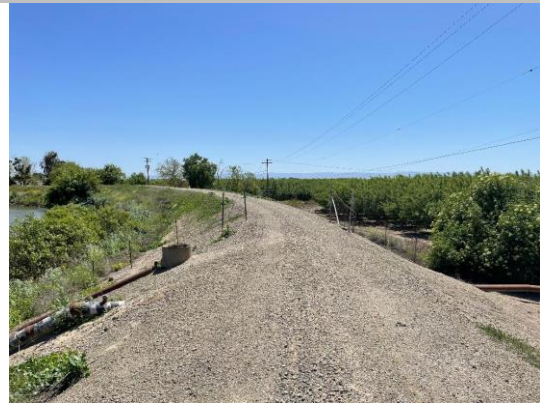
Photo 1 of 3 : UCIP_FA_2024_84032_123046.jpg

Comment Code					
Inspector Comment					
DS_ID:20650 FS_ID:84032 EP_NO: N/A Repair Type: Urgent EVAL Issue: 1, Pipe Integrity Crossing Status: Found UCIP Comments: 04/29/2024 Record updated from Non-Urgent to Urgent. Hole in pipe on WS slope. (J. Taylor - DWR UCIP) Record updated from No Action Needed to Non-Urgent. No permit has been identified authorizing pipe. (D.Sanoski - DWR UCIP) FIELD_STRUCT_DESC: 12-inch steel storm drainage pipe through the levee, 5 feet below the crown. Pump on the landside (LS) toe. Siphon breaker on the waterside (WS) shoulder. Power pole at the LS toe. [Additional Reference(s): DWR Levee Log, 2004 (HLM 5.88)]. FS Date: 4/29/2024 2:28:12 PM

Overview of levee crown.

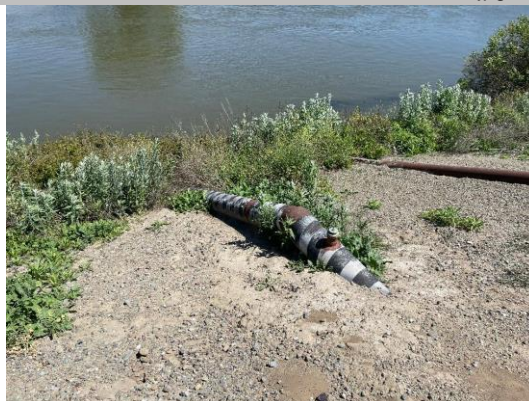
Photo 2 of 3 : UCIP_FA_2024_84032_123047.jpg

WS view: overview of WS slope and channel. Pipe visible on slope and shoulder with siphon breaker.

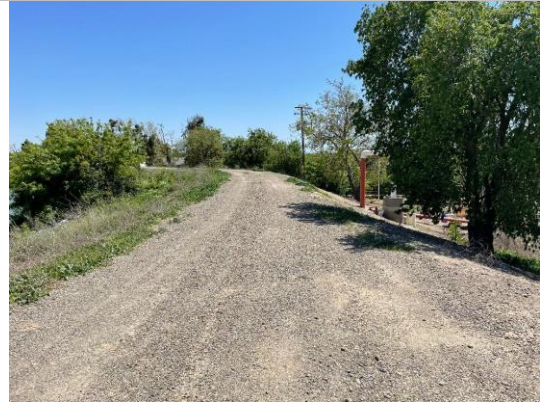
Photo 1 of 3 : UCIP_FA_2024_83813_123056.jpg

Comment Code						
Inspector Comment						
DS_ID:20637 FS_ID:83813 EP_NO: N/A Repair Type: Non-Urgent EVAL Issue: Crossing Status: Not Found UCIP Comments: 04/29/2024 Record remains Non-Urgent. Geophysical results did not confirm presence of pipe through levee. Record will remain in UCIP's inspection records until future Levee Improvement Project can confirm no crossing was found through the levee. (J. Taylor - DWR UCIP) 06/25/2020 Record updated from No Action Needed to Non-Urgent. Geophysical results did not confirm presence of pipe through levee. Record will remain in UCIP's inspection records until future Levee Improvement Project can confirm no crossing was found through the levee. System Feature. (D.Sanoski - DWR UCIP) FIELD_STRUCT_DESC: 12-inch drainage pipe of an unknown material through the levee, 8 feet below the crown. Concrete box structure on the waterside (WS) slope. [Additional Reference(s): DWR Levee Log, 2004 (HLM 5.91). USACE San Joaquin O&M Manual, Unit 7, April 1964, Revised 29 December 2016, (5.91), listed as 12-inch pipe, abandoned]. FS Date: 4/29/2024 2:46:18 PM

Overview of levee crown.

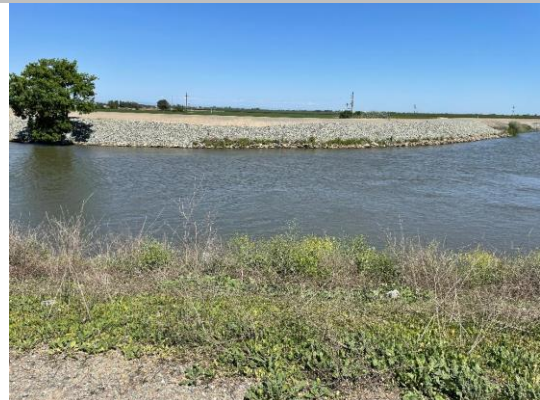
Photo 2 of 3 : UCIP_FA_2024_83813_123057.jpg

WS view: overview of WS slope and channel.

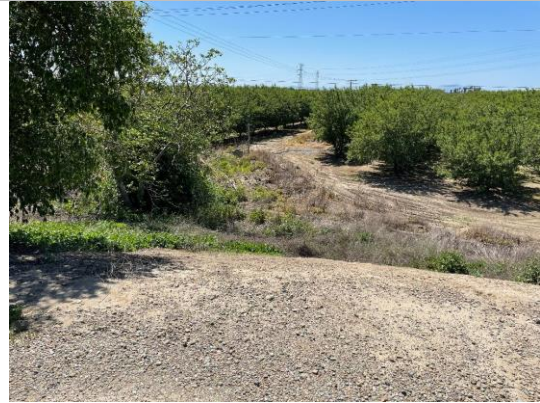
Photo 3 of 3 : UCIP_FA_2024_83813_123058.jpg

LS view: overview of LS slope and toe.

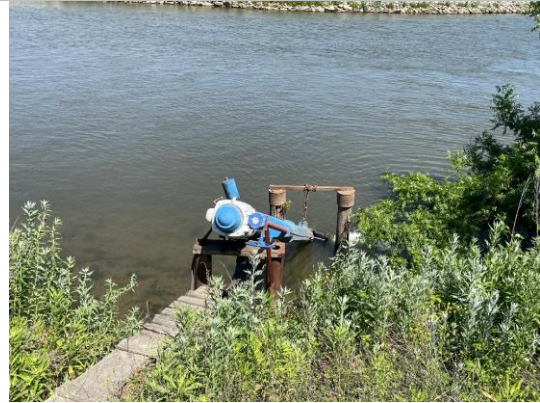
Photo 2 of 3 : UCIP_FA_2024_83816_123064.jpg

DS_ID:20639
FS_ID:83816
EP_NO: N/A
Repair Type: Non-Urgent
EVAL Issue:
Crossing Status: Indicator Found
UCIP Comments: 04/29/2024 Record remains Non-Urgent. Grouted pipe found in concrete riser beneath 12-inch pipe DSID 20638. Distribution box on WS may have been repurposed for DSID 20638. Unable to locate a permit and confirm proper pipe abandonment. (J. Taylor - DWR UCIP 06/25/2020 Record updated from No Action Needed to Non-Urgent. Crossing not found. Geophysical results did not confirm presence of pipe through levee. Record will remain in UCIP's inspection records until future Levee Improvement Project can confirm no crossing was found through the levee. System Feature. (D.Sanoski - DWR UCIP)
FIELD_STRUCT_DESC: 21-inch by 21-inch reinforced concrete box drainage culvert through the levee, 20 feet below the crown. Brick distribution box at the toe of the waterside (WS) slope. Concrete distribution box at the toe of the landside (LS) slope. [Additional Reference(s): DWR Levee Log, 2004. USACE San Joaquin O&M Manual 7, April 1964, (HLM 5.94)].

WS view: overview of WS slope and channel.

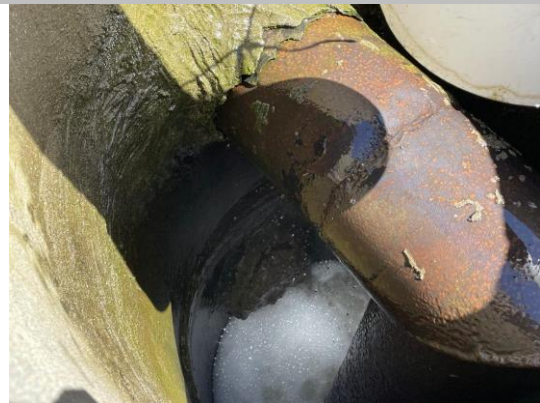
Photo 3 of 3 : UCIP_FA_2024_83816_123065.jpg

LS view: inside concrete riser on LS toe. Grouted pipe under visible pipe.
