**Flood Control Project Maintenance
Levee Inspections**

Maintenance Issue Types Only, Levee Inspection Report By Mile - Fall 2014

Reclamation District No. 0524 Middle Roberts Island

Waterway	Bank	Unit Miles	Inspection Start/End	Inspector
Unit No. 01 San Joaquin River	Left	6.20	10/20/2014 10/20/2014	Richard Willoughby

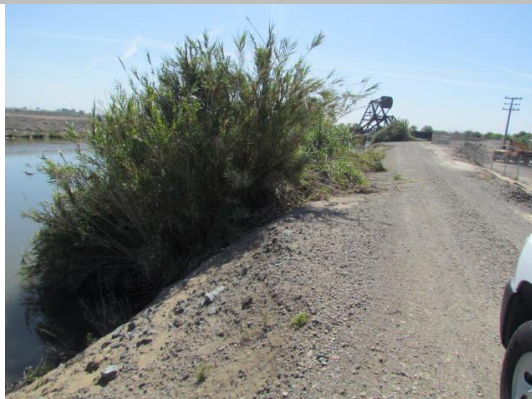
Photo 1 of 3 : FA_2014_RD0524_107_11_20141020_00014.jpg

LM Start	0.63	Rating **	M	Issue No.	11 (cont)
LM End	0.63	Issue Type +	Ma	Location *	WS

Looking southeast at bamboo on waterside slope. (Spring 2012)

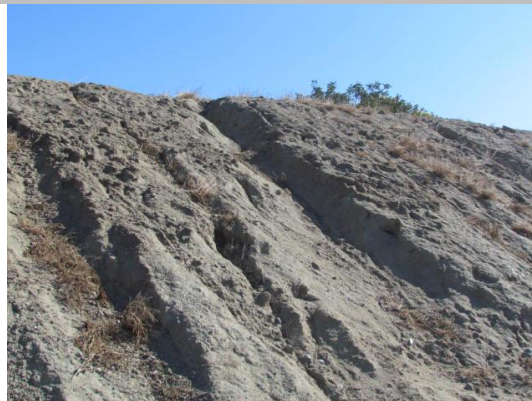
Photo 3 of 5 : FA_2014_RD0524_107_2_20141020_00004.jpg

LM Start	0.82	Rating **	U	Issue No.	2 (cont)	
LM End	0.82	Issue Type +	Ma	Location *	LS	
Category	Earthen Levee			GPS Latitude/Longitude		
				Start		End
Item	Erosion / Bank Caving			37.936093 °	37.936004 °	
				-121.334648 °	-121.334615 °	
DWR ID	DWR_RD0524_01_f_2013_2					
Action/Comments						
Schedule repair of erosion site prior to the next inspection. Inspector Comments: Several holes and finger erosions on landward slope.

Looking southeast at finger erosion on landward slope.

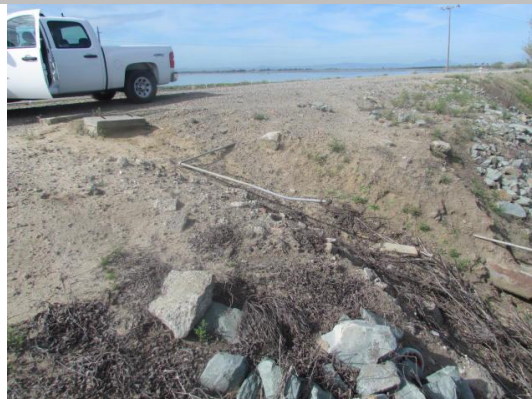
Photo 1 of 1 : FA_2014_RD0524_107_122_20141020_00113.jpg

LM Start	0.92	Rating **	M	Issue No.	122
LM End	0.92	Issue Type +	Ma	Location *	WS
Category	Earthen Levee			GPS Latitude/Longitude	
				Start	End
Item	Encroachments			37.935267 °	37.935267 °
				-121.332985 °	-121.332985 °
DWR ID	DWR_RD0524_01_s_2013_122				
Action/Comments					
Pipe					
Inspector Comments: Inch and half metal pipe should be removed.

Looking northwest at inch and half metal pipe on waterward slope.

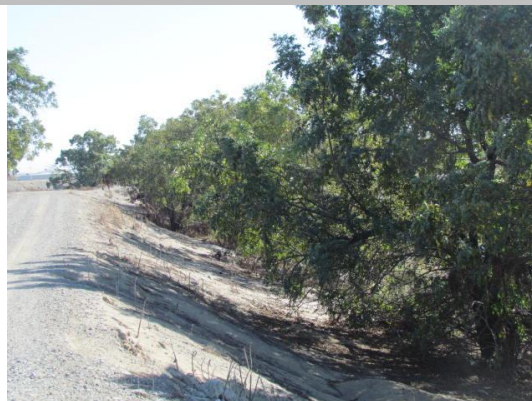
Photo 1 of 1 : FA_2014_RD0524_107_77_20141020_00079.jpg

Looking south at low hanging tree branches at landside toe.

LM Start	0.94	Rating **	M	Issue No.	77
LM End	1.02	Issue Type +	Ma	Location *	LS
Category	Earthen Levee			GPS Latitude/Longitude	
				Start	End
Item	Trim / Thin Trees			37.935259 °	37.935049 °
				-121.332864 °	-121.331334 °
DWR ID	DWR_RD0524_01_s_2012_77				
Action/Comments					
Trim trees to at least five feet above ground level.

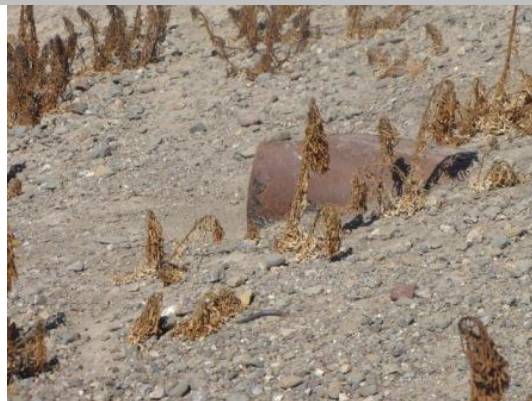
Photo 1 of 2 : FA_2014_RD0524_107_33_20141020_00041.jpg

LM Start	1.31	Rating **	M	Issue No.	33
LM End	1.31	Issue Type +	Ma	Location *	WS
Category	Earthen Levee			GPS Latitude/Longitude	
				Start	End
Item	Encroachments			37.931948 °	37.931948 °
				-121.328387 °	-121.328387 °
DWR ID	DWR_RD0524_01_s_2012_33				
Action/Comments					
Pipe Inspector Comments: Pipe is not in use and should be properly abandoned.

Looking west at pipe on landside slope.

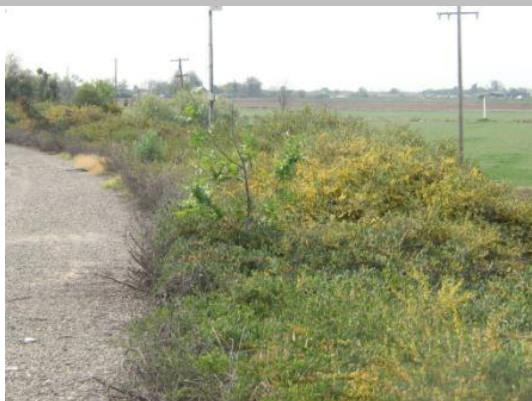
Photo 1 of 5 : FA_2014_RD0524_107_23_20141020_00035.jpg

Overgrown landscaping on landward slope from LM 1.56 to 1.74

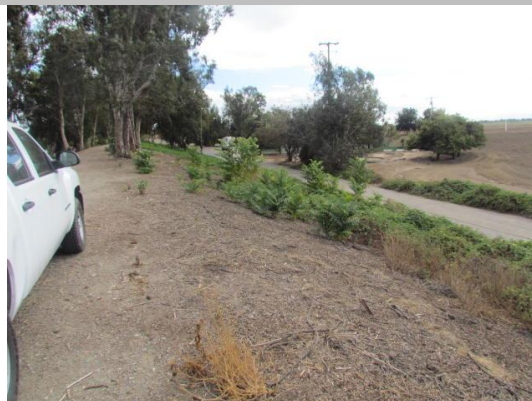
Photo 1 of 2 : FA_2014_RD0524_107_24_20141023_00199.jpg

Looking south at vegetation blocking view of landward toe.

LM Start	1.62	Rating **	M	Issue No.	24
LM End	1.63	Issue Type +	Ma	Location *	LS
Category	Earthen Levee			GPS Latitude/Longitude	
				Start	End
Item	Vegetation			37.927635 °	37.927540 °
				-121.327812 °	-121.327648 °
DWR ID	DWR_RD0524_01_s_2012_24				
Action/Comments					
Remove the wild growth other than native grasses from the levee slopes.					
Inspector Comments: Vegetation blocking landward toe.

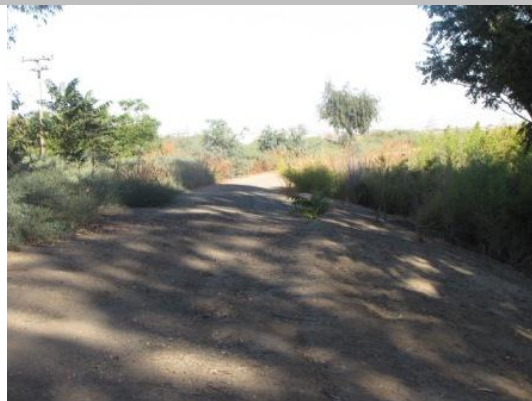
Photo 2 of 2 : FA_2014_RD0524_107_24_20141020_00036.jpg

Looking north at dense vegetation on the landside and waterside slopes.

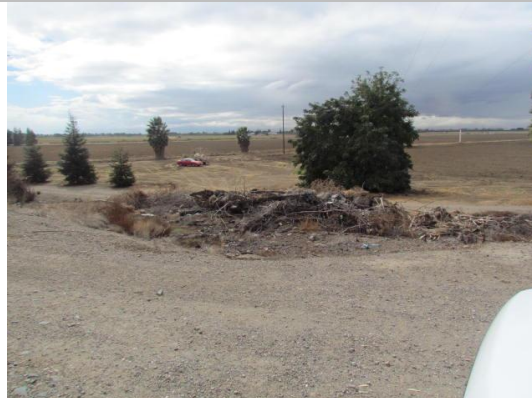
Photo 1 of 2 : FA_2014_RD0524_107_28_20141023_00200.jpg

LM Start	1.75	Rating **	M	Issue No.	28
LM End	1.75	Issue Type +	Ma	Location *	LS
Category	Earthen Levee			GPS Latitude/Longitude	
				Start	End
Item	Encroachments			37.926322 °	37.926322 °
				-121.326115 °	-121.326115 °
DWR ID	DWR_RD0524_01_s_2012_28				
Action/Comments					
Garbage Inspector Comments: Large pruning piles on landside slope.

Looking southwest at trash and a pruning pile on landward berm.

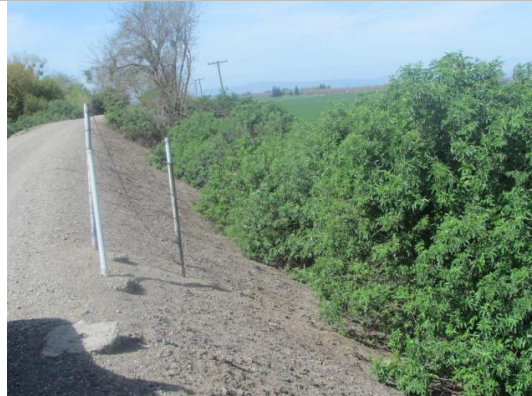
Photo 1 of 1 : FA_2014_RD0524_107_35_20141020_00044.jpg

LM Start	2.44	Rating **	U	Issue No.	35
LM End	2.48	Issue Type +	Ma	Location *	LS
Category	Earthen Levee			GPS Latitude/Longitude	
				Start	End
Item	Vegetation			37.918498 °	37.918515 °
				-121.321078 °	-121.321110 °
DWR ID	DWR_RD0524_01_s_2012_35				
Action/Comments					
Elderberries are blocking visibility and flood fight capability.

Looking southwest at dense vegetation on landward toe.

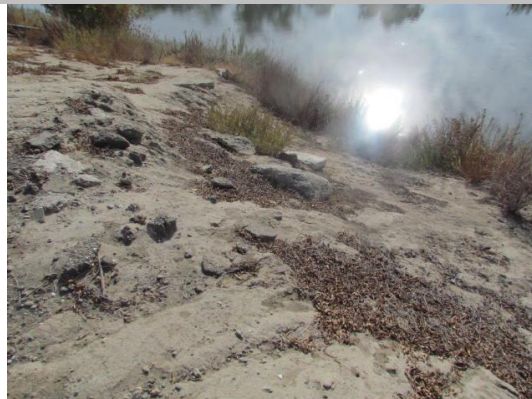
Photo 1 of 1 : FA_2014_RD0524_107_36_20141020_00045.jpg

Looking east at erosion on waterside slope.

LM Start	2.46	Rating **	M	Issue No.	36
LM End	2.50	Issue Type +	Ma	Location *	WS
Category	Earthen Levee			GPS Latitude/Longitude	
				Start	End
Item	Erosion / Bank Caving			37.918628 °	37.918438 °
				-121.320817 °	-121.321452 °
DWR ID	DWR_RD0524_01_s_2012_36				
Action/Comments					
Note and monitor erosion site.

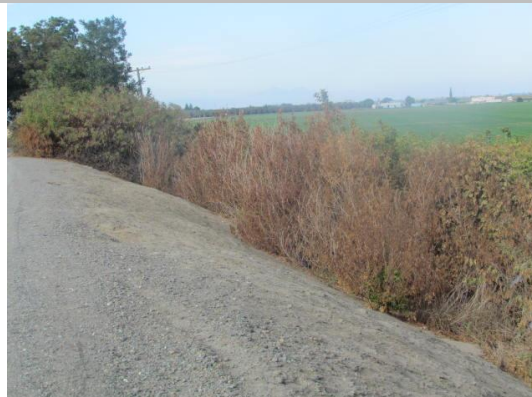
Photo 1 of 2 : FA_2014_RD0524_107_80_20141020_00082.jpg

Looking southwest at dense vegetation and trees on landside slope.
(Fall 2012)

LM Start	2.48	Rating **	M	Issue No.	80
LM End	2.48	Issue Type +	Ma	Location *	LS
Category	Earthen Levee			GPS Latitude/Longitude	
				Start	End
Item	Trim / Thin Trees			37.918480 °	37.918480 °
				-121.321114 °	-121.321114 °
DWR ID	DWR_RD0524_01_s_2012_80				
Action/Comments					
Trim trees to at least five feet above ground level.

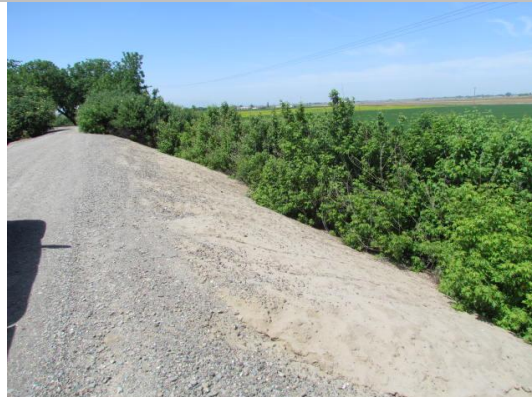
Photo 2 of 2 : FA_2014_RD0524_107_80_20141020_00083.jpg

Looking southwest at dense vegetation on landside toe.

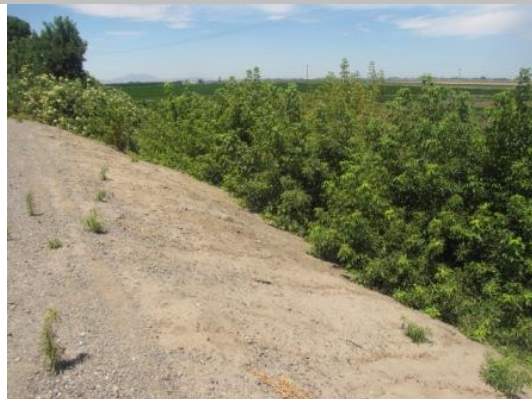
Photo 4 of 4 : FA_2014_RD0524_107_37_20141020_00049.jpg

LM Start	2.52	Rating **	U	Issue No.	37 (cont)	
LM End	2.52	Issue Type +	Ma	Location *	LS	
Category	Earthen Levee			GPS Latitude/Longitude		
				Start		End
Item	Vegetation			37.918345 °		37.918302 °
				-121.321765 °		-121.321923 °
DWR ID	DWR_RD0524_01_s_2012_37					
Action/Comments						
Elderberries are blocking visibility and flood fight capability.

Looking southwest at trees along levee landside toe.

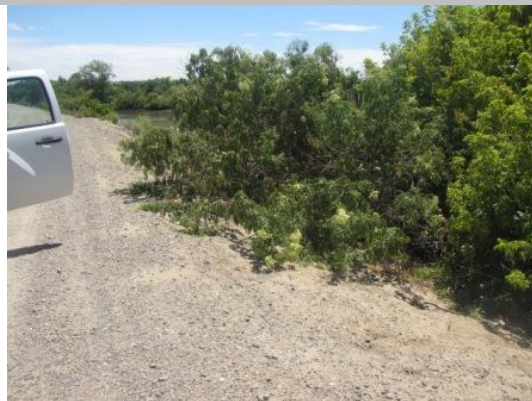
Photo 1 of 2 : FA_2014_RD0524_107_38_20141020_00050.jpg

LM Start	2.53	Rating **	U	Issue No.	38
LM End	2.53	Issue Type +	Ma	Location *	WS
Category	Earthen Levee			GPS Latitude/Longitude	
				Start	End
Item	Vegetation			37.918287 °	37.918287 °
				-121.321980 °	-121.321980 °
DWR ID	DWR_RD0524_01_s_2012_38				
Action/Comments					
Elderberries are blocking visibility and flood fight capability.

Looking north at elderberry on waterside slope.

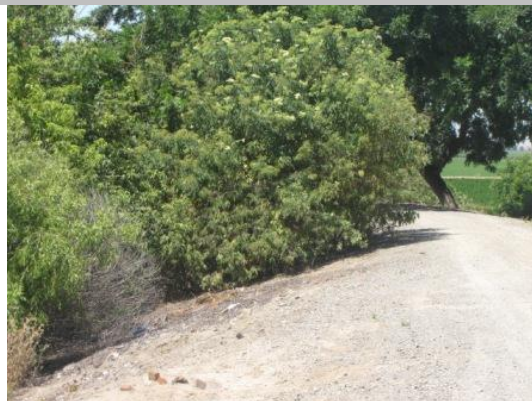
Photo 2 of 2 : FA_2014_RD0524_107_38_20141020_00051.jpg

Looking south at elderberry on waterside slope.

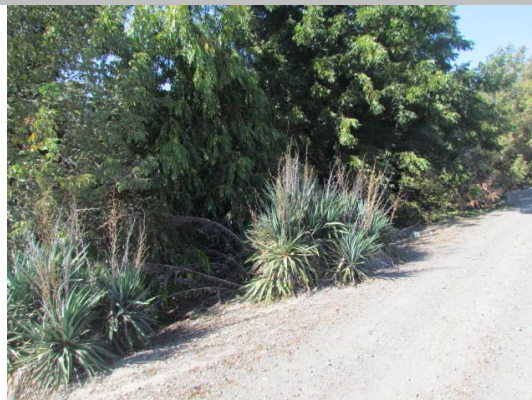
Photo 1 of 1 : FA_2014_RD0524_107_54_20141020_00065.jpg

Looking northwest at dense vegetation on landside slope.

LM Start	3.43	Rating **	U	Issue No.	54
LM End	3.49	Issue Type +	Ma	Location *	LS
Category	Earthen Levee			GPS Latitude/Longitude	
				Start	End
Item	Trim / Thin Trees			37.906747 °	37.906192 °
				-121.325248 °	-121.324543 °
DWR ID	DWR_RD0524_01_s_2012_54				
Action/Comments					
Trim and thin trees to allow visibility of the ground and room to flood fight.

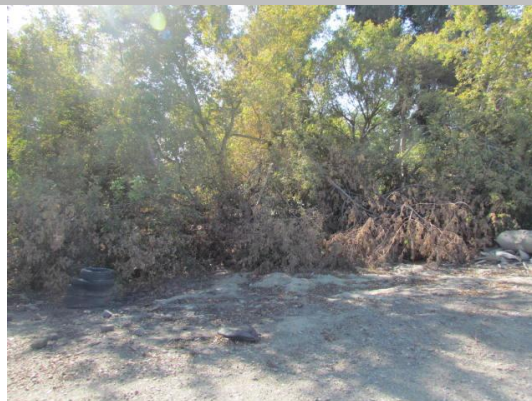
Photo 1 of 1 : FA_2014_RD0524_107_93_20141020_00088.jpg

Looking northwest at low hanging tree branches on landside slope and toe.

LM Start	3.47	Rating **	U	Issue No.	93
LM End	3.47	Issue Type +	Ma	Location *	LS
Category	Earthen Levee			GPS Latitude/Longitude	
				Start	End
Item	Trim / Thin Trees			37.906265 °	37.906265 °
				-121.324643 °	-121.324643 °
DWR ID	DWR_RD0524_01_s_2012_93				
Action/Comments					
Trim and thin trees to allow visibility of the ground and room to flood fight.

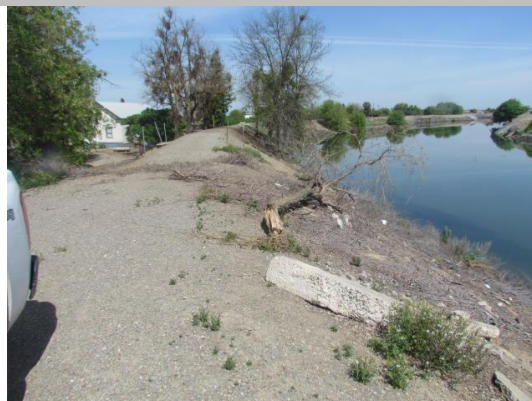
Photo 1 of 1 : FA_2014_RD0524_107_187_20141020_00140.jpg

LM Start	3.89	Rating **	M	Issue No.	187
LM End	3.89	Issue Type +	Ma	Location *	WS
Category	Earthen Levee			GPS Latitude/Longitude	
				Start	End
Item	Encroachments			37.901447 °	37.901447 °
				-121.326500 °	-121.326500 °
DWR ID	DWR_RD0524_01_s _ 2014_187				
Action/Comments					
Tree or limb					
Inspector Comments: Tree limb on waterward shoulder.

Looking northeast at tree limb on waterward slope.

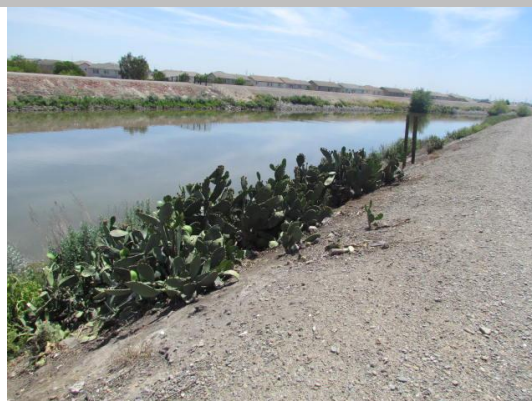
Photo 1 of 1 : FA_2014_RD0524_107_94_20141020_00089.jpg

Looking southeast at cactus on waterside slope.

LM Start	3.92	Rating **	M	Issue No.	94
LM End	3.92	Issue Type +	Ma	Location *	WS
Category	Earthen Levee			GPS Latitude/Longitude	
				Start	End
Item	Vegetation			37.900952 °	37.900952 °
				-121.326443 °	-121.326443 °
DWR ID	DWR_RD0524_01_s _ 2012_94				
Action/Comments					
Remove the wild growth other than native grasses from the levee slopes.					
Inspector Comments: Remove cactus

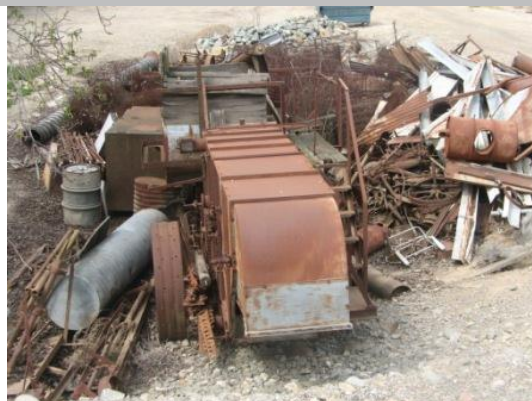
Photo 1 of 1 : FA_2014_RD0524_107_66_20141020_00073.jpg

LM Start	4.64	Rating **	M	Issue No.	66
LM End	4.64	Issue Type +	Ma	Location *	LS
Category	Earthen Levee			GPS Latitude/Longitude	
				Start	End
Item	Encroachments			37.891365 °	37.891365 °
				-121.328633 °	-121.328633 °
DWR ID	DWR_RD0524_01_s_2012_66				
Action/Comments					
Garbage

Garbage at landward toe next to ramp at LM 4.64

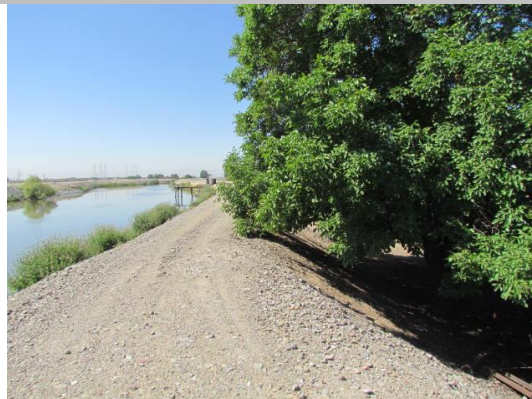
Photo 1 of 1 : FA_2014_RD0524_107_63_20141020_00072.jpg

Looking south at dense trees on landside slope.

LM Start	4.65	Rating **	M	Issue No.	63
LM End	4.65	Issue Type +	Ma	Location *	LS
Category	Earthen Levee			GPS Latitude/Longitude	
				Start	End
Item	Trim / Thin Trees			37.891285 °	37.891285 °
				-121.328728 °	-121.328728 °
DWR ID	DWR_RD0524_01_s_2012_63				
Action/Comments					
Trim trees to at least five feet above ground level.

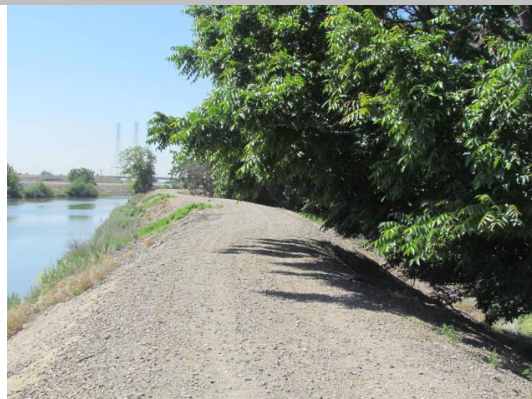
Photo 1 of 1 : FA_2014_RD0524_107_68_20141020_00074.jpg

Looking south at overhanging trees.

LM Start	5.11	Rating **	U	Issue No.	68
LM End	5.11	Issue Type +	Ma	Location *	LS
Category	Earthen Levee			GPS Latitude/Longitude	
				Start	End
Item	Trim / Thin Trees			37.885400 °	37.885400 °
				-121.332153 °	-121.332153 °
DWR ID	DWR_RD0524_01_s_2012_68				
Action/Comments					
Trim trees over roadway to at least 12 feet above ground level.

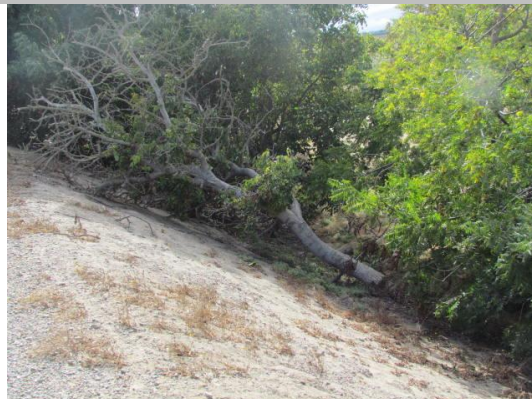
Photo 1 of 1 : FA_2014_RD0524_107_178_20141023_00212.jpg

LM Start	5.44	Rating **	M	Issue No.	178
LM End	5.44	Issue Type +	Ma	Location *	N/A
Category	Earthen Levee			GPS Latitude/Longitude	
				Start	End
Item	Encroachments			37.880806 °	37.880806 °
				-121.332833 °	-121.332833 °
DWR ID	DWR_RD0524_01_f_2014_178				
Action/Comments					
Tree or limb					
Inspector Comments: Downed tree on landward toe.

Looking south at downed tree on landward slope.

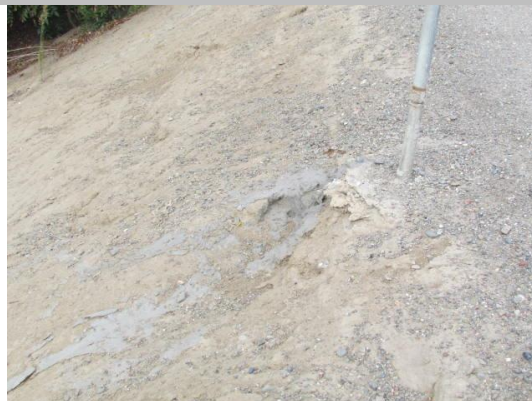
Photo 1 of 2 : FA_2014_RD0524_107_931_20141023_00213.jpg

LM Start	5.46	Rating **	A/W	Issue No.	931
LM End	5.46	Issue Type +	Ma	Location *	LS
Category	Earthen Levee			GPS Latitude/Longitude	
				Start	End
Item	Animal Control			37.880575 °	37.880575 °
				-121.332890 °	-121.332890 °
DWR ID	DWR_RD0524_01_s_2012_931				
Action/Comments					
Exterminate rodents and backfill and compact or grout burrows. Inspector Comments: LMA grouted rodent holes.

Looking north at typical view of grouted rodent holes on landward shoulder and slope.

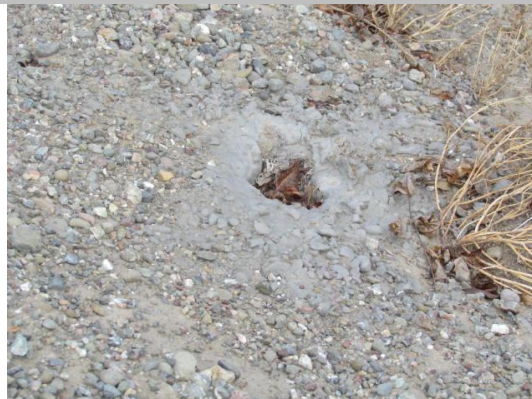
Photo 2 of 2 : FA_2014_RD0524_107_931_20141023_00214.jpg

Looking north at typical view of grouted rodent holes on waterward slope.

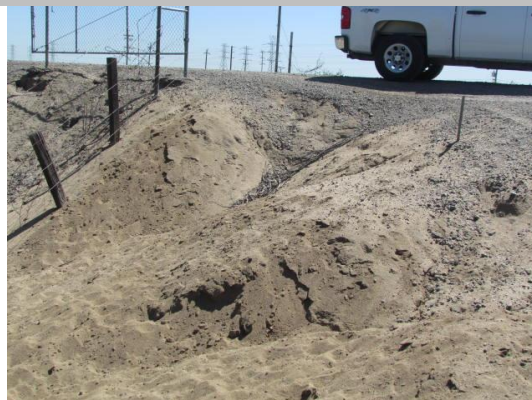
Photo 3 of 3 : FA_2014_RD0524_107_118_20141020_00110.jpg

LM Start	5.47	Rating **	M	Issue No.	118 (cont)
LM End	5.47	Issue Type +	Ma	Location *	LS

Looking east at slope caving on landside slope.

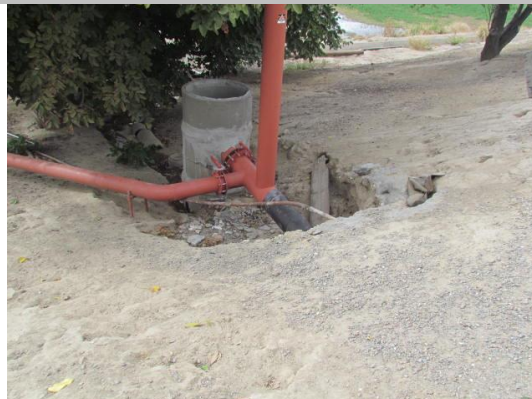
Photo 2 of 3 : FA_2014_RD0524_107_74_20141023_00216.jpg

LM Start	5.92	Rating **	M	Issue No.	74 (cont)
LM End	5.92	Issue Type +	Ma	Location *	WS
Category	Earthen Levee			GPS Latitude/Longitude	
				Start	End
Item	Erosion / Bank Caving			37.874240 °	37.874165 °
				-121.333185 °	-121.333155 °
DWR ID	DWR_RD0524_01_s_2012_74				
Action/Comments					
Note and monitor erosion site.					
Inspector Comments: Erosion on landward slope around intake pipe.

Looking west at erosion around intake pipe on landward slope.

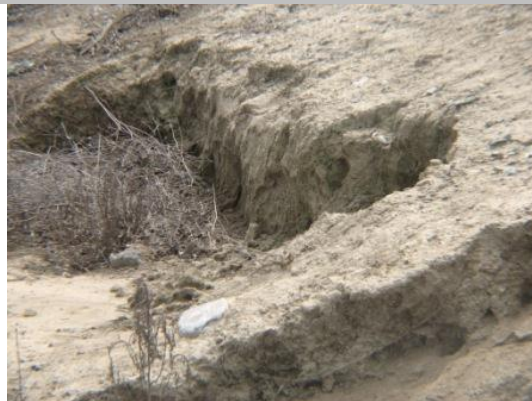
Photo 3 of 3 : FA_2014_RD0524_107_74_20141020_00076.jpg

LM Start	5.92	Rating **	M	Issue No.	74 (cont)
LM End	5.92	Issue Type +	Ma	Location *	WS

Erosion at waterward toe and around irrigation pipe at LM 5.92

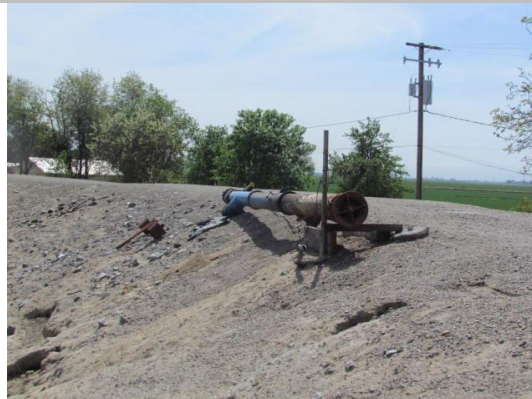
Photo 1 of 1 : FA_2014_RD0524_107_190_20141020_00141.jpg

LM Start	5.92	Rating **	A/W	Issue No.	190
LM End	5.92	Issue Type +	Ma	Location *	WS
Category	Earthen Levee			GPS Latitude/Longitude	
				Start	End
Item	Encroachments			37.874197 °	37.874197 °
				-121.333208 °	-121.333208 °
DWR ID	DWR_RD0524_01_s_2014_190				
Action/Comments					
Pipe Inspector Comments: Landowner is replacing pump and left old pipe on waterward shoulder.

Looking southeast at old pump shaft on waterward shoulder.

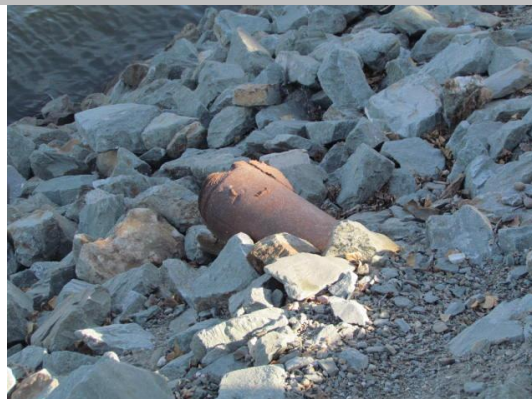
Photo 1 of 1 : FA_2014_RD0524_107_268_20141020_00150.jpg

LM Start	6.21	Rating **	M	Issue No.	268
LM End	6.21	Issue Type +	Ma	Location *	WS
Category	Earthen Levee			GPS Latitude/Longitude	
				Start	End
Item	Encroachments			37.871137 °	37.871137 °
				-121.330138 °	-121.330138 °
DWR ID	DWR_RD0524_01_s_2012_268				
Action/Comments					
Pipe Inspector Comments: Open abandoned 10" pipe on waterside slope below flood elevation. Pipe should be removed or properly abandoned.

Looking southeast at abandoned pipe on waterside slope.
