**Flood Control Project Maintenance
Levee Inspections**

Maintenance Issue Types Only, Levee Inspection Report By Mile - Fall 2015

Reclamation District No. 0524 Middle Roberts Island

Waterway	Bank	Unit Miles	Inspection Start/End	Inspector
Unit No. 01 San Joaquin River	Left	6.20	10/21/2015 10/21/2015	Richard Willoughby

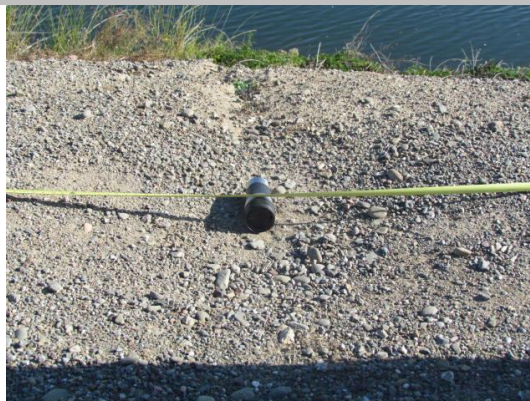
Photo 2 of 3 : FA_2015_RD0524_107_3_20150914_00007.jpg

LM Start	0.21	Rating **	M	Issue No.	3 (cont)
LM End	0.21	Issue Type +	Ma	Location *	CR
Category	Earthen Levee			GPS Latitude/Longitude	
				Start	End
Item	Crown Surface / Depressions / Rutting			37.938890 °	37.938890 °
				-121.343657 °	-121.343657 °
DWR ID	DWR_RD0524_01_s _ 2012_3				
Action/Comments					
Repair depressions or ruts in the crown or slope.					
Inspector Comments: No change in status.

Looking west at depression on levee crown near waterward shoulder.

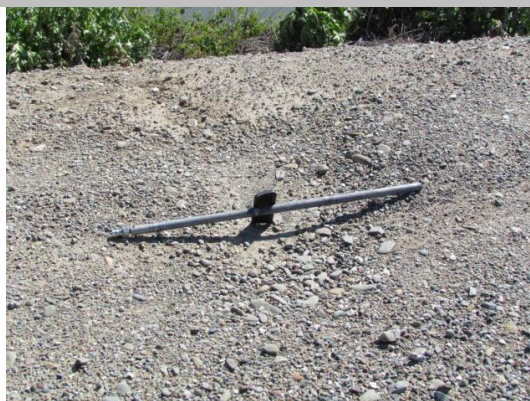
Photo 3 of 3 : FA_2015_RD0524_107_3_20150914_00008.jpg

Looking east at 3" depression on levee crown. (Spring 2012)

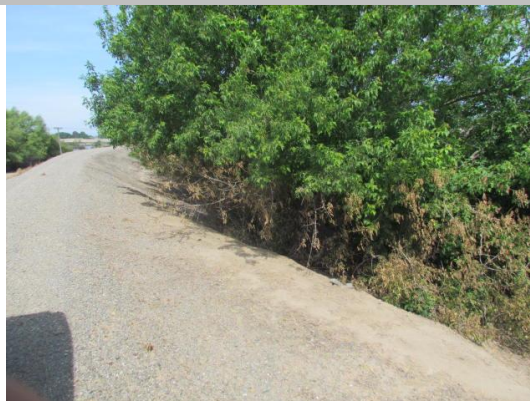
Photo 1 of 2 : FA_2015_RD0524_107_179_20150914_00169.jpg

LM Start	0.27	Rating **	U	Issue No.	179
LM End	0.27	Issue Type +	Ma	Location *	WS
Category	Earthen Levee			GPS Latitude/Longitude	
				Start	End
Item	Trim / Thin Trees			37.938438 °	37.938438 °
				-121.342883 °	-121.342883 °
DWR ID	DWR_RD0524_01_s _ 2014_179				
Action/Comments					
Thin trees to allow visibility of the ground and room to flood fight.

Looking north at untrimmed tree on waterward slope. (Spring 2015)

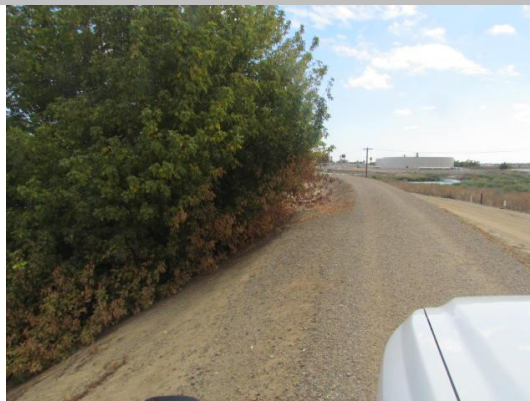
Photo 2 of 2 : FA_2015_RD0524_107_179_20150914_00170.jpg

LM Start	0.27	Rating **	U	Issue No.	179 (cont)
LM End	0.27	Issue Type +	Ma	Location *	WS
Category	Earthen Levee			GPS Latitude/Longitude	
				Start	End
Item	Trim / Thin Trees			37.938438 °	37.938438 °
				-121.342883 °	-121.342883 °
DWR ID	DWR_RD0524_01_s_2014_179				
Action/Comments					
Thin trees to allow visibility of the ground and room to flood fight.

Looking south at untrimmed tree on waterward slope. (Fall 2014)

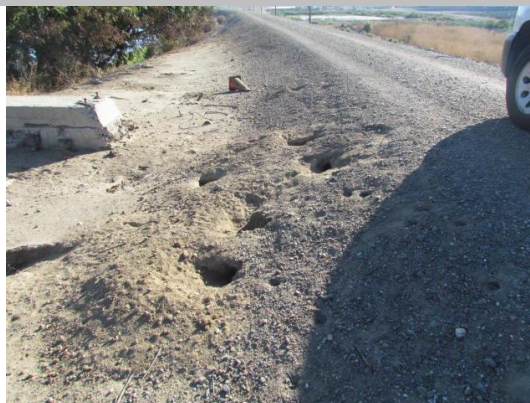
Photo 1 of 3 : FA_2015_RD0524_107_174_20151023_00240.jpg

LM Start	0.30	Rating **	U	Issue No.	174
LM End	0.30	Issue Type +	Ma	Location *	WS
Category	Earthen Levee			GPS Latitude/Longitude	
				Start	End
Item	Animal Control			37.938382 °	37.938382 °
				-121.342352 °	-121.342352 °
DWR ID	DWR_RD0524_01_f_2014_174				
Action/Comments					
No rodents visible, but rodent burrows visible; need to backfill and compact or grout burrows.					
Inspector Comments: Several rodent holes present at this site.

Looking southeast at several rodent holes on waterward slope Fall 2015.

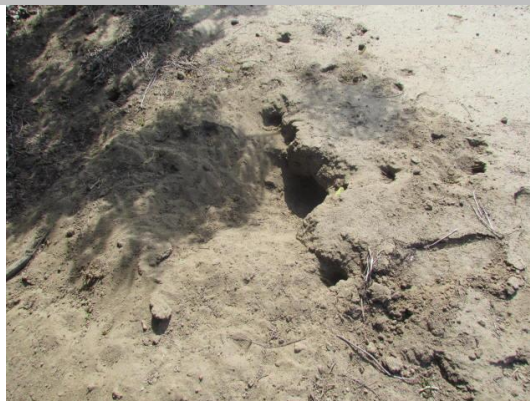
Photo 2 of 3 : FA_2015_RD0524_107_174_20150914_00164.jpg

Looking west at several rodent holes on waterward shoulder. (Spring 2015)

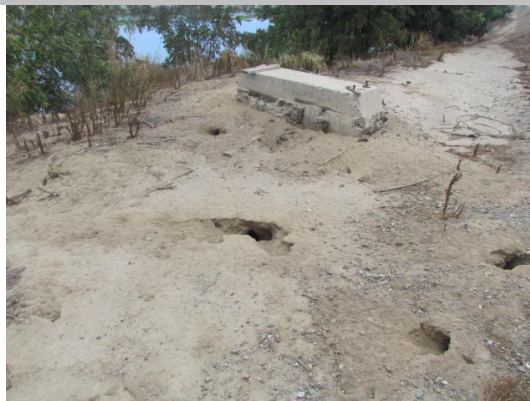
Photo 3 of 3 : FA_2015_RD0524_107_174_20150914_00165.jpg

LM Start	0.30	Rating **	U	Issue No.	174 (cont)	
LM End	0.30	Issue Type +	Ma	Location *	WS	
Category	Earthen Levee			GPS Latitude/Longitude		
				Start		End
Item	Animal Control			37.938382 °	37.938382 °	
				-121.342352 °	-121.342352 °	
DWR ID	DWR_RD0524_01_f_2014_174					
Action/Comments						
No rodents visible, but rodent burrows visible; need to backfill and compact or grout burrows.						
Inspector Comments: Several rodent holes present at this site.

Looking southeast at several rodent holes on waterward slope.

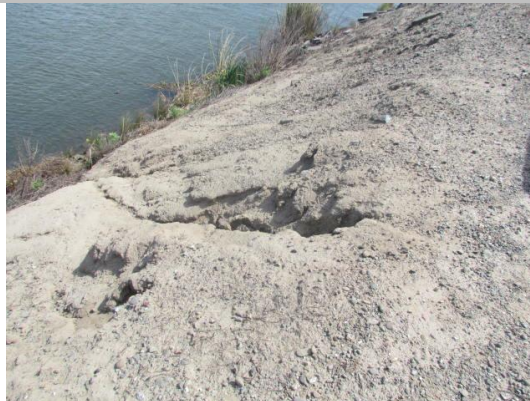
Photo 2 of 2 : FA_2015_RD0524_107_170_20150914_00159.jpg

LM Start	0.41	Rating **	M	Issue No.	170 (cont)
LM End	0.45	Issue Type +	Ma	Location *	WS
Category	Earthen Levee			GPS Latitude/Longitude	
				Start	End
Item	Slope Stability			37.938628 °	37.938688 °
				-121.340385 °	-121.339627 °
DWR ID	DWR_RD0524_01_s_2015_170				
Action/Comments					
Repair slope instability.					
Inspector Comments: Several slope instabilites within this reach.

Looking west at waterward slope erosion.

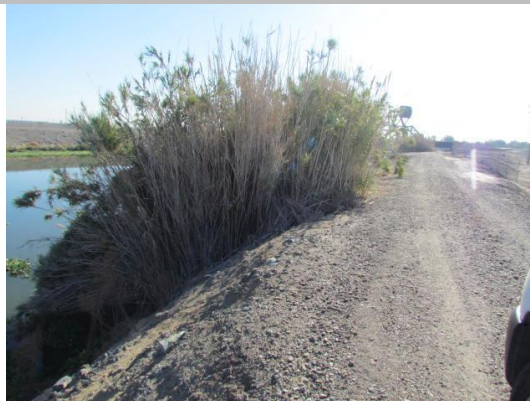
Photo 1 of 4 : FA_2015_RD0524_107_11_20151023_00241.jpg

LM Start	0.62	Rating **	U	Issue No.	11
LM End	0.63	Issue Type +	Ma	Location *	WS
Category	Earthen Levee			GPS Latitude/Longitude	
				Start	End
Item	Vegetation			37.938278 °	37.938247 °
				-121.336524 °	-121.336503 °
DWR ID	DWR_RD0524_01_s_2012_11				
Action/Comments					
Remove the wild growth other than native grasses from the levee slopes.					
Inspector Comments: Bamboo on waterward slope.

Looking south at bamboo on waterside slope. (Fall 2015)

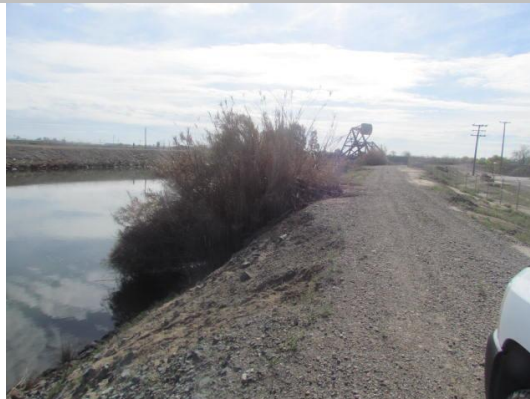
Photo 2 of 4 : FA_2015_RD0524_107_11_20150914_00014.jpg

Looking south at dying bamboo on waterward slope. (Spring 2013)

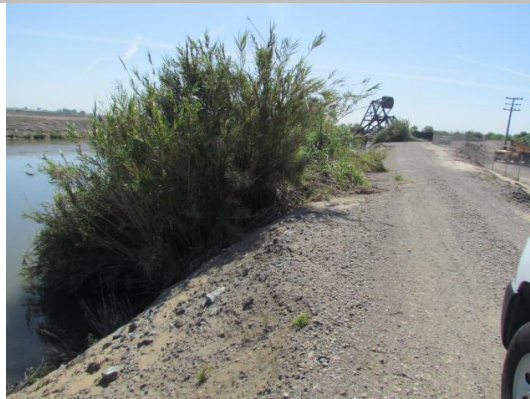
Photo 3 of 4 : FA_2015_RD0524_107_11_20150914_00013.jpg

Looking southeast at bamboo on waterside slope. (Spring 2012)

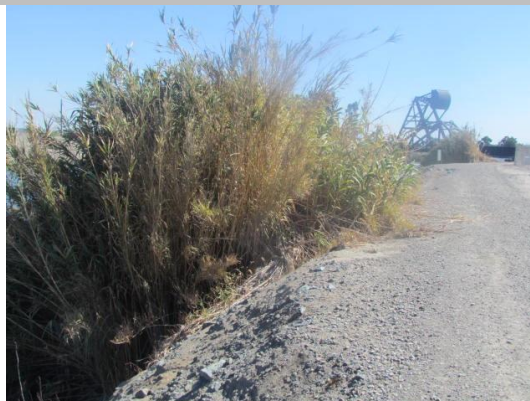
Photo 4 of 4 : FA_2015_RD0524_107_11_20150914_00015.jpg

Looking south at bamboo on waterside slope. (Fall Inspection 2012)

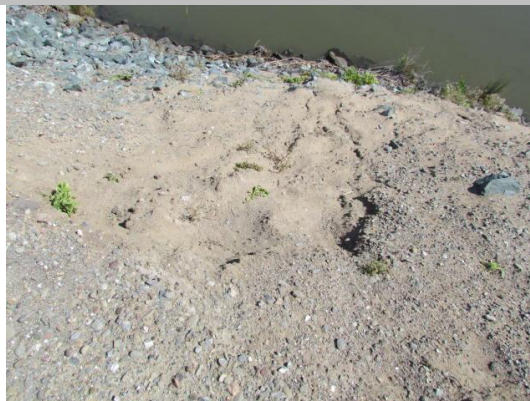
Photo 1 of 1 : FA_2015_RD0524_107_10_20150914_00012.jpg

LM Start	0.63	Rating **	U	Issue No.	10
LM End	0.63	Issue Type +	Ma	Location *	WS
Category	Earthen Levee			GPS Latitude/Longitude	
				Start	End
Item	Slope Stability			37.938247 °	37.938247 °
				-121.336503 °	-121.336503 °
DWR ID	DWR_RD0524_01_f _ 2015_10				
Action/Comments					
Repair the levee slope damaged by foot traffic and prevent access where possible.

Looking east at waterside erosion appears to be caused by runoff.

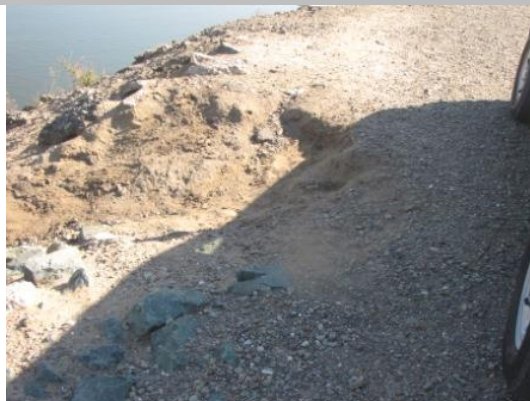
Photo 4 of 4 : FA_2015_RD0524_107_13_20150914_00019.jpg

LM Start	0.64	Rating **	M	Issue No.	13 (cont)	
LM End	0.65	Issue Type +	Ma	Location *	WS	
Category	Earthen Levee			GPS Latitude/Longitude		
				Start		End
Item	Slope Stability			37.938105 °		37.938023 °
				-121.336288 °		-121.336173 °
DWR ID	DWR_RD0524_01_s_2012_13					
Action/Comments						
Repair slope instability. Inspector Comments: Depression extend from shoulder to mid levee slope two site with this section.

Update view of the erosion site.

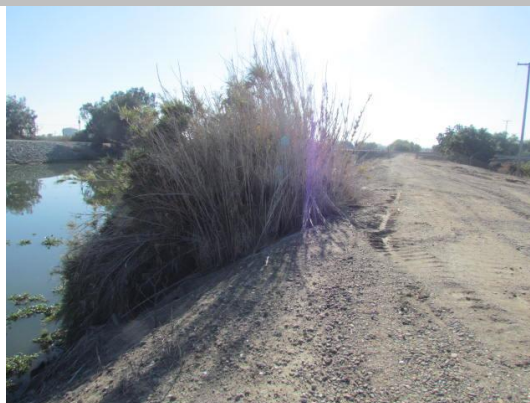
Photo 1 of 3 : FA_2015_RD0524_107_14_20151023_00244.jpg

LM Start	0.67	Rating **	U	Issue No.	14
LM End	0.67	Issue Type +	Ma	Location *	WS
Category	Earthen Levee			GPS Latitude/Longitude	
				Start	End
Item	Vegetation			37.937808 °	37.937808 °
				-121.335913 °	-121.335913 °
DWR ID	DWR_RD0524_01_s_2012_14				
Action/Comments					
Remove the wild growth other than native grasses from the levee slopes.					
Inspector Comments: Bamboo on waterward slope.

Looking south at dying bamboo on waterward slope. Fall 2015

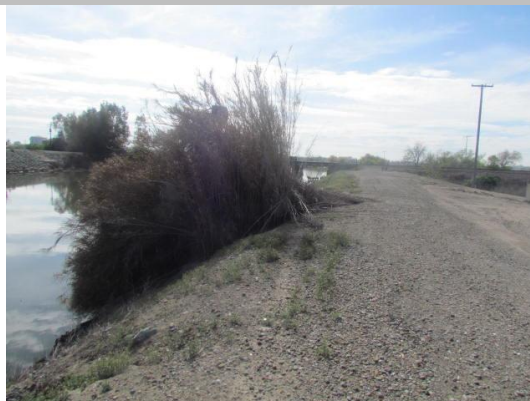
Photo 2 of 3 : FA_2015_RD0524_107_14_20150914_00021.jpg

Looking south at dying bamboo on waterward slope. (Spring 2013)

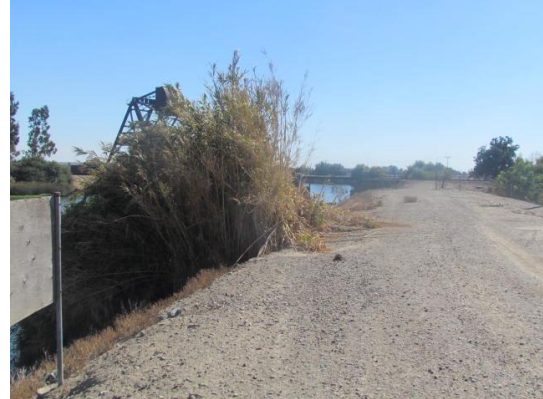
Photo 3 of 3 : FA_2015_RD0524_107_14_20150914_00022.jpg

LM Start	0.67	Rating **	U	Issue No.	14 (cont)
LM End	0.67	Issue Type +	Ma	Location *	WS
Category	Earthen Levee			GPS Latitude/Longitude	
				Start	End
Item	Vegetation			37.937808 °	37.937808 °
				-121.335913 °	-121.335913 °
DWR ID	DWR_RD0524_01_s_2012_14				
Action/Comments					
Remove the wild growth other than native grasses from the levee slopes.					
Inspector Comments: Bamboo on waterward slope.

Looking south at bamboo on waterside slope. (Fall 2012)

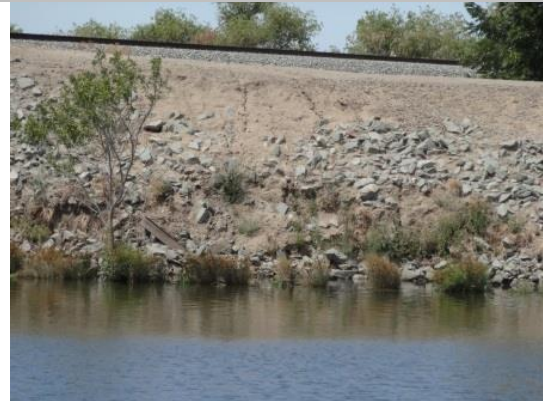
Photo 1 of 2 : SJR2015_RD0524U01RM41.36_4.JPG

LM Start	0.71	Rating **	M	Issue No.	132
LM End	0.73	Issue Type +	Ma	Location *	WS
Category	Supplemental			GPS Latitude/Longitude	
				Start	End
Item	DWR Erosion Survey			37.937222 °	37.937222 °
				-121.335277 °	-121.335277 °
DWR ID					
Action/Comments					
Inspector Comments: 06/24/2015: The ersoion site is immediatley downstream of the RR bridge. [2015 Site ID:RD0524U01RM41.36]

Close view of the erosion.

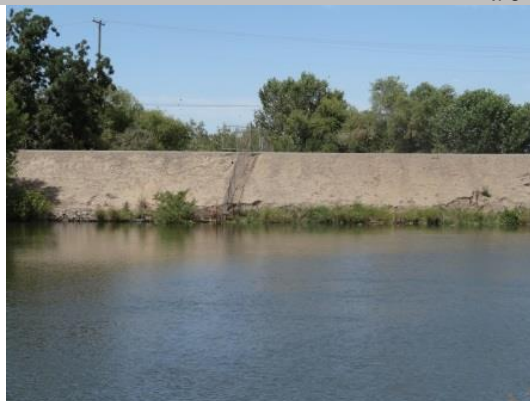
Photo 1 of 2 : SJR2015_RD0524U01RM41.39_1.jpg

LM Start	0.76	Rating **	U	Issue No.	133
LM End	0.77	Issue Type +	Ma	Location *	WS
Category	Supplemental			GPS Latitude/Longitude	
				Start	End
Item	DWR Erosion Survey			37.936821 °	37.936821 °
				-121.334582 °	-121.334582 °
DWR ID					
Action/Comments					
Inspector Comments: 06/24/2015: No significant change observed. 06/19/2014: No significant change observed. 08/13/2013: No significant change at this site. 08/07/2012: The site has been visited by boat survey. No significant change observed. 08/23/2011: The site is located immediately upstream of a Railroad

Front view of the erosion site.

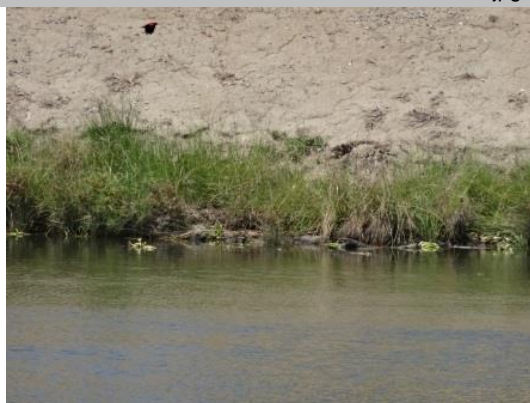
Photo 2 of 2 : SJR2015_RD0524U01RM41.39_4.jpg

Front view of the erosion site. Vegetation is visible.

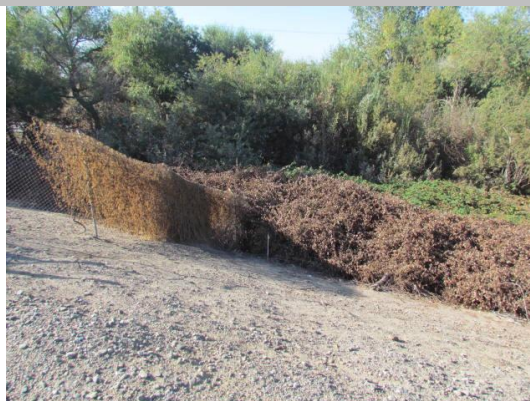
Photo 1 of 3 : FA_2015_RD0524_107_262_20151023_00245.jpg

LM Start	0.77	Rating **	U	Issue No.	262
LM End	0.77	Issue Type +	Ma	Location *	LS
Category	Earthen Levee			GPS Latitude/Longitude	
				Start	End
Item	Vegetation			37.936555 °	37.936555 °
				-121.334847 °	-121.334847 °
DWR ID	DWR_RD0524_01_s_2012_262				
Action/Comments					
Remove the wild growth other than native grasses from the levee slopes.					
Inspector Comments: Dense vegetation at landside toe along fence line.

Looking west at dense vegetation at landward slope and toe fall 2015.

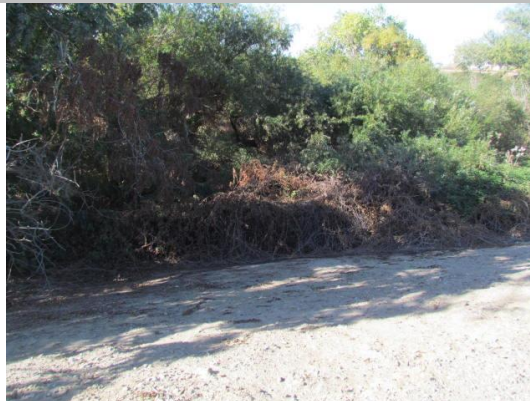
Photo 2 of 3 : FA_2015_RD0524_107_262_20150914_00188.jpg

Looking west at dense vegetation on landside toe. Spring 2014

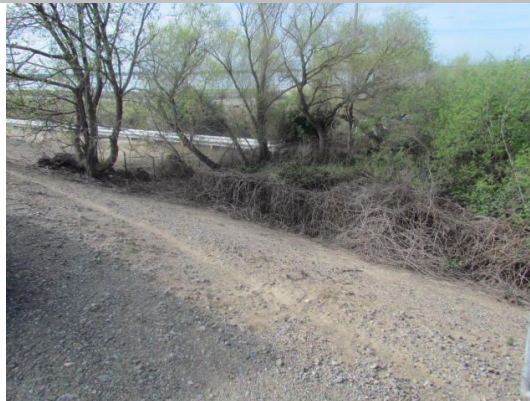
Photo 3 of 3 : FA_2015_RD0524_107_262_20150914_00187.jpg

Looking southwest at vegetation on landward slope and toe. (Spring 2013)

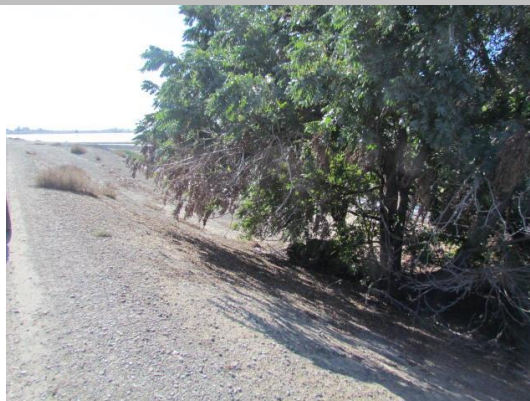
Photo 1 of 1 : FA_2015_RD0524_107_76_20150914_00099.jpg

LM Start	0.78	Rating **	U	Issue No.	76
LM End	0.78	Issue Type +	Ma	Location *	LS
Category	Earthen Levee			GPS Latitude/Longitude	
				Start	End
Item	Trim / Thin Trees			37.936444 °	37.936444 °
				-121.334797 °	-121.334797 °
DWR ID	DWR_RD0524_01_s _ 2012_76				
Action/Comments					
Trim trees to at least five feet above ground level.

Looking southwest at low hanging tree branches at landside toe.

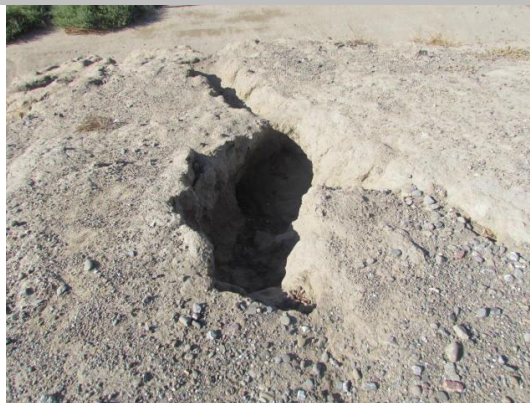
Photo 2 of 5 : FA_2015_RD0524_107_2_20150914_00002.jpg

LM Start	0.81	Rating **	U	Issue No.	2
LM End	0.81	Issue Type +	Ma	Location *	LS
Category	Earthen Levee			GPS Latitude/Longitude	
				Start	End
Item	Erosion / Bank Caving			37.936093 °	37.936004 °
				-121.334648 °	-121.334615 °
DWR ID	DWR_RD0524_01_f _ 2013_2				
Action/Comments					
Schedule repair of erosion site prior to the next inspection. Inspector Comments: One large hole. Hole is over 12" deep and 12" wide and several holes and finger erosions on landward slope.

Looking west at hole on landward shoulder.

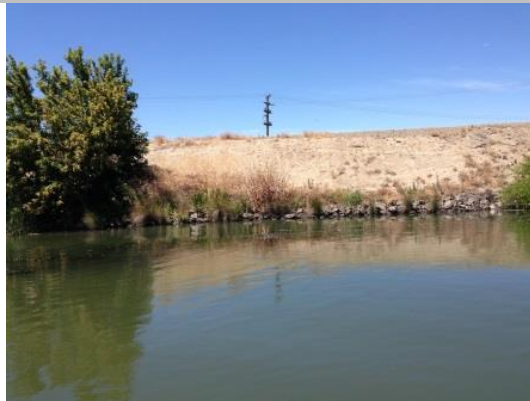
Photo 2 of 2 : SJR2015_RD0524U01RM41.44_2.JPG

LM Start	0.83	Rating **	U	Issue No.	134 (cont)
LM End	0.84	Issue Type +	Ma	Location *	WS
Category	Supplemental			GPS Latitude/Longitude	
				Start	End
Item	DWR Erosion Survey			37.935930 °	37.935930 °
				-121.334133 °	-121.334133 °
DWR ID					
Action/Comments					
Inspector Comments: 06/24/2015: No significant change observed. 06/19/2014: No significant change observed. 08/13/2013: Site was discovered during boat survey. The dense vegetation blocks a clear view of the erosion. Size of erosion site was very roughly estimated. [2015 Site ID:RD0524U01RM41.44]

The erosion is invisible because of the dense vegetation.

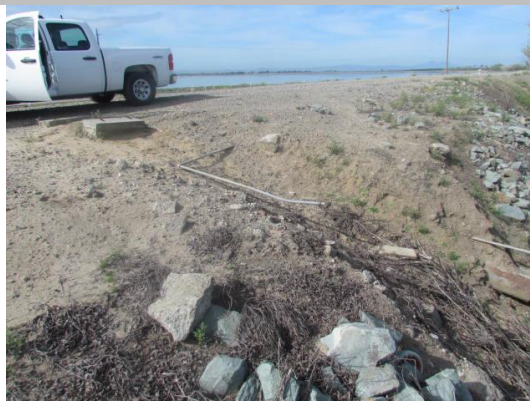
Photo 1 of 1 : FA_2015_RD0524_107_122_20150914_00137.jpg

LM Start	0.92	Rating **	M	Issue No.	122
LM End	0.92	Issue Type +	Ma	Location *	WS
Category	Earthen Levee			GPS Latitude/Longitude	
				Start	End
Item	Encroachments			37.935267 °	37.935267 °
				-121.332985 °	-121.332985 °
DWR ID	DWR_RD0524_01_s _ 2013_122				
Action/Comments					
Pipe					
Inspector Comments: Inch and half metal pipe should be removed.

Looking northwest at inch and half metal pipe on waterward slope.

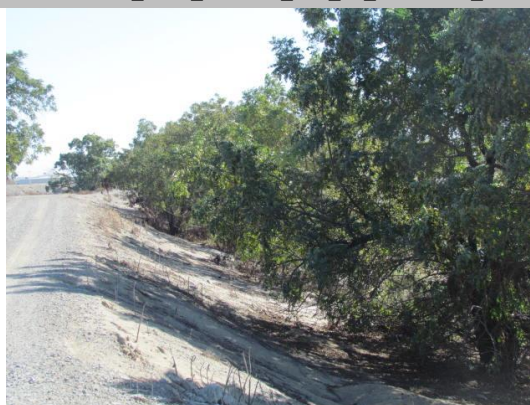
Photo 1 of 1 : FA_2015_RD0524_107_77_20150914_00100.jpg

Looking south at low hanging tree branches at landside toe.

LM Start	0.93	Rating **	U	Issue No.	77
LM End	1.01	Issue Type +	Ma	Location *	LS
Category	Earthen Levee			GPS Latitude/Longitude	
				Start	End
Item	Trim / Thin Trees			37.935259 °	37.935049 °
				-121.332864 °	-121.331334 °
DWR ID	DWR_RD0524_01_s _ 2012_77				
Action/Comments					
Trim trees to at least five feet above ground level.

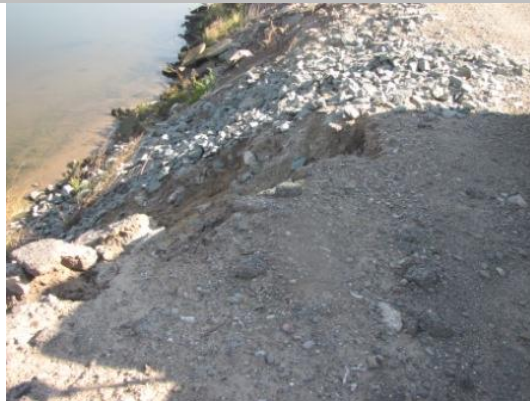
Photo 1 of 3 : FA_2015_RD0524_107_17_20150914_00023.jpg

LM Start	1.00	Rating **	M	Issue No.	17
LM End	1.02	Issue Type +	Ma	Location *	WS
Category	Earthen Levee			GPS Latitude/Longitude	
				Start	End
Item	Erosion / Bank Caving			37.935098 °	37.935018 °
				-121.331645 °	-121.331248 °
DWR ID	DWR_RD0524_01_s _ 2012_17				
Action/Comments					
Schedule repair of erosion site prior to the next inspection.					
Inspector Comments: Minor erosion was noted next to repaired site.

Looking upstream (south) at erosion site.

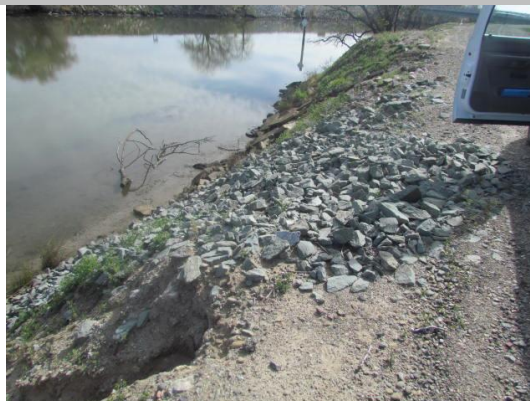
Photo 2 of 3 : FA_2015_RD0524_107_17_20150914_00024.jpg

Looking southeast at erosion next to repaired site on waterward slope (Spring 2013)

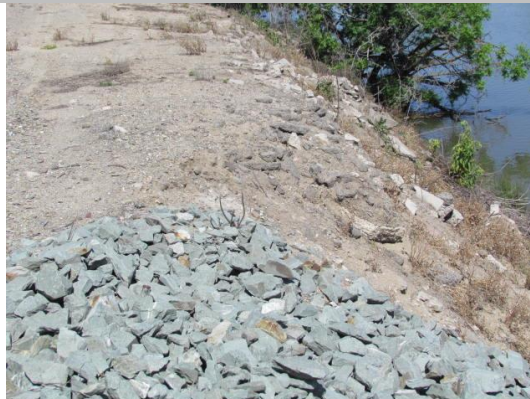
Photo 3 of 3 : FA_2015_RD0524_107_17_20150914_00025.jpg

Looking north at erosion site next to repaired site. (Spring 2012)

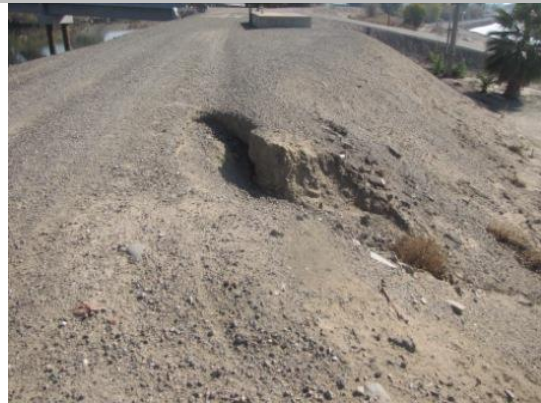
Photo 4 of 7 : FA_2015_RD0524_107_18_20150914_00028.jpg

Updated picture of the erosion site on the landside shoulder. Fall 2014

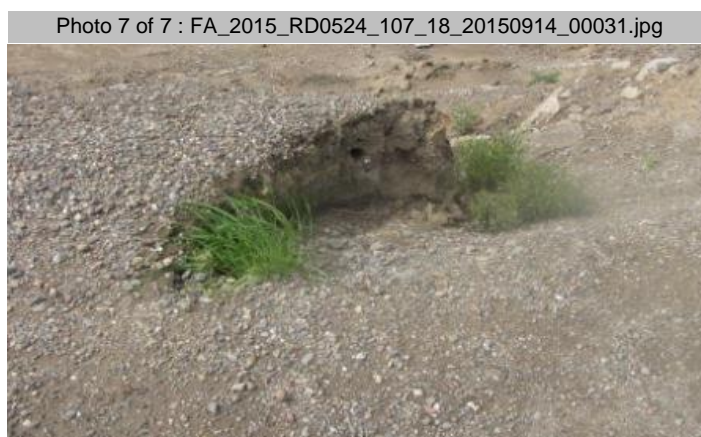
Updated view from above the slope stability.

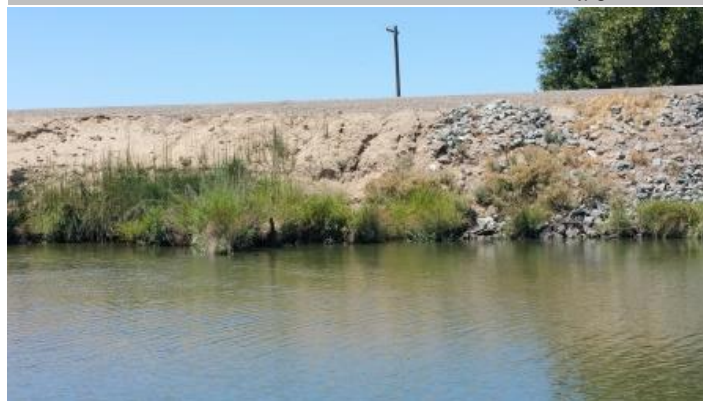
Photo 1 of 2 : SJR2015_RD0524U01RM41.79_3.jpg

Inspector Comments: 06/24/2015: No significant change observed.
 6/19/2014: No significant change observed.
 08/13/2013: No significant change at this site.
 08/07/2012: The site has been visited by boat survey. No significant change observed
 08/23/2011: No significant change observed on site.
 9/07/2010: No significant change observed on site. Vegetation is visible at the water line. There is an exposed pipe discharge partially hanging at the mid-slope, possibly still used for discharging irrigation/runoff water. There is minimal rip rap protection along the bank, and what's left of it is no longer adequately protecting the bank.
 9/29/2009: Site consists of a 400-foot long eroding bank with minimal vegetation and protection; the existing rip rap has sloughed, rendering it useless; note that there is an exposed section of a pipe.
 10/18/2006: There is extensive loss of rip rap on some sections; sewage disposal pond is on the landside of the levee; there is an exposed pipe outlet "hanging" from the upper slope. [2015 Site ID:RD0524U01RM41.79]

Direct view of the site.

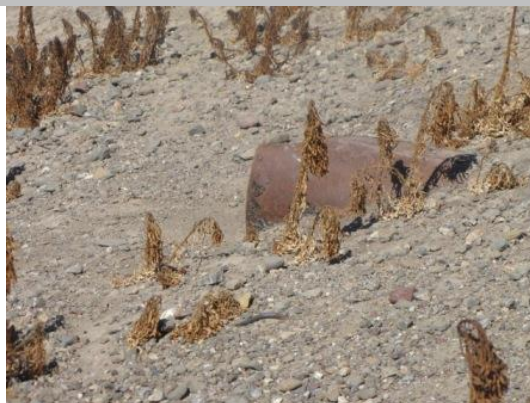
Photo 1 of 2 : FA_2015_RD0524_107_33_20150914_00051.jpg

LM Start	1.30	Rating **	U	Issue No.	33
LM End	1.30	Issue Type +	Ma	Location *	WS
Category	Earthen Levee			GPS Latitude/Longitude	
				Start	End
Item	Encroachments			37.931948 °	37.931948 °
				-121.328387 °	-121.328387 °
DWR ID	DWR_RD0524_01_s _ 2012_33				
Action/Comments					
Pipe Inspector Comments: Pipe is not in use and should be properly abandoned.

Looking west at pipe on landside slope.

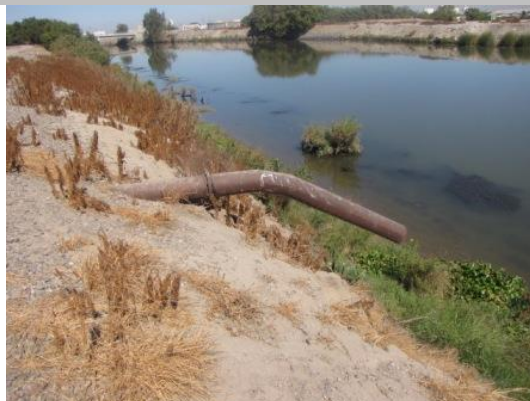
Photo 2 of 2 : FA_2015_RD0524_107_33_20150914_00052.jpg

Looking north at broken pipe.

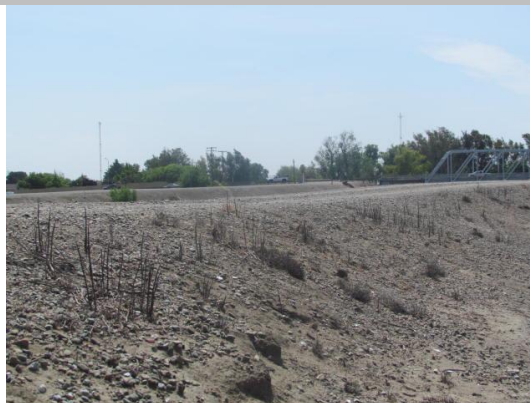
Photo 1 of 2 : FA_2015_RD0524_107_172_20150914_00161.jpg

LM Start	1.36	Rating **	U	Issue No.	172
LM End	1.40	Issue Type +	Ma	Location *	CR
Category	Earthen Levee			GPS Latitude/Longitude	
				Start	End
Item	Crown Surface / Depressions / Rutting			37.931085 °	37.930517 °
				-121.328112 °	-121.328072 °
DWR ID	DWR_RD0524_01_s _ 2015_172				
Action/Comments					
Repair depressions or ruts in the crown or slope. Inspector Comments: Levee crown depression several inches below original crown elevation. Section should be survey to determine proper elevation.

Looking east at depression on levee crown.

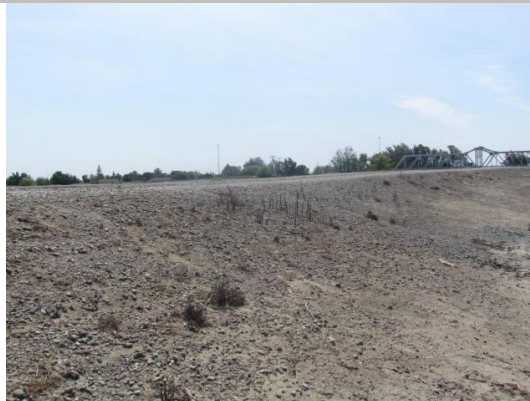
Photo 2 of 2 : FA_2015_RD0524_107_172_20150914_00162.jpg

Looking southeast at depression on levee crown.

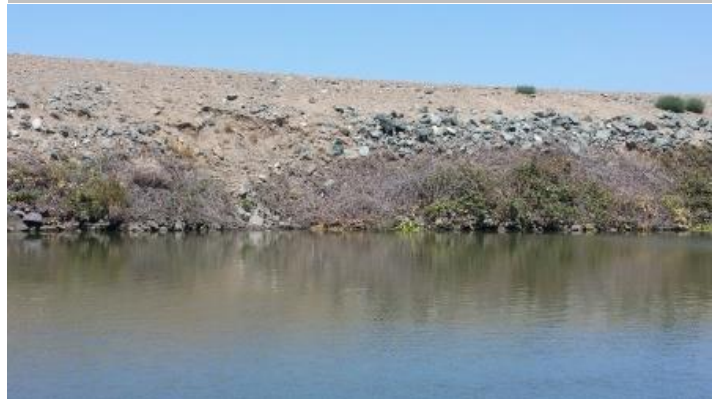
Photo 2 of 3 : SJR2015_RD0524U01RM42.09_2.JPG

Close view of the erosion.

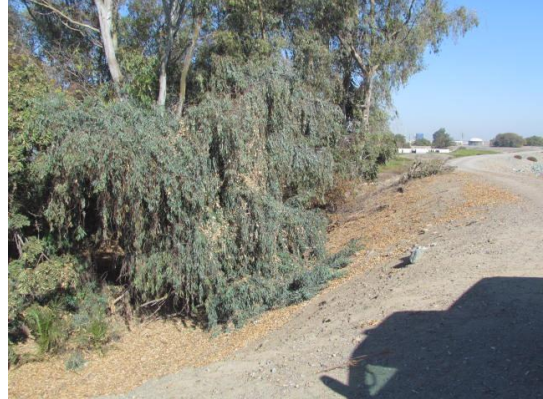
Photo 1 of 4 : FA_2015_RD0524_107_916_20151023_00247.jpg

Looking southwest at dense trees on landward slope and toe fall 2015

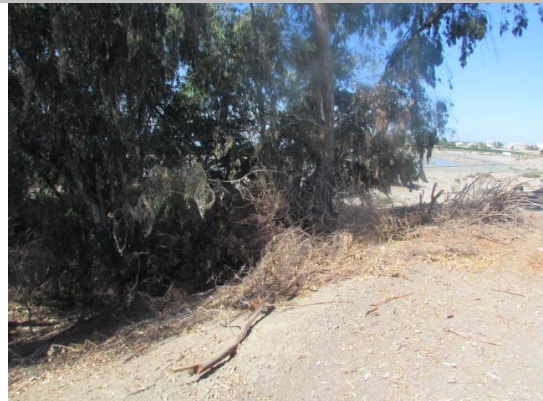
Photo 2 of 4 : FA_2015_RD0524_107_916_20150914_00199.jpg

Looking south at trees on landside slope. (Fall 2012)

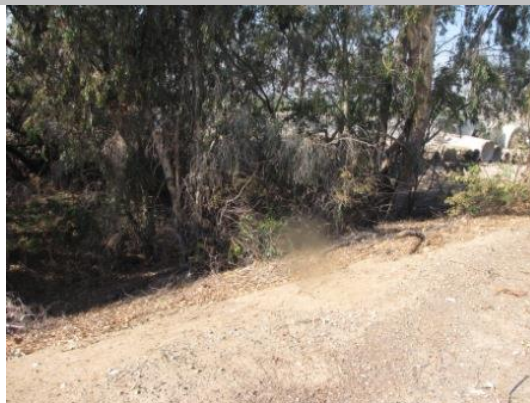
Photo 4 of 4 : FA_2015_RD0524_107_916_20150914_00198.jpg

LM Start	1.49	Rating **	U	Issue No.	916 (cont)	
LM End	1.49	Issue Type +	Ma	Location *	LS	
Category	Earthen Levee			GPS Latitude/Longitude		
				Start		End
Item	Trim / Thin Trees			37.929118 °		37.929118 °
				-121.328368 °		-121.328368 °
DWR ID	DWR_RD0524_01_s_2012_916					
Action/Comments						
Trim and thin trees to allow visibility of the ground and room to flood fight.						
Inspector Comments: Untrimmed trees and dense vegetation on landward toe.

Dense vegetation on landside toe.

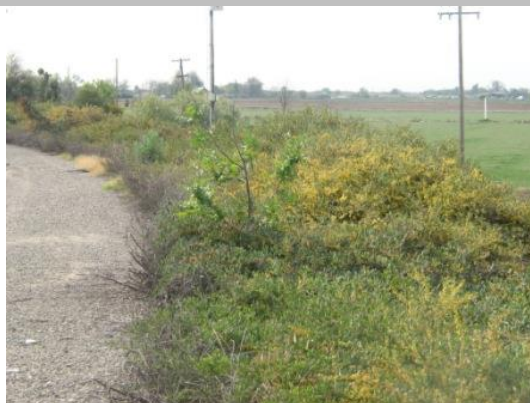
Photo 1 of 5 : FA_2015_RD0524_107_23_20150914_00035.jpg

Overgrown landscaping on landward slope from LM 1.56 to 1.74

LM Start	1.55	Rating **	A/W	Issue No.	23
LM End	1.59	Issue Type +	Ma	Location *	LS
Category	Earthen Levee			GPS Latitude/Longitude	
				Start	End
Item	Vegetation			37.928388 °	37.927797 °
				-121.328280 °	-121.327854 °
DWR ID	DWR_RD0524_01_s_2012_23				
Action/Comments					
Remove the wild growth other than native grasses from the levee slopes.

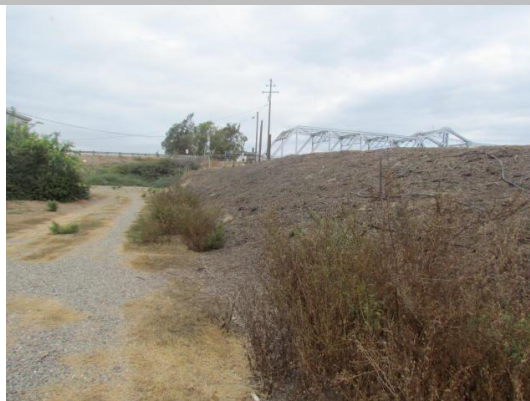
Photo 2 of 5 : FA_2015_RD0524_107_23_20150914_00036.jpg

Looking north from landward berm at corrected site.

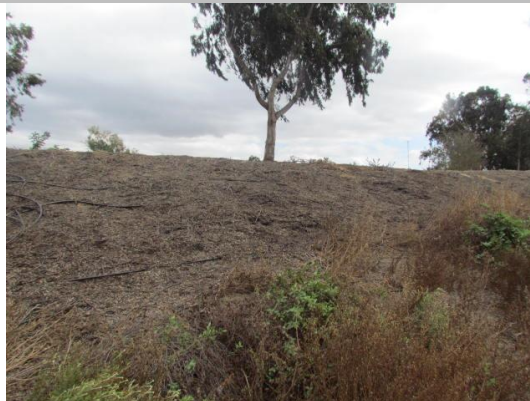
Photo 3 of 5 : FA_2015_RD0524_107_23_20150914_00037.jpg

Looking east from landward berm at corrected site.

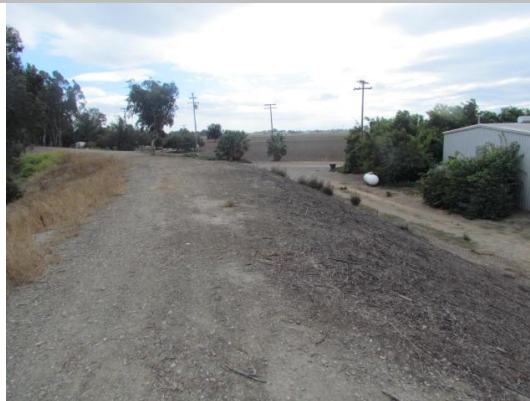
Photo 4 of 5 : FA_2015_RD0524_107_23_20150914_00038.jpg

Looking south from levee crown at corrected site.

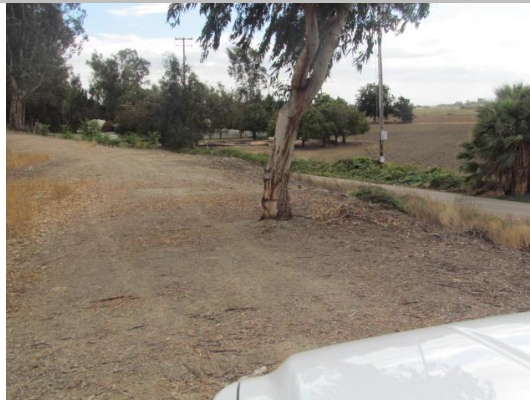
Photo 5 of 5 : FA_2015_RD0524_107_23_20150914_00039.jpg

Looking south from levee crown at upstream end of corrected site.

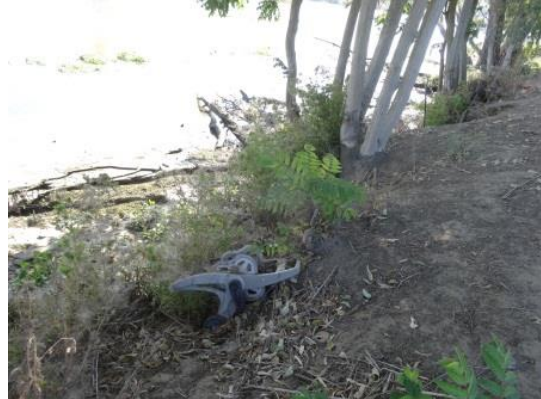
Photo 1 of 2 : SJR2015_RD0524U01RM42.20_1.jpg

Front view of the site where undermining has occurred.

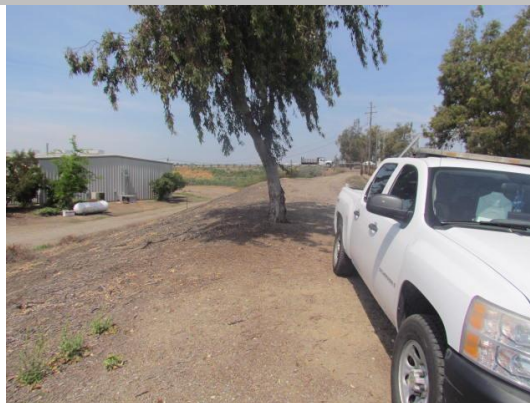
Photo 1 of 1 : FA_2015_RD0524_107_173_20150914_00163.jpg

LM Start	1.58	Rating **	U	Issue No.	173
LM End	1.58	Issue Type +	Ma	Location *	LS
Category	Earthen Levee			GPS Latitude/Longitude	
				Start	End
Item	Trim / Thin Trees			37.927975 °	37.927975 °
				-121.328088 °	-121.328088 °
DWR ID	DWR_RD0524_01_s_2015_173				
Action/Comments					
Trim trees to at least five feet above ground level. Inspector Comments: Tree is located on landward shoulder and crown should be removed.

Looking northwest at tree on within levee crown.

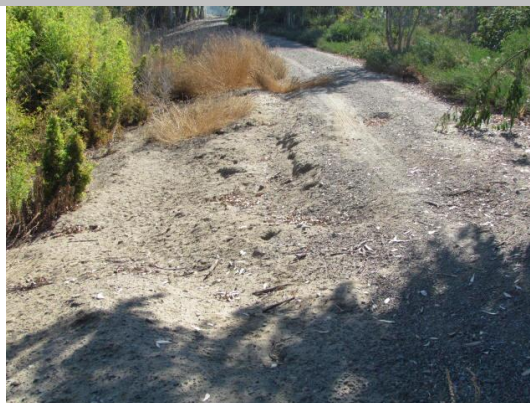
Photo 1 of 1 : FA_2015_RD0524_107_136_20150914_00149.jpg

LM Start	1.59	Rating **	M	Issue No.	136
LM End	1.59	Issue Type +	Ma	Location *	CR
Category	Earthen Levee			GPS Latitude/Longitude	
				Start	End
Item	Slope Stability			37.927775 °	37.927775 °
				-121.327860 °	-121.327860 °
DWR ID	DWR_RD0524_01_s_2013_136				
Action/Comments					
Repair the levee slope damaged by foot traffic and prevent access where possible.					
Inspector Comments: Waterward shoulder caving.

Looking south at depression on levee crown near waterward shoulder.

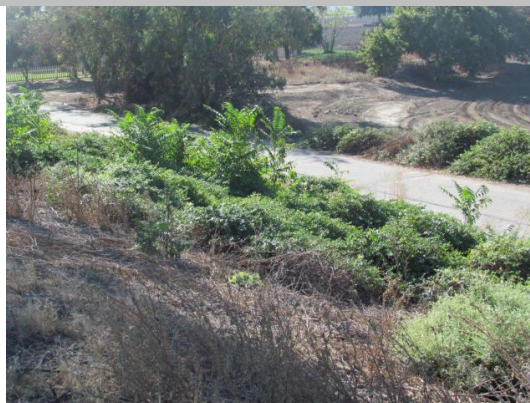
Photo 1 of 3 : FA_2015_RD0524_107_24_20151023_00248.jpg

LM Start	1.60	Rating **	U	Issue No.	24
LM End	1.61	Issue Type +	Ma	Location *	LS
Category	Earthen Levee			GPS Latitude/Longitude	
				Start	End
Item	Vegetation			37.927635 °	37.927540 °
				-121.327812 °	-121.327648 °
DWR ID	DWR_RD0524_01_s_2012_24				
Action/Comments					
Remove the wild growth other than native grasses from the levee slopes.					
Inspector Comments: Vegetation blocking landward toe.

Looking southwest at dense vegetation on landward slope fall 2015

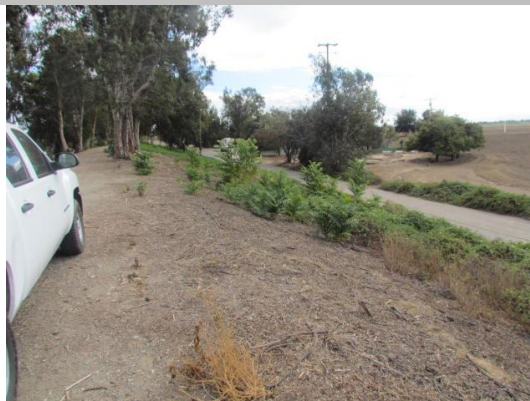
Photo 2 of 3 : FA_2015_RD0524_107_24_20150914_00040.jpg

Looking south at vegetation blocking view of landward toe.

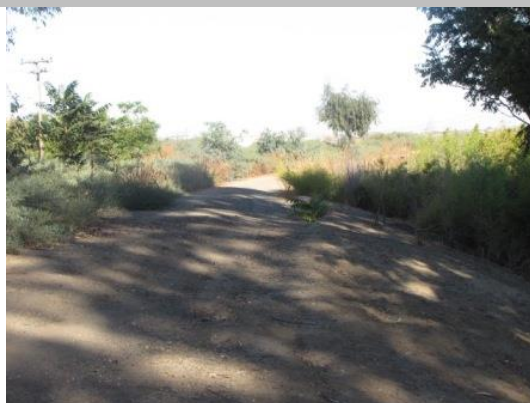
Photo 3 of 3 : FA_2015_RD0524_107_24_20150914_00041.jpg

Looking north at dense vegetation on the landside and waterside slopes.

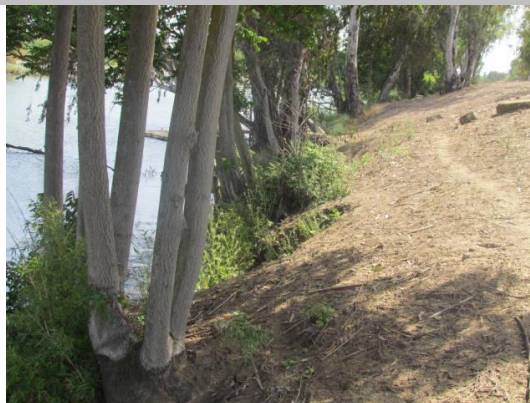
Photo 1 of 3 : FA_2015_RD0524_107_26_20150914_00043.jpg

LM Start	1.62	Rating **	M	Issue No.	26
LM End	1.64	Issue Type +	Ma	Location *	WS
Category	Earthen Levee			GPS Latitude/Longitude	
				Start	End
Item	Erosion / Bank Caving			37.927507 °	37.927295 °
				-121.327593 °	-121.327298 °
DWR ID	DWR_RD0524_01_s _ 2012_26				
Action/Comments					
Note and monitor erosion site.					
Inspector Comments: Several erosions along this reach.

Looking south at waterward erosion.

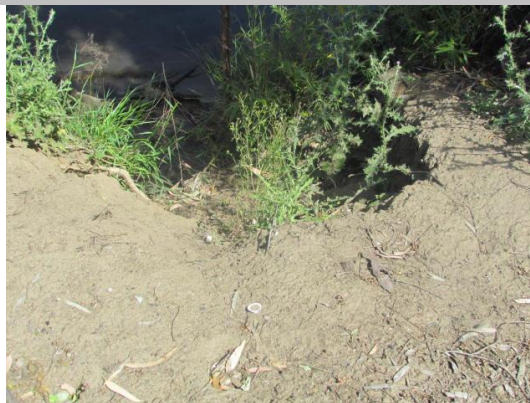
Photo 2 of 3 : FA_2015_RD0524_107_26_20150914_00044.jpg

LM Start	1.62	Rating **	M	Issue No.	26 (cont)
LM End	1.64	Issue Type +	Ma	Location *	WS

Looking east at waterward erosion.

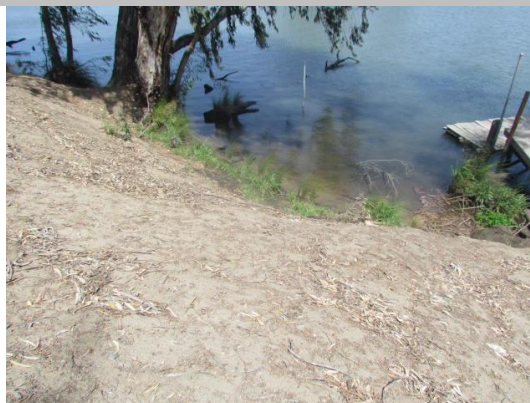
Photo 3 of 3 : FA_2015_RD0524_107_26_20150914_00045.jpg

Looking east at waterward erosion and depression.

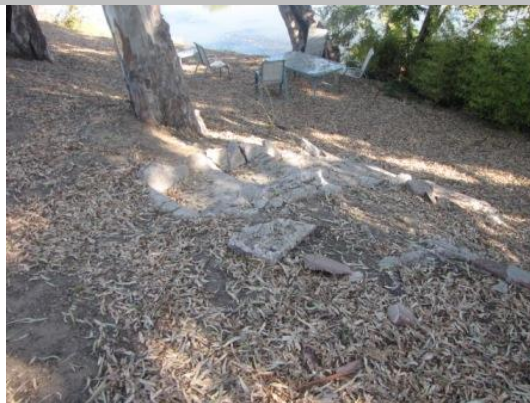
Photo 1 of 3 : FA_2015_RD0524_107_45_20150914_00067.jpg

LM Start	1.67	Rating **	U	Issue No.	45 (cont)
LM End	1.67	Issue Type +	Ma	Location *	WS

Looking northeast at non-permitted concrete stairs on waterside slope.

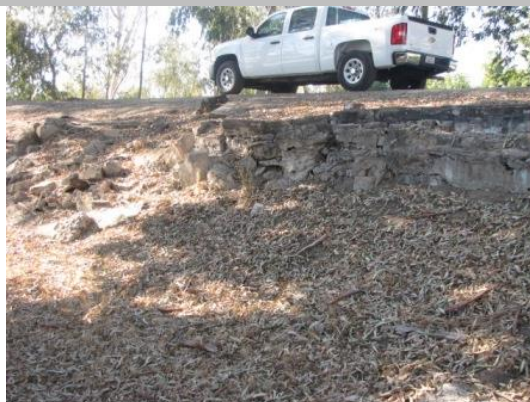
Photo 2 of 3 : FA_2015_RD0524_107_45_20150914_00068.jpg

Looking southwest at retaining wall connected to concrete stairs.

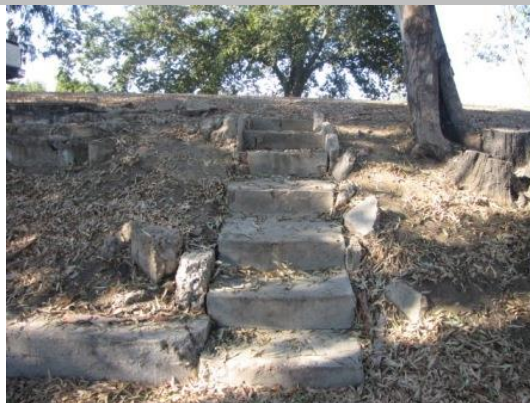
Photo 3 of 3 : FA_2015_RD0524_107_45_20150914_00069.jpg

LM Start	1.67	Rating **	U	Issue No.	45 (cont)
LM End	1.67	Issue Type +	Ma	Location *	WS
Category	Earthen Levee			GPS Latitude/Longitude	
				Start	End
Item	Encroachments			37.927018 °	37.927018 °
				-121.326872 °	-121.326872 °
DWR ID	DWR_RD0524_01_s_2012_45				
Action/Comments					
Stairway					
Inspector Comments: Stairs and retaining wall

Looking west at concrete stairs on waterside slope.

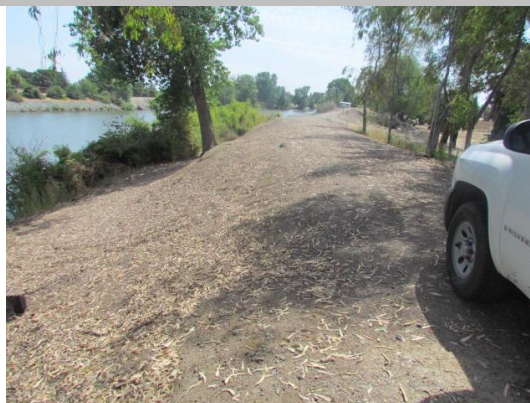
Photo 1 of 1 : FA_2015_RD0524_107_27_20150914_00046.jpg

LM Start	1.69	Rating **	M	Issue No.	27
LM End	1.70	Issue Type +	Ma	Location *	WS
Category	Earthen Levee			GPS Latitude/Longitude	
				Start	End
Item	Slope Stability			37.926728 °	37.926730 °
				-121.326597 °	-121.326508 °
DWR ID	DWR_RD0524_01_s_2012_27				
Action/Comments					
Repair slope instability. Inspector Comments: Slope damage several feet long and greater than one inch deep.

Looking south at landward slope depression.

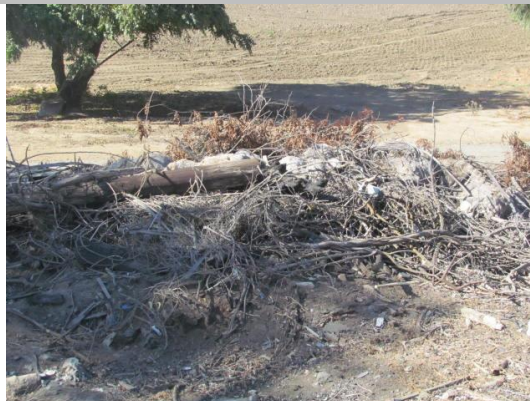
Photo 1 of 1 : FA_2015_RD0524_107_28_20151023_00249.jpg

LM Start	1.73	Rating **	M	Issue No.	28
LM End	1.73	Issue Type +	Ma	Location *	LS
Category	Earthen Levee			GPS Latitude/Longitude	
				Start	End
Item	Encroachments			37.926322 °	37.926322 °
				-121.326115 °	-121.326115 °
DWR ID	DWR_RD0524_01_s_2012_28				
Action/Comments					
Garbage Inspector Comments: Large pruning piles on landside slope.

Looking west at pruning pile at landward toe fall 2015.

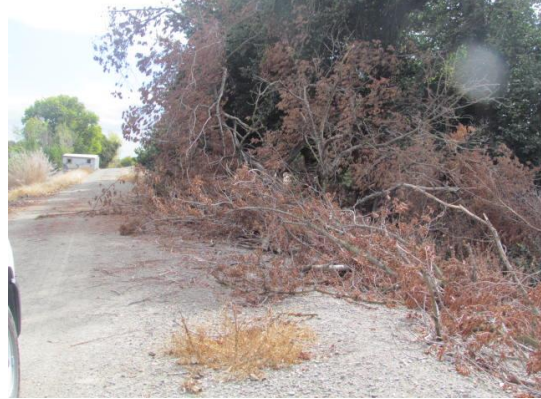
Photo 1 of 4 : FA_2015_RD0524_107_46_20150914_00070.jpg

LM Start	1.75	Rating **	U	Issue No.	46
LM End	1.76	Issue Type +	Ma	Location *	LS
Category	Earthen Levee			GPS Latitude/Longitude	
				Start	End
Item	Encroachments			37.926152 °	37.925993 °
				-121.325927 °	-121.325777 °
DWR ID	DWR_RD0524_01_s _ 2012_46				
Action/Comments					
Tree or limb					
Inspector Comments: Downed tree limbs on landward slope.

Looking south at tree limbs on landward slope.

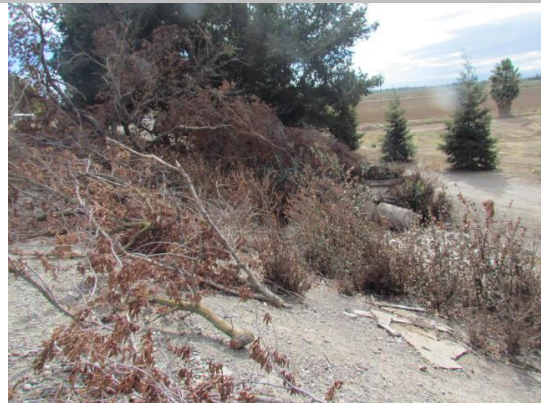
Photo 2 of 4 : FA_2015_RD0524_107_46_20150914_00071.jpg

Looking southwest at tree limbs on landward slope.

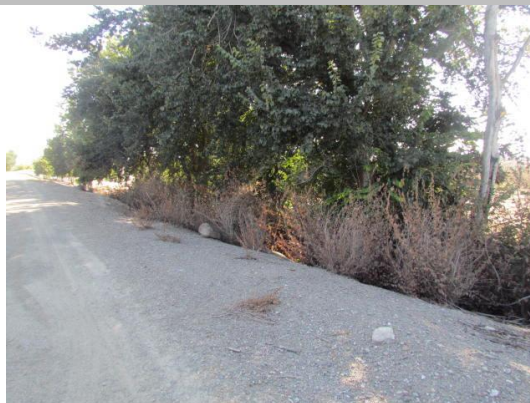
Photo 4 of 4 : FA_2015_RD0524_107_46_20150914_00073.jpg

LM Start	1.75	Rating **	U	Issue No.	46 (cont)
LM End	1.76	Issue Type +	Ma	Location *	LS
Category	Earthen Levee			GPS Latitude/Longitude	
				Start	End
Item	Encroachments			37.926152 °	37.925993 °
				-121.325927 °	-121.325777 °
DWR ID	DWR_RD0524_01_s _ 2012_46				
Action/Comments					
Tree or limb					
Inspector Comments: Downed tree limbs on landward slope.

Looking southwest at dense vegetation and low hanging tree branches on landside slope and toe.

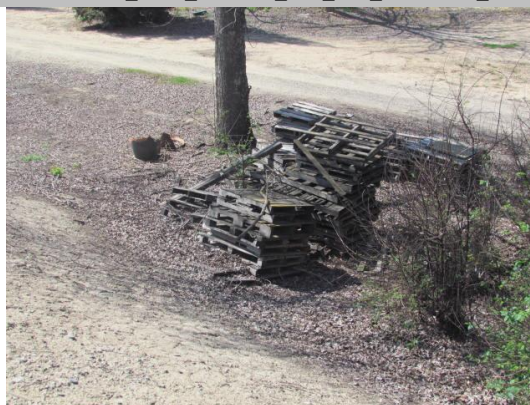
Photo 1 of 1 : FA_2015_RD0524_107_181_20150914_00173.jpg

LM Start	1.76	Rating **	A/W	Issue No.	181
LM End	1.76	Issue Type +	Ma	Location *	LS
Category	Earthen Levee			GPS Latitude/Longitude	
				Start	End
Item	Encroachments			37.925972 °	37.925972 °
				-121.325769 °	-121.325769 °
DWR ID	DWR_RD0524_01_s _ 2014_181				
Action/Comments					
Material					
Inspector Comments: Landowner stockpiling pallets at landward toe.

Looking west at wooden pallets at landward toe.

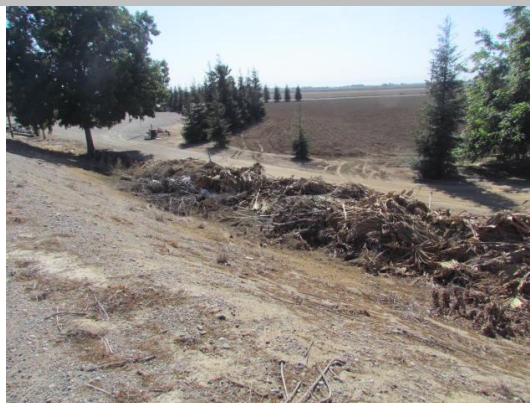
Photo 1 of 1 : FA_2015_RD0524_107_100_20150914_00119.jpg

LM Start	1.78	Rating **	A/W	Issue No.	100
LM End	1.78	Issue Type +	Ma	Location *	LS
Category	Earthen Levee			GPS Latitude/Longitude	
				Start	End
Item	Encroachments			37.925752 °	37.925752 °
				-121.325592 °	-121.325592 °
DWR ID	DWR_RD0524_01_s _ 2012_100				
Action/Comments					
Prunings

Looking southwest at prunings on landside toe.

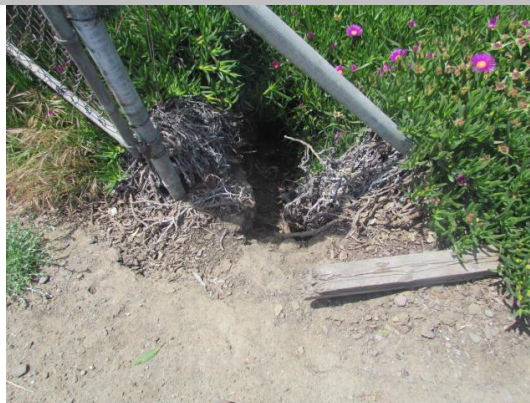
Photo 1 of 2 : FA_2015_RD0524_107_176_20150914_00166.jpg

LM Start	1.94	Rating **	U	Issue No.	176
LM End	1.94	Issue Type +	Ma	Location *	LS
Category	Earthen Levee			GPS Latitude/Longitude	
				Start	End
Item	Erosion / Bank Caving			37.923688 °	37.923688 °
				-121.324223 °	-121.324223 °
DWR ID	DWR_RD0524_01_s _ 2015_176				
Action/Comments					
Schedule repair of erosion site prior to the next inspection. Inspector Comments: Landward caving (3 x 18" x 5) caused by broken sprinklers.

Looking west at erosion within landscaping on landward shoulder and slope.

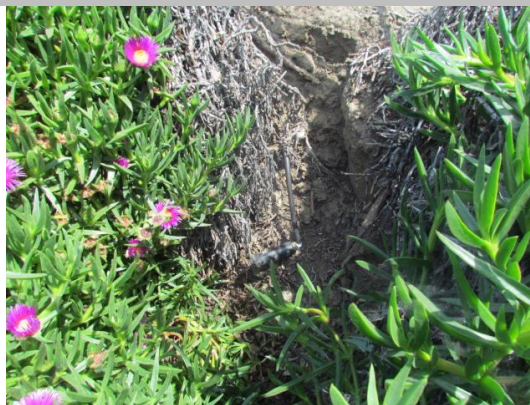
Photo 2 of 2 : FA_2015_RD0524_107_176_20150914_00167.jpg

Looking east at erosion within landscaping on landward slope and shoulder.

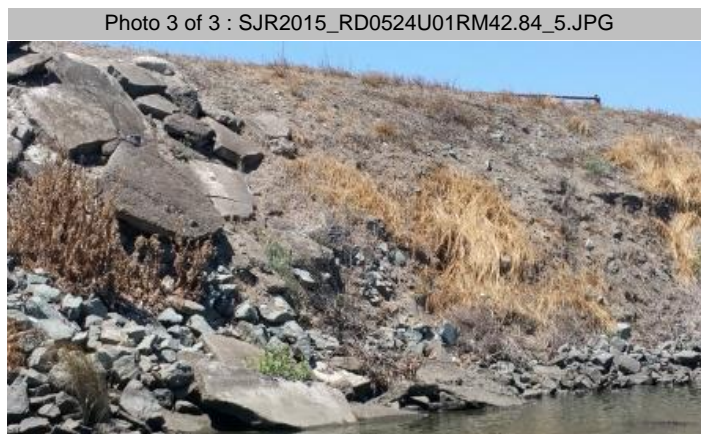
LM Start	2.24	Rating **	U	Issue No.	103 (cont)
LM End	2.27	Issue Type +	Ma	Location *	WS

Close view of the erosion.

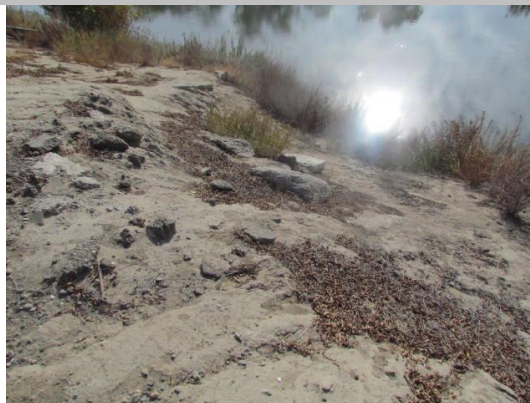
Photo 1 of 1 : FA_2015_RD0524_107_36_20150914_00055.jpg

LM Start	2.44	Rating **	M	Issue No.	36
LM End	2.47	Issue Type +	Ma	Location *	WS
Category	Earthen Levee			GPS Latitude/Longitude	
				Start	End
Item	Erosion / Bank Caving			37.918628 °	37.918438 °
				-121.320817 °	-121.321452 °
DWR ID	DWR_RD0524_01_s_2012_36				
Action/Comments					
Note and monitor erosion site.

Looking east at erosion on waterside slope.

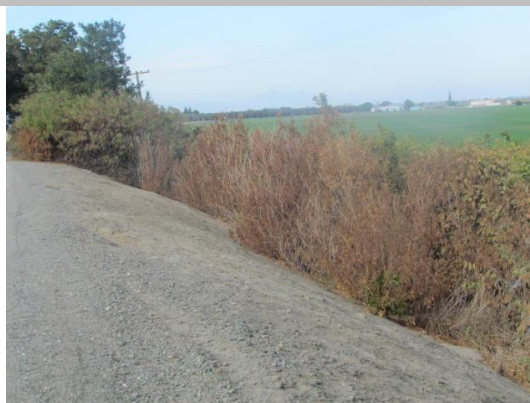
Photo 1 of 2 : FA_2015_RD0524_107_80_20150914_00103.jpg

LM Start	2.45	Rating **	M	Issue No.	80
LM End	2.45	Issue Type +	Ma	Location *	LS
Category	Earthen Levee			GPS Latitude/Longitude	
				Start	End
Item	Trim / Thin Trees			37.918480 °	37.918480 °
				-121.321114 °	-121.321114 °
DWR ID	DWR_RD0524_01_s_2012_80				
Action/Comments					
Trim trees to at least five feet above ground level.

Looking southwest at dense vegetation and trees on landside slope.
(Fall 2012)

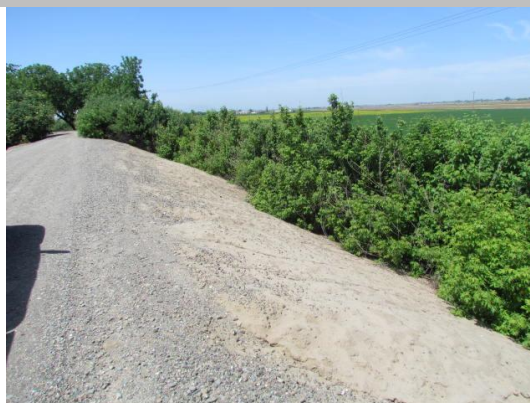
Photo 2 of 2 : FA_2015_RD0524_107_80_20150914_00104.jpg

Looking southwest at dense vegetation on landside toe.
