**Flood Control Project Maintenance
Levee Inspections**

Maintenance Issue Types Only, Levee Inspection Report By Mile - Fall 2015

Reclamation District No. 0524 Middle Roberts Island

Waterway	Bank	Unit Miles	Inspection Start/End	Inspector
Unit No. 01 San Joaquin River	Left	6.20	10/21/2015 10/21/2015	Richard Willoughby

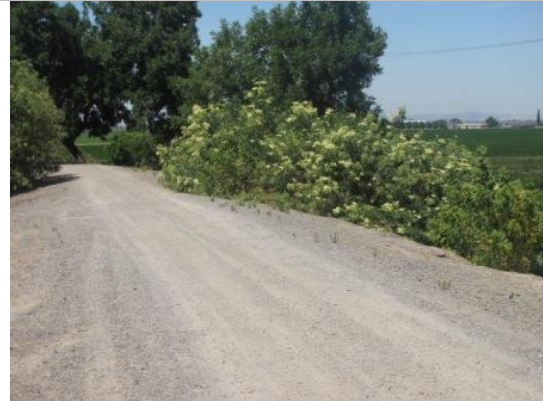
Photo 1 of 4 : FA_2015_RD0524_107_37_20150914_00056.jpg

LM Start	2.49	Rating **	U	Issue No.	37
LM End	2.50	Issue Type +	Ma	Location *	LS
Category	Earthen Levee			GPS Latitude/Longitude	
				Start	End
Item	Vegetation			37.918345 °	37.918302 °
				-121.321765 °	-121.321923 °
DWR ID	DWR_RD0524_01_s _ 2012_37				
Action/Comments					
Elderberries are blocking visibility and flood fight capability.

Looking south at elderberry on landside slope.

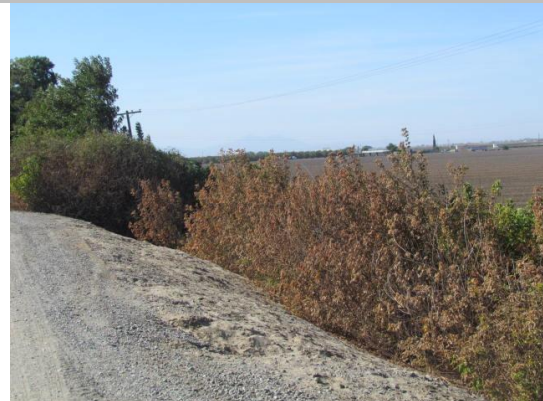
Photo 2 of 4 : FA_2015_RD0524_107_37_20150914_00057.jpg

Looking southwest at dense vegetation on landside toe.

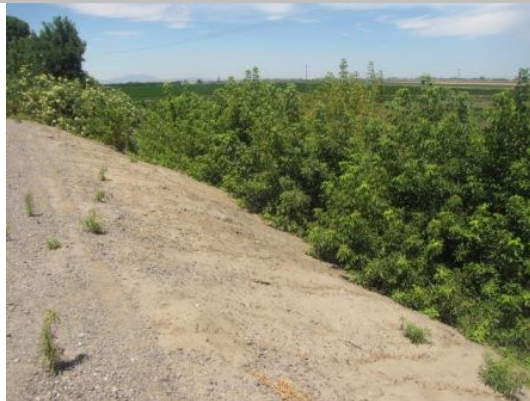
Photo 4 of 4 : FA_2015_RD0524_107_37_20150914_00059.jpg

LM Start	2.49	Rating **	U	Issue No.	37 (cont)	
LM End	2.50	Issue Type +	Ma	Location *	LS	
Category	Earthen Levee			GPS Latitude/Longitude		
				Start		End
Item	Vegetation			37.918345 °		37.918302 °
				-121.321765 °		-121.321923 °
DWR ID	DWR_RD0524_01_s _ 2012_37					
Action/Comments						
Elderberries are blocking visibility and flood fight capability.

Looking southwest at trees along levee landside toe.

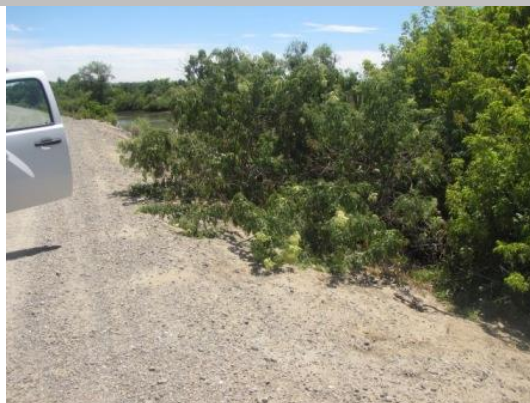
Photo 1 of 2 : FA_2015_RD0524_107_38_20150914_00060.jpg

LM Start	2.50	Rating **	U	Issue No.	38
LM End	2.50	Issue Type +	Ma	Location *	WS
Category	Earthen Levee			GPS Latitude/Longitude	
				Start	End
Item	Vegetation			37.918287 °	37.918287 °
				-121.321980 °	-121.321980 °
DWR ID	DWR_RD0524_01_s _ 2012_38				
Action/Comments					
Elderberries are blocking visibility and flood fight capability.

Looking north at elderberry on waterside slope.

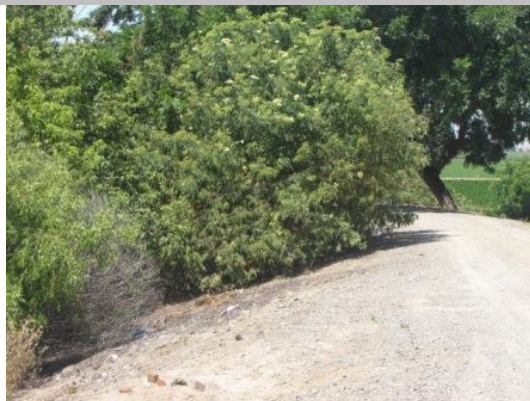
Photo 2 of 2 : FA_2015_RD0524_107_38_20150914_00061.jpg

Looking south at elderberry on waterside slope.

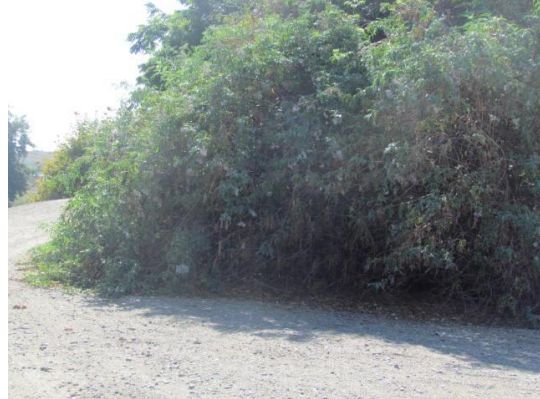
Photo 1 of 1 : FA_2015_RD0524_107_43_20151023_00251.jpg

LM Start	2.64	Rating **	U	Issue No.	43
LM End	2.64	Issue Type +	Ma	Location *	LS
Category	Earthen Levee			GPS Latitude/Longitude	
				Start	End
Item	Vegetation			37.916780 °	37.916780 °
				-121.322095 °	-121.322095 °
DWR ID	DWR_RD0524_01_s _ 2012_43				
Action/Comments					
Elderberries are blocking visibility and flood fight capability. Inspector Comments: Dense elderberry on landward shoulder, slope, and toe.

Looking southeast at dense veg on landward slope and toe fall 2015.

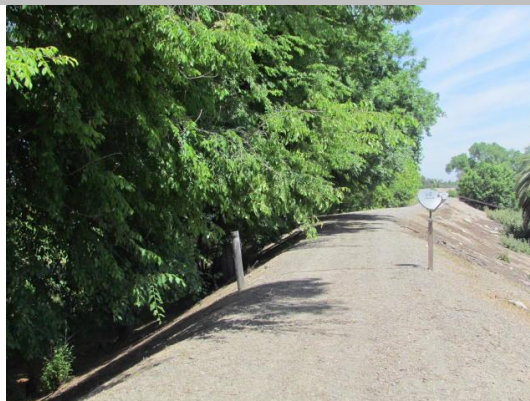
Photo 1 of 1 : FA_2015_RD0524_107_44_20150914_00066.jpg

LM Start	2.67	Rating **	A/W	Issue No.	44
LM End	2.77	Issue Type +	Ma	Location *	LS
Category	Earthen Levee			GPS Latitude/Longitude	
				Start	End
Item	Trim / Thin Trees			37.916418 °	37.915142 °
				-121.321963 °	-121.323018 °
DWR ID	DWR_RD0524_01_s_2012_44				
Action/Comments					
Trim trees over roadway to at least 12 feet above ground level. Inspector Comments: Trim over hanging trees at least 12 feet above ground level.

Looking north at dense trees overhanging levee crown.

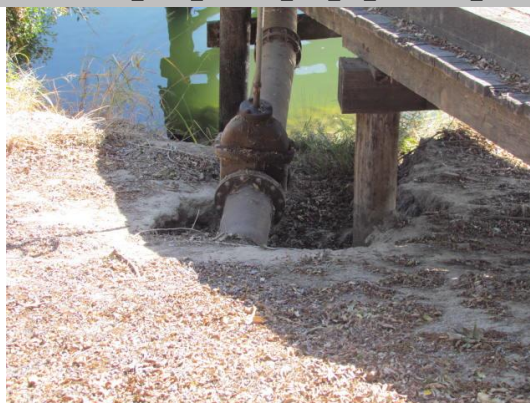
Photo 2 of 2 : FA_2015_RD0524_107_21_20150914_00034.jpg

LM Start	2.68	Rating **	M	Issue No.	21
LM End	2.68	Issue Type +	Ma	Location *	WS
Category	Earthen Levee			GPS Latitude/Longitude	
				Start	End
Item	Erosion / Bank Caving			37.916224 °	37.916224 °
				-121.322115 °	-121.322115 °
DWR ID	DWR_RD0524_01_f_2013_21				
Action/Comments					
Schedule repair of erosion site prior to the next inspection. Inspector Comments: Large erosion around irrigation pipe.

Looking east at erosion around irrigation pipe on waterward slope.

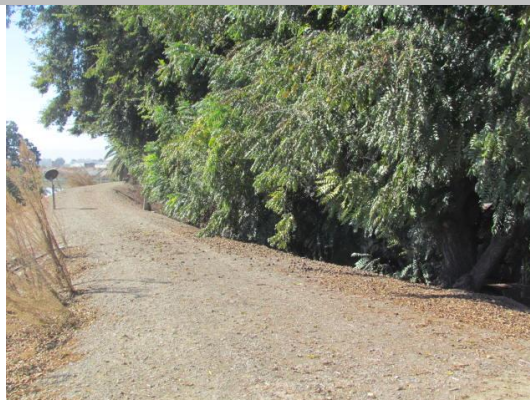
Photo 1 of 1 : FA_2015_RD0524_107_60_20151023_00252.jpg

LM Start	2.72	Rating **	U	Issue No.	60
LM End	2.74	Issue Type +	Ma	Location *	LS
Category	Earthen Levee			GPS Latitude/Longitude	
				Start	End
Item	Trim / Thin Trees			37.915747 °	37.915492 °
				-121.322470 °	-121.322639 °
DWR ID	DWR_RD0524_01_s _ 2012_60				
Action/Comments					
Trim trees to at least five feet above ground level.					
Inspector Comments: Untrimmed trees on landward slope.

Looking southwest at dense untrimmed trees on landward slope and toe fall 2015.

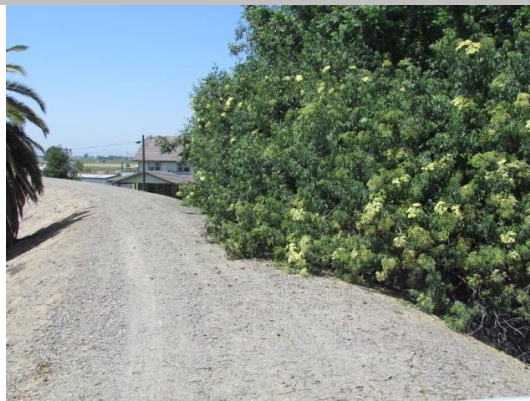
Photo 1 of 2 : FA_2015_RD0524_107_48_20150914_00074.jpg

LM Start	2.80	Rating **	U	Issue No.	48
LM End	2.80	Issue Type +	Ma	Location *	LS
Category	Earthen Levee			GPS Latitude/Longitude	
				Start	End
Item	Vegetation			37.915022 °	37.915022 °
				-121.323443 °	-121.323443 °
DWR ID	DWR_RD0524_01_s _ 2012_48				
Action/Comments					
Elderberries are blocking visibility and flood fight capability.

Looking south at dense elderberry on landside slope.(Spring 2012)

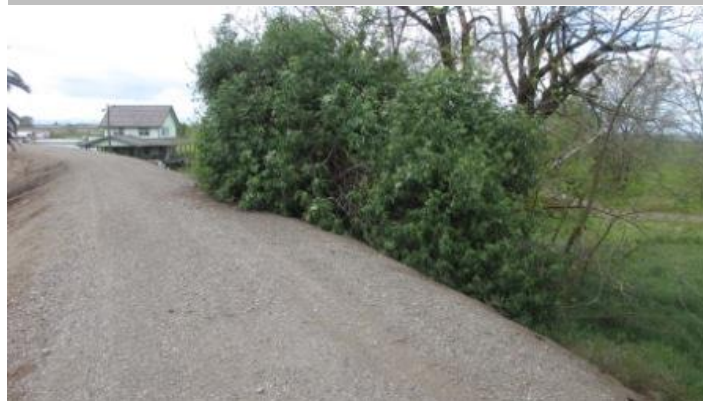
Photo 2 of 2 : FA_2015_RD0524_107_48_20150914_00075.jpg

Looking south at elderberry on landside slope.(Spring 2011)

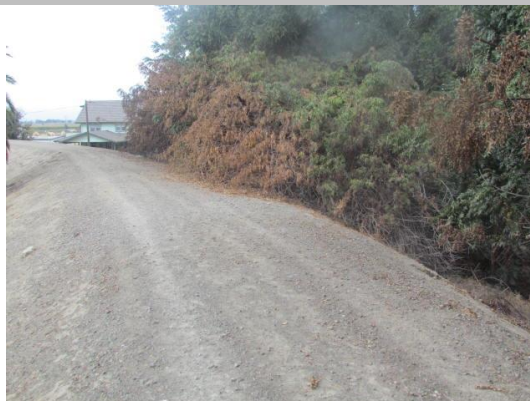
Photo 1 of 1 : FA_2015_RD0524_107_91_20150914_00111.jpg

LM Start	2.80	Rating **	U	Issue No.	91
LM End	2.80	Issue Type +	Ma	Location *	LS
Category	Earthen Levee			GPS Latitude/Longitude	
				Start	End
Item	Trim / Thin Trees			37.915063 °	37.915063 °
				-121.323585 °	-121.323585 °
DWR ID	DWR_RD0524_01_s _ 2012_91				
Action/Comments					
Thin trees to allow visibility of the ground and room to flood fight.

Looking southwest at dense vegetation on landside slope.

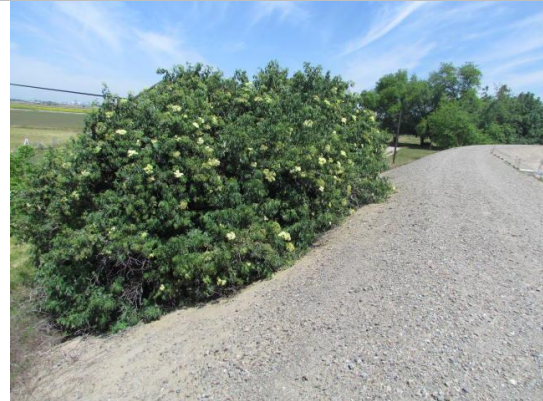
Photo 1 of 1 : FA_2015_RD0524_107_49_20150914_00076.jpg

LM Start	2.86	Rating **	U	Issue No.	49
LM End	2.86	Issue Type +	Ma	Location *	LS
Category	Earthen Levee			GPS Latitude/Longitude	
				Start	End
Item	Vegetation			37.914427 °	37.914427 °
				-121.324198 °	-121.324198 °
DWR ID	DWR_RD0524_01_s_2012_49				
Action/Comments					
Elderberries are blocking visibility and flood fight capability.

Looking northwest at elderberry on landside slope.

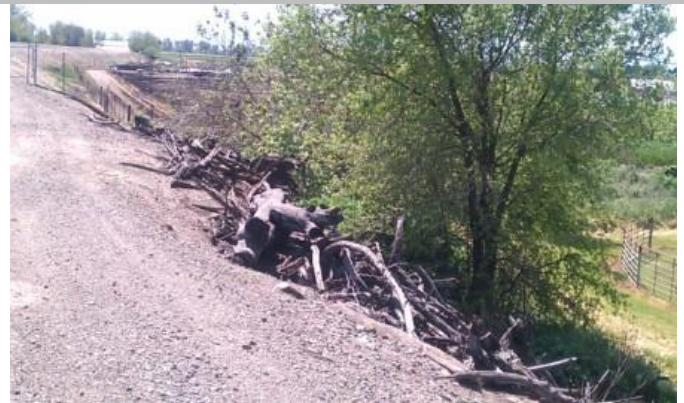
Photo 1 of 1 : FA_2015_RD0524_107_50_20150914_00077.jpg

LM Start	2.90	Rating **	U	Issue No.	50
LM End	2.92	Issue Type +	Ma	Location *	LS
Category	Earthen Levee			GPS Latitude/Longitude	
				Start	End
Item	Encroachments			37.913767 °	37.913503 °
				-121.324427 °	-121.324488 °
DWR ID	DWR_RD0524_01_s_2012_50				
Action/Comments					
Prunings

Looking southwest at prunings on landside slope.

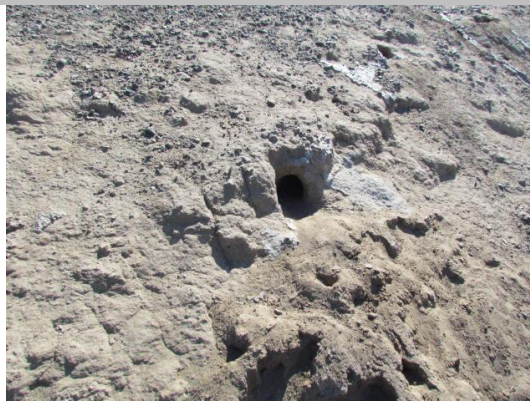
Photo 1 of 2 : FA_2015_RD0524_107_925_20151023_00254.jpg

LM Start	3.07	Rating **	M	Issue No.	925
LM End	3.27	Issue Type +	Ma	Location *	LS
Category	Earthen Levee			GPS Latitude/Longitude	
				Start	End
Item	Animal Control			37.911382 °	37.908602 °
				-121.324928 °	-121.325395 °
DWR ID	DWR_RD0524_01_s _ 2012_925				
Action/Comments					
Exterminate rodents and backfill and compact or grout burrows. Inspector Comments: Several rodent holes on levee slopes.

Looking at typical view of rodent hole with this section fall 2015.

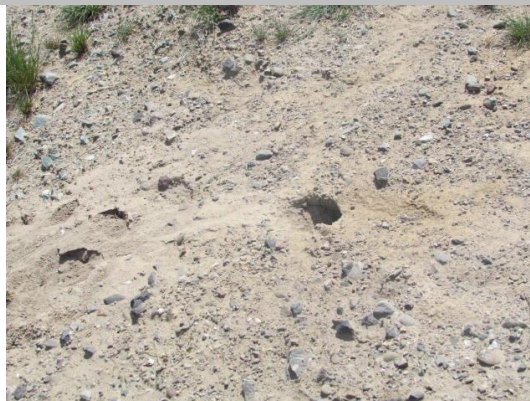
Photo 2 of 2 : FA_2015_RD0524_107_925_20150914_00202.jpg

Looking at typical rodent holes on landward slope along this reach.

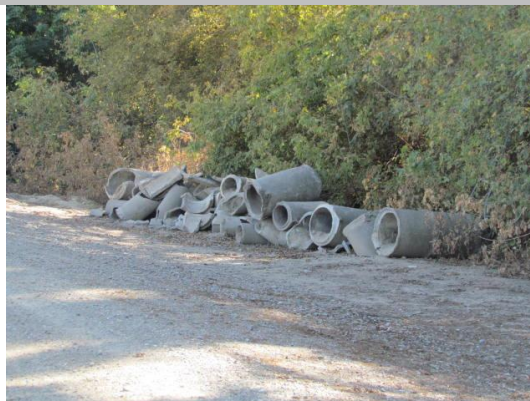
Photo 1 of 1 : FA_2015_RD0524_107_56_20150914_00081.jpg

LM Start	3.42	Rating **	M	Issue No.	56
LM End	3.42	Issue Type +	Ma	Location *	LS
Category	Earthen Levee			GPS Latitude/Longitude	
				Start	End
Item	Encroachments			37.906540 °	37.906540 °
				-121.325015 °	-121.325015 °
DWR ID	DWR_RD0524_01_s_2012_56				
Action/Comments					
Material					
Inspector Comments: Broken concrete pipes

Looking southwest at concrete pipes on landside toe.

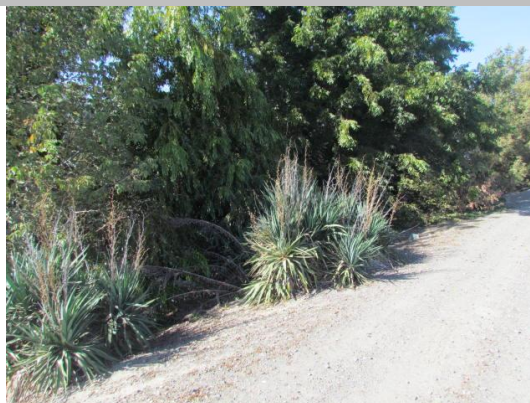
Photo 1 of 1 : FA_2015_RD0524_107_54_20150914_00079.jpg

LM Start	3.45	Rating **	U	Issue No.	54
LM End	3.45	Issue Type +	Ma	Location *	LS
Category	Earthen Levee			GPS Latitude/Longitude	
				Start	End
Item	Trim / Thin Trees			37.906227 °	37.906227 °
				-121.324683 °	-121.324683 °
DWR ID	DWR_RD0524_01_s_2012_54				
Action/Comments					
Trim and thin trees to allow visibility of the ground and room to flood fight.					
Inspector Comments: Dense untrimmed trees on landward slope.

Looking northwest at dense vegetation on landside slope.

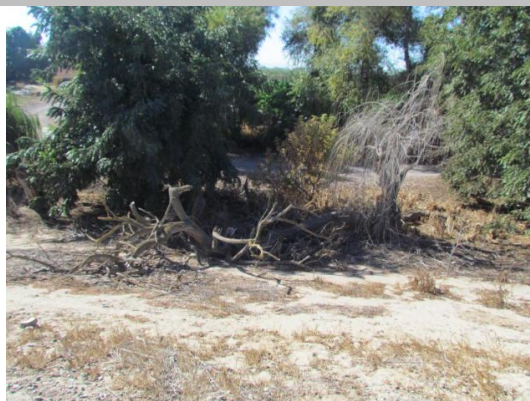
Photo 1 of 1 : FA_2015_RD0524_107_177_20151023_00255.jpg

LM Start	3.48	Rating **	M	Issue No.	177
LM End	3.48	Issue Type +	Ma	Location *	LS
Category	Earthen Levee			GPS Latitude/Longitude	
				Start	End
Item	Encroachments			37.905994 °	37.905994 °
				-121.324194 °	-121.324194 °
DWR ID	DWR_RD0524_01_f_2014_177				
Action/Comments					
Tree or limb					
Inspector Comments: Dead tree on landward toe.

Looking at dead tree limb at landward toe fall 2015.

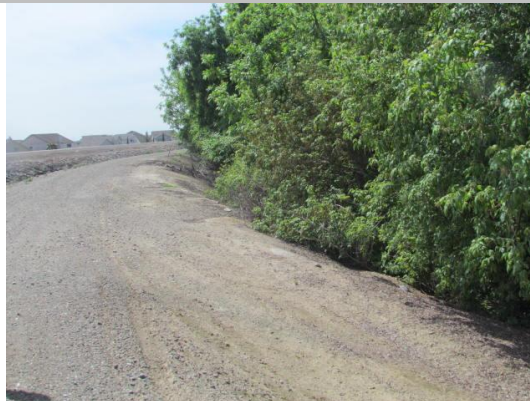
Photo 1 of 1 : FA_2015_RD0524_107_57_20150914_00082.jpg

LM Start	3.51	Rating **	U	Issue No.	57
LM End	3.61	Issue Type +	Ma	Location *	LS
Category	Earthen Levee			GPS Latitude/Longitude	
				Start	End
Item	Trim / Thin Trees			37.905638 °	37.904430 °
				-121.323892 °	-121.324570 °
DWR ID	DWR_RD0524_01_s _ 2012_57				
Action/Comments					
Trim and thin trees to allow visibility of the ground and room to flood fight.

Looking south at dense trees on landward slope.

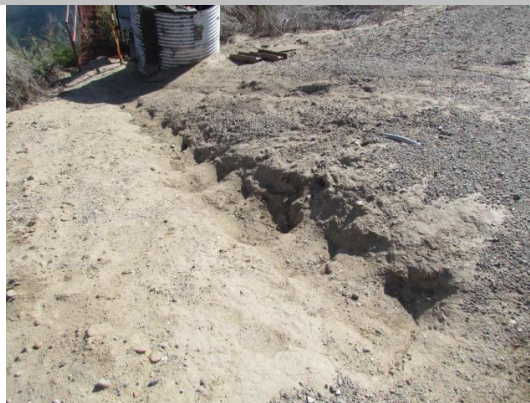
Photo 1 of 1 : FA_2015_RD0524_107_58_20150914_00083.jpg

LM Start	3.64	Rating **	M	Issue No.	58
LM End	3.64	Issue Type +	Ma	Location *	WS
Category	Earthen Levee			GPS Latitude/Longitude	
				Start	End
Item	Slope Stability			37.904113 °	37.904113 °
				-121.325080 °	-121.325080 °
DWR ID	DWR_RD0524_01_s _ 2012_58				
Action/Comments					
Repair the levee slope damaged by foot traffic and prevent access where possible.					
Inspector Comments: Landowner cut steps into waterside slope.

Looking southeast steps cut into waterside slope.

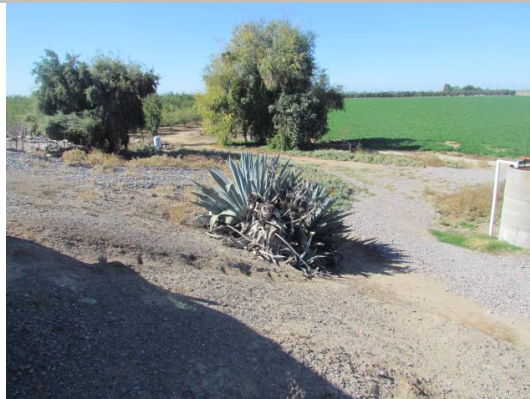
Photo 1 of 1 : FA_2015_RD0524_107_190_20151023_00256.jpg

LM Start	3.65	Rating **	U	Issue No.	190
LM End	3.65	Issue Type +	Ma	Location *	LS
Category	Earthen Levee			GPS Latitude/Longitude	
				Start	End
Item	Vegetation			37.904070 °	37.904070 °
				-121.325118 °	-121.325118 °
DWR ID	DWR_RD0524_01_f_2015_190				
Action/Comments					
Remove the wild growth other than native grasses from the levee slopes.					
Inspector Comments: Large century plant at landward toe.

Looking southwest at century plant at landward toe fall 2015.

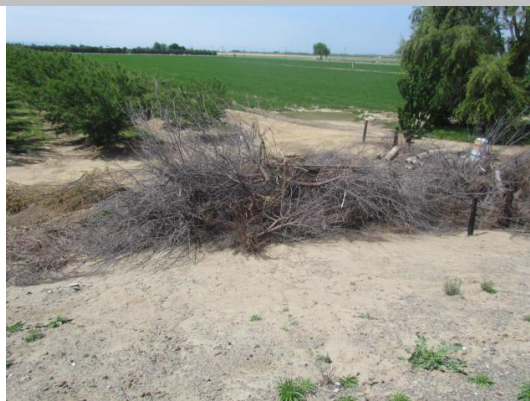
Photo 1 of 1 : FA_2015_RD0524_107_192_20150914_00177.jpg

LM Start	3.67	Rating **	U	Issue No.	192
LM End	3.67	Issue Type +	Ma	Location *	LS
Category	Earthen Levee			GPS Latitude/Longitude	
				Start	End
Item	Encroachments			37.903782 °	37.903782 °
				-121.325363 °	-121.325363 °
DWR ID	DWR_RD0524_01_s_2015_192				
Action/Comments					
Prunings					
Inspector Comments: Large pruning piles at landward toe.

Looking east at pruning pile at landward toe.

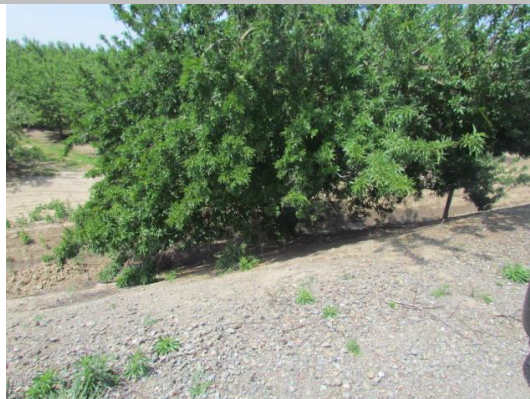
Photo 1 of 1 : FA_2015_RD0524_107_927_20150914_00203.jpg

LM Start	3.77	Rating **	M	Issue No.	927
LM End	3.77	Issue Type +	Ma	Location *	LS
Category	Earthen Levee			GPS Latitude/Longitude	
				Start	End
Item	Trim / Thin Trees			37.902645 °	37.902645 °
				-121.326340 °	-121.326340 °
DWR ID	DWR_RD0524_01_s_2012_927				
Action/Comments					
Trim trees to at least five feet above ground level.

Looking east at untrimmed tree on landward slope.

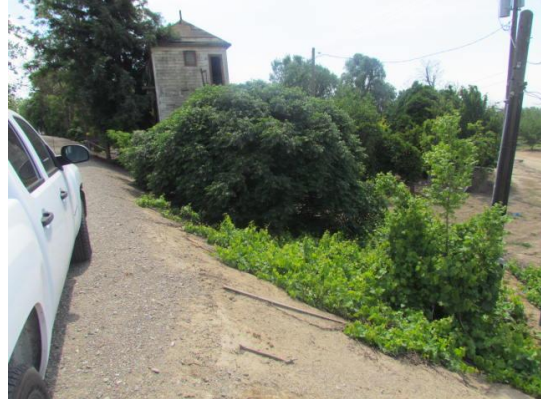
Photo 1 of 1 : FA_2015_RD0524_107_59_20150914_00084.jpg

LM Start	3.78	Rating **	M	Issue No.	59
LM End	3.78	Issue Type +	Ma	Location *	LS
Category	Earthen Levee			GPS Latitude/Longitude	
				Start	End
Item	Trim / Thin Trees			37.902417 °	37.902417 °
				-121.326482 °	-121.326482 °
DWR ID	DWR_RD0524_01_s _ 2012_59				
Action/Comments					
Trim trees to at least five feet above ground level.

Looking south at untrimmed trees on landward slope.

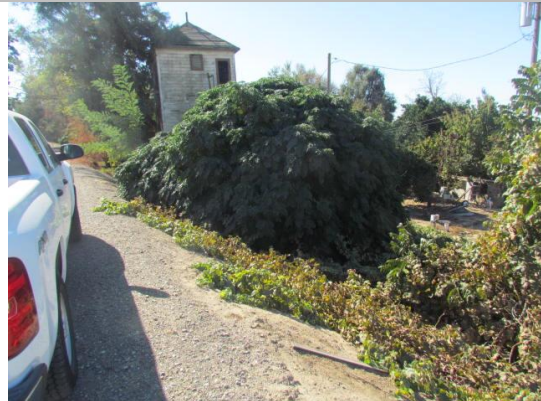
Photo 1 of 1 : FA_2015_RD0524_107_928_20151023_00257.jpg

LM Start	3.80	Rating **	U	Issue No.	928
LM End	3.81	Issue Type +	Ma	Location *	LS
Category	Earthen Levee			GPS Latitude/Longitude	
				Start	End
Item	Trim / Thin Trees			37.902155 °	37.902002 °
				-121.326523 °	-121.326550 °
DWR ID	DWR_RD0524_01_s _ 2012_928				
Action/Comments					
Trim trees to at least five feet above ground level.					
Inspector Comments: Several trees on landward slope.

Looking south at dense vegetation on landward slope and toe.

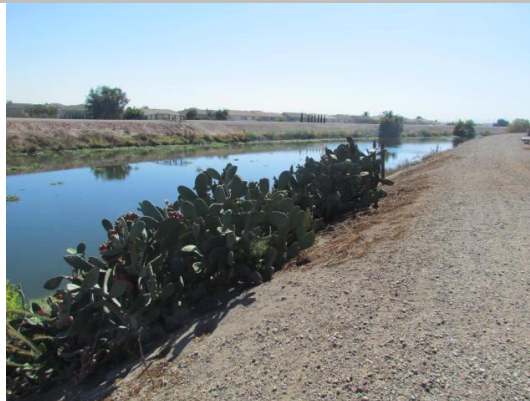
Photo 1 of 2 : FA_2015_RD0524_107_94_20151023_00258.jpg

LM Start	3.88	Rating **	U	Issue No.	94
LM End	3.88	Issue Type +	Ma	Location *	WS
Category	Earthen Levee			GPS Latitude/Longitude	
				Start	End
Item	Vegetation			37.900952 °	37.900952 °
				-121.326443 °	-121.326443 °
DWR ID	DWR_RD0524_01_s _ 2012_94				
Action/Comments					
Remove the wild growth other than native grasses from the levee slopes.					
Inspector Comments: Remove cactus from waterward slope.

Looking southeast at cactus on waterward slope fall 2015

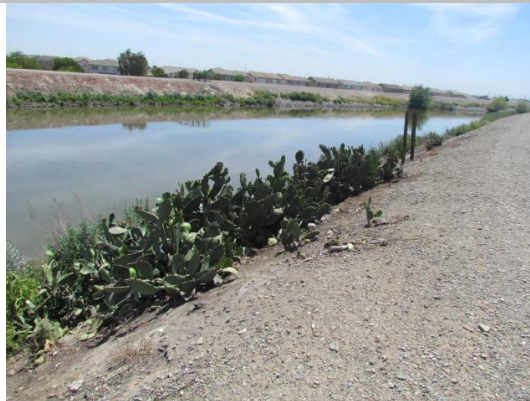
Photo 2 of 2 : FA_2015_RD0524_107_94_20150914_00114.jpg

Looking southeast at cactus on waterside slope. Fall 2013

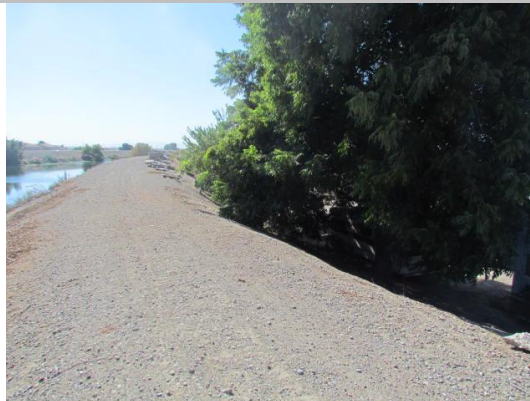
Photo 1 of 1 : FA_2015_RD0524_107_83_20151023_00259.jpg

LM Start	3.89	Rating **	U	Issue No.	83
LM End	3.89	Issue Type +	Ma	Location *	LS
Category	Earthen Levee			GPS Latitude/Longitude	
				Start	End
Item	Trim / Thin Trees			37.900854 °	37.900854 °
				-121.326438 °	-121.326438 °
DWR ID	DWR_RD0524_01_s _ 2012_83				
Action/Comments					
Trim trees to at least five feet above ground level.					
Inspector Comments: Untrimmed tree on landward slope.

Looking south at untrimmed trees on landward slope and toe.

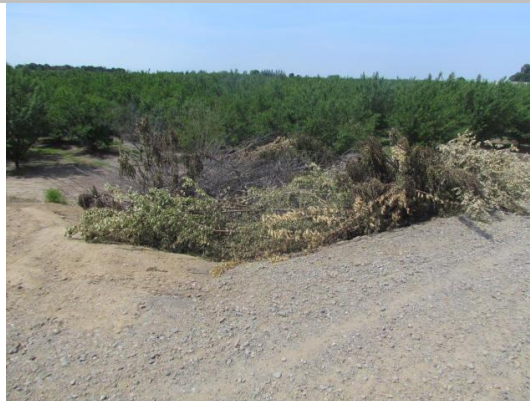
Photo 1 of 1 : FA_2015_RD0524_107_195_20150914_00181.jpg

LM Start	4.02	Rating **	U	Issue No.	195
LM End	4.02	Issue Type +	Ma	Location *	LS
Category	Earthen Levee			GPS Latitude/Longitude	
				Start	End
Item	Encroachments			37.899093 °	37.899093 °
				-121.326933 °	-121.326933 °
DWR ID	DWR_RD0524_01_s _ 2015_195				
Action/Comments					
Prunings					
Inspector Comments: Pruning pile blocking view of landward slope.

Looking east at pruning pile at landward toe.

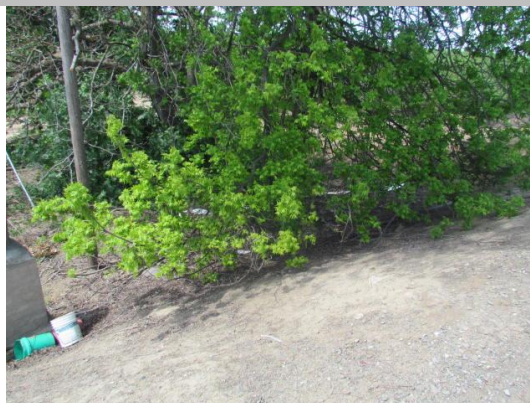
Photo 1 of 1 : FA_2015_RD0524_107_61_20150914_00085.jpg

LM Start	4.03	Rating **	M	Issue No.	61
LM End	4.03	Issue Type +	Ma	Location *	LS
Category	Earthen Levee			GPS Latitude/Longitude	
				Start	End
Item	Trim / Thin Trees			37.898925 °	37.898925 °
				-121.327015 °	-121.327015 °
DWR ID	DWR_RD0524_01_s _ 2012_61				
Action/Comments					
Trim trees to at least five feet above ground level.

Looking east at untrimmed tree at landward toe.

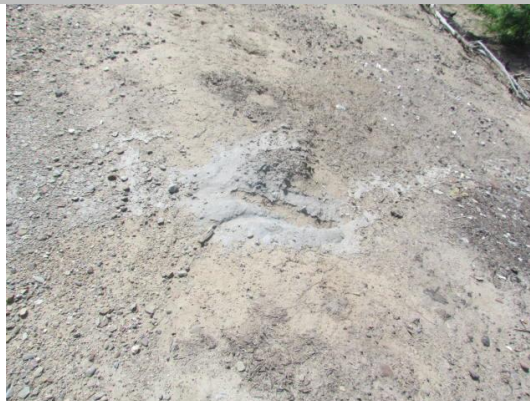
Photo 1 of 1 : FA_2015_RD0524_107_64_20150914_00089.jpg

LM Start	4.04	Rating **	M	Issue No.	64
LM End	4.09	Issue Type +	Ma	Location *	LS
Category	Earthen Levee			GPS Latitude/Longitude	
				Start	End
Item	Animal Control			37.898832 °	37.898090 °
				-121.327092 °	-121.327457 °
DWR ID	DWR_RD0524_01_s _ 2012_64				
Action/Comments					
No rodents visible, but rodent burrows visible; need to backfill and compact or grout burrows.

Looking at typical view of grouted rodent holes on landward slope.

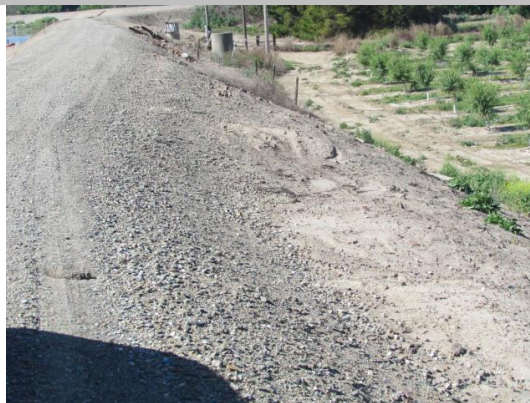
Photo 1 of 1 : FA_2015_RD0524_107_108_20150914_00125.jpg

LM Start	4.10	Rating **	M	Issue No.	108
LM End	4.10	Issue Type +	Ma	Location *	LS
Category	Earthen Levee			GPS Latitude/Longitude	
				Start	End
Item	Slope Stability			37.898035 °	37.898035 °
				-121.327447 °	-121.327447 °
DWR ID	DWR_RD0524_01_s_2012_108				
Action/Comments					
Repair slope instability.

Looking southwest at caving slope on landside of levee.

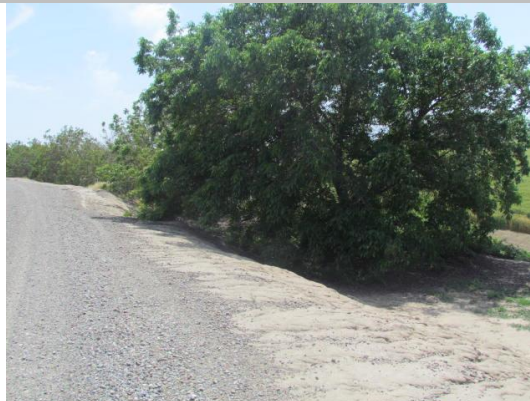
Photo 1 of 2 : FA_2015_RD0524_107_112_20150914_00128.jpg

LM Start	4.40	Rating **	U	Issue No.	112
LM End	4.53	Issue Type +	Ma	Location *	LS
Category	Earthen Levee			GPS Latitude/Longitude	
				Start	End
Item	Trim / Thin Trees			37.893928 °	37.892230 °
				-121.329203 °	-121.328187 °
DWR ID	DWR_RD0524_01_s _ 2012_112				
Action/Comments					
Trim trees to at least five feet above ground level.					
Inspector Comments: Untrimmed trees along landward slope and toe.

Looking southeast at untrimmed tree at landward toe.

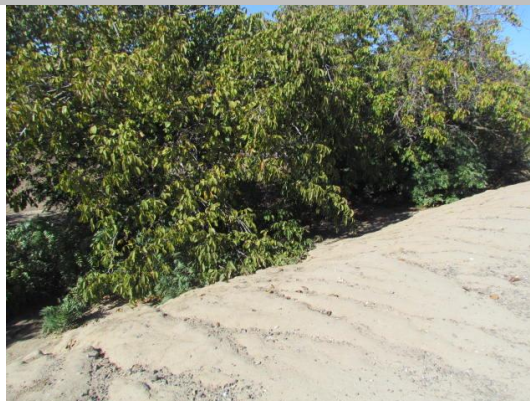
Photo 2 of 2 : FA_2015_RD0524_107_112_20151023_00260.jpg

Looking northeast at untrimmed tree on landward slope and toe fall 2015.

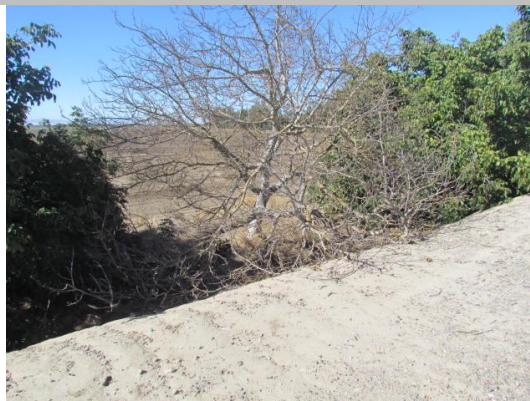
Photo 1 of 1 : FA_2015_RD0524_107_199_20151023_00261.jpg

LM Start	4.43	Rating **	U	Issue No.	199
LM End	4.43	Issue Type +	Ma	Location *	LS
Category	Earthen Levee			GPS Latitude/Longitude	
				Start	End
Item	Encroachments			37.893582 °	37.893582 °
				-121.329108 °	-121.329108 °
DWR ID	DWR_RD0524_01_f _ 2015_199				
Action/Comments					
Tree or limb					
Inspector Comments: Remove dead tree from landward toe.

Looking west at dead tree on landward slope and toe fall 2015.

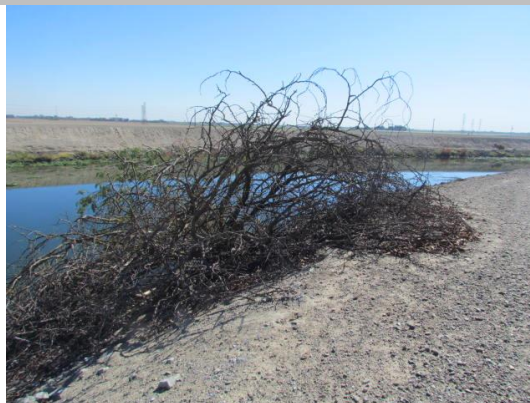
Photo 1 of 2 : FA_2015_RD0524_107_102_20151023_00262.jpg

LM Start	4.52	Rating **	U	Issue No.	102
LM End	4.52	Issue Type +	Ma	Location *	WS
Category	Earthen Levee			GPS Latitude/Longitude	
				Start	End
Item	Encroachments			37.892368 °	37.892368 °
				-121.328200 °	-121.328200 °
DWR ID	DWR_RD0524_01_s _ 2012_102				
Action/Comments					
Prunings					
Inspector Comments: Dead tree on waterward slope.

Looking southeast at dead tree on waterside slope fall 2015

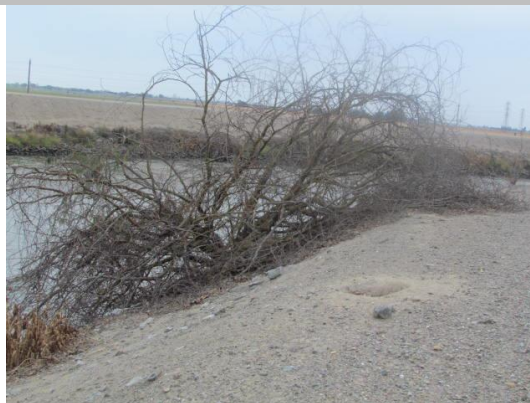
Photo 2 of 2 : FA_2015_RD0524_107_102_20150914_00121.jpg

Looking southeast at dead tree on waterside slope.

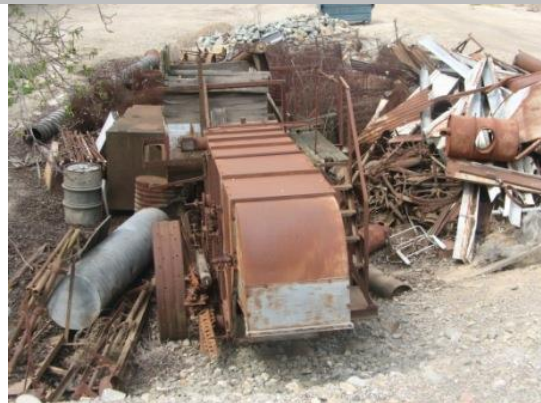
Photo 1 of 1 : FA_2015_RD0524_107_66_20150914_00090.jpg

LM Start	4.60	Rating **	M	Issue No.	66
LM End	4.60	Issue Type +	Ma	Location *	LS
Category	Earthen Levee			GPS Latitude/Longitude	
				Start	End
Item	Encroachments			37.891365 °	37.891365 °
				-121.328633 °	-121.328633 °
DWR ID	DWR_RD0524_01_s_2012_66				
Action/Comments					
Garbage

Garbage at landward toe next to ramp at LM 4.64

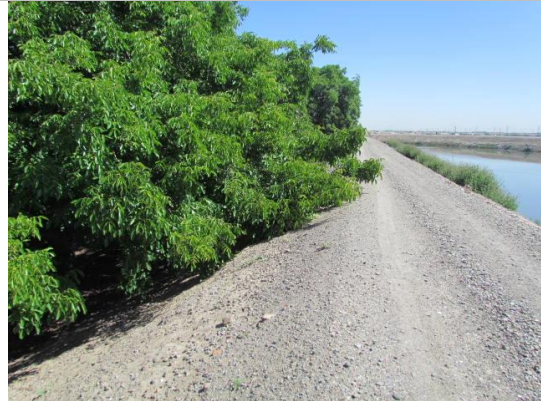
Photo 1 of 1 : FA_2015_RD0524_107_113_20150914_00129.jpg

LM Start	4.63	Rating **	M	Issue No.	113
LM End	4.63	Issue Type +	Ma	Location *	LS
Category	Earthen Levee			GPS Latitude/Longitude	
				Start	End
Item	Trim / Thin Trees			37.890973 °	37.890973 °
				-121.328970 °	-121.328970 °
DWR ID	DWR_RD0524_01_s _ 2012_113				
Action/Comments					
Trim trees to at least five feet above ground level.

Looking north at dense trees on landside slope.

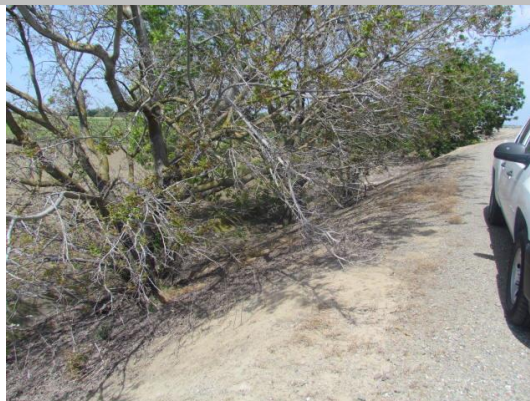
Photo 1 of 1 : FA_2015_RD0524_107_84_20150914_00108.jpg

LM Start	4.90	Rating **	U	Issue No.	84
LM End	4.93	Issue Type +	Ma	Location *	LS
Category	Earthen Levee			GPS Latitude/Longitude	
				Start	End
Item	Trim / Thin Trees			37.887655 °	37.887277 °
				-121.331202 °	-121.331609 °
DWR ID	DWR_RD0524_01_s_2012_84				
Action/Comments					
Trim trees to at least five feet above ground level.

Looking northeast at untrimmed trees on landward slope.

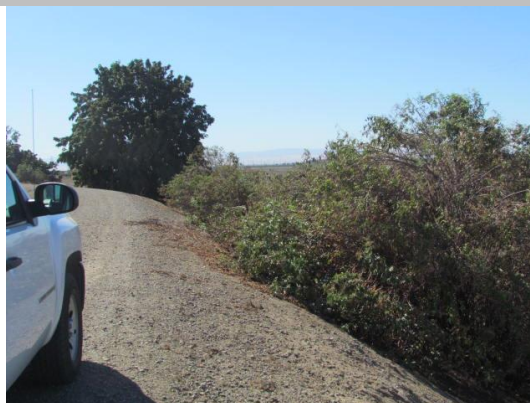
Photo 1 of 1 : FA_2015_RD0524_107_114_20151023_00263.jpg

LM Start	4.96	Rating **	U	Issue No.	114
LM End	4.98	Issue Type +	Ma	Location *	LS
Category	Earthen Levee			GPS Latitude/Longitude	
				Start	End
Item	Vegetation			37.886907 °	37.886673 °
				-121.331862 °	-121.331965 °
DWR ID	DWR_RD0524_01_s_2012_114				
Action/Comments					
Elderberries are blocking visibility and flood fight capability. Inspector Comments: Dense elderberry on landward slope.

Looking southwest at dense elderberry bush on landward slope and toe fall 2015.

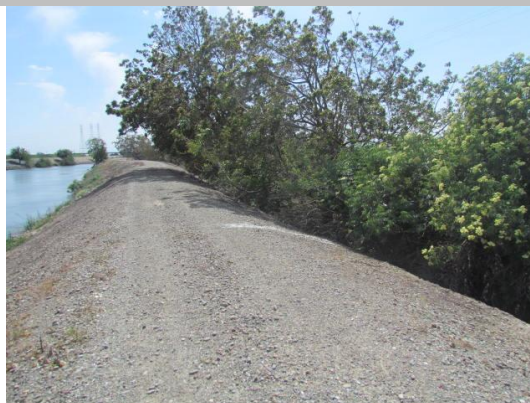
Photo 1 of 1 : FA_2015_RD0524_107_71_20150914_00092.jpg

LM Start	5.00	Rating **	U	Issue No.	71
LM End	5.07	Issue Type +	Ma	Location *	LS
Category	Earthen Levee			GPS Latitude/Longitude	
				Start	End
Item	Trim / Thin Trees			37.886410 °	37.885286 °
				-121.332092 °	-121.332167 °
DWR ID	DWR_RD0524_01_s_2012_71				
Action/Comments					
Trim trees to at least five feet above ground level.

Looking south at untrimmed trees on landward slope.

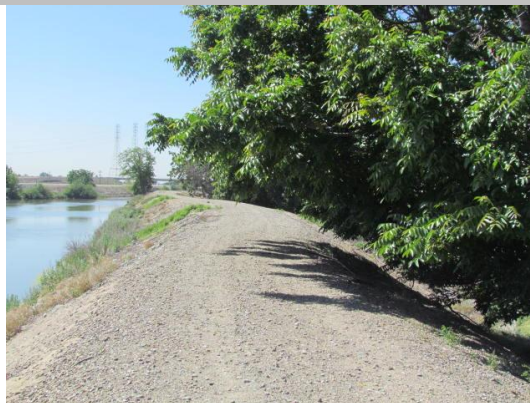
Photo 1 of 1 : FA_2015_RD0524_107_68_20150914_00091.jpg

LM Start	5.07	Rating **	U	Issue No.	68
LM End	5.07	Issue Type +	Ma	Location *	LS
Category	Earthen Levee			GPS Latitude/Longitude	
				Start	End
Item	Trim / Thin Trees			37.885400 °	37.885400 °
				-121.332153 °	-121.332153 °
DWR ID	DWR_RD0524_01_s _ 2012_68				
Action/Comments					
Trim trees over roadway to at least 12 feet above ground level.

Looking south at overhanging trees.

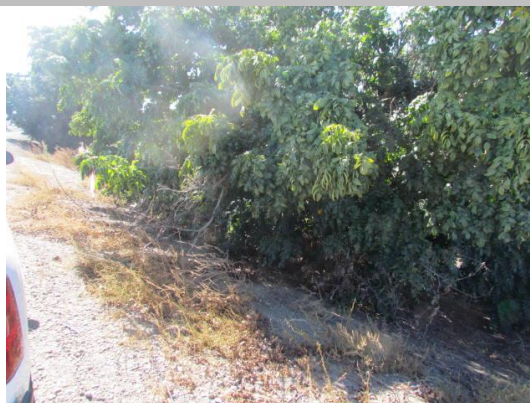
Photo 1 of 1 : FA_2015_RD0524_107_188_20151023_00264.jpg

LM Start	5.12	Rating **	U	Issue No.	188
LM End	5.17	Issue Type +	Ma	Location *	LS
Category	Earthen Levee			GPS Latitude/Longitude	
				Start	End
Item	Trim / Thin Trees			37.884627 °	37.883965 °
				-121.332172 °	-121.332152 °
DWR ID	DWR_RD0524_01_s _ 2014_188				
Action/Comments					
Trim trees to at least five feet above ground level.					
Inspector Comments: Untrimmed trees on landward slope and toe.

Looking southwest at untrimmed trees on landward slope and toe.

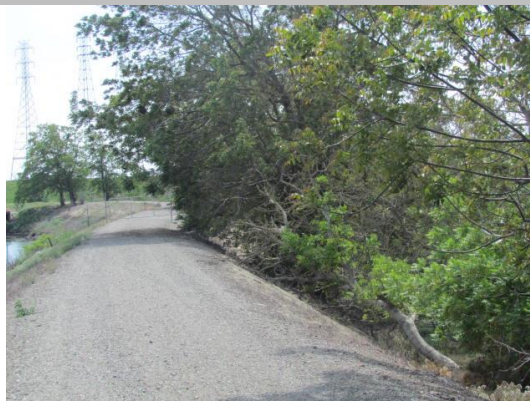
Photo 1 of 1 : FA_2015_RD0524_107_932_20150914_00206.jpg

LM Start	5.38	Rating **	U	Issue No.	932
LM End	5.41	Issue Type +	Ma	Location *	LS
Category	Earthen Levee			GPS Latitude/Longitude	
				Start	End
Item	Trim / Thin Trees			37.880945 °	37.880522 °
				-121.332837 °	-121.332918 °
DWR ID	DWR_RD0524_01_s _ 2012_932				
Action/Comments					
Trim trees to at least five feet above ground level.

Looking south at untrimmed trees on landward slope and toe.

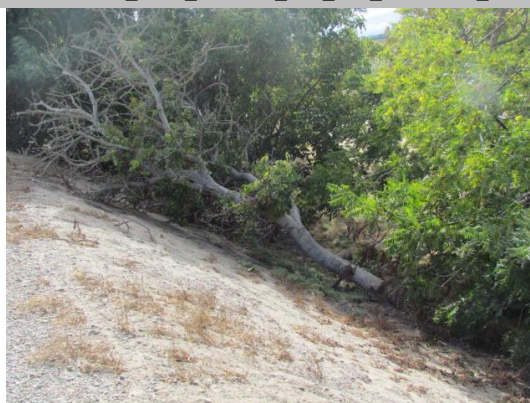
Photo 1 of 1 : FA_2015_RD0524_107_178_20150914_00168.jpg

LM Start	5.39	Rating **	M	Issue No.	178
LM End	5.39	Issue Type +	Ma	Location *	LS
Category	Earthen Levee			GPS Latitude/Longitude	
				Start	End
Item	Encroachments			37.880806 °	37.880806 °
				-121.332833 °	-121.332833 °
DWR ID	DWR_RD0524_01_f _ 2014_178				
Action/Comments					
Tree or limb					
Inspector Comments: Downed tree on landward toe.

Looking south at downed tree on landward slope.

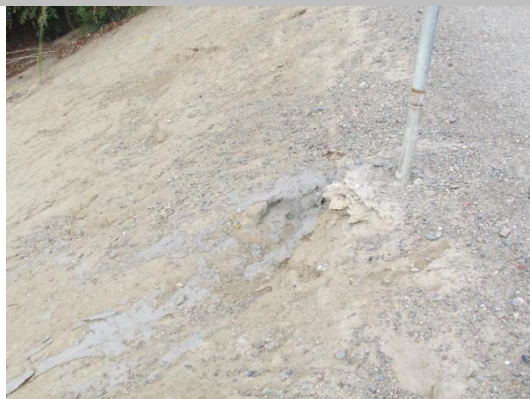
Photo 1 of 2 : FA_2015_RD0524_107_931_20150914_00204.jpg

LM Start	5.41	Rating **	A/W	Issue No.	931
LM End	5.41	Issue Type +	Ma	Location *	LS
Category	Earthen Levee			GPS Latitude/Longitude	
				Start	End
Item	Animal Control			37.880575 °	37.880575 °
				-121.332890 °	-121.332890 °
DWR ID	DWR_RD0524_01_s _ 2012_931				
Action/Comments					
Exterminate rodents and backfill and compact or grout burrows. Inspector Comments: LMA grouted rodent holes.

Looking north at typical view of grouted rodent holes on landward shoulder and slope.

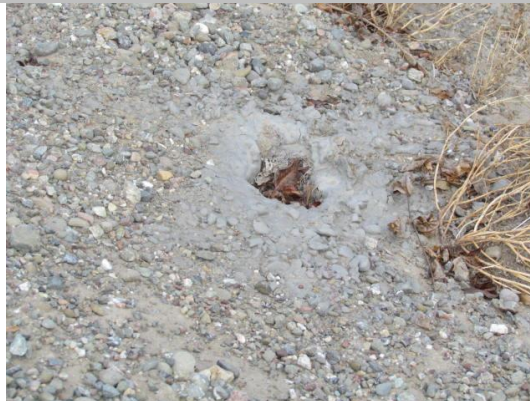
Photo 2 of 2 : FA_2015_RD0524_107_931_20150914_00205.jpg

LM Start	5.41	Rating **	A/W	Issue No.	931 (cont)
LM End	5.41	Issue Type +	Ma	Location *	LS
Category	Earthen Levee			GPS Latitude/Longitude	
				Start	End
Item	Animal Control			37.880575 °	37.880575 °
				-121.332890 °	-121.332890 °
DWR ID	DWR_RD0524_01_s_2012_931				
Action/Comments					
Exterminate rodents and backfill and compact or grout burrows. Inspector Comments: LMA grouted rodent holes.

Looking north at typical view of grouted rodent holes on waterward slope.

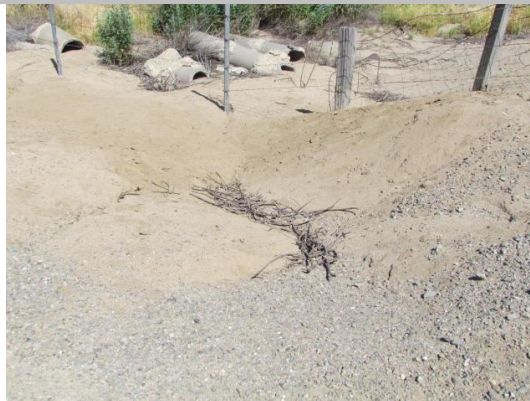
Photo 1 of 3 : FA_2015_RD0524_107_118_20150914_00131.jpg

LM Start	5.42	Rating **	M	Issue No.	118
LM End	5.42	Issue Type +	Ma	Location *	LS
Category	Earthen Levee			GPS Latitude/Longitude	
				Start	End
Item	Slope Stability			37.880323 °	37.880323 °
				-121.332968 °	-121.332968 °
DWR ID	DWR_RD0524_01_s_2012_118				
Action/Comments					
Repair slope instability.					
Inspector Comments: Slope damage caused by human activity.

Looking west at slope damage on landside slope.

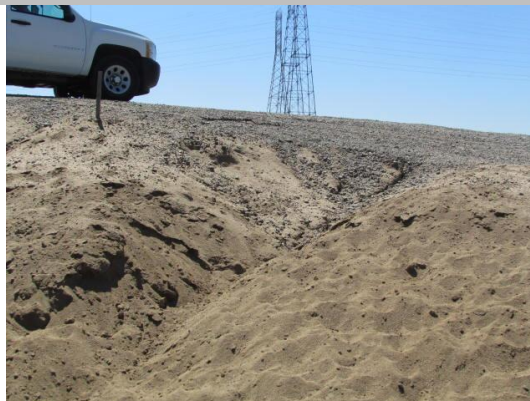
Photo 2 of 3 : FA_2015_RD0524_107_118_20150914_00132.jpg

Looking southeast at damaged slope.

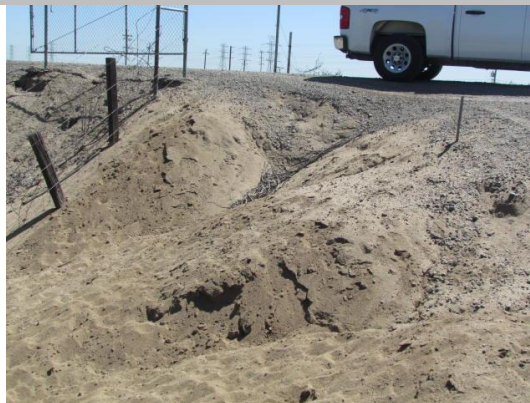
Photo 3 of 3 : FA_2015_RD0524_107_118_20150914_00133.jpg

LM Start	5.42	Rating **	M	Issue No.	118 (cont)
LM End	5.42	Issue Type +	Ma	Location *	LS
Category	Earthen Levee			GPS Latitude/Longitude	
				Start	End
Item	Slope Stability			37.880323 °	37.880323 °
				-121.332968 °	-121.332968 °
DWR ID	DWR_RD0524_01_s_2012_118				
Action/Comments					
Repair slope instability.					
Inspector Comments: Slope damage caused by human activity.

Looking east at slope caving on landside slope.

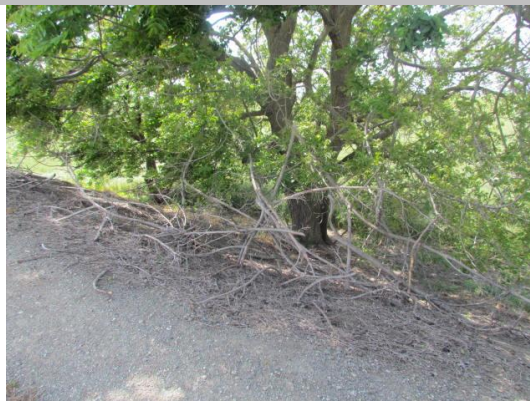
Photo 1 of 1 : FA_2015_RD0524_107_73_20150914_00093.jpg

LM Start	5.44	Rating **	U	Issue No.	73
LM End	5.44	Issue Type +	Ma	Location *	LS
Category	Earthen Levee			GPS Latitude/Longitude	
				Start	End
Item	Trim / Thin Trees			37.880085 °	37.880085 °
				-121.333045 °	-121.333045 °
DWR ID	DWR_RD0524_01_s _ 2012_73				
Action/Comments					
Trim trees to at least five feet above ground level.

Looking east at untrimmed trees on landward slope.

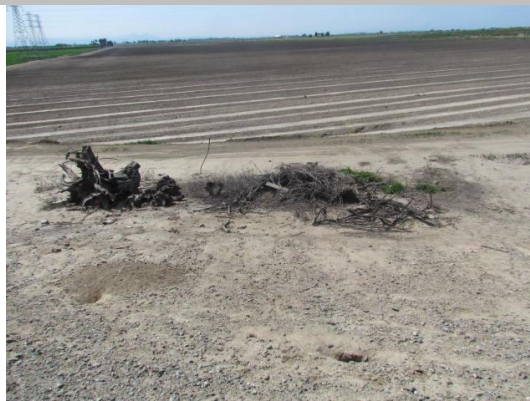
Photo 1 of 1 : FA_2015_RD0524_107_267_20150914_00195.jpg

LM Start	5.79	Rating **	M	Issue No.	267
LM End	5.79	Issue Type +	Ma	Location *	LS
Category	Earthen Levee			GPS Latitude/Longitude	
				Start	End
Item	Encroachments			37.875328 °	37.875328 °
				-121.333050 °	-121.333050 °
DWR ID	DWR_RD0524_01_s _ 2012_267				
Action/Comments					
Prunings					
Inspector Comments: Prunings at landside toe should be burned or removed.

Looking east at pruning piles at landward toe and berm.

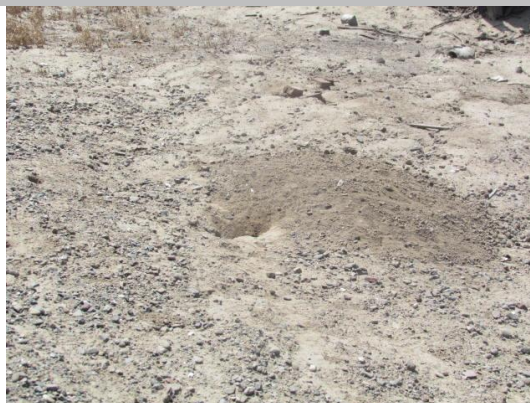
Photo 1 of 2 : FA_2015_RD0524_107_197_20150914_00182.jpg

LM Start	5.79	Rating **	M	Issue No.	197
LM End	5.79	Issue Type +	Ma	Location *	LS
Category	Earthen Levee			GPS Latitude/Longitude	
				Start	End
Item	Animal Control			37.875310 °	37.875310 °
				-121.333065 °	-121.333065 °
DWR ID	DWR_RD0524_01_s _ 2015_197				
Action/Comments					
Exterminate rodents and backfill and compact or grout burrows. Inspector Comments: Several rodent holes on landward slope and levee crown.

Looking north at typical view of rodent holes on landward slope.

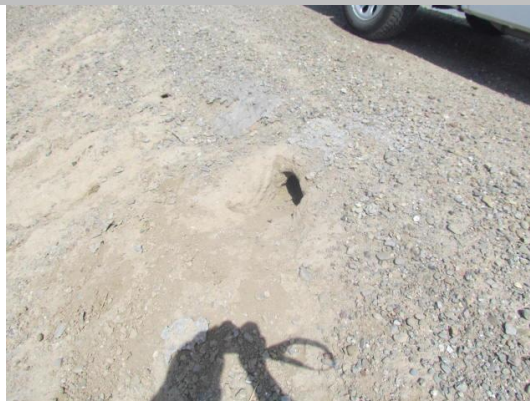
Photo 2 of 2 : FA_2015_RD0524_107_197_20150914_00183.jpg

Looking southwest at typical view of rodent hole at landward shoulder.

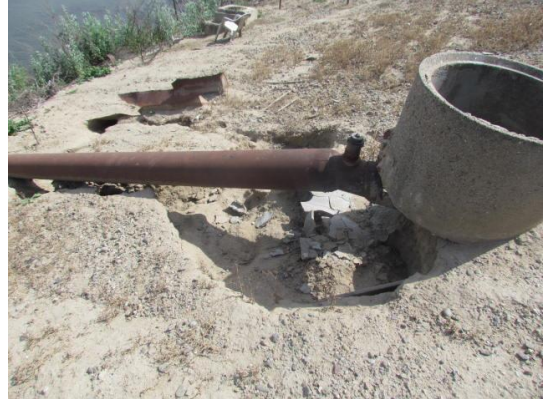
Photo 1 of 3 : FA_2015_RD0524_107_198_20150914_00184.jpg

Looking south at erosion around irrigation pipe on waterward slope.

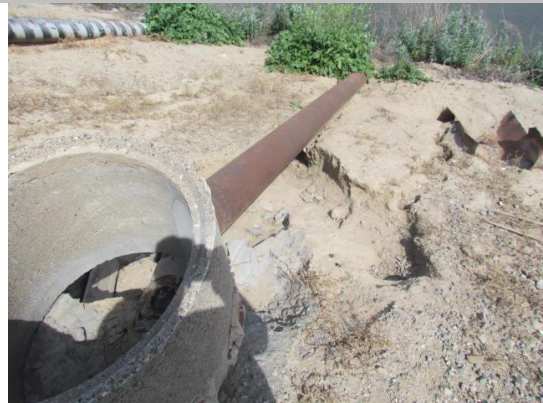
Photo 2 of 3 : FA_2015_RD0524_107_198_20150914_00185.jpg

Looking east at erosion around irrigation pipe.

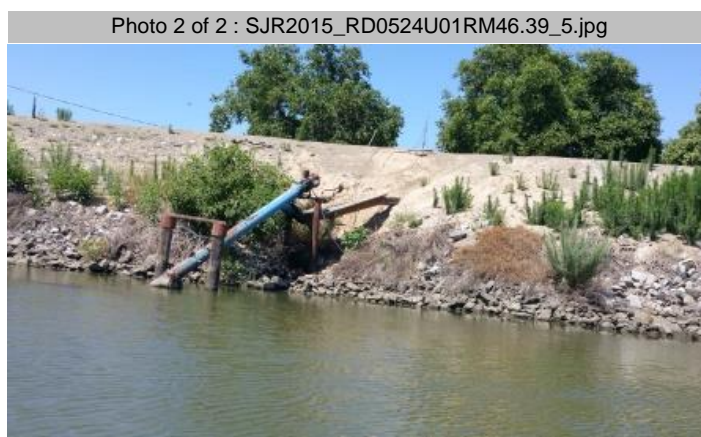
LM Start	5.86	Rating **	U	Issue No.	47
LM End	5.86	Issue Type +	Ma	Location *	WS
Category	Supplemental			GPS Latitude/Longitude	
				Start	End
Item	DWR Erosion Survey			37.874370 °	37.874370 °
				-121.332850 °	-121.332850 °
DWR ID					
Action/Comments					
Inspector Comments: 06/24/2015: No significant change observed. 06/19/2014: No significant change observed. 08/13/2013: No significant change observed. 08/07/2012: The erosion is near a water-intake structure. Pipe leakage likely caused the erosion. [2015 Site ID:RD0524U01RM46.39]

Front view of the site.

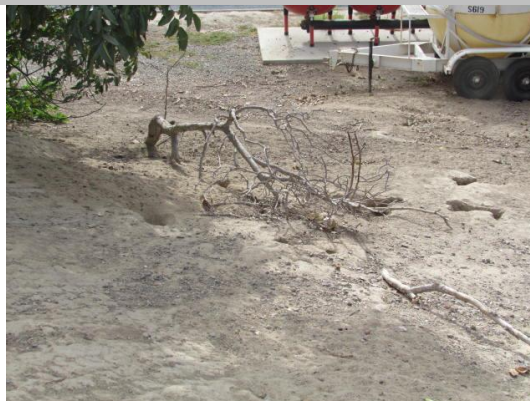
Photo 2 of 2 : FA_2015_RD0524_107_75_20150914_00098.jpg

LM Start	5.86	Rating **	M	Issue No.	75 (cont)	
LM End	5.88	Issue Type +	Ma	Location *	WS	
Category	Earthen Levee			GPS Latitude/Longitude		
				Start		End
Item	Animal Control			37.874240 °		37.874002 °
				-121.333187 °		-121.333027 °
DWR ID	DWR_RD0524_01_s_2012_75					
Action/Comments						
No rodents visible, but rodent burrows visible; need to backfill and compact or grout burrows. Inspector Comments: District has grouted rodent holes, but other rodent holes have appeared.

Looking typical view of several rodent holes on landward slope and toe.

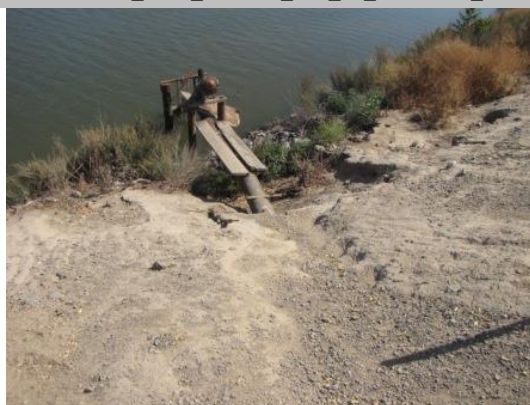
Photo 1 of 3 : FA_2015_RD0524_107_74_20150914_00094.jpg

LM Start	5.86	Rating **	M	Issue No.	74
LM End	5.87	Issue Type +	Ma	Location *	WS
Category	Earthen Levee			GPS Latitude/Longitude	
				Start	End
Item	Erosion / Bank Caving			37.874240 °	37.874165 °
				-121.333185 °	-121.333155 °
DWR ID	DWR_RD0524_01_s_2012_74				
Action/Comments					
Note and monitor erosion site.					
Inspector Comments: Erosion on landward slope around intake pipe.

Looking southeast at erosion around pipe.

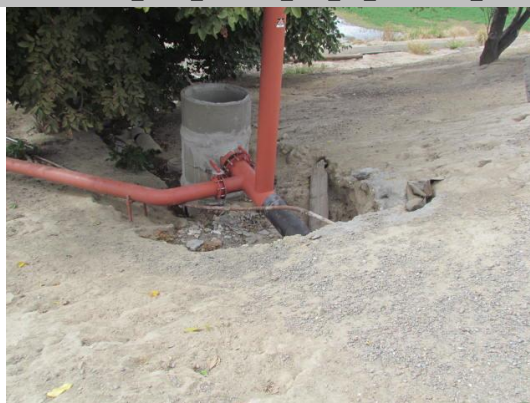
Photo 2 of 3 : FA_2015_RD0524_107_74_20150914_00095.jpg

Looking west at erosion around intake pipe on landward slope.

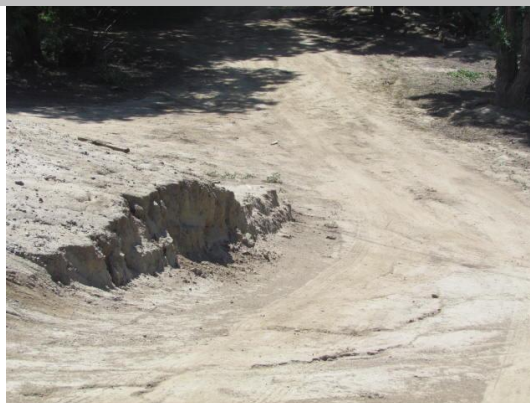
Photo 1 of 2 : FA_2015_RD0524_107_119_20150914_00134.jpg

LM Start	5.89	Rating **	U	Issue No.	119
LM End	5.89	Issue Type +	Ma	Location *	LS
Category	Earthen Levee			GPS Latitude/Longitude	
				Start	End
Item	Slope Stability			37.873893 °	37.873893 °
				-121.332978 °	-121.332978 °
DWR ID	DWR_RD0524_01_s_2012_119				
Action/Comments					
Repair the levee slope damaged by vehicle traffic and prevent access where possible.					
Inspector Comments: Landowner is using damaged area as a ramp.

Looking west at unauthorized ramp and landside slope damage.

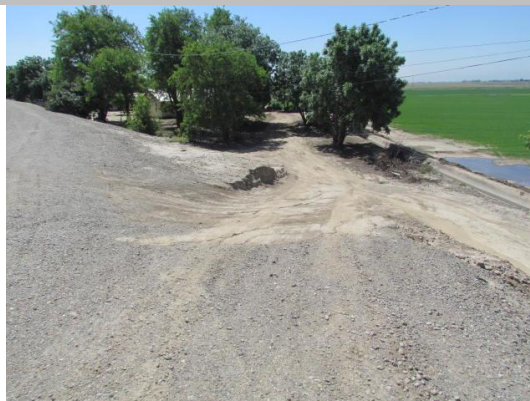
Photo 2 of 2 : FA_2015_RD0524_107_119_20150914_00135.jpg

Looking southwest at damaged slope and ramp on landside slope.

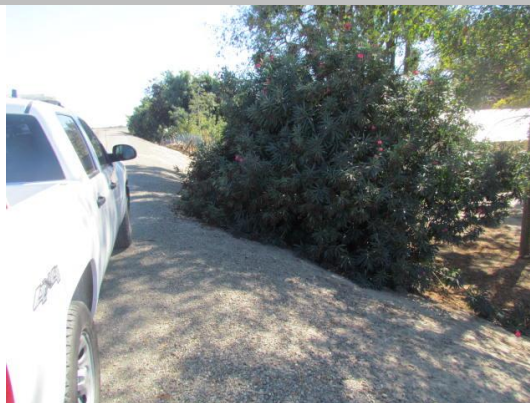
Photo 1 of 1 : FA_2015_RD0524_107_200_20151023_00266.jpg

LM Start	5.92	Rating **	U	Issue No.	200
LM End	5.92	Issue Type +	Ma	Location *	LS
Category	Earthen Levee			GPS Latitude/Longitude	
				Start	End
Item	Vegetation			37.873623 °	37.873623 °
				-121.332585 °	-121.332585 °
DWR ID	DWR_RD0524_01_f _ 2015_200				
Action/Comments					
Remove the wild growth other than native grasses from the levee slopes.					
Inspector Comments: Oleander bush on landward slope.

Looking south at oleander on landward slope fall 2015.

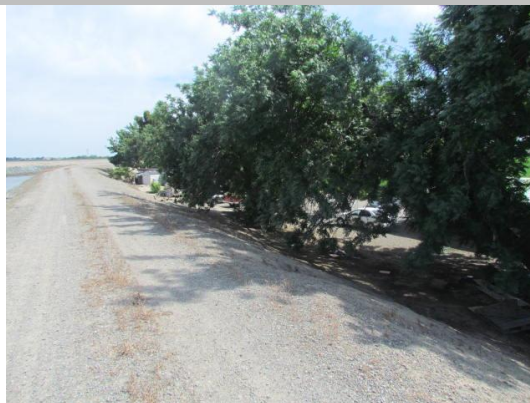
Photo 1 of 1 : FA_2015_RD0524_107_120_20150914_00136.jpg

LM Start	5.96	Rating **	U	Issue No.	120
LM End	5.96	Issue Type +	Ma	Location *	LS
Category	Earthen Levee			GPS Latitude/Longitude	
				Start	End
Item	Trim / Thin Trees			37.873347 °	37.873347 °
				-121.332028 °	-121.332028 °
DWR ID	DWR_RD0524_01_s _ 2012_120				
Action/Comments					
Trim trees to at least five feet above ground level.

Looking south at untrimmed trees on landward slope and toe.

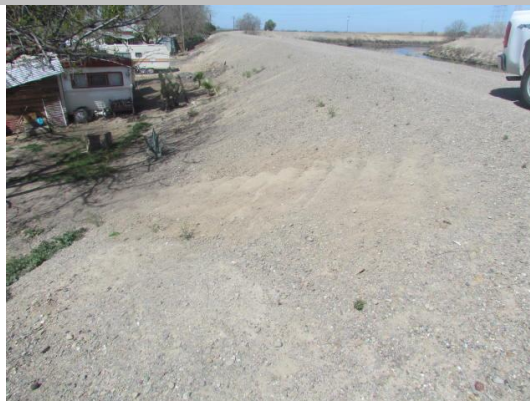
Photo 1 of 1 : FA_2015_RD0524_107_933_20150914_00207.jpg

LM Start	6.00	Rating **	M	Issue No.	933
LM End	6.00	Issue Type +	Ma	Location *	LS
Category	Earthen Levee			GPS Latitude/Longitude	
				Start	End
Item	Slope Stability			37.873047 °	37.873047 °
				-121.331408 °	-121.331408 °
DWR ID	DWR_RD0524_01_s _ 2012_933				
Action/Comments					
Repair the levee slope damaged by foot traffic and prevent access where possible.					
Inspector Comments: Landowner cut steps into landside slope.

Looking north at steps cut into landward slope.
