**Flood Control Project Maintenance
Levee Inspections**

Maintenance Issue Types Only, Levee Inspection Report By Mile - Fall 2015

Reclamation District No. 0524 Middle Roberts Island

Waterway	Bank	Unit Miles	Inspection Start/End	Inspector
Unit No. 01 San Joaquin River	Left	6.20	10/21/2015 10/21/2015	Richard Willoughby

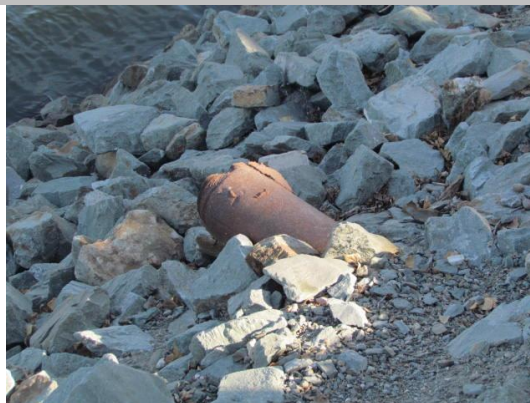
Photo 1 of 1 : FA_2015_RD0524_107_268_20150914_00196.jpg

LM Start	6.15	Rating **	M	Issue No.	268
LM End	6.15	Issue Type +	Ma	Location *	WS
Category	Earthen Levee			GPS Latitude/Longitude	
				Start	End
Item	Encroachments			37.871137 °	37.871137 °
				-121.330138 °	-121.330138 °
DWR ID	DWR_RD0524_01_s _ 2012_268				
Action/Comments					
Pipe Inspector Comments: Open abandoned 10" pipe on waterside slope below flood elevation. Pipe should be removed or properly abandoned.

Looking southeast at abandoned pipe on waterside slope.

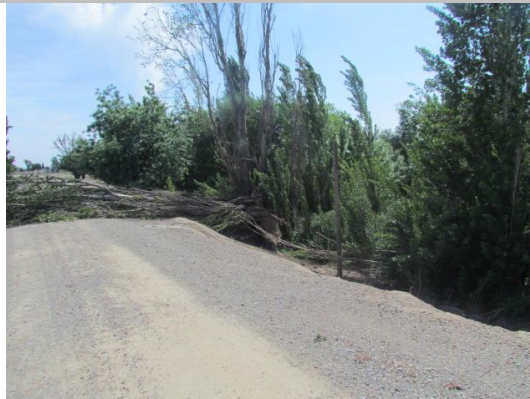
Photo 1 of 2 : FA_2015_RD0524_107_81_20150914_00105.jpg

LM Start	6.15	Rating **	U	Issue No.	81
LM End	6.15	Issue Type +	Ma	Location *	LS
Category	Earthen Levee			GPS Latitude/Longitude	
				Start	End
Item	Encroachments			37.871097 °	37.871097 °
				-121.330100 °	-121.330100 °
DWR ID	DWR_RD0524_01_s _ 2015_81				
Action/Comments					
Tree or limb					
Inspector Comments: Large tree fallen across levee crown blocking access.

Looking southwest at large tree across levee crown.

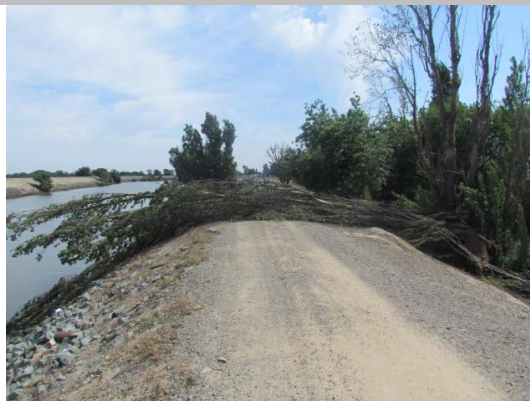
Photo 2 of 2 : FA_2015_RD0524_107_81_20150914_00106.jpg

Looking south at large tree across levee crown.

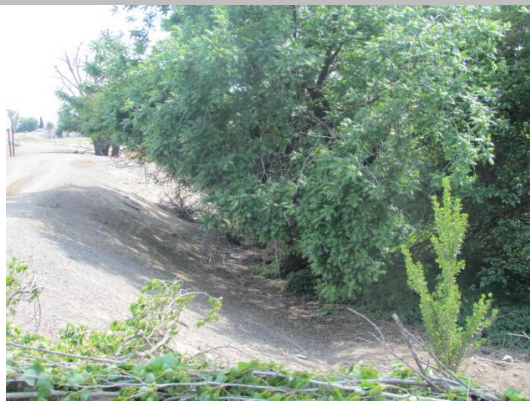
Photo 1 of 1 : FA_2015_RD0524_107_98_20150914_00118.jpg

LM Start	6.17	Rating **	U	Issue No.	98
LM End	6.17	Issue Type +	Ma	Location *	LS
Category	Earthen Levee			GPS Latitude/Longitude	
				Start	End
Item	Trim / Thin Trees			37.870842 °	37.870842 °
				-121.330000 °	-121.330000 °
DWR ID	DWR_RD0524_01_s _ 2012_98				
Action/Comments					
Trim trees to at least five feet above ground level.

Looking southeast at untrimmed trees at landward toe.
