**Flood Control Project Maintenance
Levee Inspections**

Maintenance Issue Types Only, Levee Inspection Report By Mile - Fall 2016

Reclamation District No. 0524 Middle Roberts Island

Waterway	Bank	Unit Miles	Inspection Start/End	Inspector
Unit No. 01 San Joaquin River	Left	6.20	10/10/2016 10/11/2016	Richard Willoughby

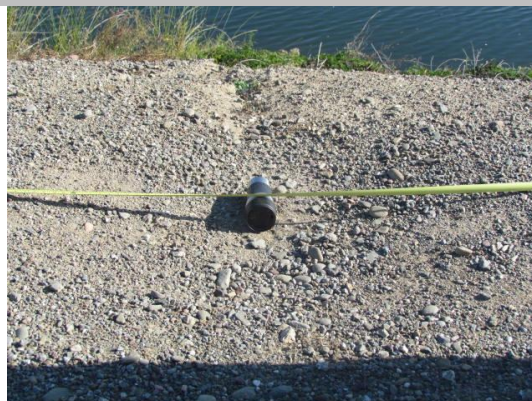
Photo 2 of 3 : FA_2016_RD0524_107_3_20160929_00008.jpg

Looking west at depression on levee crown near waterward shoulder.

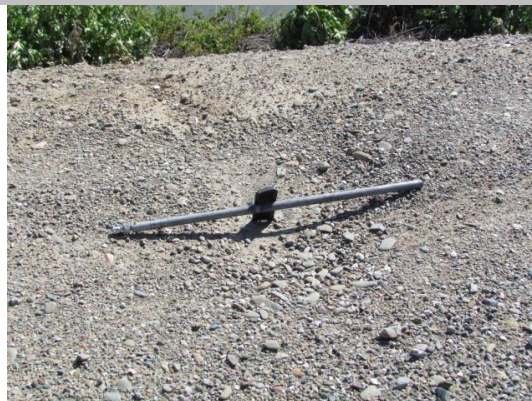
Photo 3 of 3 : FA_2016_RD0524_107_3_20160929_00009.jpg

Looking east at 3" depression on levee crown. (Spring 2012)

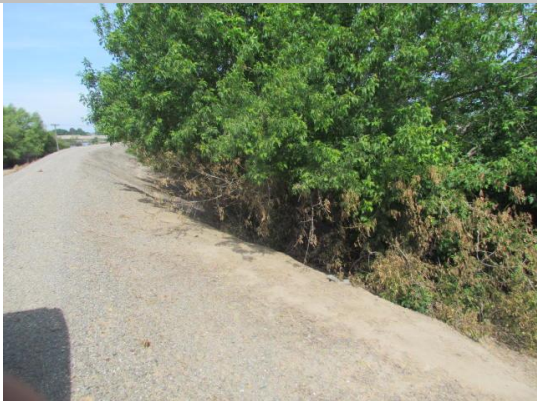
Photo 3 of 4 : FA_2016_RD0524_107_179_20160929_00225.jpg

Looking west at untrimmed tree on waterward slope. (Spring 2015)

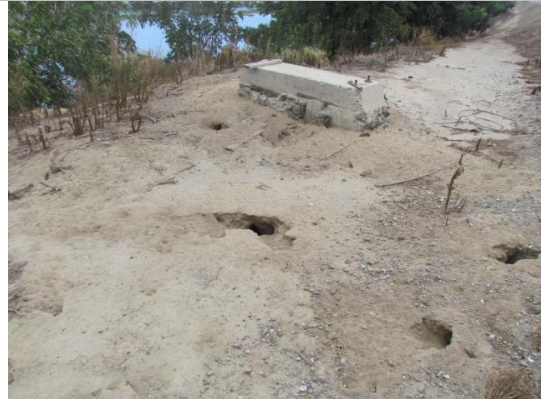
Photo 2 of 4 : FA_2016_RD0524_107_174_20160929_00219.jpg

LM Start	0.30	Rating **	U	Issue No.	174 (cont)
LM End	0.30	Issue Type +	Ma	Location *	WS
Category	Earthen Levee			GPS Latitude/Longitude	
				Start	End
Item	Animal Control			37.938382 °	37.938382 °
				-121.342352 °	-121.342352 °
DWR ID	DWR_RD0524_01_f _ 2014_174				
Comment Code					
A3 : No rodents visible, but rodent burrows visible; need to backfill and compact or grout burrows.					
Inspector Comment					
Several rodent holes present at this site. No change at site during spring 2016 inspection.

Looking southeast at several rodent holes on waterward slope. (Spring 2016)

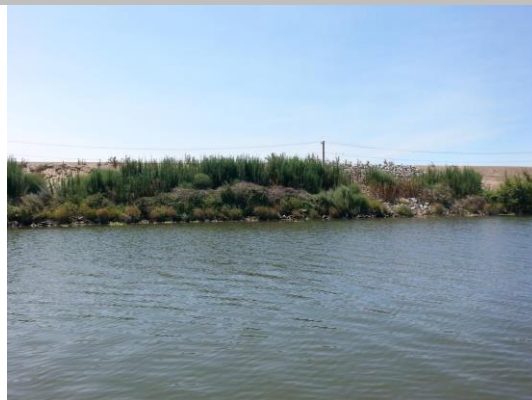
Photo 1 of 2 : SJR2016_RD0524U01RM40.99_2.jpg

LM Start	0.40	Rating **	U	Issue No.	16
LM End	0.40	Issue Type +	Ma	Location *	WS
Category	Supplemental			GPS Latitude/Longitude	
				Start	End
Item	DWR Erosion Survey			37.938870 °	37.938870 °
				-121.340460 °	-121.340460 °
DWR ID					
Comment Code					
Inspector Comment					
07/25/2016: More vegetation observed at the site.					
06/24/2015: No significant change observed.					
06/19/2014: No significant change observed.					
08/13/2013: No significant change at this site.					
08/07/2012: The erosion is at the upper levee slope, and likely caused by slope slip. The lower levee slope is covered with dense vegetation.					
[2016 Site ID:RD0524U01RM40.99]

Front view of the site.

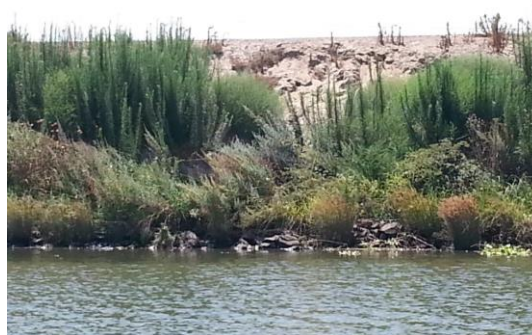
Photo 2 of 2 : SJR2016_RD0524U01RM40.99_4.jpg

Close view of the erosion.

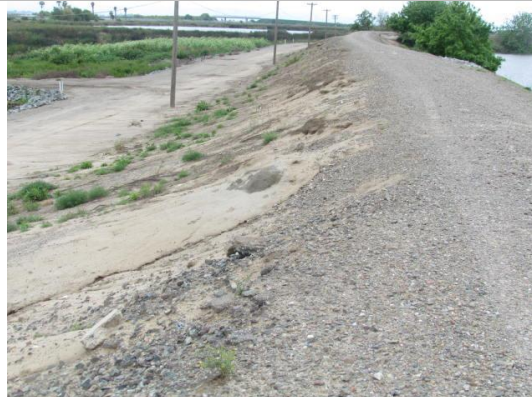
Photo 1 of 2 : FA_2016_RD0524_107_205_20160929_00246.jpg

LM Start	0.40	Rating **	U	Issue No.	205
LM End	0.46	Issue Type +	Ma	Location *	LS
Category	Earthen Levee			GPS Latitude/Longitude	
				Start	End
Item	Slope Stability			37.938625 °	37.938695 °
				-121.340479 °	-121.339420 °
DWR ID	DWR_RD0524_01_s_2016_205				
Comment Code					
S1 : Repair slope instability.					
Inspector Comment					
Several damage site within this reach.

Looking at slope damage on landward slope.

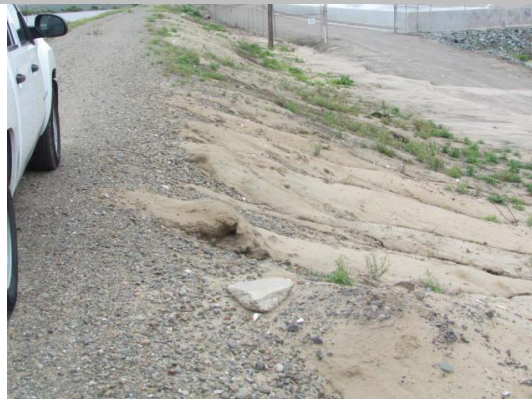
Photo 2 of 2 : FA_2016_RD0524_107_205_20160929_00247.jpg

Looking at slope damage on landward slope.

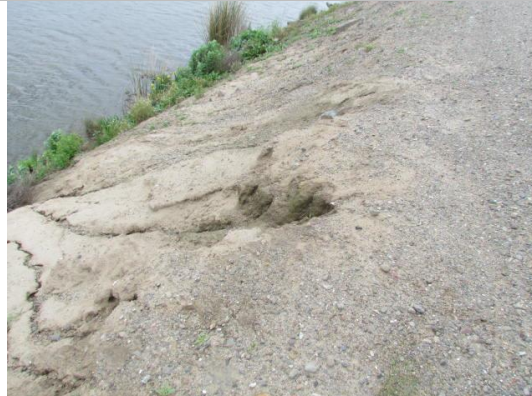
Photo 1 of 3 : FA_2016_RD0524_107_170_20160929_00210.jpg

LM Start	0.41	Rating **	U	Issue No.	170
LM End	0.45	Issue Type +	Ma	Location *	WS
Category	Earthen Levee			GPS Latitude/Longitude	
				Start	End
Item	Slope Stability			37.938628 °	37.938688 °
				-121.340385 °	-121.339627 °
DWR ID	DWR_RD0524_01_s_2015_170				
Comment Code					
S1 : Repair slope instability.					
Inspector Comment					
Several slope instabilities within this reach.

Looking at slope damage on waterward shoulder (Spring 2016)

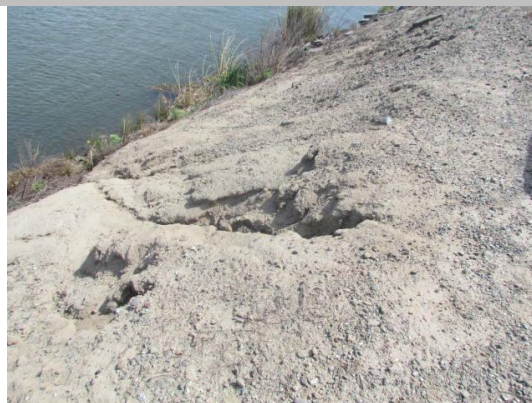
Photo 3 of 3 : FA_2016_RD0524_107_170_20160929_00212.jpg

Looking at waterward slope erosion.

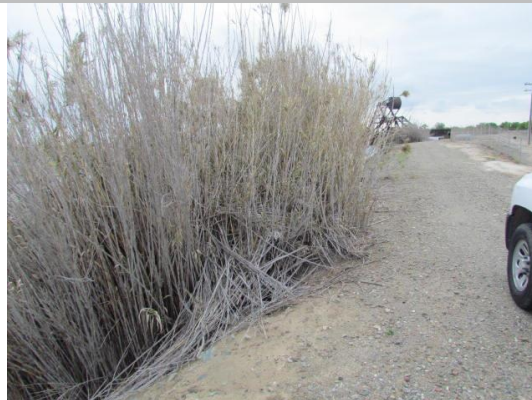
Photo 1 of 5 : FA_2016_RD0524_107_11_20160929_00018.jpg

LM Start	0.62	Rating **	U	Issue No.	11
LM End	0.63	Issue Type +	Ma	Location *	WS
Category	Earthen Levee			GPS Latitude/Longitude	
				Start	End
Item	Vegetation			37.938278°	37.938247°
				-121.336524°	-121.336503°
DWR ID	DWR_RD0524_01_s_2012_11				
Comment Code					
V2 : Remove the wild growth other than native grasses from the levee slopes.					
Inspector Comment					
Bamboo on waterward slope. Bamboo has been killed but still blocking view of waterward slope.

Looking at bamboo on waterward slope. (Spring 2016)

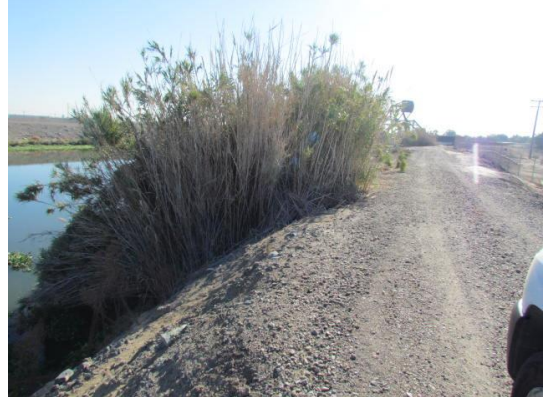
Photo 2 of 5 : FA_2016_RD0524_107_11_20160929_00019.jpg

Looking at bamboo on waterside slope. (Fall 2015)

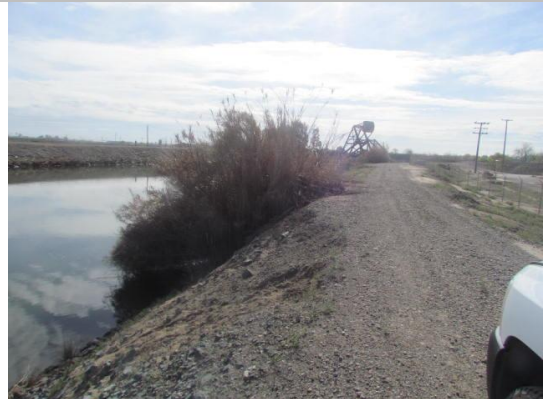
Photo 3 of 5 : FA_2016_RD0524_107_11_20160929_00020.jpg

Looking at dying bamboo on waterward slope. (Spring 2013)

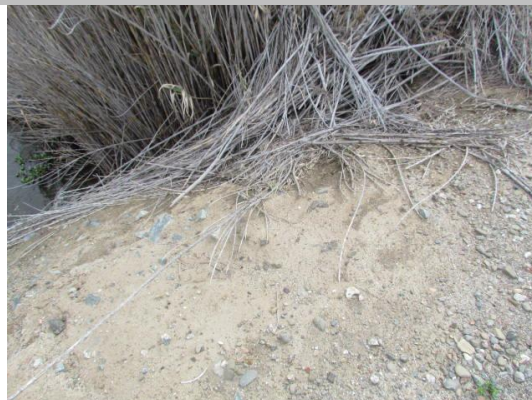
Photo 2 of 3 : FA_2016_RD0524_107_10_20160929_00016.jpg

LM Start	0.63	Rating **	U	Issue No.	10 (cont)	
LM End	0.63	Issue Type +	Ma	Location *	WS	
Category	Earthen Levee			GPS Latitude/Longitude		
				Start		End
Item	Erosion / Bank Caving			37.938247 °		37.938247 °
				-121.336503 °		-121.336503 °
DWR ID	DWR_RD0524_01_f_2015_10					
Comment Code						
E2 : Schedule repair of erosion site prior to the next inspection.						
Inspector Comment						
Erosion located next to and under bamboo.

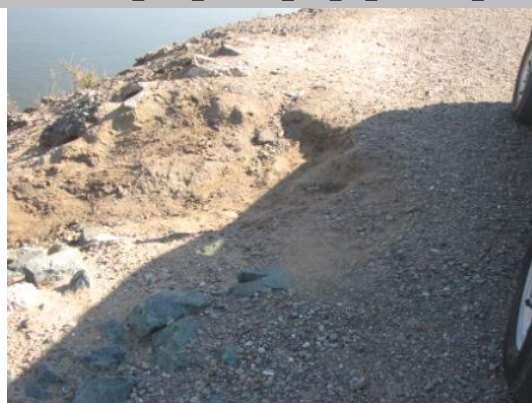
Photo 4 of 4 : FA_2016_RD0524_107_13_20160929_00027.jpg

LM Start	0.64	Rating **	M	Issue No.	13 (cont)	
LM End	0.65	Issue Type +	Ma	Location *	WS	
Category	Earthen Levee			GPS Latitude/Longitude		
				Start		End
Item	Slope Stability			37.938105 °		37.938023 °
				-121.336288 °		-121.336173 °
DWR ID	DWR_RD0524_01_s_2012_13					
Comment Code						
S1 : Repair slope instability.						
Inspector Comment						
Depression extend from shoulder to mid levee slope two site with this section.

Update view of the erosion site.

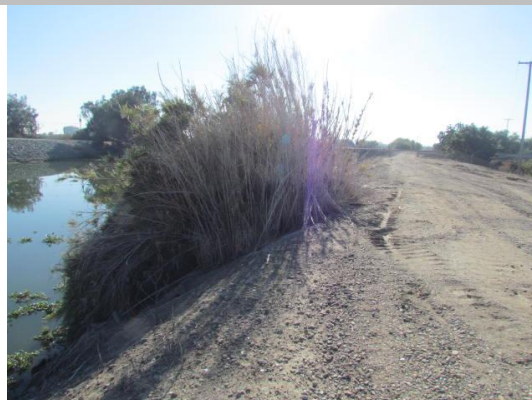
Photo 1 of 3 : FA_2016_RD0524_107_14_20160929_00028.jpg

LM Start	0.67	Rating **	U	Issue No.	14
LM End	0.67	Issue Type +	Ma	Location *	WS
Category	Earthen Levee			GPS Latitude/Longitude	
				Start	End
Item	Vegetation			37.937808 °	37.937808 °
				-121.335913 °	-121.335913 °
DWR ID	DWR_RD0524_01_s_2012_14				
Comment Code					
V2 : Remove the wild growth other than native grasses from the levee slopes.					
Inspector Comment					
Bamboo on waterward slope.Bamboo has been killed but still blocking view of levee slope.

Looking south at dying bamboo on waterward slope. Fall 2015

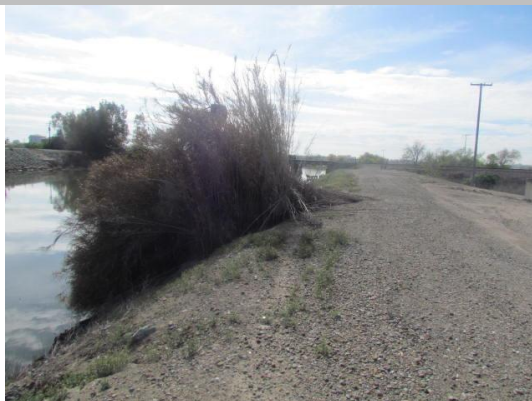
Photo 2 of 3 : FA_2016_RD0524_107_14_20160929_00029.jpg

Looking south at dying bamboo on waterward slope. (Spring 2013)

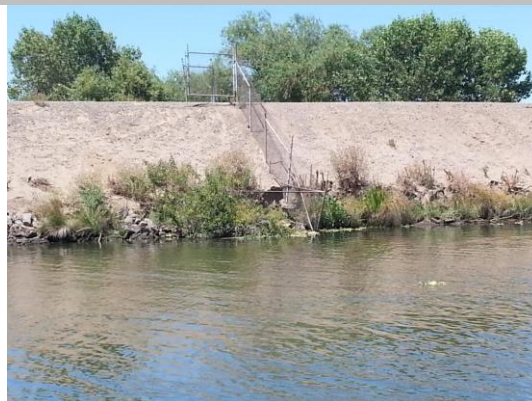
Photo 1 of 2 : SJR2016_RD0524U01RM41.39_1.jpg

07/25/2016: No significant change observed.
 06/24/2015: No significant change observed.
 06/19/2014: No significant change observed.
 08/13/2013: No significant change at this site.
 08/07/2012: The site has been visited by boat survey. No significant change observed.
 08/23/2011: The site is located immediately upstream of a Railroad bridge. Dense vegetation at the water line blocks the view of erosion.
 [2016 Site ID:RD0524U01RM41.39]

Front view of the erosion site.

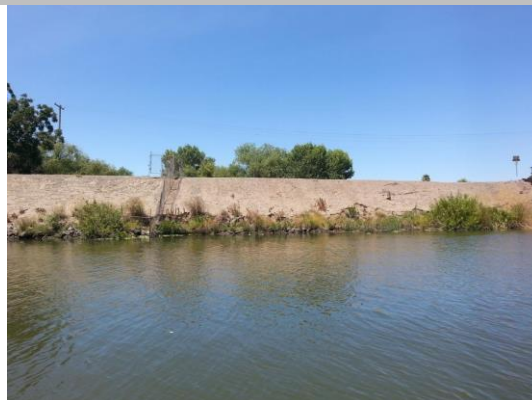
Photo 2 of 2 : SJR2016_RD0524U01RM41.39_4.jpg

Front view of the erosion.

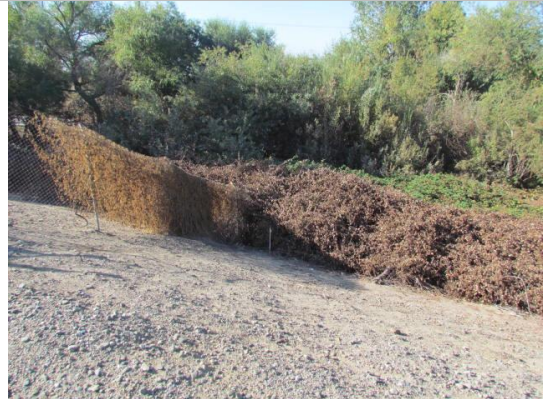
Photo 1 of 3 : FA_2016_RD0524_107_262_20160929_00264.jpg

Looking west at dense vegetation at landward slope and toe fall 2015.

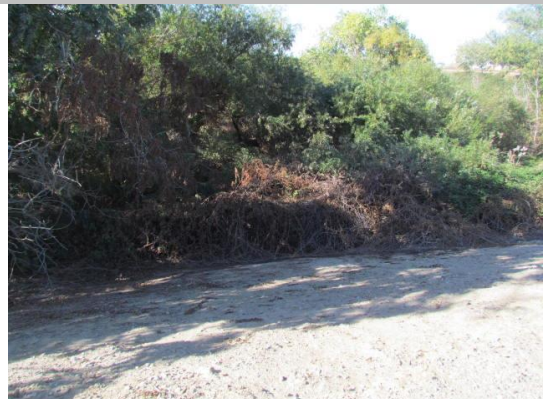
Photo 2 of 3 : FA_2016_RD0524_107_262_20160929_00265.jpg

Looking west at dense vegetation on landside toe. Spring 2014

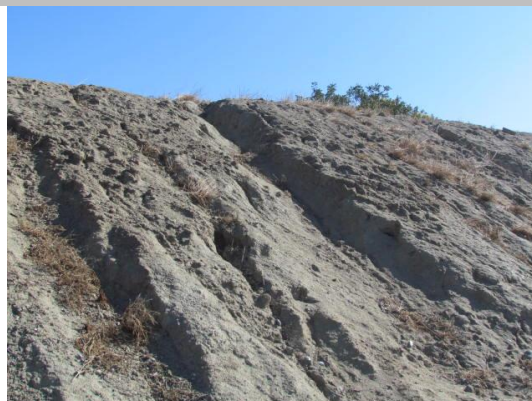
Photo 4 of 6 : FA_2016_RD0524_107_2_20160929_00004.jpg

LM Start	0.81	Rating **	U	Issue No.	2 (cont)	
LM End	0.81	Issue Type +	Ma	Location *	LS	
Category	Earthen Levee			GPS Latitude/Longitude		
				Start		End
Item	Erosion / Bank Caving			37.936093°	37.936004°	
				-121.334648°	-121.334615°	
DWR ID	DWR_RD0524_01_f_2013_2					
Comment Code						
E2 : Schedule repair of erosion site prior to the next inspection.						
Inspector Comment						
One large hole. Hole is over 12" deep and 12" wide and several holes and finger erosions on landward slope.

Looking southeast at finger erosion on landward slope.

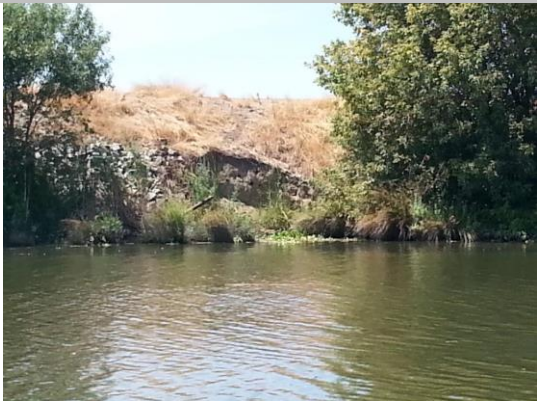
Photo 2 of 2 : SJR2016_RD0524U01RM41.5_2.jpg

Close view of the erosion.

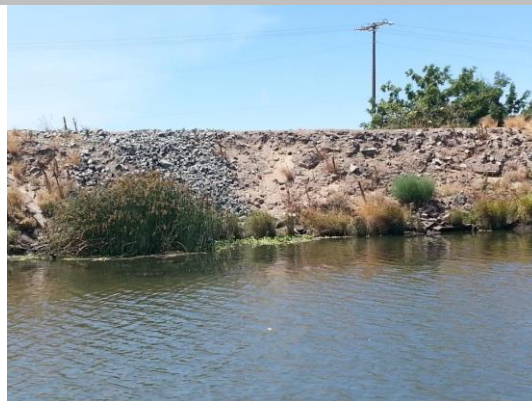
Photo 2 of 3 : SJR2016_RD0524U01RM41.59_2.jpg

Close view of the erosion.

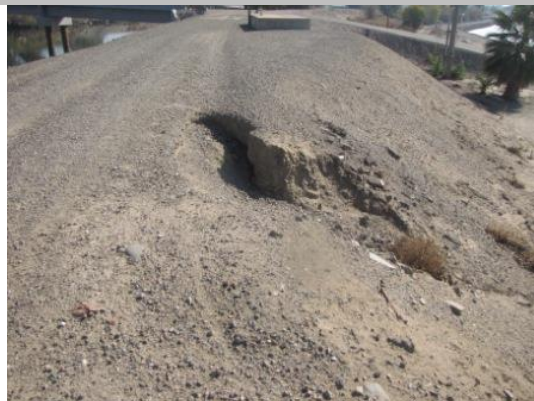
Photo 4 of 7 : FA_2016_RD0524_107_18_20160929_00040.jpg

Updated picture of the erosion site on the landside shoulder. Fall 2014

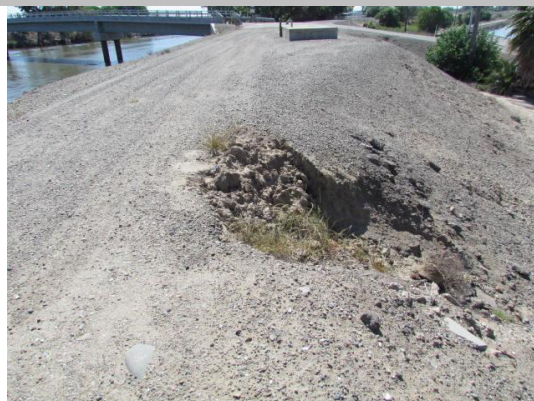
Photo 5 of 7 : FA_2016_RD0524_107_18_20160929_00041.jpg

Looking south at caving on landside shoulder. (Spring 2013)

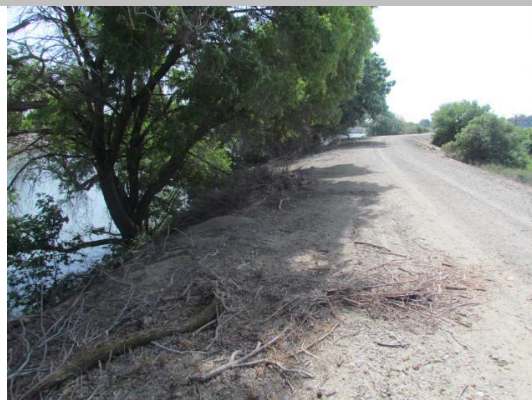
Photo 1 of 1 : FA_2016_RD0524_107_171_20160929_00213.jpg

LM Start	1.12	Rating **	M	Issue No.	171
LM End	1.16	Issue Type +	Ma	Location *	WS
Category	Earthen Levee			GPS Latitude/Longitude	
				Start	End
Item	Encroachments			37.934225 °	37.933815 °
				-121.329693 °	-121.329242 °
DWR ID	DWR_RD0524_01_s_2015_171				
Comment Code					
PR : Prunings					
Inspector Comment					
Prunings left on waterward shoulder and slope.

Looking south at prunings on waterward shoulders.

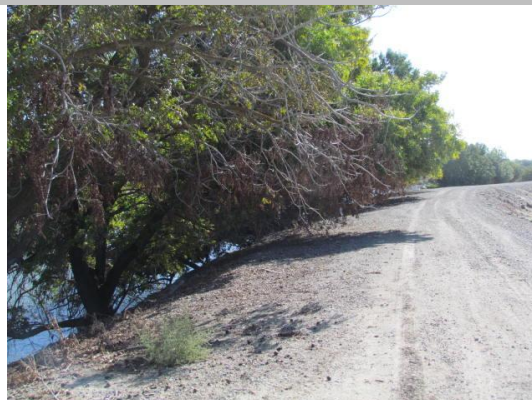
Photo 1 of 1 : FA_2016_RD0524_107_19_20160929_00044.jpg

Looking southeast at low hanging tree branches at waterside toe.

LM Start	1.13	Rating **	M	Issue No.	19
LM End	1.16	Issue Type +	Ma	Location *	WS
Category	Earthen Levee			GPS Latitude/Longitude	
				Start	End
Item	Trim / Thin Trees			37.934118 °	37.933775 °
				-121.329657 °	-121.329305 °
DWR ID	DWR_RD0524_01_s_2012_19				
Comment Code					
T1 : Trim trees to at least five feet above ground level.					
Inspector Comment

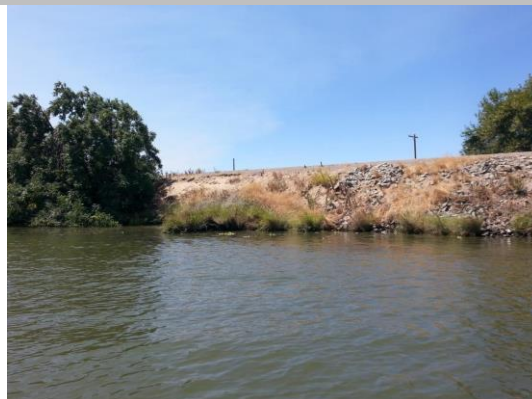
Photo 1 of 3 : SJR2016_RD0524U01RM41.79_2.jpg

10/18/2006: There is extensive loss of rip rap on some sections; sewage disposal pond is on the landside of the levee; there is an exposed pipe outlet "hanging" from the upper slope. [2016 Site ID:RD0524U01RM41.79]

Direct view of the site.

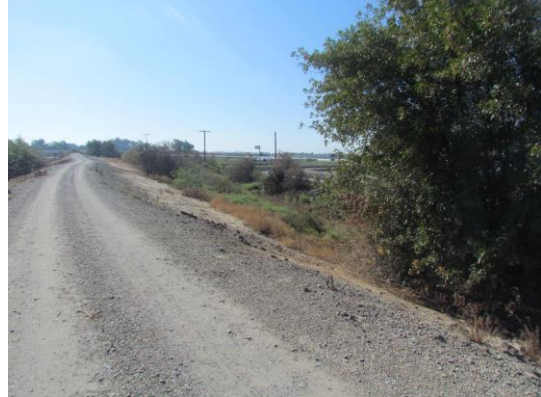
Photo 1 of 4 : FA_2016_RD0524_107_915_20161013_00387.jpg

Looking southwest at dense veg at landward toe and berm. (Fall 2016)

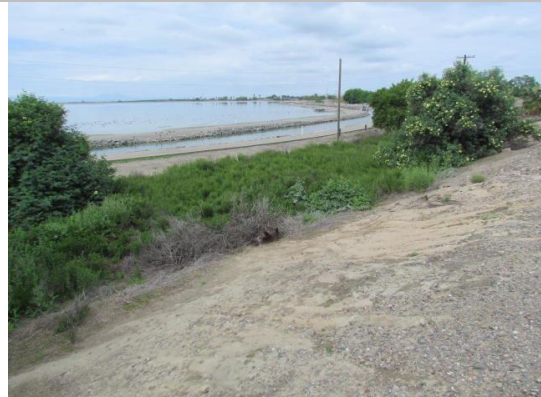
Photo 2 of 4 : FA_2016_RD0524_107_915_20160929_00274.jpg

Looking northwest at dense veg at landward toe and berm. (Spring 2016)

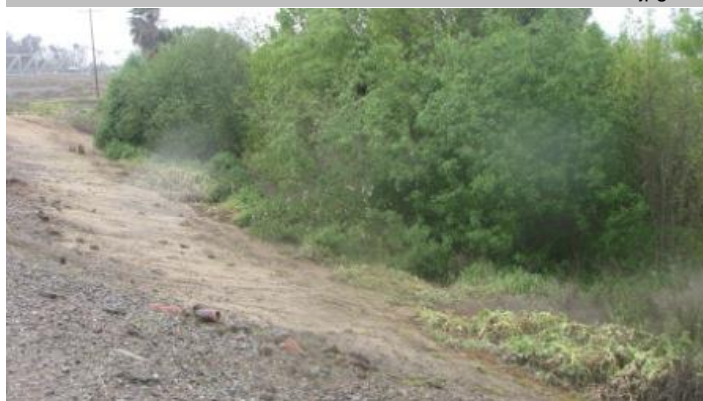
Photo 4 of 4 : FA_2016_RD0524_107_915_20160929_00276.jpg

LM Start	1.16	Rating **	U	Issue No.	915 (cont)	
LM End	1.23	Issue Type +	Ma	Location *	LS	
Category	Earthen Levee			GPS Latitude/Longitude		
				Start		End
Item	Vegetation			37.933775 °		37.932784 °
				-121.329250 °		-121.328765 °
DWR ID	DWR_RD0524_01_s_2012_915					
Comment Code						
V2 : Remove the wild growth other than native grasses from the levee slopes.						
Inspector Comment						
Control veg at landward toe and berm.

Looking southwest at dense veg. on landside toe. (Fall 2015)

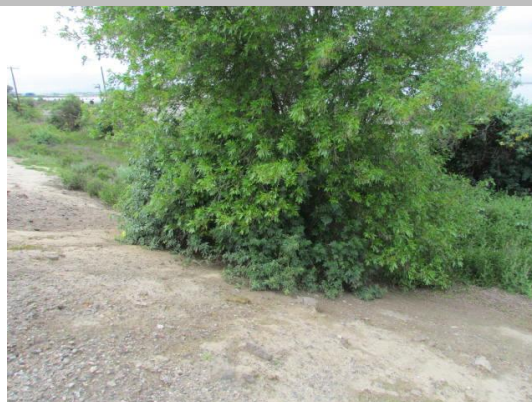
Photo 1 of 1 : FA_2016_RD0524_107_206_20160929_00248.jpg

Looking southwest a untrimmed tree at landward toe. (Spring 2016)

LM Start	1.17	Rating **	U	Issue No.	206
LM End	1.17	Issue Type +	Ma	Location *	LS
Category	Earthen Levee			GPS Latitude/Longitude	
				Start	End
Item	Trim / Thin Trees			37.933591°	37.933591°
				-121.329154°	-121.329154°
DWR ID	DWR_RD0524_01_s_2016_206				
Comment Code					
T1 : Trim trees to at least five feet above ground level.					
Inspector Comment

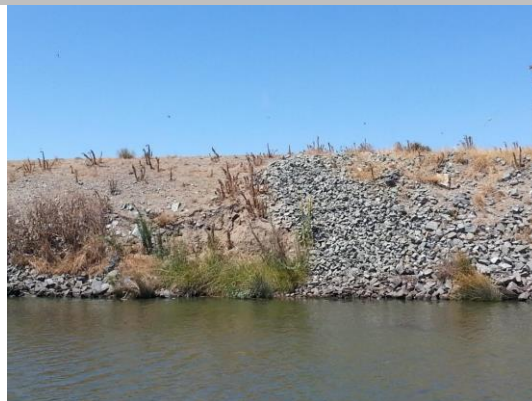
Photo 1 of 3 : SJR2016_RD0524U01RM41.92_2.jpg

Front view of the erosion.

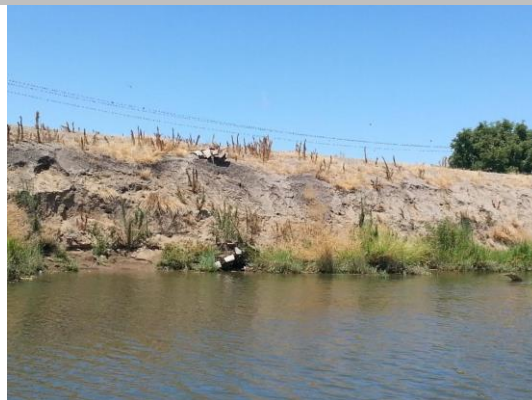
Photo 2 of 3 : SJR2016_RD0524U01RM41.92_3.jpg

Front view of the erosion.

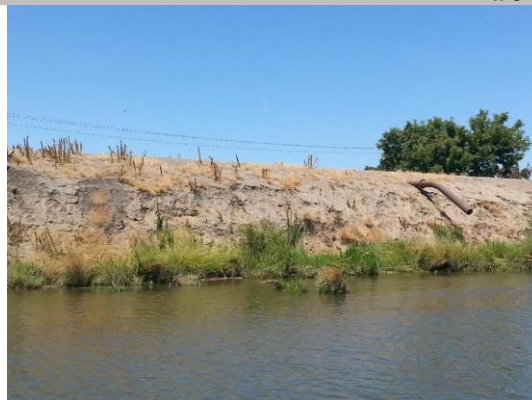
Photo 3 of 3 : SJR2016_RD0524U01RM41.92_4.jpg

Front view of the erosion. Note the drainage pipe on the site.

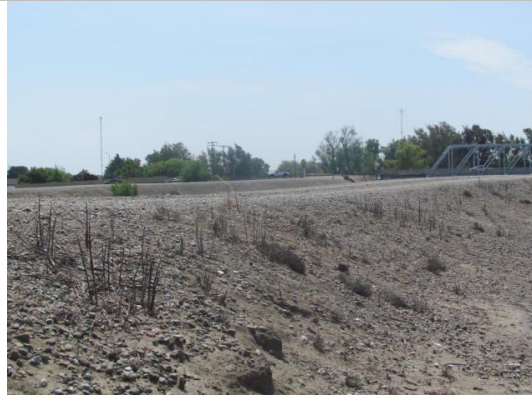
Photo 1 of 2 : FA_2016_RD0524_107_172_20160929_00214.jpg

LM Start	1.36	Rating **	U	Issue No.	172
LM End	1.40	Issue Type +	Ma	Location *	CR
Category	Earthen Levee			GPS Latitude/Longitude	
				Start	End
Item	Crown Surface / Depressions / Rutting			37.931085 °	37.930517 °
				-121.328112 °	-121.328072 °
DWR ID	DWR_RD0524_01_s_2015_172				
Comment Code					
C2 : Repair depressions or ruts in the crown or slope.					
Inspector Comment					
Levee crown depression several inches below original crown elevation. Section should be survey to determine proper elevation.

Looking east at depression on levee crown.

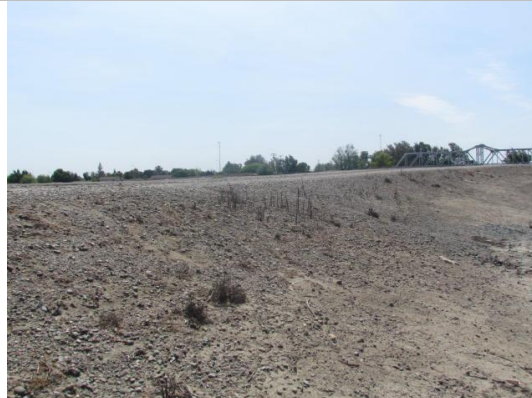
Photo 2 of 2 : FA_2016_RD0524_107_172_20160929_00215.jpg

LM Start	1.36	Rating **	U	Issue No.	172 (cont)
LM End	1.40	Issue Type +	Ma	Location *	CR

Looking southeast at depression on levee crown.

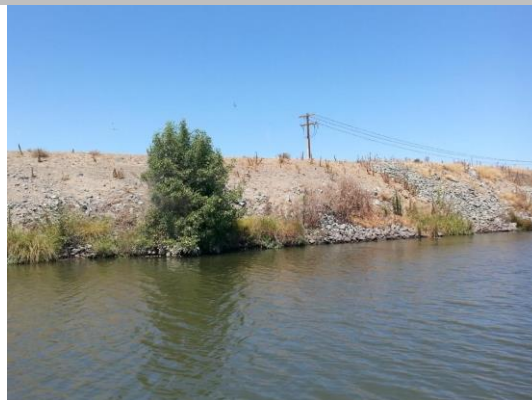
Photo 1 of 3 : SJR2016_RD0524U01RM42.03_2.jpg

LM Start	1.39	Rating **	U	Issue No.	79
LM End	1.39	Issue Type +	Ma	Location *	WS
Category	Supplemental			GPS Latitude/Longitude	
				Start	End
Item	DWR Erosion Survey			37.930575 °	37.930575 °
				-121.328090 °	-121.328090 °
DWR ID					
Comment Code					
Inspector Comment					
07/25/2016: No significant change observed					
06/24/2015: No significant change observed.					
06/19/2014: No significant change observed.					
08/13/2013: No significant change observed.					
08/07/2012: The site was first reported in 2012 spring levee inspection report. The site is located about 750 ft downstream of SR 4 Bridge.					
[2016 Site ID:RD0524U01RM42.03]

Front view of the erosion.

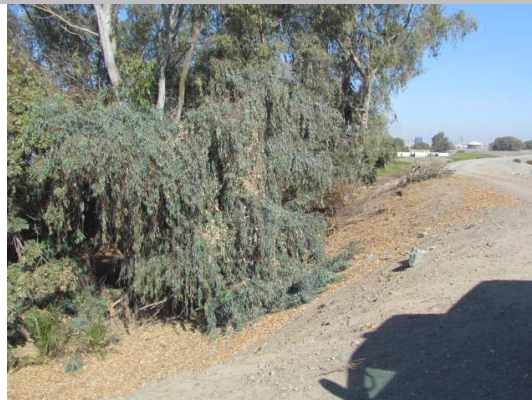
Photo 1 of 4 : FA_2016_RD0524_107_916_20160929_00277.jpg

LM Start	1.49	Rating **	U	Issue No.	916
LM End	1.49	Issue Type +	Ma	Location *	LS
Category	Earthen Levee			GPS Latitude/Longitude	
				Start	End
Item	Trim / Thin Trees			37.929118 °	37.929118 °
				-121.328368 °	-121.328368 °
DWR ID	DWR_RD0524_01_s_2012_916				
Comment Code					
T3 : Trim and thin trees to allow visibility of the ground and room to flood fight.					
Inspector Comment					
Untrimmed trees and dense vegetation on landward toe.

Looking at dense trees on landward slope and toe fall 2015

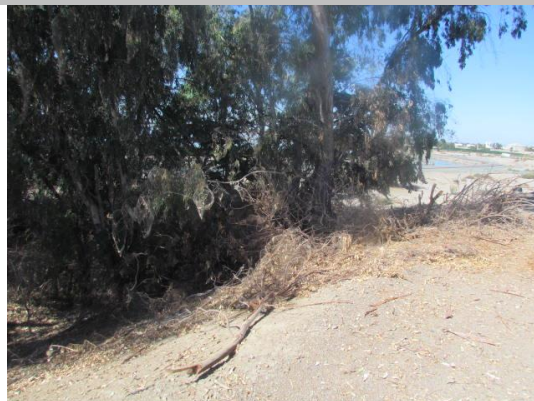
Photo 2 of 4 : FA_2016_RD0524_107_916_20160929_00278.jpg

LM Start	1.49	Rating **	U	Issue No.	916 (cont)	
LM End	1.49	Issue Type +	Ma	Location *	LS	
Category	Earthen Levee			GPS Latitude/Longitude		
				Start		End
Item	Trim / Thin Trees			37.929118 °		37.929118 °
				-121.328368 °		-121.328368 °
DWR ID	DWR_RD0524_01_s_2012_916					
Comment Code						
T3 : Trim and thin trees to allow visibility of the ground and room to flood fight.						
Inspector Comment						
Untrimmed trees and dense vegetation on landward toe.

Looking at trees on landside slope. (Fall 2012)

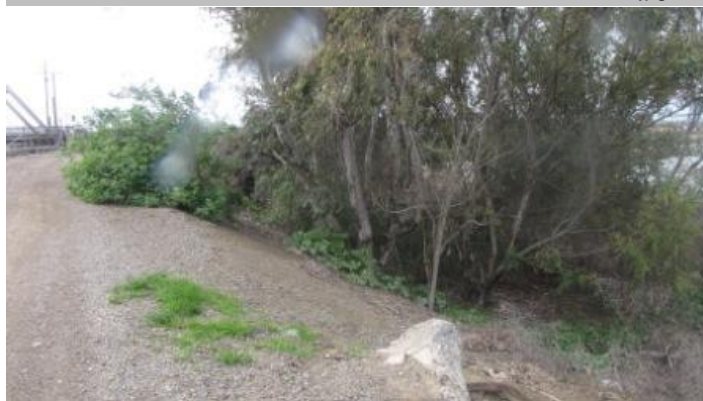
Photo 3 of 4 : FA_2016_RD0524_107_916_20160929_00279.jpg

Looking at dense veg. on landside slope and toe.

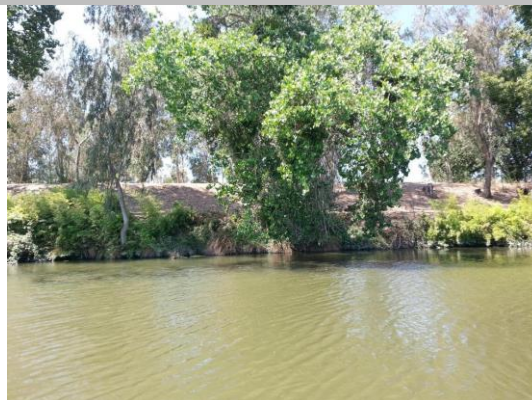
Photo 1 of 3 : SJR2016_RD0524U01RM42.2_1.jpg

07/25/2016: No significant change observed.
 06/24/2015: No significant change observed.
 06/19/2014: No significant change observed.
 08/13/2013: No significant change observed.
 08/07/2012: The site has been visited by boat survey. No significant change observed
 08/23/2011: No significant change observed on site. Trees concerned still in place.
 09/07/2010: No significant change observed on site. The concern here is the undermining of the levee toe where most of trees are. There are erosion pockets lined along the lower slope and at the base of the trees, exposing tree roots. There is minimal slope protection.
 09/29/2009: The lower slope is lined with minor erosion pockets; some tree roots are exposed; there is visible undermining of the levee toe; site is immediately upstream of the Highway 4 Bridge; the bridge is possibly causing a scour to occur, eroding the bank. [2016 Site ID:RD0524U01RM42.2]

Front view of the site where undermining has occurred.

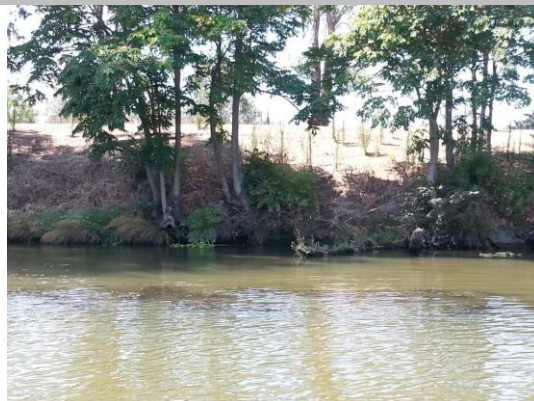
Photo 3 of 3 : SJR2016_RD0524U01RM42.2_4.jpg

Close view of the erosion at the levee toe.

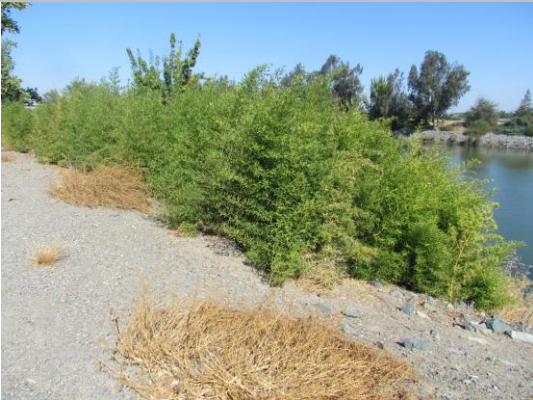
Photo 2 of 3 : FA_2016_RD0524_107_25_20161013_00393.jpg

Looking northwest at end of dense veg on waterward slope.

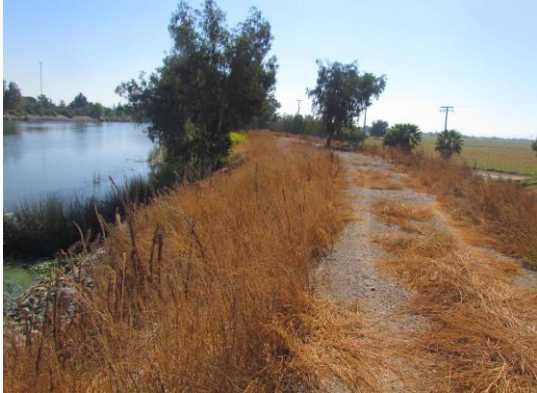
Photo 3 of 3 : FA_2016_RD0524_107_25_20161013_00391.jpg

Looking southwest at dense veg on waterward slope.

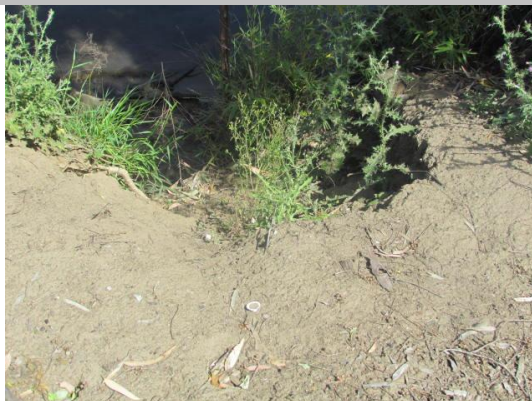
Photo 2 of 3 : FA_2016_RD0524_107_26_20160929_00060.jpg

LM Start	1.62	Rating **	M	Issue No.	26 (cont)	
LM End	1.64	Issue Type +	Ma	Location *	WS	
Category	Earthen Levee			GPS Latitude/Longitude		
				Start		End
Item	Erosion / Bank Caving			37.927507 °		37.927295 °
				-121.327593 °		-121.327298 °
DWR ID	DWR_RD0524_01_s_2012_26					
Comment Code						
E1 : Note and monitor erosion site.						
Inspector Comment						
Several erosions along this reach.

Looking east at waterward erosion.

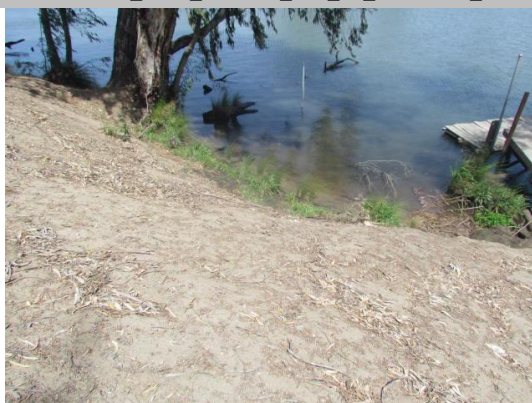
Photo 3 of 3 : FA_2016_RD0524_107_26_20160929_00061.jpg

Looking east at waterward erosion and depression.

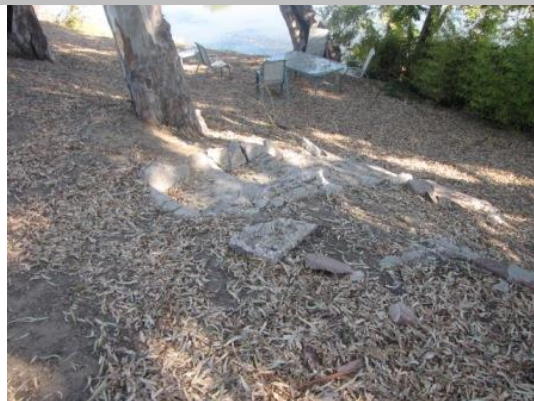
Photo 1 of 3 : FA_2016_RD0524_107_45_20160929_00089.jpg

Looking northeast at non-permitted concrete stairs on waterside slope.

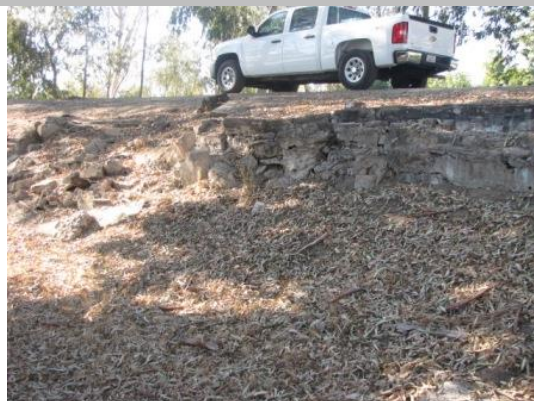
Photo 2 of 3 : FA_2016_RD0524_107_45_20160929_00090.jpg

Looking southwest at retaining wall connected to concrete stairs.

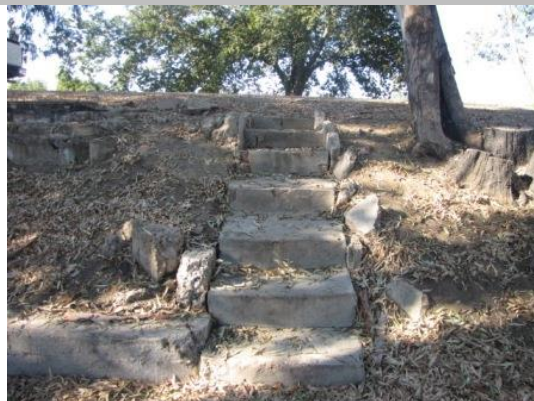
Photo 3 of 3 : FA_2016_RD0524_107_45_20160929_00091.jpg

Looking west at concrete stairs on waterside slope.

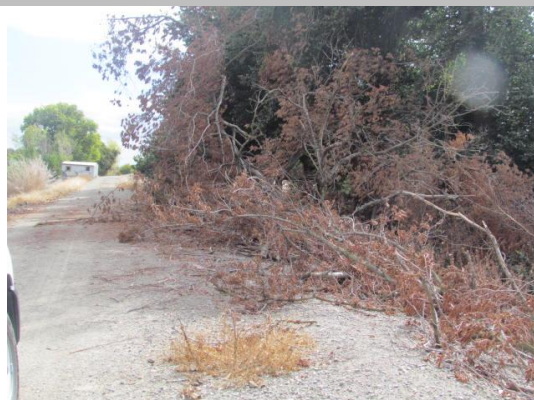
Photo 1 of 4 : FA_2016_RD0524_107_46_20160929_00092.jpg

LM Start	1.75	Rating **	U	Issue No.	46
LM End	1.76	Issue Type +	Ma	Location *	LS
Category	Earthen Levee			GPS Latitude/Longitude	
				Start	End
Item	Encroachments			37.926152 °	37.925993 °
				-121.325927 °	-121.325777 °
DWR ID	DWR_RD0524_01_s_2012_46				
Comment Code					
TR : Tree or limb					
Inspector Comment					
Downed tree limbs on landward slope.

Looking south at tree limbs on landward slope.

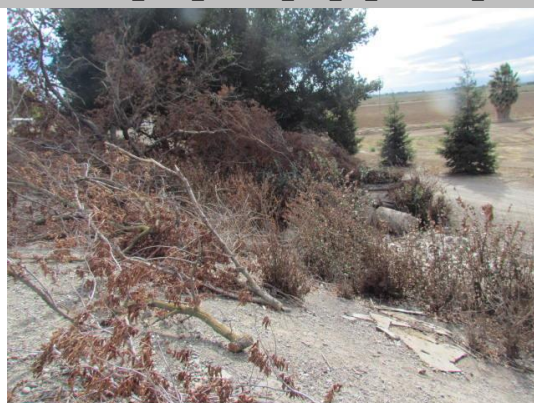
Photo 2 of 4 : FA_2016_RD0524_107_46_20160929_00093.jpg

Looking southwest at tree limbs on landward slope.

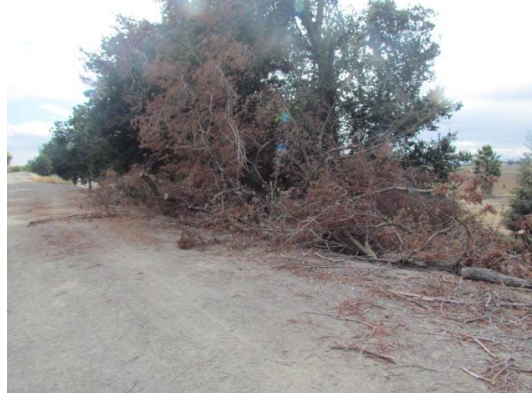
Photo 3 of 4 : FA_2016_RD0524_107_46_20160929_00094.jpg

LM Start	1.75	Rating **	U	Issue No.	46 (cont)	
LM End	1.76	Issue Type +	Ma	Location *	LS	
Category	Earthen Levee			GPS Latitude/Longitude		
				Start		End
Item	Encroachments			37.926152°	37.925993°	
				-121.325927°	-121.325777°	
DWR ID	DWR_RD0524_01_s_2012_46					
Comment Code						
TR : Tree or limb						
Inspector Comment						
Downed tree limbs on landward slope.

Looking south at tree limbs on landward slope.

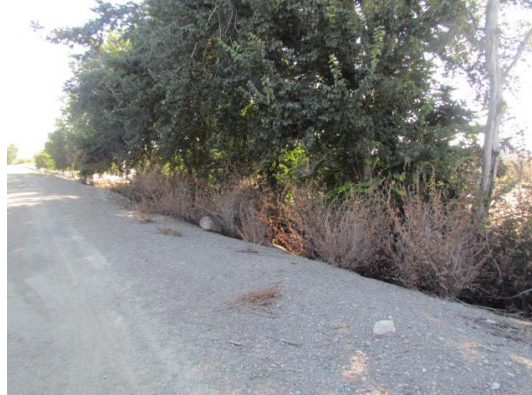
Photo 4 of 4 : FA_2016_RD0524_107_46_20160929_00095.jpg

Looking southwest at dense vegetation and low hanging tree branches on landside slope and toe.

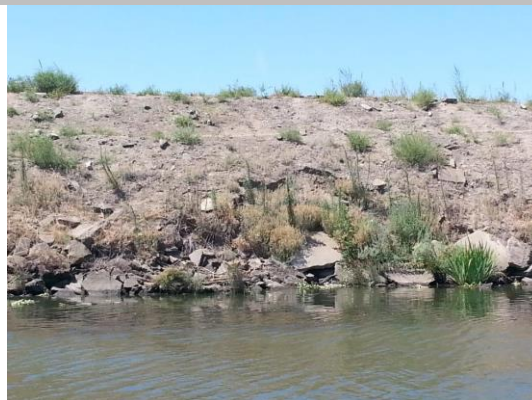
Photo 1 of 2 : SJR2016_RD0524U01RM42.79_2.jpg

LM Start	2.19	Rating **	U	Issue No.	91
LM End	2.19	Issue Type +	Ma	Location *	WS
Category	Supplemental			GPS Latitude/Longitude	
				Start	End
Item	DWR Erosion Survey			37.920992 °	37.920992 °
				-121.321370 °	-121.321370 °
DWR ID					
Comment Code					
Inspector Comment					
07/25/2016: No significant change observed.					
06/24/2015: No significant change observed.					
07/22/2014: The erosion has increased in size.					
08/13/2013: No significant change observed. Slightly more vegetation was visible.					
08/07/2012: The site was first reported in 2012 spring levee inspection report. [2016 Site ID:RD0524U01RM42.79]

Close view of the pocket erosion.

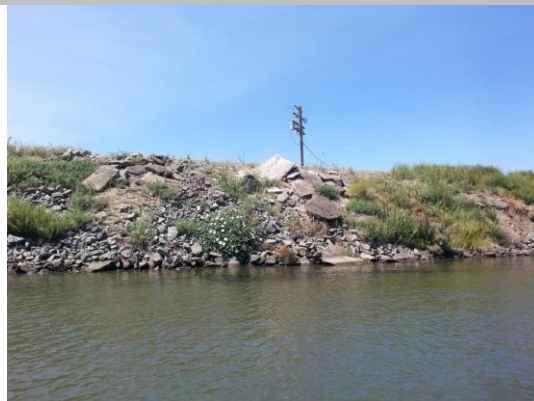
Photo 1 of 3 : SJR2016_RD0524U01RM42.84_1.jpg

LM Start	2.24	Rating **	U	Issue No.	99
LM End	2.27	Issue Type +	Ma	Location *	WS
Category	Supplemental			GPS Latitude/Longitude	
				Start	End
Item	DWR Erosion Survey			37.920650 °	37.920650 °
				-121.320370 °	-121.320370 °
DWR ID					
Comment Code					
Inspector Comment					
07/25/2016: No significant change observed.					
06/24/2015: No significant change observed.					
06/19/2014: No significant change observed.					
08/13/2013: An irrigation pipe is on site. [2016 Site					
ID:RD0524U01RM42.84]

Close view of the erosion.

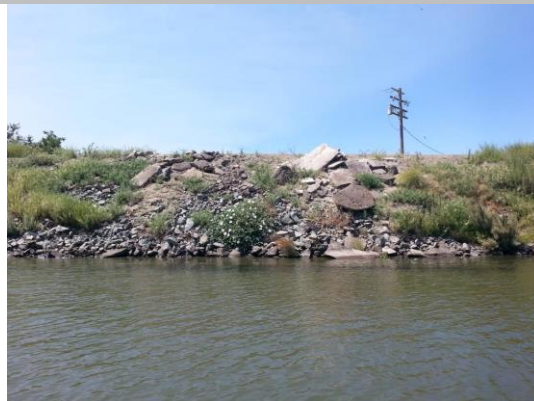
Photo 2 of 3 : SJR2016_RD0524U01RM42.84_3.jpg

Close view of the erosion.

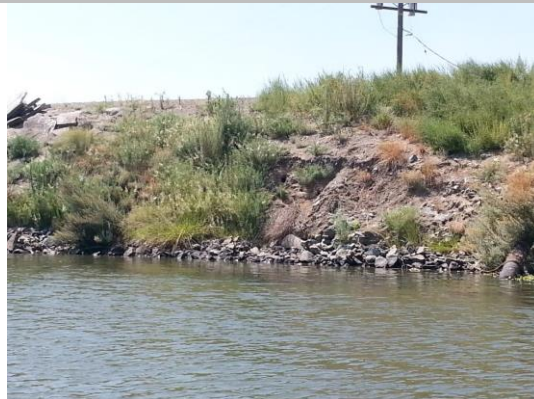
Photo 3 of 3 : SJR2016_RD0524U01RM42.84_4.jpg

Close view of the erosion. Note the irrigation pipe next to the erosion.

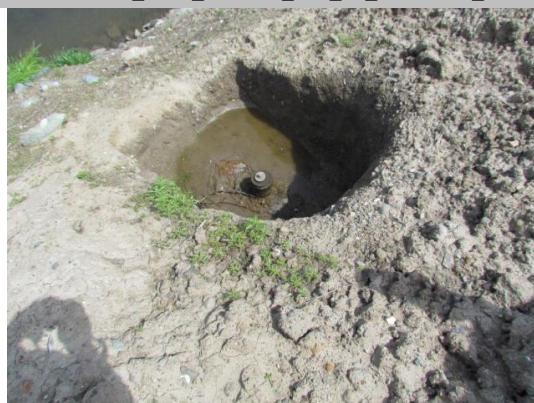
Photo 2 of 3 : FA_2016_RD0524_107_31_20160929_00066.jpg

LM Start	2.25	Rating **	U	Issue No.	31
LM End	2.25	Issue Type +	Ma	Location *	WS
Category	Earthen Levee			GPS Latitude/Longitude	
				Start	End
Item	Slope Stability			37.920493 °	37.920493 °
				-121.320565 °	-121.320565 °
DWR ID	DWR_RD0524_01_s_2012_31				
Comment Code					
S1 : Repair slope instability.					
Inspector Comment					
Slope instability probably cause by leak in irrigation pipe. Pipe should be inspected internally.

Looking east at siphon on waterward slope.

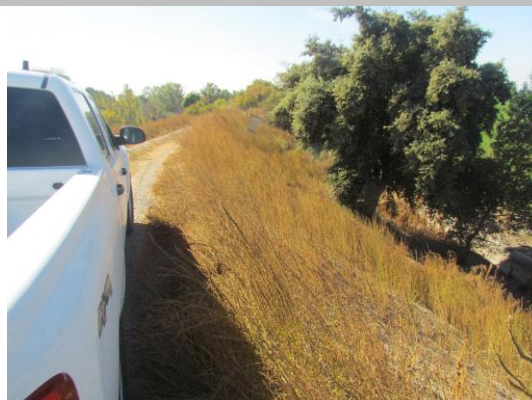
Photo 1 of 1 : FA_2016_RD0524_107_204_20161013_00398.jpg

LM Start	2.38	Rating **	U	Issue No.	204
LM End	2.42	Issue Type +	Ma	Location *	LS
Category	Earthen Levee			GPS Latitude/Longitude	
				Start	End
Item	Vegetation			37.919067 °	37.918713 °
				-121.319935 °	-121.320595 °
DWR ID	DWR_RD0524_01_f_2016_204				
Comment Code					
V2 : Remove the wild growth other than native grasses from the levee slopes.					
Inspector Comment					
Dense vegetation on landward slope and waterward slope.

Looking south at dense veg on landward slope.

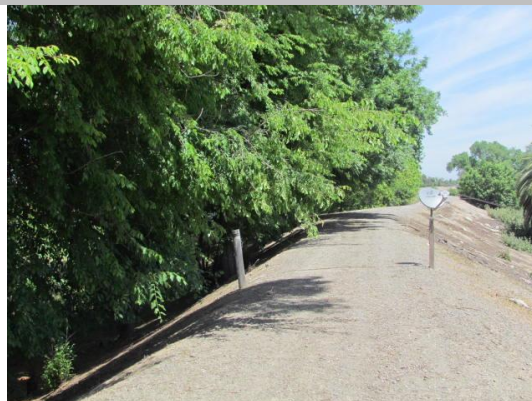
Photo 1 of 1 : FA_2016_RD0524_107_44_20160929_00088.jpg

LM Start	2.67	Rating **	M	Issue No.	44
LM End	2.77	Issue Type +	Ma	Location *	LS
Category	Earthen Levee			GPS Latitude/Longitude	
				Start	End
Item	Trim / Thin Trees			37.916418 °	37.915142 °
				-121.321963 °	-121.323018 °
DWR ID	DWR_RD0524_01_s_2012_44				
Comment Code					
T4 : Trim trees over roadway to at least 12 feet above ground level.					
Inspector Comment					
Trim over hanging trees at least 12 feet above ground level.

Looking north at dense trees overhanging levee crown.

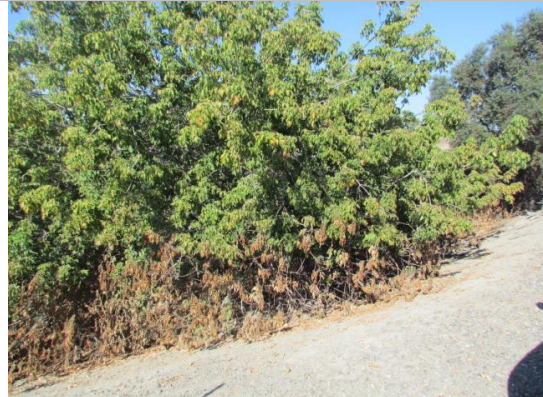
Photo 1 of 2 : FA_2016_RD0524_107_51_20160929_00102.jpg

Looking south at dense trees on landward slope fall 2015

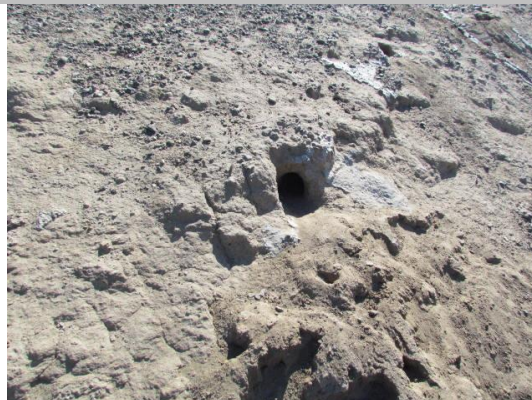
Photo 1 of 2 : FA_2016_RD0524_107_925_20160929_00282.jpg

LM Start	3.07	Rating **	M	Issue No.	925
LM End	3.27	Issue Type +	Ma	Location *	LS
Category	Earthen Levee			GPS Latitude/Longitude	
				Start	End
Item	Animal Control			37.911382 °	37.908602 °
				-121.324928 °	-121.325395 °
DWR ID	DWR_RD0524_01_s_2012_925				
Comment Code					
A1 : Exterminate rodents and backfill and compact or grout burrows.					
Inspector Comment					
Several rodent holes on levee slopes.

Looking at typical view of rodent hole with this section fall 2015.

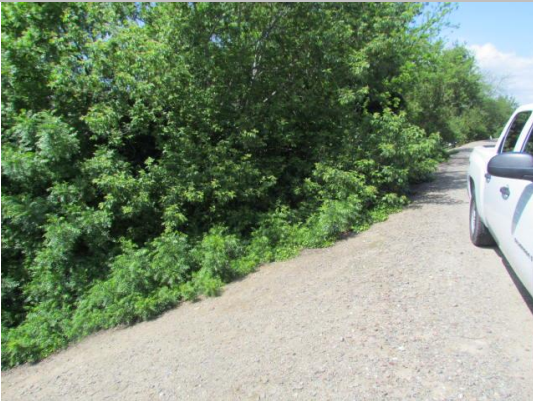
Photo 1 of 2 : FA_2016_RD0524_107_926_20160929_00284.jpg

Looking southwest at dense veg on landward slope.

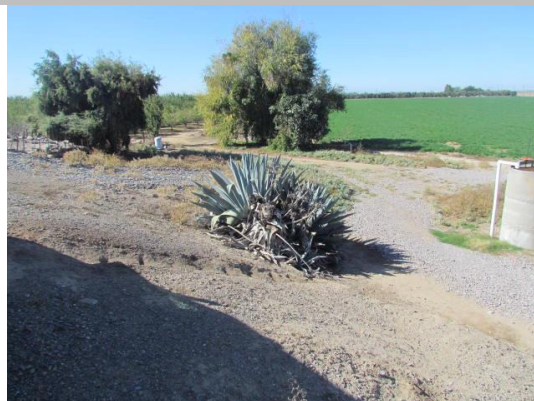
Photo 1 of 1 : FA_2016_RD0524_107_190_20160929_00234.jpg

LM Start	3.65	Rating **	U	Issue No.	190
LM End	3.65	Issue Type +	Ma	Location *	LS
Category	Earthen Levee			GPS Latitude/Longitude	
				Start	End
Item	Vegetation			37.904070 °	37.904070 °
				-121.325118 °	-121.325118 °
DWR ID	DWR_RD0524_01_f_2015_190				
Comment Code					
V2 : Remove the wild growth other than native grasses from the levee slopes.					
Inspector Comment					
Large century plant at landward toe.

Looking southwest at century plant at landward toe fall 2015.

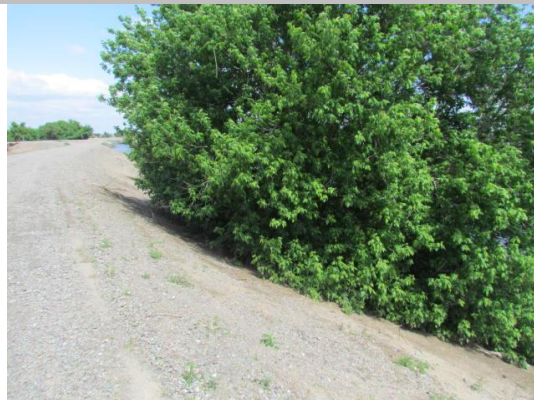
Photo 1 of 1 : FA_2016_RD0524_107_52_20160929_00104.jpg

LM Start	3.75	Rating **	U	Issue No.	52
LM End	3.75	Issue Type +	Ma	Location *	WS
Category	Earthen Levee			GPS Latitude/Longitude	
				Start	End
Item	Trim / Thin Trees			37.902828 °	37.902828 °
				-121.326170 °	-121.326170 °
DWR ID	DWR_RD0524_01_s_2016_52				
Comment Code					
T1 : Trim trees to at least five feet above ground level.					
Inspector Comment

Looking south at untrimmed tree on landward slope and toe.

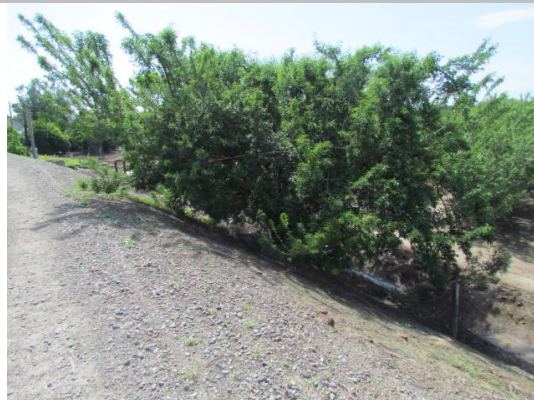
Photo 1 of 1 : FA_2016_RD0524_107_927_20160929_00286.jpg

LM Start	3.77	Rating **	U	Issue No.	927
LM End	3.77	Issue Type +	Ma	Location *	LS
Category	Earthen Levee			GPS Latitude/Longitude	
				Start	End
Item	Trim / Thin Trees			37.902645 °	37.902645 °
				-121.326340 °	-121.326340 °
DWR ID	DWR_RD0524_01_s_2012_927				
Comment Code					
T1 : Trim trees to at least five feet above ground level.					
Inspector Comment					
Untrimmed almond tree on landward slope.

Looking southwest at untrimmed tree at landward toe.

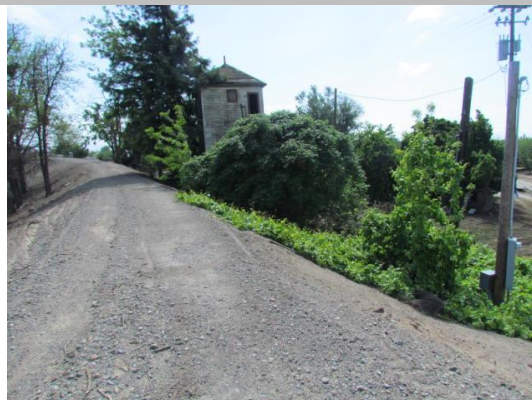
Photo 1 of 1 : FA_2016_RD0524_107_59_20160929_00110.jpg

LM Start	3.78	Rating **	U	Issue No.	59
LM End	3.78	Issue Type +	Ma	Location *	LS
Category	Earthen Levee			GPS Latitude/Longitude	
				Start	End
Item	Trim / Thin Trees			37.902417 °	37.902417 °
				-121.326482 °	-121.326482 °
DWR ID	DWR_RD0524_01_s _ 2012_59				
Comment Code					
T1 : Trim trees to at least five feet above ground level.					
Inspector Comment

Looking south at dense veg on landward slope and toe.

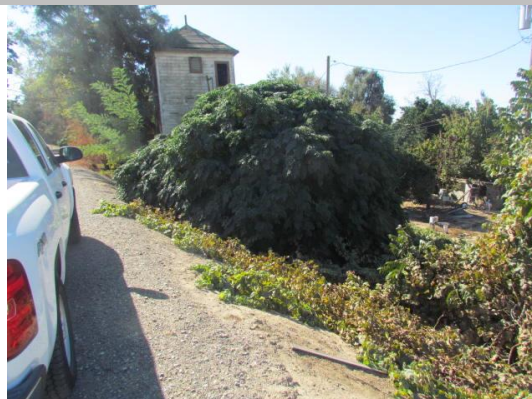
Photo 1 of 1 : FA_2016_RD0524_107_928_20160929_00287.jpg

LM Start	3.80	Rating **	U	Issue No.	928
LM End	3.81	Issue Type +	Ma	Location *	LS
Category	Earthen Levee			GPS Latitude/Longitude	
				Start	End
Item	Trim / Thin Trees			37.902155 °	37.902002 °
				-121.326523 °	-121.326550 °
DWR ID	DWR_RD0524_01_s _ 2012_928				
Comment Code					
T1 : Trim trees to at least five feet above ground level.					
Inspector Comment					
Several trees on landward slope.

Looking south at dense vegetation on landward slope and toe.

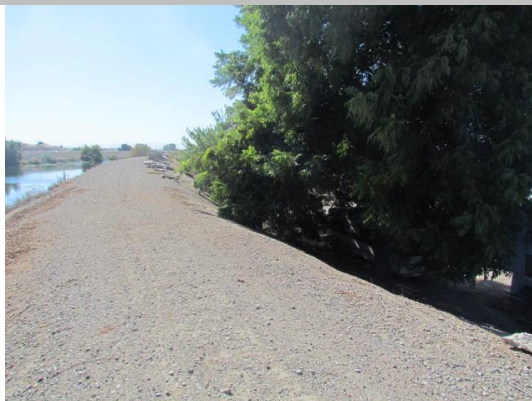
Photo 1 of 1 : FA_2016_RD0524_107_83_20160929_00137.jpg

LM Start	3.89	Rating **	U	Issue No.	83
LM End	3.89	Issue Type +	Ma	Location *	LS
Category	Earthen Levee			GPS Latitude/Longitude	
				Start	End
Item	Trim / Thin Trees			37.900854 °	37.900854 °
				-121.326438 °	-121.326438 °
DWR ID	DWR_RD0524_01_s _ 2012_83				
Comment Code					
T1 : Trim trees to at least five feet above ground level.					
Inspector Comment					
Untrimmed tree on landward slope.

Looking south at untrimmed trees on landward slope and toe.

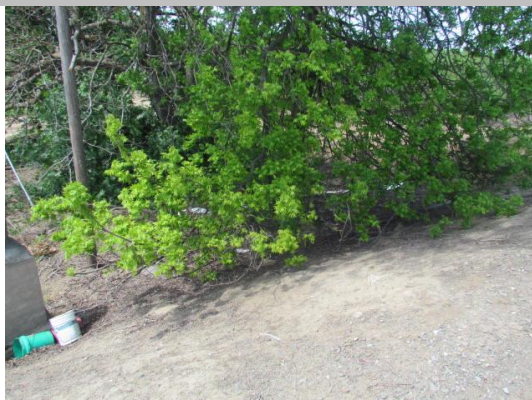
Photo 1 of 1 : FA_2016_RD0524_107_61_20160929_00112.jpg

LM Start	4.03	Rating **	M	Issue No.	61
LM End	4.03	Issue Type +	Ma	Location *	LS
Category	Earthen Levee			GPS Latitude/Longitude	
				Start	End
Item	Trim / Thin Trees			37.898925 °	37.898925 °
				-121.327015 °	-121.327015 °
DWR ID	DWR_RD0524_01_s _ 2012_61				
Comment Code					
T1 : Trim trees to at least five feet above ground level.					
Inspector Comment

Looking east at untrimmed tree at landward toe.

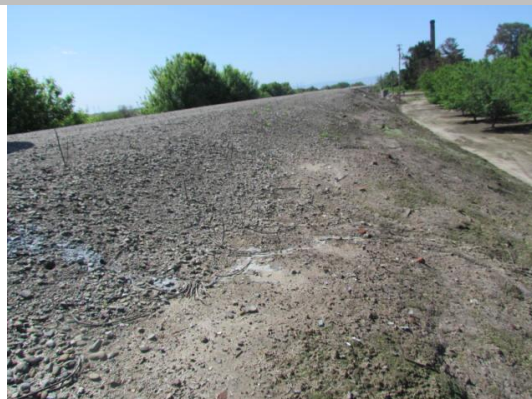
Photo 1 of 3 : FA_2016_RD0524_107_108_20160929_00169.jpg

LM Start	4.10	Rating **	U	Issue No.	108	
LM End	4.15	Issue Type +	Ma	Location *	LS	
Category	Earthen Levee			GPS Latitude/Longitude		
				Start		End
Item	Slope Stability			37.898035 °		°
				-121.327447 °		-121.327806 °
DWR ID	DWR_RD0524_01_s_2012_108					
Comment Code						
S1 : Repair slope instability.						
Inspector Comment						
Slope depression is greater than 1" and longer than 200'.

Looking north at caving slope on landside of levee.
