**Flood Control Project Maintenance
Levee Inspections**

Maintenance Issue Types Only, Levee Inspection Report By Mile - Fall 2016

Reclamation District No. 0524 Middle Roberts Island

Waterway	Bank	Unit Miles	Inspection Start/End	Inspector
Unit No. 01 San Joaquin River	Left	6.20	10/10/2016 10/11/2016	Richard Willoughby

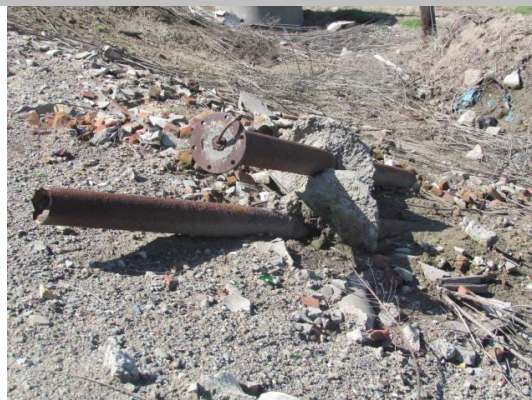
Photo 1 of 1 : FA_2016_RD0524_107_213_20160929_00257.jpg

LM Start	4.16	Rating **	M	Issue No.	213
LM End	4.16	Issue Type +	Ma	Location *	LS
Category	Earthen Levee			GPS Latitude/Longitude	
				Start	End
Item	Encroachments			37.897235 °	37.897235 °
				-121.327865 °	-121.327865 °
DWR ID	DWR_RD0524_01_s_2016_213				
Comment Code					
GA : Garbage					
Inspector Comment					
Old fence post and concrete and brick rubble on landward slope.

Looking west at old fence post and concrete rubble on landward slope.

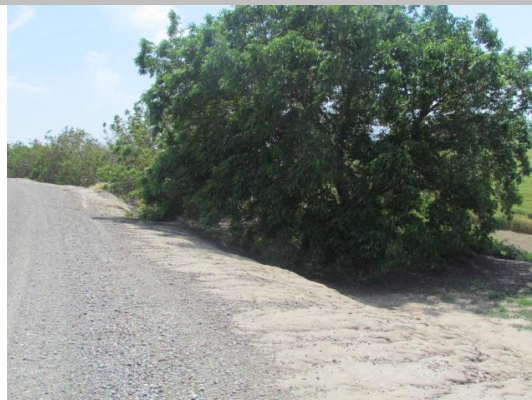
Photo 1 of 2 : FA_2016_RD0524_107_112_20160929_00174.jpg

LM Start	4.40	Rating **	U	Issue No.	112
LM End	4.53	Issue Type +	Ma	Location *	LS
Category	Earthen Levee			GPS Latitude/Longitude	
				Start	End
Item	Trim / Thin Trees			37.893928 °	37.892230 °
				-121.329203 °	-121.328187 °
DWR ID	DWR_RD0524_01_s_2012_112				
Comment Code					
T1 : Trim trees to at least five feet above ground level.					
Inspector Comment					
Untrimmed trees along landward slope and toe.

Looking southeast at untrimmed tree at landward toe.

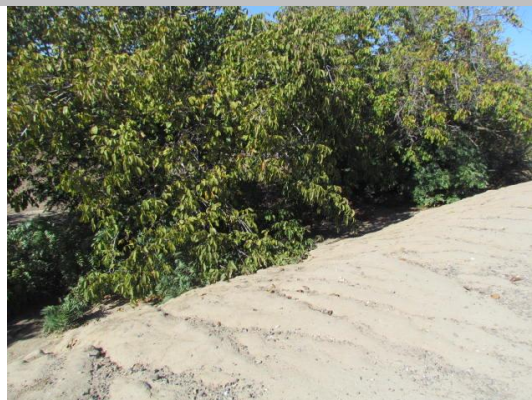
Photo 2 of 2 : FA_2016_RD0524_107_112_20160929_00175.jpg

Looking northeast at untrimmed tree on landward slope and toe fall 2015.

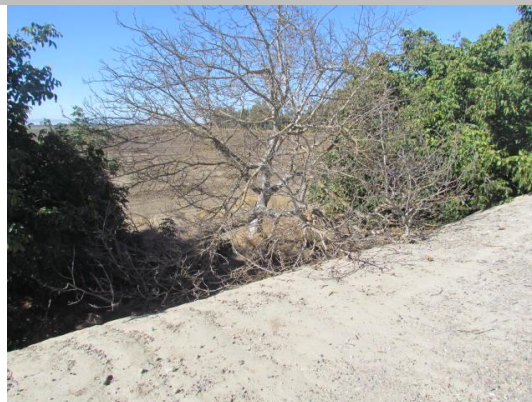
Photo 1 of 1 : FA_2016_RD0524_107_199_20160929_00244.jpg

LM Start	4.43	Rating **	U	Issue No.	199
LM End	4.43	Issue Type +	Ma	Location *	LS
Category	Earthen Levee			GPS Latitude/Longitude	
				Start	End
Item	Encroachments			37.893582 °	37.893582 °
				-121.329108 °	-121.329108 °
DWR ID	DWR_RD0524_01_f_2015_199				
Comment Code					
TR : Tree or limb					
Inspector Comment					
Remove dead tree from landward toe.

Looking west at dead tree on landward slope and toe fall 2015.

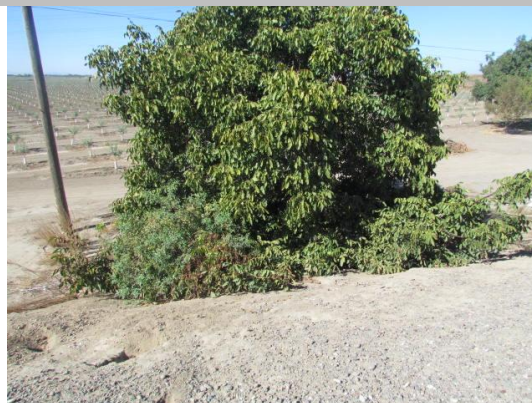
Photo 1 of 1 : FA_2016_RD0524_107_84_20161013_00412.jpg

LM Start	4.90	Rating **	U	Issue No.	84
LM End	4.93	Issue Type +	Ma	Location *	LS
Category	Earthen Levee			GPS Latitude/Longitude	
				Start	End
Item	Trim / Thin Trees			37.887655 °	37.887277 °
				-121.331202 °	-121.331609 °
DWR ID	DWR_RD0524_01_s_2012_84				
Comment Code					
T1 : Trim trees to at least five feet above ground level.					
Inspector Comment					
Untrimmed trees on landward slope.

Looking west at untrimmed tree on landward slope.

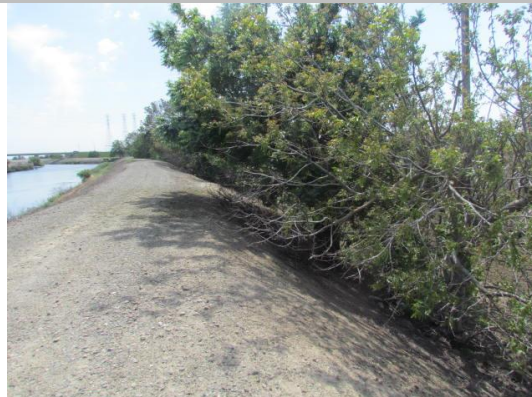
Photo 1 of 1 : FA_2016_RD0524_107_85_20160929_00139.jpg

LM Start	5.28	Rating **	U	Issue No.	85
LM End	5.34	Issue Type +	Ma	Location *	LS
Category	Earthen Levee			GPS Latitude/Longitude	
				Start	End
Item	Trim / Thin Trees			37.882377°	37.881498°
				-121.332598°	-121.332800°
DWR ID	DWR_RD0524_01_s_2012_85				
Comment Code					
T1 : Trim trees to at least five feet above ground level.					
Inspector Comment

Looking south at untrimmed trees on landward slope.

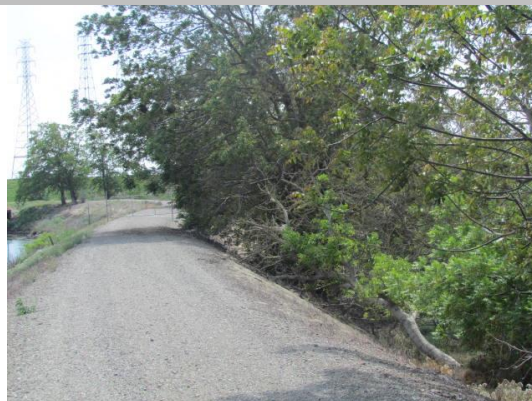
Photo 1 of 1 : FA_2016_RD0524_107_932_20160929_00290.jpg

LM Start	5.38	Rating **	U	Issue No.	932
LM End	5.41	Issue Type +	Ma	Location *	LS
Category	Earthen Levee			GPS Latitude/Longitude	
				Start	End
Item	Trim / Thin Trees			37.880945°	37.880522°
				-121.332837°	-121.332918°
DWR ID	DWR_RD0524_01_s_2012_932				
Comment Code					
T1 : Trim trees to at least five feet above ground level.					
Inspector Comment

Looking south at untrimmed trees on landward slope and toe.

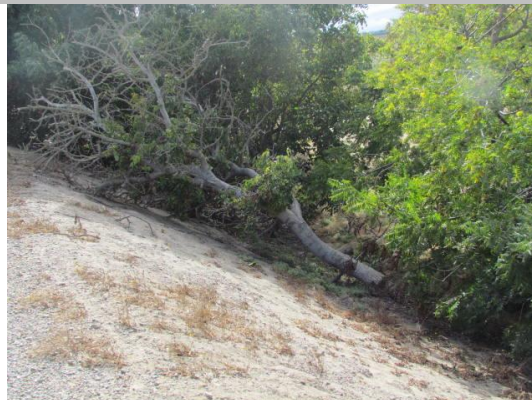
Photo 1 of 1 : FA_2016_RD0524_107_178_20160929_00223.jpg

LM Start	5.39	Rating **	M	Issue No.	178
LM End	5.39	Issue Type +	Ma	Location *	LS
Category	Earthen Levee			GPS Latitude/Longitude	
				Start	End
Item	Encroachments			37.880806 °	37.880806 °
				-121.332833 °	-121.332833 °
DWR ID	DWR_RD0524_01_f_2014_178				
Comment Code					
TR : Tree or limb					
Inspector Comment					
Downed tree on landward toe.

Looking south at downed tree on landward slope.

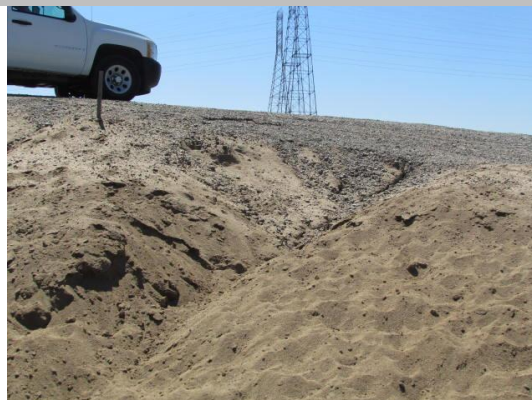
Photo 2 of 3 : FA_2016_RD0524_107_118_20160929_00181.jpg

LM Start	5.42	Rating **	M	Issue No.	118
LM End	5.42	Issue Type +	Ma	Location *	LS
Category	Earthen Levee			GPS Latitude/Longitude	
				Start	End
Item	Slope Stability			37.880323°	37.880323°
				-121.332968°	-121.332968°
DWR ID	DWR_RD0524_01_s_2012_118				
Comment Code					
S1 : Repair slope instability.					
Inspector Comment					
Slope damage caused by human activity.

Looking southeast at damaged slope.

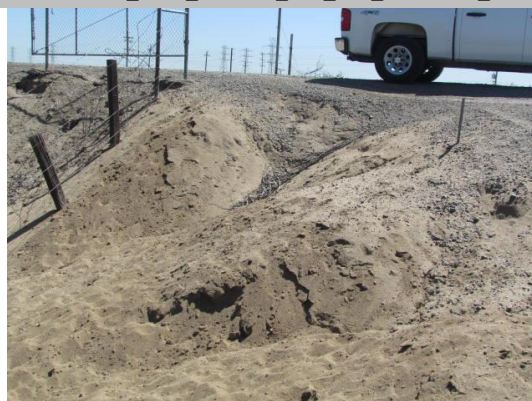
Photo 3 of 3 : FA_2016_RD0524_107_118_20160929_00182.jpg

Looking east at slope caving on landside slope.

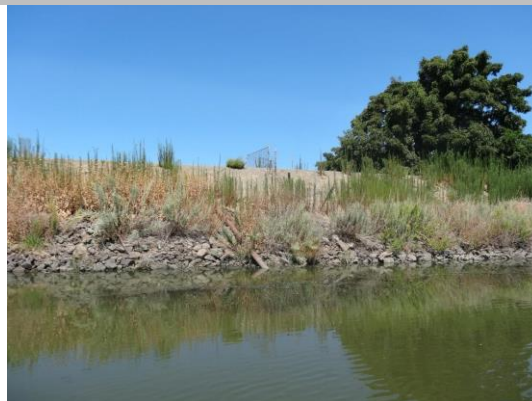
Photo 1 of 2 : SJR2016_RD0524U01RM45.97_1.jpg

07/25/2016: No significant change observed.
 06/24/2015: No significant change observed.
 06/19/2014: No significant change observed.
 08/13/2013: The erosion seems to be getting worse. More material sloughing visible.
 08/07/2012: The erosion is underneath an irrigation pipe. The likely cause of the erosion is the pipe leakage. [2016 Site ID:RD0524U01RM45.97]

Close view of the erosion and the pipe on the site.

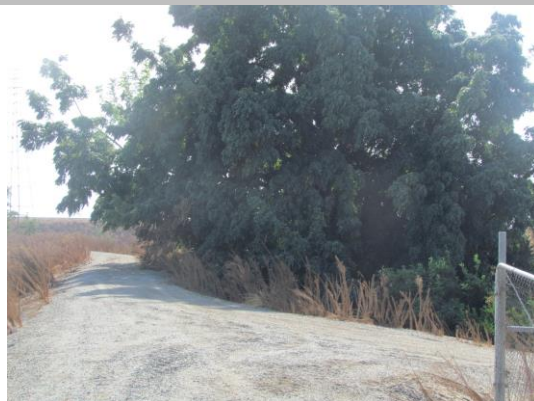
Photo 1 of 1 : FA_2016_RD0524_107_73_20161013_00414.jpg

LM Start	5.44	Rating **	U	Issue No.	73
LM End	5.44	Issue Type +	Ma	Location *	LS
Category	Earthen Levee			GPS Latitude/Longitude	
				Start	End
Item	Trim / Thin Trees			37.880085 °	37.880085 °
				-121.333045 °	-121.333045 °
DWR ID	DWR_RD0524_01_s_2012_73				
Comment Code					
T1 : Trim trees to at least five feet above ground level.					
Inspector Comment					
Untrimmed trees on landward slope.

Looking southwest at large untrimmed tree on landward slope.

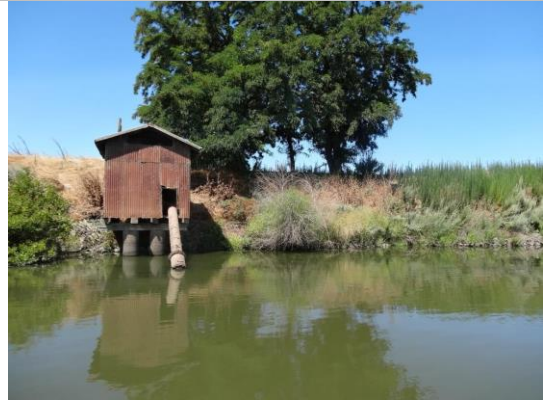
Photo 1 of 2 : SJR2016_RD0524U01RM46.06_3.jpg

LM Start	5.53	Rating **	M	Issue No.	135
LM End	5.53	Issue Type +	Ma	Location *	WS
Category	Supplemental			GPS Latitude/Longitude	
				Start	End
Item	DWR Erosion Survey			37.878920 °	37.878920 °
				-121.332670 °	-121.332670 °
DWR ID					
Comment Code					
Inspector Comment					
07/25/2016: No significant change observed.					
06/24/2015: No significant change observed.					
6/19/2014: No significant change observed.					
08/13/2013: Larger trees are at the levee shoulder, and an irrigation pump station is next to the erosion site. [2016 Site ID:RD0524U01RM46.06]

Close view of the site. Note large trees at the levee shoulder.

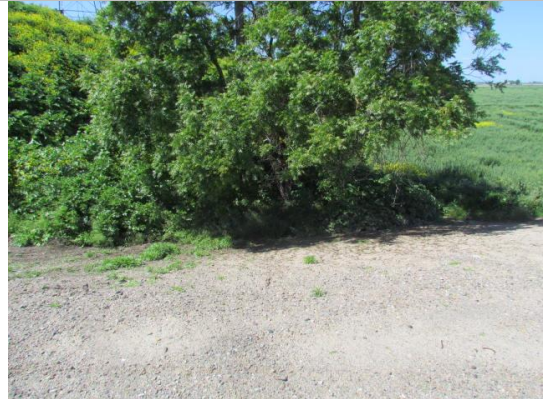
Photo 1 of 2 : FA_2016_RD0524_107_214_20160929_00258.jpg

LM Start	5.58	Rating **	U	Issue No.	214
LM End	5.58	Issue Type +	Ma	Location *	LS
Category	Earthen Levee			GPS Latitude/Longitude	
				Start	End
Item	Vegetation			37.878083°	37.878083°
				-121.332717°	-121.332717°
DWR ID	DWR_RD0524_01_s_2016_214				
Comment Code					
V2 : Remove the wild growth other than native grasses from the levee slopes.					
Inspector Comment					
Tall weeds, grasses and trees blocking view of landward toe.

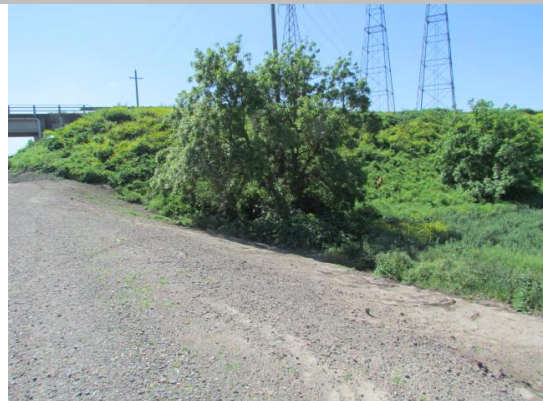
Photo 2 of 2 : FA_2016_RD0524_107_214_20160929_00259.jpg

Looking west at dense veg at landward toe.

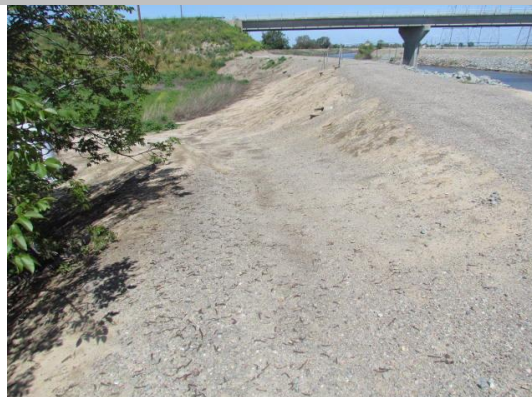
Photo 2 of 3 : FA_2016_RD0524_107_215_20160929_00261.jpg

LM Start	5.64	Rating **	U	Issue No.	215 (cont)	
LM End	5.64	Issue Type +	Ma	Location *	LS	
Category	Earthen Levee			GPS Latitude/Longitude		
				Start		End
Item	Slope Stability			37.877378 °		37.877378 °
				-121.332343 °		-121.332343 °
DWR ID	DWR_RD0524_01_s_2016_215					
Comment Code						
S1 : Repair slope instability.						
Inspector Comment						
Levee slope damage is due vehicle traffic and foot traffic. Vehicle traffic created a ramp on landward slope.

Looking north at slope damage (ramp) on landward slope.

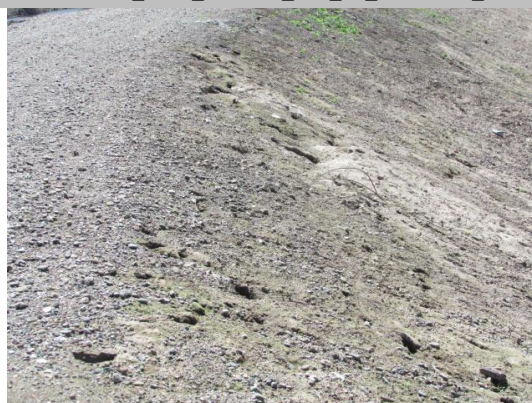
Photo 1 of 2 : FA_2016_RD0524_107_69_20160929_00117.jpg

LM Start	5.64	Rating **	U	Issue No.	69
LM End	5.80	Issue Type +	Ma	Location *	LS
Category	Earthen Levee			GPS Latitude/Longitude	
				Start	End
Item	Animal Control			37.877298°	37.875073°
				-121.332343°	-121.333168°
DWR ID	DWR_RD0524_01_s_2012_69				
Comment Code					
A3 : No rodents visible, but rodent burrows visible; need to backfill and compact or grout burrows.					
Inspector Comment					
District has grouted rodent holes. But rodents have re-appeared.

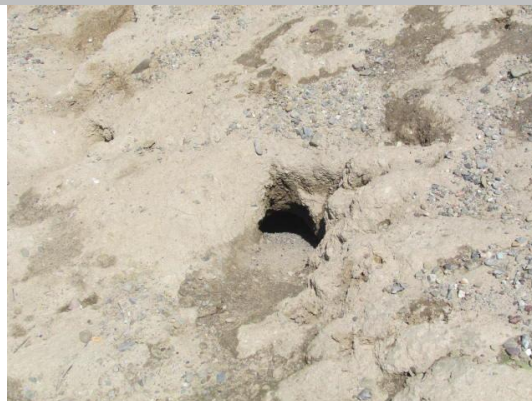
Photo 2 of 2 : FA_2016_RD0524_107_69_20160929_00118.jpg

LM Start	5.64	Rating **	U	Issue No.	69 (cont)	
LM End	5.80	Issue Type +	Ma	Location *	LS	
Category	Earthen Levee			GPS Latitude/Longitude		
				Start	End	
Item	Animal Control			37.877298 °	37.875073 °	
				-121.332343 °	-121.333168 °	
DWR ID	DWR_RD0524_01_s_2012_69					
Comment Code						
A3 : No rodents visible, but rodent burrows visible; need to backfill and compact or grout burrows.						
Inspector Comment						
District has grouted rodent holes. But rodents have re-appeared.

Looking south at rodent holes on landward slope.

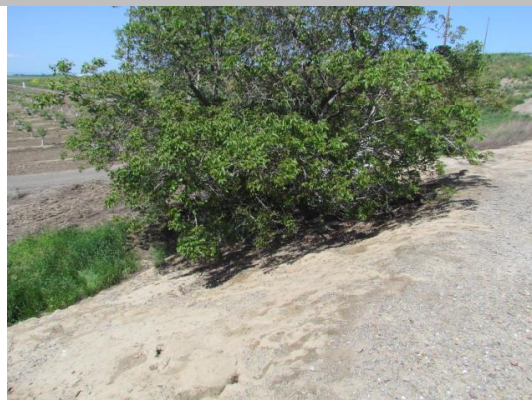
Photo 1 of 1 : FA_2016_RD0524_107_117_20160929_00179.jpg

LM Start	5.64	Rating **	U	Issue No.	117
LM End	5.64	Issue Type +	Ma	Location *	LS
Category	Earthen Levee			GPS Latitude/Longitude	
				Start	End
Item	Trim / Thin Trees			37.877272 °	37.877272 °
				-121.332400 °	-121.332400 °
DWR ID	DWR_RD0524_01_f_2013_117				
Comment Code					
T1 : Trim trees to at least five feet above ground level.					
Inspector Comment

Looking northwest at untrimmed tree on landward slope.

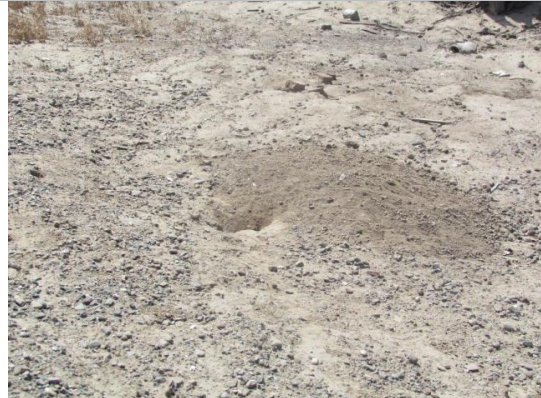
Photo 1 of 2 : FA_2016_RD0524_107_197_20160929_00239.jpg

Looking north at typical view of rodent holes on landward slope.

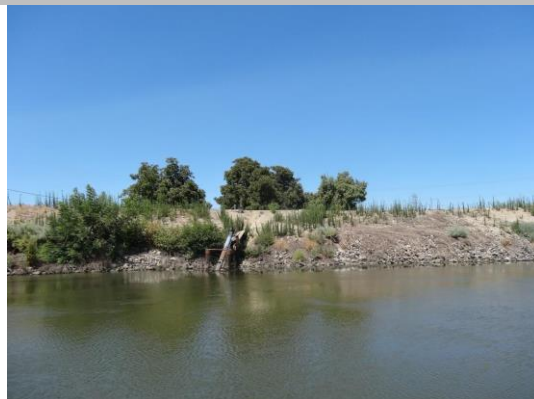
Photo 1 of 2 : SJR2016_RD0524U01RM46.39_2.jpg

LM Start	5.86	Rating **	U	Issue No.	139
LM End	5.86	Issue Type +	Ma	Location *	WS
Category	Supplemental			GPS Latitude/Longitude	
				Start	End
Item	DWR Erosion Survey			37.874370 °	37.874370 °
				-121.332850 °	-121.332850 °
DWR ID					
Comment Code					
Inspector Comment					
07/25/2016: No significant change observed.					
06/24/2015: No significant change observed.					
06/19/2014: No significant change observed.					
08/13/2013: No significant change observed.					
08/07/2012: The erosion is near a water-intake structure. Pipe leakage likely caused the erosion. [2016 Site ID:RD0524U01RM46.39]

Close view of the erosion and the pipe on the site.

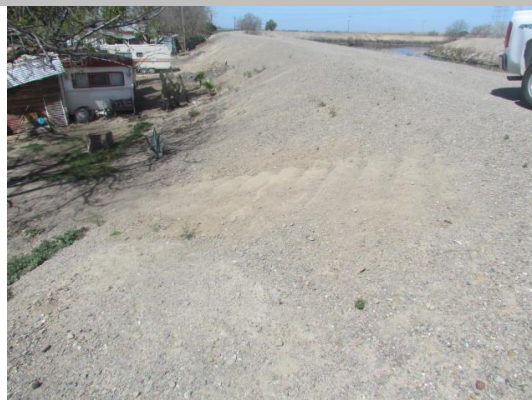
Photo 1 of 1 : FA_2016_RD0524_107_933_20160929_00291.jpg

LM Start	6.00	Rating **	M	Issue No.	933
LM End	6.00	Issue Type +	Ma	Location *	LS
Category	Earthen Levee			GPS Latitude/Longitude	
				Start	End
Item	Slope Stability			37.873047 °	37.873047 °
				-121.331408 °	-121.331408 °
DWR ID	DWR_RD0524_01_s_2012_933				
Comment Code					
S2 : Repair the levee slope damaged by foot traffic and prevent access where possible.					
Inspector Comment					
Landowner cut steps into landside slope.

Looking north at steps cut into landward slope.

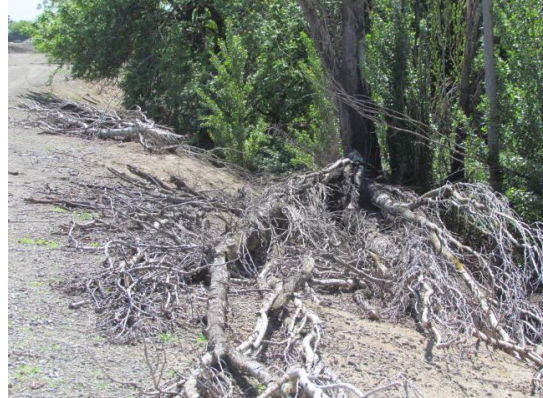
Photo 1 of 4 : FA_2016_RD0524_107_81_20160929_00132.jpg

LM Start	6.15	Rating **	U	Issue No.	81 (cont)
LM End	6.15	Issue Type +	Ma	Location *	LS

Looking west at tree branches and limbs left on landward shoulder and slope. (Spring 2016)
