**Flood Control Project Maintenance
Levee Inspections**

Maintenance Issue Types Only, Levee Inspection Report By Mile - Fall 2017

Reclamation District No. 0524 Middle Roberts Island

Waterway	Bank	Unit Miles	Inspection Start/End	Inspector
Unit No. 01 San Joaquin River	Left	6.20	11/08/2017 11/08/2017	Dave Torres

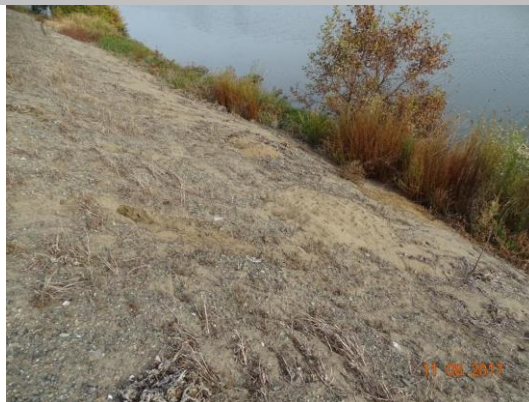
Photo 1 of 1 : FA_2017_RD0524_107_237_20171116_00465.jpg

LM Start	0.14	Rating **	M	Issue No.	237
LM End	0.14	Issue Type +	Ma	Location *	WS
Category	Earthen Levee		GPS Latitude/Longitude		
			Start	End	
Item	Animal Control		37.939774 °	37.939774 °	
			-121.344490 °	-121.344490 °	
DWR ID	DWR_RD0524_01_f_2017_237				
Comment Code					
A3 : No rodents visible, but rodent burrows visible; need to backfill and compact or grout burrows.					
Inspector Comment

Looking northwest at the waterside slope.

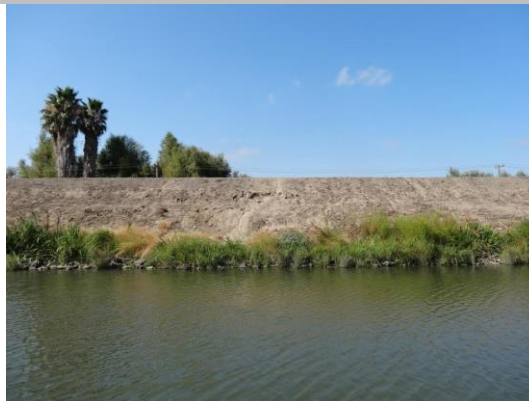
Photo 1 of 3 : SJR2017_RD0524U01RM40.85_1.jpg

LM Start	0.19	Rating **	U	Issue No.	1
LM End	0.19	Issue Type +	Ma	Location *	WS
Category	Supplemental			GPS Latitude/Longitude	
				Start	End
Item	DWR Erosion Survey			37.939085 °	37.939085 °
				-121.343917 °	-121.343917 °
DWR ID	RD0524U01RM40.85				
Comment Code					
Inspector Comment					
09/13/2017: No significant change observed.					
07/25/2016: No significant change observed.					
06/24/2015: No significant change observed.					
06/19/2014: No significant change observed.					
08/13/2013: The erosion was discovered during 2013 spring levee inspection. Inspector comment: Erosion is located along the lower level of water-ward slope. [2017 Site ID:RD0524U01RM40.85]

Close view of the erosion.

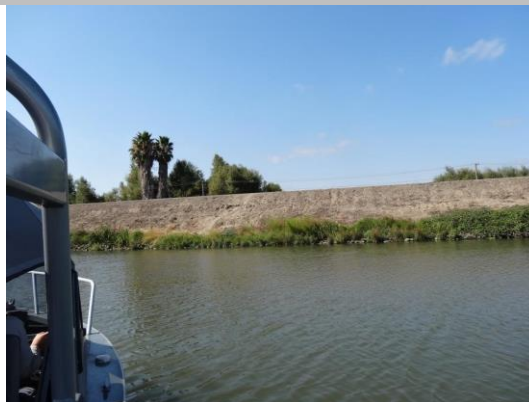
Photo 2 of 3 : SJR2017_RD0524U01RM40.85_2.jpg

Front view of the erosion.

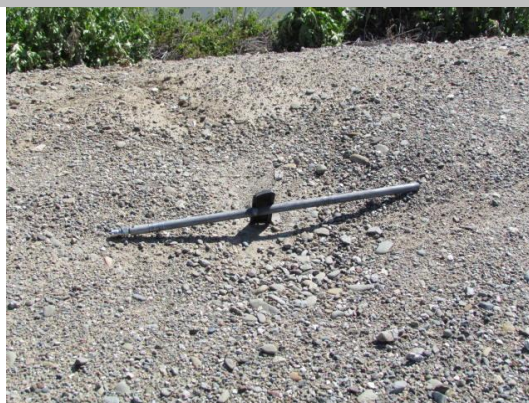
Photo 3 of 3 : FA_2017_RD0524_107_3_20170919_00003.jpg

LM Start	0.21	Rating **	M	Issue No.	3 (cont)	
LM End	0.21	Issue Type +	Ma	Location *	CR	
Category	Earthen Levee			GPS Latitude/Longitude		
				Start		End
Item	Crown Surface / Depressions / Rutting			37.938890 °		37.938890 °
				-121.343657 °		-121.343657 °
DWR ID	DWR_RD0524_01_s_2016_3					
Comment Code						
C2 : Repair depressions or ruts in the crown or slope.						
Inspector Comment						
No change in status.

Looking east at 3" depression on levee crown. (Spring 2012)

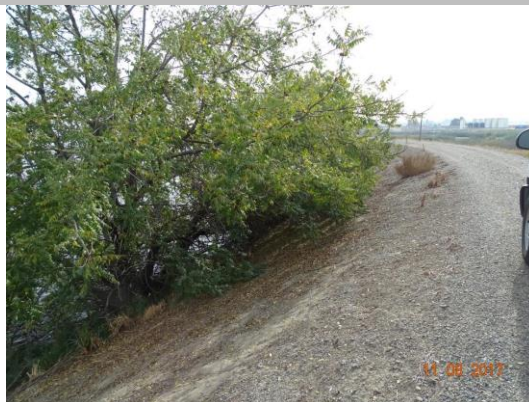
Photo 1 of 1 : FA_2017_RD0524_107_201_20171116_00466.jpg

LM Start	0.23	Rating **	U	Issue No.	201
LM End	0.23	Issue Type +	Ma	Location *	WS
Category	Earthen Levee			GPS Latitude/Longitude	
				Start	End
Item	Trim / Thin Trees			37.938648 °	37.938648 °
				-121.343480 °	-121.343480 °
DWR ID	DWR_RD0524_01_f_2016_201				
Comment Code					
T2 : Thin trees to allow visibility of the ground and room to flood fight.					
Inspector Comment					
Untrimmed trees on waterside slope.

Looking southeast at the waterside slope.

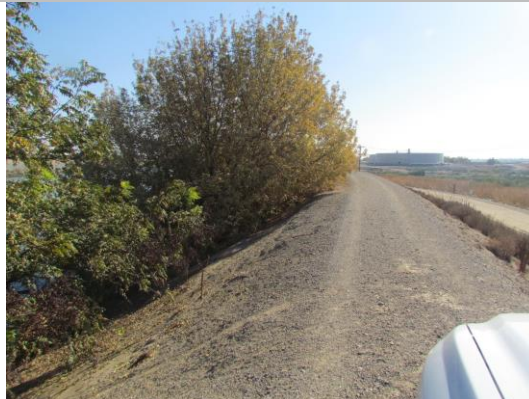
Photo 1 of 4 : FA_2017_RD0524_107_179_20170919_00217.jpg

LM Start	0.27	Rating **	U	Issue No.	179
LM End	0.27	Issue Type +	Ma	Location *	WS
Category	Earthen Levee			GPS Latitude/Longitude	
				Start	End
Item	Trim / Thin Trees			37.938438 °	37.938438 °
				-121.342883 °	-121.342883 °
DWR ID	DWR_RD0524_01_s_2014_179				
Comment Code					
T2 : Thin trees to allow visibility of the ground and room to flood fight.					
Inspector Comment					
Tree blocking view of waterside slope.

Looking east at untrimmed tree on waterward slope. (Fall 2016)

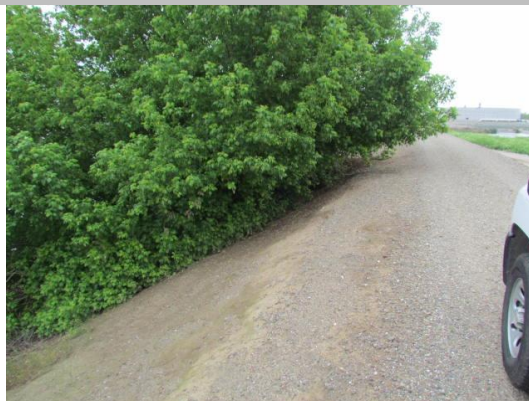
Photo 2 of 4 : FA_2017_RD0524_107_179_20170919_00218.jpg

Looking east at untrimmed tree on waterward slope (Spring 2016)

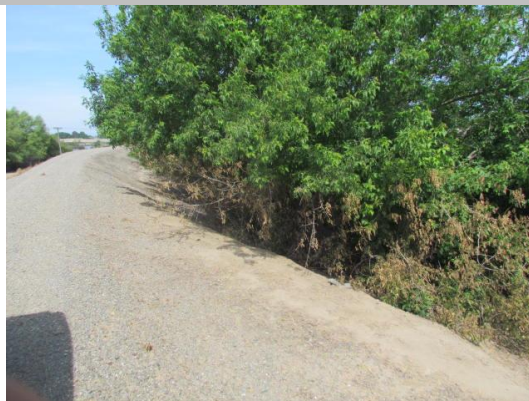
Photo 3 of 4 : FA_2017_RD0524_107_179_20170919_00219.jpg

Looking west at untrimmed tree on waterward slope. (Spring 2015)

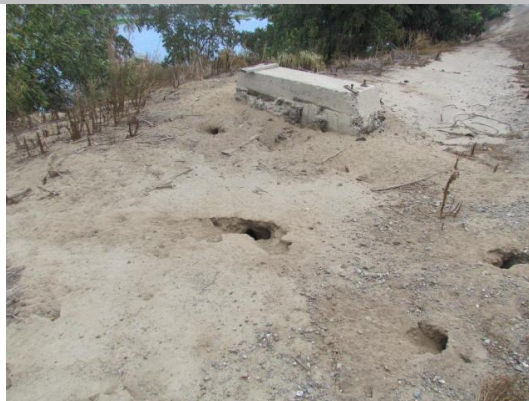
Photo 2 of 4 : FA_2017_RD0524_107_174_20170919_00209.jpg

Looking southeast at several rodent holes on waterward slope. (Spring 2016)

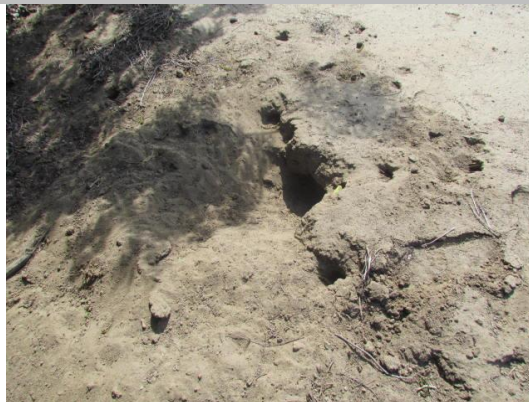
Photo 3 of 4 : FA_2017_RD0524_107_174_20170919_00210.jpg

Looking west at several rodent holes on waterward shoulder. (Spring 2015)

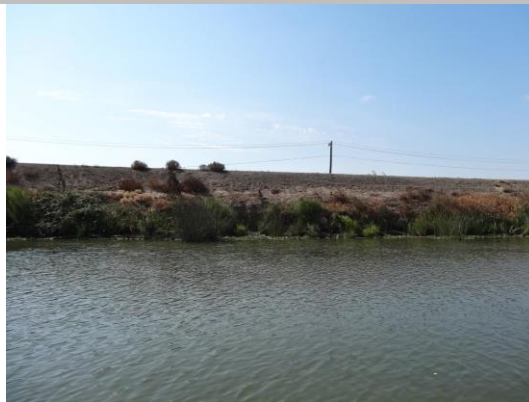
Photo 1 of 4 : SJR2017_RD0524U01RM40.93_1.jpg

LM Start	0.34	Rating **	M	Issue No.	2
LM End	0.34	Issue Type +	Ma	Location *	WS
Category	Supplemental			GPS Latitude/Longitude	
				Start	End
Item	DWR Erosion Survey			37.938461 °	37.938461 °
				-121.341526 °	-121.341526 °
DWR ID	RD0524U01RM40.93				
Comment Code					
Inspector Comment					
09/13/2017: There are two pocket erosions at the site; both erosions are around 10 ft long and 6 ft high. [2017 Site ID:RD0524U01RM40.93]

Front view of the erosion site.

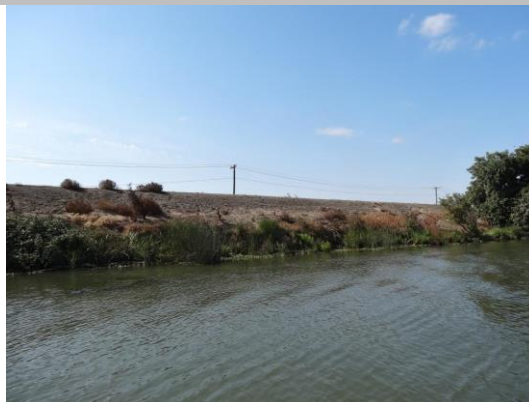
Photo 2 of 4 : SJR2017_RD0524U01RM40.93_2.jpg

Looking downstream of the erosion.

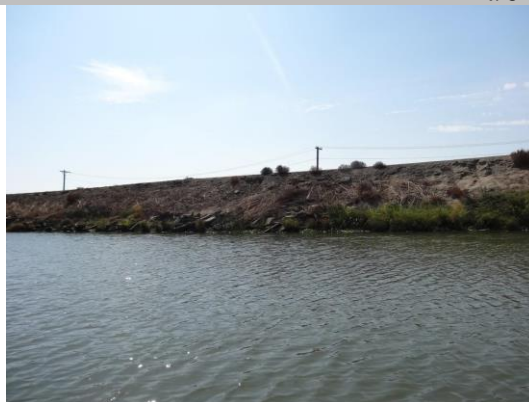
Photo 3 of 4 : SJR2017_RD0524U01RM40.93_3.jpg

Close view of the erosion site.

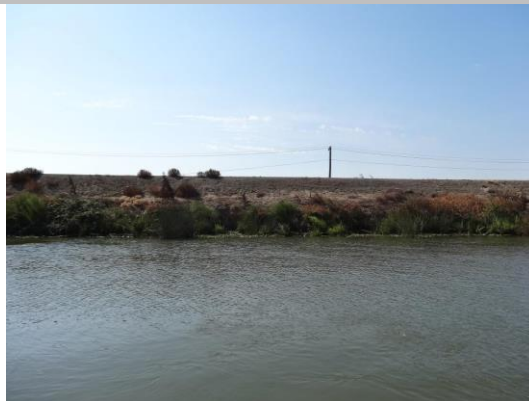
Photo 4 of 4 : SJR2017_RD0524U01RM40.93_4.jpg

LM Start	0.34	Rating **	M	Issue No.	2 (cont)	
LM End	0.34	Issue Type +	Ma	Location *	WS	
Category	Supplemental			GPS Latitude/Longitude		
				Start		End
Item	DWR Erosion Survey			37.938461 °	37.938461 °	
				-121.341526 °	-121.341526 °	
DWR ID	RD0524U01RM40.93					
Comment Code						
Inspector Comment						
09/13/2017: There are two pocket erosions at the site; both erosions are around 10 ft long and 6 ft high. [2017 Site ID:RD0524U01RM40.93]

Front view of the erosion.

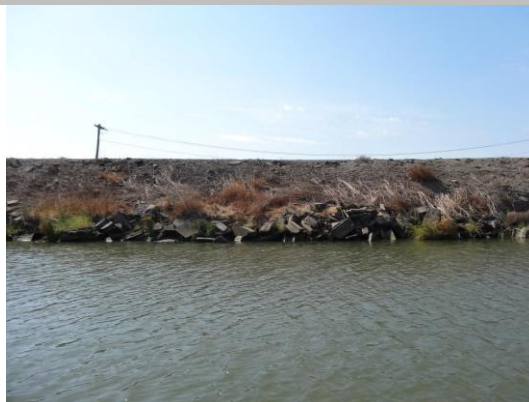
Photo 1 of 4 : SJR2017_RD0524U01RM40.99_1.jpg

LM Start	0.40	Rating **	A/W	Issue No.	5	
LM End	0.40	Issue Type +	Ma	Location *	WS	
Category	Supplemental			GPS Latitude/Longitude		
				Start	End	
Item	DWR Erosion Survey			37.938870 °	37.938870 °	
				-121.340460 °	-121.340460 °	
DWR ID	RD0524U01RM40.99					
Comment Code						
Inspector Comment						
09/13/2017: No significant change observed.						
07/25/2016: More vegetation observed at the site.						
06/24/2015: No significant change observed.						
06/19/2014: No significant change observed.						
08/13/2013: No significant change at this site.						
08/07/2012: The erosion is at the upper levee slope, and likely caused by slope slip. The lower levee slope is covered with dense vegetation.						
[2017 Site ID:RD0524U01RM40.99]

Front view of the erosion site.

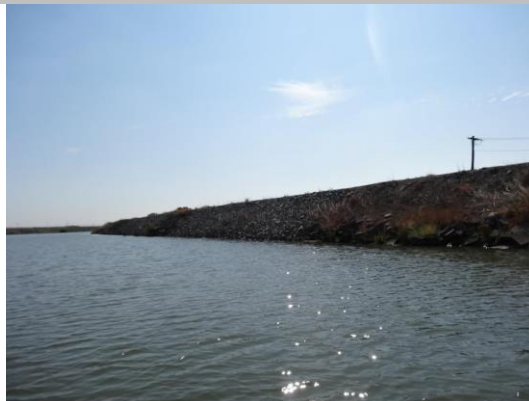
Photo 2 of 4 : SJR2017_RD0524U01RM40.99_2.jpg

LM Start	0.40	Rating **	A/W	Issue No.	5 (cont)	
LM End	0.40	Issue Type +	Ma	Location *	WS	
Category	Supplemental			GPS Latitude/Longitude		
				Start	End	
Item	DWR Erosion Survey			37.938870 °	37.938870 °	
				-121.340460 °	-121.340460 °	
DWR ID	RD0524U01RM40.99					
Comment Code						
Inspector Comment						
09/13/2017: No significant change observed.						
07/25/2016: More vegetation observed at the site.						
06/24/2015: No significant change observed.						
06/19/2014: No significant change observed.						
08/13/2013: No significant change at this site.						
08/07/2012: The erosion is at the upper levee slope, and likely caused by slope slip. The lower levee slope is covered with dense vegetation.						
[2017 Site ID:RD0524U01RM40.99]

Downstream view of the site.

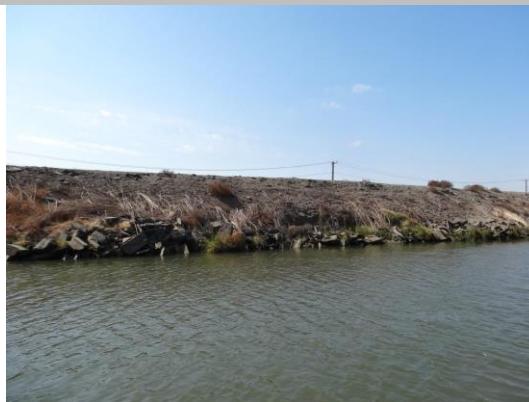
Photo 3 of 4 : SJR2017_RD0524U01RM40.99_3.jpg

Close view of the erosion.

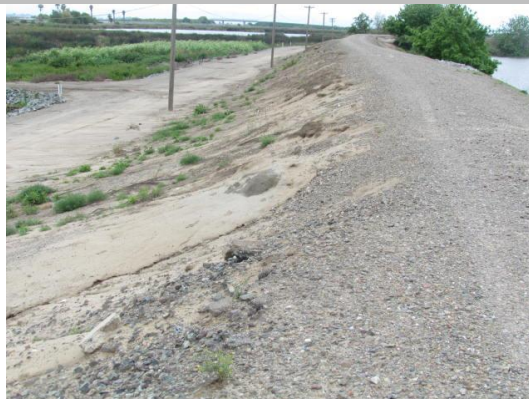
Photo 1 of 2 : FA_2017_RD0524_107_205_20170919_00246.jpg

LM Start	0.40	Rating **	U	Issue No.	205
LM End	0.46	Issue Type +	Ma	Location *	LS
Category	Earthen Levee			GPS Latitude/Longitude	
				Start	End
Item	Erosion / Bank Caving			37.938625 °	37.938695 °
				-121.340479 °	-121.339420 °
DWR ID	DWR_RD0524_01_s_2016_205				
Comment Code					
E2 : Schedule repair of erosion site prior to the next inspection.					
Inspector Comment					
Several damaged sites within this reach.

Looking at slope damage on landward slope.

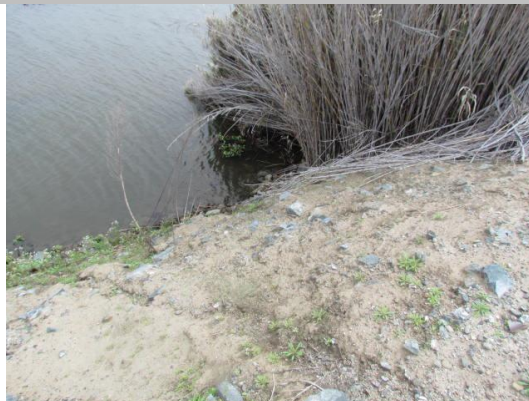
Photo 3 of 3 : FA_2017_RD0524_107_10_20170919_00013.jpg

LM Start	0.63	Rating **	U	Issue No.	10 (cont)	
LM End	0.63	Issue Type +	Ma	Location *	WS	
Category	Earthen Levee			GPS Latitude/Longitude		
				Start		End
Item	Erosion / Bank Caving			37.938247 °	37.938247 °	
				-121.336503 °	-121.336503 °	
DWR ID	DWR_RD0524_01_f_2015_10					
Comment Code						
E2 : Schedule repair of erosion site prior to the next inspection.						
Inspector Comment						
Erosion located next to and under bamboo.

Looking east at erosion under bamboo on waterward slope.

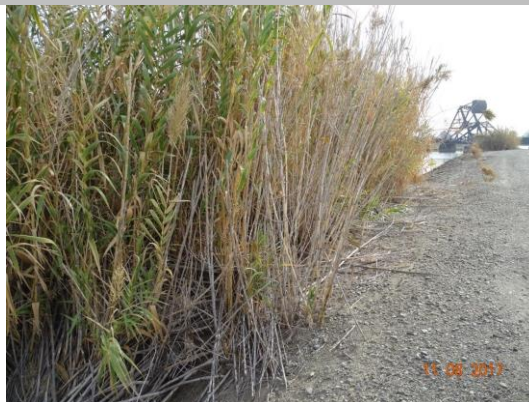
Photo 1 of 4 : FA_2017_RD0524_107_11_20171116_00467.jpg

LM Start	0.63	Rating **	U	Issue No.	11
LM End	0.64	Issue Type +	Ma	Location *	WS
Category	Earthen Levee			GPS Latitude/Longitude	
				Start	End
Item	Vegetation			37.938232 °	37.938160 °
				-121.336484 °	-121.336357 °
DWR ID	DWR_RD0524_01_s_2012_11				
Comment Code					
V2 : Remove the wild growth other than native grasses from the levee slopes.					
Inspector Comment					
Bamboo on waterside slope.

Looking southeast at the waterside slope.

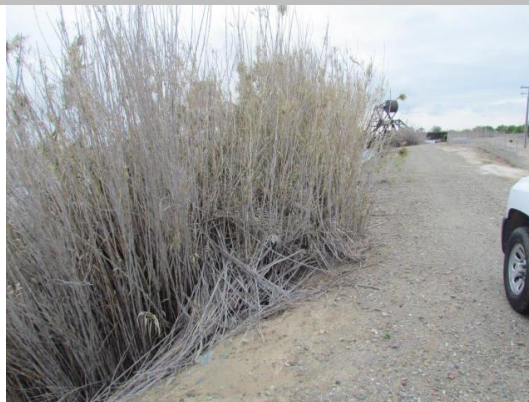
Photo 2 of 4 : FA_2017_RD0524_107_11_20170919_00014.jpg

Looking at bamboo on waterward slope. (Spring 2016)

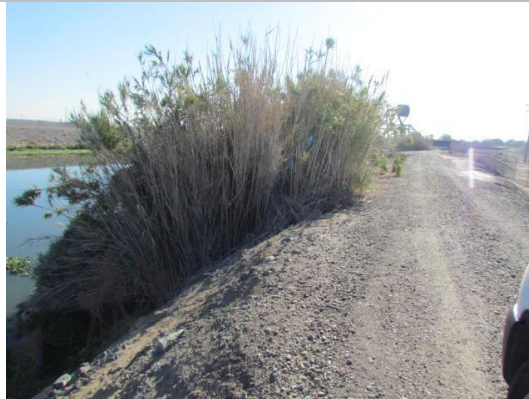
Photo 3 of 4 : FA_2017_RD0524_107_11_20170919_00015.jpg

LM Start	0.63	Rating **	U	Issue No.	11 (cont)	
LM End	0.64	Issue Type +	Ma	Location *	WS	
Category	Earthen Levee			GPS Latitude/Longitude		
				Start		End
Item	Vegetation			37.938232 °		37.938160 °
				-121.336484 °		-121.336357 °
DWR ID	DWR_RD0524_01_s_2012_11					
Comment Code						
V2 : Remove the wild growth other than native grasses from the levee slopes.						
Inspector Comment						
Bamboo on waterside slope.

Looking at bamboo on waterside slope. (Fall 2015)

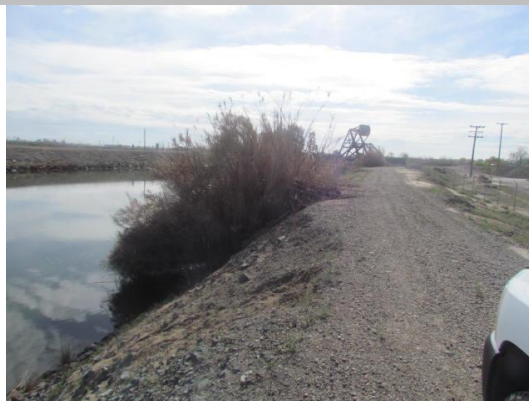
Photo 4 of 4 : FA_2017_RD0524_107_11_20170919_00016.jpg

Looking at dying bamboo on waterward slope. (Spring 2013)

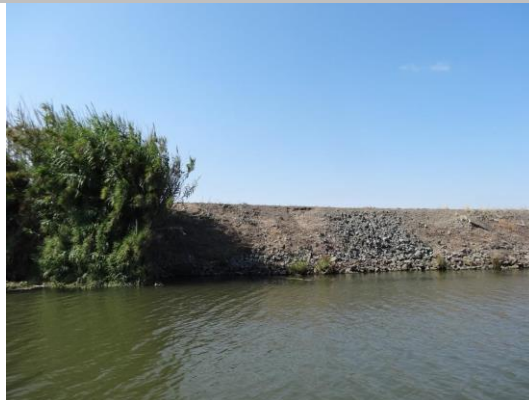
Photo 1 of 2 : SJR2017_RD0524U01RM41.26_1.jpg

LM Start	0.63	Rating **	U	Issue No.	15
LM End	0.63	Issue Type +	Ma	Location *	WS
Category	Supplemental			GPS Latitude/Longitude	
				Start	End
Item	DWR Erosion Survey			37.938247 °	37.938247 °
				-121.336503 °	-121.336503 °
DWR ID	RD0524U01RM41.26				
Comment Code					
Inspector Comment					
09/13/2017: The erosion was discovered by levee inspection. The erosion site is immediately downstream of tall vegetations. [2017 Site ID:RD0524U01RM41.26]

Front view of the erosion. The erosion is located at the shadow of the vegetation.

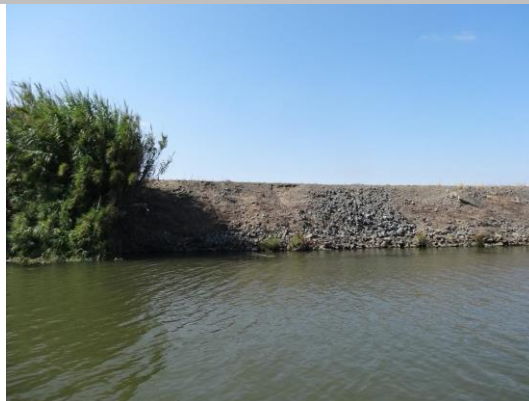
Photo 2 of 2 : SJR2017_RD0524U01RM41.26_2.jpg

LM Start	0.63	Rating **	U	Issue No.	15 (cont)
LM End	0.63	Issue Type +	Ma	Location *	WS
Category	Supplemental			GPS Latitude/Longitude	
				Start	End
Item	DWR Erosion Survey			37.938247 °	37.938247 °
				-121.336503 °	-121.336503 °
DWR ID	RD0524U01RM41.26				
Comment Code					
Inspector Comment					
09/13/2017: The erosion was discovered by levee inspection. The erosion site is immediately downstream of tall vegetations. [2017 Site ID:RD0524U01RM41.26]

Front view of the erosion.

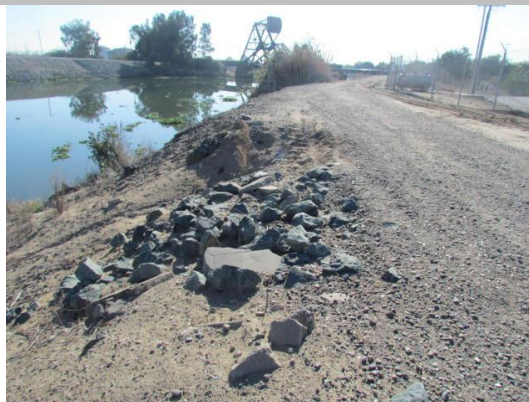
Photo 1 of 4 : FA_2017_RD0524_107_13_20170919_00020.jpg

LM Start	0.64	Rating **	M	Issue No.	13
LM End	0.65	Issue Type +	Ma	Location *	WS
Category	Earthen Levee			GPS Latitude/Longitude	
				Start	End
Item	Slope Stability			37.938105 °	37.938023 °
				-121.336288 °	-121.336173 °
DWR ID	DWR_RD0524_01_s_2012_13				
Comment Code					
S1 : Repair slope instability.					
Inspector Comment					
Depression extends from shoulder to mid levee slope two site with this section.

Looking southeast at depression on waterward shoulder fall 2015

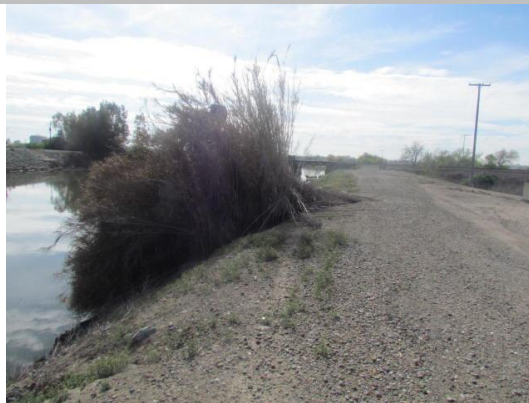
Photo 2 of 3 : FA_2017_RD0524_107_14_20170919_00025.jpg

LM Start	0.67	Rating **	U	Issue No.	14 (cont)	
LM End	0.67	Issue Type +	Ma	Location *	WS	
Category	Earthen Levee			GPS Latitude/Longitude		
				Start		End
Item	Vegetation			37.937808 °		37.937808 °
				-121.335913 °		-121.335913 °
DWR ID	DWR_RD0524_01_s_2012_14					
Comment Code						
V2 : Remove the wild growth other than native grasses from the levee slopes.						
Inspector Comment						
Bamboo on waterside slope.

Looking south at dying bamboo on waterward slope. (Spring 2013)

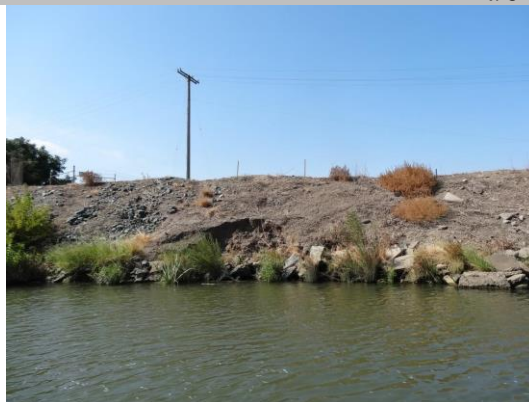
Photo 1 of 4 : SJR2017_RD0524U01RM41.34_1.jpg

LM Start	0.70	Rating **	M	Issue No.	16
LM End	0.70	Issue Type +	Ma	Location *	WS
Category	Supplemental			GPS Latitude/Longitude	
				Start	End
Item	DWR Erosion Survey			37.937577 °	37.937577 °
				-121.335491 °	-121.335491 °
DWR ID	RD0524U01RM41.34				
Comment Code					
Inspector Comment					
09/13/2017: Pocket erosion above the protected levee toe. [2017 Site ID:RD0524U01RM41.34]

Front view of the erosion.

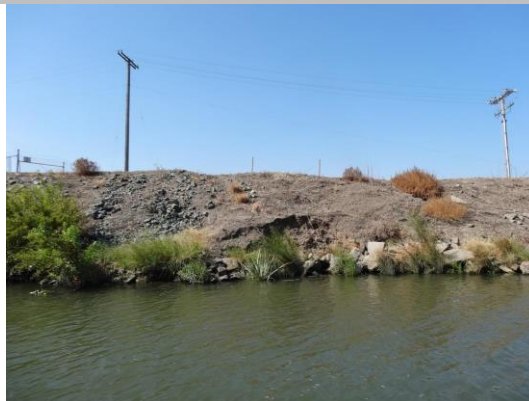
Photo 2 of 4 : SJR2017_RD0524U01RM41.34_2.jpg

LM Start	0.70	Rating **	M	Issue No.	16 (cont)	
LM End	0.70	Issue Type +	Ma	Location *	WS	
Category	Supplemental			GPS Latitude/Longitude		
				Start		End
Item	DWR Erosion Survey			37.937577 °		37.937577 °
				-121.335491 °		-121.335491 °
DWR ID	RD0524U01RM41.34					
Comment Code						
Inspector Comment						
09/13/2017: Pocket erosion above the protected levee toe. [2017 Site ID:RD0524U01RM41.34]

Close view of the erosion.

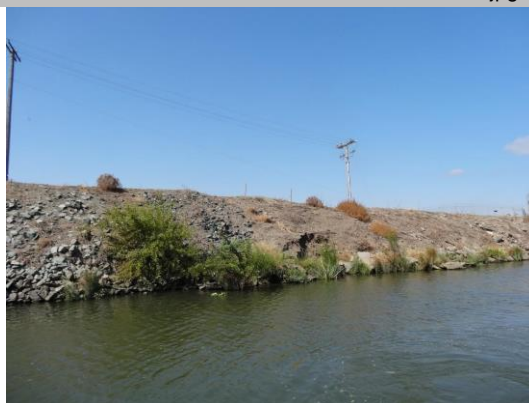
Photo 3 of 4 : SJR2017_RD0524U01RM41.34_3.jpg

Looking downstream of the erosion site.

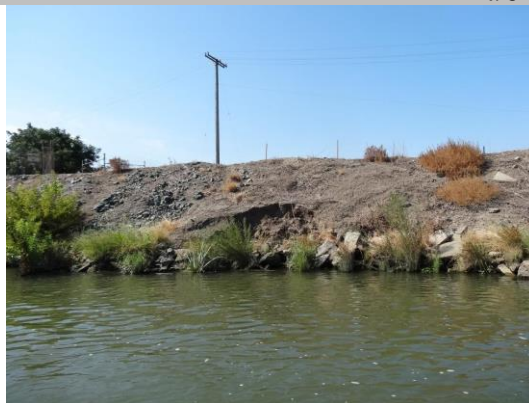
Photo 4 of 4 : SJR2017_RD0524U01RM41.34_4.jpg

Close view of the erosion.

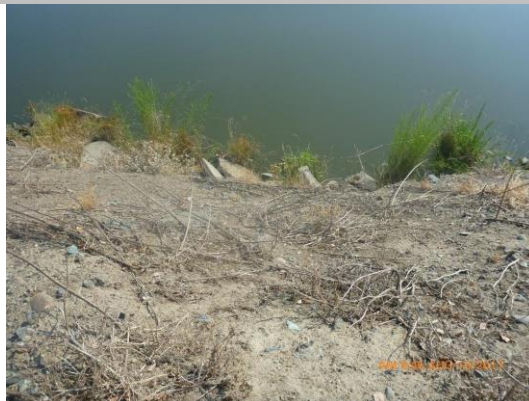
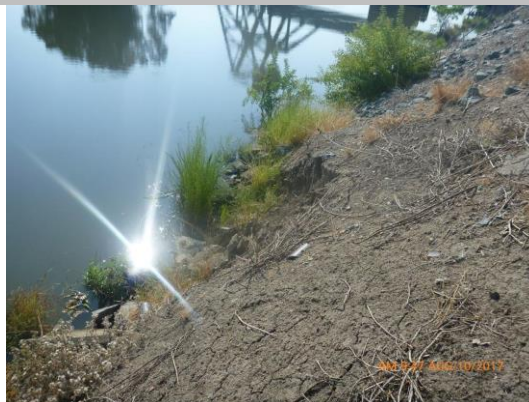
LM Start	0.70	Rating **	A/W	Issue No.	153							
LM End	0.70	Issue Type +	Ma	Location *								
Category	Supplemental		GPS Latitude/Longitude									
			Start	End								
Item	2017 Storm Damage		37.937500°	37.937500°								
			-121.335500°	-121.335500°								
DWR ID	DWR_RD0524_01_f_2017_153											
Comment Code												
Inspector Comment												
Levee Evaluation Comments Description: Slope protection repairs are needed along the waterside slope due to erosion and riprap displacement from high water. Based upon levee inspections, it was determined the waterside levee slope is eroding, deteriorating, and degrading. The eroded levee sections need to be restored back to design standards to prevent further deterioration and damage. Site ID No: 541 Site Designation: LMA-447 Repair Type: Erosion Rating: Area of Concern Field Date: 8/10/2017 Notes:

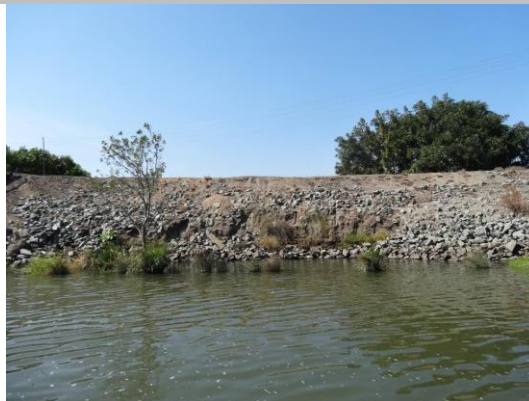
Photo 2 of 3 : SJR2017_RD0524U01RM41.36_2.jpg

LM Start	0.71	Rating **	M	Issue No.	17 (cont)	
LM End	0.73	Issue Type +	Ma	Location *	WS	
Category	Supplemental			GPS Latitude/Longitude		
				Start	End	
Item	DWR Erosion Survey			37.937222 °	37.937222 °	
				-121.335277 °	-121.335277 °	
DWR ID	RD0524U01RM41.36					
Comment Code						
Inspector Comment						
09/13/2017: No significant change observed.						
07/25/2016: No significant change observed.						
06/24/2015: The erosion site is immediately downstream of the RR bridge. [2017 Site ID:RD0524U01RM41.36]

Close view of the erosion.

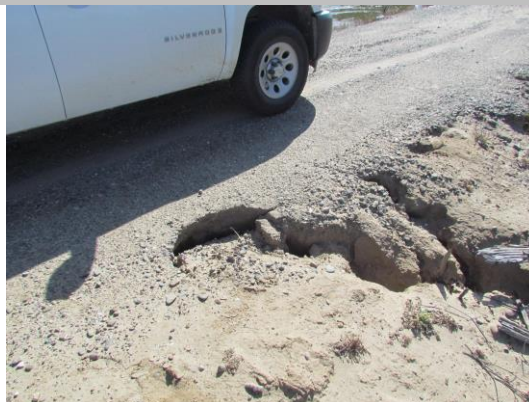
Photo 1 of 2 : FA_2017_RD0524_107_157_20170919_00190.jpg

LM Start	0.72	Rating **	U	Issue No.	157
LM End	0.72	Issue Type +	Ma	Location *	LS
Category	Earthen Levee			GPS Latitude/Longitude	
				Start	End
Item	Erosion / Bank Caving			37.937290 °	37.937290 °
				-121.335417 °	-121.335417 °
DWR ID	DWR_RD0524_01_s_2017_157				
Comment Code					
Inspector Comment					
Slope damage caused by rain runoff on landside slope.

Looking south at slope damage caused by rain runoff on landward slope.

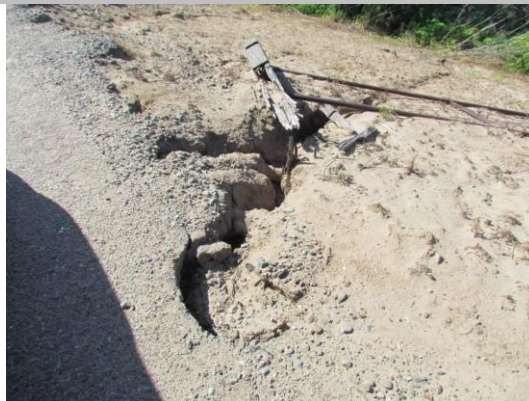
Photo 2 of 2 : FA_2017_RD0524_107_157_20170919_00191.jpg

LM Start	0.72	Rating **	U	Issue No.	157 (cont)	
LM End	0.72	Issue Type +	Ma	Location *	LS	
Category	Earthen Levee			GPS Latitude/Longitude		
				Start		End
Item	Erosion / Bank Caving			37.937290 °	37.937290 °	
				-121.335417 °	-121.335417 °	
DWR ID	DWR_RD0524_01_s_2017_157					
Comment Code						
Inspector Comment						
Slope damage caused by rain runoff on landside slope.

Looking west at slope damage caused by rain runoff on landward slope.

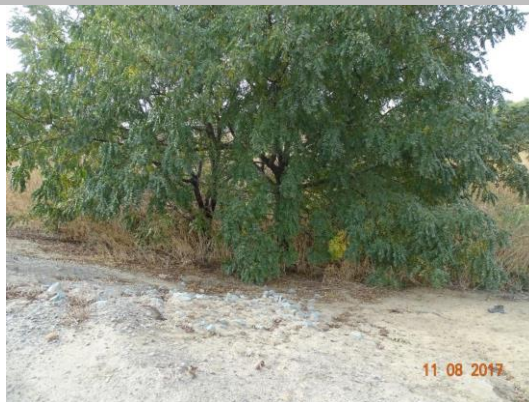
Photo 1 of 2 : FA_2017_RD0524_107_156_20171116_00468.jpg

LM Start	0.72	Rating **	M	Issue No.	156
LM End	0.72	Issue Type +	Ma	Location *	LS
Category	Earthen Levee			GPS Latitude/Longitude	
				Start	End
Item	Trim / Thin Trees			37.937258 °	37.937258 °
				-121.335373 °	-121.335373 °
DWR ID	DWR_RD0524_01_s_2017_156				
Comment Code					
T1 : Trim trees to at least five feet above ground level.					
Inspector Comment					
Dense vegetation on landside slope.

Looking southwest at the landside slope.

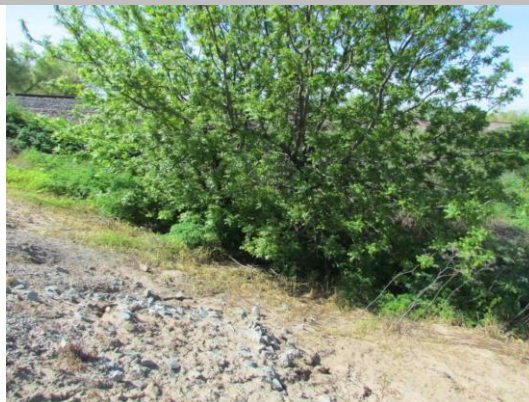
Photo 2 of 2 : FA_2017_RD0524_107_156_20170919_00189.jpg

Looking west at dense untrimmed tree on landward slope.

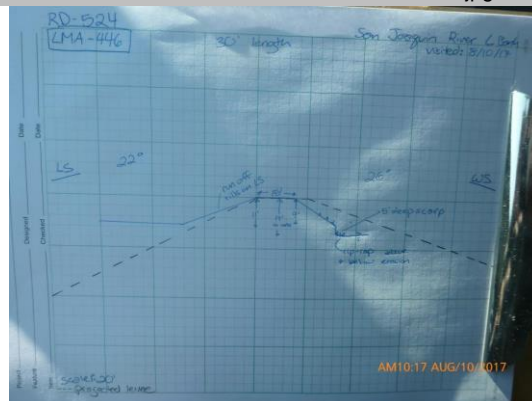
Photo 3 of 3 : LEVAL_FA_2017_540_4089.jpg

LM Start	0.72	Rating **	A/W	Issue No.	154 (cont)
LM End	0.73	Issue Type +	Ma	Location *	
Category	Supplemental		GPS Latitude/Longitude		
			Start	End	
Item	2017 Storm Damage		37.937200°	37.937100°	
			-121.335300°	-121.335300°	
DWR ID	DWR_RD0524_01_f_2017_154				
Comment Code					
Inspector Comment					
<p>Levee Evaluation Comments</p> <p>Description: Slope protection repairs are needed along the waterside slope due to erosion and riprap displacement from high water. Based upon levee inspections, it was determined the waterside levee slope is eroding, deteriorating, and degrading. The eroded levee sections need to be restored back to design standards to prevent further deterioration and damage.</p> <p>Site ID No: 540</p> <p>Site Designation: LMA-446</p> <p>Repair Type: Erosion</p> <p>Rating: Area of Concern</p> <p>Field Date: 8/10/2017</p> <p>Notes:</p>

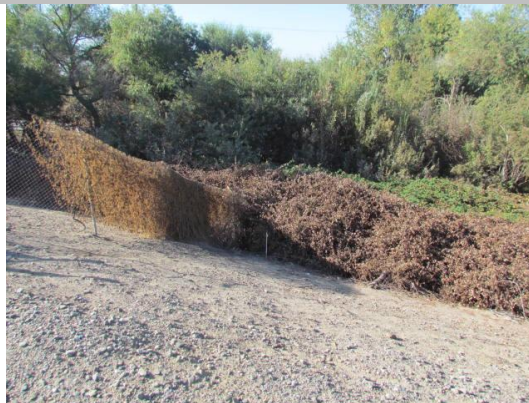
Photo 2 of 3 : FA_2017_RD0524_107_262_20170919_00269.jpg

LM Start	0.75	Rating **	U	Issue No.	262
LM End	0.78	Issue Type +	Ma	Location *	LS
Category	Earthen Levee		GPS Latitude/Longitude		
			Start	End	
Item	Vegetation		37.936813°	37.936539°	
			-121.335019°	-121.334863°	
DWR ID	DWR_RD0524_01_s_2012_262				
Comment Code					
V2 : Remove the wild growth other than native grasses from the levee slopes.					
Inspector Comment					
Dense vegetation at landside toe along fence line.

Looking west at dense vegetation at landward slope and toe fall 2015.

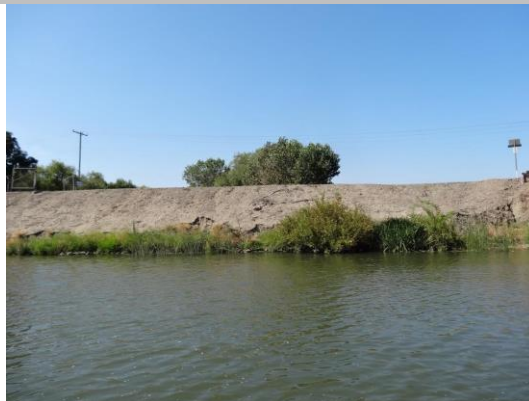
Photo 1 of 4 : SJR2017_RD0524U01RM41.39_1.jpg

LM Start	0.76	Rating **	U	Issue No.	21
LM End	0.77	Issue Type +	Ma	Location *	WS
Category	Supplemental			GPS Latitude/Longitude	
				Start	End
Item	DWR Erosion Survey			37.936821 °	37.936821 °
				-121.334582 °	-121.334582 °
DWR ID	RD0524U01RM41.39				
Comment Code					
Inspector Comment					
09/13/2017: No significant change observed.					
07/25/2016: No significant change observed.					
06/24/2015: No significant change observed.					
06/19/2014: No significant change observed.					
08/13/2013: No significant change at this site.					
08/07/2012: The site has been visited by boat survey. No significant change observed.					
08/23/2011: The site is located immediately upstream of a Railroad bridge. Dense vegetation at the water line blocks the view of erosion.					
[2017 Site ID:RD0524U01RM41.39]

Front view of the erosion site.

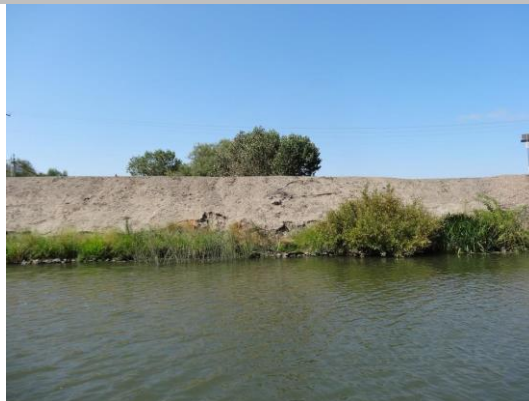
Photo 2 of 4 : SJR2017_RD0524U01RM41.39_2.jpg

Front view of the erosion site. Vegetation is visible.

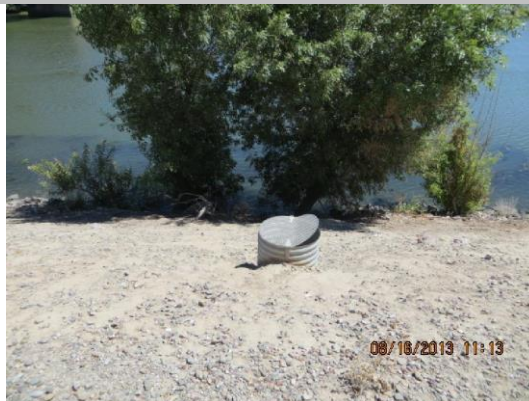
Photo 1 of 2 : UCIP_FA_2017_17571_29719.jpg

Siphon breaker in 24-inch cmp riser on WS slope.

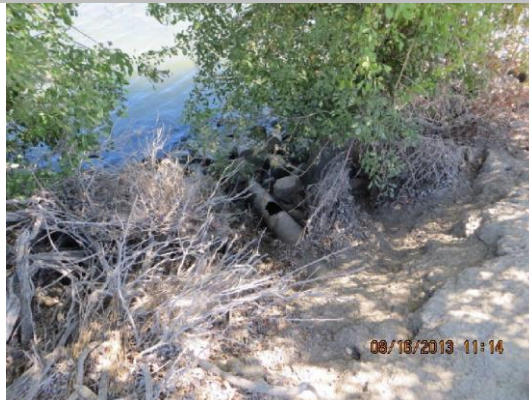
Photo 2 of 2 : UCIP_FA_2017_17571_29718.jpg

FS_ID:17571
DS_ID:20596
EP_NO: N/A
Repair Type: Non-Urgent
Crossing Status: Found
UCIP Comments: Large hole in pipe at WS toe. Appears abandoned and should be done so properly.
FIELD_STRUCT_DESC: 8-inch steel pipe of unknown purpose through the levee, 4 feet below the crown. Pump at the toe of the landside (LS) slope, not found 8/16/13. Siphon breaker in 24-inch corrugated metal riser unit on the waterside (WS) slope. [Additional Reference(s): USACE San Joaquin O&M Manual 7, April 1964, (HLM 0.79)].
FS Date: 8/16/2013

Large hole in pipe at WS toe.

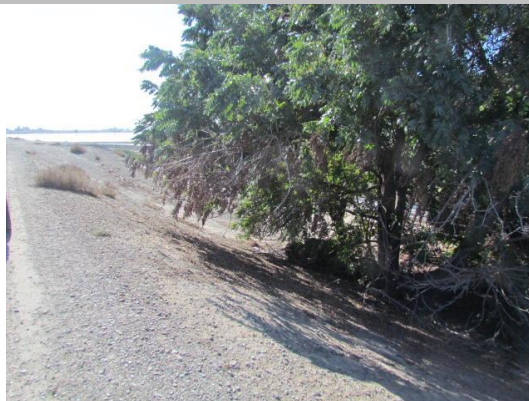
Photo 1 of 1 : FA_2017_RD0524_107_76_20170919_00120.jpg

LM Start	0.78	Rating **	U	Issue No.	76
LM End	0.78	Issue Type +	Ma	Location *	LS
Category	Earthen Levee			GPS Latitude/Longitude	
				Start	End
Item	Trim / Thin Trees			37.936444 °	37.936444 °
				-121.334797 °	-121.334797 °
DWR ID	DWR_RD0524_01_s_2012_76				
Comment Code					
T1 : Trim trees to at least five feet above ground level.					
Inspector Comment

Looking southwest at low hanging tree branches at landside toe.

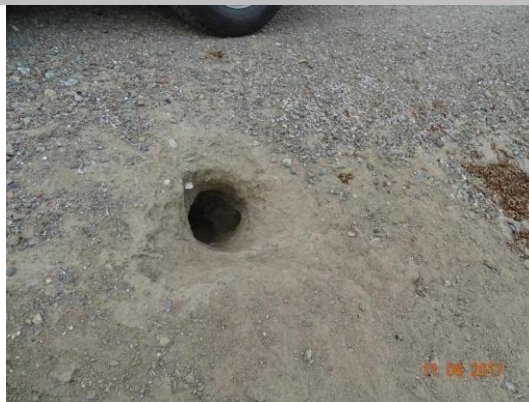
Photo 1 of 1 : FA_2017_RD0524_107_239_20171116_00471.jpg

LM Start	0.79	Rating **	U	Issue No.	239
LM End	0.79	Issue Type +	Ma	Location *	WS
Category	Earthen Levee			GPS Latitude/Longitude	
				Start	End
Item	Animal Control			37.936413 °	37.936413 °
				-121.334779 °	-121.334779 °
DWR ID	DWR_RD0524_01_f_2017_239				
Comment Code					
A3 : No rodents visible, but rodent burrows visible; need to backfill and compact or grout burrows.					
Inspector Comment

Looking west at the waterside shoulder.

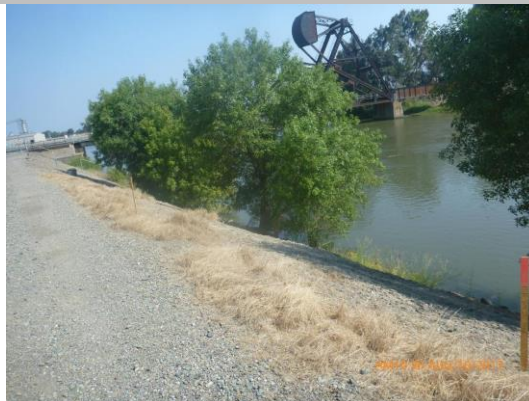
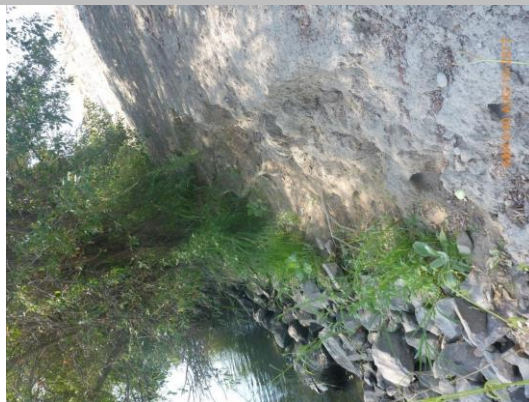
LM Start	0.79	Rating **	A/W	Issue No.	155
LM End	0.80	Issue Type +	Ma	Location *	
Category	Supplemental			GPS Latitude/Longitude	
				Start	End
Item	2017 Storm Damage			37.936300 °	37.936200 °
				-121.334700 °	-121.334600 °
DWR ID	DWR_RD0524_01_f_2017_155				
Comment Code					
Inspector Comment					
Levee Evaluation Comments					
Description:Slope protection repairs are needed along the waterside slope due to erosion and riprap displacement from high water. Based upon levee inspections, it was determined the waterside levee slope is eroding, deteriorating, and degrading. The eroded levee sections need to be restored back to design standards to prevent further deterioration and damage.					
Site ID No:538					
Site Designation:LMA-444					
Repair Type: Erosion					
Rating:Area of Concern					
Field Date:8/10/2017					
Notes:

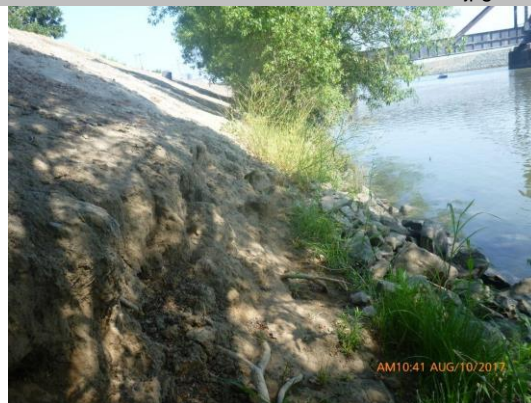
Photo 3 of 3 : LEVAL_FA_2017_538_4099.jpg

LM Start	0.79	Rating **	A/W	Issue No.	155 (cont)							
LM End	0.80	Issue Type +	Ma	Location *								
Category	Supplemental		GPS Latitude/Longitude									
			Start	End								
Item	2017 Storm Damage		37.936300 °	37.936200 °								
			-121.334700 °	-121.334600 °								
DWR ID	DWR_RD0524_01_f_2017_155											
Comment Code												
Inspector Comment												
Levee Evaluation Comments Description: Slope protection repairs are needed along the waterside slope due to erosion and riprap displacement from high water. Based upon levee inspections, it was determined the waterside levee slope is eroding, deteriorating, and degrading. The eroded levee sections need to be restored back to design standards to prevent further deterioration and damage. Site ID No: 538 Site Designation: LMA-444 Repair Type: Erosion Rating: Area of Concern Field Date: 8/10/2017 Notes:

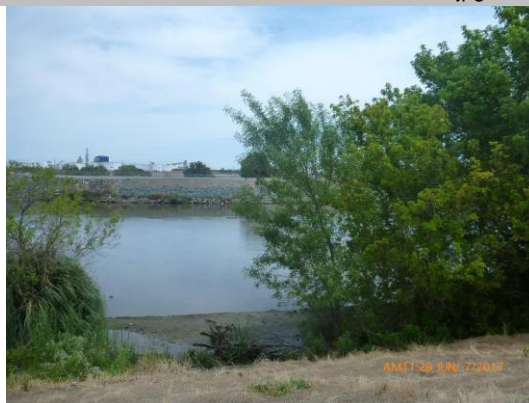
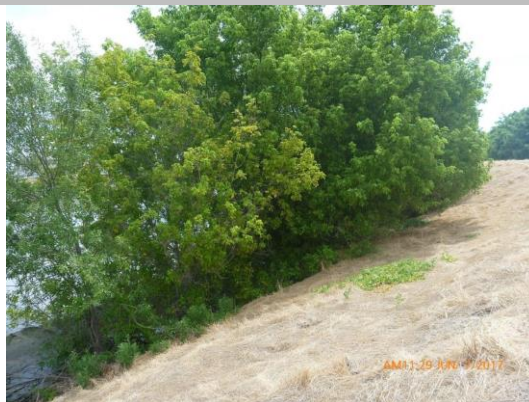
LM Start	0.91	Rating **	A/W	Issue No.	187	
LM End		Issue Type +	Ma	Location *		
Category	Supplemental			GPS Latitude/Longitude		
				Start	End	
Item	2017 Storm Damage			37.935580 °		°
				-121.333200 °		°
DWR ID	DWR_RD0524_01_f_2017_187					
Comment Code						
Inspector Comment						
Levee Evaluation Comments						
Description:						
Site ID No:87						
Site Designation:DWR_RD0524_01_s_2012_99						
Repair Type: Erosion						
Rating:Area of Concern						
Field Date:6/7/2017						
Notes: no observable defects to levee, vegetation blocks ws toe

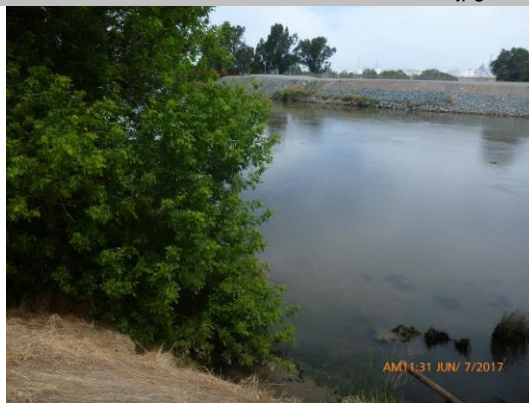
Photo 3 of 3 : LEVAL_FA_2017_87_1290.jpg

LM Start	0.91	Rating **	A/W	Issue No.	187 (cont)	
LM End		Issue Type +	Ma	Location *		
Category	Supplemental			GPS Latitude/Longitude		
				Start	End	
Item	2017 Storm Damage			37.935580 °	°	
				-121.333200 °	°	
DWR ID	DWR_RD0524_01_f_2017_187					
Comment Code						
Inspector Comment						
Levee Evaluation Comments						
Description:						
Site ID No:87						
Site Designation:DWR_RD0524_01_s_2012_99						
Repair Type: Erosion						
Rating:Area of Concern						
Field Date:6/7/2017						
Notes: no observable defects to levee, vegetation blocks ws toe

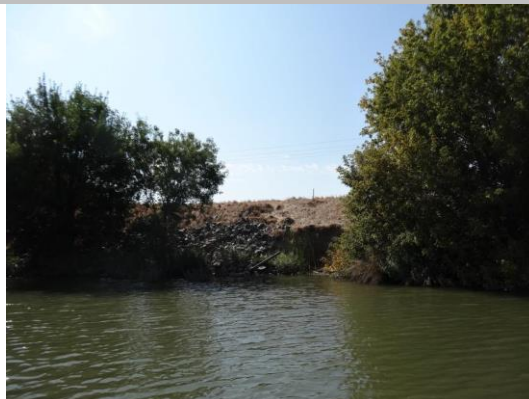
Photo 1 of 3 : SJR2017_RD0524U01RM41.5_1.jpg

LM Start	0.91	Rating **	U	Issue No.	29
LM End	0.91	Issue Type +	Ma	Location *	WS
Category	Supplemental			GPS Latitude/Longitude	
				Start	End
Item	DWR Erosion Survey			37.935576 °	37.935576 °
				-121.333202 °	-121.333202 °
DWR ID	RD0524U01RM41.5				
Comment Code					
Inspector Comment					
09/13/2017: No significant change observed.					
07/25/2016: No significant change observed.					
06/24/2015: No significant change observed.					
06/19/2014: No significant change observed.					
08/13/2013: No significant change at this site.					
08/07/2012: The site has been visited by boat survey. No significant change observed					
08/23/2011: The erosion site is immediately downstream of the riprap protection. [2017 Site ID:RD0524U01RM41.5]

Front view of the erosion. Note the riprap protection near the site.

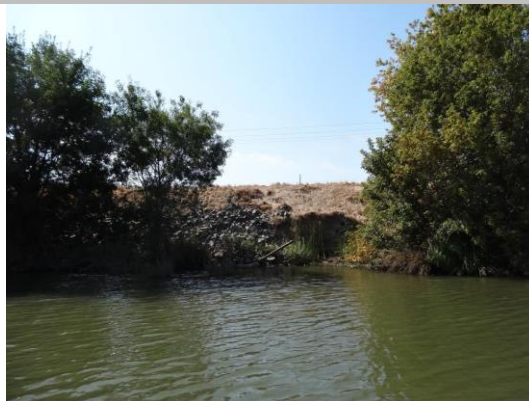
Photo 2 of 3 : SJR2017_RD0524U01RM41.5_2.jpg

Close view of the erosion.

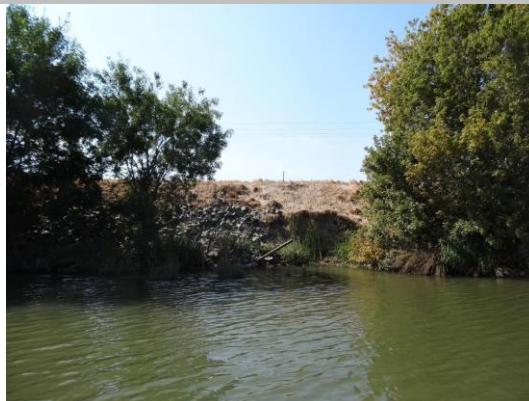
Photo 3 of 3 : SJR2017_RD0524U01RM41.5_3.jpg

Close view of the erosion.

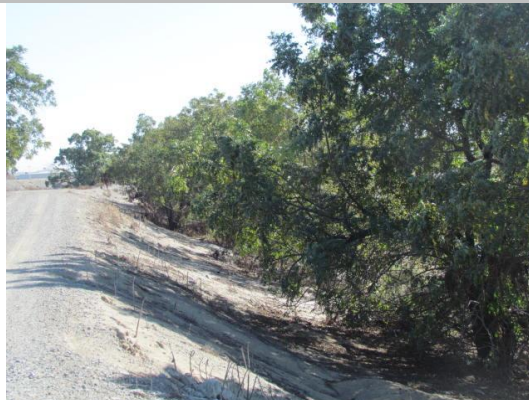
Photo 1 of 1 : FA_2017_RD0524_107_77_20170919_00121.jpg

LM Start	0.93	Rating **	M	Issue No.	77
LM End	1.01	Issue Type +	Ma	Location *	LS
Category	Earthen Levee			GPS Latitude/Longitude	
				Start	End
Item	Trim / Thin Trees			37.935259 °	37.935049 °
				-121.332864 °	-121.331334 °
DWR ID	DWR_RD0524_01_s_2012_77				
Comment Code					
T1 : Trim trees to at least five feet above ground level.					
Inspector Comment

Looking south at low hanging tree branches at landside toe.

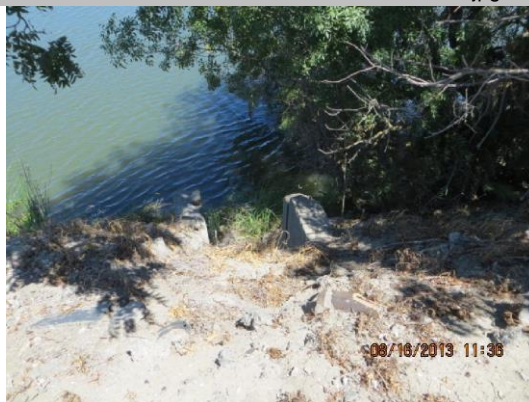
Photo 1 of 2 : UCIP_FA_2017_17575_29736.jpg

FS_ID:17575
DS_ID:20598
EP_NO: N/A
Repair Type: No Action Needed
Crossing Status: Found
UCIP Comments:
FIELD_STRUCT_DESC: *ABANDONED* 36-inch drainage pipe of an unknown material through the levee, 15 feet below the crown. Landside (LS) end is not visible. Concrete headwall at outlet on the waterside (WS) slope is visible. Pipe appears to be abandoned in place. Slide gate on the WS removed. [Additional Reference(s): DWR Levee Log, 2004. USACE San Joaquin O&M Manual 7, April 1964, (HLM 0.99)].
FS Date: 8/16/2013

Concrete headwall visible on WS slope.

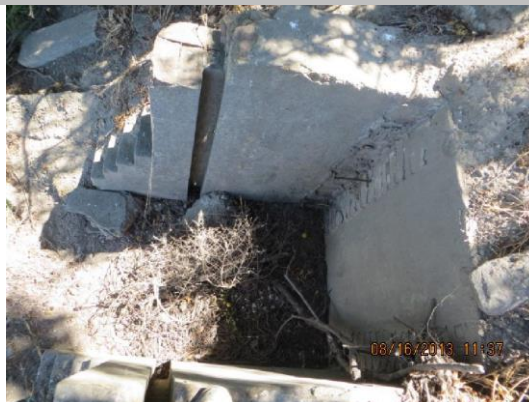
Photo 2 of 2 : UCIP_FA_2017_17575_29735.jpg

Slide gate removed from headwall on WS slope.

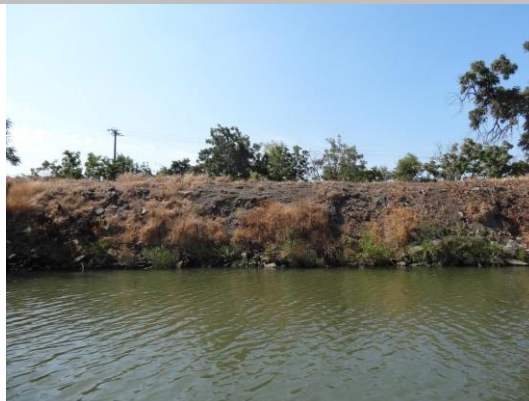
Photo 1 of 4 : SJR2017_RD0524U01RM41.58_1.jpg

LM Start	1.00	Rating **	U	Issue No.	30
LM End	1.00	Issue Type +	Ma	Location *	WS
Category	Supplemental			GPS Latitude/Longitude	
				Start	End
Item	DWR Erosion Survey			37.935410 °	37.935410 °
				-121.331560 °	-121.331560 °
DWR ID	RD0524U01RM41.58				
Comment Code					
Inspector Comment					
09/13/2017: No significant change observed.					
07/25/2016: No significant change observed.					
06/24/2015: No significant change observed.					
06/19/2014: No significant change observed.					
08/13/2013: No significant change at this site.					
08/07/2012: The erosion was discovered during the boat survey. [2017					
Site ID:RD0524U01RM41.58]

Front view of the erosion.

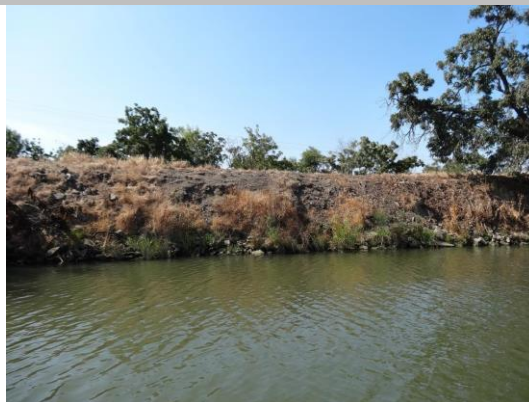
Photo 2 of 4 : SJR2017_RD0524U01RM41.58_2.jpg

Close view of the erosion.

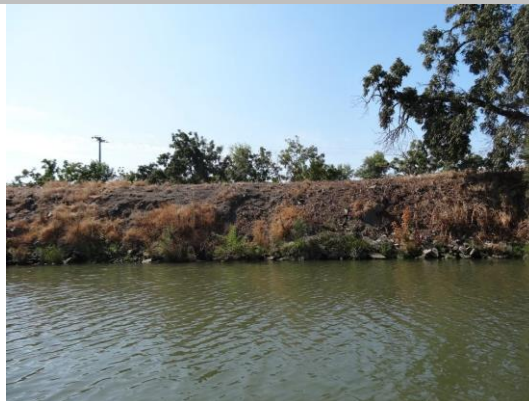
Photo 3 of 4 : SJR2017_RD0524U01RM41.58_3.jpg

LM Start	1.00	Rating **	U	Issue No.	30 (cont)
LM End	1.00	Issue Type +	Ma	Location *	WS
Category	Supplemental			GPS Latitude/Longitude	
				Start	End
Item	DWR Erosion Survey			37.935410 °	37.935410 °
				-121.331560 °	-121.331560 °
DWR ID	RD0524U01RM41.58				
Comment Code					
Inspector Comment					
09/13/2017: No significant change observed.					
07/25/2016: No significant change observed.					
06/24/2015: No significant change observed.					
06/19/2014: No significant change observed.					
08/13/2013: No significant change at this site.					
08/07/2012: The erosion was discovered during the boat survey. [2017					
Site ID:RD0524U01RM41.58]

Front view of the erosion.

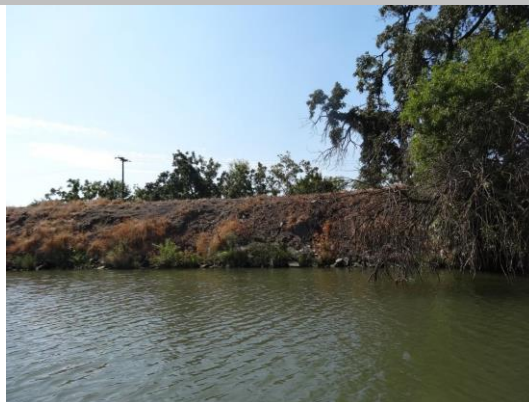
Photo 4 of 4 : SJR2017_RD0524U01RM41.58_4.jpg

Downstream view of the erosion.

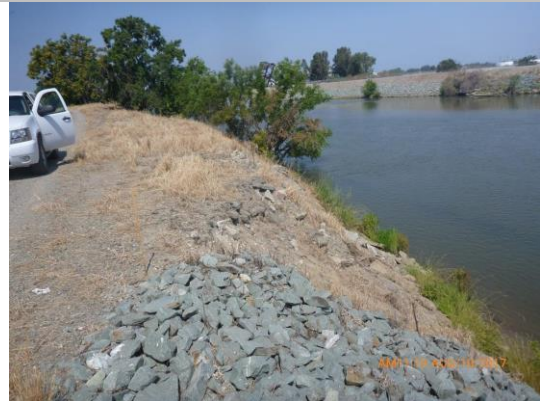
Photo 3 of 3 : LEVAL_FA_2017_536_4111.jpg

Item	2017 Storm Damage			37.935100 °	37.935100 °	
				-121.331500 °	-121.331300 °	
DWR ID	DWR_RD0524_01_f _ 2017_198					
Comment Code						
Inspector Comment						
Levee Evaluation Comments						
Description:Slope protection repairs are needed along the waterside slope due to erosion and riprap displacement from high water. Based upon levee inspections, it was determined the waterside levee slope is eroding, deteriorating, and degrading. The eroded levee sections need to be restored back to design standards to prevent further deterioration and damage.						
Site ID No:536						
Site Designation:LMA-442						
Repair Type: Erosion						
Rating:Area of Concern						
Field Date:8/10/2017						
Notes: Appears to be previous repair site adjacent to LMA-442. Large fox den on land side

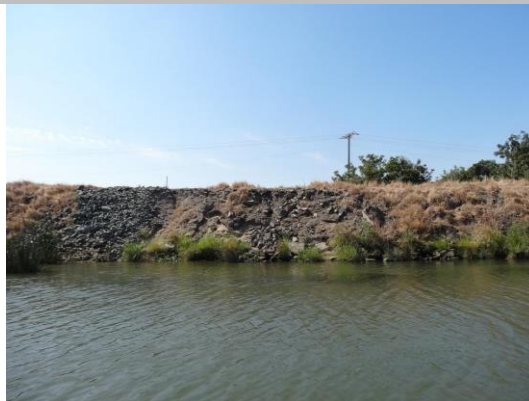
Photo 2 of 3 : SJR2017_RD0524U01RM41.59_2.jpg

Comment Code					
Inspector Comment					
09/13/2017: No significant change observed.					
07/25/2016: No significant change observed.					
06/24/2015: No significant change observed.					
06/19/2014: No significant change observed.					
08/13/2013: No significant change at this site.					
08/07/2012: The site has been visited by boat survey. Site has been repaired, but new erosion occurred at the levee slope and immediately upstream of the repaired site.					
08/23/2011: The site is about 500 ft downstream of bridge. The levee toe seems to be protected, but the protection is being washed away.					
[2017 Site ID:RD0524U01RM41.59]

Close view of the erosion.

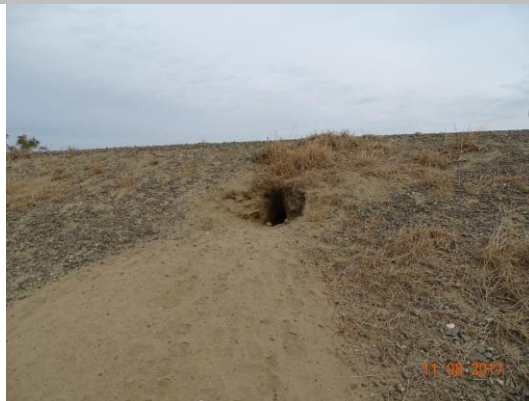
Photo 1 of 1 : FA_2017_RD0524_107_238_20171116_00469.jpg

LM Start	1.02	Rating **	U	Issue No.	238
LM End	1.02	Issue Type +	Ma	Location *	LS
Category	Earthen Levee			GPS Latitude/Longitude	
				Start	End
Item	Animal Control			37.934991 °	37.934991 °
				-121.331160 °	-121.331160 °
DWR ID	DWR_RD0524_01_f_2017_238				
Comment Code					
A3 : No rodents visible, but rodent burrows visible; need to backfill and compact or grout burrows.					
Inspector Comment

Looking northeast at the landside slope.

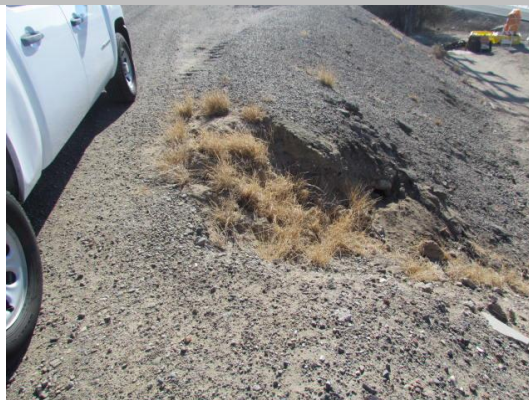
Photo 1 of 7 : FA_2017_RD0524_107_18_20170919_00031.jpg

LM Start	1.07	Rating **	U	Issue No.	18
LM End	1.07	Issue Type +	Ma	Location *	LS
Category	Earthen Levee			GPS Latitude/Longitude	
				Start	End
Item	Slope Stability			37.934715 °	37.934715 °
				-121.330343 °	-121.330343 °
DWR ID	DWR_RD0524_01_s_2012_18				
Comment Code					
S1 : Repair slope instability.					
Inspector Comment					
Slope damage extends from shoulder to middle of slope.

Looking south at caving on landward shoulder. (Fall 2015)

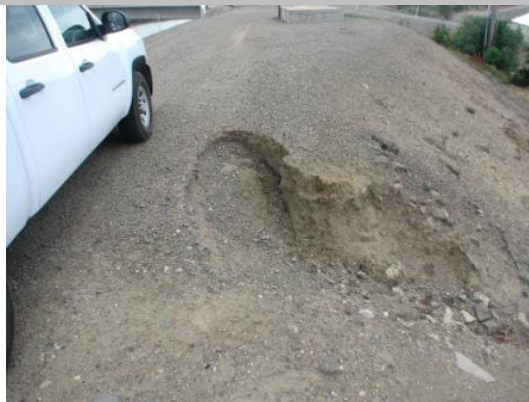
Photo 2 of 7 : FA_2017_RD0524_107_18_20170919_00032.jpg

Landward slope damage. Spring 2014
