**Flood Control Project Maintenance
Levee Inspections**

Maintenance Issue Types Only, Levee Inspection Report By Mile - Fall 2017

Reclamation District No. 0524 Middle Roberts Island

Waterway	Bank	Unit Miles	Inspection Start/End	Inspector
Unit No. 01 San Joaquin River	Left	6.20	11/08/2017 11/08/2017	Dave Torres

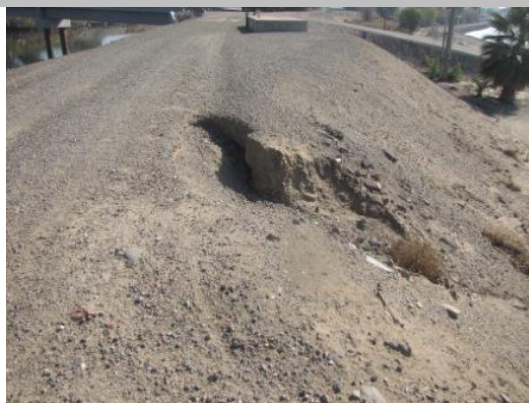
Photo 4 of 7 : FA_2017_RD0524_107_18_20170919_00034.jpg

LM Start	1.07	Rating **	U	Issue No.	18 (cont)	
LM End	1.07	Issue Type +	Ma	Location *	LS	
Category	Earthen Levee			GPS Latitude/Longitude		
				Start		End
Item	Slope Stability			37.934715 °		37.934715 °
				-121.330343 °		-121.330343 °
DWR ID	DWR_RD0524_01_s_2012_18					
Comment Code						
S1 : Repair slope instability.						
Inspector Comment						
Slope damage extends from shoulder to middle of slope.

Updated picture of the erosion site on the landside shoulder. Fall 2014

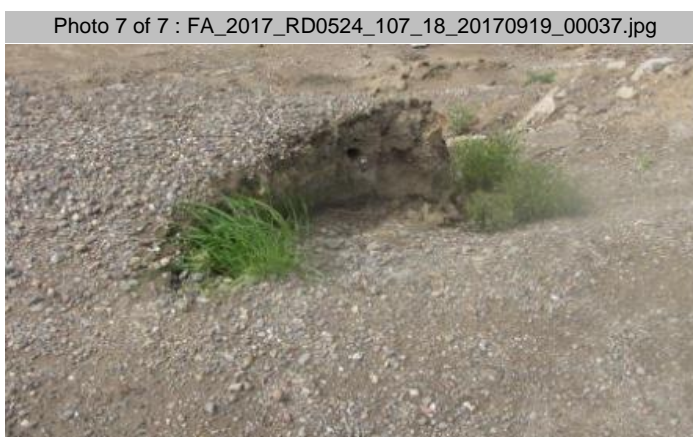
LM Start	1.07	Rating **	U	Issue No.	18 (cont)	
LM End	1.07	Issue Type +	Ma	Location *	LS	
Category	Earthen Levee			GPS Latitude/Longitude		
				Start		End
Item	Slope Stability			37.934715 °		37.934715 °
				-121.330343 °		-121.330343 °
DWR ID	DWR_RD0524_01_s_2012_18					
Comment Code						
S1 : Repair slope instability.						
Inspector Comment						
Slope damage extends from shoulder to middle of slope.

Updated view from above the slope stability.

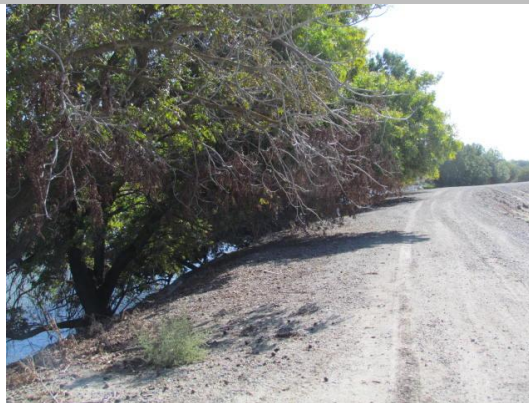
Photo 1 of 1 : FA_2017_RD0524_107_19_20170919_00038.jpg

LM Start	1.13	Rating **	M	Issue No.	19
LM End	1.16	Issue Type +	Ma	Location *	WS
Category	Earthen Levee			GPS Latitude/Longitude	
				Start	End
Item	Trim / Thin Trees			37.934118 °	37.933775 °
				-121.329657 °	-121.329305 °
DWR ID	DWR_RD0524_01_s_2012_19				
Comment Code					
T1 : Trim trees to at least five feet above ground level.					
Inspector Comment

Looking southeast at low hanging tree branches at waterside toe.

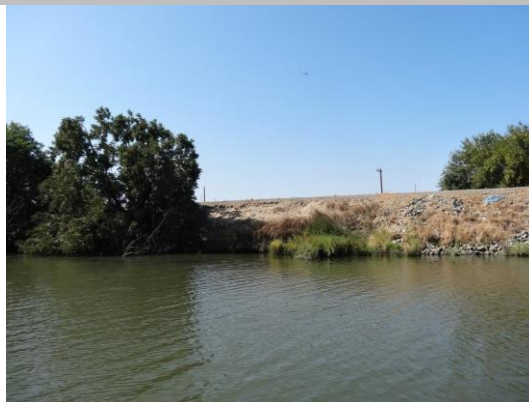
Photo 1 of 4 : SJR2017_RD0524U01RM41.79_1.jpg

Comment Code					
Inspector Comment					
09/13/2017: No significant change observed.					
07/25/2016: No significant change observed.					
06/24/2015: No significant change observed.					
06/19/2014: No significant change observed.					
08/13/2013: No significant change at this site.					
08/07/2012: The site has been visited by boat survey. No significant change observed					
08/23/2011: No significant change observed on site.					
09/07/2010: No significant change observed on site. Vegetation is visible at the water line. There is an exposed pipe discharge partially hanging at the mid-slope, possibly still used for discharging irrigation/runoff water. There is minimal rip rap protection along the bank, and what's left of it is no longer adequately protecting the bank.					
9/29/2009: Site consists of a 400-foot long eroding bank with minimal vegetation and protection; the existing rip rap has sloughed, rendering it useless; note that there is an exposed section of a pipe.

10/18/2006: There is extensive loss of rip rap on some sections; sewage disposal pond is on the landside of the levee; there is an exposed pipe outlet "hanging" from the upper slope. [2017 Site ID:RD0524U01RM41.79]

Direct view of the site.

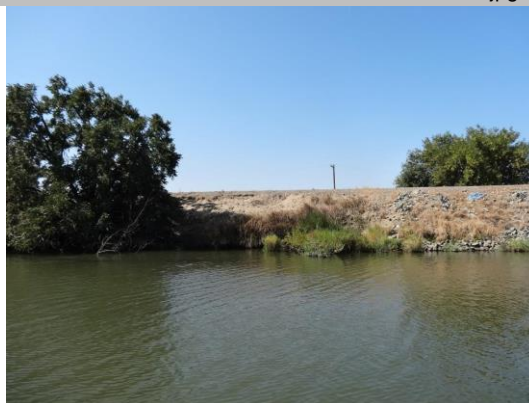
Photo 2 of 4 : SJR2017_RD0524U01RM41.79_2.jpg

Comment Code					
Inspector Comment					
09/13/2017: No significant change observed.					
07/25/2016: No significant change observed.					
06/24/2015: No significant change observed.					
06/19/2014: No significant change observed.					
08/13/2013: No significant change at this site.					
08/07/2012: The site has been visited by boat survey. No significant change observed					
08/23/2011: No significant change observed on site.					
09/07/2010: No significant change observed on site. Vegetation is visible at the water line. There is an exposed pipe discharge partially hanging at the mid-slope, possibly still used for discharging irrigation/runoff water. There is minimal rip rap protection along the bank, and what's left of it is no longer adequately protecting the bank.					
9/29/2009: Site consists of a 400-foot long eroding bank with minimal vegetation and protection; the existing rip rap has sloughed, rendering it useless; note that there is an exposed section of a pipe.

Direct view of the site.

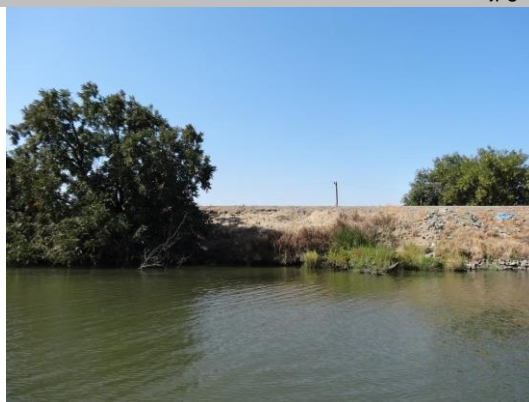
Photo 3 of 4 : SJR2017_RD0524U01RM41.79_3.jpg

View of the erosion.

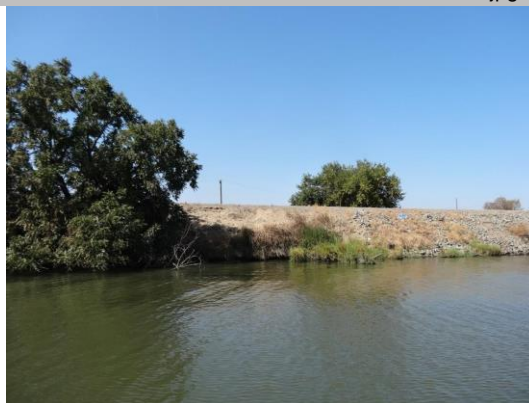
Photo 4 of 4 : SJR2017_RD0524U01RM41.79_4.jpg

Comment Code					
Inspector Comment					
09/13/2017: No significant change observed.					
07/25/2016: No significant change observed.					
06/24/2015: No significant change observed.					
06/19/2014: No significant change observed.					
08/13/2013: No significant change at this site.					
08/07/2012: The site has been visited by boat survey. No significant change observed					
08/23/2011: No significant change observed on site.					
09/07/2010: No significant change observed on site. Vegetation is visible at the water line. There is an exposed pipe discharge partially hanging at the mid-slope, possibly still used for discharging irrigation/runoff water. There is minimal rip rap protection along the bank, and what's left of it is no longer adequately protecting the bank.					
9/29/2009: Site consists of a 400-foot long eroding bank with minimal vegetation and protection; the existing rip rap has sloughed, rendering it useless; note that there is an exposed section of a pipe.

10/18/2006: There is extensive loss of rip rap on some sections; sewage disposal pond is on the landside of the levee; there is an exposed pipe outlet "hanging" from the upper slope. [2017 Site ID:RD0524U01RM41.79]

View of the site. Note the tree near the erosion site.

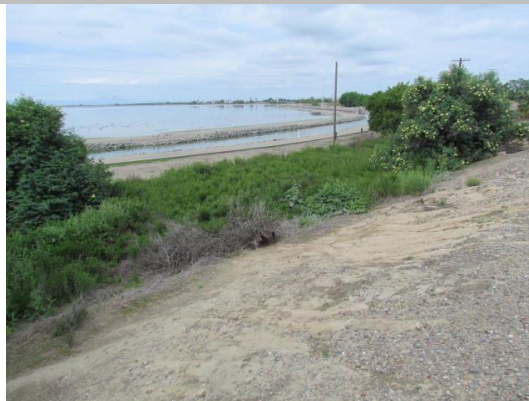
Photo 2 of 4 : FA_2017_RD0524_107_915_20170919_00278.jpg

LM Start	1.16	Rating **	U	Issue No.	915 (cont)	
LM End	1.23	Issue Type +	Ma	Location *	LS	
Category	Earthen Levee			GPS Latitude/Longitude		
				Start	End	
Item	Vegetation			37.933775 °	37.932784 °	
				-121.329250 °	-121.328765 °	
DWR ID	DWR_RD0524_01_s_2012_915					
Comment Code						
V2 : Remove the wild growth other than native grasses from the levee slopes.						
Inspector Comment						
Control veg at landside toe and berm.

Looking northwest at dense veg at landward toe and berm. (Spring 2016)

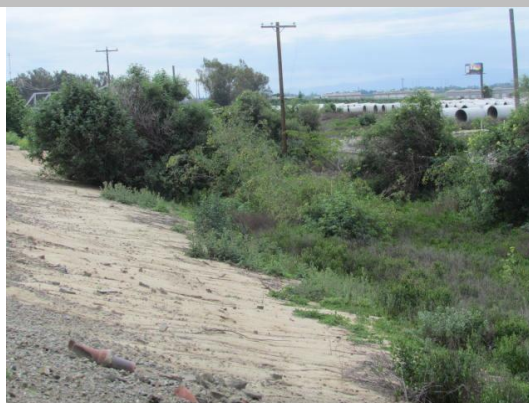
Photo 3 of 4 : FA_2017_RD0524_107_915_20170919_00279.jpg

Looking southwest at dense veg at landward toe and berm. (Spring 2015)

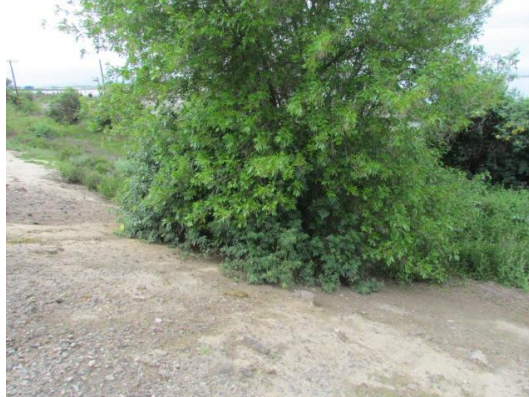
Photo 1 of 1 : FA_2017_RD0524_107_206_20170919_00248.jpg

LM Start	1.17	Rating **	U	Issue No.	206
LM End	1.17	Issue Type +	Ma	Location *	LS
Category	Earthen Levee			GPS Latitude/Longitude	
				Start	End
Item	Trim / Thin Trees			37.933591 °	37.933591 °
				-121.329154 °	-121.329154 °
DWR ID	DWR_RD0524_01_s_2016_206				
Comment Code					
T1 : Trim trees to at least five feet above ground level.					
Inspector Comment

Looking southwest a untrimmed tree at landward toe. (Spring 2016)

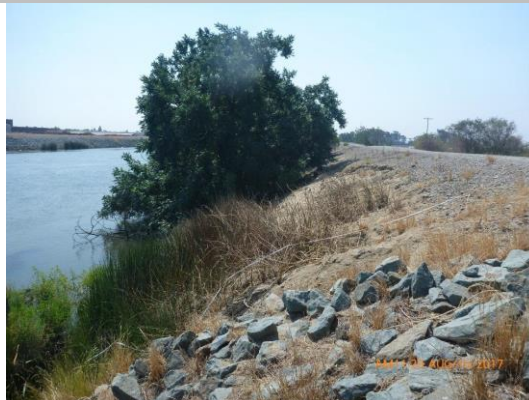
Photo 1 of 3 : LEVAL_FA_2017_535_4115.jpg

LM Start	1.18	Rating **	A/W	Issue No.	221
LM End	1.20	Issue Type +	Ma	Location *	
Category	Supplemental			GPS Latitude/Longitude	
				Start	End
Item	2017 Storm Damage			37.933500 °	37.933200 °
				-121.329100 °	-121.328900 °
DWR ID	DWR_RD0524_01_f_2017_221				
Comment Code					
Inspector Comment					
Levee Evaluation Comments					
Description:Slope protection repairs are needed along the waterside slope due to erosion and riprap displacement from high water. Based upon levee inspections, it was determined the waterside levee slope is eroding, deteriorating, and degrading. The eroded levee sections need to be restored back to design standards to prevent further deterioration and damage.					
Site ID No:535					
Site Designation:LMA-441					
Repair Type: Erosion					
Rating:Area of Concern					
Field Date:8/10/2017					
Notes:

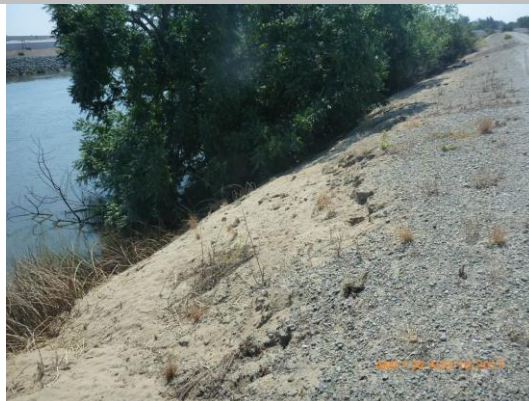
Photo 2 of 3 : LEVAL_FA_2017_535_4116.jpg

LM Start	1.18	Rating **	A/W	Issue No.	221 (cont)
LM End	1.20	Issue Type +	Ma	Location *	
Category	Supplemental			GPS Latitude/Longitude	
				Start	End
Item	2017 Storm Damage			37.933500 °	37.933200 °
				-121.329100 °	-121.328900 °
DWR ID	DWR_RD0524_01_f_2017_221				
Comment Code					
Inspector Comment					
Levee Evaluation Comments					
Description:Slope protection repairs are needed along the waterside slope due to erosion and riprap displacement from high water. Based upon levee inspections, it was determined the waterside levee slope is eroding, deteriorating, and degrading. The eroded levee sections need to be restored back to design standards to prevent further deterioration and damage.					
Site ID No:535					
Site Designation:LMA-441					
Repair Type: Erosion					
Rating:Area of Concern					
Field Date:8/10/2017					
Notes:

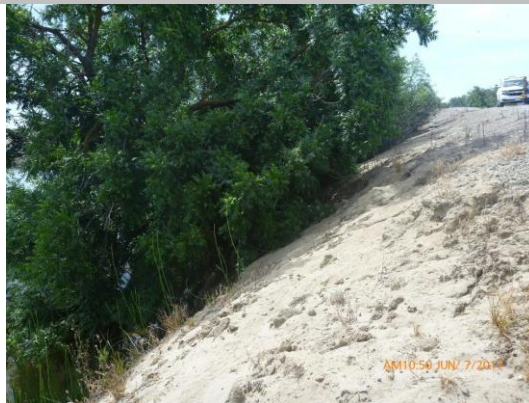
Photo 1 of 3 : LEVAL_FA_2017_84_1225.jpg

LM Start	1.19	Rating **	A/W	Issue No.	220
LM End		Issue Type +	Ma	Location *	
Category	Supplemental			GPS Latitude/Longitude	
				Start	End
Item	2017 Storm Damage			37.933347 °	°
				-121.329110 °	°
DWR ID	DWR_RD0524_01_f_2017_220				
Comment Code					
Inspector Comment					
Levee Evaluation Comments					
Description:					
Site ID No:84					
Site Designation:FSRP-13-42					
Repair Type: Erosion					
Rating:Area of Concern					
Field Date:6/7/2017					
Notes:

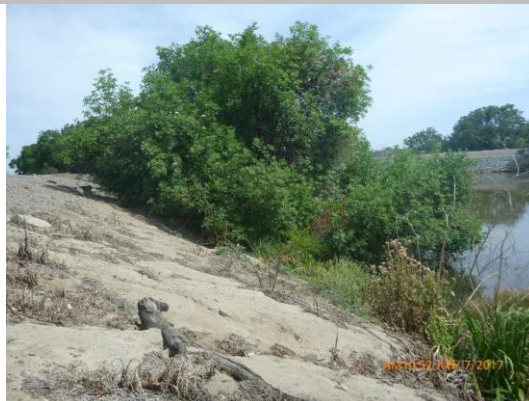
Photo 3 of 3 : LEVAL_FA_2017_84_1280.jpg

LM Start	1.19	Rating **	A/W	Issue No.	220 (cont)
LM End		Issue Type +	Ma	Location *	
Category	Supplemental			GPS Latitude/Longitude	
				Start	End
Item	2017 Storm Damage			37.933347 °	°
				-121.329110 °	°
DWR ID	DWR_RD0524_01_f_2017_220				
Comment Code					
Inspector Comment					
Levee Evaluation Comments					
Description:					
Site ID No:84					
Site Designation:FSRP-13-42					
Repair Type: Erosion					
Rating:Area of Concern					
Field Date:6/7/2017					
Notes:

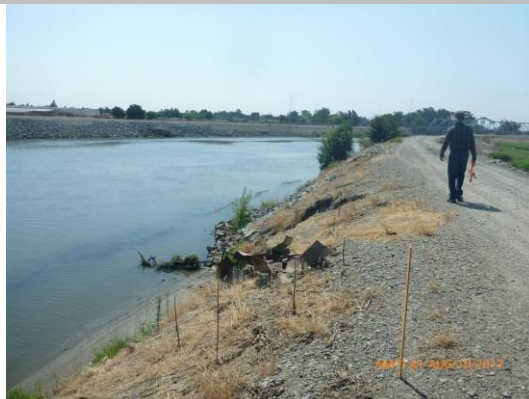
Photo 1 of 3 : LEVAL_FA_2017_534_4121.jpg

LM Start	1.25	Rating **	A/W	Issue No.	222
LM End	1.30	Issue Type +	Ma	Location *	
Category	Supplemental			GPS Latitude/Longitude	
				Start	End
Item	2017 Storm Damage			37.932600 °	37.931900 °
				-121.328700 °	-121.328400 °
DWR ID	DWR_RD0524_01_f_2017_222				
Comment Code					
Inspector Comment					
Levee Evaluation Comments					
Description:Slope protection repairs are needed along the waterside slope due to erosion and riprap displacement from high water. Based upon levee inspections, it was determined the waterside levee slope is eroding, deteriorating, and degrading. The eroded levee sections need to be restored back to design standards to prevent further deterioration and damage.					
Site ID No:534					
Site Designation:LMA-440					
Repair Type: Erosion					
Rating:Serious					
Field Date:8/10/2017					
Notes: site is related to, but not combined with, LMA-439

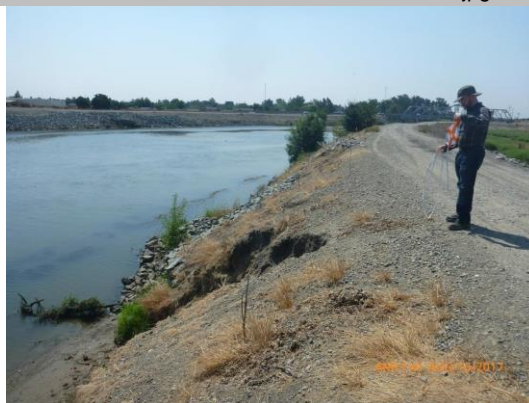
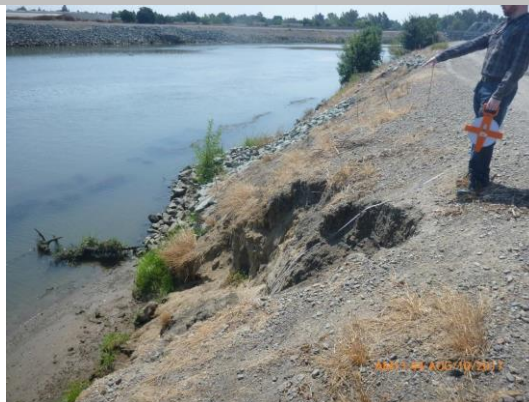
LM Start	1.25	Rating **	A/W	Issue No.	222 (cont)
LM End	1.30	Issue Type +	Ma	Location *	
Category	Supplemental			GPS Latitude/Longitude	
				Start	End
Item	2017 Storm Damage			37.932600 °	37.931900 °
				-121.328700 °	-121.328400 °
DWR ID	DWR_RD0524_01_f_2017_222				
Comment Code					
Inspector Comment					
Levee Evaluation Comments					
Description:Slope protection repairs are needed along the waterside slope due to erosion and riprap displacement from high water. Based upon levee inspections, it was determined the waterside levee slope is eroding, deteriorating, and degrading. The eroded levee sections need to be restored back to design standards to prevent further deterioration and damage.					
Site ID No:534					
Site Designation:LMA-440					
Repair Type: Erosion					
Rating:Serious					
Field Date:8/10/2017					
Notes: site is related to, but not combined with, LMA-439

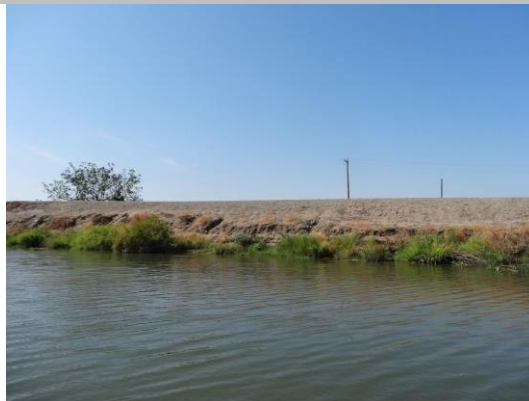
Photo 1 of 4 : SJR2017_RD0524U01RM41.92_1.jpg

LM Start	1.27	Rating **	U	Issue No.	47
LM End	1.33	Issue Type +	Ma	Location *	WS
Category	Supplemental			GPS Latitude/Longitude	
				Start	End
Item	DWR Erosion Survey			37.931858 °	37.931858 °
				-121.328300 °	-121.328300 °
DWR ID	RD0524U01RM41.92				
Comment Code					
Inspector Comment					
09/13/2017. The erosion has developed along the levee slope. The length of the erosion is nearly doubled comparing to the prior survey.					
07/25/2016: No significant change observed.					
06/24/2015: No significant change observed.					
06/19/2014: No significant change observed.					
08/13/2013: New signs of animal activity were found.					
08/07/2012: The site was first reported in 2012 spring levee inspection report. [2017 Site ID:RD0524U01RM41.92]

Front view of the erosion.

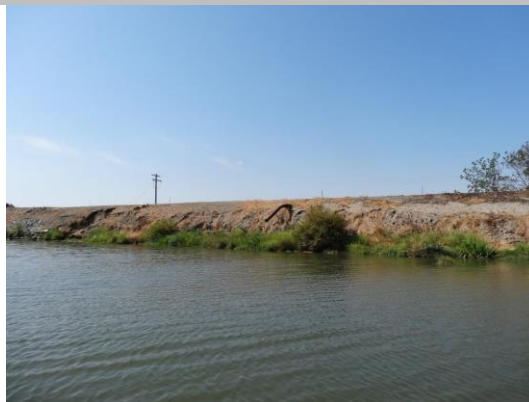
Photo 2 of 4 : SJR2017_RD0524U01RM41.92_2.jpg

Front view of the erosion.

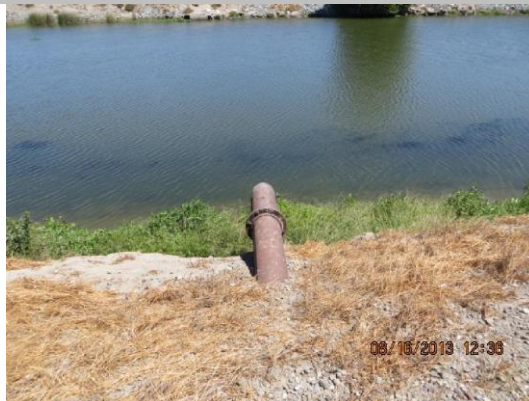
Photo 1 of 3 : UCIP_FA_2017_51319_29862.jpg

FS_ID:51319
DS_ID:20602
EP_NO: N/A
Repair Type: Urgent
Crossing Status: Found
UCIP Comments: 11/16/2016 same as previous inspection both ends are open. This pipe does not appear in use. Need to contact owner to determine status of crossing. If the crossing is abandoned or in use, owner will need to coordinate with the CVFPB to comply with Title 23 requirements. (O. Magana - DWR UCIP)08/16/2013 Pipe appears to be open on both ends. Abandoned and should be done so properly. (W. Wylie - DWR UCIP)
FIELD_STRUCT_DESC: *ABANDONED* 12-inch steel drainage pipe through the levee, 3.5 feet below the crown. Pipe is opened on the waterside (WS) and landside (LS) ends. The pump house referenced in O&M manual is missing from the LS (2013). [Additional Reference(s): DWR Levee Log, 2004. USACE San Joaquin O&M Manual 7, April 1964, (HLM 1.31)].
FS Date: 11/16/2016

Pipe visible and open on WS slope.

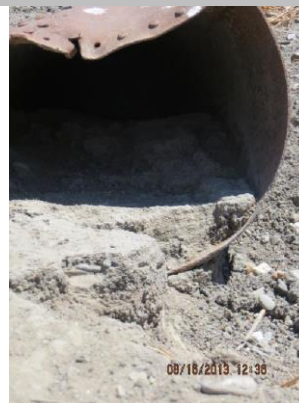
Photo 3 of 3 : UCIP_FA_2017_51319_29860.jpg

FS_ID:51319
DS_ID:20602
EP_NO: N/A
Repair Type: Urgent
Crossing Status: Found
UCIP Comments: 11/16/2016 same as previous inspection both ends are open. This pipe does not appear in use. Need to contact owner to determine status of crossing. If the crossing is abandoned or in use, owner will need to coordinate with the CVFPB to comply with Title 23 requirements. (O. Magana - DWR UCIP)08/16/2013 Pipe appears to be open on both ends. Abandoned and should be done so properly. (W. Wylie - DWR UCIP)
FIELD_STRUCT_DESC: *ABANDONED* 12-inch steel drainage pipe through the levee, 3.5 feet below the crown. Pipe is opened on the waterside (WS) and landside (LS) ends. The pump house referenced in O&M manual is missing from the LS (2013). [Additional Reference(s): DWR Levee Log, 2004. USACE San Joaquin O&M Manual 7, April 1964, (HLM 1.31)].
FS Date: 11/16/2016

Pipe appears open on both ends. View from LS slope.

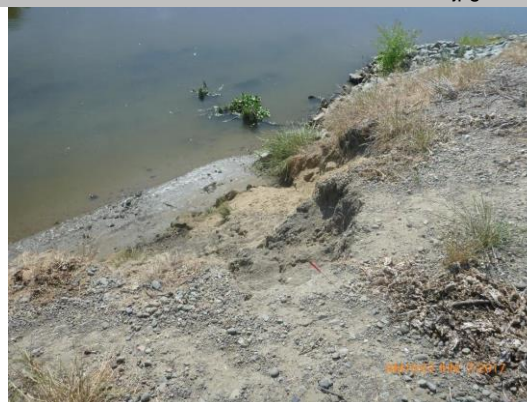
Photo 1 of 3 : LEVAL_FA_2017_85_398.jpg

Levee Evaluation Comments
Description:
Site ID No:85
Site Designation:DWR_RD0524_01_s_2012_21
Repair Type: Erosion
Rating:Critical
Field Date:6/7/2017
Notes: fox den inside erosion site

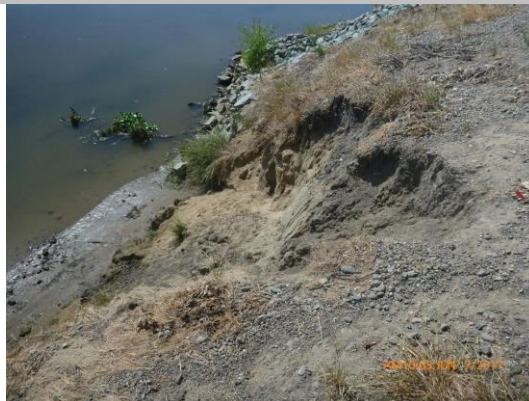
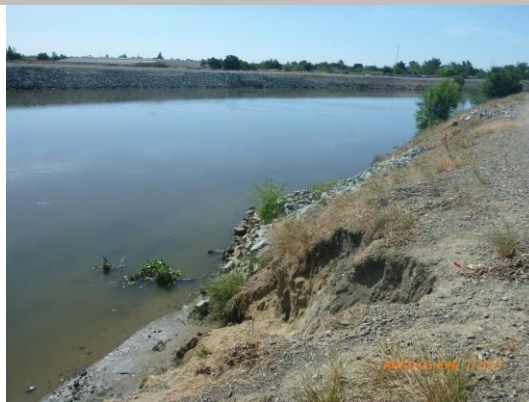
LM Start	1.30	Rating **	A/W	Issue No.	223 (cont)	
LM End	1.31	Issue Type +	Ma	Location *		
Category	Supplemental			GPS Latitude/Longitude		
				Start	End	
Item	2017 Storm Damage			37.931860 °	37.931690 °	
				-121.328310 °	-121.328280 °	
DWR ID	DWR_RD0524_01_f_2017_223					
Comment Code						
Inspector Comment						
Levee Evaluation Comments						
Description:						
Site ID No:85						
Site Designation:DWR_RD0524_01_s_2012_21						
Repair Type: Erosion						
Rating:Critical						
Field Date:6/7/2017						
Notes: fox den inside erosion site

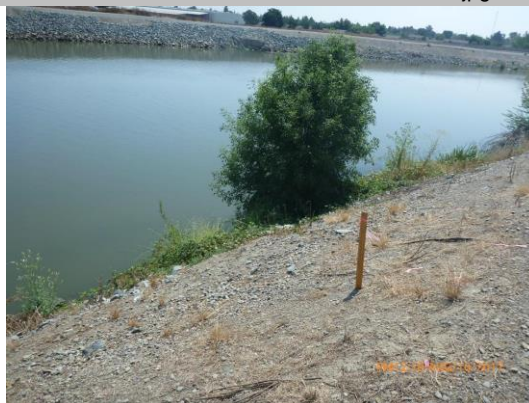
Photo 3 of 3 : LEVAL_FA_2017_532_4174.jpg

LM Start	1.33	Rating **	A/W	Issue No.	225 (cont)
LM End	1.33	Issue Type +	Ma	Location *	
Category	Supplemental			GPS Latitude/Longitude	
				Start	End
Item	2017 Storm Damage			37.931500 °	37.931500 °
				-121.328200 °	-121.328200 °
DWR ID	DWR_RD0524_01_f_2017_225				
Comment Code					
Inspector Comment					
Levee Evaluation Comments					
Description:Slope protection repairs are needed along the waterside slope due to erosion and riprap displacement from high water. Based upon levee inspections, it was determined the waterside levee slope is eroding, deteriorating, and degrading. The eroded levee sections need to be restored back to design standards to prevent further deterioration and damage.					
Site ID No:532					
Site Designation:LMA-438					
Repair Type: Erosion					
Rating:Area of Concern					
Field Date:8/10/2017					
Notes:

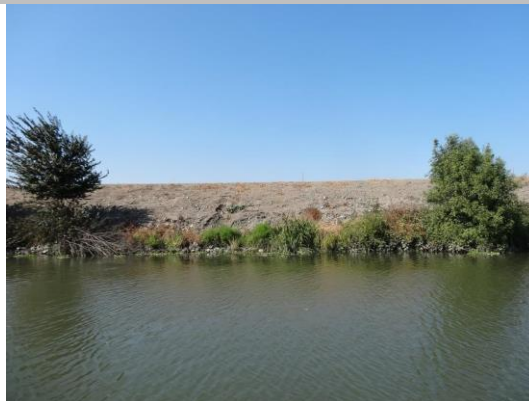
Photo 1 of 3 : SJR2017_RD0524U01RM42.03_1.jpg

LM Start	1.39	Rating **	U	Issue No.	56
LM End	1.39	Issue Type +	Ma	Location *	WS
Category	Supplemental			GPS Latitude/Longitude	
				Start	End
Item	DWR Erosion Survey			37.930575 °	37.930575 °
				-121.328090 °	-121.328090 °
DWR ID	RD0524U01RM42.03				
Comment Code					
Inspector Comment					
09/13/2017: No significant change observed 07/25/2016: No significant change observed 06/24/2015: No significant change observed. 06/19/2014: No significant change observed. 08/13/2013: No significant change observed. 08/07/2012: The site was first reported in 2012 spring levee inspection report. The site is located about 750 ft downstream of SR 4 Bridge. [2017 Site ID:RD0524U01RM42.03]

Front view of the erosion.

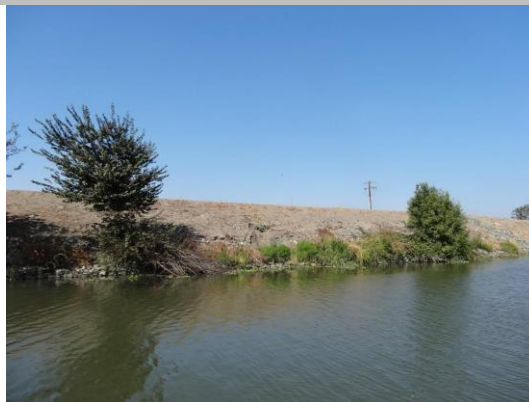
Photo 2 of 3 : SJR2017_RD0524U01RM42.03_2.jpg

Front view of the erosion.

LM Start	1.39	Rating **	U	Issue No.	56 (cont)
LM End	1.39	Issue Type +	Ma	Location *	WS
Category	Supplemental			GPS Latitude/Longitude	
				Start	End
Item	DWR Erosion Survey			37.930575 °	37.930575 °
				-121.328090 °	-121.328090 °
DWR ID	RD0524U01RM42.03				
Comment Code					
Inspector Comment					
09/13/2017: No significant change observed 07/25/2016: No significant change observed 06/24/2015: No significant change observed. 06/19/2014: No significant change observed. 08/13/2013: No significant change observed. 08/07/2012: The site was first reported in 2012 spring levee inspection report. The site is located about 750 ft downstream of SR 4 Bridge. [2017 Site ID:RD0524U01RM42.03]

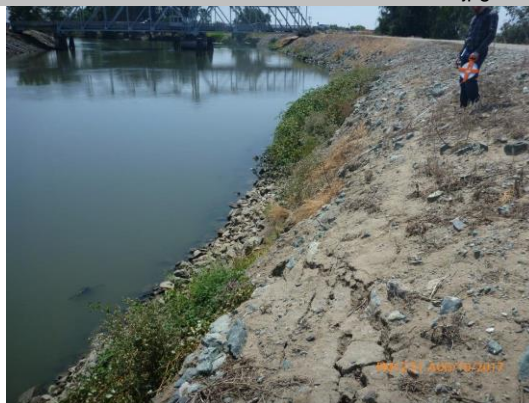
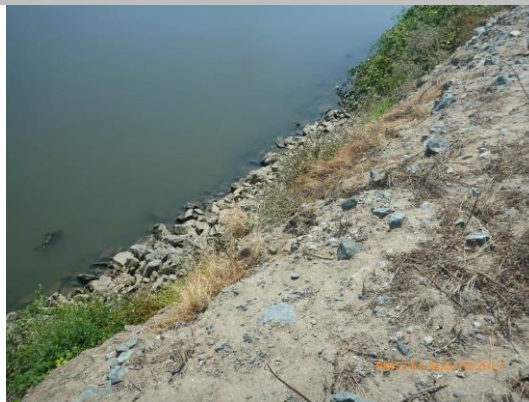
LM Start	1.43	Rating **	A/W	Issue No.	226 (cont)
LM End	1.44	Issue Type +	Ma	Location *	
Category	Supplemental			GPS Latitude/Longitude	
				Start	End
Item	2017 Storm Damage			37.930100°	37.929900°
				-121.328300°	-121.328300°
DWR ID	DWR_RD0524_01_f_2017_226				
Comment Code					
Inspector Comment					
<p>Levee Evaluation Comments</p> <p>Description: Slope protection repairs are needed along the waterside slope due to erosion and riprap displacement from high water. Based upon levee inspections, it was determined the waterside levee slope is eroding, deteriorating, and degrading. The eroded levee sections need to be restored back to design standards to prevent further deterioration and damage.</p> <p>Site ID No: 530</p> <p>Site Designation: LMA-436</p> <p>Repair Type: Erosion</p> <p>Rating: Area of Concern</p> <p>Field Date: 8/10/2017</p> <p>Notes:</p>

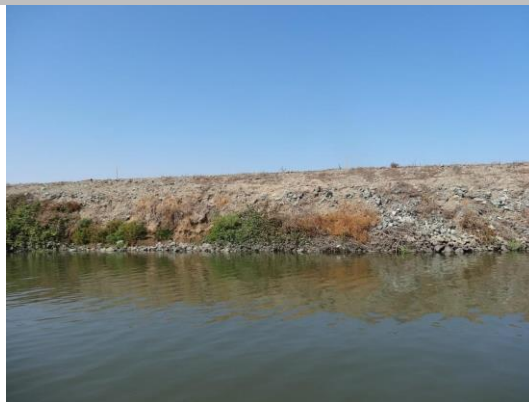
Photo 2 of 4 : SJR2017_RD0524U01RM42.09_2.jpg

LM Start	1.45	Rating **	U	Issue No.	60
LM End	1.47	Issue Type +	Ma	Location *	WS
Category	Supplemental			GPS Latitude/Longitude	
				Start	End
Item	DWR Erosion Survey			37.929650 °	37.929650 °
				-121.328110 °	-121.328110 °
DWR ID	RD0524U01RM42.09				
Comment Code					
Inspector Comment					
09/13/2017: No significant change observed.					
07/25/2016: No significant change observed.					
06/24/2015: No significant change observed.					
06/19/2014: No significant change observed.					
08/13/2013: The site is located approximately 400 ft. downstream SR 4 Bridge. Dense vegetation is visible at the toe. [2017 Site ID:RD0524U01RM42.09]

Front view of the erosion.

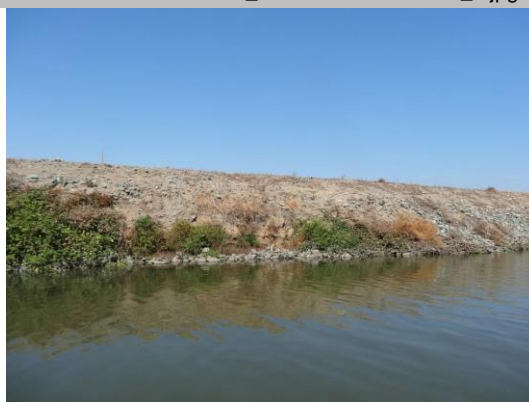
Photo 4 of 4 : SJR2017_RD0524U01RM42.09_4.jpg

LM Start	1.45	Rating **	U	Issue No.	60 (cont)	
LM End	1.47	Issue Type +	Ma	Location *	WS	
Category	Supplemental			GPS Latitude/Longitude		
				Start	End	
Item	DWR Erosion Survey			37.929650 °	37.929650 °	
				-121.328110 °	-121.328110 °	
DWR ID	RD0524U01RM42.09					
Comment Code						
Inspector Comment						
09/13/2017: No significant change observed.						
07/25/2016: No significant change observed.						
06/24/2015: No significant change observed.						
06/19/2014: No significant change observed.						
08/13/2013: The site is located approximately 400 ft. downstream SR 4						
Bridge. Dense vegetation is visible at the toe. [2017 Site						
ID:RD0524U01RM42.09]

Close view of the erosion.

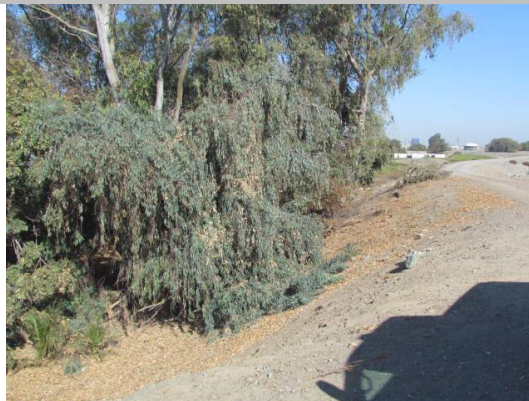
Photo 1 of 4 : FA_2017_RD0524_107_916_20170919_00281.jpg

LM Start	1.49	Rating **	U	Issue No.	916
LM End	1.49	Issue Type +	Ma	Location *	LS
Category	Earthen Levee			GPS Latitude/Longitude	
				Start	End
Item	Trim / Thin Trees			37.929118 °	37.929118 °
				-121.328368 °	-121.328368 °
DWR ID	DWR_RD0524_01_s_2012_916				
Comment Code					
T3 : Trim and thin trees to allow visibility of the ground and room to flood fight.					
Inspector Comment					
Untrimmed trees and dense vegetation on landside toe.

Looking at dense trees on landward slope and toe fall 2015

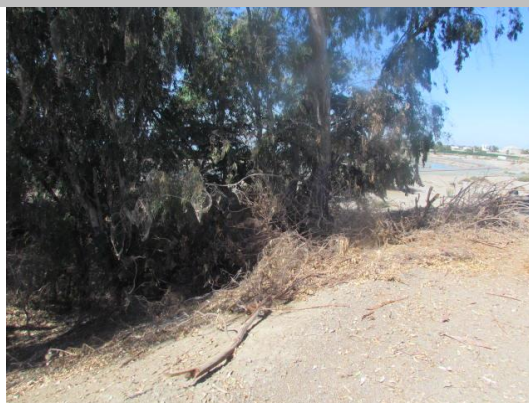
Photo 2 of 4 : FA_2017_RD0524_107_916_20170919_00282.jpg

Looking at trees on landside slope. (Fall 2012)

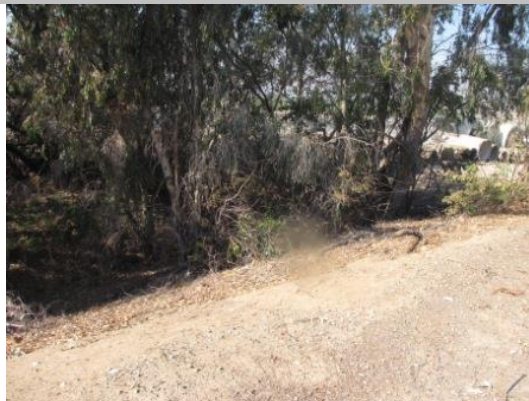
Photo 4 of 4 : FA_2017_RD0524_107_916_20170919_00284.jpg

LM Start	1.49	Rating **	U	Issue No.	916 (cont)	
LM End	1.49	Issue Type +	Ma	Location *	LS	
Category	Earthen Levee			GPS Latitude/Longitude		
				Start		End
Item	Trim / Thin Trees			37.929118 °		37.929118 °
				-121.328368 °		-121.328368 °
DWR ID	DWR_RD0524_01_s_2012_916					
Comment Code						
T3 : Trim and thin trees to allow visibility of the ground and room to flood fight.						
Inspector Comment						
Untrimmed trees and dense vegetation on landside toe.

Dense vegetation on landside toe.

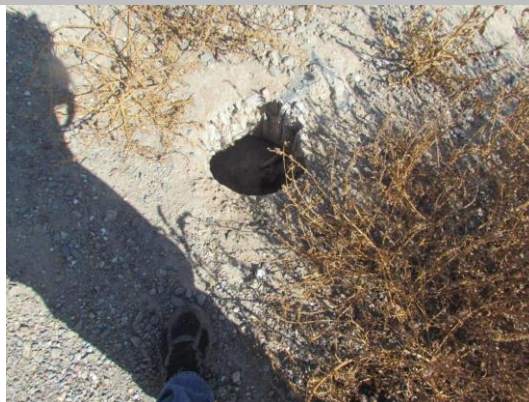
Photo 1 of 2 : FA_2017_RD0524_107_202_20170919_00242.jpg

LM Start	1.55	Rating **	U	Issue No.	202
LM End	1.55	Issue Type +	Ma	Location *	WS
Category	Earthen Levee			GPS Latitude/Longitude	
				Start	End
Item	Erosion / Bank Caving			37.928391 °	37.928391 °
				-121.328273 °	-121.328273 °
DWR ID	DWR_RD0524_01_f_2016_202				
Comment Code					
E2 : Schedule repair of erosion site prior to the next inspection.					
Inspector Comment					
Large hole (looks like fences post or telephone pole) on waterside shoulder.

Looking at large hole (Fence/telephone post hole) on waterward shoulder.

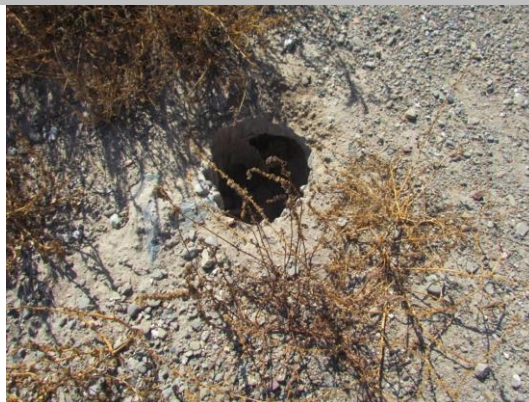
Photo 2 of 2 : FA_2017_RD0524_107_202_20170919_00243.jpg

Looking at hole on waterward shoulder.

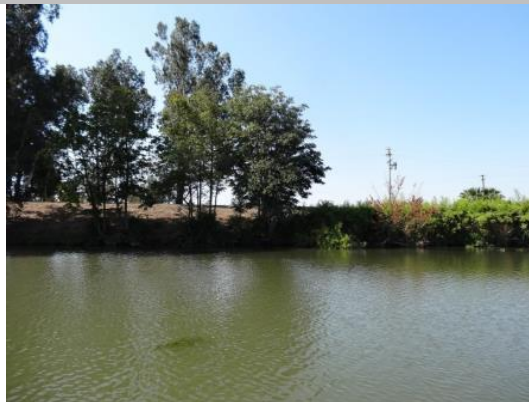
Photo 1 of 3 : SJR2017_RD0524U01RM42.2_1.jpg

Comment Code					
Inspector Comment					
09/13/2017: No significant change observed.					
07/25/2016: No significant change observed.					
06/24/2015: No significant change observed.					
06/19/2014: No significant change observed.					
08/13/2013: No significant change observed.					
08/07/2012: The site has been visited by boat survey. No significant change observed					
08/23/2011: No significant change observed on site. Trees concerned still in place.					
09/07/2010: No significant change observed on site. The concern here is the undermining of the levee toe where most of trees are. There are erosion pockets lined along the lower slope and at the base of the trees, exposing tree roots. There is minimal slope protection.					
09/29/2009: The lower slope is lined with minor erosion pockets; some tree roots are exposed; there is visible undermining of the levee toe; site is immediately upstream of the Highway 4 Bridge; the bridge is possibly causing a scour to occur, eroding the bank. [2017 Site ID:RD0524U01RM42.2]

Front view of the site where undermining has occurred.

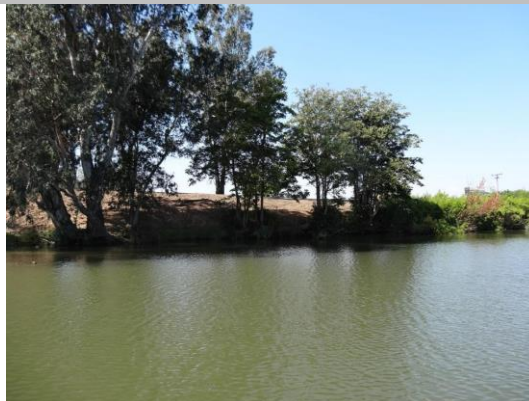
Photo 2 of 3 : SJR2017_RD0524U01RM42.2_2.jpg

Comment Code					
Inspector Comment					
09/13/2017: No significant change observed. 07/25/2016: No significant change observed. 06/24/2015: No significant change observed. 06/19/2014: No significant change observed. 08/13/2013: No significant change observed. 08/07/2012: The site has been visited by boat survey. No significant change observed 08/23/2011: No significant change observed on site. Trees concerned still in place. 09/07/2010: No significant change observed on site. The concern here is the undermining of the levee toe where most of trees are. There are erosion pockets lined along the lower slope and at the base of the trees, exposing tree roots. There is minimal slope protection. 09/29/2009: The lower slope is lined with minor erosion pockets; some tree roots are exposed; there is visible undermining of the levee toe; site is immediately upstream of the Highway 4 Bridge; the bridge is possibly causing a scour to occur, eroding the bank. [2017 Site ID:RD0524U01RM42.2]

Close view of the erosion.

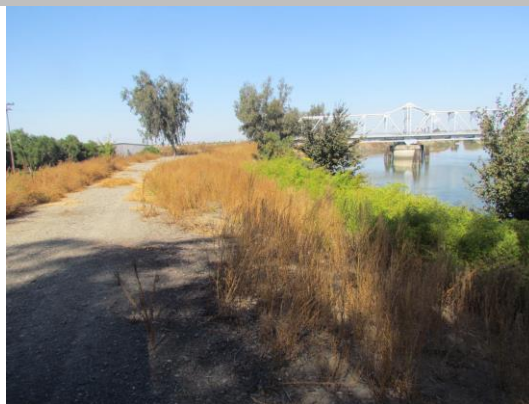
Photo 1 of 3 : FA_2017_RD0524_107_25_20170919_00045.jpg

Looking northwest at dense veg on waterward slope.

LM Start	1.60	Rating **	U	Issue No.	25
LM End	1.61	Issue Type +	Ma	Location *	WS
Category	Earthen Levee			GPS Latitude/Longitude	
				Start	End
Item	Vegetation			37.927635 °	37.927540 °
				-121.327812 °	-121.327648 °
DWR ID	DWR_RD0524_01_s_2012_25				
Comment Code					
V2 : Remove the wild growth other than native grasses from the levee slopes.					
Inspector Comment

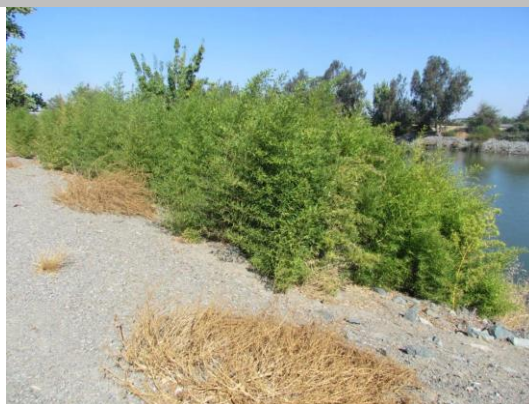
Photo 2 of 3 : FA_2017_RD0524_107_25_20170919_00046.jpg

Looking northwest at end of dense veg on waterward slope.

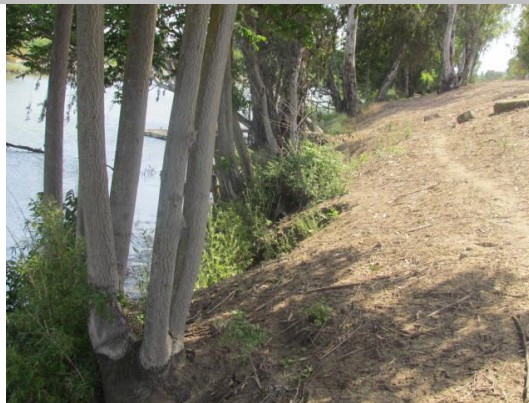
Photo 1 of 3 : FA_2017_RD0524_107_26_20170919_00048.jpg

LM Start	1.62	Rating **	M	Issue No.	26
LM End	1.64	Issue Type +	Ma	Location *	WS
Category	Earthen Levee			GPS Latitude/Longitude	
				Start	End
Item	Erosion / Bank Caving			37.927507 °	37.927295 °
				-121.327593 °	-121.327298 °
DWR ID	DWR_RD0524_01_s_2012_26				
Comment Code					
E1 : Note and monitor erosion site.					
Inspector Comment					
Several erosions along this reach.

Looking south at waterward erosion.

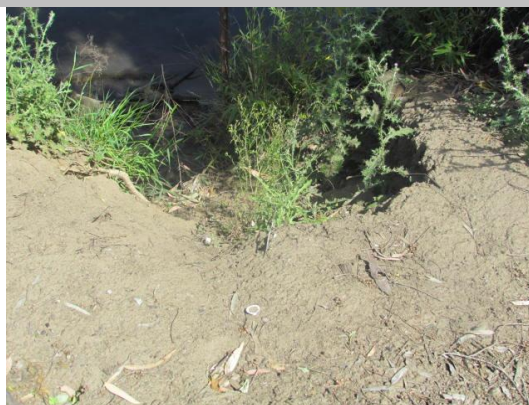
Photo 2 of 3 : FA_2017_RD0524_107_26_20170919_00049.jpg

LM Start	1.62	Rating **	M	Issue No.	26 (cont)
LM End	1.64	Issue Type +	Ma	Location *	WS

Looking east at waterward erosion.

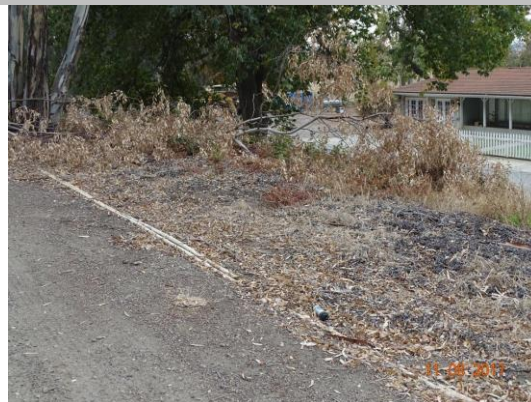
Photo 1 of 1 : FA_2017_RD0524_107_240_20171116_00473.jpg

LM Start	1.66	Rating **	M	Issue No.	240
LM End	1.66	Issue Type +	Ma	Location *	LS
Category	Earthen Levee			GPS Latitude/Longitude	
				Start	End
Item	Encroachments			37.927159 °	37.927159 °
				-121.327022 °	-121.327022 °
DWR ID	DWR_RD0524_01_f_2017_240				
Comment Code					
TR : Tree or limb					
Inspector Comment

Looking southeast at the landside slope.

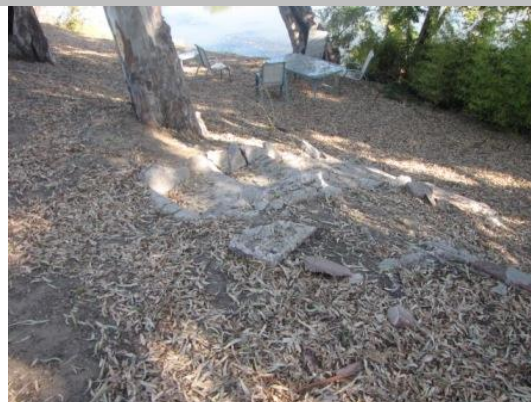
Photo 1 of 3 : FA_2017_RD0524_107_45_20170919_00077.jpg

LM Start	1.67	Rating **	U	Issue No.	45
LM End	1.67	Issue Type +	Ma	Location *	WS
Category	Earthen Levee			GPS Latitude/Longitude	
				Start	End
Item	Encroachments			37.927018 °	37.927018 °
				-121.326872 °	-121.326872 °
DWR ID	DWR_RD0524_01_s_2012_45				
Comment Code					
ST : Stairway					
Inspector Comment					
Stairs and retaining wall.

Looking northeast at non-permitted concrete stairs on waterside slope.

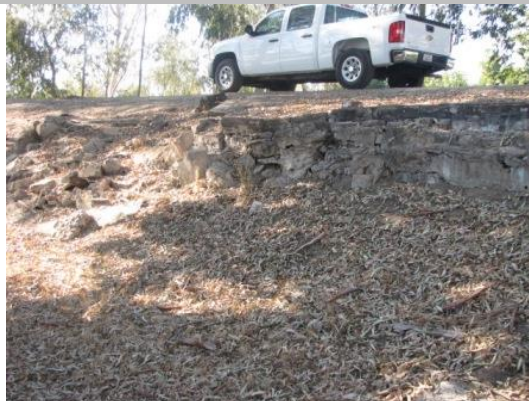
Photo 2 of 3 : FA_2017_RD0524_107_45_20170919_00078.jpg

LM Start	1.67	Rating **	U	Issue No.	45 (cont)	
LM End	1.67	Issue Type +	Ma	Location *	WS	
Category	Earthen Levee			GPS Latitude/Longitude		
				Start	End	
Item	Encroachments			37.927018 °	37.927018 °	
				-121.326872 °	-121.326872 °	
DWR ID	DWR_RD0524_01_s_2012_45					
Comment Code						
ST : Stairway						
Inspector Comment						
Stairs and retaining wall.

Looking southwest at retaining wall connected to concrete stairs.

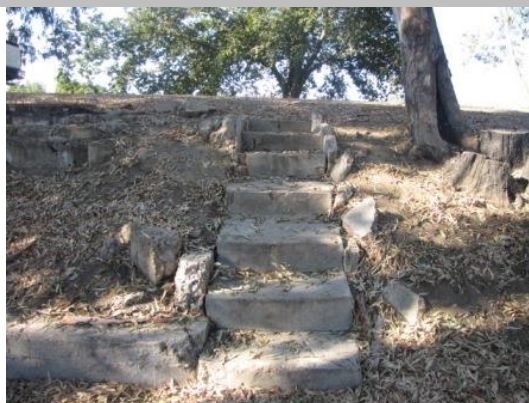
Photo 3 of 3 : FA_2017_RD0524_107_45_20170919_00079.jpg

LM Start	1.67	Rating **	U	Issue No.	45 (cont)
LM End	1.67	Issue Type +	Ma	Location *	WS

Looking west at concrete stairs on waterside slope.

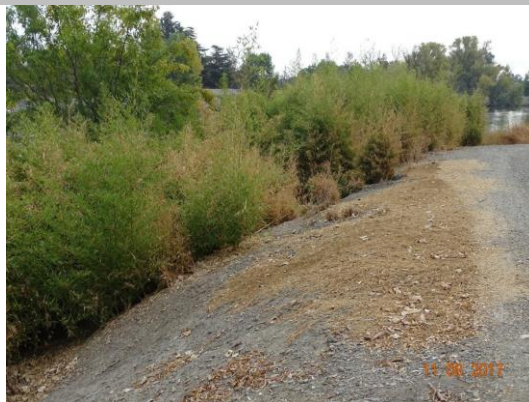
Photo 1 of 1 : FA_2017_RD0524_107_243_20171116_00475.jpg

LM Start	1.71	Rating **	U	Issue No.	243
LM End	1.72	Issue Type +	Ma	Location *	WS
Category	Earthen Levee			GPS Latitude/Longitude	
				Start	End
Item	Vegetation			37.926638 °	37.926471 °
				-121.326374 °	-121.326175 °
DWR ID	DWR_RD0524_01_f_2017_243				
Comment Code					
V2 : Remove the wild growth other than native grasses from the levee slopes.					
Inspector Comment

Looking southeast at the waterside slope.

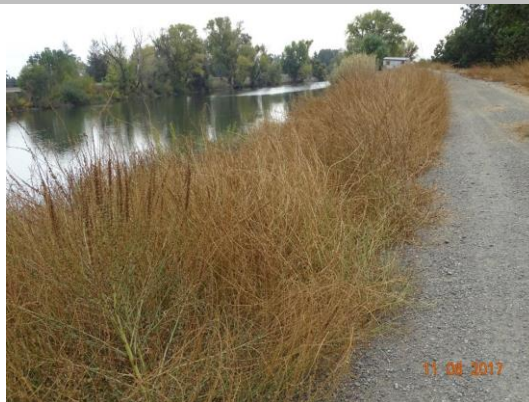
Photo 1 of 1 : FA_2017_RD0524_107_244_20171116_00476.jpg

LM Start	1.73	Rating **	U	Issue No.	244
LM End	1.75	Issue Type +	Ma	Location *	WS
Category	Earthen Levee			GPS Latitude/Longitude	
				Start	End
Item	Vegetation			37.926395 °	37.926191 °
				-121.326125 °	-121.325952 °
DWR ID	DWR_RD0524_01_f_2017_244				
Comment Code					
V2 : Remove the wild growth other than native grasses from the levee slopes.					
Inspector Comment

Looking southeast at the waterside slope.

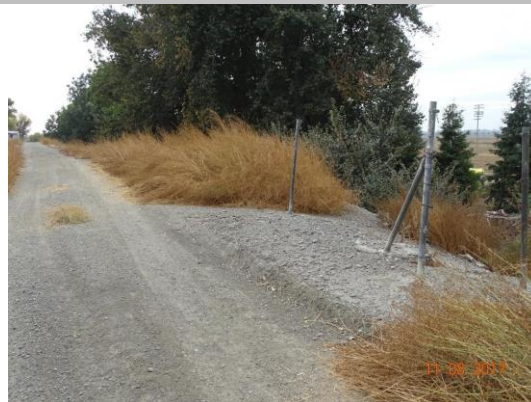
Photo 1 of 1 : FA_2017_RD0524_107_245_20171116_00477.jpg

LM Start	1.73	Rating **	U	Issue No.	245
LM End	1.75	Issue Type +	Ma	Location *	LS
Category	Earthen Levee			GPS Latitude/Longitude	
				Start	End
Item	Vegetation			37.926312 °	37.926093 °
				-121.326065 °	-121.325864 °
DWR ID	DWR_RD0524_01_f_2017_245				
Comment Code					
V2 : Remove the wild growth other than native grasses from the levee slopes.					
Inspector Comment

Looking southeast at the landside slope.

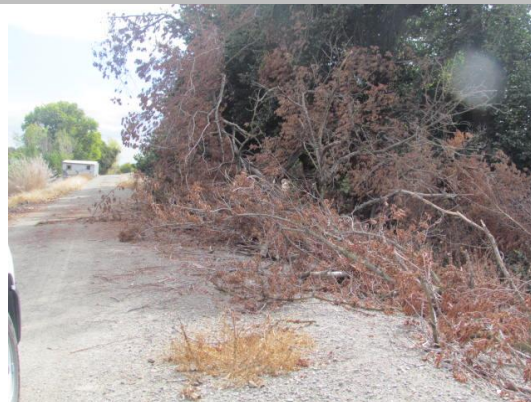
Photo 1 of 4 : FA_2017_RD0524_107_46_20170919_00080.jpg

LM Start	1.75	Rating **	U	Issue No.	46
LM End	1.76	Issue Type +	Ma	Location *	LS
Category	Earthen Levee			GPS Latitude/Longitude	
				Start	End
Item	Encroachments			37.926152 °	37.925993 °
				-121.325927 °	-121.325777 °
DWR ID	DWR_RD0524_01_s_2012_46				
Comment Code					
TR : Tree or limb					
Inspector Comment					
Downed tree limbs on landside slope.

Looking south at tree limbs on landward slope.

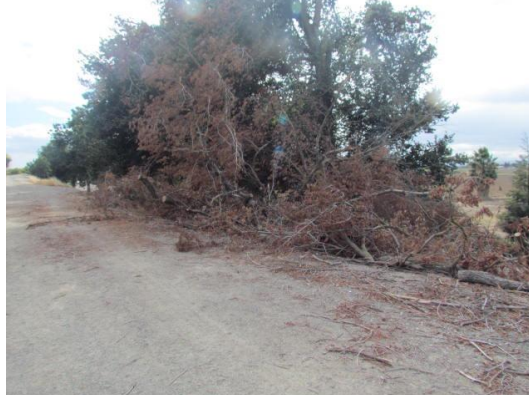
Photo 3 of 4 : FA_2017_RD0524_107_46_20170919_00082.jpg

LM Start	1.75	Rating **	U	Issue No.	46 (cont)	
LM End	1.76	Issue Type +	Ma	Location *	LS	
Category	Earthen Levee			GPS Latitude/Longitude		
				Start		End
Item	Encroachments			37.926152 °	37.925993 °	
				-121.325927 °	-121.325777 °	
DWR ID	DWR_RD0524_01_s_2012_46					
Comment Code						
TR : Tree or limb						
Inspector Comment						
Downed tree limbs on landside slope.

Looking south at tree limbs on landward slope.

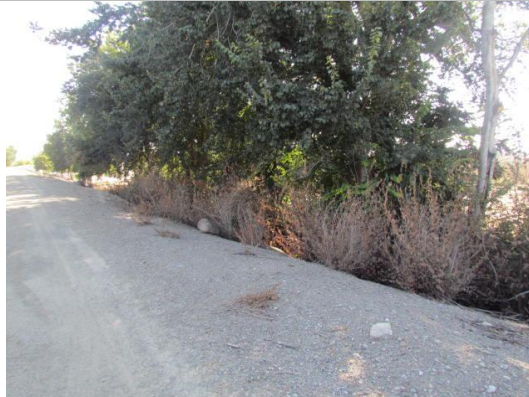
Photo 4 of 4 : FA_2017_RD0524_107_46_20170919_00083.jpg

LM Start	1.75	Rating **	U	Issue No.	46 (cont)
LM End	1.76	Issue Type +	Ma	Location *	LS

Looking southwest at dense vegetation and low hanging tree branches on landside slope and toe.

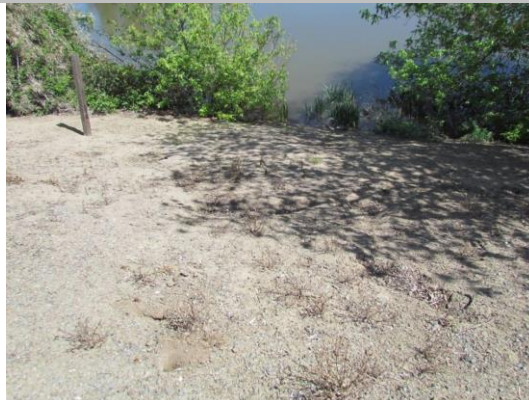
Photo 1 of 1 : FA_2017_RD0524_107_159_20170919_00192.jpg

LM Start	1.94	Rating **	M	Issue No.	159
LM End	1.95	Issue Type +	Ma	Location *	WS
Category	Earthen Levee			GPS Latitude/Longitude	
				Start	End
Item	Slope Stability			37.923703 °	37.923645 °
				-121.324238 °	-121.324233 °
DWR ID	DWR_RD0524_01_s_2017_159				
Comment Code					
S1 : Repair slope instability.					
Inspector Comment					
Minor sloughing and cracking.

Looking at minor cracking and sloughing on waterward slope.

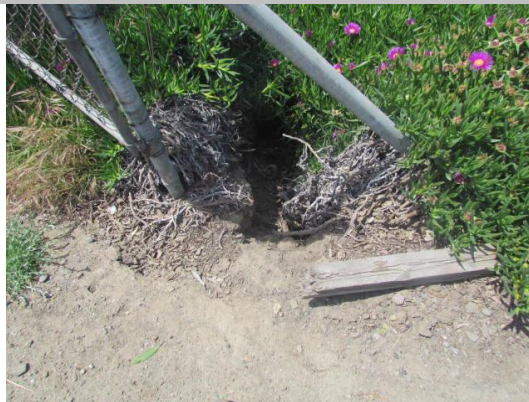
Photo 1 of 2 : FA_2017_RD0524_107_176_20170919_00213.jpg

LM Start	1.94	Rating **	U	Issue No.	176
LM End	1.94	Issue Type +	Ma	Location *	LS
Category	Earthen Levee			GPS Latitude/Longitude	
				Start	End
Item	Erosion / Bank Caving			37.923688 °	37.923688 °
				-121.324223 °	-121.324223 °
DWR ID	DWR_RD0524_01_s_2015_176				
Comment Code					
E2 : Schedule repair of erosion site prior to the next inspection.					
Inspector Comment					
Landside caving (3 x 18" x 5) caused by broken sprinklers.

Looking west at erosion within landscaping on landward shoulder and slope.

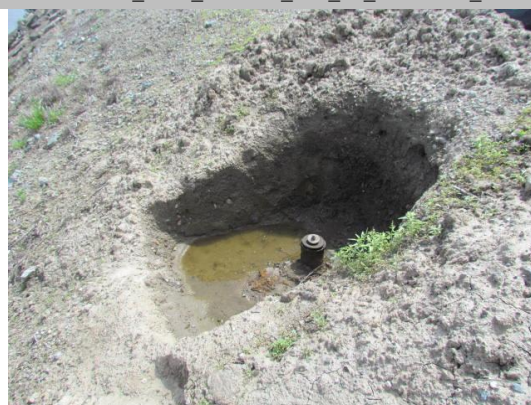
Photo 2 of 4 : FA_2017_RD0524_107_31_20170919_00053.jpg

LM Start	2.25	Rating **	U	Issue No.	31
LM End	2.25	Issue Type +	Ma	Location *	WS
Category	Earthen Levee			GPS Latitude/Longitude	
				Start	End
Item	Slope Stability			37.920493 °	37.920493 °
				-121.320565 °	-121.320565 °
DWR ID	DWR_RD0524_01_s_2012_31				
Comment Code					
S1 : Repair slope instability.					
Inspector Comment					
Slope instability probably cause by leak in irrigation pipe. Pipe should be inspected internally.

LM Start	2.25	Rating **	U	Issue No.	31 (cont)
LM End	2.25	Issue Type +	Ma	Location *	WS

Looking south at siphon on waterward slope.

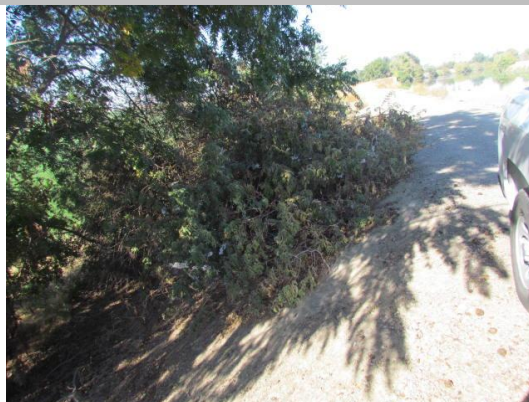
Photo 1 of 2 : FA_2017_RD0524_107_32_20170919_00056.jpg

LM Start	2.27	Rating **	U	Issue No.	32
LM End	2.29	Issue Type +	Ma	Location *	LS
Category	Earthen Levee			GPS Latitude/Longitude	
				Start	End
Item	Vegetation			37.920372 °	37.920167 °
				-121.320230 °	-121.319890 °
DWR ID	DWR_RD0524_01_s_2012_32				
Comment Code					
V4 : Elderberries are blocking visibility and flood fight capability.					
Inspector Comment					
Dense elderberry bushes on landside slope and toe.

Looking northwest at dense veg on landward slope and toe fall 2015.

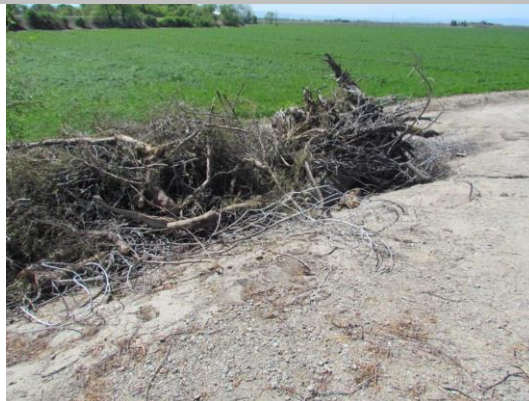
Photo 1 of 1 : FA_2017_RD0524_107_203_20170919_00244.jpg

LM Start	2.27	Rating **	U	Issue No.	203
LM End	2.27	Issue Type +	Ma	Location *	LS
Category	Earthen Levee			GPS Latitude/Longitude	
				Start	End
Item	Encroachments			37.920327 °	37.920327 °
				-121.320175 °	-121.320175 °
DWR ID	DWR_RD0524_01_f_2016_203				
Comment Code					
PR : Prunings					
Inspector Comment					
Large pruning pile on landside slope and toe.

Looking west at pruning pile on waterward slope.

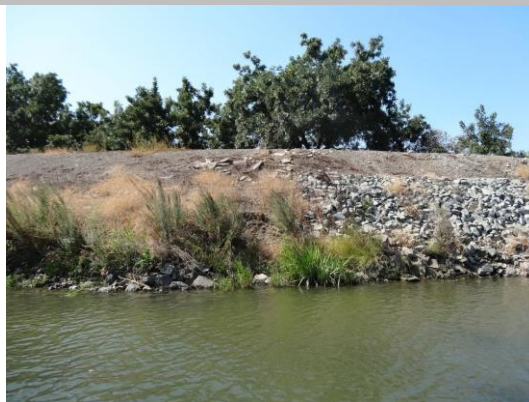
Photo 1 of 3 : SJR2017_RD0524U01RM42.9_1.jpg

LM Start	2.30	Rating **	M	Issue No.	70
LM End	2.30	Issue Type +	Ma	Location *	WS
Category	Supplemental			GPS Latitude/Longitude	
				Start	End
Item	DWR Erosion Survey			37.920150 °	37.920150 °
				-121.319700 °	-121.319700 °
DWR ID	RD0524U01RM42.9				
Comment Code					
Inspector Comment					
09/13/2017: The erosion is located immediately upstream of a repaired levee section. [2017 Site ID:RD0524U01RM42.9]

Front view of the pocket erosion.

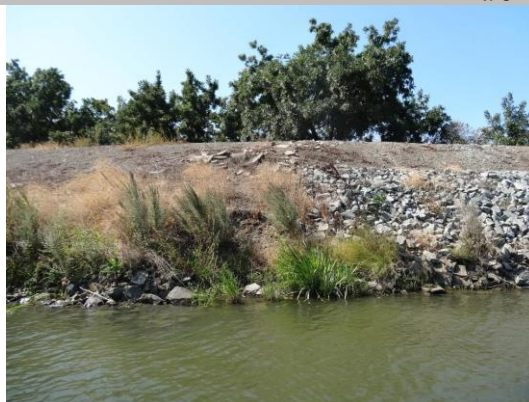
Photo 2 of 3 : SJR2017_RD0524U01RM42.9_2.jpg

LM Start	2.30	Rating **	M	Issue No.	70 (cont)
LM End	2.30	Issue Type +	Ma	Location *	WS

Close view of the erosion.

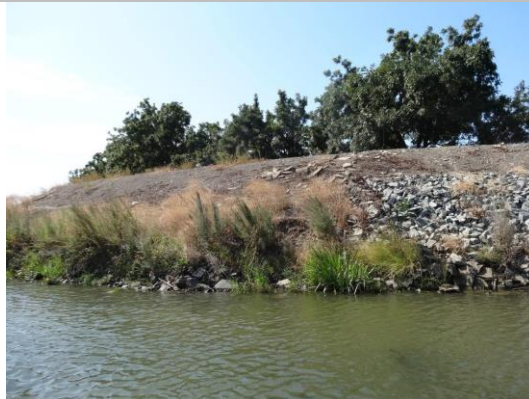
Photo 3 of 3 : SJR2017_RD0524U01RM42.9_3.jpg

LM Start	2.30	Rating **	M	Issue No.	70 (cont)
LM End	2.30	Issue Type +	Ma	Location *	WS
Category	Supplemental			GPS Latitude/Longitude	
				Start	End
Item	DWR Erosion Survey			37.920150 °	37.920150 °
				-121.319700 °	-121.319700 °
DWR ID	RD0524U01RM42.9				
Comment Code					
Inspector Comment					
09/13/2017: The erosion is located immediately upstream of a repaired levee section. [2017 Site ID:RD0524U01RM42.9]

Front view of the erosion.

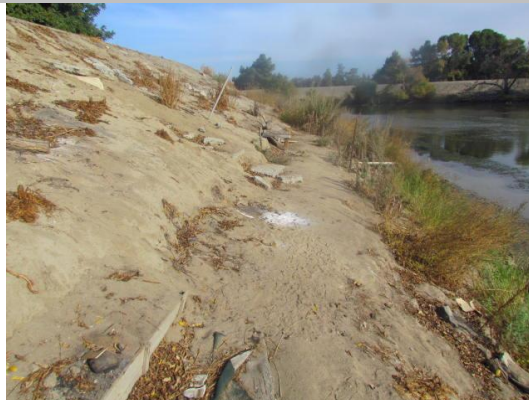
Photo 1 of 1 : FA_2017_RD0524_107_34_20170919_00060.jpg

LM Start	2.32	Rating **	M	Issue No.	34
LM End	2.33	Issue Type +	Ma	Location *	WS
Category	Earthen Levee			GPS Latitude/Longitude	
				Start	End
Item	Slope Stability			37.919885 °	37.919703 °
				-121.319713 °	-121.319702 °
DWR ID	DWR_RD0524_01_s_2012_34				
Comment Code					
S2 : Repair the levee slope damaged by foot traffic and prevent access where possible.					
Inspector Comment					
Slope damage caused by walking traffic and using bank as a fishing platform.

Looking northeast at damage to the slope possibly caused by human activity.
