**Flood Control Project Maintenance
Levee Inspections**

Maintenance Issue Types Only, Levee Inspection Report By Mile - Fall 2017

Reclamation District No. 0524 Middle Roberts Island

Waterway	Bank	Unit Miles	Inspection Start/End	Inspector
Unit No. 01 San Joaquin River	Left	6.20	11/08/2017 11/08/2017	Dave Torres

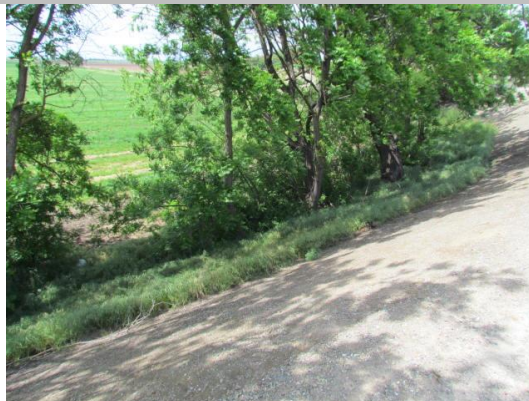
Photo 1 of 1 : FA_2017_RD0524_107_107_20170919_00158.jpg

LM Start	2.33	Rating **	M	Issue No.	107
LM End	2.33	Issue Type +	Ma	Location *	LS
Category	Earthen Levee			GPS Latitude/Longitude	
				Start	End
Item	Trim / Thin Trees			37.919742 °	37.919742 °
				-121.319623 °	-121.319623 °
DWR ID	DWR_RD0524_01_s_2012_107				
Comment Code					
T1 : Trim trees to at least five feet above ground level.					
Inspector Comment

Looking northwest at untrimmed trees at landward toe.

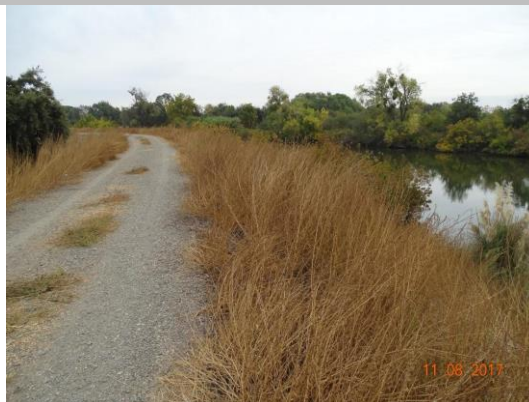
Photo 1 of 1 : FA_2017_RD0524_107_248_20171116_00479.jpg

LM Start	2.34	Rating **	U	Issue No.	248
LM End	2.44	Issue Type +	Ma	Location *	WS
Category	Earthen Levee			GPS Latitude/Longitude	
				Start	End
Item	Vegetation			37.919505 °	37.918574 °
				-121.319654 °	-121.320876 °
DWR ID	DWR_RD0524_01_f_2017_248				
Comment Code					
V2 : Remove the wild growth other than native grasses from the levee slopes.					
Inspector Comment

Looking northeast at the waterside slope.

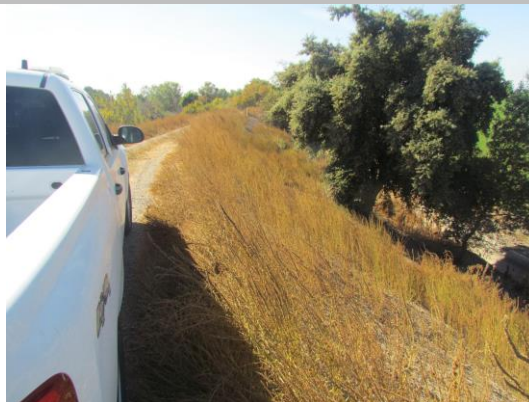
Photo 1 of 1 : FA_2017_RD0524_107_204_20170919_00245.jpg

LM Start	2.38	Rating **	M	Issue No.	204
LM End	2.42	Issue Type +	Ma	Location *	LS
Category	Earthen Levee			GPS Latitude/Longitude	
				Start	End
Item	Vegetation			37.919067 °	37.918713 °
				-121.319935 °	-121.320595 °
DWR ID	DWR_RD0524_01_f_2016_204				
Comment Code					
V2 : Remove the wild growth other than native grasses from the levee slopes.					
Inspector Comment					
Dense vegetation on landside slope and waterside slope.

Looking south at dense veg on landward slope.

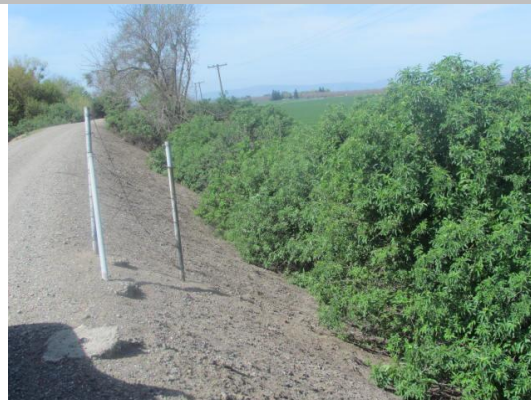
Photo 1 of 1 : FA_2017_RD0524_107_35_20170919_00061.jpg

LM Start	2.41	Rating **	U	Issue No.	35
LM End	2.45	Issue Type +	Ma	Location *	LS
Category	Earthen Levee			GPS Latitude/Longitude	
				Start	End
Item	Vegetation			37.918785 °	37.918515 °
				-121.320417 °	-121.321110 °
DWR ID	DWR_RD0524_01_s_2012_35				
Comment Code					
V4 : Elderberries are blocking visibility and flood fight capability.					
Inspector Comment

Looking southwest at dense vegetation on landward toe.

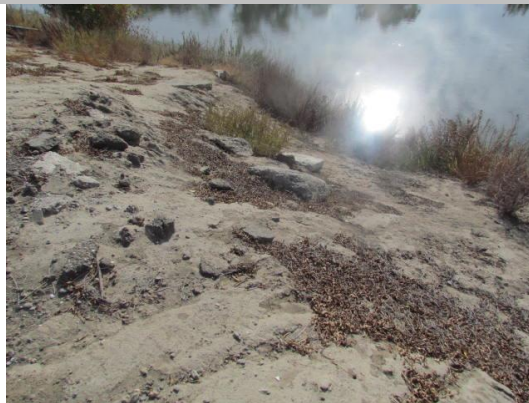
Photo 1 of 1 : FA_2017_RD0524_107_36_20170919_00062.jpg

LM Start	2.44	Rating **	M	Issue No.	36
LM End	2.47	Issue Type +	Ma	Location *	WS
Category	Earthen Levee			GPS Latitude/Longitude	
				Start	End
Item	Erosion / Bank Caving			37.918628 °	37.918438 °
				-121.320817 °	-121.321452 °
DWR ID	DWR_RD0524_01_s_2012_36				
Comment Code					
E1 : Note and monitor erosion site.					
Inspector Comment

Looking east at erosion on waterside slope.

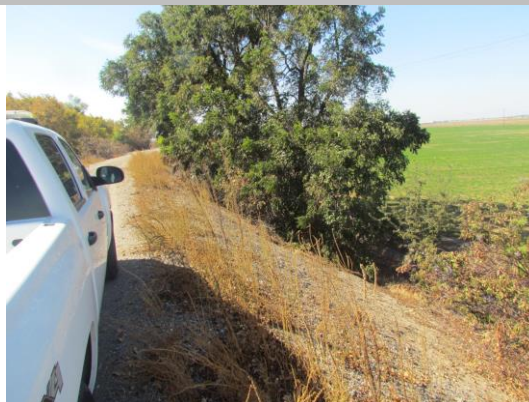
Photo 1 of 1 : FA_2017_RD0524_107_80_20170919_00126.jpg

LM Start	2.45	Rating **	U	Issue No.	80
LM End	2.45	Issue Type +	Ma	Location *	LS
Category	Earthen Levee			GPS Latitude/Longitude	
				Start	End
Item	Trim / Thin Trees			37.918480 °	37.918480 °
				-121.321114 °	-121.321114 °
DWR ID	DWR_RD0524_01_s_2012_80				
Comment Code					
T1 : Trim trees to at least five feet above ground level.					
Inspector Comment					
Untrimmed tree on landside slope.

Looking south at untrimmed tree on landward slope.

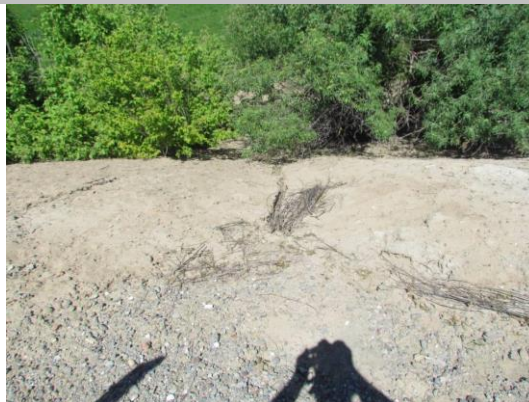
Photo 1 of 1 : FA_2017_RD0524_107_160_20170919_00193.jpg

LM Start	2.47	Rating **	M	Issue No.	160
LM End	2.48	Issue Type +	Ma	Location *	WS
Category	Earthen Levee			GPS Latitude/Longitude	
				Start	End
Item	Erosion / Bank Caving			37.918403 °	37.918383 °
				-121.321442 °	-121.321497 °
DWR ID	DWR_RD0524_01_s_2017_160				
Comment Code					
E1 : Note and monitor erosion site.					
Inspector Comment					
Runoff erosion on landside slope

Looking east at erosion caused by rain runoff on waterward slope.

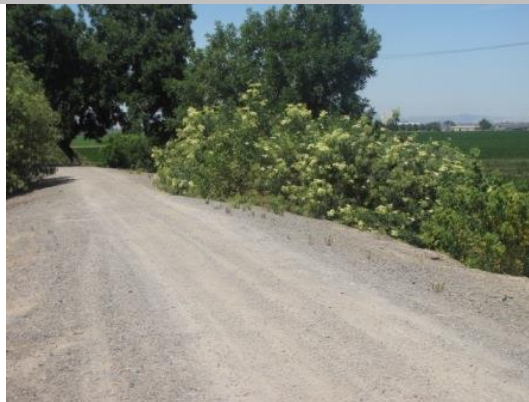
Photo 1 of 4 : FA_2017_RD0524_107_37_20170919_00063.jpg

LM Start	2.49	Rating **	U	Issue No.	37
LM End	2.50	Issue Type +	Ma	Location *	LS
Category	Earthen Levee			GPS Latitude/Longitude	
				Start	End
Item	Vegetation			37.918345 °	37.918302 °
				-121.321765 °	-121.321923 °
DWR ID	DWR_RD0524_01_s_2012_37				
Comment Code					
V4 : Elderberries are blocking visibility and flood fight capability.					
Inspector Comment

Looking south at elderberry on landside slope.

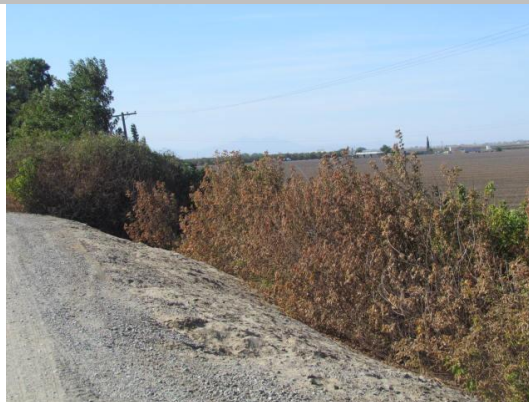
Photo 2 of 4 : FA_2017_RD0524_107_37_20170919_00064.jpg

Looking southwest at dense vegetation on landside toe.

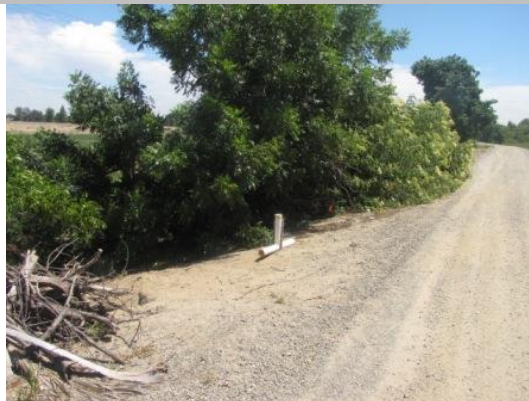
Photo 3 of 4 : FA_2017_RD0524_107_37_20170919_00065.jpg

LM Start	2.49	Rating **	U	Issue No.	37 (cont)	
LM End	2.50	Issue Type +	Ma	Location *	LS	
Category	Earthen Levee			GPS Latitude/Longitude		
				Start		End
Item	Vegetation			37.918345 °		37.918302 °
				-121.321765 °		-121.321923 °
DWR ID	DWR_RD0524_01_s_2012_37					
Comment Code						
V4 : Elderberries are blocking visibility and flood fight capability.						
Inspector Comment

Looking north at elderberry and trees on landside slope.

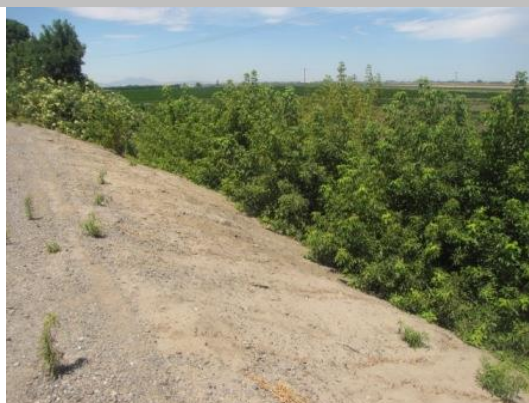
Photo 4 of 4 : FA_2017_RD0524_107_37_20170919_00066.jpg

Looking southwest at trees along levee landside toe.

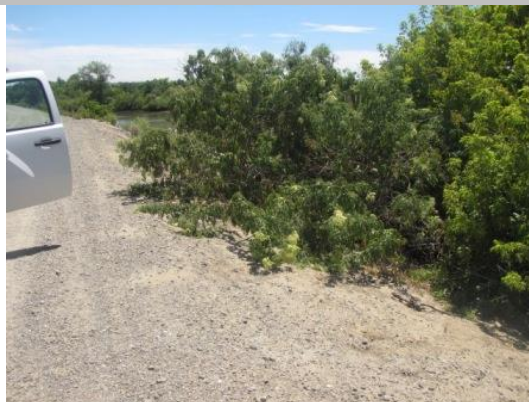
Photo 1 of 2 : FA_2017_RD0524_107_38_20170919_00067.jpg

LM Start	2.50	Rating **	U	Issue No.	38
LM End	2.50	Issue Type +	Ma	Location *	WS
Category	Earthen Levee			GPS Latitude/Longitude	
				Start	End
Item	Vegetation			37.918287 °	37.918287 °
				-121.321980 °	-121.321980 °
DWR ID	DWR_RD0524_01_s_2012_38				
Comment Code					
V4 : Elderberries are blocking visibility and flood fight capability.					
Inspector Comment

Looking north at elderberry on waterside slope.

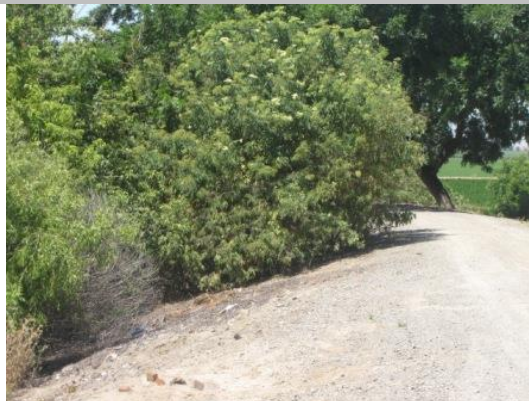
Photo 2 of 2 : FA_2017_RD0524_107_38_20170919_00068.jpg

LM Start	2.50	Rating **	U	Issue No.	38 (cont)
LM End	2.50	Issue Type +	Ma	Location *	WS
Category	Earthen Levee			GPS Latitude/Longitude	
				Start	End
Item	Vegetation			37.918287 °	37.918287 °
				-121.321980 °	-121.321980 °
DWR ID	DWR_RD0524_01_s_2012_38				
Comment Code					
V4 : Elderberries are blocking visibility and flood fight capability.					
Inspector Comment

Looking south at elderberry on waterside slope.

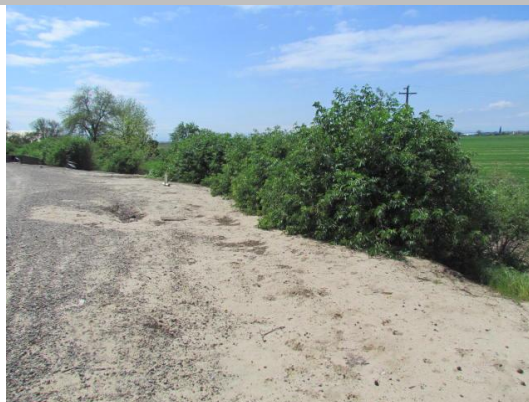
Photo 1 of 1 : FA_2017_RD0524_107_40_20170919_00071.jpg

LM Start	2.53	Rating **	U	Issue No.	40
LM End	2.57	Issue Type +	Ma	Location *	LS
Category	Earthen Levee			GPS Latitude/Longitude	
				Start	End
Item	Vegetation			37.918047 °	37.917498 °
				-121.322415 °	-121.322797 °
DWR ID	DWR_RD0524_01_s_2012_40				
Comment Code					
V4 : Elderberries are blocking visibility and flood fight capability.					
Inspector Comment

Looking southwest at dense veg on landward slope.

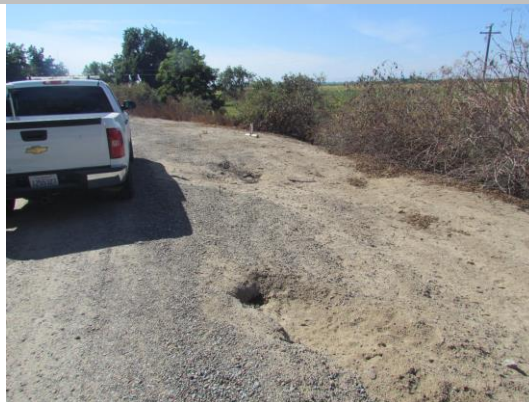
Photo 1 of 2 : FA_2017_RD0524_107_82_20170919_00131.jpg

LM Start	2.54	Rating **	M	Issue No.	82
LM End	2.54	Issue Type +	Ma	Location *	LS
Category	Earthen Levee			GPS Latitude/Longitude	
				Start	End
Item	Animal Control			37.917978 °	37.917978 °
				-121.322483 °	-121.322483 °
DWR ID	DWR_RD0524_01_s_2012_82				
Comment Code					
A3 : No rodents visible, but rodent burrows visible; need to backfill and compact or grout burrows.					
Inspector Comment					
Landside slope damage from animal digging into levee.

Looking southwest at large holes on landward slope. (Fall 2016)

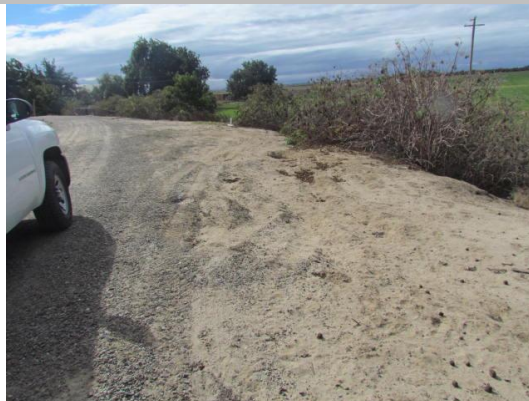
Photo 2 of 2 : FA_2017_RD0524_107_82_20170919_00132.jpg

LM Start	2.54	Rating **	M	Issue No.	82 (cont)
LM End	2.54	Issue Type +	Ma	Location *	LS
Category	Earthen Levee			GPS Latitude/Longitude	
				Start	End
Item	Animal Control			37.917978 °	37.917978 °
				-121.322483 °	-121.322483 °
DWR ID	DWR_RD0524_01_s_2012_82				
Comment Code					
A3 : No rodents visible, but rodent burrows visible; need to backfill and compact or grout burrows.					
Inspector Comment					
Landside slope damage from animal digging into levee.

Looking southwest at damaged landward slope. (Spring 2016)

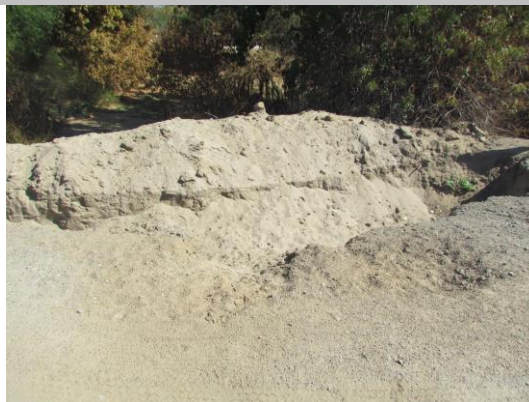
Photo 1 of 3 : FA_2017_RD0524_107_218_20170919_00264.jpg

LM Start	2.57	Rating **	U	Issue No.	218
LM End	2.57	Issue Type +	Ma	Location *	WS
Category	Earthen Levee			GPS Latitude/Longitude	
				Start	End
Item	Erosion / Bank Caving			37.917492 °	37.917492 °
				-121.322795 °	-121.322795 °
DWR ID	DWR_RD0524_01_f_2016_218				
Comment Code					
E2 : Schedule repair of erosion site prior to the next inspection.					
Inspector Comment					
Large trench on waterside shoulder and slope. Trench is 45 x 15 x 5.

Looking east at trench on waterward shoulder.

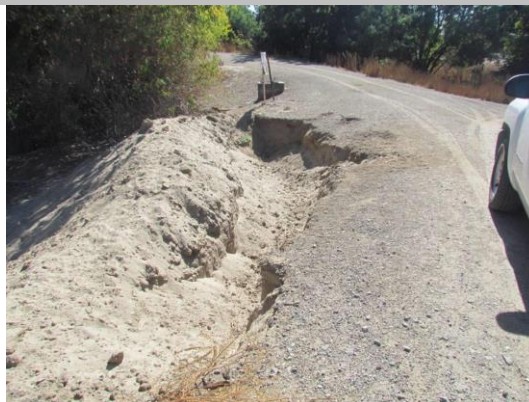
Photo 2 of 3 : FA_2017_RD0524_107_218_20170919_00265.jpg

Looking south at trench on waterward shoulder.

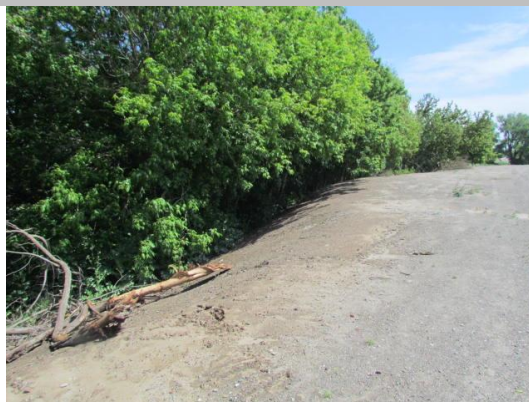
Photo 1 of 1 : FA_2017_RD0524_107_185_20170919_00229.jpg

LM Start	2.60	Rating **	U	Issue No.	185
LM End	2.64	Issue Type +	Ma	Location *	WS
Category	Earthen Levee			GPS Latitude/Longitude	
				Start	End
Item	Trim / Thin Trees			37.917152 °	37.916807 °
				-121.322582 °	-121.322069 °
DWR ID	DWR_RD0524_01_s_2014_185				
Comment Code					
T2 : Thin trees to allow visibility of the ground and room to flood fight.					
Inspector Comment

Looking northwest at untrimmed trees on landward slope and toe.

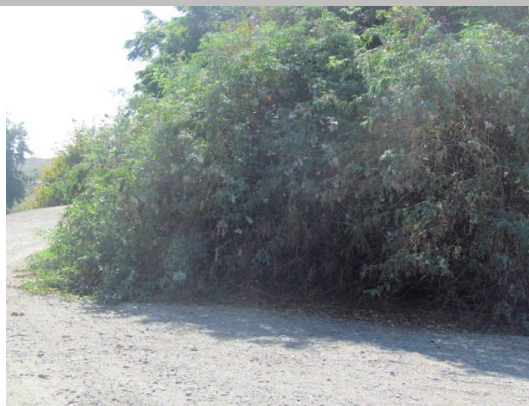
Photo 1 of 1 : FA_2017_RD0524_107_43_20170919_00075.jpg

LM Start	2.64	Rating **	U	Issue No.	43
LM End	2.64	Issue Type +	Ma	Location *	LS
Category	Earthen Levee			GPS Latitude/Longitude	
				Start	End
Item	Vegetation			37.916780 °	37.916780 °
				-121.322095 °	-121.322095 °
DWR ID	DWR_RD0524_01_s_2012_43				
Comment Code					
V4 : Elderberries are blocking visibility and flood fight capability.					
Inspector Comment					
Dense elderberry on landside shoulder, slope, and toe.

Looking southeast at dense veg on landward slope and toe fall 2015.

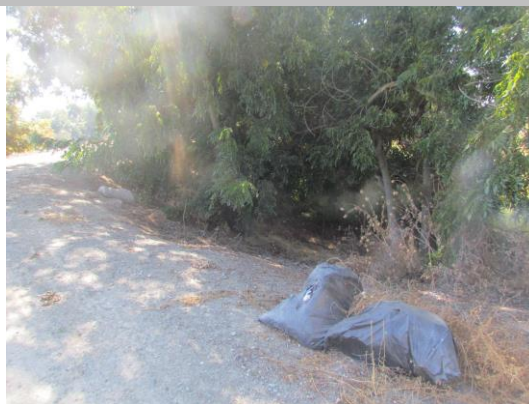
Photo 1 of 1 : FA_2017_RD0524_107_918_20170919_00285.jpg

LM Start	2.65	Rating **	U	Issue No.	918
LM End	2.66	Issue Type +	Ma	Location *	LS
Category	Earthen Levee			GPS Latitude/Longitude	
				Start	End
Item	Trim / Thin Trees			37.916718 °	37.916502 °
				-121.322020 °	-121.321980 °
DWR ID	DWR_RD0524_01_s_2012_918				
Comment Code					
T1 : Trim trees to at least five feet above ground level.					
Inspector Comment					
Untrimmed trees on landside slope and toe.

Looking south at untrimmed trees on landward slope.

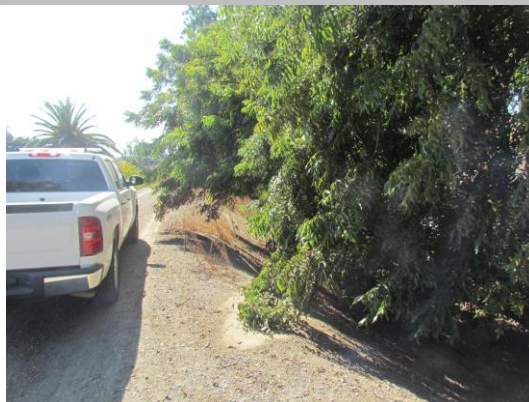
Photo 1 of 2 : FA_2017_RD0524_107_264_20170919_00274.jpg

LM Start	2.70	Rating **	M	Issue No.	264
LM End	2.76	Issue Type +	Ma	Location *	LS
Category	Earthen Levee			GPS Latitude/Longitude	
				Start	End
Item	Trim / Thin Trees			37.915945 °	37.915276 °
				-121.322290 °	-121.322808 °
DWR ID	DWR_RD0524_01_s_2012_264				
Comment Code					
T2 : Thin trees to allow visibility of the ground and room to flood fight.					
Inspector Comment					
Untrimmed trees along landside slope and toe. Additionally, trim over hanging trees at least 12 feet above ground level.

Looking south at untrimmed trees on landward slope.

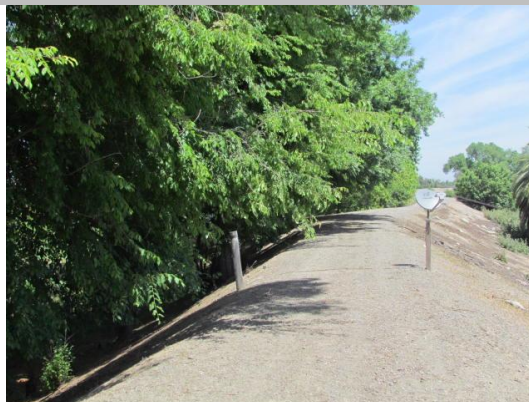
Photo 2 of 2 : FA_2017_RD0524_107_264_20171120_00494.jpg

Looking north at dense trees overhanging levee crown.

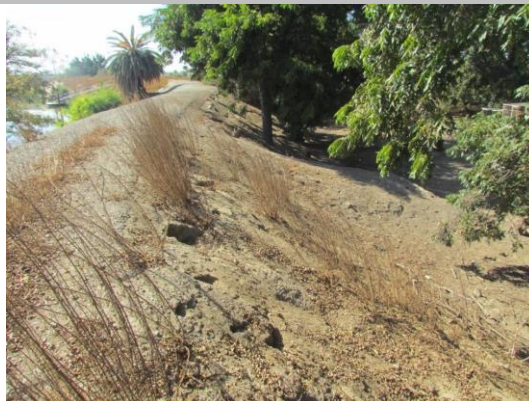
Photo 1 of 2 : FA_2017_RD0524_107_219_20170919_00267.jpg

LM Start	2.77	Rating **	U	Issue No.	219
LM End	2.80	Issue Type +	Ma	Location *	LS
Category	Earthen Levee			GPS Latitude/Longitude	
				Start	End
Item	Animal Control			37.915195 °	37.915052 °
				-121.322930 °	-121.323430 °
DWR ID	DWR_RD0524_01_f_2016_219				
Comment Code					
A1 : Exterminate rodents and backfill and compact or grout burrows.					
Inspector Comment					
Several large rodent holes on landside slope.

Looking south at several rodent holes on landward slope.

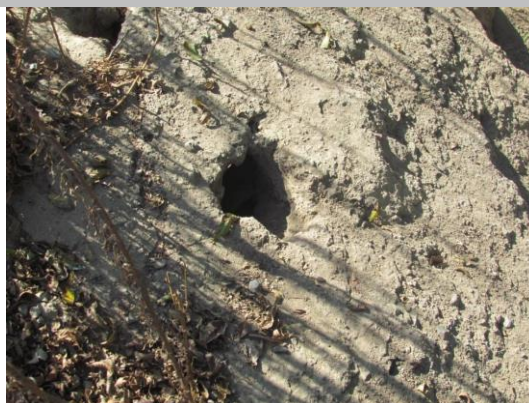
Photo 2 of 2 : FA_2017_RD0524_107_219_20170919_00268.jpg

Looking at typical rodent hole on waterward slope.

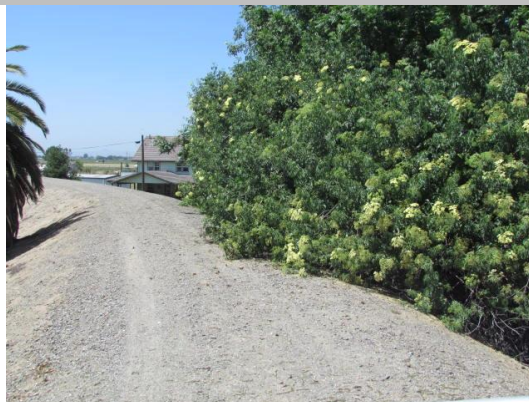
Photo 1 of 2 : FA_2017_RD0524_107_48_20170919_00086.jpg

LM Start	2.80	Rating **	U	Issue No.	48
LM End	2.80	Issue Type +	Ma	Location *	LS
Category	Earthen Levee			GPS Latitude/Longitude	
				Start	End
Item	Vegetation			37.915022 °	37.915022 °
				-121.323443 °	-121.323443 °
DWR ID	DWR_RD0524_01_s_2012_48				
Comment Code					
V4 : Elderberries are blocking visibility and flood fight capability.					
Inspector Comment

Looking south at dense elderberry on landside slope.(Spring 2012)

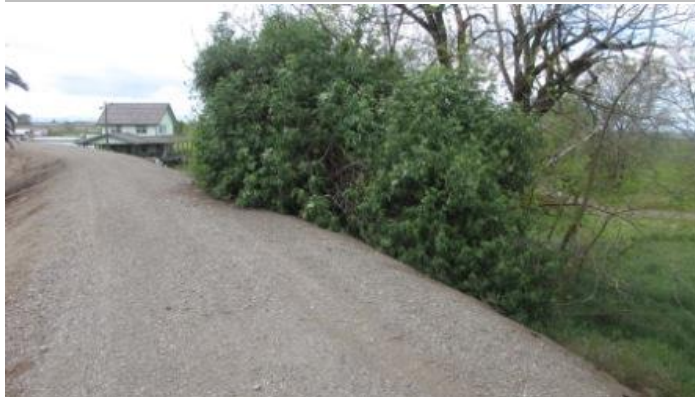
Photo 2 of 2 : FA_2017_RD0524_107_48_20170919_00087.jpg

LM Start	2.80	Rating **	U	Issue No.	48 (cont)	
LM End	2.80	Issue Type +	Ma	Location *	LS	
Category	Earthen Levee			GPS Latitude/Longitude		
				Start		End
Item	Vegetation			37.915022 °		37.915022 °
				-121.323443 °		-121.323443 °
DWR ID	DWR_RD0524_01_s_2012_48					
Comment Code						
V4 : Elderberries are blocking visibility and flood fight capability.						
Inspector Comment

Looking south at elderberry on landside slope.(Spring 2011)

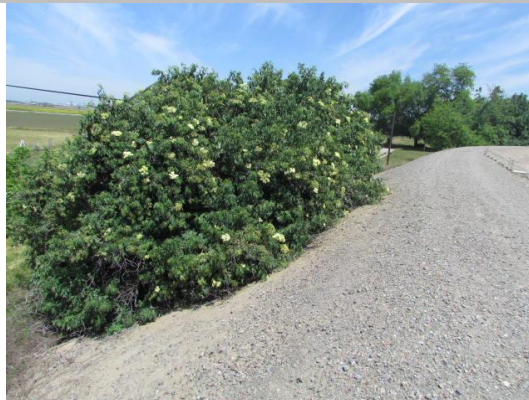
Photo 1 of 1 : FA_2017_RD0524_107_49_20170919_00088.jpg

LM Start	2.86	Rating **	U	Issue No.	49
LM End	2.86	Issue Type +	Ma	Location *	LS
Category	Earthen Levee			GPS Latitude/Longitude	
				Start	End
Item	Vegetation			37.914427 °	37.914427 °
				-121.324198 °	-121.324198 °
DWR ID	DWR_RD0524_01_s_2012_49				
Comment Code					
V4 : Elderberries are blocking visibility and flood fight capability.					
Inspector Comment

Looking northwest at elderberry on landside slope.

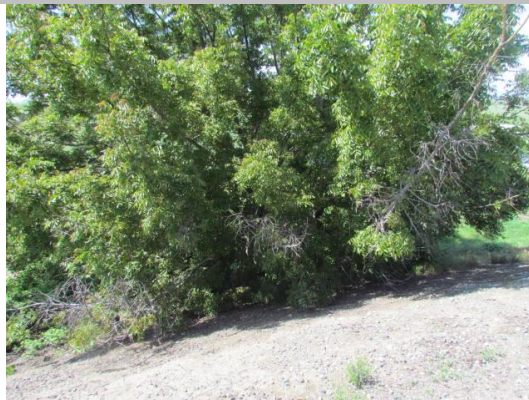
Photo 1 of 1 : FA_2017_RD0524_107_209_20170919_00251.jpg

LM Start	2.87	Rating **	U	Issue No.	209
LM End	2.87	Issue Type +	Ma	Location *	LS
Category	Earthen Levee			GPS Latitude/Longitude	
				Start	End
Item	Trim / Thin Trees			37.914257 °	37.914257 °
				-121.324317 °	-121.324317 °
DWR ID	DWR_RD0524_01_s_2016_209				
Comment Code					
T1 : Trim trees to at least five feet above ground level.					
Inspector Comment					
Untrimmed walnut tree on landside slope and toe.

Looking northwest at untrimmed tree at landward toe.

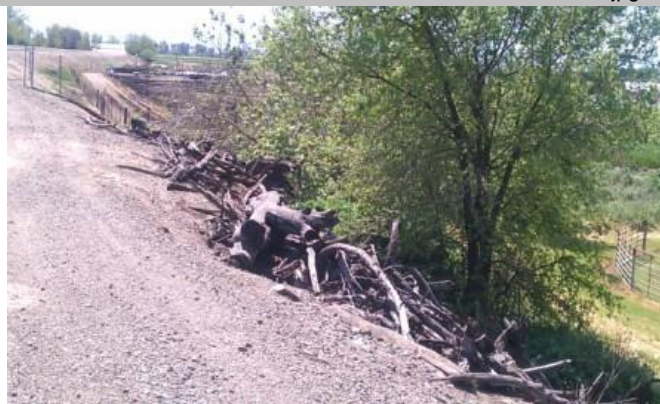
Photo 1 of 1 : FA_2017_RD0524_107_50_20170919_00089.jpg

LM Start	2.90	Rating **	U	Issue No.	50
LM End	2.92	Issue Type +	Ma	Location *	LS
Category	Earthen Levee			GPS Latitude/Longitude	
				Start	End
Item	Encroachments			37.913767 °	37.913486 °
				-121.324427 °	-121.324428 °
DWR ID	DWR_RD0524_01_s_2012_50				
Comment Code					
PR : Prunings					
Inspector Comment

Looking southwest at prunings on landside slope.

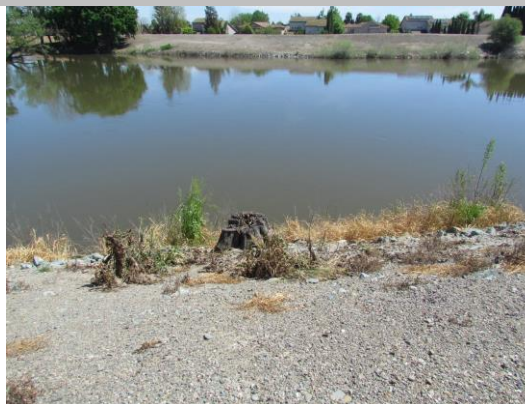
Photo 1 of 1 : FA_2017_RD0524_107_161_20170919_00194.jpg

LM Start	2.91	Rating **	U	Issue No.	161
LM End	2.91	Issue Type +	Ma	Location *	WS
Category	Earthen Levee			GPS Latitude/Longitude	
				Start	End
Item	Trim / Thin Trees			37.913733 °	37.913733 °
				-121.324398 °	-121.324398 °
DWR ID	DWR_RD0524_01_s_2017_161				
Comment Code					
T5 : Tree stumps.					
Inspector Comment

Looking east at large tree stump on waterward shoulder.

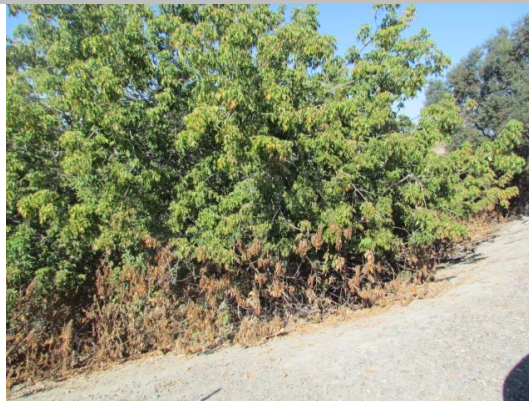
Photo 1 of 2 : FA_2017_RD0524_107_51_20170919_00090.jpg

LM Start	2.93	Rating **	U	Issue No.	51
LM End	2.93	Issue Type +	Ma	Location *	LS
Category	Earthen Levee			GPS Latitude/Longitude	
				Start	End
Item	Trim / Thin Trees			37.913415 °	37.913389 °
				-121.324503 °	-121.324440 °
DWR ID	DWR_RD0524_01_s_2012_51				
Comment Code					
T1 : Trim trees to at least five feet above ground level.					
Inspector Comment					
Untrimmed trees on landside slope and toe.

Looking south at dense trees on landward slope fall 2015

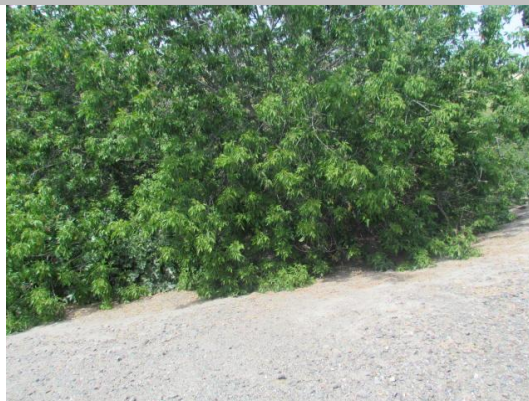
Photo 2 of 2 : FA_2017_RD0524_107_51_20170919_00091.jpg

Looking south at dense trees on landward slope spring 2015

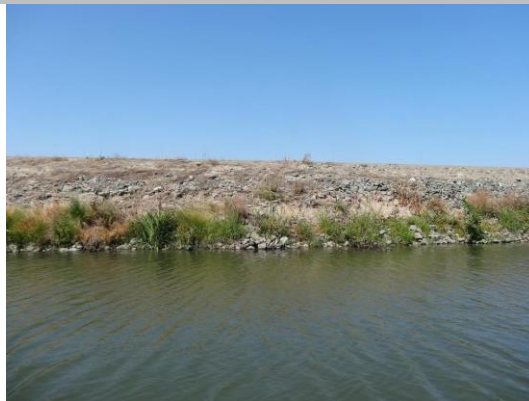
Photo 1 of 4 : SJR2017_RD0524U01RM43.52_1.jpg

LM Start	2.96	Rating **	U	Issue No.	71
LM End	2.96	Issue Type +	Ma	Location *	WS
Category	Supplemental			GPS Latitude/Longitude	
				Start	End
Item	DWR Erosion Survey			37.913010 °	37.913010 °
				-121.324490 °	-121.324490 °
DWR ID	RD0524U01RM43.52				
Comment Code					
Inspector Comment					
09/13/2017: A new pocket erosion observed at the eroison site, next to an irrigation pipe.					
07/25/2016: No significant change observed.					
06/24/2015: No significant change observed.					
06/19/2014: No significant change observed.					
08/13/2013: No significant change observed.					
08/07/2012: The site was first reported in 2012 spring levee inspection report. [2017 Site ID:RD0524U01RM43.52]

Front view of the erosion.

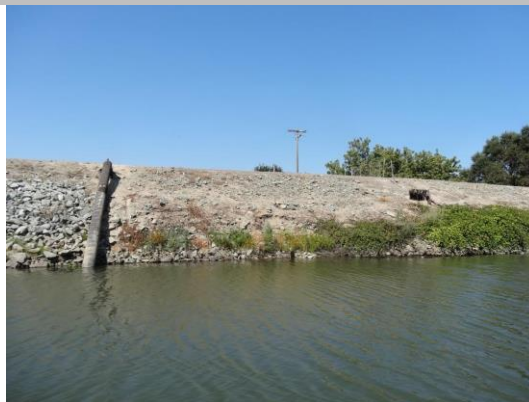
Photo 2 of 4 : SJR2017_RD0524U01RM43.52_2.jpg

View of the newly developed pocket erosion next to an irrigation pipe.

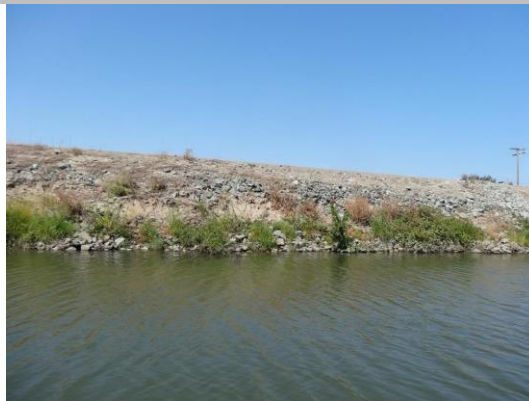
Photo 3 of 4 : SJR2017_RD0524U01RM43.52_3.jpg

Close view of the erosion.

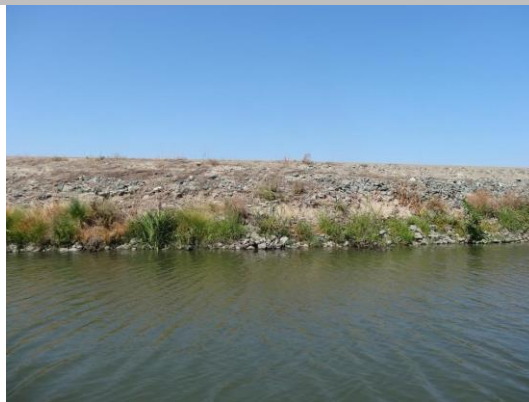
Photo 4 of 4 : SJR2017_RD0524U01RM43.52_4.jpg

Close view of the erosion. Note the new pocket erosion next to the irrigation pipe on the site.

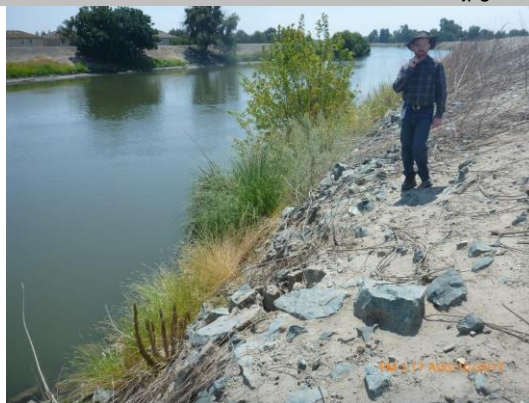
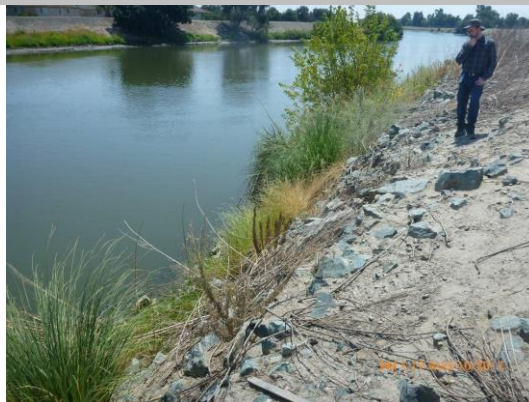
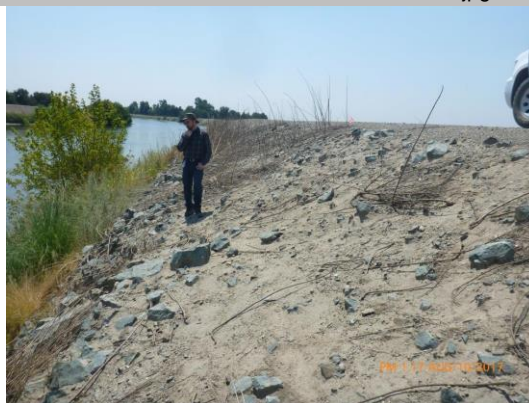
LM Start	2.99	Rating **	A/W	Issue No.	228
LM End	3.01	Issue Type +	Ma	Location *	
Category	Supplemental			GPS Latitude/Longitude	
				Start	End
Item	2017 Storm Damage			37.912500 °	37.912300 °
				-121.324700 °	-121.324700 °
DWR ID	DWR_RD0524_01_f_2017_228				
Comment Code					
Inspector Comment					
Levee Evaluation Comments					
Description:Slope protection repairs are needed along the waterside slope due to erosion and riprap displacement from high water. Based upon levee inspections, it was determined the waterside levee slope is eroding, deteriorating, and degrading. The eroded levee sections need to be restored back to design standards to prevent further deterioration and damage.					
Site ID No:529					
Site Designation:LMA-435					
Repair Type: Erosion					
Rating:Area of Concern					
Field Date:8/10/2017					
Notes:

LM Start	2.99	Rating **	A/W	Issue No.	228 (cont)
LM End	3.01	Issue Type +	Ma	Location *	
Category	Supplemental			GPS Latitude/Longitude	
				Start	End
Item	2017 Storm Damage			37.912500 °	37.912300 °
				-121.324700 °	-121.324700 °
DWR ID	DWR_RD0524_01_f_2017_228				
Comment Code					
Inspector Comment					
<p>Levee Evaluation Comments</p> <p>Description: Slope protection repairs are needed along the waterside slope due to erosion and riprap displacement from high water. Based upon levee inspections, it was determined the waterside levee slope is eroding, deteriorating, and degrading. The eroded levee sections need to be restored back to design standards to prevent further deterioration and damage.</p> <p>Site ID No: 529</p> <p>Site Designation: LMA-435</p> <p>Repair Type: Erosion</p> <p>Rating: Area of Concern</p> <p>Field Date: 8/10/2017</p> <p>Notes:</p>

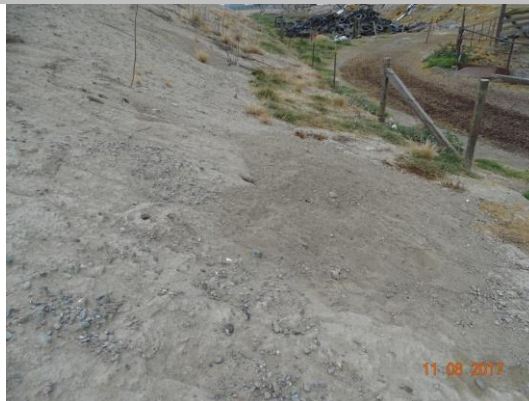
Photo 1 of 3 : FA_2017_RD0524_107_925_20171116_00480.jpg

LM Start	3.07	Rating **	M	Issue No.	925
LM End	3.27	Issue Type +	Ma	Location *	LS
Category	Earthen Levee			GPS Latitude/Longitude	
				Start	End
Item	Animal Control			37.911382 °	37.908602 °
				-121.324928 °	-121.325395 °
DWR ID	DWR_RD0524_01_s_2012_925				
Comment Code					
A1 : Exterminate rodents and backfill and compact or grout burrows.					
Inspector Comment					
Several rodent holes on levee slopes.

Looking southwest at the landside slope.

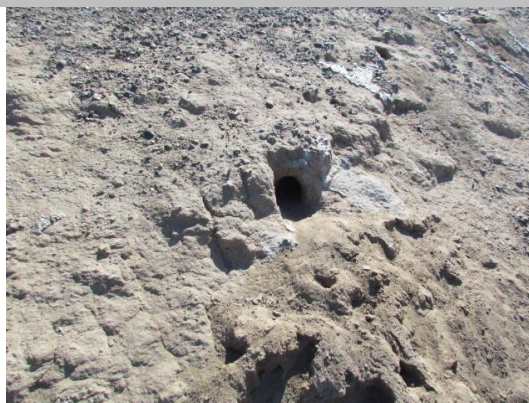
Photo 2 of 3 : FA_2017_RD0524_107_925_20170919_00288.jpg

Looking at typical view of rodent hole with this section fall 2015.

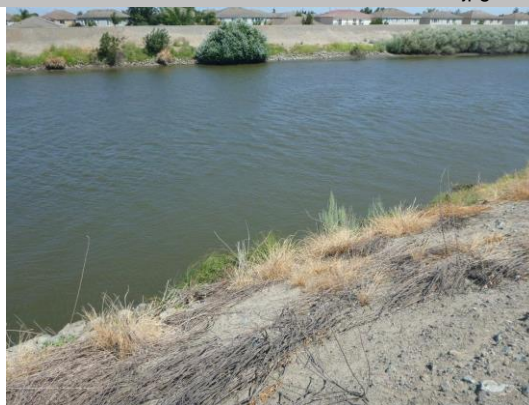
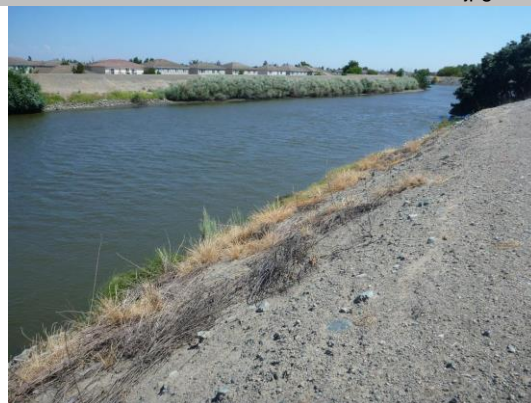
Comment Code					
Inspector Comment					
Levee Evaluation Comments					
Description:Slope protection repairs are needed along the waterside slope due to erosion. Based upon levee inspections, it was determined the waterside levee slopes were eroding, deteriorating and degrading in concave pocket sections at various locations along this levee reach. The eroded levee sections need to be restored back to design standards to prevent further deterioration of the damaged levee sections.					
Site ID No:466					
Site Designation:LMA-293					
Repair Type: Erosion					
Rating:Area of Concern					
Field Date:7/26/2017					
Notes: Lower priority because damage is only on the lower 1/5 of slope. The slopes US and DS are rocked. Levee is narrow here.

Comment Code					
Inspector Comment					
<p>Levee Evaluation Comments</p> <p>Description: Slope protection repairs are needed along the waterside slope due to erosion. Based upon levee inspections, it was determined the waterside levee slopes were eroding, deteriorating and degrading in concave pocket sections at various locations along this levee reach. The eroded levee sections need to be restored back to design standards to prevent further deterioration of the damaged levee sections.</p> <p>Site ID No: 466</p> <p>Site Designation: LMA-293</p> <p>Repair Type: Erosion</p> <p>Rating: Area of Concern</p> <p>Field Date: 7/26/2017</p> <p>Notes: Lower priority because damage is only on the lower 1/5 of slope. The slopes US and DS are rocky. Levee is narrow here.</p>

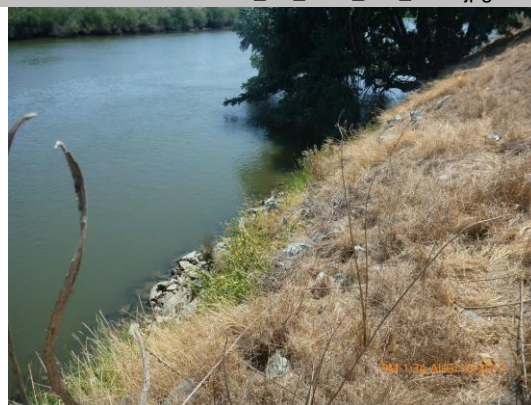
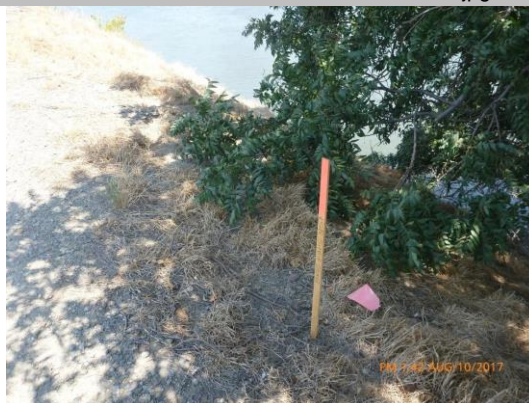
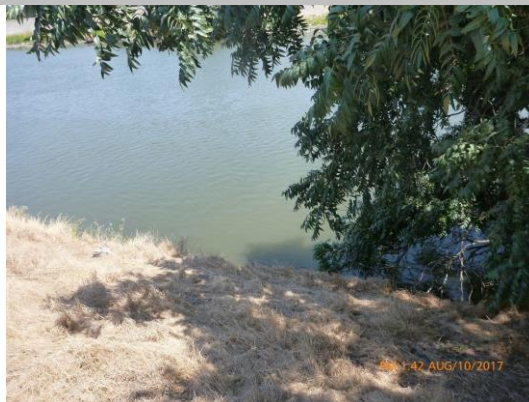
LM Start	3.26	Rating **	A/W	Issue No.	230
LM End	3.26	Issue Type +	Ma	Location *	
Category	Supplemental			GPS Latitude/Longitude	
				Start	End
Item	2017 Storm Damage			37.908800 °	37.908700 °
				-121.325400 °	-121.325300 °
DWR ID	DWR_RD0524_01_f_2017_230				
Comment Code					
Inspector Comment					
<p>Levee Evaluation Comments</p> <p>Description: Slope protection repairs are needed along the waterside slope due to erosion and riprap displacement from high water. Based upon levee inspections, it was determined the waterside levee slope is eroding, deteriorating, and degrading. The eroded levee sections need to be restored back to design standards to prevent further deterioration and damage.</p> <p>Site ID No: 528</p> <p>Site Designation: LMA-434</p> <p>Repair Type: Erosion</p> <p>Rating: Area of Concern</p> <p>Field Date: 8/10/2017</p> <p>Notes: combined with LMA-433</p>

LM Start	3.26	Rating **	A/W	Issue No.	230 (cont)	
LM End	3.26	Issue Type +	Ma	Location *		
Category	Supplemental			GPS Latitude/Longitude		
				Start		End
Item	2017 Storm Damage			37.908800 °		37.908700 °
				-121.325400 °		-121.325300 °
DWR ID	DWR_RD0524_01_f_2017_230					
Comment Code						
Inspector Comment						
Levee Evaluation Comments						
Description:Slope protection repairs are needed along the waterside slope due to erosion and riprap displacement from high water. Based upon levee inspections, it was determined the waterside levee slope is eroding, deteriorating, and degrading. The eroded levee sections need to be restored back to design standards to prevent further deterioration and damage.						
Site ID No:528						
Site Designation:LMA-434						
Repair Type: Erosion						
Rating:Area of Concern						
Field Date:8/10/2017						
Notes: combined with LMA-433

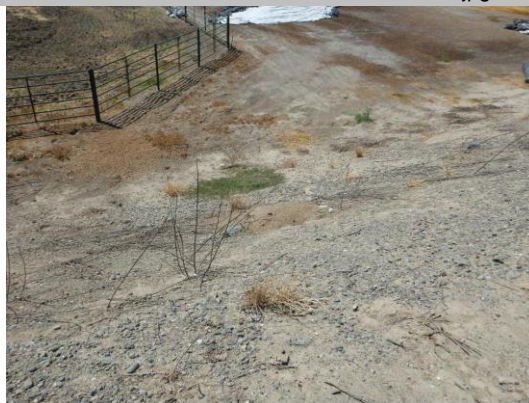
Photo 3 of 3 : LEVAL_FA_2017_467_2225.jpg

Comment Code					
Inspector Comment					
<p>Levee Evaluation Comments</p> <p>Description: Slope protection repairs are needed along the waterside slope due to erosion. Based upon levee inspections, it was determined the waterside levee slopes were eroding, deteriorating and degrading in concave pocket sections at various locations along this levee reach. The eroded levee sections need to be restored back to design standards to prevent further deterioration of the damaged levee sections.</p> <p>Site ID No: 467</p> <p>Site Designation: LMA-294</p> <p>Repair Type: Erosion</p> <p>Rating: Area of Concern</p> <p>Field Date: 7/26/2017</p> <p>Notes: It looks like new rip rap was placed on the lower 1/4 of the slope. There is a 2-3 ft scarp above the rip rap.</p>

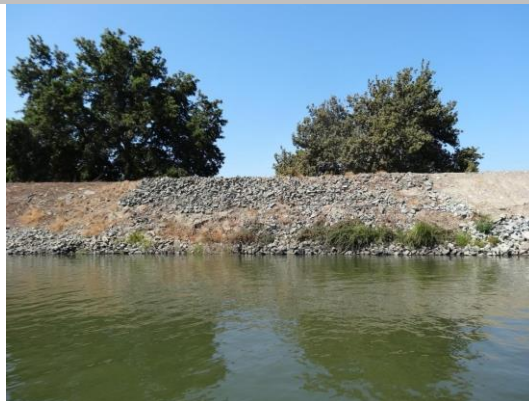
Photo 2 of 4 : SJR2017_RD0524U01RM43.86_2.jpg

LM Start	3.30	Rating **	U	Issue No.	79
LM End	3.32	Issue Type +	Ma	Location *	WS
Category	Supplemental			GPS Latitude/Longitude	
				Start	End
Item	DWR Erosion Survey			37.908090 °	37.908090 °
				-121.325090 °	-121.325090 °
DWR ID	RD0524U01RM43.86				
Comment Code					
Inspector Comment					
<p>09/13/2017: No significant change observed.</p> <p>07/25/2016: No significant change observed.</p> <p>06/24/2015: No significant change observed.</p> <p>06/19/2014: No significant change observed.</p> <p>08/13/2013: The levee toe seems to have been protected by river rocks and vegetation on site. [2017 Site ID: RD0524U01RM43.86]</p>

Front view of the erosion.

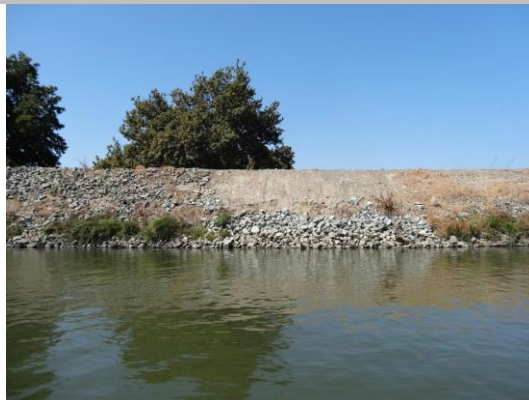
Photo 3 of 4 : SJR2017_RD0524U01RM43.86_3.jpg

Close view of the erosion. Note the river rocks and vegetation at the levee toe.

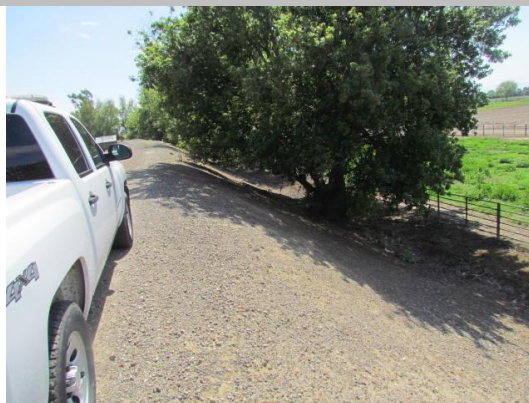
Photo 2 of 2 : FA_2017_RD0524_107_926_20170919_00291.jpg

LM Start	3.30	Rating **	U	Issue No.	926 (cont)	
LM End	3.37	Issue Type +	Ma	Location *	LS	
Category	Earthen Levee			GPS Latitude/Longitude		
				Start		End
Item	Trim / Thin Trees			37.908158 °		37.907112 °
				-121.325418 °		-121.325350 °
DWR ID	DWR_RD0524_01_s _ 2012_926					
Comment Code						
T1 : Trim trees to at least five feet above ground level.						
Inspector Comment

Looking at untrimmed trees on landward slope and toe.

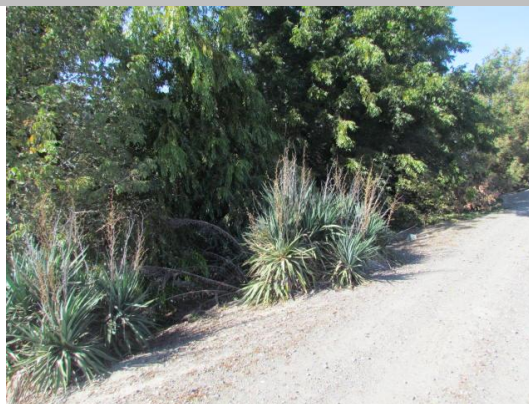
Photo 1 of 1 : FA_2017_RD0524_107_54_20170919_00093.jpg

LM Start	3.45	Rating **	U	Issue No.	54
LM End	3.45	Issue Type +	Ma	Location *	LS
Category	Earthen Levee			GPS Latitude/Longitude	
				Start	End
Item	Trim / Thin Trees			37.906227 °	37.906227 °
				-121.324683 °	-121.324683 °
DWR ID	DWR_RD0524_01_s _ 2012_54				
Comment Code					
T3 : Trim and thin trees to allow visibility of the ground and room to flood fight.					
Inspector Comment					
Dense untrimmed trees on landside slope.

Looking northwest at dense vegetation on landside slope.

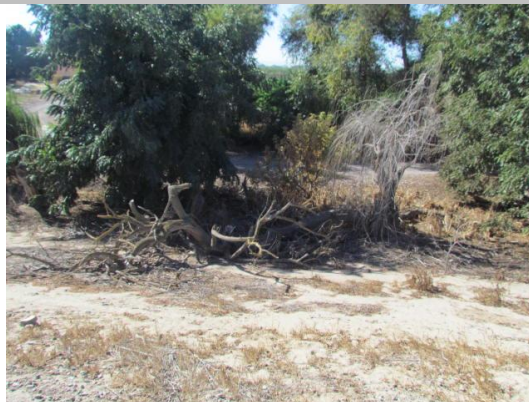
Photo 1 of 1 : FA_2017_RD0524_107_177_20170919_00215.jpg

LM Start	3.48	Rating **	M	Issue No.	177
LM End	3.48	Issue Type +	Ma	Location *	LS
Category	Earthen Levee			GPS Latitude/Longitude	
				Start	End
Item	Encroachments			37.905994 °	37.905994 °
				-121.324194 °	-121.324194 °
DWR ID	DWR_RD0524_01_f_2014_177				
Comment Code					
TR : Tree or limb					
Inspector Comment					
Dead tree on landside toe.

Looking at dead tree limb at landward toe fall 2015.

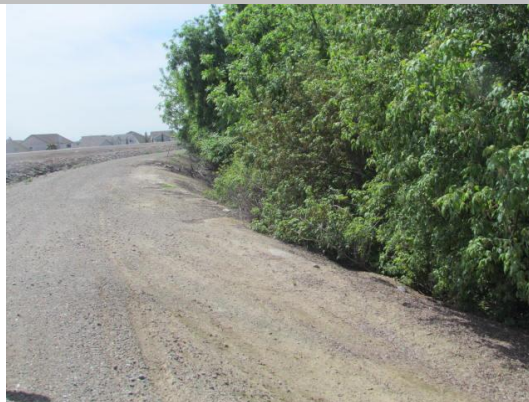
Photo 1 of 1 : FA_2017_RD0524_107_57_20170919_00097.jpg

LM Start	3.51	Rating **	U	Issue No.	57
LM End	3.59	Issue Type +	Ma	Location *	LS
Category	Earthen Levee			GPS Latitude/Longitude	
				Start	End
Item	Trim / Thin Trees			37.905638 °	37.904570 °
				-121.323892 °	-121.324215 °
DWR ID	DWR_RD0524_01_s_2012_57				
Comment Code					
T3 : Trim and thin trees to allow visibility of the ground and room to flood fight.					
Inspector Comment

Looking south at dense trees on landward slope.

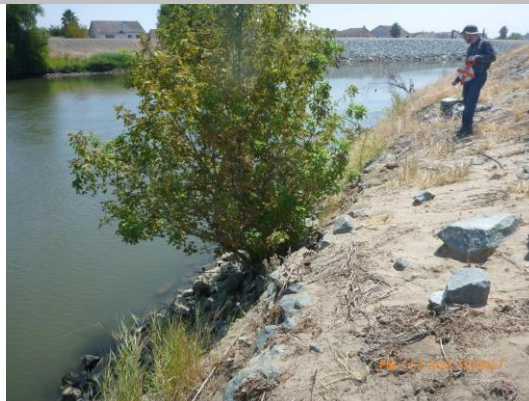
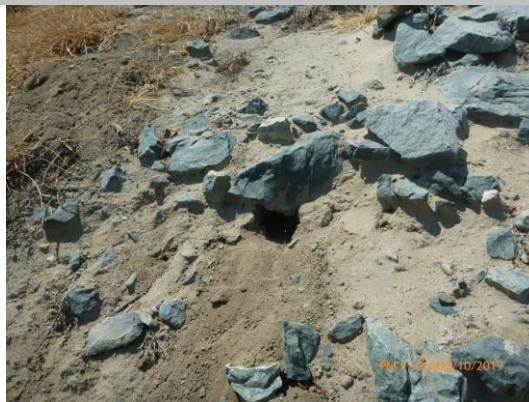
LM Start	3.53	Rating **	A/W	Issue No.	233
LM End	3.54	Issue Type +	Ma	Location *	
Category	Supplemental			GPS Latitude/Longitude	
				Start	End
Item	2017 Storm Damage			37.905300 °	37.905200 °
				-121.323800 °	-121.323900 °
DWR ID	DWR_RD0524_01_f_2017_233				
Comment Code					
Inspector Comment					
Levee Evaluation Comments					
Description:Slope protection repairs are needed along the waterside slope due to erosion and riprap displacement from high water. Based upon levee inspections, it was determined the waterside levee slope is eroding, deteriorating, and degrading. The eroded levee sections need to be restored back to design standards to prevent further deterioration and damage.					
Site ID No:526					
Site Designation:LMA-432					
Repair Type: Erosion					
Rating:Area of Concern					
Field Date:8/10/2017					
Notes:

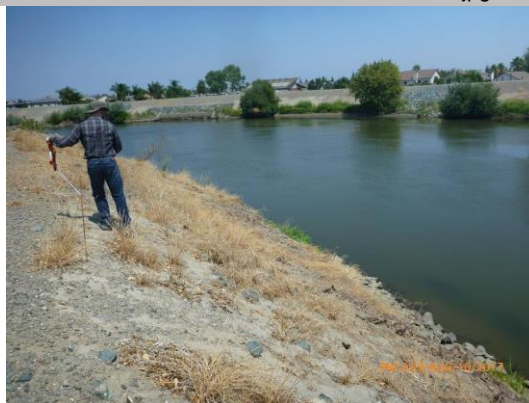
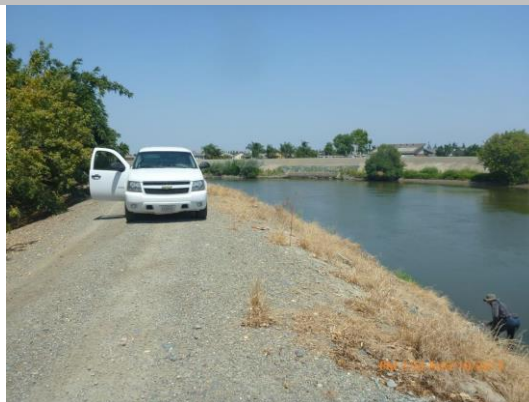
Photo 2 of 3 : LEVAL_FA_2017_525_4206.jpg

LM Start	3.56	Rating **	A/W	Issue No.	234 (cont)
LM End	3.57	Issue Type +	Ma	Location *	
Category	Supplemental			GPS Latitude/Longitude	
				Start	End
Item	2017 Storm Damage			37.904900 °	37.904800 °
				-121.323900 °	-121.324100 °
DWR ID	DWR_RD0524_01_f_2017_234				
Comment Code					
Inspector Comment					
Levee Evaluation Comments					
Description:Slope protection repairs are needed along the waterside slope due to erosion and riprap displacement from high water. Based upon levee inspections, it was determined the waterside levee slope is eroding, deteriorating, and degrading. The eroded levee sections need to be restored back to design standards to prevent further deterioration and damage.					
Site ID No:525					
Site Designation:LMA-431					
Repair Type: Erosion					
Rating:Area of Concern					
Field Date:8/10/2017					
Notes:

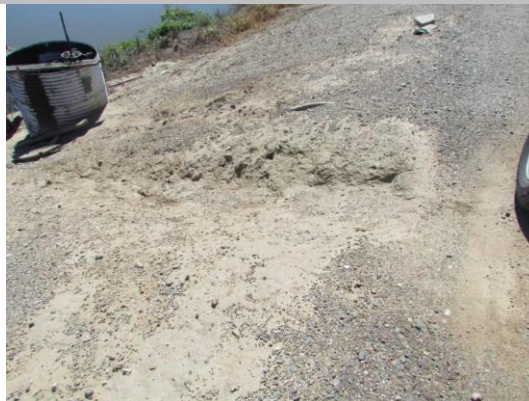
Photo 1 of 2 : FA_2017_RD0524_107_58_20170919_00098.jpg

LM Start	3.64	Rating **	M	Issue No.	58
LM End	3.64	Issue Type +	Ma	Location *	WS
Category	Earthen Levee			GPS Latitude/Longitude	
				Start	End
Item	Slope Stability			37.904113 °	37.904113 °
				-121.325080 °	-121.325080 °
DWR ID	DWR_RD0524_01_s_2012_58				
Comment Code					
S2 : Repair the levee slope damaged by foot traffic and prevent access where possible.					
Inspector Comment					
Landowner cut steps into waterside slope.					
4/3/17: Steps washed away slope damage remains.

Looking south at step cut into waterward slope. (Spring 2017)

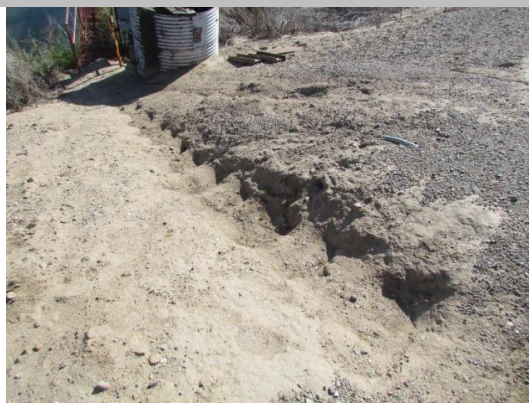
Photo 2 of 2 : FA_2017_RD0524_107_58_20170919_00099.jpg

Looking southeast steps cut into waterside slope.

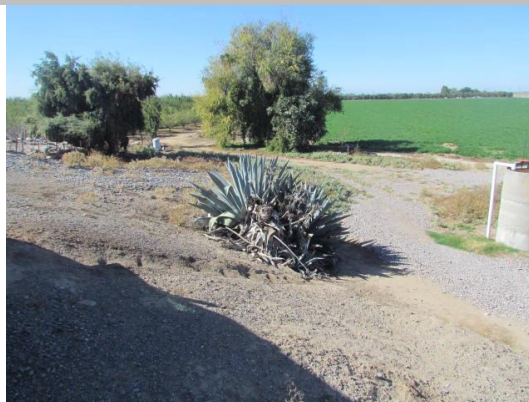
Photo 1 of 1 : FA_2017_RD0524_107_190_20170919_00231.jpg

LM Start	3.65	Rating **	U	Issue No.	190
LM End	3.65	Issue Type +	Ma	Location *	LS
Category	Earthen Levee			GPS Latitude/Longitude	
				Start	End
Item	Vegetation			37.904070 °	37.904070 °
				-121.325118 °	-121.325118 °
DWR ID	DWR_RD0524_01_f_2015_190				
Comment Code					
V2 : Remove the wild growth other than native grasses from the levee slopes.					
Inspector Comment					
Large century plant at landside toe.

Looking southwest at century plant at landward toe fall 2015.

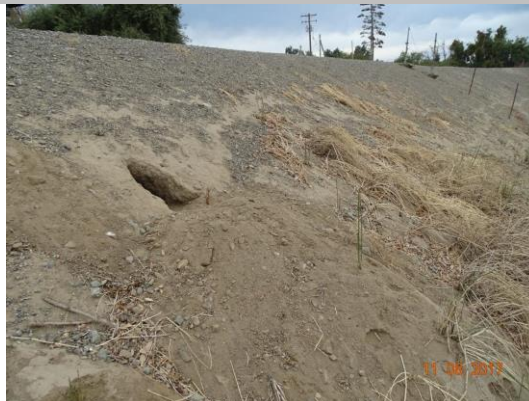
Photo 1 of 1 : FA_2017_RD0524_107_251_20171116_00481.jpg

LM Start	3.67	Rating **	U	Issue No.	251
LM End	3.67	Issue Type +	Ma	Location *	WS
Category	Earthen Levee			GPS Latitude/Longitude	
				Start	End
Item	Animal Control			37.903776 °	37.903776 °
				-121.325323 °	-121.325323 °
DWR ID	DWR_RD0524_01_f_2017_251				
Comment Code					
A3 : No rodents visible, but rodent burrows visible; need to backfill and compact or grout burrows.					
Inspector Comment					
Large rodent holes on both waterside and landside slope.

Looking northwest at the waterside slope.

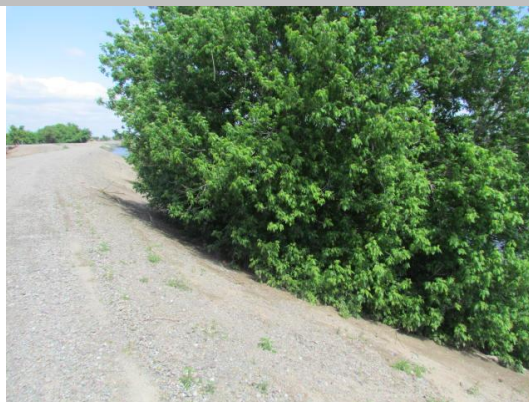
Photo 1 of 1 : FA_2017_RD0524_107_52_20170919_00092.jpg

LM Start	3.75	Rating **	U	Issue No.	52
LM End	3.75	Issue Type +	Ma	Location *	WS
Category	Earthen Levee			GPS Latitude/Longitude	
				Start	End
Item	Trim / Thin Trees			37.902828 °	37.902828 °
				-121.326170 °	-121.326170 °
DWR ID	DWR_RD0524_01_s_2016_52				
Comment Code					
T1 : Trim trees to at least five feet above ground level.					
Inspector Comment

Looking south at untrimmed tree on landward slope and toe.

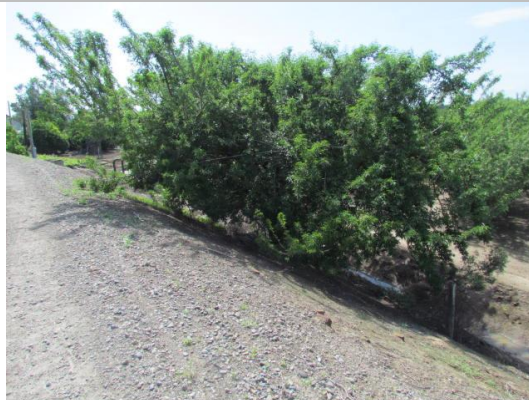
Photo 1 of 1 : FA_2017_RD0524_107_927_20170919_00292.jpg

LM Start	3.77	Rating **	U	Issue No.	927
LM End	3.77	Issue Type +	Ma	Location *	LS
Category	Earthen Levee			GPS Latitude/Longitude	
				Start	End
Item	Trim / Thin Trees			37.902645 °	37.902645 °
				-121.326340 °	-121.326340 °
DWR ID	DWR_RD0524_01_s_2012_927				
Comment Code					
T1 : Trim trees to at least five feet above ground level.					
Inspector Comment					
Untrimmed almond tree on landside slope.

Looking southwest at untrimmed tree at landward toe.

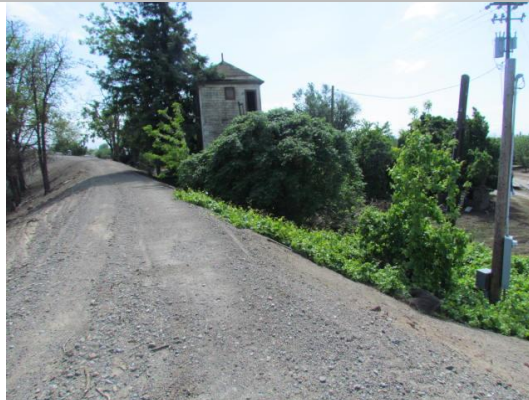
Photo 1 of 1 : FA_2017_RD0524_107_59_20170919_00100.jpg

LM Start	3.79	Rating **	U	Issue No.	59
LM End	3.80	Issue Type +	Ma	Location *	LS
Category	Earthen Levee			GPS Latitude/Longitude	
				Start	End
Item	Trim / Thin Trees			37.902287 °	37.902163 °
				-121.326462 °	-121.326476 °
DWR ID	DWR_RD0524_01_s_2012_59				
Comment Code					
T1 : Trim trees to at least five feet above ground level.					
Inspector Comment

Looking south at dense veg on landward slope and toe.
