**Flood Control Project Maintenance
Levee Inspections**

Maintenance Issue Types Only, Levee Inspection Report By Mile - Fall 2017

Reclamation District No. 0524 Middle Roberts Island

Waterway	Bank	Unit Miles	Inspection Start/End	Inspector
Unit No. 01 San Joaquin River	Left	6.20	11/08/2017 11/08/2017	Dave Torres

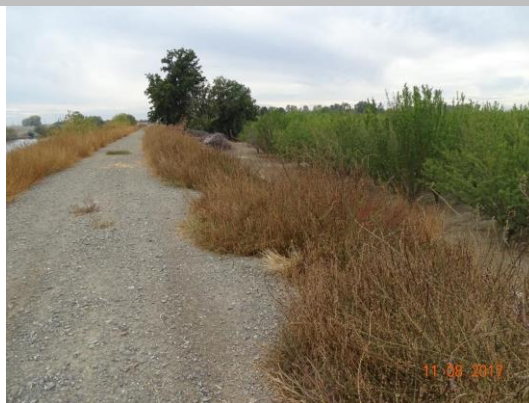
Photo 1 of 1 : FA_2017_RD0524_107_253_20171116_00482.jpg

LM Start	3.97	Rating **	U	Issue No.	253
LM End	4.02	Issue Type +	Ma	Location *	LS
Category	Earthen Levee			GPS Latitude/Longitude	
				Start	End
Item	Vegetation			37.899748 °	37.899116 °
				-121.326596 °	-121.326905 °
DWR ID	DWR_RD0524_01_f_2017_253				
Comment Code					
V2 : Remove the wild growth other than native grasses from the levee slopes.					
Inspector Comment

Looking southwest at the landside slope.

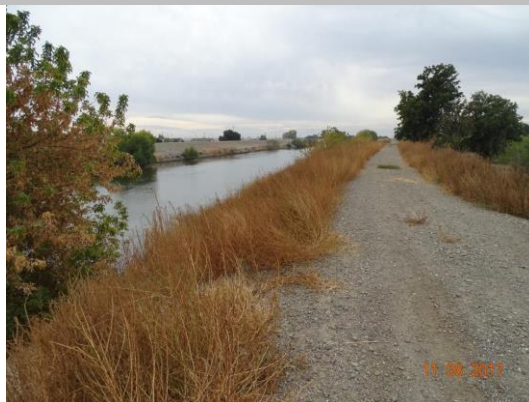
Photo 1 of 1 : FA_2017_RD0524_107_254_20171116_00483.jpg

LM Start	3.97	Rating **	U	Issue No.	254
LM End	4.03	Issue Type +	Ma	Location *	WS
Category	Earthen Levee			GPS Latitude/Longitude	
				Start	End
Item	Vegetation			37.899718 °	37.898945 °
				-121.326605 °	-121.327003 °
DWR ID	DWR_RD0524_01_f_2017_254				
Comment Code					
V2 : Remove the wild growth other than native grasses from the levee slopes.					
Inspector Comment

Looking southwest at the waterside slope.

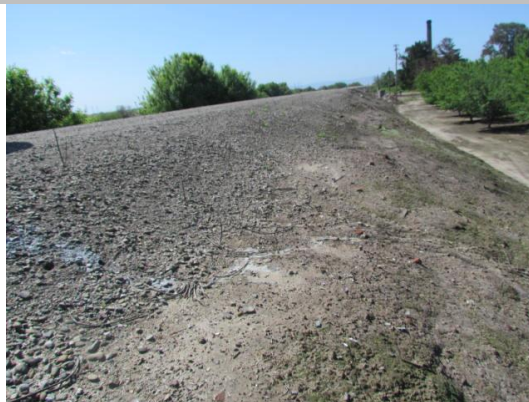
Photo 1 of 3 : FA_2017_RD0524_107_108_20170919_00159.jpg

LM Start	4.10	Rating **	U	Issue No.	108
LM End	4.15	Issue Type +	Ma	Location *	LS
Category	Earthen Levee			GPS Latitude/Longitude	
				Start	End
Item	Slope Stability			37.898035 °	°
				-121.327447 °	-121.327806 °
DWR ID	DWR_RD0524_01_s_2012_108				
Comment Code					
S1 : Repair slope instability.					
Inspector Comment					
Slope depression is greater than 1" and longer than 200'.

Looking north at caving slope on landside of levee.

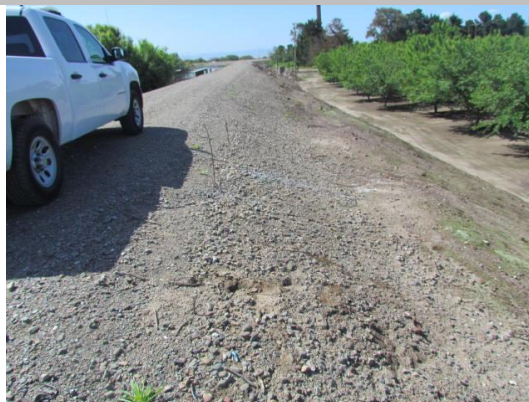
Photo 2 of 3 : FA_2017_RD0524_107_108_20170919_00160.jpg

Looking south at damage slope on landside of levee.

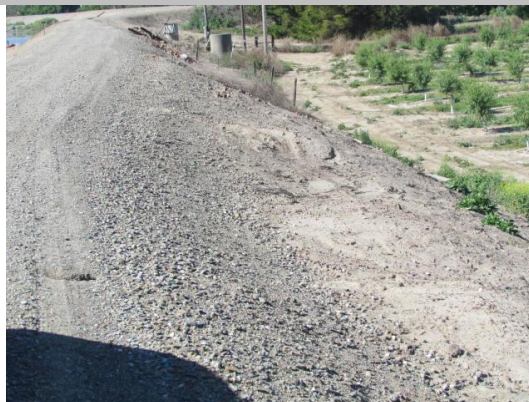
Photo 3 of 3 : FA_2017_RD0524_107_108_20170919_00161.jpg

Looking southwest at caving slope on landside of levee. (Spring 2014)

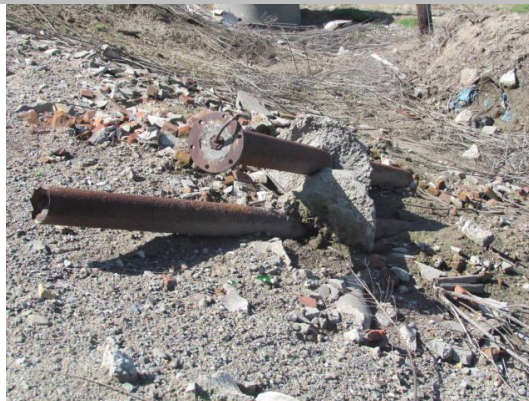
Photo 1 of 1 : FA_2017_RD0524_107_213_20170919_00256.jpg

LM Start	4.16	Rating **	M	Issue No.	213
LM End	4.16	Issue Type +	Ma	Location *	LS
Category	Earthen Levee			GPS Latitude/Longitude	
				Start	End
Item	Encroachments			37.897235 °	37.897235 °
				-121.327865 °	-121.327865 °
DWR ID	DWR_RD0524_01_s_2016_213				
Comment Code					
GA : Garbage					
Inspector Comment					
Old fence post and concrete and brick rubble on landside slope.

Looking west at old fence post and concrete rubble on landward slope.

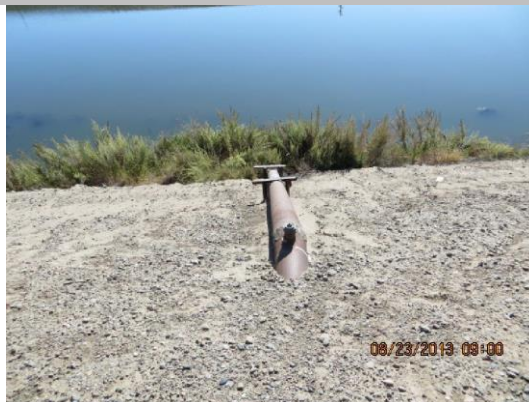
Photo 1 of 3 : UCIP_FA_2017_18320_30594.jpg

LM Start	4.37	Rating **	M	Issue No.	959	
LM End	4.37	Issue Type +	Ma	Location *		
Category	Supplemental			GPS Latitude/Longitude		
				Start	End	
Item	DWR UCIP LMA Responsibility			37.894453 °	37.894453 °	
				-121.329232 °	-121.329232 °	
DWR ID						
Comment Code						
Inspector Comment						
FS_ID:18320 DS_ID:20626 EP_NO: N/A Repair Type: Non-Urgent Crossing Status: Found UCIP Comments: Small leak in pipe on LS slope and pipe slightly crushed on LS toe. FIELD_STRUCT_DESC: 9-inch steel pipe of unknown purpose through the levee, 3 feet below the crown. Pump in drainage ditch on the landside (LS). Siphon breaker on the waterside (WS) slope. [Additional Reference(s): DWR Levee Log, 2004. USACE San Joaquin O&M Manual 7, April 1964, (HLM 4.42) 8-inch pipe listed]. FS Date: 8/23/2013

Pipe and siphon breaker on WS slope.

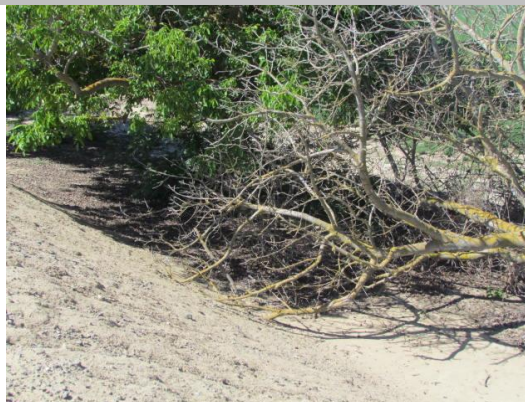
Photo 1 of 1 : FA_2017_RD0524_107_111_20170919_00163.jpg

LM Start	4.38	Rating **	M	Issue No.	111
LM End	4.38	Issue Type +	Ma	Location *	LS
Category	Earthen Levee			GPS Latitude/Longitude	
				Start	End
Item	Encroachments			37.894258 °	37.894258 °
				-121.329247 °	-121.329247 °
DWR ID	DWR_RD0524_01_s_2012_111				
Comment Code					
TR : Tree or limb					
Inspector Comment					
Dead tree at landside toe should be removed from levee toe.

Looking west at dead tree at landside toe.

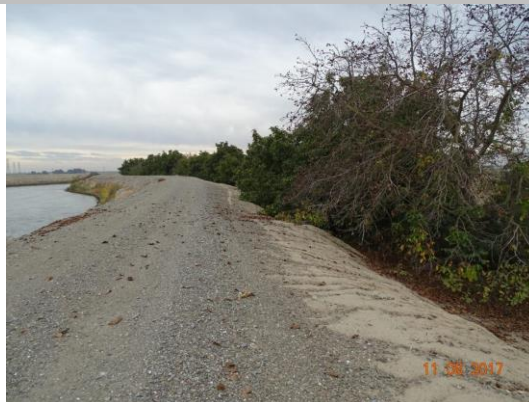
Photo 1 of 3 : FA_2017_RD0524_107_112_20171116_00484.jpg

LM Start	4.40	Rating **	U	Issue No.	112
LM End	4.52	Issue Type +	Ma	Location *	LS
Category	Earthen Levee			GPS Latitude/Longitude	
				Start	End
Item	Trim / Thin Trees			37.893933 °	37.892347 °
				-121.329181 °	-121.328192 °
DWR ID	DWR_RD0524_01_s_2012_112				
Comment Code					
T1 : Trim trees to at least five feet above ground level.					
Inspector Comment					
Untrimmed trees along landside slope and toe.

Looking southeast at the landside slope.

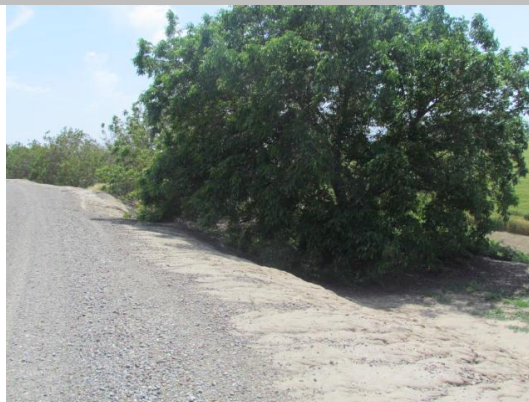
Photo 2 of 3 : FA_2017_RD0524_107_112_20170919_00164.jpg

Looking southeast at untrimmed tree at landward toe.

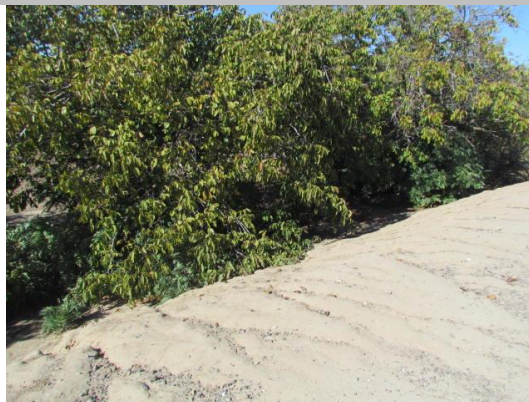
Photo 3 of 3 : FA_2017_RD0524_107_112_20170919_00165.jpg

Looking northeast at untrimmed tree on landward slope and toe fall 2015.

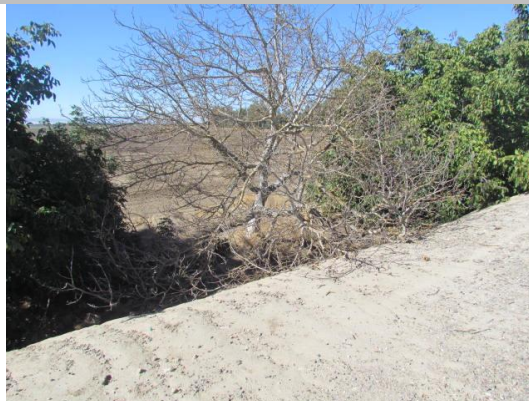
Photo 1 of 1 : FA_2017_RD0524_107_199_20170919_00239.jpg

LM Start	4.42	Rating **	U	Issue No.	199
LM End	4.42	Issue Type +	Ma	Location *	LS
Category	Earthen Levee			GPS Latitude/Longitude	
				Start	End
Item	Encroachments			37.893659 °	37.893659 °
				-121.329092 °	-121.329092 °
DWR ID	DWR_RD0524_01_f_2015_199				
Comment Code					
TR : Tree or limb					
Inspector Comment					
Remove dead tree from landside toe.

Looking west at dead tree on landward slope and toe fall 2015.

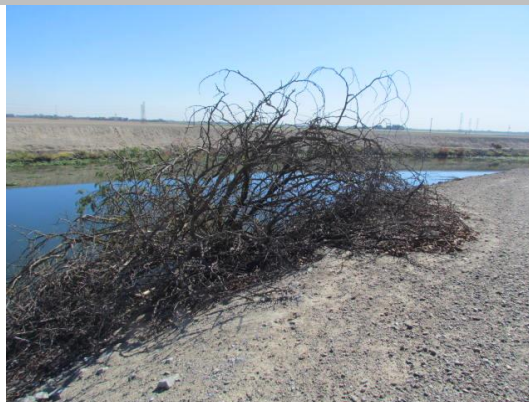
Photo 1 of 2 : FA_2017_RD0524_107_102_20170919_00155.jpg

LM Start	4.52	Rating **	U	Issue No.	102
LM End	4.52	Issue Type +	Ma	Location *	WS
Category	Earthen Levee			GPS Latitude/Longitude	
				Start	End
Item	Encroachments			37.892383 °	37.892383 °
				-121.328194 °	-121.328194 °
DWR ID	DWR_RD0524_01_f_2016_102				
Comment Code					
TR : Tree or limb					
Inspector Comment					
Dead tree on waterside slope.

Looking southeast at dead tree on waterside slope fall 2015

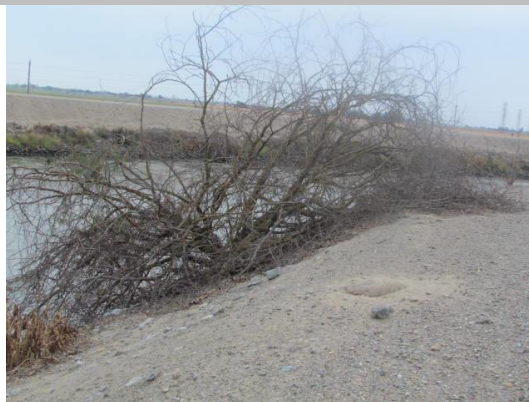
Photo 2 of 2 : FA_2017_RD0524_107_102_20170919_00156.jpg

Looking southeast at dead tree on waterside slope.

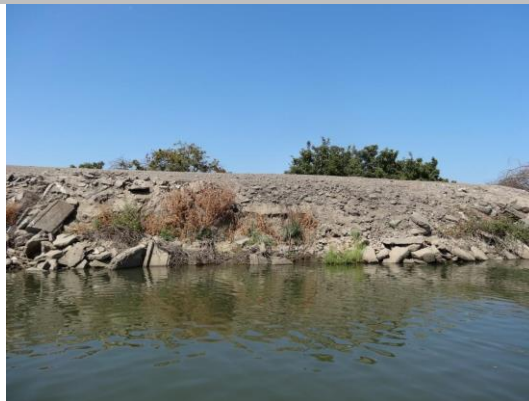
Photo 3 of 3 : SJR2017_RD0524U01RM45.07_3.jpg

LM Start	4.53	Rating **	A/W	Issue No.	90 (cont)	
LM End	4.54	Issue Type +	Ma	Location *	WS	
Category	Supplemental			GPS Latitude/Longitude		
				Start	End	
Item	DWR Erosion Survey			37.892230 °	37.892230 °	
				-121.327930 °	-121.327930 °	
DWR ID	RD0524U01RM45.07					
Comment Code						
Inspector Comment						
09/13/2017: No significant change observed.						
07/25/2016: No significant change observed.						
06/24/2015: No significant change observed.						
06/19/2014: No significant change observed.						
08/13/2013: No significant change observed.						
08/07/2012: The erosion is located at the inside of a river bend. Site is covered with broken concrete blocks and other debris. [2017 Site ID:RD0524U01RM45.07]

Front view of the site. Note the loosely placed concrete blocks at the site.

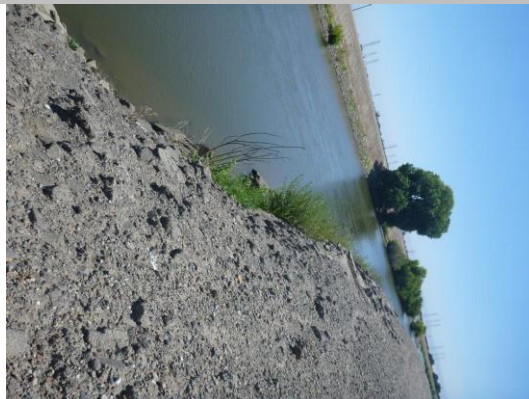
Photo 1 of 3 : LEVAL_FA_2017_468_2219.jpg

Comment Code					
Inspector Comment					
Levee Evaluation Comments					
Description:Slope protection repairs are needed along the waterside slope due to erosion. Based upon levee inspections, it was determined the waterside levee slopes were eroding, deteriorating and degrading in concave pocket sections at various locations along this levee reach. The eroded levee sections need to be restored back to design standards to prevent further deterioration of the damaged levee sections.					
Site ID No:468					
Site Designation:LMA-295					
Repair Type: Erosion					
Rating:Serious					
Field Date:7/26/2017					
Notes: Serious because erosion is impacting the levee, but there is some slope protection here. Slope is armored with asphalt and concrete rubble. The surrounding slopes are pretty baren, but there is a small bush within the site so it may be older.

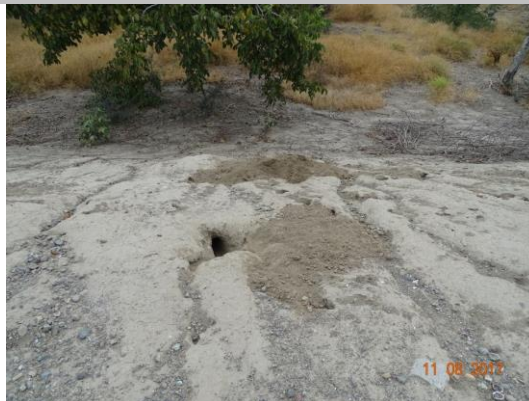
Photo 1 of 1 : FA_2017_RD0524_107_257_20171116_00486.jpg

LM Start	4.56	Rating **	M	Issue No.	257
LM End	4.56	Issue Type +	Ma	Location *	LS
Category	Earthen Levee			GPS Latitude/Longitude	
				Start	End
Item	Animal Control			37.891903 °	37.891903 °
				-121.328264 °	-121.328264 °
DWR ID	DWR_RD0524_01_f_2017_257				
Comment Code					
A3 : No rodents visible, but rodent burrows visible; need to backfill and compact or grout burrows.					
Inspector Comment

Looking west at the landside slope.

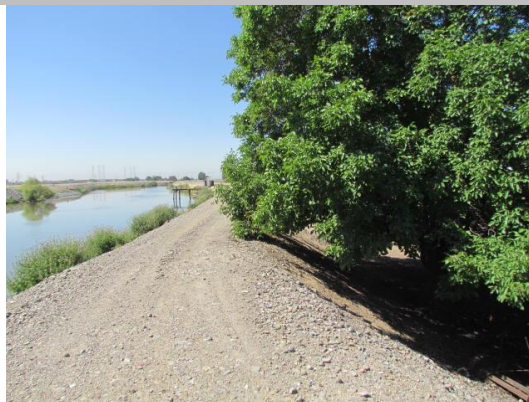
Photo 1 of 1 : FA_2017_RD0524_107_63_20170919_00105.jpg

LM Start	4.61	Rating **	U	Issue No.	63
LM End	4.61	Issue Type +	Ma	Location *	LS
Category	Earthen Levee			GPS Latitude/Longitude	
				Start	End
Item	Trim / Thin Trees			37.891285 °	37.891285 °
				-121.328728 °	-121.328728 °
DWR ID	DWR_RD0524_01_s_2012_63				
Comment Code					
T1 : Trim trees to at least five feet above ground level.					
Inspector Comment

Looking south at dense trees on landside slope.

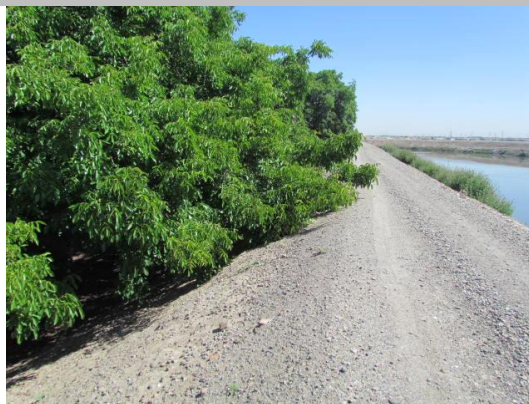
Photo 1 of 1 : FA_2017_RD0524_107_113_20170919_00166.jpg

LM Start	4.63	Rating **	M	Issue No.	113
LM End	4.63	Issue Type +	Ma	Location *	LS
Category	Earthen Levee			GPS Latitude/Longitude	
				Start	End
Item	Trim / Thin Trees			37.890973 °	37.890973 °
				-121.328970 °	-121.328970 °
DWR ID	DWR_RD0524_01_s_2012_113				
Comment Code					
T1 : Trim trees to at least five feet above ground level.					
Inspector Comment

Looking north at dense trees on landside slope.

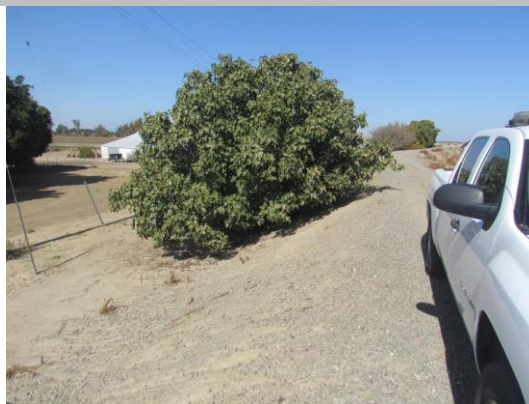
Photo 1 of 1 : FA_2017_RD0524_107_67_20170919_00107.jpg

LM Start	4.70	Rating **	U	Issue No.	67
LM End	4.70	Issue Type +	Ma	Location *	LS
Category	Earthen Levee			GPS Latitude/Longitude	
				Start	End
Item	Trim / Thin Trees			37.890108 °	37.890108 °
				-121.329523 °	-121.329523 °
DWR ID	DWR_RD0524_01_s_2012_67				
Comment Code					
T1 : Trim trees to at least five feet above ground level.					
Inspector Comment					
Fig tree at landside toe.

Looking northwest at untrimmed tree on landward slope.

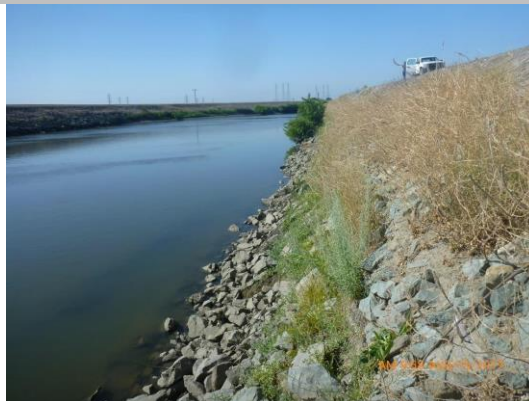
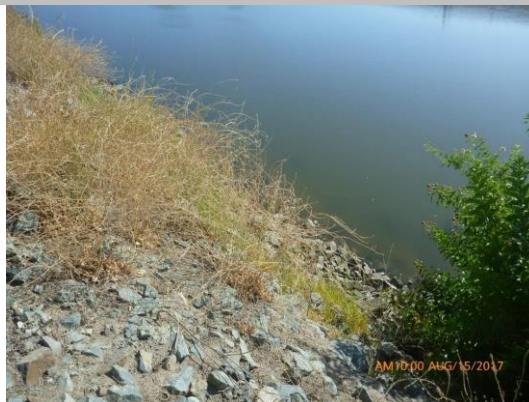
Photo 1 of 3 : LEVAL_FA_2017_523_4217.jpg

LM Start	4.76	Rating **	A/W	Issue No.	236
LM End	4.76	Issue Type +	Ma	Location *	
Category	Supplemental			GPS Latitude/Longitude	
				Start	End
Item	2017 Storm Damage			37.889300 °	37.889300 °
				-121.329800 °	-121.329800 °
DWR ID	DWR_RD0524_01_f_2017_236				
Comment Code					
Inspector Comment					
Levee Evaluation Comments					
Description:Slope protection repairs are needed along the waterside slope due to erosion and riprap displacement from high water. Based upon levee inspections, it was determined the waterside levee slope is eroding, deteriorating, and degrading. The eroded levee sections need to be restored back to design standards to prevent further deterioration and damage.					
Site ID No:523					
Site Designation:LMA-429					
Repair Type: Erosion					
Rating:Area of Concern					
Field Date:8/15/2017					
Notes:

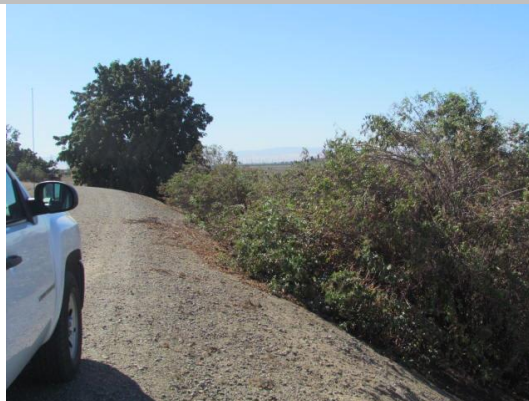
Photo 1 of 1 : FA_2017_RD0524_107_114_20170919_00167.jpg

LM Start	4.96	Rating **	U	Issue No.	114
LM End	4.98	Issue Type +	Ma	Location *	LS
Category	Earthen Levee			GPS Latitude/Longitude	
				Start	End
Item	Vegetation			37.886948 °	37.886672 °
				-121.331834 °	-121.331962 °
DWR ID	DWR_RD0524_01_s_2012_114				
Comment Code					
V4 : Elderberries are blocking visibility and flood fight capability.					
Inspector Comment					
Dense elderberry on landside slope.

Looking southwest at dense elderberry bush on landward slope and toe fall 2015.

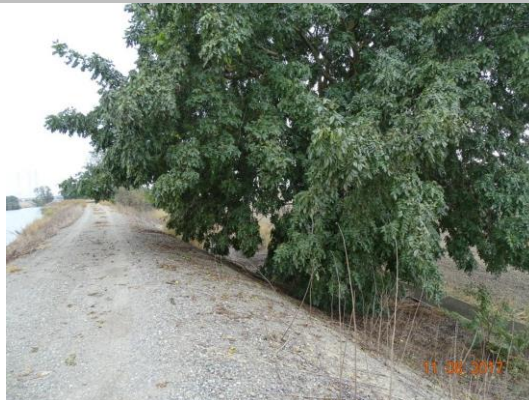
Photo 1 of 1 : FA_2017_RD0524_107_260_20171116_00487.jpg

LM Start	5.00	Rating **	M	Issue No.	260
LM End	5.00	Issue Type +	Ma	Location *	LS
Category	Earthen Levee			GPS Latitude/Longitude	
				Start	End
Item	Trim / Thin Trees			37.886367 °	37.886367 °
				-121.332047 °	-121.332047 °
DWR ID	DWR_RD0524_01_f_2017_260				
Comment Code					
T4 : Trim trees over roadway to at least 12 feet above ground level.					
Inspector Comment

Looking southwest at the landside slope.

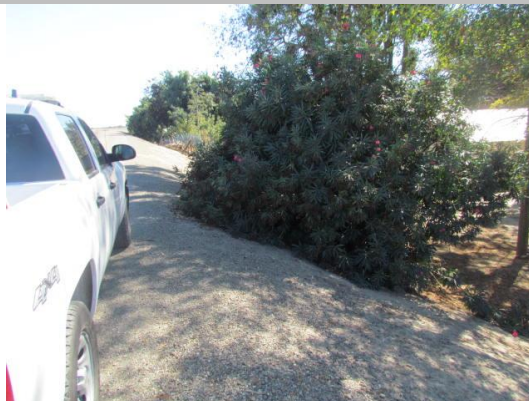
Photo 1 of 1 : FA_2017_RD0524_107_188_20170919_00230.jpg

LM Start	5.05	Rating **	U	Issue No.	188
LM End	5.07	Issue Type +	Ma	Location *	LS
Category	Earthen Levee			GPS Latitude/Longitude	
				Start	End
Item	Trim / Thin Trees			37.885673 °	37.885315 °
				-121.332122 °	-121.332139 °
DWR ID	DWR_RD0524_01_s_2014_188				
Comment Code					
T1 : Trim trees to at least five feet above ground level.					
Inspector Comment					
Untrimmed trees on landside slope and toe.

Looking south at oleander on landward slope.

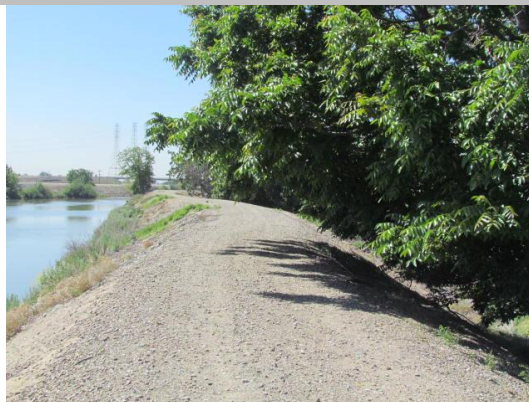
Photo 1 of 1 : FA_2017_RD0524_107_68_20170919_00108.jpg

LM Start	5.07	Rating **	U	Issue No.	68
LM End	5.07	Issue Type +	Ma	Location *	LS
Category	Earthen Levee			GPS Latitude/Longitude	
				Start	End
Item	Trim / Thin Trees			37.885400 °	37.885400 °
				-121.332153 °	-121.332153 °
DWR ID	DWR_RD0524_01_s_2012_68				
Comment Code					
T4 : Trim trees over roadway to at least 12 feet above ground level.					
Inspector Comment

Looking south at overhanging trees.

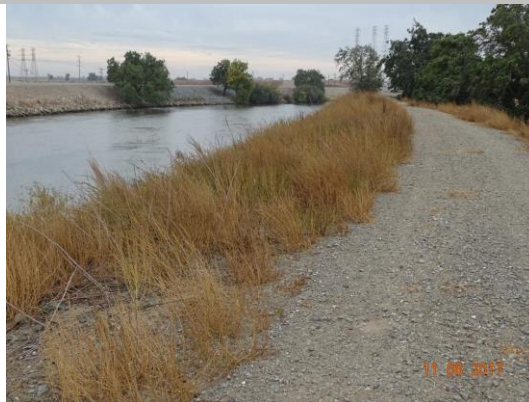
Photo 1 of 1 : FA_2017_RD0524_107_261_20171116_00488.jpg

LM Start	5.08	Rating **	U	Issue No.	261
LM End	5.13	Issue Type +	Ma	Location *	WS
Category	Earthen Levee			GPS Latitude/Longitude	
				Start	End
Item	Vegetation			37.885206 °	37.884465 °
				-121.332159 °	-121.332134 °
DWR ID	DWR_RD0524_01_f_2017_261				
Comment Code					
V2 : Remove the wild growth other than native grasses from the levee slopes.					
Inspector Comment

Looking south at the waterside slope.

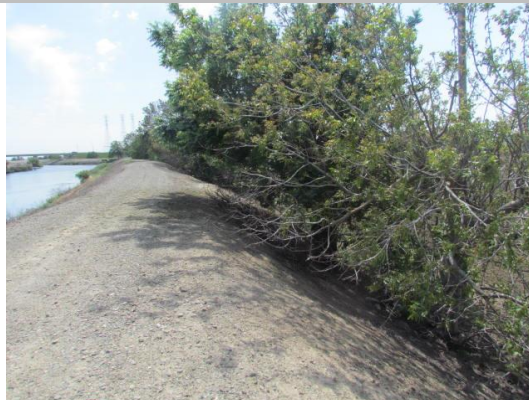
Photo 1 of 1 : FA_2017_RD0524_107_85_20170919_00135.jpg

LM Start	5.28	Rating **	U	Issue No.	85
LM End	5.34	Issue Type +	Ma	Location *	LS
Category	Earthen Levee			GPS Latitude/Longitude	
				Start	End
Item	Trim / Thin Trees			37.882363 °	37.881511 °
				-121.332577 °	-121.332777 °
DWR ID	DWR_RD0524_01_s_2012_85				
Comment Code					
T1 : Trim trees to at least five feet above ground level.					
Inspector Comment

Looking south at untrimmed trees on landward slope.

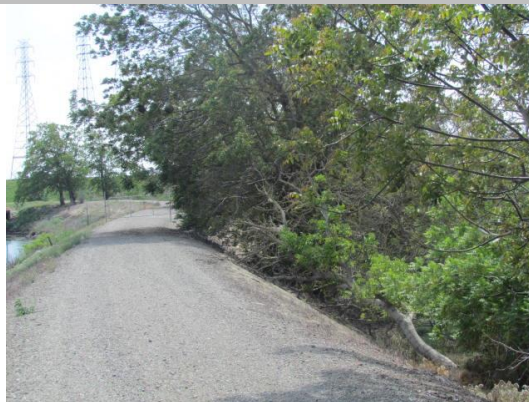
Photo 1 of 1 : FA_2017_RD0524_107_932_20170919_00293.jpg

LM Start	5.38	Rating **	U	Issue No.	932
LM End	5.41	Issue Type +	Ma	Location *	LS
Category	Earthen Levee			GPS Latitude/Longitude	
				Start	End
Item	Trim / Thin Trees			37.880945 °	37.880522 °
				-121.332837 °	-121.332918 °
DWR ID	DWR_RD0524_01_s_2012_932				
Comment Code					
T1 : Trim trees to at least five feet above ground level.					
Inspector Comment

Looking south at untrimmed trees on landward slope and toe.

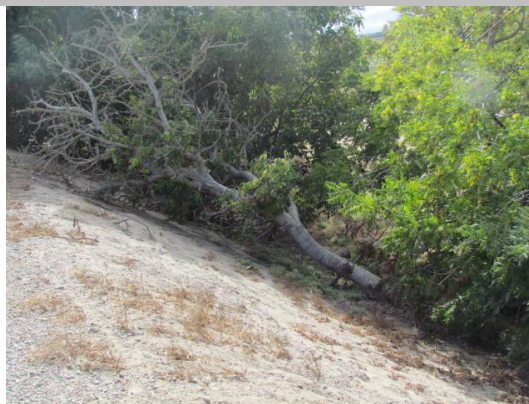
Photo 1 of 1 : FA_2017_RD0524_107_178_20170919_00216.jpg

LM Start	5.39	Rating **	M	Issue No.	178
LM End	5.39	Issue Type +	Ma	Location *	LS
Category	Earthen Levee			GPS Latitude/Longitude	
				Start	End
Item	Encroachments			37.880806 °	37.880806 °
				-121.332833 °	-121.332833 °
DWR ID	DWR_RD0524_01_f_2014_178				
Comment Code					
TR : Tree or limb					
Inspector Comment					
Downed tree on landside toe.

Looking south at downed tree on landward slope.

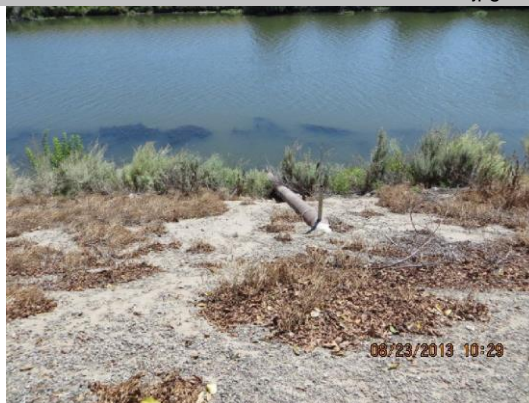
Photo 1 of 3 : UCIP_FA_2017_51633_30689.jpg

FS_ID:51633
DS_ID:20630
EP_NO: N/A
Repair Type: Urgent
Crossing Status: Found
UCIP Comments: 11/16/2016 same as previous inspection hole in pipe is still present on WS near toe. This pipe does not appear to be in use. Need to contact owner to determine status of crossing. If the crossing is abandoned or still in use, owner will need to coordinate with the CVFPB to comply with Title 23 requirements. (O. Magana - DWR UCIP)08/23/2013 flap gate damage and does not work at WS toe. Large hole in pipe at WS toe. Pipe appears abandoned and should be done so properly. (W. Wylie - DWR UCIP)
FIELD_STRUCT_DESC: *ABANDONED* 1 of 2: 12-inch steel irrigation pipe through the levee, 6 feet below the crown. Pump located on the waterside (WS), no pump found in 2013. Flap gate located on the WS end. [Additional Reference(s): DWR Levee Log, 2004. USACE San Joaquin O&M Manual 7, April 1964, (HLM 5.48) 10-inch pipe listed, Drawing No. 07-04-1490, Sheet 1490/4, (Station 8+01.3)].

Pipe visible on WS slope.

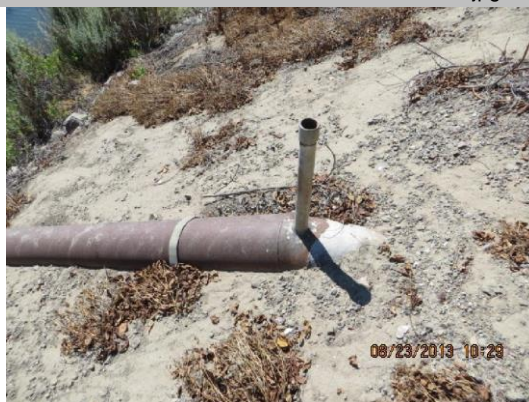
Photo 2 of 3 : UCIP_FA_2017_51633_30688.jpg

Vent on pipe on WS slope. Possible slurry standpipe that has not yet been used.

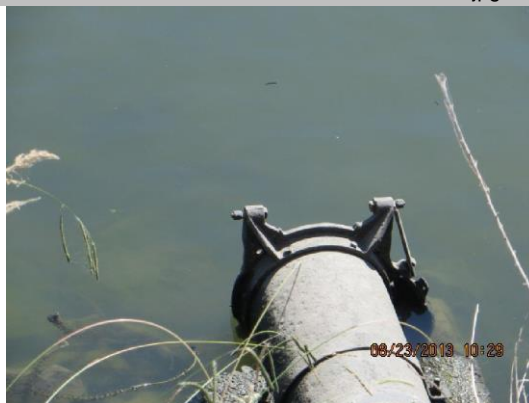
Photo 3 of 3 : UCIP_FA_2017_51633_30687.jpg

FS_ID:51633
DS_ID:20630
EP_NO: N/A
Repair Type: Urgent
Crossing Status: Found
UCIP Comments: 11/16/2016 same as previous inspection hole in pipe is still present on WS near toe. This pipe does not appear to be in use. Need to contact owner to determine status of crossing. If the crossing is abandoned or still in use, owner will need to coordinate with the CVFPB to comply with Title 23 requirements. (O. Magana - DWR UCIP)08/23/2013 flap gate damage and does not work at WS toe. Large hole in pipe at WS toe. Pipe appears abandoned and should be done so properly. (W. Wylie - DWR UCIP)
FIELD_STRUCT_DESC: *ABANDONED* 1 of 2: 12-inch steel irrigation pipe through the levee, 6 feet below the crown. Pump located on the waterside (WS), no pump found in 2013. Flap gate located on the WS end. [Additional Reference(s): DWR Levee Log, 2004. USACE San Joaquin O&M Manual 7, April 1964, (HLM 5.48) 10-inch pipe listed, Drawing No. 07-04-1490, Sheet 1490/4, (Station 8+01.3)].

Broken flap gate at WS toe.

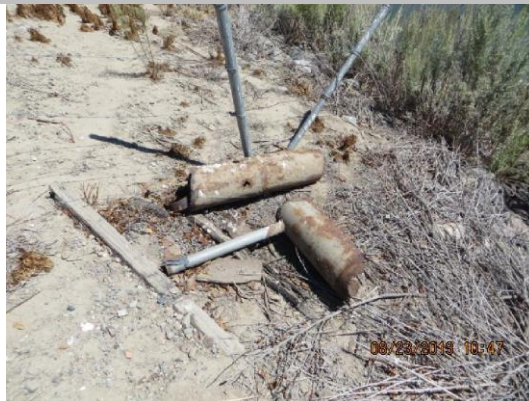
Photo 1 of 3 : UCIP_FA_2017_18348_30706.jpg

LM Start	5.42	Rating **	M	Issue No.	963
LM End	5.42	Issue Type +	Ma	Location *	
Category	Supplemental			GPS Latitude/Longitude	
				Start	End
Item	DWR UCIP LMA Responsibility			37.880358 °	37.880358 °
				-121.332972 °	-121.332972 °
DWR ID					
Comment Code					
Inspector Comment					
FS_ID:18348					
DS_ID:20631					
EP_NO: N/A					
Repair Type: Non-Urgent					
Crossing Status: Found					
UCIP Comments: Recent work being done on WS slope. Pipe may still be in use.					
FIELD_STRUCT_DESC: 10-inch steel drainage pipe through the levee, 6 feet below the crown. Pump not found on the landside (LS).					
[Additional Reference(s): DWR Levee Log, 2004. USACE San Joaquin O&M Manual 7, April 1964, (HLM 5.50)].					
FS Date: 8/23/2013

10-inch pipe debris on the WS slope.

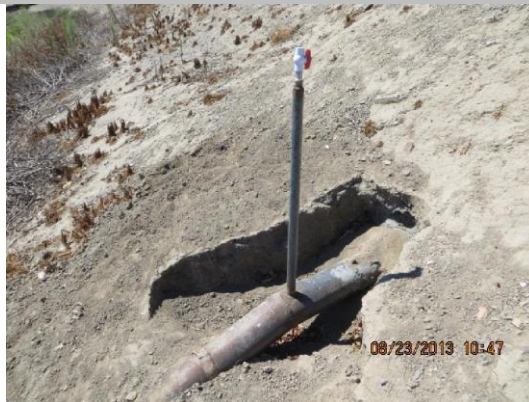
Photo 2 of 3 : UCIP_FA_2017_18348_30705.jpg

8-inch pipe sleeved through 10-inch pipe with vent on WS slope.

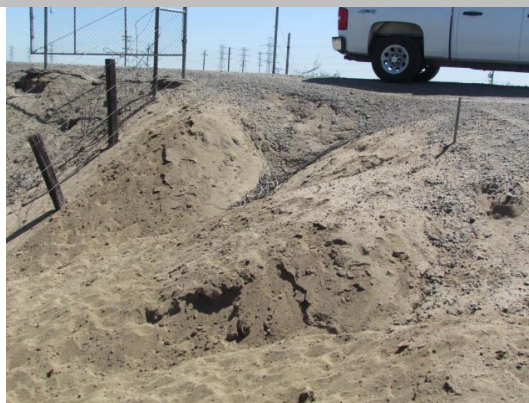
Photo 3 of 3 : FA_2017_RD0524_107_118_20170919_00172.jpg

LM Start	5.42	Rating **	M	Issue No.	118 (cont)	
LM End	5.42	Issue Type +	Ma	Location *	LS	
Category	Earthen Levee			GPS Latitude/Longitude		
				Start		End
Item	Slope Stability			37.880323 °		37.880323 °
				-121.332968 °		-121.332968 °
DWR ID	DWR_RD0524_01_s_2012_118					
Comment Code						
S1 : Repair slope instability.						
Inspector Comment						
Slope damage caused by human activity.

Looking east at slope caving on landside slope.

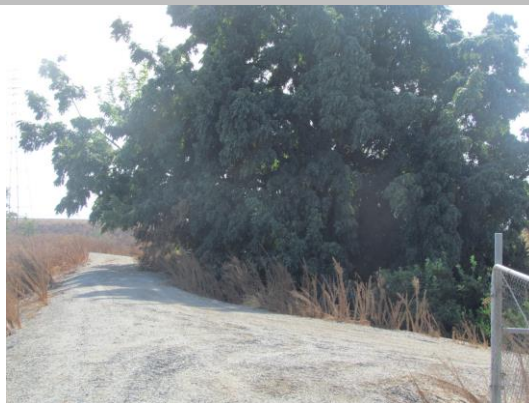
Photo 1 of 1 : FA_2017_RD0524_107_73_20170919_00114.jpg

LM Start	5.44	Rating **	U	Issue No.	73
LM End	5.44	Issue Type +	Ma	Location *	LS
Category	Earthen Levee			GPS Latitude/Longitude	
				Start	End
Item	Trim / Thin Trees			37.880085 °	37.880085 °
				-121.333045 °	-121.333045 °
DWR ID	DWR_RD0524_01_s_2012_73				
Comment Code					
T1 : Trim trees to at least five feet above ground level.					
Inspector Comment					
Untrimmed trees on landside slope.

Looking southwest at large untrimmed tree on landward slope.

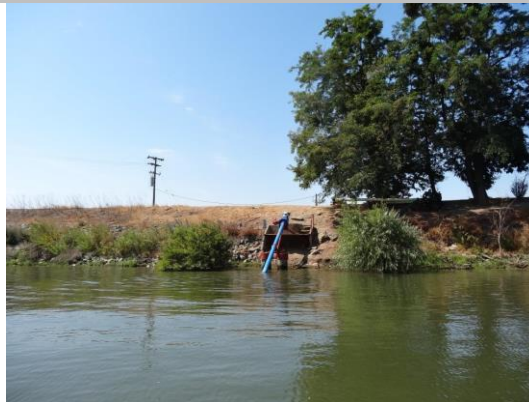
Photo 1 of 2 : SJR2017_RD0524U01RM46.06_1.jpg

LM Start	5.53	Rating **	M	Issue No.	92
LM End	5.53	Issue Type +	Ma	Location *	WS
Category	Supplemental			GPS Latitude/Longitude	
				Start	End
Item	DWR Erosion Survey			37.878920 °	37.878920 °
				-121.332670 °	-121.332670 °
DWR ID	RD0524U01RM46.06				
Comment Code					
Inspector Comment					
09/13/2017: No significant change observed.					
07/25/2016: No significant change observed.					
06/24/2015: No significant change observed.					
06/19/2014: No significant change observed.					
08/13/2013: Larger trees are at the levee shoulder, and an irrigation pump station is next to the erosion site. [2017 Site ID:RD0524U01RM46.06]

Front view of the erosion.

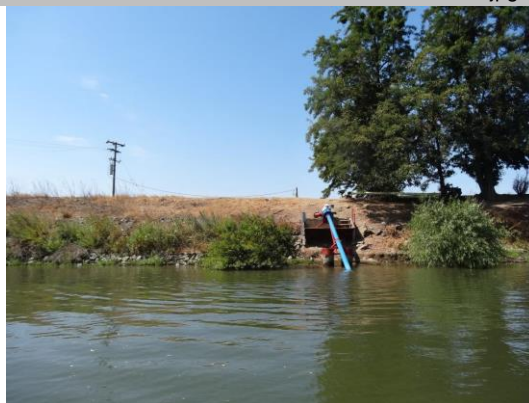
Photo 2 of 2 : SJR2017_RD0524U01RM46.06_2.jpg

LM Start	5.53	Rating **	M	Issue No.	92 (cont)	
LM End	5.53	Issue Type +	Ma	Location *	WS	
Category	Supplemental			GPS Latitude/Longitude		
				Start	End	
Item	DWR Erosion Survey			37.878920 °	37.878920 °	
				-121.332670 °	-121.332670 °	
DWR ID	RD0524U01RM46.06					
Comment Code						
Inspector Comment						
09/13/2017: No significant change observed.						
07/25/2016: No significant change observed.						
06/24/2015: No significant change observed.						
06/19/2014: No significant change observed.						
08/13/2013: Larger trees are at the levee shoulder, and an irrigation pump station is next to the erosion site. [2017 Site ID:RD0524U01RM46.06]

Close view of the site.

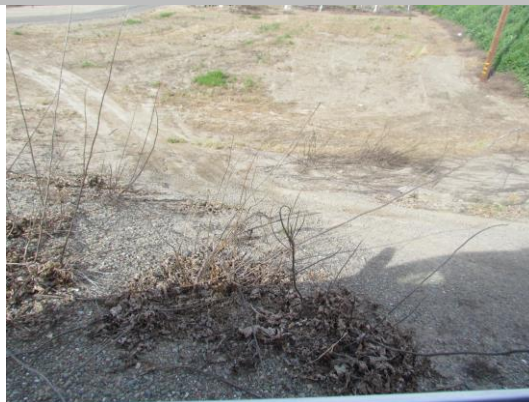
Photo 1 of 1 : FA_2017_RD0524_107_168_20170919_00199.jpg

LM Start	5.63	Rating **	M	Issue No.	168
LM End	5.63	Issue Type +	Ma	Location *	LS
Category	Earthen Levee			GPS Latitude/Longitude	
				Start	End
Item	Slope Stability			37.877527 °	37.877527 °
				-121.332385 °	-121.332385 °
DWR ID	DWR_RD0524_01_s_2017_168				
Comment Code					
S3 : Repair the levee slope damaged by vehicle traffic and prevent access where possible.					
Inspector Comment					
Slope damage on landside slope.

Looking northwest at slope damage caused by vehicle traffic on landward slope.

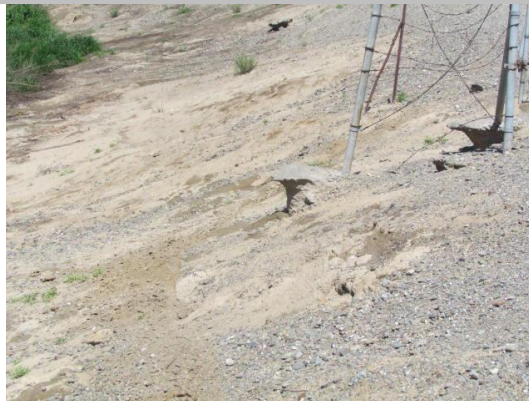
Photo 1 of 3 : FA_2017_RD0524_107_215_20170919_00259.jpg

LM Start	5.64	Rating **	U	Issue No.	215
LM End	5.64	Issue Type +	Ma	Location *	LS
Category	Earthen Levee			GPS Latitude/Longitude	
				Start	End
Item	Slope Stability			37.877378 °	37.877378 °
				-121.332343 °	-121.332343 °
DWR ID	DWR_RD0524_01_s_2016_215				
Comment Code					
S1 : Repair slope instability.					
Inspector Comment					
Levee slope damage is due vehicle traffic and foot traffic. Vehicle traffic created a ramp on landside slope.

Looking north at damage slope on landward slope.

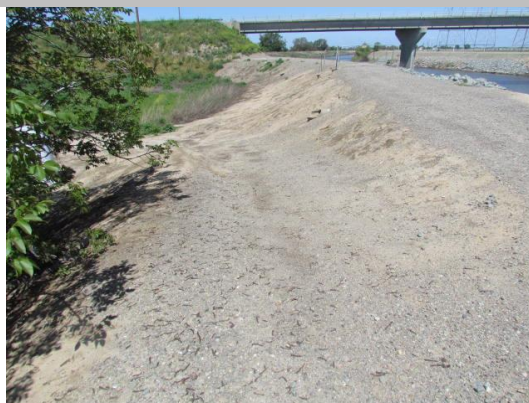
Photo 2 of 3 : FA_2017_RD0524_107_215_20170919_00260.jpg

Looking north at slope damage (ramp) on landward slope.

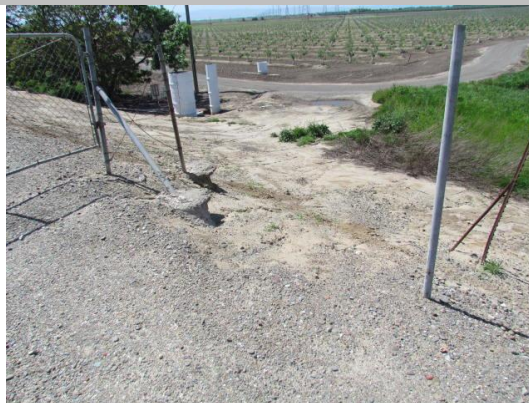
Photo 3 of 3 : FA_2017_RD0524_107_215_20170919_00261.jpg

Looking west at damage slope on landward slope.

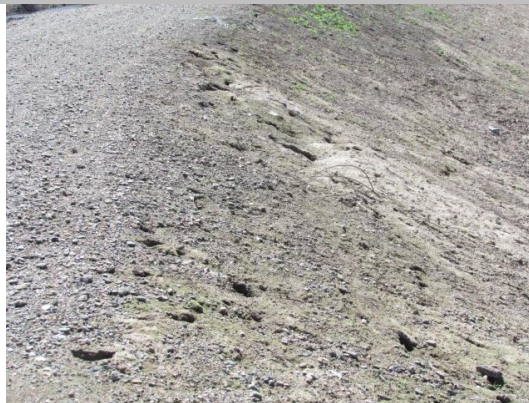
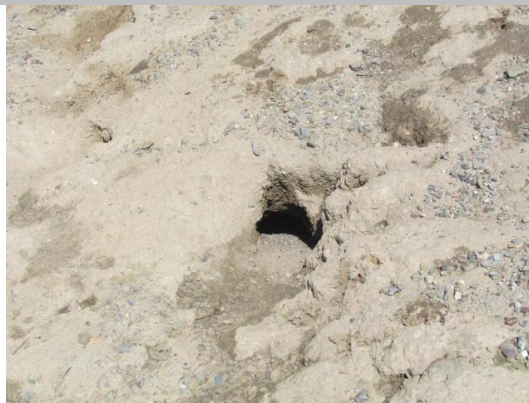
LM Start	5.64	Rating **	M	Issue No.	69
LM End	5.80	Issue Type +	Ma	Location *	LS
Category	Earthen Levee			GPS Latitude/Longitude	
				Start	End
Item	Animal Control			37.877298 °	37.875073 °
				-121.332343 °	-121.333168 °
DWR ID	DWR_RD0524_01_s_2012_69				
Comment Code					
A3 : No rodents visible, but rodent burrows visible; need to backfill and compact or grout burrows.					
Inspector Comment					
District has grouted rodent holes, but rodents are still present.

Looking south at rodent holes on landward slope.

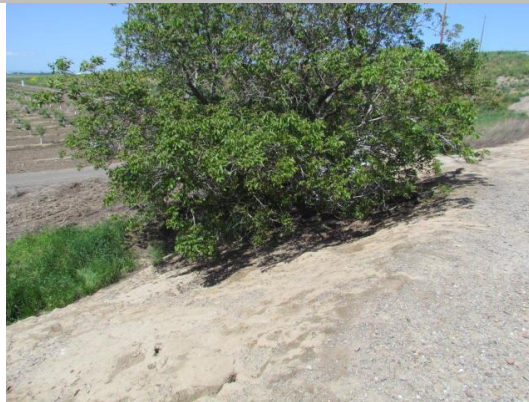
Photo 1 of 1 : FA_2017_RD0524_107_117_20170919_00169.jpg

LM Start	5.64	Rating **	U	Issue No.	117
LM End	5.64	Issue Type +	Ma	Location *	LS
Category	Earthen Levee			GPS Latitude/Longitude	
				Start	End
Item	Trim / Thin Trees			37.877272 °	37.877272 °
				-121.332400 °	-121.332400 °
DWR ID	DWR_RD0524_01_f_2013_117				
Comment Code					
T1 : Trim trees to at least five feet above ground level.					
Inspector Comment

Looking northwest at untrimmed tree on landward slope.

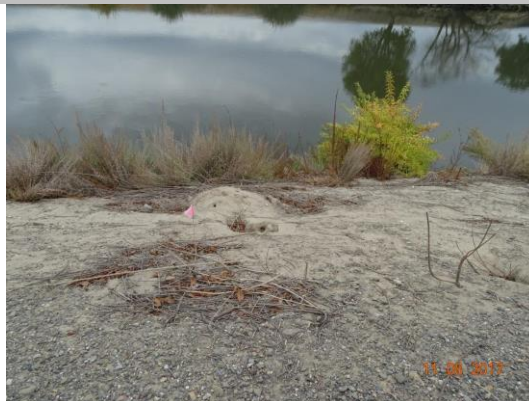
Photo 1 of 1 : FA_2017_RD0524_107_271_20171116_00492.jpg

LM Start	5.76	Rating **	U	Issue No.	271
LM End	5.76	Issue Type +	Ma	Location *	WS
Category	Earthen Levee			GPS Latitude/Longitude	
				Start	End
Item	Animal Control			37.875631 °	37.875631 °
				-121.332907 °	-121.332907 °
DWR ID	DWR_RD0524_01_f_2017_271				
Comment Code					
A3 : No rodents visible, but rodent burrows visible; need to backfill and compact or grout burrows.					
Inspector Comment

Looking east at the waterside slope.

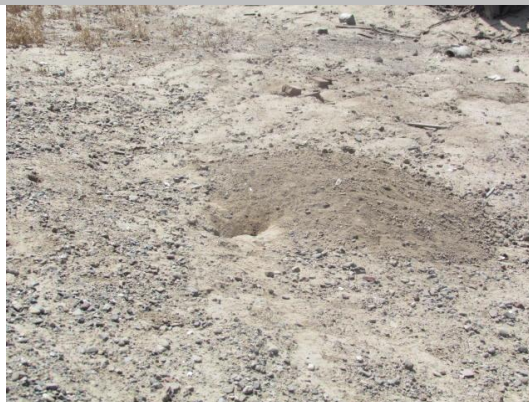
Photo 1 of 2 : FA_2017_RD0524_107_197_20170919_00237.jpg

LM Start	5.77	Rating **	M	Issue No.	197
LM End	5.79	Issue Type +	Ma	Location *	LS
Category	Earthen Levee			GPS Latitude/Longitude	
				Start	End
Item	Animal Control			37.875545 °	37.875310 °
				-121.332952 °	-121.333065 °
DWR ID	DWR_RD0524_01_s_2015_197				
Comment Code					
A1 : Exterminate rodents and backfill and compact or grout burrows.					
Inspector Comment					
Several rodent holes on landside slope and levee crown.

Looking north at typical view of rodent holes on landward slope.

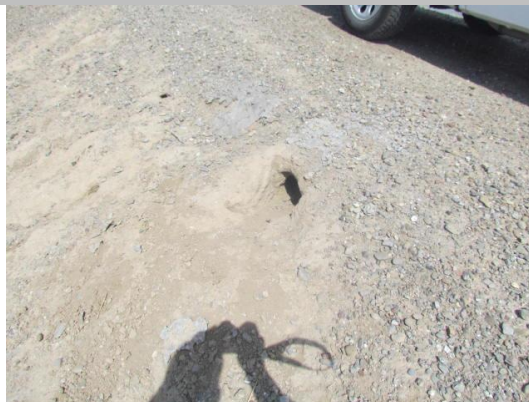
Photo 2 of 2 : FA_2017_RD0524_107_197_20170919_00238.jpg

Looking southwest at typical view of rodent hole at landward shoulder.

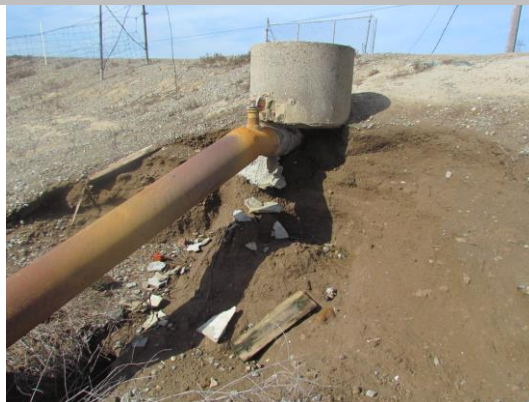
Photo 1 of 3 : FA_2017_RD0524_107_183_20170919_00226.jpg

LM Start	5.81	Rating **	U	Issue No.	183	
LM End	5.81	Issue Type +	Ma	Location *	WS	
Category	Earthen Levee			GPS Latitude/Longitude		
				Start	End	
Item	Erosion / Bank Caving			37.874973 °	37.874973 °	
				-121.333227 °	-121.333227 °	
DWR ID	DWR_RD0524_01_s_2017_183					
Comment Code						
E2 : Schedule repair of erosion site prior to the next inspection.						
Inspector Comment						
Bank caving on waterside around pipe structure.

Looking west at erosion around pipe and on waterward slope.

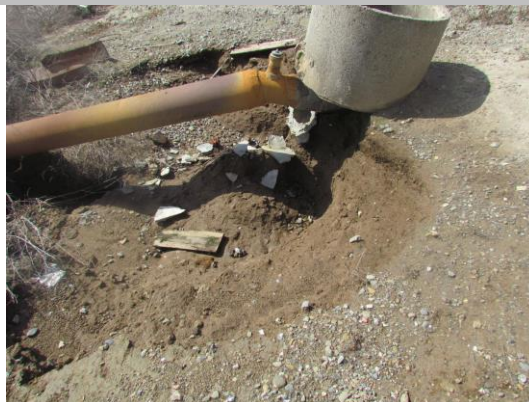
Photo 2 of 3 : FA_2017_RD0524_107_183_20170919_00227.jpg

Looking south at erosion around pipe and on waterward slope.

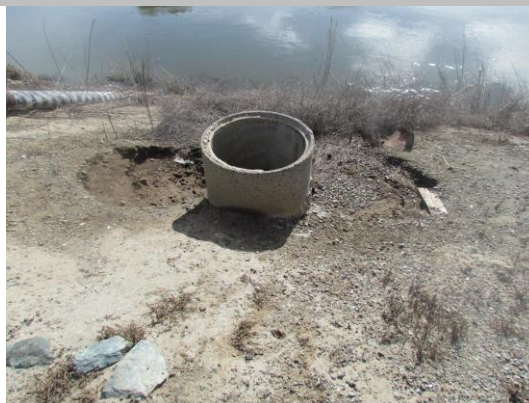
Photo 3 of 3 : FA_2017_RD0524_107_183_20170919_00228.jpg

LM Start	5.81	Rating **	U	Issue No.	183 (cont)	
LM End	5.81	Issue Type +	Ma	Location *	WS	
Category	Earthen Levee			GPS Latitude/Longitude		
				Start		End
Item	Erosion / Bank Caving			37.874973 °		37.874973 °
				-121.333227 °		-121.333227 °
DWR ID	DWR_RD0524_01_s_2017_183					
Comment Code						
E2 : Schedule repair of erosion site prior to the next inspection.						
Inspector Comment						
Bank caving on waterside around pipe structure.

Looking east at erosion on waterward slope.

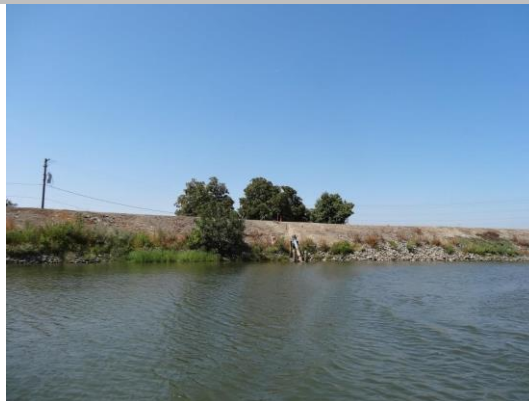
Photo 2 of 2 : SJR2017_RD0524U01RM46.39_2.jpg

LM Start	5.86	Rating **	U	Issue No.	93 (cont)
LM End	5.86	Issue Type +	Ma	Location *	WS
Category	Supplemental			GPS Latitude/Longitude	
				Start	End
Item	DWR Erosion Survey			37.874370 °	37.874370 °
				-121.332850 °	-121.332850 °
DWR ID	RD0524U01RM46.39				
Comment Code					
Inspector Comment					
09/13/2017: No significant change observed.					
07/25/2016: No significant change observed.					
06/24/2015: No significant change observed.					
06/19/2014: No significant change observed.					
08/13/2013: No significant change observed.					
08/07/2012: The erosion is near a water-intake structure. Pipe leakage likely caused the erosion. [2017 Site ID:RD0524U01RM46.39]

View of the erosion.

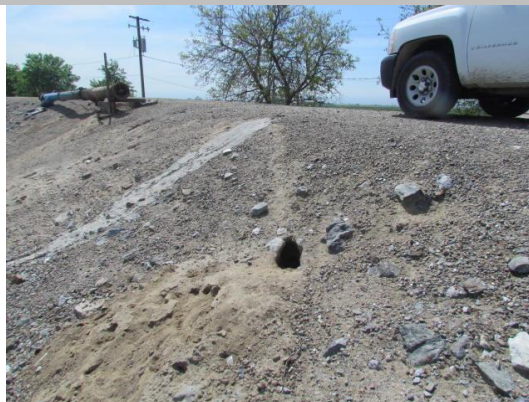
Photo 1 of 2 : FA_2017_RD0524_107_75_20170919_00118.jpg

LM Start	5.86	Rating **	M	Issue No.	75
LM End	5.88	Issue Type +	Ma	Location *	WS
Category	Earthen Levee			GPS Latitude/Longitude	
				Start	End
Item	Animal Control			37.874240 °	37.874002 °
				-121.333187 °	-121.333027 °
DWR ID	DWR_RD0524_01_s_2012_75				
Comment Code					
A1 : Exterminate rodents and backfill and compact or grout burrows.					
Inspector Comment					
District has grouted rodent holes, but other rodent holes have appeared. Active rodents in area.

Looking southwest at typical rodent holes on waterward slope.

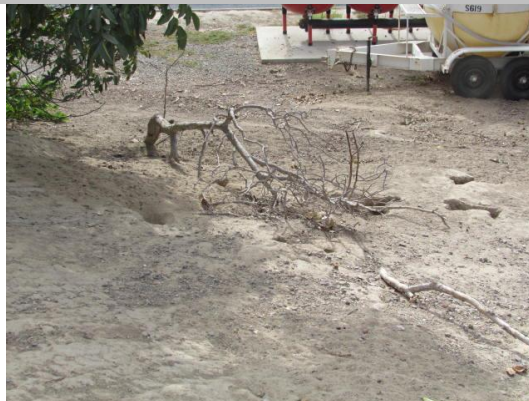
Photo 2 of 2 : FA_2017_RD0524_107_75_20170919_00119.jpg

Looking typical view of several rodent holes on landward slope and toe.

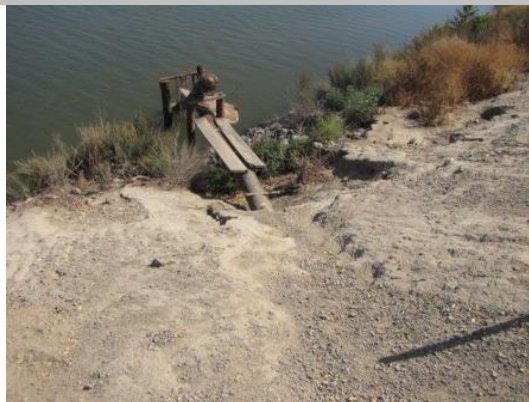
Photo 1 of 3 : FA_2017_RD0524_107_74_20170919_00115.jpg

LM Start	5.87	Rating **	U	Issue No.	74
LM End	5.87	Issue Type +	Ma	Location *	WS
Category	Earthen Levee			GPS Latitude/Longitude	
				Start	End
Item	Erosion / Bank Caving			37.874202 °	37.874086 °
				-121.333197 °	-121.333153 °
DWR ID	DWR_RD0524_01_s_2012_74				
Comment Code					
E1 : Note and monitor erosion site.					
Inspector Comment					
Erosion on landside slope around intake pipe.

Looking southeast at erosion around pipe.

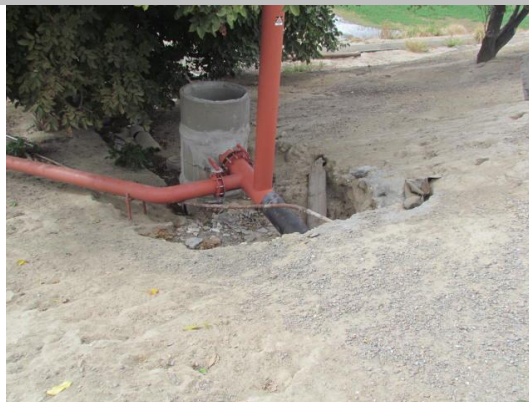
Photo 2 of 3 : FA_2017_RD0524_107_74_20170919_00116.jpg

Looking west at erosion around intake pipe on landward slope.

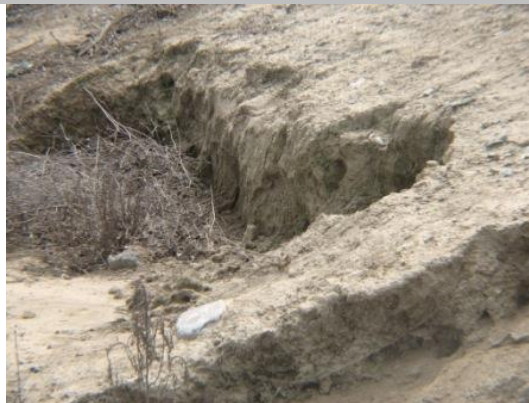
Photo 3 of 3 : FA_2017_RD0524_107_74_20170919_00117.jpg

Erosion at waterward toe and around irrigation pipe at LM 5.92

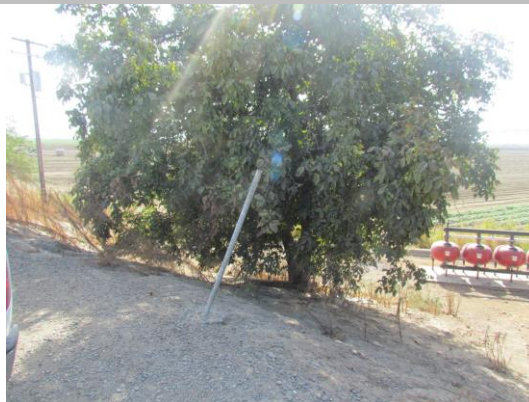
Photo 1 of 1 : FA_2017_RD0524_107_98_20171120_00493.jpg

LM Start	5.87	Rating **	M	Issue No.	98
LM End	5.87	Issue Type +	Ma	Location *	LS
Category	Earthen Levee			GPS Latitude/Longitude	
				Start	End
Item	Trim / Thin Trees			37.874085 °	37.874085 °
				-121.333154 °	-121.333154 °
DWR ID	DWR_RD0524_01_s_2012_98				
Comment Code					
T1 : Trim trees to at least five feet above ground level.					
Inspector Comment					
Untrimmed walnut tree on landside slope.

Looking west at walnut tree on landward slope.

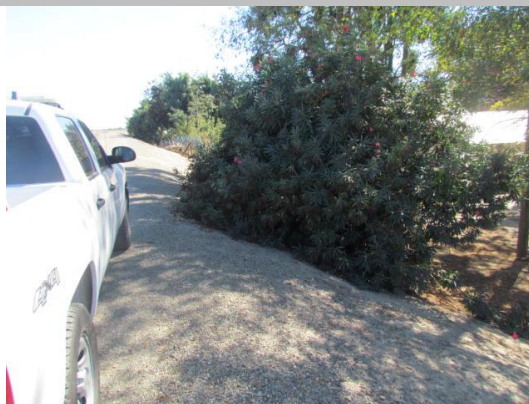
Photo 1 of 1 : FA_2017_RD0524_107_200_20170919_00240.jpg

LM Start	5.92	Rating **	U	Issue No.	200
LM End	5.92	Issue Type +	Ma	Location *	LS
Category	Earthen Levee			GPS Latitude/Longitude	
				Start	End
Item	Vegetation			37.873623 °	37.873623 °
				-121.332585 °	-121.332585 °
DWR ID	DWR_RD0524_01_f_2015_200				
Comment Code					
V2 : Remove the wild growth other than native grasses from the levee slopes.					
Inspector Comment					
Oleander bush on landside slope.

Looking south at oleander on landward slope fall 2015.

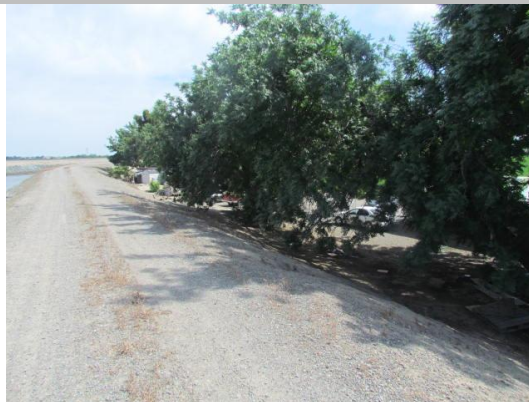
Photo 1 of 1 : FA_2017_RD0524_107_120_20170919_00175.jpg

LM Start	5.96	Rating **	U	Issue No.	120
LM End	5.96	Issue Type +	Ma	Location *	LS
Category	Earthen Levee			GPS Latitude/Longitude	
				Start	End
Item	Trim / Thin Trees			37.873347 °	37.873347 °
				-121.332028 °	-121.332028 °
DWR ID	DWR_RD0524_01_s_2012_120				
Comment Code					
T1 : Trim trees to at least five feet above ground level.					
Inspector Comment

Looking south at untrimmed trees on landward slope and toe.

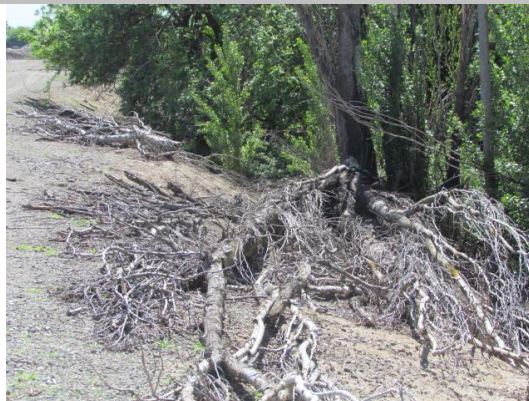
Photo 1 of 4 : FA_2017_RD0524_107_81_20170919_00127.jpg

LM Start	6.15	Rating **	M	Issue No.	81
LM End	6.15	Issue Type +	Ma	Location *	LS
Category	Earthen Levee			GPS Latitude/Longitude	
				Start	End
Item	Encroachments			37.871097 °	37.871097 °
				-121.330100 °	-121.330100 °
DWR ID	DWR_RD0524_01_s_2015_81				
Comment Code					
TR : Tree or limb					
Inspector Comment					
Fallen tree branches and limbs on landside slope.

Looking west at tree branches and limbs left on landward shoulder and slope. (Spring 2016)

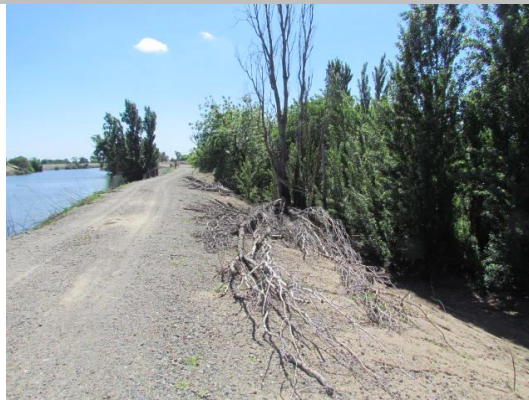
Photo 2 of 4 : FA_2017_RD0524_107_81_20170919_00128.jpg

Looking south at tree branches and limbs left on landward shoulder and slope. (Spring 2016)

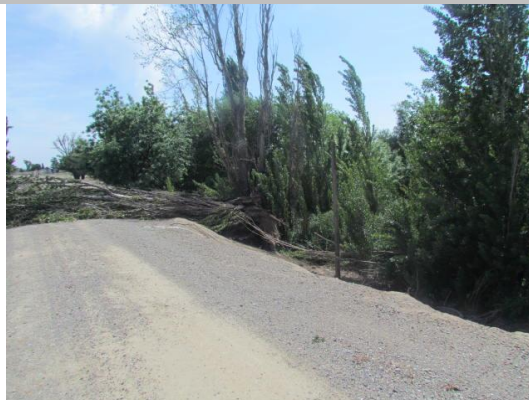
Photo 3 of 4 : FA_2017_RD0524_107_81_20170919_00129.jpg

Looking southwest at large tree across levee crown. (Fall 2015)

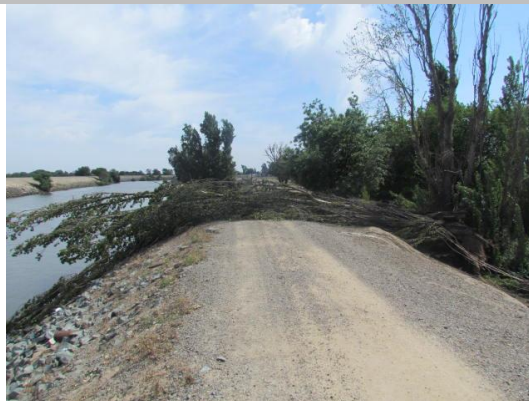
Photo 4 of 4 : FA_2017_RD0524_107_81_20170919_00130.jpg

Looking south at large tree across levee crown. (Fall 2015)
