**Flood Control Project Maintenance
Levee Inspections**

Maintenance Issue Types Only, Levee Inspection Report By Mile - Fall 2018

Reclamation District No. 0524 Middle Roberts Island

Waterway	Bank	Unit Miles	Inspection Start/End	Inspector
Unit No. 01 San Joaquin River	Left	6.20	09/11/2018 09/11/2018	Richard Willoughby

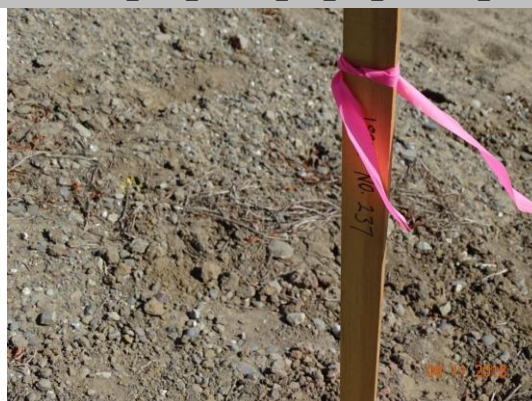
Photo 2 of 4 : FA_2018_RD0524_107_237_20180919_00466.jpg

Looking at site staking on waterward shoulder.(Fall 2018)

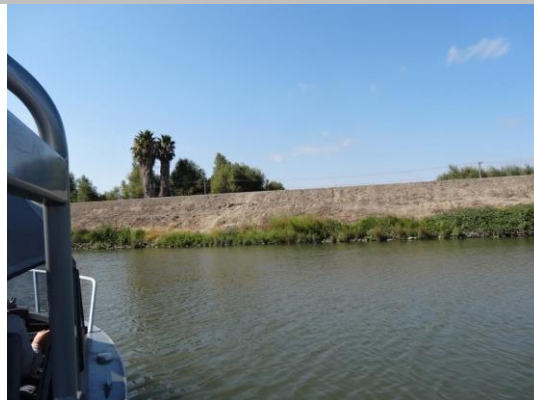
Photo 2 of 3 : FA_2018_RD0524_107_1_20180906_00002.jpg

LM Start	0.19	Rating **	U	Issue No.	1 (cont)	
LM End	0.19	Issue Type +	Ma	Location *	WS	
Category	Supplemental			GPS Latitude/Longitude		
				Start		End
Item	DWR Erosion Survey			37.939085 °		37.939085 °
				-121.343917 °		-121.343917 °
DWR ID	RD0524U01RM40.85					
Comment Code						
Inspector Comment						
09/13/2017: No significant change observed.						
07/25/2016: No significant change observed.						
06/24/2015: No significant change observed.						
06/19/2014: No significant change observed.						
08/13/2013: The erosion was discovered during 2013 spring levee inspection. Inspector comment: Erosion is located along the lower level of water-ward slope. [2017 Site ID:RD0524U01RM40.85]

Front view of the erosion.

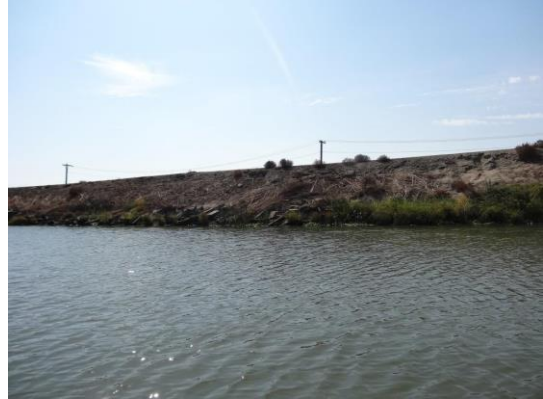
Photo 3 of 4 : FA_2018_RD0524_107_2_20180906_00006.jpg

LM Start	0.34	Rating **	M	Issue No.	2 (cont)	
LM End	0.34	Issue Type +	Ma	Location *	WS	
Category	Supplemental			GPS Latitude/Longitude		
				Start		End
Item	DWR Erosion Survey			37.938461°		37.938461°
				-121.341526°		-121.341526°
DWR ID	RD0524U01RM40.93					
Comment Code						
Inspector Comment						
09/13/2017: There are two pocket erosions at the site; both erosions are around 10 ft long and 6 ft high. [2017 Site ID:RD0524U01RM40.93]

Close view of the erosion site.

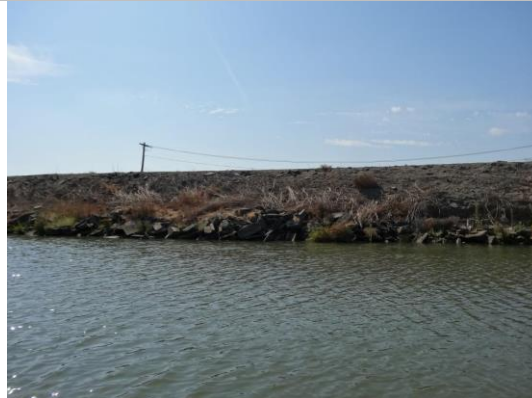
Photo 4 of 4 : FA_2018_RD0524_107_5_20180906_00014.jpg

Close view of the erosion.

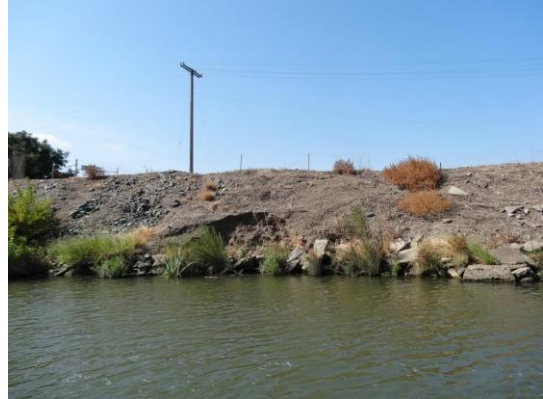
Photo 1 of 4 : FA_2018_RD0524_107_16_20180906_00026.jpg

LM Start	0.70	Rating **	M	Issue No.	16
LM End	0.70	Issue Type +	Ma	Location *	WS
Category	Supplemental			GPS Latitude/Longitude	
				Start	End
Item	DWR Erosion Survey			37.937577 °	37.937577 °
				-121.335491 °	-121.335491 °
DWR ID	RD0524U01RM41.34				
Comment Code					
Inspector Comment					
09/13/2017: Pocket erosion above the protected levee toe. [2017 Site ID:RD0524U01RM41.34]

Front view of the erosion.

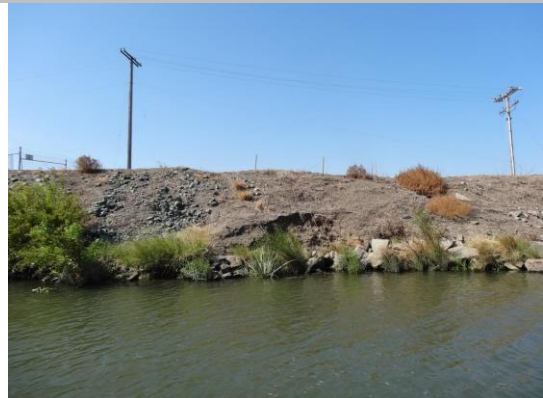
Photo 2 of 4 : FA_2018_RD0524_107_16_20180906_00027.jpg

Close view of the erosion.

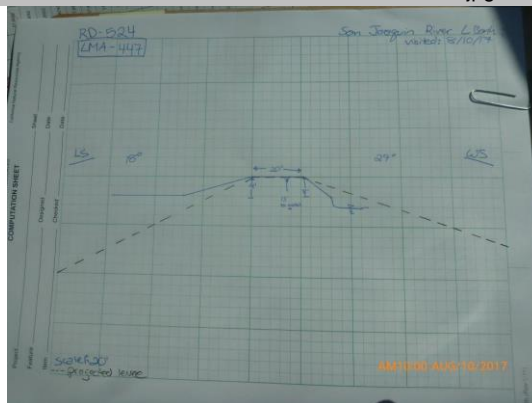
Photo 3 of 3 : LEVAL_FA_2018_541_4083.jpg

LM Start	0.70	Rating **	A/W	Issue No.	153 (cont)							
LM End	0.70	Issue Type +	Ma	Location *								
Category	Supplemental		GPS Latitude/Longitude									
			Start	End								
Item	2017 Storm Damage		37.937500°	37.937500°								
			-121.335500°	-121.335500°								
DWR ID	DWR_RD0524_01_f_2017_153											
Comment Code												
Inspector Comment												
Levee Evaluation Comments Description: Slope protection repairs are needed along the waterside slope due to erosion and riprap displacement from high water. Based upon levee inspections, it was determined the waterside levee slope is eroding, deteriorating, and degrading. The eroded levee sections need to be restored back to design standards to prevent further deterioration and damage. Site ID No: 541 Site Designation: LMA-447 Repair Type: Erosion Rating: Area of Concern Field Date: 8/10/2017 Notes:

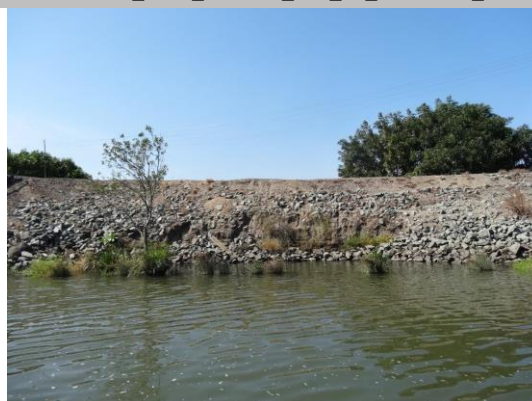
Photo 2 of 3 : FA_2018_RD0524_107_17_20180906_00031.jpg

Close view of the erosion.

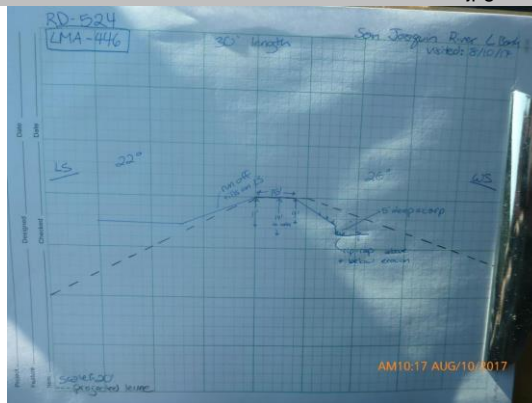
Item	2017 Storm Damage		37.937200°	37.937100°								
			-121.335300°	-121.335300°								
DWR ID	DWR_RD0524_01_f_2017_154											
Comment Code												
Inspector Comment												
<p>Levee Evaluation Comments</p> <p>Description: Slope protection repairs are needed along the waterside slope due to erosion and riprap displacement from high water. Based upon levee inspections, it was determined the waterside levee slope is eroding, deteriorating, and degrading. The eroded levee sections need to be restored back to design standards to prevent further deterioration and damage.</p> <p>Site ID No: 540</p> <p>Site Designation: LMA-446</p> <p>Repair Type: Erosion</p> <p>Rating: Area of Concern</p> <p>Field Date: 8/10/2017</p> <p>Notes:</p>

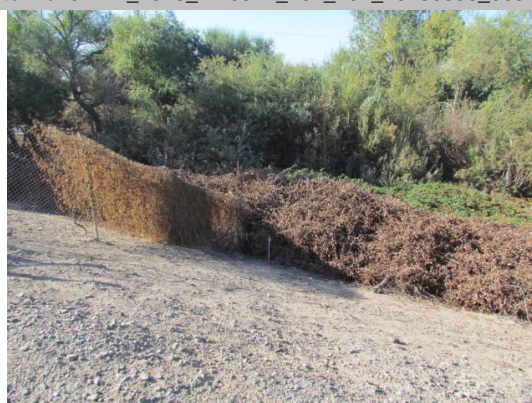
Photo 2 of 3 : FA_2018_RD0524_107_262_20180906_00348.jpg

Looking west at dense vegetation at landward slope and toe fall 2015.

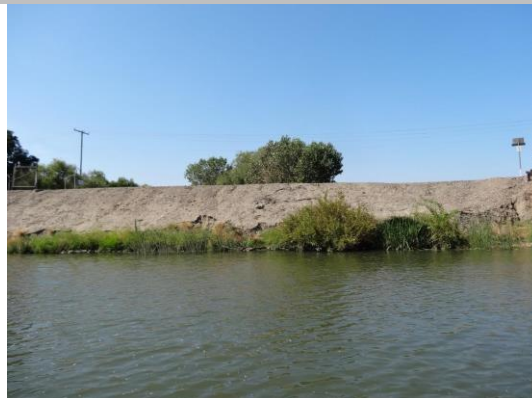
Photo 1 of 4 : FA_2018_RD0524_107_21_20180906_00036.jpg

LM Start	0.76	Rating **	U	Issue No.	21
LM End	0.77	Issue Type +	Ma	Location *	WS
Category	Supplemental			GPS Latitude/Longitude	
				Start	End
Item	DWR Erosion Survey			37.936821 °	37.936821 °
				-121.334582 °	-121.334582 °
DWR ID	RD0524U01RM41.39				
Comment Code					
Inspector Comment					
09/13/2017: No significant change observed.					
07/25/2016: No significant change observed.					
06/24/2015: No significant change observed.					
06/19/2014: No significant change observed.					
08/13/2013: No significant change at this site.					
08/07/2012: The site has been visited by boat survey. No significant change observed.					
08/23/2011: The site is located immediately upstream of a Railroad bridge. Dense vegetation at the water line blocks the view of erosion.					
[2017 Site ID:RD0524U01RM41.39]

Front view of the erosion site.

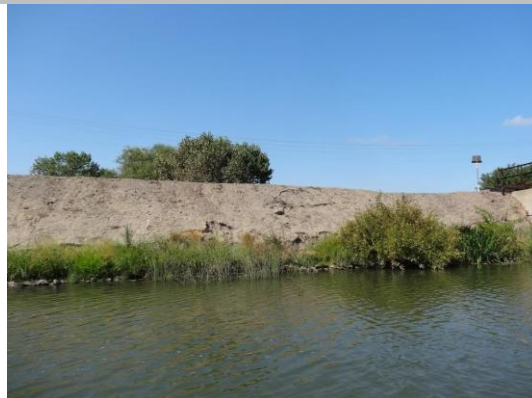
Photo 3 of 4 : FA_2018_RD0524_107_21_20180906_00038.jpg

LM Start	0.76	Rating **	U	Issue No.	21 (cont)
LM End	0.77	Issue Type +	Ma	Location *	WS
Category	Supplemental			GPS Latitude/Longitude	
				Start	End
Item	DWR Erosion Survey			37.936821 °	37.936821 °
				-121.334582 °	-121.334582 °
DWR ID	RD0524U01RM41.39				
Comment Code					
Inspector Comment					
09/13/2017: No significant change observed.					
07/25/2016: No significant change observed.					
06/24/2015: No significant change observed.					
06/19/2014: No significant change observed.					
08/13/2013: No significant change at this site.					
08/07/2012: The site has been visited by boat survey. No significant change observed.					
08/23/2011: The site is located immediately upstream of a Railroad bridge. Dense vegetation at the water line blocks the view of erosion.					
[2017 Site ID:RD0524U01RM41.39]

Front view of the erosion.

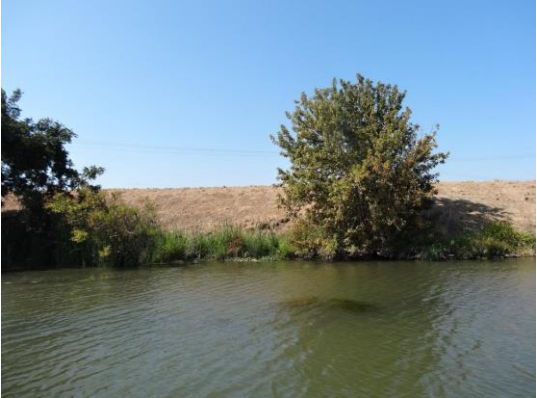
Photo 1 of 2 : FA_2018_RD0524_107_22_20180906_00040.jpg

Front view of the erosion. The tree and vegetation block the view of the site.

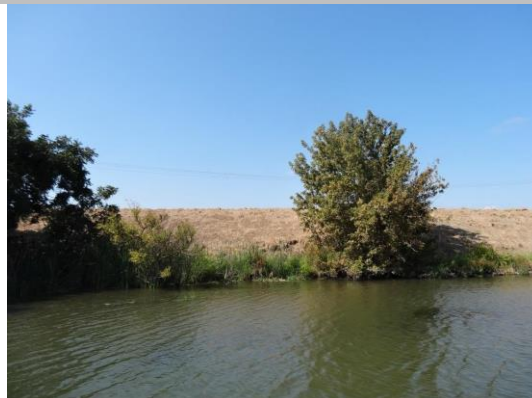
Photo 2 of 2 : FA_2018_RD0524_107_22_20180906_00041.jpg

LM Start	0.83	Rating **	U	Issue No.	22 (cont)	
LM End	0.84	Issue Type +	Ma	Location *	WS	
Category	Supplemental			GPS Latitude/Longitude		
				Start		End
Item	DWR Erosion Survey			37.935930 °		37.935930 °
				-121.334133 °		-121.334133 °
DWR ID	RD0524U01RM41.44					
Comment Code						
Inspector Comment						
09/13/2017: No significant change observed.						
07/25/2016: No significant change observed.						
06/24/2015: No significant change observed.						
06/19/2014: No significant change observed.						
08/13/2013: Site was discovered during boat survey. The dense vegetation blocks a clear view of the erosion. Size of erosion site was very roughly estimated. [2017 Site ID:RD0524U01RM41.44]

Close view of the erosion site.

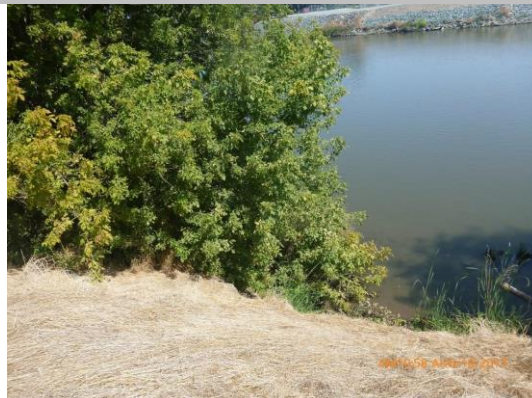
Photo 3 of 3 : LEVAL_FA_2018_537_4104.jpg

LM Start	0.90	Rating **	A/W	Issue No.	193 (cont)
LM End	0.91	Issue Type +	Ma	Location *	
Category	Supplemental			GPS Latitude/Longitude	
				Start	End
Item	2017 Storm Damage			37.935400 °	37.935300 °
				-121.333300 °	-121.333200 °
DWR ID	DWR_RD0524_01_f_2017_193				
Comment Code					
Inspector Comment					
Levee Evaluation Comments					
Description:Slope protection repairs are needed along the waterside slope due to erosion and riprap displacement from high water. Based upon levee inspections, it was determined the waterside levee slope is eroding, deteriorating, and degrading. The eroded levee sections need to be restored back to design standards to prevent further deterioration and damage.					
Site ID No:537					
Site Designation:LMA-443					
Repair Type: Erosion					
Rating:Serious					
Field Date:8/10/2017					
Notes:

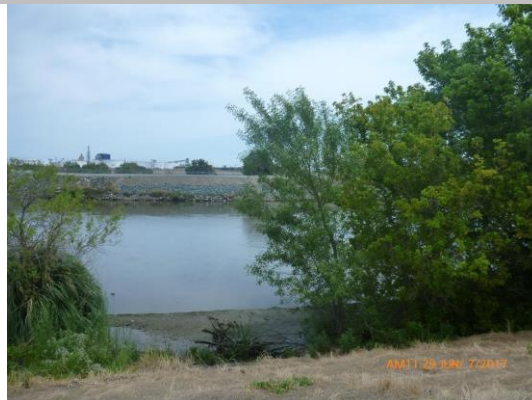
LM Start	0.91	Rating **	A/W	Issue No.	187	
LM End		Issue Type +	Ma	Location *		
Category	Supplemental			GPS Latitude/Longitude		
				Start	End	
Item	2017 Storm Damage			37.935580°		°
				-121.333200°		°
DWR ID	DWR_RD0524_01_f_2017_187					
Comment Code						
Inspector Comment						
Levee Evaluation Comments						
Description:						
Site ID No:87						
Site Designation:DWR_RD0524_01_s_2012_99						
Repair Type: Erosion						
Rating:Area of Concern						
Field Date:6/7/2017						
Notes: no observable defects to levee, vegetation blocks ws toe

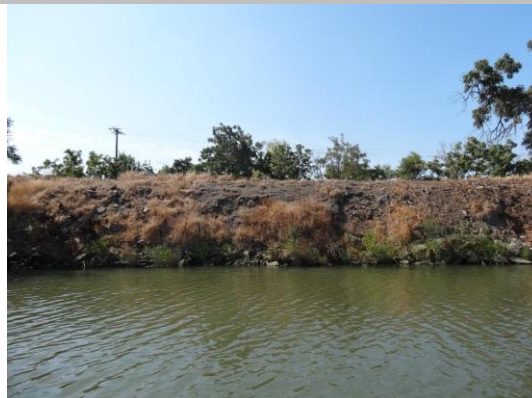
Photo 1 of 4 : FA_2018_RD0524_107_30_20180906_00053.jpg

Front view of the erosion.

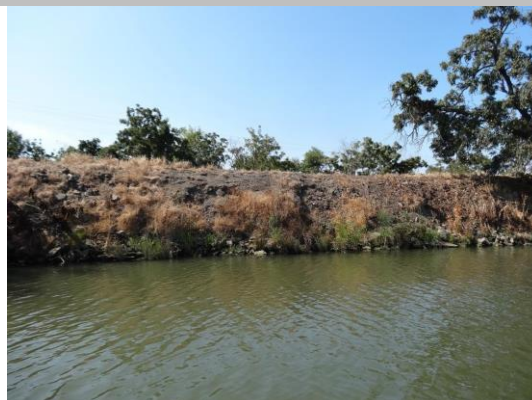
Photo 2 of 4 : FA_2018_RD0524_107_30_20180906_00054.jpg

Close view of the erosion.

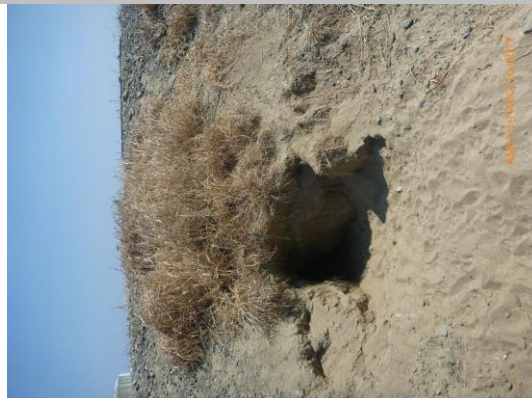
Photo 2 of 3 : LEVAL_FA_2018_536_4110.jpg

Item	2017 Storm Damage			37.935100 °	37.935100 °	
				-121.331500 °	-121.331300 °	
DWR ID	DWR_RD0524_01_f_2017_198					
Comment Code						
Inspector Comment						
Levee Evaluation Comments						
Description:Slope protection repairs are needed along the waterside slope due to erosion and riprap displacement from high water. Based upon levee inspections, it was determined the waterside levee slope is eroding, deteriorating, and degrading. The eroded levee sections need to be restored back to design standards to prevent further deterioration and damage.						
Site ID No:536						
Site Designation:LMA-442						
Repair Type: Erosion						
Rating:Area of Concern						
Field Date:8/10/2017						
Notes: Appears to be previous repair site adjacent to LMA-442. Large fox den on land side

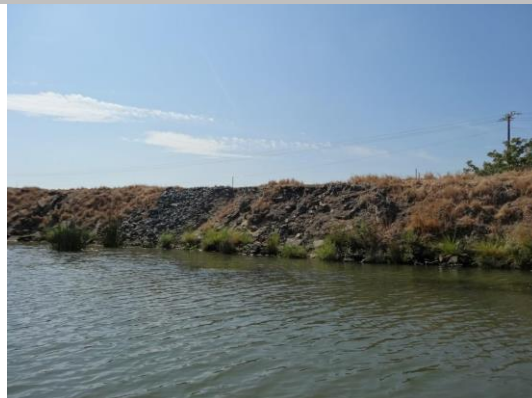
Photo 1 of 3 : FA_2018_RD0524_107_33_20180906_00061.jpg

LM Start	1.02	Rating **	U	Issue No.	33
LM End	1.02	Issue Type +	Ma	Location *	WS
Category	Supplemental			GPS Latitude/Longitude	
				Start	End
Item	DWR Erosion Survey			37.935078°	37.935078°
				-121.331134°	-121.331134°
DWR ID	RD0524U01RM41.59				
Comment Code					
Inspector Comment					
09/13/2017: No significant change observed.					
07/25/2016: No significant change observed.					
06/24/2015: No significant change observed.					
06/19/2014: No significant change observed.					
08/13/2013: No significant change at this site.					
08/07/2012: The site has been visited by boat survey. Site has been repaired, but new erosion occurred at the levee slope and immediately upstream of the repaired site.					
08/23/2011: The site is about 500 ft downstream of bridge. The levee toe seems to be protected, but the protection is being washed away.					
[2017 Site ID:RD0524U01RM41.59]

Upstream view of the site.

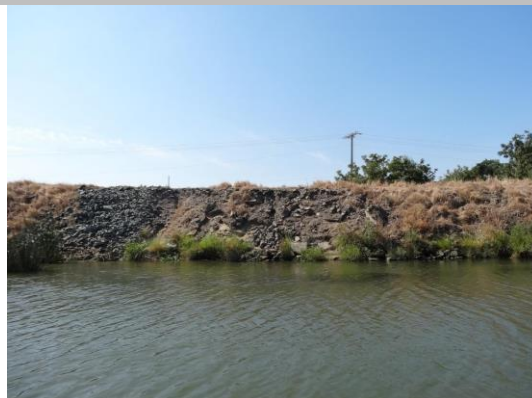
Photo 2 of 3 : FA_2018_RD0524_107_33_20180906_00062.jpg

Close view of the erosion.

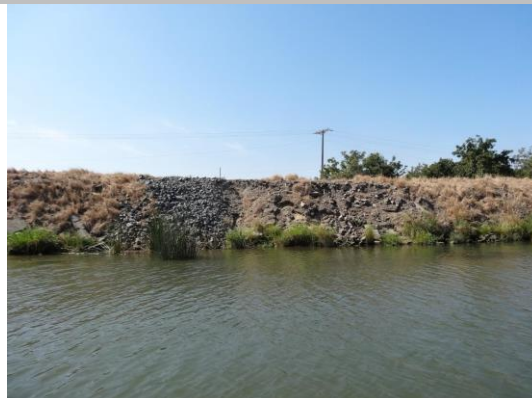
Photo 3 of 3 : FA_2018_RD0524_107_33_20180906_00063.jpg

Comment Code						
Inspector Comment						
09/13/2017: No significant change observed.						
07/25/2016: No significant change observed.						
06/24/2015: No significant change observed.						
06/19/2014: No significant change observed.						
08/13/2013: No significant change at this site.						
08/07/2012: The site has been visited by boat survey. Site has been repaired, but new erosion occurred at the levee slope and immediately upstream of the repaired site.						
08/23/2011: The site is about 500 ft downstream of bridge. The levee toe seems to be protected, but the protection is being washed away.						
[2017 Site ID:RD0524U01RM41.59]

Front view of the site.

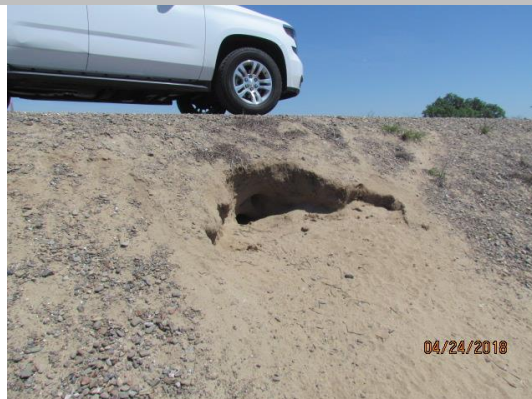
Photo 1 of 2 : FA_2018_RD0524_107_238_20180906_00330.jpg

LM Start	1.02	Rating **	U	Issue No.	238
LM End	1.02	Issue Type +	Ma	Location *	LS
Category	Earthen Levee			GPS Latitude/Longitude	
				Start	End
Item	Animal Control			37.934991 °	37.934991 °
				-121.331160 °	-121.331160 °
DWR ID	DWR_RD0524_01_f_2017_238				
Comment Code					
A3 : No rodents visible, but rodent burrows visible; need to backfill and compact or grout burrows.					
Inspector Comment					
Two large rodent holes on landward slope and toe. Large erosion around holes.

Looking east at large rodent hole on landward slope. (Spring 2018)

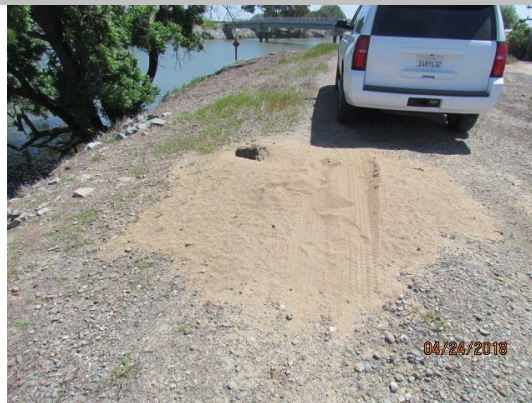
Photo 2 of 3 : FA_2018_RD0524_107_150_20180906_00192.jpg

LM Start	1.04	Rating **	U	Issue No.	150
LM End	1.04	Issue Type +	Ma	Location *	WS
Category	Earthen Levee			GPS Latitude/Longitude	
				Start	End
Item	Animal Control			37.934896 °	37.934896 °
				-121.330781 °	-121.330781 °
DWR ID	DWR_RD0524_01_s_2018_150				
Comment Code					
A3 : No rodents visible, but rodent burrows visible; need to backfill and compact or grout burrows.					
Inspector Comment					
Large rodent or beaver or nutria hole on waterward shoulder and crown of levee. Over 2 cubic feet of material was observed beside hole.

Looking south at large rodent hole on waterward shoulder. (Spring 2018)

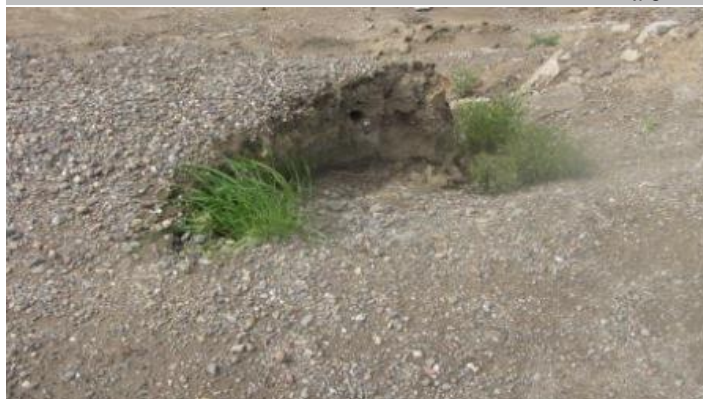
Photo 2 of 2 : FA_2018_RD0524_107_18_20180906_00034.jpg

LM Start	1.07	Rating **	U	Issue No.	18
LM End	1.07	Issue Type +	Ma	Location *	LS
Category	Earthen Levee			GPS Latitude/Longitude	
				Start	End
Item	Slope Stability			37.934715 °	37.934715 °
				-121.330343 °	-121.330343 °
DWR ID	DWR_RD0524_01_s_2012_18				
Comment Code					
S1 : Repair slope instability.					
Inspector Comment					
Slope damage extends from shoulder to middle of slope.

Updated view from above the slope stability.

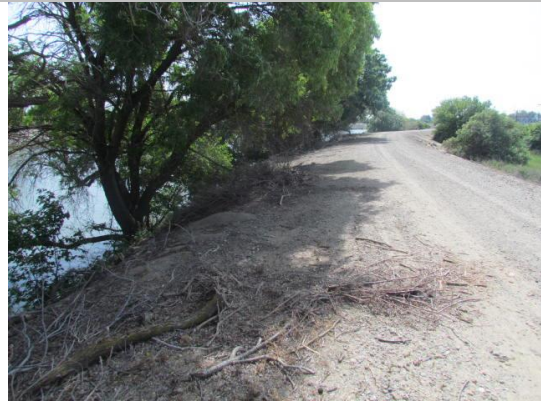
Photo 1 of 1 : FA_2018_RD0524_107_171_20180906_00223.jpg

LM Start	1.12	Rating **	M	Issue No.	171
LM End	1.16	Issue Type +	Ma	Location *	WS
Category	Earthen Levee			GPS Latitude/Longitude	
				Start	End
Item	Encroachments			37.934225 °	37.933815 °
				-121.329693 °	-121.329242 °
DWR ID	DWR_RD0524_01_s_2015_171				
Comment Code					
PR : Prunings					
Inspector Comment					
Prunings left on waterside shoulder and slope.

Looking south at prunings on waterward shoulders.

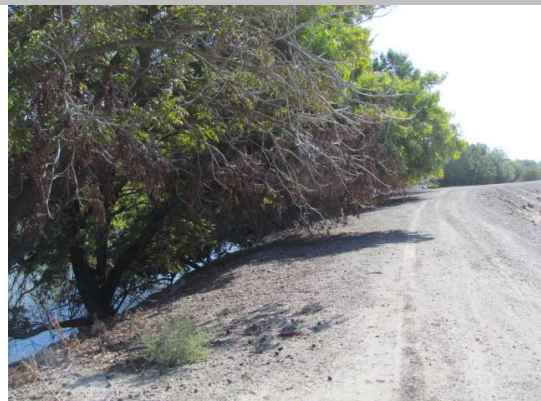
Photo 1 of 1 : FA_2018_RD0524_107_19_20180906_00035.jpg

Looking southeast at low hanging tree branches at waterside toe.

LM Start	1.13	Rating **	M	Issue No.	19
LM End	1.16	Issue Type +	Ma	Location *	WS
Category	Earthen Levee			GPS Latitude/Longitude	
				Start	End
Item	Trim / Thin Trees			37.934118°	37.933775°
				-121.329657°	-121.329305°
DWR ID	DWR_RD0524_01_s_2012_19				
Comment Code					
T1 : Trim trees to at least five feet above ground level.					
Inspector Comment

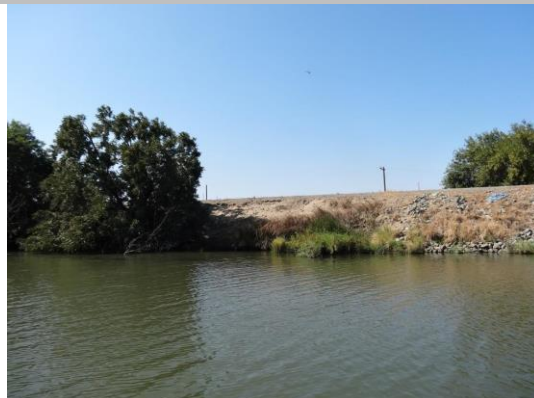
Photo 1 of 4 : FA_2018_RD0524_107_44_20180906_00073.jpg

Comment Code					
Inspector Comment					
09/13/2017: No significant change observed.					
07/25/2016: No significant change observed.					
06/24/2015: No significant change observed.					
06/19/2014: No significant change observed.					
08/13/2013: No significant change at this site.					
08/07/2012: The site has been visited by boat survey. No significant change observed					
08/23/2011: No significant change observed on site.					
09/07/2010: No significant change observed on site. Vegetation is visible at the water line. There is an exposed pipe discharge partially hanging at the mid-slope, possibly still used for discharging irrigation/runoff water. There is minimal rip rap protection along the bank, and what's left of it is no longer adequately protecting the bank.					
9/29/2009: Site consists of a 400-foot long eroding bank with minimal vegetation and protection; the existing rip rap has sloughed, rendering it useless; note that there is an exposed section of a pipe.

Direct view of the site.

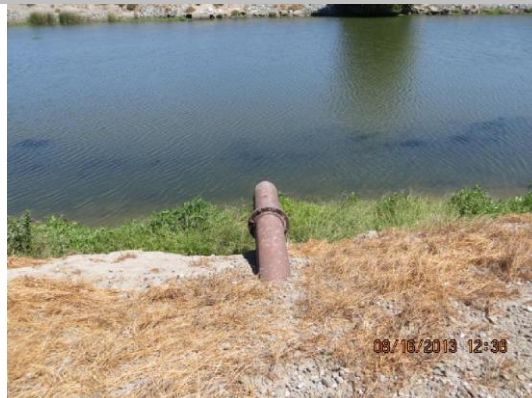
Photo 1 of 3 : UCIP_FA_2018_53162_29862.jpg

UCIP Comments: 10/2/2018 Pipe appears abandoned, but both the pipe and levee appear in good condition; downgrading to Non-Urgent (D. Sanoski - DWR UCIP). 11/16/2016 same as previous inspection both ends are open. This pipe does not appear in use. Need to contact owner to determine status of crossing. If the crossing is abandoned or in use, owner will need to coordinate with the CVFPB to comply with Title 23 requirements. (O. Magana - DWR UCIP) 08/16/2013 Pipe appears to be open on both ends. Abandoned and should be done so properly. (W. Wylie - DWR UCIP)

FIELD_STRUCT_DESC: *ABANDONED* 12-inch steel drainage pipe through the levee, 3.5 feet below the crown. Pipe is opened on the waterside (WS) and landside (LS) ends. The pump house referenced in O&M manual is missing from the LS (2013). [Additional Reference(s): DWR Levee Log, 2004. USACE San Joaquin O&M Manual 7, April 1964, (HLM 1.31)].

Pipe visible and open on WS slope.

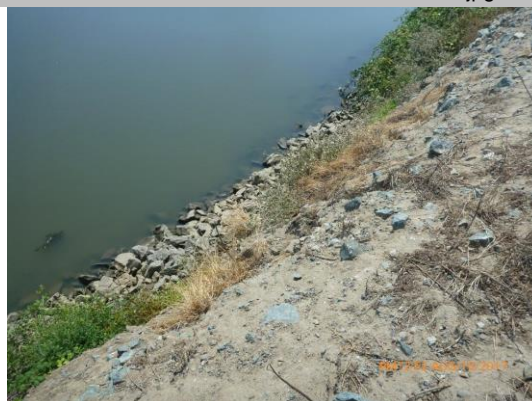
Photo 3 of 3 : LEVAL_FA_2018_530_4185.jpg

LM Start	1.43	Rating **	A/W	Issue No.	226 (cont)	
LM End	1.44	Issue Type +	Ma	Location *		
Category	Supplemental			GPS Latitude/Longitude		
				Start	End	
Item	2017 Storm Damage			37.930100 °	37.929900 °	
				-121.328300 °	-121.328300 °	
DWR ID	DWR_RD0524_01_f_2017_226					
Comment Code						
Inspector Comment						
Levee Evaluation Comments						
Description:Slope protection repairs are needed along the waterside slope due to erosion and riprap displacement from high water. Based upon levee inspections, it was determined the waterside levee slope is eroding, deteriorating, and degrading. The eroded levee sections need to be restored back to design standards to prevent further deterioration and damage.						
Site ID No:530						
Site Designation:LMA-436						
Repair Type: Erosion						
Rating:Area of Concern						
Field Date:8/10/2017						
Notes:

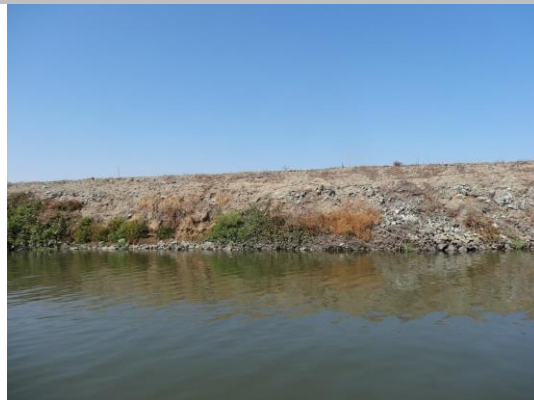
Photo 2 of 4 : FA_2018_RD0524_107_60_20180906_00107.jpg

LM Start	1.45	Rating **	U	Issue No.	60 (cont)	
LM End	1.47	Issue Type +	Ma	Location *	WS	
Category	Supplemental			GPS Latitude/Longitude		
				Start		End
Item	DWR Erosion Survey			37.929650 °		37.929650 °
				-121.328110 °		-121.328110 °
DWR ID	RD0524U01RM42.09					
Comment Code						
Inspector Comment						
09/13/2017: No significant change observed.						
07/25/2016: No significant change observed.						
06/24/2015: No significant change observed.						
06/19/2014: No significant change observed.						
08/13/2013: The site is located approximately 400 ft. downstream SR 4 Bridge. Dense vegetation is visible at the toe. [2017 Site ID:RD0524U01RM42.09]

Front view of the erosion.

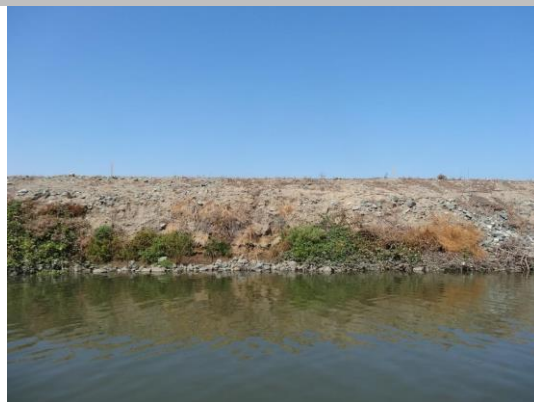
Photo 3 of 4 : FA_2018_RD0524_107_60_20180906_00108.jpg

Close view of the erosion. Note the vegetation at the site.

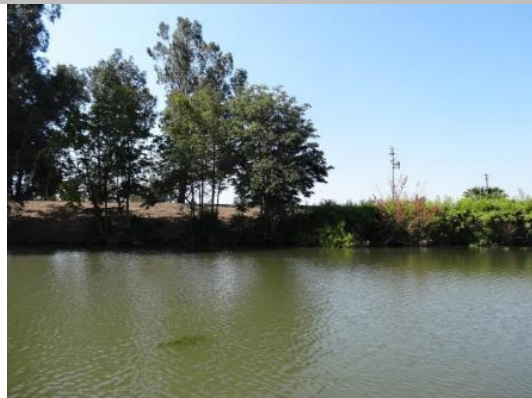
Photo 1 of 3 : FA_2018_RD0524_107_62_20180906_00111.jpg

Comment Code					
Inspector Comment					
09/13/2017: No significant change observed.					
07/25/2016: No significant change observed.					
06/24/2015: No significant change observed.					
06/19/2014: No significant change observed.					
08/13/2013: No significant change observed.					
08/07/2012: The site has been visited by boat survey. No significant change observed					
08/23/2011: No significant change observed on site. Trees concerned still in place.					
09/07/2010: No significant change observed on site. The concern here is the undermining of the levee toe where most of trees are. There are erosion pockets lined along the lower slope and at the base of the trees, exposing tree roots. There is minimal slope protection.					
09/29/2009: The lower slope is lined with minor erosion pockets; some tree roots are exposed; there is visible undermining of the levee toe; site is immediately upstream of the Highway 4 Bridge; the bridge is possibly causing a scour to occur, eroding the bank. [2017 Site ID:RD0524U01RM42.2]

Front view of the site where undermining has occurred.

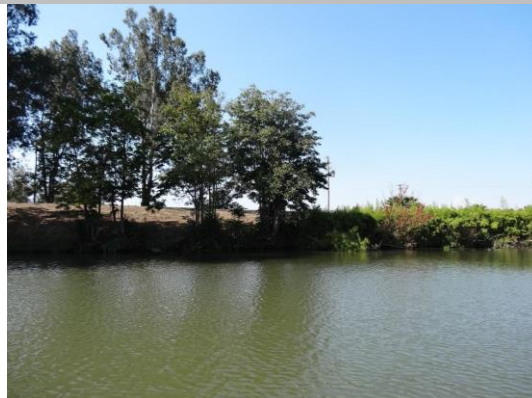
Photo 3 of 3 : FA_2018_RD0524_107_62_20180906_00113.jpg

Comment Code						
Inspector Comment						
09/13/2017: No significant change observed.						
07/25/2016: No significant change observed.						
06/24/2015: No significant change observed.						
06/19/2014: No significant change observed.						
08/13/2013: No significant change observed.						
08/07/2012: The site has been visited by boat survey. No significant change observed						
08/23/2011: No significant change observed on site. Trees concerned still in place.						
09/07/2010: No significant change observed on site. The concern here is the undermining of the levee toe where most of trees are. There are erosion pockets lined along the lower slope and at the base of the trees, exposing tree roots. There is minimal slope protection.						
09/29/2009: The lower slope is lined with minor erosion pockets; some tree roots are exposed; there is visible undermining of the levee toe; site is immediately upstream of the Highway 4 Bridge; the bridge is possibly causing a scour to occur, eroding the bank. [2017 Site ID:RD0524U01RM42.2]

Front view of the erosion. Dense vegetation is visible.

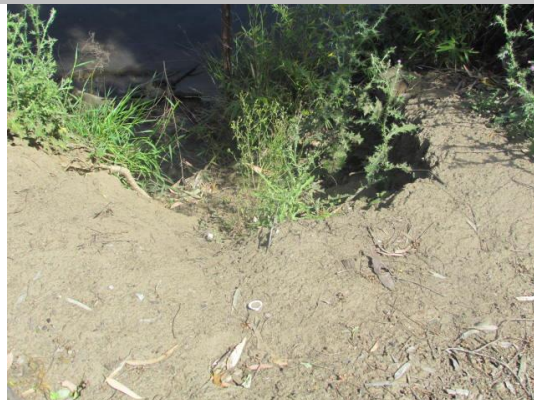
Photo 2 of 3 : FA_2018_RD0524_107_26_20180906_00046.jpg

LM Start	1.62	Rating **	M	Issue No.	26 (cont)	
LM End	1.64	Issue Type +	Ma	Location *	WS	
Category	Earthen Levee			GPS Latitude/Longitude		
				Start		End
Item	Erosion / Bank Caving			37.927507 °	37.927295 °	
				-121.327593 °	-121.327298 °	
DWR ID	DWR_RD0524_01_s_2012_26					
Comment Code						
E1 : Note and monitor erosion site.						
Inspector Comment						
Several erosions along this reach.

Looking east at waterward erosion.

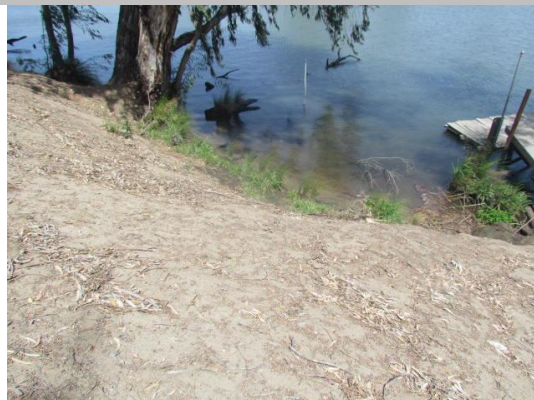
Photo 3 of 3 : FA_2018_RD0524_107_26_20180906_00047.jpg

Looking east at waterward erosion and depression.

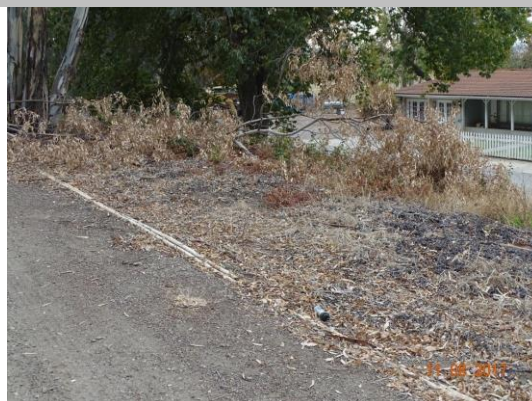
Photo 1 of 1 : FA_2018_RD0524_107_240_20180906_00335.jpg

LM Start	1.66	Rating **	M	Issue No.	240
LM End	1.66	Issue Type +	Ma	Location *	LS
Category	Earthen Levee			GPS Latitude/Longitude	
				Start	End
Item	Encroachments			37.927159 °	37.927159 °
				-121.327022 °	-121.327022 °
DWR ID	DWR_RD0524_01_f_2017_240				
Comment Code					
TR : Tree or limb					
Inspector Comment

Looking southeast at the landside slope.

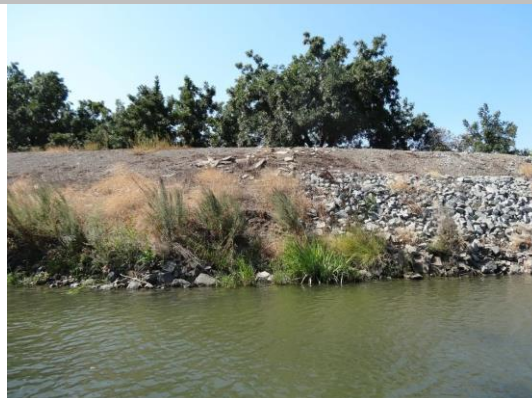
Photo 1 of 3 : FA_2018_RD0524_107_70_20180906_00120.jpg

LM Start	2.30	Rating **	M	Issue No.	70
LM End	2.30	Issue Type +	Ma	Location *	WS
Category	Supplemental			GPS Latitude/Longitude	
				Start	End
Item	DWR Erosion Survey			37.920150°	37.920150°
				-121.319700°	-121.319700°
DWR ID	RD0524U01RM42.9				
Comment Code					
Inspector Comment					
09/13/2017: The erosion is located immediately upstream of a repaired levee section. [2017 Site ID:RD0524U01RM42.9]

Front view of the pocket erosion.

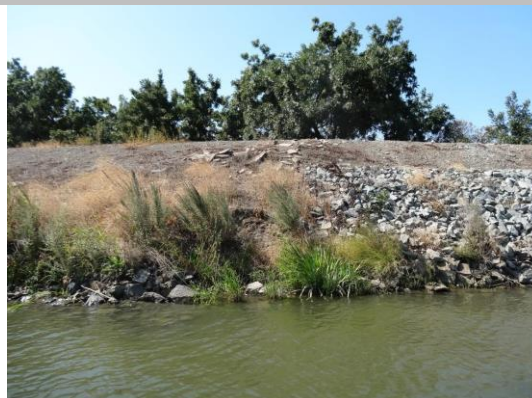
Photo 2 of 3 : FA_2018_RD0524_107_70_20180906_00121.jpg

Close view of the erosion.

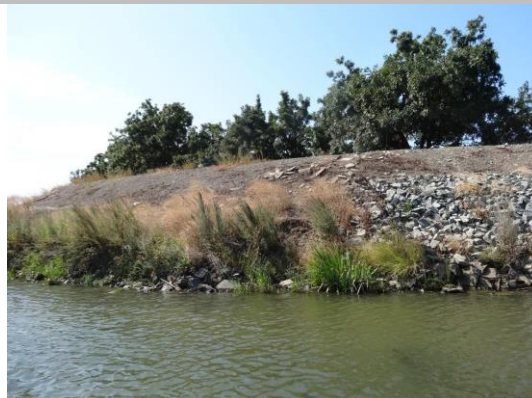
Photo 3 of 3 : FA_2018_RD0524_107_70_20180906_00122.jpg

Front view of the erosion.

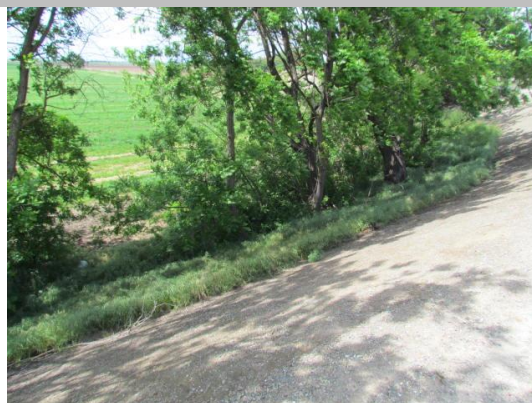
Photo 1 of 1 : FA_2018_RD0524_107_107_20180906_00169.jpg

LM Start	2.33	Rating **	M	Issue No.	107
LM End	2.33	Issue Type +	Ma	Location *	LS
Category	Earthen Levee			GPS Latitude/Longitude	
				Start	End
Item	Trim / Thin Trees			37.919742°	37.919742°
				-121.319623°	-121.319623°
DWR ID	DWR_RD0524_01_s_2012_107				
Comment Code					
T1 : Trim trees to at least five feet above ground level.					
Inspector Comment

Looking northwest at untrimmed trees at landward toe.

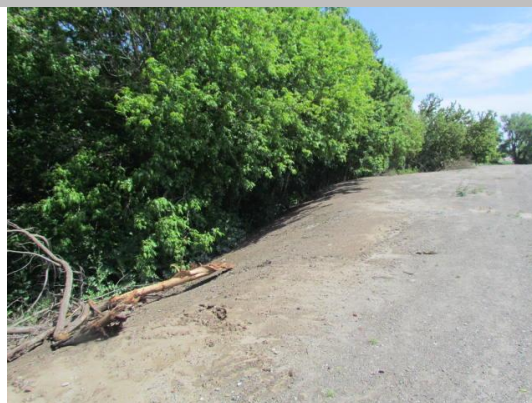
Photo 1 of 1 : FA_2018_RD0524_107_185_20180906_00245.jpg

LM Start	2.60	Rating **	U	Issue No.	185
LM End	2.64	Issue Type +	Ma	Location *	WS
Category	Earthen Levee			GPS Latitude/Longitude	
				Start	End
Item	Trim / Thin Trees			37.917152°	37.916807°
				-121.322582°	-121.322069°
DWR ID	DWR_RD0524_01_s_2014_185				
Comment Code					
T2 : Thin trees to allow visibility of the ground and room to flood fight.					
Inspector Comment

Looking northwest at untrimmed trees on landward slope and toe.

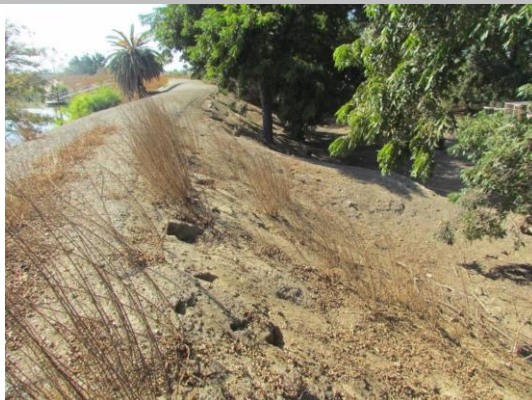
Photo 1 of 2 : FA_2018_RD0524_107_219_20180906_00287.jpg

LM Start	2.77	Rating **	U	Issue No.	219
LM End	2.80	Issue Type +	Ma	Location *	LS
Category	Earthen Levee			GPS Latitude/Longitude	
				Start	End
Item	Animal Control			37.915195°	37.915052°
				-121.322930°	-121.323430°
DWR ID	DWR_RD0524_01_f_2016_219				
Comment Code					
A1 : Exterminate rodents and backfill and compact or grout burrows.					
Inspector Comment					
Several large rodent holes on landside slope.

Looking south at several rodent holes on landward slope.

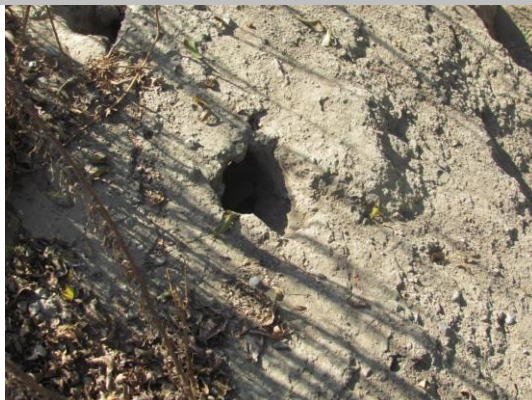
Photo 2 of 2 : FA_2018_RD0524_107_219_20180906_00288.jpg

Looking at typical rodent hole on waterward slope.

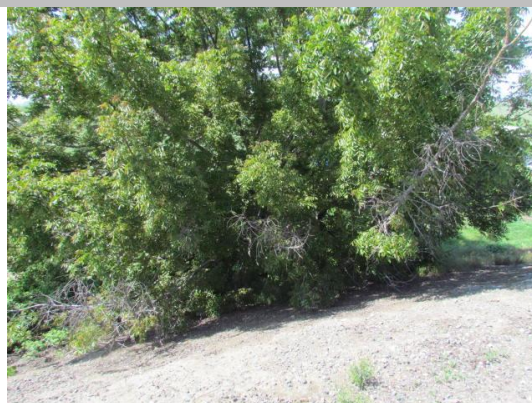
Photo 1 of 1 : FA_2018_RD0524_107_209_20180906_00275.jpg

LM Start	2.87	Rating **	U	Issue No.	209
LM End	2.87	Issue Type +	Ma	Location *	LS
Category	Earthen Levee			GPS Latitude/Longitude	
				Start	End
Item	Trim / Thin Trees			37.914257 °	37.914257 °
				-121.324317 °	-121.324317 °
DWR ID	DWR_RD0524_01_s_2016_209				
Comment Code					
T1 : Trim trees to at least five feet above ground level.					
Inspector Comment					
Untrimmed walnut tree on landside slope and toe.

Looking northwest at untrimmed tree at landward toe.

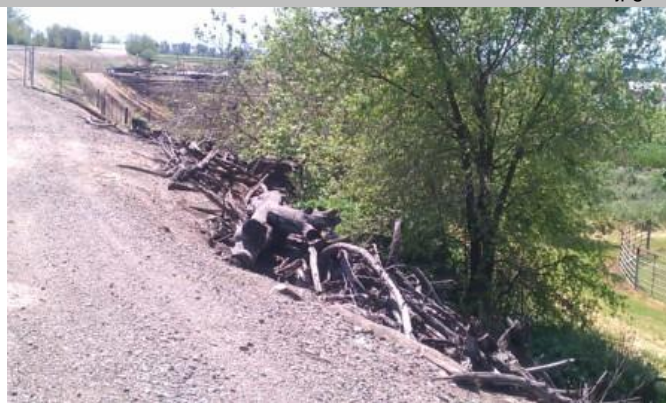
Photo 1 of 1 : FA_2018_RD0524_107_50_20180906_00091.jpg

LM Start	2.90	Rating **	U	Issue No.	50
LM End	2.92	Issue Type +	Ma	Location *	LS
Category	Earthen Levee			GPS Latitude/Longitude	
				Start	End
Item	Encroachments			37.913767 °	37.913486 °
				-121.324427 °	-121.324428 °
DWR ID	DWR_RD0524_01_s_2012_50				
Comment Code					
PR : Prunings					
Inspector Comment

Looking southwest at prunings on landside slope.

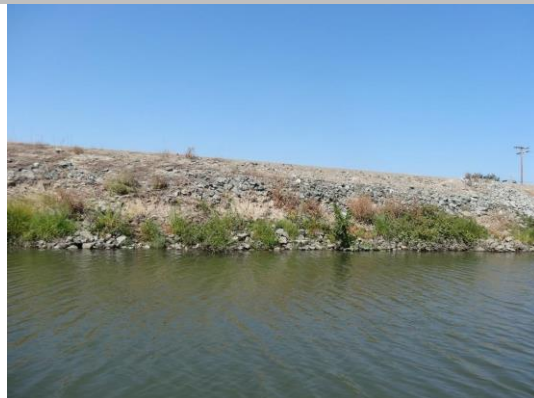
Photo 3 of 4 : FA_2018_RD0524_107_71_20180906_00125.jpg

Close view of the erosion.

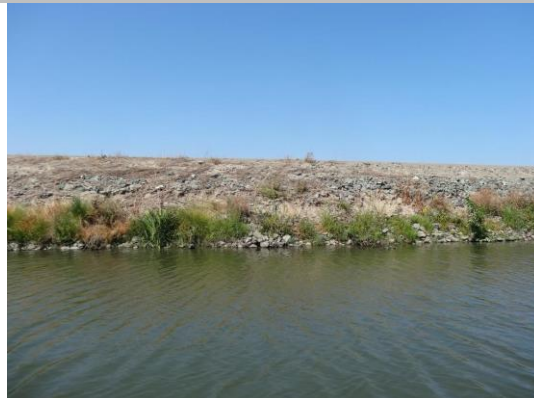
Photo 4 of 4 : FA_2018_RD0524_107_71_20180906_00126.jpg

Close view of the erosion. Note the new pocket erosion next to the irrigation pipe on the site.

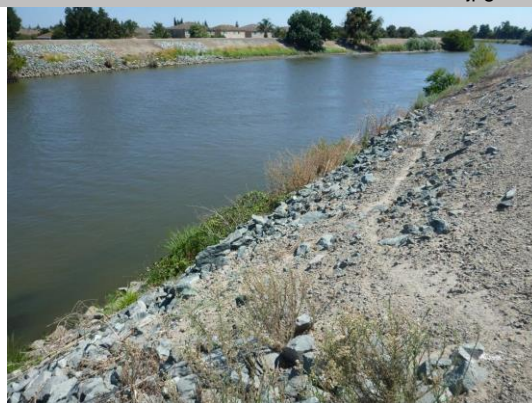
Repair Type: Erosion

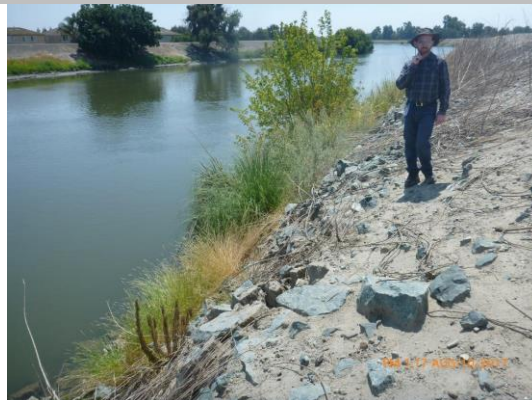
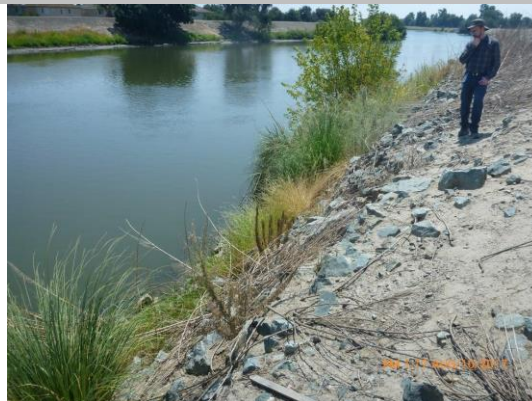
Repair Type: Erosion

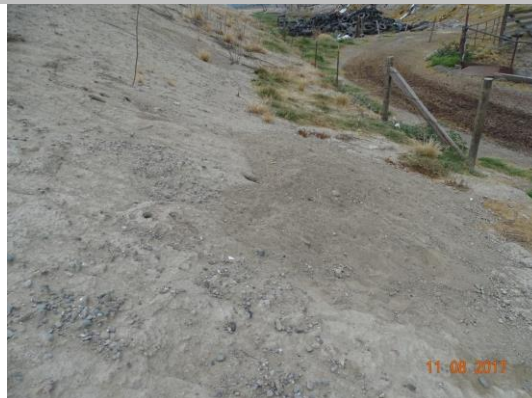
Photo 1 of 3 : FA_2018_RD0524_107_925_20180906_00364.jpg

LM Start	3.07	Rating **	M	Issue No.	925 (cont)
LM End	3.27	Issue Type +	Ma	Location *	LS

Looking southwest at the landside slope.

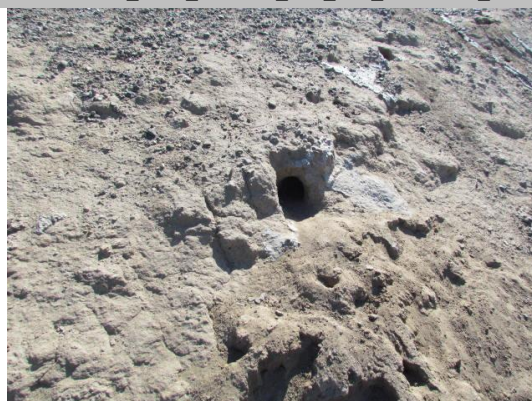
Photo 2 of 3 : FA_2018_RD0524_107_925_20180906_00365.jpg

Looking at typical view of rodent hole with this section fall 2015.

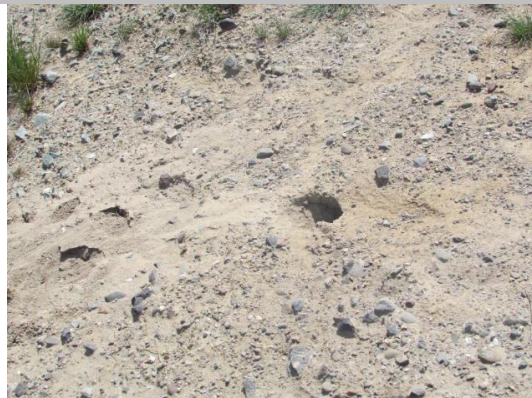
Photo 3 of 3 : FA_2018_RD0524_107_925_20180906_00366.jpg

Looking at typical rodent holes on landward slope along this reach.

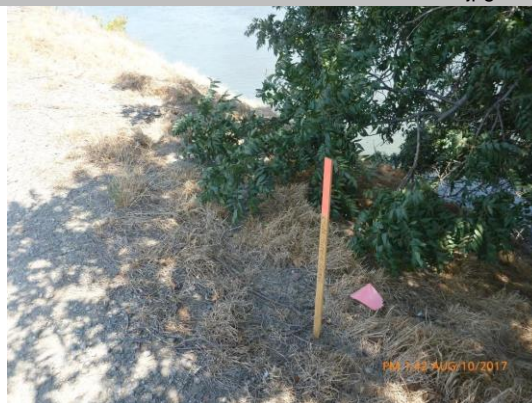
LM Start	3.26	Rating **	A/W	Issue No.	230
LM End	3.26	Issue Type +	Ma	Location *	
Category	Supplemental			GPS Latitude/Longitude	
				Start	End
Item	2017 Storm Damage			37.908800 °	37.908700 °
				-121.325400 °	-121.325300 °
DWR ID	DWR_RD0524_01_f_2017_230				
Comment Code					
Inspector Comment					
Levee Evaluation Comments					
Description:Slope protection repairs are needed along the waterside slope due to erosion and riprap displacement from high water. Based upon levee inspections, it was determined the waterside levee slope is eroding, deteriorating, and degrading. The eroded levee sections need to be restored back to design standards to prevent further deterioration and damage.					
Site ID No:528					
Site Designation:LMA-434					
Repair Type: Erosion					
Rating:Area of Concern					
Field Date:8/10/2017					
Notes: combined with LMA-433

LM Start	3.26	Rating **	A/W	Issue No.	230 (cont)
LM End	3.26	Issue Type +	Ma	Location *	
Category	Supplemental			GPS Latitude/Longitude	
				Start	End
Item	2017 Storm Damage			37.908800 °	37.908700 °
				-121.325400 °	-121.325300 °
DWR ID	DWR_RD0524_01_f_2017_230				
Comment Code					
Inspector Comment					
<p>Levee Evaluation Comments</p> <p>Description: Slope protection repairs are needed along the waterside slope due to erosion and riprap displacement from high water. Based upon levee inspections, it was determined the waterside levee slope is eroding, deteriorating, and degrading. The eroded levee sections need to be restored back to design standards to prevent further deterioration and damage.</p> <p>Site ID No: 528</p> <p>Site Designation: LMA-434</p> <p>Repair Type: Erosion</p> <p>Rating: Area of Concern</p> <p>Field Date: 8/10/2017</p> <p>Notes: combined with LMA-433</p>

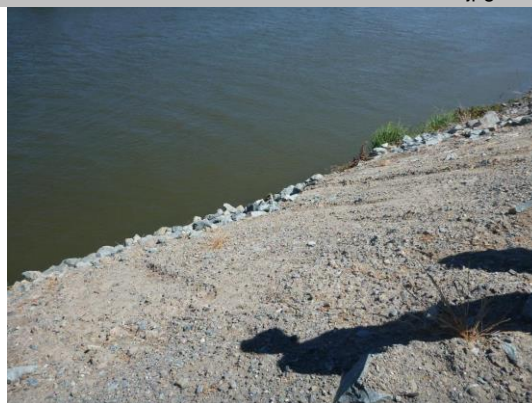
Photo 1 of 3 : LEVAL_FA_2018_467_2223.jpg

LM Start	3.30	Rating **	A/W	Issue No.	232
LM End		Issue Type +	Ma	Location *	
Category	Supplemental			GPS Latitude/Longitude	
				Start	End
Item	2017 Storm Damage			37.908200 °	°
				-121.325300 °	°
DWR ID	DWR_RD0524_01_f_2017_232

Comment Code					
Inspector Comment					
Levee Evaluation Comments					
Description:Slope protection repairs are needed along the waterside slope due to erosion. Based upon levee inspections, it was determined the waterside levee slopes were eroding, deteriorating and degrading in concave pocket sections at various locations along this levee reach. The eroded levee sections need to be restored back to design standards to prevent further deterioration of the damaged levee sections.					
Site ID No:467					
Site Designation:LMA-294					
Repair Type: Erosion					
Rating:Area of Concern					
Field Date:7/26/2017					
Notes: It looks like new rip rap was played on the lower 1/4 of the slope. There is a 2-3 ft scarp above the rip rap.

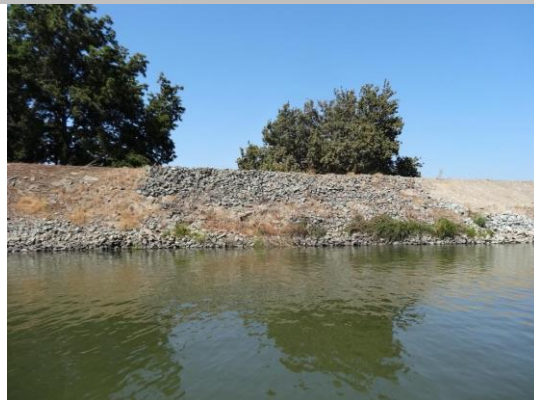
Photo 1 of 4 : FA_2018_RD0524_107_79_20180906_00136.jpg

LM Start	3.30	Rating **	U	Issue No.	79
LM End	3.32	Issue Type +	Ma	Location *	WS
Category	Supplemental			GPS Latitude/Longitude	
				Start	End
Item	DWR Erosion Survey			37.908090 °	37.908090 °
				-121.325090 °	-121.325090 °
DWR ID	RD0524U01RM43.86				
Comment Code					
Inspector Comment					
09/13/2017: No significant change observed.					
07/25/2016: No significant change observed.					
06/24/2015: No significant change observed.					
06/19/2014: No significant change observed.					
08/13/2013: The levee toe seems to have been protected by river rocks and vegetation on site. [2017 Site ID:RD0524U01RM43.86]

Front View of the erosion.

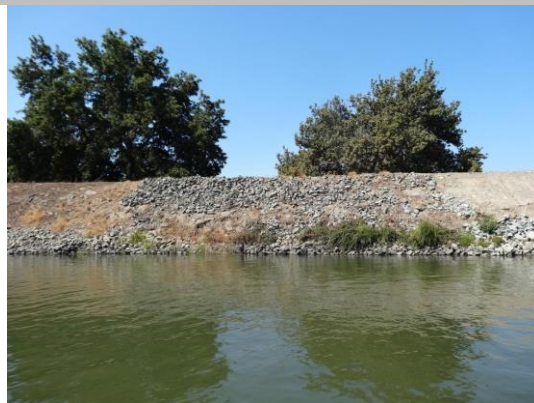
Photo 2 of 4 : FA_2018_RD0524_107_79_20180906_00137.jpg

Front view of the erosion.

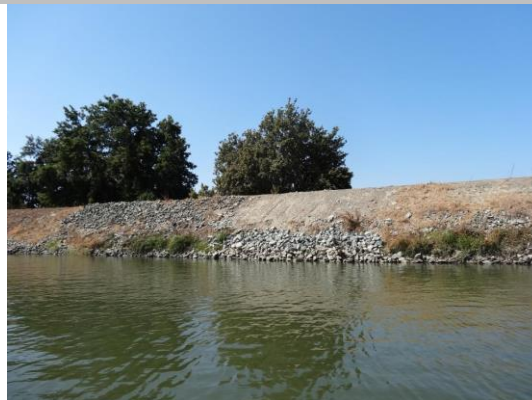
Photo 4 of 4 : FA_2018_RD0524_107_79_20180906_00139.jpg

LM Start	3.30	Rating **	U	Issue No.	79 (cont)
LM End	3.32	Issue Type +	Ma	Location *	WS
Category	Supplemental			GPS Latitude/Longitude	
				Start	End
Item	DWR Erosion Survey			37.908090 °	37.908090 °
				-121.325090 °	-121.325090 °
DWR ID	RD0524U01RM43.86				
Comment Code					
Inspector Comment					
09/13/2017: No significant change observed.					
07/25/2016: No significant change observed.					
06/24/2015: No significant change observed.					
06/19/2014: No significant change observed.					
08/13/2013: The levee toe seems to have been protected by river rocks and vegetation on site. [2017 Site ID:RD0524U01RM43.86]

Front View of the erosion.

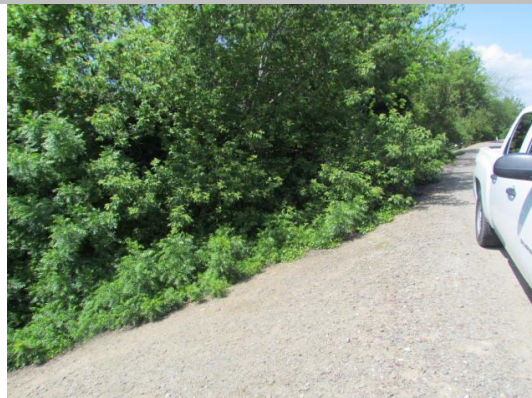
Photo 1 of 2 : FA_2018_RD0524_107_926_20180906_00367.jpg

Looking southwest at dense veg on landward slope.

LM Start	3.30	Rating **	U	Issue No.	926
LM End	3.37	Issue Type +	Ma	Location *	LS
Category	Earthen Levee			GPS Latitude/Longitude	
				Start	End
Item	Trim / Thin Trees			37.908158°	37.907112°
				-121.325418°	-121.325350°
DWR ID	DWR_RD0524_01_s_2012_926				
Comment Code					
T1 : Trim trees to at least five feet above ground level.					
Inspector Comment

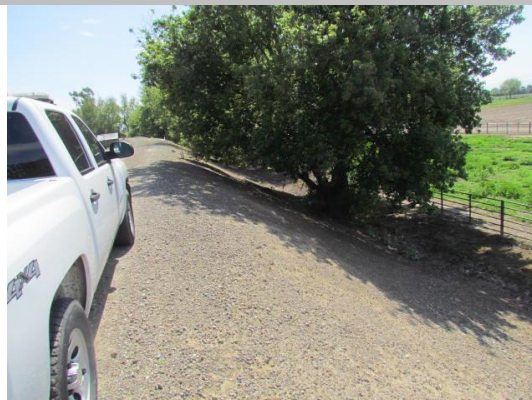
Photo 2 of 2 : FA_2018_RD0524_107_926_20180906_00368.jpg

Looking at untrimmed trees on landward slope and toe.

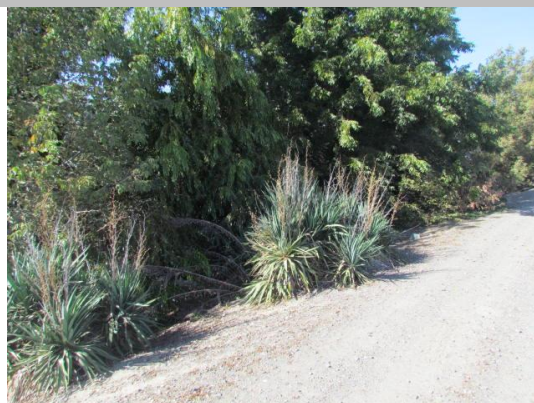
Photo 1 of 1 : FA_2018_RD0524_107_54_20180906_00095.jpg

LM Start	3.45	Rating **	U	Issue No.	54
LM End	3.45	Issue Type +	Ma	Location *	LS
Category	Earthen Levee			GPS Latitude/Longitude	
				Start	End
Item	Trim / Thin Trees			37.906227 °	37.906227 °
				-121.324683 °	-121.324683 °
DWR ID	DWR_RD0524_01_s_2012_54				
Comment Code					
T3 : Trim and thin trees to allow visibility of the ground and room to flood fight.					
Inspector Comment					
Dense untrimmed trees on landside slope.

Looking northwest at dense vegetation on landside slope.

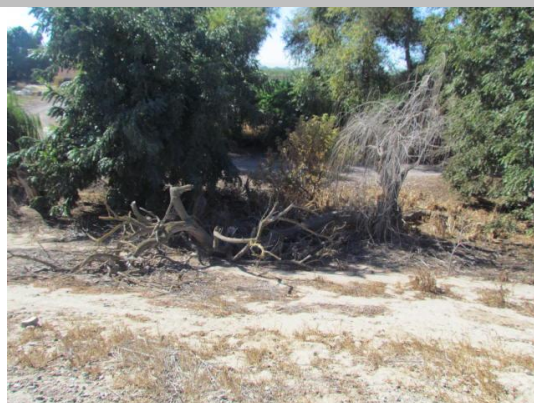
Photo 1 of 1 : FA_2018_RD0524_107_177_20180906_00233.jpg

LM Start	3.48	Rating **	M	Issue No.	177
LM End	3.48	Issue Type +	Ma	Location *	LS
Category	Earthen Levee			GPS Latitude/Longitude	
				Start	End
Item	Encroachments			37.905994 °	37.905994 °
				-121.324194 °	-121.324194 °
DWR ID	DWR_RD0524_01_f_2014_177				
Comment Code					
TR : Tree or limb					
Inspector Comment					
Dead tree on landside toe.

Looking at dead tree limb at landward toe fall 2015.
