**Flood Control Project Maintenance
Levee Inspections**

Maintenance Issue Types Only, Levee Inspection Report By Mile - Fall 2018

Reclamation District No. 0524 Middle Roberts Island

Waterway	Bank	Unit Miles	Inspection Start/End	Inspector
Unit No. 01 San Joaquin River	Left	6.20	09/11/2018 09/11/2018	Richard Willoughby

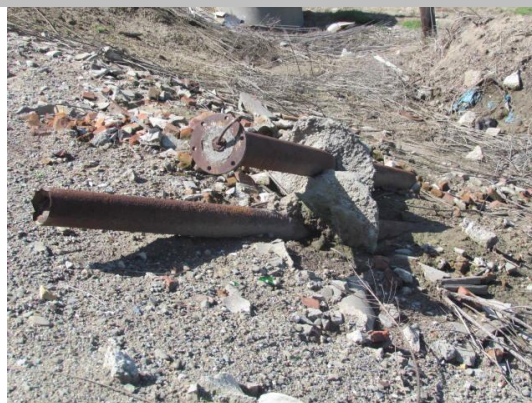
Photo 1 of 1 : FA_2018_RD0524_107_213_20180906_00280.jpg

LM Start	4.16	Rating **	M	Issue No.	213
LM End	4.16	Issue Type +	Ma	Location *	LS
Category	Earthen Levee			GPS Latitude/Longitude	
				Start	End
Item	Encroachments			37.897235 °	37.897235 °
				-121.327865 °	-121.327865 °
DWR ID	DWR_RD0524_01_s_2016_213				
Comment Code					
GA : Garbage					
Inspector Comment					
Old fence post and concrete and brick rubble on landside slope.

Looking west at old fence post and concrete rubble on landward slope.

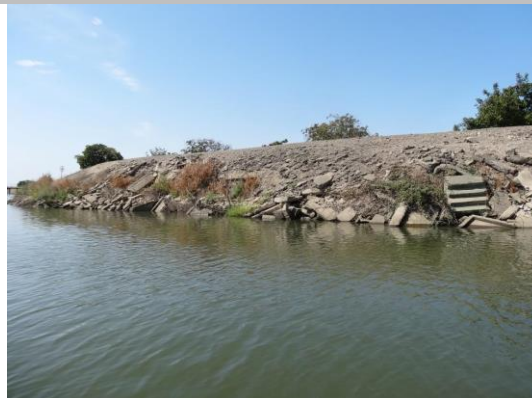
Photo 1 of 3 : FA_2018_RD0524_107_90_20180906_00152.jpg

LM Start	4.53	Rating **	A/W	Issue No.	90
LM End	4.54	Issue Type +	Ma	Location *	WS
Category	Supplemental			GPS Latitude/Longitude	
				Start	End
Item	DWR Erosion Survey			37.892230 °	37.892230 °
				-121.327930 °	-121.327930 °
DWR ID	RD0524U01RM45.07				
Comment Code					
Inspector Comment					
09/13/2017: No significant change observed.					
07/25/2016: No significant change observed.					
06/24/2015: No significant change observed.					
06/19/2014: No significant change observed.					
08/13/2013: No significant change observed.					
08/07/2012: The erosion is located at the inside of a river bend. Site is covered with broken concrete blocks and other debris. [2017 Site ID:RD0524U01RM45.07]

Front view of the erosion site.

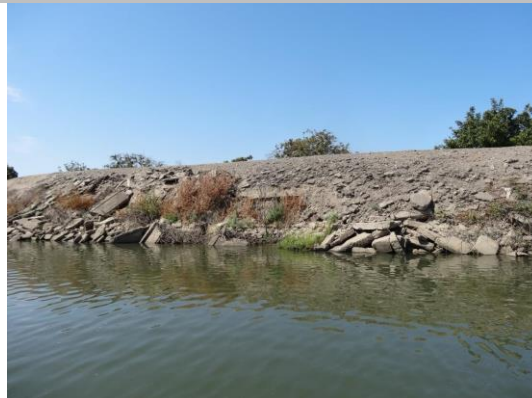
Photo 2 of 3 : FA_2018_RD0524_107_90_20180906_00153.jpg

Close view of the site.

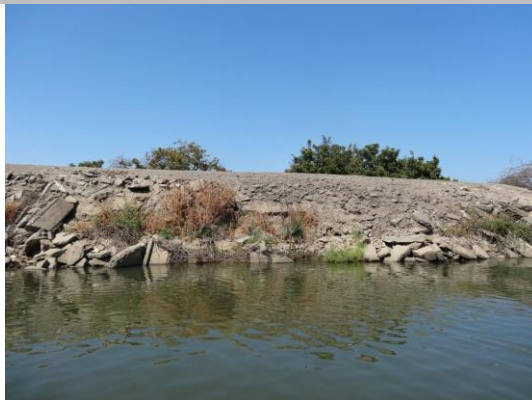
Photo 3 of 3 : FA_2018_RD0524_107_90_20180906_00154.jpg

LM Start	4.53	Rating **	A/W	Issue No.	90 (cont)
LM End	4.54	Issue Type +	Ma	Location *	WS
Category	Supplemental			GPS Latitude/Longitude	
				Start	End
Item	DWR Erosion Survey			37.892230 °	37.892230 °
				-121.327930 °	-121.327930 °
DWR ID	RD0524U01RM45.07				
Comment Code					
Inspector Comment					
09/13/2017: No significant change observed.					
07/25/2016: No significant change observed.					
06/24/2015: No significant change observed.					
06/19/2014: No significant change observed.					
08/13/2013: No significant change observed.					
08/07/2012: The erosion is located at the inside of a river bend. Site is covered with broken concrete blocks and other debris. [2017 Site ID:RD0524U01RM45.07]

Front view of the site. Note the loosely placed concrete blocks at the site.

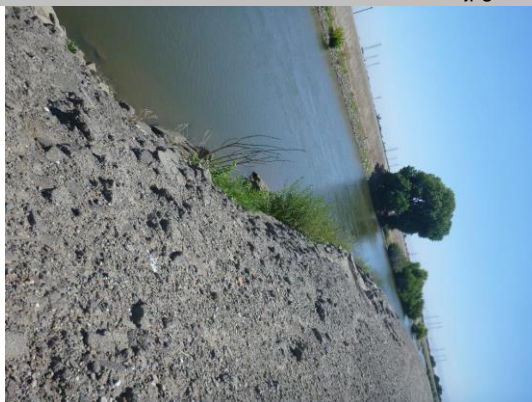
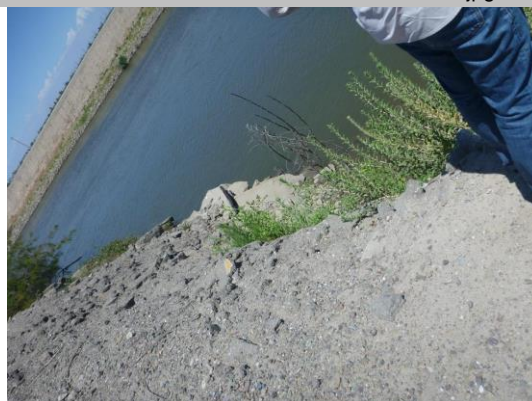
Photo 1 of 3 : LEVAL_FA_2018_468_2219.jpg

Comment Code					
Inspector Comment					
Levee Evaluation Comments					
Description:Slope protection repairs are needed along the waterside slope due to erosion. Based upon levee inspections, it was determined the waterside levee slopes were eroding, deteriorating and degrading in concave pocket sections at various locations along this levee reach. The eroded levee sections need to be restored back to design standards to prevent further deterioration of the damaged levee sections.					
Site ID No:468					
Site Designation:LMA-295					
Repair Type: Erosion					
Rating:Serious					
Field Date:7/26/2017					
Notes: Serious because erosion is impacting the levee, but there is some slope protection here. Slope is armored with asphalt and concrete rubble. The surrounding slopes are pretty baren, but there is a small bush within the site so it may be older.

Description: Slope protection repairs are needed along the waterside slope due to erosion. Based upon levee inspections, it was determined the waterside levee slopes were eroding, deteriorating and degrading in concave pocket sections at various locations along this levee reach. The eroded levee sections need to be restored back to design standards to prevent further deterioration of the damaged levee sections.

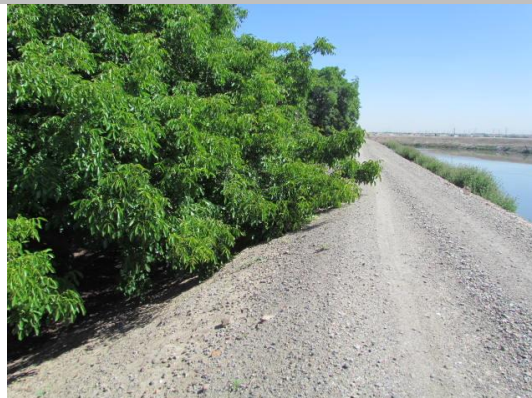
Photo 1 of 1 : FA_2018_RD0524_107_113_20180906_00178.jpg

LM Start	4.63	Rating **	M	Issue No.	113
LM End	4.63	Issue Type +	Ma	Location *	LS
Category	Earthen Levee			GPS Latitude/Longitude	
				Start	End
Item	Trim / Thin Trees			37.890973 °	37.890973 °
				-121.328970 °	-121.328970 °
DWR ID	DWR_RD0524_01_s_2012_113				
Comment Code					
T1 : Trim trees to at least five feet above ground level.					
Inspector Comment

Looking north at dense trees on landside slope.

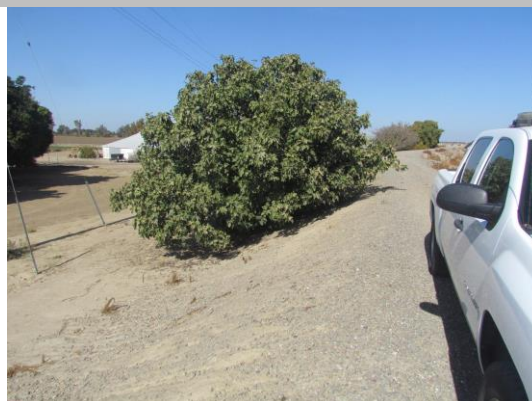
Photo 1 of 1 : FA_2018_RD0524_107_67_20180906_00116.jpg

LM Start	4.70	Rating **	U	Issue No.	67
LM End	4.70	Issue Type +	Ma	Location *	LS
Category	Earthen Levee			GPS Latitude/Longitude	
				Start	End
Item	Trim / Thin Trees			37.890108 °	37.890108 °
				-121.329523 °	-121.329523 °
DWR ID	DWR_RD0524_01_s_2012_67				
Comment Code					
T1 : Trim trees to at least five feet above ground level.					
Inspector Comment					
Fig tree at landside toe.

Looking northwest at untrimmed tree on landward slope.

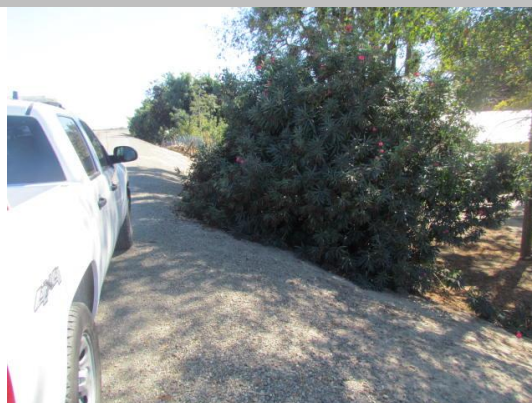
Photo 1 of 1 : FA_2018_RD0524_107_188_20180906_00249.jpg

LM Start	5.05	Rating **	U	Issue No.	188
LM End	5.07	Issue Type +	Ma	Location *	LS
Category	Earthen Levee			GPS Latitude/Longitude	
				Start	End
Item	Trim / Thin Trees			37.885673 °	37.885315 °
				-121.332122 °	-121.332139 °
DWR ID	DWR_RD0524_01_s_2014_188				
Comment Code					
T1 : Trim trees to at least five feet above ground level.					
Inspector Comment					
Untrimmed trees on landside slope and toe.

Looking south at oleander on landward slope.

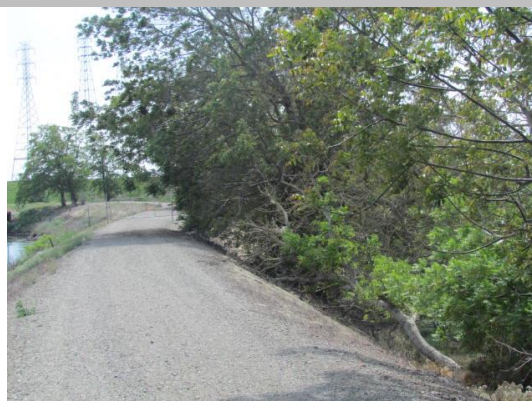
Photo 1 of 1 : FA_2018_RD0524_107_932_20180906_00370.jpg

LM Start	5.38	Rating **	U	Issue No.	932
LM End	5.41	Issue Type +	Ma	Location *	LS
Category	Earthen Levee			GPS Latitude/Longitude	
				Start	End
Item	Trim / Thin Trees			37.880945 °	37.880522 °
				-121.332837 °	-121.332918 °
DWR ID	DWR_RD0524_01_s_2012_932				
Comment Code					
T1 : Trim trees to at least five feet above ground level.					
Inspector Comment

Looking south at untrimmed trees on landward slope and toe.

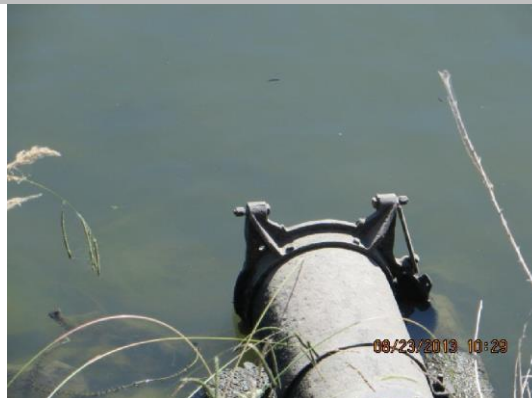
Photo 3 of 3 : UCIP_FA_2018_53358_30687.jpg

Comment Code						
Inspector Comment						
FS_ID:53358 DS_ID:20630 EP_NO: N/A Repair Type: Urgent Crossing Status: Found UCIP Comments: 10/2/2018 Same as last inspection. Holes present in pipe pose a potential threat to levee's internal integrity. Recommend video inspection (D. Sanoski - DWR UCIP).11/16/2016 same as previous inspection hole in pipe is still pressent on WS near toe. This pipe does not appear to be in use. Need to contact owner to determine status of crossing. If the crossing is abandoned or still in use, owner will need to coordinate with the CVFPB to comply with Title 23 requirements. (O. Magana - DWR UCIP)08/23/2013 flap gate damage and does not work at WS toe. Large hole in pipe at WS toe. Pipe appears abandoned and should be done so properly. (W. Wylie - DWR UCIP) FIELD_STRUCT_DESC: *ABANDONED* 1 of 2: 12-inch steel irrigation pipe through the levee, 6 feet below the crown. Pump located on the waterside (WS), no pump found in 2013. Flap gate located on the WS end. [Additional Reference(s): DWR Levee Log, 2004. USACE San Joaquin O&M Manual 7, April 1964, (HLM 5.48) 10-inch pipe listed, Drawing No. 07-04-1490, Sheet 1490/4, (Station 8+01.3)]. FS Date: 10/2/2018 1:34:00 PM

Broken flap gate at WS toe.

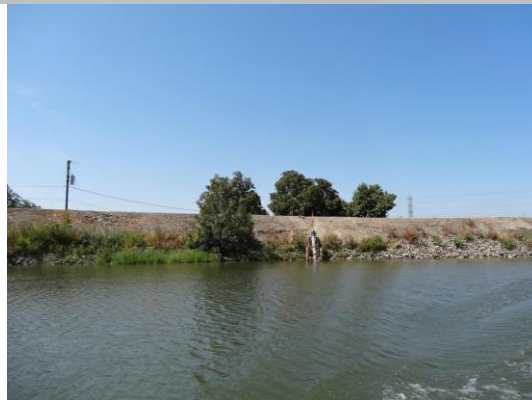
Photo 1 of 2 : FA_2018_RD0524_107_93_20180906_00157.jpg

LM Start	5.86	Rating **	U	Issue No.	93
LM End	5.86	Issue Type +	Ma	Location *	WS
Category	Supplemental			GPS Latitude/Longitude	
				Start	End
Item	DWR Erosion Survey			37.874370 °	37.874370 °
				-121.332850 °	-121.332850 °
DWR ID	RD0524U01RM46.39				
Comment Code					
Inspector Comment					
09/13/2017: No significant change observed.					
07/25/2016: No significant change observed.					
06/24/2015: No significant change observed.					
06/19/2014: No significant change observed.					
08/13/2013: No significant change observed.					
08/07/2012: The erosion is near a water-intake structure. Pipe leakage likely caused the erosion. [2017 Site ID:RD0524U01RM46.39]

Front view of the site.

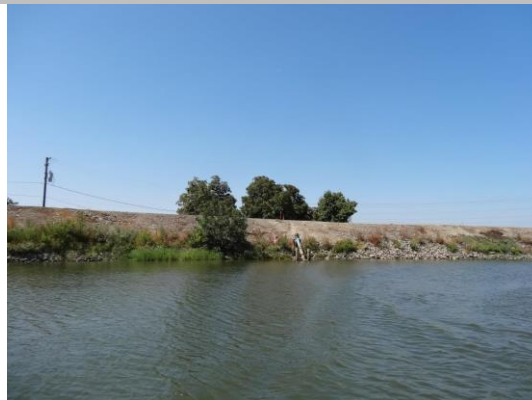
Photo 2 of 2 : FA_2018_RD0524_107_93_20180906_00158.jpg

View of the erosion.

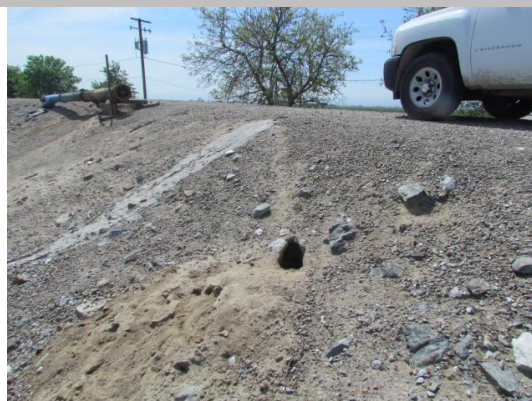
Photo 1 of 2 : FA_2018_RD0524_107_75_20180906_00131.jpg

LM Start	5.86	Rating **	M	Issue No.	75
LM End	5.88	Issue Type +	Ma	Location *	WS
Category	Earthen Levee			GPS Latitude/Longitude	
				Start	End
Item	Animal Control			37.874240 °	37.874002 °
				-121.333187 °	-121.333027 °
DWR ID	DWR_RD0524_01_s_2012_75				
Comment Code					
A1 : Exterminate rodents and backfill and compact or grout burrows.					
Inspector Comment					
District has grouted rodent holes, but other rodent holes have appeared. Active rodents in area.

Looking southwest at typical rodent holes on waterward slope.

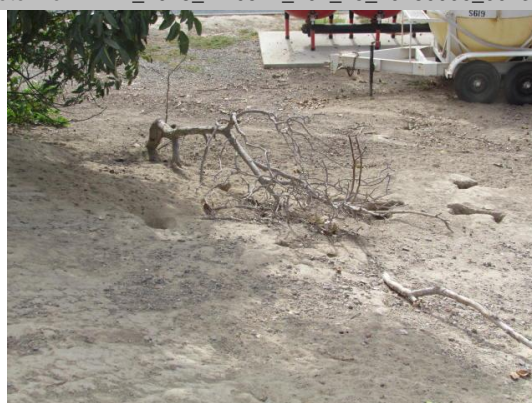
Photo 2 of 2 : FA_2018_RD0524_107_75_20180906_00132.jpg

Looking typical view of several rodent holes on landward slope and toe.
