**Flood Control Project Maintenance
Levee Inspections**

Maintenance Issue Types Only, Levee Inspection Report By Mile - Fall 2019

Reclamation District No. 0524 Middle Roberts Island

Waterway	Bank	Unit Miles	Inspection Start/End	Inspector
Unit No. 01 San Joaquin River	Left	6.20	10/02/2019 11/14/2019	Alberto De Leon

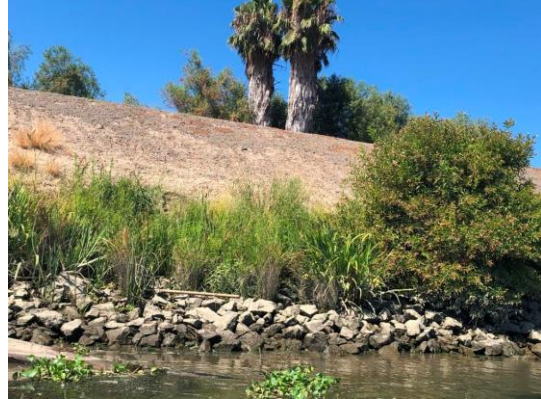
Photo 1 of 3 : SJR2019_RD0524U01RM40.85_4.JPG

Close-up view of the erosion.

LM Start	0.18	Rating **	U	Issue No.	1 (cont)	
LM End	0.18	Issue Type +	Ma	Location *		
Category	Supplemental			GPS Latitude/Longitude		
				Start		End
Item	DWR Erosion Survey			37.939085 °		37.939085 °
				-121.343917 °		-121.343917 °
DWR ID	RD0524U01RM40.85					
Comment Code						
Inspector Comment						
Site ID: RD0524U01RM40.85 08/13/2019: No significant change observed. 09/13/2017: No significant change observed. 07/25/2016: No significant change observed. 06/24/2015: No significant change observed. 06/19/2014: No significant change observed. 08/13/2013: The erosion was discovered during 2013 spring levee inspection. Inspector comment: Erosion is located along the lower level of water-ward slope.

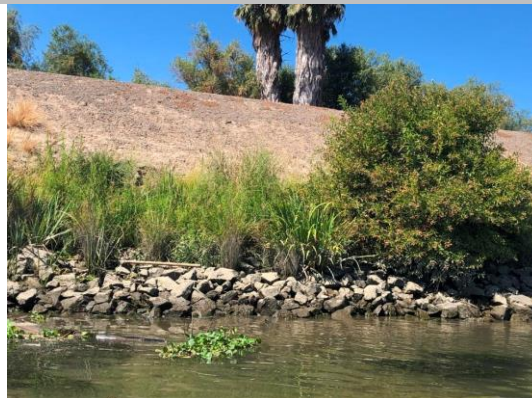
Photo 3 of 3 : SJR2019_RD0524U01RM40.85_2.JPG

Front view of the erosion.

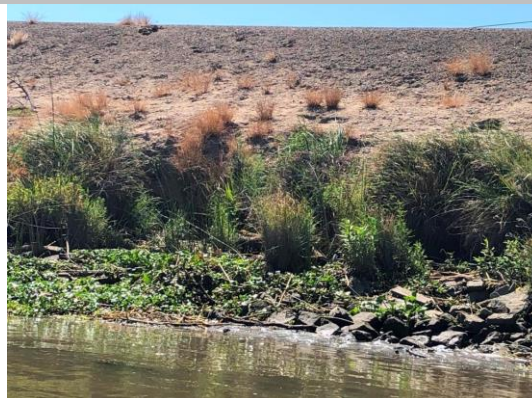
Photo 3 of 3 : SJR2019_RD0524U01RM40.93_3.JPG

LM Start	0.34	Rating **	M	Issue No.	2 (cont)	
LM End	0.34	Issue Type +	Ma	Location *		
Category	Supplemental			GPS Latitude/Longitude		
				Start		End
Item	DWR Erosion Survey			37.938461 °		37.938461 °
				-121.341526 °		-121.341526 °
DWR ID	RD0524U01RM40.93					
Comment Code						
Inspector Comment						
Site ID: RD0524U01RM40.93						
08/13/2019: No significant change observed.						
09/13/2017: There are two pocket erosions at the site; both erosions are around 10 ft long and 6 ft high.

Close-up view of the erosion site.

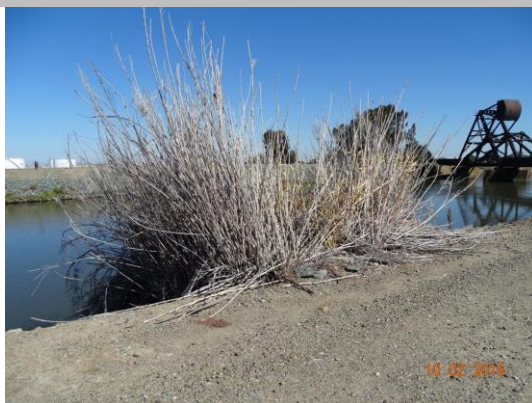
Photo 1 of 2 : FA_2019_RD0524_107_14_20191117_00363.jpg

LM Start	0.67	Rating **	U	Issue No.	14
LM End	0.67	Issue Type +	Ma	Location *	WS
Category	Earthen Levee			GPS Latitude/Longitude	
				Start	End
Item	Vegetation			37.937808 °	37.937808 °
				-121.335913 °	-121.335913 °
DWR ID	DWR_RD0524_01_s_2012_14				
Comment Code					
V2 : Remove the wild growth other than native grasses from the levee slopes.					
Inspector Comment					
Arundo on waterside slope

View of bamboo on waterside slope. Fall 2019

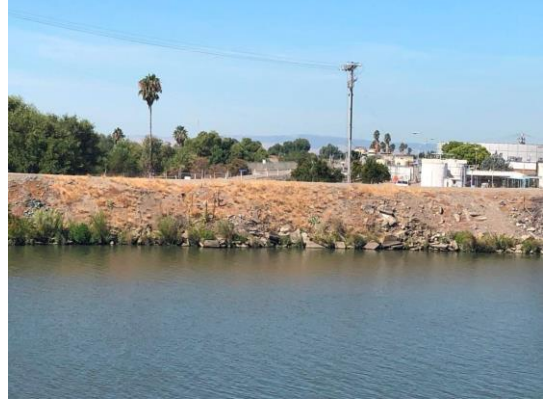
Photo 1 of 2 : SJR2019_RD0524U01RM41.34_1.JPG

LM Start	0.70	Rating **	M	Issue No.	16	
LM End	0.70	Issue Type +	Ma	Location *		
Category	Supplemental			GPS Latitude/Longitude		
				Start	End	
Item	DWR Erosion Survey			37.937577 °	37.937577 °	
				-121.335491 °	-121.335491 °	
DWR ID	RD0524U01RM41.34					
Comment Code						
Inspector Comment						
Site ID: RD0524U01RM41.34						
08/22/2019: No significant change observed.						
09/13/2017: Pocket erosion above the protected levee toe.

Front view of the erosion.

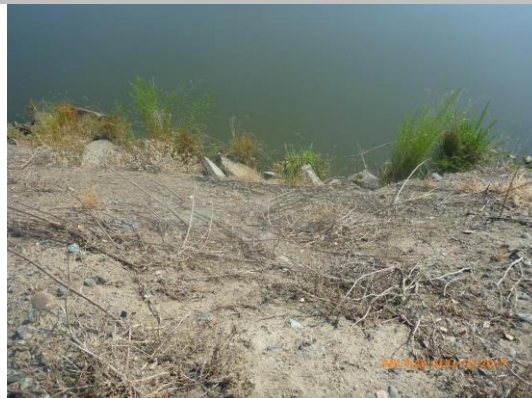
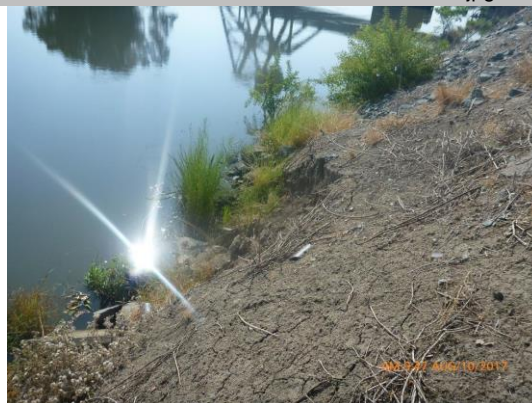
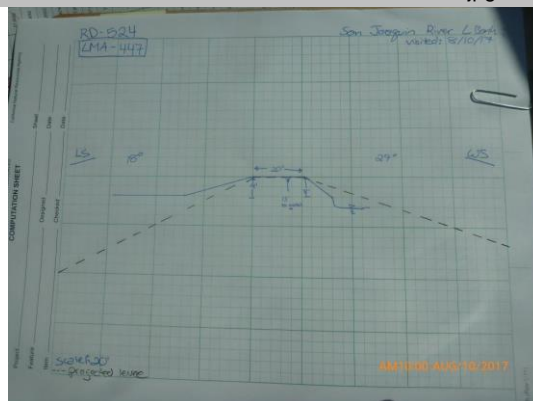
LM Start	0.70	Rating **	A/W	Issue No.	153
LM End	0.70	Issue Type +	Ma	Location *	
Category	Supplemental			GPS Latitude/Longitude	
				Start	End
Item	2017 Storm Damage			37.937500 °	37.937500 °
				-121.335500 °	-121.335500 °
DWR ID	LMA-447				
Comment Code					
Inspector Comment					
Levee Evaluation Comments					
Description:Slope protection repairs are needed along the waterside slope due to erosion and riprap displacement from high water. Based upon levee inspections, it was determined the waterside levee slope is eroding, deteriorating, and degrading. The eroded levee sections need to be restored back to design standards to prevent further deterioration and damage.					
Site ID No:541					
Site Designation:LMA-447					
Repair Type: Erosion					
Rating:Area of Concern					
Field Date:8/10/2017					
Notes:

LM Start	0.70	Rating **	A/W	Issue No.	153 (cont)
LM End	0.70	Issue Type +	Ma	Location *	
Category	Supplemental			GPS Latitude/Longitude	
				Start	End
Item	2017 Storm Damage			37.937500°	37.937500°
				-121.335500°	-121.335500°
DWR ID	LMA-447				
Comment Code					
Inspector Comment					
<p>Levee Evaluation Comments</p> <p>Description: Slope protection repairs are needed along the waterside slope due to erosion and riprap displacement from high water. Based upon levee inspections, it was determined the waterside levee slope is eroding, deteriorating, and degrading. The eroded levee sections need to be restored back to design standards to prevent further deterioration and damage.</p> <p>Site ID No: 541</p> <p>Site Designation: LMA-447</p> <p>Repair Type: Erosion</p> <p>Rating: Area of Concern</p> <p>Field Date: 8/10/2017</p> <p>Notes:</p>

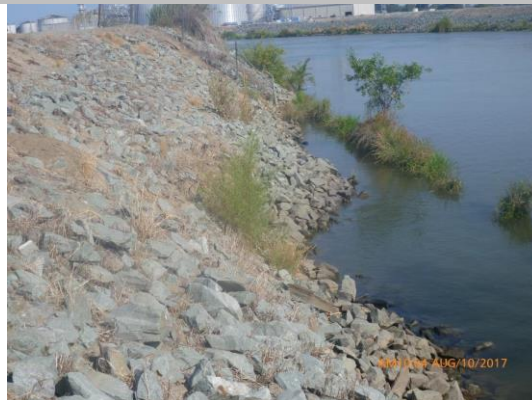
Photo 1 of 3 : LEVAL_FA_2019_540_4087.jpg

Description: Slope protection repairs are needed along the waterside slope due to erosion and riprap displacement from high water. Based upon levee inspections, it was determined the waterside levee slope is eroding, deteriorating, and degrading. The eroded levee sections need to be restored back to design standards to prevent further deterioration and damage.

LM Start	0.72	Rating **	A/W	Issue No.	154 (cont)	
LM End	0.73	Issue Type +	Ma	Location *		
Category	Supplemental			GPS Latitude/Longitude		
				Start	End	
Item	2017 Storm Damage			37.937200 °	37.937100 °	
				-121.335300 °	-121.335300 °	
DWR ID	LMA-446					
Comment Code						
Inspector Comment						
Levee Evaluation Comments						
Description:Slope protection repairs are needed along the waterside slope due to erosion and riprap displacement from high water. Based upon levee inspections, it was determined the waterside levee slope is eroding, deteriorating, and degrading. The eroded levee sections need to be restored back to design standards to prevent further deterioration and damage.						
Site ID No:540						
Site Designation:LMA-446						
Repair Type: Erosion						
Rating:Area of Concern						
Field Date:8/10/2017						
Notes:

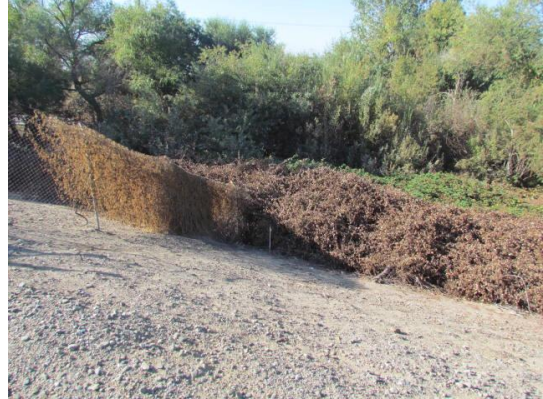
Photo 2 of 3 : FA_2019_RD0524_107_262_20190830_00245.jpg

Looking west at dense vegetation at landward slope and toe fall 2015.

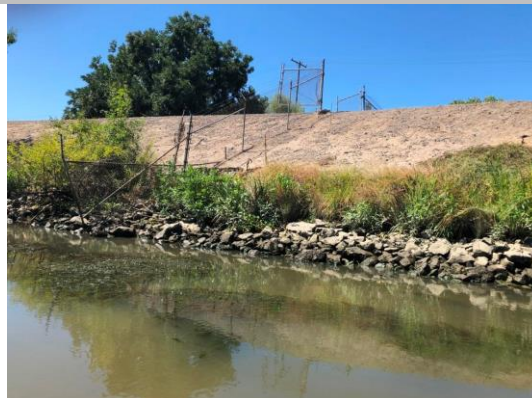
Photo 3 of 3 : SJR2019_RD0524U01RM41.39_3.jpg

LM Start	0.76	Rating **	U	Issue No.	21 (cont)	
LM End	0.77	Issue Type +	Ma	Location *		
Category	Supplemental			GPS Latitude/Longitude		
				Start	End	
Item	DWR Erosion Survey			37.936821 °	37.936821 °	
				-121.334582 °	-121.334582 °	
DWR ID	RD0524U01RM41.39					
Comment Code						
Inspector Comment						
Site ID: RD0524U01RM41.39						
08/13/2019: No significant change observed.						
09/13/2017: No significant change observed.						
07/25/2016: No significant change observed.						
06/24/2015: No significant change observed.						
06/19/2014: No significant change observed.						
08/13/2013: No significant change at this site.						
08/07/2012: The site has been visited by boat survey. No significant change observed.						
08/23/2011: The site is located immediately upstream of a Railroad bridge. Dense vegetation at the water line blocks the view of erosion.

Downstream view of the erosion.

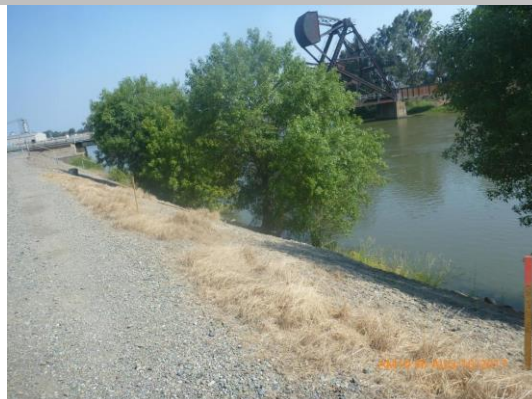
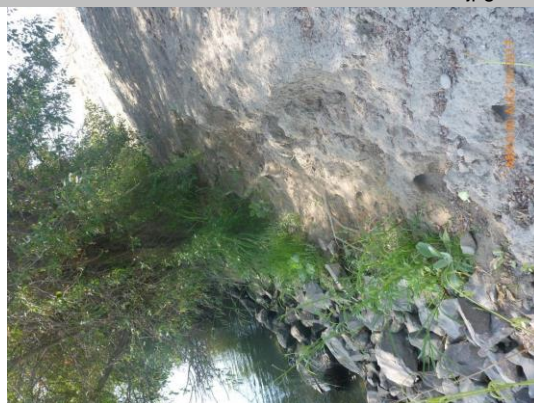
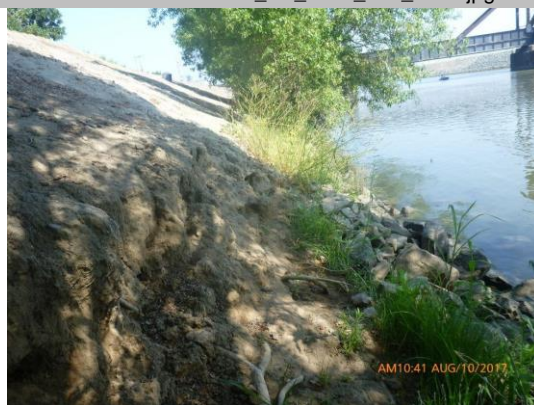
LM Start	0.79	Rating **	A/W	Issue No.	155
LM End	0.80	Issue Type +	Ma	Location *	WS
Category	Supplemental			GPS Latitude/Longitude	
				Start	End
Item	2017 Storm Damage			37.936300 °	37.936200 °
				-121.334700 °	-121.334600 °
DWR ID	LMA-444				
Comment Code					
Inspector Comment					
Levee Evaluation Comments					
Description:Slope protection repairs are needed along the waterside slope due to erosion and riprap displacement from high water. Based upon levee inspections, it was determined the waterside levee slope is eroding, deteriorating, and degrading. The eroded levee sections need to be restored back to design standards to prevent further deterioration and damage.					
Site ID No:538					
Site Designation:LMA-444					
Repair Type: Erosion					
Rating:Area of Concern					
Field Date:8/10/2017					
Notes:

LM Start	0.79	Rating **	A/W	Issue No.	155 (cont)	
LM End	0.80	Issue Type +	Ma	Location *	WS	
Category	Supplemental			GPS Latitude/Longitude		
				Start	End	
Item	2017 Storm Damage			37.936300 °	37.936200 °	
				-121.334700 °	-121.334600 °	
DWR ID	LMA-444					
Comment Code						
Inspector Comment						
Levee Evaluation Comments						
Description:Slope protection repairs are needed along the waterside slope due to erosion and riprap displacement from high water. Based upon levee inspections, it was determined the waterside levee slope is eroding, deteriorating, and degrading. The eroded levee sections need to be restored back to design standards to prevent further deterioration and damage.						
Site ID No:538						
Site Designation:LMA-444						
Repair Type: Erosion						
Rating:Area of Concern						
Field Date:8/10/2017						
Notes:

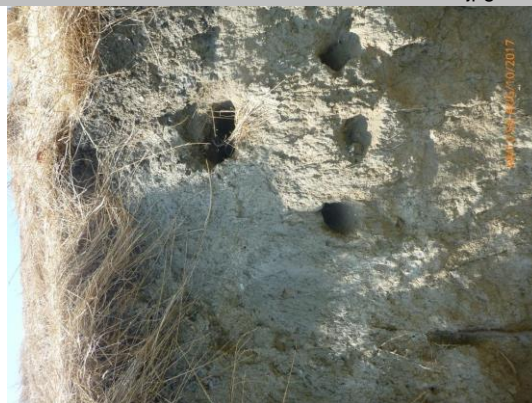
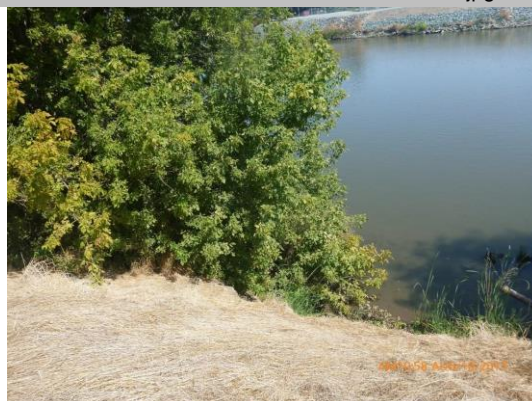
LM Start	0.90	Rating **	A/W	Issue No.	193 (cont)
LM End	0.91	Issue Type +	Ma	Location *	
Category	Supplemental			GPS Latitude/Longitude	
				Start	End
Item	2017 Storm Damage			37.935400 °	37.935300 °
				-121.333300 °	-121.333200 °
DWR ID	LMA-443				
Comment Code					
Inspector Comment					
Levee Evaluation Comments					
Description:Slope protection repairs are needed along the waterside slope due to erosion and riprap displacement from high water. Based upon levee inspections, it was determined the waterside levee slope is eroding, deteriorating, and degrading. The eroded levee sections need to be restored back to design standards to prevent further deterioration and damage.					
Site ID No:537					
Site Designation:LMA-443					
Repair Type: Erosion					
Rating:Serious					
Field Date:8/10/2017					
Notes:

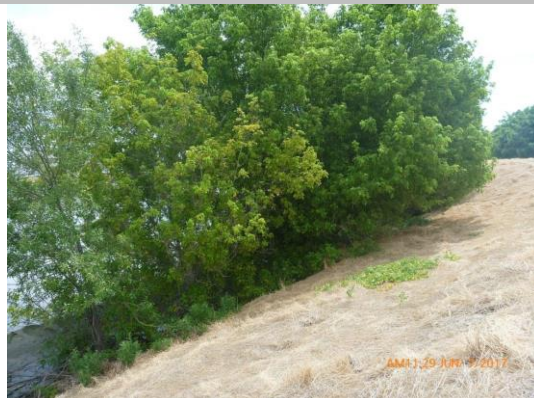
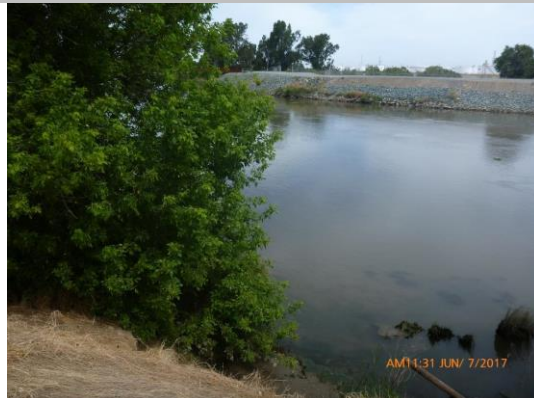
LM Start	0.91	Rating **	A/W	Issue No.	187
LM End		Issue Type +	Ma	Location *	
Category	Supplemental			GPS Latitude/Longitude	
				Start	End
Item	2017 Storm Damage			37.935580°	°
				-121.333200°	°
DWR ID	DWR_RD0524_01_s_2012_99				
Comment Code					
Inspector Comment					
Levee Evaluation Comments					
Description:					
Site ID No:87					
Site Designation:DWR_RD0524_01_s_2012_99					
Repair Type: Erosion					
Rating:Area of Concern					
Field Date:6/7/2017					
Notes: no observable defects to levee, vegetation blocks ws toe

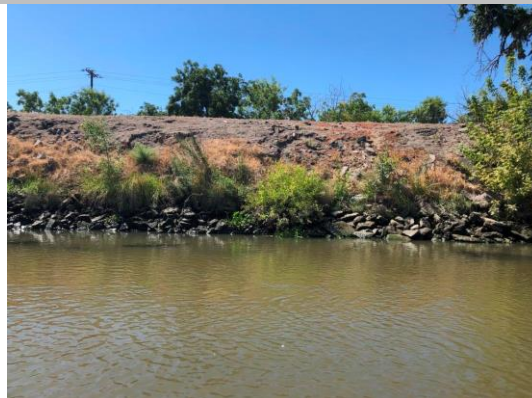
Photo 1 of 3 : SJR2019_RD0524U01RM41.58_1.jpg

Front view of the erosion.

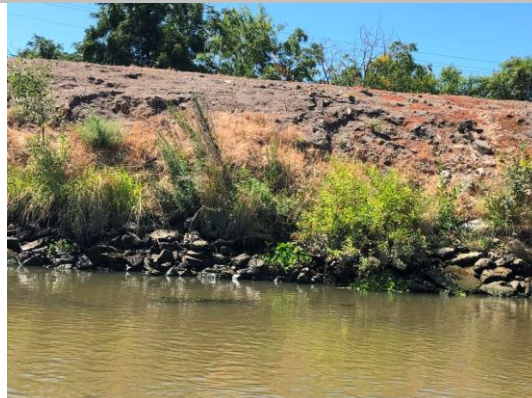
Photo 2 of 3 : SJR2019_RD0524U01RM41.58_3.jpg

Close-up view of the erosion.

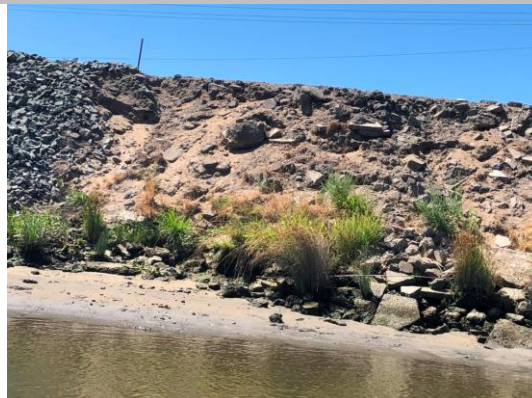
Photo 2 of 3 : SJR2019_RD0524U01RM41.59_3.jpg

Close-up view of the erosion.

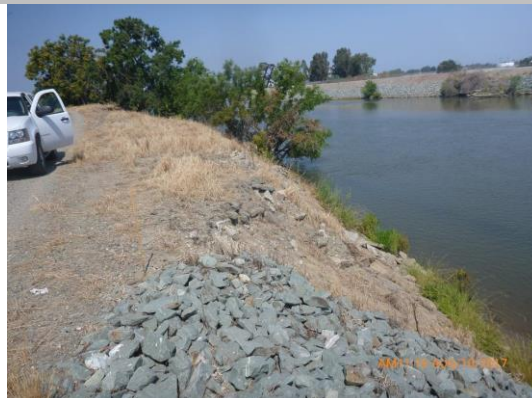
Photo 3 of 3 : LEVAL_FA_2019_536_4111.jpg

Comment Code					
Inspector Comment					
Levee Evaluation Comments					
Description:Slope protection repairs are needed along the waterside slope due to erosion and riprap displacement from high water. Based upon levee inspections, it was determined the waterside levee slope is eroding, deteriorating, and degrading. The eroded levee sections need to be restored back to design standards to prevent further deterioration and damage.					
Site ID No:536					
Site Designation:LMA-442					
Repair Type: Erosion					
Rating:Area of Concern					
Field Date:8/10/2017					
Notes: Appears to be previous repair site adjacent to LMA-442. Large fox den on land side

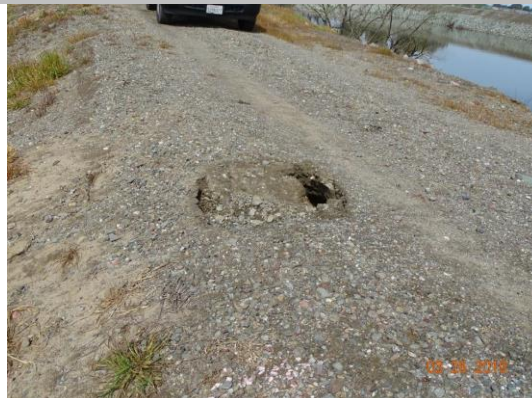
Photo 1 of 3 : FA_2019_RD0524_107_238_20190830_00233.jpg

LM Start	1.02	Rating **	U	Issue No.	238
LM End	1.02	Issue Type +	Ma	Location *	LS
Category	Earthen Levee			GPS Latitude/Longitude	
				Start	End
Item	Animal Control			37.934991 °	37.934991 °
				-121.331160 °	-121.331160 °
DWR ID	DWR_RD0524_01_f_2017_238				
Comment Code					
A3 : No rodents visible, but rodent burrows visible; need to backfill and compact or grout burrows.					
Inspector Comment					
Multiple large rodent holes on landward slope and toe. Large hole on crown near landside shoulder

Large rodent hole landside shoulder looking downstream. Spring 2019.

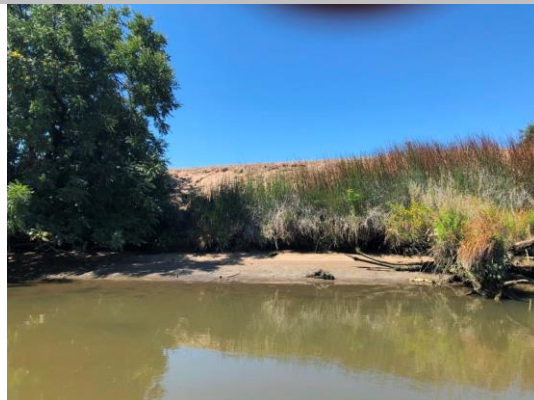
Photo 1 of 3 : SJR2019_RD0524U01RM41.79_1.jpg

Direct view of the site.

Comment Code						
Inspector Comment						
Site ID: RD0524U01RM41.79 08/13/2019: No significant change observed. 09/13/2017: No significant change observed. 07/25/2016: No significant change observed. 06/24/2015: No significant change observed. 06/19/2014: No significant change observed. 08/13/2013: No significant change at this site. 08/07/2012: The site has been visited by boat survey. No significant change observed 08/23/2011: No significant change observed on site. 09/07/2010: No significant change observed on site. Vegetation is visible at the water line. There is an exposed pipe discharge partially hanging at the mid-slope, possibly still used for discharging irrigation/runoff water. There is minimal rip rap protection along the bank, and what's left of it is no longer adequately protecting the bank. 9/29/2009: Site consists of a 400-foot long eroding bank with minimal vegetation and protection; the existing rip rap has sloughed, rendering it useless; note that there is an exposed section of a pipe. 10/18/2006: There is extensive loss of rip rap on some sections; sewage disposal pond is on the landside of the levee; there is an exposed pipe outlet "hanging" from the upper slope.

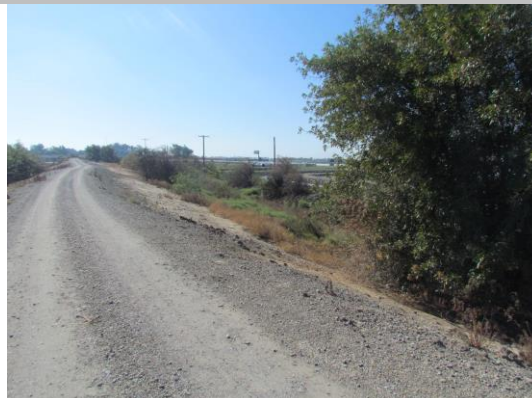
Photo 1 of 1 : FA_2019_RD0524_107_915_20190830_00254.jpg

LM Start	1.16	Rating **	M	Issue No.	915
LM End	1.23	Issue Type +	Ma	Location *	LS
Category	Earthen Levee			GPS Latitude/Longitude	
				Start	End
Item	Vegetation			37.933775 °	37.932784 °
				-121.329250 °	-121.328765 °
DWR ID	DWR_RD0524_01_s_2012_915				
Comment Code					
V2 : Remove the wild growth other than native grasses from the levee slopes.					
Inspector Comment					
Control veg at landside toe.

Looking southwest at dense veg at landward toe and berm. (Fall 2016)

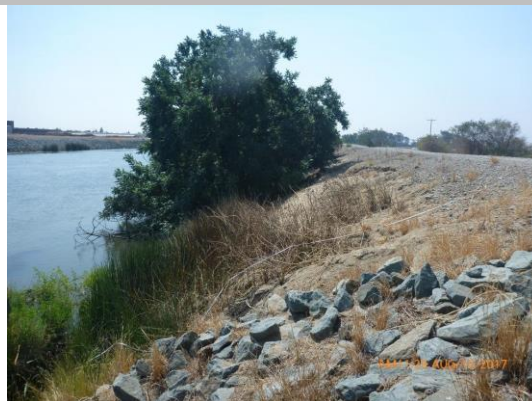
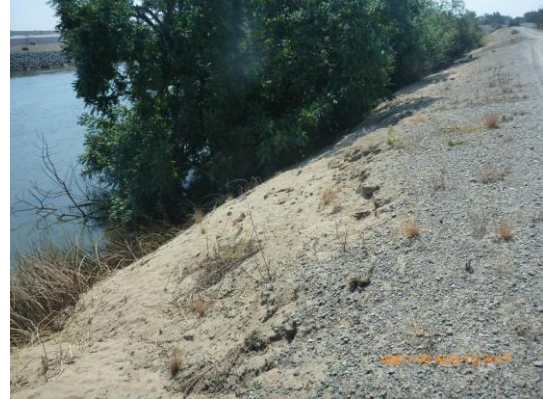
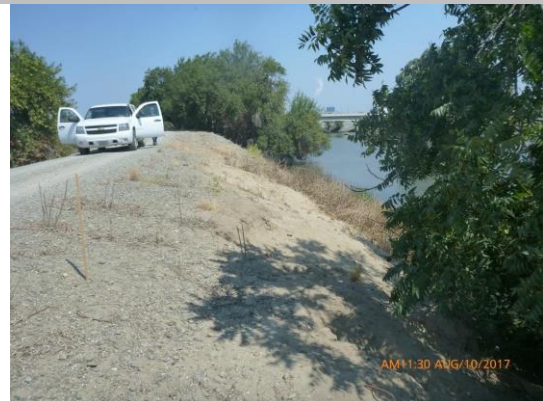
LM Start	1.18	Rating **	A/W	Issue No.	221
LM End	1.20	Issue Type +	Ma	Location *	
Category	Supplemental			GPS Latitude/Longitude	
				Start	End
Item	2017 Storm Damage			37.933500 °	37.933200 °
				-121.329100 °	-121.328900 °
DWR ID	LMA-441				
Comment Code					
Inspector Comment					
Levee Evaluation Comments					
Description:Slope protection repairs are needed along the waterside slope due to erosion and riprap displacement from high water. Based upon levee inspections, it was determined the waterside levee slope is eroding, deteriorating, and degrading. The eroded levee sections need to be restored back to design standards to prevent further deterioration and damage.					
Site ID No:535					
Site Designation:LMA-441					
Repair Type: Erosion					
Rating:Area of Concern					
Field Date:8/10/2017					
Notes:

LM Start	1.18	Rating **	A/W	Issue No.	221 (cont)
LM End	1.20	Issue Type +	Ma	Location *	
Category	Supplemental			GPS Latitude/Longitude	
				Start	End
Item	2017 Storm Damage			37.933500°	37.933200°
				-121.329100°	-121.328900°
DWR ID	LMA-441				
Comment Code					
Inspector Comment					
Levee Evaluation Comments					
Description:Slope protection repairs are needed along the waterside slope due to erosion and riprap displacement from high water. Based upon levee inspections, it was determined the waterside levee slope is eroding, deteriorating, and degrading. The eroded levee sections need to be restored back to design standards to prevent further deterioration and damage.					
Site ID No:535					
Site Designation:LMA-441					
Repair Type: Erosion					
Rating:Area of Concern					
Field Date:8/10/2017					
Notes:

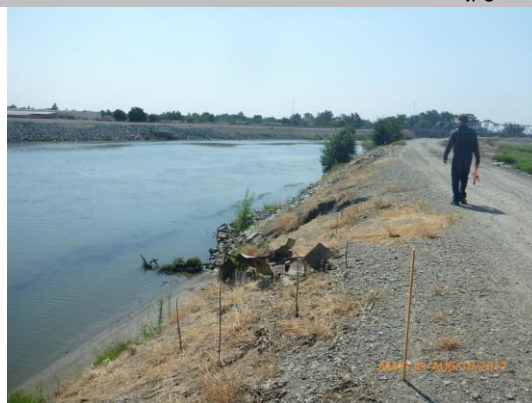
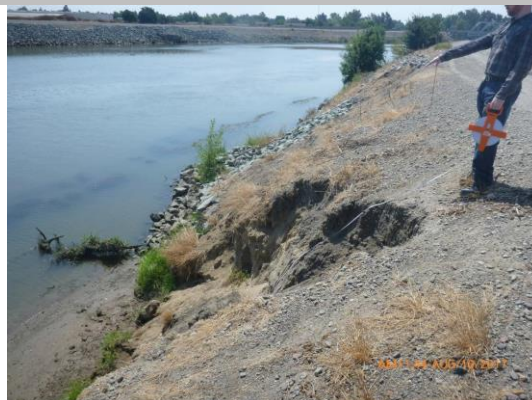
Comment Code					
Inspector Comment					
Levee Evaluation Comments					
Description:Slope protection repairs are needed along the waterside slope due to erosion and riprap displacement from high water. Based upon levee inspections, it was determined the waterside levee slope is eroding, deteriorating, and degrading. The eroded levee sections need to be restored back to design standards to prevent further deterioration and damage.					
Site ID No:534					
Site Designation:LMA-440					
Repair Type: Erosion					
Rating:Serious					
Field Date:8/10/2017					
Notes: site is related to, but not combined with, LMA-439 a portion of this site has been repaired.

Item	2017 Storm Damage		37.932600 °	37.931900 °								
			-121.328700 °	-121.328400 °								
DWR ID	LMA-440											
Comment Code												
Inspector Comment												
<p>Levee Evaluation Comments</p> <p>Description: Slope protection repairs are needed along the waterside slope due to erosion and riprap displacement from high water. Based upon levee inspections, it was determined the waterside levee slope is eroding, deteriorating, and degrading. The eroded levee sections need to be restored back to design standards to prevent further deterioration and damage.</p> <p>Site ID No: 534</p> <p>Site Designation: LMA-440</p> <p>Repair Type: Erosion</p> <p>Rating: Serious</p> <p>Field Date: 8/10/2017</p> <p>Notes: site is related to, but not combined with, LMA-439 a portion of this site has been repaired.</p>

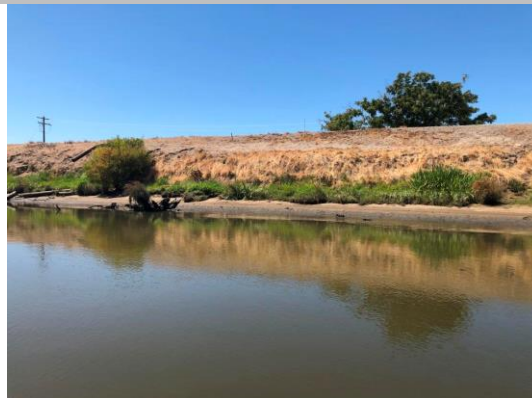
Photo 2 of 3 : SJR2019_RD0524U01RM41.92_1.jpg

LM Start	1.27	Rating **	A/W	Issue No.	47 (cont)	
LM End	1.33	Issue Type +	Ma	Location *		
Category	Supplemental			GPS Latitude/Longitude		
				Start	End	
Item	DWR Erosion Survey			37.931858 °	37.931858 °	
				-121.328300 °	-121.328300 °	
DWR ID	RD0524U01RM41.92					
Comment Code						
Inspector Comment						
Site ID: RD0524U01RM41.92 08/13/2019: No significant change observed. 09/13/2017: The erosion has developed along the levee slope. The length of the erosion is nearly doubled comparing to the prior survey. 07/25/2016: No significant change observed. 06/24/2015: No significant change observed. 06/19/2014: No significant change observed. 08/13/2013: New signs of animal activity were found. 08/07/2012: The site was first reported in 2012 spring levee inspection report.

Front view of the erosion.

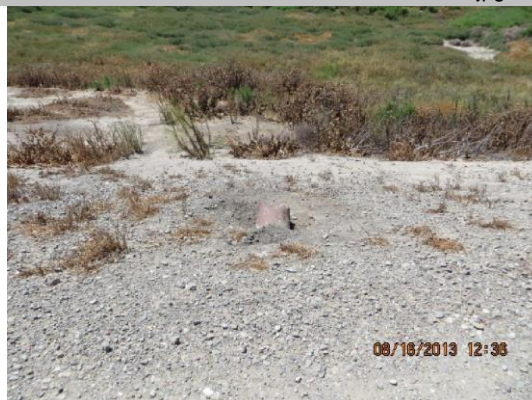
Photo 2 of 3 : UCIP_FA_2019_53162_29861.jpg

Comment Code					
Inspector Comment					
DS_ID:20602 FS_ID:53162 EP_NO: N/A Repair Type: Non-Urgent Crossing Status: Found UCIP Comments: 10/2/2018 Pipe appears abandoned, but both the pipe and levee appear in good condition; downgrading to Non-Urgent (D. Sanoski - DWR UCIP).11/16/2016 same as previous inspection both ends are open. This pipe does not appear in use. Need to contact owner to determine status of crossing. If the crossing is abandoned or in use, owner will need to coordinate with the CVFPB to comply with Title 23 requirements. (O. Magana - DWR UCIP)08/16/2013 Pipe appears to be open on both ends. Abandoned and should be done so properly. (W. Wylie - DWR UCIP) FIELD_STRUCT_DESC: *ABANDONED* 12-inch steel drainage pipe through the levee, 3.5 feet below the crown. Pipe is opened on the waterside (WS) and landside (LS) ends. The pump house referenced in O&M manual is missing from the LS (2013). [Additional Reference(s): DWR Levee Log, 2004. USACE San Joaquin O&M Manual 7, April 1964, (HLM 1.31)]. FS Date: 10/2/2018 1:10:16 PM

Pipe open and visible on LS slope.

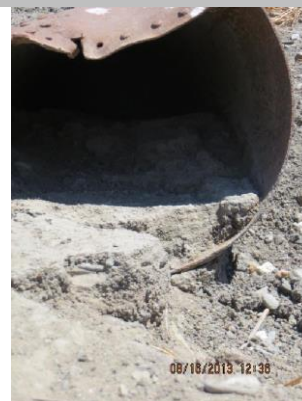
Photo 3 of 3 : UCIP_FA_2019_53162_29860.jpg

Comment Code						
Inspector Comment						
DS_ID:20602 FS_ID:53162 EP_NO: N/A Repair Type: Non-Urgent Crossing Status: Found UCIP Comments: 10/2/2018 Pipe appears abandoned, but both the pipe and levee appear in good condition; downgrading to Non-Urgent (D. Sanoski - DWR UCIP).11/16/2016 same as previous inspection both ends are open. This pipe does not appear in use. Need to contact owner to determine status of crossing. If the crossing is abandoned or in use, owner will need to coordinate with the CVFPB to comply with Title 23 requirements. (O. Magana - DWR UCIP)08/16/2013 Pipe appears to be open on both ends. Abandoned and should be done so properly. (W. Wylie - DWR UCIP) FIELD_STRUCT_DESC: *ABANDONED* 12-inch steel drainage pipe through the levee, 3.5 feet below the crown. Pipe is opened on the waterside (WS) and landside (LS) ends. The pump house referenced in O&M manual is missing from the LS (2013). [Additional Reference(s): DWR Levee Log, 2004. USACE San Joaquin O&M Manual 7, April 1964, (HLM 1.31)]. FS Date: 10/2/2018 1:10:16 PM

Pipe appears open on both ends. View from LS slope.

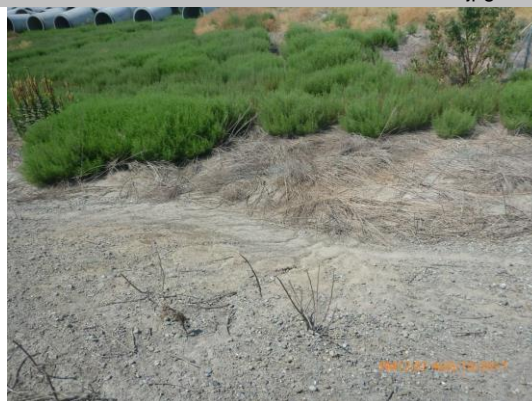
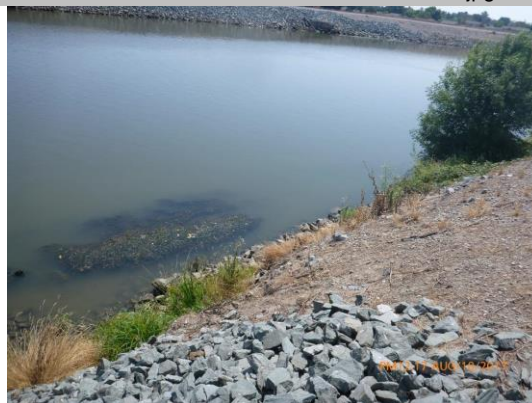
LM Start	1.33	Rating **	A/W	Issue No.	225
LM End	1.33	Issue Type +	Ma	Location *	
Category	Supplemental			GPS Latitude/Longitude	
				Start	End
Item	2017 Storm Damage			37.931500°	37.931500°
				-121.328200°	-121.328200°
DWR ID	LMA-438				
Comment Code					
Inspector Comment					
Levee Evaluation Comments Description: Slope protection repairs are needed along the waterside slope due to erosion and riprap displacement from high water. Based upon levee inspections, it was determined the waterside levee slope is eroding, deteriorating, and degrading. The eroded levee sections need to be restored back to design standards to prevent further deterioration and damage. Site ID No: 532 Site Designation: LMA-438 Repair Type: Erosion Rating: Area of Concern Field Date: 8/10/2017 Notes:

LM Start	1.33	Rating **	A/W	Issue No.	225 (cont)							
LM End	1.33	Issue Type +	Ma	Location *								
Category	Supplemental		GPS Latitude/Longitude									
			Start	End								
Item	2017 Storm Damage		37.931500°	37.931500°								
			-121.328200°	-121.328200°								
DWR ID	LMA-438											
Comment Code												
Inspector Comment												
Levee Evaluation Comments Description: Slope protection repairs are needed along the waterside slope due to erosion and riprap displacement from high water. Based upon levee inspections, it was determined the waterside levee slope is eroding, deteriorating, and degrading. The eroded levee sections need to be restored back to design standards to prevent further deterioration and damage. Site ID No: 532 Site Designation: LMA-438 Repair Type: Erosion Rating: Area of Concern Field Date: 8/10/2017 Notes:

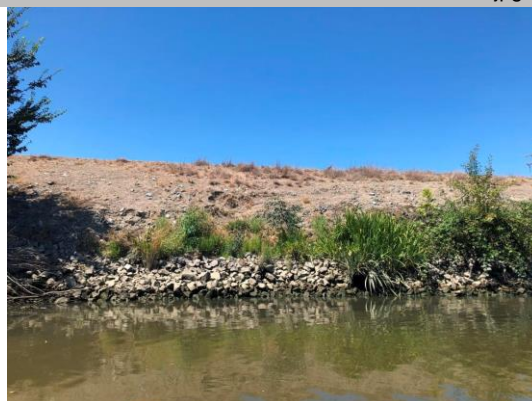
Photo 2 of 3 : SJR2019_RD0524U01RM42.03_4.jpg

LM Start	1.39	Rating **	U	Issue No.	56 (cont)	
LM End	1.39	Issue Type +	Ma	Location *		
Category	Supplemental			GPS Latitude/Longitude		
				Start	End	
Item	DWR Erosion Survey			37.930575 °	37.930575 °	
				-121.328090 °	-121.328090 °	
DWR ID	RD0524U01RM42.03					
Comment Code						
Inspector Comment						
Site ID: RD0524U01RM42.03 08/13/2019: No significant change observed. 09/13/2017: No significant change observed 07/25/2016: No significant change observed 06/24/2015: No significant change observed. 06/19/2014: No significant change observed. 08/13/2013: No significant change observed. 08/07/2012: The site was first reported in 2012 spring levee inspection report. The site is located about 750 ft downstream of SR 4 Bridge.

Front view of the erosion.

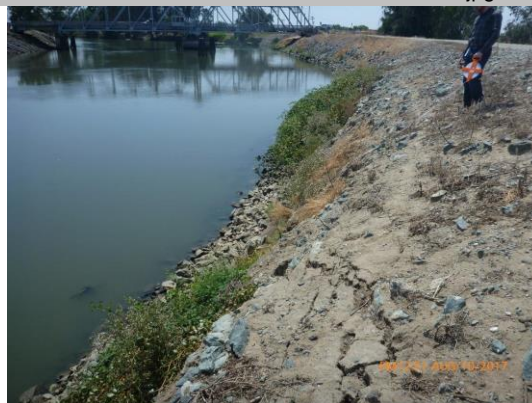
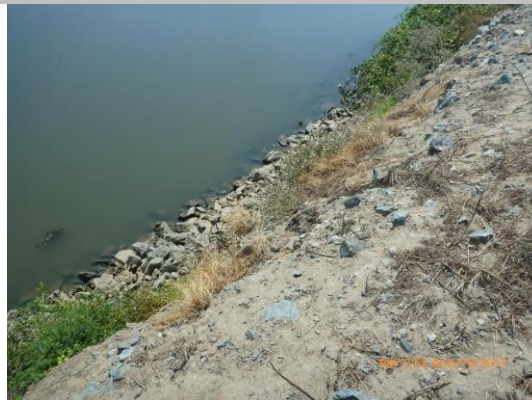
LM Start	1.43	Rating **	A/W	Issue No.	226
LM End	1.44	Issue Type +	Ma	Location *	
Category	Supplemental			GPS Latitude/Longitude	
				Start	End
Item	2017 Storm Damage			37.930100 °	37.929900 °
				-121.328300 °	-121.328300 °
DWR ID	LMA-436				
Comment Code					
Inspector Comment					
Levee Evaluation Comments					
Description:Slope protection repairs are needed along the waterside slope due to erosion and riprap displacement from high water. Based upon levee inspections, it was determined the waterside levee slope is eroding, deteriorating, and degrading. The eroded levee sections need to be restored back to design standards to prevent further deterioration and damage.					
Site ID No:530					
Site Designation:LMA-436					
Repair Type: Erosion					
Rating:Area of Concern					
Field Date:8/10/2017					
Notes:

LM Start	1.43	Rating **	A/W	Issue No.	226 (cont)							
LM End	1.44	Issue Type +	Ma	Location *								
Category	Supplemental		GPS Latitude/Longitude									
			Start	End								
Item	2017 Storm Damage		37.930100°	37.929900°								
			-121.328300°	-121.328300°								
DWR ID	LMA-436											
Comment Code												
Inspector Comment												
Levee Evaluation Comments Description: Slope protection repairs are needed along the waterside slope due to erosion and riprap displacement from high water. Based upon levee inspections, it was determined the waterside levee slope is eroding, deteriorating, and degrading. The eroded levee sections need to be restored back to design standards to prevent further deterioration and damage. Site ID No: 530 Site Designation: LMA-436 Repair Type: Erosion Rating: Area of Concern Field Date: 8/10/2017 Notes:

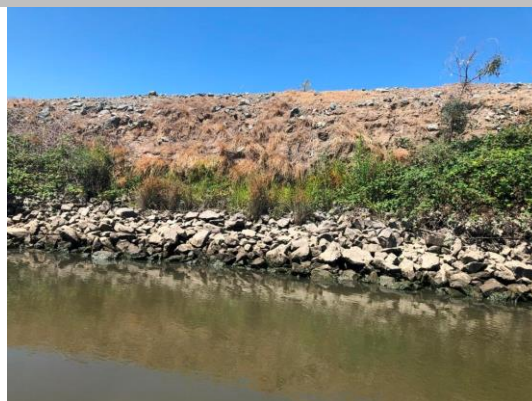
Photo 2 of 3 : SJR2019_RD0524U01RM42.09_2.JPG

LM Start	1.45	Rating **	U	Issue No.	60 (cont)	
LM End	1.47	Issue Type +	Ma	Location *		
Category	Supplemental			GPS Latitude/Longitude		
				Start	End	
Item	DWR Erosion Survey			37.929650 °	37.929650 °	
				-121.328110 °	-121.328110 °	
DWR ID	RD0524U01RM42.09					
Comment Code						
Inspector Comment						
Site ID: RD0524U01RM42.09 08/13/2019: No significant change observed. 09/13/2017: No significant change observed. 07/25/2016: No significant change observed. 06/24/2015: No significant change observed. 06/19/2014: No significant change observed. 08/13/2013: The site is located approximately 400 ft. downstream SR 4 Bridge. Dense vegetation is visible at the toe.

Front view of the erosion.

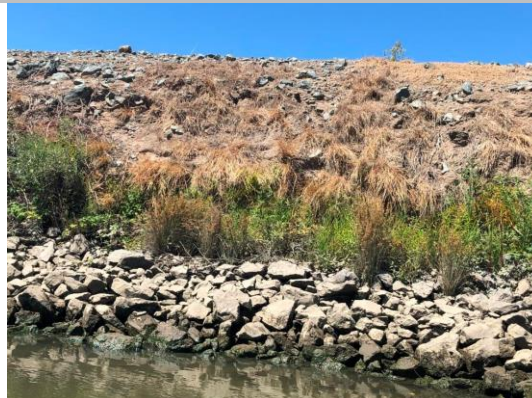
Photo 3 of 3 : SJR2019_RD0524U01RM42.09_3.JPG

Close-up view of the erosion. Note the vegetation at the site.

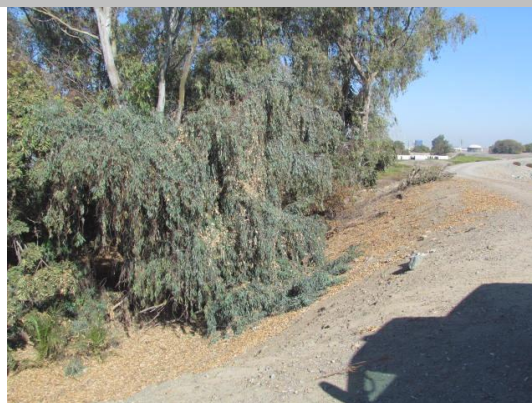
Photo 1 of 1 : FA_2019_RD0524_107_916_20190830_00255.jpg

LM Start	1.49	Rating **	U	Issue No.	916
LM End	1.49	Issue Type +	Ma	Location *	LS
Category	Earthen Levee			GPS Latitude/Longitude	
				Start	End
Item	Trim / Thin Trees			37.929118 °	37.929118 °
				-121.328368 °	-121.328368 °
DWR ID	DWR_RD0524_01_s_2012_916				
Comment Code					
T3 : Trim and thin trees to allow visibility of the ground and room to flood fight.					
Inspector Comment					
Untrimmed trees and dense vegetation on landside toe.

Looking at dense trees on landward slope and toe fall 2015

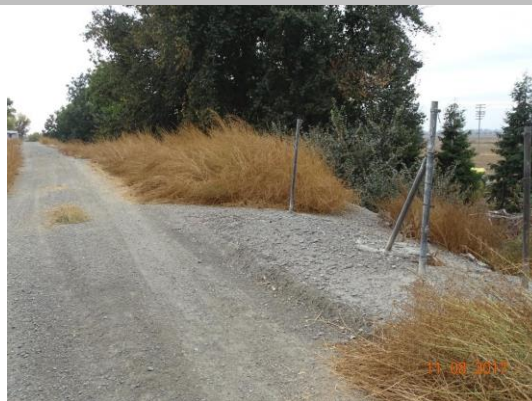
Photo 1 of 1 : FA_2019_RD0524_107_245_20190830_00238.jpg

LM Start	1.73	Rating **	U	Issue No.	245
LM End	1.75	Issue Type +	Ma	Location *	LS
Category	Earthen Levee			GPS Latitude/Longitude	
				Start	End
Item	Vegetation			37.926312 °	37.926093 °
				-121.326065 °	-121.325864 °
DWR ID	DWR_RD0524_01_f_2017_245				
Comment Code					
V2 : Remove the wild growth other than native grasses from the levee slopes.					
Inspector Comment

Looking southeast at the landside slope.

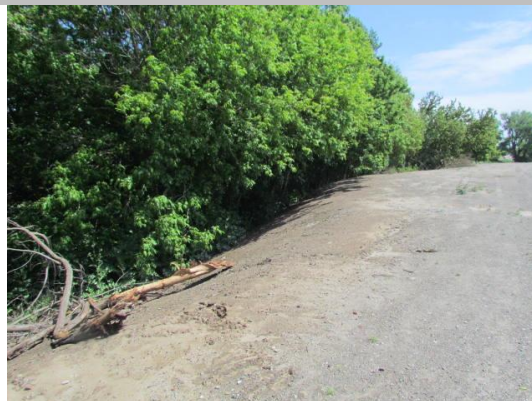
Photo 1 of 1 : FA_2019_RD0524_107_185_20190830_00164.jpg

LM Start	2.60	Rating **	M	Issue No.	185
LM End	2.64	Issue Type +	Ma	Location *	WS
Category	Earthen Levee			GPS Latitude/Longitude	
				Start	End
Item	Trim / Thin Trees			37.917152°	37.916807°
				-121.322582°	-121.322069°
DWR ID	DWR_RD0524_01_s_2014_185				
Comment Code					
T2 : Thin trees to allow visibility of the ground and room to flood fight.					
Inspector Comment

Looking northwest at untrimmed trees on landward slope and toe.

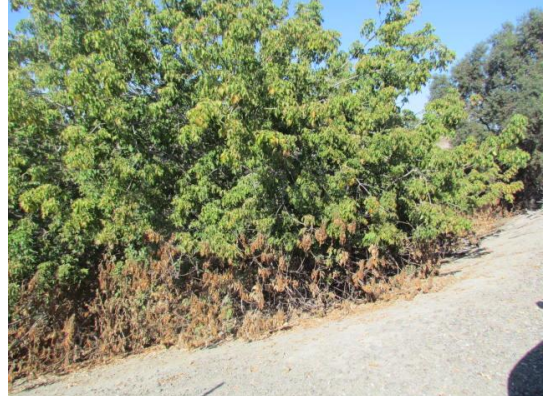
Photo 1 of 2 : FA_2019_RD0524_107_51_20190830_00067.jpg

Looking south at dense trees on landward slope fall 2015

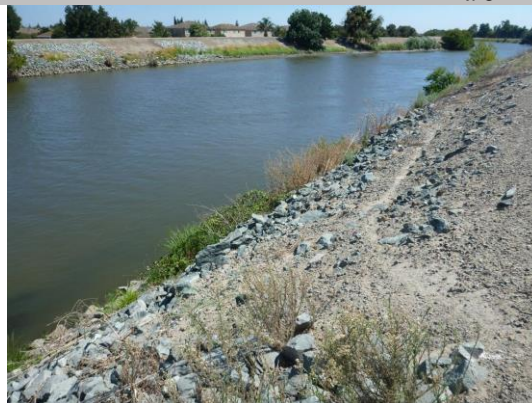
Photo 1 of 2 : LEVAL_FA_2019_465_2231.jpg

LM Start	2.96	Rating **	A/W	Issue No.	227
LM End		Issue Type +	Ma	Location *	
Category	Supplemental			GPS Latitude/Longitude	
				Start	End
Item	2017 Storm Damage			37.912900 °	°
				-121.324400 °	°
DWR ID	LMA-292

Comment Code					
Inspector Comment					
Levee Evaluation Comments					
Description:Slope protection repairs are needed along the waterside slope due to erosion. Based upon levee inspections, it was determined the waterside levee slopes were eroding, deteriorating and degrading in concave pocket sections at various locations along this levee reach. The eroded levee sections need to be restored back to design standards to prevent further deterioration of the damaged levee sections.					
Site ID No:465					
Site Designation:LMA-292					
Repair Type: Erosion					
Rating:Area of Concern					
Field Date:7/26/2017					
Notes: Lower priority because erosion is within rip rap, is only present on lower slope and is not too deep. Levee is narrow here.

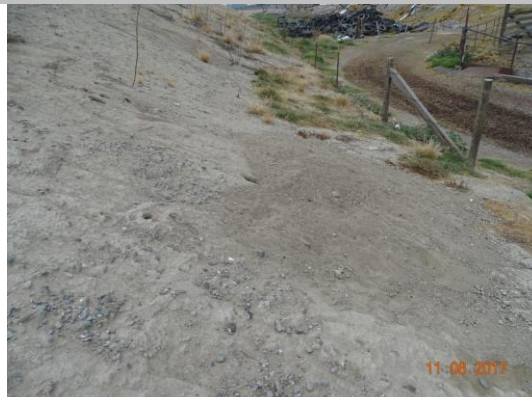
Photo 1 of 3 : FA_2019_RD0524_107_925_20190830_00256.jpg

LM Start	3.07	Rating **	M	Issue No.	925							
LM End	3.27	Issue Type +	Ma	Location *	LS							
Category	Earthen Levee		GPS Latitude/Longitude									
			Start	End								
Item	Animal Control		37.911382 °	37.908602 °								
			-121.324928 °	-121.325395 °								
DWR ID	DWR_RD0524_01_s_2012_925											
Comment Code												
A1 : Exterminate rodents and backfill and compact or grout burrows.												
Inspector Comment												
Several rodent holes on levee slopes.

Looking southwest at the landside slope.

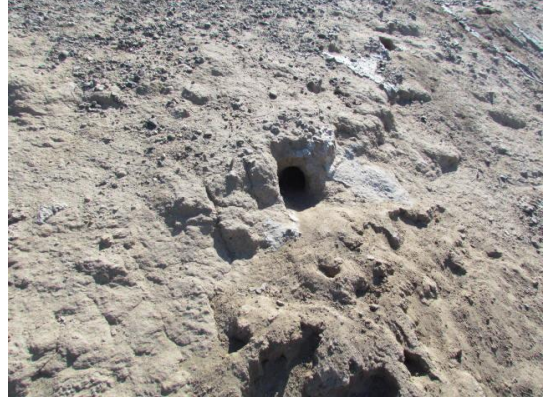
Photo 2 of 3 : FA_2019_RD0524_107_925_20190830_00257.jpg

Looking at typical view of rodent hole with this section fall 2015.

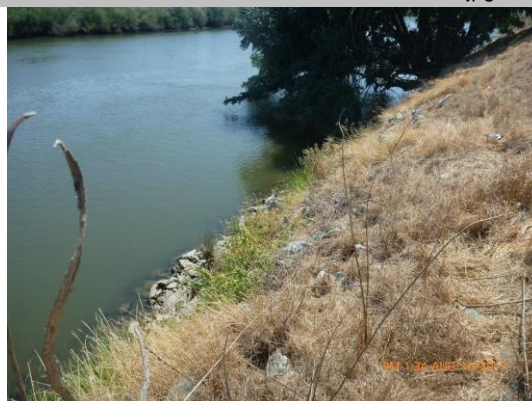
Photo 1 of 3 : LEVAL_FA_2019_528_4193.jpg

LM Start	3.26	Rating **	A/W	Issue No.	230
LM End	3.26	Issue Type +	Ma	Location *	
Category	Supplemental			GPS Latitude/Longitude	
				Start	End
Item	2017 Storm Damage			37.908800 °	37.908700 °
				-121.325400 °	-121.325300 °
DWR ID	LMA-434				
Comment Code					
Inspector Comment					
Levee Evaluation Comments					
Description:Slope protection repairs are needed along the waterside slope due to erosion and riprap displacement from high water. Based upon levee inspections, it was determined the waterside levee slope is eroding, deteriorating, and degrading. The eroded levee sections need to be restored back to design standards to prevent further deterioration and damage.					
Site ID No:528					
Site Designation:LMA-434					
Repair Type: Erosion					
Rating:Area of Concern					
Field Date:8/10/2017					
Notes: combined with LMA-433

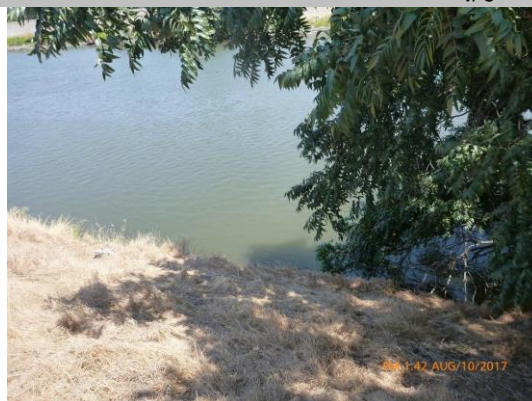
Photo 3 of 3 : LEVAL_FA_2019_528_4198.jpg

LM Start	3.26	Rating **	A/W	Issue No.	230 (cont)
LM End	3.26	Issue Type +	Ma	Location *	
Category	Supplemental			GPS Latitude/Longitude	
				Start	End
Item	2017 Storm Damage			37.908800 °	37.908700 °
				-121.325400 °	-121.325300 °
DWR ID	LMA-434				
Comment Code					
Inspector Comment					
<p>Levee Evaluation Comments</p> <p>Description: Slope protection repairs are needed along the waterside slope due to erosion and riprap displacement from high water. Based upon levee inspections, it was determined the waterside levee slope is eroding, deteriorating, and degrading. The eroded levee sections need to be restored back to design standards to prevent further deterioration and damage.</p> <p>Site ID No: 528</p> <p>Site Designation: LMA-434</p> <p>Repair Type: Erosion</p> <p>Rating: Area of Concern</p> <p>Field Date: 8/10/2017</p> <p>Notes: combined with LMA-433</p>

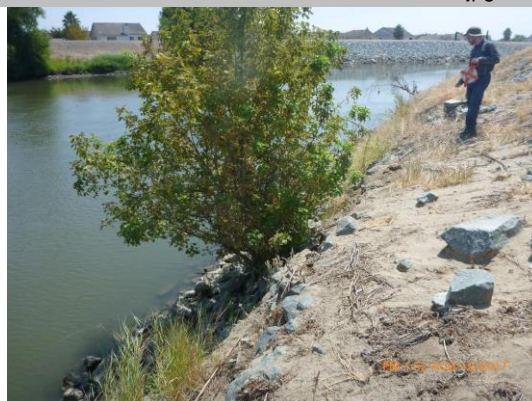
Photo 1 of 3 : LEVAL_FA_2019_526_4201.jpg

LM Start	3.53	Rating **	A/W	Issue No.	233	
LM End	3.54	Issue Type +	Ma	Location *		
Category	Supplemental			GPS Latitude/Longitude		
				Start	End	
Item	2017 Storm Damage			37.905300 °	37.905200 °	
				-121.323800 °	-121.323900 °	
DWR ID	LMA-432					
Comment Code						
Inspector Comment						
Levee Evaluation Comments						
Description:Slope protection repairs are needed along the waterside slope due to erosion and riprap displacement from high water. Based upon levee inspections, it was determined the waterside levee slope is eroding, deteriorating, and degrading. The eroded levee sections need to be restored back to design standards to prevent further deterioration and damage.						
Site ID No:526						
Site Designation:LMA-432						
Repair Type: Erosion						
Rating:Area of Concern						
Field Date:8/10/2017						
Notes:

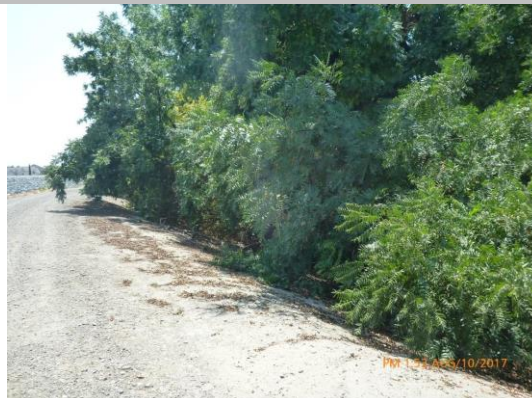
Photo 3 of 3 : LEVAL_FA_2019_526_4203.jpg

LM Start	3.53	Rating **	A/W	Issue No.	233 (cont)
LM End	3.54	Issue Type +	Ma	Location *	
Category	Supplemental			GPS Latitude/Longitude	
				Start	End
Item	2017 Storm Damage			37.905300 °	37.905200 °
				-121.323800 °	-121.323900 °
DWR ID	LMA-432				
Comment Code					
Inspector Comment					
Levee Evaluation Comments					
Description:Slope protection repairs are needed along the waterside slope due to erosion and riprap displacement from high water. Based upon levee inspections, it was determined the waterside levee slope is eroding, deteriorating, and degrading. The eroded levee sections need to be restored back to design standards to prevent further deterioration and damage.					
Site ID No:526					
Site Designation:LMA-432					
Repair Type: Erosion					
Rating:Area of Concern					
Field Date:8/10/2017					
Notes:

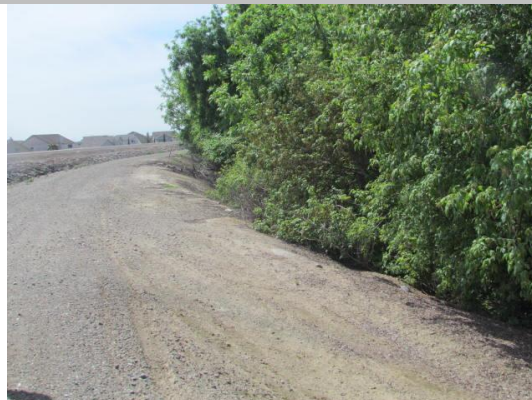
Photo 1 of 1 : FA_2019_RD0524_107_57_20190830_00075.jpg

LM Start	3.53	Rating **	M	Issue No.	57
LM End	3.60	Issue Type +	Ma	Location *	LS
Category	Earthen Levee			GPS Latitude/Longitude	
				Start	End
Item	Trim / Thin Trees			37.905280 °	37.904475 °
				-121.323840 °	-121.324409 °
DWR ID	DWR_RD0524_01_s_2012_57				
Comment Code					
T3 : Trim and thin trees to allow visibility of the ground and room to flood fight.					
Inspector Comment

Looking south at dense trees on landward slope.

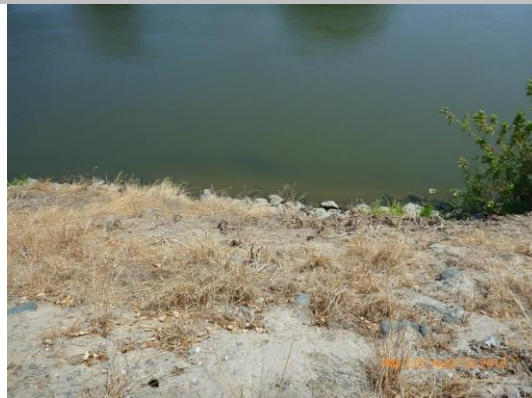
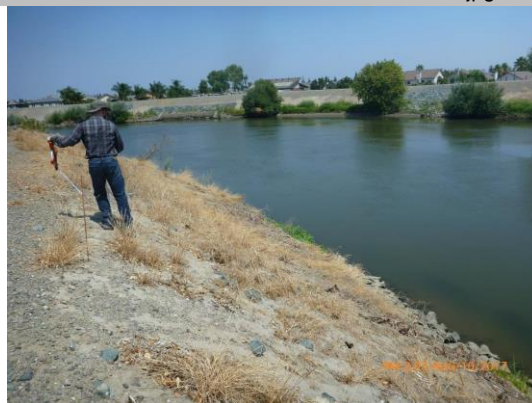
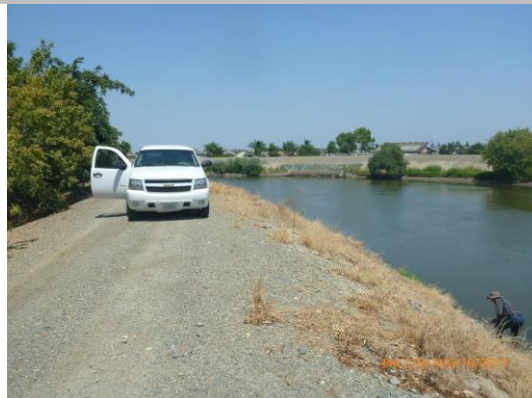
LM Start	3.56	Rating **	A/W	Issue No.	234
LM End	3.57	Issue Type +	Ma	Location *	
Category	Supplemental			GPS Latitude/Longitude	
				Start	End
Item	2017 Storm Damage			37.904900 °	37.904800 °
				-121.323900 °	-121.324100 °
DWR ID	LMA-431				
Comment Code					
Inspector Comment					
Levee Evaluation Comments					
Description:Slope protection repairs are needed along the waterside slope due to erosion and riprap displacement from high water. Based upon levee inspections, it was determined the waterside levee slope is eroding, deteriorating, and degrading. The eroded levee sections need to be restored back to design standards to prevent further deterioration and damage.					
Site ID No:525					
Site Designation:LMA-431					
Repair Type: Erosion					
Rating:Area of Concern					
Field Date:8/10/2017					
Notes: No appearance of erosion, continue to monitor

LM Start	3.56	Rating **	A/W	Issue No.	234 (cont)	
LM End	3.57	Issue Type +	Ma	Location *		
Category	Supplemental			GPS Latitude/Longitude		
				Start	End	
Item	2017 Storm Damage			37.904900 °	37.904800 °	
				-121.323900 °	-121.324100 °	
DWR ID	LMA-431					
Comment Code						
Inspector Comment						
Levee Evaluation Comments						
Description:Slope protection repairs are needed along the waterside slope due to erosion and riprap displacement from high water. Based upon levee inspections, it was determined the waterside levee slope is eroding, deteriorating, and degrading. The eroded levee sections need to be restored back to design standards to prevent further deterioration and damage.						
Site ID No:525						
Site Designation:LMA-431						
Repair Type: Erosion						
Rating:Area of Concern						
Field Date:8/10/2017						
Notes: No appearance of erosion, continue to monitor

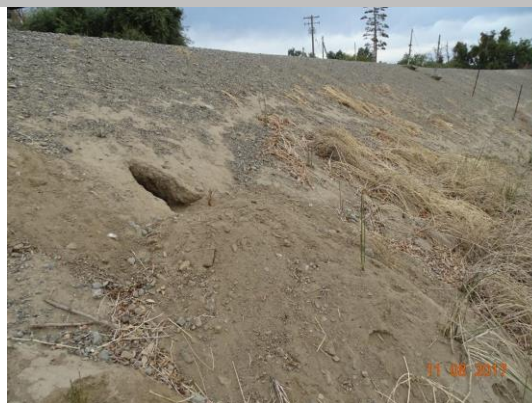
Photo 1 of 1 : FA_2019_RD0524_107_251_20190830_00239.jpg

LM Start	3.67	Rating **	U	Issue No.	251
LM End	3.67	Issue Type +	Ma	Location *	WS
Category	Earthen Levee			GPS Latitude/Longitude	
				Start	End
Item	Animal Control			37.903776 °	37.903776 °
				-121.325323 °	-121.325323 °
DWR ID	DWR_RD0524_01_f_2017_251				
Comment Code					
A3 : No rodents visible, but rodent burrows visible; need to backfill and compact or grout burrows.					
Inspector Comment					
Large rodent holes on both waterside and landside slope.

Looking northwest at the waterside slope.

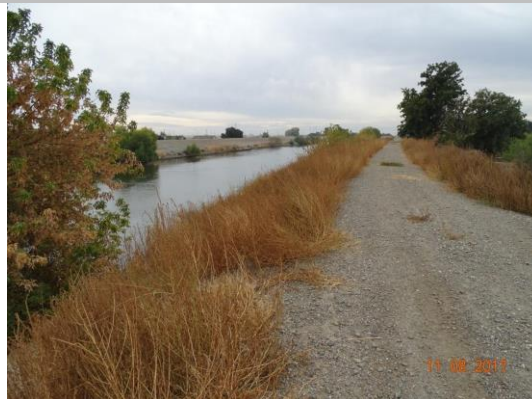
Photo 1 of 1 : FA_2019_RD0524_107_254_20190830_00241.jpg

LM Start	3.97	Rating **	M	Issue No.	254
LM End	4.03	Issue Type +	Ma	Location *	WS
Category	Earthen Levee			GPS Latitude/Longitude	
				Start	End
Item	Vegetation			37.899718 °	37.898945 °
				-121.326605 °	-121.327003 °
DWR ID	DWR_RD0524_01_f_2017_254				
Comment Code					
V2 : Remove the wild growth other than native grasses from the levee slopes.					
Inspector Comment

Looking southwest at the waterside slope.

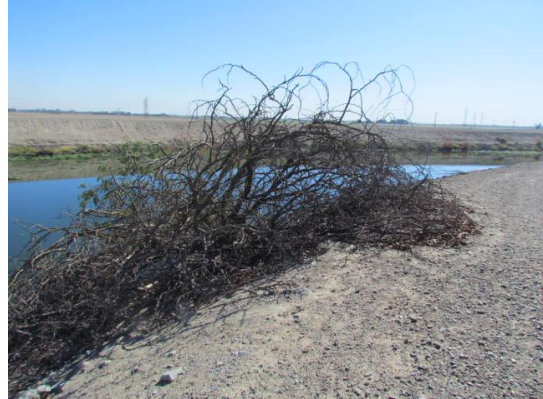
Photo 1 of 2 : FA_2019_RD0524_107_102_20190830_00124.jpg

Looking southeast at dead tree on waterside slope fall 2015
