**Flood Control Project Maintenance
Levee Inspections**

Maintenance Issue Types Only, Levee Inspection Report By Mile - Fall 2019

Reclamation District No. 0524 Middle Roberts Island

Waterway	Bank	Unit Miles	Inspection Start/End	Inspector
Unit No. 01 San Joaquin River	Left	6.20	10/02/2019 11/14/2019	Alberto De Leon

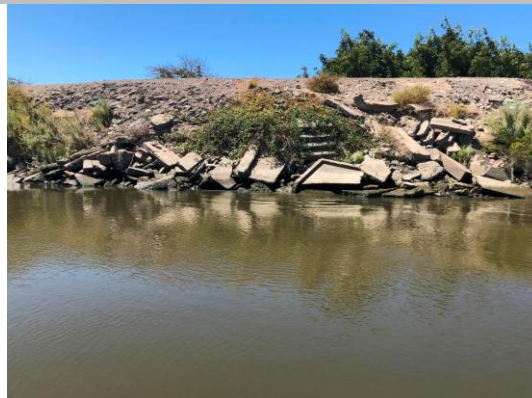
Photo 1 of 3 : SJR2019_RD0524U01RM45.07_1.jpg

Site ID: RD0524U01RM45.07
 08/13/2019: No significant change observed.
 09/13/2017: No significant change observed.
 07/25/2016: No significant change observed.
 06/24/2015: No significant change observed.
 06/19/2014: No significant change observed.
 08/13/2013: No significant change observed.
 08/07/2012: The erosion is located at the inside of a river bend. Site is covered with broken concrete blocks and other debris.

Front view of the erosion site.

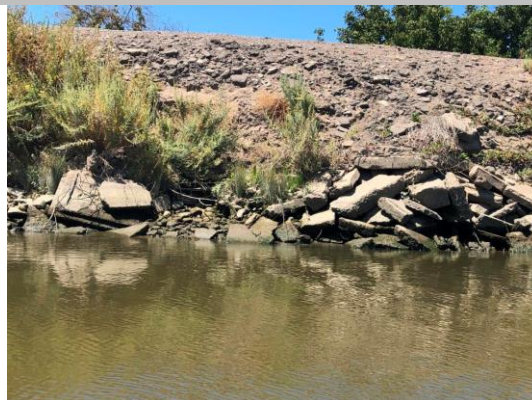
Photo 2 of 3 : SJR2019_RD0524U01RM45.07_3.jpg

Close-up view of the site.

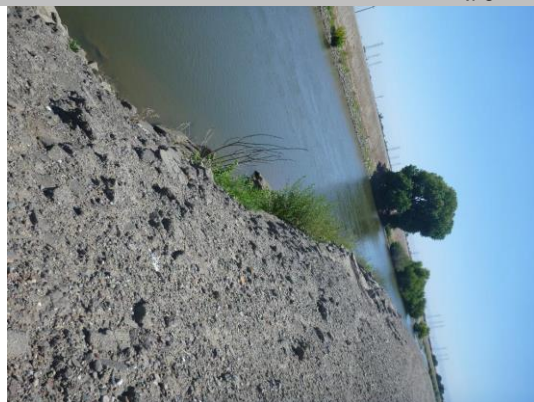
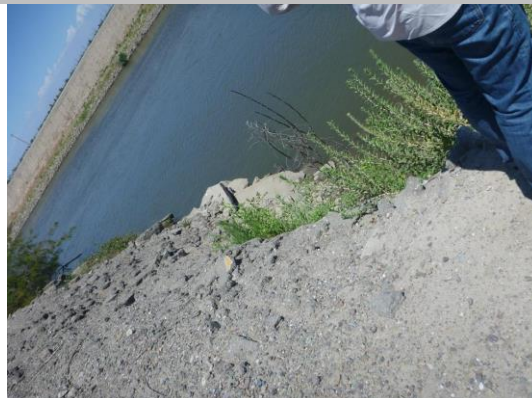
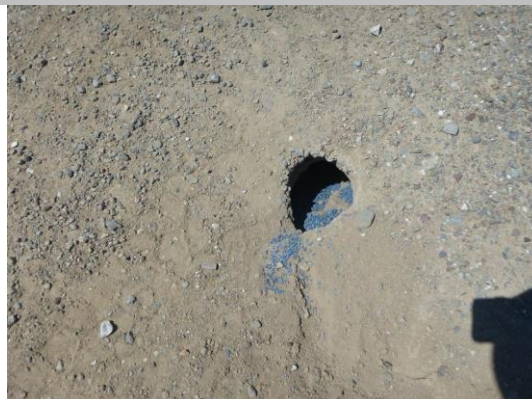
Comment Code					
Inspector Comment					
Levee Evaluation Comments					
Description:Slope protection repairs are needed along the waterside slope due to erosion. Based upon levee inspections, it was determined the waterside levee slopes were eroding, deteriorating and degrading in concave pocket sections at various locations along this levee reach. The eroded levee sections need to be restored back to design standards to prevent further deterioration of the damaged levee sections.					
Site ID No:468					
Site Designation:LMA-295					
Repair Type: Erosion					
Rating:Serious					
Field Date:7/26/2017					
Notes: Serious because erosion is impacting the levee, but there is some slope protection here. Slope is armored with asphalt and concrete rubble. The surrounding slopes are pretty baren, but there is a small bush within the site so it may be older.

Description: Slope protection repairs are needed along the waterside slope due to erosion. Based upon levee inspections, it was determined the waterside levee slopes were eroding, deteriorating and degrading in concave pocket sections at various locations along this levee reach. The eroded levee sections need to be restored back to design standards to prevent further deterioration of the damaged levee sections.

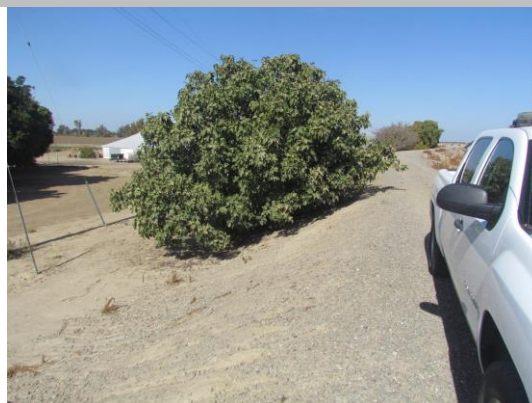
Photo 1 of 1 : FA_2019_RD0524_107_67_20190830_00087.jpg

LM Start	4.70	Rating **	M	Issue No.	67
LM End	4.70	Issue Type +	Ma	Location *	LS
Category	Earthen Levee			GPS Latitude/Longitude	
				Start	End
Item	Trim / Thin Trees			37.890108°	37.890108°
				-121.329523°	-121.329523°
DWR ID	DWR_RD0524_01_s_2012_67				
Comment Code					
T1 : Trim trees to at least five feet above ground level.					
Inspector Comment					
Fig tree at landside toe.

Looking northwest at untrimmed tree on landward slope.

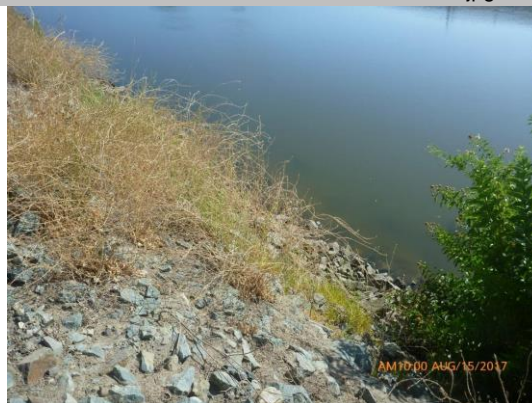
LM Start	4.76	Rating **	A/W	Issue No.	236
LM End	4.76	Issue Type +	Ma	Location *	
Category	Supplemental			GPS Latitude/Longitude	
				Start	End
Item	2017 Storm Damage			37.889300 °	37.889300 °
				-121.329800 °	-121.329800 °
DWR ID	LMA-429				
Comment Code					
Inspector Comment					
Levee Evaluation Comments					
Description:Slope protection repairs are needed along the waterside slope due to erosion and riprap displacement from high water. Based upon levee inspections, it was determined the waterside levee slope is eroding, deteriorating, and degrading. The eroded levee sections need to be restored back to design standards to prevent further deterioration and damage.					
Site ID No:523					
Site Designation:LMA-429					
Repair Type: Erosion					
Rating:Area of Concern					
Field Date:8/15/2017					
Notes:

LM Start	4.76	Rating **	A/W	Issue No.	236 (cont)
LM End	4.76	Issue Type +	Ma	Location *	
Category	Supplemental			GPS Latitude/Longitude	
				Start	End
Item	2017 Storm Damage			37.889300°	37.889300°
				-121.329800°	-121.329800°
DWR ID	LMA-429				
Comment Code					
Inspector Comment					
<p>Levee Evaluation Comments</p> <p>Description: Slope protection repairs are needed along the waterside slope due to erosion and riprap displacement from high water. Based upon levee inspections, it was determined the waterside levee slope is eroding, deteriorating, and degrading. The eroded levee sections need to be restored back to design standards to prevent further deterioration and damage.</p> <p>Site ID No: 523</p> <p>Site Designation: LMA-429</p> <p>Repair Type: Erosion</p> <p>Rating: Area of Concern</p> <p>Field Date: 8/15/2017</p> <p>Notes:</p>

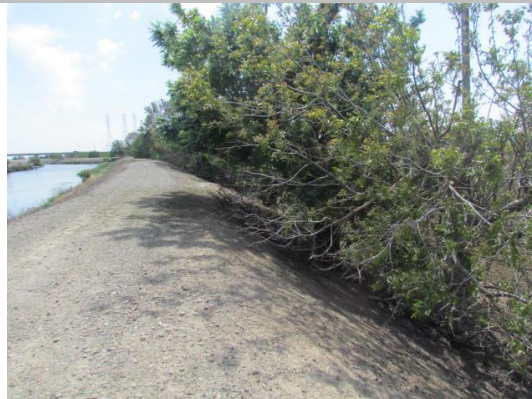
Photo 1 of 1 : FA_2019_RD0524_107_85_20190830_00107.jpg

LM Start	5.28	Rating **	M	Issue No.	85
LM End	5.34	Issue Type +	Ma	Location *	LS
Category	Earthen Levee			GPS Latitude/Longitude	
				Start	End
Item	Trim / Thin Trees			37.882363 °	37.881511 °
				-121.332577 °	-121.332777 °
DWR ID	DWR_RD0524_01_s_2012_85				
Comment Code					
T1 : Trim trees to at least five feet above ground level.					
Inspector Comment

Looking south at untrimmed trees on landward slope.

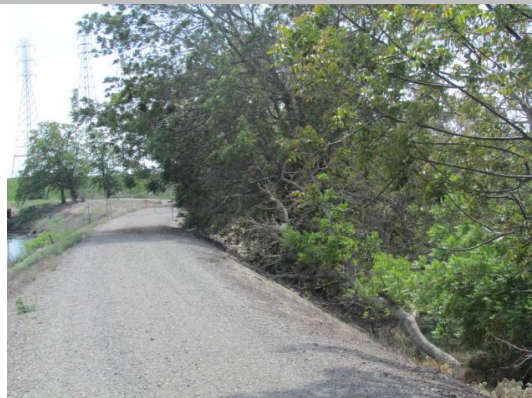
Photo 1 of 1 : FA_2019_RD0524_107_932_20190830_00262.jpg

LM Start	5.38	Rating **	M	Issue No.	932
LM End	5.41	Issue Type +	Ma	Location *	LS
Category	Earthen Levee			GPS Latitude/Longitude	
				Start	End
Item	Trim / Thin Trees			37.880945 °	37.880522 °
				-121.332837 °	-121.332918 °
DWR ID	DWR_RD0524_01_s_2012_932				
Comment Code					
T1 : Trim trees to at least five feet above ground level.					
Inspector Comment

Looking south at untrimmed trees on landward slope and toe.

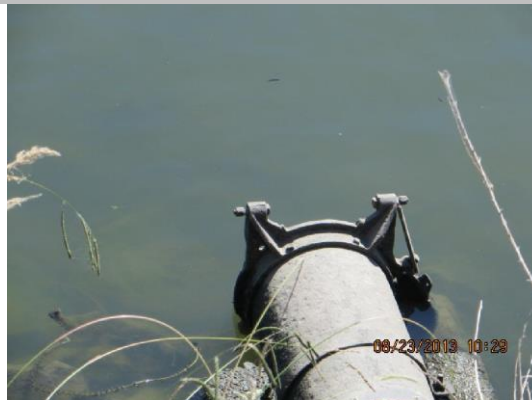
Photo 3 of 3 : UCIP_FA_2019_53358_30687.jpg

Comment Code						
Inspector Comment						
DS_ID:20630 FS_ID:53358 EP_NO: N/A Repair Type: Urgent Crossing Status: Found UCIP Comments: 10/2/2018 Same as last inspection. Holes present in pipe pose a potential threat to levee's internal integrity. Recommend video inspection (D. Sanoski - DWR UCIP).11/16/2016 same as previous inspection hole in pipe is still pressent on WS near toe. This pipe does not appear to be in use. Need to contact owner to determine status of crossing. If the crossing is abandoned or still in use, owner will need to coordinate with the CVFPB to comply with Title 23 requirements. (O. Magana - DWR UCIP)08/23/2013 flap gate damage and does not work at WS toe. Large hole in pipe at WS toe. Pipe appears abandoned and should be done so properly. (W. Wylie - DWR UCIP) FIELD_STRUCT_DESC: *ABANDONED* 1 of 2: 12-inch steel irrigation pipe through the levee, 6 feet below the crown. Pump located on the waterside (WS), no pump found in 2013. Flap gate located on the WS end. [Additional Reference(s): DWR Levee Log, 2004. USACE San Joaquin O&M Manual 7, April 1964, (HLM 5.48) 10-inch pipe listed, Drawing No. 07-04-1490, Sheet 1490/4, (Station 8+01.3)]. FS Date: 10/2/2018 1:34:00 PM

Broken flap gate at WS toe.

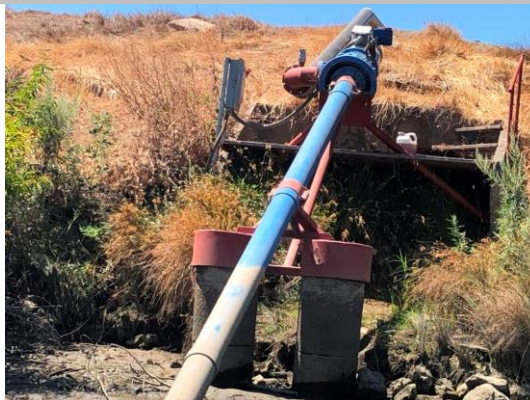
Photo 2 of 2 : SJR2019_RD0524U01RM46.06_4.JPG

LM Start	5.53	Rating **	M	Issue No.	71 (cont)	
LM End	5.53	Issue Type +	Ma	Location *		
Category	Supplemental			GPS Latitude/Longitude		
				Start		End
Item	DWR Erosion Survey			37.878920 °		37.878920 °
				-121.332670 °		-121.332670 °
DWR ID	RD0524U01RM46.06					
Comment Code						
Inspector Comment						
Site ID: RD0524U01RM46.06 08/13/2019: No significant change observed. More vegetation was observed at the site. 09/13/2017: No significant change observed. 07/25/2016: No significant change observed. 06/24/2015: No significant change observed. 06/19/2014: No significant change observed. 08/13/2013: Larger trees are at the levee shoulder, and an irrigation pump station is next to the erosion site.

Close-up view of the site.

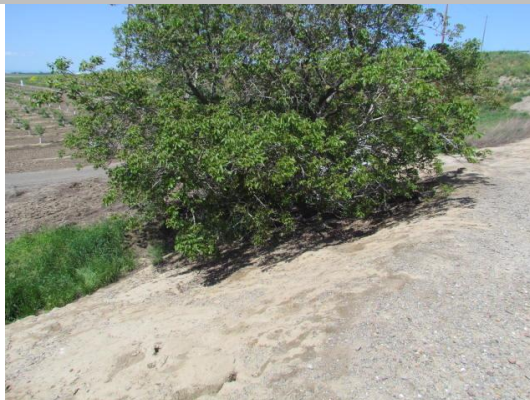
Photo 1 of 1 : FA_2019_RD0524_107_117_20190830_00130.jpg

LM Start	5.66	Rating **	M	Issue No.	117
LM End	5.66	Issue Type +	Ma	Location *	LS
Category	Earthen Levee			GPS Latitude/Longitude	
				Start	End
Item	Trim / Thin Trees			37.877100 °	37.877100 °
				-121.332323 °	-121.332323 °
DWR ID	DWR_RD0524_01_f _ 2013_117				
Comment Code					
T1 : Trim trees to at least five feet above ground level.					
Inspector Comment

Looking northwest at untrimmed tree on landward slope.

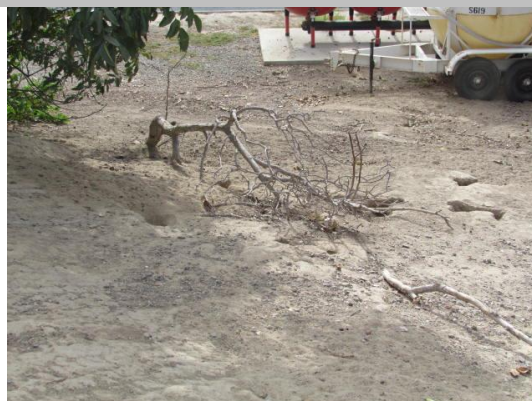
Photo 2 of 2 : FA_2019_RD0524_107_75_20190830_00097.jpg

LM Start	5.86	Rating **	M	Issue No.	75 (cont)
LM End	5.88	Issue Type +	Ma	Location *	WS
Category	Earthen Levee			GPS Latitude/Longitude	
				Start	End
Item	Animal Control			37.874240 °	37.874002 °
				-121.333187 °	-121.333027 °
DWR ID	DWR_RD0524_01_s_2012_75				
Comment Code					
A1 : Exterminate rodents and backfill and compact or grout burrows.					
Inspector Comment					
District has grouted rodent holes, but other rodent holes have appeared. Active rodents in area.

Looking typical view of several rodent holes on landward slope and toe.

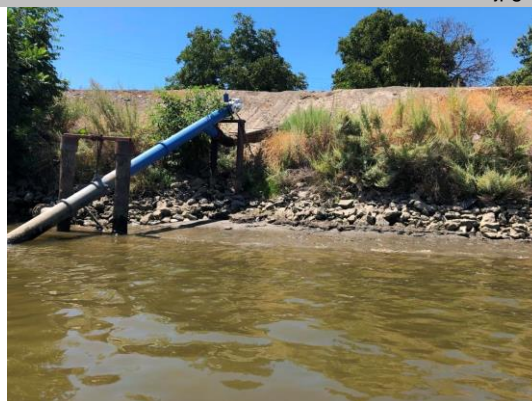
Photo 1 of 2 : SJR2019_RD0524U01RM46.39_1.jpg

LM Start	5.87	Rating **	U	Issue No.	79
LM End	5.87	Issue Type +	Ma	Location *	
Category	Supplemental			GPS Latitude/Longitude	
				Start	End
Item	DWR Erosion Survey			37.874185 °	37.874185 °
				-121.333110 °	-121.333110 °
DWR ID	RD0524U01RM46.39				
Comment Code					
Inspector Comment					
Site ID: RD0524U01RM46.39 08/13/2019: No significant change observed. 09/13/2017: No significant change observed. 07/25/2016: No significant change observed. 06/24/2015: No significant change observed. 06/19/2014: No significant change observed. 08/13/2013: No significant change observed. 08/07/2012: The erosion is near a water-intake structure. Pipe leakage likely caused the erosion.

Front view of the site.

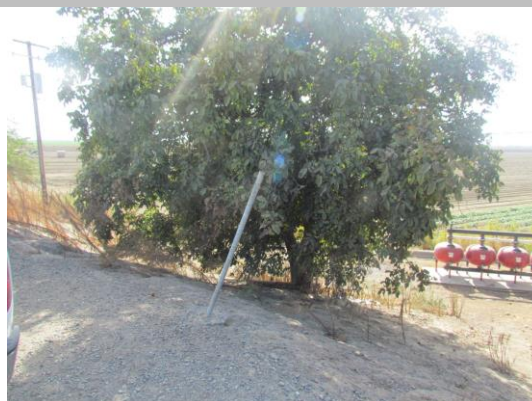
Photo 1 of 1 : FA_2019_RD0524_107_98_20190830_00122.jpg

LM Start	5.87	Rating **	M	Issue No.	98
LM End	5.87	Issue Type +	Ma	Location *	LS
Category	Earthen Levee			GPS Latitude/Longitude	
				Start	End
Item	Trim / Thin Trees			37.874085 °	37.874085 °
				-121.333154 °	-121.333154 °
DWR ID	DWR_RD0524_01_s_2012_98				
Comment Code					
T1 : Trim trees to at least five feet above ground level.					
Inspector Comment					
Untrimmed walnut tree on landside slope.

Looking west at walnut tree on landward slope.

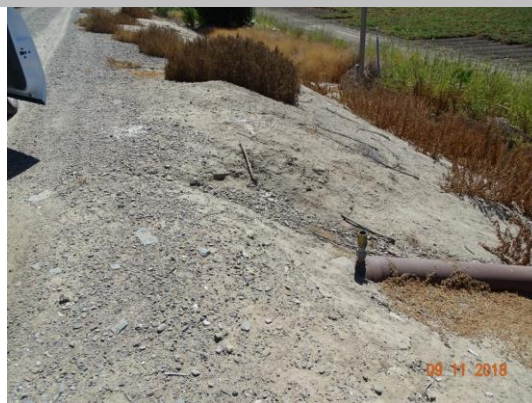
Photo 1 of 1 : FA_2019_RD0524_107_147_20190830_00134.jpg

LM Start	6.08	Rating **	M	Issue No.	147
LM End	6.08	Issue Type +	Ma	Location *	LS
Category	Earthen Levee			GPS Latitude/Longitude	
				Start	End
Item	Erosion / Bank Caving			37.872017 °	37.872017 °
				-121.330487 °	-121.330487 °
DWR ID	DWR_RD0524_01_f_2018_147				
Comment Code					
E1 : Note and monitor erosion site.					
Inspector Comment					
Erosion around and near pipe on landward slope.

Looking at landward erosion. (Fall 2018)

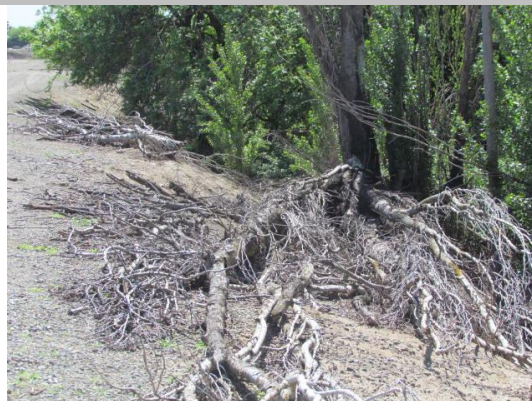
Photo 1 of 2 : FA_2019_RD0524_107_81_20190830_00104.jpg

LM Start	6.15	Rating **	M	Issue No.	81
LM End	6.15	Issue Type +	Ma	Location *	LS
Category	Earthen Levee			GPS Latitude/Longitude	
				Start	End
Item	Encroachments			37.871097°	37.871097°
				-121.330100°	-121.330100°
DWR ID	DWR_RD0524_01_s_2015_81				
Comment Code					
TR : Tree or limb					
Inspector Comment					
Fallen tree branches and limbs on landside slope.

Looking west at tree branches and limbs left on landward shoulder and slope. (Spring 2016)

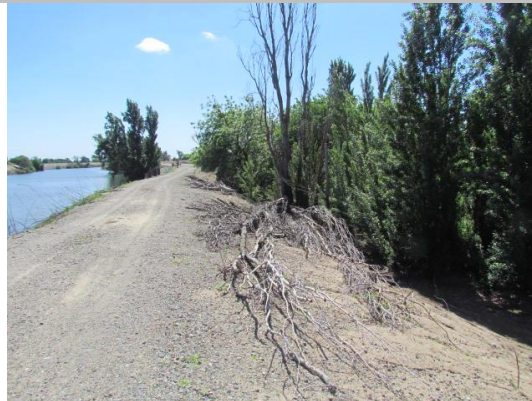
Photo 2 of 2 : FA_2019_RD0524_107_81_20190830_00105.jpg

Looking south at tree branches and limbs left on landward shoulder and slope. (Spring 2016)
