**Flood Control Project Maintenance  
Levee Inspections**

**Maintenance Issue Types Only, Levee Inspection Report By Mile - Fall 2020**

**Reclamation District No. 0524 Middle Roberts Island**

Waterway	Bank	Unit Miles	Inspection Start/End	Inspector
Unit No. 01 San Joaquin River	Left	6.20	09/25/2020 09/25/2020	Alberto De Leon

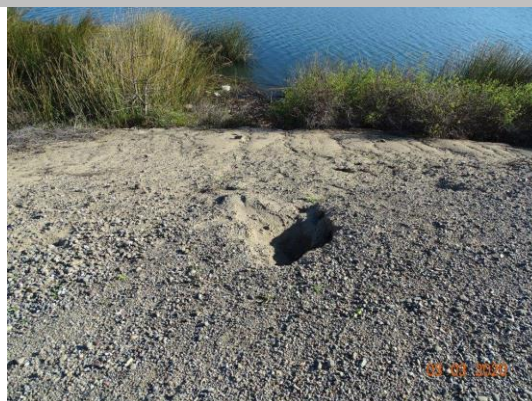
Photo 1 of 1 : FA\_2020\_RD0524\_107\_96\_20200901\_00044.jpg

LM Start	0.00	Rating **	U	Issue No.	96
LM End	0.00	Issue Type +	Ma	Location *	WS
Category	Earthen Levee			GPS Latitude/Longitude	
				Start	End
Item	Animal Control			37.941193 °	37.941193 °
				-121.346093 °	-121.346093 °
DWR ID	DWR_RD0524_01_s_2020_96				
Comment Code					
A1 : Exterminate rodents and backfill and compact or grout burrows.					
Inspector Comment

View of large animal burrow on waterside hinge. Spring 2020

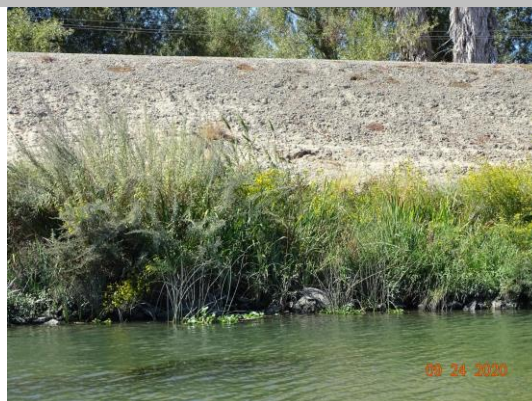
Photo 2 of 2 : SJR2019\_RD0524U01RM40.85\_05.JPG

LM Start	0.18	Rating **	U	Issue No.	5
LM End	0.18	Issue Type +	Ma	Location *	WS
Category	Supplemental			GPS Latitude/Longitude	
				Start	End
Item	DWR Erosion Survey			37.939085 °	37.939085 °
				-121.343917 °	-121.343917 °
DWR ID	RD0524U01RM40.85				
Comment Code					
Inspector Comment					
Site ID: RD0524U01RM40.85					
09/24/2020: From 2014 to present, no significant changes were observed during the annual survey.					
08/13/2013: The erosion was discovered during 2013 spring levee inspection. Inspector comment: Erosion is located along the lower level of water-ward slope.

LM Start	<b>0.18</b>	Rating **	U	Issue No.	<b>5 (cont)</b>
LM End	<b>0.18</b>	Issue Type +	Ma	Location *	WS
Category	Supplemental			GPS Latitude/Longitude	
				Start	End
Item	DWR Erosion Survey			37.939085 °	37.939085 °
				-121.343917 °	-121.343917 °
DWR ID	RD0524U01RM40.85

9/24/2020: Close-up view of the erosion.

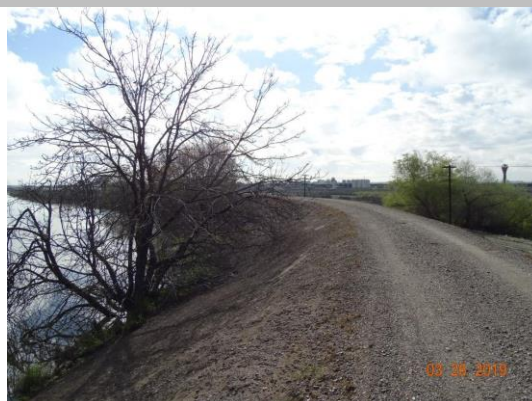
Photo 1 of 1 : FA\_2020\_RD0524\_107\_201\_20200901\_00083.jpg

LM Start	0.23	Rating **	M	Issue No.	201
LM End	0.23	Issue Type +	Ma	Location *	WS
Category	Earthen Levee			GPS Latitude/Longitude	
				Start	End
Item	Trim / Thin Trees			37.938648 °	37.938648 °
				-121.343480 °	-121.343480 °
DWR ID	DWR_RD0524_01_f_2016_201				
Comment Code					
T1 : Trim trees to at least five feet above ground level.					
Inspector Comment

View of tree on waterside slope looking upstream. Spring 2019.

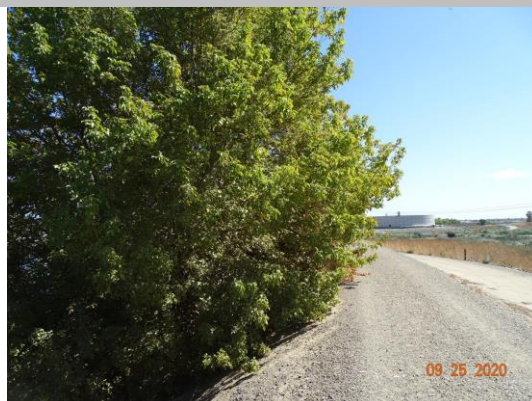
Photo 1 of 1 : FA\_2020\_RD0524\_107\_179\_20201005\_00225.jpg

LM Start	0.27	Rating **	U	Issue No.	179
LM End	0.27	Issue Type +	Ma	Location *	WS
Category	Earthen Levee			GPS Latitude/Longitude	
				Start	End
Item	Trim / Thin Trees			37.938438 °	37.938438 °
				-121.342883 °	-121.342883 °
DWR ID	DWR_RD0524_01_s_2014_179				
Comment Code					
T3 : Trim and thin trees to allow visibility of the ground and room to flood fight.					
Inspector Comment					
Tree blocking view of waterside slope.

View of large untrimmed walnut tree on landside slope. Fall 2020

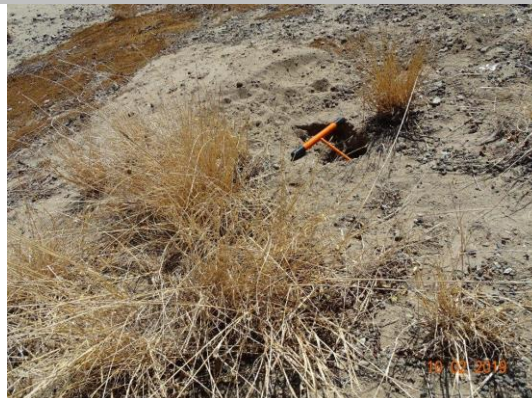
Photo 1 of 1 : FA\_2020\_RD0524\_107\_125\_20200901\_00056.jpg

LM Start	0.35	Rating **	U	Issue No.	125
LM End	0.36	Issue Type +	Ma	Location *	LS
Category	Earthen Levee			GPS Latitude/Longitude	
				Start	End
Item	Animal Control			37.938487 °	37.938509 °
				-121.341491 °	-121.341300 °
DWR ID	DWR_RD0524_01_f_2019_125				
Comment Code					
A3 : No rodents visible, but rodent burrows visible; need to backfill and compact or grout burrows.					
Inspector Comment

View of large rodent hole on landside slope. Fall 2019

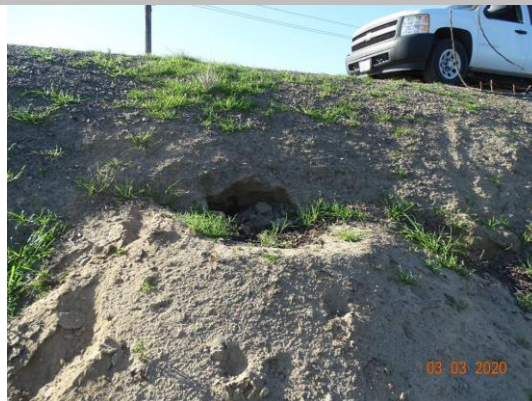
Photo 1 of 1 : FA\_2020\_RD0524\_107\_122\_20200901\_00055.jpg

LM Start	0.36	Rating **	U	Issue No.	122
LM End	0.36	Issue Type +	Ma	Location *	WS
Category	Earthen Levee			GPS Latitude/Longitude	
				Start	End
Item	Animal Control			37.938509 °	37.938509 °
				-121.341297 °	-121.341297 °
DWR ID	DWR_RD0524_01_f_2019_122				
Comment Code					
A3 : No rodents visible, but rodent burrows visible; need to backfill and compact or grout burrows.					
Inspector Comment

View of large animal burrow on waterside slope. Spring 2020

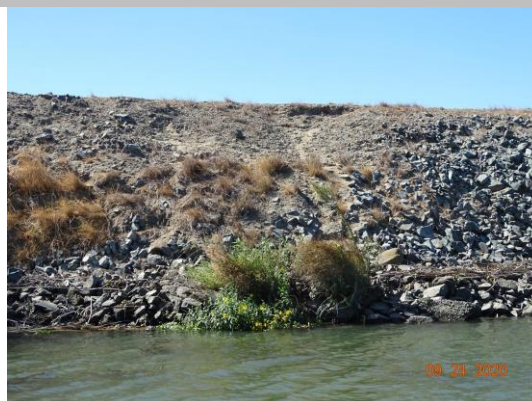
Photo 2 of 2 : SJR2019\_RD0524U01RM41.26\_02.JPG

LM Start	0.63	Rating **	M	Issue No.	25
LM End	0.63	Issue Type +	Ma	Location *	WS
Category	Supplemental			GPS Latitude/Longitude	
				Start	End
Item	DWR Erosion Survey			37.938247 °	37.938247 °
				-121.336503 °	-121.336503 °
DWR ID	RD0524U01RM41.26				
Comment Code					
Inspector Comment					
Site ID: RD0524U01RM41.26					
09/24/2020: From 2018 to present, no significant changes were observed during the annual survey.					
09/13/2017: The erosion was discovered by levee inspection. The erosion site is immediately downstream of tall vegetation.

9/24/2020: Close-up view of the erosion.

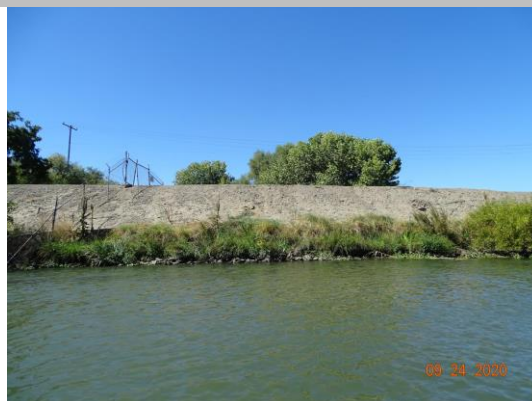
Photo 1 of 2 : SJR2019\_RD0524U01RM41.39\_01.JPG

LM Start	0.76	Rating **	U	Issue No.	4
LM End	0.77	Issue Type +	Ma	Location *	WS
Category	Supplemental			GPS Latitude/Longitude	
				Start	End
Item	DWR Erosion Survey			37.936749 °	37.936749 °
				-121.334971 °	-121.334971 °
DWR ID	RD0524U01RM41.39				
Comment Code					
Inspector Comment					
Site ID: RD0524U01RM41.39					
09/24/2020: From 2013 to present, no significant changes were observed during the annual survey.					
08/07/2012: The site has been visited by boat survey. No significant change observed.					
08/23/2011: The site is located immediately upstream of a Railroad bridge. Dense vegetation at the water line blocks the view of erosion.

9/24/2020: Front view of the erosion.

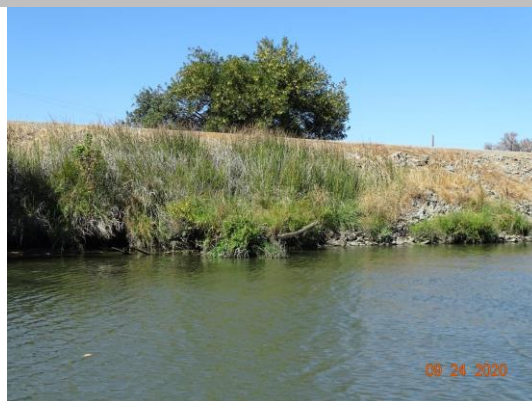
Photo 2 of 2 : SJR2019\_RD0524U01RM41.79\_02.JPG

LM Start	1.15	Rating **	U	Issue No.	22 (cont)
LM End	1.23	Issue Type +	Ma	Location *	WS
Category	Supplemental			GPS Latitude/Longitude	
				Start	End
Item	DWR Erosion Survey			37.933347 °	37.933347 °
				-121.329110 °	-121.329110 °
DWR ID	RD0524U01RM41.79

9/24/2020: Front view of the erosion with riprap on the levee slope.

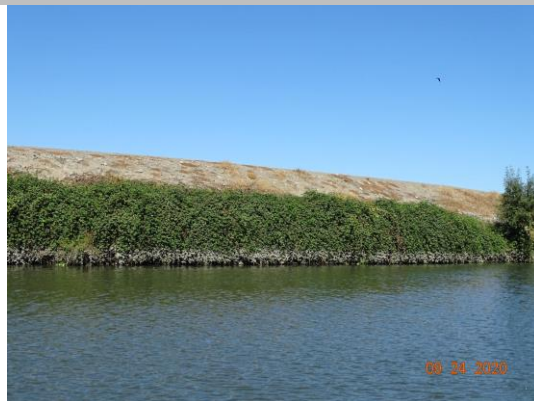
Photo 1 of 2 : SJR2019\_RD0524U01RM42.03\_02.JPG

9/24/2020: Dense vegetation is limiting the view of the erosion.

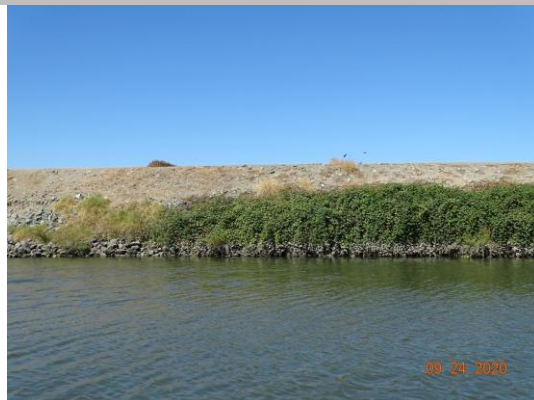
Photo 2 of 2 : SJR2019\_RD0524U01RM42.03\_01.JPG

9/24/2020: Another view of the erosion site.

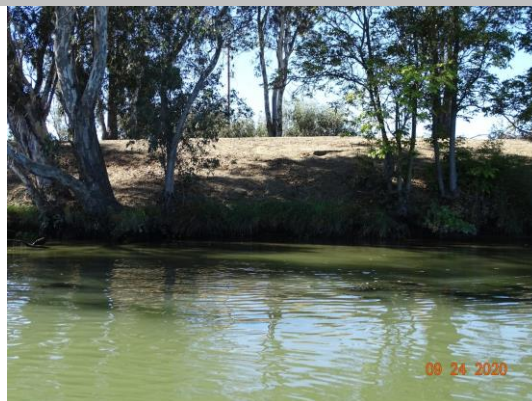
Photo 1 of 3 : SJR2019\_RD0524U01RM42.2\_02.JPG

9/24/2020: View of an erosion pocket between trees.

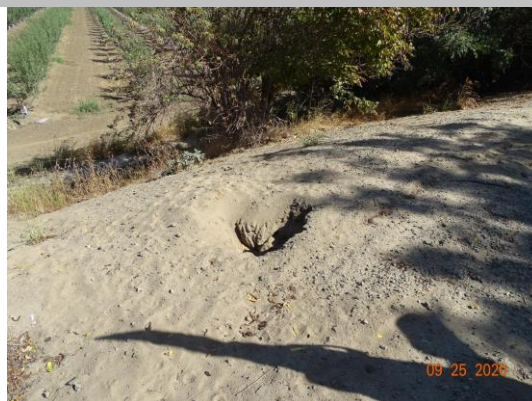
Photo 1 of 1 : FA\_2020\_RD0524\_107\_160\_20201005\_00224.jpg

LM Start	2.51	Rating **	U	Issue No.	160
LM End	2.51	Issue Type +	Ma	Location *	LS
Category	Earthen Levee			GPS Latitude/Longitude	
				Start	End
Item	Animal Control			37.918212 °	37.918212 °
				-121.322107 °	-121.322107 °
DWR ID	DWR_RD0524_01_f_2020_160				
Comment Code					
A3 : No rodents visible, but rodent burrows visible; need to backfill and compact or grout burrows.					
Inspector Comment

View of large rodent hole on landside slope. Fall 2020

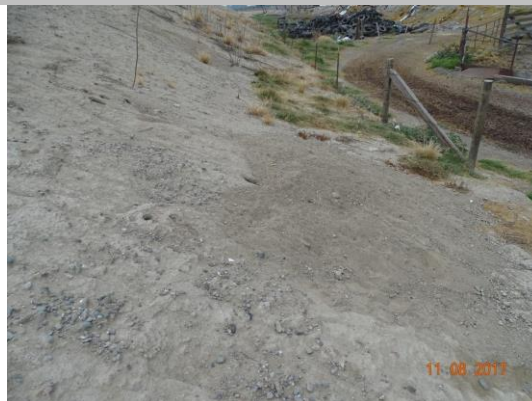
Photo 1 of 1 : FA\_2020\_RD0524\_107\_925\_20200901\_00120.jpg

LM Start	3.10	Rating **	M	Issue No.	925
LM End	3.27	Issue Type +	Ma	Location *	LS
Category	Earthen Levee			GPS Latitude/Longitude	
				Start	End
Item	Animal Control			37.910946 °	37.908602 °
				-121.325147 °	-121.325395 °
DWR ID	DWR_RD0524_01_s_2012_925				
Comment Code					
A1 : Exterminate rodents and backfill and compact or grout burrows.					
Inspector Comment					
Several rodent holes on levee slopes.

Looking southwest at the landside slope.

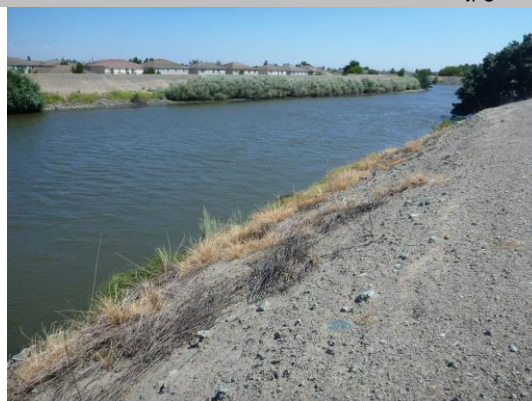
Photo 1 of 1 : LEVAL\_FA\_2020\_466\_2229.jpg

LM Start	3.23	Rating **	M	Issue No.	229
LM End	3.29	Issue Type +	Ma	Location *	WS
Category	Earthen Levee			GPS Latitude/Longitude	
				Start	End
Item	Erosion / Bank Caving			37.909200 °	37.908200 °
				-121.325300 °	-121.325300 °
DWR ID	LMA-293				
Comment Code					
E2 : Schedule repair of erosion site prior to the next inspection.					
Inspector Comment					
2017 Storm Damage Site ID 466, 528, 527, 467, Slope protection repairs are needed along the waterside slope due to erosion. Notes: Lower priority because damage is only on the lower 1/5 of slope.

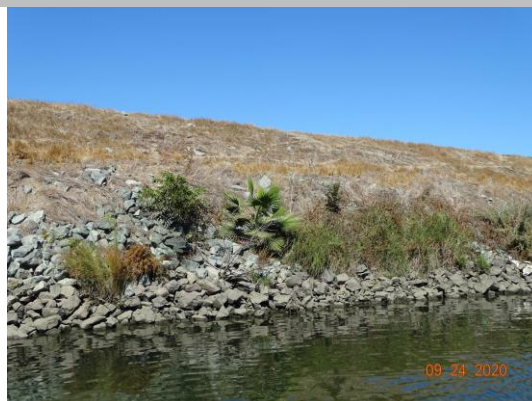
Photo 2 of 2 : SJR2019\_RD0524U01RM43.86\_03.JPG

LM Start	3.29	Rating **	A/W	Issue No.	8
LM End	3.31	Issue Type +	Ma	Location *	WS
Category	Supplemental			GPS Latitude/Longitude	
				Start	End
Item	DWR Erosion Survey			37.908036 °	37.908036 °
				-121.325397 °	-121.325397 °
DWR ID	RD0524U01RM43.86				
Comment Code					
Inspector Comment					
Site ID: RD0524U01RM43.86					
09/24/2020: No changes observed since the previous inspection. The site will be removed from the erosion survey list in 2021.					
08/13/2019: This erosion site has been repaired.					
09/13/2017: From 2014 to present, no significant changes were observed during the annual survey.					
08/13/2013: The levee toe seems to have been protected by river rocks and vegetation on site.

9/24/2020: Close-up view of the erosion.

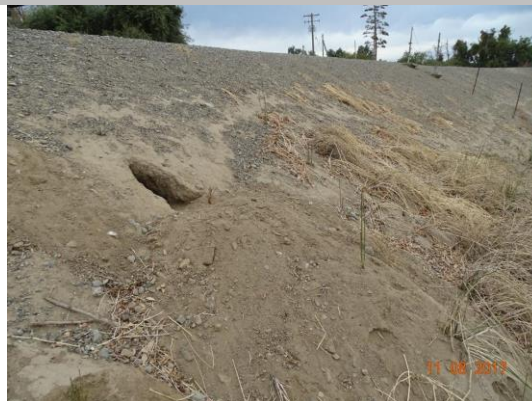
Photo 1 of 1 : FA\_2020\_RD0524\_107\_251\_20200901\_00110.jpg

LM Start	3.67	Rating **	U	Issue No.	251
LM End	3.69	Issue Type +	Ma	Location *	WS
Category	Earthen Levee			GPS Latitude/Longitude	
				Start	End
Item	Animal Control			37.903776 °	37.903513 °
				-121.325323 °	-121.325494 °
DWR ID	DWR_RD0524_01_f_2017_251				
Comment Code					
A3 : No rodents visible, but rodent burrows visible; need to backfill and compact or grout burrows.					
Inspector Comment					
Large rodent holes on waterside slope.

Looking northwest at the waterside slope.

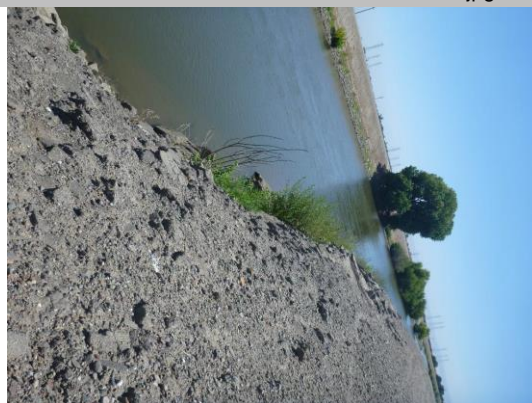
Photo 1 of 3 : LEVAL\_FA\_2020\_468\_2219.jpg

Notes: Serious because erosion is impacting the levee, but there is some slope protection here. Slope is armored with asphalt and concrete rubble. The surrounding slopes are pretty barren, but there is a small bush within the site so it may be older.

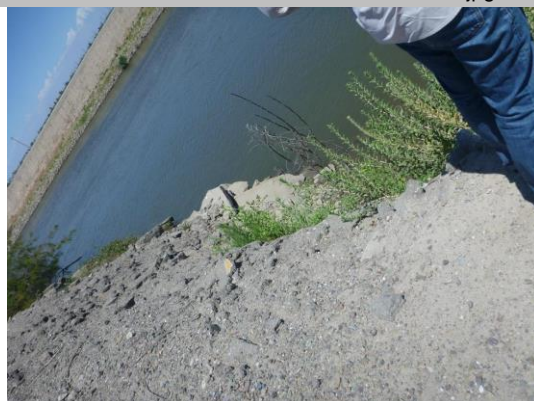
Photo 2 of 3 : LEVAL\_FA\_2020\_468\_2220.jpg

LM Start	<b>4.53</b>	Rating **	A/W	Issue No.	<b>30 (cont)</b>
LM End	<b>4.53</b>	Issue Type +	Ma	Location *	WS
Category	Supplemental			GPS Latitude/Longitude	
				Start	End
Item	2017 Storm Damage			37.892230 °	37.892200 °
				-121.327930 °	-121.328000 °
DWR ID	LMA-295

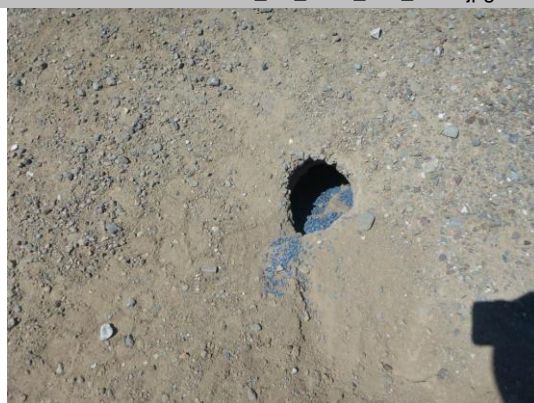
Photo 3 of 3 : LEVAL\_FA\_2020\_468\_2221.jpg

LM Start	<b>4.53</b>	Rating **	A/W	Issue No.	<b>30 (cont)</b>
LM End	<b>4.53</b>	Issue Type +	Ma	Location *	WS

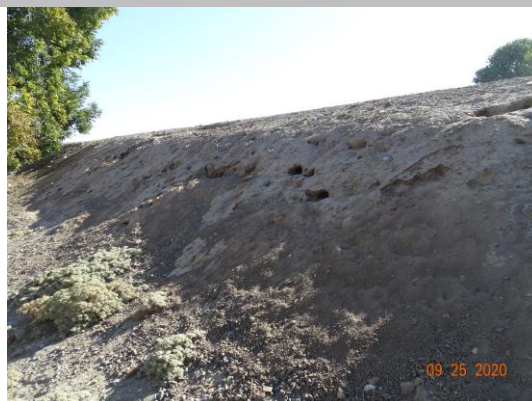
Photo 1 of 1 : FA\_2020\_RD0524\_107\_124\_20201005\_00222.jpg

LM Start	4.61	Rating **	U	Issue No.	124
LM End	4.63	Issue Type +	Ma	Location *	LS
Category	Earthen Levee			GPS Latitude/Longitude	
				Start	End
Item	Animal Control			37.891298 °	37.891061 °
				-121.328750 °	-121.328938 °
DWR ID	DWR_RD0524_01_f_2020_124				
Comment Code					
A3 : No rodents visible, but rodent burrows visible; need to backfill and compact or grout burrows.					
Inspector Comment

View of multiple large rodent holes on landside slope. Fall 2020

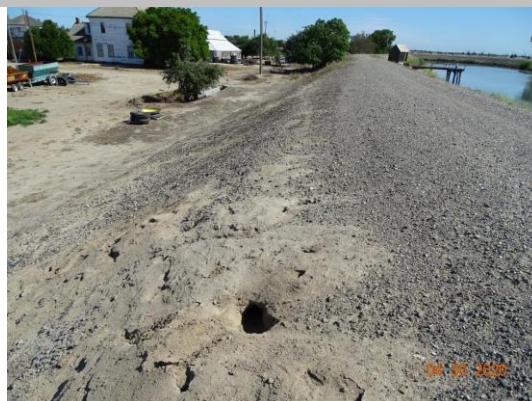
Photo 1 of 1 : FA\_2020\_RD0524\_107\_189\_20200901\_00074.jpg

LM Start	4.70	Rating **	U	Issue No.	189
LM End	4.75	Issue Type +	Ma	Location *	LS
Category	Earthen Levee			GPS Latitude/Longitude	
				Start	End
Item	Animal Control			37.890041 °	37.889395 °
				-121.329565 °	-121.329839 °
DWR ID	DWR_RD0524_01_s_2020_189				
Comment Code					
A3 : No rodents visible, but rodent burrows visible; need to backfill and compact or grout burrows.					
Inspector Comment

View of multiple large animal burrows on the landside slope. Spring 2020

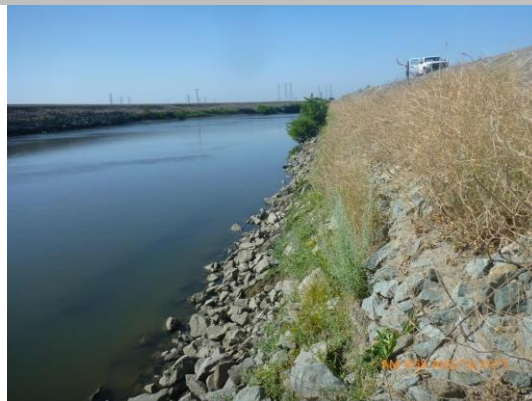
Photo 1 of 1 : LEVAL\_FA\_2020\_523\_4217.jpg

LM Start	4.76	Rating **	M	Issue No.	236
LM End	4.76	Issue Type +	Ma	Location *	WS
Category	Earthen Levee			GPS Latitude/Longitude	
				Start	End
Item	Erosion / Bank Caving			37.889300 °	37.889300 °
				-121.329800 °	-121.329800 °
DWR ID	DWR_RD0524_01_s_2020_236				
Comment Code					
E2 : Schedule repair of erosion site prior to the next inspection.					
Inspector Comment					
2017 Strom Damage Site, ID No. 523, LMA-429, Slope protection repairs are needed along the waterside slope due to erosion and riprap displacement from high water.

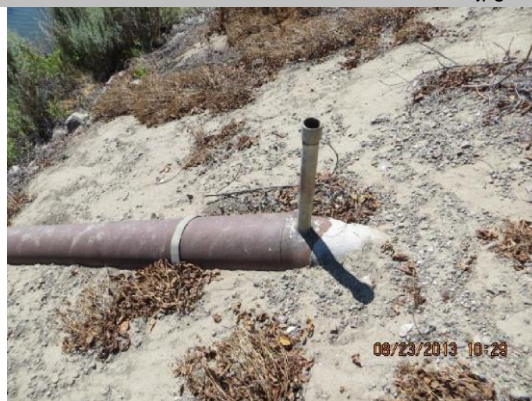
Photo 2 of 3 : UCIP\_FA\_2020\_62007\_30688.jpg

Comment Code						
Inspector Comment						
DS_ID:20630 FS_ID:62007 EP_NO: N/A Repair Type: Non-Urgent EVAL Issue: Pipe Damage Crossing Status: Found UCIP Comments: 06/24/2020 Record updated from Urgent to Non-Urgent. Pipe damage visible on WS. Limited inspection on LS due to overgrown vegetation. Unauthorized encroachment recorded in Levee Log prior to 2011. No permit has been identified authorizing pipe. Crossing appears abandoned. (D.Sanoski - DWR UCIP) 10/2/2018 Same as last inspection. Holes present in pipe pose a potential threat to levee's internal integrity. Recommend video inspection (D. Sanoski - DWR UCIP).11/16/2016 same as previous inspection hole in pipe is still present on WS near toe. This pipe does not appear to be in use. Need to contact owner to determine status of crossing. If the crossing is abandoned or still in use, owner will need to coordinate with the CVFPB to comply with Title 23 requirements. (O. Magana - DWR UCIP)08/23/2013 flap gate damage and does not work at WS toe. Large hole in pipe at WS toe. Pipe appears abandoned and should be done so properly. (W. Wylie - DWR UCIP) FIELD_STRUCT_DESC: *ABANDONED* 1 of 2: 12-inch steel irrigation pipe through the levee, 6 feet below the crown. Pump located on the waterside (WS), no pump found in 2013. Flap gate located on the WS end. [Additional Reference(s): DWR Levee Log, 2004. USACE San Joaquin O&M Manual 7, April 1964, (HLM 5.48) 10-inch pipe listed, Drawing No. 07-04-1490, Sheet 1490/4, (Station 8+01.3)]. FS Date: 6/24/2020 2:53:00 PM

Vent on pipe on WS slope. Possible slurry standpipe that has not yet been used.

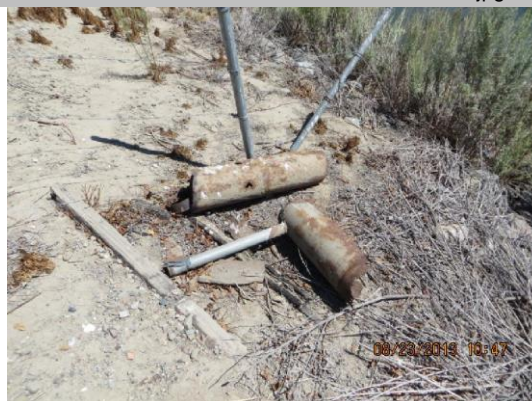
Photo 1 of 3 : UCIP\_FA\_2020\_62014\_30706.jpg

Comment Code						
Inspector Comment						
DS_ID:20631 FS_ID:62014 EP_NO: N/A Repair Type: Non-Urgent EVAL Issue: Limited Inspection/No UCIP Evaluation Crossing Status: Found UCIP Comments: 06/25/2020 Record remains Non-Urgent. Limited inspection on LS due to overgrown vegetation. Unauthorized encroachment recorded in Levee Log prior to 2011. No permit has been identified authorizing pipe. Recommend combining this DSID with 24050 due to same location and 8-inch pipe sleeved through this 10-inch pipe. (D.Sanoski - DWR UCIP) Recent work being done on WS slope. Pipe may still be in use. FIELD_STRUCT_DESC: 10-inch steel drainage pipe through the levee, 6 feet below the crown. Pump not found on the landside (LS). [Additional Reference(s): DWR Levee Log, 2004. USACE San Joaquin O&M Manual 7, April 1964, (HLM 5.50)]. FS Date: 6/25/2020 2:53:00 PM

10-inch pipe debris on the WS slope.

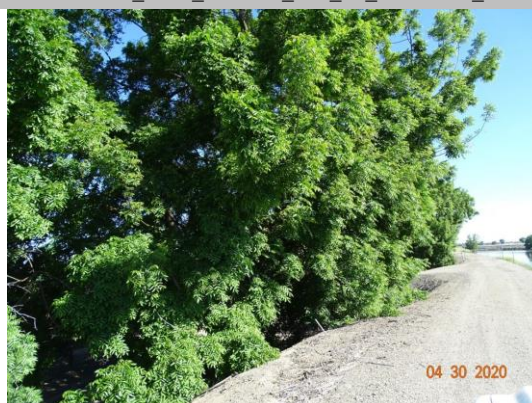
Photo 1 of 1 : FA\_2020\_RD0524\_107\_73\_20200901\_00035.jpg

LM Start	5.43	Rating **	U	Issue No.	73
LM End	5.45	Issue Type +	Ma	Location *	LS
Category	Earthen Levee			GPS Latitude/Longitude	
				Start	End
Item	Trim / Thin Trees			37.880220 °	37.879926 °
				-121.333031 °	-121.333125 °
DWR ID	DWR_RD0524_01_s_2012_73				
Comment Code					
T3 : Trim and thin trees to allow visibility of the ground and room to flood fight.					
Inspector Comment					
Trim walnut trees on the levee slope.

View of trees that need to be trimmed and thinned on landside slope.  
Spring 2020

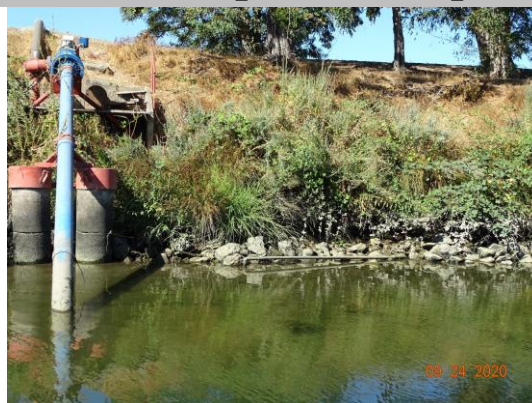
Photo 2 of 2 : SJR2019\_RD0524U01RM46.06\_03.JPG

LM Start	5.53	Rating **	M	Issue No.	6
LM End	5.53	Issue Type +	Ma	Location *	WS
Category	Supplemental			GPS Latitude/Longitude	
				Start	End
Item	DWR Erosion Survey			37.878798 °	37.878798 °
				-121.333111 °	-121.333111 °
DWR ID	RD0524U01RM46.06				
Comment Code					
Inspector Comment					
Site ID: RD0524U01RM46.06					
09/24/2020: From 2014 to present, no significant changes were observed during the annual survey. Vegetation is limiting the view but undercutting of the levee toe is still visible.					
08/13/2013: Larger trees are at the levee shoulder, and an irrigation pump station is next to the erosion site.

9/24/2020: Close-up view of the undercutting.

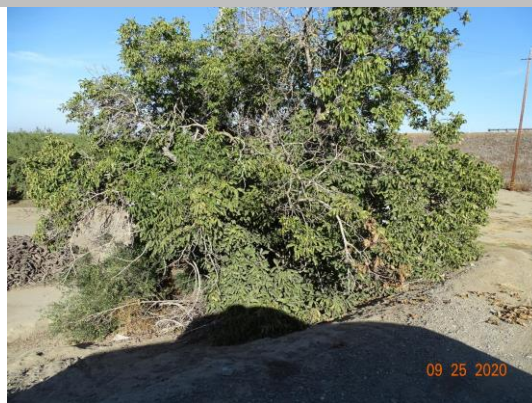
Photo 1 of 1 : FA\_2020\_RD0524\_107\_117\_20201005\_00218.jpg

LM Start	5.66	Rating **	M	Issue No.	117	
LM End	5.66	Issue Type +	Ma	Location *	LS	
Category	Earthen Levee			GPS Latitude/Longitude		
				Start		End
Item	Trim / Thin Trees			37.877100 °		37.877100 °
				-121.332323 °		-121.332323 °
DWR ID	DWR_RD0524_01_f_2013_117					
Comment Code						
T1 : Trim trees to at least five feet above ground level.						
Inspector Comment

View of large untrimmed walnut tree on landside slope. Fall 2020

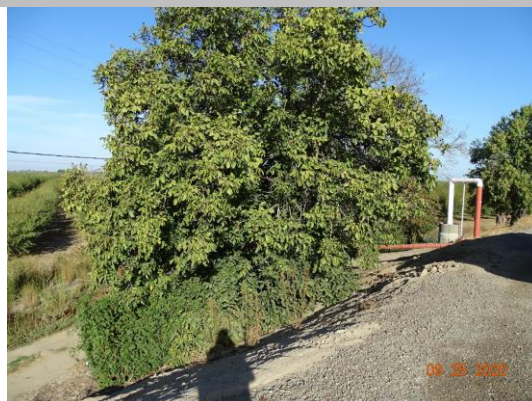
Photo 1 of 1 : FA\_2020\_RD0524\_107\_98\_20201005\_00217.jpg

LM Start	5.87	Rating **	M	Issue No.	98
LM End	5.87	Issue Type +	Ma	Location *	LS
Category	Earthen Levee			GPS Latitude/Longitude	
				Start	End
Item	Trim / Thin Trees			37.874085 °	37.874085 °
				-121.333154 °	-121.333154 °
DWR ID	DWR_RD0524_01_s_2012_98				
Comment Code					
T1 : Trim trees to at least five feet above ground level.					
Inspector Comment					
Untrimmed walnut tree on landside slope.

View of large untrimmed walnut tree on landside slope. Fall 2020

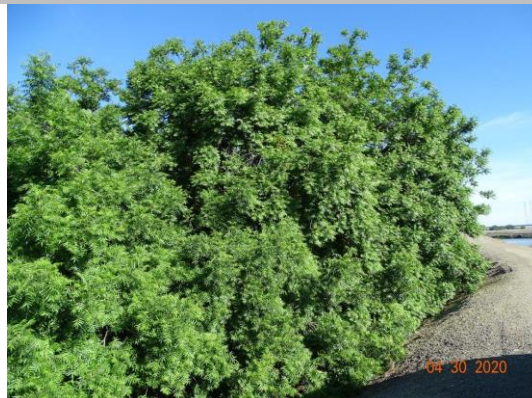
Photo 1 of 1 : FA\_2020\_RD0524\_107\_103\_20200901\_00047.jpg

LM Start	6.15	Rating **	U	Issue No.	103
LM End	6.18	Issue Type +	Ma	Location *	LS
Category	Earthen Levee			GPS Latitude/Longitude	
				Start	End
Item	Trim / Thin Trees			37.871083 °	37.870699 °
				-121.330133 °	-121.329990 °
DWR ID	DWR_RD0524_01_s_2020_103				
Comment Code					
T3 : Trim and thin trees to allow visibility of the ground and room to flood fight.					
Inspector Comment

View of trees on landside slope that need to be trimmed and thinned. Spring 2020
