**Flood Control Project Maintenance  
Levee Inspections**

**Maintenance Issue Types Only, Levee Inspection Report By Mile - Fall 2021**

**Reclamation District No. 0524 Middle Roberts Island**

Waterway	Bank	Unit Miles	Inspection Start/End	Inspector
Unit No. 01 San Joaquin River	Left	6.20	10/22/2021 10/22/2021	Alberto De Leon

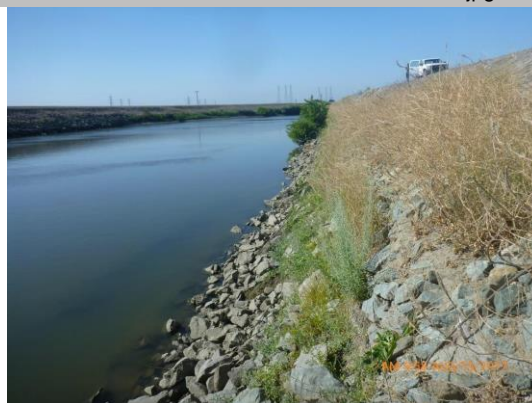
Photo 1 of 1 : LEVAL\_FA\_2021\_523\_4217.jpg

LM Start	<b>4.76</b>	Rating **	M	Issue No.	<b>236</b>							
LM End	<b>4.76</b>	Issue Type +	Ma	Location *	WS							
Category	Earthen Levee		GPS Latitude/Longitude									
			Start	End								
Item	Erosion / Bank Caving		37.889300 °	37.889300 °								
			-121.329800 °	-121.329800 °								
DWR ID	DWR_RD0524_01_s_2020_236											
Comment Code												
E2 : Schedule repair of erosion site prior to the next inspection.												
Inspector Comment												
2017 Storm Damage Site, ID No. 523, LMA-429, Slope protection repairs are needed along the waterside slope due to erosion and riprap displacement from high water.
