**Flood Control Project Maintenance
Levee Inspections**

Maintenance Issue Types Only, Levee Inspection Report By Mile - Fall 2022

Reclamation District No. 0524 Middle Roberts Island

Waterway	Bank	Unit Miles	Inspection Start/End	Inspector
Unit No. 01 San Joaquin River	Left	6.20	11/04/2022 11/04/2022	Alberto De Leon

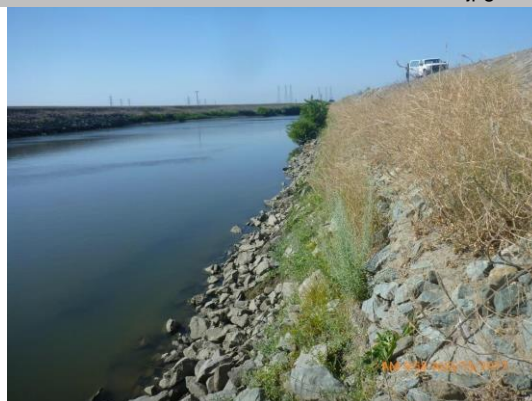
Photo 1 of 1 : LEVAL_FA_2022_523_4217.jpg

LM Start	4.76	Rating **	A/W	Issue No.	236
LM End	4.76	Issue Type +	Ma	Location *	WS
Category	Earthen Levee			GPS Latitude/Longitude	
				Start	End
Item	Erosion / Bank Caving			37.889300 °	37.889300 °
				-121.329800 °	-121.329800 °
DWR ID	DWR_RD0524_01_s_2020_236				
Comment Code					
E1 : Note and monitor erosion site.					
Inspector Comment					
2017 Strom Damage Site, ID No. 523, LMA-429,
