**Flood Control Project Maintenance  
Levee Inspections**

## Maintenance Issue Types Only, Levee Inspection Report By Mile - Spring 2015

### Reclamation District No. 0524 Middle Roberts Island

Waterway		Bank	Unit Miles	Inspection Start/End	Inspector
Unit No. 01 San Joaquin River		Left	6.20	04/21/2015 04/21/2015	Richard Willoughby

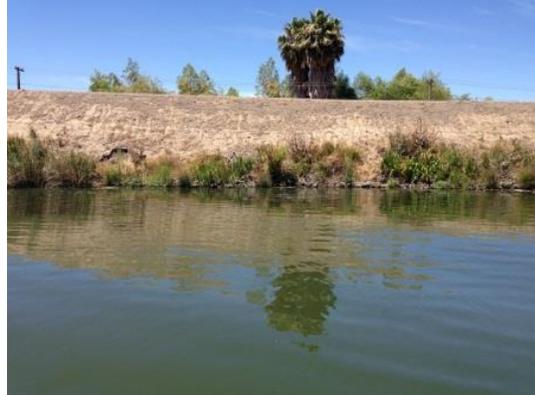
Photo 1 of 1 : SP\_2015\_RD0524\_107\_129\_20150309\_00129.jpg

LM Start	<b>0.19</b>	Rating **	U	Issue No.	<b>129</b>
LM End	<b>0.19</b>	Issue Type +	Ma	Location *	WS
Category	Supplemental			GPS Latitude/Longitude	
				Start	End
Item	DWR Erosion Survey			37.939085 °	37.939085 °
				-121.343917 °	-121.343917 °
DWR ID	DWR_RD0524_01_s_2015_129				
Action/Comments					
Inspector Comments: 6/19/2014: No significant change observed. 08/13/2013: The erosion was discovered during 2013 spring levee inspection. Inspector comment: Erosion is located along the lower level of water-ward slope. [2014 Site ID:RD0524U01RM40.85]

Close view of the erosion.

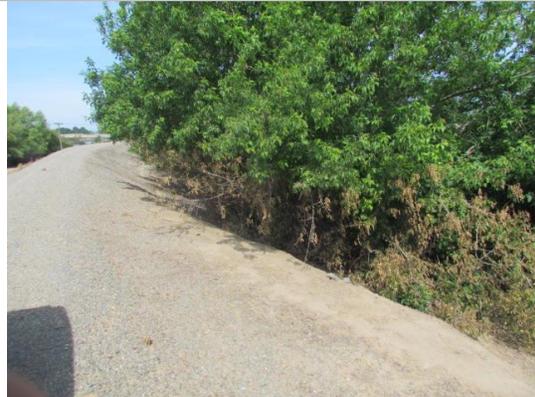
Photo 1 of 2 : SP\_2015\_RD0524\_107\_179\_20150424\_00204.jpg

Looking north at untrimmed tree on waterward slope. (Spring 2015)

LM Start	<b>0.27</b>	Rating **	U	Issue No.	<b>179</b>
LM End	<b>0.27</b>	Issue Type +	Ma	Location *	WS
Category	Earthen Levee			GPS Latitude/Longitude	
				Start	End
Item	Trim / Thin Trees			37.938438 °	37.938438 °
				-121.342883 °	-121.342883 °
DWR ID	DWR_RD0524_01_s_2014_179				
Action/Comments					
Thin trees to allow visibility of the ground and room to flood fight.

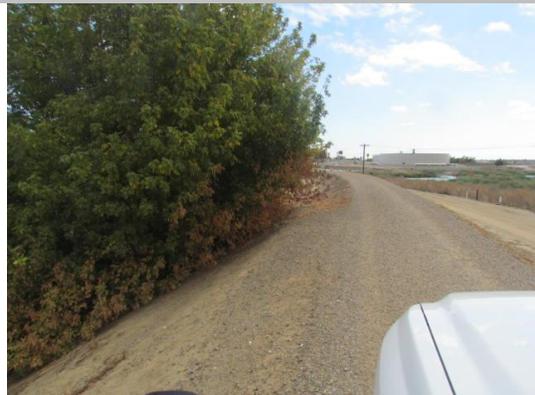
Photo 2 of 2 : SP\_2015\_RD0524\_107\_179\_20150309\_00146.jpg

Looking south at untrimmed tree on waterward slope. (Fall 2014)

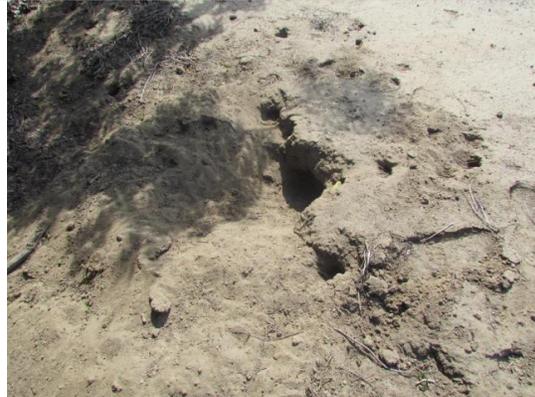
Photo 1 of 2 : SP\_2015\_RD0524\_107\_174\_20150424\_00205.jpg

LM Start	<b>0.30</b>	Rating **	U	Issue No.	<b>174</b>
LM End	<b>0.30</b>	Issue Type +	Ma	Location *	WS
Category	Earthen Levee		GPS Latitude/Longitude		
			Start	End	
Item	Animal Control		37.938382 °	37.938382 °	
			-121.342352 °	-121.342352 °	
DWR ID	DWR_RD0524_01_f_2014_174				
Action/Comments					
No rodents visible, but rodent burrows visible; need to backfill and compact or grout burrows. Inspector Comments: Several rodent holes present at this site.

Looking west at several rodent holes on waterward shoulder. (Spring 2015)

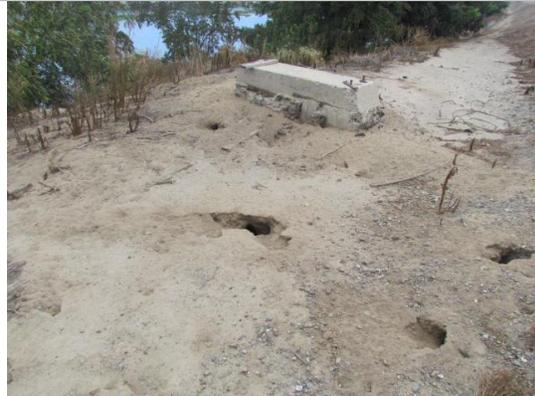
Photo 2 of 2 : SP\_2015\_RD0524\_107\_174\_20150309\_00144.jpg

Looking southeast at several rodent holes on waterward slope.

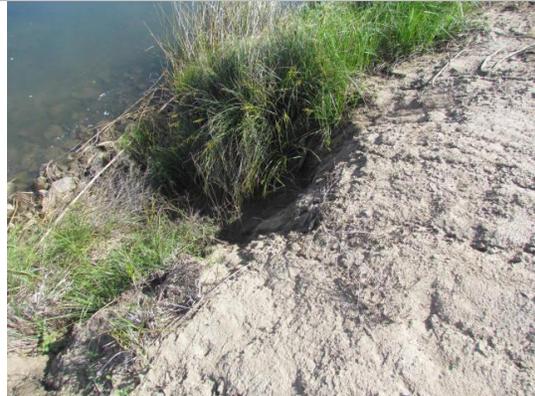
Photo 1 of 2 : SP\_2015\_RD0524\_107\_180\_20150309\_00147.jpg

LM Start	<b>0.34</b>	Rating **	M	Issue No.	<b>180</b>
LM End	<b>0.34</b>	Issue Type +	Ma	Location *	WS
Category	Earthen Levee		GPS Latitude/Longitude		
			Start	End	
Item	Erosion / Bank Caving		37.938461 °	37.938461 °	
			-121.341626 °	-121.341626 °	
DWR ID	DWR_RD0524_01_s_2014_180				
Action/Comments					
Schedule repair of erosion site prior to the next inspection. Inspector Comments: Erosion is located along the lower level of waterward slope.

Looking southeast at erosion on waterward toe.

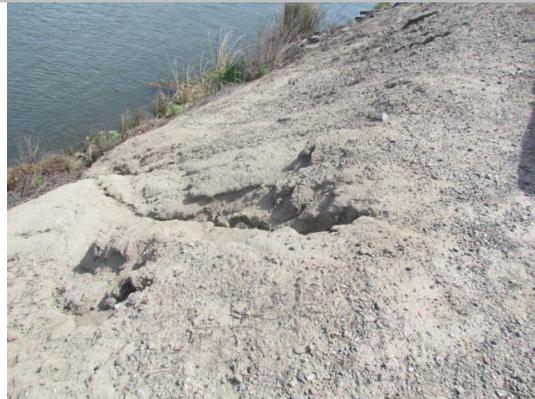
Photo 2 of 2 : SP\_2015\_RD0524\_107\_170\_20150424\_00208.jpg

LM Start	<b>0.41</b>	Rating **	M	Issue No.	<b>170</b>
LM End	<b>0.65</b>	Issue Type +	Ma	Location *	WS
Category	Earthen Levee			GPS Latitude/Longitude	
				Start	End
Item	Slope Stability			37.938628 °	37.938015 °
				-121.340385 °	-121.336165 °
DWR ID	DWR_RD0524_01_s_2015_170				
Action/Comments					
Repair slope instability. Inspector Comments: Several slope instabilities within this reach.

Looking west at waterward slope erosion.

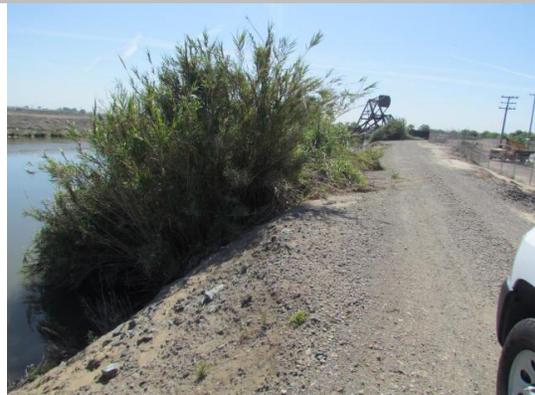
Photo 1 of 3 : SP\_2015\_RD0524\_107\_11\_20150309\_00013.jpg

LM Start	<b>0.62</b>	Rating **	M	Issue No.	<b>11</b>
LM End	<b>0.63</b>	Issue Type +	Ma	Location *	WS
Category	Earthen Levee			GPS Latitude/Longitude	
				Start	End
Item	Vegetation			37.938278 °	37.938247 °
				-121.336524 °	-121.336503 °
DWR ID	DWR_RD0524_01_s_2012_11				
Action/Comments					
Remove the wild growth other than native grasses from the levee slopes. Inspector Comments: Bamboo on waterward slope.

Looking southeast at bamboo on waterside slope. (Spring 2012)

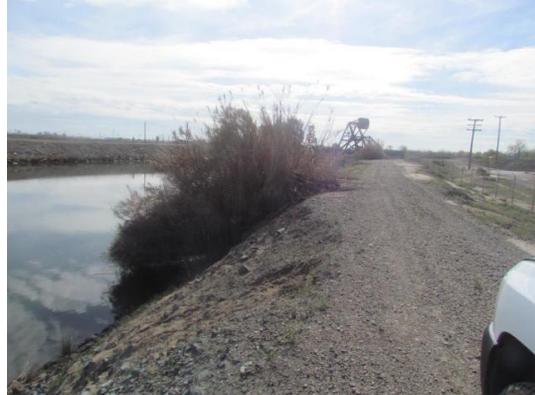
Photo 2 of 3 : SP\_2015\_RD0524\_107\_11\_20150309\_00014.jpg

Looking south at dying bamboo on waterward slope. (Spring 2013)

LM Start	<b>0.62</b>	Rating **	M	Issue No.	<b>11 (cont)</b>
LM End	<b>0.63</b>	Issue Type +	Ma	Location *	WS
Category	Earthen Levee		GPS Latitude/Longitude		
			Start	End	
Item	Vegetation		37.938278 °	37.938247 °	
			-121.336524 °	-121.336503 °	
DWR ID	DWR_RD0524_01_s_2012_11				
Action/Comments					
Remove the wild growth other than native grasses from the levee slopes. Inspector Comments: Bamboo on waterward slope.

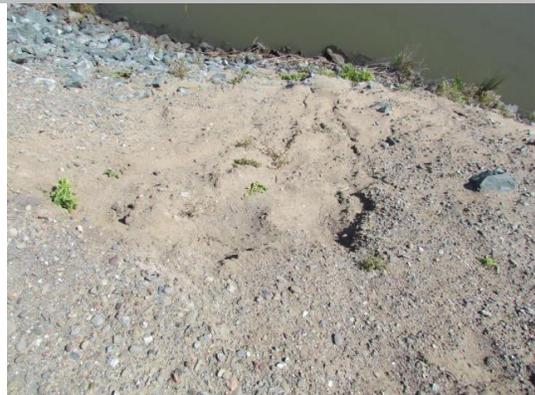
Photo 1 of 1 : SP\_2015\_RD0524\_107\_10\_20150309\_00012.jpg

Looking east at waterside erosion appears to be caused by runoff.

LM Start	<b>0.63</b>	Rating **	M	Issue No.	<b>10</b>
LM End	<b>0.63</b>	Issue Type +	Ma	Location *	WS
Category	Earthen Levee		GPS Latitude/Longitude		
			Start	End	
Item	Slope Stability		37.938247 °	37.938247 °	
			-121.336503 °	-121.336503 °	
DWR ID	DWR_RD0524_01_s_2012_10				
Action/Comments					
Repair the levee slope damaged by foot traffic and prevent access where possible.

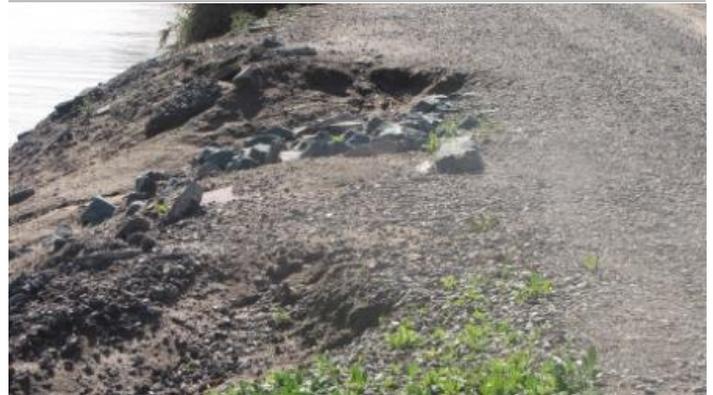
Photo 2 of 3 : SP\_2015\_RD0524\_107\_13\_20150309\_00018.jpg

LM Start	<b>0.64</b>	Rating **	M	Issue No.	<b>13</b>
LM End	<b>0.65</b>	Issue Type +	Ma	Location *	WS
Category	Earthen Levee		GPS Latitude/Longitude		
			Start	End	
Item	Slope Stability		37.938105 °	37.938023 °	
			-121.336288 °	-121.336173 °	
DWR ID	DWR_RD0524_01_s_2012_13				
Action/Comments					
Repair slope instability. Inspector Comments: Erosion extends from mid levee slope to shoulder.

Looking south at erosion on waterside shoulder.

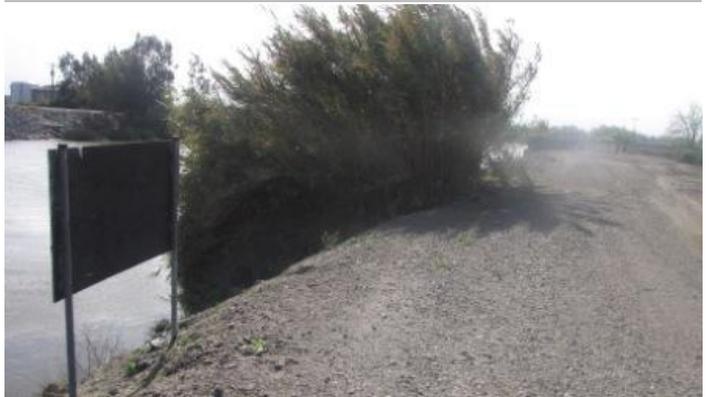
Photo 1 of 3 : SP\_2015\_RD0524\_107\_14\_20150309\_00020.jpg

LM Start	<b>0.67</b>	Rating **	M	Issue No.	<b>14</b>
LM End	<b>0.67</b>	Issue Type +	Ma	Location *	WS
Category	Earthen Levee		GPS Latitude/Longitude		
			Start	End	
Item	Vegetation		37.937808 °	37.937808 °	
			-121.335913 °	-121.335913 °	
DWR ID	DWR_RD0524_01_s_2012_14				
Action/Comments					
Remove the wild growth other than native grasses from the levee slopes. Inspector Comments: Bamboo on waterward slope.

Looking southeast at bamboo on waterside shoulder as of 4/2010.

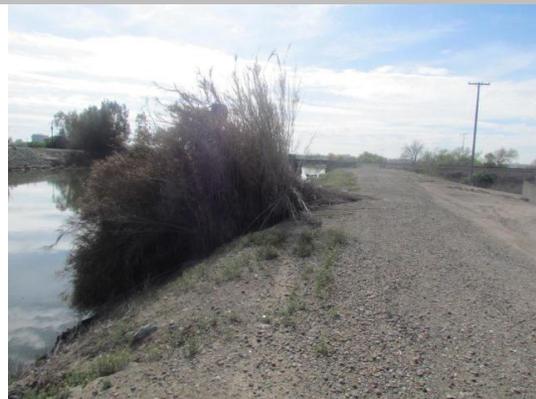
Photo 2 of 3 : SP\_2015\_RD0524\_107\_14\_20150309\_00021.jpg

Looking south at dying bamboo on waterward slope. (Spring 2013)

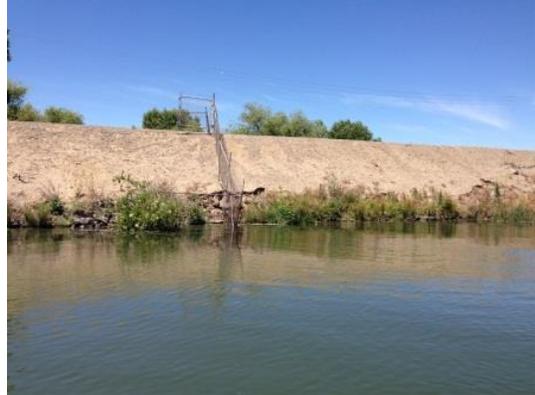
Photo 1 of 1 : SP\_2015\_RD0524\_107\_132\_20150309\_00131.jpg

LM Start	<b>0.76</b>	Rating **	U	Issue No.	<b>132</b>
LM End	<b>0.76</b>	Issue Type +	Ma	Location *	WS
Category	Supplemental			GPS Latitude/Longitude	
				Start	End
Item	DWR Erosion Survey			37.936821 °	37.936821 °
				-121.334582 °	-121.334582 °
DWR ID	DWR_RD0524_01_s_2015_132				
Action/Comments					
Inspector Comments: 06/19/2014: No significant change observed. 08/13/2013: No significant change at this site. 08/07/2012: The site has been visited by boat survey. No significant change observed. 08/23/2011: The site is located immediately upstream of a Railroad bridge. Dense vegetation at the water line blocks the view of erosion.

Front view of the erosion site. Vegetation is visible.

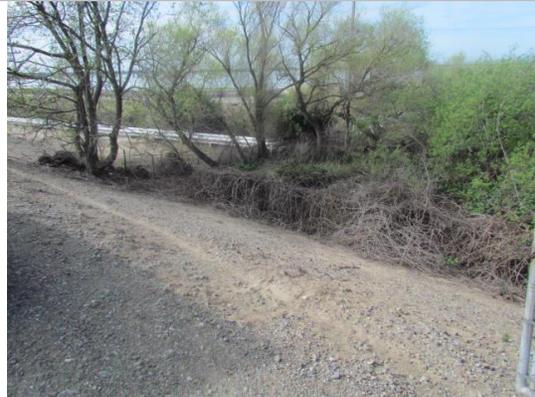
Photo 1 of 2 : SP\_2015\_RD0524\_107\_262\_20150309\_00155.jpg

LM Start	<b>0.77</b>	Rating **	M	Issue No.	<b>262</b>
LM End	<b>0.77</b>	Issue Type +	Ma	Location *	LS
Category	Earthen Levee			GPS Latitude/Longitude	
				Start	End
Item	Vegetation			37.936555 °	37.936555 °
				-121.334847 °	-121.334847 °
DWR ID	DWR_RD0524_01_s_2012_262				
Action/Comments					
Remove the wild growth other than native grasses from the levee slopes. Inspector Comments: Dense vegetation at landside toe along fence line.

Looking southwest at vegetation on landward slope and toe. (Spring 2013)

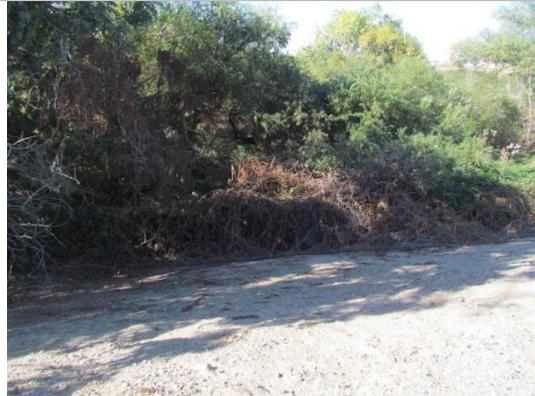
Photo 2 of 2 : SP\_2015\_RD0524\_107\_262\_20150309\_00156.jpg

Looking west at dense vegetation on landside toe.

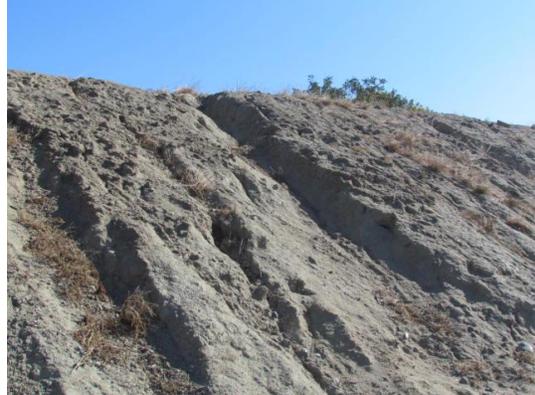
Photo 3 of 5 : SP\_2015\_RD0524\_107\_2\_20150309\_00003.jpg

LM Start	<b>0.81</b>	Rating **	U	Issue No.	<b>2 (cont)</b>
LM End	<b>0.81</b>	Issue Type +	Ma	Location *	LS
Category	Earthen Levee			GPS Latitude/Longitude	
				Start	End
Item	Erosion / Bank Caving			37.936093 °	37.936004 °
				-121.334648 °	-121.334615 °
DWR ID	DWR_RD0524_01_f_2013_2				
Action/Comments					
Schedule repair of erosion site prior to the next inspection. Inspector Comments: Several holes and finger erosions on landward slope.

Looking southeast at finger erosion on landward slope.

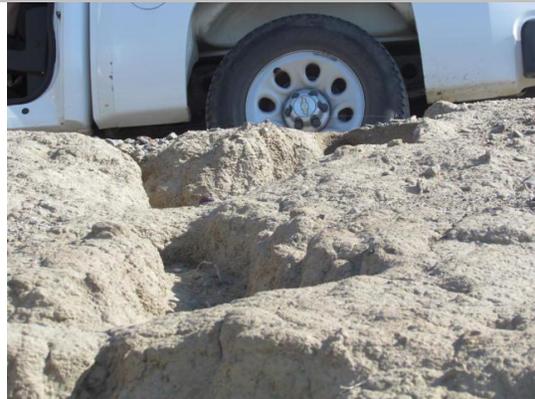
Photo 4 of 5 : SP\_2015\_RD0524\_107\_2\_20150309\_00004.jpg

Looking east at erosion on landward slope.

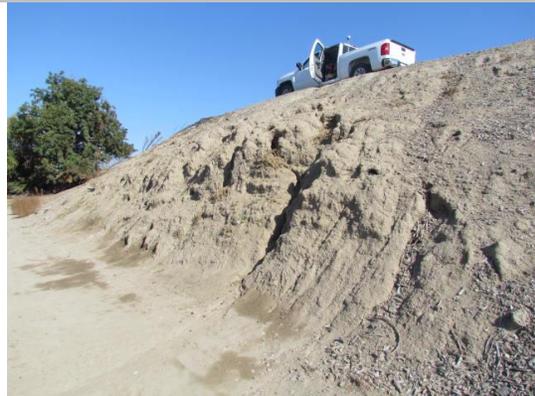
Photo 5 of 5 : SP\_2015\_RD0524\_107\_2\_20150309\_00005.jpg

Looking northeast at several finger erosion on landward slope.

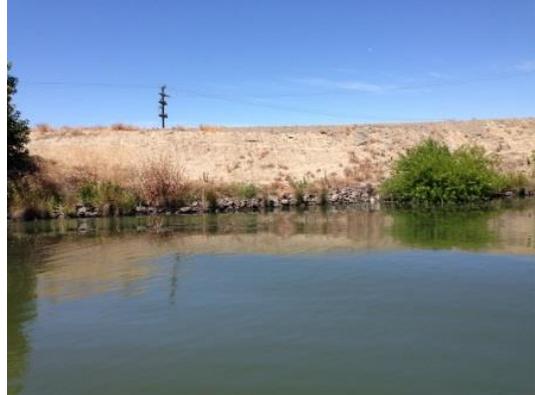
Photo 1 of 1 : SP\_2015\_RD0524\_107\_133\_20150309\_00132.jpg

LM Start	<b>0.83</b>	Rating **	U	Issue No.	<b>133</b>
LM End	<b>0.83</b>	Issue Type +	Ma	Location *	WS
Category	Supplemental			GPS Latitude/Longitude	
				Start	End
Item	DWR Erosion Survey			37.935930 °	37.935930 °
				-121.334133 °	-121.334133 °
DWR ID	DWR_RD0524_01_s_2015_133				
Action/Comments					
Inspector Comments: 06/19/2014: No significant change observed. 08/13/2013: Site was discovered during boat survey. The dense vegetation blocks a clear view of the erosion. Size of erosion site was very roughly estimated. [2014 Site ID:RD0524U01RM41.44]

Close view of the site. Dense vegetation covers the erosion.

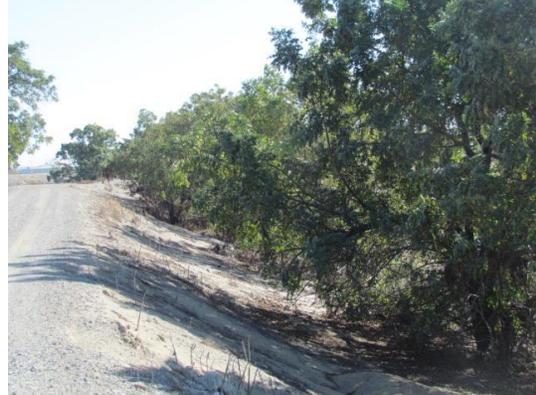
Photo 1 of 1 : SP\_2015\_RD0524\_107\_77\_20150309\_00089.jpg

Looking south at low hanging tree branches at landside toe.

LM Start	<b>0.93</b>	Rating **	M	Issue No.	<b>77</b>
LM End	<b>1.01</b>	Issue Type +	Ma	Location *	LS
Category	Earthen Levee			GPS Latitude/Longitude	
				Start	End
Item	Trim / Thin Trees			37.935259 °	37.935049 °
				-121.332864 °	-121.331334 °
DWR ID	DWR_RD0524_01_s_2012_77				
Action/Comments					
Trim trees to at least five feet above ground level.

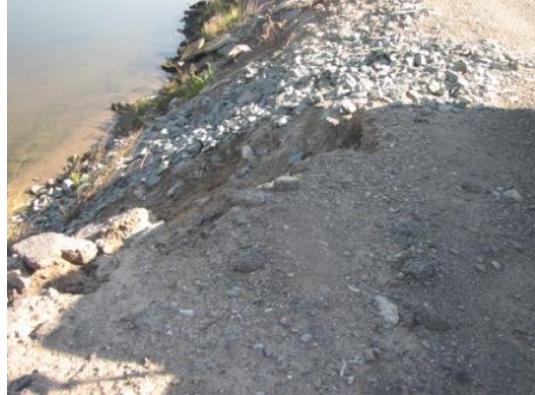
Photo 1 of 3 : SP\_2015\_RD0524\_107\_17\_20150309\_00023.jpg

LM Start	<b>1.00</b>	Rating **	M	Issue No.	<b>17</b>
LM End	<b>1.02</b>	Issue Type +	Ma	Location *	WS
Category	Earthen Levee			GPS Latitude/Longitude	
				Start	End
Item	Erosion / Bank Caving			37.935098 °	37.935018 °
				-121.331645 °	-121.331248 °
DWR ID	DWR_RD0524_01_s_2012_17				
Action/Comments					
Schedule repair of erosion site prior to the next inspection. Inspector Comments: Minor erosion was noted next to repaired site.

Looking upstream (south) at erosion site.

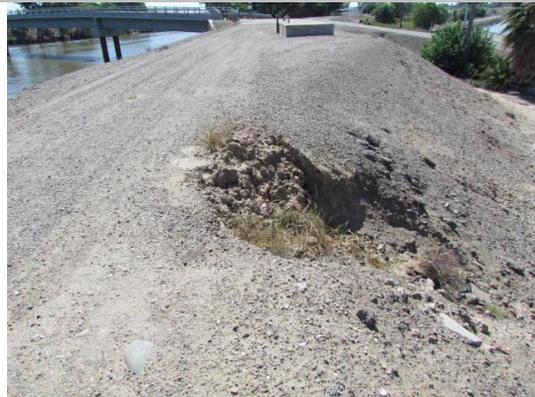
Photo 4 of 6 : SP\_2015\_RD0524\_107\_18\_20150309\_00028.jpg

Looking south at caving on landside shoulder. (Spring 2012)

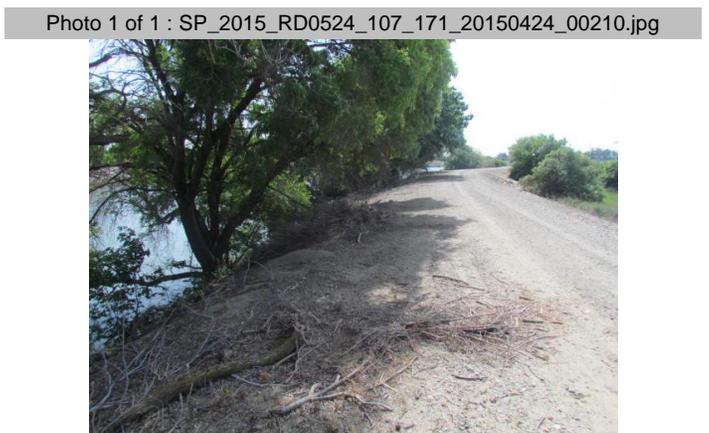
LM Start	<b>1.12</b>	Rating **	M	Issue No.	<b>171</b>
LM End	<b>1.16</b>	Issue Type +	Ma	Location *	WS
Category	Earthen Levee			GPS Latitude/Longitude	
				Start	End
Item	Encroachments			37.934225 °	37.933815 °
				-121.329693 °	-121.329242 °
DWR ID	DWR_RD0524_01_s_2015_171				
Action/Comments					
Prunings Inspector Comments: Prunings left on waterward shoulder and slope.

Looking south at prunings on waterward shoulders.

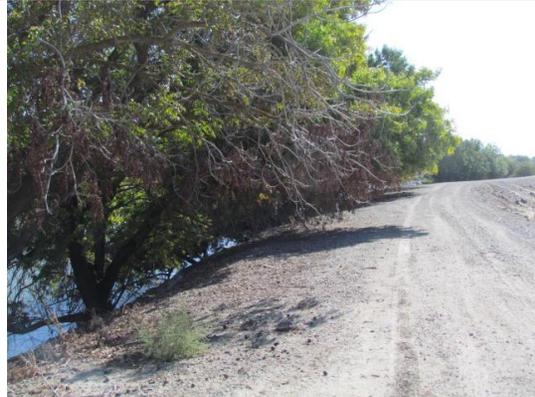
Photo 1 of 1 : SP\_2015\_RD0524\_107\_19\_20150309\_00031.jpg

Looking northwest at low hanging tree branches at waterside toe.

LM Start	<b>1.13</b>	Rating **	M	Issue No.	<b>19</b>
LM End	<b>1.16</b>	Issue Type +	Ma	Location *	WS
Category	Earthen Levee			GPS Latitude/Longitude	
				Start	End
Item	Trim / Thin Trees			37.934118 °	37.933775 °
				-121.329657 °	-121.329305 °
DWR ID	DWR_RD0524_01_s_2012_19				
Action/Comments					
Trim trees to at least five feet above ground level.

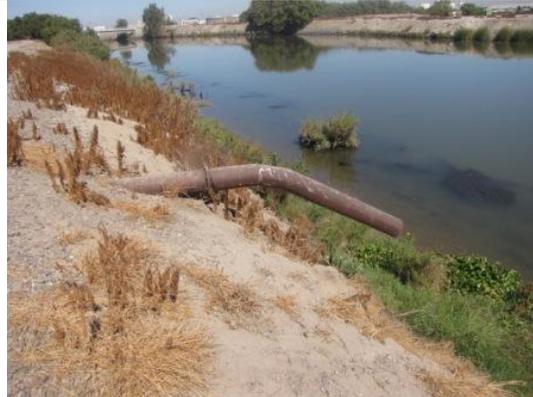
Photo 2 of 2 : SP\_2015\_RD0524\_107\_33\_20150309\_00047.jpg

LM Start	<b>1.30</b>	Rating **	M	Issue No.	<b>33 (cont)</b>
LM End	<b>1.30</b>	Issue Type +	Ma	Location *	WS
Category	Earthen Levee			GPS Latitude/Longitude	
				Start	End
Item	Encroachments			37.931948 °	37.931948 °
				-121.328387 °	-121.328387 °
DWR ID	DWR_RD0524_01_s_2012_33				
Action/Comments					
Pipe Inspector Comments: Pipe is not in use and should be properly abandoned.

Looking north at broken pipe.

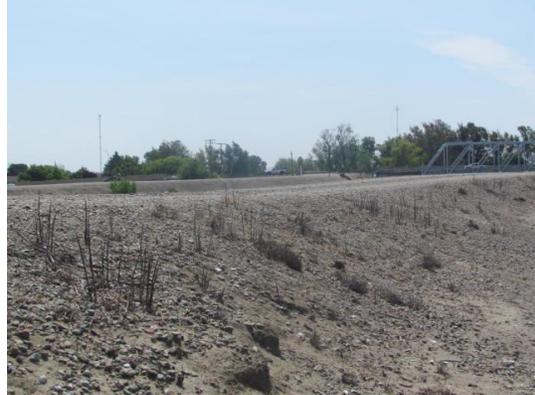
Photo 1 of 2 : SP\_2015\_RD0524\_107\_172\_20150424\_00211.jpg

LM Start	<b>1.35</b>	Rating **	U	Issue No.	<b>172</b>
LM End	<b>1.40</b>	Issue Type +	Ma	Location *	CR
Category	Earthen Levee			GPS Latitude/Longitude	
				Start	End
Item	Crown Surface / Depressions / Rutting			37.931143 °	37.930517 °
				-121.328097 °	-121.328072 °
DWR ID	DWR_RD0524_01_s_2015_172				
Action/Comments					
Repair depressions or ruts in the crown or slope. Inspector Comments: Levee crown depression several inches below original crown elevation. Section should be survey to determine proper elevation.

Looking east at depression on levee crown.

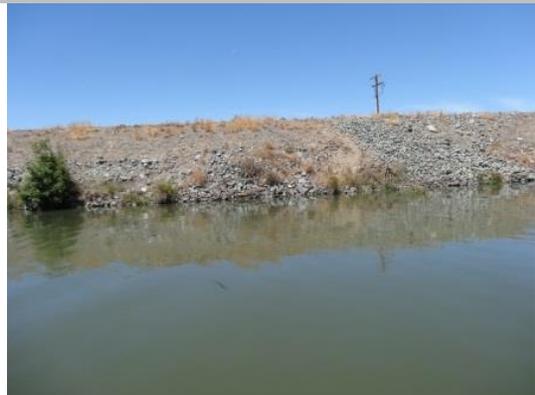
Photo 1 of 1 : SP\_2015\_RD0524\_107\_143\_20150309\_00139.jpg

LM Start	<b>1.39</b>	Rating **	U	Issue No.	<b>143</b>
LM End	<b>1.39</b>	Issue Type +	Ma	Location *	WS
Category	Supplemental			GPS Latitude/Longitude	
				Start	End
Item	DWR Erosion Survey			37.930575 °	37.930575 °
				-121.328090 °	-121.328090 °
DWR ID	DWR_RD0524_01_s_2015_143				
Action/Comments					
Inspector Comments: 6/19/2014: No significant change observed. 08/13/2013: No significant change observed. 08/07/2012: The site was first reported in 2012 spring levee inspection report. The site is located about 750 ft downstream of SR 4 Bridge. [2014 Site ID:RD0524U01RM42.03]

Front view of the erosion.

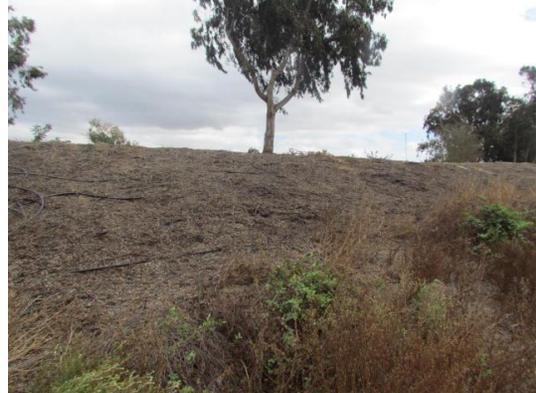
Photo 3 of 5 : SP\_2015\_RD0524\_107\_23\_20150309\_00036.jpg

Looking east from landward berm at corrected site.

LM Start	<b>1.55</b>	Rating **	A/W	Issue No.	<b>23 (cont)</b>
LM End	<b>1.59</b>	Issue Type +	Ma	Location *	LS
Category	Earthen Levee			GPS Latitude/Longitude	
				Start	End
Item	Vegetation			37.928388 °	37.927797 °
				-121.328280 °	-121.327854 °
DWR ID	DWR_RD0524_01_s_2012_23				
Action/Comments					
Remove the wild growth other than native grasses from the levee slopes.

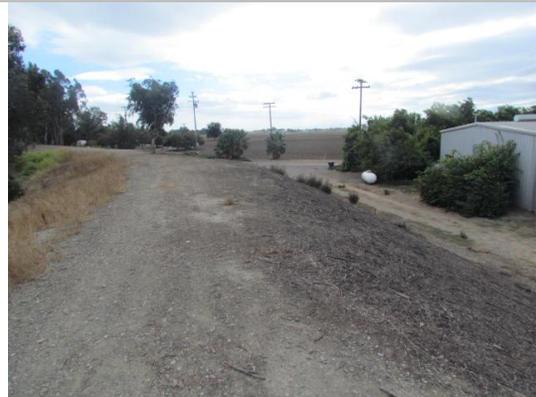
Photo 4 of 5 : SP\_2015\_RD0524\_107\_23\_20150309\_00037.jpg

Looking south from levee crown at corrected site.

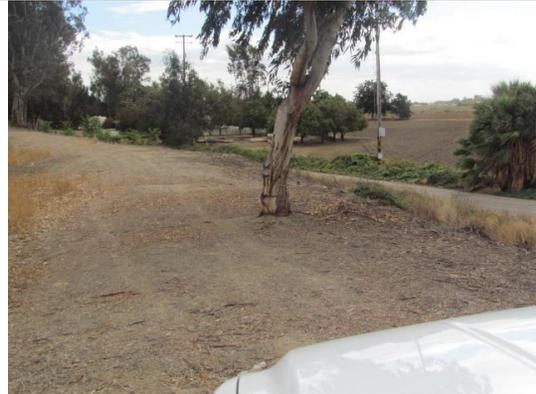
Photo 5 of 5 : SP\_2015\_RD0524\_107\_23\_20150309\_00038.jpg

Looking south from levee crown at upstream end of corrected site.

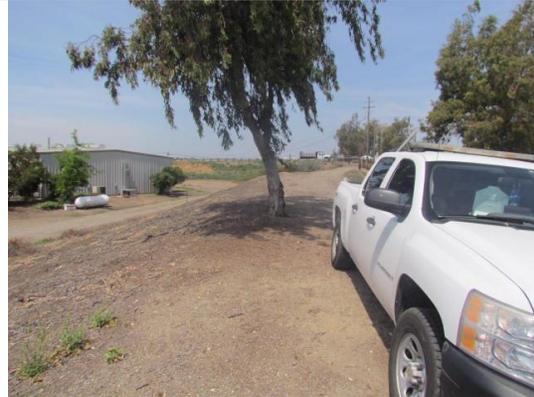
Photo 1 of 1 : SP\_2015\_RD0524\_107\_173\_20150424\_00213.jpg

LM Start	<b>1.58</b>	Rating **	U	Issue No.	<b>173</b>
LM End	<b>1.58</b>	Issue Type +	Ma	Location *	LS
Category	Earthen Levee			GPS Latitude/Longitude	
				Start	End
Item	Trim / Thin Trees			37.927975 °	37.927975 °
				-121.328088 °	-121.328088 °
DWR ID	DWR_RD0524_01_s_2015_173				
Action/Comments					
Trim trees to at least five feet above ground level. Inspector Comments: Tree is located on landward shoulder and crown should be removed.

Looking northwest at tree on within levee crown.

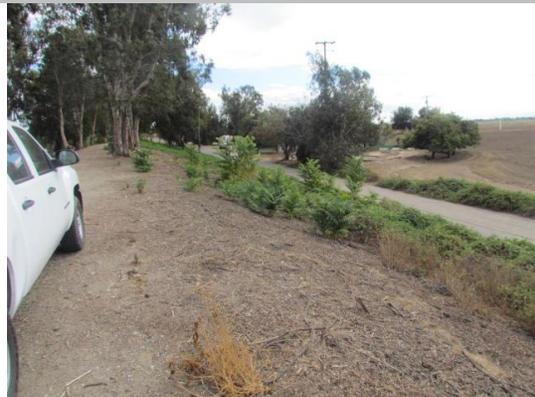
Photo 1 of 2 : SP\_2015\_RD0524\_107\_24\_20150309\_00039.jpg

LM Start	<b>1.60</b>	Rating **	M	Issue No.	<b>24</b>
LM End	<b>1.61</b>	Issue Type +	Ma	Location *	LS
Category	Earthen Levee			GPS Latitude/Longitude	
				Start	End
Item	Vegetation			37.927635 °	37.927540 °
				-121.327812 °	-121.327648 °
DWR ID	DWR_RD0524_01_s_2012_24				
Action/Comments					
Remove the wild growth other than native grasses from the levee slopes. Inspector Comments: Vegetation blocking landward toe.

Looking south at vegetation blocking view of landward toe.

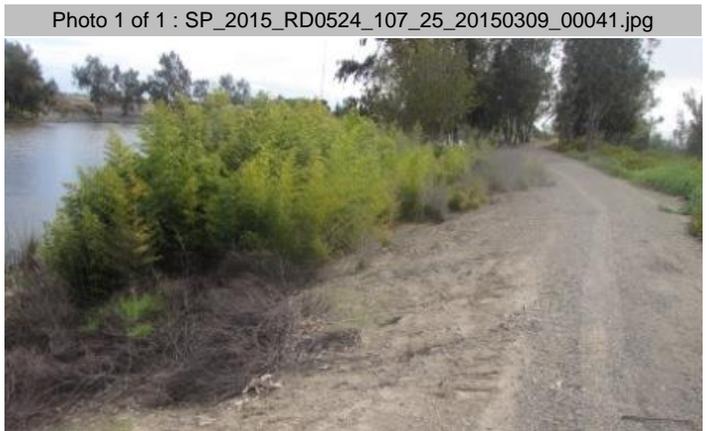
Looking southeast at dense vegetation on the waterside slope.

LM Start	<b>1.60</b>	Rating **	A/W	Issue No.	<b>25</b>
LM End	<b>1.61</b>	Issue Type +	Ma	Location *	WS
Category	Earthen Levee			GPS Latitude/Longitude	
				Start	End
Item	Vegetation			37.927635 °	37.927540 °
				-121.327812 °	-121.327648 °
DWR ID	DWR_RD0524_01_s_2012_25				
Action/Comments					
Remove the wild growth other than native grasses from the levee slopes.

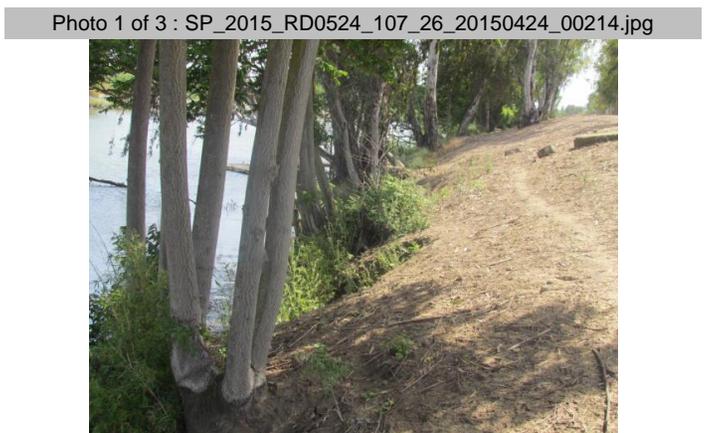
LM Start	<b>1.62</b>	Rating **	M	Issue No.	<b>26</b>
LM End	<b>1.64</b>	Issue Type +	Ma	Location *	WS
Category	Earthen Levee			GPS Latitude/Longitude	
				Start	End
Item	Erosion / Bank Caving			37.927507 °	37.927295 °
				-121.327593 °	-121.327298 °
DWR ID	DWR_RD0524_01_s_2012_26				
Action/Comments					
Note and monitor erosion site. Inspector Comments: Several erosions along this reach.

Looking south at waterward erosion.

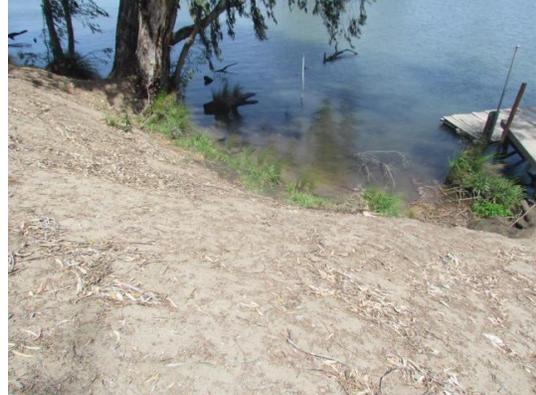
Photo 3 of 3 : SP\_2015\_RD0524\_107\_26\_20150424\_00216.jpg

LM Start	<b>1.62</b>	Rating **	M	Issue No.	<b>26 (cont)</b>
LM End	<b>1.64</b>	Issue Type +	Ma	Location *	WS
Category	Earthen Levee			GPS Latitude/Longitude	
				Start	End
Item	Erosion / Bank Caving			37.927507 °	37.927295 °
				-121.327593 °	-121.327298 °
DWR ID	DWR_RD0524_01_s_2012_26				
Action/Comments					
Note and monitor erosion site. Inspector Comments: Several erosions along this reach.

Looking east at waterward erosion and depression.

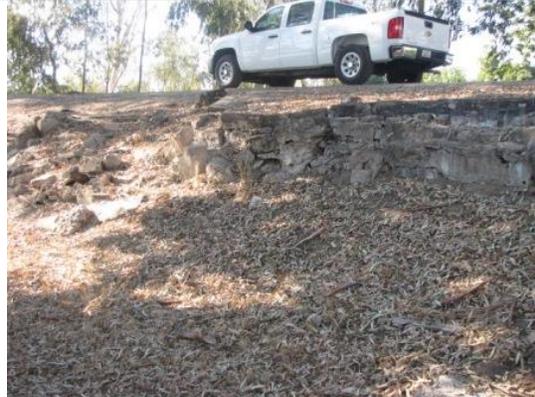
Photo 2 of 3 : SP\_2015\_RD0524\_107\_45\_20150309\_00063.jpg

LM Start	<b>1.67</b>	Rating **	M	Issue No.	<b>45 (cont)</b>
LM End	<b>1.67</b>	Issue Type +	Ma	Location *	WS
Category	Earthen Levee			GPS Latitude/Longitude	
				Start	End
Item	Encroachments			37.927018 °	37.927018 °
				-121.326872 °	-121.326872 °
DWR ID	DWR_RD0524_01_s_2012_45				
Action/Comments					
Stairway Inspector Comments: Stairs and retaining wall

Looking southwest at retaning wall connected to concrete stairs.

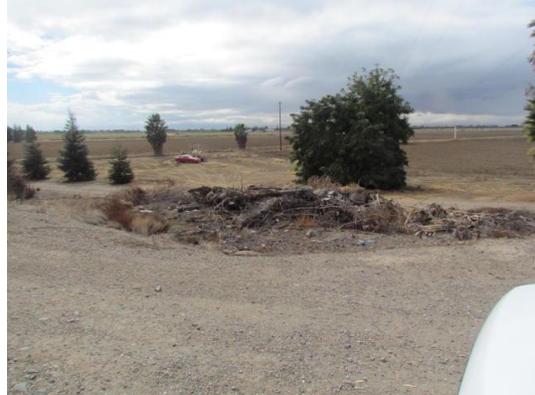
Photo 1 of 2 : SP\_2015\_RD0524\_107\_28\_20150309\_00042.jpg

LM Start	<b>1.73</b>	Rating **	A/W	Issue No.	<b>28</b>
LM End	<b>1.73</b>	Issue Type +	Ma	Location *	LS
Category	Earthen Levee			GPS Latitude/Longitude	
				Start	End
Item	Encroachments			37.926322 °	37.926322 °
				-121.326115 °	-121.326115 °
DWR ID	DWR_RD0524_01_s_2012_28				
Action/Comments					
Garbage Inspector Comments: Large pruning piles on landside slope.

Looking southwest at trash and a pruning pile on landward berm.

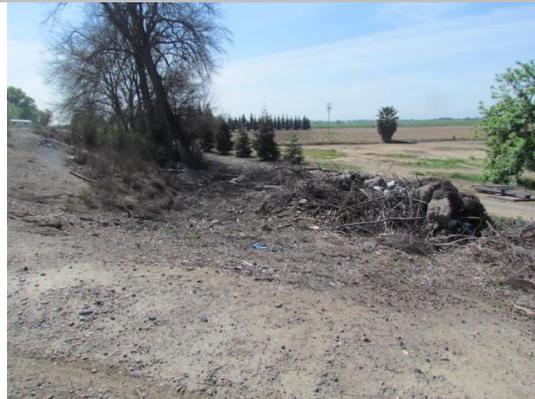
Photo 2 of 2 : SP\_2015\_RD0524\_107\_28\_20150309\_00043.jpg

Looking at southwest at a pruning pile at landward berm.

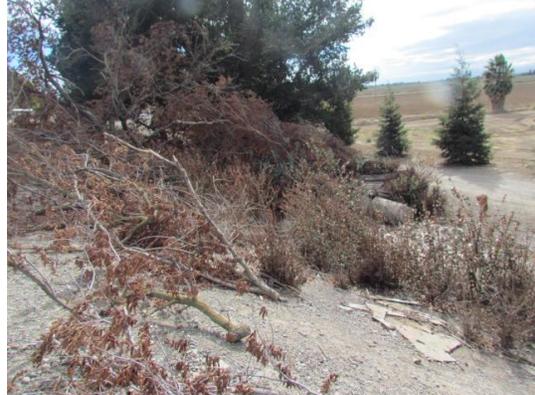
Photo 2 of 4 : SP\_2015\_RD0524\_107\_46\_20150309\_00066.jpg

LM Start	<b>1.75</b>	Rating **	U	Issue No.	<b>46 (cont)</b>
LM End	<b>1.76</b>	Issue Type +	Ma	Location *	LS
Category	Earthen Levee			GPS Latitude/Longitude	
				Start	End
Item	Encroachments			37.926152 °	37.925993 °
				-121.325927 °	-121.325777 °
DWR ID	DWR_RD0524_01_s_2012_46				
Action/Comments					
Tree or limb Inspector Comments: Downed tree limbs on landward slope.

Looking southwest at tree limbs on landward slope.

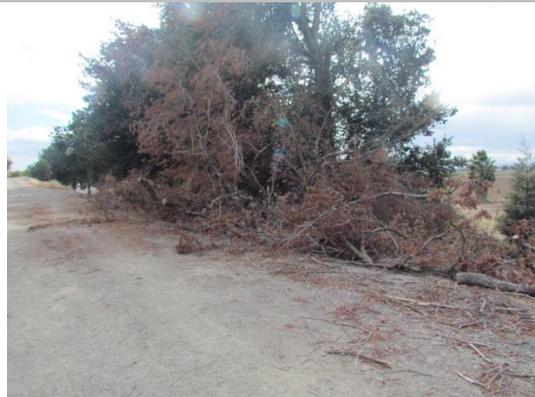
Photo 3 of 4 : SP\_2015\_RD0524\_107\_46\_20150309\_00067.jpg

Looking south at tree limbs on landward slope.

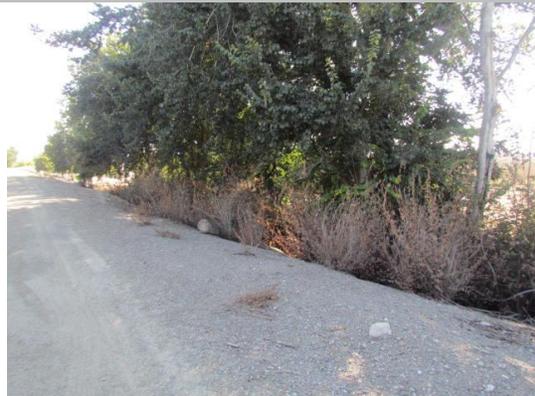
Photo 4 of 4 : SP\_2015\_RD0524\_107\_46\_20150309\_00068.jpg

Looking southwest at dense vegetation and low hanging tree branches on landside slope and toe.

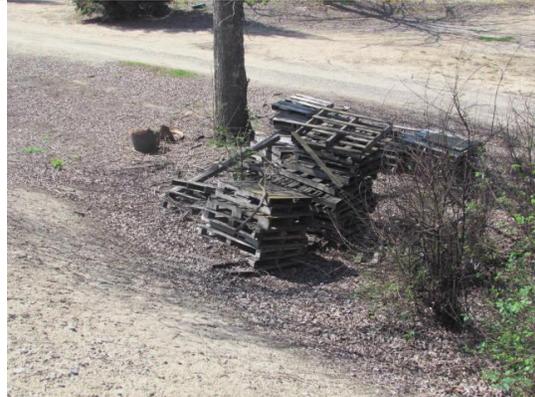
Photo 1 of 1 : SP\_2015\_RD0524\_107\_181\_20150309\_00149.jpg

LM Start	<b>1.76</b>	Rating **	A/W	Issue No.	<b>181</b>
LM End	<b>1.76</b>	Issue Type +	Ma	Location *	N/A
Category	Earthen Levee			GPS Latitude/Longitude	
				Start	End
Item	Encroachments			37.925972 °	37.925972 °
				-121.325769 °	-121.325769 °
DWR ID	DWR_RD0524_01_s_2014_181				
Action/Comments					
Material Inspector Comments: Landowner stockpiling pallets at landward toe.

Looking west at wooden pallets at landward toe.

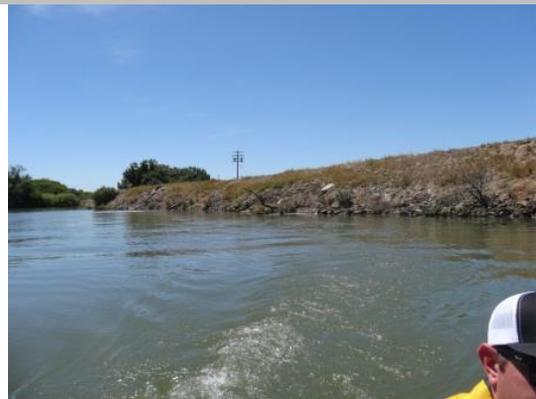
Photo 1 of 1 : SP\_2015\_RD0524\_107\_146\_20150309\_00142.jpg

LM Start	<b>2.19</b>	Rating **	U	Issue No.	<b>146</b>
LM End	<b>2.19</b>	Issue Type +	Ma	Location *	WS
Category	Supplemental		GPS Latitude/Longitude		
			Start	End	
Item	DWR Erosion Survey		37.920992 °	37.920992 °	
			-121.321370 °	-121.321370 °	
DWR ID	DWR_RD0524_01_s_2015_146				
Action/Comments					
Inspector Comments: 7/22/2014: The erosion has increased in size. 08/13/2013: No significant change observed. Slightly more vegetation was visible. 08/07/2012: The site was first reported in 2012 spring levee inspection report. [2014 Site ID:RD0524U01RM42.79]

View from downstream.

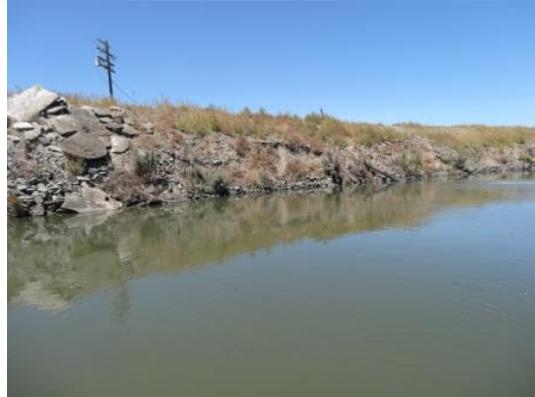
Photo 1 of 1 : SP\_2015\_RD0524\_107\_147\_20150309\_00143.jpg

LM Start	<b>2.25</b>	Rating **	U	Issue No.	<b>147</b>
LM End	<b>2.25</b>	Issue Type +	Ma	Location *	WS
Category	Supplemental			GPS Latitude/Longitude	
				Start	End
Item	DWR Erosion Survey			37.920650 °	37.920650 °
				-121.320370 °	-121.320370 °
DWR ID	DWR_RD0524_01_s_2015_147				
Action/Comments					
Inspector Comments: 6/19/2014: No significant change observed. 08/13/2013: An irrigation pipe is on site. [2014 Site ID:RD0524U01RM42.84]

View from upstream.

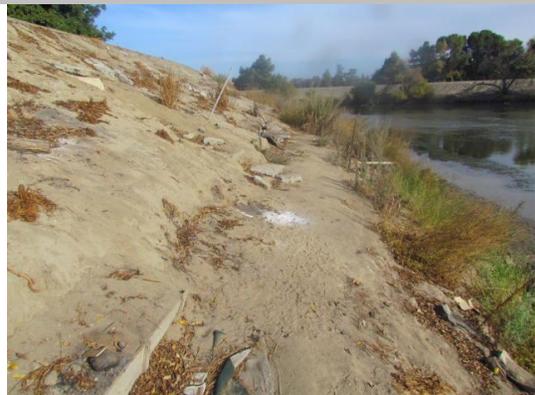
Photo 1 of 1 : SP\_2015\_RD0524\_107\_34\_20150309\_00048.jpg

LM Start	<b>2.32</b>	Rating **	M	Issue No.	<b>34</b>
LM End	<b>2.33</b>	Issue Type +	Ma	Location *	WS
Category	Earthen Levee			GPS Latitude/Longitude	
				Start	End
Item	Slope Stability			37.919885 °	37.919703 °
				-121.319713 °	-121.319702 °
DWR ID	DWR_RD0524_01_s_2012_34				
Action/Comments					
Repair the levee slope damaged by foot traffic and prevent access where possible. Inspector Comments: Slope damage caused by walking traffic and using bank as a fishing platform.

Looking northeast at damage to the slope possibly caused by human activity.

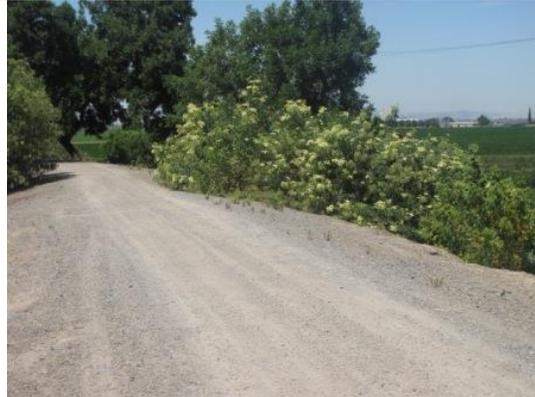
Photo 1 of 4 : SP\_2015\_RD0524\_107\_37\_20150309\_00051.jpg

LM Start	<b>2.49</b>	Rating **	U	Issue No.	<b>37</b>
LM End	<b>2.50</b>	Issue Type +	Ma	Location *	LS
Category	Earthen Levee		GPS Latitude/Longitude		
			Start	End	
Item	Vegetation		37.918345 °	37.918302 °	
			-121.321765 °	-121.321923 °	
DWR ID	DWR_RD0524_01_s_2012_37				
Action/Comments					
Elderberries are blocking visibility and flood fight capability.

Looking south at elderberry on landside slope.

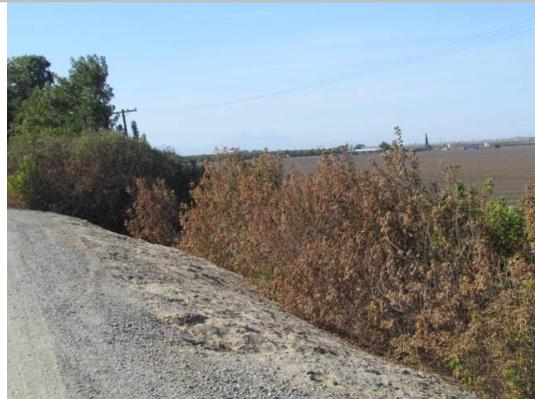
Photo 2 of 4 : SP\_2015\_RD0524\_107\_37\_20150309\_00052.jpg

Looking southwest at dense vegetation on landside toe.

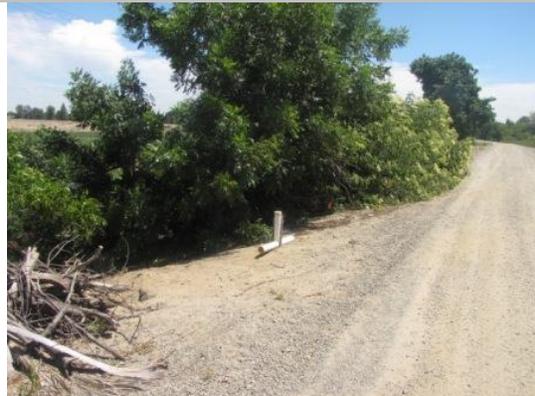
Photo 3 of 4 : SP\_2015\_RD0524\_107\_37\_20150309\_00053.jpg

Looking north at elderberry and trees on landside slope.

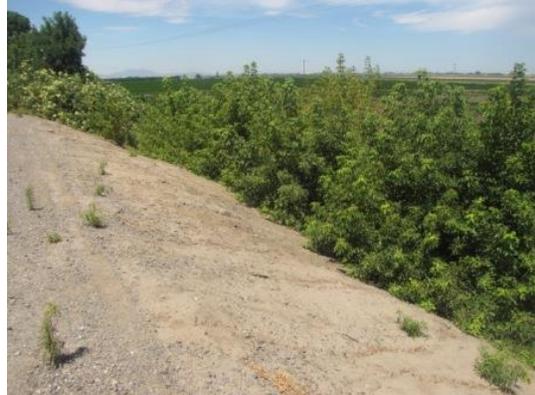
Photo 4 of 4 : SP\_2015\_RD0524\_107\_37\_20150309\_00054.jpg

LM Start	<b>2.49</b>	Rating **	U	Issue No.	<b>37 (cont)</b>
LM End	<b>2.50</b>	Issue Type +	Ma	Location *	LS
Category	Earthen Levee			GPS Latitude/Longitude	
				Start	End
Item	Vegetation			37.918345 °	37.918302 °
				-121.321765 °	-121.321923 °
DWR ID	DWR_RD0524_01_s_2012_37				
Action/Comments					
Elderberries are blocking visibility and flood fight capability.

Looking southwest at trees along levee landside toe.

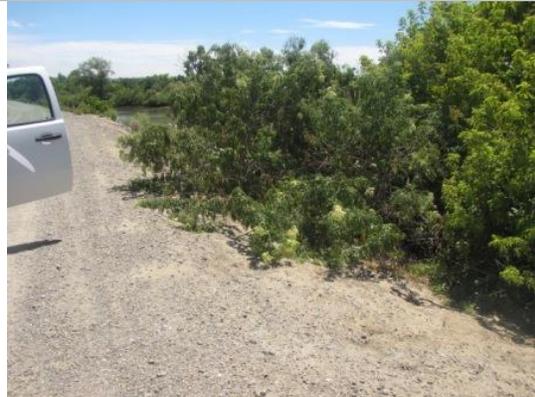
Photo 1 of 2 : SP\_2015\_RD0524\_107\_38\_20150309\_00055.jpg

LM Start	<b>2.50</b>	Rating **	U	Issue No.	<b>38</b>
LM End	<b>2.50</b>	Issue Type +	Ma	Location *	WS
Category	Earthen Levee			GPS Latitude/Longitude	
				Start	End
Item	Vegetation			37.918287 °	37.918287 °
				-121.321980 °	-121.321980 °
DWR ID	DWR_RD0524_01_s_2012_38				
Action/Comments					
Elderberries are blocking visibility and flood fight capability.

Looking north at elderberry on waterside slope.

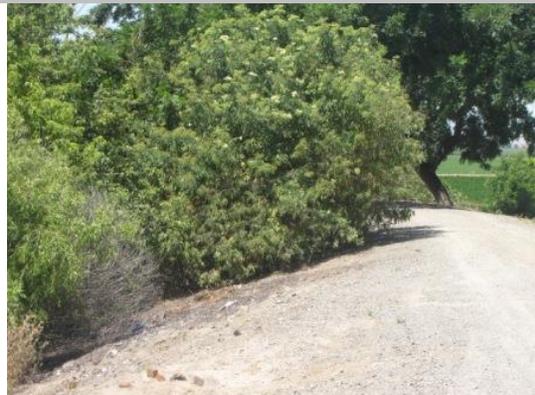
Photo 2 of 2 : SP\_2015\_RD0524\_107\_38\_20150309\_00056.jpg

Looking south at elderberry on waterside slope.

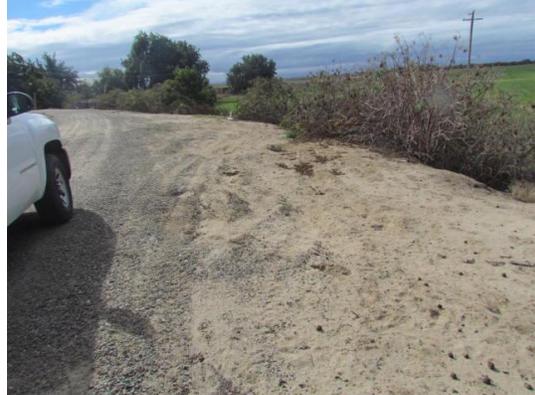
Photo 1 of 1 : SP\_2015\_RD0524\_107\_82\_20150309\_00094.jpg

LM Start	<b>2.53</b>	Rating **	M	Issue No.	<b>82</b>
LM End	<b>2.56</b>	Issue Type +	Ma	Location *	LS
Category	Earthen Levee			GPS Latitude/Longitude	
				Start	End
Item	Slope Stability			37.918060 °	37.917667 °
				-121.322384 °	-121.322713 °
DWR ID	DWR_RD0524_01_s_2012_82				
Action/Comments					
Repair slope instability.

Looking southwest at damaged landward slope.

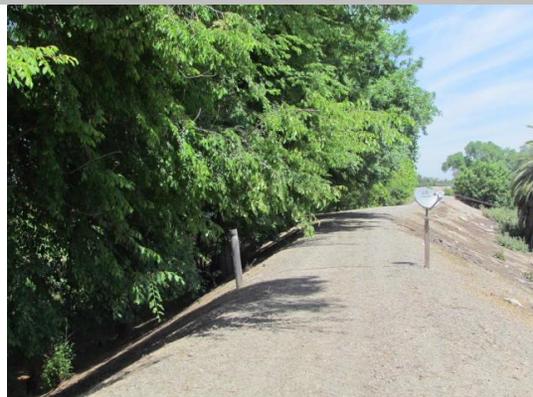
Photo 1 of 1 : SP\_2015\_RD0524\_107\_44\_20150309\_00061.jpg

LM Start	<b>2.67</b>	Rating **	A/W	Issue No.	<b>44</b>
LM End	<b>2.77</b>	Issue Type +	Ma	Location *	LS
Category	Earthen Levee		GPS Latitude/Longitude		
			Start	End	
Item	Trim / Thin Trees		37.916418 °	37.915142 °	
			-121.321963 °	-121.323018 °	
DWR ID	DWR_RD0524_01_s_2012_44				
Action/Comments					
Trim trees over roadway to at least 12 feet above ground level. Inspector Comments: Trim over hanging trees at least 12 feet above ground level.

Looking north at dense trees overhanging levee crown.

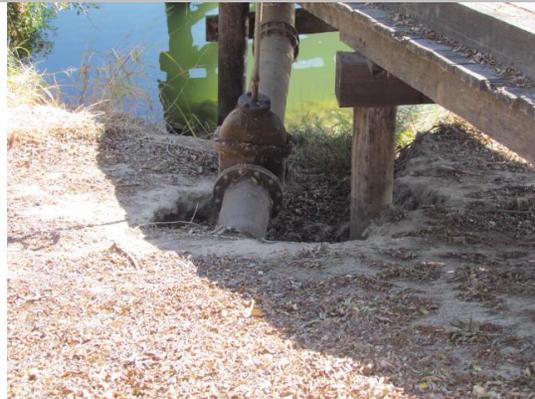
Photo 2 of 2 : SP\_2015\_RD0524\_107\_21\_20150309\_00033.jpg

LM Start	<b>2.68</b>	Rating **	M	Issue No.	<b>21</b>
LM End	<b>2.68</b>	Issue Type +	Ma	Location *	WS
Category	Earthen Levee			GPS Latitude/Longitude	
				Start	End
Item	Erosion / Bank Caving			37.916224 °	37.916224 °
				-121.322115 °	-121.322115 °
DWR ID	DWR_RD0524_01_f_2013_21				
Action/Comments					
Schedule repair of erosion site prior to the next inspection. Inspector Comments: Large erosion around irrigation pipe.

Looking east at erosion around irrigation pipe on waterward slope.

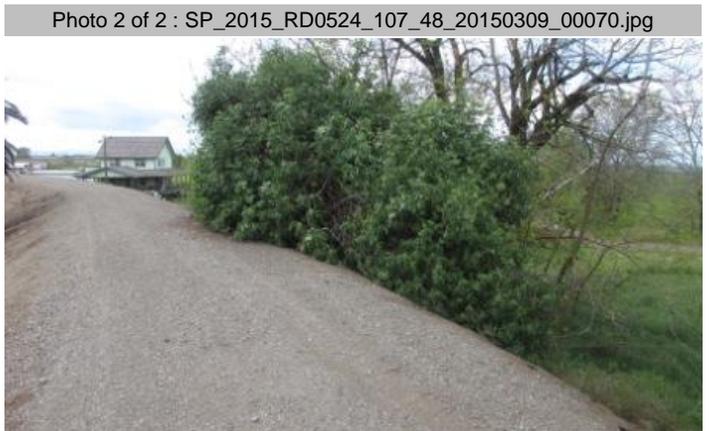
LM Start	<b>2.80</b>	Rating **	U	Issue No.	<b>48 (cont)</b>
LM End	<b>2.80</b>	Issue Type +	Ma	Location *	LS
Category	Earthen Levee			GPS Latitude/Longitude	
				Start	End
Item	Vegetation			37.915022 °	37.915022 °
				-121.323443 °	-121.323443 °
DWR ID	DWR_RD0524_01_s_2012_48				
Action/Comments					
Elderberries are blocking visibility and flood fight capability.

Looking south at elderberry on landside slope.(Spring 2011)

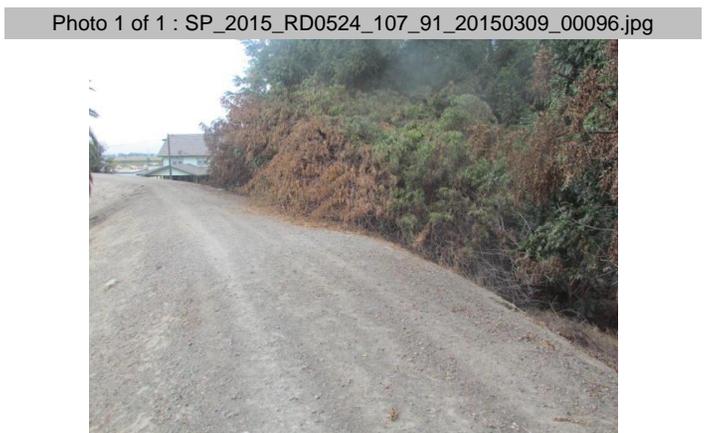
LM Start	<b>2.80</b>	Rating **	U	Issue No.	<b>91</b>
LM End	<b>2.80</b>	Issue Type +	Ma	Location *	LS
Category	Earthen Levee			GPS Latitude/Longitude	
				Start	End
Item	Trim / Thin Trees			37.915063 °	37.915063 °
				-121.323585 °	-121.323585 °
DWR ID	DWR_RD0524_01_s_2012_91				
Action/Comments					
Thin trees to allow visibility of the ground and room to flood fight.

Looking southwest at dense vegetation on landside slope.

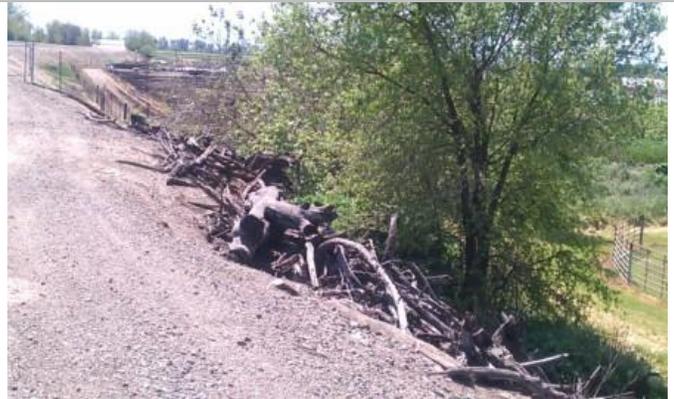
Photo 1 of 1 : SP\_2015\_RD0524\_107\_50\_20150309\_00072.jpg

LM Start	<b>2.90</b>	Rating **	U	Issue No.	<b>50</b>
LM End	<b>2.92</b>	Issue Type +	Ma	Location *	LS
Category	Earthen Levee			GPS Latitude/Longitude	
				Start	End
Item	Encroachments			37.913767 °	37.913503 °
				-121.324427 °	-121.324488 °
DWR ID	DWR_RD0524_01_s_2012_50				
Action/Comments					
Prunings

Looking southwest at prunings on landside slope.

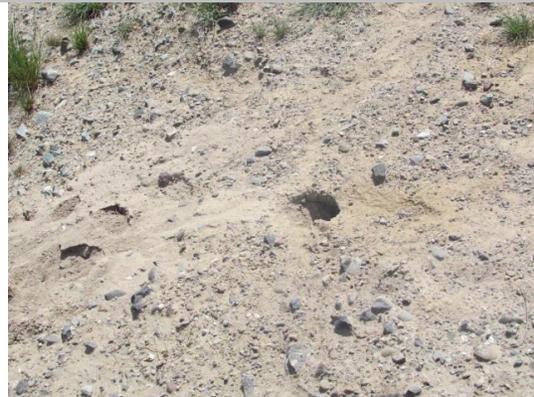
Photo 1 of 1 : SP\_2015\_RD0524\_107\_925\_20150424\_00221.jpg

LM Start	<b>3.07</b>	Rating **	M	Issue No.	<b>925</b>
LM End	<b>3.14</b>	Issue Type +	Ma	Location *	LS
Category	Earthen Levee		GPS Latitude/Longitude		
			Start	End	
Item	Animal Control		37.911382 °	37.910558 °	
			-121.324928 °	-121.325432 °	
DWR ID	DWR_RD0524_01_s_2012_925				
Action/Comments					
Exterminate rodents and backfill and compact or grout burrows. Inspector Comments: Several rodent holes on levee slopes.

Looking at typical rodent holes on landward slope along this reach.

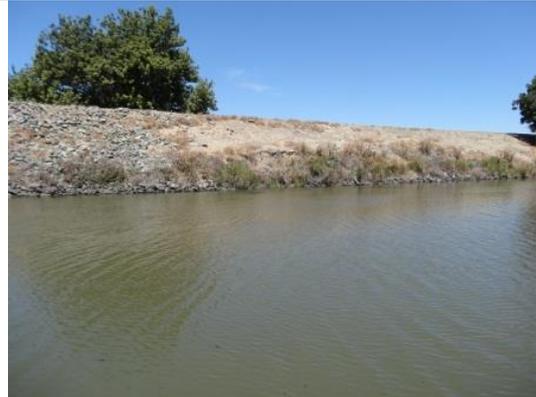
Photo 1 of 1 : SP\_2015\_RD0524\_107\_5\_20150309\_00010.jpg

LM Start	<b>3.31</b>	Rating **	U	Issue No.	<b>5</b>
LM End	<b>3.31</b>	Issue Type +	Ma	Location *	WS
Category	Supplemental			GPS Latitude/Longitude	
				Start	End
Item	DWR Erosion Survey			37.908090 °	37.908090 °
				-121.325090 °	-121.325090 °
DWR ID	DWR_RD0524_01_s_2015_5				
Action/Comments					
Inspector Comments: 6/19/2014: No significant change observed. 08/13/2013: The levee toe seems to have been protected by river rocks and vegetation on site. [2014 Site ID:RD0524U01RM43.86]

View from upstream of the erosion.

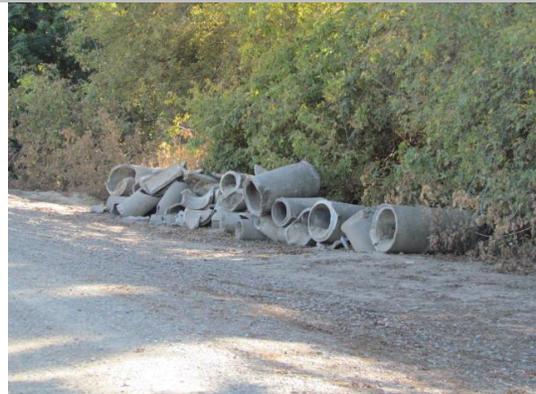
Photo 1 of 1 : SP\_2015\_RD0524\_107\_56\_20150309\_00075.jpg

LM Start	<b>3.42</b>	Rating **	M	Issue No.	<b>56</b>
LM End	<b>3.42</b>	Issue Type +	Ma	Location *	LS
Category	Earthen Levee		GPS Latitude/Longitude		
			Start	End	
Item	Encroachments		37.906540 °	37.906540 °	
			-121.325015 °	-121.325015 °	
DWR ID	DWR_RD0524_01_s_2012_56				
Action/Comments					
Material Inspector Comments: Broken concrete pipes

Looking southwest at concrete pipes on landside toe.

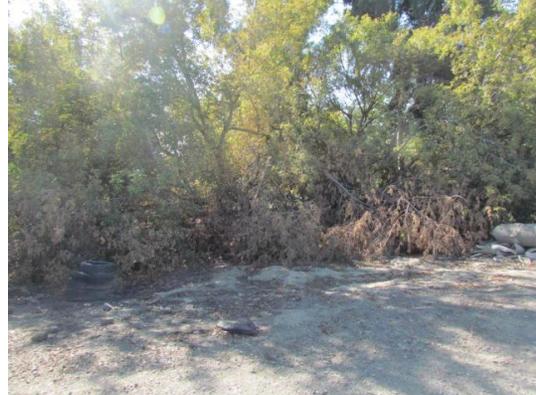
Photo 1 of 1 : SP\_2015\_RD0524\_107\_93\_20150309\_00098.jpg

LM Start	<b>3.45</b>	Rating **	U	Issue No.	<b>93</b>
LM End	<b>3.45</b>	Issue Type +	Ma	Location *	LS
Category	Earthen Levee			GPS Latitude/Longitude	
				Start	End
Item	Trim / Thin Trees			37.906265 °	37.906265 °
				-121.324643 °	-121.324643 °
DWR ID	DWR_RD0524_01_s_2012_93				
Action/Comments					
Trim and thin trees to allow visibility of the ground and room to flood fight.

Looking northwest at low hanging tree branches on landside slope and toe.

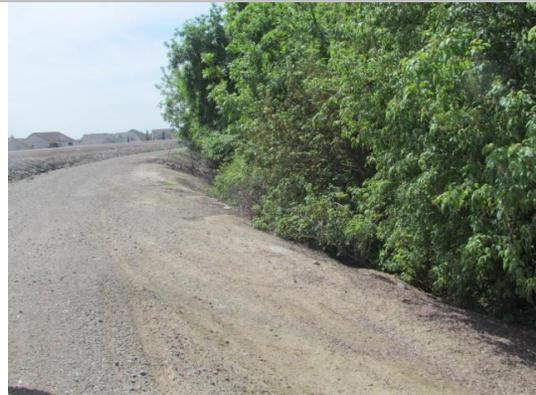
Photo 1 of 1 : SP\_2015\_RD0524\_107\_57\_20150309\_00076.jpg

LM Start	<b>3.51</b>	Rating **	U	Issue No.	<b>57</b>
LM End	<b>3.61</b>	Issue Type +	Ma	Location *	LS
Category	Earthen Levee			GPS Latitude/Longitude	
				Start	End
Item	Trim / Thin Trees			37.905638 °	37.904430 °
				-121.323892 °	-121.324570 °
DWR ID	DWR_RD0524_01_s_2012_57				
Action/Comments					
Trim and thin trees to allow visibility of the ground and room to flood fight.

Looking south at dense trees on landward slope.

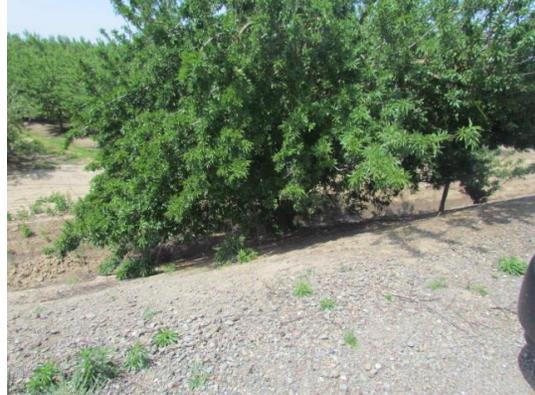
Photo 1 of 1 : SP\_2015\_RD0524\_107\_927\_20150424\_00225.jpg

LM Start	<b>3.77</b>	Rating **	M	Issue No.	<b>927</b>
LM End	<b>3.77</b>	Issue Type +	Ma	Location *	LS
Category	Earthen Levee			GPS Latitude/Longitude	
				Start	End
Item	Trim / Thin Trees			37.902645 °	37.902645 °
				-121.326340 °	-121.326340 °
DWR ID	DWR_RD0524_01_s_2012_927				
Action/Comments					
Trim trees to at least five feet above ground level.

Looking east at untrimmed tree on landward slope.

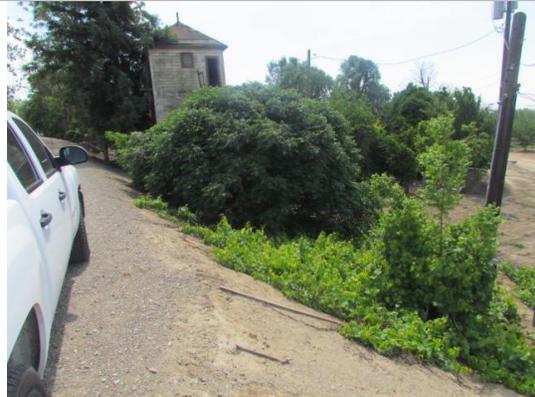
Photo 1 of 1 : SP\_2015\_RD0524\_107\_59\_20150424\_00226.jpg

LM Start	<b>3.78</b>	Rating **	M	Issue No.	<b>59</b>
LM End	<b>3.78</b>	Issue Type +	Ma	Location *	LS
Category	Earthen Levee			GPS Latitude/Longitude	
				Start	End
Item	Trim / Thin Trees			37.902417 °	37.902417 °
				-121.326482 °	-121.326482 °
DWR ID	DWR_RD0524_01_s_2012_59				
Action/Comments					
Trim trees to at least five feet above ground level.

Looking south at untrimmed trees on landward slope.
