**Flood Control Project Maintenance  
Levee Inspections**

## Maintenance Issue Types Only, Levee Inspection Report By Mile - Spring 2015

### Reclamation District No. 0524 Middle Roberts Island

Waterway		Bank	Unit Miles	Inspection Start/End	Inspector
Unit No. 01 San Joaquin River		Left	6.20	04/21/2015 04/21/2015	Richard Willoughby

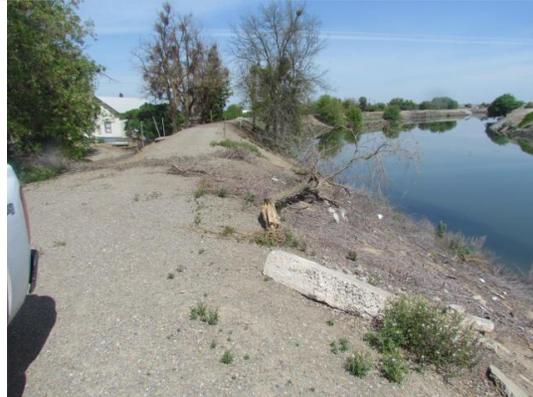
Photo 1 of 1 : SP\_2015\_RD0524\_107\_187\_20150309\_00152.jpg

LM Start	<b>3.85</b>	Rating **	M	Issue No.	<b>187</b>
LM End	<b>3.85</b>	Issue Type +	Ma	Location *	WS
Category	Earthen Levee		GPS Latitude/Longitude		
			Start	End	
Item	Encroachments		37.901447 °	37.901447 °	
			-121.326500 °	-121.326500 °	
DWR ID	DWR_RD0524_01_s_2014_187				
Action/Comments					
Tree or limb Inspector Comments: Tree limb on waterward shoulder.

Looking northeast at tree limb on waterward slope.

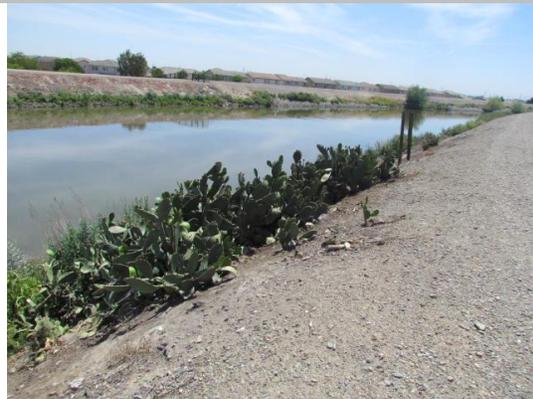
Photo 1 of 1 : SP\_2015\_RD0524\_107\_94\_20150309\_00099.jpg

LM Start	<b>3.88</b>	Rating **	M	Issue No.	<b>94</b>
LM End	<b>3.88</b>	Issue Type +	Ma	Location *	WS
Category	Earthen Levee		GPS Latitude/Longitude		
			Start	End	
Item	Vegetation		37.900952 °	37.900952 °	
			-121.326443 °	-121.326443 °	
DWR ID	DWR_RD0524_01_s_2012_94				
Action/Comments					
Remove the wild growth other than native grasses from the levee slopes. Inspector Comments: Remove cactus

Looking southeast at cactus on waterside slope.

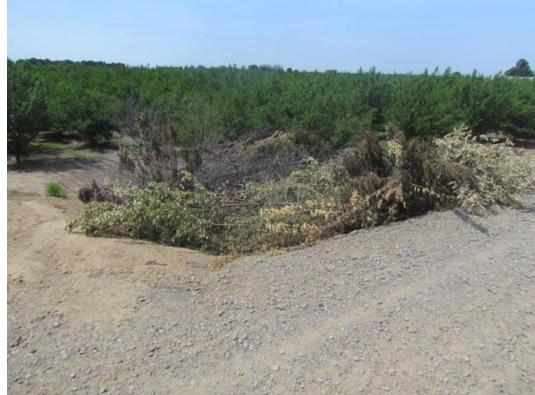
Photo 1 of 1 : SP\_2015\_RD0524\_107\_195\_20150424\_00227.jpg

LM Start	<b>4.02</b>	Rating **	U	Issue No.	<b>195</b>
LM End	<b>4.02</b>	Issue Type +	Ma	Location *	LS
Category	Earthen Levee		GPS Latitude/Longitude		
			Start	End	
Item	Encroachments		37.899093 °	37.899093 °	
			-121.326933 °	-121.326933 °	
DWR ID	DWR_RD0524_01_s_2015_195				
Action/Comments					
Prunings Inspector Comments: Pruning pile blocking view of landward slope.

Looking east at pruning pile at landward toe.

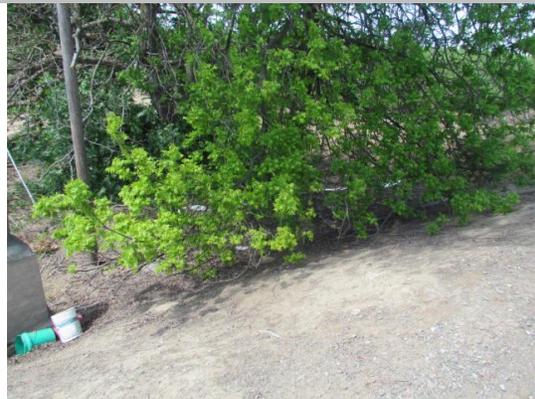
Photo 1 of 1 : SP\_2015\_RD0524\_107\_61\_20150424\_00228.jpg

LM Start	<b>4.03</b>	Rating **	M	Issue No.	<b>61</b>
LM End	<b>4.03</b>	Issue Type +	Ma	Location *	LS
Category	Earthen Levee		GPS Latitude/Longitude		
			Start	End	
Item	Trim / Thin Trees		37.898925 °	37.898925 °	
			-121.327015 °	-121.327015 °	
DWR ID	DWR_RD0524_01_s_2012_61				
Action/Comments					
Trim trees to at least five feet above ground level.

Looking east at untrimmed tree at landward toe.

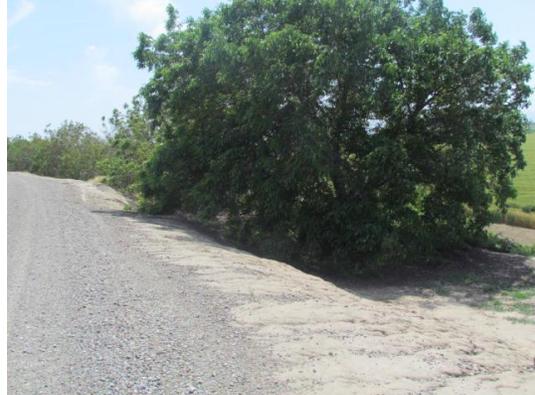
Photo 1 of 1 : SP\_2015\_RD0524\_107\_112\_20150424\_00230.jpg

LM Start	<b>4.40</b>	Rating **	M	Issue No.	<b>112</b>
LM End	<b>4.53</b>	Issue Type +	Ma	Location *	LS
Category	Earthen Levee			GPS Latitude/Longitude	
				Start	End
Item	Trim / Thin Trees			37.893928 °	37.892230 °
				-121.329203 °	-121.328187 °
DWR ID	DWR_RD0524_01_s_2012_112				
Action/Comments					
Trim trees to at least five feet above ground level.

Looking southeast at untrimmed tree at landward toe.

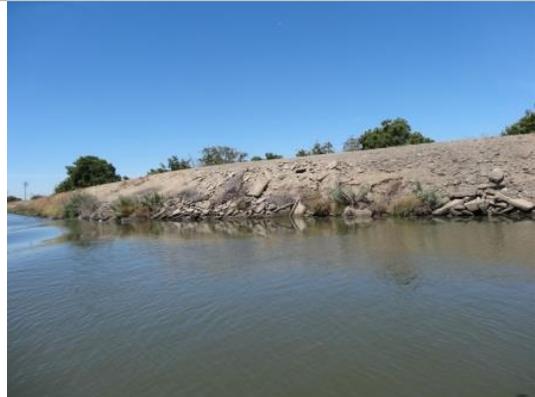
Photo 1 of 1 : SP\_2015\_RD0524\_107\_79\_20150309\_00091.jpg

LM Start	<b>4.53</b>	Rating **	U	Issue No.	<b>79</b>
LM End	<b>4.53</b>	Issue Type +	Ma	Location *	WS
Category	Supplemental			GPS Latitude/Longitude	
				Start	End
Item	DWR Erosion Survey			37.892230 °	37.892230 °
				-121.327930 °	-121.327930 °
DWR ID	DWR_RD0524_01_s_2015_79				
Action/Comments					
Inspector Comments: 6/19/2014: No significant change observed. 08/13/2013: No significant change observed. 08/07/2012: The erosion is located at the inside of a river bend. Site is covered with broken concrete blocks and other debris. [2014 Site ID:RD0524U01RM45.07]

Downstream view of the erosion site.

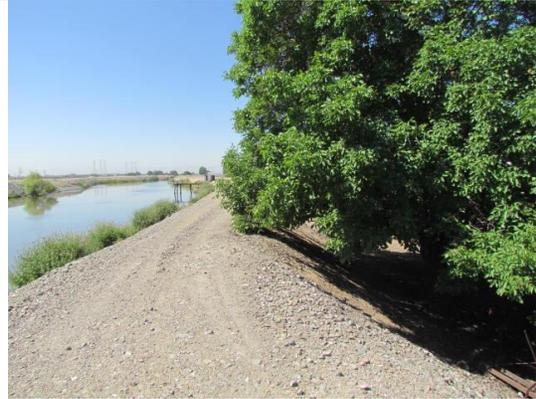
Photo 1 of 1 : SP\_2015\_RD0524\_107\_63\_20150309\_00080.jpg

LM Start	<b>4.61</b>	Rating **	M	Issue No.	<b>63</b>
LM End	<b>4.61</b>	Issue Type +	Ma	Location *	LS
Category	Earthen Levee		GPS Latitude/Longitude		
			Start	End	
Item	Trim / Thin Trees		37.891285 °	37.891285 °	
			-121.328728 °	-121.328728 °	
DWR ID	DWR_RD0524_01_s_2012_63				
Action/Comments					
Trim trees to at least five feet above ground level.

Looking south at dense trees on landside slope.

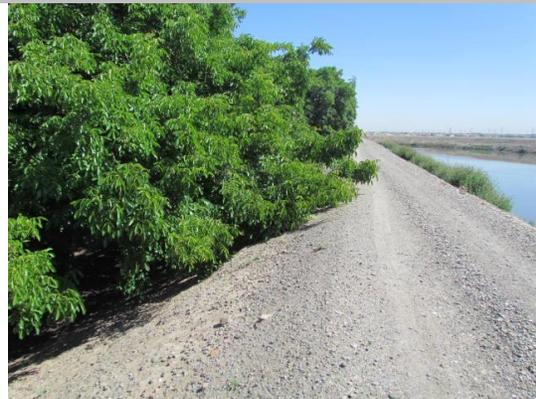
Photo 1 of 1 : SP\_2015\_RD0524\_107\_113\_20150309\_00117.jpg

LM Start	<b>4.63</b>	Rating **	A/W	Issue No.	<b>113</b>
LM End	<b>4.63</b>	Issue Type +	Ma	Location *	LS
Category	Earthen Levee		GPS Latitude/Longitude		
			Start	End	
Item	Trim / Thin Trees		37.890973 °	37.890973 °	
			-121.328970 °	-121.328970 °	
DWR ID	DWR_RD0524_01_s_2012_113				
Action/Comments					
Trim trees to at least five feet above ground level.

Looking north at dense trees on landside slope.

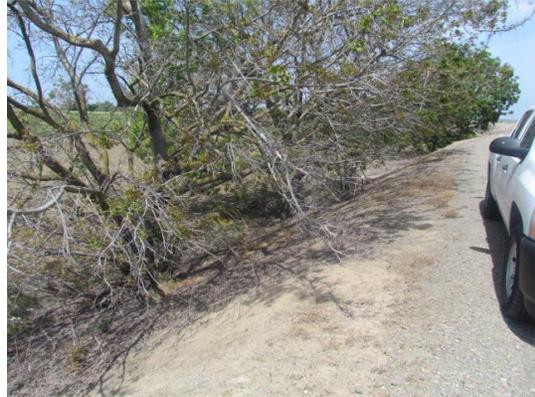
Photo 1 of 1 : SP\_2015\_RD0524\_107\_84\_20150424\_00231.jpg

LM Start	<b>4.90</b>	Rating **	U	Issue No.	<b>84</b>
LM End	<b>4.93</b>	Issue Type +	Ma	Location *	LS
Category	Earthen Levee		GPS Latitude/Longitude		
			Start	End	
Item	Trim / Thin Trees		37.887655 °	37.887277 °	
			-121.331202 °	-121.331609 °	
DWR ID	DWR_RD0524_01_s_2012_84				
Action/Comments					
Trim trees to at least five feet above ground level.

Looking northeast at untrimmed trees on landward slope.

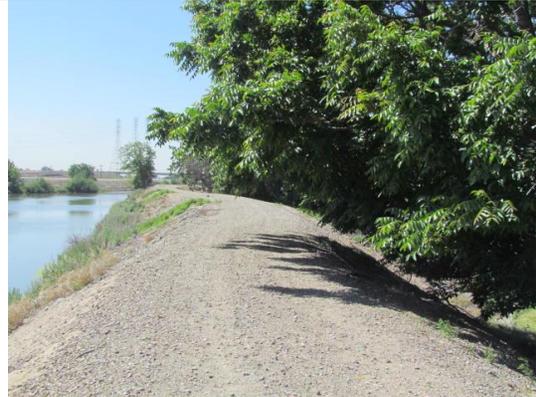
Photo 1 of 1 : SP\_2015\_RD0524\_107\_68\_20150309\_00082.jpg

LM Start	<b>5.07</b>	Rating **	U	Issue No.	<b>68</b>
LM End	<b>5.07</b>	Issue Type +	Ma	Location *	LS
Category	Earthen Levee			GPS Latitude/Longitude	
				Start	End
Item	Trim / Thin Trees			37.885400 °	37.885400 °
				-121.332153 °	-121.332153 °
DWR ID	DWR_RD0524_01_s_2012_68				
Action/Comments					
Trim trees over roadway to at least 12 feet above ground level.

Looking south at overhanging trees.

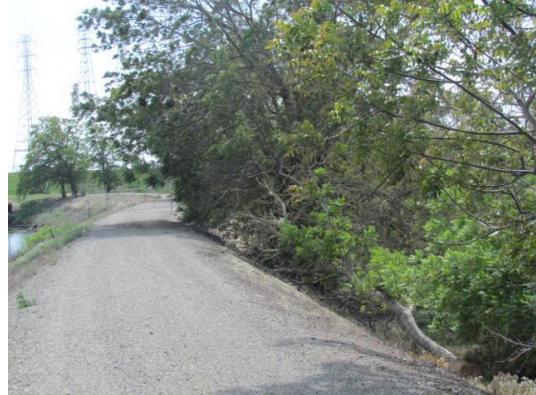
Photo 1 of 1 : SP\_2015\_RD0524\_107\_932\_20150424\_00234.jpg

LM Start	<b>5.38</b>	Rating **	M	Issue No.	<b>932</b>
LM End	<b>5.41</b>	Issue Type +	Ma	Location *	LS
Category	Earthen Levee			GPS Latitude/Longitude	
				Start	End
Item	Trim / Thin Trees			37.880945 °	37.880522 °
				-121.332837 °	-121.332918 °
DWR ID	DWR_RD0524_01_s_2012_932				
Action/Comments					
Trim trees to at least five feet above ground level.

Looking south at untrimmed trees on landward slope and toe.

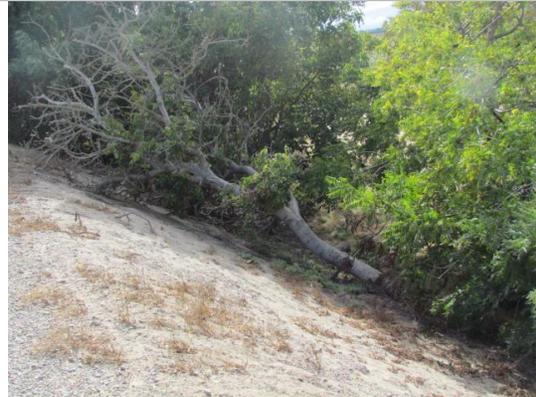
Photo 1 of 1 : SP\_2015\_RD0524\_107\_178\_20150309\_00145.jpg

LM Start	<b>5.39</b>	Rating **	M	Issue No.	<b>178</b>
LM End	<b>5.39</b>	Issue Type +	Ma	Location *	N/A
Category	Earthen Levee			GPS Latitude/Longitude	
				Start	End
Item	Encroachments			37.880806 °	37.880806 °
				-121.332833 °	-121.332833 °
DWR ID	DWR_RD0524_01_f_2014_178				
Action/Comments					
Tree or limb Inspector Comments: Downed tree on landward toe.

Looking south at downed tree on landward slope.

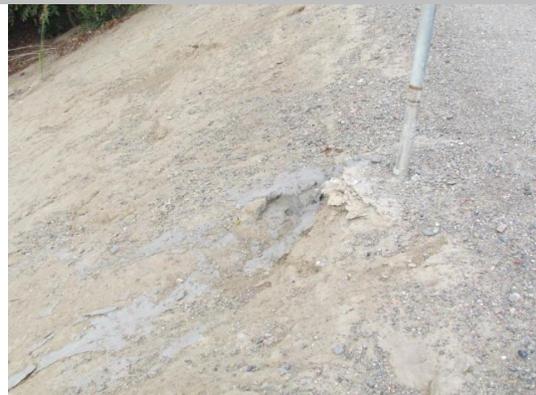
Photo 1 of 2 : SP\_2015\_RD0524\_107\_931\_20150309\_00169.jpg

LM Start	<b>5.41</b>	Rating **	A/W	Issue No.	<b>931</b>
LM End	<b>5.41</b>	Issue Type +	Ma	Location *	LS
Category	Earthen Levee			GPS Latitude/Longitude	
				Start	End
Item	Animal Control			37.880575 °	37.880575 °
				-121.332890 °	-121.332890 °
DWR ID	DWR_RD0524_01_s_2012_931				
Action/Comments					
Exterminate rodents and backfill and compact or grout burrows. Inspector Comments: LMA grouted rodent holes.

Looking north at typical view of grouted rodent holes on landward shoulder and slope.

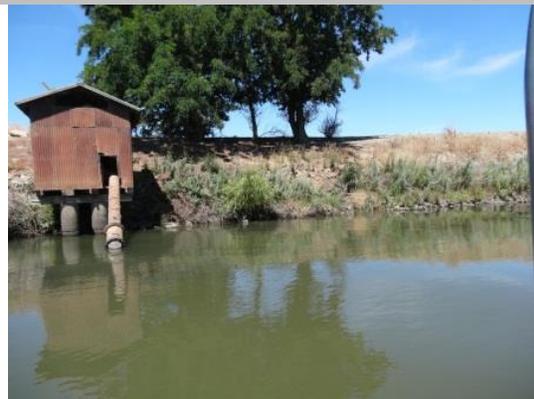
Photo 1 of 1 : SP\_2015\_RD0524\_107\_126\_20150309\_00127.jpg

LM Start	<b>5.53</b>	Rating **	M	Issue No.	<b>126</b>
LM End	<b>5.53</b>	Issue Type +	Ma	Location *	WS
Category	Supplemental		GPS Latitude/Longitude		
			Start	End	
Item	DWR Erosion Survey		37.878920 °	37.878920 °	
			-121.332670 °	-121.332670 °	
DWR ID	DWR_RD0524_01_s_2015_126				
Action/Comments					
Inspector Comments: 6/19/2014: No significant change observed. 08/13/2013: Larger trees are at the levee shoulder, and an irrigation pump station is next to the erosion site. [2014 Site ID:RD0524U01RM46.06]

Front view of the erosion.

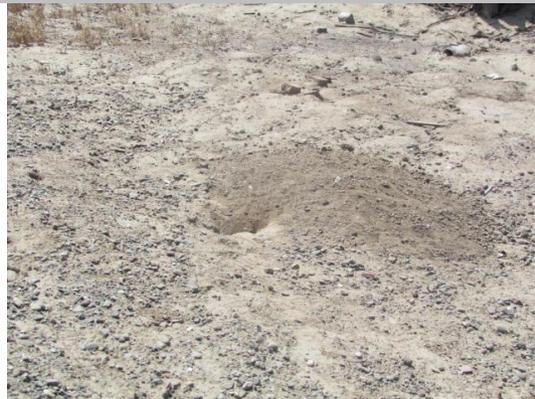
Photo 1 of 2 : SP\_2015\_RD0524\_107\_197\_20150424\_00237.jpg

LM Start	<b>5.79</b>	Rating **	M	Issue No.	<b>197</b>
LM End	<b>5.79</b>	Issue Type +	Ma	Location *	LS
Category	Earthen Levee			GPS Latitude/Longitude	
				Start	End
Item	Animal Control			37.875310 °	37.875310 °
				-121.333065 °	-121.333065 °
DWR ID	DWR_RD0524_01_s_2015_197				
Action/Comments					
Exterminate rodents and backfill and compact or grout burrows. Inspector Comments: Several rodent holes on landward slope and levee crown.

Looking north at typical view of rodent holes on landward slope.

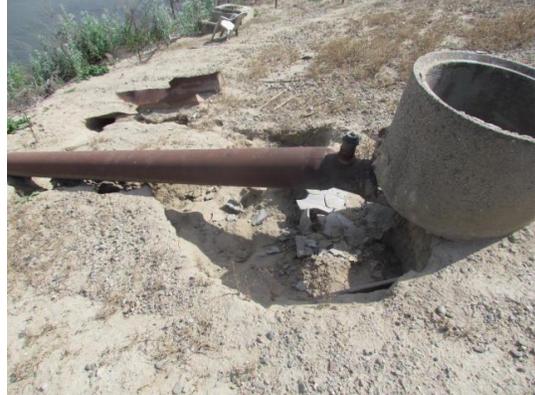
Photo 1 of 3 : SP\_2015\_RD0524\_107\_198\_20150424\_00239.jpg

LM Start	<b>5.81</b>	Rating **	U	Issue No.	<b>198</b>
LM End	<b>5.81</b>	Issue Type +	Ma	Location *	WS
Category	Interior Drainage & Piping Systems		GPS Latitude/Longitude		
			Start	End	
Item	Erosion Areas		37.874950 °	37.874950 °	
			-121.333273 °	-121.333273 °	
DWR ID	DWR_RD0524_01_s_2015_198				
Action/Comments					
Inspector Comments: Large erosion around irrigation pipe on waterward slope.

Looking south at erosion around irrigation pipe on waterward slope.

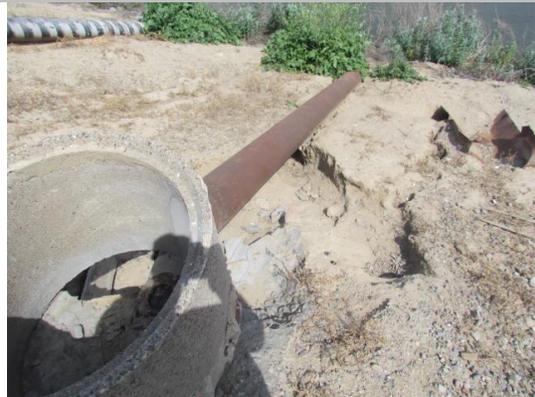
Photo 2 of 3 : SP\_2015\_RD0524\_107\_198\_20150424\_00240.jpg

Looking east at erosion around irrigation pipe.

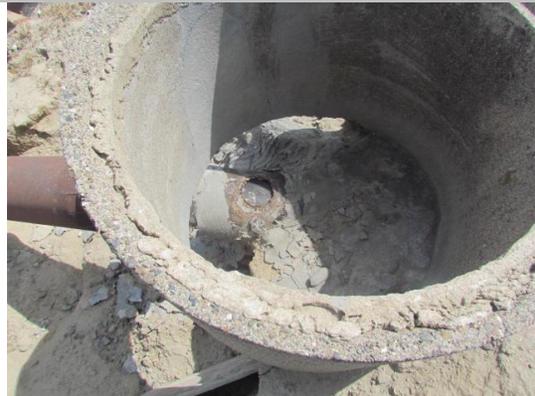
Photo 3 of 3 : SP\_2015\_RD0524\_107\_198\_20150424\_00241.jpg

Looking at erosion around pipe inside concrete collar.

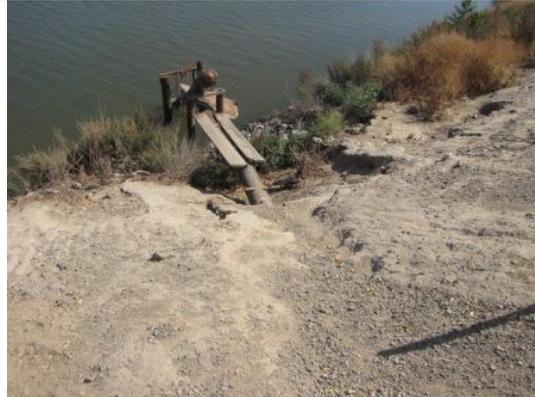
Photo 1 of 3 : SP\_2015\_RD0524\_107\_74\_20150309\_00083.jpg

LM Start	<b>5.86</b>	Rating **	M	Issue No.	<b>74</b>
LM End	<b>5.87</b>	Issue Type +	Ma	Location *	WS
Category	Earthen Levee		GPS Latitude/Longitude		
			Start	End	
Item	Erosion / Bank Caving		37.874240 °	37.874165 °	
			-121.333185 °	-121.333155 °	
DWR ID	DWR_RD0524_01_s_2012_74				
Action/Comments					
Note and monitor erosion site. Inspector Comments: Erosion on landward slope around intake pipe.

Looking southeast at erosion around pipe.

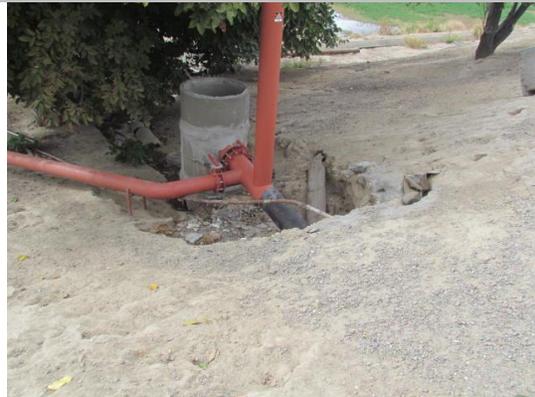
Photo 2 of 3 : SP\_2015\_RD0524\_107\_74\_20150309\_00084.jpg

Looking west at erosion around intake pipe on landward slope.

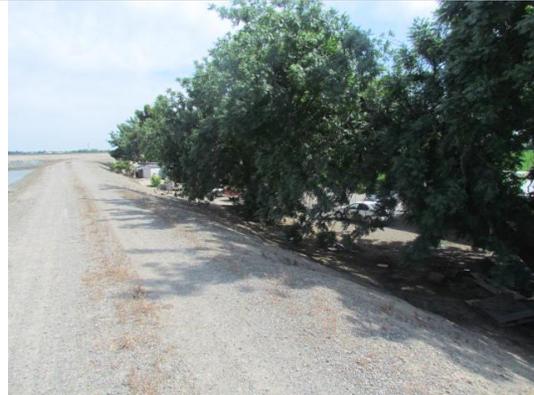
Photo 1 of 1 : SP\_2015\_RD0524\_107\_120\_20150424\_00242.jpg

LM Start	<b>5.96</b>	Rating **	M	Issue No.	<b>120</b>
LM End	<b>5.96</b>	Issue Type +	Ma	Location *	LS
Category	Earthen Levee		GPS Latitude/Longitude		
			Start	End	
Item	Trim / Thin Trees		37.873347 °	37.873347 °	
			-121.332028 °	-121.332028 °	
DWR ID	DWR_RD0524_01_s_2012_120				
Action/Comments					
Trim trees to at least five feet above ground level.

Looking south at untrimmed trees on landward slope and toe.

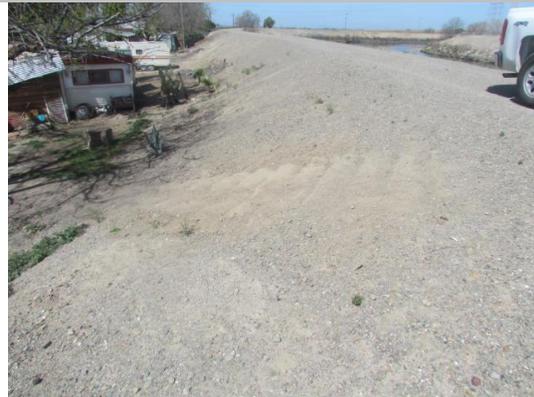
Photo 1 of 1 : SP\_2015\_RD0524\_107\_933\_20150309\_00171.jpg

LM Start	<b>6.00</b>	Rating **	M	Issue No.	<b>933</b>
LM End	<b>6.00</b>	Issue Type +	Ma	Location *	LS
Category	Earthen Levee		GPS Latitude/Longitude		
			Start	End	
Item	Slope Stability		37.873047 °	37.873047 °	
			-121.331408 °	-121.331408 °	
DWR ID	DWR_RD0524_01_s_2012_933				
Action/Comments					
Repair the levee slope damaged by foot traffic and prevent access where possible. Inspector Comments: Landowner cut steps into landside slope.

Looking north at steps cut into landward slope.

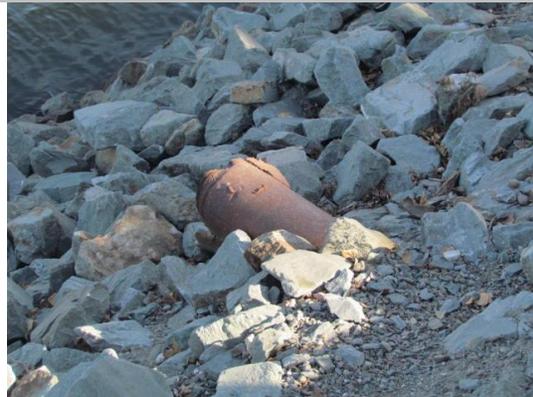
Photo 1 of 1 : SP\_2015\_RD0524\_107\_268\_20150309\_00163.jpg

LM Start	<b>6.15</b>	Rating **	M	Issue No.	<b>268</b>
LM End	<b>6.15</b>	Issue Type +	Ma	Location *	WS
Category	Earthen Levee		GPS Latitude/Longitude		
			Start	End	
Item	Encroachments		37.871137 °	37.871137 °	
			-121.330138 °	-121.330138 °	
DWR ID	DWR_RD0524_01_s_2012_268				
Action/Comments					
Pipe Inspector Comments: Open abandoned 10" pipe on waterside slope below flood elevation. Pipe should be removed or properly abandoned.

Looking southeast at abandoned pipe on waterside slope.

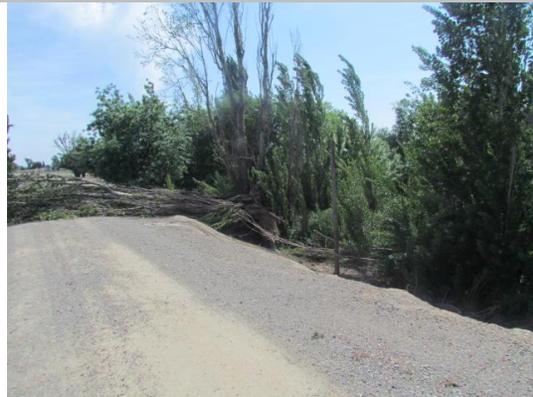
Photo 1 of 2 : SP\_2015\_RD0524\_107\_81\_20150424\_00243.jpg

LM Start	<b>6.15</b>	Rating **	U	Issue No.	<b>81</b>
LM End	<b>6.15</b>	Issue Type +	Ma	Location *	LS
Category	Earthen Levee		GPS Latitude/Longitude		
			Start	End	
Item	Encroachments		37.871097 °	37.871097 °	
			-121.330100 °	-121.330100 °	
DWR ID	DWR_RD0524_01_s_2015_81				
Action/Comments					
Tree or limb Inspector Comments: Large tree fallen across levee crown blocking access.

Looking southwest at large tree across levee crown.

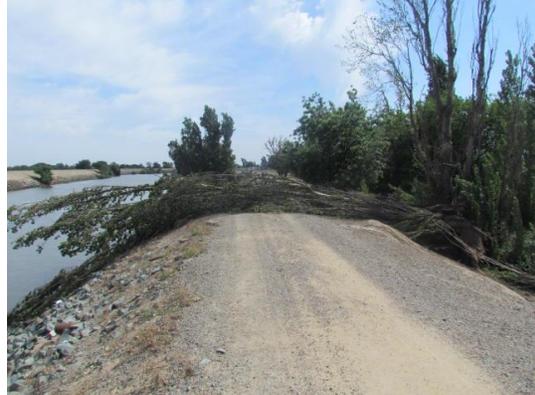
Photo 2 of 2 : SP\_2015\_RD0524\_107\_81\_20150424\_00244.jpg

LM Start	<b>6.15</b>	Rating **	U	Issue No.	<b>81 (cont)</b>
LM End	<b>6.15</b>	Issue Type +	Ma	Location *	LS
Category	Earthen Levee			GPS Latitude/Longitude	
				Start	End
Item	Encroachments			37.871097 °	37.871097 °
				-121.330100 °	-121.330100 °
DWR ID	DWR_RD0524_01_s_2015_81				
Action/Comments					
Tree or limb Inspector Comments: Large tree fallen across levee crown blocking access.

Looking south at large tree across levee crown.

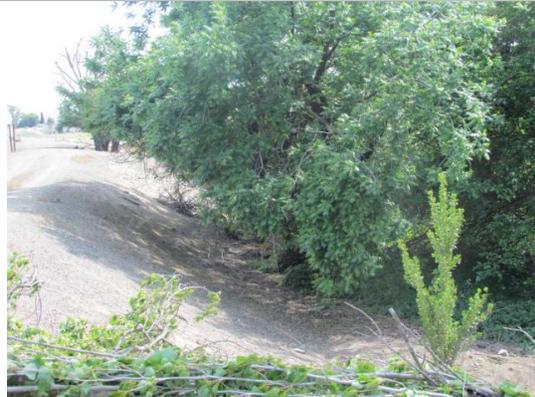
Photo 1 of 1 : SP\_2015\_RD0524\_107\_98\_20150424\_00245.jpg

Looking southeast at untrimmed trees at landward toe.

LM Start	<b>6.17</b>	Rating **	M	Issue No.	<b>98</b>
LM End	<b>6.17</b>	Issue Type +	Ma	Location *	LS
Category	Earthen Levee			GPS Latitude/Longitude	
				Start	End
Item	Trim / Thin Trees			37.870842 °	37.870842 °
				-121.330000 °	-121.330000 °
DWR ID	DWR_RD0524_01_s_2012_98				
Action/Comments					
Trim trees to at least five feet above ground level.
