**Flood Control Project Maintenance
Levee Inspections**
LMA District Cover Sheet
Spring 2014 Levee Inspection Results

Reclamation District No. 0537 Lovdal

Levee Inspection Report By Mile - Spring 2014

Waterway		Bank	Unit Miles	Inspection Start/End	Inspector
Unit No. 01 Sacramento River		Right	4.76	03/27/2014 03/27/2014	John Williamson

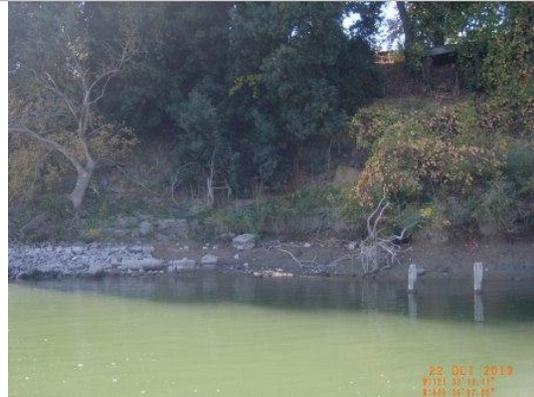
Photo 1 of 1 : USACE2013A_SAC_63-0_R_2.jpg

LM Start	4.25	Rating **	M	Issue No.	2
LM End	4.27	Issue Type +	Ma	Location *	WS
Category	Supplemental		GPS Latitude/Longitude		
			Start	End	
Item	USACE Erosion Survey		38.602101 °	38.601708 °	
			-121.553909 °	-121.553603 °	
DWR ID					
Action/Comments					
Inspector Comments: 1997 - Erosion near the downstream corner of
