**Flood Control Project Maintenance  
Levee Inspections**

## Maintenance Issue Types Only, Levee Inspection Report By Mile - Spring 2015

### Reclamation District No. 0544 Upper Roberts Island

Waterway	Bank	Unit Miles	Inspection Start/End	Inspector
Unit No. 01 San Joaquin River	Left	6.05	04/28/2015 04/28/2015	Richard Willoughby

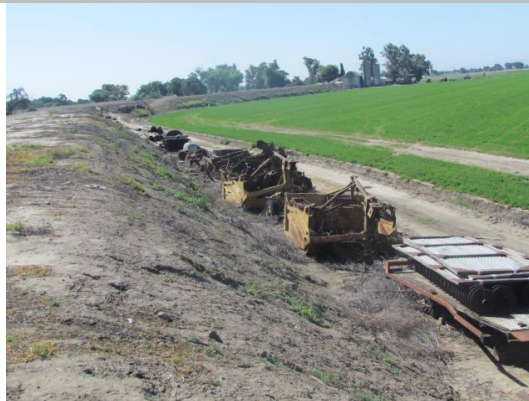
Photo 1 of 3 : SP\_2015\_RD0544\_108\_4\_20150430\_00070.jpg

LM Start	0.23	Rating **	M	Issue No.	4
LM End	0.23	Issue Type +	Ma	Location *	LS
Category	Earthen Levee			GPS Latitude/Longitude	
				Start	End
Item	Encroachments			37.867590 °	37.867590 °
				-121.327813 °	-121.327813 °
DWR ID	DWR_RD0544_01_s_2012_4				
Action/Comments					
Equipment					
Inspector Comments: Farm equipment and supplies stored at landward toe.

Looking south at farm equipment at landward toe. (Spring 2015)

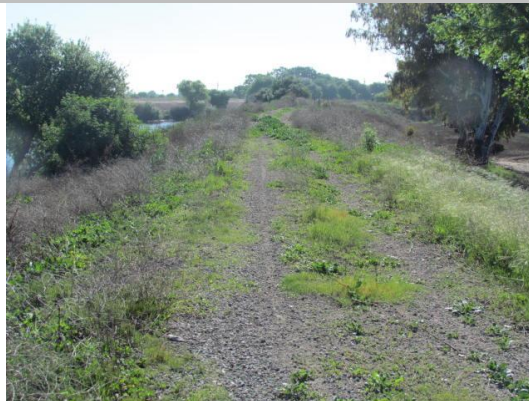
Photo 1 of 2 : SP\_2015\_RD0544\_108\_3\_20150309\_00001.jpg

Looking south at typical view of levee. (Spring 2014)

LM Start	0.48	Rating **	A/W	Issue No.	3
LM End	0.67	Issue Type +	Ma	Location *	WS
Category	Earthen Levee			GPS Latitude/Longitude	
				Start	End
Item	Vegetation			37.864578 °	37.863753 °
				-121.326210 °	-121.322835 °
DWR ID	DWR_RD0544_01_s_2012_3				
Action/Comments					
Remove the wild growth other than native grasses from the levee slopes.

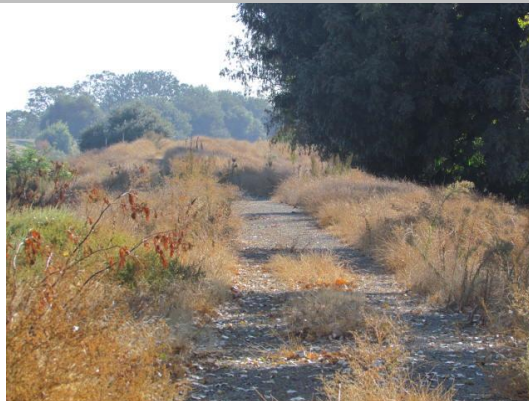
Photo 2 of 2 : SP\_2015\_RD0544\_108\_3\_20150309\_00002.jpg

Looking south at overgrown on landward and waterward slopes.

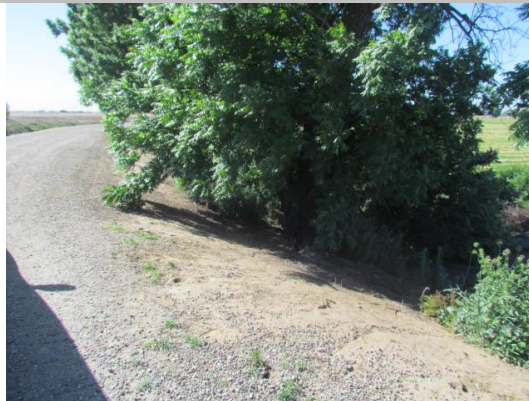
Photo 1 of 1 : SP\_2015\_RD0544\_108\_39\_20150430\_00075.jpg

Looking southwest at untrimmed tree at landward slope and toe.

LM Start	1.12	Rating **	M	Issue No.	39
LM End	1.12	Issue Type +	Ma	Location *	LS
Category	Earthen Levee			GPS Latitude/Longitude	
				Start	End
Item	Trim / Thin Trees			37.859423 °	37.859423 °
				-121.318328 °	-121.318328 °
DWR ID	DWR_RD0544_01_s _ 2012_39				
Action/Comments					
Trim trees to at least five feet above ground level.

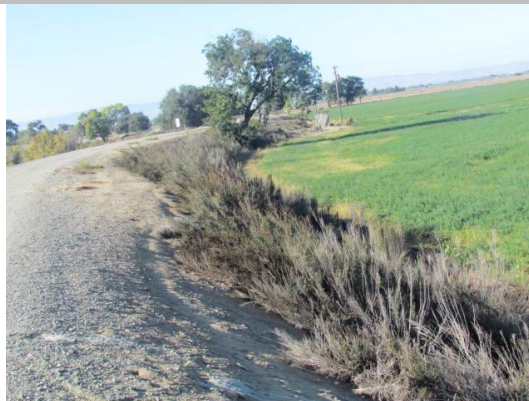
Photo 1 of 1 : SP\_2015\_RD0544\_108\_15\_20150309\_00009.jpg

Looking southeast at dense vegetation on landward toe.

LM Start	1.13	Rating **	M	Issue No.	15
LM End	1.30	Issue Type +	Ma	Location *	LS
Category	Earthen Levee			GPS Latitude/Longitude	
				Start	End
Item	Vegetation			37.859287 °	37.857322 °
				-121.318333 °	-121.319985 °
DWR ID	DWR_RD0544_01_s _ 2012_15				
Action/Comments					
Remove the wild growth other than native grasses from the levee slopes.

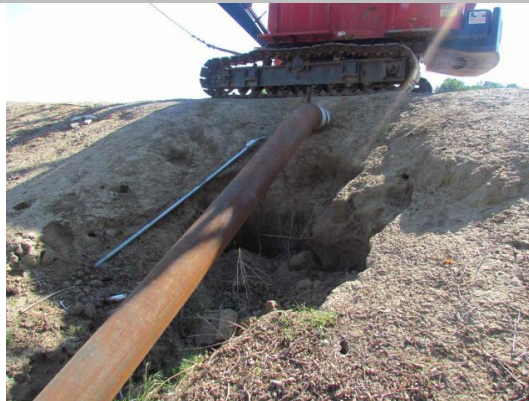
Photo 3 of 3 : SP\_2015\_RD0544\_108\_23\_20150309\_00026.jpg

LM Start	2.26	Rating **	U	Issue No.	23 (cont)
LM End	2.26	Issue Type +	Ma	Location *	LS
Category	Earthen Levee			GPS Latitude/Longitude	
				Start	End
Item	Erosion / Bank Caving			37.848155 °	37.848155 °
				-121.324897 °	-121.324897 °
DWR ID	DWR_RD0544_01_s_2012_23				
Action/Comments					
Schedule repair of erosion site prior to the next inspection. Inspector Comments: Caving/erosion around irrigation pipe on landside slope.

Looking east at erosion under irrigation pipe on landside slope.

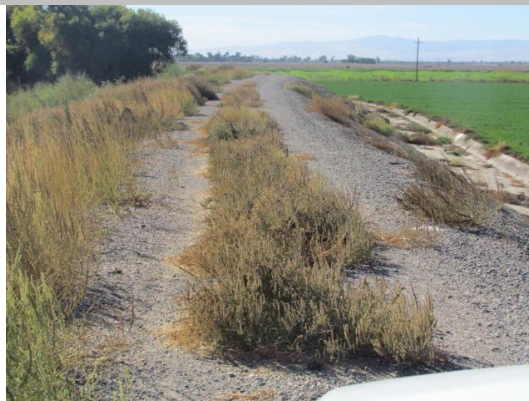
Photo 1 of 1 : SP\_2015\_RD0544\_108\_100\_20150309\_00056.jpg

Looking south at vegetation on levee crown.

LM Start	2.65	Rating **	A/W	Issue No.	100
LM End	2.94	Issue Type +	Ma	Location *	CR
Category	Earthen Levee			GPS Latitude/Longitude	
				Start	End
Item	Vegetation			37.843262 °	37.840656 °
				-121.321666 °	-121.318590 °
DWR ID	DWR_RD0544_01_f_2014_100				
Action/Comments					
Remove the wild growth other than native grasses from the levee slopes.

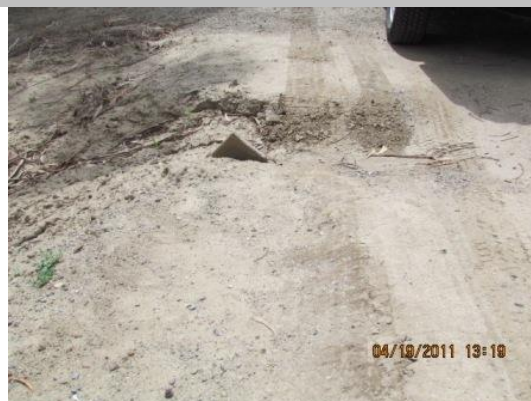
Photo 2 of 2 : SP\_2015\_RD0544\_108\_58\_20150309\_00038.jpg

Looking south at depression greater than 6" on waterside shoulder.

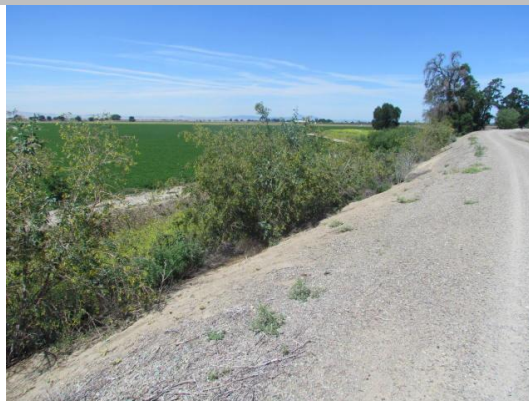
Photo 2 of 5 : SP\_2015\_RD0544\_108\_33\_20150430\_00085.jpg

Looking northwest at dense vegetation at landward toe. (Spring 2015)

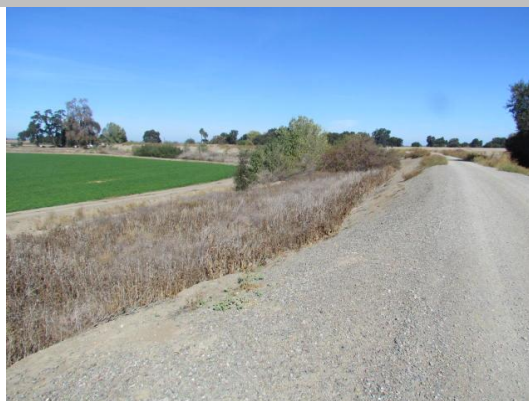
Photo 3 of 5 : SP\_2015\_RD0544\_108\_33\_20150309\_00029.jpg

Looking north at dead vegetation still blocking landward toe.

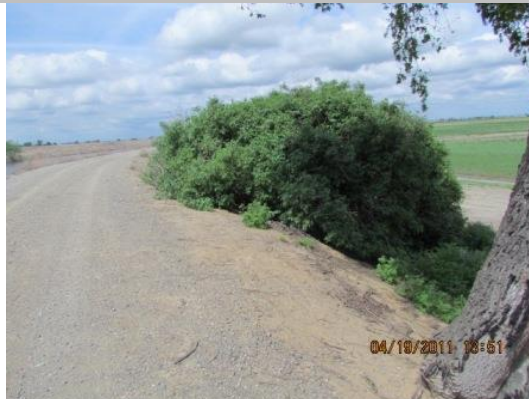
Photo 3 of 3 : SP\_2015\_RD0544\_109\_4\_20150309\_00003.jpg

Looking south at elderberries on landside slope.

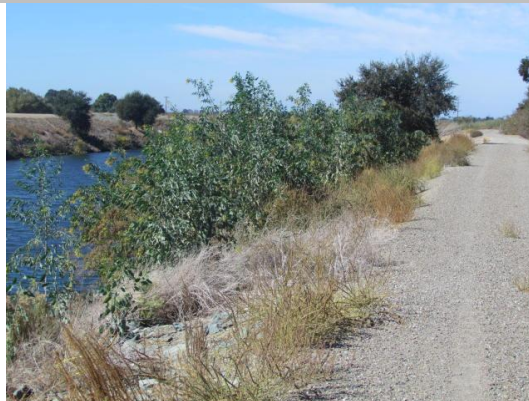
Photo 2 of 2 : SP\_2015\_RD0544\_109\_49\_20150309\_00040.jpg

LM Start	1.30	Rating **	U	Issue No.	49 (cont)	
LM End	1.40	Issue Type +	Ma	Location *	WS	
Category	Earthen Levee			GPS Latitude/Longitude		
				Start		End
Item	Vegetation			37.820767 °		37.821582 °
				-121.336611 °		-121.338102 °
DWR ID	DWR_RD0544_02_f_2014_49					
Action/Comments						
Remove the wild growth other than native grasses from the levee slopes.						
Inspector Comments: Tobacco plants on waterward slope.

Looking south at several tobacco plants on waterward slope.

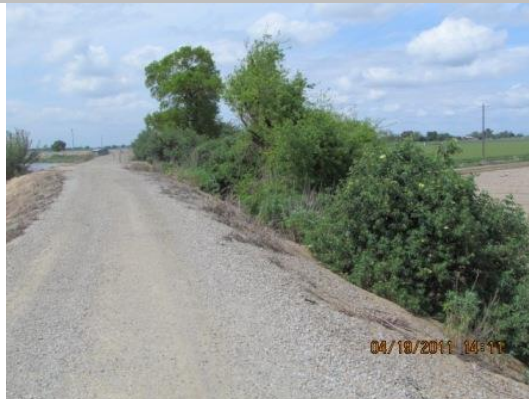
Photo 1 of 2 : SP\_2015\_RD0544\_109\_10\_20150309\_00015.jpg

LM Start	1.38	Rating **	U	Issue No.	10
LM End	1.38	Issue Type +	Ma	Location *	LS
Category	Earthen Levee			GPS Latitude/Longitude	
				Start	End
Item	Vegetation			37.821423 °	37.821423 °
				-121.337878 °	-121.337878 °
DWR ID	DWR_RD0544_02_s_2012_10				
Action/Comments					
Elderberries are blocking visibility and flood fight capability.

Looking southwest at elderberries on landside slope.

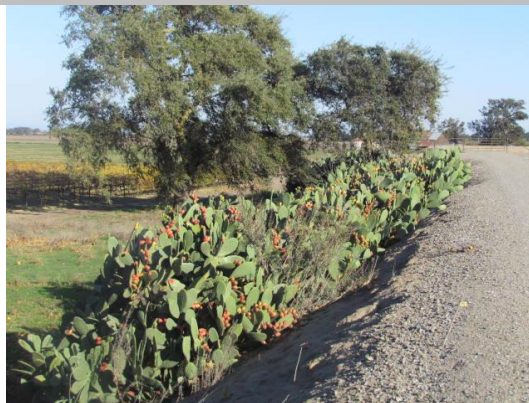
Photo 1 of 2 : SP\_2015\_RD0544\_109\_36\_20150309\_00037.jpg

LM Start	3.48	Rating **	M	Issue No.	36
LM End	3.51	Issue Type +	Ma	Location *	LS
Category	Earthen Levee			GPS Latitude/Longitude	
				Start	End
Item	Vegetation			37.819576 °	37.819530 °
				-121.364056 °	-121.364653 °
DWR ID	DWR_RD0544_02_s_2012_36				
Action/Comments					
Remove the wild growth other than native grasses from the levee slopes.					
Inspector Comments: Cactus on landside slope.

Looking north at cactus on landside slope and toe.
