**Flood Control Project Maintenance
Levee Inspections**

Maintenance Issue Types Only, Levee Inspection Report By Mile - Spring 2016

Reclamation District No. 0544 Upper Roberts Island

Waterway	Bank	Unit Miles	Inspection Start/End	Inspector
Unit No. 01 San Joaquin River	Left	6.05	04/19/2016 04/19/2016	Richard Willoughby

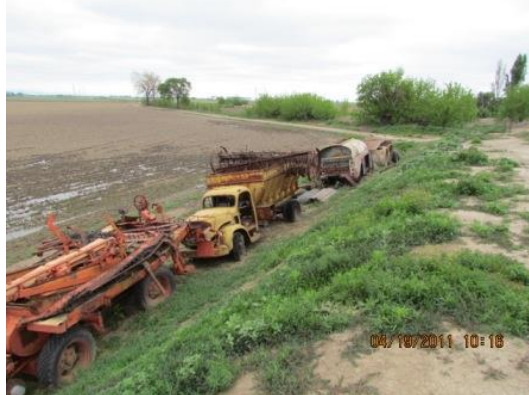
Photo 4 of 5 : SP_2016_RD0544_108_4_20160404_00007.jpg

LM Start	0.06	Rating **	M	Issue No.	4 (cont)	
LM End	0.19	Issue Type +	Ma	Location *	LS	
Category	Earthen Levee			GPS Latitude/Longitude		
				Start		End
Item	Encroachments			37.869606 °	37.868163 °	
				-121.329571 °	-121.328132 °	
DWR ID	DWR_RD0544_01_s_2012_4					
Comment Code						
EQ : Equipment						
Inspector Comment						
Farm equipment and supplies stored at landward toe.

Looking north at equipment along landside toe.

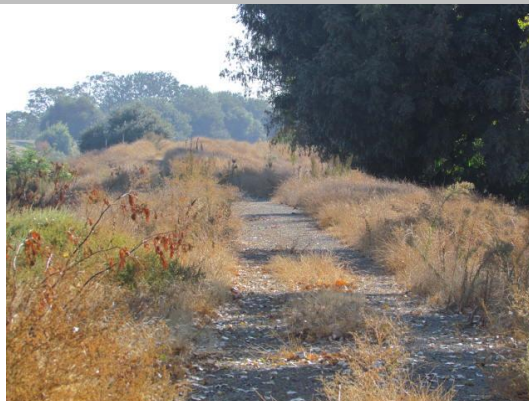
Photo 2 of 2 : SP_2016_RD0544_108_3_20160404_00003.jpg

Looking south at overgrown on landward and waterward slopes.

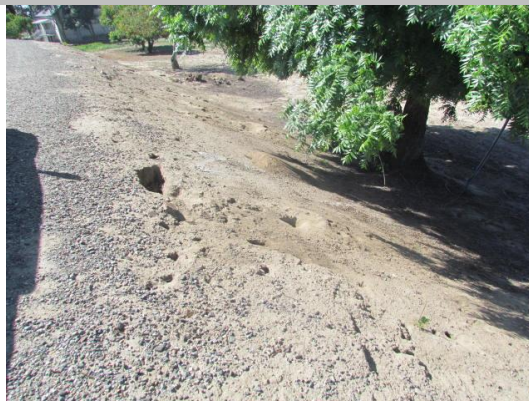
Photo 1 of 2 : SP_2016_RD0544_108_34_20160404_00025.jpg

LM Start	2.32	Rating **	M	Issue No.	34
LM End	2.36	Issue Type +	Ma	Location *	LS
Category	Earthen Levee			GPS Latitude/Longitude	
				Start	End
Item	Animal Control			37.847292 °	37.846743 °
				-121.324662 °	-121.324336 °
DWR ID	DWR_RD0544_01_s_2012_34				
Comment Code					
A1 : Exterminate rodents and backfill and compact or grout burrows.					
Inspector Comment					
Several rodent hole within this reach.

Looking south at several rodent holes on landward shoulder and slope.

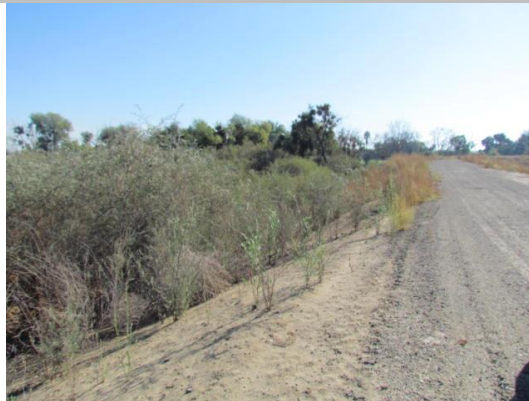
Photo 1 of 1 : SP_2016_RD0544_108_106_20160404_00064.jpg

LM Start	2.89	Rating **	U	Issue No.	106
LM End	3.16	Issue Type +	Ma	Location *	WS
Category	Earthen Levee			GPS Latitude/Longitude	
				Start	End
Item	Vegetation			37.840952 °	37.837588 °
				-121.319327 °	-121.317540 °
DWR ID	DWR_RD0544_01_s_2015_106				
Comment Code					
V2 : Remove the wild growth other than native grasses from the levee slopes.					
Inspector Comment					
Dense willows and vegetation waterward slope.

Looking southeast at dense willows (veg) on waterward slope and toe fall 2015.

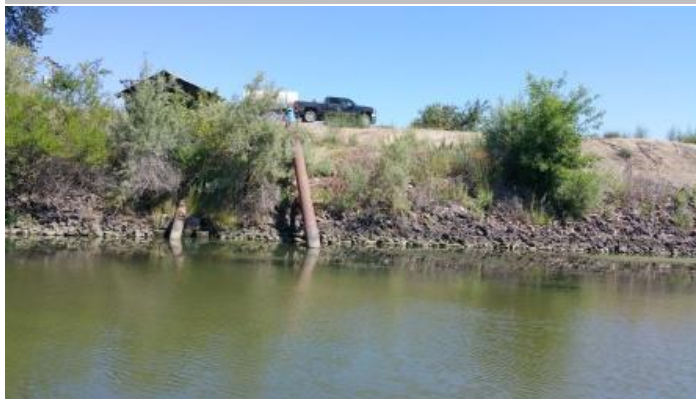
Photo 1 of 2 : SP_2016_RD0544_108_46_20160404_00035.jpg

Front view of the site.

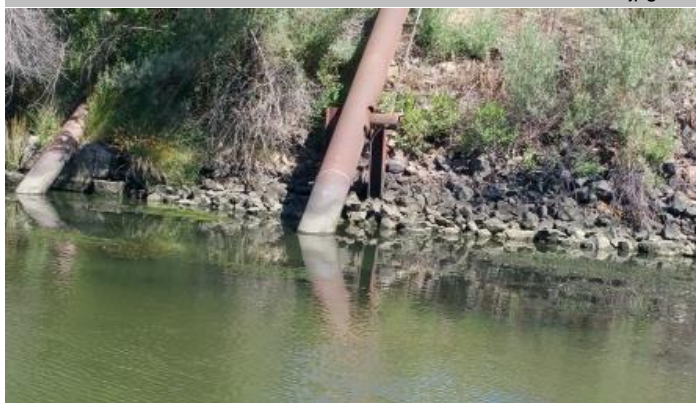
Photo 2 of 2 : SP_2016_RD0544_108_46_20160404_00036.jpg

Close view of the site.

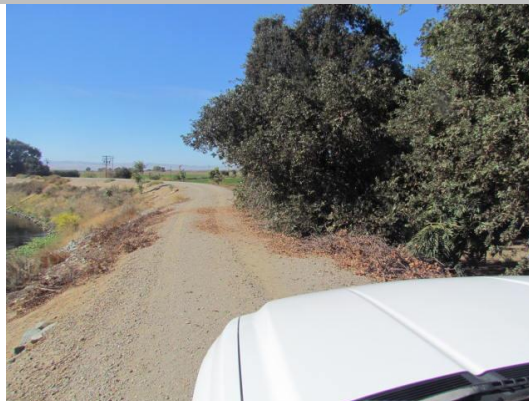
Photo 1 of 1 : SP_2016_RD0544_108_105_20160404_00063.jpg

LM Start	4.69	Rating **	U	Issue No.	105
LM End	4.69	Issue Type +	Ma	Location *	LS
Category	Earthen Levee			GPS Latitude/Longitude	
				Start	End
Item	Trim / Thin Trees			37.821775 °	37.821775 °
				-121.320203 °	-121.320203 °
DWR ID	DWR_RD0544_01_f_2014_105				
Comment Code					
T2 : Thin trees to allow visibility of the ground and room to flood fight.					
Inspector Comment					
Tree has overgrown onto levee crown.

Looking south at overgrown tree on landward shoulder.

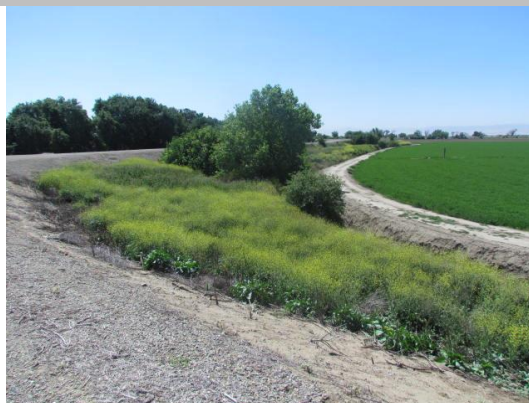
Photo 2 of 2 : SP_2016_RD0544_108_33_20160404_00024.jpg

Looking southwest at dense vegetation at landward slope and toe.(Spring 2015)

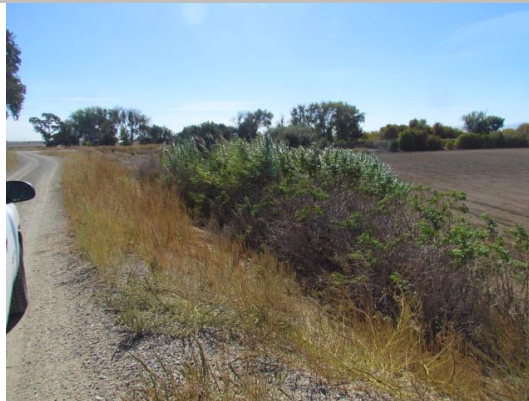
Photo 1 of 1 : SP_2016_RD0544_108_35_20160404_00027.jpg

LM Start	5.34	Rating **	M	Issue No.	35
LM End	5.34	Issue Type +	Ma	Location *	LS
Category	Earthen Levee			GPS Latitude/Longitude	
				Start	End
Item	Vegetation			37.813659 °	37.813659 °
				-121.319614 °	-121.319614 °
DWR ID	DWR_RD0544_01_s_2012_35				
Comment Code					
V2 : Remove the wild growth other than native grasses from the levee slopes.					
Inspector Comment					
LMA corrected site, but some vegetation still exists.

Looking south at bamboo on landward slope and toe.

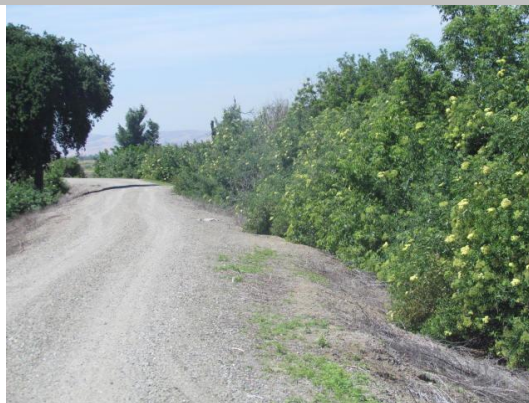
Photo 1 of 2 : SP_2016_RD0544_108_18_20160404_00015.jpg

LM Start	5.49	Rating **	U	Issue No.	18
LM End	5.55	Issue Type +	Ma	Location *	LS
Category	Earthen Levee			GPS Latitude/Longitude	
				Start	End
Item	Vegetation			37.812033 °	37.811687 °
				-121.319737 °	-121.320677 °
DWR ID	DWR_RD0544_01_s_2012_18				
Comment Code					
V4 : Elderberries are blocking visibility and flood fight capability.					
Inspector Comment					
Elderberry exists on the slope of the levee.

Looking south at dense vegetation on landward slope and toe. (Spirig 2015)

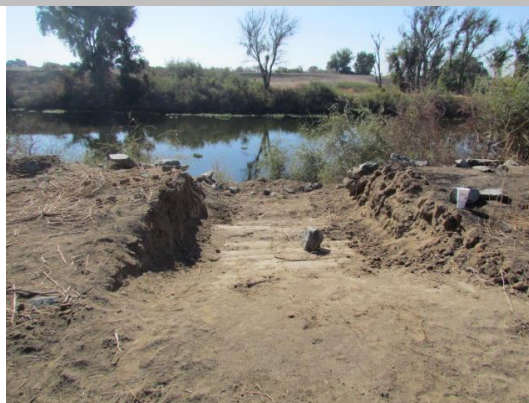
Photo 2 of 4 : SP_2016_RD0544_108_121_20160404_00077.jpg

Looking east at excavation on waterward berm.

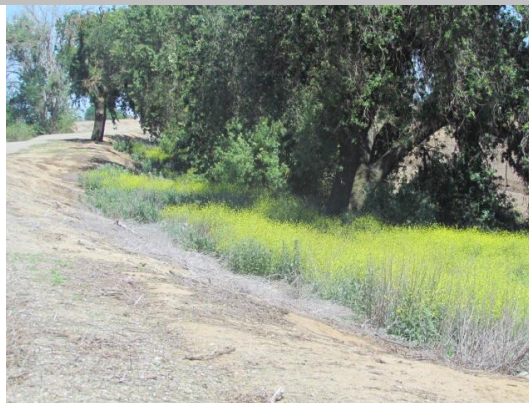
Photo 1 of 1 : SP_2016_RD0544_109_1_20160404_00001.jpg

LM Start	0.43	Rating **	A/W	Issue No.	1
LM End	1.12	Issue Type +	Ma	Location *	LS
Category	Earthen Levee			GPS Latitude/Longitude	
				Start	End
Item	Vegetation			37.810250 °	37.819452 °
				-121.334933 °	-121.333755 °
DWR ID	DWR_RD0544_02_s_2012_1				
Comment Code					
V2 : Remove the wild growth other than native grasses from the levee slopes.					
Inspector Comment

Looking southwest at dense vegetation at landward toe.

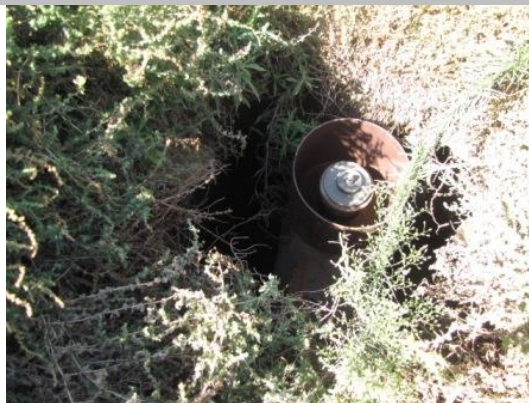
Photo 1 of 8 : SP_2016_RD0544_109_8_20160404_00007.jpg

LM Start	0.78	Rating **	U	Issue No.	8
LM End	0.78	Issue Type +	Ma	Location *	WS
Category	Interior Drainage & Piping Systems			GPS Latitude/Longitude	
				Start	End
Item	Erosion Areas			37.815094 °	37.815094 °
				-121.333927 °	-121.333927 °
DWR ID	DWR_RD0544_02_s_2012_8				
Comment Code					
Inspector Comment					
Caving under and around siphon on waterside shoulder. No material 3' below pipe. Caving around siphon is 20" to 24" deep approximately 72" in diameter. During 2012 spring inspection hole appears to be enlarging.

Looking at top of siphon on waterside shoulder with 3' of caving around pipe.

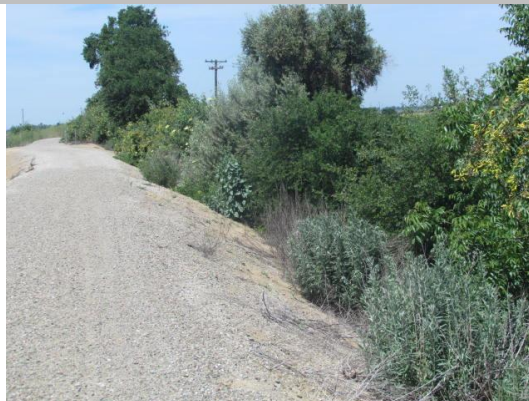
Photo 1 of 2 : SP_2016_RD0544_109_49_20160404_00041.jpg

LM Start	1.30	Rating **	U	Issue No.	49
LM End	1.40	Issue Type +	Ma	Location *	WS
Category	Earthen Levee			GPS Latitude/Longitude	
				Start	End
Item	Vegetation			37.820767 °	37.821582 °
				-121.336611 °	-121.338102 °
DWR ID	DWR_RD0544_02_f_2014_49				
Comment Code					
V2 : Remove the wild growth other than native grasses from the levee slopes.					
Inspector Comment					
Tobacco plants on waterward slope.

Looking southwest at dense vegetation on landward slope and toe.

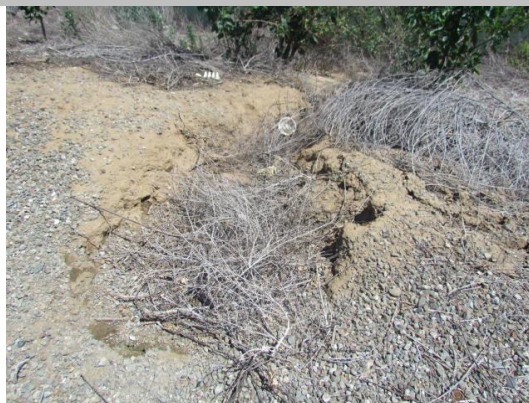
Photo 2 of 2 : SP_2016_RD0544_109_38_20160404_00038.jpg

Looking east at erosion/caving on waterward slope.

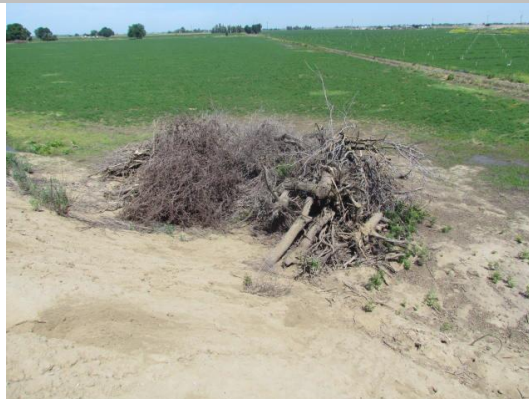
Photo 1 of 1 : SP_2016_RD0544_109_57_20160404_00048.jpg

LM Start	2.02	Rating **	A/W	Issue No.	57
LM End	2.02	Issue Type +	Ma	Location *	LS
Category	Earthen Levee			GPS Latitude/Longitude	
				Start	End
Item	Encroachments			37.818853 °	37.818853 °
				-121.343473 °	-121.343473 °
DWR ID	DWR_RD0544_02_s _ 2015_57				
Comment Code					
PR : Prunings					
Inspector Comment					
Large pruning pile at landward toe.

Looking west at pruning pile at landward toe.(Spring 2015)

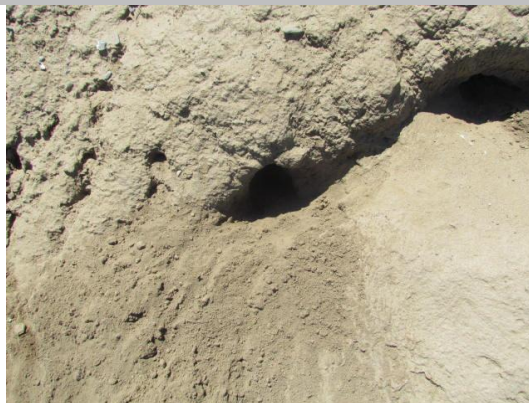
Photo 1 of 1 : SP_2016_RD0544_109_58_20160404_00049.jpg

LM Start	2.02	Rating **	U	Issue No.	58
LM End	2.09	Issue Type +	Ma	Location *	LS
Category	Earthen Levee			GPS Latitude/Longitude	
				Start	End
Item	Animal Control			37.818853 °	37.819493 °
				-121.343473 °	-121.344545 °
DWR ID	DWR_RD0544_02_s _ 2015_58				
Comment Code					
A1 : Exterminate rodents and backfill and compact or grout burrows.					
Inspector Comment					
Several rodent holes within reach on landward slope.

Looking at typical rodent holes on landward slope.

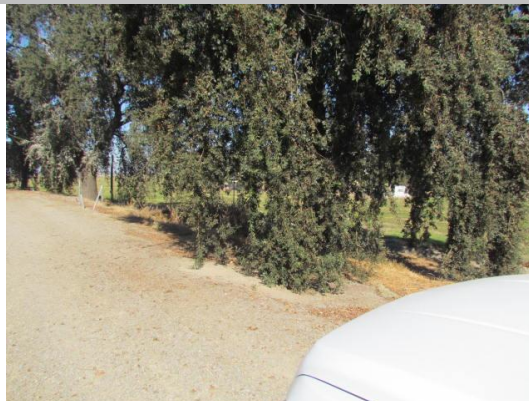
Photo 1 of 1 : SP_2016_RD0544_109_61_20160404_00051.jpg

LM Start	2.28	Rating **	U	Issue No.	61
LM End	2.28	Issue Type +	Ma	Location *	LS
Category	Earthen Levee			GPS Latitude/Longitude	
				Start	End
Item	Trim / Thin Trees			37.821473 °	37.821473 °
				-121.346860 °	-121.346860 °
DWR ID	DWR_RD0544_02_s_2015_61				
Comment Code					
T1 : Trim trees to at least five feet above ground level.					
Inspector Comment					
Untrimmed tree on landward shoulder.

Looking west at untrimmed trees on landward slope fall 2015.

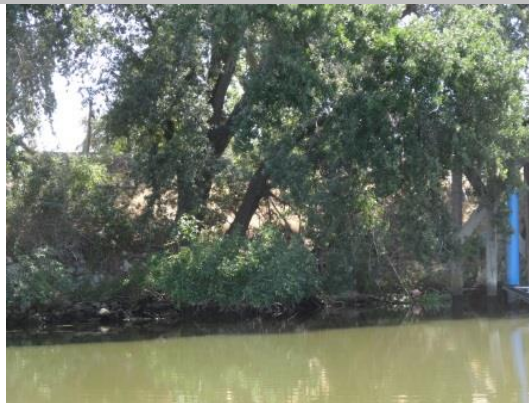
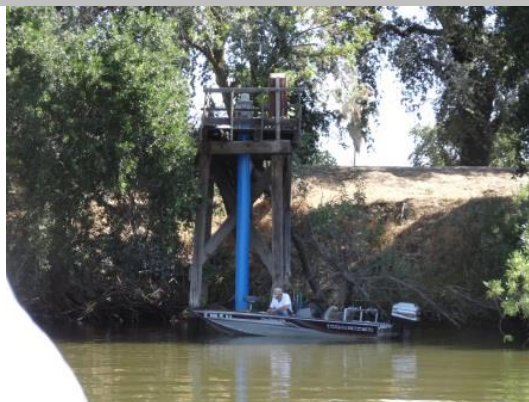
LM Start	2.31	Rating **	M	Issue No.	12
LM End	2.31	Issue Type +	Ma	Location *	WS
Category	Supplemental			GPS Latitude/Longitude	
				Start	End
Item	DWR Erosion Survey			37.821763 °	37.821763 °
				-121.347275 °	-121.347275 °
DWR ID	DWR_RD0544_02_s_2016_12				
Comment Code					
Inspector Comment					
06/25/2015: No significant change observed. 07/02/2014: No significant change observed. 08/20/2013: No significant change observed. 08/07/2012: The site was first reported in 2012 spring levee inspection report. The data were estimated as the site is underneath a irrigation pump station and inaccessible by boat or land survey. It?s possible the pump station played a role in the erosion. [2015 Site ID:RD0544U02RM33.21]

Front view of the site.

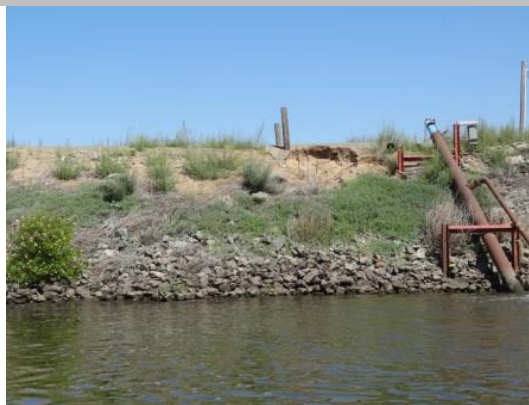
Photo 1 of 3 : SP_2016_RD0544_109_9_20160404_00015.jpg

LM Start	2.61	Rating **	U	Issue No.	9
LM End	2.61	Issue Type +	Ma	Location *	WS
Category	Supplemental			GPS Latitude/Longitude	
				Start	End
Item	DWR Erosion Survey			37.818861 °	37.818861 °
				-121.350400 °	-121.350400 °
DWR ID	DWR_RD0544_02_f_2015_9				
Comment Code					
Inspector Comment					
06/25/2015: The site was discovered during the boat survey. Irrigation pipe leakage caused the soil to sink at the upper levee shoulder. The lower part of the levee is protected by riprap rocks. The irrigation pump was operating at the site. [2015 Site ID:RD0544U02RM33]

Front view of the erosion site.

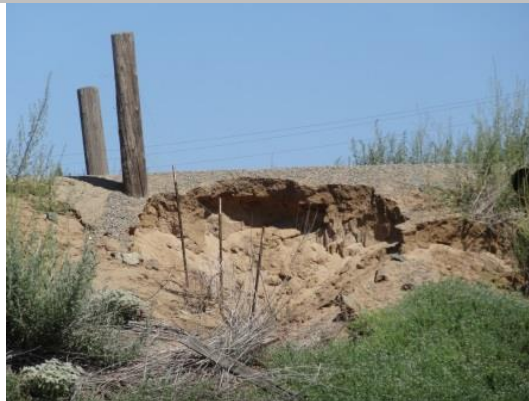
Photo 2 of 3 : SP_2016_RD0544_109_9_20160404_00016.jpg

Close view of the erosion.

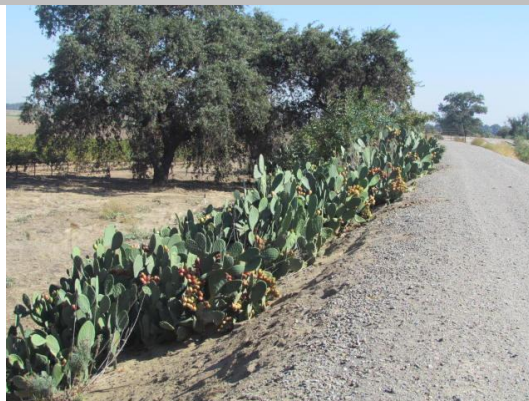
Photo 1 of 3 : SP_2016_RD0544_109_36_20160404_00034.jpg

Looking northwest at cactus on landward slope and toe fall 2015

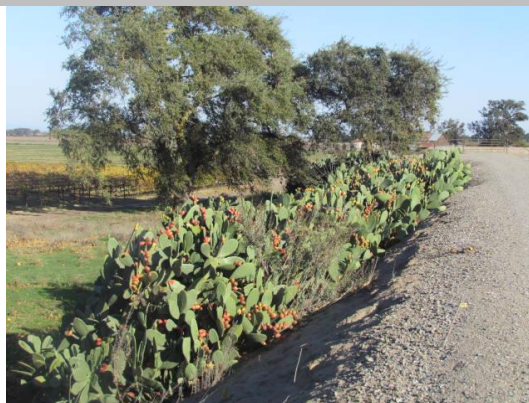
Photo 2 of 3 : SP_2016_RD0544_109_36_20160404_00035.jpg

Looking north at cactus on landside slope and toe spring 2015
