**Flood Control Project Maintenance
Levee Inspections**

Maintenance Issue Types Only, Levee Inspection Report By Mile - Spring 2017

Reclamation District No. 0544 Upper Roberts Island

Waterway	Bank	Unit Miles	Inspection Start/End	Inspector
Unit No. 01 San Joaquin River	Left	6.05	04/05/2017 04/05/2017	Richard Willoughby

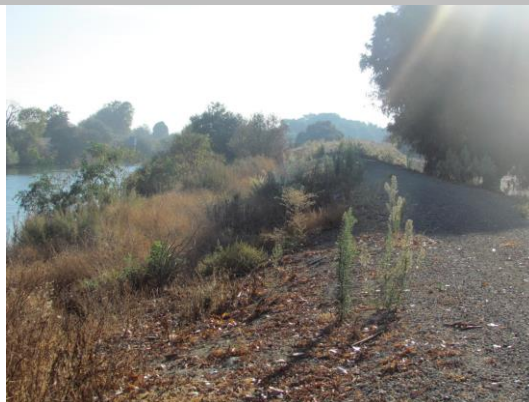
Photo 1 of 1 : SP_2017_RD0544_108_3_20170316_00003.jpg

LM Start	0.48	Rating **	U	Issue No.	3
LM End	0.67	Issue Type +	Ma	Location *	WS
Category	Earthen Levee			GPS Latitude/Longitude	
				Start	End
Item	Vegetation			37.864578 °	37.863753 °
				-121.326210 °	-121.322835 °
DWR ID	DWR_RD0544_01_s_2012_3				
Comment Code					
V2 : Remove the wild growth other than native grasses from the levee slopes.					
Inspector Comment					
Dense vegetation on waterward and landward slopes.

Looking south at dense veg on waterward slope.

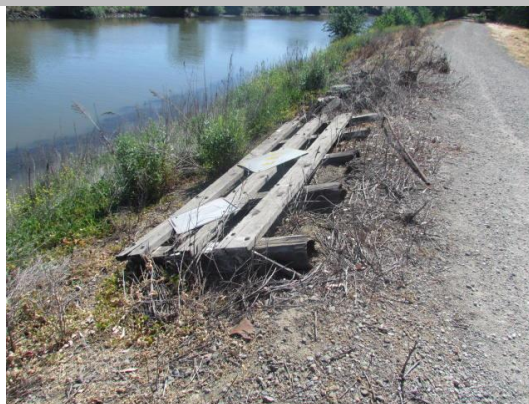
Photo 1 of 1 : SP_2017_RD0544_108_86_20170316_00055.jpg

LM Start	0.64	Rating **	U	Issue No.	86
LM End	0.64	Issue Type +	Ma	Location *	WS
Category	Earthen Levee			GPS Latitude/Longitude	
				Start	End
Item	Encroachments			37.863972 °	37.863972 °
				-121.323443 °	-121.323443 °
DWR ID	DWR_RD0544_01_s_2015_86				
Comment Code					
GA : Garbage					
Inspector Comment					
Old "dead end" sign on waterward slope.

Looking southeast at wooden sign on waterward slope.

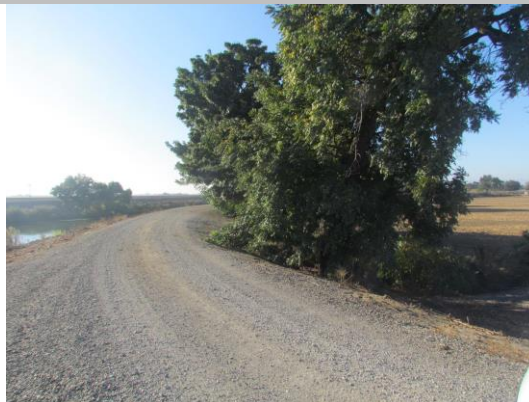
Photo 1 of 1 : SP_2017_RD0544_108_39_20170316_00030.jpg

LM Start	1.12	Rating **	U	Issue No.	39
LM End	1.12	Issue Type +	Ma	Location *	LS
Category	Earthen Levee			GPS Latitude/Longitude	
				Start	End
Item	Trim / Thin Trees			37.859423 °	37.859423 °
				-121.318328 °	-121.318328 °
DWR ID	DWR_RD0544_01_s_2012_39				
Comment Code					
T1 : Trim trees to at least five feet above ground level.					
Inspector Comment					
Untrimmed trees on landward slope.

Looking southwest at untrimmed tree on landward slope.

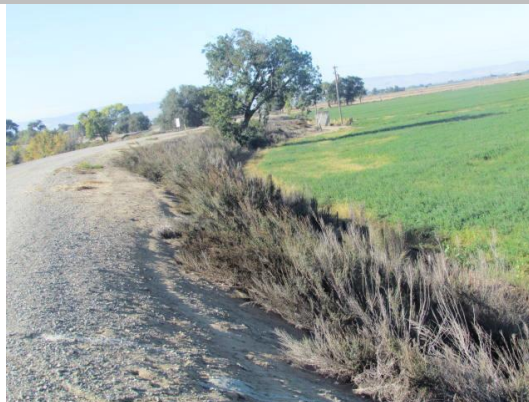
Photo 1 of 1 : SP_2017_RD0544_108_15_20170316_00014.jpg

LM Start	1.13	Rating **	M	Issue No.	15
LM End	1.30	Issue Type +	Ma	Location *	LS
Category	Earthen Levee			GPS Latitude/Longitude	
				Start	End
Item	Vegetation			37.859287 °	37.857322 °
				-121.318333 °	-121.319985 °
DWR ID	DWR_RD0544_01_s_2012_15				
Comment Code					
V2 : Remove the wild growth other than native grasses from the levee slopes.					
Inspector Comment

Looking southeast at dense vegetation on landward toe.

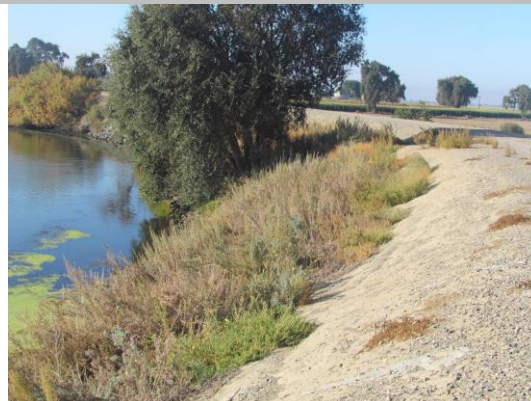
Photo 1 of 1 : SP_2017_RD0544_108_19_20170316_00017.jpg

LM Start	1.33	Rating **	U	Issue No.	19
LM End	1.43	Issue Type +	Ma	Location *	WS
Category	Earthen Levee			GPS Latitude/Longitude	
				Start	End
Item	Vegetation			37.857042 °	37.855792 °
				-121.320480 °	-121.321212 °
DWR ID	DWR_RD0544_01_s_2012_19				
Comment Code					
V2 : Remove the wild growth other than native grasses from the levee slopes.					
Inspector Comment					
Dense vegetation on waterward slope.

Looking south at typical of dense veg on waterward slope.

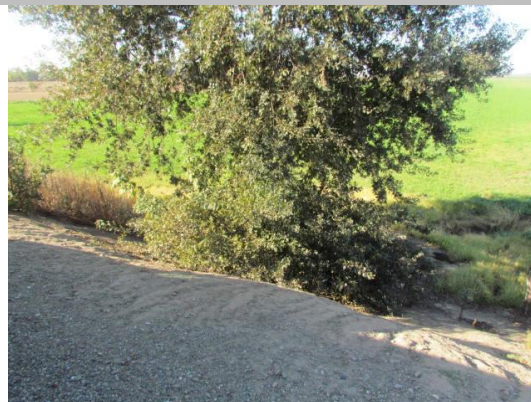
Photo 1 of 1 : SP_2017_RD0544_108_87_20170316_00056.jpg

LM Start	1.42	Rating **	U	Issue No.	87
LM End	1.48	Issue Type +	Ma	Location *	LS
Category	Earthen Levee			GPS Latitude/Longitude	
				Start	End
Item	Trim / Thin Trees			37.855948 °	37.855043 °
				-121.321250 °	-121.321122 °
DWR ID	DWR_RD0544_01_s_2015_87				
Comment Code					
T1 : Trim trees to at least five feet above ground level.					
Inspector Comment

Looking west at untrimmed tree at landward toe fall 2015.

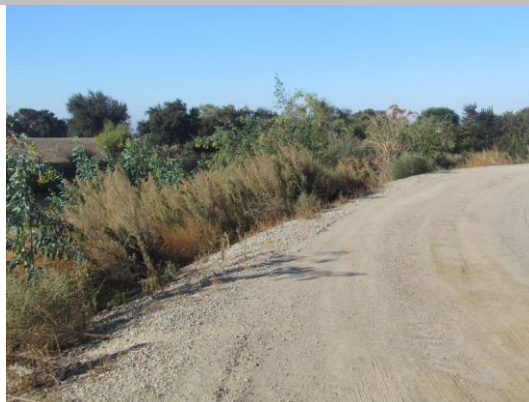
Photo 1 of 1 : SP_2017_RD0544_108_43_20170316_00033.jpg

LM Start	1.57	Rating **	U	Issue No.	43
LM End	1.76	Issue Type +	Ma	Location *	WS
Category	Earthen Levee			GPS Latitude/Longitude	
				Start	End
Item	Vegetation			37.854108 °	37.853980 °
				-121.321582 °	-121.324213 °
DWR ID	DWR_RD0544_01_s_2012_43				
Comment Code					
V2 : Remove the wild growth other than native grasses from the levee slopes.					
Inspector Comment					
Dense vegetation waterward slope.

Looking east at dense veg on waterward slope.

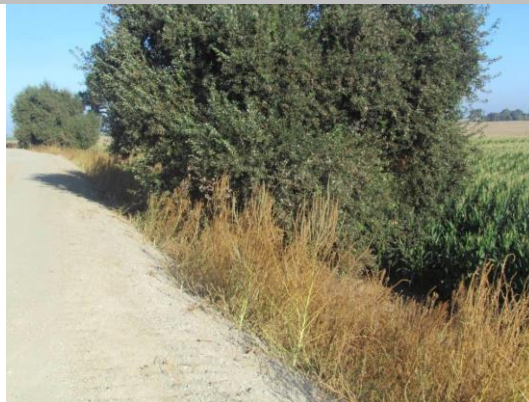
Photo 1 of 1 : SP_2017_RD0544_108_95_20170316_00061.jpg

LM Start	1.59	Rating **	U	Issue No.	95
LM End	1.59	Issue Type +	Ma	Location *	LS
Category	Earthen Levee			GPS Latitude/Longitude	
				Start	End
Item	Trim / Thin Trees			37.854299 °	37.854299 °
				-121.321865 °	-121.321865 °
DWR ID	DWR_RD0544_01_f_2014_95				
Comment Code					
T1 : Trim trees to at least five feet above ground level.					
Inspector Comment					
Untrimmed tree on landward slope.

Looking southwest at untrimmed tree on landward slope.

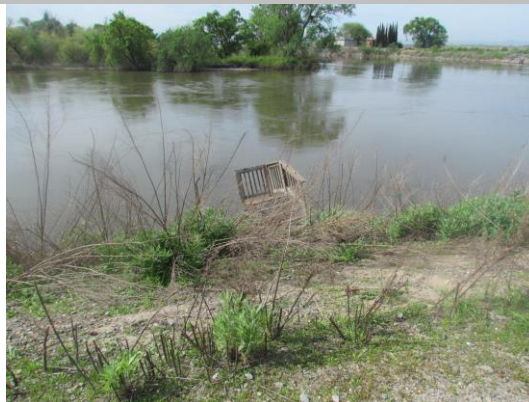
Photo 1 of 1 : SP_2017_RD0544_108_79_20170407_00128.jpg

LM Start	1.63	Rating **	M	Issue No.	79
LM End	1.63	Issue Type +	Ma	Location *	WS
Category	Earthen Levee			GPS Latitude/Longitude	
				Start	End
Item	Encroachments			37.854598 °	37.854598 °
				-121.322320 °	-121.322320 °
DWR ID	DWR_RD0544_01_s_2017_79				
Comment Code					
GA : Garbage					
Inspector Comment					
Remove abandoned stairs to boat dock.

Looking southeast at abandoned wooden boat dock stairs on waterward slope.

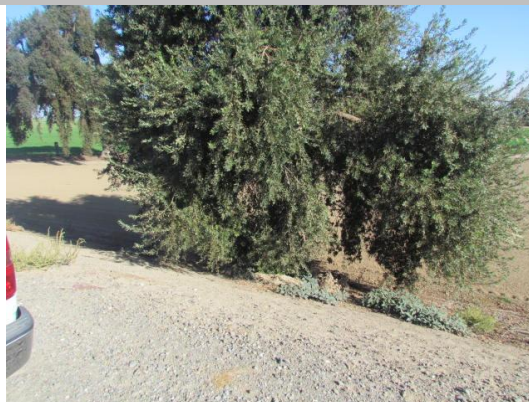
Photo 1 of 1 : SP_2017_RD0544_108_96_20170316_00062.jpg

LM Start	1.64	Rating **	U	Issue No.	96
LM End	1.64	Issue Type +	Ma	Location *	LS
Category	Earthen Levee			GPS Latitude/Longitude	
				Start	End
Item	Trim / Thin Trees			37.854681 °	37.854681 °
				-121.322493 °	-121.322493 °
DWR ID	DWR_RD0544_01_f_2014_96				
Comment Code					
T2 : Thin trees to allow visibility of the ground and room to flood fight.					
Inspector Comment

Looking at untrimmed tree on landward slope and toe.

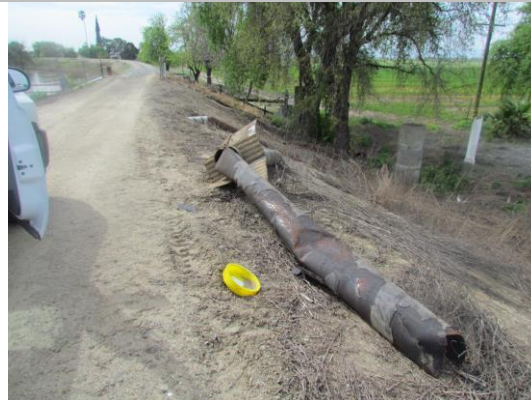
Photo 1 of 1 : SP_2017_RD0544_108_82_20170407_00131.jpg

LM Start	2.25	Rating **	M	Issue No.	82
LM End	2.25	Issue Type +	Ma	Location *	LS
Category	Earthen Levee			GPS Latitude/Longitude	
				Start	End
Item	Encroachments			37.848302 °	37.848302 °
				-121.324877 °	-121.324877 °
DWR ID	DWR_RD0544_01_s_2017_82				
Comment Code					
EQ : Equipment					
Inspector Comment					
Old irrigation pipe.

Looking southwest at old irrigation pipe on landward shoulder.

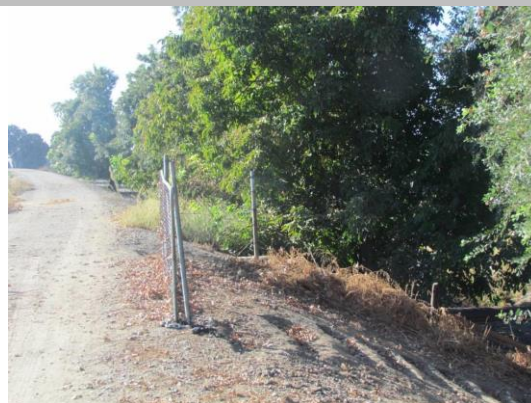
Photo 1 of 1 : SP_2017_RD0544_108_98_20170316_00063.jpg

LM Start	2.26	Rating **	A/W	Issue No.	98
LM End	2.31	Issue Type +	Ma	Location *	LS
Category	Earthen Levee			GPS Latitude/Longitude	
				Start	End
Item	Trim / Thin Trees			37.848021 °	37.847343 °
				-121.324839 °	-121.324672 °
DWR ID	DWR_RD0544_01_f_2014_98				
Comment Code					
T2 : Thin trees to allow visibility of the ground and room to flood fight.					
Inspector Comment					
Untrimmed trees on landward slope.

Looking south at untrimmed trees on landward slope.

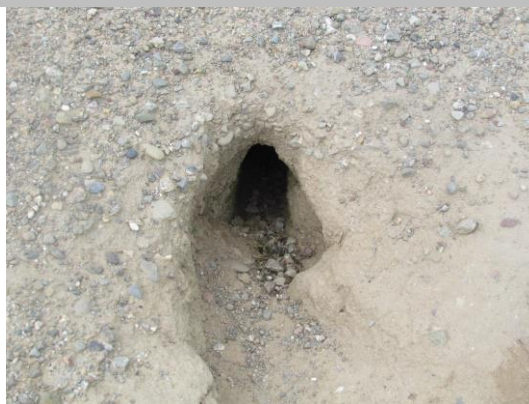
Photo 1 of 3 : SP_2017_RD0544_108_34_20170410_00134.jpg

LM Start	2.32	Rating **	U	Issue No.	34
LM End	2.36	Issue Type +	Ma	Location *	LS
Category	Earthen Levee			GPS Latitude/Longitude	
				Start	End
Item	Animal Control			37.847292 °	37.846743 °
				-121.324662 °	-121.324336 °
DWR ID	DWR_RD0544_01_s_2012_34				
Comment Code					
A1 : Exterminate rodents and backfill and compact or grout burrows.					
Inspector Comment					
Several rodent hole within this reach.

Looking east at large rodent hole on landward slope.

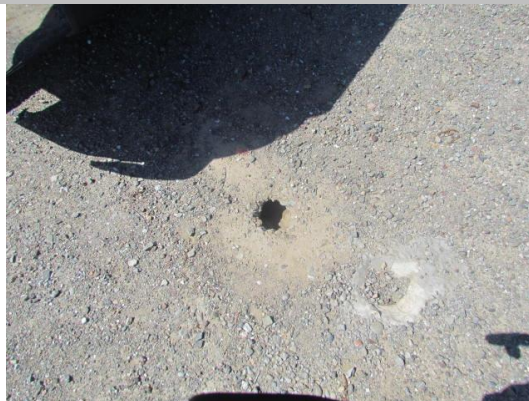
Photo 3 of 3 : SP_2017_RD0544_108_34_20170316_00027.jpg

LM Start	2.32	Rating **	U	Issue No.	34 (cont)	
LM End	2.36	Issue Type +	Ma	Location *	LS	
Category	Earthen Levee			GPS Latitude/Longitude		
				Start		End
Item	Animal Control			37.847292 °		37.846743 °
				-121.324662 °		-121.324336 °
DWR ID	DWR_RD0544_01_s_2012_34					
Comment Code						
A1 : Exterminate rodents and backfill and compact or grout burrows.						
Inspector Comment						
Several rodent hole within this reach.

Looking at rodent hole on levee crown.

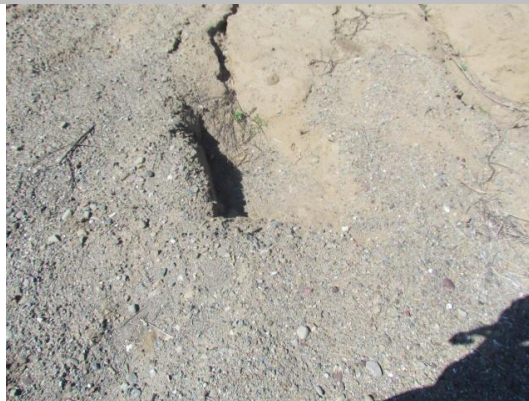
Photo 1 of 2 : SP_2017_RD0544_108_107_20170316_00068.jpg

LM Start	2.95	Rating **	M	Issue No.	107 (cont)
LM End	2.96	Issue Type +	Ma	Location *	LS

Looking south at depression on landward slope.

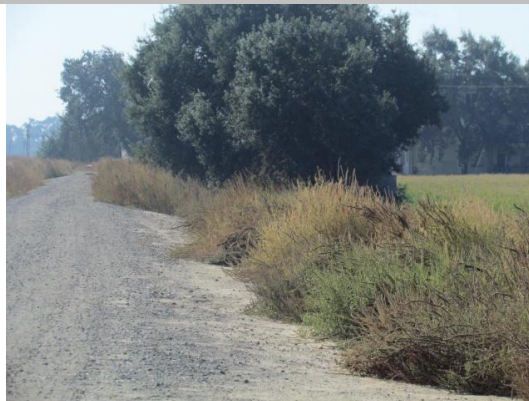
Photo 1 of 1 : SP_2017_RD0544_108_47_20170316_00037.jpg

LM Start	2.95	Rating **	U	Issue No.	47
LM End	3.19	Issue Type +	Ma	Location *	LS
Category	Earthen Levee			GPS Latitude/Longitude	
				Start	End
Item	Vegetation			37.840485 °	37.837225 °
				-121.318390 °	-121.317408 °
DWR ID	DWR_RD0544_01_s_2012_47				
Comment Code					
V2 : Remove the wild growth other than native grasses from the levee slopes.					
Inspector Comment

Looking south at dense veg on landward slope fall 2015.

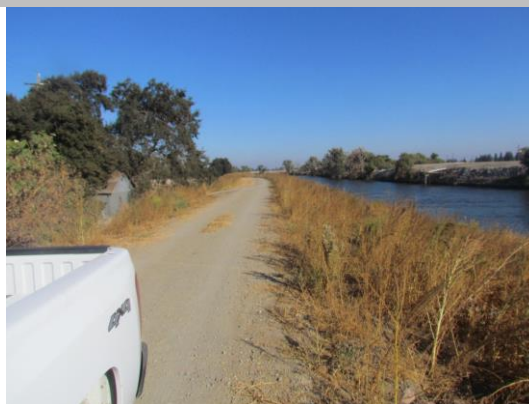
Photo 1 of 1 : SP_2017_RD0544_108_49_20170316_00039.jpg

LM Start	3.22	Rating **	U	Issue No.	49
LM End	3.84	Issue Type +	Ma	Location *	WS
Category	Earthen Levee			GPS Latitude/Longitude	
				Start	End
Item	Vegetation			37.836763 °	37.829195 °
				-121.317307 °	-121.311918 °
DWR ID	DWR_RD0544_01_s_2012_49				
Comment Code					
V2 : Remove the wild growth other than native grasses from the levee slopes.					
Inspector Comment					
Dense vegetation on waterward slope.

Looking northeast at dense veg on waterward slope.

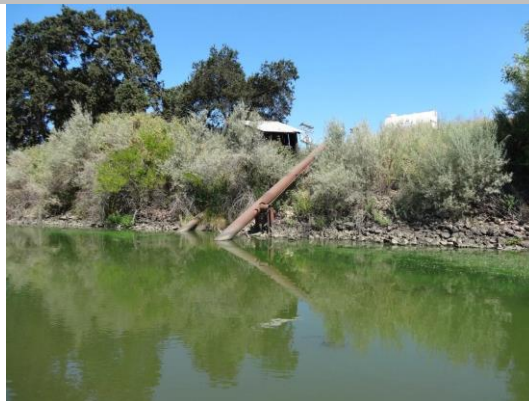
Photo 1 of 2 : SP_2017_RD0544_108_84_20170316_00052.jpg

LM Start	4.23	Rating **	M	Issue No.	84
LM End	4.24	Issue Type +	Ma	Location *	WS
Category	Supplemental			GPS Latitude/Longitude	
				Start	End
Item	DWR Erosion Survey			37.825248 °	37.825248 °
				-121.313856 °	-121.313856 °
DWR ID	DWR_RD0544_01_s_2017_84				
Comment Code					
Inspector Comment					
07/25/2016: No significant change observed.					
06/24/2015: No significant change observed.					
06/19/2014: No significant change observed.					
08/13/2013: The erosion has been caused by irrigation pipe. [2016 Site ID:RD0544U01RM51.04]

Front view of the site.

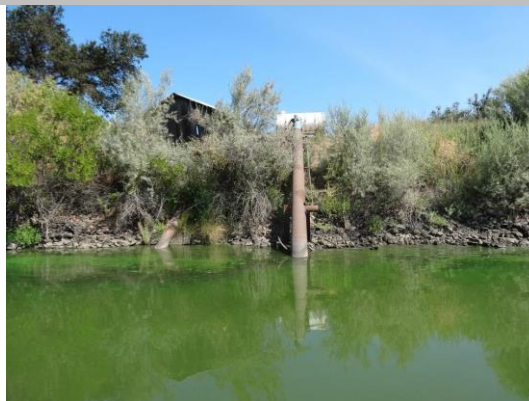
Photo 2 of 2 : SP_2017_RD0544_108_84_20170316_00053.jpg

LM Start	4.23	Rating **	M	Issue No.	84 (cont)
LM End	4.24	Issue Type +	Ma	Location *	WS

Close view of the site.

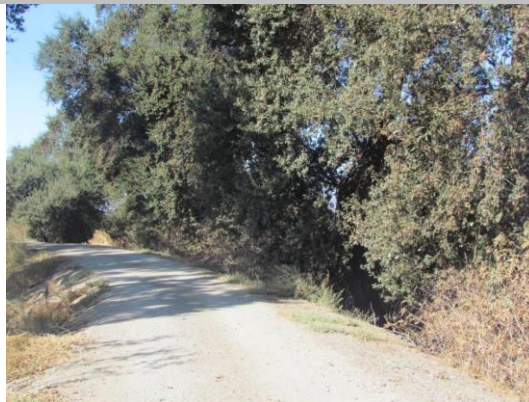
Photo 1 of 1 : SP_2017_RD0544_108_120_20170316_00079.jpg

LM Start	4.25	Rating **	U	Issue No.	120
LM End	4.28	Issue Type +	Ma	Location *	LS
Category	Earthen Levee			GPS Latitude/Longitude	
				Start	End
Item	Trim / Thin Trees			37.825482 °	37.825229 °
				-121.314298 °	-121.314771 °
DWR ID	DWR_RD0544_01_f_2015_120				
Comment Code					
T1 : Trim trees to at least five feet above ground level.					
Inspector Comment					
Several untrimmed trees on landward slope.

Looking southwest at untrimmed trees on landward slope.

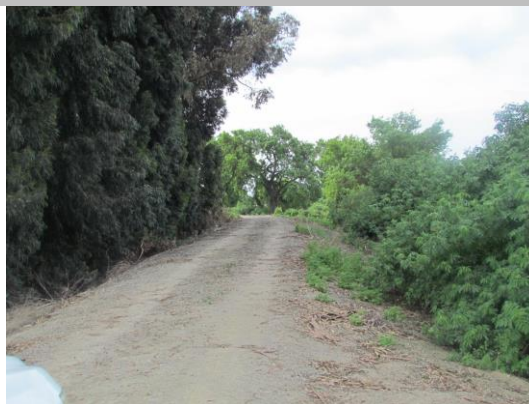
Photo 1 of 1 : SP_2017_RD0544_108_59_20170410_00136.jpg

LM Start	4.30	Rating **	M	Issue No.	59
LM End	4.30	Issue Type +	Ma	Location *	LS
Category	Earthen Levee			GPS Latitude/Longitude	
				Start	End
Item	Vegetation			37.824943 °	37.824943 °
				-121.315008 °	-121.315008 °
DWR ID	DWR_RD0544_01_s_2012_59				
Comment Code					
V4 : Elderberries are blocking visibility and flood fight capability.					
Inspector Comment

Looking south at dense veg on landward and waterward slopes.

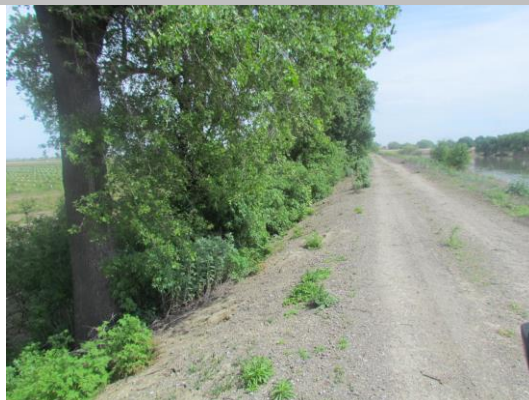
Photo 1 of 1 : SP_2017_RD0544_108_54_20170410_00138.jpg

LM Start	4.37	Rating **	U	Issue No.	54
LM End	6.05	Issue Type +	Ma	Location *	LS
Category	Earthen Levee			GPS Latitude/Longitude	
				Start	End
Item	Vegetation			37.824018 °	37.808766 °
				-121.315247 °	-121.328198 °
DWR ID	DWR_RD0544_01_s_2012_54				
Comment Code					
V2 : Remove the wild growth other than native grasses from the levee slopes.					
Inspector Comment

Looking northwest at dense veg. on landward slope.

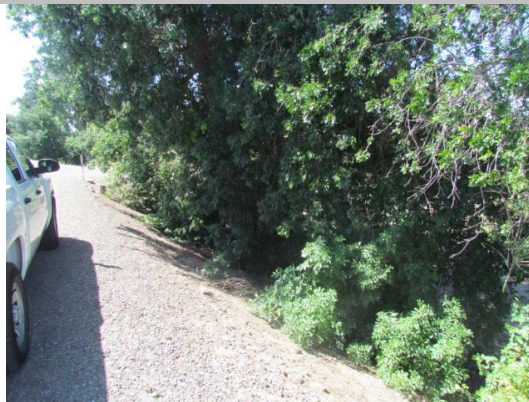
Photo 1 of 1 : SP_2017_RD0544_108_112_20170316_00070.jpg

LM Start	4.77	Rating **	U	Issue No.	112
LM End	4.77	Issue Type +	Ma	Location *	LS
Category	Earthen Levee			GPS Latitude/Longitude	
				Start	End
Item	Trim / Thin Trees			37.820828 °	37.820828 °
				-121.321193 °	-121.321193 °
DWR ID	DWR_RD0544_01_s_2015_112				
Comment Code					
T1 : Trim trees to at least five feet above ground level.					
Inspector Comment

Looking southwest at dense trees on landward slope and toe.

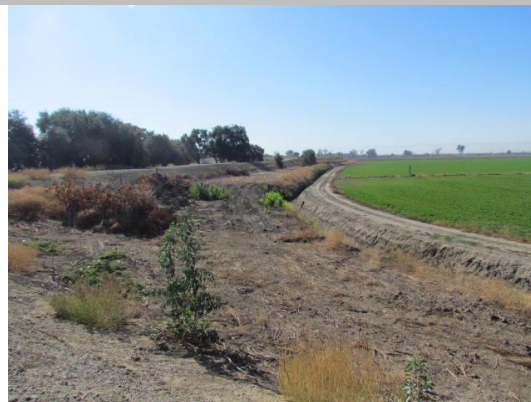
Photo 1 of 2 : SP_2017_RD0544_108_33_20170316_00024.jpg

LM Start	4.95	Rating **	M	Issue No.	33
LM End	5.26	Issue Type +	Ma	Location *	LS
Category	Earthen Levee			GPS Latitude/Longitude	
				Start	End
Item	Vegetation			37.818718 °	37.814662 °
				-121.319508 °	-121.320302 °
DWR ID	DWR_RD0544_01_s_2012_33				
Comment Code					
V2 : Remove the wild growth other than native grasses from the levee slopes.					
Inspector Comment					
Vegetation has been sprayed, and it should be monitored.

Looking southwest at cleared landward slope and berm fall 2015.

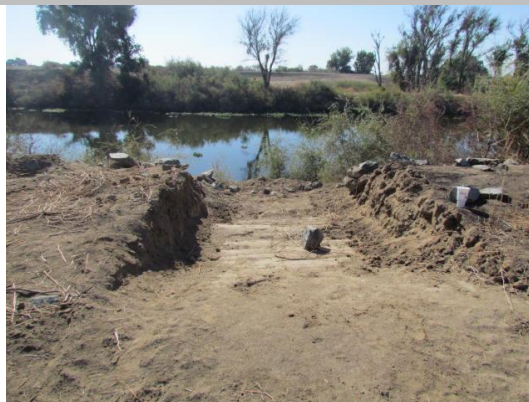
Photo 2 of 4 : SP_2017_RD0544_108_121_20170316_00081.jpg

LM Start	5.60	Rating **	U	Issue No.	121
LM End	5.60	Issue Type +	Ma	Location *	WS
Category	Earthen Levee			GPS Latitude/Longitude	
				Start	End
Item	Erosion / Bank Caving			37.811234 °	37.811234 °
				-121.321412 °	-121.321412 °
DWR ID	DWR_RD0544_01_f_2015_121				
Comment Code					
E2 : Schedule repair of erosion site prior to the next inspection.					
Inspector Comment					
Someone digging/excavating on waterward berm. Excavation in 3ft wide and eighteen inches deep and ten feet long.

Looking east at excavation on waterward berm.

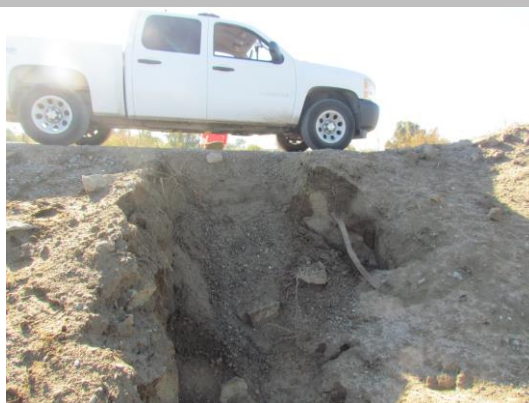
Photo 3 of 3 : SP_2017_RD0544_108_115_20170316_00074.jpg

LM Start	5.72	Rating **	U	Issue No.	115 (cont)	
LM End	5.72	Issue Type +	Ma	Location *	LS	
Category	Earthen Levee			GPS Latitude/Longitude		
				Start	End	
Item	Slope Stability			37.811225 °	37.811225 °	
				-121.323575 °	-121.323575 °	
DWR ID	DWR_RD0544_01_s_2015_115					
Comment Code						
S2 : Repair the levee slope damaged by foot traffic and prevent access where possible.						
Inspector Comment						
Landowner excavated hole above pipe.Large hole left on landward shoulder and slope. Call LMA about repair.

Looking westly at large excavation on landward slope.

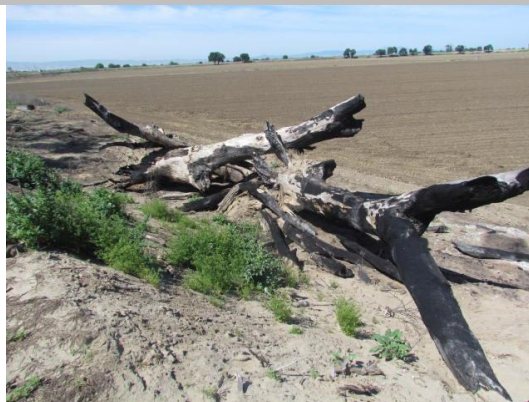
Photo 1 of 2 : SP_2017_RD0544_108_124_20170316_00087.jpg

LM Start	5.82	Rating **	U	Issue No.	124
LM End	5.82	Issue Type +	Ma	Location *	LS
Category	Earthen Levee			GPS Latitude/Longitude	
				Start	End
Item	Encroachments			37.811049 °	37.811049 °
				-121.325451 °	-121.325451 °
DWR ID	DWR_RD0544_01_s_2016_124				
Comment Code					
TR : Tree or limb					
Inspector Comment

Looking east at tree limbs on waterward slope.

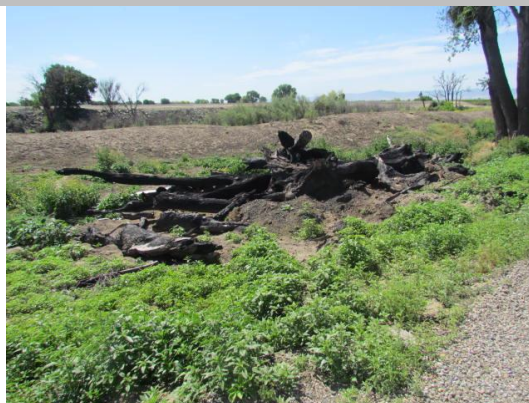
Photo 2 of 2 : SP_2017_RD0544_108_124_20170316_00088.jpg

LM Start	5.82	Rating **	U	Issue No.	124 (cont)	
LM End	5.82	Issue Type +	Ma	Location *	LS	
Category	Earthen Levee			GPS Latitude/Longitude		
				Start		End
Item	Encroachments			37.811049 °		37.811049 °
				-121.325451 °		-121.325451 °
DWR ID	DWR_RD0544_01_s_2016_124					
Comment Code						
TR : Tree or limb						
Inspector Comment

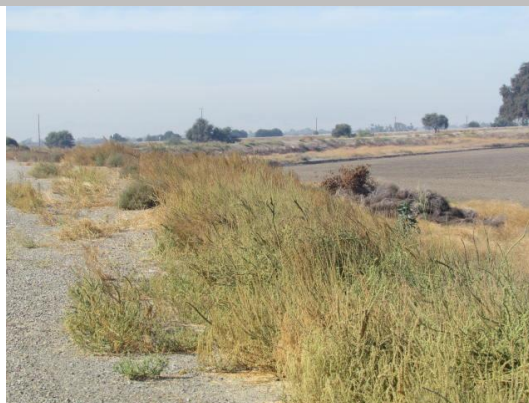
Photo 1 of 2 : SP_2017_RD0544_109_3_20170316_00002.jpg

LM Start	0.03	Rating **	M	Issue No.	3
LM End	0.17	Issue Type +	Ma	Location *	LS
Category	Earthen Levee			GPS Latitude/Longitude	
				Start	End
Item	Vegetation			37.808603 °	37.808213 °
				-121.328719 °	-121.331241 °
DWR ID	DWR_RD0544_02_s_2012_3				
Comment Code					
V2 : Remove the wild growth other than native grasses from the levee slopes.					
Inspector Comment

Looking south at dense veg on landward slope and toe fall 2015.

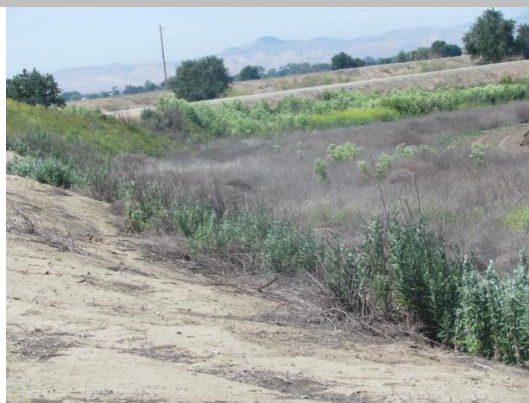
Photo 2 of 2 : SP_2017_RD0544_109_3_20170316_00003.jpg

Looking south at dense vegetation at landward toe spring 2014.

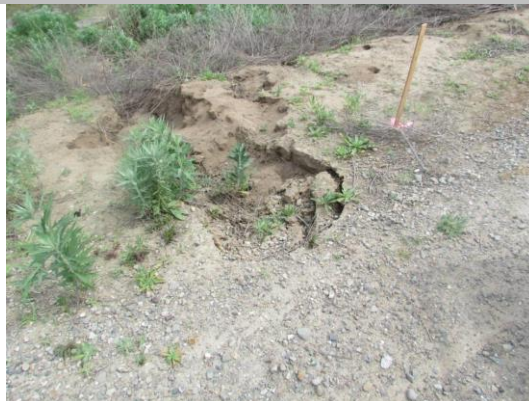
Photo 1 of 1 : SP_2017_RD0544_109_71_20170410_00088.jpg

LM Start	0.44	Rating **	U	Issue No.	71
LM End	0.44	Issue Type +	Ma	Location *	LS
Category	Earthen Levee			GPS Latitude/Longitude	
				Start	End
Item	Erosion / Bank Caving			37.810388 °	37.810388 °
				-121.334977 °	-121.334977 °
DWR ID	DWR_RD0544_02_s_2017_71				
Comment Code					
Inspector Comment					
Landside erosion due to runoff.

Looking northwest at runoff erosion on landward shoulder and slope.

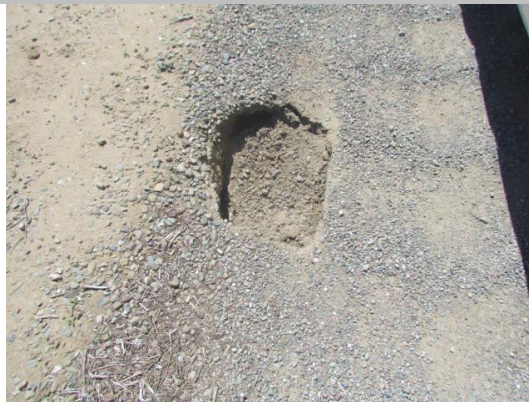
Photo 1 of 1 : SP_2017_RD0544_109_46_20170316_00037.jpg

LM Start	0.64	Rating **	U	Issue No.	46
LM End	0.64	Issue Type +	Ma	Location *	LS
Category	Earthen Levee			GPS Latitude/Longitude	
				Start	End
Item	Erosion / Bank Caving			37.813197 °	37.813197 °
				-121.335055 °	-121.335055 °
DWR ID	DWR_RD0544_02_s_2015_46				
Comment Code					
E1 : Note and monitor erosion site.					
Inspector Comment					
Depression greater than one inch deep and greater that three inches on landward shoulder

Looking at depression on landward shoulder.

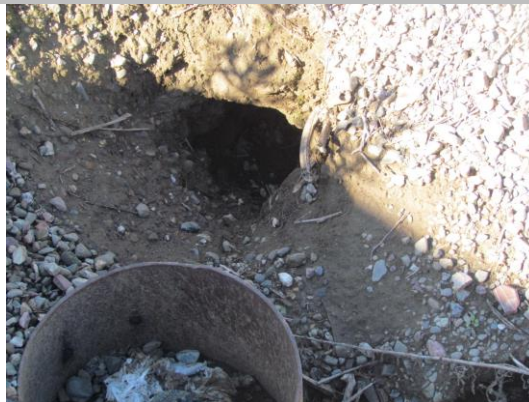
Photo 1 of 6 : SP_2017_RD0544_109_8_20170316_00007.jpg

Looking at hole next to siphon on waterward shoulder. (Fall 2016)

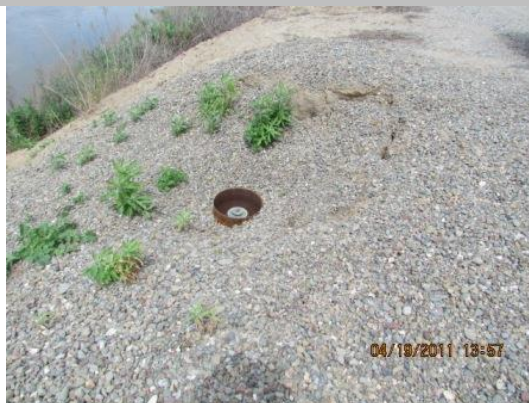
Photo 3 of 6 : SP_2017_RD0544_109_8_20170316_00009.jpg

Looking south at depression greater than 6" on waterside shoulder.

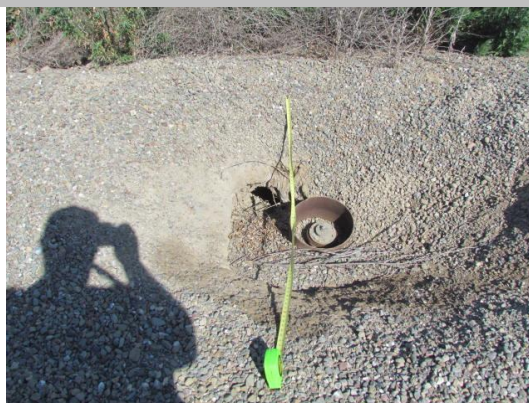
Photo 4 of 6 : SP_2017_RD0544_109_8_20170316_00010.jpg

Looking east at caving around siphon on waterside shoulder. (Spring 2012)

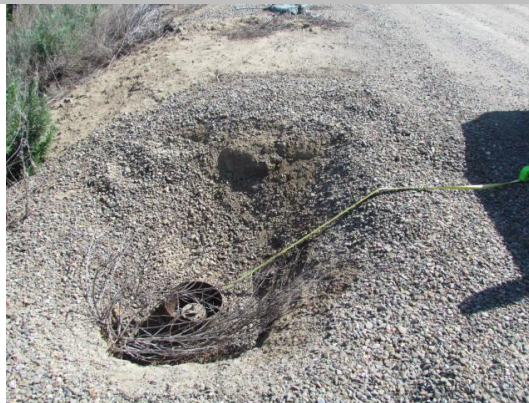
Photo 6 of 6 : SP_2017_RD0544_109_8_20170316_00012.jpg

LM Start	0.78	Rating **	U	Issue No.	8 (cont)	
LM End	0.78	Issue Type +	Ma	Location *	WS	
Category	Interior Drainage & Piping Systems			GPS Latitude/Longitude		
				Start		End
Item	Erosion Areas			37.815094 °		37.815094 °
				-121.333927 °		-121.333927 °
DWR ID	DWR_RD0544_02_s_2012_8					
Comment Code						
Inspector Comment						
Caving under and around siphon on waterside shoulder. No material 3' below pipe. Caving around siphon is 20" to 24" deep approximately 72" in diameter. During 2012 spring inspection hole appears to be enlarging.

Looking south at caving around siphon on waterside shoulder. (Spring 2012)

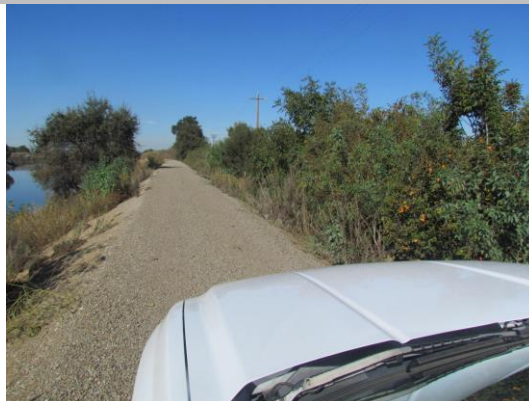
Photo 1 of 2 : SP_2017_RD0544_109_49_20170316_00038.jpg

LM Start	1.30	Rating **	U	Issue No.	49
LM End	1.40	Issue Type +	Ma	Location *	WS
Category	Earthen Levee			GPS Latitude/Longitude	
				Start	End
Item	Vegetation			37.820767 °	37.821582 °
				-121.336611 °	-121.338102 °
DWR ID	DWR_RD0544_02_f_2014_49				
Comment Code					
V2 : Remove the wild growth other than native grasses from the levee slopes.					
Inspector Comment					
Tobacco plants on waterward slope.

Looking southwest at dense veg on landward slope. (Fall 2016)

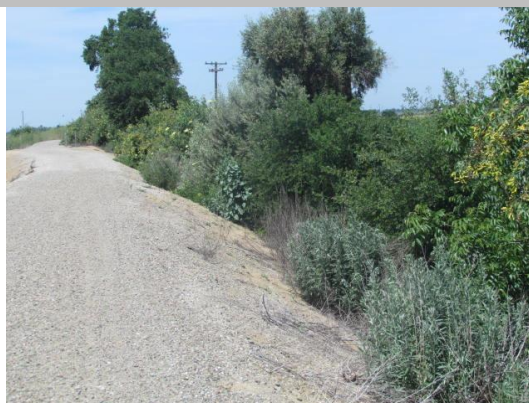
Photo 2 of 2 : SP_2017_RD0544_109_49_20170316_00039.jpg

Looking southwest at dense vegetation on landward slope and toe.

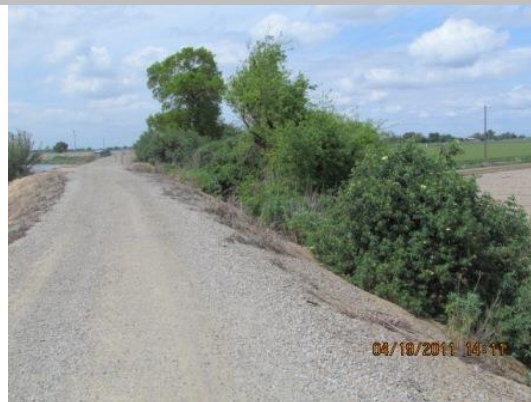
Photo 1 of 2 : SP_2017_RD0544_109_10_20170316_00015.jpg

LM Start	1.38	Rating **	U	Issue No.	10	
LM End	1.38	Issue Type +	Ma	Location *	LS	
Category	Earthen Levee			GPS Latitude/Longitude		
				Start		End
Item	Vegetation			37.821423 °		37.821423 °
				-121.337878 °		-121.337878 °
DWR ID	DWR_RD0544_02_s_2012_10					
Comment Code						
V4 : Elderberries are blocking visibility and flood fight capability.						
Inspector Comment						
Dense elderberry on landward slope and toe.

Looking southwest at elderberries on landside slope.

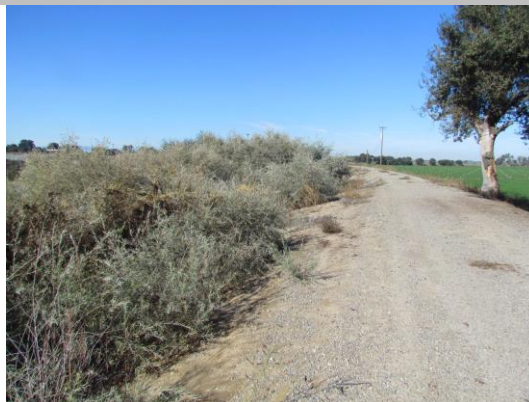
Photo 1 of 1 : SP_2017_RD0544_109_66_20170316_00051.jpg

LM Start	1.44	Rating **	U	Issue No.	66
LM End	1.46	Issue Type +	Ma	Location *	WS
Category	Earthen Levee			GPS Latitude/Longitude	
				Start	End
Item	Vegetation			37.821907 °	37.822098 °
				-121.338725 °	-121.338985 °
DWR ID	DWR_RD0544_02_f_2016_66				
Comment Code					
V2 : Remove the wild growth other than native grasses from the levee slopes.					
Inspector Comment					
Dense willows on waterward slope.

Looking southeast at dense veg on waterward slope.

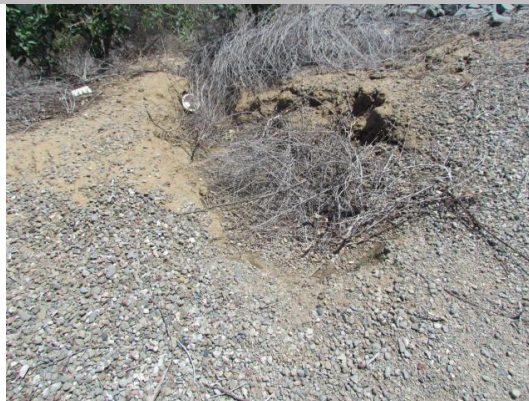
Photo 1 of 2 : SP_2017_RD0544_109_38_20170316_00034.jpg

LM Start	1.86	Rating **	U	Issue No.	38
LM End	1.86	Issue Type +	Ma	Location *	WS
Category	Earthen Levee			GPS Latitude/Longitude	
				Start	End
Item	Erosion / Bank Caving			37.817983 °	37.817983 °
				-121.341682 °	-121.341682 °
DWR ID	DWR_RD0544_02_s_2015_38				
Comment Code					
E1 : Note and monitor erosion site.					
Inspector Comment					
Erosion/Caving on waterward shoulder and slope 18" x 6" x 15'.

Looking southeast at erosion/caving on waterward slope.

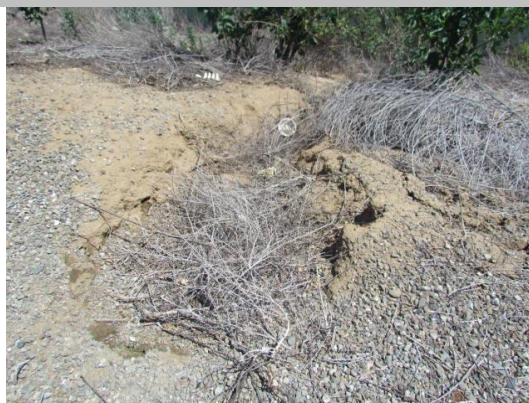
Photo 2 of 2 : SP_2017_RD0544_109_38_20170316_00035.jpg

Looking east at erosion/caving on waterward slope.

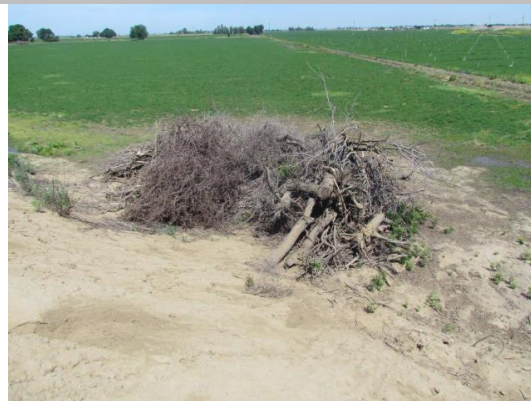
Photo 1 of 1 : SP_2017_RD0544_109_57_20170316_00045.jpg

LM Start	2.02	Rating **	A/W	Issue No.	57
LM End	2.02	Issue Type +	Ma	Location *	LS
Category	Earthen Levee			GPS Latitude/Longitude	
				Start	End
Item	Encroachments			37.818853 °	37.818853 °
				-121.343473 °	-121.343473 °
DWR ID	DWR_RD0544_02_s_2015_57				
Comment Code					
PR : Prunings					
Inspector Comment					
Large pruning pile at landward toe.

Looking west at pruning pile at landward toe.(Spring 2015)

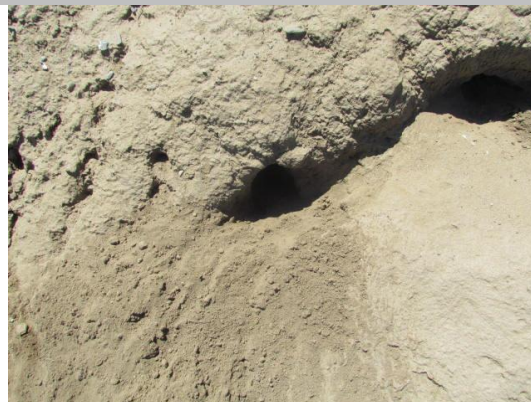
Photo 1 of 1 : SP_2017_RD0544_109_58_20170316_00046.jpg

LM Start	2.02	Rating **	U	Issue No.	58
LM End	2.09	Issue Type +	Ma	Location *	LS
Category	Earthen Levee			GPS Latitude/Longitude	
				Start	End
Item	Animal Control			37.818853 °	37.819493 °
				-121.343473 °	-121.344545 °
DWR ID	DWR_RD0544_02_s_2015_58				
Comment Code					
A1 : Exterminate rodents and backfill and compact or grout burrows.					
Inspector Comment					
Several rodent holes within reach on landward slope.

Looking at typical rodent holes on landward slope.

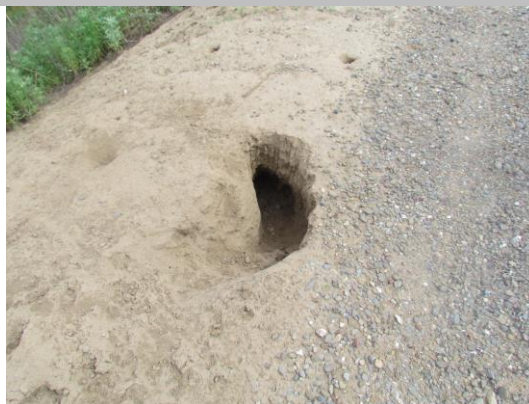
Photo 1 of 1 : SP_2017_RD0544_109_73_20170410_00092.jpg

LM Start	2.02	Rating **	U	Issue No.	73
LM End	2.02	Issue Type +	Ma	Location *	LS
Category	Earthen Levee			GPS Latitude/Longitude	
				Start	End
Item	Animal Control			37.818833 °	37.818833 °
				-121.343547 °	-121.343547 °
DWR ID	DWR_RD0544_02_s_2017_73				
Comment Code					
A3 : No rodents visible, but rodent burrows visible; need to backfill and compact or grout burrows.					
Inspector Comment

Looking west at large rodent hole on landward shoulder and slope.

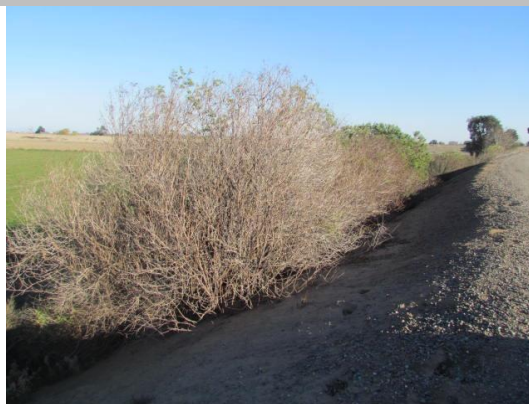
Photo 1 of 1 : SP_2017_RD0544_109_13_20170316_00019.jpg

LM Start	2.07	Rating **	M	Issue No.	13	
LM End	2.09	Issue Type +	Ma	Location *	LS	
Category	Earthen Levee			GPS Latitude/Longitude		
				Start		End
Item	Vegetation			37.819337 °		37.819460 °
				-121.344275 °		-121.344492 °
DWR ID	DWR_RD0544_02_s_2012_13					
Comment Code						
V4 : Elderberries are blocking visibility and flood fight capability.						
Inspector Comment

Looking northwest at elderberries on landside slope and toe.

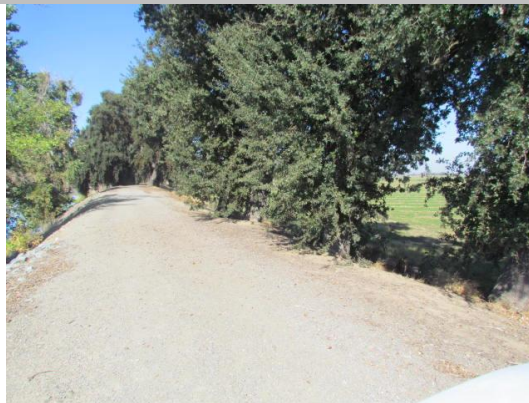
Photo 1 of 1 : SP_2017_RD0544_109_59_20170316_00047.jpg

LM Start	2.12	Rating **	U	Issue No.	59
LM End	2.12	Issue Type +	Ma	Location *	LS
Category	Earthen Levee			GPS Latitude/Longitude	
				Start	End
Item	Trim / Thin Trees			37.819738 °	37.819738 °
				-121.344922 °	-121.344922 °
DWR ID	DWR_RD0544_02_s_2015_59				
Comment Code					
T1 : Trim trees to at least five feet above ground level.					
Inspector Comment					
Untrimmed trees on landward shoulder and slope.

Looking southwest at untrimmed trees on landward slope and toe fall 2015.

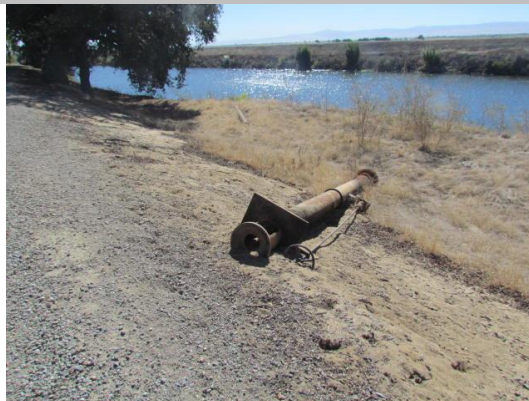
Photo 1 of 1 : SP_2017_RD0544_109_50_20170316_00040.jpg

LM Start	2.21	Rating **	M	Issue No.	50
LM End	2.21	Issue Type +	Ma	Location *	WS
Category	Earthen Levee			GPS Latitude/Longitude	
				Start	End
Item	Encroachments			37.820646 °	37.820646 °
				-121.346014 °	-121.346014 °
DWR ID	DWR_RD0544_02_f_2014_50				
Comment Code					
GA : Garbage					
Inspector Comment					
Discarded intake pipe on waterward slope.

Looking northwest at pipe on waterward slope.

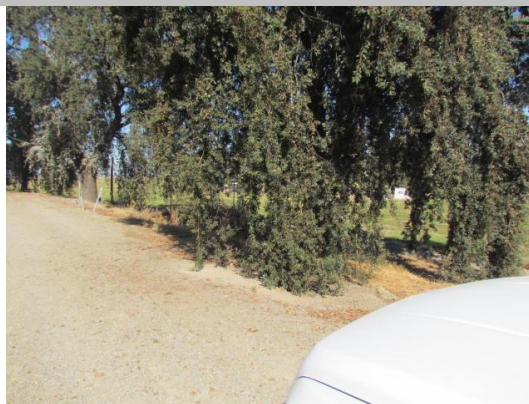
Photo 1 of 1 : SP_2017_RD0544_109_61_20170316_00048.jpg

LM Start	2.28	Rating **	U	Issue No.	61
LM End	2.28	Issue Type +	Ma	Location *	LS
Category	Earthen Levee			GPS Latitude/Longitude	
				Start	End
Item	Trim / Thin Trees			37.821473 °	37.821473 °
				-121.346860 °	-121.346860 °
DWR ID	DWR_RD0544_02_s_2015_61				
Comment Code					
T1 : Trim trees to at least five feet above ground level.					
Inspector Comment					
Untrimmed tree on landward shoulder.

Looking west at untrimmed trees on landward slope fall 2015.

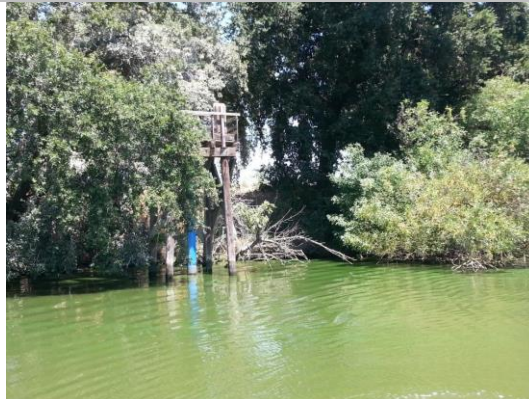
Photo 2 of 2 : SP_2017_RD0544_109_12_20170316_00018.jpg

LM Start	2.31	Rating **	M	Issue No.	12 (cont)
LM End	2.31	Issue Type +	Ma	Location *	WS
Category	Supplemental			GPS Latitude/Longitude	
				Start	End
Item	DWR Erosion Survey			37.821763 °	37.821763 °
				-121.347275 °	-121.347275 °
DWR ID	DWR_RD0544_02_s_2017_12				
Comment Code					
Inspector Comment					
07/25/2016: No significant change observed. 06/25/2015: No significant change observed. 07/02/2014: No significant change observed. 08/20/2013: No significant change observed. 08/07/2012: The site was first reported in 2012 spring levee inspection report. The data were estimated as the site is underneath a irrigation pump station and inaccessible by boat or land survey. It's possible the pump station played a role in the erosion. [2016 Site ID:RD0544U02RM33.21]

Close view of the site.

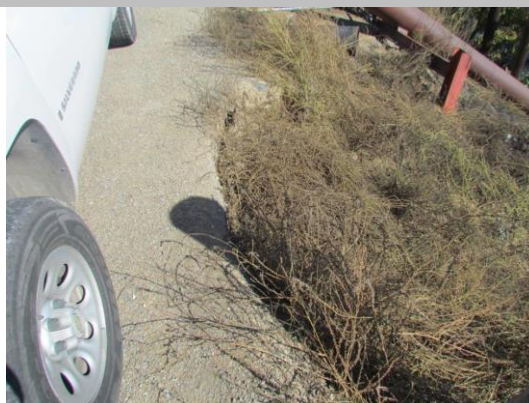
Photo 2 of 3 : SP_2017_RD0544_109_69_20170316_00056.jpg

LM Start	2.61	Rating **	U	Issue No.	69
LM End	2.61	Issue Type +	Ma	Location *	WS
Category	Earthen Levee			GPS Latitude/Longitude	
				Start	End
Item	Erosion / Bank Caving			37.818806 °	37.818806 °
				-121.350437 °	-121.350437 °
DWR ID	DWR_RD0544_02_f_2016_69				
Comment Code					
E2 : Schedule repair of erosion site prior to the next inspection.					
Inspector Comment					
Erosion greater than 1' deep and greater than 3' wide.

Looking north at erosion on waterward shoulder and slope.

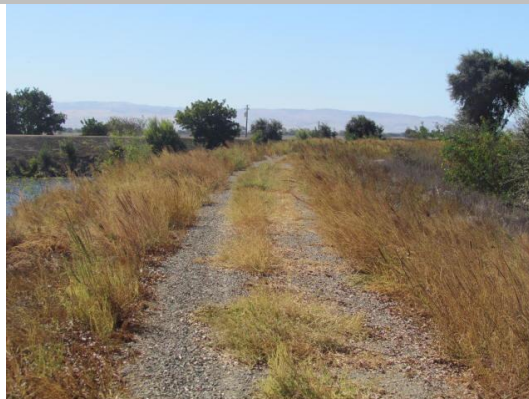
Photo 1 of 1 : SP_2017_RD0544_109_52_20170316_00042.jpg

LM Start	2.69	Rating **	M	Issue No.	52
LM End	3.20	Issue Type +	Ma	Location *	CR
Category	Earthen Levee			GPS Latitude/Longitude	
				Start	End
Item	Vegetation			37.817928 °	37.818824 °
				-121.351355 °	-121.359523 °
DWR ID	DWR_RD0544_02_f_2014_52				
Comment Code					
V2 : Remove the wild growth other than native grasses from the levee slopes.					
Inspector Comment					
LMA placed new gravel on crown. Some minor areas of vegetation still exist on crown.

Looking south at vegetation on levee crown.

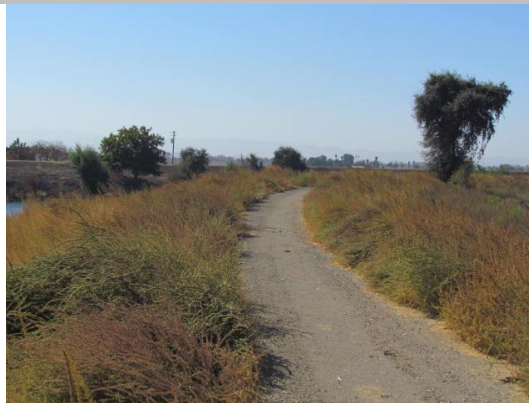
Photo 1 of 1 : SP_2017_RD0544_109_43_20170316_00036.jpg

LM Start	2.71	Rating **	U	Issue No.	43
LM End	3.05	Issue Type +	Ma	Location *	LS
Category	Earthen Levee			GPS Latitude/Longitude	
				Start	End
Item	Vegetation			37.817747 °	37.817497 °
				-121.351578 °	-121.357490 °
DWR ID	DWR_RD0544_02_s_2012_43				
Comment Code					
V2 : Remove the wild growth other than native grasses from the levee slopes.					
Inspector Comment

Looking at dense vegetation on landward and waterward slope.

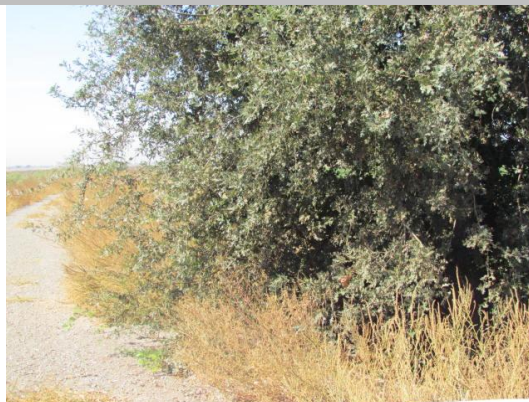
Photo 1 of 1 : SP_2017_RD0544_109_53_20170316_00043.jpg

LM Start	2.80	Rating **	U	Issue No.	53
LM End	2.80	Issue Type +	Ma	Location *	LS
Category	Earthen Levee			GPS Latitude/Longitude	
				Start	End
Item	Trim / Thin Trees			37.817187 °	37.817187 °
				-121.352964 °	-121.352964 °
DWR ID	DWR_RD0544_02_f_2014_53				
Comment Code					
T2 : Thin trees to allow visibility of the ground and room to flood fight.					
Inspector Comment

Looking southwest at untrimmed tree on landward slope fall 2015.

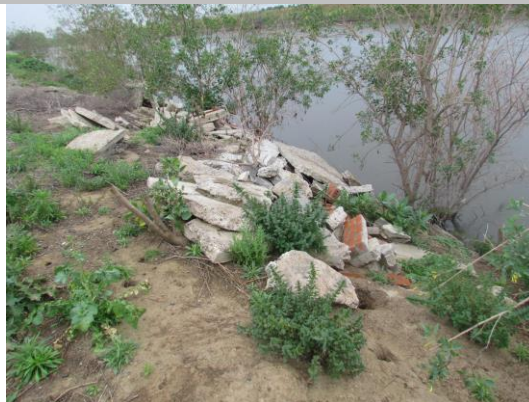
Photo 1 of 1 : SP_2017_RD0544_109_77_20170410_00093.jpg

LM Start	3.10	Rating **	U	Issue No.	77
LM End	3.10	Issue Type +	Ma	Location *	WS
Category	Earthen Levee			GPS Latitude/Longitude	
				Start	End
Item	Erosion / Bank Caving			37.817588 °	37.817588 °
				-121.358352 °	-121.358352 °
DWR ID	DWR_RD0544_02_s_2017_77				
Comment Code					
E1 : Note and monitor erosion site.					
Inspector Comment					
Rip rap was placed but does not meet Title 23 standards.

Looking northeast at concrete rubble on waterward slope.

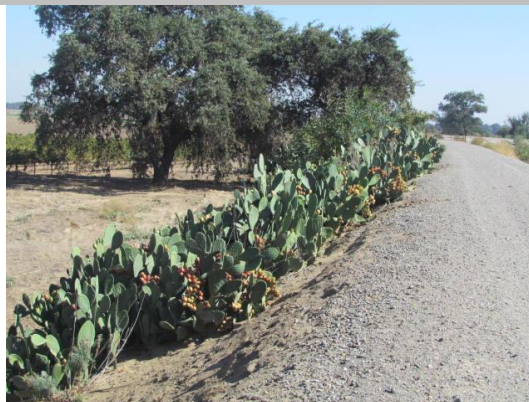
Photo 1 of 3 : SP_2017_RD0544_109_36_20170316_00031.jpg

LM Start	3.48	Rating **	U	Issue No.	36
LM End	3.51	Issue Type +	Ma	Location *	LS
Category	Earthen Levee			GPS Latitude/Longitude	
				Start	End
Item	Vegetation			37.819576 °	37.819530 °
				-121.364056 °	-121.364653 °
DWR ID	DWR_RD0544_02_s_2012_36				
Comment Code					
V2 : Remove the wild growth other than native grasses from the levee slopes.					
Inspector Comment					
Cactus on landside slope.

Looking northwest at cactus on landward slope and toe fall 2015

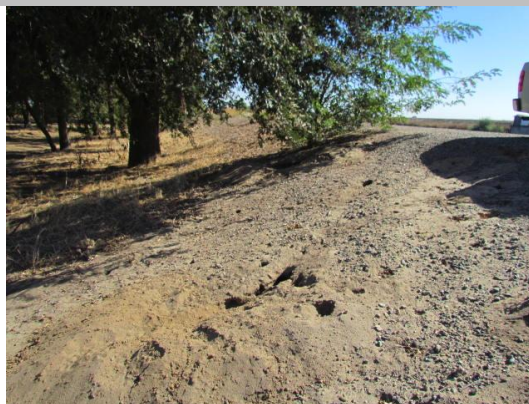
Photo 1 of 2 : SP_2017_RD0544_109_67_20170316_00052.jpg

LM Start	3.58	Rating **	U	Issue No.	67
LM End	3.58	Issue Type +	Ma	Location *	LS
Category	Earthen Levee			GPS Latitude/Longitude	
				Start	End
Item	Animal Control			37.819419 °	37.819419 °
				-121.365854 °	-121.365854 °
DWR ID	DWR_RD0544_02_f_2015_67				
Comment Code					
A1 : Exterminate rodents and backfill and compact or grout burrows.					
Inspector Comment					
Large rodent holes on landward slope.

Looking northeast at typical view of rodent holes on landward slope.

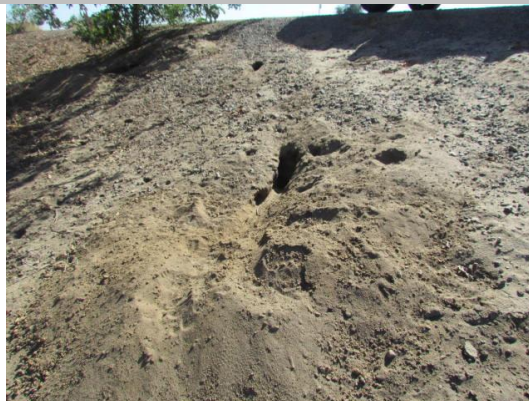
Photo 2 of 2 : SP_2017_RD0544_109_67_20170316_00053.jpg

LM Start	3.58	Rating **	U	Issue No.	67 (cont)	
LM End	3.58	Issue Type +	Ma	Location *	LS	
Category	Earthen Levee			GPS Latitude/Longitude		
				Start		End
Item	Animal Control			37.819419 °		37.819419 °
				-121.365854 °		-121.365854 °
DWR ID	DWR_RD0544_02_f_2015_67					
Comment Code						
A1 : Exterminate rodents and backfill and compact or grout burrows.						
Inspector Comment						
Large rodent holes on landward slope.

Looking north at typical view of rodent holes on landward slope.
