**Flood Control Project Maintenance
Levee Inspections**

Maintenance Issue Types Only, Levee Inspection Report By Mile - Spring 2018

Reclamation District No. 0544 Upper Roberts Island

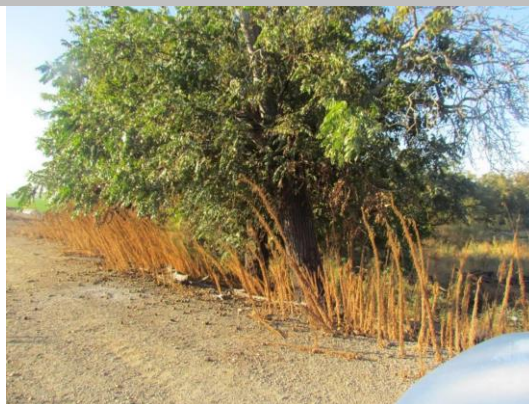
Photo 1 of 1 : SP_2018_RD0544_108_92_20180323_00068.jpg

| Untrimmed tree on landside slope. | | | | | |

Looking southwest at untrimmed tree on landward slope.

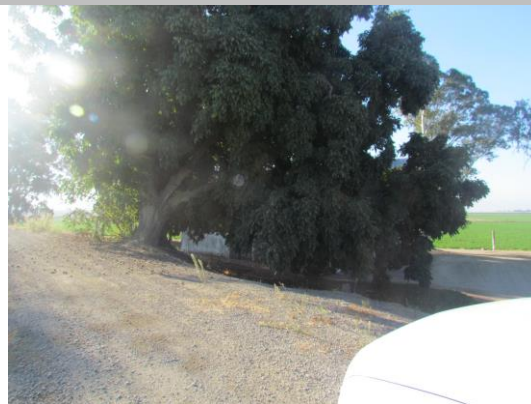
Photo 1 of 1 : SP_2018_RD0544_108_2_20180323_00002.jpg

| Large untrimmed tree on landside slope. | | | | | |

Looking southwest at untrimmed tree on landward slope.

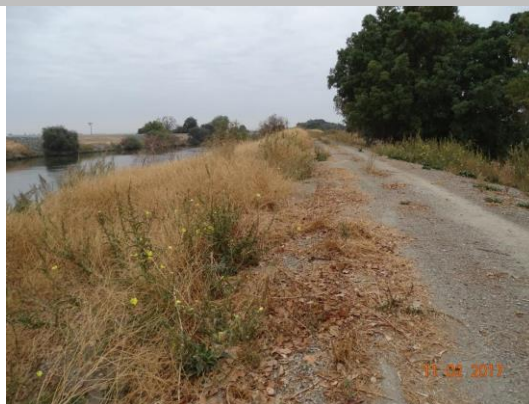
Photo 1 of 2 : SP_2018_RD0544_108_3_20180323_00003.jpg

| Dense vegetation on waterside and landside slopes. | | | | | |

Looking southeast at the waterside slope.

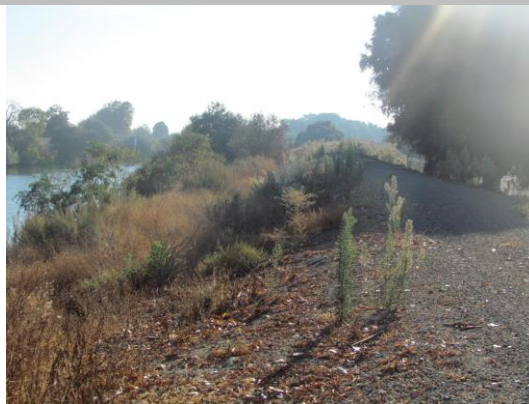
Photo 2 of 2 : SP_2018_RD0544_108_3_20180323_00004.jpg

Looking south at dense veg on waterward slope.

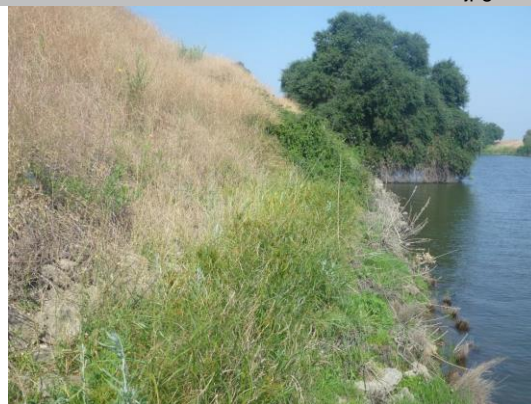
Photo 1 of 3 : LEVAL_SP_2018_571_4478.jpg

| Description:Slope protection repairs are needed along the waterside slope due to erosion and riprap displacement from high water. Based upon levee inspections, it was determined the waterside levee slope is eroding, deteriorating, and degrading. The eroded levee sections need to be restored back to design standards to prevent further deterioration and damage. | | | | | |
| Repair Type: Erosion | | | | | |

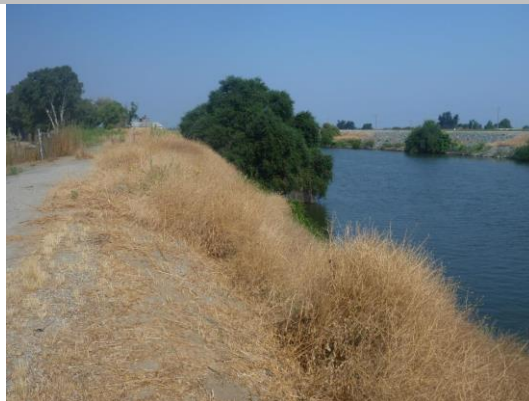
Photo 3 of 3 : LEVAL_SP_2018_571_4487.jpg

| <p>Levee Evaluation Comments</p> <p>Description: Slope protection repairs are needed along the waterside slope due to erosion and riprap displacement from high water. Based upon levee inspections, it was determined the waterside levee slope is eroding, deteriorating, and degrading. The eroded levee sections need to be restored back to design standards to prevent further deterioration and damage.</p> <p>Site ID No: 571</p> <p>Site Designation: LMA-477</p> <p>Repair Type: Erosion</p> <p>Rating: Area of Concern</p> <p>Field Date: 8/10/2017</p> <p>Notes:</p> | | | | | |

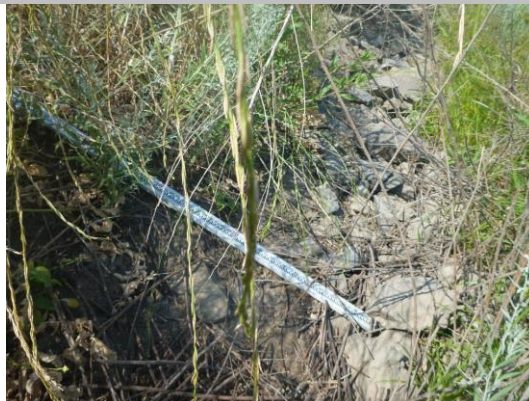
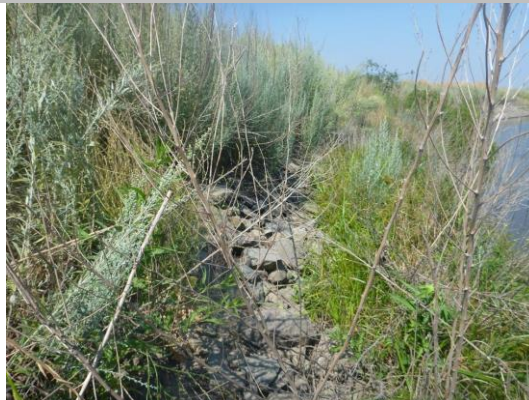
| Description:Slope protection repairs are needed along the waterside slope due to erosion and riprap displacement from high water. Based upon levee inspections, it was determined the waterside levee slope is eroding, deteriorating, and degrading. The eroded levee sections need to be restored back to design standards to prevent further deterioration and damage. | | | | | |
| Repair Type: Erosion | | | | | |

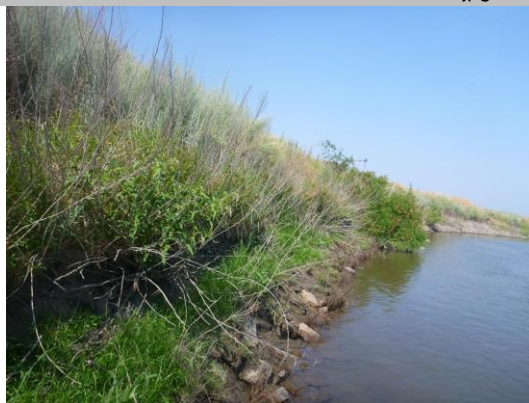
Photo 3 of 3 : LEVAL_SP_2018_570_4602.jpg

| Description:Slope protection repairs are needed along the waterside slope due to erosion and riprap displacement from high water. Based upon levee inspections, it was determined the waterside levee slope is eroding, deteriorating, and degrading. The eroded levee sections need to be restored back to design standards to prevent further deterioration and damage. | | | | | |
| Repair Type: Erosion | | | | | |

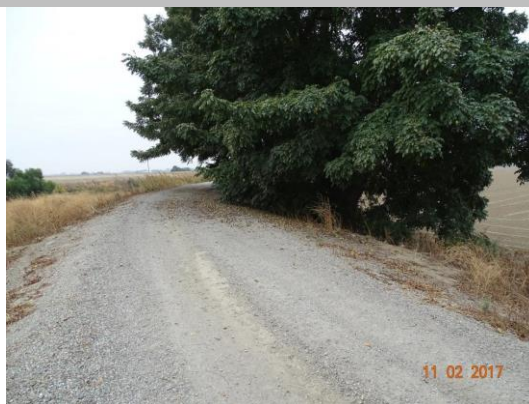
Photo 1 of 2 : SP_2018_RD0544_108_39_20180323_00033.jpg

| Untrimmed trees on landside slope. | | | | | |

Looking southwest at landside slope.

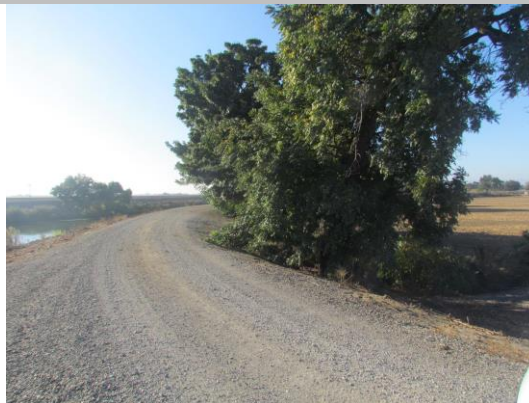
Photo 2 of 2 : SP_2018_RD0544_108_39_20180323_00034.jpg

| Untrimmed trees on landside slope. | | | | | | |

Looking southwest at untrimmed tree on landward slope.

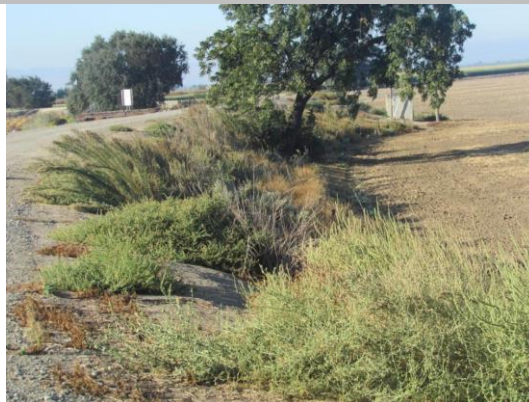
Photo 1 of 1 : SP_2018_RD0544_108_89_20180323_00065.jpg

Looking southwest at dense veg on landward slope and toe.

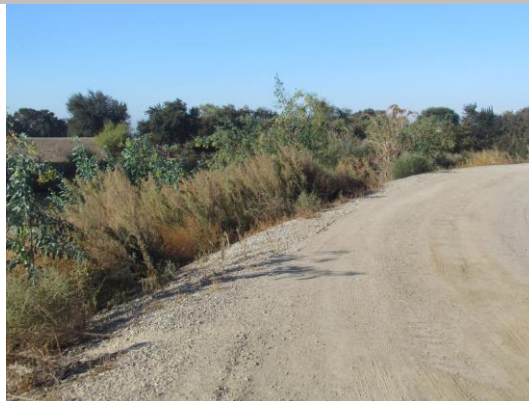
Photo 1 of 1 : SP_2018_RD0544_108_43_20180323_00036.jpg

| Dense vegetation waterside slope. | | | | | |

Looking east at dense veg on waterward slope.

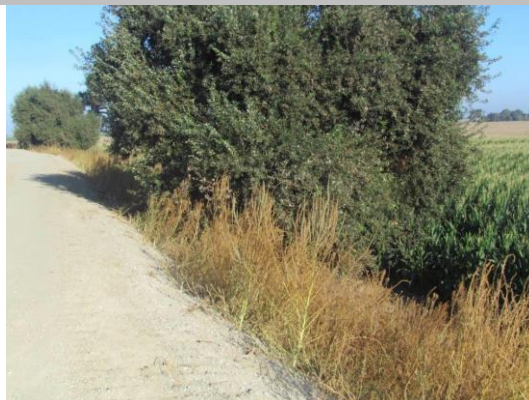
Photo 1 of 1 : SP_2018_RD0544_108_95_20180323_00071.jpg

| Untrimmed tree on landside slope. | | | | | |

Looking southwest at untrimmed tree on landward slope.

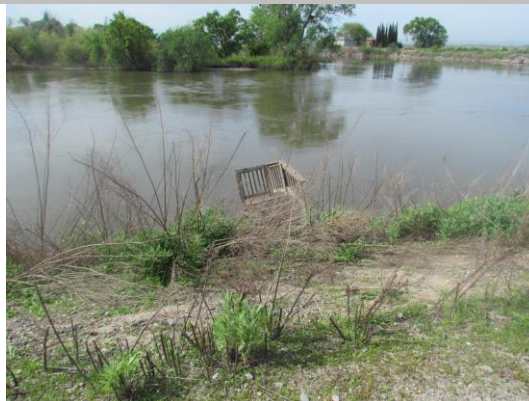
Photo 1 of 1 : SP_2018_RD0544_108_79_20180323_00057.jpg

Looking southeast at abandoned wooden boat dock stairs on waterward slope.

| Remove abandoned stairs to boat dock. | | | | | |

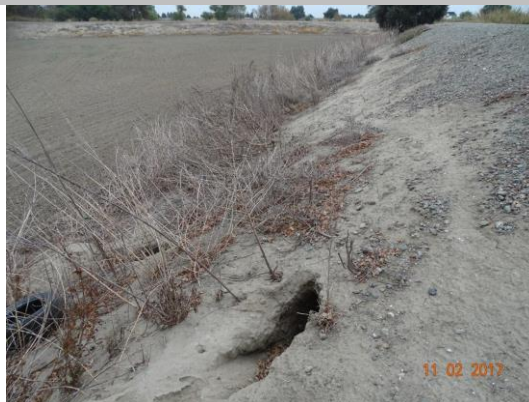
Photo 1 of 1 : SP_2018_RD0544_108_146_20180323_00136.jpg

| Large rodent hole on landside slope. | | | | | |

Looking east at the landside slope.

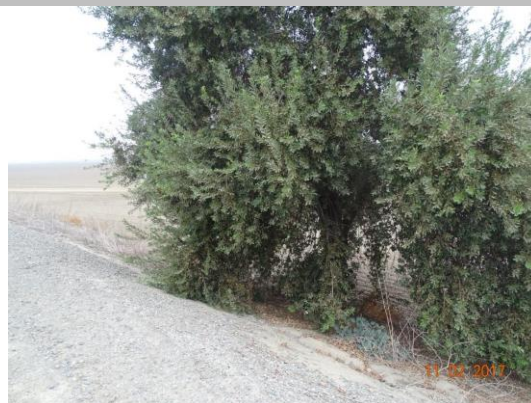
Photo 1 of 1 : SP_2018_RD0544_108_145_20180323_00135.jpg

Looking northwest at the landside slope.

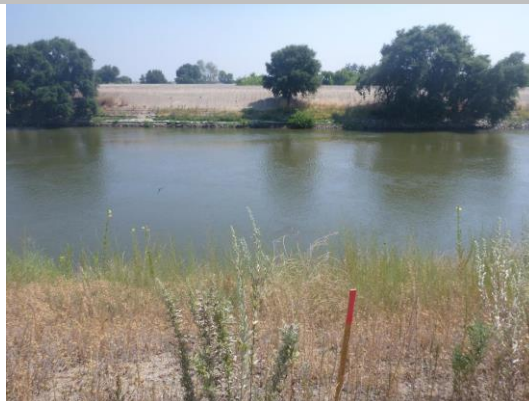
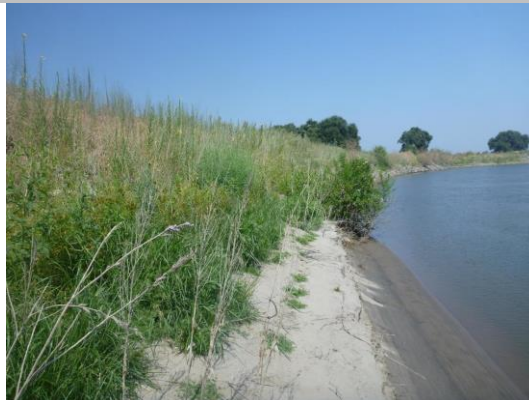
| Description:Slope protection repairs are needed along the waterside slope due to erosion and riprap displacement from high water. Based upon levee inspections, it was determined the waterside levee slope is eroding, deteriorating, and degrading. The eroded levee sections need to be restored back to design standards to prevent further deterioration and damage. | | | | | |
| Repair Type: Erosion | | | | | |

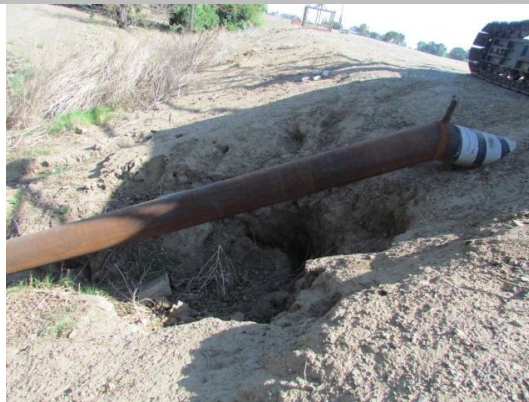
Photo 2 of 3 : SP_2018_RD0544_108_23_20180323_00025.jpg

Looking north at erosion under irrigation pipe on landside slope.

| E2 : Schedule repair of erosion site prior to the next inspection. | | | | | |

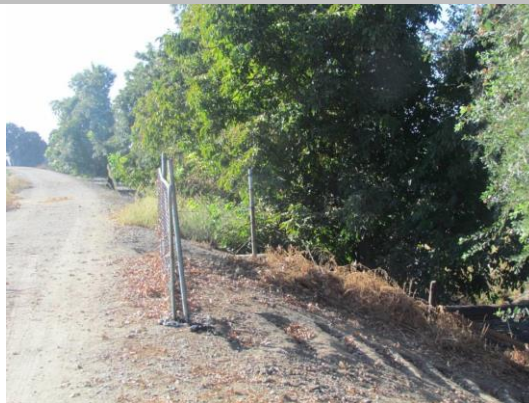
Photo 1 of 1 : SP_2018_RD0544_108_98_20180323_00073.jpg

| Untrimmed trees on landside slope. | | | | | |

Looking south at untrimmed trees on landward slope.

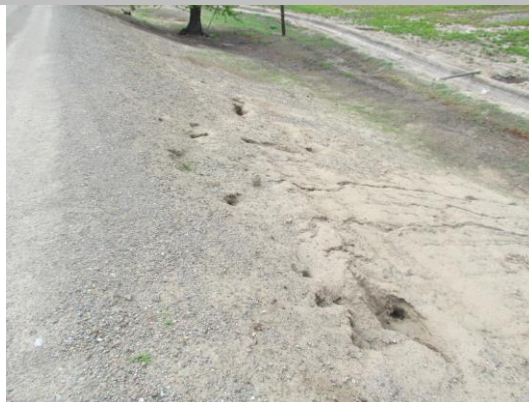
Photo 1 of 1 : SP_2018_RD0544_108_8_20180323_00014.jpg

Looking southwest at several rodent holes on landward shoulder and slope.

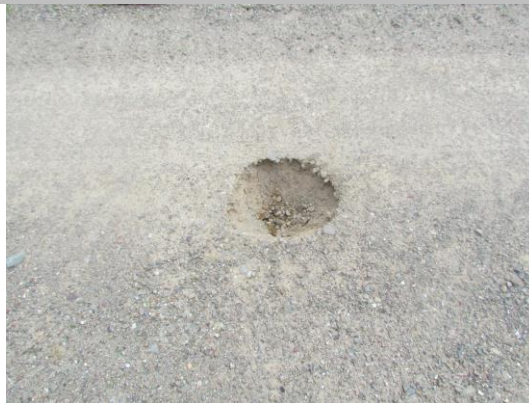
Photo 1 of 1 : SP_2018_RD0544_108_90_20180323_00066.jpg

| Sinkhole forming in crown. | | | | | |

Looking at sinkhole on levee crown.

| C2 : Repair depressions or ruts in the crown or slope. | | | | | |

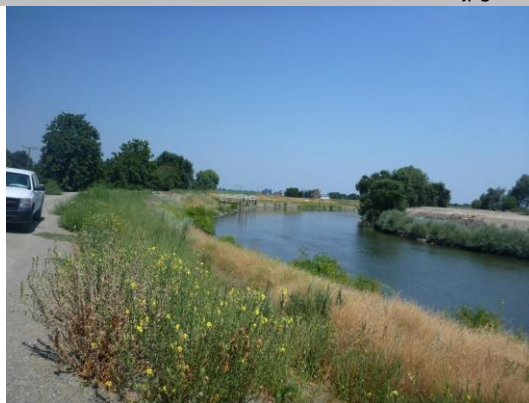
Photo 1 of 3 : LEVAL_SP_2018_568_4540.jpg

| Description:Slope protection repairs are needed along the waterside slope due to erosion and riprap displacement from high water. Based upon levee inspections, it was determined the waterside levee slope is eroding, deteriorating, and degrading. The eroded levee sections need to be restored back to design standards to prevent further deterioration and damage. | | | | | |
| Repair Type: Erosion | | | | | |

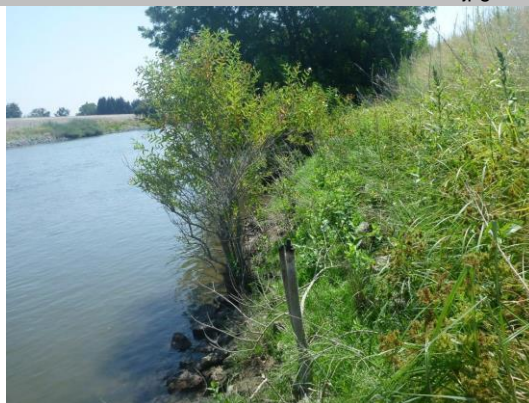
Photo 3 of 3 : LEVAL_SP_2018_568_4547.jpg

| Description:Slope protection repairs are needed along the waterside slope due to erosion and riprap displacement from high water. Based upon levee inspections, it was determined the waterside levee slope is eroding, deteriorating, and degrading. The eroded levee sections need to be restored back to design standards to prevent further deterioration and damage. | | | | | | |
| Repair Type: Erosion | | | | | | |

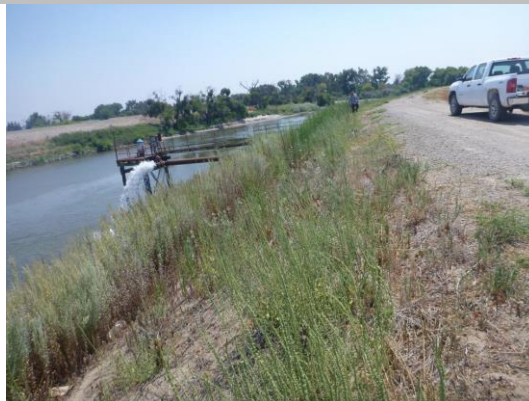
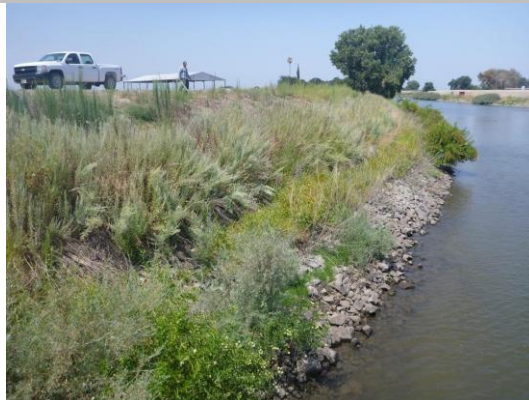
| Levee Evaluation Comments Description: Slope protection repairs are needed along the waterside slope due to erosion and riprap displacement from high water. Based upon levee inspections, it was determined the waterside levee slope is eroding, deteriorating, and degrading. The eroded levee sections need to be restored back to design standards to prevent further deterioration and damage. Site ID No: 567 Site Designation: LMA-473 Repair Type: Erosion Rating: Area of Concern Field Date: 8/10/2017 Notes: large rodent holes observed on landside slope. | | | | | | | | | | | | |

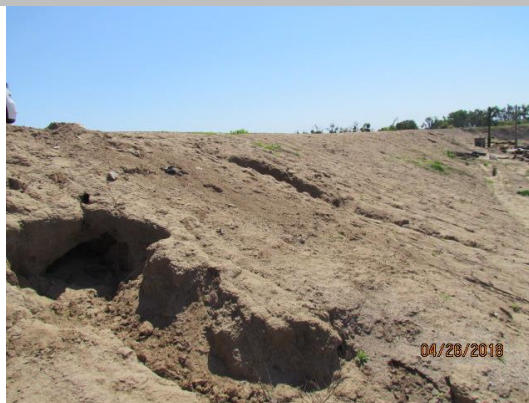
Photo 2 of 2 : SP_2018_RD0544_108_15_20180427_00182.jpg

| Large finger erosions on landward slope. | | | | | | |

Looking south at slope erosion on landward slope. (Spring 2018)

| S1 : Repair slope instability. | | | | | | |

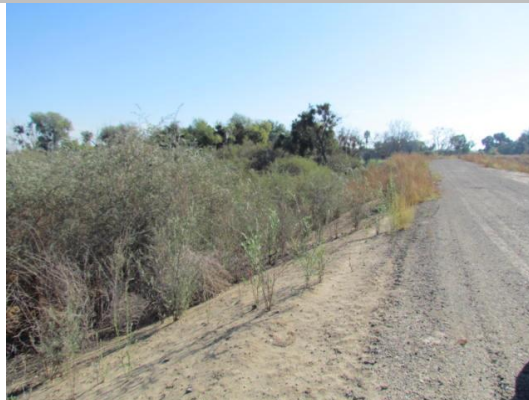
Photo 1 of 1 : SP_2018_RD0544_108_106_20180323_00077.jpg

| Dense willows and vegetation on waterside slope. | | | | | |

Looking southeast at dense willows (veg) on waterward slope and toe fall 2015.

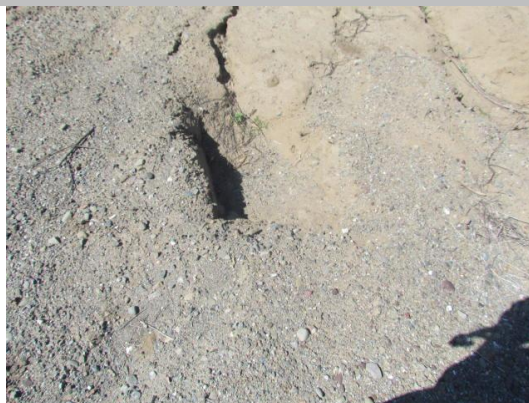
Photo 1 of 2 : SP_2018_RD0544_108_107_20180323_00078.jpg

| Several depressions on landside slope within this reach. | | | | | |

Looking south at depression on landward slope.

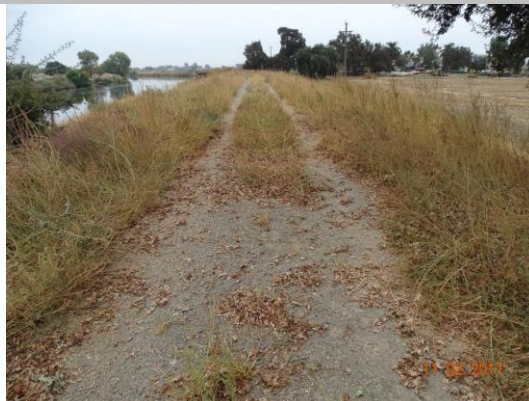
Photo 1 of 1 : SP_2018_RD0544_108_151_20180323_00137.jpg

Looking south at the levee crown.

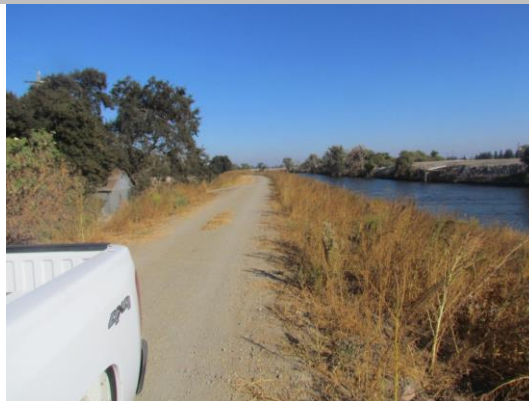
Photo 1 of 1 : SP_2018_RD0544_108_49_20180323_00040.jpg

| Dense vegetation on waterside slope. | | | | | |

Looking northeast at dense veg on waterward slope.

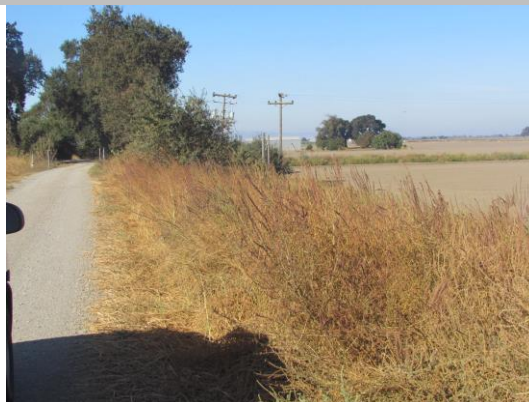
Photo 1 of 1 : SP_2018_RD0544_108_48_20180323_00039.jpg

Looking south at typical view of dense veg on landward slope.

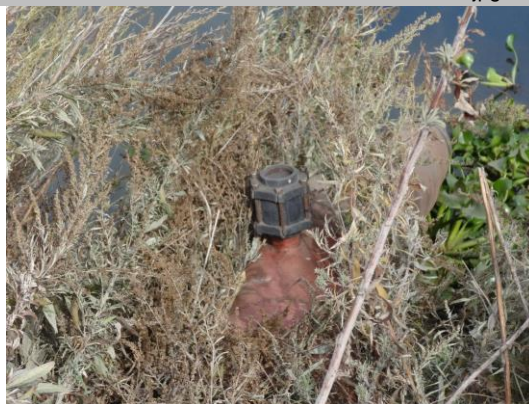
Photo 1 of 3 : UCIP_SP_2018_24892_44853.jpg

WS view: exposed steel pipe on bank of the channel.

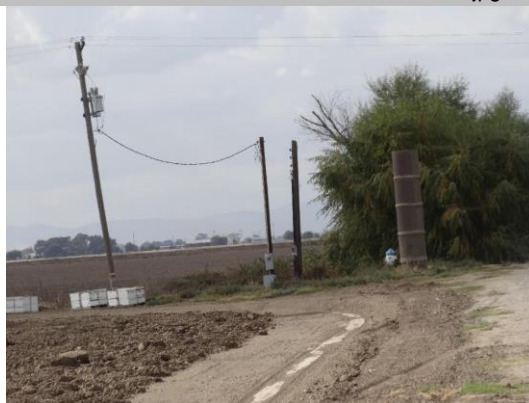
Photo 3 of 3 : UCIP_SP_2018_24892_44851.jpg

| FS_ID:24892 DS_ID:22658 EP_NO: N/A Repair Type: No Action Needed Crossing Status: Found UCIP Comments: - pipe on channel bank looks comparatively new.- pump approximately 500 ft. from the levee center on landside in drainage ditch.- a tall concrete standpipe and service pole near the pump. FIELD_STRUCT_DESC: 12-inch steel drainage discharge pipe through the levee, 3 feet below the crown. Pump and concrete standpipe in a drainage ditch on the landside (LS). Air vent on the waterside (WS). [Additional Reference(s): DWR Levee Log, 2005. USACE San Joaquin O&M Manual 7, April 1964, (HLM 3.53)]. FS Date: 10/29/2013 | | | | | | |

LS view: service pole, pump, and a concrete standpipe on bank of drainage ditch about 500 ft from the levee.

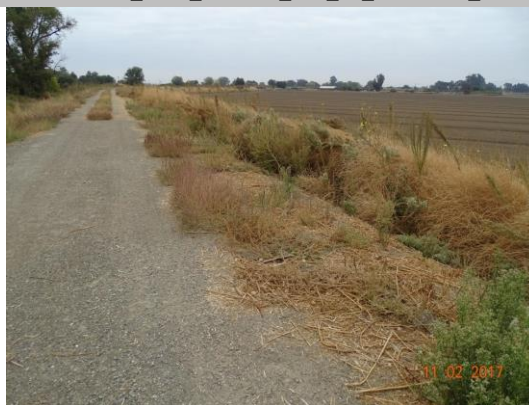
Photo 1 of 1 : SP_2018_RD0544_108_51_20180323_00041.jpg

Looking southeast at the landside slope.

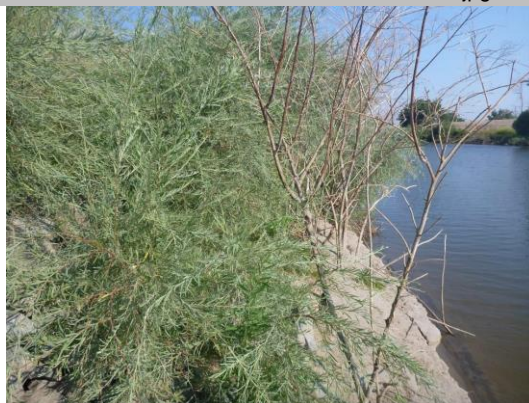
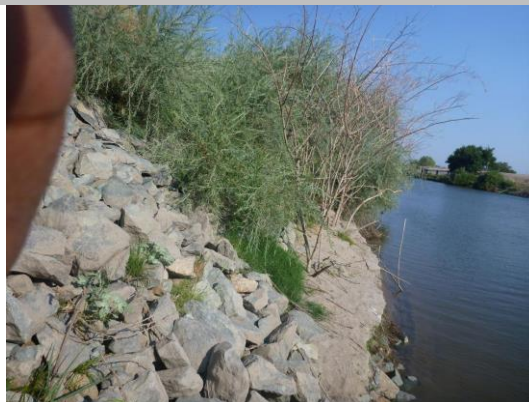
| Notes: dense shrubs on levee slope | | | | | |

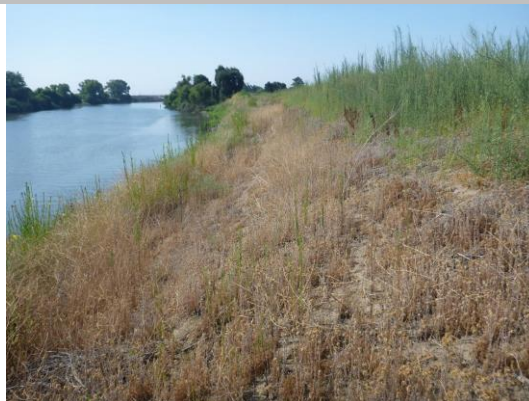
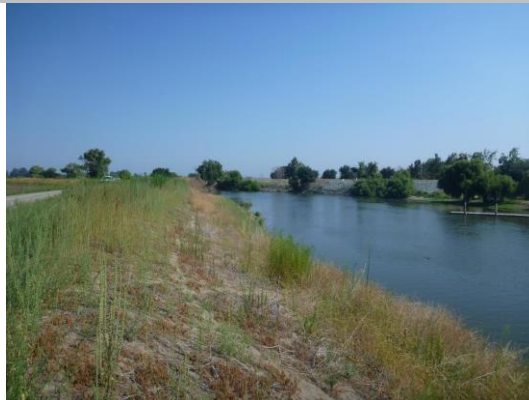
| Notes: big rodent holes on levee slopes | | | | | |

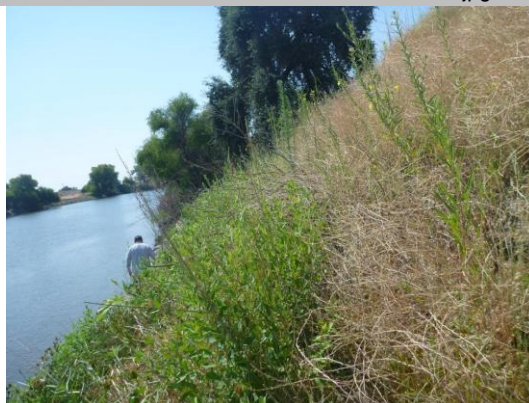
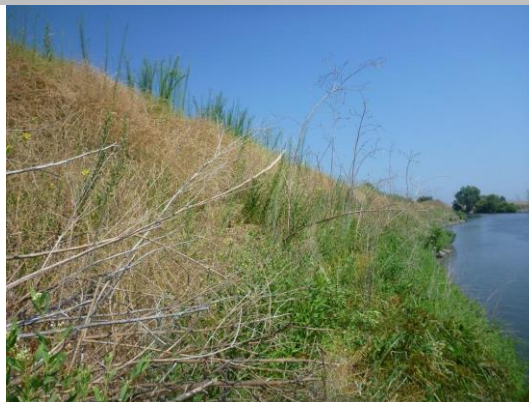
Photo 1 of 3 : LEVAL_SP_2018_562_4770.jpg

| Description:Slope protection repairs are needed along the waterside slope due to erosion and riprap displacement from high water. Based upon levee inspections, it was determined the waterside levee slope is eroding, deteriorating, and degrading. The eroded levee sections need to be restored back to design standards to prevent further deterioration and damage. | | | | | |
| Notes: Site combined with LMA-469; | | | | | |

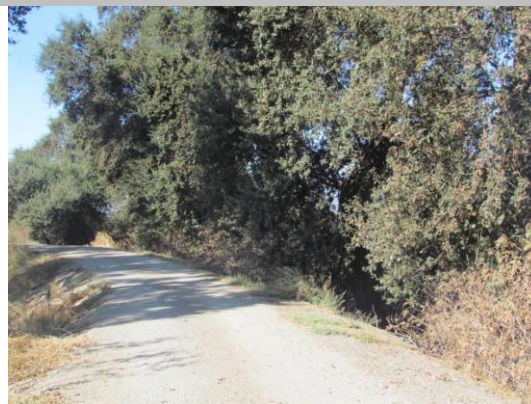
Photo 1 of 1 : SP_2018_RD0544_108_120_20180323_00092.jpg

| Several untrimmed trees on landside slope. | | | | | |

Looking southwest at untrimmed trees on landward slope.

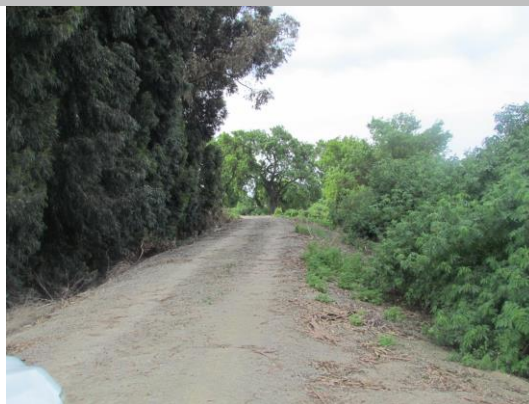
Photo 1 of 1 : SP_2018_RD0544_108_59_20180323_00042.jpg

Looking south at dense veg on landward and waterward slopes.

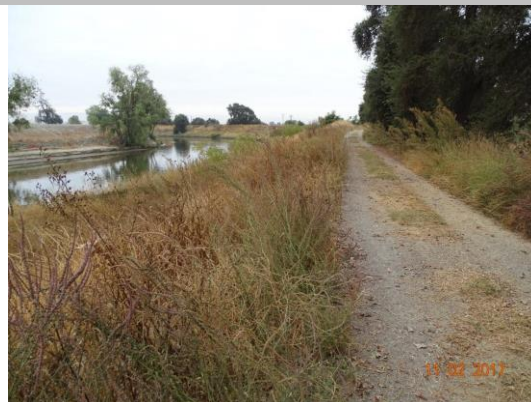
Photo 1 of 2 : SP_2018_RD0544_108_117_20180323_00086.jpg

Looking southwest at the waterside slope.

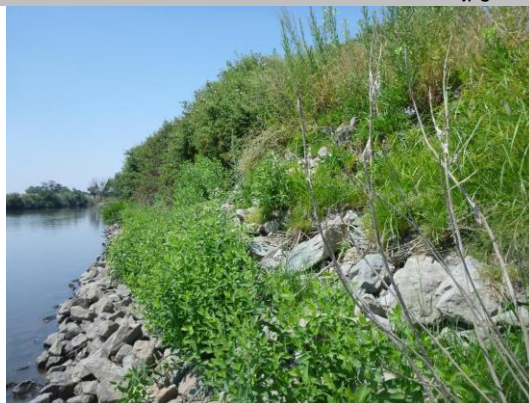
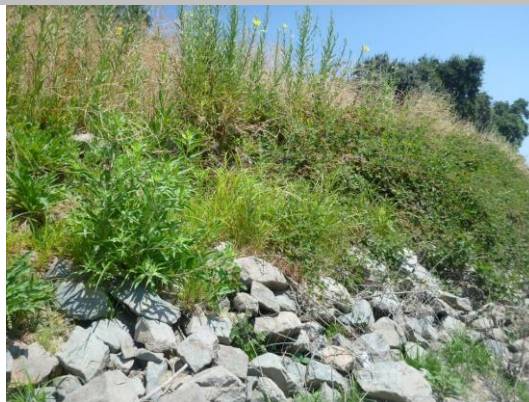
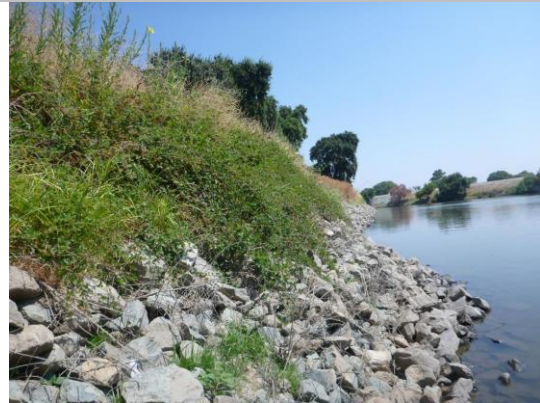
| Description:Slope protection repairs are needed along the waterside slope due to erosion and riprap displacement from high water. Based upon levee inspections, it was determined the waterside levee slope is eroding, deteriorating, and degrading. The eroded levee sections need to be restored back to design standards to prevent further deterioration and damage. | | | | | |
| Notes: site combined with LMA-466 in field; length and coordinates redefined in field. | | | | | |

| <p>Levee Evaluation Comments</p> <p>Description: Slope protection repairs are needed along the waterside slope due to erosion and riprap displacement from high water. Based upon levee inspections, it was determined the waterside levee slope is eroding, deteriorating, and degrading. The eroded levee sections need to be restored back to design standards to prevent further deterioration and damage.</p> <p>Site ID No: 561</p> <p>Site Designation: LMA-467</p> <p>Repair Type: Erosion</p> <p>Rating: Area of Concern</p> <p>Field Date: 8/11/2017</p> <p>Notes: site combined with LMA-466 in field; length and coordinates redefined in field.</p> | | | | | |

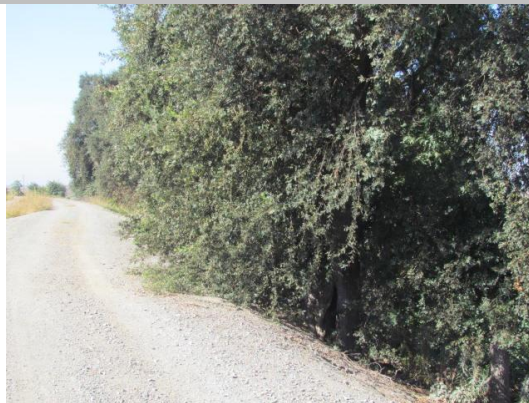
Photo 1 of 1 : SP_2018_RD0544_108_104_20180323_00075.jpg

| Dense untrimmed trees on landside slope. | | | | | |

Looking southwest at dense untrimmed trees on landward slope fall 2015.

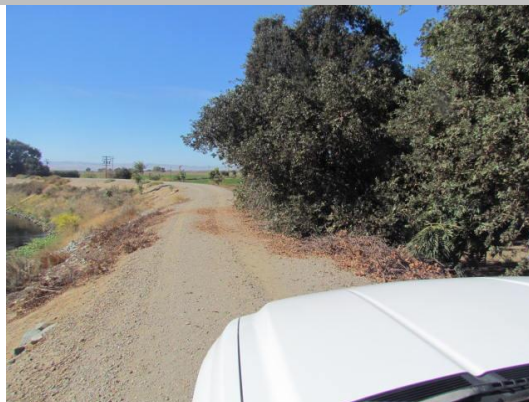
Photo 1 of 1 : SP_2018_RD0544_108_105_20180323_00076.jpg

| Tree has overgrown onto levee crown. | | | | | |

Looking south at overgrown tree on landward shoulder.

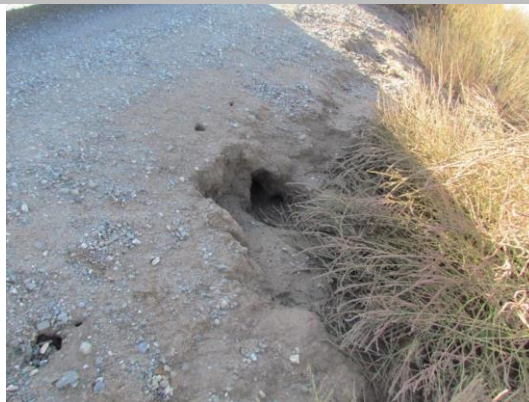
Photo 1 of 1 : SP_2018_RD0544_108_83_20180323_00061.jpg

| Large rodent hole on waterside shoulder. | | | | | |

Looking at large rodent hole on landward slope.

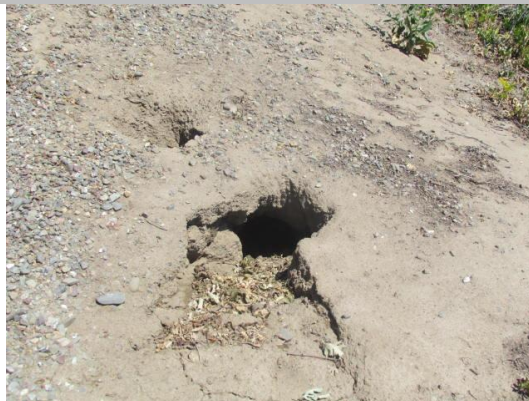
Photo 1 of 1 : SP_2018_RD0544_108_113_20180323_00082.jpg

| Large hole, possibly a rodent hole, on waterside slope. | | | | | |

Looking north at large hole on waterward slope.

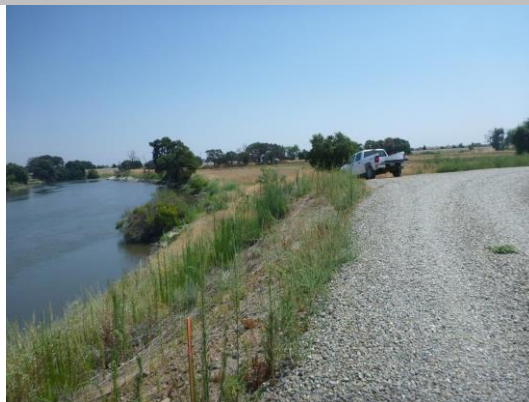
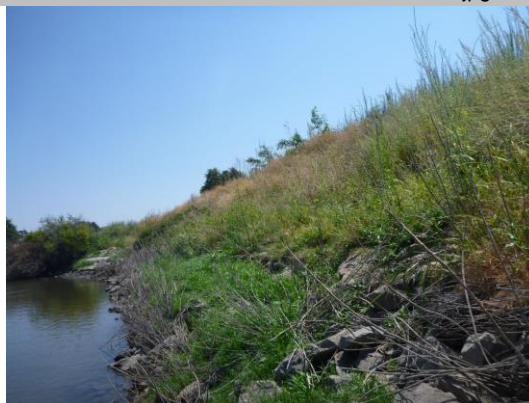
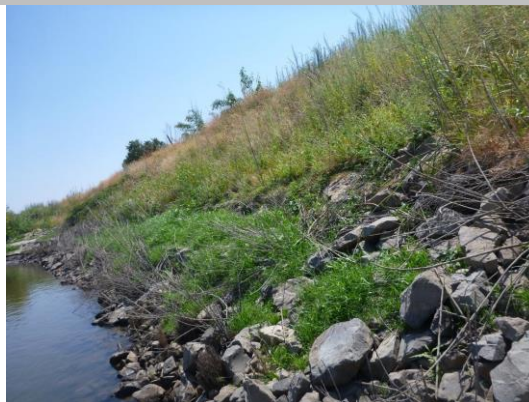
| Description:Slope protection repairs are needed along the waterside slope due to erosion and riprap displacement from high water. Based upon levee inspections, it was determined the waterside levee slope is eroding, deteriorating, and degrading. The eroded levee sections need to be restored back to design standards to prevent further deterioration and damage. | | | | | |

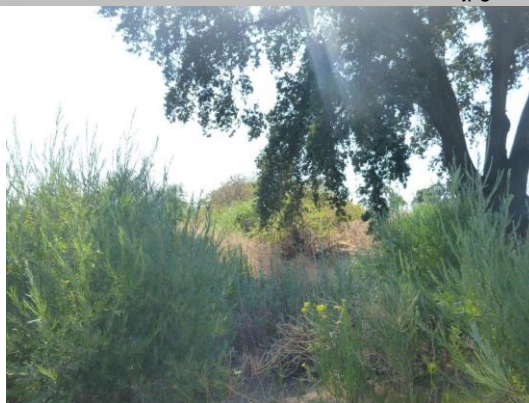
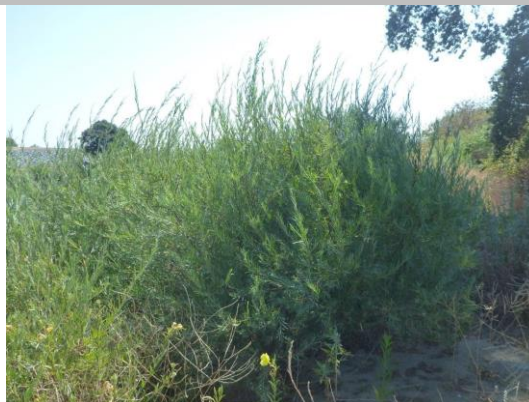
| <p>Levee Evaluation Comments</p> <p>Description: Slope protection repairs are needed along the waterside slope due to erosion and riprap displacement from high water. Based upon levee inspections, it was determined the waterside levee slope is eroding, deteriorating, and degrading. The eroded levee sections need to be restored back to design standards to prevent further deterioration and damage.</p> <p>Site ID No: 557</p> <p>Site Designation: LMA-463</p> <p>Repair Type: Erosion</p> <p>Rating: Area of Concern</p> <p>Field Date: 8/16/2017</p> <p>Notes:</p> | | | | | |

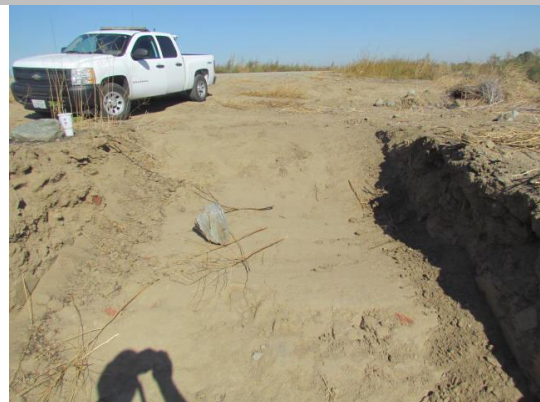
Photo 1 of 4 : SP_2018_RD0544_108_121_20180323_00093.jpg

Looking west at excavation on waterward berm.

| Someone digging/excavating on waterward berm. Excavation in 3ft wide and eighteen inches deep and ten feet long. | | | | | | |

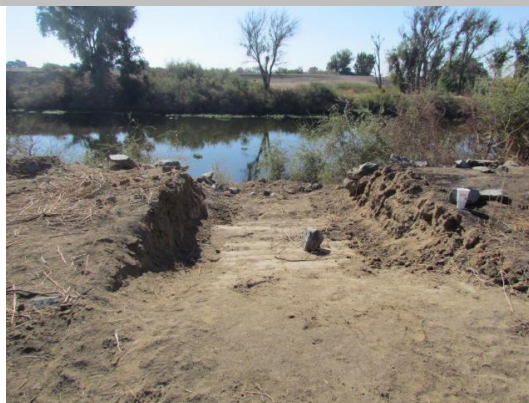
Photo 2 of 4 : SP_2018_RD0544_108_121_20180323_00094.jpg

Looking east at excavation on waterward berm.

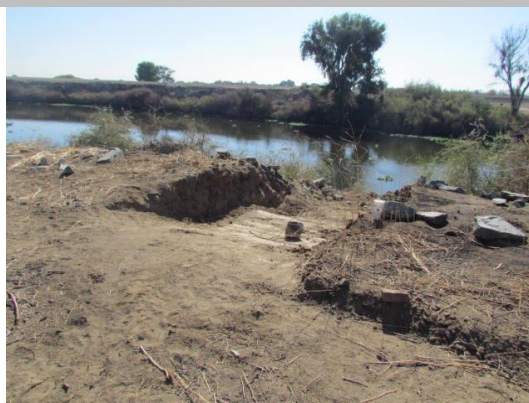
Photo 3 of 4 : SP_2018_RD0544_108_121_20180323_00095.jpg

Looking northeast at excavation on waterward berm

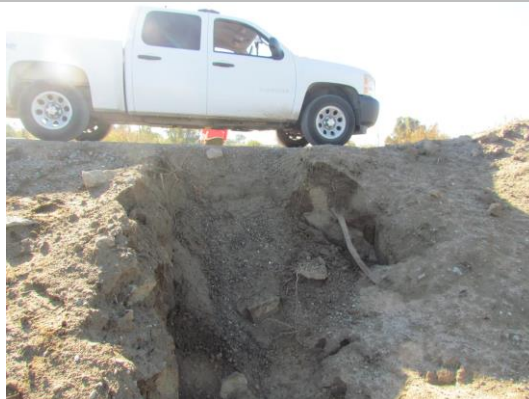
Photo 3 of 3 : SP_2018_RD0544_108_115_20180323_00085.jpg

| Landowner excavated hole above pipe.Large hole left on landward shoulder and slope. Call LMA about repair. | | | | | | |

Looking westly at large excavation on landward slope.

| S2 : Repair the levee slope damaged by foot traffic and prevent access where possible. | | | | | | |

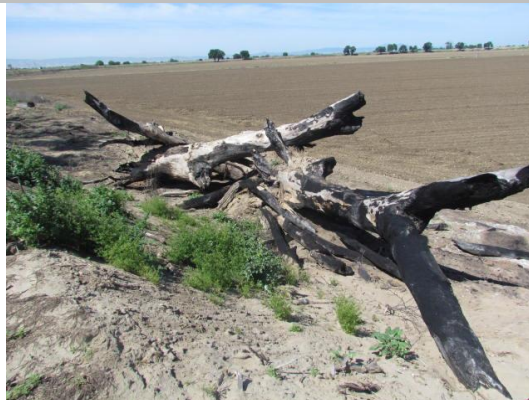
Photo 1 of 2 : SP_2018_RD0544_108_124_20180323_00100.jpg

Looking east at tree limbs on waterward slope.

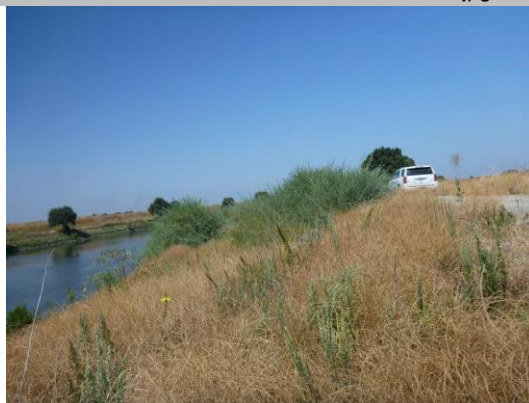
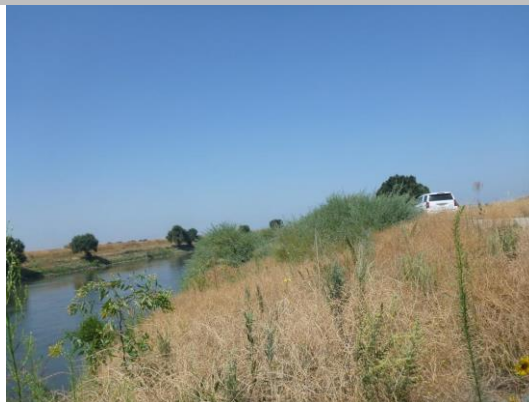
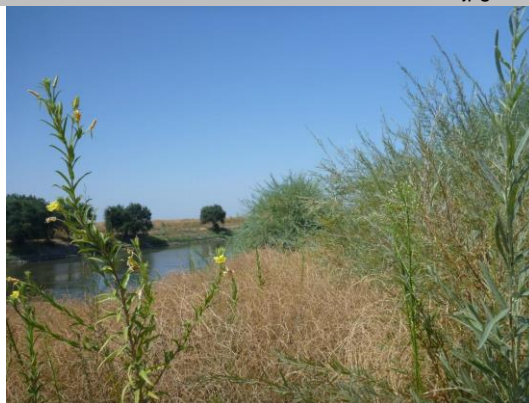
| Description:Slope protection repairs are needed along the waterside slope due to erosion and riprap displacement from high water. Based upon levee inspections, it was determined the waterside levee slope is eroding, deteriorating, and degrading. The eroded levee sections need to be restored back to design standards to prevent further deterioration and damage. | | | | | |

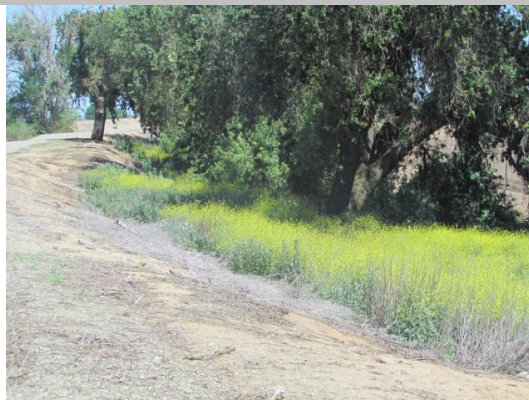
Photo 1 of 1 : SP_2018_RD0544_109_1_20180323_00001.jpg

Looking southwest at dense vegetation at landward toe.

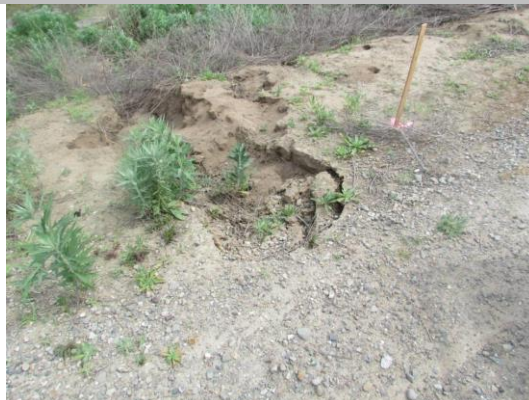
Photo 1 of 1 : SP_2018_RD0544_109_71_20180323_00060.jpg

| Landside erosion due to runoff. | | | | | |

Looking northwest at runoff erosion on landward shoulder and slope.

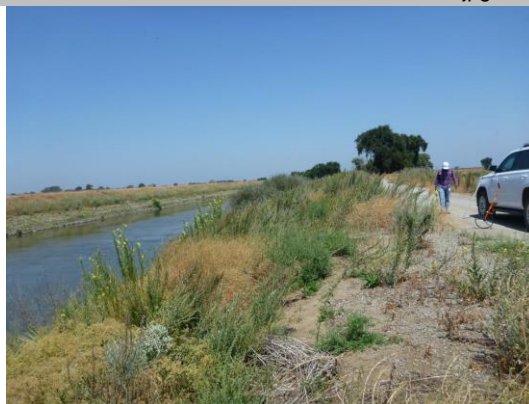
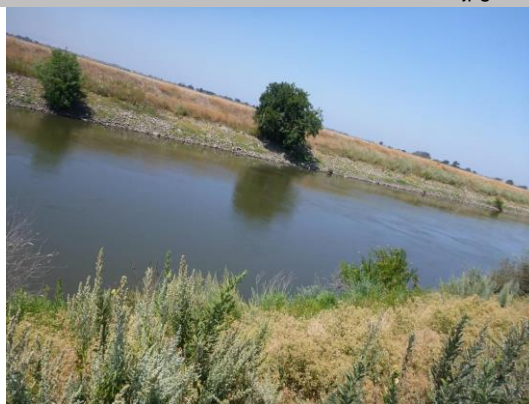
| Description:Slope protection repairs are needed along the waterside slope due to erosion and riprap displacement from high water. Based upon levee inspections, it was determined the waterside levee slope is eroding, deteriorating, and degrading. The eroded levee sections need to be restored back to design standards to prevent further deterioration and damage. | | | | | |

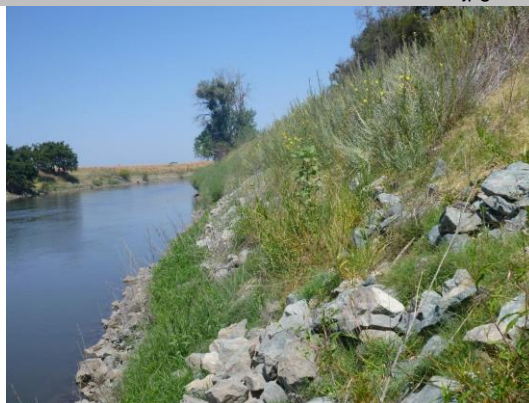
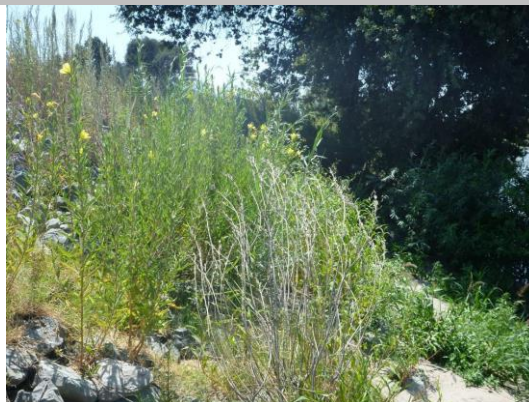
| <p>Levee Evaluation Comments</p> <p>Description: Slope protection repairs are needed along the waterside slope due to erosion and riprap displacement from high water. Based upon levee inspections, it was determined the waterside levee slope is eroding, deteriorating, and degrading. The eroded levee sections need to be restored back to design standards to prevent further deterioration and damage.</p> <p>Site ID No: 554</p> <p>Site Designation: LMA-460</p> <p>Repair Type: Erosion</p> <p>Rating: Area of Concern</p> <p>Field Date: 8/16/2017</p> <p>Notes:</p> | | | | | |

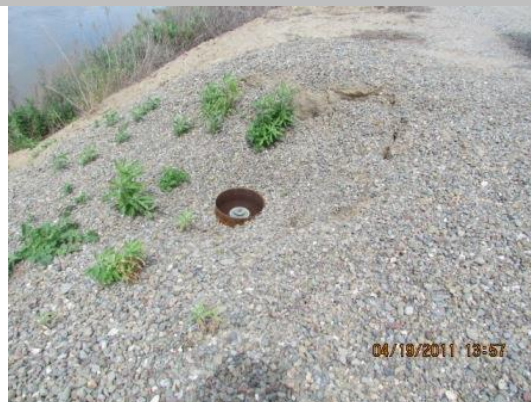
Photo 1 of 4 : SP_2018_RD0544_109_8_20180323_00010.jpg

| Caving under and around siphon on waterside shoulder. No material 3' below pipe. Caving around siphon is 20" to 24" deep approximately 72" in diameter. During 2012 spring inspection hole appears to be enlarging. | | | | | |

Looking south at depression greater than 6" on waterside shoulder.

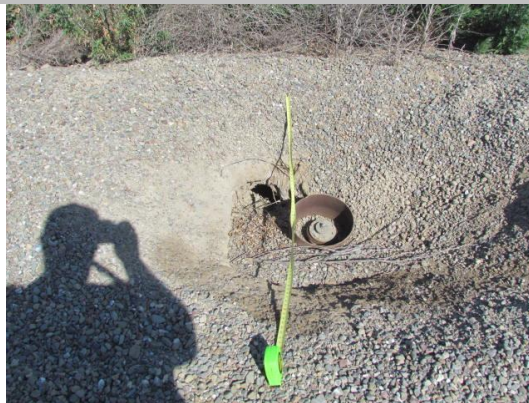
Photo 2 of 4 : SP_2018_RD0544_109_8_20180323_00011.jpg

Looking east at caving around siphon on waterside shoulder. (Spring 2012)

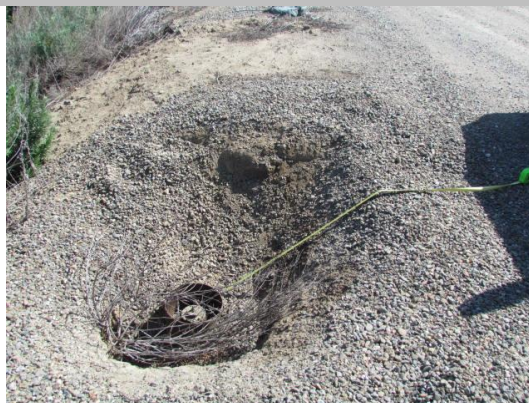
Photo 4 of 4 : SP_2018_RD0544_109_8_20180323_00013.jpg

| Caving under and around siphon on waterside shoulder. No material 3' below pipe. Caving around siphon is 20" to 24" deep approximately 72" in diameter. During 2012 spring inspection hole appears to be enlarging. | | | | | | |

Looking south at caving around siphon on waterside shoulder.(Spring 2012)

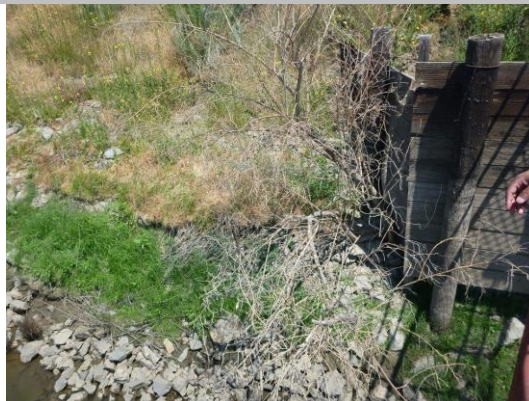
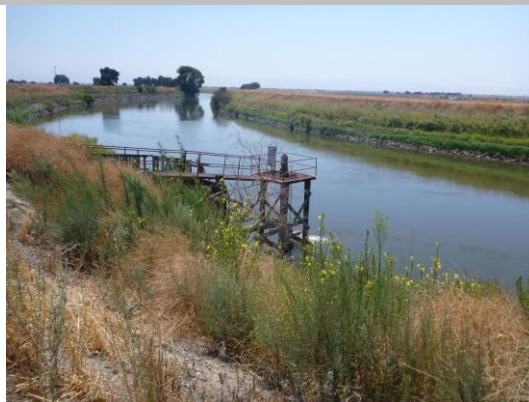
| <p>Levee Evaluation Comments</p> <p>Description: Slope protection repairs are needed along the waterside slope due to erosion and riprap displacement from high water. Based upon levee inspections, it was determined the waterside levee slope is eroding, deteriorating, and degrading. The eroded levee sections need to be restored back to design standards to prevent further deterioration and damage.</p> <p>Site ID No: 552</p> <p>Site Designation: LMA-458</p> <p>Repair Type: Erosion</p> <p>Rating: Area of Concern</p> <p>Field Date: 8/16/2017</p> <p>Notes:</p> | | | | | | | | | | |

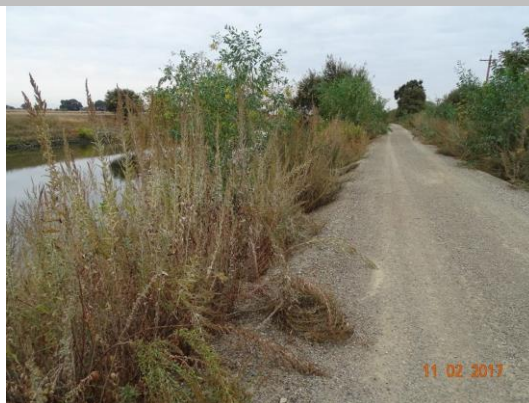
Photo 1 of 1 : SP_2018_RD0544_109_101_20180323_00098.jpg

Looking northwest at the waterside slope.

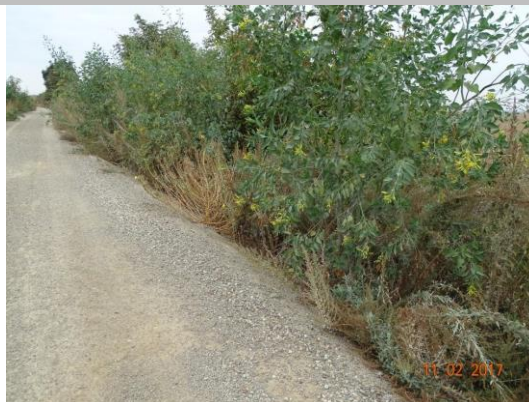
Photo 1 of 1 : SP_2018_RD0544_109_102_20180323_00099.jpg

Looking northwest at the landside slope.

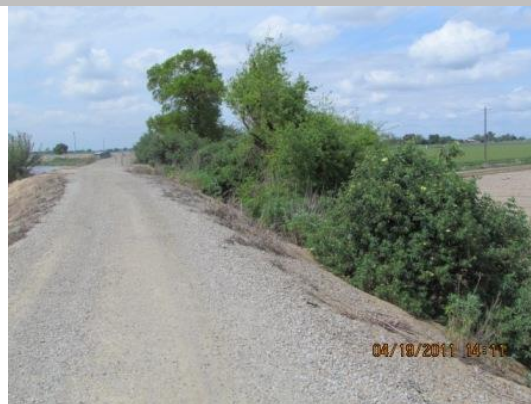
Photo 1 of 2 : SP_2018_RD0544_109_10_20180323_00014.jpg

| Dense elderberry on landside slope and toe. | | | | | |

Looking southwest at elderberries on landside slope.

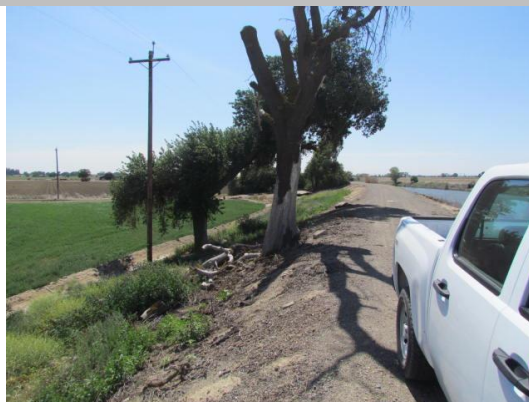
Photo 1 of 1 : SP_2018_RD0544_109_23_20180323_00027.jpg

Looking north at dead tree and tree limbs on landside shoulder and slope.

| Dead tree and limbs should be removed from landside shoulder and slope. | | | | | |

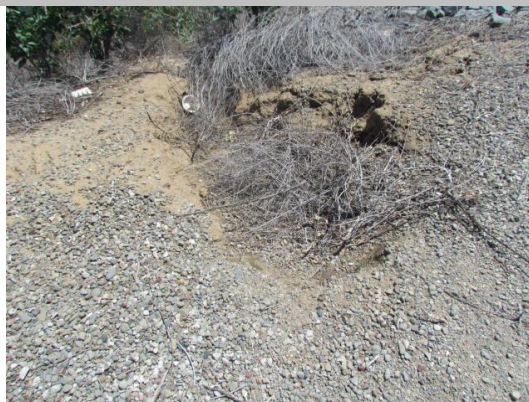
Photo 1 of 2 : SP_2018_RD0544_109_38_20180323_00036.jpg

| Erosion/Caving on waterside shoulder and slope 18" x 6" x 15'. | | | | | |

Looking southeast at erosion/caving on waterward slope.

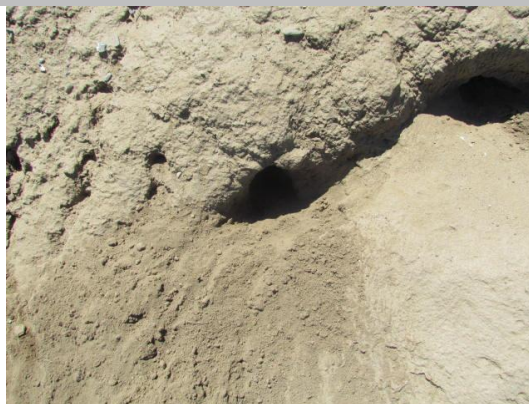
Photo 1 of 1 : SP_2018_RD0544_109_58_20180323_00046.jpg

| Several rodent holes within reach on landside slope. | | | | | |

Looking at typical rodent holes on landward slope.

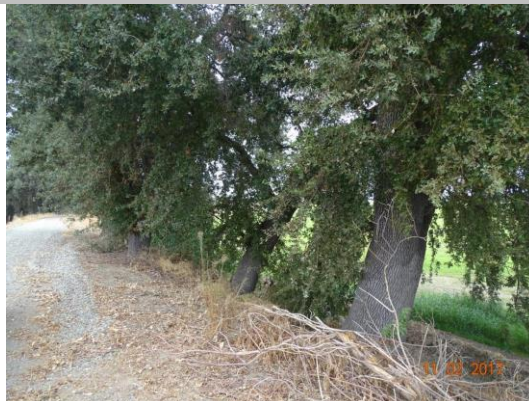
Photo 1 of 2 : SP_2018_RD0544_109_59_20180323_00047.jpg

Looking northwest at the landside slope.
