**Flood Control Project Maintenance
Levee Inspections**

Maintenance Issue Types Only, Levee Inspection Report By Mile - Spring 2018

Reclamation District No. 0544 Upper Roberts Island

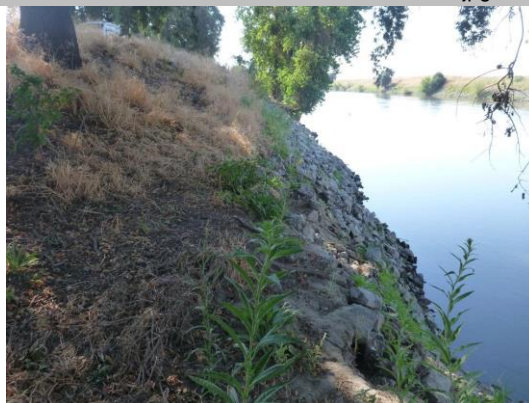
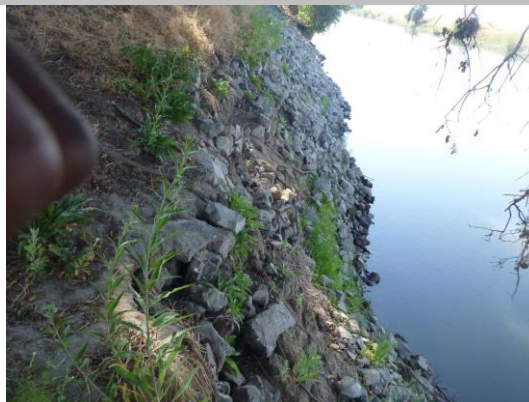
| <p>Levee Evaluation Comments</p> <p>Description: Slope protection repairs are needed along the waterside slope due to erosion and riprap displacement from high water. Based upon levee inspections, it was determined the waterside levee slope is eroding, deteriorating, and degrading. The eroded levee sections need to be restored back to design standards to prevent further deterioration and damage.</p> <p>Site ID No: 551</p> <p>Site Designation: LMA-457</p> <p>Repair Type: Erosion</p> <p>Rating: Serious</p> <p>Field Date: 8/18/2017</p> <p>Notes:</p> | | | | | |

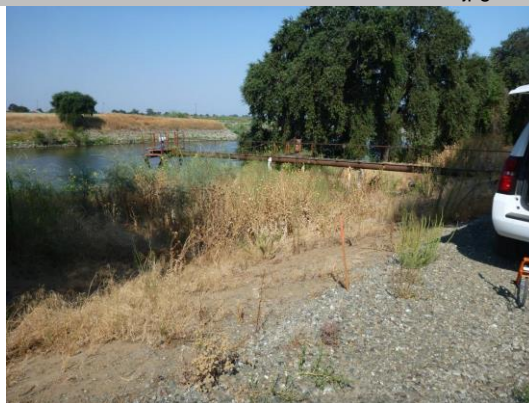
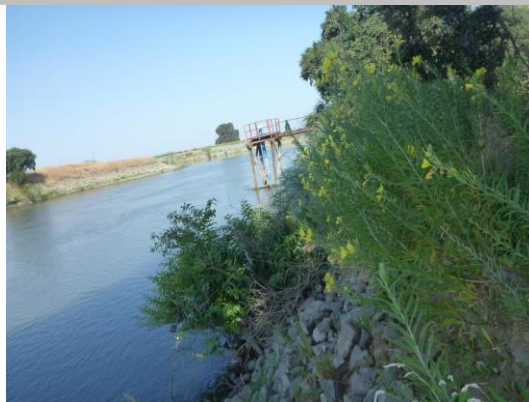
| <p>Levee Evaluation Comments</p> <p>Description: Slope protection repairs are needed along the waterside slope due to erosion and riprap displacement from high water. Based upon levee inspections, it was determined the waterside levee slope is eroding, deteriorating, and degrading. The eroded levee sections need to be restored back to design standards to prevent further deterioration and damage.</p> <p>Site ID No: 550</p> <p>Site Designation: LMA-456</p> <p>Repair Type: Erosion</p> <p>Rating: Area of Concern</p> <p>Field Date: 8/18/2017</p> <p>Notes:</p> | | | | | | | | | | |

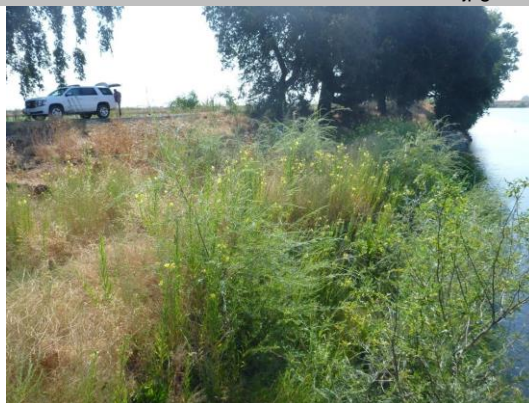
Photo 4 of 4 : LEVAL_SP_2018_550_4575.jpg

| <p>Levee Evaluation Comments</p> <p>Description: Slope protection repairs are needed along the waterside slope due to erosion and riprap displacement from high water. Based upon levee inspections, it was determined the waterside levee slope is eroding, deteriorating, and degrading. The eroded levee sections need to be restored back to design standards to prevent further deterioration and damage.</p> <p>Site ID No: 550</p> <p>Site Designation: LMA-456</p> <p>Repair Type: Erosion</p> <p>Rating: Area of Concern</p> <p>Field Date: 8/18/2017</p> <p>Notes:</p> | | | | | |

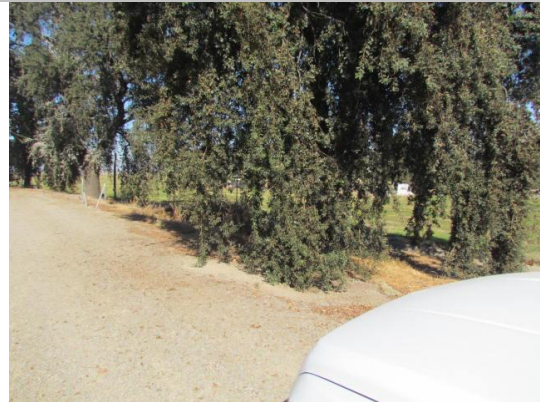
Photo 1 of 1 : SP_2018_RD0544_109_61_20180323_00049.jpg

| Untrimmed tree on landside shoulder. Tree was trimmed but still requires additional trimming. | | | | | |

Looking west at untrimmed trees on landward slope fall 2015.

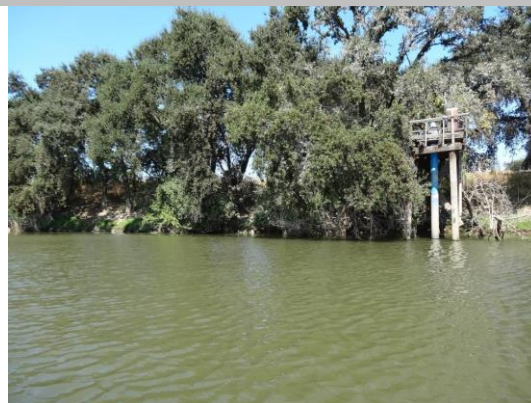
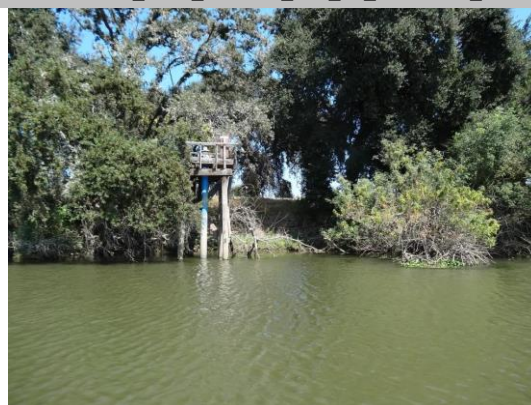
| 08/07/2012: The site was first reported in 2012 spring levee inspection report. The data were estimated as the site is underneath a irrigation pump station and inaccessible by boat or land survey. It's possible the pump station played a role in the erosion. [2017 Site ID:RD0544U02RM33.21] | | | | | |

Front view of the site.

Close view of the site.

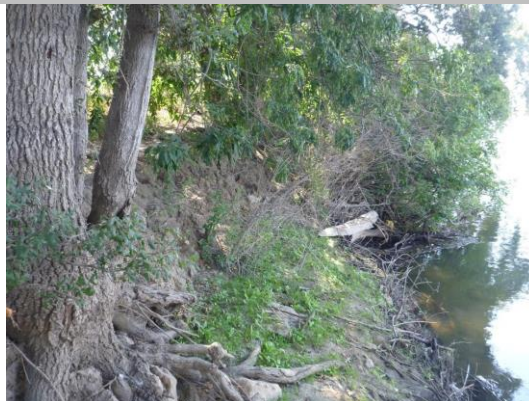
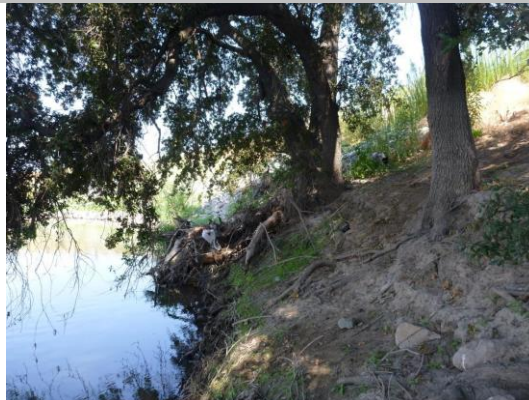
| Description:Slope protection repairs are needed along the waterside slope due to erosion and riprap displacement from high water. Based upon levee inspections, it was determined the waterside levee slope is eroding, deteriorating, and degrading. The eroded levee sections need to be restored back to design standards to prevent further deterioration and damage. | | | | | |

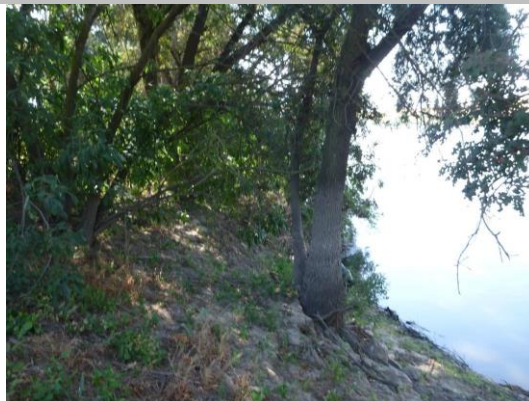
Photo 3 of 3 : LEVAL_SP_2018_549_4654.jpg

| Description:Slope protection repairs are needed along the waterside slope due to erosion and riprap displacement from high water. Based upon levee inspections, it was determined the waterside levee slope is eroding, deteriorating, and degrading. The eroded levee sections need to be restored back to design standards to prevent further deterioration and damage. | | | | | |

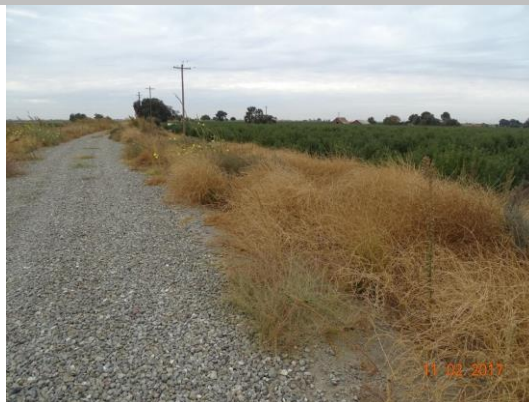
Photo 1 of 1 : SP_2018_RD0544_109_73_20180323_00061.jpg

Looking southwest at the landside slope.

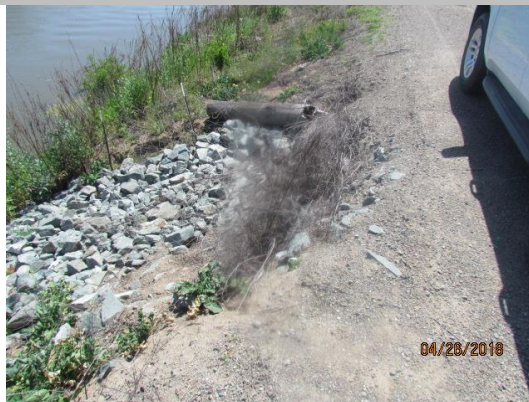
Photo 1 of 5 : SP_2018_RD0544_109_69_20180427_00132.jpg

| Erosion greater than 1' deep and greater than 3' wide. Owner backfilled erosion with rock 3/4 filled. Still need to backfill the remaining erosion. | | | | | |

Looking south at erosion on shoulder. (Spring 2018)

| E2 : Schedule repair of erosion site prior to the next inspection. | | | | | |

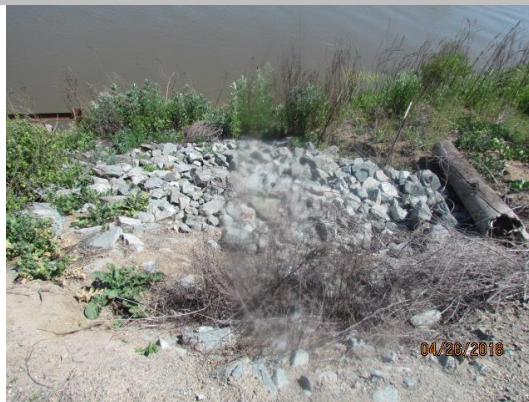
Photo 2 of 5 : SP_2018_RD0544_109_69_20180427_00133.jpg

Looking east at erosion on waterward slope. (Spring 2018)

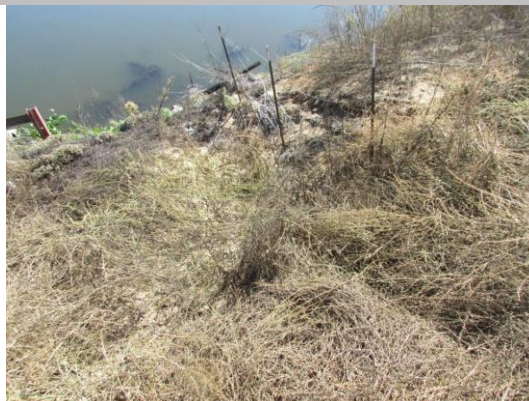
Photo 4 of 5 : SP_2018_RD0544_109_69_20180323_00056.jpg

Looking south at waterward erosion.

| E2 : Schedule repair of erosion site prior to the next inspection. | | | | | | |

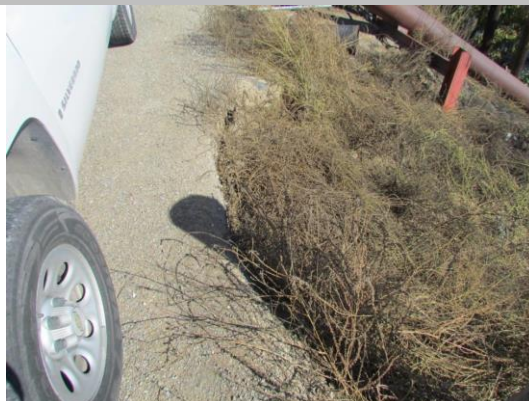
Photo 5 of 5 : SP_2018_RD0544_109_69_20180323_00055.jpg

Looking north at erosion on waterward shoulder and slope.

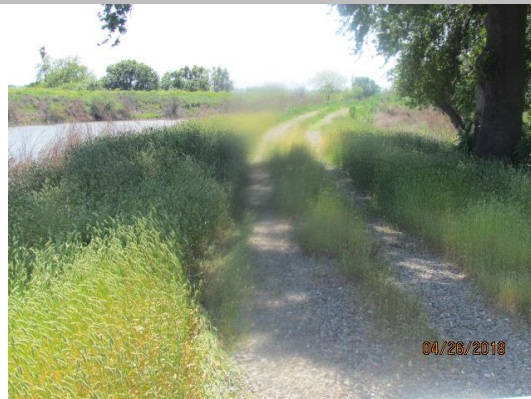
Photo 1 of 3 : SP_2018_RD0544_109_52_20180427_00131.jpg

Looking south at veg on levee crown. (Spring 2018)

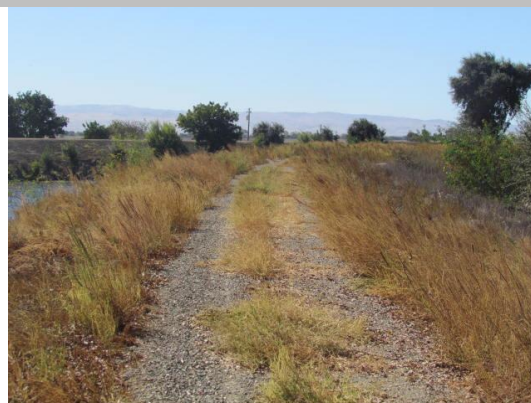
Photo 2 of 3 : SP_2018_RD0544_109_52_20180323_00043.jpg

Looking south at vegetation on levee crown.

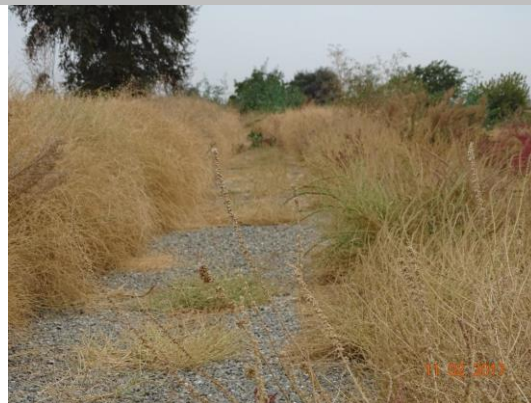
Photo 3 of 3 : SP_2018_RD0544_109_52_20180323_00042.jpg

Looking southwest at levee crown.

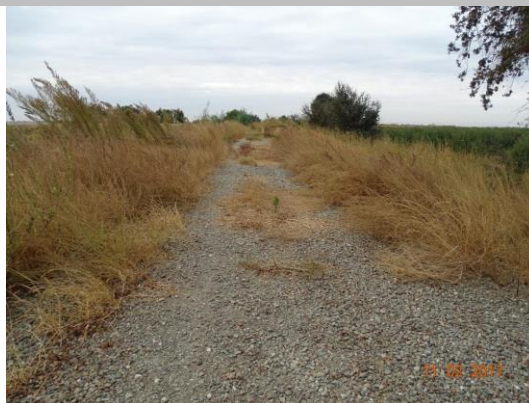
Photo 1 of 2 : SP_2018_RD0544_109_43_20180323_00039.jpg

Looking southwest and levee.

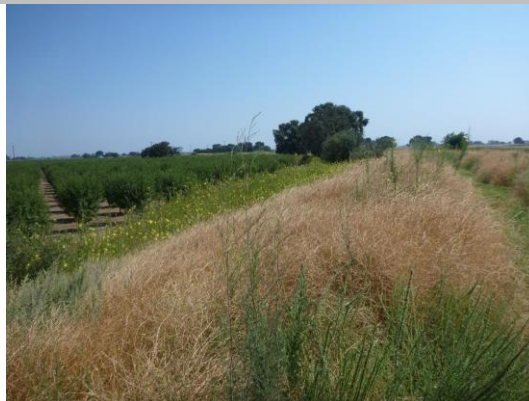
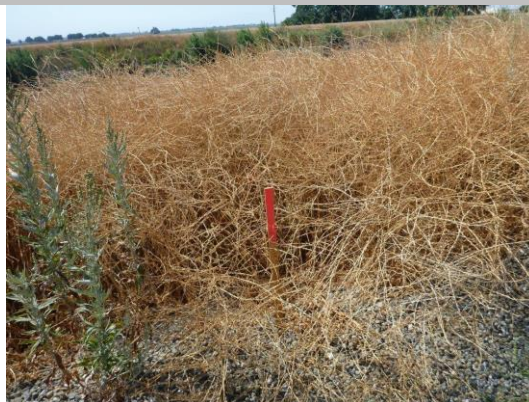
| Description:Slope protection repairs are needed along the waterside slope due to erosion and riprap displacement from high water. Based upon levee inspections, it was determined the waterside levee slope is eroding, deteriorating, and degrading. The eroded levee sections need to be restored back to design standards to prevent further deterioration and damage. | | | | | |
| Notes: levee slopes covered in dense vegetations that hindered visibility. | | | | | |

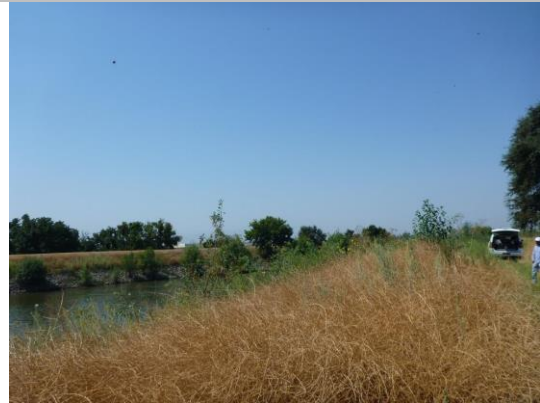
Photo 3 of 3 : LEVAL_SP_2018_547_4688.jpg

| Description:Slope protection repairs are needed along the waterside slope due to erosion and riprap displacement from high water. Based upon levee inspections, it was determined the waterside levee slope is eroding, deteriorating, and degrading. The eroded levee sections need to be restored back to design standards to prevent further deterioration and damage. | | | | | | |
| Notes: levee slopes covered in dense vegetations that hindered visibility. | | | | | | |

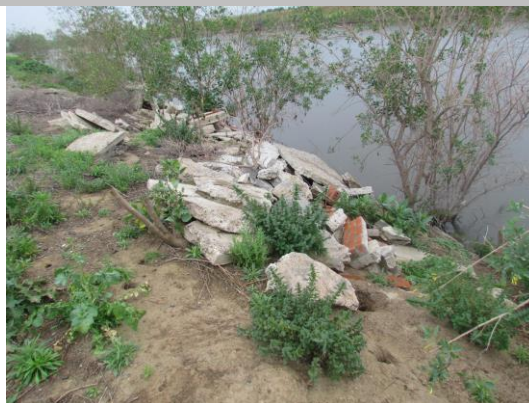
Photo 1 of 1 : SP_2018_RD0544_109_77_20180323_00062.jpg

| Rip rap was placed but does not meet Title 23 standards. | | | | | |

Looking northeast at concrete rubble on waterward slope.

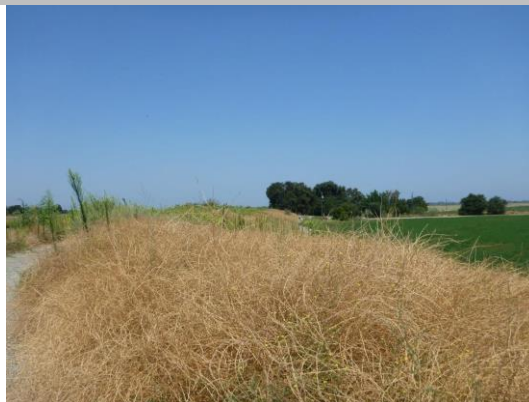
Photo 1 of 3 : LEVAL_SP_2018_546_4693.jpg

| Description:Slope protection repairs are needed along the waterside slope due to erosion and riprap displacement from high water. Based upon levee inspections, it was determined the waterside levee slope is eroding, deteriorating, and degrading. The eroded levee sections need to be restored back to design standards to prevent further deterioration and damage. | | | | | |
| Notes: dense vegetations on both sides of the levee made the slopes inaccessible | | | | | |

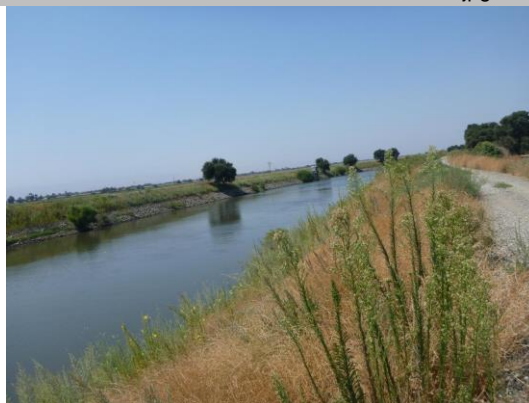
Photo 3 of 3 : LEVAL_SP_2018_545_4774.jpg

| Levee Evaluation Comments Description: Slope protection repairs are needed along the waterside slope due to erosion and riprap displacement from high water. Based upon levee inspections, it was determined the waterside levee slope is eroding, deteriorating, and degrading. The eroded levee sections need to be restored back to design standards to prevent further deterioration and damage. Site ID No: 545 Site Designation: LMA-451 Repair Type: Erosion Rating: Area of Concern Field Date: 8/18/2017 Notes: | | | | | |

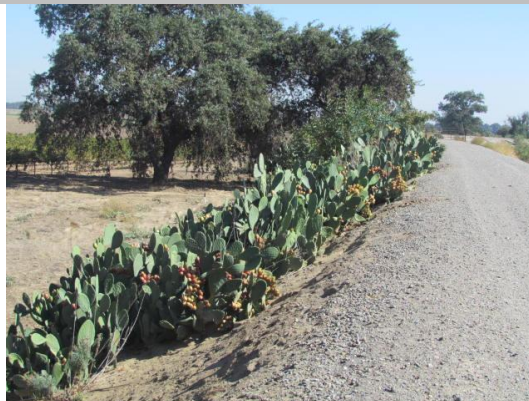
Photo 1 of 3 : SP_2018_RD0544_109_36_20180323_00030.jpg

| Cactus on landside slope. | | | | | |

Looking northwest at cactus on landward slope and toe fall 2015

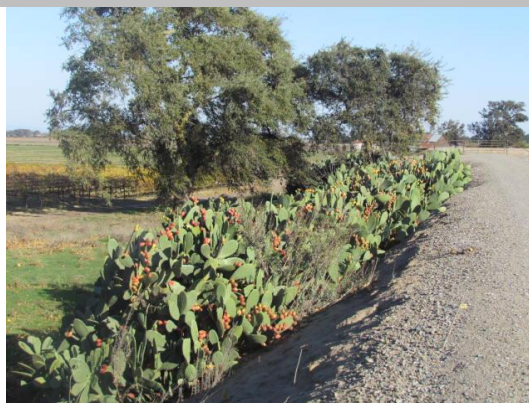
Photo 2 of 3 : SP_2018_RD0544_109_36_20180323_00031.jpg

Looking north at cactus on landside slope and toe spring 2015

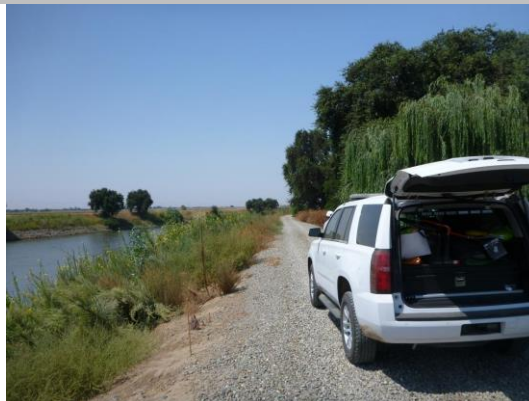
Photo 2 of 3 : LEVAL_SP_2018_544_4782.jpg

| <p>Levee Evaluation Comments</p> <p>Description: Slope protection repairs are needed along the waterside slope due to erosion and riprap displacement from high water. Based upon levee inspections, it was determined the waterside levee slope is eroding, deteriorating, and degrading. The eroded levee sections need to be restored back to design standards to prevent further deterioration and damage.</p> <p>Site ID No: 544</p> <p>Site Designation: LMA-450</p> <p>Repair Type: Erosion</p> <p>Rating: Area of Concern</p> <p>Field Date: 8/18/2017</p> <p>Notes:</p> | | | | | | | | | | | | |

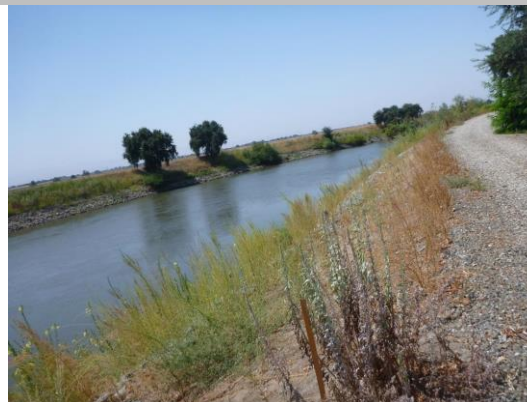
Photo 1 of 3 : LEVAL_SP_2018_543_4790.jpg

| Description:Slope protection repairs are needed along the waterside slope due to erosion and riprap displacement from high water. Based upon levee inspections, it was determined the waterside levee slope is eroding, deteriorating, and degrading. The eroded levee sections need to be restored back to design standards to prevent further deterioration and damage. | | | | | |
| Repair Type: Erosion | | | | | |

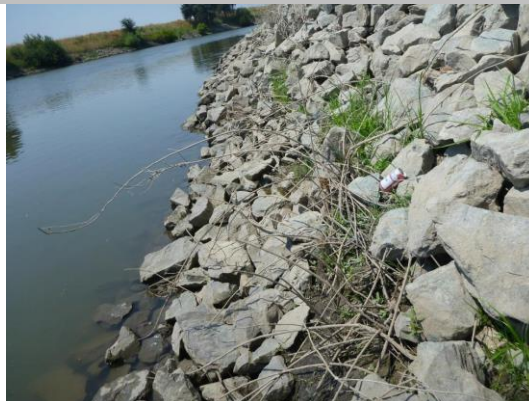
Photo 2 of 3 : LEVAL_SP_2018_543_4797.jpg

| <p>Levee Evaluation Comments</p> <p>Description: Slope protection repairs are needed along the waterside slope due to erosion and riprap displacement from high water. Based upon levee inspections, it was determined the waterside levee slope is eroding, deteriorating, and degrading. The eroded levee sections need to be restored back to design standards to prevent further deterioration and damage.</p> <p>Site ID No: 543</p> <p>Site Designation: LMA-449</p> <p>Repair Type: Erosion</p> <p>Rating: Area of Concern</p> <p>Field Date: 8/18/2017</p> <p>Notes:</p> | | | | | |

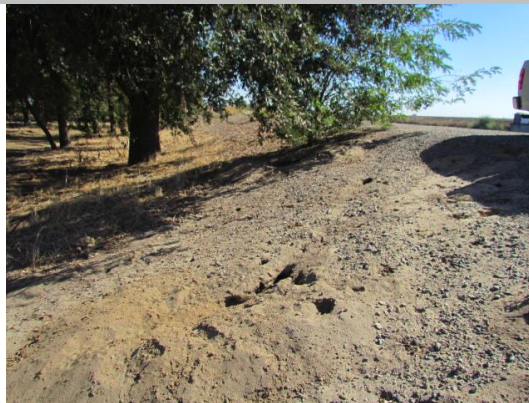
Photo 1 of 2 : SP_2018_RD0544_109_67_20180323_00051.jpg

| Large rodent holes on landward slope. | | | | | |

Looking northeast at typical view of rodent holes on landward slope.

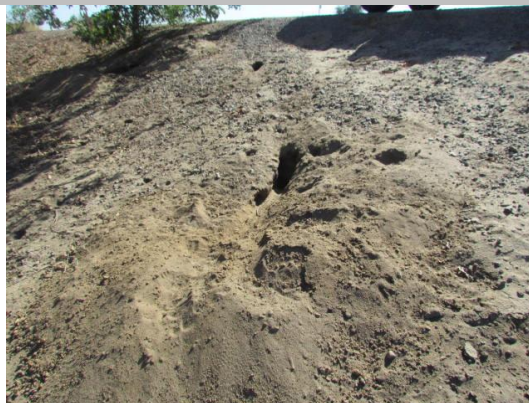
Photo 2 of 2 : SP_2018_RD0544_109_67_20180323_00052.jpg

Looking north at typical view of rodent holes on landward slope.
