**Flood Control Project Maintenance
Levee Inspections**

Maintenance Issue Types Only, Levee Inspection Report By Mile - Spring 2019

Reclamation District No. 0544 Upper Roberts Island

Waterway	Bank	Unit Miles	Inspection Start/End	Inspector
Unit No. 01 San Joaquin River	Left	6.05	05/09/2019 05/09/2019	Alberto De Leon

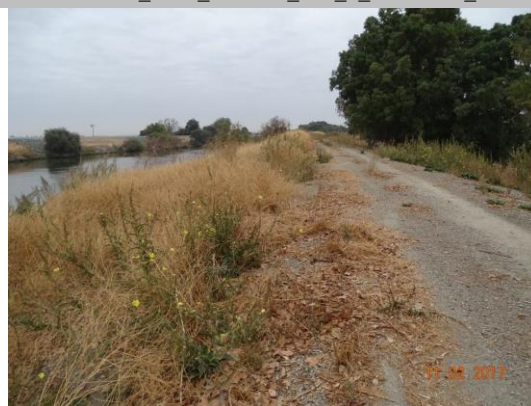
Photo 1 of 2 : SP_2019_RD0544_108_3_20190313_00003.jpg

LM Start	0.48	Rating **	M	Issue No.	3
LM End	0.57	Issue Type +	Ma	Location *	WS
Category	Earthen Levee			GPS Latitude/Longitude	
				Start	End
Item	Vegetation			37.864578 °	37.864312 °
				-121.326210 °	-121.324576 °
DWR ID	DWR_RD0544_01_s_2012_3				
Comment Code					
V1 : Control annual grass and weeds on the levee slopes and easements.					
Inspector Comment

Looking southeast at the waterside slope.

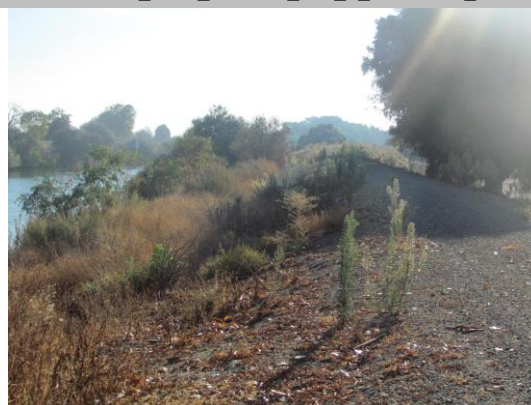
Photo 2 of 2 : SP_2019_RD0544_108_3_20190313_00004.jpg

Looking south at dense veg on waterward slope.

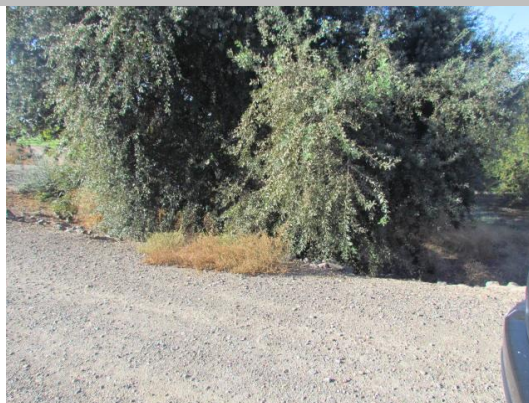
Photo 1 of 1 : SP_2019_RD0544_108_93_20190313_00061.jpg

LM Start	0.81	Rating **	M	Issue No.	93
LM End	0.81	Issue Type +	Ma	Location *	LS
Category	Earthen Levee			GPS Latitude/Longitude	
				Start	End
Item	Trim / Thin Trees			37.862694 °	37.862694 °
				-121.320887 °	-121.320887 °
DWR ID	DWR_RD0544_01_f_2014_93				
Comment Code					
T1 : Trim trees to at least five feet above ground level.					
Inspector Comment

Looking west at untrimmed trees on landward slope and toe, Fall 2015.

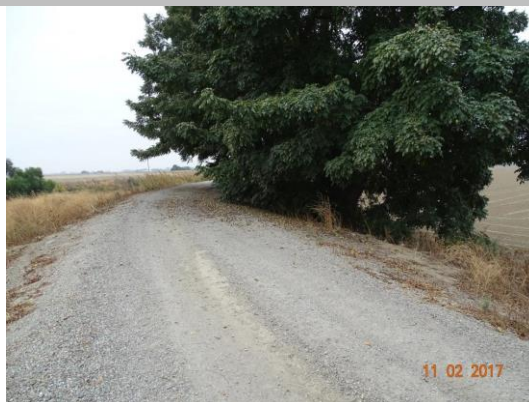
Photo 1 of 2 : SP_2019_RD0544_108_39_20190313_00027.jpg

LM Start	1.12	Rating **	M	Issue No.	39
LM End	1.12	Issue Type +	Ma	Location *	LS
Category	Earthen Levee			GPS Latitude/Longitude	
				Start	End
Item	Trim / Thin Trees			37.859423 °	37.859423 °
				-121.318328 °	-121.318328 °
DWR ID	DWR_RD0544_01_s_2012_39				
Comment Code					
T1 : Trim trees to at least five feet above ground level.					
Inspector Comment					
There are untrimmed trees on the landside slope.

Looking southwest at landside slope.

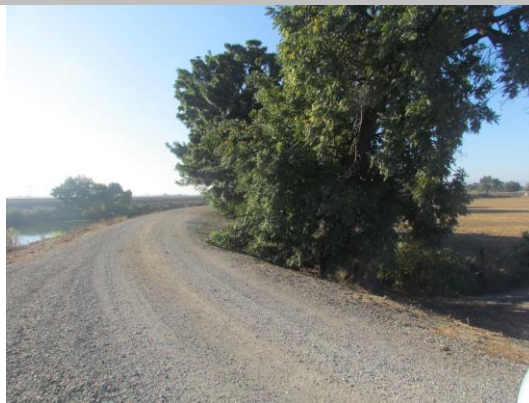
Photo 2 of 2 : SP_2019_RD0544_108_39_20190313_00028.jpg

LM Start	1.12	Rating **	M	Issue No.	39 (cont)	
LM End	1.12	Issue Type +	Ma	Location *	LS	
Category	Earthen Levee			GPS Latitude/Longitude		
				Start		End
Item	Trim / Thin Trees			37.859423 °		37.859423 °
				-121.318328 °		-121.318328 °
DWR ID	DWR_RD0544_01_s_2012_39					
Comment Code						
T1 : Trim trees to at least five feet above ground level.						
Inspector Comment						
There are untrimmed trees on the landside slope.

Looking southwest at untrimmed tree on landward slope.

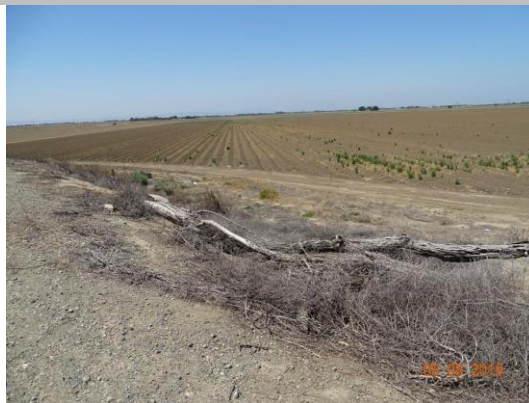
Photo 1 of 1 : SP_2019_RD0544_108_63_20190523_00162.jpg

LM Start	1.32	Rating **	M	Issue No.	63
LM End	1.32	Issue Type +	Ma	Location *	LS
Category	Earthen Levee			GPS Latitude/Longitude	
				Start	End
Item	Encroachments			37.857093 °	37.857093 °
				-121.320378 °	-121.320378 °
DWR ID	DWR_RD0544_01_s_2019_63				
Comment Code					
TR : Tree or limb					
Inspector Comment

View of tree limbs on landside slope. (Spring 2019)

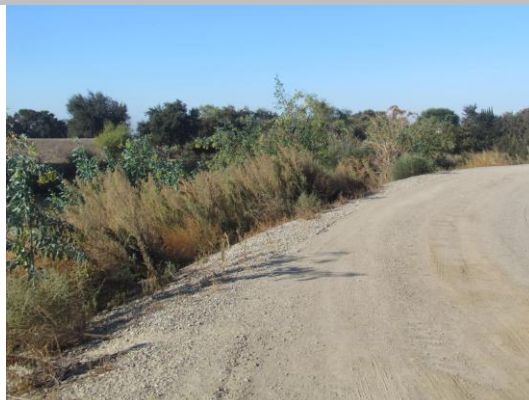
Photo 1 of 1 : SP_2019_RD0544_108_43_20190313_00030.jpg

LM Start	1.56	Rating **	U	Issue No.	43
LM End	1.66	Issue Type +	Ma	Location *	WS
Category	Earthen Levee			GPS Latitude/Longitude	
				Start	End
Item	Vegetation			37.854068 °	37.854815 °
				-121.321387 °	-121.322939 °
DWR ID	DWR_RD0544_01_s_2012_43				
Comment Code					
V2 : Remove the wild growth other than native grasses from the levee slopes.					
Inspector Comment					
There is dense vegetation on the waterside slope.

Looking east at dense veg on waterward slope.

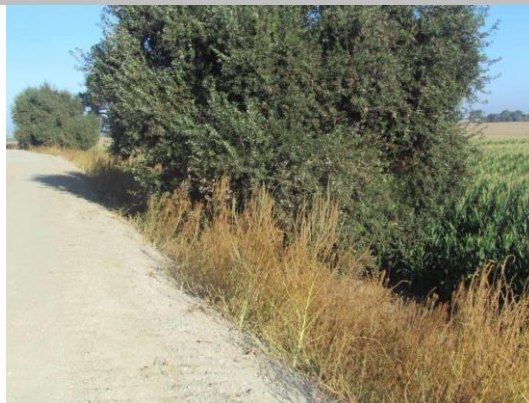
Photo 1 of 1 : SP_2019_RD0544_108_95_20190313_00062.jpg

LM Start	1.59	Rating **	M	Issue No.	95
LM End	1.59	Issue Type +	Ma	Location *	LS
Category	Earthen Levee			GPS Latitude/Longitude	
				Start	End
Item	Trim / Thin Trees			37.854299 °	37.854299 °
				-121.321865 °	-121.321865 °
DWR ID	DWR_RD0544_01_s_2018_95				
Comment Code					
T1 : Trim trees to at least five feet above ground level.					
Inspector Comment					
There is an untrimmed tree on the landside slope.

Looking southwest at untrimmed tree on landward slope.

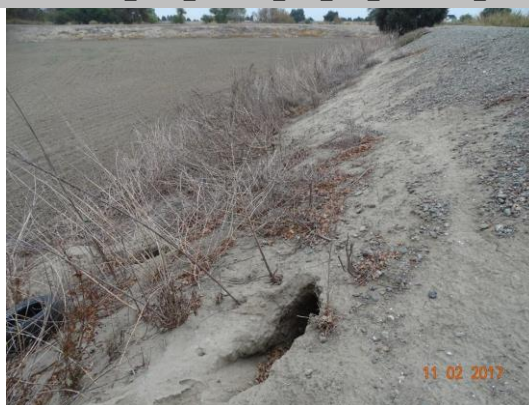
Photo 1 of 1 : SP_2019_RD0544_108_146_20190313_00116.jpg

LM Start	1.63	Rating **	U	Issue No.	146
LM End	1.63	Issue Type +	Ma	Location *	LS
Category	Earthen Levee			GPS Latitude/Longitude	
				Start	End
Item	Animal Control			37.854643 °	37.854643 °
				-121.322429 °	-121.322429 °
DWR ID	DWR_RD0544_01_f_2017_146				
Comment Code					
A3 : No rodents visible, but rodent burrows visible; need to backfill and compact or grout burrows.					
Inspector Comment					
There is a large rodent hole on the landside slope.

Looking east at the landside slope.

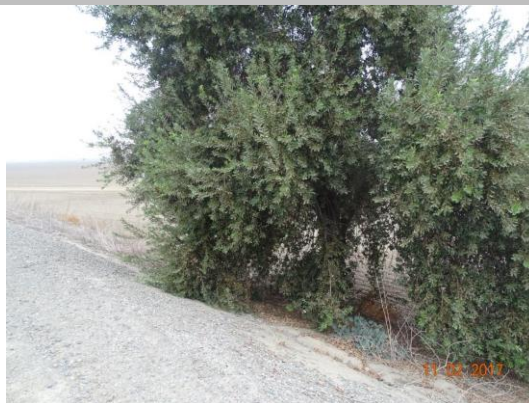
Photo 1 of 1 : SP_2019_RD0544_108_145_20190313_00115.jpg

LM Start	1.64	Rating **	M	Issue No.	145
LM End	1.64	Issue Type +	Ma	Location *	LS
Category	Earthen Levee			GPS Latitude/Longitude	
				Start	End
Item	Trim / Thin Trees			37.854673 °	37.854673 °
				-121.322492 °	-121.322492 °
DWR ID	DWR_RD0544_01_f_2017_145				
Comment Code					
T1 : Trim trees to at least five feet above ground level.					
Inspector Comment

Looking northwest at the landside slope.

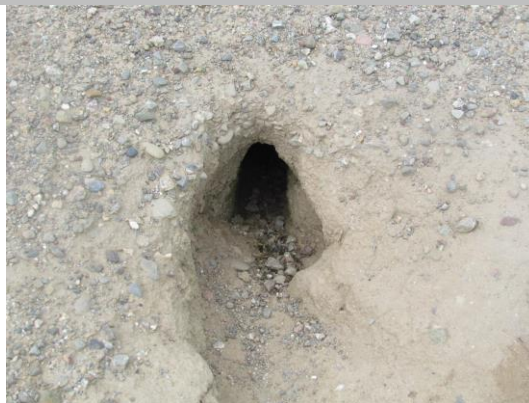
Photo 1 of 3 : SP_2019_RD0544_108_34_20190313_00023.jpg

LM Start	2.32	Rating **	U	Issue No.	34
LM End	2.36	Issue Type +	Ma	Location *	LS
Category	Earthen Levee			GPS Latitude/Longitude	
				Start	End
Item	Animal Control			37.847292 °	37.846743 °
				-121.324662 °	-121.324336 °
DWR ID	DWR_RD0544_01_s_2012_34				
Comment Code					
A1 : Exterminate rodents and backfill and compact or grout burrows.					
Inspector Comment					
There are several rodent holes within this reach.

Looking east at large rodent hole on landward slope.

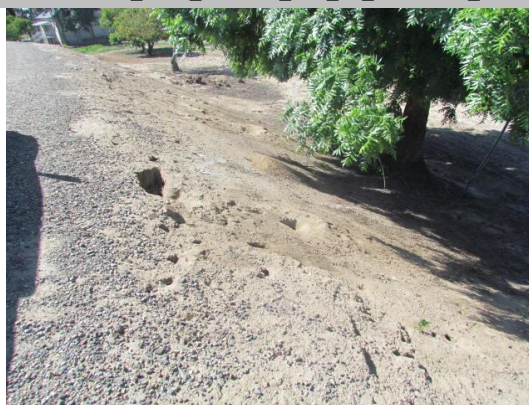
Photo 2 of 3 : SP_2019_RD0544_108_34_20190313_00024.jpg

Looking south at several rodent holes on landward shoulder and slope.

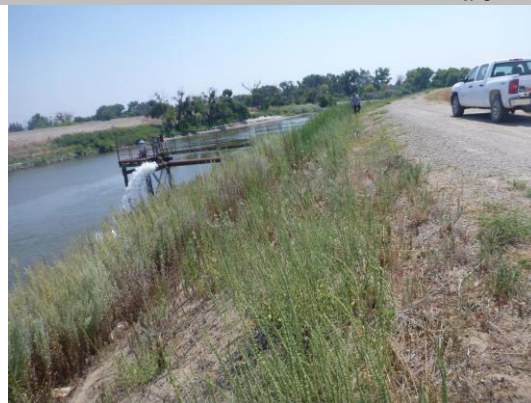
Photo 1 of 3 : LEVAL_SP_2019_567_4552.jpg

Item	2017 Storm Damage		37.844900 °	37.844500 °								
			-121.322300 °	-121.321900 °								
DWR ID	DWR_RD0544_01_f_2017_129											
Comment Code												
Inspector Comment												
<p>Levee Evaluation Comments</p> <p>Description: Slope protection repairs are needed along the waterside slope due to erosion and riprap displacement from high water. Based upon levee inspections, it was determined the waterside levee slope is eroding, deteriorating, and degrading. The eroded levee sections need to be restored back to design standards to prevent further deterioration and damage.</p> <p>Site ID No: 567</p> <p>Site Designation: LMA-473</p> <p>Repair Type: Erosion</p> <p>Rating: Area of Concern</p> <p>Field Date: 8/10/2017</p> <p>Notes: large rodent holes observed on landside slope.</p>

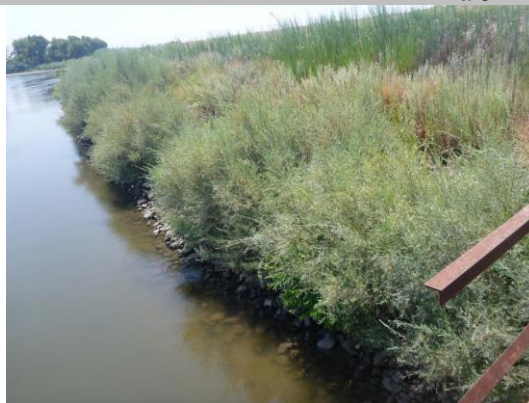
Photo 3 of 3 : LEVAL_SP_2019_567_4556.jpg

LM Start	2.53	Rating **	A/W	Issue No.	129 (cont)
LM End	2.56	Issue Type +	Ma	Location *	
Category	Supplemental			GPS Latitude/Longitude	
				Start	End
Item	2017 Storm Damage			37.844900 °	37.844500 °
				-121.322300 °	-121.321900 °
DWR ID	DWR_RD0544_01_f_2017_129				
Comment Code					
Inspector Comment					
Levee Evaluation Comments					
Description:Slope protection repairs are needed along the waterside slope due to erosion and riprap displacement from high water. Based upon levee inspections, it was determined the waterside levee slope is eroding, deteriorating, and degrading. The eroded levee sections need to be restored back to design standards to prevent further deterioration and damage.					
Site ID No:567					
Site Designation:LMA-473					
Repair Type: Erosion					
Rating:Area of Concern					
Field Date:8/10/2017					
Notes: large rodent holes observed on landside slope.

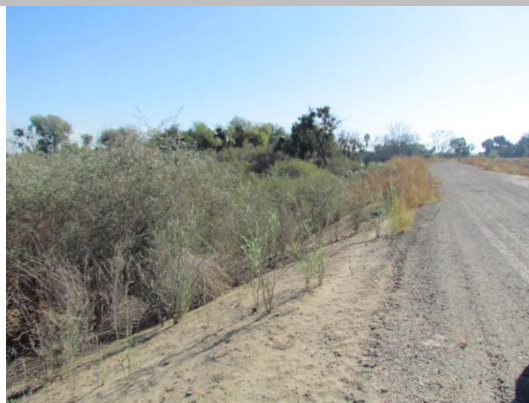
Photo 1 of 1 : SP_2019_RD0544_108_106_20190313_00066.jpg

LM Start	2.89	Rating **	U	Issue No.	106
LM End	3.16	Issue Type +	Ma	Location *	WS
Category	Earthen Levee			GPS Latitude/Longitude	
				Start	End
Item	Vegetation			37.840952 °	37.837588 °
				-121.319327 °	-121.317540 °
DWR ID	DWR_RD0544_01_s_2015_106				
Comment Code					
V2 : Remove the wild growth other than native grasses from the levee slopes.					
Inspector Comment					
There are dense willows and vegetation on the waterside slope.

Looking southeast at dense willows (veg) on waterward slope and toe, Fall 2015.

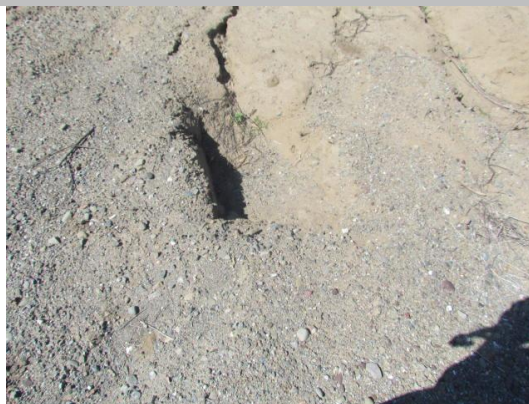
Photo 1 of 2 : SP_2019_RD0544_108_107_20190313_00067.jpg

LM Start	2.95	Rating **	M	Issue No.	107
LM End	2.96	Issue Type +	Ma	Location *	LS
Category	Earthen Levee			GPS Latitude/Longitude	
				Start	End
Item	Erosion / Bank Caving			37.840560 °	37.840467 °
				-121.318463 °	-121.318367 °
DWR ID	DWR_RD0544_01_s_2015_107				
Comment Code					
E1 : Note and monitor erosion site.					
Inspector Comment					
Several depressions are on the landside slope within this reach.

Looking south at depression on landward slope.

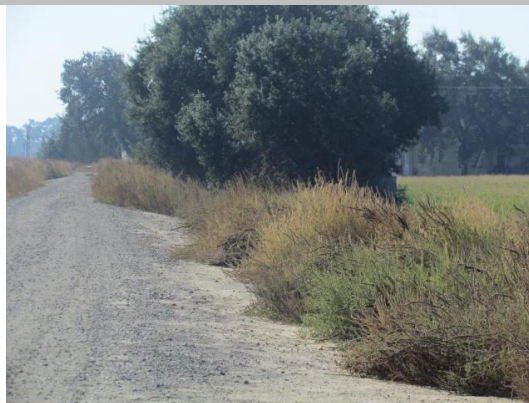
Photo 1 of 1 : SP_2019_RD0544_108_47_20190313_00036.jpg

LM Start	2.95	Rating **	M	Issue No.	47
LM End	3.19	Issue Type +	Ma	Location *	LS
Category	Earthen Levee			GPS Latitude/Longitude	
				Start	End
Item	Vegetation			37.840485 °	37.837225 °
				-121.318390 °	-121.317408 °
DWR ID	DWR_RD0544_01_s_2012_47				
Comment Code					
V2 : Remove the wild growth other than native grasses from the levee slopes.					
Inspector Comment

Looking south at dense veg on landward slope, Fall 2015.

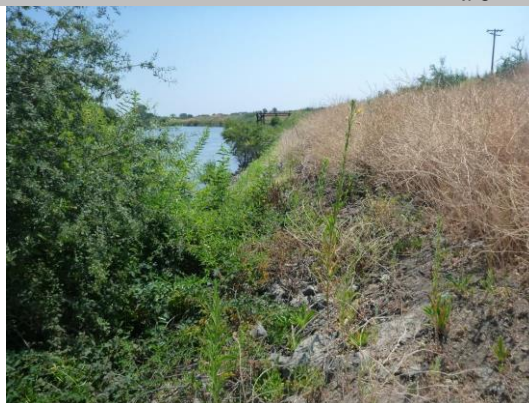
Photo 1 of 3 : LEVAL_SP_2019_566_4714.jpg

LM Start	3.21	Rating **	A/W	Issue No.	131
LM End	3.22	Issue Type +	Ma	Location *	
Category	Supplemental			GPS Latitude/Longitude	
				Start	End
Item	2017 Storm Damage			37.836900 °	37.836700 °
				-121.317300 °	-121.317300 °
DWR ID	DWR_RD0544_01_f_2017_131				
Comment Code					
Inspector Comment					
Levee Evaluation Comments					
Description:Slope protection repairs are needed along the waterside slope due to erosion and riprap displacement from high water. Based upon levee inspections, it was determined the waterside levee slope is eroding, deteriorating, and degrading. The eroded levee sections need to be restored back to design standards to prevent further deterioration and damage.					
Site ID No:566					
Site Designation:LMA-472					
Repair Type: Erosion					
Rating:Area of Concern					
Field Date:8/10/2017					
Notes:

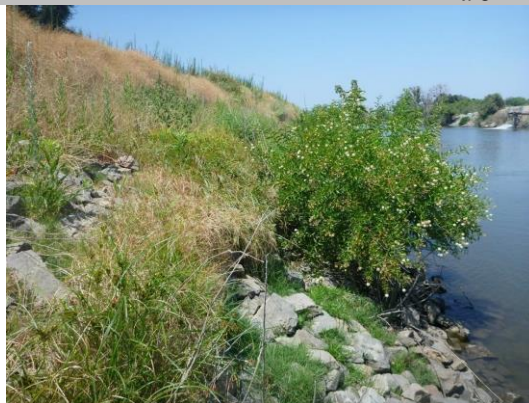
Photo 2 of 3 : LEVAL_SP_2019_566_4717.jpg

LM Start	3.21	Rating **	A/W	Issue No.	131 (cont)
LM End	3.22	Issue Type +	Ma	Location *	
Category	Supplemental			GPS Latitude/Longitude	
				Start	End
Item	2017 Storm Damage			37.836900 °	37.836700 °
				-121.317300 °	-121.317300 °
DWR ID	DWR_RD0544_01_f_2017_131				
Comment Code					
Inspector Comment					
Levee Evaluation Comments					
Description:Slope protection repairs are needed along the waterside slope due to erosion and riprap displacement from high water. Based upon levee inspections, it was determined the waterside levee slope is eroding, deteriorating, and degrading. The eroded levee sections need to be restored back to design standards to prevent further deterioration and damage.					
Site ID No:566					
Site Designation:LMA-472					
Repair Type: Erosion					
Rating:Area of Concern					
Field Date:8/10/2017					
Notes:

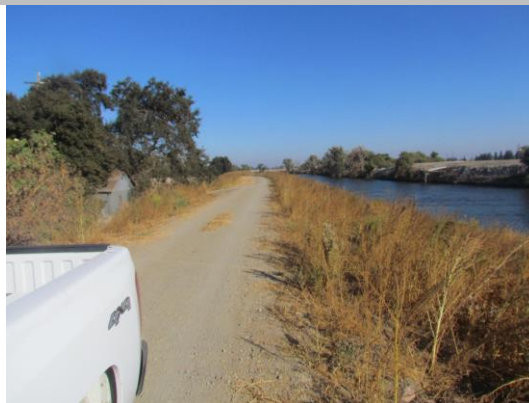
Photo 1 of 1 : SP_2019_RD0544_108_49_20190313_00038.jpg

LM Start	3.22	Rating **	U	Issue No.	49
LM End	3.67	Issue Type +	Ma	Location *	WS
Category	Earthen Levee			GPS Latitude/Longitude	
				Start	End
Item	Vegetation			37.836763 °	37.831494 °
				-121.317307 °	-121.312569 °
DWR ID	DWR_RD0544_01_s_2012_49				
Comment Code					
V2 : Remove the wild growth other than native grasses from the levee slopes.					
Inspector Comment					
There is dense vegetation on the waterside slope.

Looking northeast at dense veg on waterward slope.

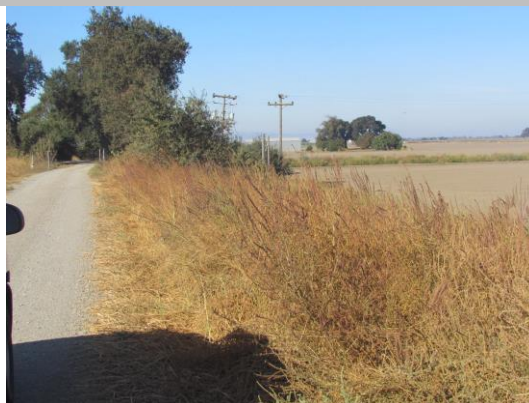
Photo 1 of 1 : SP_2019_RD0544_108_48_20190313_00037.jpg

LM Start	3.23	Rating **	U	Issue No.	48
LM End	3.26	Issue Type +	Ma	Location *	LS
Category	Earthen Levee			GPS Latitude/Longitude	
				Start	End
Item	Vegetation			37.836615 °	37.836133 °
				-121.317285 °	-121.317153 °
DWR ID	DWR_RD0544_01_s_2012_48				
Comment Code					
V2 : Remove the wild growth other than native grasses from the levee slopes.					
Inspector Comment

Looking south at typical view of dense veg on landward slope.

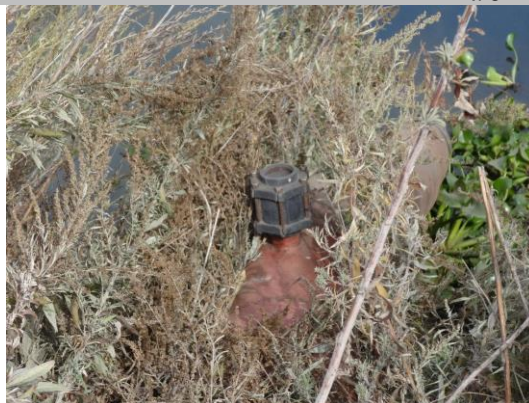
Photo 1 of 3 : UCIP_SP_2019_24892_44853.jpg

Comment Code					
Inspector Comment					
FS_ID:24892 DS_ID:22658 EP_NO: N/A Repair Type: No Action Needed Crossing Status: Found UCIP Comments: - pipe on channel bank looks comparatively new.- pump approximately 500 ft. from the levee center on landside in drainage ditch.- a tall concrete standpipe and service pole near the pump. FIELD_STRUCT_DESC: 12-inch steel drainage discharge pipe through the levee, 3 feet below the crown. Pump and concrete standpipe in a drainage ditch on the landside (LS). Air vent on the waterside (WS). [Additional Reference(s): DWR Levee Log, 2005. USACE San Joaquin O&M Manual 7, April 1964, (HLM 3.53)]. FS Date: 10/29/2013

WS view: exposed steel pipe on bank of the channel.

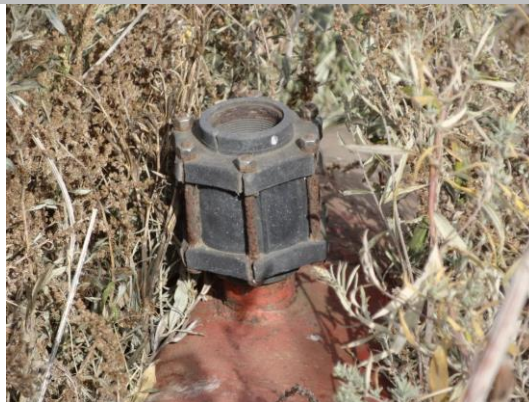
Photo 2 of 3 : UCIP_SP_2019_24892_44852.jpg

WS view: exposed steel pipe and air vent on the pipe.

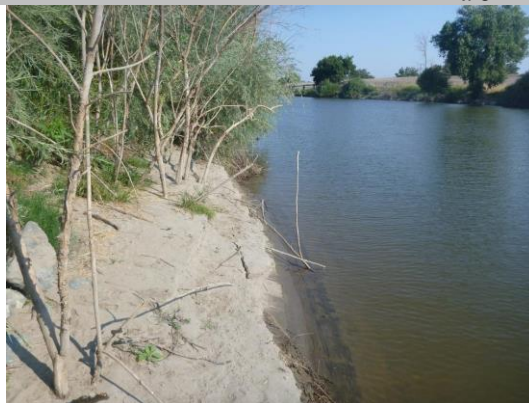
Photo 3 of 3 : LEVAL_SP_2019_565_4745.jpg

LM Start	3.65	Rating **	A/W	Issue No.	132 (cont)	
LM End	3.67	Issue Type +	Ma	Location *		
Category	Supplemental			GPS Latitude/Longitude		
				Start		End
Item	2017 Storm Damage			37.831800 °		37.831600 °
				-121.312700 °		-121.312600 °
DWR ID	DWR_RD0544_01_f_2017_132					
Comment Code						
Inspector Comment						
Levee Evaluation Comments						
Description:Slope protection repairs are needed along the waterside slope due to erosion and riprap displacement from high water. Based upon levee inspections, it was determined the waterside levee slope is eroding, deteriorating, and degrading. The eroded levee sections need to be restored back to design standards to prevent further deterioration and damage.						
Site ID No:565						
Site Designation:LMA-471						
Repair Type: Erosion						
Rating:Area of Concern						
Field Date:8/11/2017						
Notes: dense shrubs on levee slope

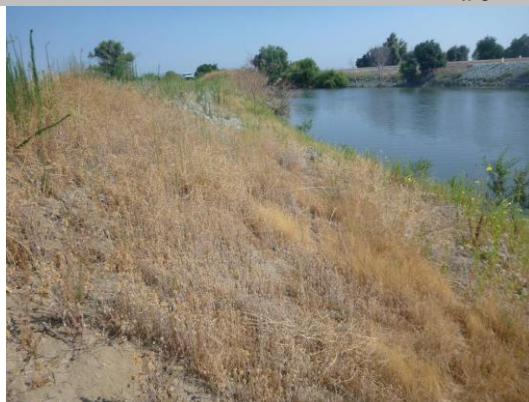
Photo 1 of 3 : LEVAL_SP_2019_564_4748.jpg

LM Start	3.69	Rating **	A/W	Issue No.	133
LM End	3.73	Issue Type +	Ma	Location *	
Category	Supplemental			GPS Latitude/Longitude	
				Start	End
Item	2017 Storm Damage			37.831300 °	37.830700 °
				-121.312600 °	-121.312300 °
DWR ID	DWR_RD0544_01_f_2017_133				
Comment Code					
Inspector Comment					
Levee Evaluation Comments					
Description:Slope protection repairs are needed along the waterside slope due to erosion and riprap displacement from high water. Based upon levee inspections, it was determined the waterside levee slope is eroding, deteriorating, and degrading. The eroded levee sections need to be restored back to design standards to prevent further deterioration and damage.					
Site ID No:564					
Site Designation:LMA-470					
Repair Type: Erosion					
Rating:Area of Concern					
Field Date:8/11/2017					
Notes: big rodent holes on levee slopes

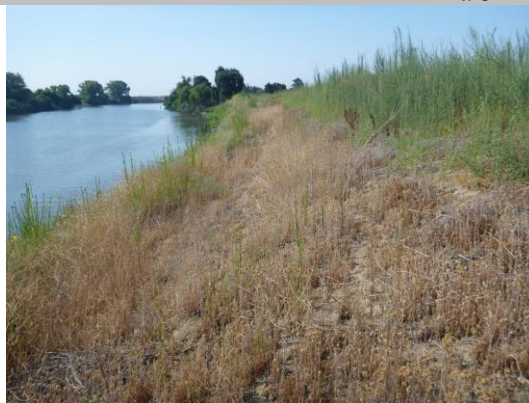
Photo 2 of 3 : LEVAL_SP_2019_564_4750.jpg

LM Start	3.69	Rating **	A/W	Issue No.	133 (cont)
LM End	3.73	Issue Type +	Ma	Location *	
Category	Supplemental			GPS Latitude/Longitude	
				Start	End
Item	2017 Storm Damage			37.831300 °	37.830700 °
				-121.312600 °	-121.312300 °
DWR ID	DWR_RD0544_01_f_2017_133				
Comment Code					
Inspector Comment					
Levee Evaluation Comments					
Description:Slope protection repairs are needed along the waterside slope due to erosion and riprap displacement from high water. Based upon levee inspections, it was determined the waterside levee slope is eroding, deteriorating, and degrading. The eroded levee sections need to be restored back to design standards to prevent further deterioration and damage.					
Site ID No:564					
Site Designation:LMA-470					
Repair Type: Erosion					
Rating:Area of Concern					
Field Date:8/11/2017					
Notes: big rodent holes on levee slopes

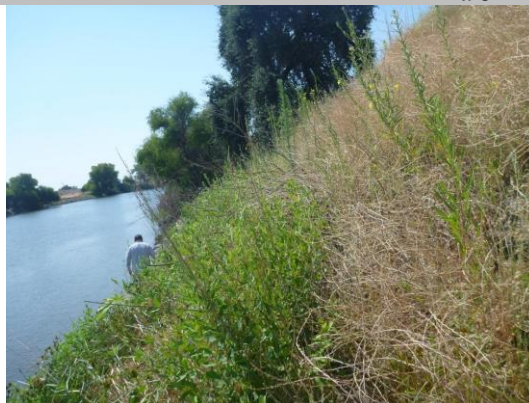
Photo 1 of 3 : LEVAL_SP_2019_562_4770.jpg

LM Start	3.81	Rating **	A/W	Issue No.	135
LM End	3.82	Issue Type +	Ma	Location *	
Category	Supplemental			GPS Latitude/Longitude	
				Start	End
Item	2017 Storm Damage			37.829600 °	37.829400 °
				-121.312000 °	-121.312000 °
DWR ID	DWR_RD0544_01_f_2017_135				
Comment Code					
Inspector Comment					
Levee Evaluation Comments					
Description:Slope protection repairs are needed along the waterside slope due to erosion and riprap displacement from high water. Based upon levee inspections, it was determined the waterside levee slope is eroding, deteriorating, and degrading. The eroded levee sections need to be restored back to design standards to prevent further deterioration and damage.					
Site ID No:562					
Site Designation:LMA-468					
Repair Type: Erosion					
Rating:Serious					
Field Date:8/11/2017					
Notes: Site combined with LMA-469;

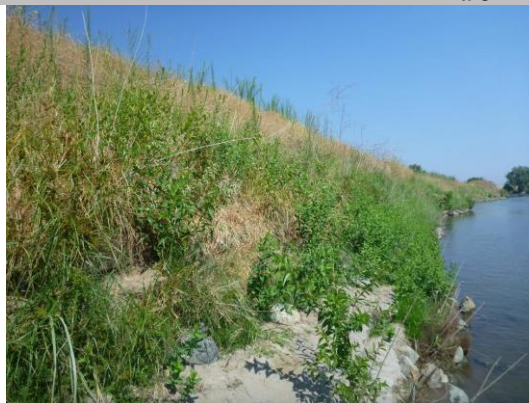
Photo 3 of 3 : LEVAL_SP_2019_562_4836.jpg

LM Start	3.81	Rating **	A/W	Issue No.	135 (cont)	
LM End	3.82	Issue Type +	Ma	Location *		
Category	Supplemental			GPS Latitude/Longitude		
				Start	End	
Item	2017 Storm Damage			37.829600 °	37.829400 °	
				-121.312000 °	-121.312000 °	
DWR ID	DWR_RD0544_01_f_2017_135					
Comment Code						
Inspector Comment						
Levee Evaluation Comments						
Description:Slope protection repairs are needed along the waterside slope due to erosion and riprap displacement from high water. Based upon levee inspections, it was determined the waterside levee slope is eroding, deteriorating, and degrading. The eroded levee sections need to be restored back to design standards to prevent further deterioration and damage.						
Site ID No:562						
Site Designation:LMA-468						
Repair Type: Erosion						
Rating:Serious						
Field Date:8/11/2017						
Notes: Site combined with LMA-469;

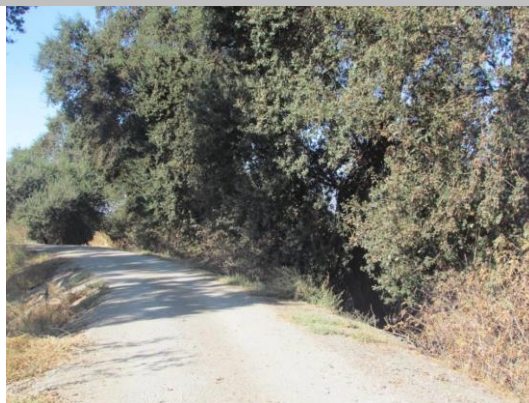
Photo 1 of 1 : SP_2019_RD0544_108_120_20190313_00077.jpg

LM Start	4.25	Rating **	U	Issue No.	120
LM End	4.28	Issue Type +	Ma	Location *	LS
Category	Earthen Levee			GPS Latitude/Longitude	
				Start	End
Item	Trim / Thin Trees			37.825482 °	37.825229 °
				-121.314298 °	-121.314771 °
DWR ID	DWR_RD0544_01_f_2015_120				
Comment Code					
T1 : Trim trees to at least five feet above ground level.					
Inspector Comment					
There are several untrimmed trees on the landside slope.

Looking southwest at untrimmed trees on landward slope.

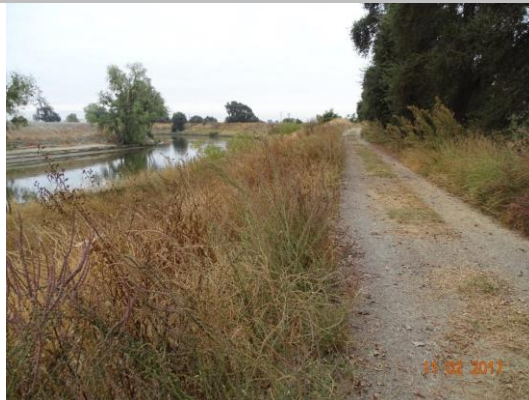
Photo 1 of 2 : SP_2019_RD0544_108_117_20190313_00071.jpg

LM Start	4.41	Rating **	U	Issue No.	117
LM End	4.79	Issue Type +	Ma	Location *	WS
Category	Earthen Levee			GPS Latitude/Longitude	
				Start	End
Item	Vegetation			37.823522 °	37.820557 °
				-121.315735 °	-121.321217 °
DWR ID	DWR_RD0544_01_s_2017_117				
Comment Code					
V2 : Remove the wild growth other than native grasses from the levee slopes.					
Inspector Comment

Looking southwest at the waterside slope.

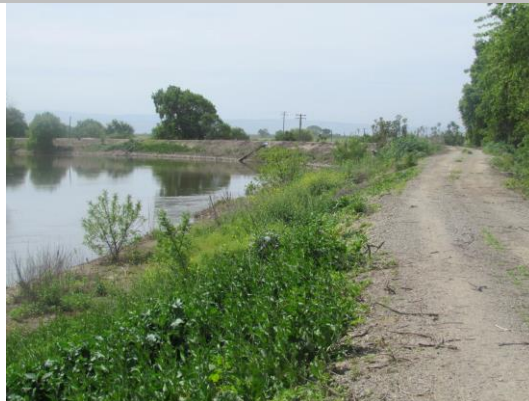
Photo 2 of 2 : SP_2019_RD0544_108_117_20190313_00072.jpg

Looking south at dense veg on waterward slope.

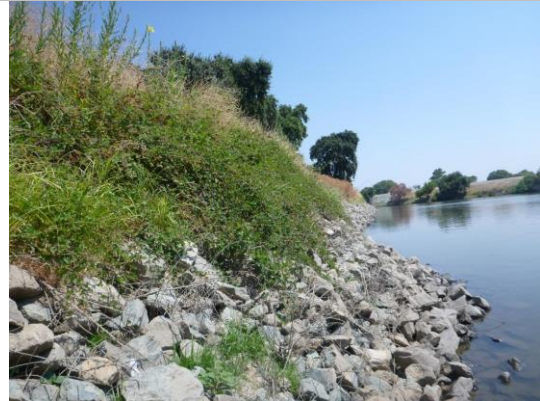
Photo 3 of 3 : LEVAL_SP_2019_561_4867.jpg

Item	2017 Storm Damage			37.823200 °	37.823000 °	
				-121.316400 °	-121.316800 °	
DWR ID	DWR_RD0544_01_f_2017_136					
Comment Code						
Inspector Comment						
Levee Evaluation Comments						
Description:Slope protection repairs are needed along the waterside slope due to erosion and riprap displacement from high water. Based upon levee inspections, it was determined the waterside levee slope is eroding, deteriorating, and degrading. The eroded levee sections need to be restored back to design standards to prevent further deterioration and damage.						
Site ID No:561						
Site Designation:LMA-467						
Repair Type: Erosion						
Rating:Area of Concern						
Field Date:8/11/2017						
Notes: site combined with LMA-466 in field; length and coordinates redefined in field.

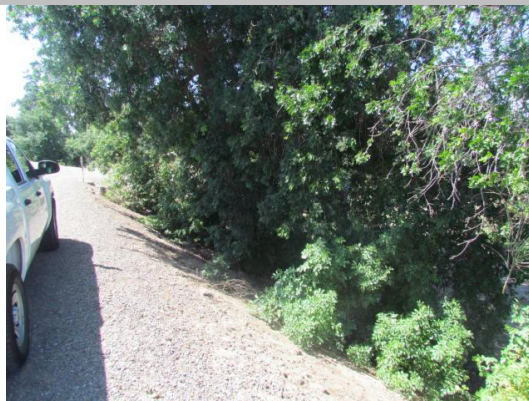
Photo 1 of 1 : SP_2019_RD0544_108_112_20190313_00069.jpg

LM Start	4.77	Rating **	M	Issue No.	112
LM End	4.77	Issue Type +	Ma	Location *	LS
Category	Earthen Levee			GPS Latitude/Longitude	
				Start	End
Item	Trim / Thin Trees			37.820828 °	37.820828 °
				-121.321193 °	-121.321193 °
DWR ID	DWR_RD0544_01_s_2015_112				
Comment Code					
T1 : Trim trees to at least five feet above ground level.					
Inspector Comment

Looking southwest at dense trees on landward slope and toe.

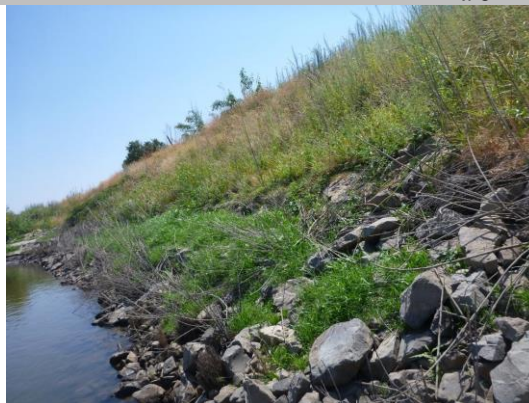
Photo 3 of 3 : LEVAL_SP_2019_559_4894.jpg

LM Start	4.97	Rating **	A/W	Issue No.	139 (cont)	
LM End	4.99	Issue Type +	Ma	Location *		
Category	Supplemental			GPS Latitude/Longitude		
				Start	End	
Item	2017 Storm Damage			37.818600 °	37.818400 °	
				-121.319200 °	-121.319000 °	
DWR ID	DWR_RD0544_01_f_2017_139					
Comment Code						
Inspector Comment						
Levee Evaluation Comments						
Description:Slope protection repairs are needed along the waterside slope due to erosion and riprap displacement from high water. Based upon levee inspections, it was determined the waterside levee slope is eroding, deteriorating, and degrading. The eroded levee sections need to be restored back to design standards to prevent further deterioration and damage.						
Site ID No:559						
Site Designation:LMA-465						
Repair Type: Erosion						
Rating:Serious						
Field Date:8/11/2017						
Notes:

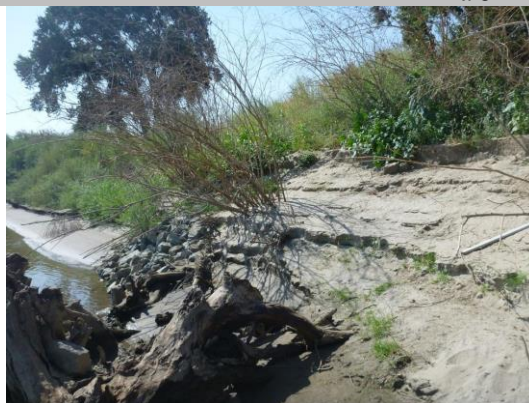
Photo 1 of 3 : LEVAL_SP_2019_558_4900.jpg

LM Start	5.32	Rating **	A/W	Issue No.	140
LM End	5.36	Issue Type +	Ma	Location *	
Category	Supplemental			GPS Latitude/Longitude	
				Start	End
Item	2017 Storm Damage			37.813900 °	37.813500 °
				-121.319900 °	-121.319400 °
DWR ID	DWR_RD0544_01_f _ 2017_140				
Comment Code					
Inspector Comment					
Levee Evaluation Comments					
Description:Slope protection repairs are needed along the waterside slope due to erosion and riprap displacement from high water. Based upon levee inspections, it was determined the waterside levee slope is eroding, deteriorating, and degrading. The eroded levee sections need to be restored back to design standards to prevent further deterioration and damage.					
Site ID No:558					
Site Designation:LMA-464					
Repair Type: Erosion					
Rating:Serious					
Field Date:8/16/2017					
Notes:

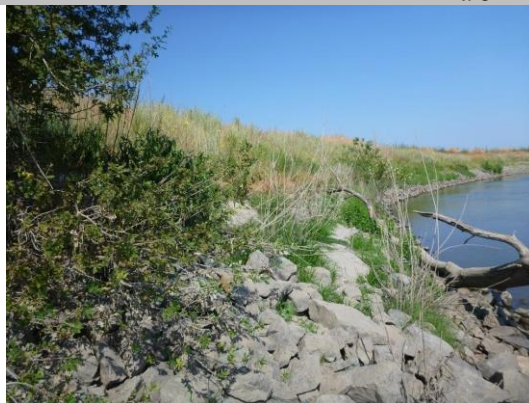
Photo 2 of 3 : LEVAL_SP_2019_558_4904.jpg

LM Start	5.32	Rating **	A/W	Issue No.	140 (cont)
LM End	5.36	Issue Type +	Ma	Location *	
Category	Supplemental			GPS Latitude/Longitude	
				Start	End
Item	2017 Storm Damage			37.813900 °	37.813500 °
				-121.319900 °	-121.319400 °
DWR ID	DWR_RD0544_01_f_2017_140				
Comment Code					
Inspector Comment					
Levee Evaluation Comments					
Description:Slope protection repairs are needed along the waterside slope due to erosion and riprap displacement from high water. Based upon levee inspections, it was determined the waterside levee slope is eroding, deteriorating, and degrading. The eroded levee sections need to be restored back to design standards to prevent further deterioration and damage.					
Site ID No:558					
Site Designation:LMA-464					
Repair Type: Erosion					
Rating:Serious					
Field Date:8/16/2017					
Notes:

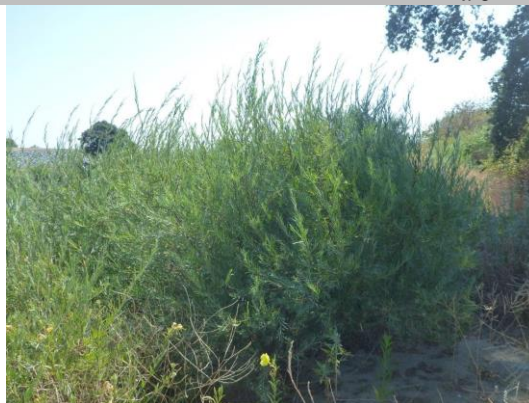
Photo 3 of 3 : LEVAL_SP_2019_557_4514.jpg

LM Start	5.36	Rating **	A/W	Issue No.	141 (cont)
LM End	5.37	Issue Type +	Ma	Location *	
Category	Supplemental			GPS Latitude/Longitude	
				Start	End
Item	2017 Storm Damage			37.813400 °	37.813300 °
				-121.319300 °	-121.319200 °
DWR ID	DWR_RD0544_01_f_2017_141				
Comment Code					
Inspector Comment					
Levee Evaluation Comments					
Description:Slope protection repairs are needed along the waterside slope due to erosion and riprap displacement from high water. Based upon levee inspections, it was determined the waterside levee slope is eroding, deteriorating, and degrading. The eroded levee sections need to be restored back to design standards to prevent further deterioration and damage.					
Site ID No:557					
Site Designation:LMA-463					
Repair Type: Erosion					
Rating:Area of Concern					
Field Date:8/16/2017					
Notes:

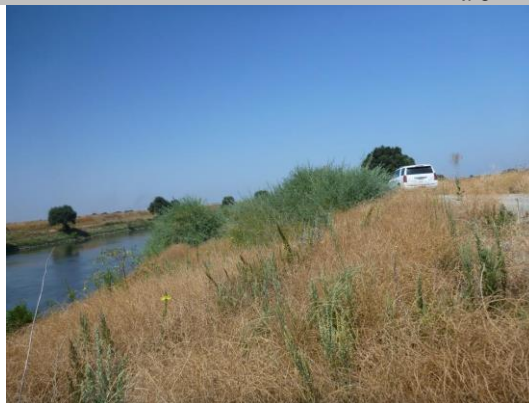
Photo 1 of 3 : LEVAL_SP_2019_556_4520.jpg

LM Start	0.21	Rating **	A/W	Issue No.	37
LM End	0.23	Issue Type +	Ma	Location *	
Category	Supplemental			GPS Latitude/Longitude	
				Start	End
Item	2017 Storm Damage			37.808300 °	37.808400 °
				-121.332000 °	-121.332200 °
DWR ID	DWR_RD0544_02_f_2017_37				
Comment Code					
Inspector Comment					
Levee Evaluation Comments					
Description:Slope protection repairs are needed along the waterside slope due to erosion and riprap displacement from high water. Based upon levee inspections, it was determined the waterside levee slope is eroding, deteriorating, and degrading. The eroded levee sections need to be restored back to design standards to prevent further deterioration and damage.					
Site ID No:556					
Site Designation:LMA-462					
Repair Type: Erosion					
Rating:Area of Concern					
Field Date:8/16/2017					
Notes:

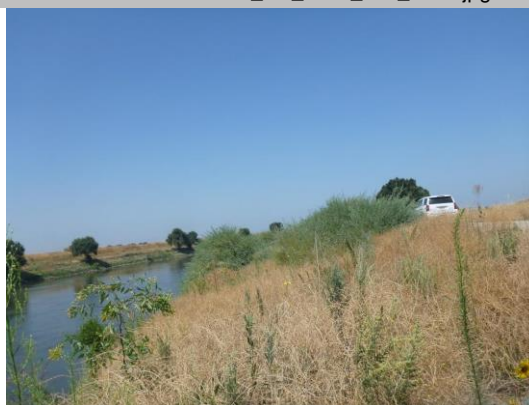
Photo 2 of 3 : LEVAL_SP_2019_556_4521.jpg

LM Start	0.21	Rating **	A/W	Issue No.	37 (cont)
LM End	0.23	Issue Type +	Ma	Location *

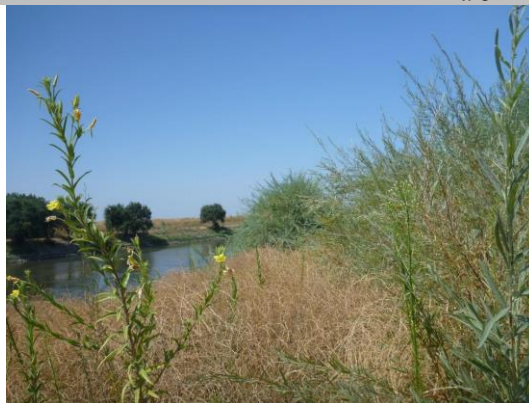
Photo 3 of 3 : LEVAL_SP_2019_556_4522.jpg

LM Start	0.21	Rating **	A/W	Issue No.	37 (cont)
LM End	0.23	Issue Type +	Ma	Location *	
Category	Supplemental			GPS Latitude/Longitude	
				Start	End
Item	2017 Storm Damage			37.808300 °	37.808400 °
				-121.332000 °	-121.332200 °
DWR ID	DWR_RD0544_02_f_2017_37				
Comment Code					
Inspector Comment					
Levee Evaluation Comments					
Description:Slope protection repairs are needed along the waterside slope due to erosion and riprap displacement from high water. Based upon levee inspections, it was determined the waterside levee slope is eroding, deteriorating, and degrading. The eroded levee sections need to be restored back to design standards to prevent further deterioration and damage.					
Site ID No:556					
Site Designation:LMA-462					
Repair Type: Erosion					
Rating:Area of Concern					
Field Date:8/16/2017					
Notes:

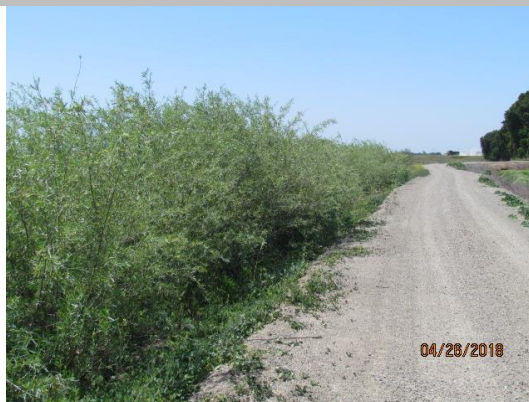
Photo 1 of 1 : SP_2019_RD0544_109_2_20190313_00002.jpg

LM Start	0.21	Rating **	U	Issue No.	2
LM End	0.26	Issue Type +	Ma	Location *	WS
Category	Earthen Levee			GPS Latitude/Longitude	
				Start	End
Item	Vegetation			37.808331 °	37.808576 °
				-121.331997 °	-121.332672 °
DWR ID	DWR_RD0544_02_s_2018_2				
Comment Code					
V2 : Remove the wild growth other than native grasses from the levee slopes.					
Inspector Comment

Looking southeast at dense veg on waterward slope. (Spring 2018)

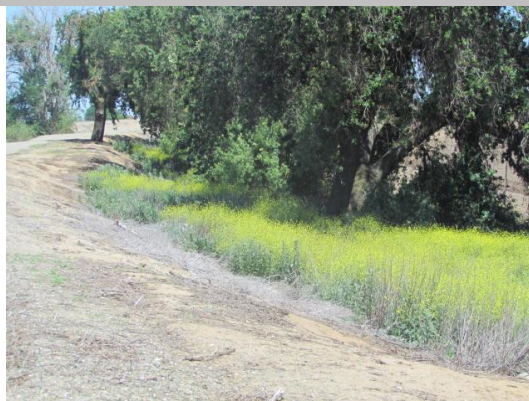
Photo 1 of 1 : SP_2019_RD0544_109_1_20190313_00001.jpg

LM Start	0.43	Rating **	M	Issue No.	1
LM End	1.12	Issue Type +	Ma	Location *	LS
Category	Earthen Levee			GPS Latitude/Longitude	
				Start	End
Item	Vegetation			37.810250 °	37.819452 °
				-121.334933 °	-121.333755 °
DWR ID	DWR_RD0544_02_s_2012_1				
Comment Code					
V2 : Remove the wild growth other than native grasses from the levee slopes.					
Inspector Comment

Looking southwest at dense vegetation at landward toe.

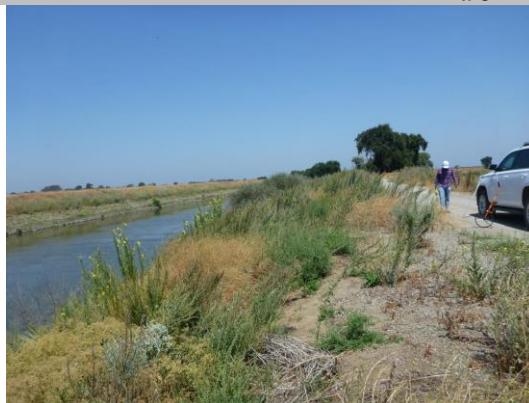
Photo 1 of 3 : LEVAL_SP_2019_555_4527.jpg

LM Start	0.44	Rating **	A/W	Issue No.	70
LM End	0.46	Issue Type +	Ma	Location *	
Category	Supplemental		GPS Latitude/Longitude		
			Start	End	
Item	2017 Storm Damage		37.810400 °	37.810700 °	
			-121.335000 °	-121.335000 °	
DWR ID	DWR_RD0544_02_f_2017_70				
Comment Code					
Inspector Comment					
Levee Evaluation Comments Description: Slope protection repairs are needed along the waterside slope due to erosion and riprap displacement from high water. Based upon levee inspections, it was determined the waterside levee slope is eroding, deteriorating, and degrading. The eroded levee sections need to be restored back to design standards to prevent further deterioration and damage. Site ID No: 555 Site Designation: LMA-461 Repair Type: Erosion Rating: Area of Concern Field Date: 8/16/2017 Notes:

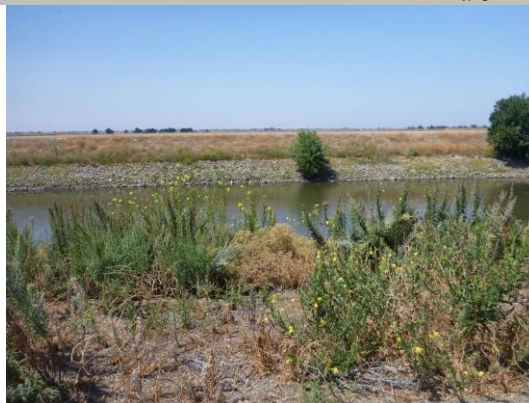
Photo 3 of 3 : LEVAL_SP_2019_555_4626.jpg

LM Start	0.44	Rating **	A/W	Issue No.	70 (cont)
LM End	0.46	Issue Type +	Ma	Location *	
Category	Supplemental		GPS Latitude/Longitude		
			Start	End	
Item	2017 Storm Damage		37.810400 °	37.810700 °	
			-121.335000 °	-121.335000 °	
DWR ID	DWR_RD0544_02_f_2017_70				
Comment Code					
Inspector Comment					
<p>Levee Evaluation Comments</p> <p>Description: Slope protection repairs are needed along the waterside slope due to erosion and riprap displacement from high water. Based upon levee inspections, it was determined the waterside levee slope is eroding, deteriorating, and degrading. The eroded levee sections need to be restored back to design standards to prevent further deterioration and damage.</p> <p>Site ID No: 555</p> <p>Site Designation: LMA-461</p> <p>Repair Type: Erosion</p> <p>Rating: Area of Concern</p> <p>Field Date: 8/16/2017</p> <p>Notes:</p>

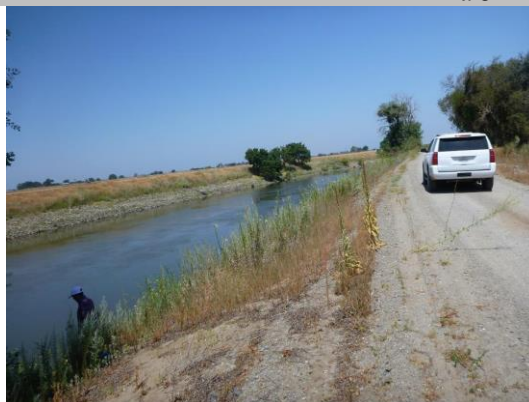
Photo 1 of 3 : LEVAL_SP_2019_554_4630.jpg

LM Start	0.57	Rating **	A/W	Issue No.	80
LM End	0.58	Issue Type +	Ma	Location *	
Category	Supplemental		GPS Latitude/Longitude		
			Start	End	
Item	2017 Storm Damage		37.812300 °	37.812400 °	
			-121.335100 °	-121.335100 °	
DWR ID	DWR_RD0544_02_f_2017_80				
Comment Code					
Inspector Comment					
<p>Levee Evaluation Comments</p> <p>Description: Slope protection repairs are needed along the waterside slope due to erosion and riprap displacement from high water. Based upon levee inspections, it was determined the waterside levee slope is eroding, deteriorating, and degrading. The eroded levee sections need to be restored back to design standards to prevent further deterioration and damage.</p> <p>Site ID No: 554</p> <p>Site Designation: LMA-460</p> <p>Repair Type: Erosion</p> <p>Rating: Area of Concern</p> <p>Field Date: 8/16/2017</p> <p>Notes:</p>

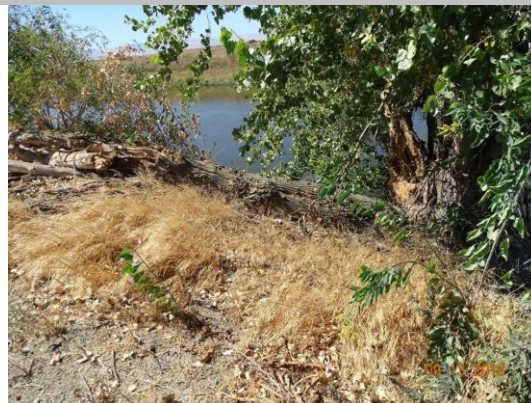
Photo 1 of 2 : SP_2019_RD0544_109_27_20190313_00019.jpg

LM Start	0.64	Rating **	U	Issue No.	27
LM End	0.64	Issue Type +	Ma	Location *	WS
Category	Earthen Levee			GPS Latitude/Longitude	
				Start	End
Item	Encroachments			37.813307 °	37.813307 °
				-121.335135 °	-121.335135 °
DWR ID	DWR_RD0544_02_f_2018_27				
Comment Code					
TR : Tree or limb					
Inspector Comment

Looking east at tree trunk on waterside slope. (Fall 2018)

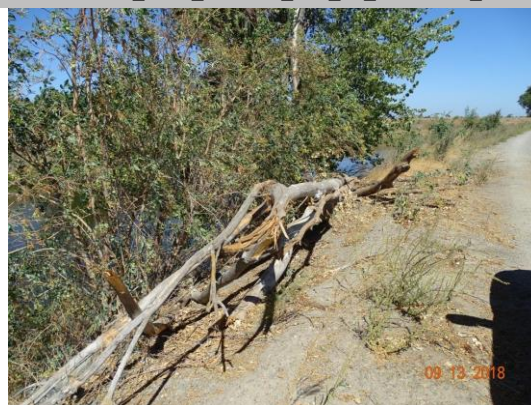
Photo 2 of 2 : SP_2019_RD0544_109_27_20190313_00020.jpg

Looking southeast at tree limbs on waterward shoulder. (Fall 2018)

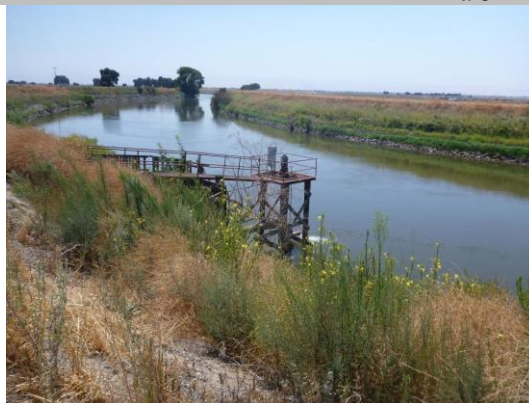
Photo 3 of 3 : LEVAL_SP_2019_552_4813.jpg

LM Start	1.01	Rating **	A/W	Issue No.	82 (cont)
LM End	1.02	Issue Type +	Ma	Location *	
Category	Supplemental			GPS Latitude/Longitude	
				Start	End
Item	2017 Storm Damage			37.818100 °	37.818200 °
				-121.332800 °	-121.332800 °
DWR ID	DWR_RD0544_02_f_2017_82				
Comment Code					
Inspector Comment					
Levee Evaluation Comments					
Description:Slope protection repairs are needed along the waterside slope due to erosion and riprap displacement from high water. Based upon levee inspections, it was determined the waterside levee slope is eroding, deteriorating, and degrading. The eroded levee sections need to be restored back to design standards to prevent further deterioration and damage.					
Site ID No:552					
Site Designation:LMA-458					
Repair Type: Erosion					
Rating:Area of Concern					
Field Date:8/16/2017					
Notes:

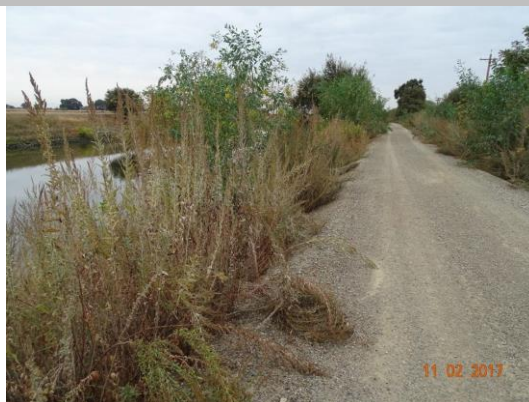
Photo 1 of 1 : SP_2019_RD0544_109_101_20190313_00087.jpg

LM Start	1.29	Rating **	U	Issue No.	101
LM End	1.56	Issue Type +	Ma	Location *	WS
Category	Earthen Levee			GPS Latitude/Longitude	
				Start	End
Item	Vegetation			37.820668 °	37.822239 °
				-121.336491 °	-121.340589 °
DWR ID	DWR_RD0544_02_f_2017_101				
Comment Code					
V2 : Remove the wild growth other than native grasses from the levee slopes.					
Inspector Comment

Looking northwest at the waterside slope.

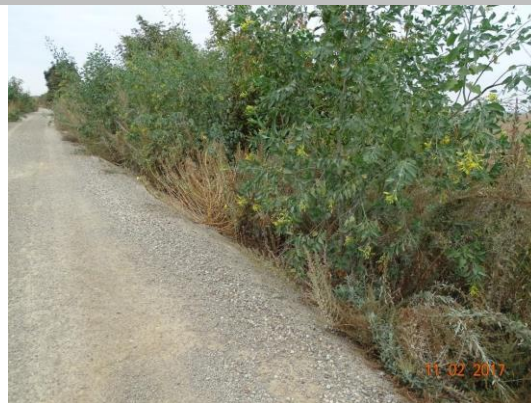
Photo 1 of 1 : SP_2019_RD0544_109_102_20190313_00088.jpg

LM Start	1.29	Rating **	U	Issue No.	102
LM End	1.56	Issue Type +	Ma	Location *	LS
Category	Earthen Levee			GPS Latitude/Longitude	
				Start	End
Item	Vegetation			37.820668 °	37.822239 °
				-121.336491 °	-121.340589 °
DWR ID	DWR_RD0544_02_f_2017_102				
Comment Code					
V2 : Remove the wild growth other than native grasses from the levee slopes.					
Inspector Comment

Looking northwest at the landside slope.

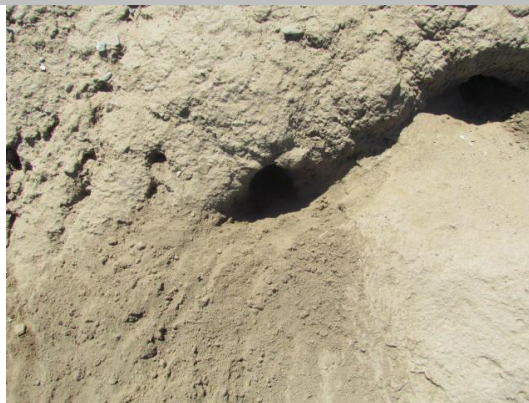
Photo 1 of 1 : SP_2019_RD0544_109_58_20190313_00038.jpg

LM Start	2.02	Rating **	U	Issue No.	58
LM End	2.09	Issue Type +	Ma	Location *	LS
Category	Earthen Levee			GPS Latitude/Longitude	
				Start	End
Item	Animal Control			37.818853 °	37.819493 °
				-121.343473 °	-121.344545 °
DWR ID	DWR_RD0544_02_s_2015_58				
Comment Code					
A1 : Exterminate rodents and backfill and compact or grout burrows.					
Inspector Comment					
Several rodent holes within reach on landside slope.

Looking at typical rodent holes on landward slope.

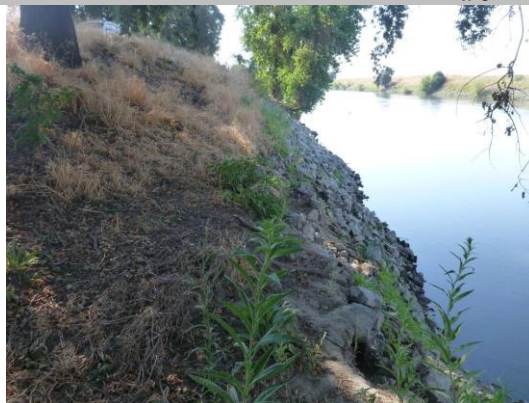
Photo 1 of 3 : LEVAL_SP_2019_551_4817.jpg

LM Start	2.17	Rating **	A/W	Issue No.	87
LM End	2.18	Issue Type +	Ma	Location *	
Category	Supplemental		GPS Latitude/Longitude		
			Start	End	
Item	2017 Storm Damage		37.820300 °	37.820300 °	
			-121.345600 °	-121.345700 °	
DWR ID	DWR_RD0544_02_f_2017_87				
Comment Code					
Inspector Comment					
<p>Levee Evaluation Comments</p> <p>Description: Slope protection repairs are needed along the waterside slope due to erosion and riprap displacement from high water. Based upon levee inspections, it was determined the waterside levee slope is eroding, deteriorating, and degrading. The eroded levee sections need to be restored back to design standards to prevent further deterioration and damage.</p> <p>Site ID No: 551</p> <p>Site Designation: LMA-457</p> <p>Repair Type: Erosion</p> <p>Rating: Serious</p> <p>Field Date: 8/18/2017</p> <p>Notes:</p>

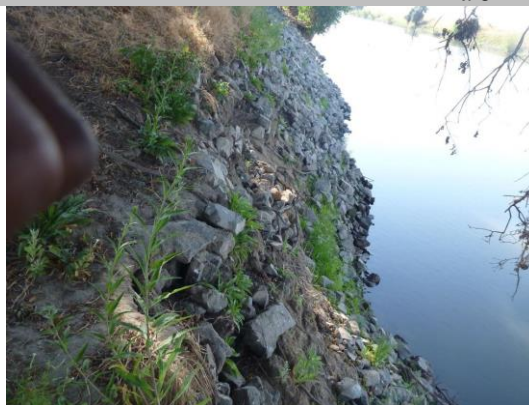
Photo 2 of 3 : LEVAL_SP_2019_551_4818.jpg

LM Start	2.17	Rating **	A/W	Issue No.	87 (cont)
LM End	2.18	Issue Type +	Ma	Location *

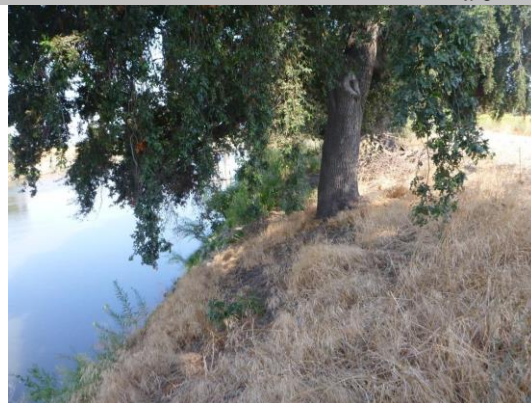
Photo 3 of 3 : LEVAL_SP_2019_551_4824.jpg

LM Start	2.17	Rating **	A/W	Issue No.	87 (cont)
LM End	2.18	Issue Type +	Ma	Location *	
Category	Supplemental			GPS Latitude/Longitude	
				Start	End
Item	2017 Storm Damage			37.820300 °	37.820300 °
				-121.345600 °	-121.345700 °
DWR ID	DWR_RD0544_02_f_2017_87				
Comment Code					
Inspector Comment					
<p>Levee Evaluation Comments</p> <p>Description: Slope protection repairs are needed along the waterside slope due to erosion and riprap displacement from high water. Based upon levee inspections, it was determined the waterside levee slope is eroding, deteriorating, and degrading. The eroded levee sections need to be restored back to design standards to prevent further deterioration and damage.</p> <p>Site ID No: 551</p> <p>Site Designation: LMA-457</p> <p>Repair Type: Erosion</p> <p>Rating: Serious</p> <p>Field Date: 8/18/2017</p> <p>Notes:</p>

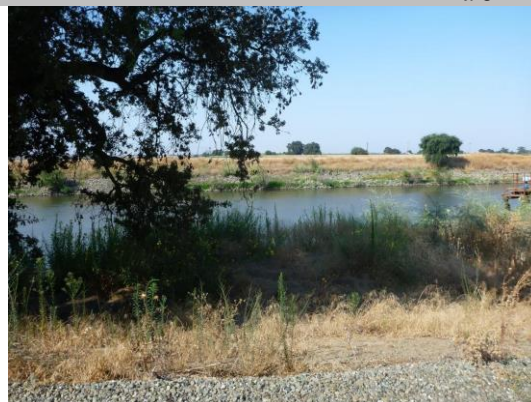
Photo 1 of 4 : LEVAL_SP_2019_550_4832.jpg

LM Start	2.18	Rating **	A/W	Issue No.	88
LM End	2.19	Issue Type +	Ma	Location *	
Category	Supplemental			GPS Latitude/Longitude	
				Start	End
Item	2017 Storm Damage			37.820400 °	37.820500 °
				-121.345800 °	-121.345900 °
DWR ID	DWR_RD0544_02_f_2017_88				
Comment Code					
Inspector Comment					
<p>Levee Evaluation Comments</p> <p>Description: Slope protection repairs are needed along the waterside slope due to erosion and riprap displacement from high water. Based upon levee inspections, it was determined the waterside levee slope is eroding, deteriorating, and degrading. The eroded levee sections need to be restored back to design standards to prevent further deterioration and damage.</p> <p>Site ID No: 550</p> <p>Site Designation: LMA-456</p> <p>Repair Type: Erosion</p> <p>Rating: Area of Concern</p> <p>Field Date: 8/18/2017</p> <p>Notes:</p>

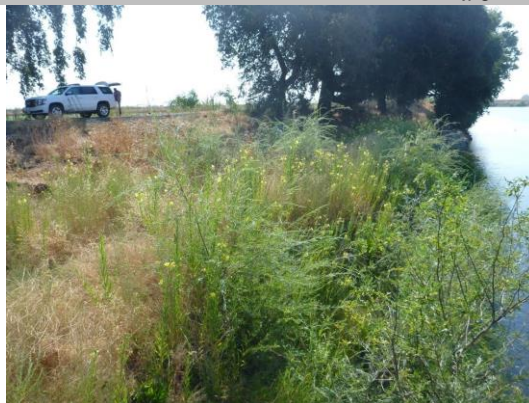
Photo 4 of 4 : LEVAL_SP_2019_550_4575.jpg

LM Start	2.18	Rating **	A/W	Issue No.	88 (cont)
LM End	2.19	Issue Type +	Ma	Location *	
Category	Supplemental			GPS Latitude/Longitude	
				Start	End
Item	2017 Storm Damage			37.820400 °	37.820500 °
				-121.345800 °	-121.345900 °
DWR ID	DWR_RD0544_02_f_2017_88				
Comment Code					
Inspector Comment					
Levee Evaluation Comments Description: Slope protection repairs are needed along the waterside slope due to erosion and riprap displacement from high water. Based upon levee inspections, it was determined the waterside levee slope is eroding, deteriorating, and degrading. The eroded levee sections need to be restored back to design standards to prevent further deterioration and damage. Site ID No: 550 Site Designation: LMA-456 Repair Type: Erosion Rating: Area of Concern Field Date: 8/18/2017 Notes:

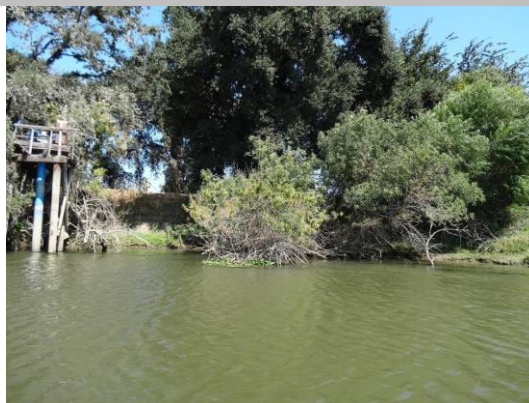
Photo 1 of 3 : SP_2019_RD0544_109_11_20190313_00010.jpg

LM Start	2.31	Rating **	M	Issue No.	11
LM End	2.31	Issue Type +	Ma	Location *	WS
Category	Supplemental			GPS Latitude/Longitude	
				Start	End
Item	DWR Erosion Survey			37.821763 °	37.821763 °
				-121.347275 °	-121.347275 °
DWR ID	RD0544U02RM33.21				
Comment Code					
Inspector Comment					
09/13/2017: No significant change observed.					
07/25/2016: No significant change observed.					
06/25/2015: No significant change observed.					
07/02/2014: No significant change observed.					
08/20/2013: No significant change observed.					
08/07/2012: The site was first reported in 2012 spring levee inspection report. The data were estimated as the site is underneath a irrigation pump station and inaccessible by boat or land survey. It's possible the pump station played a role in the erosion. [2017 Site ID:RD0544U02RM33.21]

Front view of the erosion site. View is partially blocked by the pump structure and vegetation at the site.
