**Flood Control Project Maintenance
Levee Inspections**

Maintenance Issue Types Only, Levee Inspection Report By Mile - Spring 2019

Reclamation District No. 0544 Upper Roberts Island

Waterway	Bank	Unit Miles	Inspection Start/End	Inspector
Unit No. 01 San Joaquin River	Left	6.05	05/09/2019 05/09/2019	Alberto De Leon

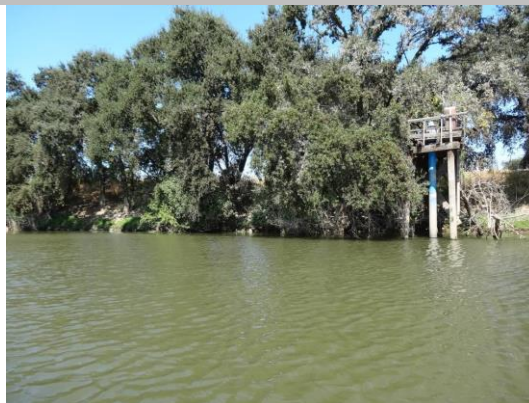
Photo 2 of 3 : SP_2019_RD0544_109_11_20190313_00011.jpg

LM Start	2.31	Rating **	M	Issue No.	11 (cont)
LM End	2.31	Issue Type +	Ma	Location *	WS
Category	Supplemental			GPS Latitude/Longitude	
				Start	End
Item	DWR Erosion Survey			37.821763 °	37.821763 °
				-121.347275 °	-121.347275 °
DWR ID	RD0544U02RM33.21				
Comment Code					
Inspector Comment					
09/13/2017: No significant change observed.					
07/25/2016: No significant change observed.					
06/25/2015: No significant change observed.					
07/02/2014: No significant change observed.					
08/20/2013: No significant change observed.					
08/07/2012: The site was first reported in 2012 spring levee inspection report. The data were estimated as the site is underneath a irrigation pump station and inaccessible by boat or land survey. It's possible the pump station played a role in the erosion. [2017 Site ID:RD0544U02RM33.21]

Front view of the site.

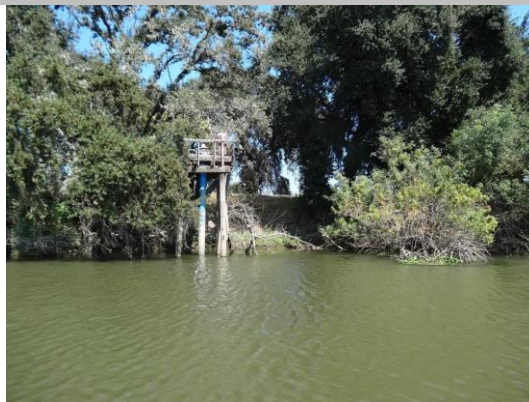
Photo 3 of 3 : SP_2019_RD0544_109_11_20190313_00012.jpg

Close view of the site.

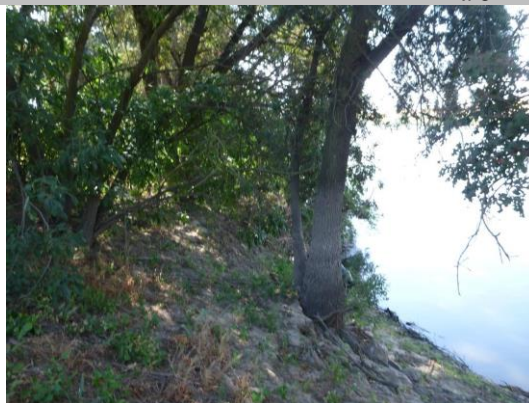
Photo 3 of 3 : LEVAL_SP_2019_549_4654.jpg

LM Start	2.32	Rating **	A/W	Issue No.	89 (cont)
LM End	2.33	Issue Type +	Ma	Location *	
Category	Supplemental			GPS Latitude/Longitude	
				Start	End
Item	2017 Storm Damage			37.821800 °	37.821900 °
				-121.347500 °	-121.347600 °
DWR ID	DWR_RD0544_02_f_2017_89				
Comment Code					
Inspector Comment					
Levee Evaluation Comments					
Description:Slope protection repairs are needed along the waterside slope due to erosion and riprap displacement from high water. Based upon levee inspections, it was determined the waterside levee slope is eroding, deteriorating, and degrading. The eroded levee sections need to be restored back to design standards to prevent further deterioration and damage.					
Site ID No:549					
Site Designation:LMA-455					
Repair Type: Erosion					
Rating:Area of Concern					
Field Date:8/18/2017					
Notes:

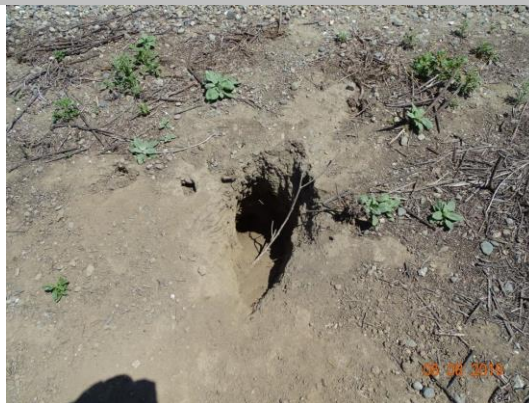
Photo 1 of 2 : SP_2019_RD0544_109_36_20190523_00120.jpg

LM Start	2.43	Rating **	U	Issue No.	36
LM End	2.50	Issue Type +	Ma	Location *	LS
Category	Earthen Levee			GPS Latitude/Longitude	
				Start	End
Item	Animal Control			37.821146 °	37.820286 °
				-121.348992 °	-121.349462 °
DWR ID	DWR_RD0544_02_s_2019_36				
Comment Code					
A3 : No rodents visible, but rodent burrows visible; need to backfill and compact or grout burrows.					
Inspector Comment

View of animal burrow on landside slope. (Spring 2019)

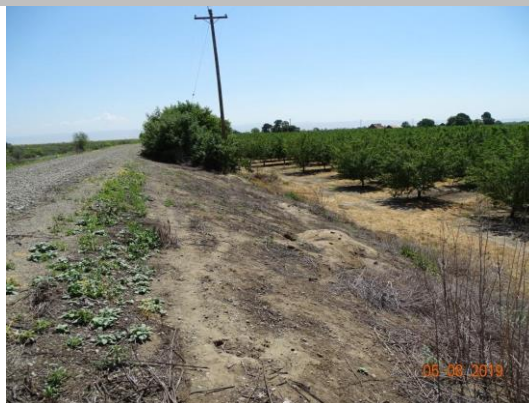
Photo 2 of 2 : SP_2019_RD0544_109_36_20190523_00121.jpg

View of landside slope with multiple animal burrows. (Spring 2019)

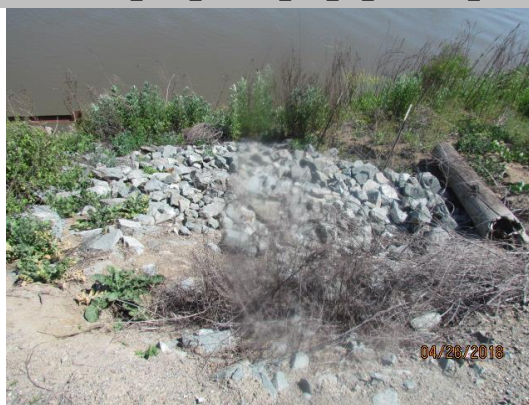
Photo 2 of 5 : SP_2019_RD0544_109_69_20190313_00042.jpg

Looking east at erosion on waterward slope. (Spring 2018)

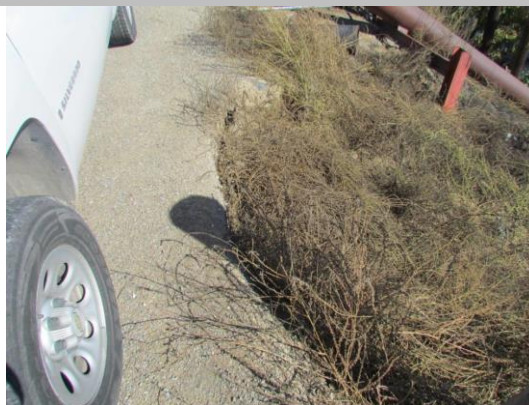
Photo 5 of 5 : SP_2019_RD0544_109_69_20190313_00045.jpg

LM Start	2.61	Rating **	M	Issue No.	69 (cont)	
LM End	2.61	Issue Type +	Ma	Location *	WS	
Category	Earthen Levee			GPS Latitude/Longitude		
				Start	End	
Item	Erosion / Bank Caving			37.818806 °	37.818806 °	
				-121.350437 °	-121.350437 °	
DWR ID	DWR_RD0544_02_f_2016_69					
Comment Code						
E2 : Schedule repair of erosion site prior to the next inspection.						
Inspector Comment						
Erosion greater than 1' deep and greater than 3' wide. Owner backfilled erosion with rock 3/4 filled. Still need to backfill the remaining erosion.

Looking north at erosion on waterward shoulder and slope.

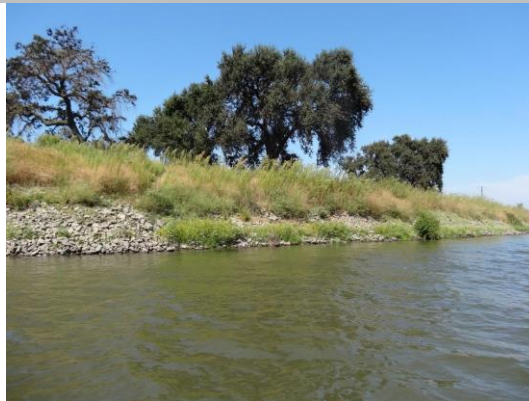
Photo 1 of 2 : SP_2019_RD0544_109_7_20190313_00004.jpg

LM Start	2.68	Rating **	M	Issue No.	7
LM End	2.70	Issue Type +	Ma	Location *	WS
Category	Supplemental			GPS Latitude/Longitude	
				Start	End
Item	DWR Erosion Survey			37.817905 °	37.817905 °
				-121.351102 °	-121.351102 °
DWR ID	RD0544U02RM32.91				
Comment Code					
Inspector Comment					
09/13/2017: No significant change observed. 07/25/2016: No significant change observed. 06/25/2015: No significant change observed. 07/02/2014: No significant change observed. 10/11/2013: No significant change observed. 08/07/2012: Series of pocket erosion were discovered at the levee toe during the boat survey. The area is covered with vegetation and riprap, but the rip rap has been washed away. [2017 Site ID:RD0544U02RM32.91]

Front view of the pocket erosion. Note vegetation and riprap at the site.

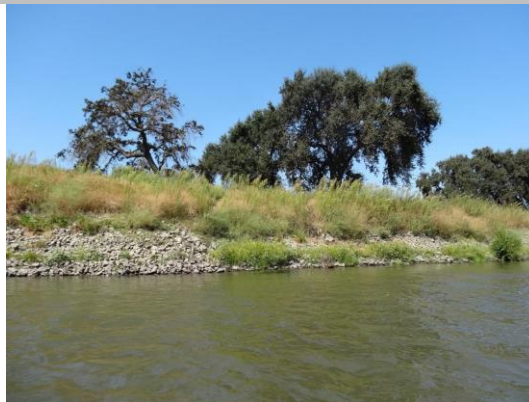
Photo 2 of 2 : SP_2019_RD0544_109_7_20190313_00005.jpg

Front view of the pocket erosion.

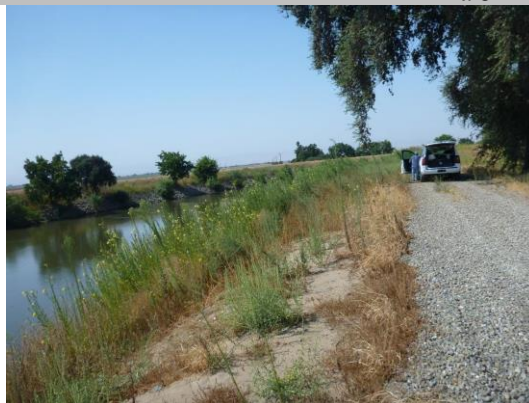
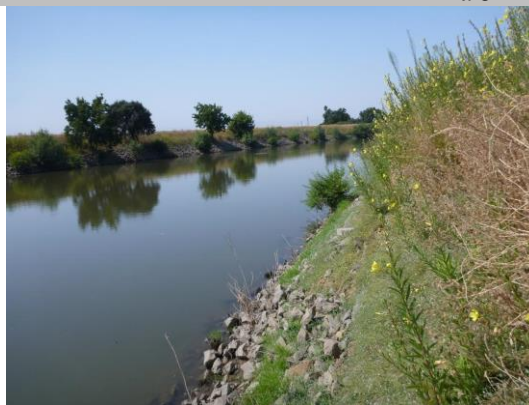
LM Start	2.68	Rating **	A/W	Issue No.	90
LM End	2.71	Issue Type +	Ma	Location *	
Category	Supplemental			GPS Latitude/Longitude	
				Start	End
Item	2017 Storm Damage			37.818000 °	37.817800 °
				-121.351200 °	-121.351500 °
DWR ID	DWR_RD0544_02_f_2017_90				
Comment Code					
Inspector Comment					
Levee Evaluation Comments					
Description:Slope protection repairs are needed along the waterside slope due to erosion and riprap displacement from high water. Based upon levee inspections, it was determined the waterside levee slope is eroding, deteriorating, and degrading. The eroded levee sections need to be restored back to design standards to prevent further deterioration and damage.					
Site ID No:548					
Site Designation:LMA-454					
Repair Type: Erosion					
Rating:Area of Concern					
Field Date:8/18/2017					
Notes:

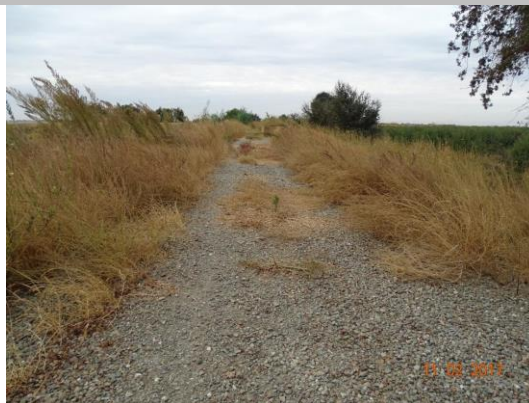
Photo 1 of 2 : SP_2019_RD0544_109_43_20190313_00031.jpg

LM Start	2.71	Rating **	U	Issue No.	43
LM End	3.45	Issue Type +	Ma	Location *	LS
Category	Earthen Levee			GPS Latitude/Longitude	
				Start	End
Item	Vegetation			37.817747 °	37.819583 °
				-121.351578 °	-121.363559 °
DWR ID	DWR_RD0544_02_s_2012_43				
Comment Code					
V2 : Remove the wild growth other than native grasses from the levee slopes.					
Inspector Comment

Looking southwest at levee.

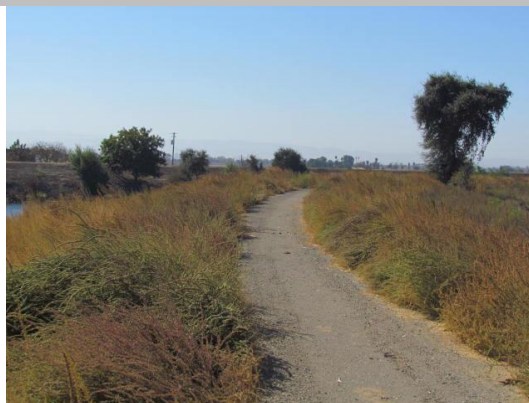
Photo 2 of 2 : SP_2019_RD0544_109_43_20190313_00032.jpg

Looking at dense vegetation on landward and waterward slope.

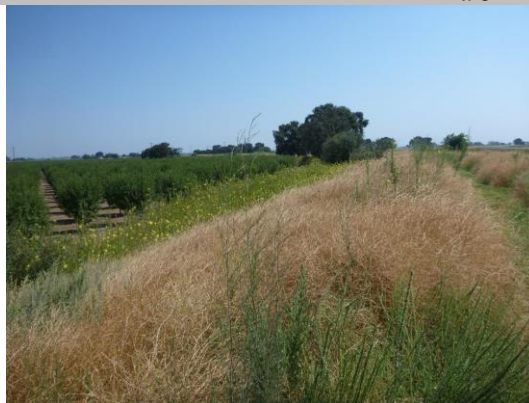
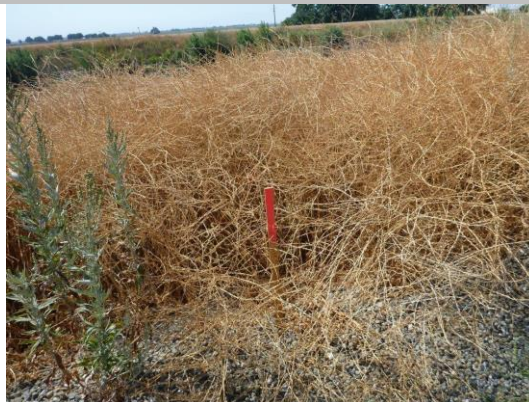
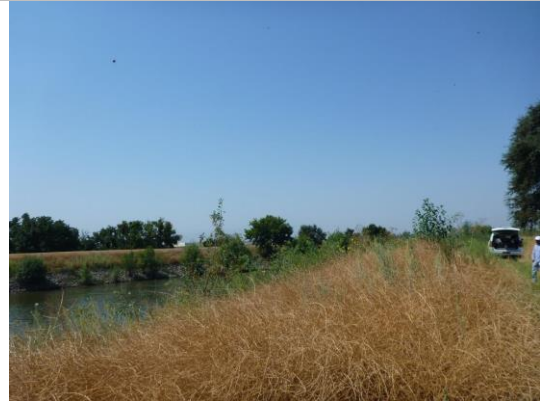
Comment Code					
Inspector Comment					
Levee Evaluation Comments					
Description:Slope protection repairs are needed along the waterside slope due to erosion and riprap displacement from high water. Based upon levee inspections, it was determined the waterside levee slope is eroding, deteriorating, and degrading. The eroded levee sections need to be restored back to design standards to prevent further deterioration and damage.					
Site ID No:547					
Site Designation:LMA-453					
Repair Type: Erosion					
Rating:Area of Concern					
Field Date:8/18/2017					
Notes: levee slopes covered in dense vegetations that hindered visibility.

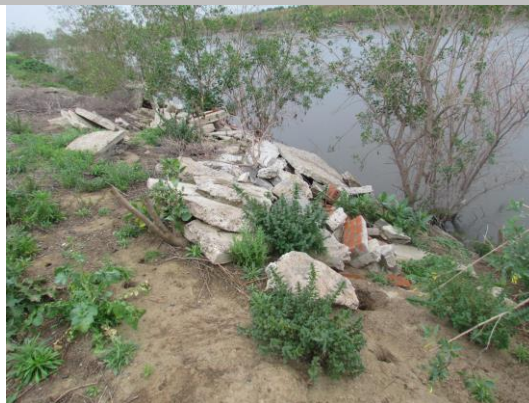
Photo 1 of 1 : SP_2019_RD0544_109_77_20190313_00051.jpg

LM Start	3.10	Rating **	U	Issue No.	77
LM End	3.10	Issue Type +	Ma	Location *	WS
Category	Earthen Levee			GPS Latitude/Longitude	
				Start	End
Item	Erosion / Bank Caving			37.817588 °	37.817588 °
				-121.358352 °	-121.358352 °
DWR ID	DWR_RD0544_02_s_2017_77				
Comment Code					
E1 : Note and monitor erosion site.					
Inspector Comment					
Rip rap was placed but does not meet Title 23 standards.

Looking northeast at concrete rubble on waterward slope.

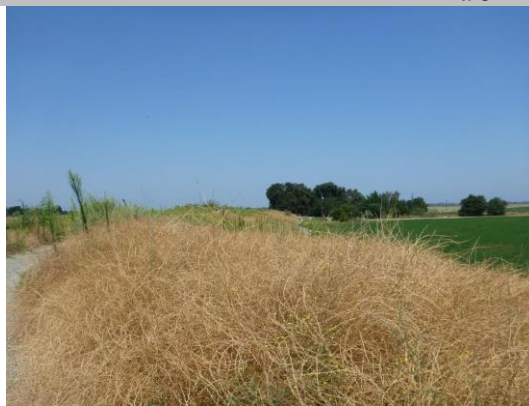
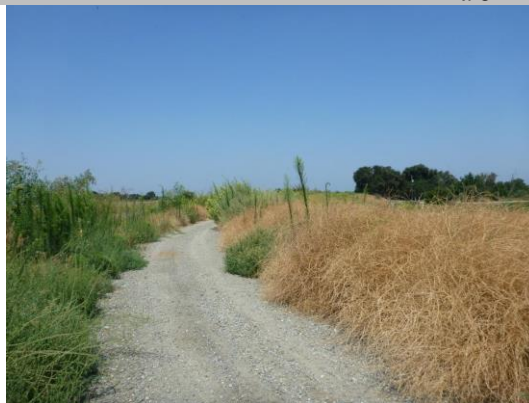
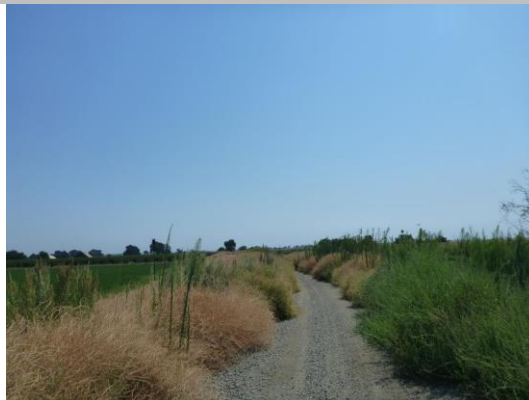
Comment Code					
Inspector Comment					
Levee Evaluation Comments					
Description:Slope protection repairs are needed along the waterside slope due to erosion and riprap displacement from high water. Based upon levee inspections, it was determined the waterside levee slope is eroding, deteriorating, and degrading. The eroded levee sections need to be restored back to design standards to prevent further deterioration and damage.					
Site ID No:546					
Site Designation:LMA-452					
Repair Type: Erosion					
Rating:Area of Concern					
Field Date:8/18/2017					
Notes: dense vegetations on both sides of the levee made the slopes inaccessible

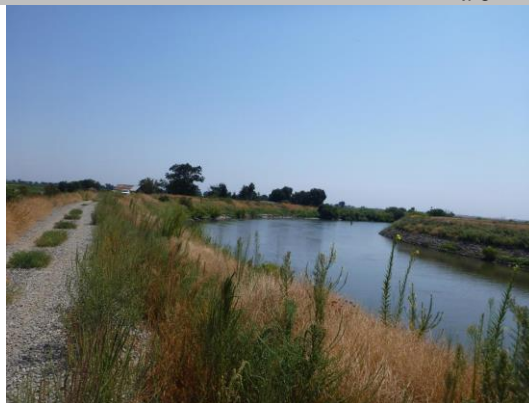
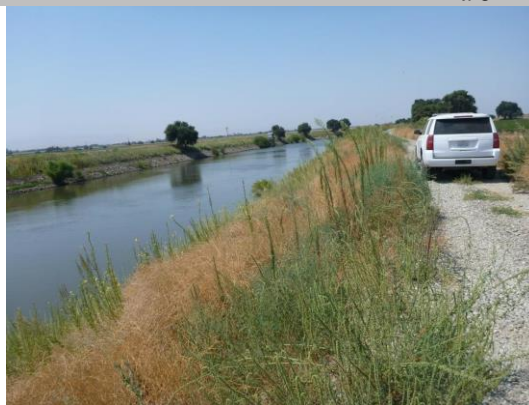
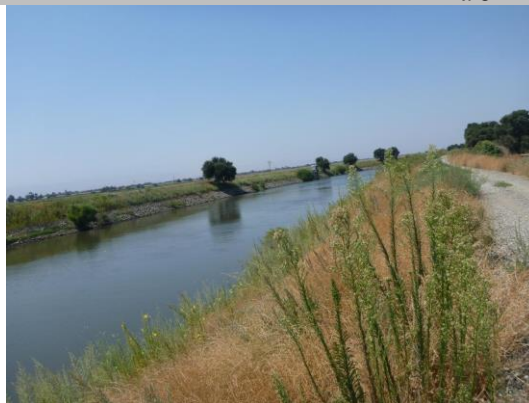
LM Start	3.25	Rating **	A/W	Issue No.	93
LM End	3.34	Issue Type +	Ma	Location *	
Category	Supplemental			GPS Latitude/Longitude	
				Start	End
Item	2017 Storm Damage			37.819300 °	37.819800 °
				-121.360200 °	-121.361600 °
DWR ID	DWR_RD0544_02_f_2017_93				
Comment Code					
Inspector Comment					
Levee Evaluation Comments					
Description:Slope protection repairs are needed along the waterside slope due to erosion and riprap displacement from high water. Based upon levee inspections, it was determined the waterside levee slope is eroding, deteriorating, and degrading. The eroded levee sections need to be restored back to design standards to prevent further deterioration and damage.					
Site ID No:545					
Site Designation:LMA-451					
Repair Type: Erosion					
Rating:Area of Concern					
Field Date:8/18/2017					
Notes:

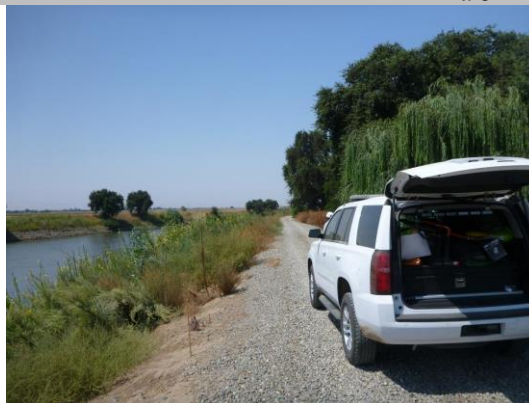
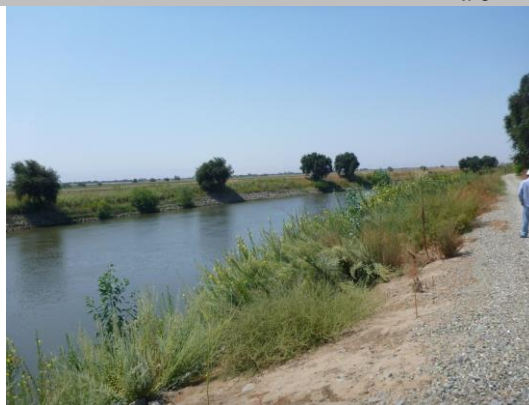
LM Start	3.51	Rating **	A/W	Issue No.	94 (cont)
LM End	3.55	Issue Type +	Ma	Location *	
Category	Supplemental			GPS Latitude/Longitude	
				Start	End
Item	2017 Storm Damage			37.819500 °	37.819400 °
				-121.364700 °	-121.365400 °
DWR ID	DWR_RD0544_02_f_2017_94				
Comment Code					
Inspector Comment					
Levee Evaluation Comments					
Description:Slope protection repairs are needed along the waterside slope due to erosion and riprap displacement from high water. Based upon levee inspections, it was determined the waterside levee slope is eroding, deteriorating, and degrading. The eroded levee sections need to be restored back to design standards to prevent further deterioration and damage.					
Site ID No:544					
Site Designation:LMA-450					
Repair Type: Erosion					
Rating:Area of Concern					
Field Date:8/18/2017					
Notes:

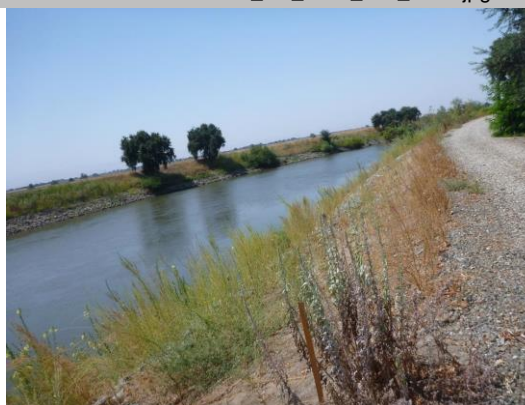
Photo 1 of 3 : LEVAL_SP_2019_543_4790.jpg

LM Start	3.57	Rating **	A/W	Issue No.	95
LM End	3.58	Issue Type +	Ma	Location *	
Category	Supplemental			GPS Latitude/Longitude	
				Start	End
Item	2017 Storm Damage			37.819400 °	37.819400 °
				-121.365800 °	-121.365900 °
DWR ID	DWR_RD0544_02_f _ 2017_95				
Comment Code					
Inspector Comment					
Levee Evaluation Comments					
Description:Slope protection repairs are needed along the waterside slope due to erosion and riprap displacement from high water. Based upon levee inspections, it was determined the waterside levee slope is eroding, deteriorating, and degrading. The eroded levee sections need to be restored back to design standards to prevent further deterioration and damage.					
Site ID No:543					
Site Designation:LMA-449					
Repair Type: Erosion					
Rating:Area of Concern					
Field Date:8/18/2017					
Notes:

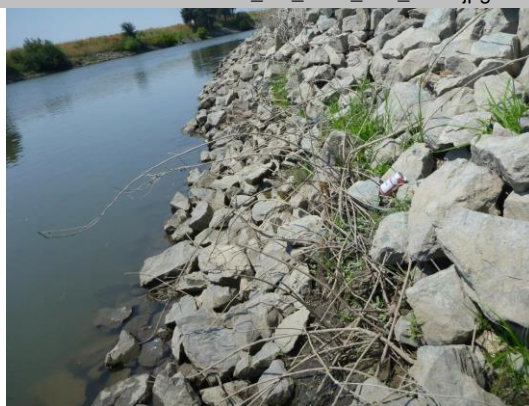
Photo 2 of 3 : LEVAL_SP_2019_543_4797.jpg

LM Start	3.57	Rating **	A/W	Issue No.	95 (cont)
LM End	3.58	Issue Type +	Ma	Location *	
Category	Supplemental			GPS Latitude/Longitude	
				Start	End
Item	2017 Storm Damage			37.819400 °	37.819400 °
				-121.365800 °	-121.365900 °
DWR ID	DWR_RD0544_02_f_2017_95				
Comment Code					
Inspector Comment					
Levee Evaluation Comments					
Description:Slope protection repairs are needed along the waterside slope due to erosion and riprap displacement from high water. Based upon levee inspections, it was determined the waterside levee slope is eroding, deteriorating, and degrading. The eroded levee sections need to be restored back to design standards to prevent further deterioration and damage.					
Site ID No:543					
Site Designation:LMA-449					
Repair Type: Erosion					
Rating:Area of Concern					
Field Date:8/18/2017					
Notes:

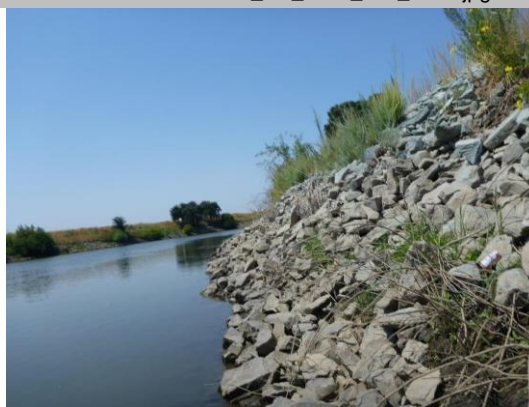
Photo 3 of 3 : LEVAL_SP_2019_543_4799.jpg

LM Start	3.57	Rating **	A/W	Issue No.	95 (cont)
LM End	3.58	Issue Type +	Ma	Location *

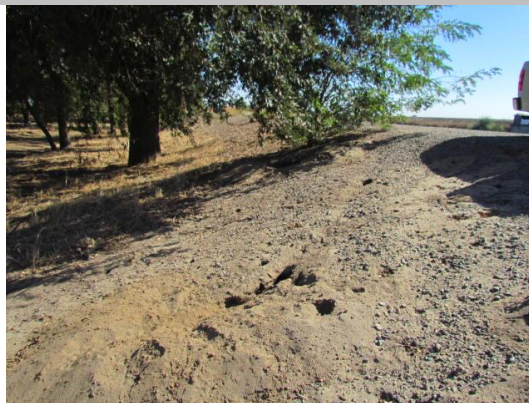
Photo 1 of 2 : SP_2019_RD0544_109_67_20190313_00039.jpg

LM Start	3.58	Rating **	M	Issue No.	67
LM End	3.58	Issue Type +	Ma	Location *	LS
Category	Earthen Levee			GPS Latitude/Longitude	
				Start	End
Item	Animal Control			37.819419 °	37.819419 °
				-121.365854 °	-121.365854 °
DWR ID	DWR_RD0544_02_f_2015_67				
Comment Code					
A3 : No rodents visible, but rodent burrows visible; need to backfill and compact or grout burrows.					
Inspector Comment					
Large rodent holes on landward slope.

Looking northeast at typical view of rodent holes on landward slope.

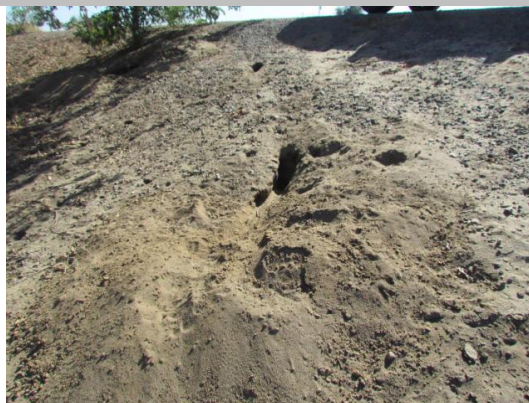
Photo 2 of 2 : SP_2019_RD0544_109_67_20190313_00040.jpg

LM Start	3.58	Rating **	M	Issue No.	67 (cont)
LM End	3.58	Issue Type +	Ma	Location *	LS

Looking north at typical view of rodent holes on landward slope.
