**Flood Control Project Maintenance
Levee Inspections**

Maintenance Issue Types Only, Levee Inspection Report By Mile - Spring 2020

Reclamation District No. 0544 Upper Roberts Island

Waterway	Bank	Unit Miles	Inspection Start/End	Inspector
Unit No. 01 San Joaquin River	Left	6.05	04/29/2020 04/29/2020	Alberto De Leon

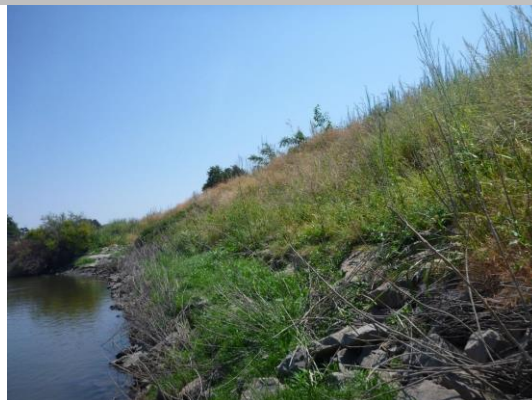
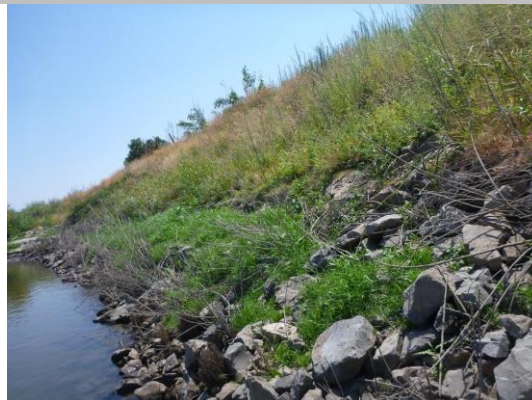
LM Start	4.97	Rating **	A/W	Issue No.	139
LM End	4.99	Issue Type +	Ma	Location *	WS
Category	Supplemental			GPS Latitude/Longitude	
				Start	End
Item	2017 Storm Damage			37.818600 °	37.818400 °
				-121.319200 °	-121.319000 °
DWR ID	LMA-465				
Comment Code					
Inspector Comment					
Planned For Repair.					
Levee Evaluation Comments					
Description:Slope protection repairs are needed along the waterside slope due to erosion and riprap displacement from high water. Based upon levee inspections, it was determined the waterside levee slope is eroding, deteriorating, and degrading. The eroded levee sections need to be restored back to design standards to prevent further deterioration and damage.					
Site ID No:559					
Site Designation:LMA-465					
Repair Type: Erosion					
Rating:Serious					
Field Date:8/11/2017					
Notes:

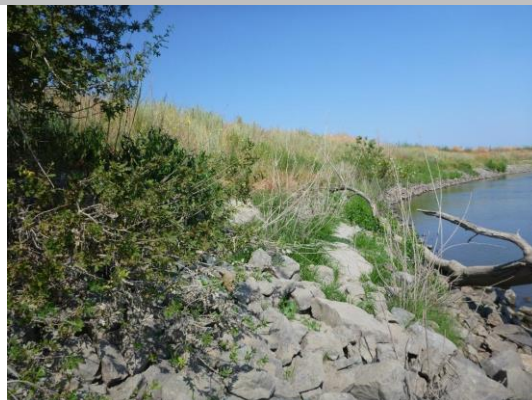
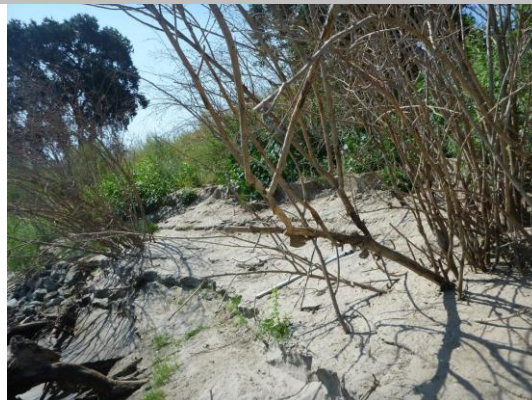
LM Start	5.32	Rating **	A/W	Issue No.	140
LM End	5.36	Issue Type +	Ma	Location *	WS
Category	Supplemental			GPS Latitude/Longitude	
				Start	End
Item	2017 Storm Damage			37.813900 °	37.813500 °
				-121.319900 °	-121.319400 °
DWR ID	LMA-464				
Comment Code					
Inspector Comment					
Planned For Repair.					
Levee Evaluation Comments					
Description:Slope protection repairs are needed along the waterside slope due to erosion and riprap displacement from high water. Based upon levee inspections, it was determined the waterside levee slope is eroding, deteriorating, and degrading. The eroded levee sections need to be restored back to design standards to prevent further deterioration and damage.					
Site ID No:558					
Site Designation:LMA-464					
Repair Type: Erosion					
Rating:Serious					
Field Date:8/16/2017					
Notes:

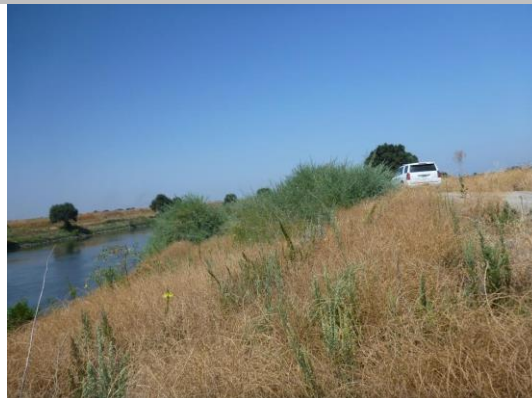
Photo 1 of 1 : LEVAL_SP_2020_556_4520.jpg

LM Start	0.21	Rating **	A/W	Issue No.	37
LM End	0.23	Issue Type +	Ma	Location *	WS
Category	Earthen Levee			GPS Latitude/Longitude	
				Start	End
Item	Erosion / Bank Caving			37.808300 °	37.808400 °
				-121.332000 °	-121.332200 °
DWR ID	LMA-462				
Comment Code					
E1 : Note and monitor erosion site.					
Inspector Comment					
2017 Storm Damage Site, ID No:556, LMA-462. Waterside slope should be monitored for erosion and riprap displacement during high water.

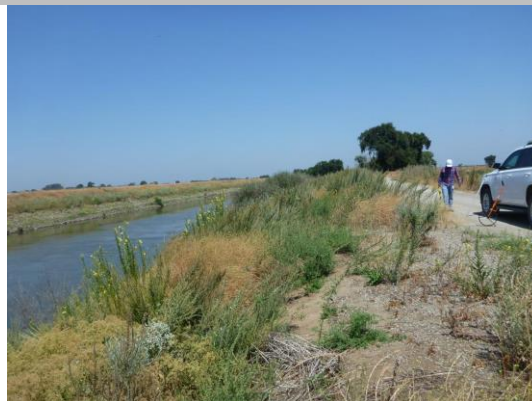
Photo 1 of 1 : LEVAL_SP_2020_555_4527.jpg

LM Start	0.44	Rating **	A/W	Issue No.	70
LM End	0.46	Issue Type +	Ma	Location *	WS
Category	Earthen Levee			GPS Latitude/Longitude	
				Start	End
Item	Erosion / Bank Caving			37.810400 °	37.810700 °
				-121.335000 °	-121.335000 °
DWR ID	LMA-461				
Comment Code					
E1 : Note and monitor erosion site.					
Inspector Comment					
2017 Storm Damage Site, ID No:555, LMA-461. Monitor waterside slope for possible erosion and rip rap displacement during high water events.

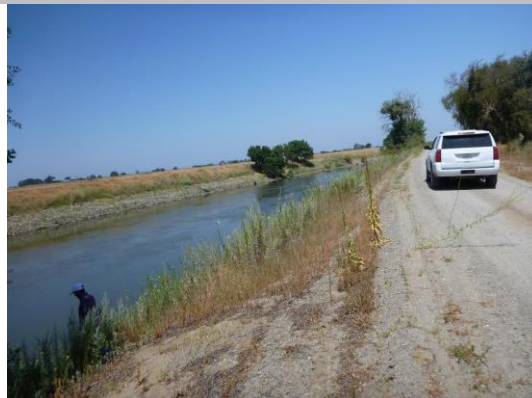
Photo 1 of 1 : LEVAL_SP_2020_554_4630.jpg

LM Start	0.57	Rating **	A/W	Issue No.	80
LM End	0.58	Issue Type +	Ma	Location *	WS
Category	Earthen Levee			GPS Latitude/Longitude	
				Start	End
Item	Erosion / Bank Caving			37.812300 °	37.812400 °
				-121.335100 °	-121.335100 °
DWR ID	LMA-460				
Comment Code					
E1 : Note and monitor erosion site.					
Inspector Comment					
2017 StormDamage Site, ID No:554, LMA-460. Monitor waterside slope for possible erosion and rip rap displacement during high water events.

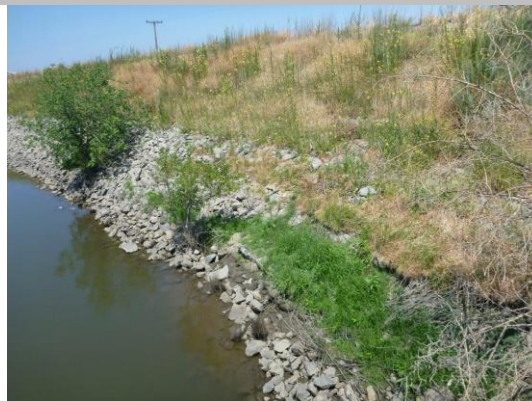
Photo 1 of 1 : LEVAL_SP_2020_552_4810.jpg

LM Start	1.01	Rating **	A/W	Issue No.	82
LM End	1.02	Issue Type +	Ma	Location *	WS
Category	Earthen Levee		GPS Latitude/Longitude		
			Start	End	
Item	Erosion / Bank Caving		37.818100 °	37.818200 °	
			-121.332800 °	-121.332800 °	
DWR ID	LMA-458				
Comment Code					
E1 : Note and monitor erosion site.					
Inspector Comment					
2017 Storm Damage Site, ID No:552, LMA-458. Monitor waterside slope for possible erosion and rip rap displacement during high water events.

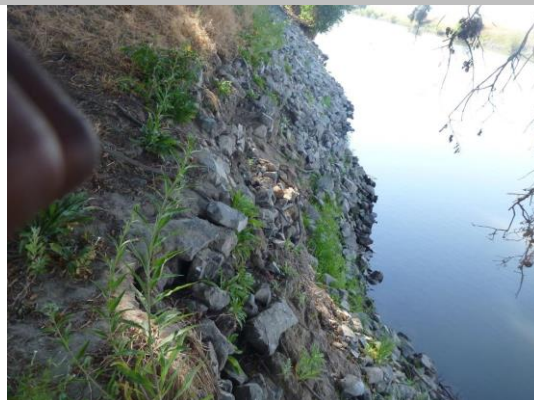
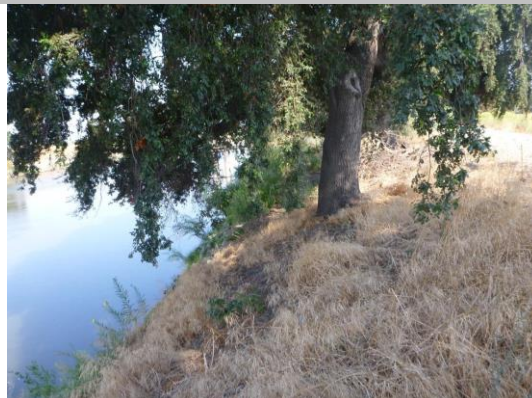
LM Start	2.17	Rating **	A/W	Issue No.	87
LM End	2.18	Issue Type +	Ma	Location *	WS
Category	Supplemental			GPS Latitude/Longitude	
				Start	End
Item	2017 Storm Damage			37.820300 °	37.820300 °
				-121.345600 °	-121.345700 °
DWR ID	LMA-457				
Comment Code					
Inspector Comment					
Planned For Repair.					
Levee Evaluation Comments					
Description:Slope protection repairs are needed along the waterside slope due to erosion and riprap displacement from high water. Based upon levee inspections, it was determined the waterside levee slope is eroding, deteriorating, and degrading. The eroded levee sections need to be restored back to design standards to prevent further deterioration and damage.					
Site ID No:551					
Site Designation:LMA-457					
Repair Type: Erosion					
Rating:Serious					
Field Date:8/18/2017					
Notes:

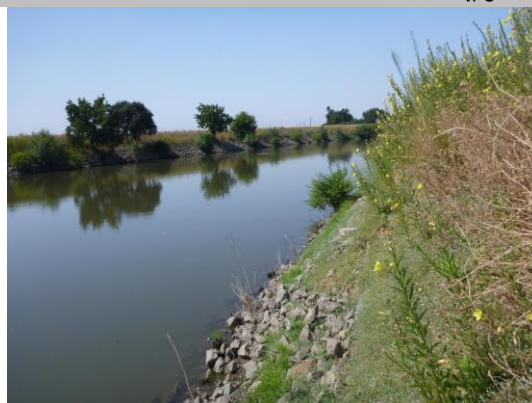
Photo 1 of 1 : LEVAL_SP_2020_548_4666.jpg

LM Start	2.68	Rating **	A/W	Issue No.	90
LM End	2.71	Issue Type +	Ma	Location *	WS
Category	Earthen Levee			GPS Latitude/Longitude	
				Start	End
Item	Erosion / Bank Caving			37.818000 °	37.817800 °
				-121.351200 °	-121.351500 °
DWR ID	LMA-454				
Comment Code					
E1 : Note and monitor erosion site.					
Inspector Comment					
2017 Storm Damage Site, ID No:548, LMA-454. Monitor waterside slope for possible erosion and rip rap displacement during high water events.

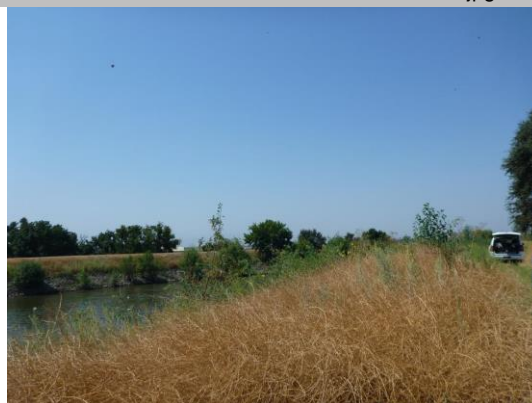
Photo 1 of 1 : LEVAL_SP_2020_547_4688.jpg

2017 Storm Damage site, ID No:547, LMA-453. Monitor waterside slope for possible erosion and rip rap displacement during high water events.

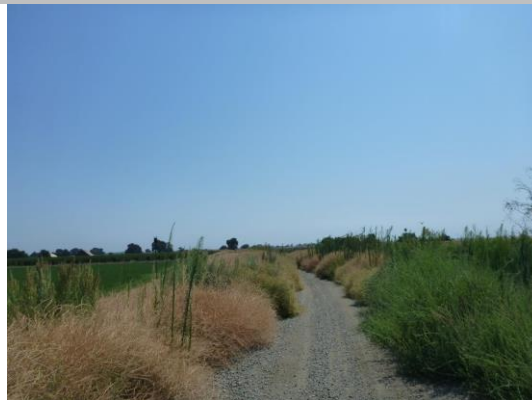
Photo 1 of 1 : LEVAL_SP_2020_546_4698.jpg

LM Start	3.11	Rating **	A/W	Issue No.	92
LM End	3.12	Issue Type +	Ma	Location *	WS
Category	Earthen Levee			GPS Latitude/Longitude	
				Start	End
Item	Erosion / Bank Caving			37.817700 °	37.817800 °
				-121.358600 °	-121.358700 °
DWR ID	LMA-452				
Comment Code					
E1 : Note and monitor erosion site.					
Inspector Comment					
2017 Storm Damage Site, ID No:546, LMA-452. Monitor waterside slope for possible erosion and rip rap displacement during high water events.

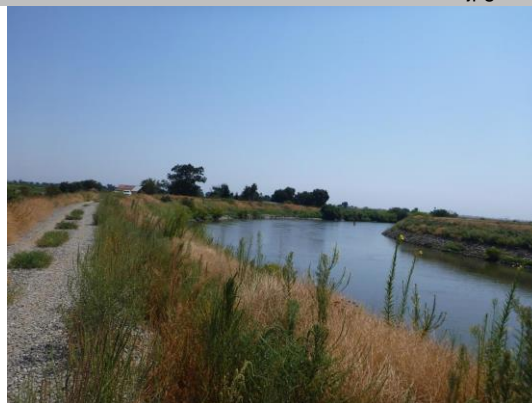
Photo 1 of 1 : LEVAL_SP_2020_545_4707.jpg

LM Start	3.25	Rating **	A/W	Issue No.	93
LM End	3.34	Issue Type +	Ma	Location *	WS
Category	Earthen Levee			GPS Latitude/Longitude	
				Start	End
Item	Erosion / Bank Caving			37.819300 °	37.819800 °
				-121.360200 °	-121.361600 °
DWR ID	LMA-451				
Comment Code					
E1 : Note and monitor erosion site.					
Inspector Comment					
2017 Strom Damage site ID No:545, LMA-451. Monitor waterside slope for possible erosion and rip rap displacement during high water events.

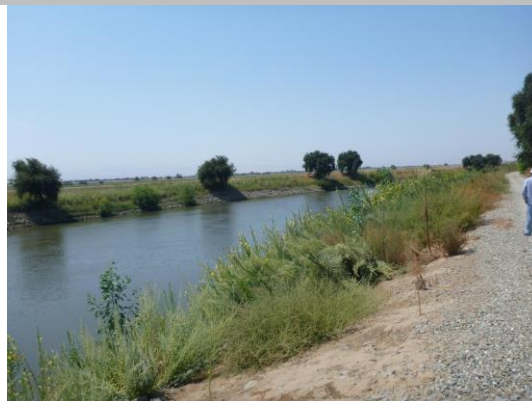
Photo 1 of 1 : LEVAL_SP_2020_544_4783.jpg

LM Start	3.51	Rating **	A/W	Issue No.	94
LM End	3.55	Issue Type +	Ma	Location *	WS
Category	Earthen Levee		GPS Latitude/Longitude		
			Start	End	
Item	Erosion / Bank Caving		37.819500 °	37.819400 °	
			-121.364700 °	-121.365400 °	
DWR ID	LMA-450				
Comment Code					
E1 : Note and monitor erosion site.					
Inspector Comment					
2017 Strom Damage site, ID No:544 LMA-450. Monitor waterside slope for possible erosion and rip rap displacement during high water events
