**Flood Control Project Maintenance
Levee Inspections**

Maintenance Issue Types Only, Levee Inspection Report By Mile - Spring 2021

Reclamation District No. 0544 Upper Roberts Island

Waterway	Bank	Unit Miles	Inspection Start/End	Inspector
Unit No. 01 San Joaquin River	Left	6.05	03/30/2021 03/30/2021	Alberto De Leon

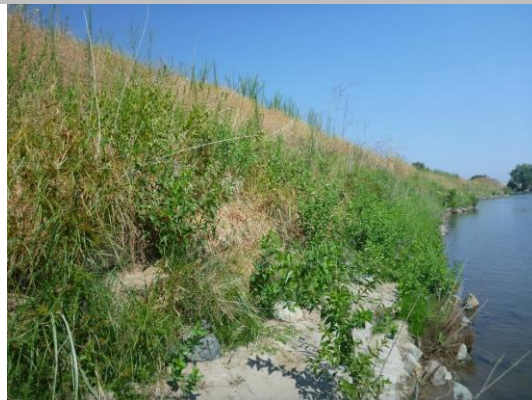
Photo 3 of 3 : LEVAL_SP_2021_562_4836.jpg

LM Start	3.79	Rating **	A/W	Issue No.	135 (cont)
LM End	3.82	Issue Type +	Ma	Location *	WS
Category	Supplemental			GPS Latitude/Longitude	
				Start	End
Item	2017 Storm Damage			37.829800 °	37.829400 °
				-121.312100 °	-121.312000 °
DWR ID	LMA 468-469

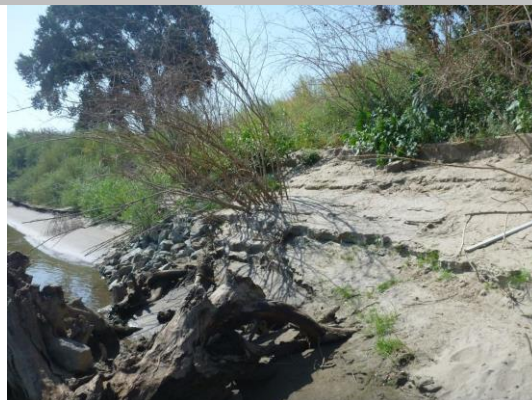
Photo 2 of 4 : LEVAL_SP_2021_558_4900.jpg

LM Start	5.32	Rating **	A/W	Issue No.	140
LM End	5.36	Issue Type +	Ma	Location *	WS
Category	Supplemental			GPS Latitude/Longitude	
				Start	End
Item	2017 Storm Damage			37.813900 °	37.813500 °
				-121.319900 °	-121.319400 °
DWR ID	LMA-464				
Comment Code					
Inspector Comment					
Planned For Repair.					
Levee Evaluation Comments					
Description:Slope protection repairs are needed along the waterside slope due to erosion and riprap displacement from high water. Based upon levee inspections, it was determined the waterside levee slope is eroding, deteriorating, and degrading. The eroded levee sections need to be restored back to design standards to prevent further deterioration and damage.					
Site ID No:558					
Site Designation:LMA-464					
Repair Type: Erosion					
Rating:Serious					
Field Date:8/16/2017					
Notes:

View of waterside erosion repair in progress. Fall 2020

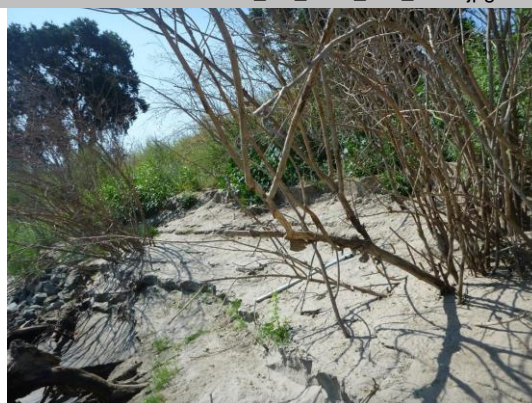
Photo 4 of 4 : LEVAL_SP_2021_558_4910.jpg

LM Start	5.32	Rating **	A/W	Issue No.	140 (cont)
LM End	5.36	Issue Type +	Ma	Location *	WS

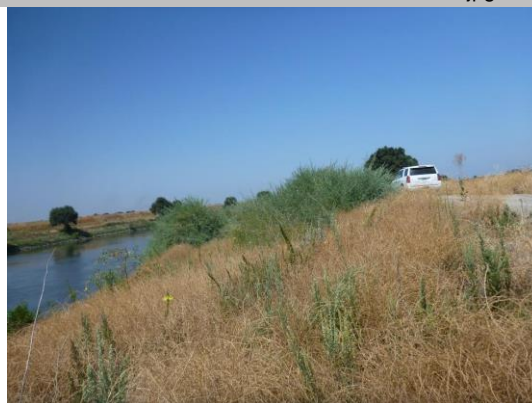
Photo 1 of 1 : LEVAL_SP_2021_556_4520.jpg

LM Start	0.21	Rating **	A/W	Issue No.	37
LM End	0.23	Issue Type +	Ma	Location *	WS
Category	Earthen Levee			GPS Latitude/Longitude	
				Start	End
Item	Erosion / Bank Caving			37.808300 °	37.808400 °
				-121.332000 °	-121.332200 °
DWR ID	LMA-462				
Comment Code					
E1 : Note and monitor erosion site.					
Inspector Comment					
2017 Storm Damage Site, ID No:556, LMA-462. Waterside slope should be monitored for erosion and riprap displacement during high water.

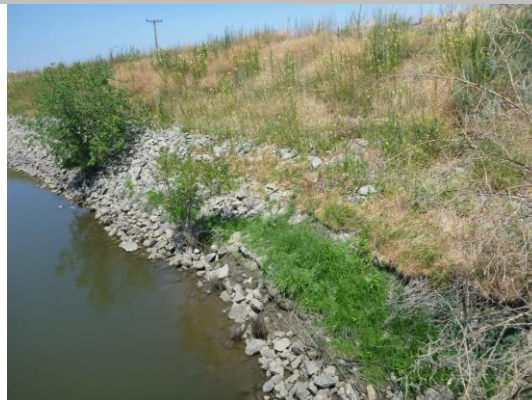
Photo 1 of 1 : LEVAL_SP_2021_552_4810.jpg

LM Start	1.01	Rating **	A/W	Issue No.	82
LM End	1.02	Issue Type +	Ma	Location *	WS
Category	Earthen Levee			GPS Latitude/Longitude	
				Start	End
Item	Erosion / Bank Caving			37.818100 °	37.818200 °
				-121.332800 °	-121.332800 °
DWR ID	LMA-458				
Comment Code					
E1 : Note and monitor erosion site.					
Inspector Comment					
2017 Storm Damage Site, ID No:552, LMA-458. Monitor waterside slope for possible erosion and rip rap displacement during high water events.

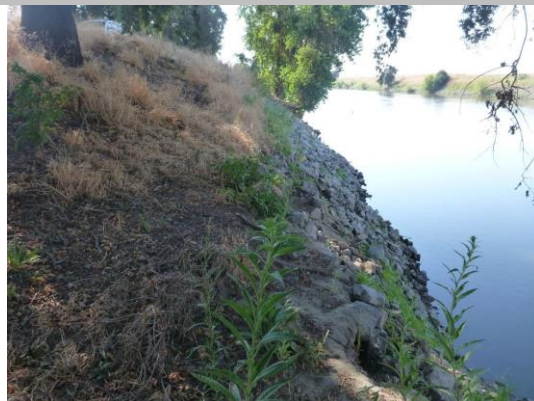
Photo 1 of 3 : LEVAL_SP_2021_551_4817.jpg

LM Start	2.17	Rating **	A/W	Issue No.	87
LM End	2.18	Issue Type +	Ma	Location *	WS
Category	Supplemental			GPS Latitude/Longitude	
				Start	End
Item	2017 Storm Damage			37.820300 °	37.820300 °
				-121.345600 °	-121.345700 °
DWR ID	LMA-457				
Comment Code					
Inspector Comment					
Planned For Repair.					
Levee Evaluation Comments					
Description:Slope protection repairs are needed along the waterside slope due to erosion and riprap displacement from high water. Based upon levee inspections, it was determined the waterside levee slope is eroding, deteriorating, and degrading. The eroded levee sections need to be restored back to design standards to prevent further deterioration and damage.					
Site ID No:551					
Site Designation:LMA-457					
Repair Type: Erosion					
Rating:Serious					
Field Date:8/18/2017					
Notes:

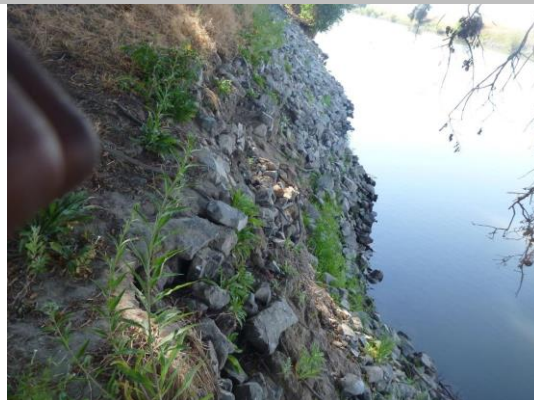
Photo 2 of 3 : LEVAL_SP_2021_551_4818.jpg

LM Start	2.17	Rating **	A/W	Issue No.	87 (cont)
LM End	2.18	Issue Type +	Ma	Location *	WS
Category	Supplemental			GPS Latitude/Longitude	
				Start	End
Item	2017 Storm Damage			37.820300 °	37.820300 °
				-121.345600 °	-121.345700 °
DWR ID	LMA-457

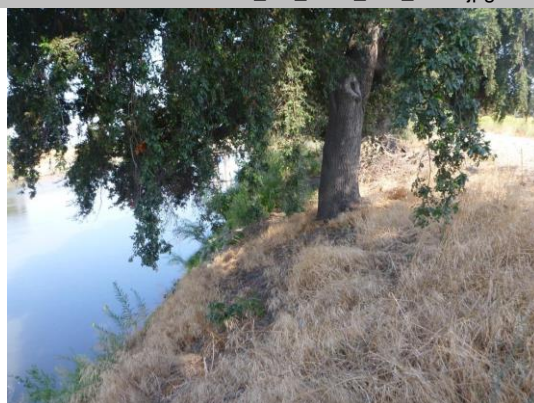
Photo 3 of 3 : LEVAL_SP_2021_551_4824.jpg

LM Start	2.17	Rating **	A/W	Issue No.	87 (cont)
LM End	2.18	Issue Type +	Ma	Location *	WS

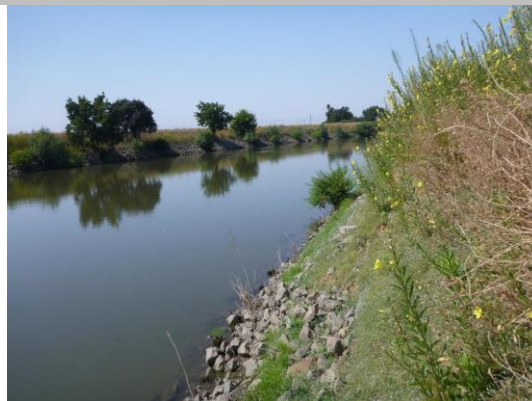
Photo 1 of 1 : LEVAL_SP_2021_548_4666.jpg

LM Start	2.68	Rating **	A/W	Issue No.	90
LM End	2.71	Issue Type +	Ma	Location *	WS
Category	Earthen Levee			GPS Latitude/Longitude	
				Start	End
Item	Erosion / Bank Caving			37.818000 °	37.817800 °
				-121.351200 °	-121.351500 °
DWR ID	LMA-454				
Comment Code					
E1 : Note and monitor erosion site.					
Inspector Comment					
2017 Storm Damage Site, ID No:548, LMA-454. Monitor waterside slope for possible erosion and rip rap displacement during high water events.

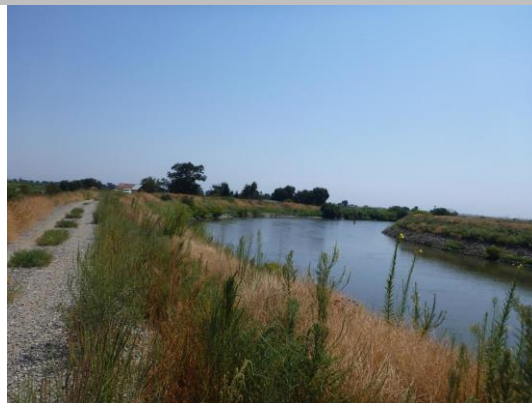
Photo 1 of 1 : LEVAL_SP_2021_545_4707.jpg

LM Start	3.25	Rating **	A/W	Issue No.	93
LM End	3.34	Issue Type +	Ma	Location *	WS
Category	Earthen Levee			GPS Latitude/Longitude	
				Start	End
Item	Erosion / Bank Caving			37.819300 °	37.819800 °
				-121.360200 °	-121.361600 °
DWR ID	LMA-451				
Comment Code					
E1 : Note and monitor erosion site.					
Inspector Comment					
2017 Strom Damage site ID No:545, LMA-451. Monitor waterside slope for possible erosion and rip rap displacement during high water events.
