**Flood Control Project Maintenance
Levee Inspections**

Maintenance Issue Types Only, Levee Inspection Report By Mile - Spring 2022

Reclamation District No. 0544 Upper Roberts Island

Waterway	Bank	Unit Miles	Inspection Start/End	Inspector
Unit No. 01 San Joaquin River	Left	6.05	04/19/2022 04/19/2022	Alberto De Leon

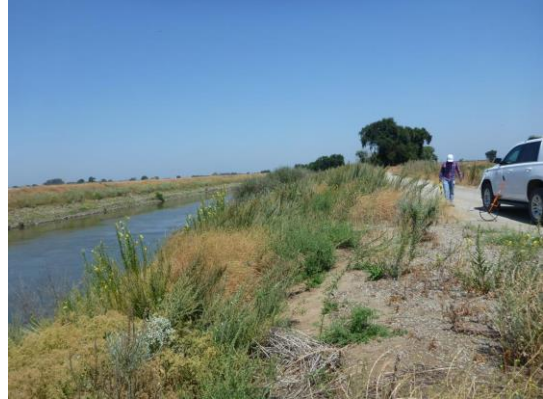
Photo 1 of 1 : LEVAL_SP_2022_555_4527.jpg

LM Start	0.44	Rating **	A/W	Issue No.	70
LM End	0.46	Issue Type +	Ma	Location *	WS
Category	Earthen Levee			GPS Latitude/Longitude	
				Start	End
Item	Erosion / Bank Caving			37.810400 °	37.810700 °
				-121.335000 °	-121.335000 °
DWR ID	LMA-461				
Comment Code					
E1 : Note and monitor erosion site.					
Inspector Comment					
2017 Storm Damage Site, ID No:555, LMA-461. Monitor waterside slope for possible erosion and rip rap displacement during high water events.

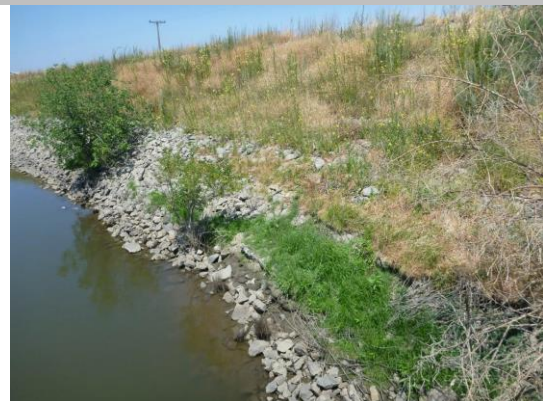
Photo 1 of 1 : LEVAL_SP_2022_552_4810.jpg

LM Start	1.01	Rating **	A/W	Issue No.	82
LM End	1.02	Issue Type +	Ma	Location *	WS
Category	Earthen Levee			GPS Latitude/Longitude	
				Start	End
Item	Erosion / Bank Caving			37.818100 °	37.818200 °
				-121.332800 °	-121.332800 °
DWR ID	LMA-458				
Comment Code					
E1 : Note and monitor erosion site.					
Inspector Comment					
2017 Storm Damage Site, ID No:552, LMA-458. Monitor waterside slope for possible erosion and rip rap displacement during high water events.

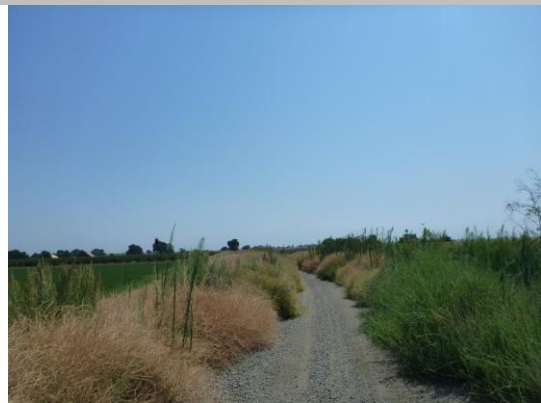
Photo 1 of 1 : LEVAL_SP_2022_546_4698.jpg

LM Start	3.11	Rating **	A/W	Issue No.	92
LM End	3.12	Issue Type +	Ma	Location *	WS
Category	Earthen Levee			GPS Latitude/Longitude	
				Start	End
Item	Erosion / Bank Caving			37.817700 °	37.817800 °
				-121.358600 °	-121.358700 °
DWR ID	LMA-452				
Comment Code					
E1 : Note and monitor erosion site.					
Inspector Comment					
2017 Storm Damage Site, ID No:546, LMA-452. Monitor waterside slope for possible erosion and rip rap displacement during high water events.

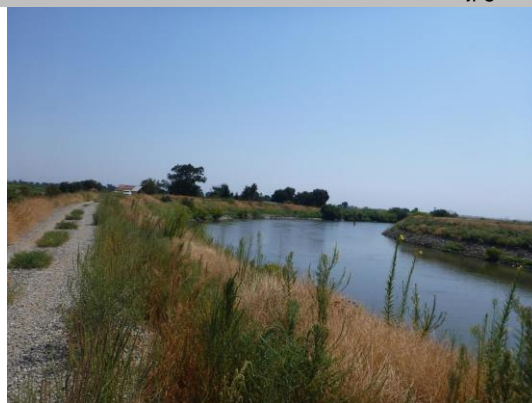
Photo 1 of 1 : LEVAL_SP_2022_545_4707.jpg

LM Start	3.25	Rating **	A/W	Issue No.	93
LM End	3.34	Issue Type +	Ma	Location *	WS
Category	Earthen Levee			GPS Latitude/Longitude	
				Start	End
Item	Erosion / Bank Caving			37.819300 °	37.819800 °
				-121.360200 °	-121.361600 °
DWR ID	LMA-451				
Comment Code					
E1 : Note and monitor erosion site.					
Inspector Comment					
2017 Strom Damage site ID No:545, LMA-451. Monitor waterside slope for possible erosion and rip rap displacement during high water events.

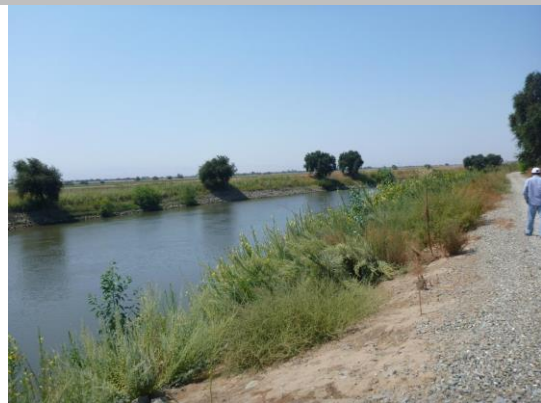
Photo 1 of 1 : LEVAL_SP_2022_544_4783.jpg

LM Start	3.51	Rating **	A/W	Issue No.	94							
LM End	3.55	Issue Type +	Ma	Location *	WS							
Category	Earthen Levee		GPS Latitude/Longitude									
			Start	End								
Item	Erosion / Bank Caving		37.819500 °	37.819400 °								
			-121.364700 °	-121.365400 °								
DWR ID	LMA-450											
Comment Code												
E1 : Note and monitor erosion site.												
Inspector Comment												
2017 Strom Damage site, ID No:544 LMA-450. Monitor waterside slope for possible erosion and rip rap displacement during high water events
