**Flood Control Project Maintenance
Levee Inspections**

Maintenance Issue Types Only, Levee Inspection Report By Mile - Spring 2023

Reclamation District No. 0544 Upper Roberts Island

Waterway	Bank	Unit Miles	Inspection Start/End	Inspector
Unit No. 01 San Joaquin River	Left	6.05	05/04/2023 05/04/2023	Alberto De Leon

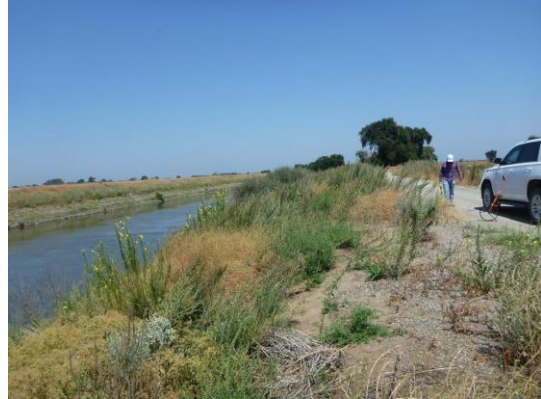
Photo 1 of 1 : LEVAL_SP_2023_555_4527.jpg

LM Start	0.44	Rating **	A/W	Issue No.	70
LM End	0.46	Issue Type +	Ma	Location *	WS
Category	Earthen Levee			GPS Latitude/Longitude	
				Start	End
Item	Erosion / Bank Caving			37.810400°	37.810700°
				-121.335000°	-121.335000°
DWR ID	LMA-461				
Comment Code					
E1 : Note and monitor erosion site.					
Inspector Comment					
This is a 2017 Storm Damage Site, ID No:555, LMA-461. Monitor waterside slope for possible erosion and rip rap displacement during high water events.

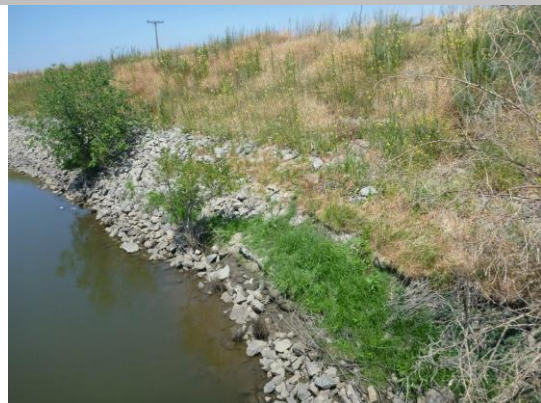
Photo 1 of 1 : LEVAL_SP_2023_552_4810.jpg

LM Start	1.01	Rating **	A/W	Issue No.	82
LM End	1.02	Issue Type +	Ma	Location *	WS
Category	Earthen Levee			GPS Latitude/Longitude	
				Start	End
Item	Erosion / Bank Caving			37.818100°	37.818200°
				-121.332800°	-121.332800°
DWR ID	LMA-458				
Comment Code					
E1 : Note and monitor erosion site.					
Inspector Comment					
This is a 2017 Storm Damage Site, ID No:552, LMA-458. Monitor waterside slope for possible erosion and rip rap displacement during high water events.

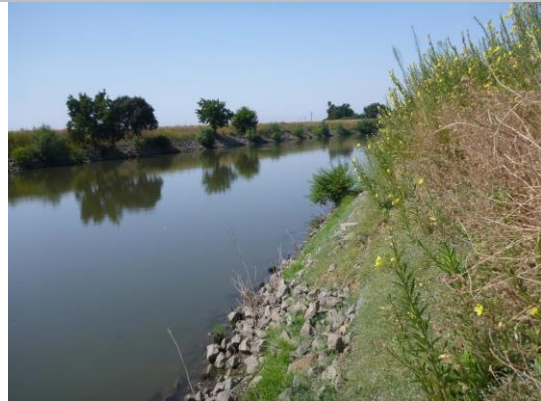
Photo 1 of 2 : LEVAL_SP_2023_548_4666.jpg

LM Start	2.65	Rating **	A/W	Issue No.	90
LM End	2.71	Issue Type +	Ma	Location *	WS
Category	Earthen Levee			GPS Latitude/Longitude	
				Start	End
Item	Erosion / Bank Caving			37.818382°	37.817800°
				-121.350804°	-121.351500°
DWR ID	LMA-454				
Comment Code					
E1 : Note and monitor erosion site.					
Inspector Comment					
This is a 2017 Storm Damage Site, ID No:548, LMA-454. Monitor waterside slope for possible erosion issues and rip rap displacement during high water events.

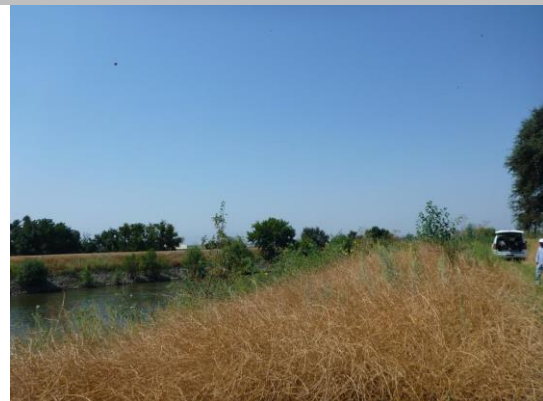
Photo 1 of 1 : LEVAL_SP_2023_547_4688.jpg

LM Start	2.76	Rating **	A/W	Issue No.	91
LM End	2.77	Issue Type +	Ma	Location *	WS
Category	Earthen Levee			GPS Latitude/Longitude	
				Start	End
Item	Erosion / Bank Caving			37.817400°	37.817300°
				-121.352300°	-121.352500°
DWR ID	LMA-453				
Comment Code					
E1 : Note and monitor erosion site.					
Inspector Comment					
This is a 2017 Storm Damage site, ID No:547, LMA-453. Monitor waterside slope for possible erosion and rip rap displacement during high water events.

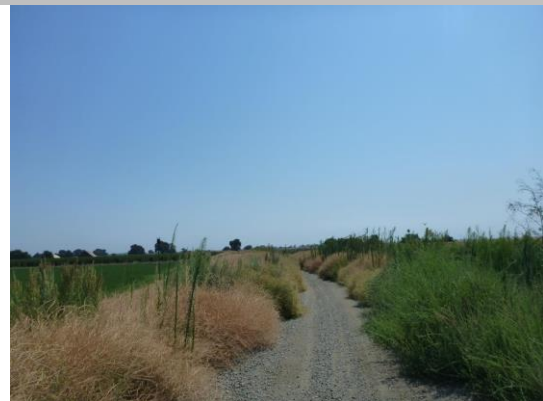
Photo 1 of 1 : LEVAL_SP_2023_546_4698.jpg

LM Start	3.11	Rating **	A/W	Issue No.	92
LM End	3.12	Issue Type +	Ma	Location *	WS
Category	Earthen Levee			GPS Latitude/Longitude	
				Start	End
Item	Erosion / Bank Caving			37.817700°	37.817800°
				-121.358600°	-121.358700°
DWR ID	LMA-452				
Comment Code					
E1 : Note and monitor erosion site.					
Inspector Comment					
This is a 2017 Storm Damage Site, ID No:546, LMA-452. Monitor waterside slope for possible erosion and rip rap displacement during high water events.

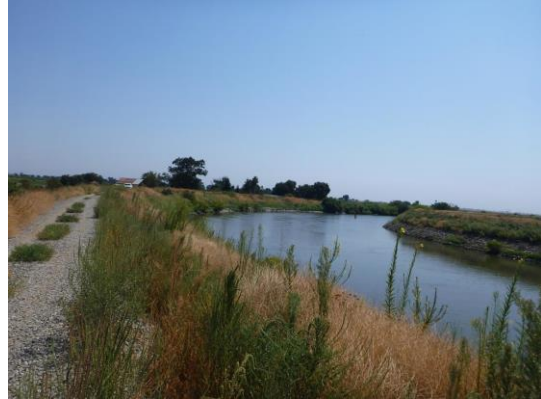
Photo 1 of 1 : LEVAL_SP_2023_545_4707.jpg

LM Start	3.25	Rating **	A/W	Issue No.	93
LM End	3.34	Issue Type +	Ma	Location *	WS
Category	Earthen Levee			GPS Latitude/Longitude	
				Start	End
Item	Erosion / Bank Caving			37.819300°	37.819800°
				-121.360200°	-121.361600°
DWR ID	LMA-451				
Comment Code					
E1 : Note and monitor erosion site.					
Inspector Comment					
This is a 2017 Strom Damage site ID No:545, LMA-451. Monitor waterside slope for possible erosion and rip rap displacement during high water events.
