**Flood Control Project Maintenance
Levee Inspections**

Maintenance Issue Types Only, Levee Inspection Report By Mile - Spring 2024

Reclamation District No. 0544 Upper Roberts Island

Waterway	Bank	Unit Miles	Inspection Start/End	Inspector
Unit No. 01 San Joaquin River	Left	6.05	03/13/2024 03/13/2024	Alberto De Leon

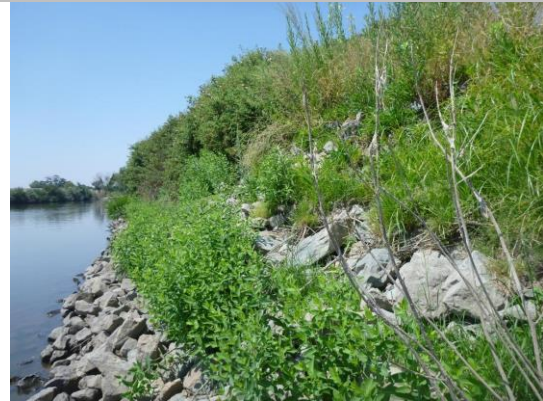
Photo 1 of 1 : LEVAL_SP_2024_561_4862.jpg

LM Start	4.46	Rating **	A/W	Issue No.	136
LM End	4.48	Issue Type +	Ma	Location *	WS
Category	Earthen Levee			GPS Latitude/Longitude	
				Start	End
Item	Erosion / Bank Caving			37.823200°	37.823000°
				-121.316400°	-121.316800°
DWR ID	LMA-467				
Comment Code					
E1 : Note and monitor erosion site.					
Inspector Comment					
This is a 2017 storm damage site, ID 561, LMA-467. Site combined with LMA-466 in field.

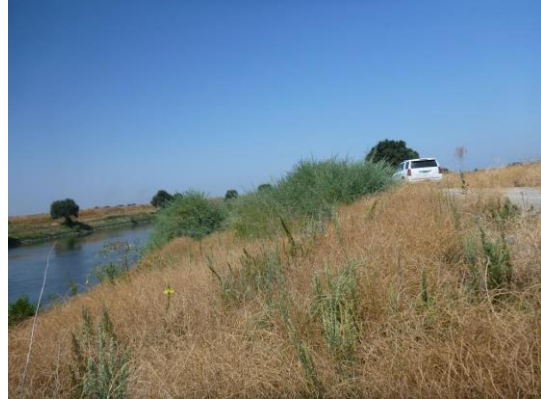
Photo 1 of 1 : LEVAL_SP_2024_556_4520.jpg

LM Start	0.21	Rating **	A/W	Issue No.	37
LM End	0.23	Issue Type +	Ma	Location *	WS
Category	Earthen Levee			GPS Latitude/Longitude	
				Start	End
Item	Erosion / Bank Caving			37.808300°	37.808400°
				-121.332000°	-121.332200°
DWR ID	LMA-462				
Comment Code					
E1 : Note and monitor erosion site.					
Inspector Comment					
This is a 2017 Storm Damage Site, ID No:556, LMA-462. Waterside slope should be monitored for erosion and riprap displacement during high water.

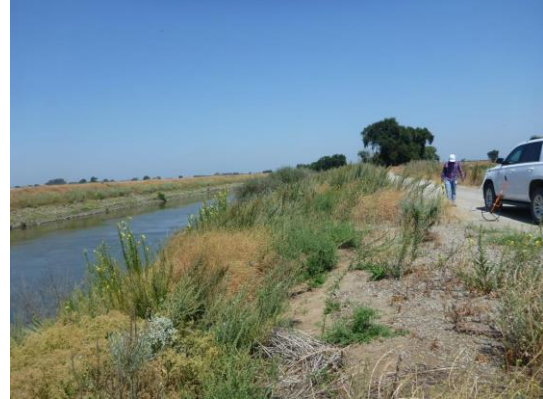
Photo 1 of 1 : LEVAL_SP_2024_555_4527.jpg

LM Start	0.44	Rating **	A/W	Issue No.	70
LM End	0.46	Issue Type +	Ma	Location *	WS
Category	Earthen Levee			GPS Latitude/Longitude	
				Start	End
Item	Erosion / Bank Caving			37.810400°	37.810700°
				-121.335000°	-121.335000°
DWR ID	LMA-461				
Comment Code					
E1 : Note and monitor erosion site.					
Inspector Comment					
This is a 2017 Storm Damage Site, ID No:555, LMA-461. Monitor waterside slope for possible erosion and rip rap displacement during high water events.

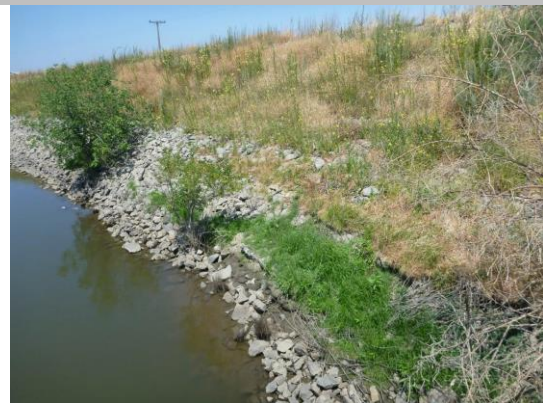
Photo 1 of 1 : LEVAL_SP_2024_552_4810.jpg

LM Start	1.01	Rating **	A/W	Issue No.	82
LM End	1.02	Issue Type +	Ma	Location *	WS
Category	Earthen Levee			GPS Latitude/Longitude	
				Start	End
Item	Erosion / Bank Caving			37.818100°	37.818200°
				-121.332800°	-121.332800°
DWR ID	LMA-458				
Comment Code					
E1 : Note and monitor erosion site.					
Inspector Comment					
This is a 2017 Storm Damage Site, ID No:552, LMA-458. Monitor waterside slope for possible erosion and rip rap displacement during high water events.

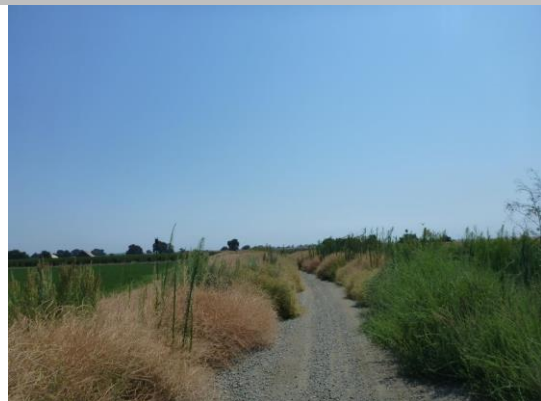
Photo 1 of 1 : LEVAL_SP_2024_546_4698.jpg

LM Start	3.11	Rating **	A/W	Issue No.	92
LM End	3.12	Issue Type +	Ma	Location *	WS
Category	Earthen Levee			GPS Latitude/Longitude	
				Start	End
Item	Erosion / Bank Caving			37.817700°	37.817800°
				-121.358600°	-121.358700°
DWR ID	LMA-452				
Comment Code					
E1 : Note and monitor erosion site.					
Inspector Comment					
This is a 2017 Storm Damage Site, ID No:546, LMA-452. Monitor waterside slope for possible erosion and rip rap displacement during high water events.
