**Flood Control Project Maintenance  
Levee Inspections**  
**LMA District Cover Sheet**  
**Spring 2018 Levee Inspection Results**

**Reclamation District No. 0551 Pearson**

**Spring 2018 Levee Inspection Results**

## Levee Inspection Report By Mile - Spring 2018

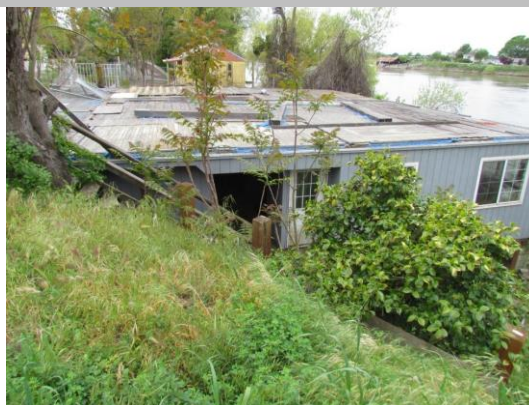
Photo 3 of 3 : SP\_2018\_RD0551\_175\_21\_20180305\_00011.jpg

Photo taken 4-06-2017 no change. No work done, no permit issued.

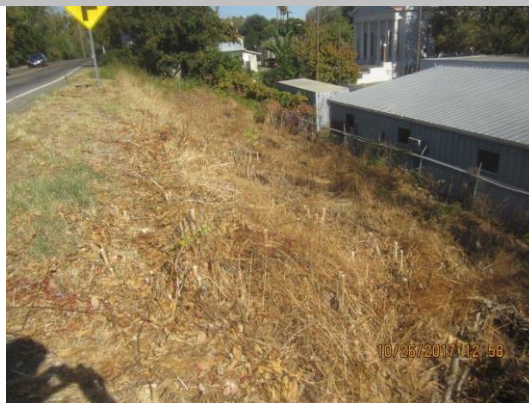
Photo 1 of 2 : SP\_2018\_RD0551\_175\_19\_20180305\_00007.jpg

LM Start	0.49	Rating **	A/W	Issue No.	19
LM End	0.49	Issue Type +	Ma	Location *	LS
Category	Earthen Levee			GPS Latitude/Longitude	
				Start	End
Item	Vegetation			38.331078 °	38.331078 °
				-121.570703 °	-121.570703 °
DWR ID	DWR_RD0551_01_f_2017_19				
Comment Code					
V2 : Remove the wild growth other than native grasses from the levee slopes.					
Inspector Comment					
Dense landside vegetation has been cleared and should be maintained.

Tall landside vegetation has been cleared.

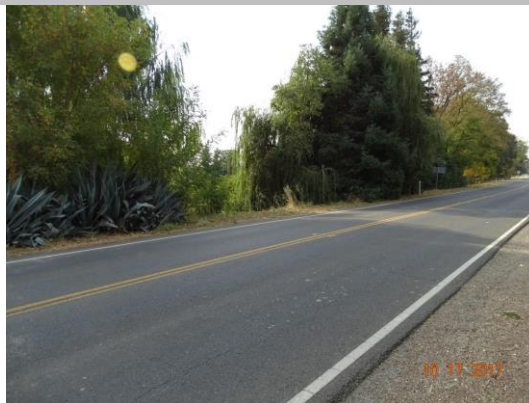
Photo 1 of 1 : SP\_2018\_RD0551\_175\_44\_20180305\_00069.jpg

LM Start	0.75	Rating **	M	Issue No.	44
LM End	0.75	Issue Type +	En	Location *	LS
Category	Earthen Levee			GPS Latitude/Longitude	
				Start	End
Item	Vegetation			38.327959 °	38.327959 °
				-121.573344 °	-121.573344 °
DWR ID	DWR_RD0551_01_f_2017_44				
Comment Code					
V6 : Landscaping					
Inspector Comment					
Landscaping should be maintained to allow inspection and access to landside slope and toe. Large cactus should be removed.

Landscaping should be maintained to allow inspection and access to landside slope and toe.

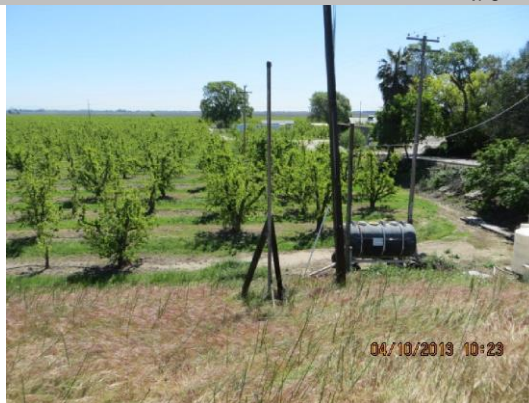
Photo 2 of 3 : UCIP\_SP\_2018\_11727\_19167.jpg

Comment Code						
Inspector Comment						
FS_ID:11727 DS_ID:21986 EP_NO: 701 Repair Type: Non-Urgent Crossing Status: Found UCIP Comments: Pipe appears abandoned and should be done so properly. Good candidate for video inspection. FIELD_STRUCT_DESC: 14-inch steel irrigation pipe through the levee, 7.2 feet below the crown. Pump in pump house on the waterside (WS) slope. Service pole on the landside (LS) slope. 1-inch galvanized filler pipe, and a 2-inch electrical conduit at the same location. (Permit No. 701, 1937 - American Trust Company). [Additional Reference(s): DWR Levee Log, 2005. USACE Sacramento O&M Manual 111, May 1959, (RM 33.91)]. FS Date: 4/10/2013

Pipe and JP visible on LS toe.

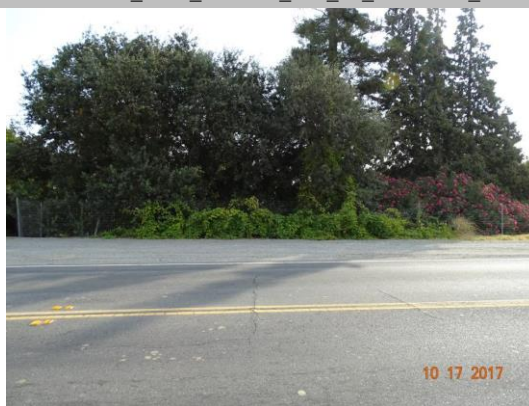
Photo 1 of 1 : SP\_2018\_RD0551\_175\_46\_20180305\_00071.jpg

LM Start	1.36	Rating **	M	Issue No.	46
LM End	1.36	Issue Type +	En	Location *	LS
Category	Earthen Levee			GPS Latitude/Longitude	
				Start	End
Item	Vegetation			38.319621 °	38.319621 °
				-121.576531 °	-121.576531 °
DWR ID	DWR_RD0551_01_f_2017_46				
Comment Code					
V6 : Landscaping					
Inspector Comment					
Landscaping should be maintained to allow inspection and access to lanside slope and toe.

Landscaping should be maintained to allow inspection and access to landside slope and toe.

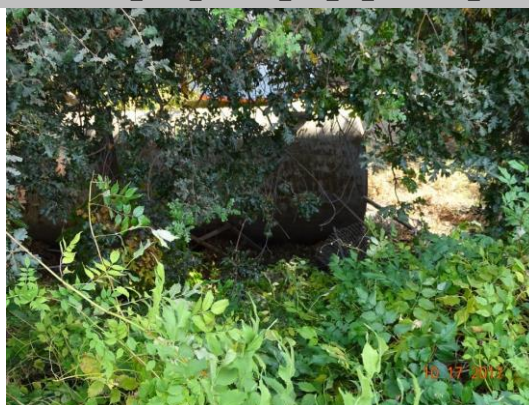
Photo 1 of 1 : SP\_2018\_RD0551\_175\_45\_20180305\_00070.jpg

LM Start	1.36	Rating **	M	Issue No.	45
LM End	1.36	Issue Type +	En	Location *	LS
Category	Earthen Levee			GPS Latitude/Longitude	
				Start	End
Item	Encroachments			38.319620 °	38.319620 °
				-121.576531 °	-121.576531 °
DWR ID	DWR_RD0551_01_f_2017_45				
Comment Code					
TA : Tank					
Inspector Comment					
LMA will talk to owner about moving the tank.

Tank at landside toe should be removed to allow inspection and access.

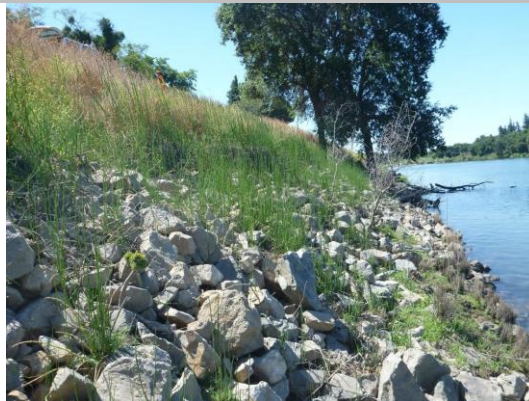
Photo 1 of 3 : SP\_2018\_RD0551\_175\_18\_20180305\_00004.jpg

Comment Code					
Inspector Comment					
Levee Evaluation Comments					
Description:District Station 84+15 to 87+60, Sec. 06, T. 5 N. R. 4 E., M.D.M. Approximately 135 linear-feet of erosion/sloughing exists along the waterside levee slope of the Sacramento River. Sloughing commences approximately 3/4 of the way down the slope from the crown and extends into the rip rap. Some existing rip rap has been pulled off in this section.					
Site ID No:331					
Site Designation:LMA-158					
Repair Type: Erosion					
Rating:Area of Concern					
Field Date:7/13/2017					
Notes: thorney veg on upper slope, light veg within rip rap. Crown is a paved road. 1 ft vertical scarp max just above rip rap so we rated it as a lower priority.

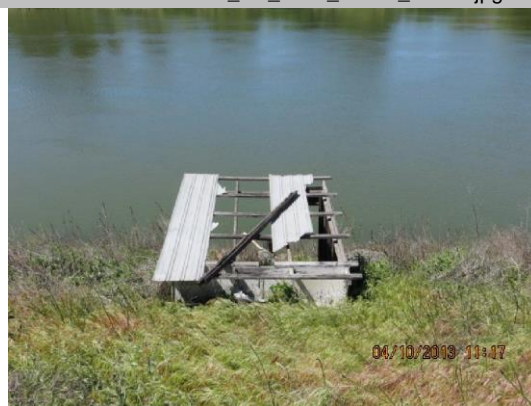
Photo 1 of 3 : UCIP\_SP\_2018\_26874\_49596.jpg

UCIP Comments: Based on District notes from January 14, 2014, pump discharge pipe has been repaired. Pipe failing on LS slope causing erosion along pipe alignment. Pipe debris on both slopes should be removed as well.: As of 12/13/2013 District President noted that the landowner had made repairs to the LS slope leaks.: As of 12/17/2013 District submitted letter to landowner explaining UCIP report details including photos of the pipe problems

Pumphouse on WS slope.

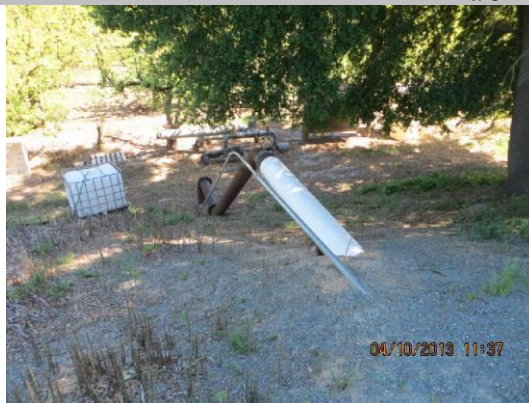
Photo 2 of 3 : UCIP\_SP\_2018\_11763\_19221.jpg

Comment Code						
Inspector Comment						
FS_ID:11763 DS_ID:21991 EP_NO: 6551 Repair Type: Non-Urgent Crossing Status: Found UCIP Comments: Rodent activity undermining pipe on LS slope. FIELD_STRUCT_DESC: 1 of 2: 14-inch polyvinyl chloride (PVC) wrapped steel irrigation pipe through the levee, 3 feet below the crown. Butterfly valve on the waterside (WS) shoulder. 2-inch galvanized electrical conduit at the same location. Pump on pile structure on the WS toe. Pressure booster and pump on the landside (LS) toe. (Permit No. 6551, 1969 - John D. Wheeler). [Additional Reference(s): DWR Levee Log, 2005. USACE Sacramento O&M Manual 111, May 1959, (RM 32.78)]. FS Date: 4/10/2013

Pipe, electrical conduit, and booster pump on LS toe.

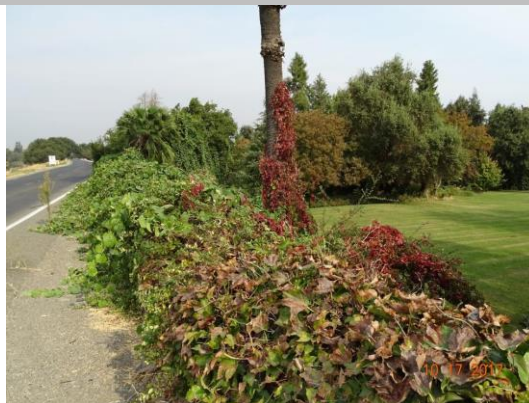
Photo 1 of 1 : SP\_2018\_RD0551\_175\_47\_20180305\_00072.jpg

LM Start	2.29	Rating **	M	Issue No.	47
LM End	2.29	Issue Type +	En	Location *	LS
Category	Earthen Levee			GPS Latitude/Longitude	
				Start	End
Item	Vegetation			38.306755 °	38.306755 °
				-121.572916 °	-121.572916 °
DWR ID	DWR_RD0551_01_f_2017_47				
Comment Code					
V6 : Landscaping					
Inspector Comment					
Landscaping hides levee slope. Toe is mostly visible.

Landscaping should be maintained to allow inspection and access to landside slope and toe.

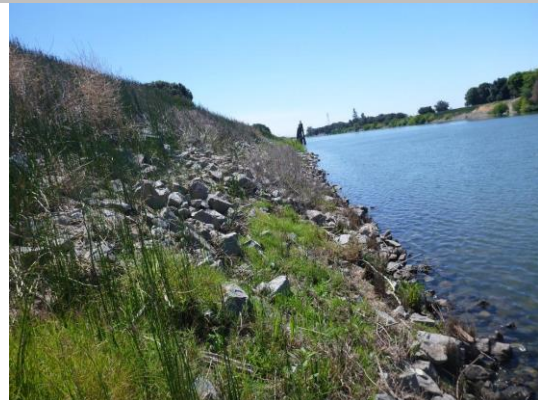
Photo 1 of 3 : SP\_2018\_RD0551\_175\_22\_20180305\_00012.jpg

LM Start	2.71	Rating **	A/W	Issue No.	22
LM End	2.74	Issue Type +	Ma	Location *	
Category	Supplemental			GPS Latitude/Longitude	
				Start	End
Item	2017 Storm Damage			38.301258 °	38.300922 °
				-121.569550 °	-121.569258 °
DWR ID	DWR_RD0551_01_f _ 2017_22				
Comment Code					
Inspector Comment					
Levee Evaluation Comments					
Description:District Station 142+31 to 143+80, Sec. 08, T. 5 N. R. 4 E., M.D.M. Approximately 149 linear-feet of erosion exists along the waterside slope of the Sacramento River. The erosion exists near the rip rap line about 3/4 of the way down the slope. Some existing rip rap has been pulled off in this section.					
Site ID No:332					
Site Designation:LMA-159					
Repair Type: Erosion					
Rating:Area of Concern					
Field Date:7/13/2017					
Notes: Crown is a paved road. Minor errosion right above and in the top of the rip rap.

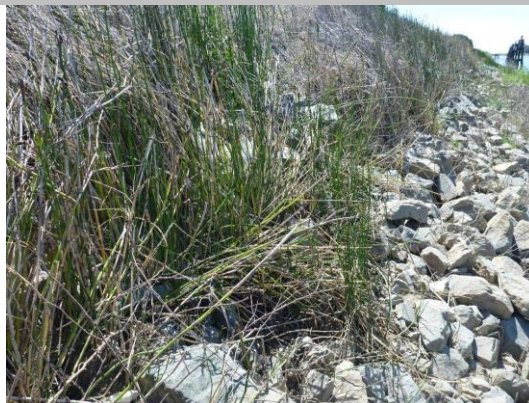
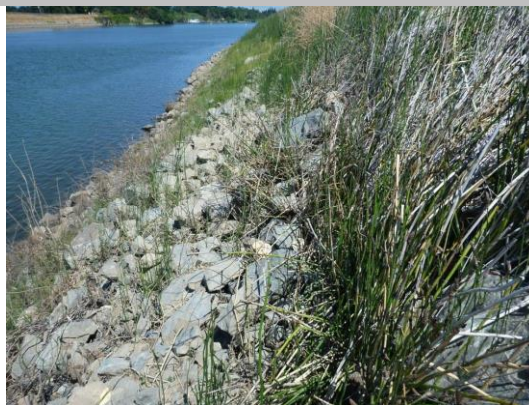
LM Start	2.71	Rating **	A/W	Issue No.	22 (cont)
LM End	2.74	Issue Type +	Ma	Location *	
Category	Supplemental			GPS Latitude/Longitude	
				Start	End
Item	2017 Storm Damage			38.301258 °	38.300922 °
				-121.569550 °	-121.569258 °
DWR ID	DWR_RD0551_01_f_2017_22				
Comment Code					
Inspector Comment					
Levee Evaluation Comments					
Description:District Station 142+31 to 143+80, Sec. 08, T. 5 N. R. 4 E., M.D.M. Approximately 149 linear-feet of erosion exists along the waterside slope of the Sacramento River. The erosion exists near the rip rap line about 3/4 of the way down the slope. Some existing rip rap has been pulled off in this section.					
Site ID No:332					
Site Designation:LMA-159					
Repair Type: Erosion					
Rating:Area of Concern					
Field Date:7/13/2017					
Notes: Crown is a paved road. Minor errosion right above and in the top of the rip rap.

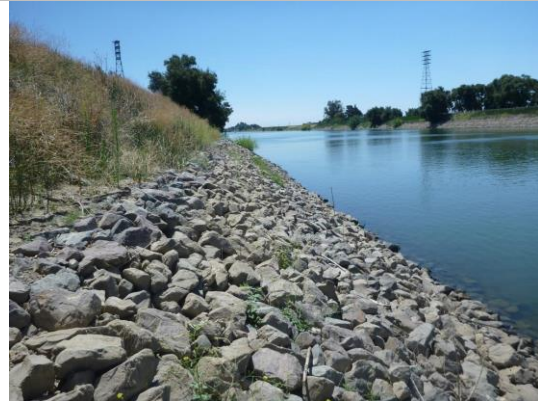
Photo 3 of 3 : SP\_2018\_RD0551\_175\_26\_20180305\_00017.jpg

Comment Code						
Inspector Comment						
Levee Evaluation Comments						
Description:District Station 159+69 to 170+73, Sec. 08, T. 5 N. R. 4 E., M.D.M. Approximately 1,104 linear-feet of erosion and subsequent sloughing exists along the waterside slope of the Sacramento River. The erosion commences approximately halfway down the slope to the rip rap line.						
Site ID No:333						
Site Designation:LMA-160						
Repair Type: Erosion						
Rating:Area of Concern						
Field Date:7/13/2017						
Notes: Crown is a paved road. Thorny veg on upper slope, none in rip rap. Scarps upto 3 ft, mostly smaller, above rip rap. Area of concern because erosion is not too deep into prism and good rip rap protection on lower slope.

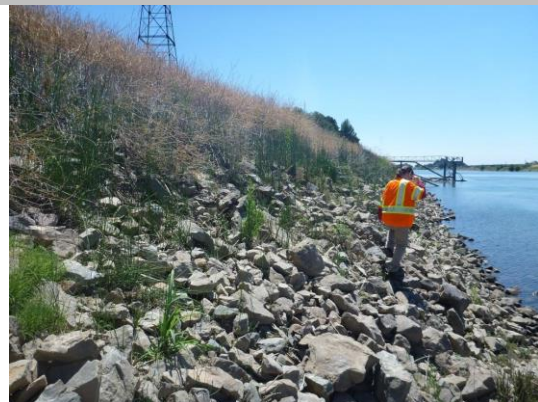
Photo 1 of 3 : SP\_2018\_RD0551\_175\_27\_20180305\_00018.jpg

Comment Code					
Inspector Comment					
Levee Evaluation Comments					
Description:District Station 175+36 to 176+30, Sec. 08, T. 5 N. R. 4 E., M.D.M. Approximately 94 linear-feet of erosion exists along the waterside slope of the Sacramento River. The erosion occurs within the rip rap area near the waterline. Sloughing is exhibited in the in the bottom half of the slope. Some existing rip rap has been pulled off in this section.					
Site ID No:334					
Site Designation:LMA-161					
Repair Type: Erosion					
Rating:Area of Concern					
Field Date:7/13/2017					
Notes: Crown is a paved road. Scarps upto 3 ft within rip rap and 18 in above rip rap. Lower priority because erosion does not significantly cut into prism and damage was not continuous through whole site.

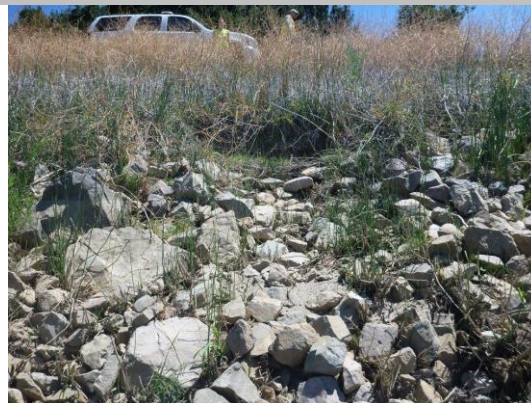
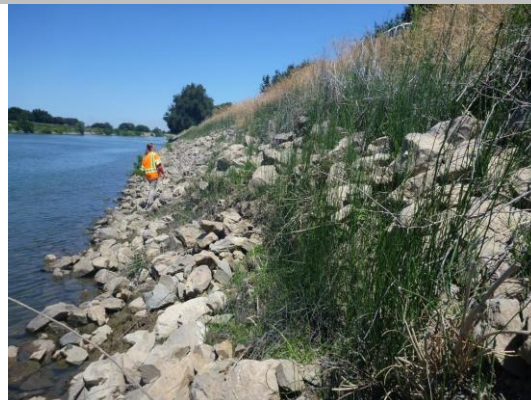
Comment Code						
Inspector Comment						
Levee Evaluation Comments						
Description:District Station 175+36 to 176+30, Sec. 08, T. 5 N. R. 4 E., M.D.M. Approximately 94 linear-feet of erosion exists along the waterside slope of the Sacramento River. The erosion occurs within the rip rap area near the waterline. Sloughing is exhibited in the in the bottom half of the slope. Some existing rip rap has been pulled off in this section.						
Site ID No:334						
Site Designation:LMA-161						
Repair Type: Erosion						
Rating:Area of Concern						
Field Date:7/13/2017						
Notes: Crown is a paved road. Scarps upto 3 ft within rip rap and 18 in above rip rap. Lower priority because erosion does not significantly cut into prism and damage was not continuous through whole site.

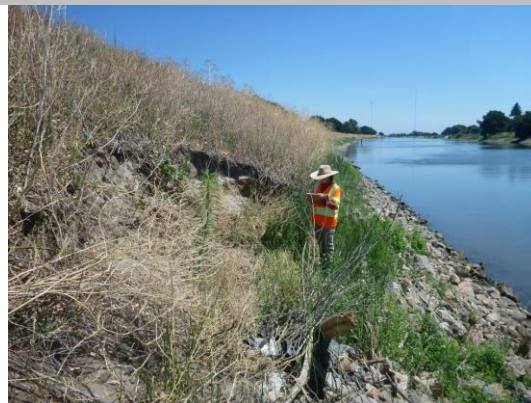
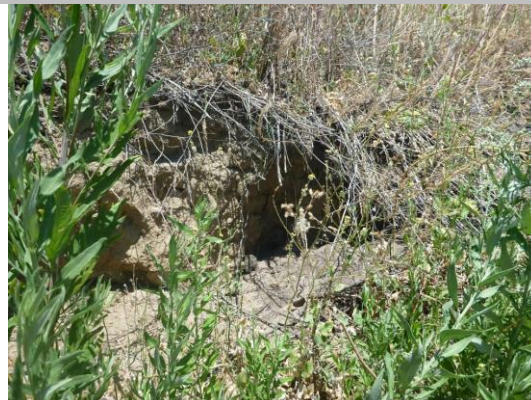
Comment Code					
Inspector Comment					
Levee Evaluation Comments					
Description:District Station 231+12 to 235+26, Sec. 16, T. 5 N. R. 4 E., M.D.M. Approximately 414 linear-feet of erosion and subsequent sloughing exists along the waterside slope of the Sacramento River. The erosion commences approximately 3/4 of the way down the slope to the rip rap line.					
Site ID No:336					
Site Designation:LMA-163					
Repair Type: Erosion					
Rating:Area of Concern					
Field Date:7/13/2017					
Notes: We only saw erosion on about 1½ the length reported by the LMA, but there is another site very close by. Crown is a paved road. Scarps up to 5 ft deep above the rip rap, mostly smaller though so rated this a lower priority site.

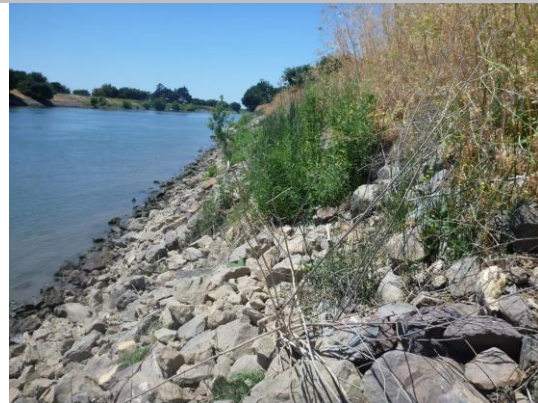
Photo 3 of 3 : SP\_2018\_RD0551\_175\_28\_20180305\_00023.jpg

Item	2017 Storm Damage			38.282778 °	38.282108 °
				-121.549531 °	-121.548386 °
DWR ID	DWR_RD0551_01_f_2017_28				
Comment Code					
Inspector Comment					
<p>Levee Evaluation Comments</p> <p>Description: District Station 231+12 to 235+26, Sec. 16, T. 5 N. R. 4 E., M.D.M. Approximately 414 linear-feet of erosion and subsequent sloughing exists along the waterside slope of the Sacramento River. The erosion commences approximately 3/4 of the way down the slope to the rip rap line.</p> <p>Site ID No: 336</p> <p>Site Designation: LMA-163</p> <p>Repair Type: Erosion</p> <p>Rating: Area of Concern</p> <p>Field Date: 7/13/2017</p> <p>Notes: We only saw erosion on about 1/2 the length reported by the LMA, but there is another site very close by. Crown is a paved road. Scarps up to 5 ft deep above the rip rap, mostly smaller though so rated this a lower priority site.</p>

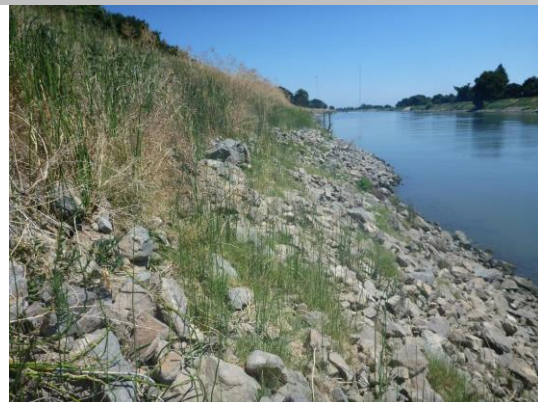
Photo 1 of 3 : SP\_2018\_RD0551\_175\_29\_20180305\_00024.jpg

Item	2017 Storm Damage			38.281994 °	38.281653 °
				-121.548214 °	-121.547700 °
DWR ID	DWR_RD0551_01_f_2017_29				
Comment Code					
Inspector Comment					
<p>Levee Evaluation Comments</p> <p>Description: District Station 235+90 to 237+83, Sec. 16, T. 5 N. R. 4 E., M.D.M. Approximately 193 linear-feet of erosion exists along the waterside slope of the Sacramento River. The erosion commences approximately halfway down the slope and extends to the rip rap. Some existing rip rap has been pulled off in this section.</p> <p>Site ID No: 337</p> <p>Site Designation: LMA-164</p> <p>Repair Type: Erosion</p> <p>Rating: Area of Concern</p> <p>Field Date: 7/13/2017</p> <p>Notes: Crown is paved road. Veg on slope, not lower bank. Scarps up to 18 in deep above rip rap. Lower priority because erosion is fairly small and rip rap is in good shape through most of the site.</p>

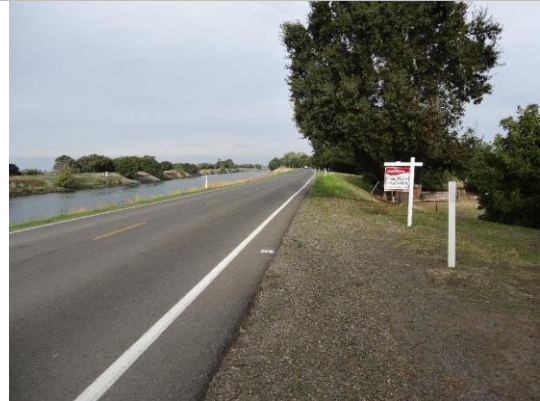
Photo 3 of 3 : UCIP\_SP\_2018\_51324\_76157.jpg

View of levee crown and LS slope, photo taken downstream of crossing looking upstream.

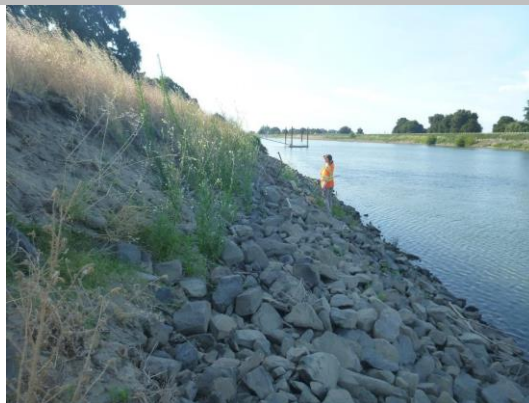
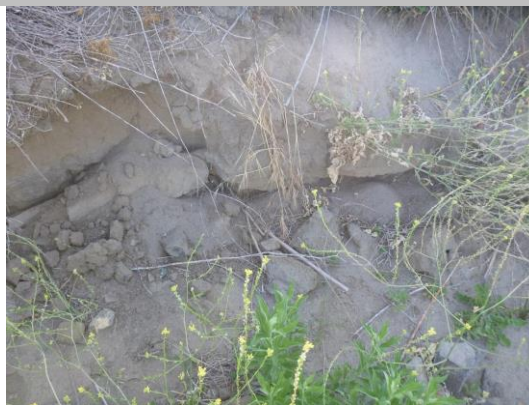
LM Start	4.92	Rating **	A/W	Issue No.	31 (cont)
LM End	4.95	Issue Type +	Ma	Location *	
Category	Supplemental			GPS Latitude/Longitude	
				Start	End
Item	2017 Storm Damage			38.277589 °	38.277256 °
				-121.542575 °	-121.542211 °
DWR ID	DWR_RD0551_01_f _ 2017_31

Comment Code					
Inspector Comment					
Levee Evaluation Comments					
Description:District Station 258+80 to 260+40, Sec. 16, T. 5 N. R. 4 E., M.D.M. Approximately 160 linear-feet of erosion exists along the waterside slope of the Sacramento River. The erosion commences approximately halfway down the slope from the crown and extends to the rip rap. Some existing rip rap has been pulled off in this section.					
Site ID No:339					
Site Designation:LMA-166					
Repair Type: Erosion					
Rating:Area of Concern					
Field Date:7/14/2017					
Notes: crown is a paved road. Scarps of 2.5 ft just above rip rap. Area of concern because erosion is fairly small.

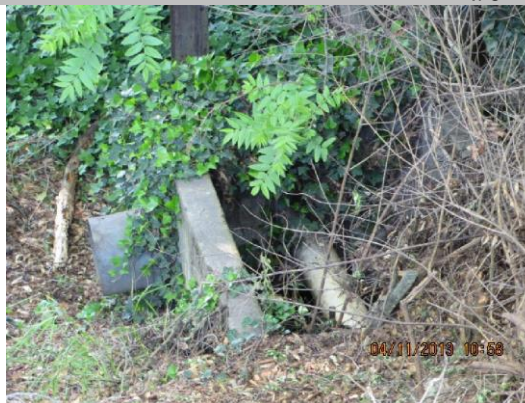
Photo 1 of 3 : UCIP\_SP\_2018\_12105\_19649.jpg

Comment Code						
Inspector Comment						
FS_ID:12105 DS_ID:22022 EP_NO: 11125 Repair Type: Non-Urgent Crossing Status: Found UCIP Comments: Pumphouse has been removed from pump and pump is in disrepair. Pipe at LS toe is sleeved or has been replaced with a 6-inch PVC pipe. This pump appears abandoned and should be done so properly. FIELD_STRUCT_DESC: 6-inch irrigation pipe of an unknown material through the levee, 6.5 feet below the crown. Pump and slide gate on the waterside (WS) slope. 1-inch electrical conduit at the same location with service pole at the landside (LS) toe. 4-foot by 6-foot concrete distribution box at the LS toe. (Automatic Board Order (ABO) issued as Permit No. 11125, 1975 - William H. and Evelyn J. Cortopassi). [Additional Reference(s): DWR Levee Log, 2005. USACE Sacramento O&M Manual 111, May 1959, (RM 29.71)]. FS Date: 4/11/2013

Pipe in distribution box at LS toe.

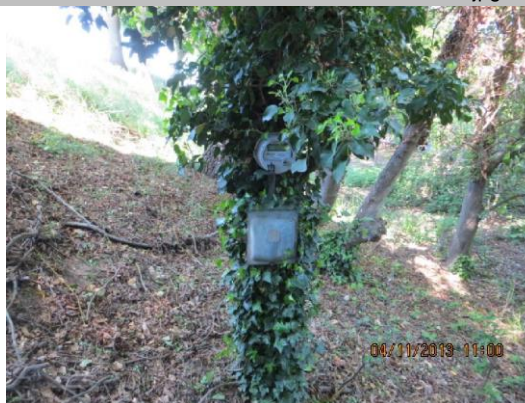
Photo 2 of 3 : UCIP\_SP\_2018\_12105\_19648.jpg

Meter on pole at LS toe.

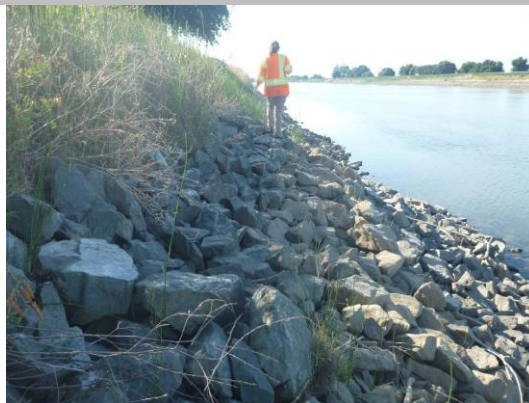
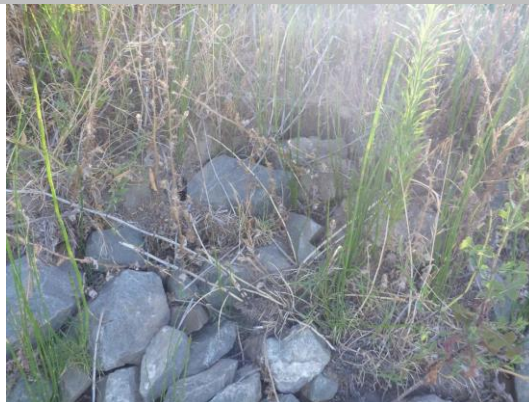
LM Start	5.12	Rating **	A/W	Issue No.	33
LM End	5.16	Issue Type +	Ma	Location *	
Category	Supplemental			GPS Latitude/Longitude	
				Start	End
Item	2017 Storm Damage			38.275442 °	38.274997 °
				-121.540094 °	-121.539514 °
DWR ID	DWR_RD0551_01_f_2017_33

Comment Code					
Inspector Comment					
Levee Evaluation Comments					
Description:District Station 269+37 to 271+66, Sec. 21, T. 5 N. R. 4 E., M.D.M. Approximately 229 linear-feet of erosion and sloughing exists along the waterside slope of the Sacramento River. The erosion commences approximately 3/4 of the way down the slope from the crown and extends to the rip rap.					
Site ID No:341					
Site Designation:LMA-168					
Repair Type: Erosion					
Rating:Area of Concern					
Field Date:7/14/2017					
Notes: crown is a paved road. Scarps upto 4-5 ft, but 18 inches for most of the length. Large tree within site. Area of concern because deeper erosion is only present for a short distance.

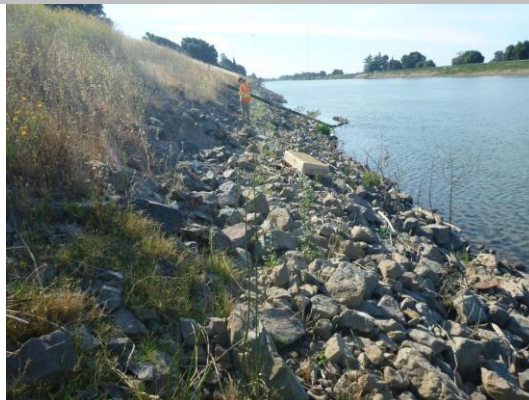
LM Start	5.20	Rating **	M	Issue No.	34 (cont)	
LM End	5.28	Issue Type +	Ma	Location *		
Category	Supplemental			GPS Latitude/Longitude		
				Start		End
Item	2017 Storm Damage			38.274592 °		38.273800 °
				-121.538958 °		-121.537869 °
DWR ID	DWR_RD0551_01_f_2017_34

Comment Code						
Inspector Comment						
Levee Evaluation Comments						
Description:District Station 273+82 to 278+08, Sec. 21 and 22, T. 5 N. R. 4 E., M.D.M. Approximately 426 linear-feet of erosion exists along the waterside slope of the Sacramento River. The erosion commences approximately halfway down the slope and extends to the rip rap. Some existing rip rap has been pulled off in this section.						
Site ID No:342						
Site Designation:LMA-169						
Repair Type: Erosion						
Rating:Serious						
Field Date:7/14/2017						
Notes: there is a 7 ft scarp that extends for 40-60 ft in very sandy soil, scarps are 2-4 ft the rest of the length. Worst site in this RD so far. Serious because of the length of this deeper scarp and the weak soil here. Crown is a paved road.

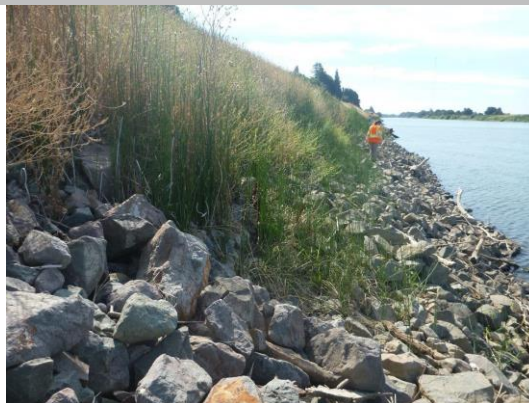
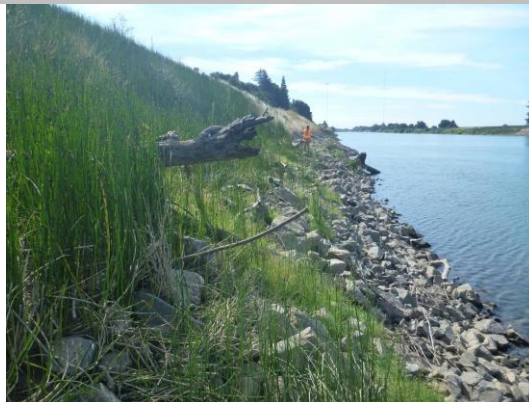
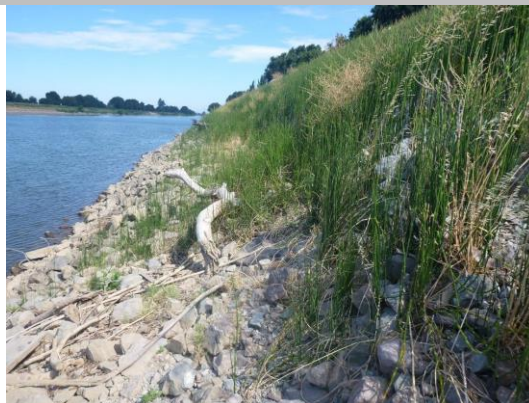
LM Start	5.38	Rating **	A/W	Issue No.	35
LM End	5.42	Issue Type +	Ma	Location *	
Category	Supplemental			GPS Latitude/Longitude	
				Start	End
Item	2017 Storm Damage			38.272867 °	38.272411 °
				-121.536597 °	-121.535983 °
DWR ID	DWR_RD0551_01_f_2017_35

Comment Code					
Inspector Comment					
Levee Evaluation Comments					
Description:District Station 283+08 to 285+49, Sec. 22, T. 5 N. R. 4 E., M.D.M. Approximately 241 linear-feet of erosion and sloughing exists along the waterside slope of the Sacramento River. The erosion commences approximately 3/4 of the way down the slope and extends to the rip rap. Some existing rip rap has been pulled off in this section. Site ID No:343					
Site Designation:LMA-170					
Repair Type: Erosion					
Rating:Area of Concern					
Field Date:7/14/2017					
Notes: Crown is a paved road. Scarps above rip rap 2-4 ft deep, but not continuous through whole site. Area of concern because erosion is not very deep into prism and is not continuous throughout site.

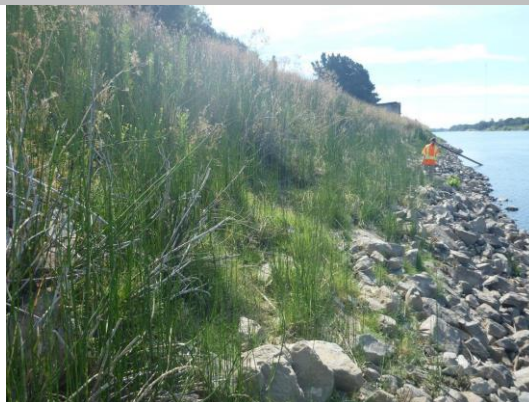
LM Start	5.52	Rating **	A/W	Issue No.	36 (cont)	
LM End	5.54	Issue Type +	Ma	Location *		
Category	Supplemental			GPS Latitude/Longitude		
				Start	End	
Item	2017 Storm Damage			38.271406 °	38.271208 °	
				-121.534644 °	-121.534381 °	
DWR ID	DWR_RD0551_01_f_2017_36

Comment Code						
Inspector Comment						
Levee Evaluation Comments						
Description:District Station 290+80 to 291+85, Sec. 22, T. 5 N. R. 4 E., M.D.M. Approximately 105 linear-feet of erosion and sloughing exists along the waterside slope of the Sacramento River. The erosion commences approximately 3/4 of the way down the slope and extends into the rip rap. Some existing rip rap has been pulled off in this section.						
Site ID No:344						
Site Designation:LMA-171						
Repair Type: Erosion						
Rating:Area of Concern						
Field Date:7/14/2017						
Notes: Crown is a paved road. Erosion scarps 1-4 ft deep just above rip rap. Area of concern because erosion is not very deep into prism.

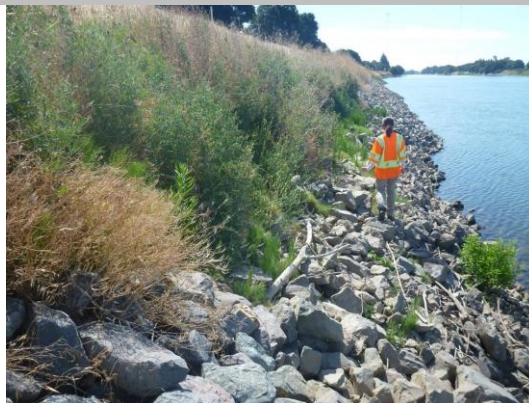
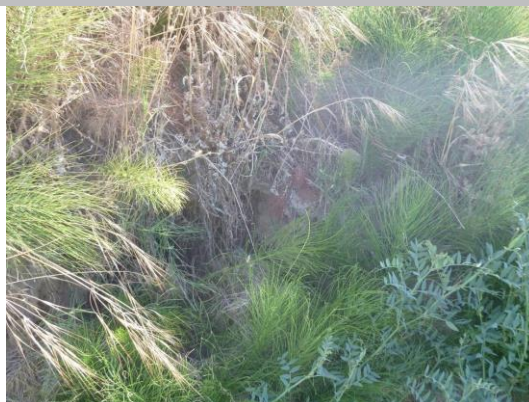
LM Start	5.77	Rating **	A/W	Issue No.	37
LM End	5.79	Issue Type +	Ma	Location *	
Category	Supplemental			GPS Latitude/Longitude	
				Start	End
Item	2017 Storm Damage			38.269025 °	38.268814 °
				-121.531361 °	-121.531058 °
DWR ID	DWR_RD0551_01_f_2017_37

Comment Code					
Inspector Comment					
Levee Evaluation Comments					
Description:District Station 303+60 to 304+75, Sec. 22, T. 5 N. R. 4 E., M.D.M. Approximately 115 linear-feet of erosion and sloughing exists along the waterside slope of the Sacramento River. The erosion occurs just above the rip rap line. Some existing rip rap has been pulled off in this section.					
Site ID No:345					
Site Designation:LMA-172					
Repair Type: Erosion					
Rating:Area of Concern					
Field Date:7/14/2017					
Notes: Crown is a paved road. 4 ft deep scarp above the rip rap. Area of concern because erosion is not very deep into prism and there was lots of vegetation growing in the damaged area indicating it may be an older issue.

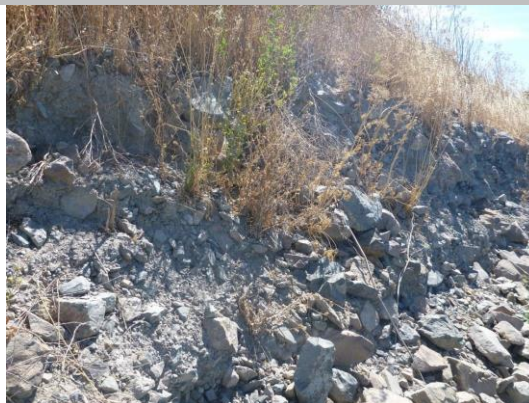
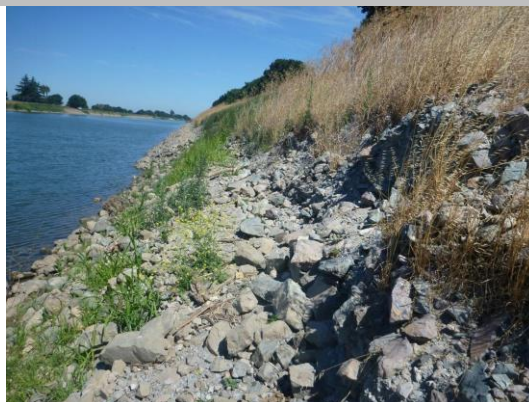
LM Start	5.85	Rating **	M	Issue No.	38
LM End	5.86	Issue Type +	Ma	Location *	
Category	Supplemental			GPS Latitude/Longitude	
				Start	End
Item	2017 Storm Damage			38.268244 °	38.268139 °
				-121.530233 °	-121.530075 °
DWR ID	DWR_RD0551_01_f_2017_38

Comment Code					
Inspector Comment					
Levee Evaluation Comments					
Description:District Station 307+90 to 305+49, Sec. 22, T. 5 N. R. 4 E., M.D.M. Approximately 59 linear-feet of erosion exists along the waterside slope of the Sacramento River. The erosion occurs approximately halfway down the slope within the rip rapped area. Existing rip rap has been pulled off in this section.					
Site ID No:346					
Site Designation:LMA-173					
Repair Type: Erosion					
Rating:Area of Concern					
Field Date:7/14/2017					
Notes: Crown is a paved road. Erosion scarps 4-6 ft high, but soil is more stable than other nearby sites with large gravel in silt or clay so we rated this as an area of concern.

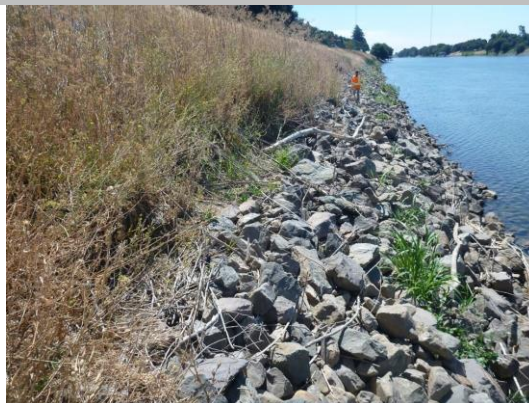
Photo 1 of 3 : SP\_2018\_RD0551\_175\_40\_20180305\_00057.jpg

LM Start	5.95	Rating **	M	Issue No.	40
LM End	5.97	Issue Type +	Ma	Location *	
Category	Supplemental			GPS Latitude/Longitude	
				Start	End
Item	2017 Storm Damage			38.267286 °	38.267094 °
				-121.528886 °	-121.528642 °
DWR ID	DWR_RD0551_01_f_2017_40

Comment Code					
Inspector Comment					
Levee Evaluation Comments					
Description:District Station 313+15 to 314+15, Sec. 22, T. 5 N. R. 4 E., M.D.M. Approximately 100 linear-feet of erosion and sloughing exists along the waterside slope of the Sacramento River. The erosion commences approximately halfway down the slope and extends into the rip rap. Some existing rip rap has been pulled off in this section.					
Site ID No:349					
Site Designation:LMA-176					
Repair Type: Erosion					
Rating:Area of Concern					
Field Date:7/14/2017					
Notes: 18 in to 3 ft vertical scarps just above rip rap. Crown is a paved road. Area of concern because erosion is not very deep into prism.

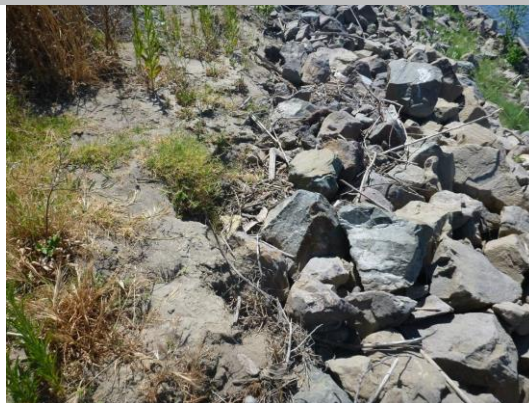
Photo 3 of 3 : SP\_2018\_RD0551\_175\_40\_20180305\_00059.jpg

Comment Code						
Inspector Comment						
Levee Evaluation Comments						
Description:District Station 313+15 to 314+15, Sec. 22, T. 5 N. R. 4 E., M.D.M. Approximately 100 linear-feet of erosion and sloughing exists along the waterside slope of the Sacramento River. The erosion commences approximately halfway down the slope and extends into the rip rap. Some existing rip rap has been pulled off in this section.						
Site ID No:349						
Site Designation:LMA-176						
Repair Type:Erosion						
Rating:Area of Concern						
Field Date:7/14/2017						
Notes: 18 in to 3 ft vertical scarps just above rip rap. Crown is a paved road. Area of concern because erosion is not very deep into prism.

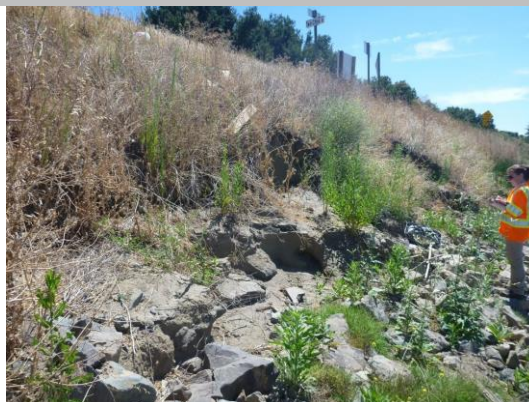
Photo 1 of 3 : SP\_2018\_RD0551\_175\_41\_20180305\_00060.jpg

Comment Code					
Inspector Comment					
Levee Evaluation Comments					
Description:District Station 316+24 to 320+12, Sec. 22, T. 5 N. R. 4 E., M.D.M. Approximately 388 linear-feet of erosion exists along the waterside slope of the Sacramento River. The erosion commences approximately halfway down the slope and extends into the rip rap. Some existing rip rap has been pulled off in this section.					
Site ID No:350					
Site Designation:LMA-177					
Repair Type: Erosion					
Rating:Area of Concern					
Field Date:7/14/2017					
Notes: Crown is a paved road. Erosion scarps between 1-6 ft deep. Area of concern because the deeper erosion only extended for a short distance.

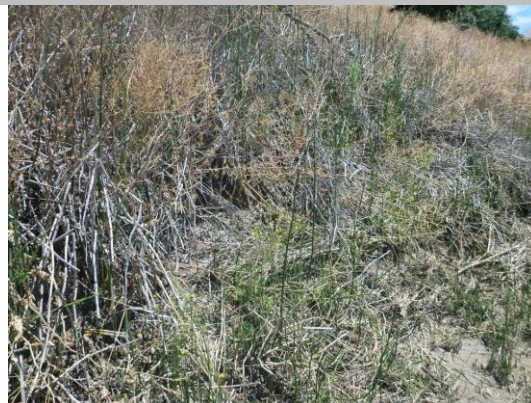
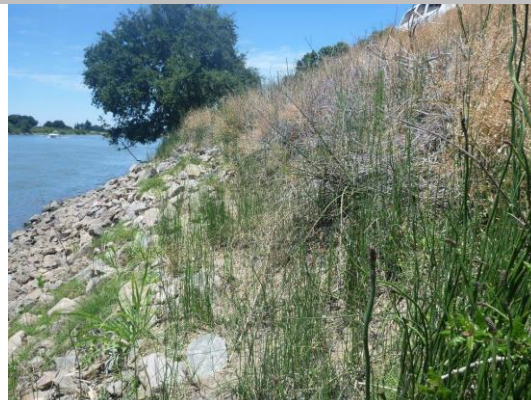
Comment Code						
Inspector Comment						
Levee Evaluation Comments						
Description:District Station 327+45 to 328+45, Sec. 22, T. 5 N. R. 4 E., M.D.M. Approximately 100 linear-feet of erosion and sloughing exists along the waterside slope of the Sacramento River. The erosion commences approximately halfway down the slope and extends into the rip rap. Existing rip rap has been pulled off in this section.						
Site ID No:351						
Site Designation:LMA-178						
Repair Type: Erosion						
Rating:Serious						
Field Date:7/14/2017						
Notes: Crown is a paved road. Scarps above rip rap are about 7 ft deep. Rated this serious because erosion scarps are pretty deep, sandy material, steep slope, the rip rap is in poor condition and high traffic on the levee road.

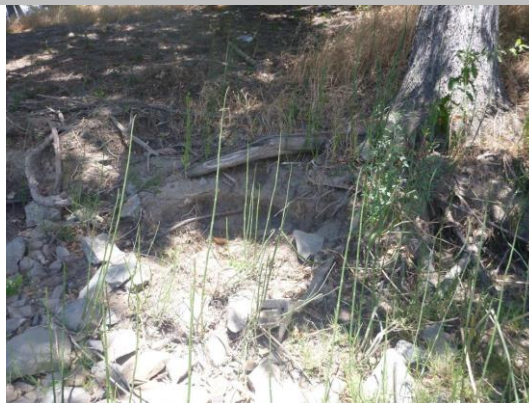
Photo 1 of 3 : SP\_2018\_RD0551\_175\_43\_20180305\_00066.jpg

Comment Code					
Inspector Comment					
Levee Evaluation Comments					
Description:District Station 330+19 to 330+99, Sec. 22, T. 5 N. R. 4 E., M.D.M. Approximately 80 linear-feet of erosion/sloughing and minor slippage exists along the waterside slope of the Sacramento River. The erosion/sloughing commences approximately halfway down the slope and extends into the rip rap. Existing rip rap has been pulled off in this section.					
Site ID No:352					
Site Designation:LMA-179					
Repair Type: Erosion					
Rating:Area of Concern					
Field Date:7/14/2017					
Notes: Crown is a paved road. Erosion scarps are only 1 ft deep. Area of concern because erosion is not very deep into prism.

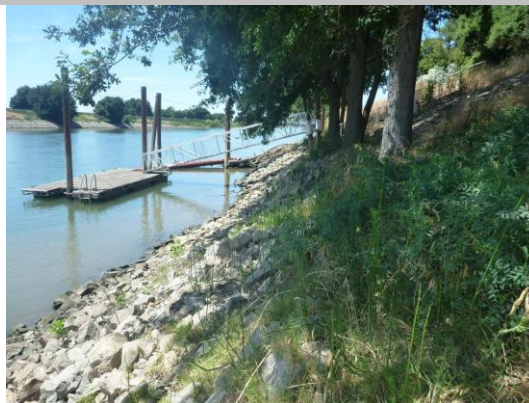
Photo 3 of 3 : SP\_2018\_RD0551\_175\_43\_20180305\_00068.jpg

Item	2017 Storm Damage		38.263906 °	38.263756 °								
			-121.524778 °	-121.524575 °								
DWR ID	DWR_RD0551_01_f_2017_43											
Comment Code												
Inspector Comment												
<p>Levee Evaluation Comments</p> <p>Description: District Station 330+19 to 330+99, Sec. 22, T. 5 N. R. 4 E., M.D.M. Approximately 80 linear-feet of erosion/sloughing and minor slippage exists along the waterside slope of the Sacramento River. The erosion/sloughing commences approximately halfway down the slope and extends into the rip rap. Existing rip rap has been pulled off in this section.</p> <p>Site ID No: 352</p> <p>Site Designation: LMA-179</p> <p>Repair Type: Erosion</p> <p>Rating: Area of Concern</p> <p>Field Date: 7/14/2017</p> <p>Notes: Crown is a paved road. Erosion scarps are only 1 ft deep. Area of concern because erosion is not very deep into prism.</p>
