**Flood Control Project Maintenance  
Levee Inspections**  
**LMA District Cover Sheet**  
**Spring 2019 Levee Inspection Results**

**Reclamation District No. 0551 Pearson**

**Levee Inspection Report By Mile - Spring 2019**

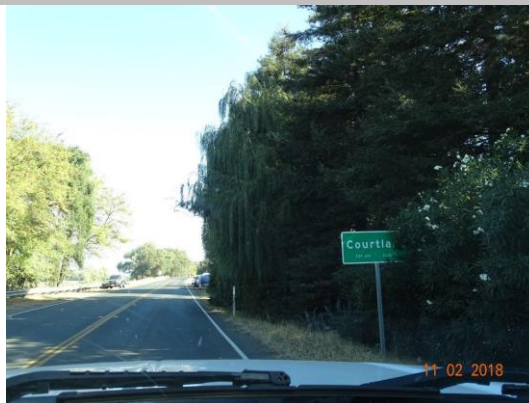
Photo 1 of 1 : SP\_2019\_RD0551\_175\_57\_20190311\_00079.jpg

LM Start	0.76	Rating **	U	Issue No.	57
LM End	0.76	Issue Type +	En	Location *	LS
Category	Earthen Levee			GPS Latitude/Longitude	
				Start	End
Item	Vegetation			38.327783 °	38.327783 °
				-121.573362 °	-121.573362 °
DWR ID	DWR_RD0551_01_f_2018_57				
Comment Code					
V6 : Landscaping					
Inspector Comment

View looking upstream at landscaping on the landside slope (November 2018).

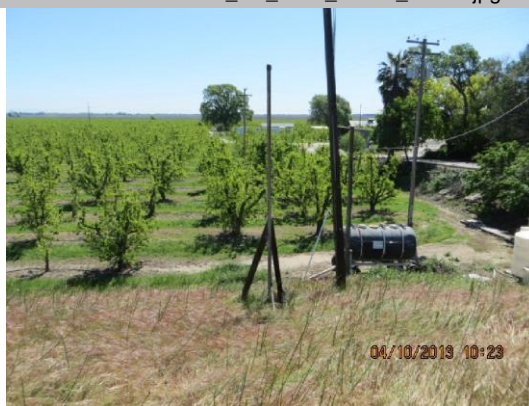
Photo 2 of 3 : UCIP\_SP\_2019\_11727\_19167.jpg

Comment Code						
Inspector Comment						
FS_ID:11727 DS_ID:21986 EP_NO: 701 Repair Type: Non-Urgent Crossing Status: Found UCIP Comments: Pipe appears abandoned and should be done so properly. Good candidate for video inspection. FIELD_STRUCT_DESC: 14-inch steel irrigation pipe through the levee, 7.2 feet below the crown. Pump in pump house on the waterside (WS) slope. Service pole on the landside (LS) slope. 1-inch galvanized filler pipe, and a 2-inch electrical conduit at the same location. (Permit No. 701, 1937 - American Trust Company). [Additional Reference(s): DWR Levee Log, 2005. USACE Sacramento O&M Manual 111, May 1959, (RM 33.91)]. FS Date: 4/10/2013

Pipe and JP visible on LS toe.

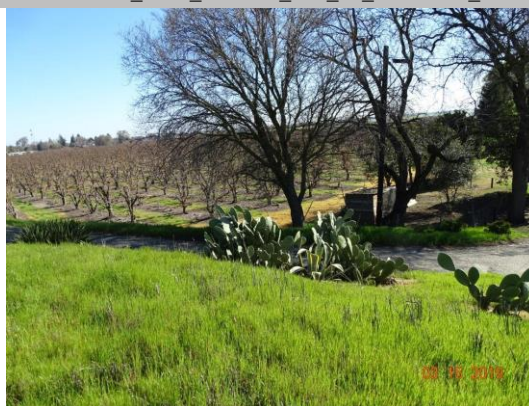
Photo 1 of 1 : SP\_2019\_RD0551\_175\_63\_20190320\_00119.jpg

LM Start	1.28	Rating **	M	Issue No.	63
LM End	1.28	Issue Type +	En	Location *	LS
Category	Earthen Levee			GPS Latitude/Longitude	
				Start	End
Item	Vegetation			38.320707 °	38.320707 °
				-121.576335 °	-121.576335 °
DWR ID	DWR_RD0551_01_s_2019_63				
Comment Code					
V6 : Landscaping					
Inspector Comment					
Cactus is located on landside slope.

View of cactus at the bottom of the landside slope (Spring 2019).

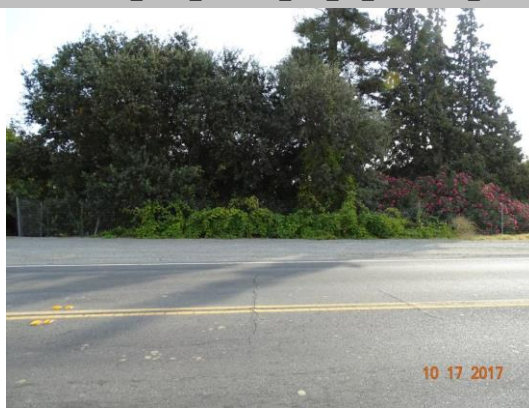
Photo 1 of 1 : SP\_2019\_RD0551\_175\_46\_20190311\_00071.jpg

LM Start	1.36	Rating **	M	Issue No.	46
LM End	1.36	Issue Type +	En	Location *	LS
Category	Earthen Levee			GPS Latitude/Longitude	
				Start	End
Item	Vegetation			38.319621 °	38.319621 °
				-121.576531 °	-121.576531 °
DWR ID	DWR_RD0551_01_f_2017_46				
Comment Code					
V6 : Landscaping					
Inspector Comment					
Landscaping should be maintained to allow inspection and access to landside slope and toe.

View of landscaping on landside slope and toe.

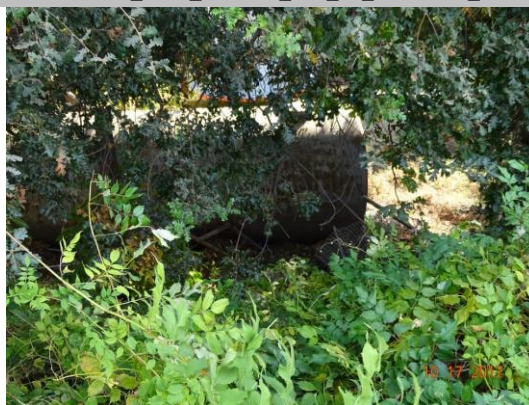
Photo 1 of 1 : SP\_2019\_RD0551\_175\_45\_20190311\_00070.jpg

LM Start	1.36	Rating **	M	Issue No.	45
LM End	1.36	Issue Type +	En	Location *	LS
Category	Earthen Levee			GPS Latitude/Longitude	
				Start	End
Item	Encroachments			38.319620 °	38.319620 °
				-121.576531 °	-121.576531 °
DWR ID	DWR_RD0551_01_f_2017_45				
Comment Code					
TA : Tank					
Inspector Comment					
LMA says tank is now 10' from levee toe. Verify in Fall 2019 inspection that tank is 10' from toe.

Tank at landside toe should be removed to allow inspection and access.

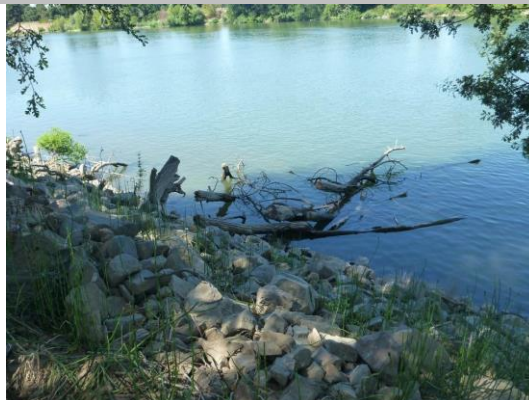
Photo 3 of 3 : SP\_2019\_RD0551\_175\_18\_20190311\_00004.jpg

Comment Code						
Inspector Comment						
Levee Evaluation Comments						
Description:District Station 84+15 to 87+60, Sec. 06, T. 5 N. R. 4 E., M.D.M. Approximately 135 linear-feet of erosion/sloughing exists along the waterside levee slope of the Sacramento River. Sloughing commences approximately 3/4 of the way down the slope from the crown and extends into the rip rap. Some existing rip rap has been pulled off in this section.						
Site ID No:331						
Site Designation:LMA-158						
Repair Type: Erosion						
Rating:Area of Concern						
Field Date:7/13/2017						
Notes: thorney veg on upper slope, light veg within rip rap. Crown is a paved road. 1 ft vertical scarp max just above rip rap so we rated it as a lower priority.

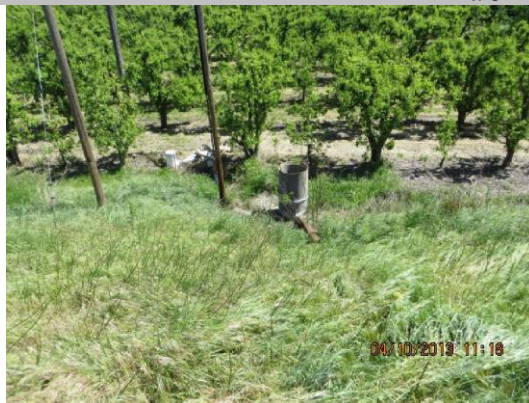
Photo 2 of 3 : UCIP\_SP\_2019\_26874\_49595.jpg

Comment Code						
Inspector Comment						
FS_ID:26874 DS_ID:21990 EP_NO: 11145 Repair Type: Non-Urgent Crossing Status: Found UCIP Comments: Based on District notes from January 14, 2014, pump discharge pipe has been repaired. Pipe failing on LS slope causing erosion along pipe alignment. Pipe debris on both slopes should be removed as well.: As of 12/13/2013 District President noted that the landowner had made repairs to the LS slope leaks.: As of 12/17/2013 District submitted letter to landowner explaining UCIP report details including photos of the pipe problems FIELD_STRUCT_DESC: 10-inch irrigation pipe of an unknown material through the levee, 4.7 feet below the crown. Pump in a 7-foot by 9-foot concrete pump house on the waterside (WS) slope. 36-inch concrete riser on the landside (LS) toe. 1-inch electrical conduit at the same location. Service pole at the LS toe. (Automatic Board Order (ABO) issued as Permit No. 11145, 1975 - Horace D. and Lucile Towne). [Additional Reference(s): DWR Levee Log, 2005. USACE Sacramento O&M Manual 111, May 1959, (RM 33.02), listed as an 8-inch pipe]. FS Date: 1/15/2014

36-inch concrete standpipe at LS toe.

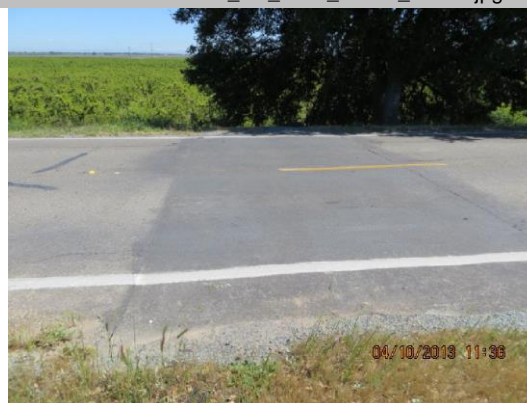
Photo 1 of 1 : UCIP\_SP\_2019\_11749\_19217.jpg

Comment Code						
Inspector Comment						
FS_ID:11749 DS_ID:22040 EP_NO: 3676 Repair Type: Non-Urgent Crossing Status: Not Found UCIP Comments: Fresh cut through pavement on crown indicates recent work on pipes at this location. Need to determine if pipe was removed or abandoned in place. FIELD_STRUCT_DESC: 2 of 2: 8-inch coated steel irrigation pipe through the levee, 5 feet below the crown. 8-inch pipe sleeved through a 12-inch pipe. Pump on platform on the waterside (WS). (Permit No. 3676, 1961 - Runyon and Dorsey). [Additional Reference(s): DWR Levee Log, 2005. USACE Sacramento O&M Manual 111, May 1959, (RM 33.02)]. FS Date: 4/10/2013

Fresh cut through pavement at crown.

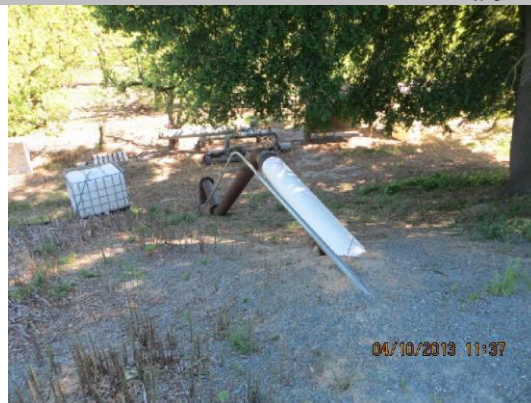
Photo 2 of 3 : UCIP\_SP\_2019\_11763\_19221.jpg

Comment Code						
Inspector Comment						
FS_ID:11763 DS_ID:21991 EP_NO: 6551 Repair Type: Non-Urgent Crossing Status: Found UCIP Comments: Rodent activity undermining pipe on LS slope. FIELD_STRUCT_DESC: 1 of 2: 14-inch polyvinyl chloride (PVC) wrapped steel irrigation pipe through the levee, 3 feet below the crown. Butterfly valve on the waterside (WS) shoulder. 2-inch galvanized electrical conduit at the same location. Pump on pile structure on the WS toe. Pressure booster and pump on the landside (LS) toe. (Permit No. 6551, 1969 - John D. Wheeler). [Additional Reference(s): DWR Levee Log, 2005. USACE Sacramento O&M Manual 111, May 1959, (RM 32.78)]. FS Date: 4/10/2013

Pipe, electrical conduit, and booster pump on LS toe.

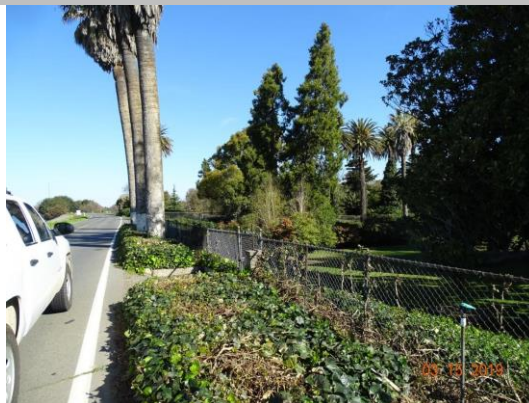
Photo 1 of 1 : SP\_2019\_RD0551\_175\_61\_20190320\_00117.jpg

LM Start	2.26	Rating **	M	Issue No.	61
LM End	2.33	Issue Type +	En	Location *	LS
Category	Earthen Levee			GPS Latitude/Longitude	
				Start	End
Item	Encroachments			38.307220 °	38.306222 °
				-121.573153 °	-121.572518 °
DWR ID	DWR_RD0551_01_s_2019_61				
Comment Code					
FE : Fence					
Inspector Comment					
A chainlink fence is located on the landside.

View looking upstream at chainlink fence on the landside slope (Spring 2019).

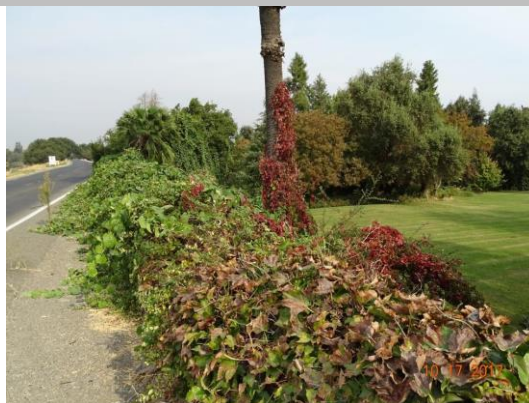
Photo 1 of 1 : SP\_2019\_RD0551\_175\_47\_20190311\_00072.jpg

LM Start	2.29	Rating **	U	Issue No.	47
LM End	2.29	Issue Type +	En	Location *	LS
Category	Earthen Levee			GPS Latitude/Longitude	
				Start	End
Item	Vegetation			38.306755 °	38.306755 °
				-121.572916 °	-121.572916 °
DWR ID	DWR_RD0551_01_f_2017_47				
Comment Code					
V6 : Landscaping					
Inspector Comment					
Landscaping hides levee slope. Toe is mostly visible. Landscaping should be maintained to allow inspection and access to landside slope and toe.

View of landscaping on landside slope and toe.

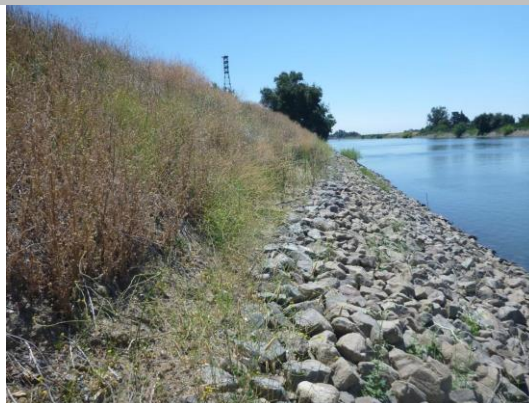
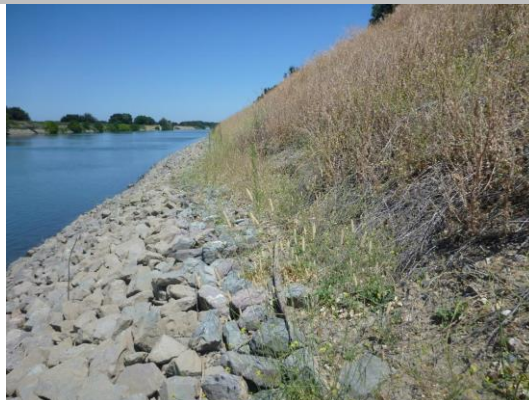
Comment Code					
Inspector Comment					
Levee Evaluation Comments					
Description:District Station 159+69 to 170+73, Sec. 08, T. 5 N. R. 4 E., M.D.M. Approximately 1,104 linear-feet of erosion and subsequent sloughing exists along the waterside slope of the Sacramento River. The erosion commences approximately halfway down the slope to the rip rap line.					
Site ID No:333					
Site Designation:LMA-160					
Repair Type: Erosion					
Rating:Area of Concern					
Field Date:7/13/2017					
Notes: Crown is a paved road. Thorny veg on upper slope, none in rip rap. Scarps upto 3 ft, mostly smaller, above rip rap. Area of concern because erosion is not too deep into prism and good rip rap protection on lower slope.

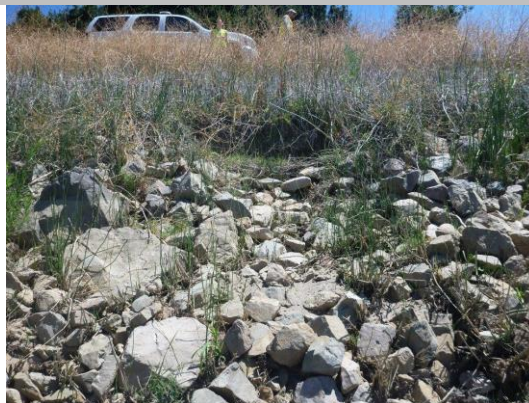
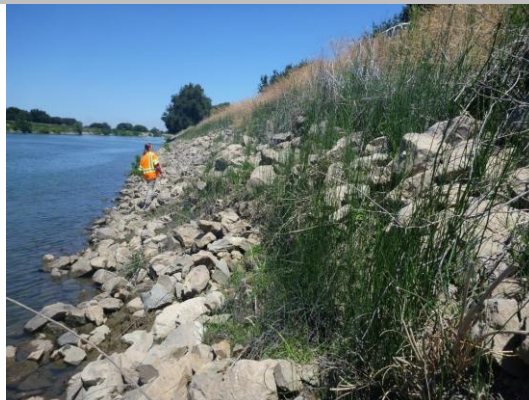
Comment Code						
Inspector Comment						
Levee Evaluation Comments						
Description:District Station 175+36 to 176+30, Sec. 08, T. 5 N. R. 4 E., M.D.M. Approximately 94 linear-feet of erosion exists along the waterside slope of the Sacramento River. The erosion occurs within the rip rap area near the waterline. Sloughing is exhibited in the in the bottom half of the slope. Some existing rip rap has been pulled off in this section.						
Site ID No:334						
Site Designation:LMA-161						
Repair Type: Erosion						
Rating:Area of Concern						
Field Date:7/13/2017						
Notes: Crown is a paved road. Scarps upto 3 ft within rip rap and 18 in above rip rap. Lower priority because erosion does not significantly cut into prism and damage was not continuous through whole site.

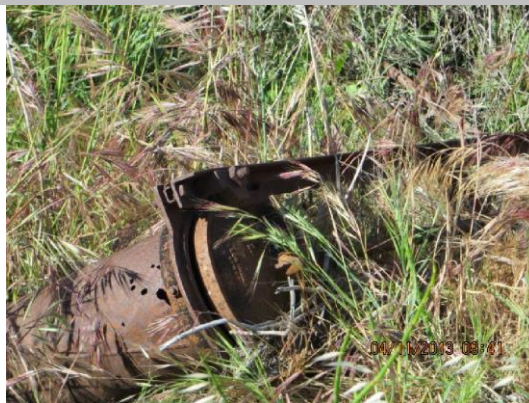
Photo 2 of 2 : UCIP\_SP\_2019\_11817\_19286.jpg

Abandoned slide gate on WS slope.

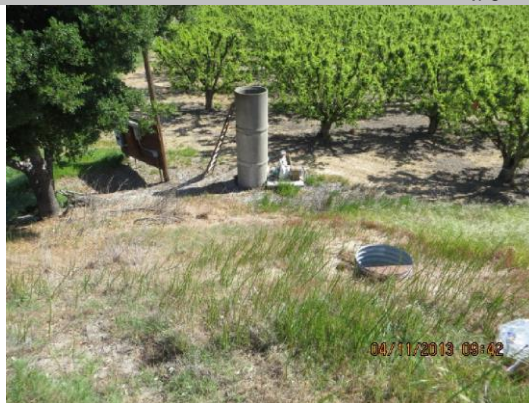
Photo 1 of 2 : UCIP\_SP\_2019\_11823\_19301.jpg

24-inch CMP riser and 48-inch concrete riser on LS slope.

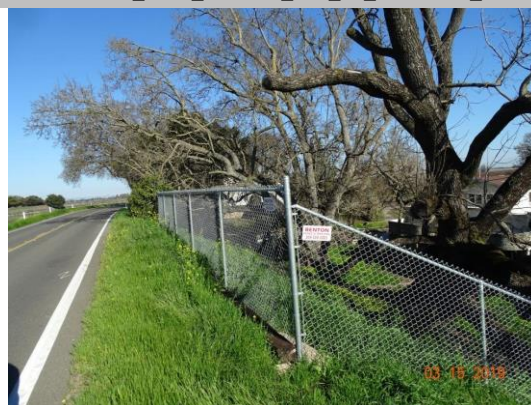
Photo 1 of 1 : SP\_2019\_RD0551\_175\_60\_20190320\_00116.jpg

LM Start	4.18	Rating **	M	Issue No.	60
LM End	4.23	Issue Type +	En	Location *	LS
Category	Earthen Levee			GPS Latitude/Longitude	
				Start	End
Item	Encroachments			38.284795 °	38.284318 °
				-121.552597 °	-121.551830 °
DWR ID	DWR_RD0551_01_s_2019_60				
Comment Code					
FE : Fence					
Inspector Comment					
A chainlink fence is located on landside.

View looking upstream at chainlink fence on the landside slope and shoulder (Spring 2019).

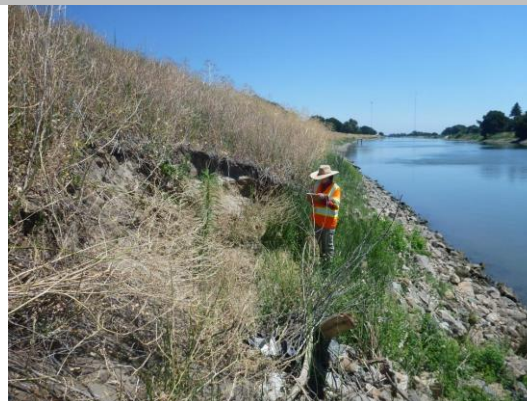
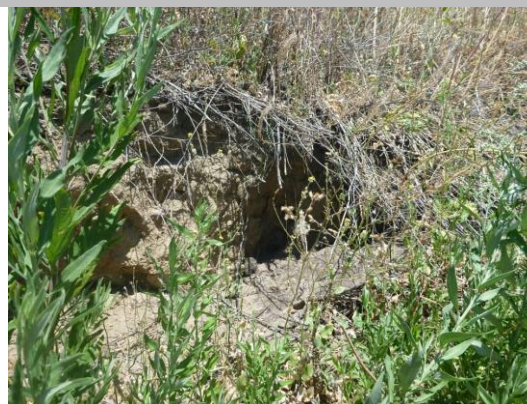
Comment Code					
Inspector Comment					
Levee Evaluation Comments					
Description:District Station 231+12 to 235+26, Sec. 16, T. 5 N. R. 4 E., M.D.M. Approximately 414 linear-feet of erosion and subsequent sloughing exists along the waterside slope of the Sacramento River. The erosion commences approximately 3/4 of the way down the slope to the rip rap line.					
Site ID No:336					
Site Designation:LMA-163					
Repair Type: Erosion					
Rating:Area of Concern					
Field Date:7/13/2017					
Notes: We only saw erosion on about 1½ the length reported by the LMA, but there is another site very close by. Crown is a paved road. Scarps up to 5 ft deep above the rip rap, mostly smaller though so rated this a lower priority site.

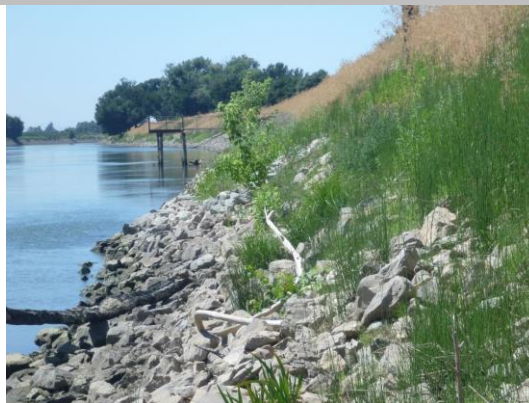
Photo 3 of 3 : SP\_2019\_RD0551\_175\_30\_20190311\_00029.jpg

Comment Code						
Inspector Comment						
Levee Evaluation Comments						
Description:District Station 245+47 to 247+26, Sec. 16, T. 5 N. R. 4 E., M.D.M. Approximately 179 linear-feet of erosion and sloughing exists along the waterside slope of the Sacramento River. The erosion commences approximately halfway down the slope and extends to the rip rap. Some existing rip rap has been pulled off in this section.						
Site ID No:338						
Site Designation:LMA-165						
Repair Type: Erosion						
Rating:Area of Concern						
Field Date:7/13/2017						
Notes: Crown is paved road. Scarps up to 7 ft deep, 2 ft typical above the rip rap. Area of concern because the deeper scarp only covered a short distance and was already vegetated so not actively eroding.

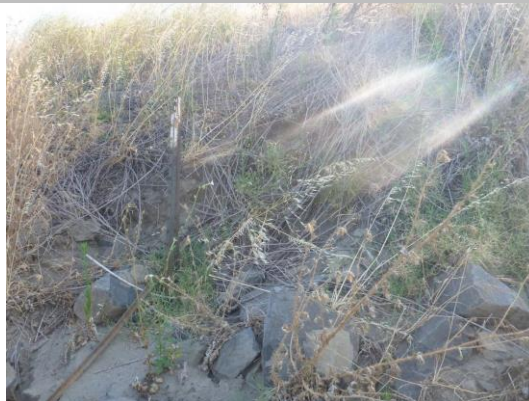
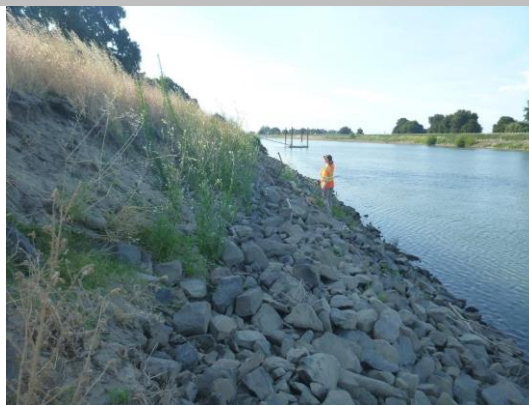
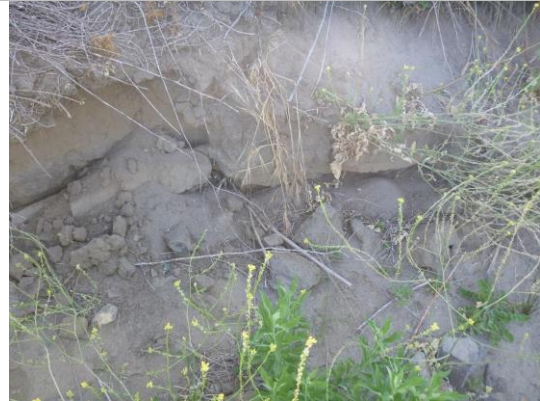
Comment Code					
Inspector Comment					
Levee Evaluation Comments					
Description:District Station 258+80 to 260+40, Sec. 16, T. 5 N. R. 4 E., M.D.M. Approximately 160 linear-feet of erosion exists along the waterside slope of the Sacramento River. The erosion commences approximately halfway down the slope from the crown and extends to the rip rap. Some existing rip rap has been pulled off in this section.					
Site ID No:339					
Site Designation:LMA-166					
Repair Type: Erosion					
Rating:Area of Concern					
Field Date:7/14/2017					
Notes: crown is a paved road. Scarps of 2.5 ft just above rip rap. Area of concern because erosion is fairly small.

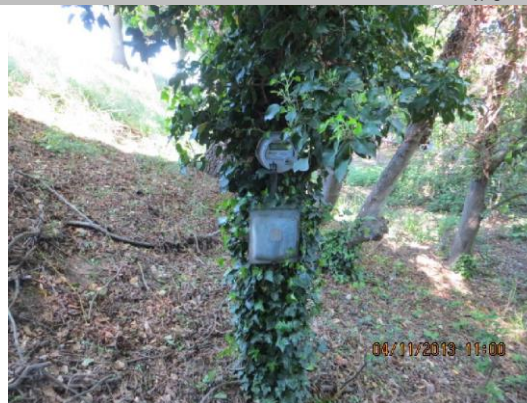
Photo 2 of 3 : UCIP\_SP\_2019\_12105\_19648.jpg

Comment Code						
Inspector Comment						
FS_ID:12105 DS_ID:22022 EP_NO: 11125 Repair Type: Non-Urgent Crossing Status: Found UCIP Comments: Pumphouse has been removed from pump and pump is in disrepair. Pipe at LS toe is sleeved or has been replaced with a 6-inch PVC pipe. This pump appears abandoned and should be done so properly. FIELD_STRUCT_DESC: 6-inch irrigation pipe of an unknown material through the levee, 6.5 feet below the crown. Pump and slide gate on the waterside (WS) slope. 1-inch electrical conduit at the same location with service pole at the landside (LS) toe. 4-foot by 6-foot concrete distribution box at the LS toe. (Automatic Board Order (ABO) issued as Permit No. 11125, 1975 - William H. and Evelyn J. Cortopassi). [Additional Reference(s): DWR Levee Log, 2005. USACE Sacramento O&M Manual 111, May 1959, (RM 29.71)]. FS Date: 4/11/2013

Meter on pole at LS toe.

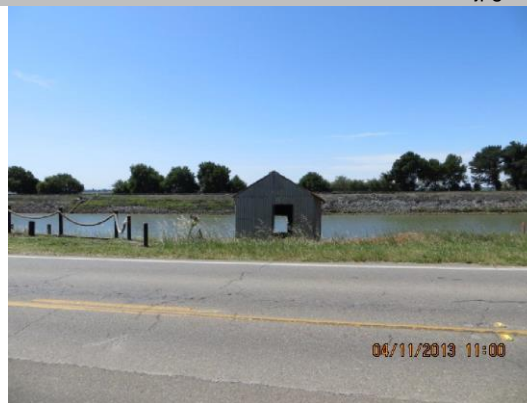
Photo 3 of 3 : UCIP\_SP\_2019\_12105\_19647.jpg

Relocated pumphouse on WS shoulder.

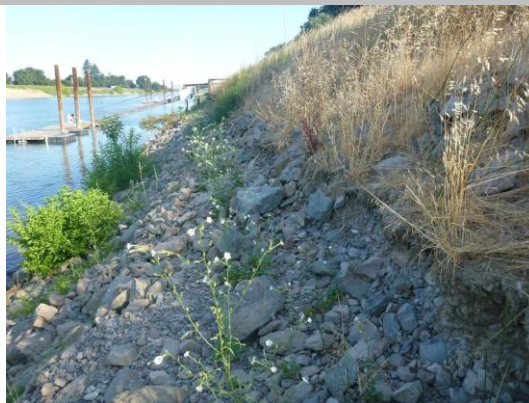
Photo 3 of 3 : SP\_2019\_RD0551\_175\_32\_20190311\_00035.jpg

Comment Code						
Inspector Comment						
Levee Evaluation Comments						
Description:District Station 266+16 to 267+71, Sec. 21, T. 5 N. R. 4 E., M.D.M. Approximately 155 linear-feet of erosion and sloughing exists along the waterside slope of the Sacramento River. The erosion commences approximately 3/4 of the way down the slope from the crown and extends into the rip rap. Some existing rip rap has been pulled off in this section.						
Site ID No:340						
Site Designation:LMA-167						
Repair Type: Erosion						
Rating:Area of Concern						
Field Date:7/14/2017						
Notes: Crown is a paved road. There is a private boat dock in the middle of the site. Some exposed filter fabric. On the upstream side erosion is above the rip rap and on the downstream side it is within the rip rap. Scarps are 2-3 ft deep. Area of concern because erosion is not very deep into prism.

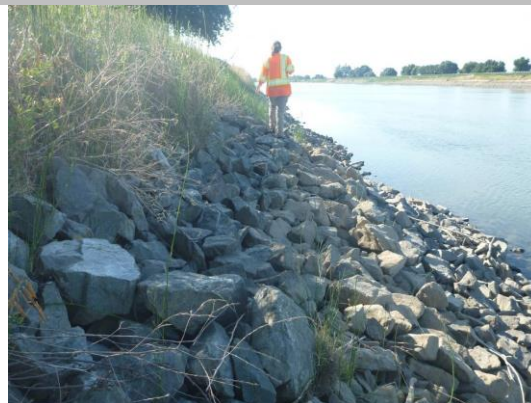
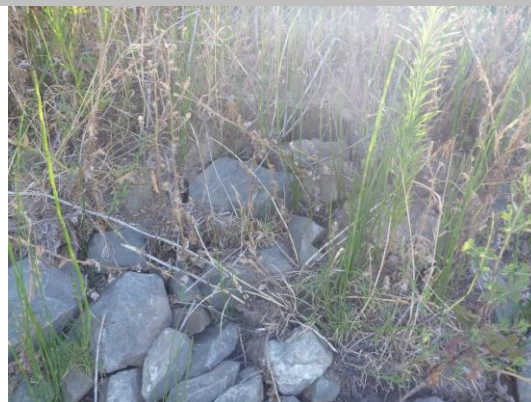
Comment Code					
Inspector Comment					
Levee Evaluation Comments					
Description:District Station 269+37 to 271+66, Sec. 21, T. 5 N. R. 4 E., M.D.M. Approximately 229 linear-feet of erosion and sloughing exists along the waterside slope of the Sacramento River. The erosion commences approximately 3/4 of the way down the slope from the crown and extends to the rip rap.					
Site ID No:341					
Site Designation:LMA-168					
Repair Type: Erosion					
Rating:Area of Concern					
Field Date:7/14/2017					
Notes: crown is a paved road. Scarps upto 4-5 ft, but 18 inches for most of the length. Large tree within site. Area of concern because deeper erosion is only present for a short distance.

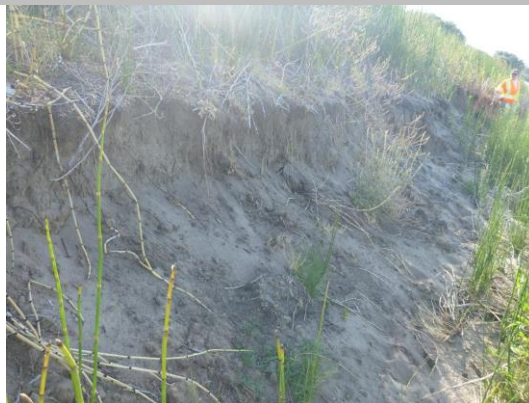
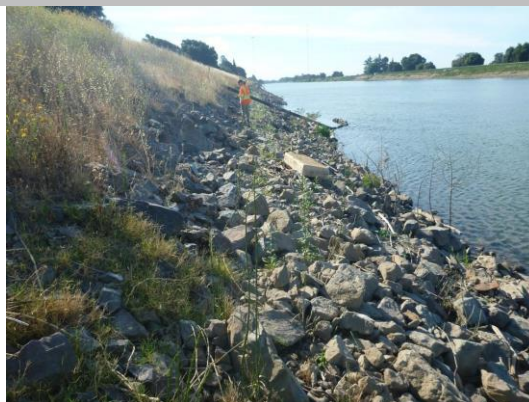
Comment Code						
Inspector Comment						
Levee Evaluation Comments						
Description:District Station 273+82 to 278+08, Sec. 21 and 22, T. 5 N. R. 4 E., M.D.M. Approximately 426 linear-feet of erosion exists along the waterside slope of the Sacramento River. The erosion commences approximately halfway down the slope and extends to the rip rap. Some existing rip rap has been pulled off in this section.						
Site ID No:342						
Site Designation:LMA-169						
Repair Type: Erosion						
Rating:Serious						
Field Date:7/14/2017						
Notes: there is a 7 ft scarp that extends for 40-60 ft in very sandy soil, scarps are 2-4 ft the rest of the length. Worst site in this RD so far. Serious because of the length of this deeper scarp and the weak soil here. Crown is a paved road.

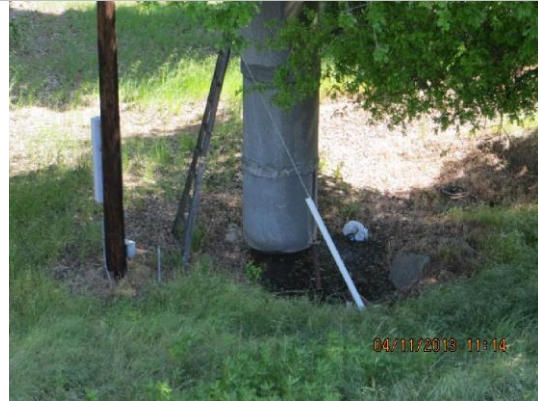
Photo 1 of 3 : UCIP\_SP\_2019\_26875\_49602.jpg

Comment Code						
Inspector Comment						
FS_ID:26875 DS_ID:22023 EP_NO: 11131 Repair Type: Non-Urgent Crossing Status: Found UCIP Comments: Based on District notes from January 15, 2014, pump discharge pipe has been repaired. Corrosion holes in pipe at LS toe good indicator that pipe is failing internally. Pipe should be examined internally for damage (video inspect).: As of 12/12/2013 the District discussed with farmer tenant what needed to be done, and the tenant informed the District that they would address the repairs.: As of 12/17/2013 District submitted letter to landowner explaining UCIP report details including photos of the pipe problems FIELD_STRUCT_DESC: 10-inch irrigation pipe of an unknown material through the levee, 7.7 feet below the crown. Pump and slide gate on a concrete pad on the waterside (WS) slope. Siphon breaker in a 24-inch corrugated metal pipe (CMP) riser on the landside (LS) slope. Concrete riser and power pole with panel box on the LS toe. (Automatic Board Order (ABO) issued as Permit No. 11131, 1975 - Helen Crofton and Sloane Latimer). [Additional Reference(s): DWR Levee Log, 2005. USACE Sacramento O&M Manual 111, May 1959, (RM 29.52) (9-inch pipe listed)]. FS Date: 1/15/2014

Concrete standpipe, JP and meter, and 4-inch steel pipe visible at LS toe.

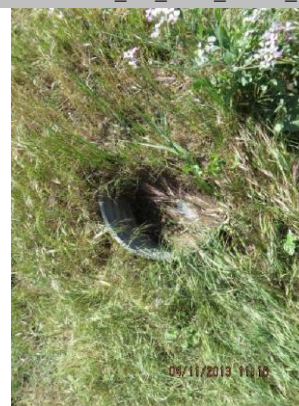
Photo 3 of 3 : UCIP\_SP\_2019\_26875\_49600.jpg

Comment Code						
Inspector Comment						
FS_ID:26875 DS_ID:22023 EP_NO: 11131 Repair Type: Non-Urgent Crossing Status: Found UCIP Comments: Based on District notes from January 15, 2014, pump discharge pipe has been repaired. Corrosion holes in pipe at LS toe good indicator that pipe is failing internally. Pipe should be examined internally for damage (video inspect).: As of 12/12/2013 the District discussed with farmer tenant what needed to be done, and the tenant informed the District that they would address the repairs.: As of 12/17/2013 District submitted letter to landowner explaining UCIP report details including photos of the pipe problems FIELD_STRUCT_DESC: 10-inch irrigation pipe of an unknown material through the levee, 7.7 feet below the crown. Pump and slide gate on a concrete pad on the waterside (WS) slope. Siphon breaker in a 24-inch corrugated metal pipe (CMP) riser on the landside (LS) slope. Concrete riser and power pole with panel box on the LS toe. (Automatic Board Order (ABO) issued as Permit No. 11131, 1975 - Helen Crofton and Sloane Latimer). [Additional Reference(s): DWR Levee Log, 2005. USACE Sacramento O&M Manual 111, May 1959, (RM 29.52) (9-inch pipe listed)]. FS Date: 1/15/2014

Siphon breaker in 24-inch CMP riser on LS slope.

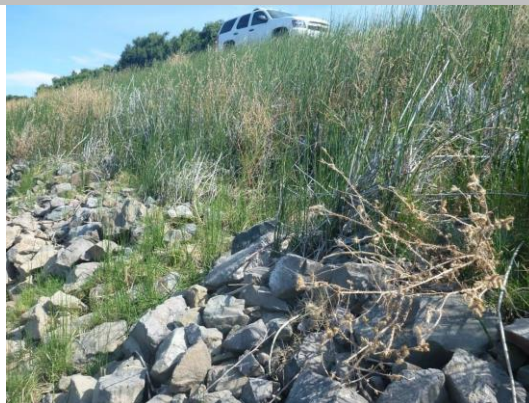
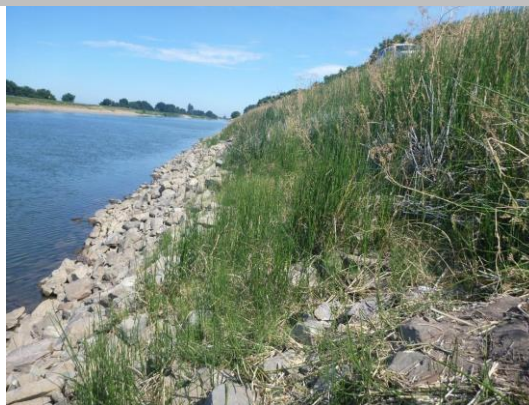
Comment Code						
Inspector Comment						
Levee Evaluation Comments						
Description:District Station 290+80 to 291+85, Sec. 22, T. 5 N. R. 4 E., M.D.M. Approximately 105 linear-feet of erosion and sloughing exists along the waterside slope of the Sacramento River. The erosion commences approximately 3/4 of the way down the slope and extends into the rip rap. Some existing rip rap has been pulled off in this section.						
Site ID No:344						
Site Designation:LMA-171						
Repair Type:Erosion						
Rating:Area of Concern						
Field Date:7/14/2017						
Notes: Crown is a paved road. Erosion scarps 1-4 ft deep just above rip rap. Area of concern because erosion is not very deep into prism.

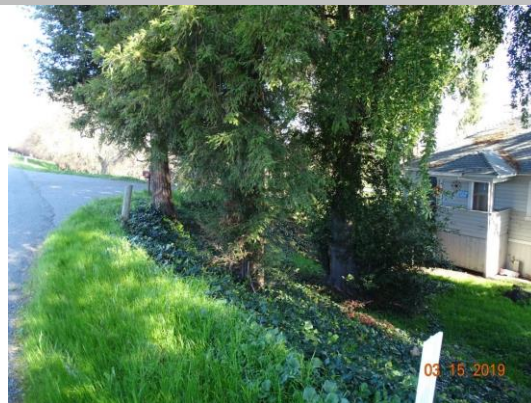
Photo 1 of 1 : SP\_2019\_RD0551\_175\_58\_20190320\_00115.jpg

LM Start	5.54	Rating **	M	Issue No.	58
LM End	5.54	Issue Type +	En	Location *	LS
Category	Earthen Levee			GPS Latitude/Longitude	
				Start	End
Item	Vegetation			38.271415 °	38.271415 °
				-121.534307 °	-121.534307 °
DWR ID	DWR_RD0551_01_s_2019_58				
Comment Code					
V6 : Landscaping					
Inspector Comment					
Thin landscaping to allow visibility and access down landside slope.

View looking upstream at landscaping on the landside slope (Spring 2019).

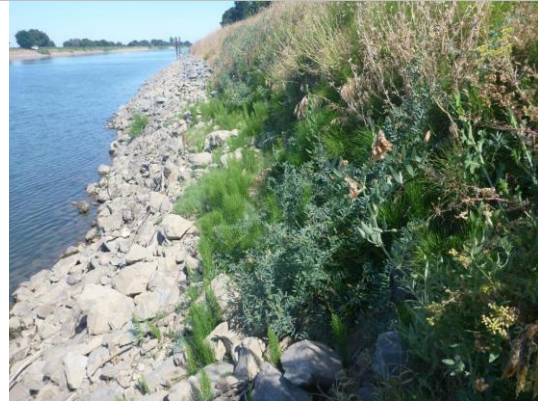
Photo 3 of 3 : SP\_2019\_RD0551\_175\_37\_20190311\_00050.jpg

Item	2017 Storm Damage			38.269025 °	38.268814 °
				-121.531361 °	-121.531058 °
DWR ID	DWR_RD0551_01_f_2017_37				
Comment Code					
Inspector Comment					
<p>Levee Evaluation Comments</p> <p>Description: District Station 303+60 to 304+75, Sec. 22, T. 5 N. R. 4 E., M.D.M. Approximately 115 linear-feet of erosion and sloughing exists along the waterside slope of the Sacramento River. The erosion occurs just above the rip rap line. Some existing rip rap has been pulled off in this section.</p> <p>Site ID No: 345</p> <p>Site Designation: LMA-172</p> <p>Repair Type: Erosion</p> <p>Rating: Area of Concern</p> <p>Field Date: 7/14/2017</p> <p>Notes: Crown is a paved road. 4 ft deep scarp above the rip rap. Area of concern because erosion is not very deep into prism and there was lots of vegetation growing in the damaged area indicating it may be an older issue.</p>

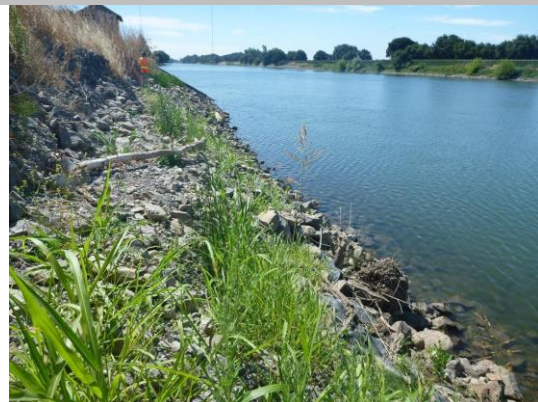
Photo 1 of 3 : SP\_2019\_RD0551\_175\_38\_20190311\_00051.jpg

Item	2017 Storm Damage			38.268244 °	38.268139 °
				-121.530233 °	-121.530075 °
DWR ID	DWR_RD0551_01_f_2017_38				
Comment Code					
Inspector Comment					
<p>Levee Evaluation Comments</p> <p>Description: District Station 307+90 to 305+49, Sec. 22, T. 5 N. R. 4 E., M.D.M. Approximately 59 linear-feet of erosion exists along the waterside slope of the Sacramento River. The erosion occurs approximately halfway down the slope within the rip rapped area. Existing rip rap has been pulled off in this section.</p> <p>Site ID No: 346</p> <p>Site Designation: LMA-173</p> <p>Repair Type: Erosion</p> <p>Rating: Area of Concern</p> <p>Field Date: 7/14/2017</p> <p>Notes: Crown is a paved road. Erosion scarps 4-6 ft high, but soil is more stable than other nearby sites with large gravel in silt or clay so we rated this as an area of concern.</p>

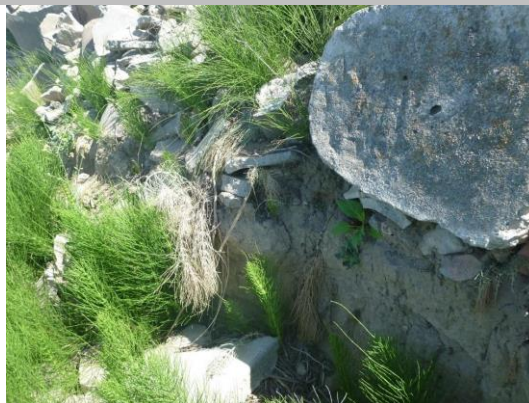
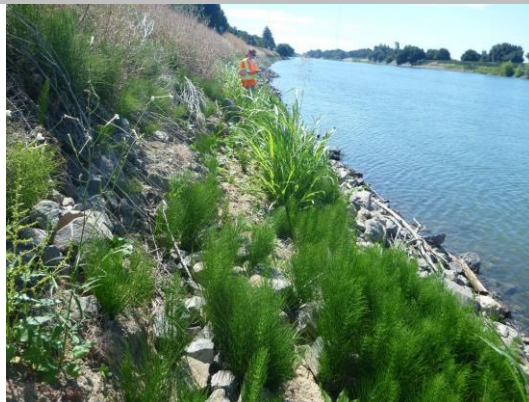
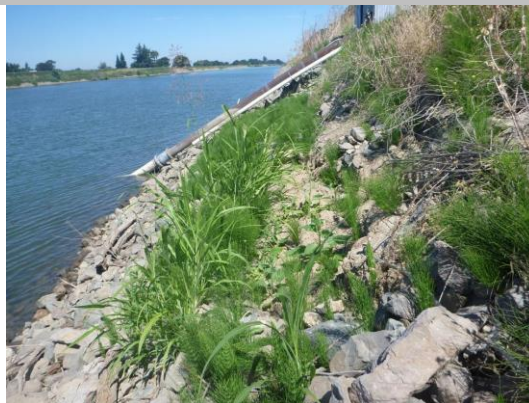
Comment Code					
Inspector Comment					
Levee Evaluation Comments					
Description:District Station 309+33 to 310+53, Sec. 22, T. 5 N. R. 4 E., M.D.M. Approximately 120 linear-feet of erosion and sloughing exists along the waterside slope of the Sacramento River. The erosion commences approximately halfway down the slope, extending into the rip rap. Some existing rip rap has been pulled off in this section.					
Site ID No:347					
Site Designation:LMA-174					
Repair Type: Erosion					
Rating:Area of Concern					
Field Date:7/14/2017					
Notes: Crown is a paved road. Pump house in the middle of this site. 18 inch scarps in and just above top of rip rap. Area of concern because erosion is not very deep into prism.

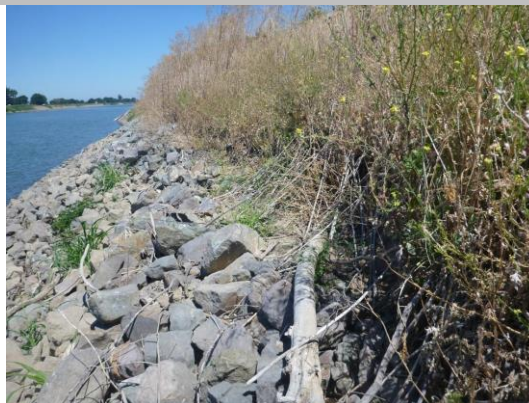
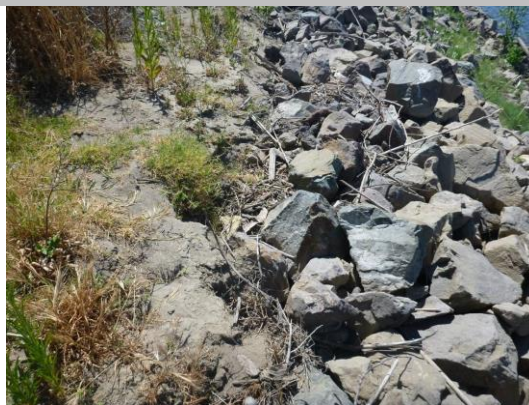
Comment Code						
Inspector Comment						
Levee Evaluation Comments						
Description:District Station 313+15 to 314+15, Sec. 22, T. 5 N. R. 4 E., M.D.M. Approximately 100 linear-feet of erosion and sloughing exists along the waterside slope of the Sacramento River. The erosion commences approximately halfway down the slope and extends into the rip rap. Some existing rip rap has been pulled off in this section.						
Site ID No:349						
Site Designation:LMA-176						
Repair Type: Erosion						
Rating:Area of Concern						
Field Date:7/14/2017						
Notes: 18 in to 3 ft vertical scarps just above rip rap. Crown is a paved road. Area of concern because erosion is not very deep into prism.

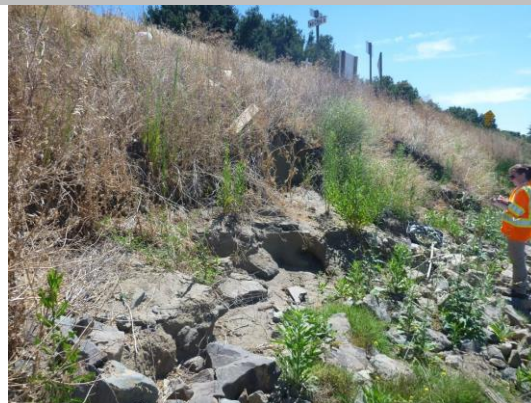
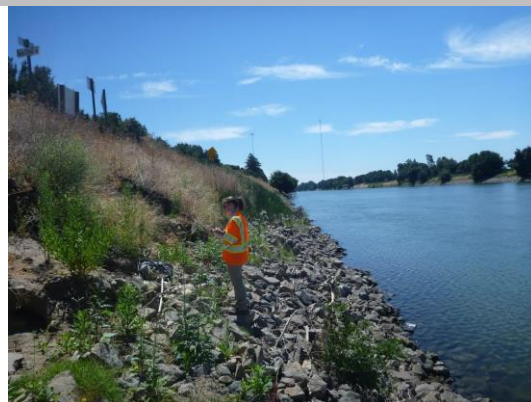
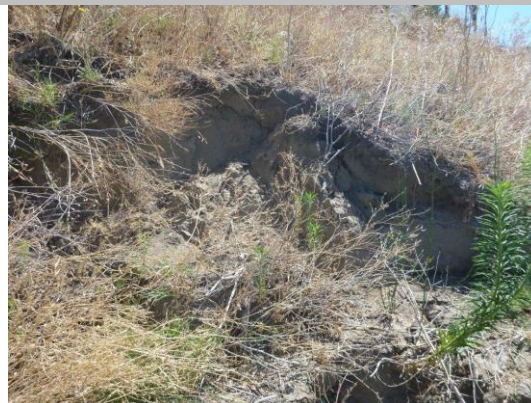
Comment Code					
Inspector Comment					
Levee Evaluation Comments					
Description:District Station 316+24 to 320+12, Sec. 22, T. 5 N. R. 4 E., M.D.M. Approximately 388 linear-feet of erosion exists along the waterside slope of the Sacramento River. The erosion commences approximately halfway down the slope and extends into the rip rap. Some existing rip rap has been pulled off in this section.					
Site ID No:350					
Site Designation:LMA-177					
Repair Type: Erosion					
Rating:Area of Concern					
Field Date:7/14/2017					
Notes: Crown is aved road. Erosion scarps between 1-6 ft deep. Area of concern because the deeper erosion only extended for a short distance.

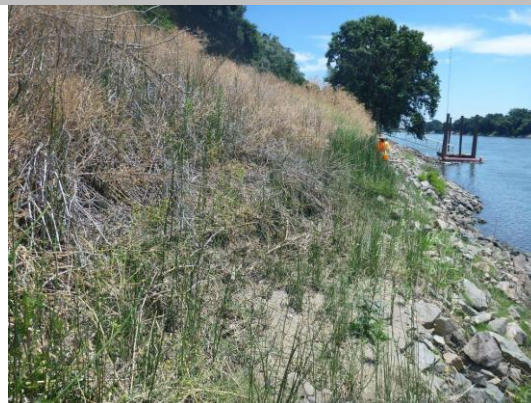
Photo 1 of 3 : SP\_2019\_RD0551\_175\_42\_20190311\_00063.jpg

Item	2017 Storm Damage		38.264436 °	38.264233 °								
			-121.525472 °	-121.525219 °								
DWR ID	DWR_RD0551_01_f_2017_42											
Comment Code												
Inspector Comment												
<p>Levee Evaluation Comments</p> <p>Description: District Station 327+45 to 328+45, Sec. 22, T. 5 N. R. 4 E., M.D.M. Approximately 100 linear-feet of erosion and sloughing exists along the waterside slope of the Sacramento River. The erosion commences approximately halfway down the slope and extends into the rip rap. Existing rip rap has been pulled off in this section.</p> <p>Site ID No: 351</p> <p>Site Designation: LMA-178</p> <p>Repair Type: Erosion</p> <p>Rating: Serious</p> <p>Field Date: 7/14/2017</p> <p>Notes: Crown is a paved road. Scarps above rip rap are about 7 ft deep. Rated this serious because erosion scarps are pretty deep, sandy material, steep slope, the rip rap is in poor condition and high traffic on the levee road.</p>

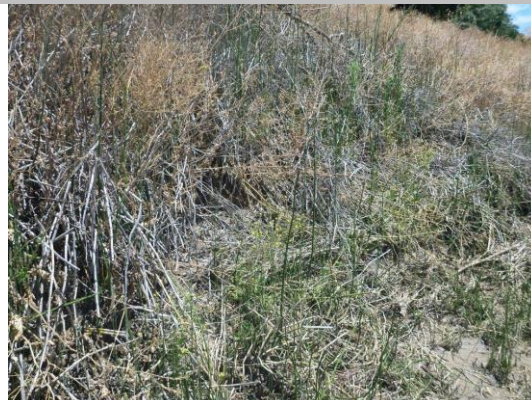
Photo 2 of 3 : SP\_2019\_RD0551\_175\_42\_20190311\_00064.jpg

Item	2017 Storm Damage			38.264436 °	38.264233 °
				-121.525472 °	-121.525219 °
DWR ID	DWR_RD0551_01_f_2017_42				
Comment Code					
Inspector Comment					
<p>Levee Evaluation Comments</p> <p>Description: District Station 327+45 to 328+45, Sec. 22, T. 5 N. R. 4 E., M.D.M. Approximately 100 linear-feet of erosion and sloughing exists along the waterside slope of the Sacramento River. The erosion commences approximately halfway down the slope and extends into the rip rap. Existing rip rap has been pulled off in this section.</p> <p>Site ID No: 351</p> <p>Site Designation: LMA-178</p> <p>Repair Type: Erosion</p> <p>Rating: Serious</p> <p>Field Date: 7/14/2017</p> <p>Notes: Crown is a paved road. Scarps above rip rap are about 7 ft deep. Rated this serious because erosion scarps are pretty deep, sandy material, steep slope, the rip rap is in poor condition and high traffic on the levee road.</p>

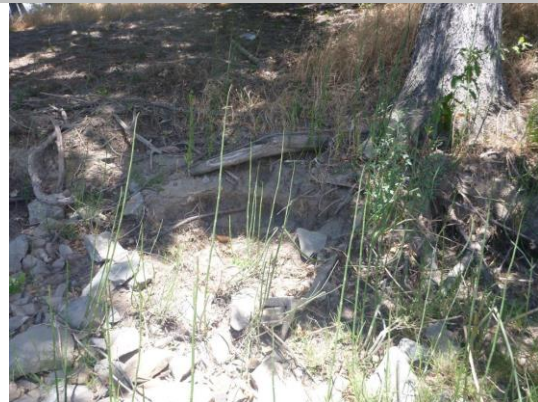
Photo 1 of 3 : SP\_2019\_RD0551\_175\_43\_20190311\_00066.jpg

LM Start	<b>6.27</b>	Rating **	A/W	Issue No.	<b>43</b>
LM End	<b>6.29</b>	Issue Type +	Ma	Location *	
Category	Supplemental			GPS Latitude/Longitude	
				Start	End

Item	2017 Storm Damage			38.263906 °	38.263756 °
				-121.524778 °	-121.524575 °
DWR ID	DWR_RD0551_01_f_2017_43				
Comment Code					
Inspector Comment					
<p>Levee Evaluation Comments</p> <p>Description: District Station 330+19 to 330+99, Sec. 22, T. 5 N. R. 4 E., M.D.M. Approximately 80 linear-feet of erosion/sloughing and minor slippage exists along the waterside slope of the Sacramento River. The erosion/sloughing commences approximately halfway down the slope and extends into the rip rap. Existing rip rap has been pulled off in this section.</p> <p>Site ID No: 352</p> <p>Site Designation: LMA-179</p> <p>Repair Type: Erosion</p> <p>Rating: Area of Concern</p> <p>Field Date: 7/14/2017</p> <p>Notes: Crown is a paved road. Erosion scarps are only 1 ft deep. Area of concern because erosion is not very deep into prism.</p>

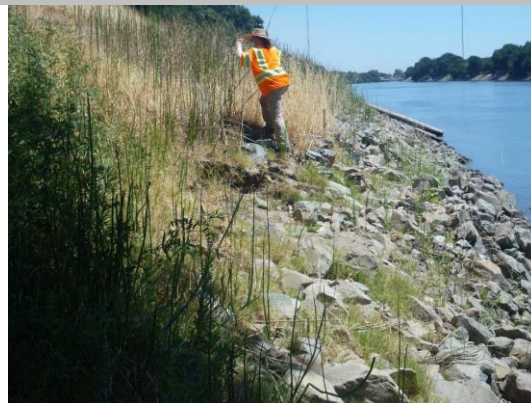
Photo 2 of 3 : SP\_2019\_RD0551\_175\_43\_20190311\_00067.jpg

LM Start	6.27	Rating **	A/W	Issue No.	43 (cont)	
LM End	6.29	Issue Type +	Ma	Location *		
Category	Supplemental			GPS Latitude/Longitude		
				Start		End
Item	2017 Storm Damage			38.263906 °		38.263756 °
				-121.524778 °		-121.524575 °
DWR ID	DWR_RD0551_01_f_2017_43

Comment Code						
Inspector Comment						
Levee Evaluation Comments						
Description:District Station 330+19 to 330+99, Sec. 22, T. 5 N. R. 4 E., M.D.M. Approximately 80 linear-feet of erosion/sloughing and minor slippage exists along the waterside slope of the Sacramento River. The erosion/sloughing commences approximately halfway down the slope and extends into the rip rap. Existing rip rap has been pulled off in this section.						
Site ID No:352						
Site Designation:LMA-179						
Repair Type: Erosion						
Rating:Area of Concern						
Field Date:7/14/2017						
Notes: Crown is a paved road. Erosion scarps are only 1 ft deep. Area of concern because erosion is not very deep into prism.
