**Flood Control Project Maintenance  
Levee Inspections**  
**LMA District Cover Sheet**  
**Spring 2020 Levee Inspection Results**

**Reclamation District No. 0551 Pearson**

**Spring 2020 Levee Inspection Results**

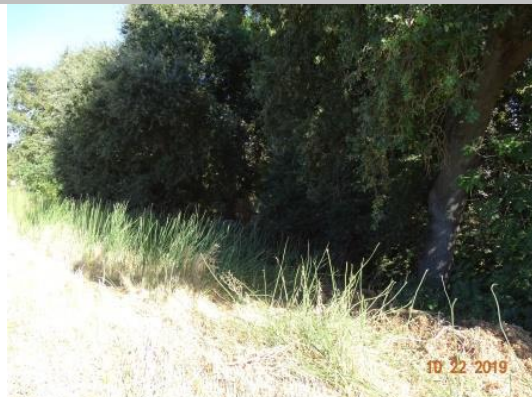
Photo 1 of 1 : SP\_2020\_RD0551\_175\_46\_20200304\_00070.jpg

LM Start	1.36	Rating **	U	Issue No.	46
LM End	1.36	Issue Type +	En	Location *	LS
Category	Earthen Levee			GPS Latitude/Longitude	
				Start	End
Item	Vegetation			38.319621 °	38.319621 °
				-121.576531 °	-121.576531 °
DWR ID	DWR_RD0551_01_f_2017_46				
Comment Code					
V6 : Landscaping					
Inspector Comment					
Landscaping should be maintained to allow inspection and access to landside slope and toe.

View looking upstream at landscaping on the landside slope (Fall 2019).

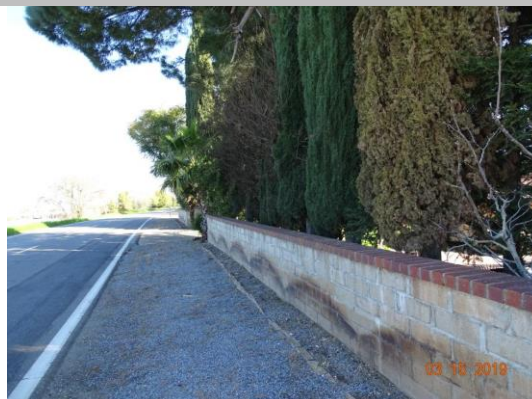
Photo 1 of 1 : SP\_2020\_RD0551\_175\_62\_20200304\_00085.jpg

LM Start	1.70	Rating **	U	Issue No.	62
LM End	1.70	Issue Type +	En	Location *	LS
Category	Earthen Levee			GPS Latitude/Longitude	
				Start	End
Item	Vegetation			38.314687 °	38.314687 °
				-121.576727 °	-121.576727 °
DWR ID	DWR_RD0551_01_s_2019_62				
Comment Code					
V6 : Landscaping					
Inspector Comment					
Landscaping is blocking the view down the landside slope.

View looking upstream at landscaping on the landside slope (Spring 2019).

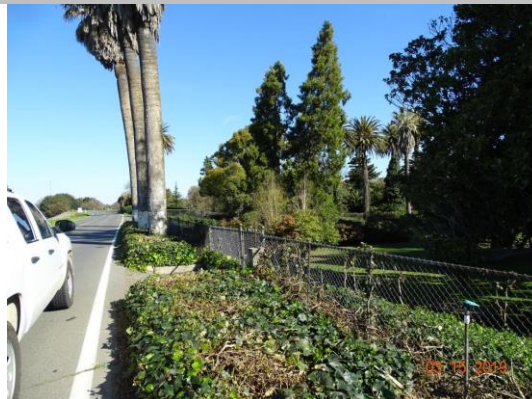
Photo 1 of 1 : SP\_2020\_RD0551\_175\_61\_20200304\_00084.jpg

LM Start	2.26	Rating **	M	Issue No.	61
LM End	2.35	Issue Type +	En	Location *	LS
Category	Earthen Levee			GPS Latitude/Longitude	
				Start	End
Item	Encroachments			38.307220 °	38.305995 °
				-121.573153 °	-121.572367 °
DWR ID	DWR_RD0551_01_s_2019_61				
Comment Code					
FE : Fence					
Inspector Comment					
A chainlink fence is located on the landside.

View looking upstream at chainlink fence on the landside slope (Spring 2019).

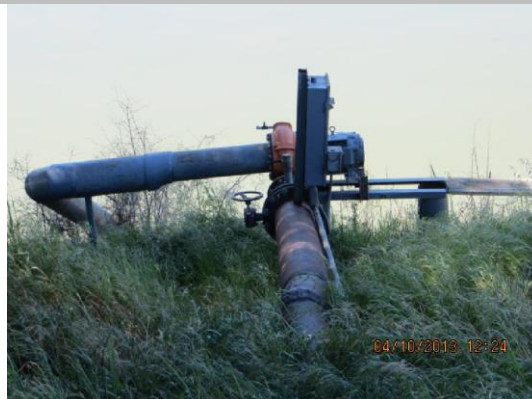
Photo 2 of 2 : UCIP\_SP\_2020\_11783\_19240.jpg

Comment Code						
Inspector Comment						
DS_ID:21994 FS_ID:11783 EP_NO: 11141 Repair Type: Non-Urgent Crossing Status: Found UCIP Comments: Records indicate this pipe was abandoned, but it appears to be active. Verify status. FIELD_STRUCT_DESC: 10-inch steel irrigation pipe through the levee, 8 feet below the crown. Slant pump on the waterside (WS) slope. Service pole on the landside (LS) slope with a 1.5-inch galvanized iron electrical conduit through the levee at the same location. (Automatic Board Order (ABO) issued as Permit No. 11141, 1975 - Adele Runyon, et al.). [Additional Reference(s): DWR Levee Log, 2005. USACE Sacramento O&M Manual 111, May 1959, (RM 32.38), listed as a 12-inch pipe]. FS Date: 4/10/2013

Pump, pipe, and butterfly valve on WS slope.

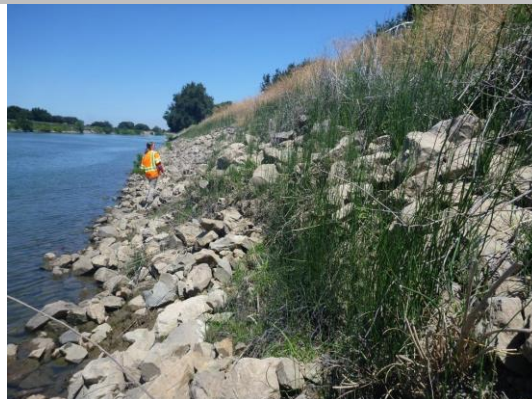
Photo 3 of 3 : SP\_2020\_RD0551\_175\_27\_20200304\_00019.jpg

LM Start	3.34	Rating **	A/W	Issue No.	27 (cont)
LM End	3.36	Issue Type +	Ma	Location *	WS
Category	Earthen Levee			GPS Latitude/Longitude	
				Start	End
Item	Erosion / Bank Caving			38.293842 °	38.293642 °
				-121.562917 °	-121.562708 °
DWR ID	LMA-161

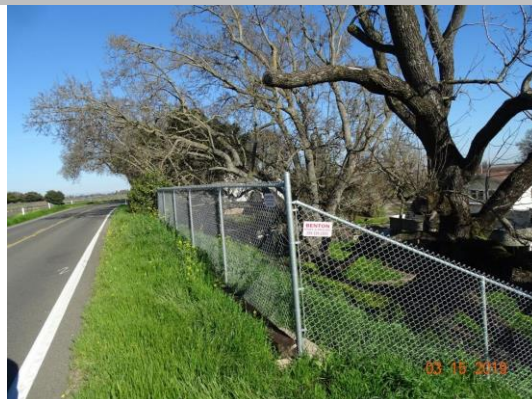
Photo 1 of 1 : SP\_2020\_RD0551\_175\_60\_20200304\_00083.jpg

LM Start	4.18	Rating **	M	Issue No.	60
LM End	4.23	Issue Type +	En	Location *	LS
Category	Earthen Levee			GPS Latitude/Longitude	
				Start	End
Item	Encroachments			38.284795 °	38.284318 °
				-121.552597 °	-121.551830 °
DWR ID	DWR_RD0551_01_s_2019_60				
Comment Code					
FE : Fence					
Inspector Comment					
A chainlink fence is located on landside.

View looking upstream at chainlink fence on the landside slope and shoulder (Spring 2019).

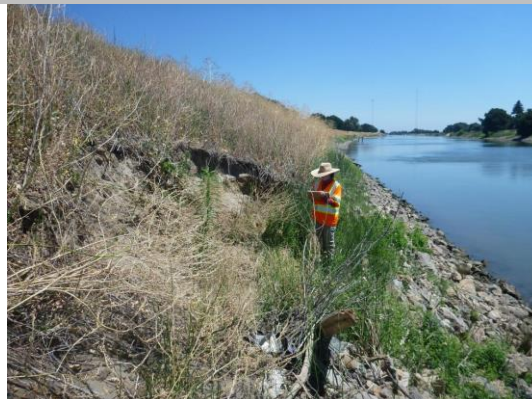
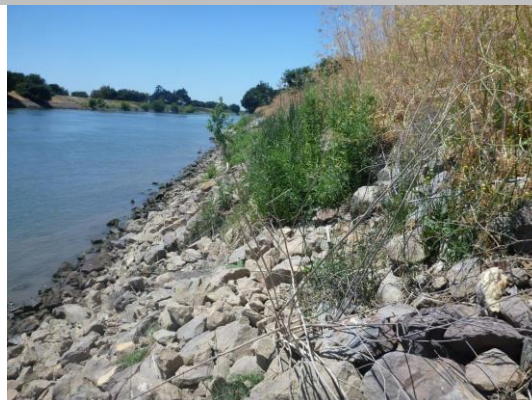
LM Start	<b>4.39</b>	Rating **	A/W	Issue No.	<b>28 (cont)</b>
LM End	<b>4.47</b>	Issue Type +	Ma	Location *	WS

This was a 2017 Storm Damage site.  
Approximately 414 linear-feet of erosion and subsequent sloughing.  
The erosion commences approximately 3/4 of the way down the slope to the rip rap line.  
Site ID No:336  
Site Designation:LMA-163  
3/25/2020 Field Notes: Do boat inspection to verify extent of erosion.  
Monitor.

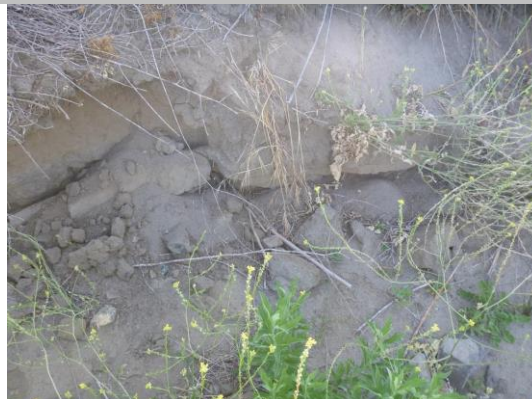
Photo 3 of 3 : SP\_2020\_RD0551\_175\_31\_20200304\_00031.jpg

LM Start	4.92	Rating **	A/W	Issue No.	31 (cont)
LM End	4.95	Issue Type +	Ma	Location *	WS
Category	Earthen Levee			GPS Latitude/Longitude	
				Start	End
Item	Erosion / Bank Caving			38.277589 °	38.277256 °
				-121.542575 °	-121.542211 °
DWR ID	LMA-166

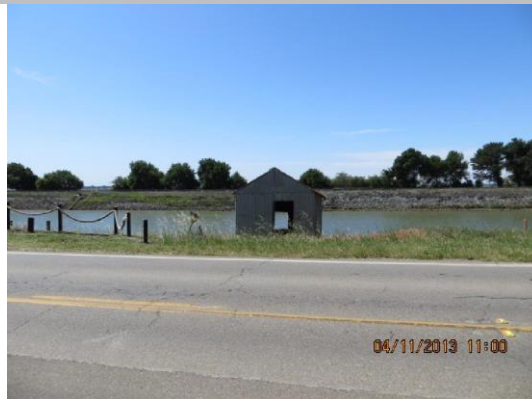
Photo 3 of 3 : UCIP\_SP\_2020\_12105\_19647.jpg

Relocated pumphouse on WS shoulder.

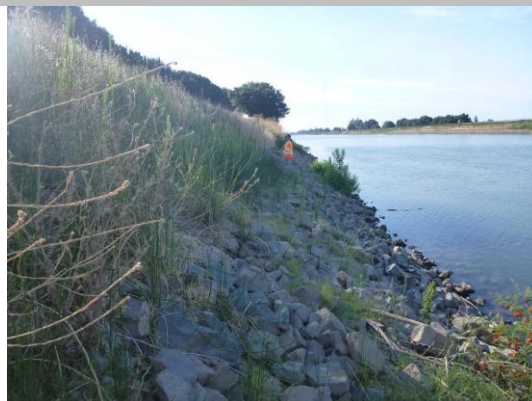
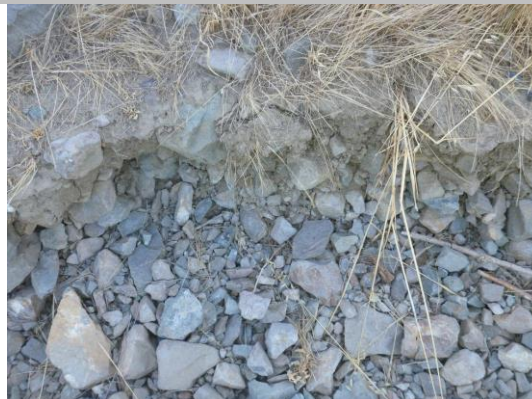
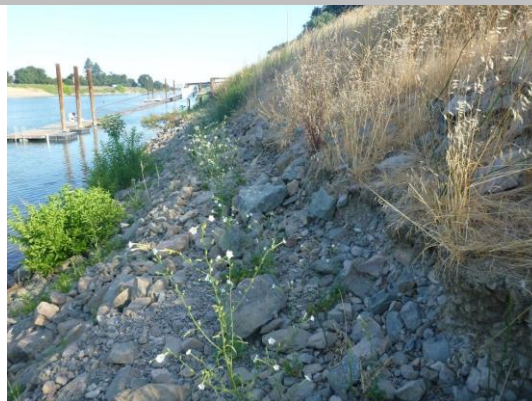
LM Start	5.06	Rating **	A/W	Issue No.	32 (cont)
LM End	5.09	Issue Type +	Ma	Location *	WS
Category	Earthen Levee			GPS Latitude/Longitude	
				Start	End
Item	Erosion / Bank Caving			38.276072 °	38.275761 °
				-121.540869 °	-121.540497 °
DWR ID	LMA-167

this was a 2017 Storm Damage site.  
Approximately 155 linear-feet of erosion and sloughing. The erosion commences approximately 3/4 of the way down the slope from the crown and extends into the rip rap. Some existing rip rap has been pulled off in this section.  
Site ID No:340  
Site Designation:LMA-167  
3/25/2020 Field Notes: Do boat inspection to verify extent of erosion.  
Monitor.

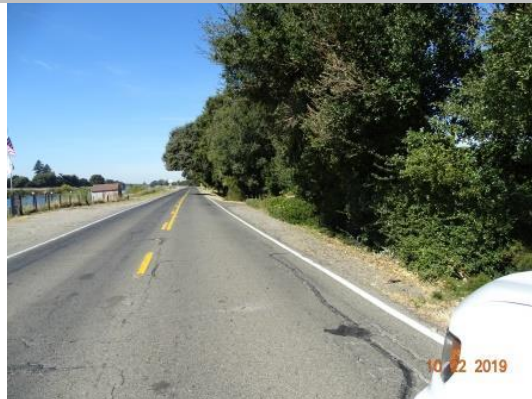
Photo 1 of 1 : SP\_2020\_RD0551\_175\_49\_20200304\_00073.jpg

LM Start	5.08	Rating **	M	Issue No.	49
LM End	5.08	Issue Type +	En	Location *	LS
Category	Earthen Levee			GPS Latitude/Longitude	
				Start	End
Item	Vegetation			38.275865 °	38.275865 °
				-121.540461 °	-121.540461 °
DWR ID	DWR_RD0551_01_f_2017_49				
Comment Code					
V6 : Landscaping					
Inspector Comment					
Landscaping should be maintained to allow inspection and access to landside slope and toe.

View looking upstream at landscaping on the landside slope (Fall 2019).

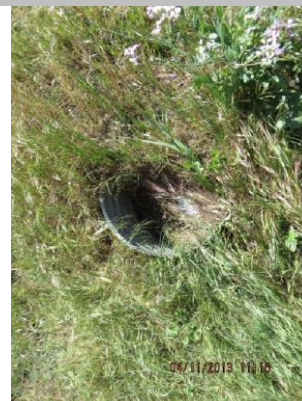
Photo 3 of 3 : UCIP\_SP\_2020\_26875\_49600.jpg

Siphon breaker in 24-inch CMP riser on LS slope.

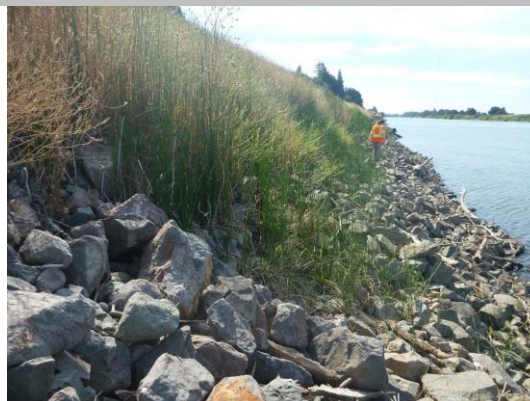
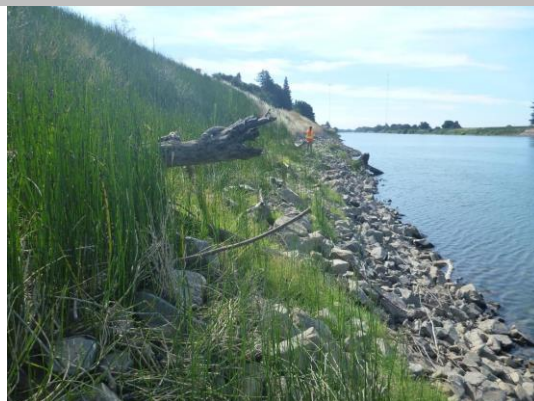
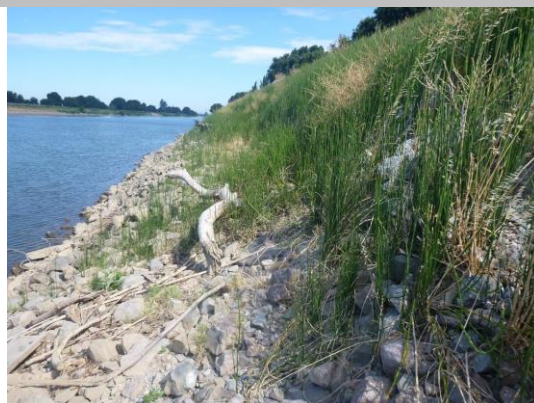
LM Start	5.38	Rating **	A/W	Issue No.	35 (cont)
LM End	5.42	Issue Type +	Ma	Location *	WS
Category	Earthen Levee			GPS Latitude/Longitude	
				Start	End
Item	Erosion / Bank Caving			38.272867 °	38.272411 °
				-121.536597 °	-121.535983 °
DWR ID	LMA-170

This was the 2017 Storm Damage site.  
Approximately 241 linear-feet of erosion and sloughing. The erosion commences approximately 3/4 of the way down the slope and extends to the rip rap. Some existing rip rap has been pulled off in this section.  
Site ID No:343  
Site Designation:LMA-170  
3/25/2020 Field Notes: Do boat inspection to verify extent of erosion.  
Monitor.

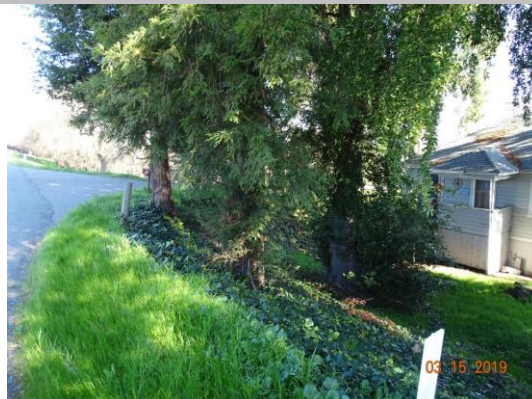
Photo 1 of 1 : SP\_2020\_RD0551\_175\_58\_20200304\_00081.jpg

LM Start	5.54	Rating **	M	Issue No.	58
LM End	5.54	Issue Type +	En	Location *	LS
Category	Earthen Levee			GPS Latitude/Longitude	
				Start	End
Item	Vegetation			38.271415 °	38.271415 °
				-121.534307 °	-121.534307 °
DWR ID	DWR_RD0551_01_s_2019_58				
Comment Code					
V6 : Landscaping					
Inspector Comment					
Thin landscaping to allow visibility and access down landside slope.

View looking upstream at landscaping on the landside slope (Spring 2019).

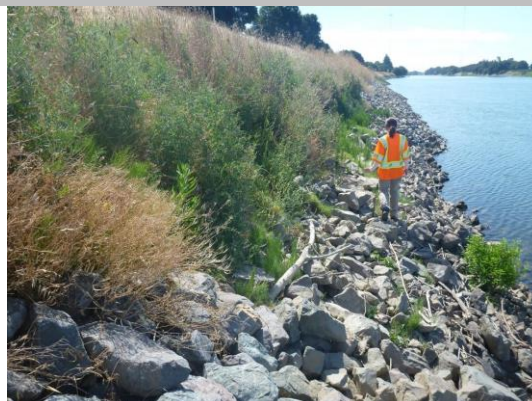
Photo 1 of 3 : SP\_2020\_RD0551\_175\_37\_20200304\_00047.jpg

LM Start	5.77	Rating **	A/W	Issue No.	37
LM End	5.79	Issue Type +	Ma	Location *	WS
Category	Earthen Levee			GPS Latitude/Longitude	
				Start	End
Item	Erosion / Bank Caving			38.269025 °	38.268814 °
				-121.531361 °	-121.531058 °
DWR ID	LMA-172				
Comment Code					
E1 : Note and monitor erosion site.					
Inspector Comment					
This was a 2017 Storm Damage site. Approximately 115 linear-feet of erosion and sloughing. The erosion occurs just above the rip rap line. Some existing rip rap has been pulled off in this section. Site ID No:345 Site Designation:LMA-172 3/25/2020 Field Notes: Do boat inspection to verify extent of erosion. Monitor.

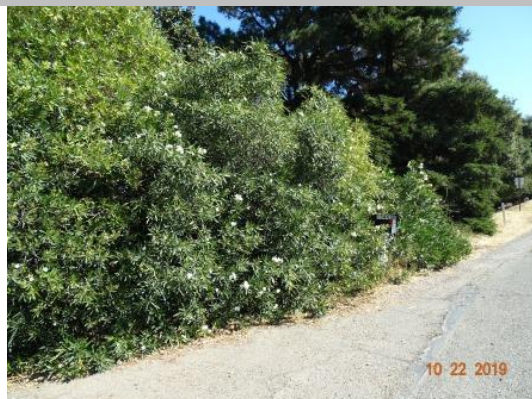
Photo 1 of 1 : SP\_2020\_RD0551\_175\_50\_20200304\_00074.jpg

LM Start	5.90	Rating **	U	Issue No.	50
LM End	5.90	Issue Type +	En	Location *	LS
Category	Earthen Levee			GPS Latitude/Longitude	
				Start	End
Item	Vegetation			38.267833 °	38.267833 °
				-121.529438 °	-121.529438 °
DWR ID	DWR_RD0551_01_f_2017_50				
Comment Code					
V6 : Landscaping					
Inspector Comment					
Landscaping should be maintained to allow inspection and access to landside slope and toe. Trim/thin oleanders and ivy.

View looking slightly downstream at landscaping on the landside slope (Fall 2019).

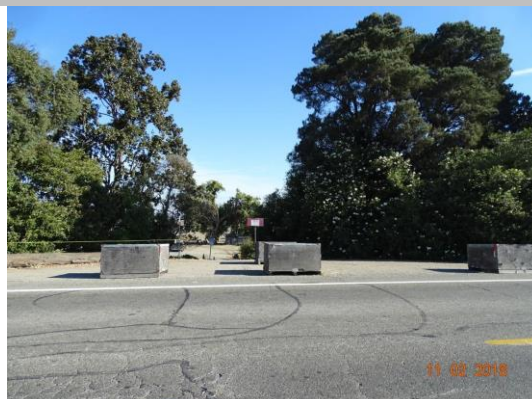
Photo 1 of 1 : SP\_2020\_RD0551\_175\_59\_20200304\_00082.jpg

LM Start	5.90	Rating **	A/W	Issue No.	59
LM End	5.90	Issue Type +	En	Location *	LS
Category	Earthen Levee			GPS Latitude/Longitude	
				Start	End
Item	Encroachments			38.267757 °	38.267757 °
				-121.529443 °	-121.529443 °
DWR ID	DWR_RD0551_01_f_2018_59				
Comment Code					
MA : Material					
Inspector Comment					
Boxes on landside shoulder inhibiting access down the levee.

View of boxes on the land side shoulder that landowner placed to block traffic from using driveway (November 2018).

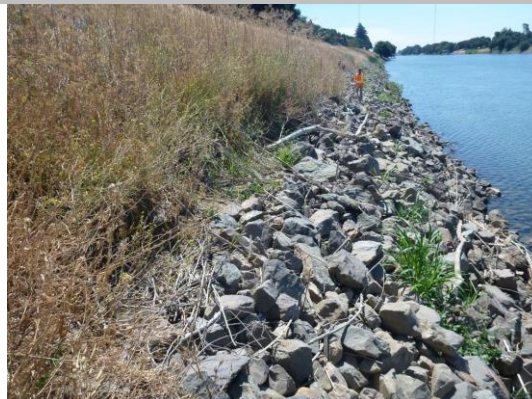
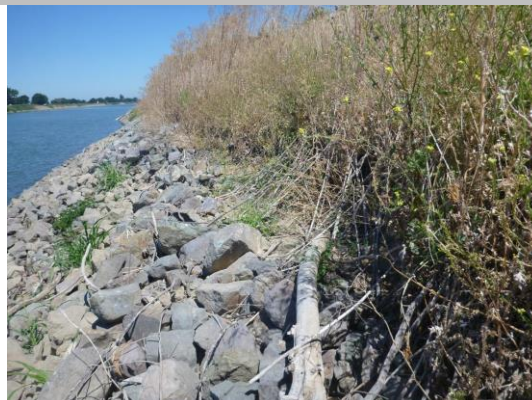
Photo 1 of 3 : SP\_2020\_RD0551\_175\_40\_20200304\_00056.jpg

This was a 2017 Storm Damage site.  
Approximately 100 linear-feet of erosion and sloughing. The erosion commences approximately halfway down the slope and extends into the rip rap. Some existing rip rap has been pulled off in this section.  
Site ID No:349  
Site Designation:LMA-176  
3/25/2020 Field Notes: Do boat inspection to verify extent of erosion.  
Monitor.

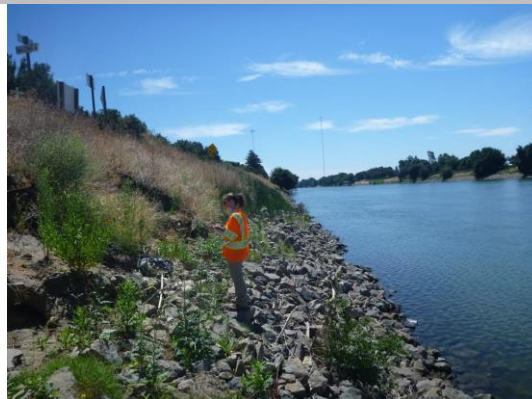
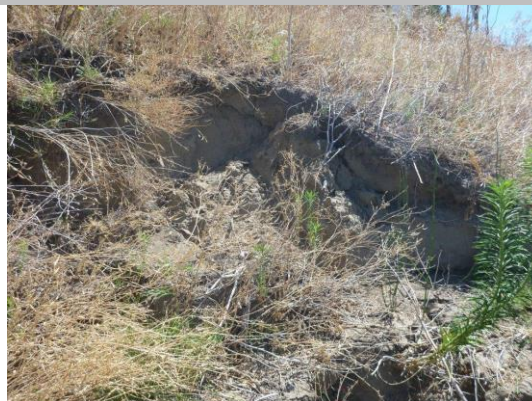
Photo 2 of 3 : SP\_2020\_RD0551\_175\_41\_20200304\_00060.jpg

LM Start	<b>6.01</b>	Rating **	A/W	Issue No.	<b>41 (cont)</b>
LM End	<b>6.08</b>	Issue Type +	Ma	Location *	WS
Category	Earthen Levee		GPS Latitude/Longitude		
			Start	End	
Item	Erosion / Bank Caving		38.266686 °	38.265917 °	
			-121.528128 °	-121.527194 °	
DWR ID	DWR_RD0551_01_s_2020_41

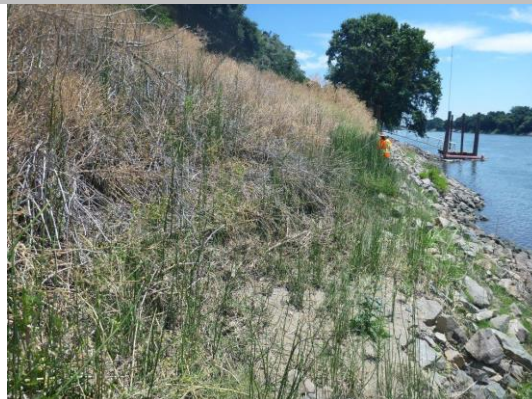
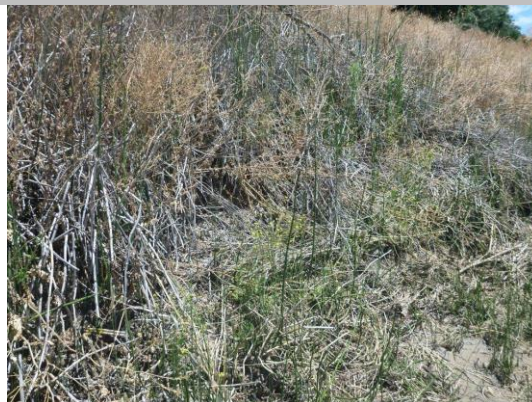
Photo 1 of 3 : SP\_2020\_RD0551\_175\_42\_20200304\_00062.jpg

LM Start	6.22	Rating **	A/W	Issue No.	42
LM End	6.24	Issue Type +	Ma	Location *	WS
Category	Supplemental			GPS Latitude/Longitude	
				Start	End
Item	2017 Storm Damage			38.264436 °	38.264233 °
				-121.525472 °	-121.525219 °
DWR ID	LMA-178

Planned For Repair.  
Levee Evaluation Comments  
Description: District Station 327+45 to 328+45, Sec. 22, T. 5 N. R. 4 E., M.D.M. Approximately 100 linear-feet of erosion and sloughing exists along the waterside slope of the Sacramento River. The erosion commences approximately halfway down the slope and extends into the rip rap. Existing rip rap has been pulled off in this section.  
Site ID No: 351  
Site Designation: LMA-178  
Repair Type: Erosion  
Rating: Serious  
Field Date: 7/14/2017  
Notes: Crown is a paved road. Scarps above rip rap are about 7 ft deep. Rated this serious because erosion scarps are pretty deep, sandy material, steep slope, the rip rap is in poor condition and high traffic on the levee road.

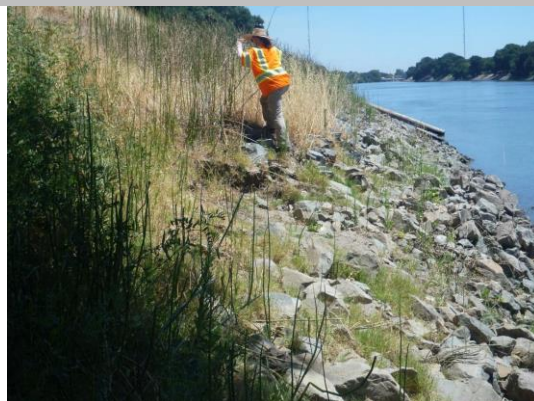
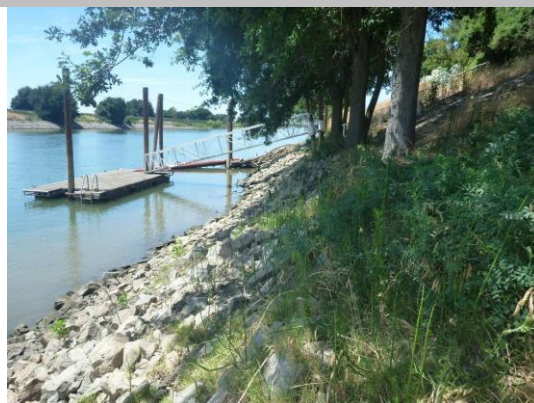
Photo 2 of 3 : SP\_2020\_RD0551\_175\_43\_20200304\_00066.jpg

LM Start	<b>6.27</b>	Rating **	A/W	Issue No.	<b>43 (cont)</b>
LM End	<b>6.29</b>	Issue Type +	Ma	Location *	WS
Category	Earthen Levee		GPS Latitude/Longitude		
			Start	End	
Item	Erosion / Bank Caving		38.263906 °	38.263756 °	
			-121.524778 °	-121.524575 °	
DWR ID	DWR_RD0551_01_s_2020_43
