**Flood Control Project Maintenance  
Levee Inspections  
LMA District Cover Sheet**

**Reclamation District No. 0551 Pearson**

**Flood Control Project Maintenance  
Levee Inspections**

**Levee Inspection Report By Mile - Spring 2021**

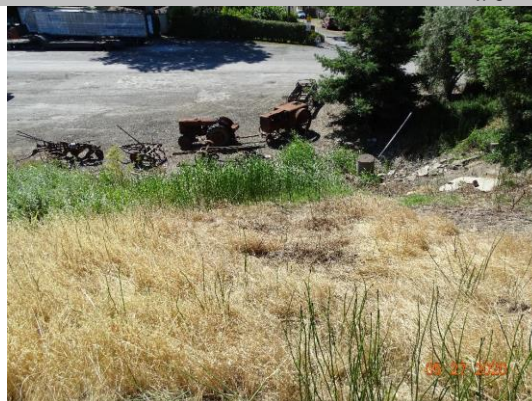
Photo 2 of 3 : UCIP\_SP\_2021\_60001\_87291.jpg

Land-Side: View of levee slope looking from crown

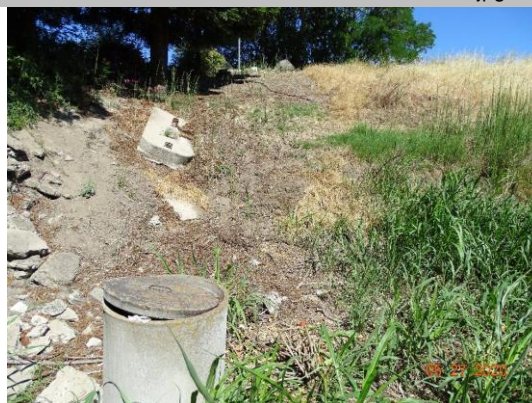
Photo 3 of 3 : UCIP\_SP\_2021\_60001\_87294.jpg

Land-Side: View of levee slope looking from toe

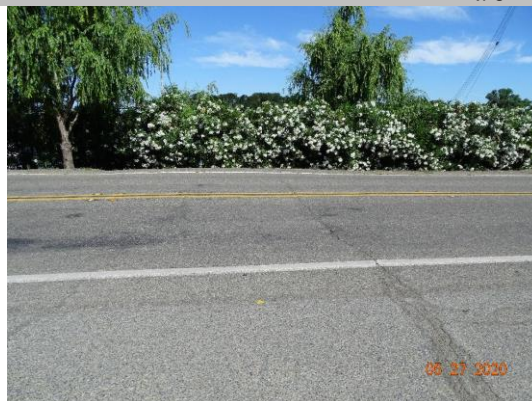
Photo 1 of 3 : UCIP\_SP\_2021\_60032\_87319.jpg

FS\_ID:60032  
DS\_ID:21982  
EP\_NO: 2759  
Repair Type: Non-Urgent  
Crossing Status: Found  
UCIP Comments: 05/27/2020 Record remains Non-Urgent.  
Unauthorized encroachment recorded in Levee Log prior to 2011.  
Unable to determine pipe material through the levee. PVC pipe is visible in a plastic box on waterside. (O.Yakimov - DWR UCIP)  
04/1-/2013 Unclear where exact crossing is located (W.Wylie - DWR UCIP)  
FIELD\_STRUCT\_DESC: [Courtland Boating Facilities] 1-inch steel water line through the levee, at an unknown depth. Ramp and boating facilities on the waterside (WS). Pipe visible under buildings at concrete foundation on the landside (LS). Water service connections for irrigation located on the WS slope. (Reference to existing 1-inch water pipe to be connected to the trailer made in Permit No. 2759, 1958 - Jack and Belva Swisley and Ed Hathaway).  
FS Date: 5/27/2020 3:05:40 PM

Top of Levee: View of levee crown looking towards waterside

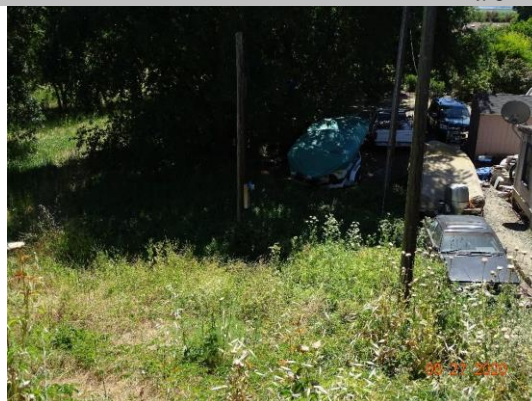
Photo 2 of 3 : UCIP\_SP\_2021\_60085\_87343.jpg

Comment Code						
Inspector Comment						
FS_ID:60085 DS_ID:21985 EP_NO: 6220 Repair Type: Non-Urgent Crossing Status: Found UCIP Comments: 05/27/2020 Record remains Non-Urgent. Two sinkholes on waterside levee slope that measure 18"x 12"x 6" deep found in pipe alignment. Crossing appears abandoned. Pipe is heavily rusted at riverbank. From conversation with adjacent property owner found out that pipe is located on easement to the property just across from the crossing and used to serve water for orchard on landside. (O.Yakimov - DWR UCIP) 04/10/2013 Pipe abandoned and should be removed. (W.Wylie - DWR UCIP) FIELD_STRUCT_DESC: 8-inch coated steel irrigation pipe through the levee, 6.1 feet below the crown. Pump on the waterside (WS) with slide gate and air vent. (8-inch pipe authorized under Permit No. 6220, 1968 - Robert U. Grant). [Additional Reference(s): DWR Levee Log, 2005 (HLM 0.71)]. FS Date: 5/27/2020 8:59:30 AM

Land-Side: View of levee slope looking from crown

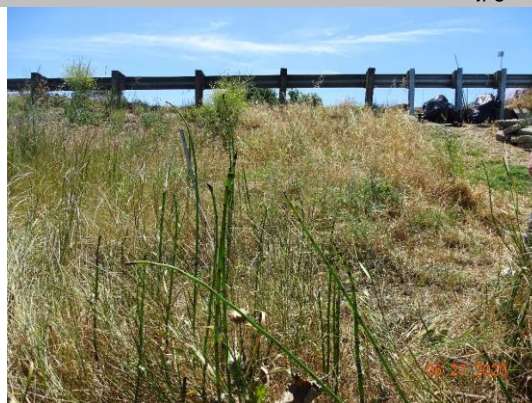
Photo 3 of 3 : UCIP\_SP\_2021\_60085\_87349.jpg

Water-Side: View of levee slope looking towards crown

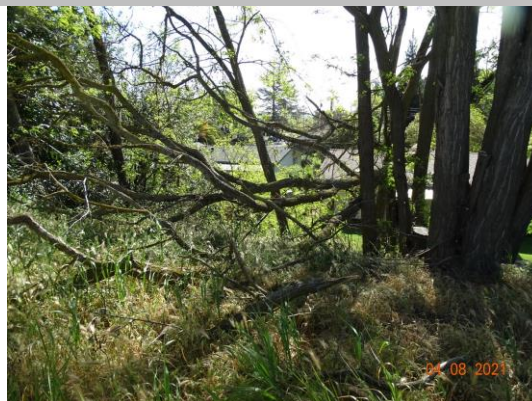
Photo 1 of 1 : SP\_2021\_RD0551\_175\_95\_20210408\_00186.jpg

LM Start	0.77	Rating **	U	Issue No.	95
LM End	0.77	Issue Type +	Ma	Location *	LS
Category	Earthen Levee			GPS Latitude/Longitude	
				Start	End
Item	Encroachments			38.327662 °	38.327662 °
				-121.573483 °	-121.573483 °
DWR ID	DWR_RD0551_01_s_2021_95				
Comment Code					
TR : Tree or limb					
Inspector Comment

View of down tree on the landside slope (Spring 2021).

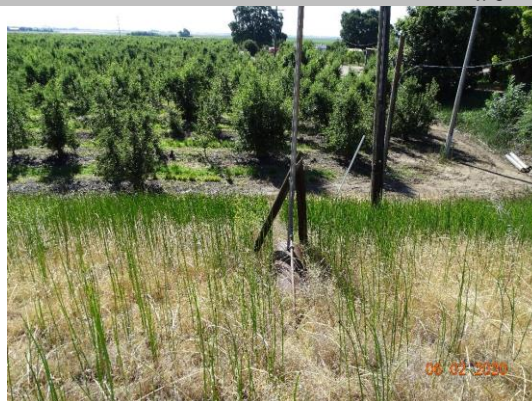
Photo 2 of 3 : UCIP\_SP\_2021\_60086\_87356.jpg

Comment Code					
Inspector Comment					
FS_ID:60086 DS_ID:21986 EP_NO: 701 Repair Type: Urgent Crossing Status: Found UCIP Comments: 06/02/2020 Record updated from Non-Urgent to Urgent. Through hole in pipe visible on landside slope, missing wall of pipe at riverbank. 2-foot diameter scour hole present around a hole in pipe on landside slope. 3-foot diameter and 3-inch deep depression of levee slope just above this hole. Crossing appears abandoned. (O.Yakimov - DWR UCIP) 04/10/2013 Pipe appears abandoned and should be done so properly. Good candidate for video inspection. (W.Wylie - DWR UCIP) FIELD_STRUCT_DESC: 14-inch steel irrigation pipe through the levee, 7.2 feet below the crown. Pump in pump house on the waterside (WS) slope. Service pole on the landside (LS) slope. 1-inch galvanized filler pipe, and a 2-inch electrical conduit at the same location. (16-inch pipe authorized under Permit No. 701, 1937 - American Trust Company). [Additional Reference(s): DWR Levee Log, 2005 (HLM 0.89). USACE Sacramento O&M Manual, Unit 111, May 1959, Revised 29 December 2016, (RM 33.91), listed as 14-inch pipe. USACE As-Built Drawing No. 06-13-1100, Sheet 12, upstream of 'L' 1348+33, January 1933]. FS Date: 6/2/2020 10:38:50 AM

Land-Side: View of levee slope looking from crown

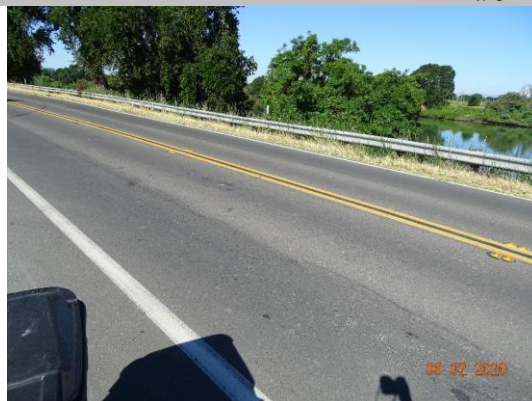
Photo 1 of 3 : UCIP\_SP\_2021\_60092\_87362.jpg

Comment Code						
Inspector Comment						
FS_ID:60092 DS_ID:21987 EP_NO: 793A Repair Type: Non-Urgent Crossing Status: Found UCIP Comments: 06/02/2020 Record updated from No Action Needed to Non-Urgent. Pump and screen filters installed on landside, capped old 12-inch pipe on landside slope next to the standpipe. Unable to find a permit authorizing modifications to this crossing. Two abandoned concrete standpipes on the landside slope and at the toe, abandoned pump piles at riverbank. Minor runoff erosion on waterside shoulder in pipe alignment. Pipe debris at riverbank. (O.Yakimov - DWR UCIP) FIELD_STRUCT_DESC: 8-inch steel irrigation pipe sleeved through a 12-inch pipe with annular space grouted 7.8 feet below the crown. Pump and pressure booster at the landside (LS) toe with switch panel and power pole. (12-inch pipe authorized under Permit No. 793, 1939 - Margaret H. Smith Estate). (Sleeving 8-inch pipe through existing 10-inch pipe and grouting annular space authorized under Permit No. 793A, 1974 - George W.G. Smith). [Additional Reference(s): DWR Levee Log, 2005 (HLM 0.90). USACE Sacramento O&M Manual, Unit 111, May 1959, Revised 29 December 2016, (RM 33.90), listed as 12-inch pipe]. FS Date: 6/2/2020 1:07:09 PM

Top of Levee: View of levee crown looking towards waterside

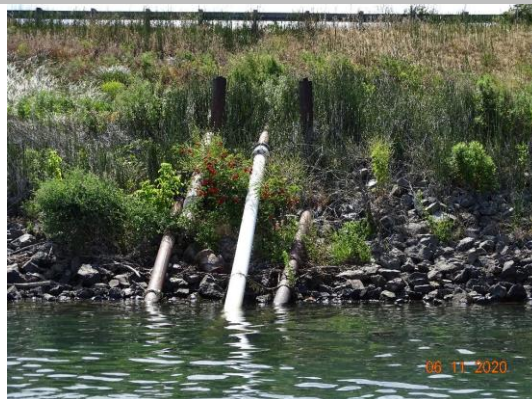
Photo 3 of 3 : UCIP\_SP\_2021\_60092\_87363.jpg

Water-Side: Pipe intake and pipe debris around. View from river

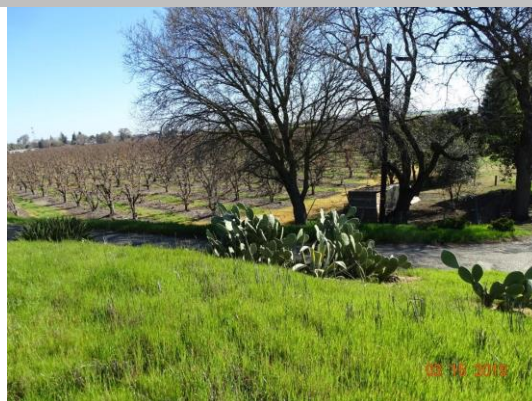
Photo 1 of 1 : SP\_2021\_RD0551\_175\_63\_20210301\_00029.jpg

LM Start	1.28	Rating **	M	Issue No.	63
LM End	1.28	Issue Type +	En	Location *	LS
Category	Earthen Levee			GPS Latitude/Longitude	
				Start	End
Item	Vegetation			38.320707 °	38.320707 °
				-121.576335 °	-121.576335 °
DWR ID	DWR_RD0551_01_s_2019_63				
Comment Code					
V6 : Landscaping					
Inspector Comment					
Cactus is located on landside slope.

View of cactus at the bottom of the landside slope (Spring 2019).

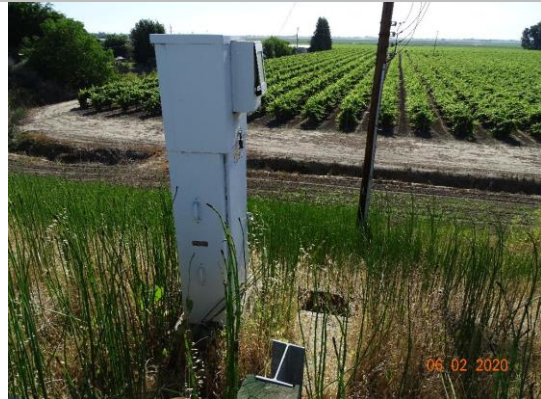
Photo 2 of 3 : UCIP\_SP\_2021\_60099\_87396.jpg

LM Start	1.43	Rating **	M	Issue No.	12	
LM End	1.43	Issue Type +	En	Location *		
Category	Supplemental			GPS Latitude/Longitude		
				Start		End
Item	DWR UCIP Field Study			38.318582 °	38.318582 °	
				-121.576498 °	-121.576498 °	
DWR ID	22972					
Comment Code						
Inspector Comment						
FS_ID:60099 DS_ID:22972 EP_NO: N/A Repair Type: Non-Urgent Crossing Status: Found UCIP Comments: 06/02/2020 Record updated from No Action Needed to Non-Urgent. No permit has been found authorizing this crossing through the levee. Conduit seems to cross intersection diagonally. (O.Yakimov - DWR UCIP)						
FIELD_STRUCT_DESC: 3-inch polyvinyl chloride (PVC) electrical conduit through the levee, 5 feet below the crown. Joint pole (JP) on the landside (LS) toe with a utility box on the LS shoulder. 2.5-inch steel conduit visible under bridge. FS Date: 6/2/2020 2:30:34 PM

Land-Side: Service box and underground christy box on levee shoulder.  
Junction pole at the toe

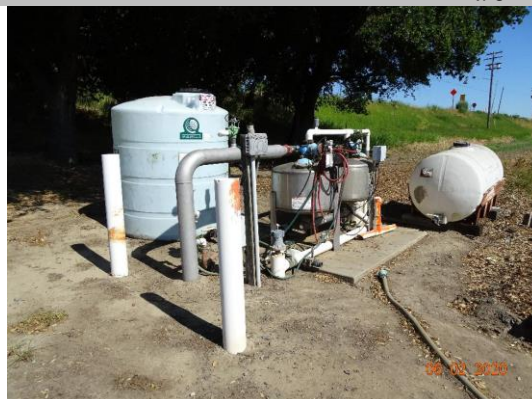
Photo 3 of 3 : UCIP\_SP\_2021\_60100\_87402.jpg

Comment Code						
Inspector Comment						
FS_ID:60100 DS_ID:21988 EP_NO: 11148 Repair Type: Non-Urgent Crossing Status: Found UCIP Comments: 06/02/2020 Record updated from No Action Needed to Non-Urgent. No permit has been identified authorizing pipe. Need to have CVFPB review ABO and determine current owner. No permit found authorizing sleeving 6-inch pipe through 10-inch pipe. Pump is running - minor leaks through pump sealing. (O.Yakimov - DWR UCIP) FIELD_STRUCT_DESC: 6-inch steel irrigation pipe sleeved through a 10-inch pipe, 6.8 feet below the crown. Pump in pump house on the waterside (WS) slope. Service pole on the landside (LS) slope. Filtration system installed on the LS toe. (10-inch pipe [HLM 1.51] authorized under Automatic Board Order (ABO) issued as Permit No. 11148, 1975 - M.C.C. Van Loben Sells). [Additional Reference(s): DWR Levee Log, 2005 (HLM 1.51). USACE Sacramento O&M Manual, Unit 111, May 1959, Revised 29 December 2016, (RM 33.29), listed as 10-inch pipe. USACE As-Built Drawing No. 06-13-1100, Sheet 12, near 'L' 1370+00, January 1933, listed as 10-inch pipe]. FS Date: 6/2/2020 3:12:27 PM

Land-Side: Filtering and mixing facility at levee toe. 6-inch pipe daylights here

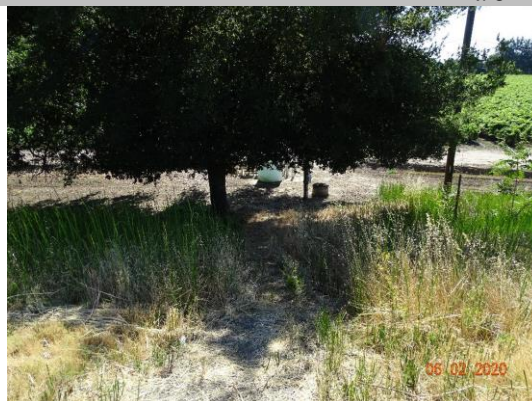
Photo 2 of 3 : UCIP\_SP\_2021\_60128\_87410.jpg

FS\_ID:60128  
 DS\_ID:22007  
 EP\_NO: 16640  
 Repair Type: Non-Urgent  
 Crossing Status: Found  
 UCIP Comments: 06/02/2020 Record updated from No Action Needed to Non-Urgent. Unable to locate a permit authorizing to sleeve 10-inch pipe through 12-inch pipe. (O.Yakimov - DWR UCIP)  
 FIELD\_STRUCT\_DESC: 10-inch coated steel irrigation pipe sleeved through a 12-inch pipe, 2 feet below the crown. Pump in pump house on the waterside (WS). Pipe discharges into a 6-foot by 10-foot concrete distribution box on the landside (LS) slope. (12-inch pipe authorized under Permit No. 16640, 1996 - Carel D. Van Loben Sels).  
 FS Date: 6/2/2020 9:21:00 AM

Land-Side: View of levee slope looking from crown

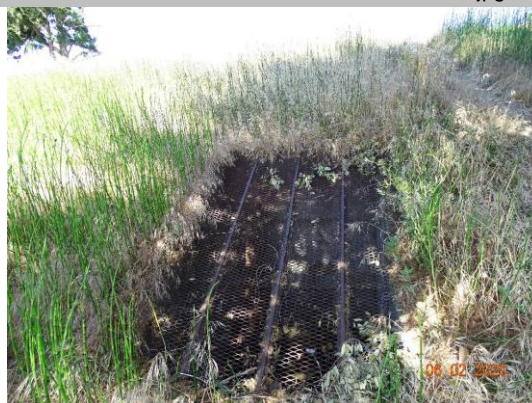
Photo 3 of 3 : UCIP\_SP\_2021\_60128\_87411.jpg

Land-Side: Concrete distribution box at levee toe covered with metal grate

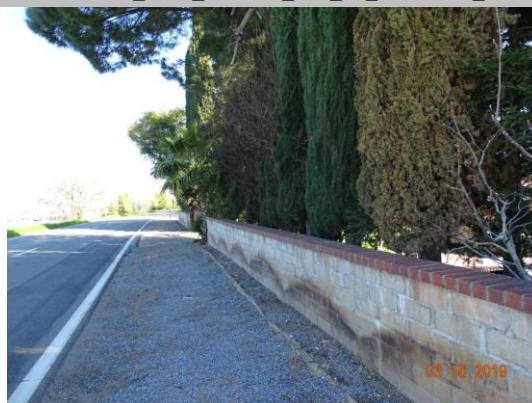
Photo 1 of 1 : SP\_2021\_RD0551\_175\_62\_20210301\_00028.jpg

LM Start	1.70	Rating **	U	Issue No.	62
LM End	1.70	Issue Type +	En	Location *	LS
Category	Earthen Levee			GPS Latitude/Longitude	
				Start	End
Item	Vegetation			38.314687 °	38.314687 °
				-121.576727 °	-121.576727 °
DWR ID	DWR_RD0551_01_s_2019_62				
Comment Code					
V6 : Landscaping					
Inspector Comment					
Landscaping is blocking the view down the landside slope.

View looking upstream at landscaping on the landside slope (Spring 2019).

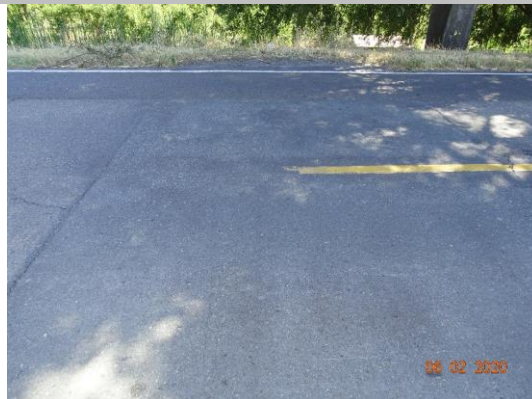
Photo 1 of 3 : UCIP\_SP\_2021\_60156\_87427.jpg

FS\_ID:60156  
DS\_ID:22040  
EP\_NO: 3676  
Repair Type: Non-Urgent  
Crossing Status: Not Found  
UCIP Comments: 06/02/2020 Record remains Non-Urgent. Crossing not found. Cut in road pavement is still visible. No permit has been identified authorizing original 12-inch pipe. (O.Yakimov - DWR UCIP) 04/10/2013 Fresh cut through pavement on crown indicates recent work on pipes at this location. Need to determine if pipe was removed or abandoned in place. (W.Wylie - DWR UCIP)  
FIELD\_STRUCT\_DESC: 8-inch coated steel irrigation pipe sleeved through a 12-inch pipe through the levee, 5 feet below the crown. Pump on platform on the waterside (WS). (Sleeving 8-inch pipe through existing 12-inch pipe authorized under Permit No. 3676, 1961 - Runyon and Dorsey). [Additional Reference(s): DWR Levee Log, 2005 (HLM 2.02). USACE Sacramento O&M Manual, Unit 111, May 1959, Revised 29 December 2016, (RM 32.78), listed as 10-inch pipe].

Top of Levee: View of levee crown looking towards landside. Cut in road pavement visible

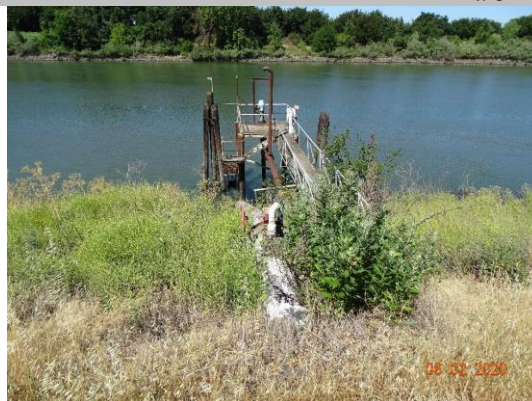
Photo 2 of 3 : UCIP\_SP\_2021\_60178\_87495.jpg

Water-Side: View of levee slope looking from crown

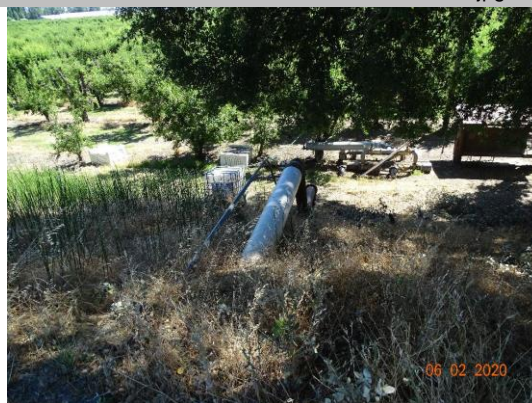
Photo 3 of 3 : UCIP\_SP\_2021\_60178\_87496.jpg

Land-Side: View of levee slope looking from crown

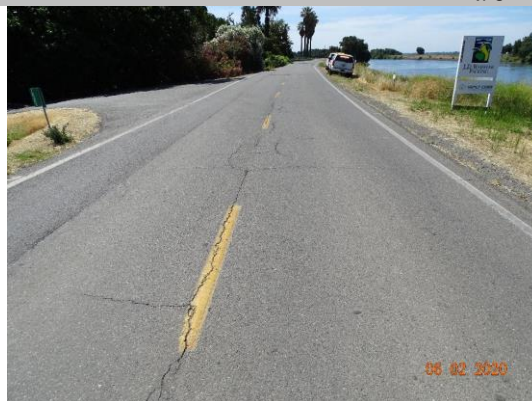
Photo 1 of 3 : UCIP\_SP\_2021\_60214\_87501.jpg

FS\_ID:60214  
DS\_ID:21992  
EP\_NO: N/A  
Repair Type: Non-Urgent  
Crossing Status: Not Found  
UCIP Comments: 06/02/2020 Record updated from No Action Needed to Non-Urgent. Crossing not found. Concrete retaining wall on waterside shoulder at this place. Need to confirm proper method of abandonment. No permit has been identified authorizing pipe. (O.Yakimov - DWR UCIP)  
FIELD\_STRUCT\_DESC: 4-inch pipe of an unknown material or purpose through the levee, 7.7 feet below the crown. Filled with concrete. Concrete headwall along the waterside (WS) shoulder may be a good indicator of pipe location. (Cat. IVA - Wheeler). [Additional Reference(s): DWR Levee Log, 2005 (HLM 2.24). USACE Sacramento O&M Manual, Unit 111, May 1959, Revised 29 December 2016, (RM 32.56), listed as 4-inch pipe. USACE As-Built Drawing No. 06-13-1100, Sheet 13, 'L' 1416+45, January 1933].  
FS Date: 6/2/2020 7:59:52 AM

Top of Levee: View of levee crown looking downstream

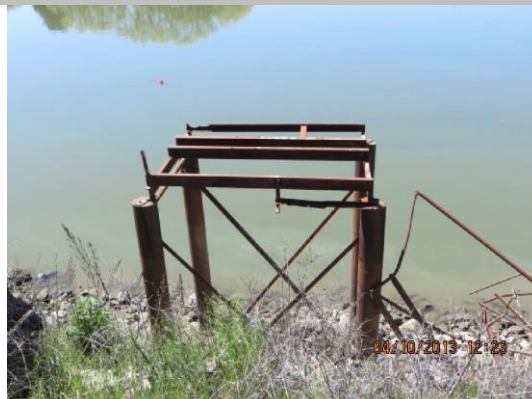
Photo 1 of 3 : UCIP\_SP\_2021\_60216\_19224.jpg

Steel pile platform remains at WS toe.

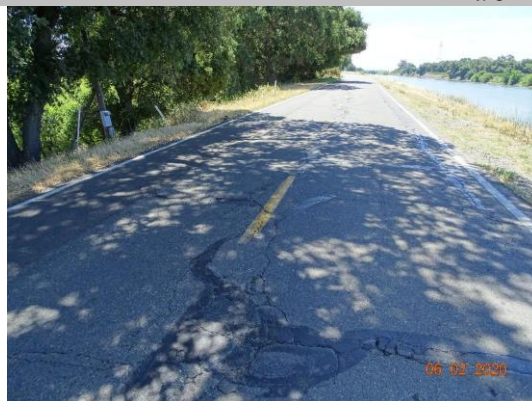
Photo 1 of 3 : UCIP\_SP\_2021\_60293\_87552.jpg

Top of Levee: View of levee crown looking downstream

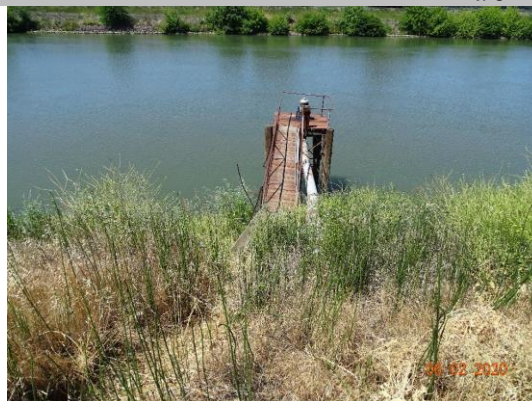
Photo 2 of 3 : UCIP\_SP\_2021\_60299\_87561.jpg

Water-Side: View of levee slope looking from crown

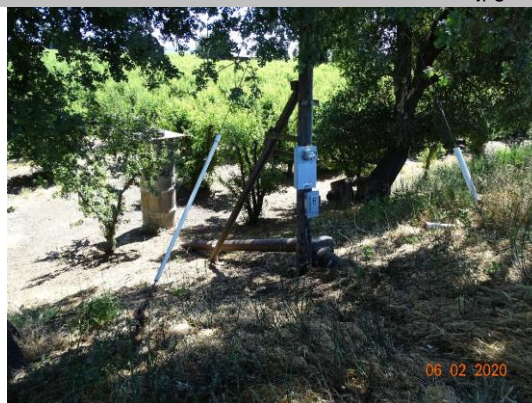
Photo 3 of 3 : UCIP\_SP\_2021\_60299\_87562.jpg

Land-Side: View of levee slope looking from crown

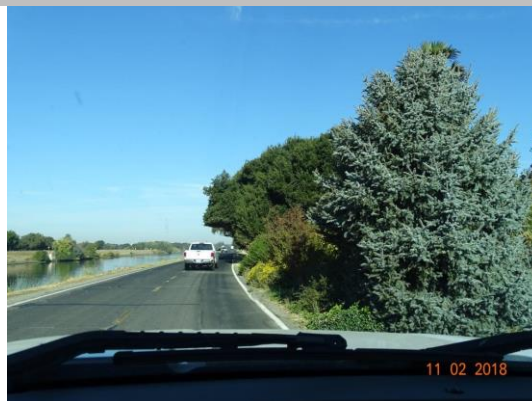
Photo 1 of 1 : SP\_2021\_RD0551\_175\_56\_20210301\_00022.jpg

LM Start	3.01	Rating **	U	Issue No.	56
LM End	3.03	Issue Type +	En	Location *	LS
Category	Earthen Levee			GPS Latitude/Longitude	
				Start	End
Item	Vegetation			38.297744 °	38.297527 °
				-121.566446 °	-121.566225 °
DWR ID	DWR_RD0551_01_f_2018_56				
Comment Code					
V6 : Landscaping					
Inspector Comment

View looking upstream at landscaping on the landside slope (November 2018).

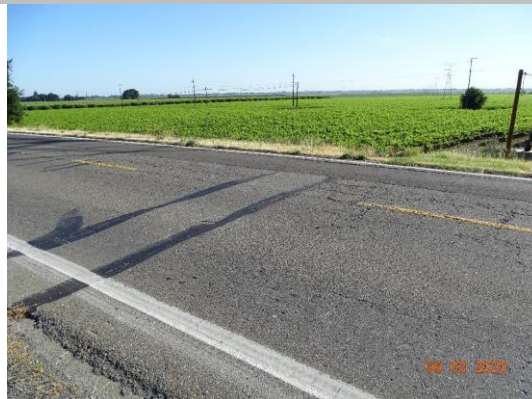
Photo 1 of 3 : UCIP\_SP\_2021\_60354\_87569.jpg

Comment Code						
Inspector Comment						
FS_ID:60354 DS_ID:22041 EP_NO: N/A Repair Type: Non-Urgent Crossing Status: Found UCIP Comments: 06/03/2020 Record updated from No Action Needed to Non-Urgent. Damaged CMP riser on landside slope missing cover - safety issue. Pump on waterside slope is removed and replaced with submersible pump. Unable to find a permit for modification. No permit has been identified authorizing pipe through levee. (O.Yakimov - DWR UCIP)  FIELD_STRUCT_DESC: 12-inch steel irrigation pipe through the levee, 6 feet below the crown. Pipe measures 10 inches in diameter at the slopes of the levee. Metal steps to pump on concrete pad on the waterside (WS). Vent in a 36-inch corrugated metal pipe (CMP) riser on the landside (LS) shoulder. 1-inch electrical conduit at the same location with an electrical panel on a pole at the LS toe. [Additional Reference(s): USACE Sacramento O&M Manual, Unit 111, May 1959, Revised 29 December 2016, (RM 31.38), listed as 12-inch pipe. USACE As-Built Drawing No. 06-13-1100, Sheet 13, upstream of 'L' 1482+00, January 1933]. FS Date: 6/3/2020 11:25:42 AM

Top of Levee: View of levee crown looking towards landside. Cut in pavement in pipe alignment is visible

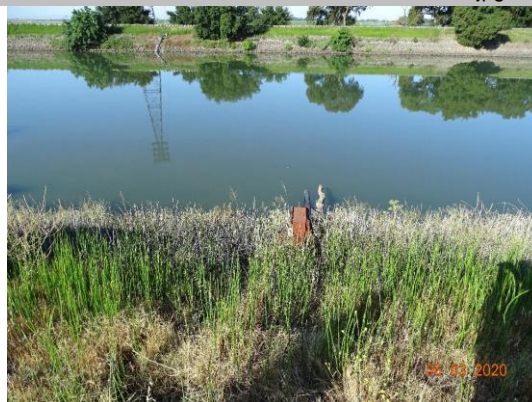
Photo 2 of 3 : UCIP\_SP\_2021\_60354\_87570.jpg

Water-Side: View of levee slope looking from crown

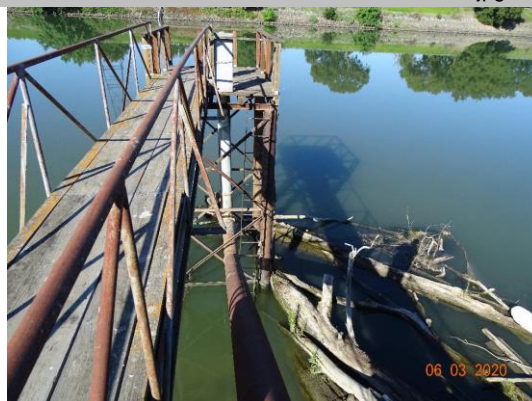
Photo 3 of 3 : UCIP\_SP\_2021\_60363\_87585.jpg

Water-Side: Pump on pile structure in the stream, walkway bridge

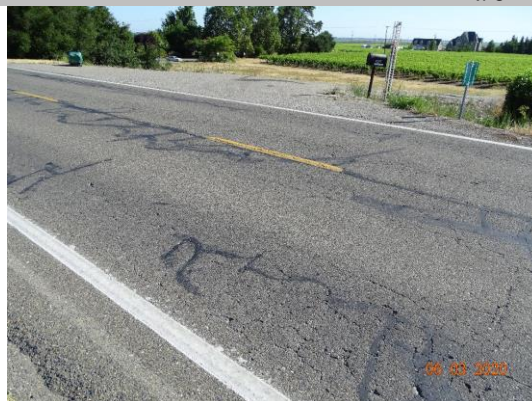
Photo 1 of 3 : UCIP\_SP\_2021\_60380\_87590.jpg

FS\_ID:60380  
DS\_ID:22033  
EP\_NO: N/A  
Repair Type: Non-Urgent  
Crossing Status: Not Found  
UCIP Comments: 06/03/2020 Record updated from No Action Needed to Non-Urgent. No permit has been identified authorizing pipe installation. Pipe was abandoned in place and grouted with concrete under Permit No. 2276. (O.Yakimov - DWR UCIP)  
FIELD\_STRUCT\_DESC: 8-inch steel irrigation pipe through the levee, 6.7 feet below the crown. Pump on the waterside (WS). (Abandonment in place by grouting with concrete authorized under Permit No. 2276, 1956 - Paul V. Amick Sr.). [Additional Reference(s): USACE Sacramento O&M Manual, Unit 111, May 1959, Revised 29 December 2016, (RM 31.26), listed as 8-inch pipe. USACE As-Built Drawing No. 06-13-1100, Sheet 13, downstream of 'L' 1482+00, January 1933].  
FS Date: 6/3/2020 2:29:58 PM

Top of Levee: View of levee crown looking towards landside

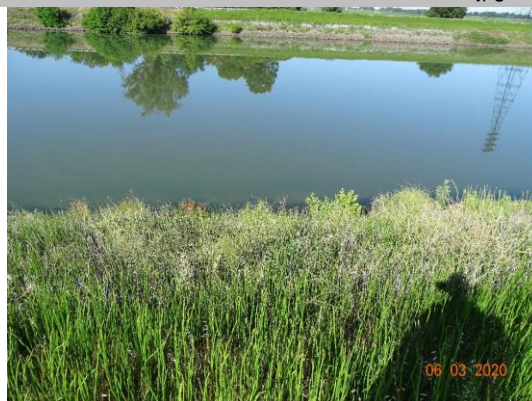
Photo 2 of 3 : UCIP\_SP\_2021\_60380\_87591.jpg

Water-Side: View of levee slope looking from crown

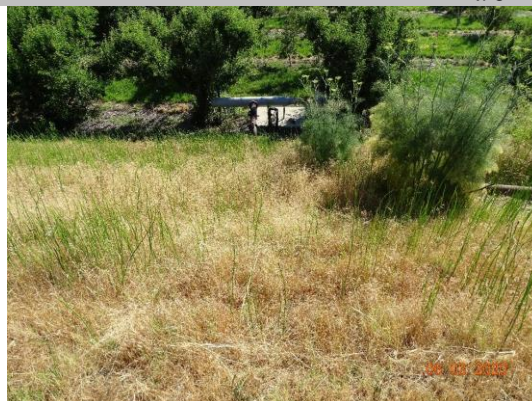
Photo 2 of 3 : UCIP\_SP\_2021\_60384\_87593.jpg

Land-Side: View of levee slope looking from crown

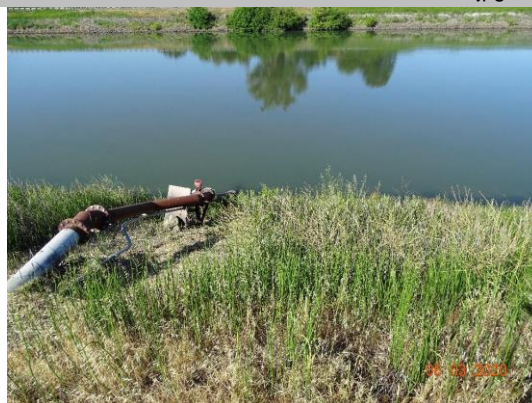
Photo 3 of 3 : UCIP\_SP\_2021\_60384\_87595.jpg

Water-Side: View of levee slope looking from crown

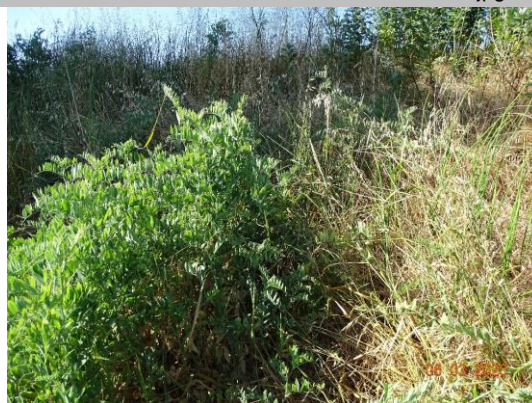
Photo 3 of 3 : UCIP\_SP\_2021\_60439\_87725.jpg

Land-Side: View of levee slope looking from crown. Overgrown vegetation prevents slope evaluation

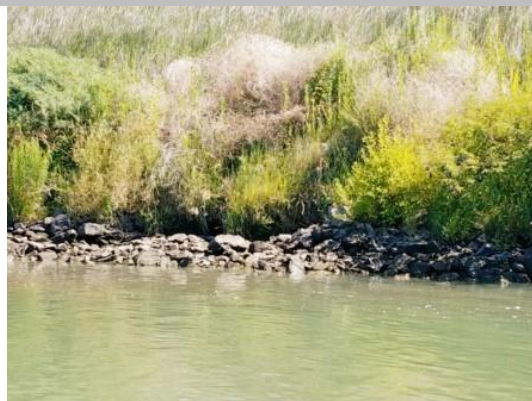
Photo 1 of 1 : SP\_2021\_RD0551\_175\_1\_20210301\_00001.jpg

LM Start	3.84	Rating **	U	Issue No.	1
LM End	3.84	Issue Type +	Ma	Location *	WS
Category	Earthen Levee			GPS Latitude/Longitude	
				Start	End
Item	Animal Control			38.288235 °	38.288235 °
				-121.557000 °	-121.557000 °
DWR ID	DWR_RD0551_01_s_2020_1				
Comment Code					
A3 : No rodents visible, but rodent burrows visible; need to backfill and compact or grout burrows.					
Inspector Comment					
Large animal hole burrowed into eroded spot of waterside toe. Hole can be submerged with higher water.

View from the channel of large animal hole burrowed into the waterside toe (Summer 2020).

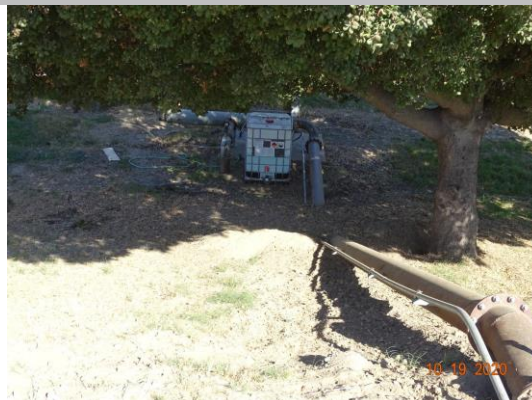
Photo 1 of 1 : SP\_2021\_RD0551\_175\_90\_20210301\_00036.jpg

LM Start	3.89	Rating **	U	Issue No.	90
LM End	3.89	Issue Type +	Ma	Location *	LS
Category	Earthen Levee			GPS Latitude/Longitude	
				Start	End
Item	Animal Control			38.287898 °	38.287898 °
				-121.556062 °	-121.556062 °
DWR ID	DWR_RD0551_01_f_2020_90				
Comment Code					
A1 : Exterminate rodents and backfill and compact or grout burrows.					
Inspector Comment					
A couple large fresh rodent holes in the landside slope.

View of large animal hole in the landside slope (Fall 2020).

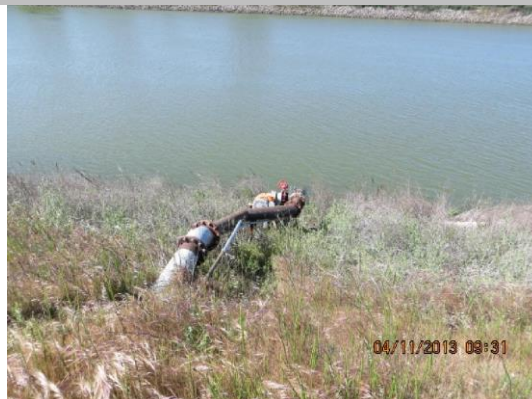
Photo 1 of 3 : UCIP\_SP\_2021\_60445\_19285.jpg

Comment Code					
Inspector Comment					
FS_ID:60445 DS_ID:22017 EP_NO: 11153 Repair Type: Non-Urgent Crossing Status: Found UCIP Comments: 06/03/2020 Record updated from No Action Needed to Non-Urgent. Unauthorized encroachment recorded in Levee Log prior to 2011. Need to have CVFPB review ABO and determine current owner. Burrow hole under pipe on landside slope. (O.Yakimov - DWR UCIP) FIELD_STRUCT_DESC: 10-inch pipe through the levee 4.0 feet below the crown. Siphon breaker on LS shoulder. Screen filter, concrete standpipe, service pole with electric meter and connection box at LS toe. 1.5-inch galvanized iron electrical conduit through the levee at same alignment. (10-inch pipe [HLM 3.93] authorized under Automatic Board Order (ABO) issued as Permit No. 11153, 1975 - Wilcox Fruit Company). [Additional Reference(s): DWR Levee Log, 2005 (HLM 3.93)]. FS Date: 6/3/2020 2:22:09 PM

Slant pump, butterfly valve, electrical conduit and pipe on WS slope.

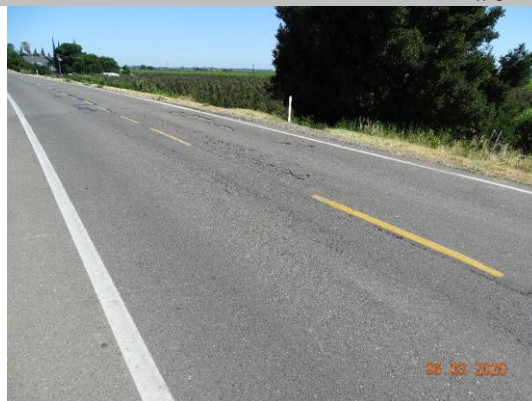
Photo 1 of 3 : UCIP\_SP\_2021\_60460\_87782.jpg

Comment Code						
Inspector Comment						
FS_ID:60460 DS_ID:22018 EP_NO: 11146 Repair Type: Non-Urgent Crossing Status: Found UCIP Comments: 06/03/2020 Record remains Non-Urgent. Pipe is exposed on landside due to 7.0' x 4.5' excavation 16 feet from levee toe. Pipe is running. Water is supplied to orchard through a hose connected to a pipe at excavation. Pipe inflow from standpipe is plugged with concrete as seen on photo. Drainage from hose connection gets into open concrete pipe at excavation that goes towards the orchard. No permit has been identified authorizing pipe. Need to have CVFPB review ABO and determine current owner. (O.Yakimov - DWR UCIP) 04/11/2013 Wooden walkway in bad repair and presents a hazard to the public. (W.Wylie - DWR UCIP) FIELD_STRUCT_DESC: 14-inch irrigation pipe of an unknown material through the levee, 10.4 feet below the crown. Pump on pile structure in stream with wooden walkway. 48-inch concrete standpipe on the landside (LS) toe with booster pump and electrical panel, media filtration facility on landside. Siphon breaker in a 24-inch corrugated metal pipe (CMP) riser on the LS slope. 1.5-inch electrical conduit at the same location. (14-inch pipe [HLM 4.04] authorized under Automatic Board Order (ABO) issued as Permit No. 11146, 1975 - Edgar D. Turner III). [Additional Reference(s): DWR Levee Log, 2005 (HLM 4.04). USACE Sacramento O&M Manual, Unit 111, May 1959, Revised 29 December 2016, (RM 30.75), listed as 14-inch pipe. USACE As-Built Drawing No. 06-13-1100, Sheet 13, downstream of 'L' 1504+00, January 1933]. FS Date: 6/3/2020 3:44:18 PM

Top of Levee: View of levee crown looking upstream

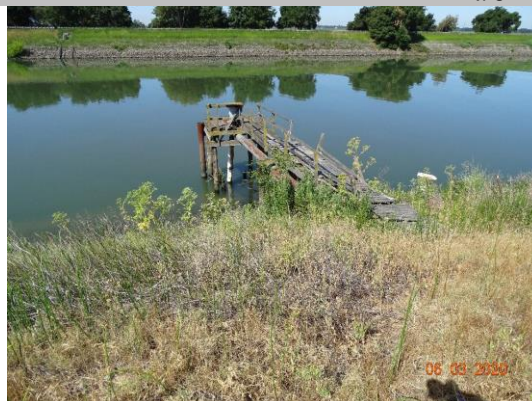
Photo 2 of 3 : UCIP\_SP\_2021\_60460\_87783.jpg

Water-Side: View of levee slope looking from crown

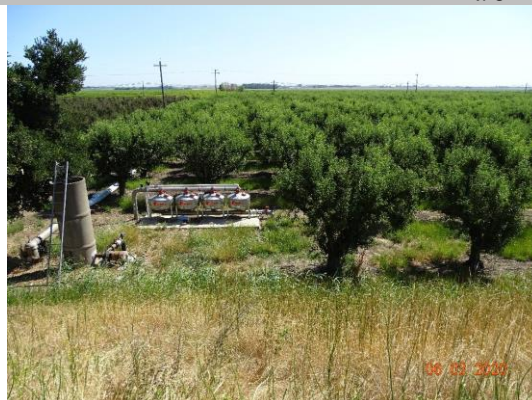
Photo 2 of 3 : UCIP\_SP\_2021\_60557\_87841.jpg

Comment Code					
Inspector Comment					
FS_ID:60557 DS_ID:22035 EP_NO: N/A Repair Type: Non-Urgent Crossing Status: Not Found UCIP Comments: 06/03/2020 Record updated from No Action Needed to Non-Urgent. Crossing not found. No permit has been identified authorizing pipe. (O.Yakimov - DWR UCIP)  FIELD_STRUCT_DESC: 10-inch irrigation pipe of an unknown material through the levee, 7.8 feet below the crown. Pump on the waterside (WS). [Additional Reference(s): USACE Sacramento O&M Manual, Unit 111, May 1959, Revised 29 December 2016, (RM 30.75), listed as 10-inch pipe. USACE As-Built Drawing No. 06-13-1100, Sheet 13, downstream of 'L' 1504+00, January 1933]. FS Date: 6/3/2020 10:29:31 AM

Land-Side: View of levee slope looking from crown

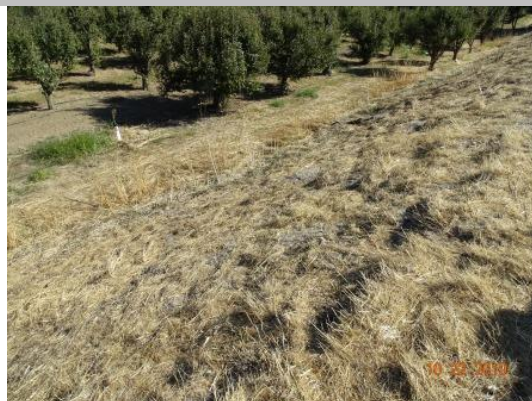
Photo 1 of 1 : SP\_2021\_RD0551\_175\_53\_20210301\_00020.jpg

LM Start	4.04	Rating **	M	Issue No.	53
LM End	4.04	Issue Type +	Ma	Location *	LS
Category	Earthen Levee			GPS Latitude/Longitude	
				Start	End
Item	Animal Control			38.286255 °	38.286255 °
				-121.554193 °	-121.554193 °
DWR ID	DWR_RD0551_01_f_2018_53				
Comment Code					
A3 : No rodents visible, but rodent burrows visible; need to backfill and compact or grout burrows.					
Inspector Comment					
Multiple fresh rodent holes on the slope.

View looking downstream at fresh rodent holes in the landside slope (Fall 2019).

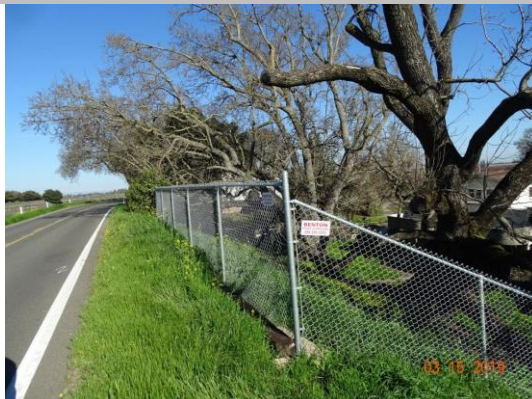
Photo 1 of 1 : SP\_2021\_RD0551\_175\_60\_20210301\_00026.jpg

LM Start	4.18	Rating **	M	Issue No.	60
LM End	4.23	Issue Type +	En	Location *	LS
Category	Earthen Levee			GPS Latitude/Longitude	
				Start	End
Item	Encroachments			38.284795 °	38.284318 °
				-121.552597 °	-121.551830 °
DWR ID	DWR_RD0551_01_s_2019_60				
Comment Code					
FE : Fence					
Inspector Comment					
A chainlink fence is located on landside.

View looking upstream at chainlink fence on the landside slope and shoulder (Spring 2019).

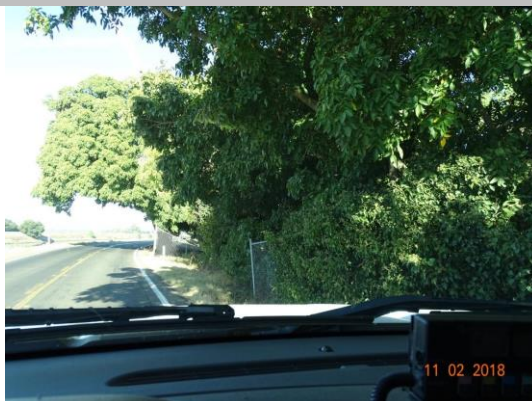
Photo 1 of 1 : SP\_2021\_RD0551\_175\_52\_20210301\_00019.jpg

LM Start	4.22	Rating **	U	Issue No.	52
LM End	4.22	Issue Type +	En	Location *	LS
Category	Earthen Levee			GPS Latitude/Longitude	
				Start	End
Item	Vegetation			38.284400 °	38.284400 °
				-121.552035 °	-121.552035 °
DWR ID	DWR_RD0551_01_f_2018_52				
Comment Code					
V6 : Landscaping					
Inspector Comment

View looking upstream at landscaping on the landside slope (November 2018).

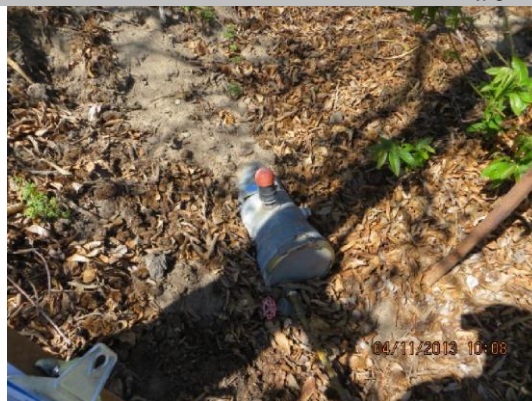
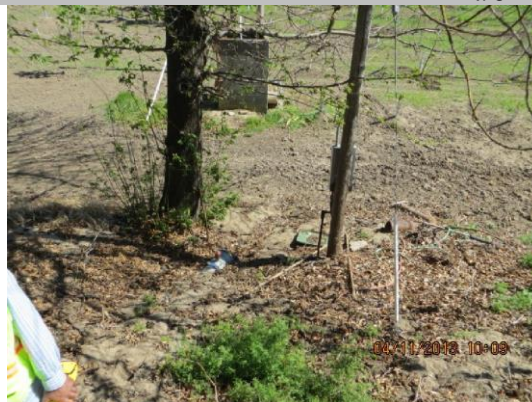
Comment Code					
Inspector Comment					
FS_ID:60558 DS_ID:22009 EP_NO: 11142 Repair Type: Non-Urgent Crossing Status: Not Found UCIP Comments: 06/03/2020 Record is Non-Urgent. Crossing not found. No permit has been identified authorizing pipe. (O.Yakimov - DWR UCIP)  FIELD_STRUCT_DESC: 6-inch irrigation pipe of an unknown material through the levee, 6.5 feet below the crown. Pump on concrete pad on the waterside (WS) slope. [Additional Reference(s): USACE Sacramento O&M Manual, Unit 111, May 1959, Revised 29 December 2016, (RM 30.31), listed as 6-inch pipe. USACE As-Built Drawing No. 06-13-1100, Sheet 14, near 'L' 1530+00, January 1933]. FS Date: 6/3/2020 10:46:37 AM

Siphon breaker and vent on pipe at LS toe.

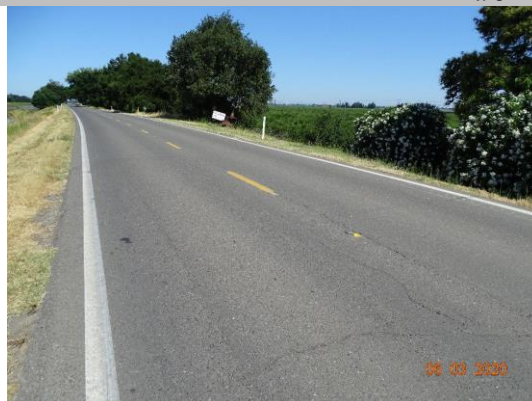
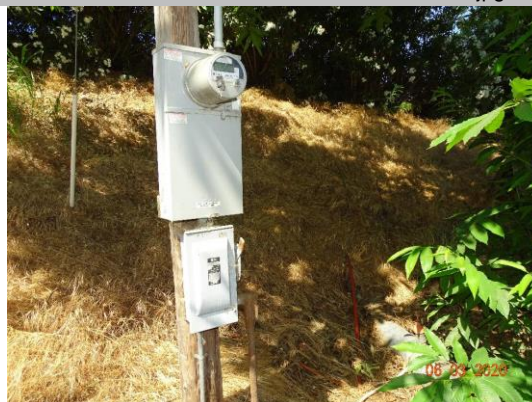
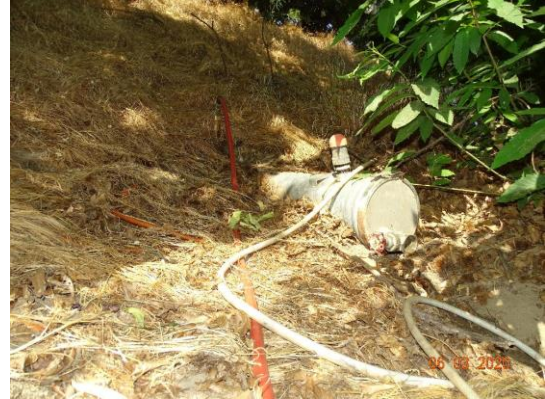
FS\_ID:60578  
DS\_ID:22019  
EP\_NO: 11142  
Repair Type: Non-Urgent  
Crossing Status: Found  
UCIP Comments: 06/03/2020 Record updated from No Action Needed to Non-Urgent. No permit has been identified authorizing original pipe. Unable to locate a permit for sleeving 6-inch pipe through 10-inch pipe. Need to have CVFPB review ABO and determine current owner. (O.Yakimov - DWR UCIP)  
FIELD\_STRUCT\_DESC: 6-inch irrigation pipe sleeved through the 10-inch irrigation pipe of an unknown material through the levee, 6.5 feet below the crown. Pump and butterfly valve on a concrete pad on the waterside (WS) slope. Air vent on pipe at landside toe. Electrical panel, and meter on a service pole at landside toe. 1-inch galvanized steel electrical conduit at the same location. (10-inch pipe [HLM 4.49] authorized under Automatic Board Order (ABO) issued as Permit No. 11142, 1975 - Tadashi Kimiye & Saburo Hirose). [Additional Reference(s): DWR Levee Log, 2005 (HLM 4.49). USACE Sacramento O&M Manual, Unit 111, May 1959, Revised 29 December 2016, (RM 30.31), listed as 10-inch pipe. USACE As-Built Drawing No. 06-13-1100, Sheet 14, near 'L' 1530+00, January 1933].

Land-Side: Service pole at levee toe

Land-Side: Pipe end with air vent at levee toe

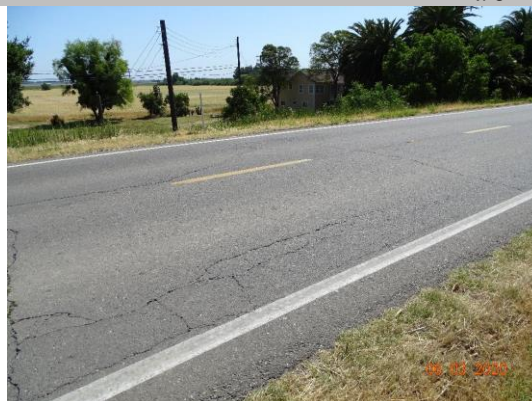
FS\_ID:60620  
DS\_ID:22020  
EP\_NO: 11152  
Repair Type: Urgent  
Crossing Status: Found  
UCIP Comments: 06/03/2020 Record updated from Non-Urgent to Urgent. Pipe is in failed condition. Pipe segment on waterside levee slope is removed. Through holes in pipe visible on waterside slope. Pump and intake pipe are removed from piled structure in the stream. 8' x 9' x 2'- deep depression on landside slope in pipe alignment. Crossing appears abandoned. (O.Yakimov - DWR UCIP)  
10/24/2016 Per Mr. Topper Van Loben, LMA contact, new owner is working with DCC Engineering to obtain CVFPB permit for pipe rehabilitation. Work rehabilitation for existing pipe includes sleeving an 8-inch steel pipe through existing pipe and grouting space between pipes. Crossing has been downgraded to Non-Urgent since walkway has been repaired and pipe in the process of being rehabilitated. UCIP staff is waiting for permit authorizing pipe rehabilitation. (O. Magana - DWR UCIP) (Olivia) As of 09/21/2015 owner is working with Gilbert Labrie, LMA consultant, to resolve issue. (T. Van Loben - LMA representative / G. Labrie - LMA Engineer - DCC Engineering)As of 12/17/2013 District submitted letter to landowner explaining UCIP report details including photos of the pipe problems. (T. Van Loben - LMA representative / G. Labrie - LMA Engineer - DCC Engineering)As of 12/13/2013 the District has contacted the tenant farmer who is in the process of contacting the owner to update on condition of pipe. (T. Van Loben - LMA representative / G. Labrie - LMA Engineer - DCC Engineering) 04/11/2013 Pier for pump is falling apart and is a hazard to the public. Some settlement along pipe on LS slope. (W. Wylie - DWR UCIP)

Water-Side: Pipe cut on levee slope

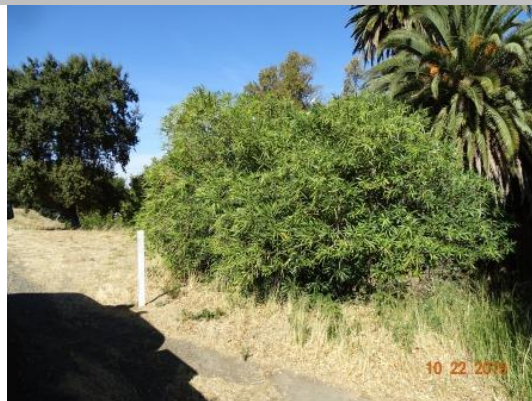
Photo 1 of 1 : SP\_2021\_RD0551\_175\_64\_20210301\_00030.jpg

LM Start	4.63	Rating **	U	Issue No.	64
LM End	4.63	Issue Type +	En	Location *	LS
Category	Earthen Levee			GPS Latitude/Longitude	
				Start	End
Item	Vegetation			38.280755 °	38.280755 °
				-121.546100 °	-121.546100 °
DWR ID	DWR_RD0551_01_f_2019_64				
Comment Code					
V6 : Landscaping					
Inspector Comment

View looking upstream at landscaping on the landside slope (Fall 2019).

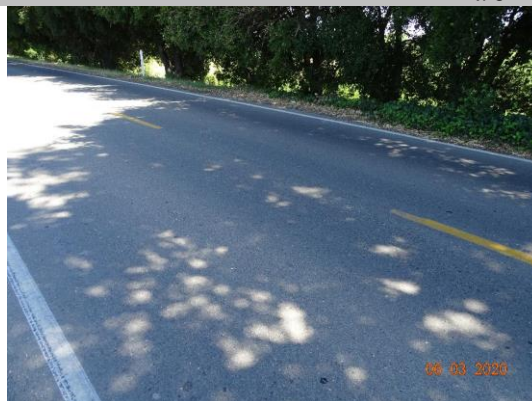
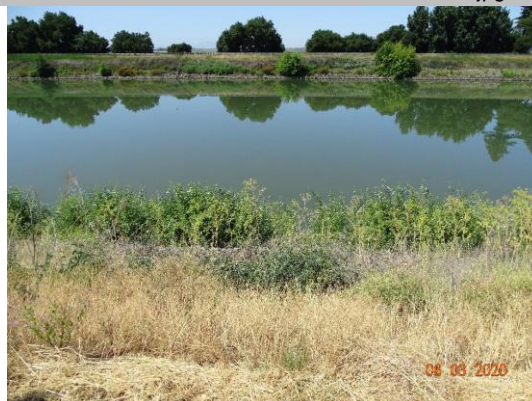
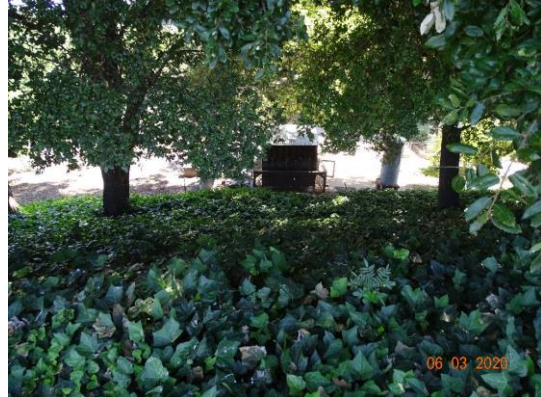
FS\_ID:60621  
DS\_ID:22036  
EP\_NO: N/A  
Repair Type: Non-Urgent  
Crossing Status: Not Found  
UCIP Comments: 06/03/2020 Record updated from No Action Needed to Non-Urgent. Crossing not found. No permit has been identified authorizing pipe. (O.Yakimov - DWR UCIP)

Land-Side: View of levee slope looking from crown. Water well and facility at levee toe

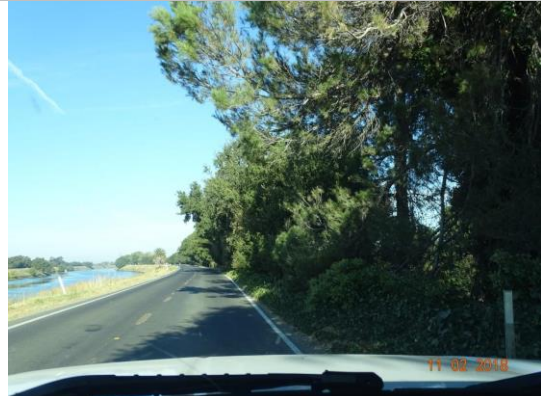
Photo 1 of 1 : SP\_2021\_RD0551\_175\_25\_20210301\_00008.jpg

LM Start	4.82	Rating **	U	Issue No.	25
LM End	4.86	Issue Type +	En	Location *	LS
Category	Earthen Levee			GPS Latitude/Longitude	
				Start	End
Item	Vegetation			38.278760 °	38.278287 °
				-121.543608 °	-121.543132 °
DWR ID	DWR_RD0551_01_f_2018_25				
Comment Code					
V6 : Landscaping					
Inspector Comment

View looking upstream at landscaping on the landside slope (November 2018).

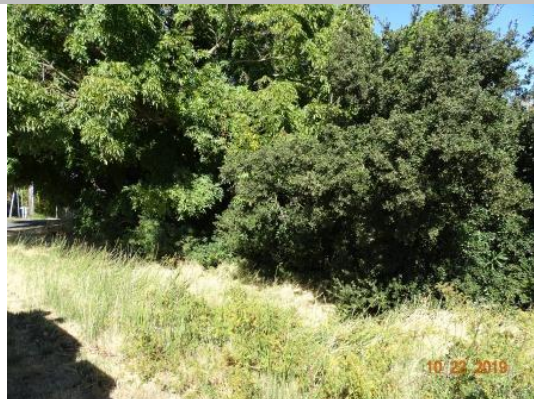
Photo 1 of 1 : SP\_2021\_RD0551\_175\_44\_20210301\_00012.jpg

LM Start	5.00	Rating **	U	Issue No.	44
LM End	5.00	Issue Type +	En	Location *	LS
Category	Earthen Levee			GPS Latitude/Longitude	
				Start	End
Item	Vegetation			38.276870 °	38.276870 °
				-121.541463 °	-121.541463 °
DWR ID	DWR_RD0551_01_f_2019_44				
Comment Code					
V6 : Landscaping					
Inspector Comment

View looking slightly upstream at landscaping on the landside slope (Fall 2019).

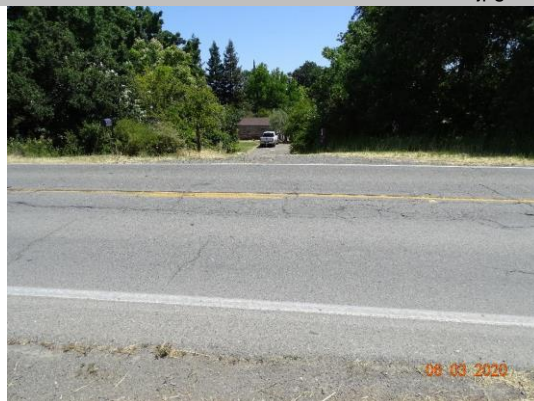
Comment Code						
Inspector Comment						
FS_ID:56199 DS_ID:25122 EP_NO: N/A Repair Type: Non-Urgent Crossing Status: Found UCIP Comments: 06/03/2020 Record is Non-Urgent. Five conduits are visible under bridge to boat launching two of which are open ended. Recommend capping conduits under bridge to prevent water backflow. (O.Yakimov - DWR UCIP) FIELD_STRUCT_DESC: 6-inch wrapped and soil proofed galvanized iron conduit through the levee 2-feet below the crown. Electric, water, and other utility pipes sleeved through conduit with welded steel caps and annular space grouted. (6-inch steel utility chase authorized under Permit No. 18769, 2013 - Michael & Jill Steinbacher). FS Date: 6/3/2020

Water-Side: Conduits under walkway

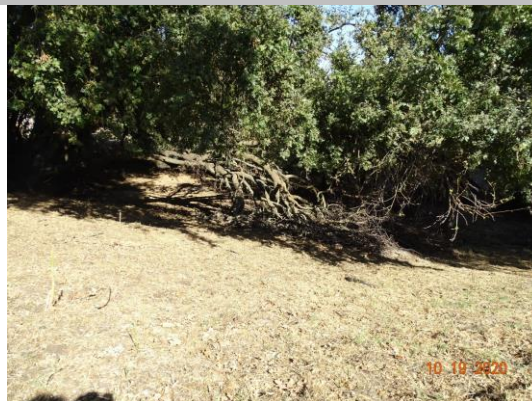
Photo 1 of 1 : SP\_2021\_RD0551\_175\_88\_20210301\_00034.jpg

LM Start	5.02	Rating **	U	Issue No.	88
LM End	5.02	Issue Type +	En	Location *	LS
Category	Earthen Levee			GPS Latitude/Longitude	
				Start	End
Item	Encroachments			38.276577 °	38.276577 °
				-121.541148 °	-121.541148 °
DWR ID	DWR_RD0551_01_f_2020_88				
Comment Code					
TR : Tree or limb					
Inspector Comment					
Remove down tree limbs on the landside toe.

View of fallen tree limbs on the landside toe (Fall 2020).

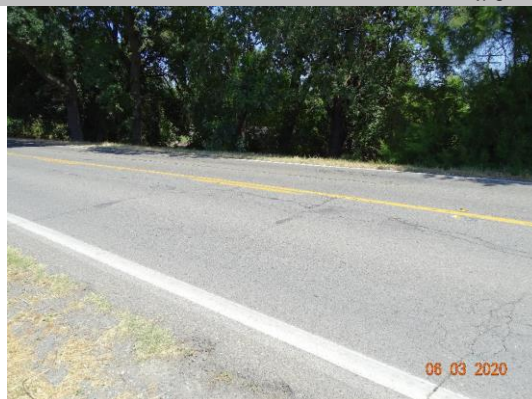
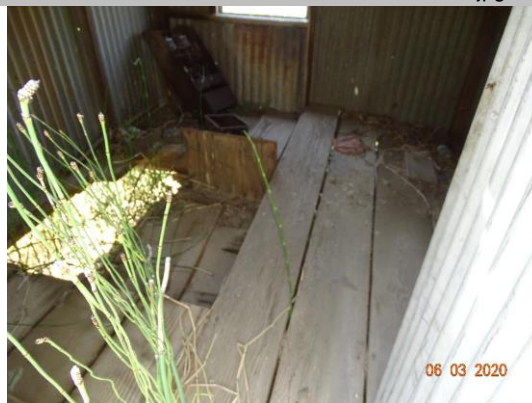
Comment Code						
Inspector Comment						
FS_ID:60628 DS_ID:22022 EP_NO: 11125 Repair Type: Non-Urgent Crossing Status: Found UCIP Comments: 06/03/2020 Record remains Non-Urgent. Crossing appears abandoned. Service pole at landside toe with electric panel and meter is broken down. Unable to evaluate waterside slope due to overgrown vegetation. Unauthorized encroachment recorded in Levee Log prior to 2011. Need to have CVFPB review ABO and determine current owner. (O.Yakimov - DWR UCIP) 04/11/2013 Pumphouse has been removed from pump and pump is in disrepair. Pipe at LS toe is sleeved or has been replaced with a 6-inch PVC pipe. This pump appears abandoned and should be done so properly. (W.Wylie - DWR UCIP) FIELD_STRUCT_DESC: 6-inch irrigation pipe of an unknown material through the levee, 6.5 feet below the crown. Pump and slide gate on the waterside (WS) slope. 1-inch electrical conduit at the same location with service pole at the landside (LS) toe. 4-foot by 6-foot concrete distribution box at the LS toe. (6-inch pipe [HLM 5.09] authorized under Automatic Board Order (ABO) issued as Permit No. 11125, 1975 - William H. And Evelyn J. Cortopassi). [Additional Reference(s): DWR Levee Log, 2005 (HLM 5.09). USACE Sacramento O&M Manual, Unit 111, May 1959, Revised 29 December 2016, (RM 29.71), listed as 6-inch pipe. USACE As-Built Drawing No. 06-13-1100, Sheet 14, downstream of 'L' 1560+12, January 1933]. FS Date: 6/3/2020 4:46:04 PM

Water-Side: View of levee slope looking from crown. Abandoned pumphouse on levee slope

Water-Side: View inside of abandoned pumphouse

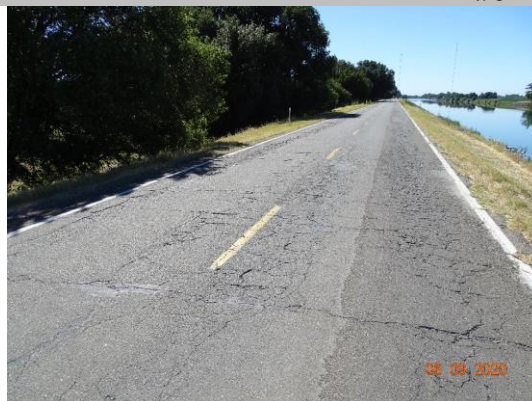
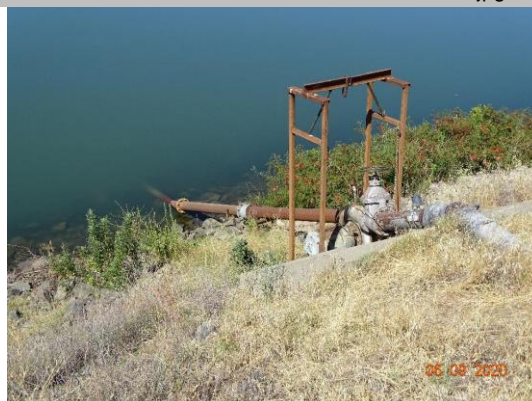
FS\_ID:60630  
DS\_ID:22023  
EP\_NO: 11131  
Repair Type: Urgent  
Crossing Status: Found  
UCIP Comments: 06/09/2020 Record updated from Non-Urgent to Urgent. 7-foot diameter 1-foot deep unauthorized excavation found at landside levee toe next to the concrete standpipe. Excavation is apparently made to expose and fix leaking pipe. Abandoned closure device and concrete standpipe at landside toe. 2.5-inch PVC connected to pipe end at landside toe. Pipe is running - no leaks detected. CMP riser on landside slope missing cover - fall hazard. No permit has been identified authorizing pipe. Need to have CVFPB review ABO and determine current owner. (O.Yakimov - DWR UCIP)  
01/15/2014 Based on District notes from January 15, 2014, pump discharge pipe has been repaired. Corrosion holes in pipe at LS toe good indicator that pipe is failing internally. Pipe should be examined internally for damage (video inspect).: As of 12/12/2013 the District discussed with farmer tenant what needed to be done, and the tenant informed the District that they would address the repairs.: As of 12/17/2013 District submitted letter to landowner explaining UCIP report details including photos of the pipe problems

FIELD\_STRUCT\_DESC: 10-inch steel exterior coated irrigation pipe through the levee, 7.7 feet below the crown. Pump and slide gate on a concrete pad on the waterside (WS) slope. Siphon breaker in a 24-inch corrugated metal pipe (CMP) riser on the landside (LS) slope. 36-inch concrete standpipe, shut off device, and power pole with panel box on the LS toe. 1.5-inch galvanized steel electrical conduit at the same location. (10-inch pipe [HLM 5.3] authorized under Automatic Board Order (ABO) issued as Permit No. 11131, 1975 - Helen Crofton Sloane Latimer). [Additional Reference(s): DWR Levee Log, 2005 (HLM 5.30). USACE Sacramento O&M Manual, Unit 111, May 1959, Revised 29 December 2016, (RM 29.52), listed as 9-inch pipe. USACE As-Built Drawing No. 06-13-1100, Sheet 14, 'L' 1571+85, January 1933, listed as 9-inch pipe].  
FS Date: 6/9/2020 10:52:00 AM

Water-Side: Pump, slide gate valve, and intake pipe on levee slope

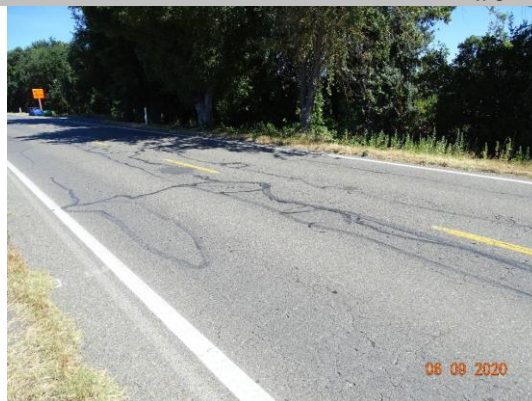
Photo 1 of 3 : UCIP\_SP\_2021\_60635\_87911.jpg

FS\_ID:60635  
DS\_ID:22024  
EP\_NO: 11131  
Repair Type: Non-Urgent  
Crossing Status: Found  
UCIP Comments: 06/09/2020 Record updated from No Action Needed to Non-Urgent. Unable to evaluate levee slopes due to overgrown vegetation on waterside and landscaping on landside. No permit has been identified authorizing pipe. Need to have CVFPB review ABO and determine current owner. (O.Yakimov - DWR UCIP)  
04/11/2013 Good candidate for video inspection. (W.Wylie - DWR UCIP)  
FIELD\_STRUCT\_DESC: 8-inch irrigation pipe of an unknown material through the levee, 7.7 feet below the crown. Pump house, pump, and slide gate on a concrete pad on the waterside (WS) slope. 5-foot by 6-foot concrete distribution box at the landside (LS) toe. Service pole on the LS slope, electrical conduit of unknown diameter at this location. (8-inch pipe [HLM 5.6] authorized under Automatic Board Order (ABO) issued as Permit No. 11131, 1975 - Helen Crofton Sloane Latimer).
