**Flood Control Project Maintenance  
Levee Inspections  
LMA District Cover Sheet**

**Reclamation District No. 0551 Pearson**

**Flood Control Project Maintenance  
Levee Inspections**

**Levee Inspection Report By Mile - Spring 2021**

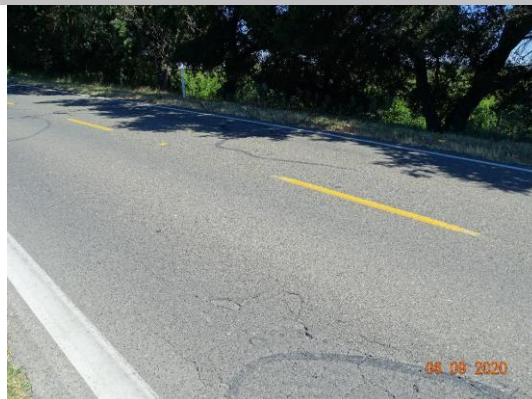
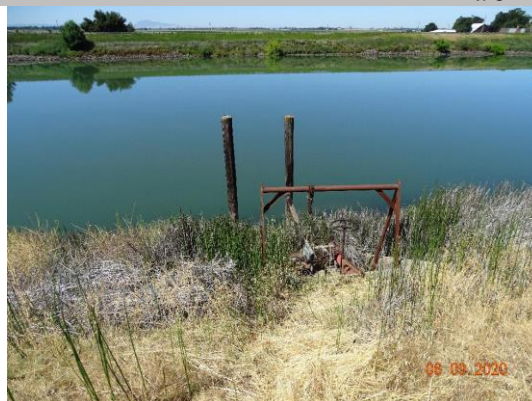
FS\_ID:60636  
DS\_ID:22025  
EP\_NO: 11134  
Repair Type: Non-Urgent  
Crossing Status: Found  
UCIP Comments: 06/09/2020 Record updated from No Action Needed to Non-Urgent. CMP riser on landside slope needs a cover - fall hazard. Pipe is running - minor leak through siphon breaker on the top of standpipe and landside toe. No permit has been identified authorizing pipe. Need to have CVFPB review ABO and determine current owner. (O.Yakimov - DWR UCIP)

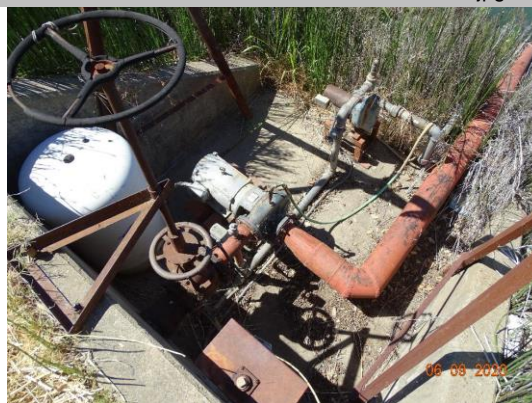
Photo 3 of 3 : UCIP\_SP\_2021\_60636\_87919.jpg

Water-Side: Concrete pad on levee slope with pumps, valve, pressure tank

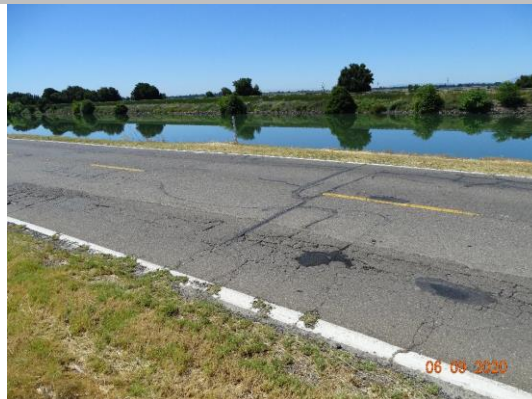
Photo 1 of 3 : UCIP\_SP\_2021\_60639\_88019.jpg

FS\_ID:60639  
DS\_ID:22038  
EP\_NO: N/A  
Repair Type: Non-Urgent  
Crossing Status: Found  
UCIP Comments: 06/09/2020 Record updated from No Action Needed to Non-Urgent. Crossing appears abandoned. Pipe is plugged with concrete as visible inside of concrete distribution box at landside toe. Unable to locate a permit and confirm proper pipe abandonment. Pipe not found on waterside. No permit has been identified authorizing pipe through the levee. (O.Yakimov - DWR UCIP)  
FIELD\_STRUCT\_DESC: 10-inch steel irrigation pipe through the levee, 4.4 feet below the crown. 4-foot by 6-foot concrete distribution box at the landside (LS) toe. Pipe filled with concrete at the LS toe. [Additional Reference(s): USACE Sacramento O&M Manual, Unit 111, May 1959, Revised 29 December 2016, (RM 28.97), listed as 8-inch pipe]. USACE As-Built Drawing No. 06-13-1100, Sheet 14, downstream of 'L' 1600+60, January 1933, listed as 8-inch pipe].

Top of Levee: View of levee crown looking downstream

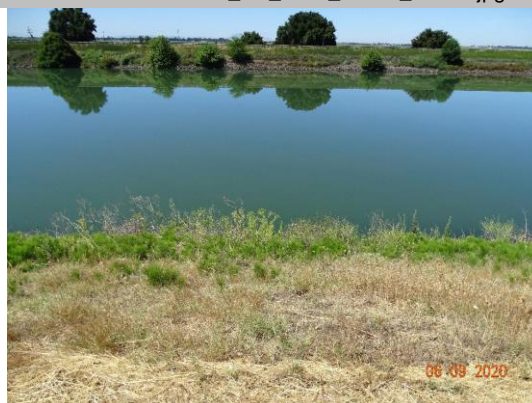
Photo 2 of 3 : UCIP\_SP\_2021\_60639\_88020.jpg

Water-Side: View of levee slope looking from crown

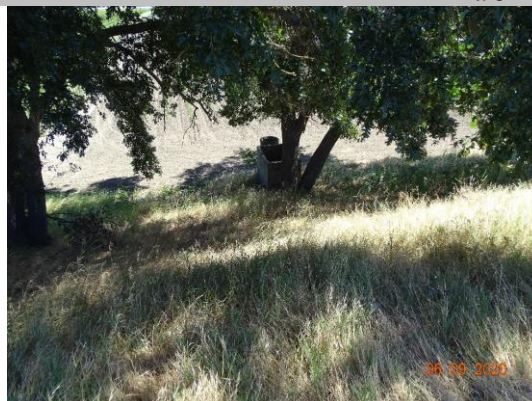
Photo 3 of 3 : UCIP\_SP\_2021\_60639\_88018.jpg

Land-Side: View of levee slope looking from crown

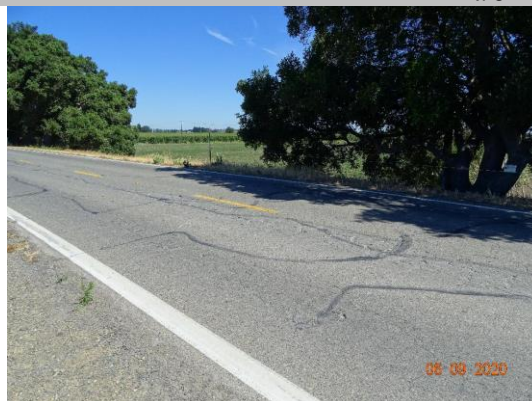
Photo 1 of 3 : UCIP\_SP\_2021\_60640\_88021.jpg

FS\_ID:60640  
DS\_ID:21997  
EP\_NO: N/A  
Repair Type: Non-Urgent  
Crossing Status: Found  
UCIP Comments: 06/09/2020 Record updated from No Action Needed to Non-Urgent. No permit has been identified authorizing pipe.  
(O.Yakimov - DWR UCIP)

FIELD\_STRUCT\_DESC: 2-inch steel domestic water line through the levee, 3 feet below the crown. Pump house on the waterside. Air vent on landside shoulder. [Additional Reference(s): USACE Sacramento O&M Manual, Unit 111, May 1959, Revised 29 December 2016, (RM 28.87), listed as 2-inch pipe].  
FS Date: 6/9/2020 3:51:38 PM

Top of Levee: View of levee crown looking upstream

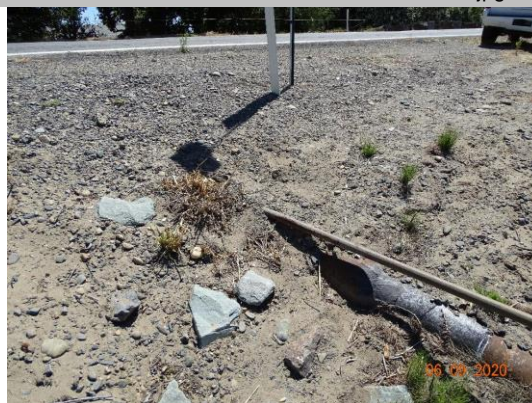
Photo 3 of 3 : UCIP\_SP\_2021\_60640\_88023.jpg

Water-Side: Pipe daylights on levee slope

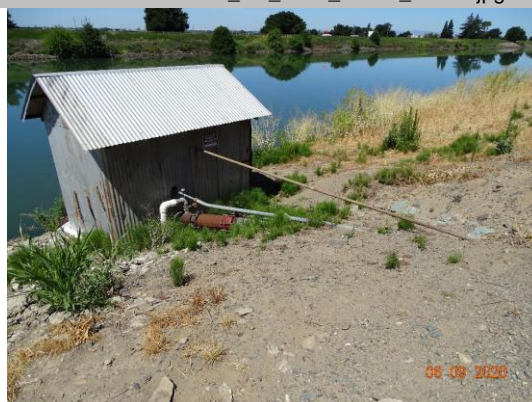
Photo 2 of 3 : UCIP\_SP\_2021\_60641\_88028.jpg

Water-Side: View of levee slope looking from crown. Pumphouse on levee slope

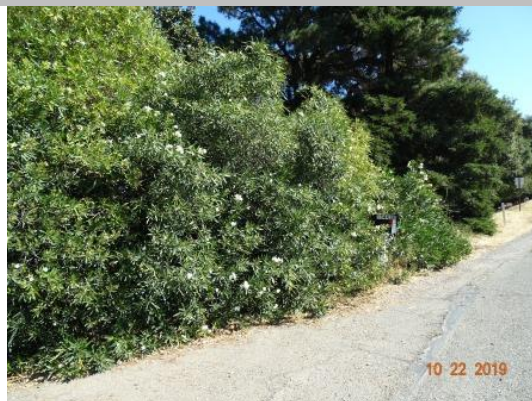
Photo 1 of 1 : SP\_2021\_RD0551\_175\_50\_20210301\_00017.jpg

LM Start	5.90	Rating **	U	Issue No.	50
LM End	5.90	Issue Type +	En	Location *	LS
Category	Earthen Levee			GPS Latitude/Longitude	
				Start	End
Item	Vegetation			38.267833 °	38.267833 °
				-121.529438 °	-121.529438 °
DWR ID	DWR_RD0551_01_f_2017_50				
Comment Code					
V6 : Landscaping					
Inspector Comment					
Landscaping should be maintained to allow inspection and access to landside slope and toe. Trim/thin oleanders and ivy.

View looking slightly downstream at landscaping on the landside slope (Fall 2019).

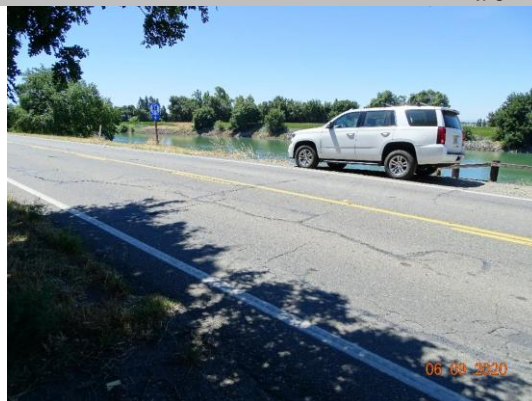
Photo 1 of 3 : UCIP\_SP\_2021\_60643\_87950.jpg

LM Start	6.16	Rating **	M	Issue No.	80	
LM End	6.16	Issue Type +	En	Location *		
Category	Supplemental			GPS Latitude/Longitude		
				Start		End
Item	DWR UCIP Field Study			38.265182 °		38.265182 °
				-121.526136 °		-121.526136 °
DWR ID	21999					
Comment Code						
Inspector Comment						
FS_ID:60643 DS_ID:21999 EP_NO: N/A Repair Type: Non-Urgent Crossing Status: Not Found UCIP Comments: 06/09/2020 Record updated from No Action Needed to Non-Urgent. Crossing not found. No permit has been identified authorizing pipe. (O.Yakimov - DWR UCIP)  FIELD_STRUCT_DESC: 3.5-inch conduit of unknown purpose of an unknown material through the levee, 5.8 feet below the crown. [Additional Reference(s): USACE Sacramento O&M Manual, Unit 111, May 1959, Revised 29 December 2016, (RM 28.59), listed as 3.5-inch pipe]. FS Date: 6/9/2020 4:31:25 PM

Top of Levee: View of levee crown looking downstream

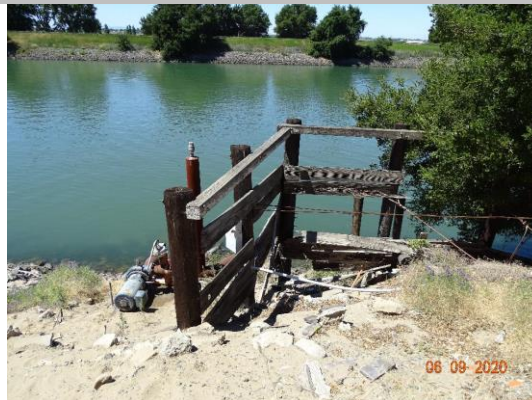
Photo 2 of 3 : UCIP\_SP\_2021\_60643\_87949.jpg

Water-Side: Electrical panel next to the pump on levee slope

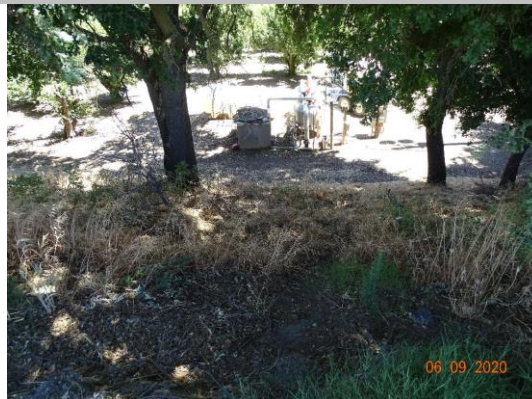
Photo 3 of 3 : UCIP\_SP\_2021\_60643\_87951.jpg

Land-Side: View of levee slope looking from crown

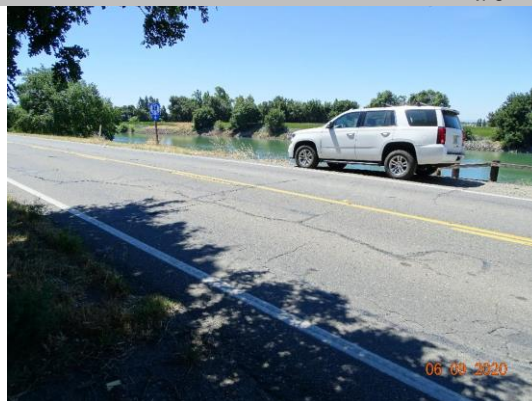
Photo 1 of 3 : UCIP\_SP\_2021\_60650\_87927.jpg

FS\_ID:60650  
DS\_ID:22027  
EP\_NO: 11122  
Repair Type: Non-Urgent  
Crossing Status: Indicator Found  
UCIP Comments: 06/09/2020 Record updated from No Action Needed to Non-Urgent. Pump is moved downstream to a separate piled steel pad and connected to existing 10-inch pipe through the levee. Concrete distribution box at landside toe seems abandoned. Fine media filtration system installed on landside and connected to this crossing. Unable to find permit for system modifications. Pipe is running - minor water leak through pump sealing on waterside slope. (O.Yakimov - DWR UCIP)  
FIELD\_STRUCT\_DESC: 10-inch steel exterior coated irrigation pipe through the levee, 8 feet below the crown. Abandoned pile structure on waterside slope and in stream. Pump and butterfly valve on steel piled pad on waterside slope downstream of abandoned structure. Service pole with electrical panel and meter, media filters off landside toe. Abandoned 4-foot by 6-foot concrete distribution box at landside levee toe. This crossing replaces 8-inch pipe (see DSID 21998). (10-inch pipe authorized under Permit No. 4303, 1963 - Robert M. Carmany). (10-inch pipe [HLM 6.21] authorized under Automatic Board Order (ABO) issued as Permit No. 11122, 1975 - Robert M. And Francis Carmany). [Additional Reference(s): DWR Levee Log, 2005 (HLM 6.21)].

Top of Levee: View of levee crown looking towards waterside

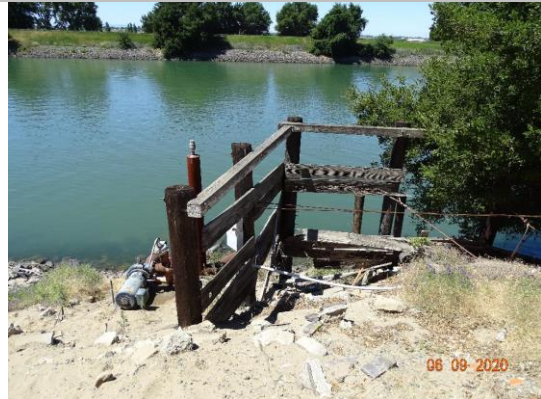
Photo 2 of 3 : UCIP\_SP\_2021\_60650\_87923.jpg

Water-Side: Abandoned pile structure on levee slope and in channel

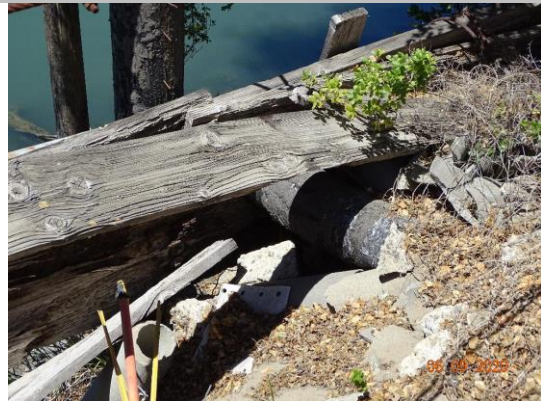
Photo 3 of 3 : UCIP\_SP\_2021\_60650\_87930.jpg

Water-Side: 10-inch pipe at abandoned structure on levee slope

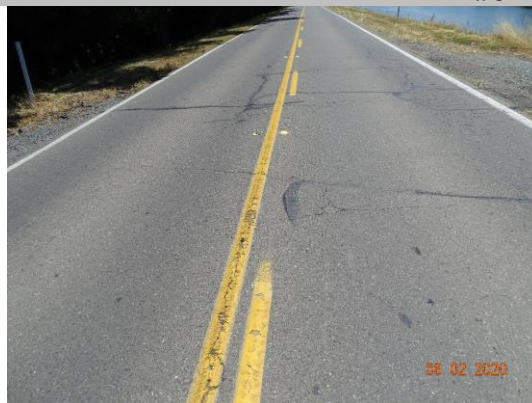
Photo 1 of 3 : UCIP\_SP\_2021\_60684\_87960.jpg

Comment Code						
Inspector Comment						
FS_ID:60684						
DS_ID:21977						
EP_NO: N/A						
Repair Type: Non-Urgent						
Crossing Status: Found						
UCIP Comments: 06/02/2020 Record updated from No Action Needed						
to Non-Urgent. No permit has been identified authorizing crossing.						
(O.Yakimov - DWR UCIP)						
FIELD_STRUCT_DESC: 1.5-inch galvanized steel electrical conduit						
through the levee, 6.3 feet below the crown. Slant pump on the						
waterside (WS) slope. [Additional Reference(s): DWR Levee Log, 2005						
(HLM 6.36), listed as 3.5-inch pipe. USACE Sacramento O&M Manual,						
Unit 111, May 1959, Revised 29 December 2016, (RM 28.44), listed as

Top of Levee: View of levee crown looking downstream

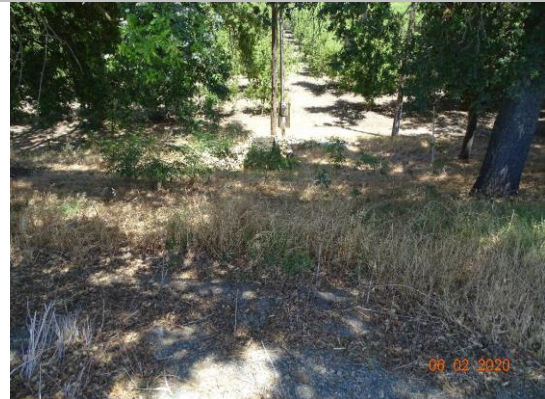
Photo 2 of 3 : UCIP\_SP\_2021\_60684\_87961.jpg

Land-Side: View of levee slope looking from crown

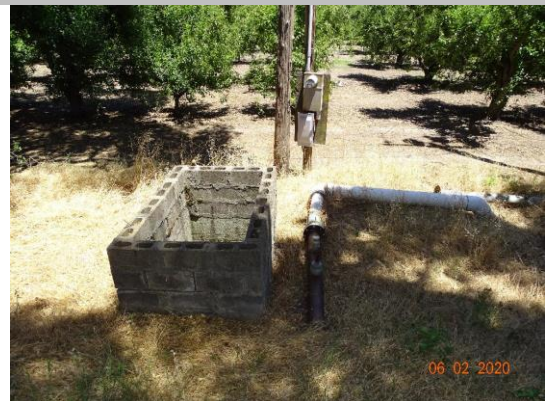
Photo 3 of 3 : UCIP\_SP\_2021\_60684\_87962.jpg

Land-Side: Service pole at levee toe

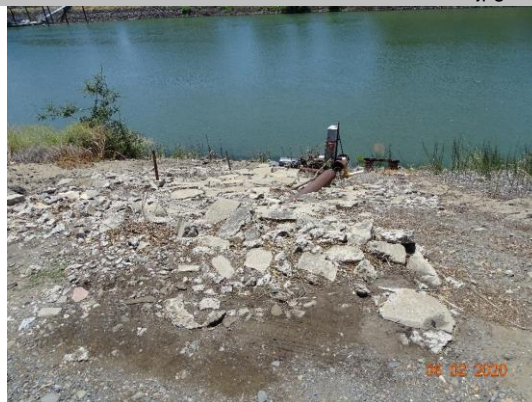
Photo 2 of 3 : UCIP\_SP\_2021\_60690\_87968.jpg

Water-Side: View of levee slope looking from crown

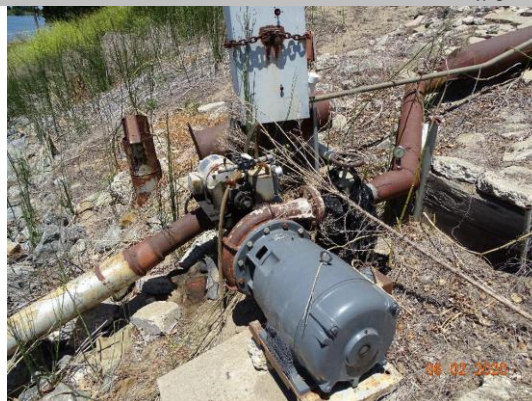
Photo 3 of 3 : UCIP\_SP\_2021\_60690\_87969.jpg

Water-Side: Pump on concrete pad on levee slope

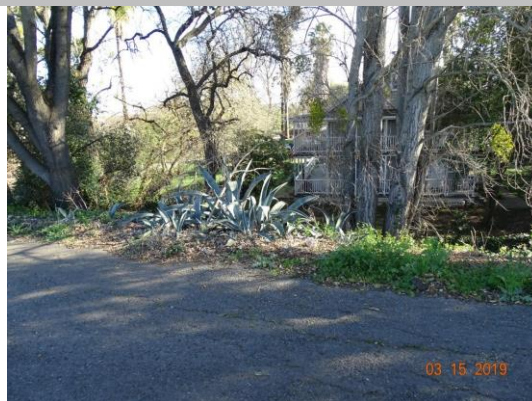
Photo 1 of 1 : SP\_2021\_RD0551\_175\_20\_20210301\_00005.jpg

LM Start	6.44	Rating **	M	Issue No.	20
LM End	6.44	Issue Type +	En	Location *	LS
Category	Earthen Levee			GPS Latitude/Longitude	
				Start	End
Item	Vegetation			38.262388 °	38.262388 °
				-121.522368 °	-121.522368 °
DWR ID	DWR_RD0551_01_s_2019_20				
Comment Code					
V6 : Landscaping					
Inspector Comment					
Cactus on the landside slope should be removed.

View of cactus on the landside shoulder (Spring 2019).

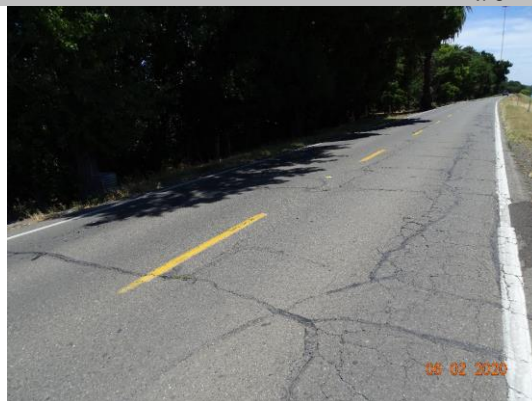
Photo 1 of 3 : UCIP\_SP\_2021\_60696\_87974.jpg

Comment Code					
Inspector Comment					
FS_ID:60696 DS_ID:22029 EP_NO: 3354 Repair Type: Non-Urgent Crossing Status: Found UCIP Comments: 06/02/2020 Record updated from No Action Needed to Non-Urgent. 12-inch pipe sleeved through 14-inch pipe through the levee. Unable to find a permit for modification. Pipe is running - leaks not detected. (O.Yakimov - DWR UCIP) FIELD_STRUCT_DESC: 12-inch steel irrigation pipe sleeved through 14-inch coated steel pipe through the levee, 3.5 feet below the crown. Slant pump on a concrete slab on the waterside (WS) slope. Siphon breaker in a 24-inch corrugated metal pipe (CMP) riser on the landside (LS) shoulder. Slide gate in a 48-inch concrete riser on the LS toe. 1.5-inch electrical conduit at the same location. This crossing replaces 12-inch pipe (see DSID 22000). (14-inch pipe authorized under Permit No. 3354, 1960 - F.I. Christie). [Additional Reference(s): DWR Levee Log, 2005 (HLM 6.53), listed as 14-inch pipe. USACE As-Built Drawing No. 06-13-1100, Sheet 14, 'L' 1640+00, January 1933, , listed as 14-inch pipe]. FS Date: 6/2/2020 2:31:53 PM

Top of Levee: View of levee crown looking downstream

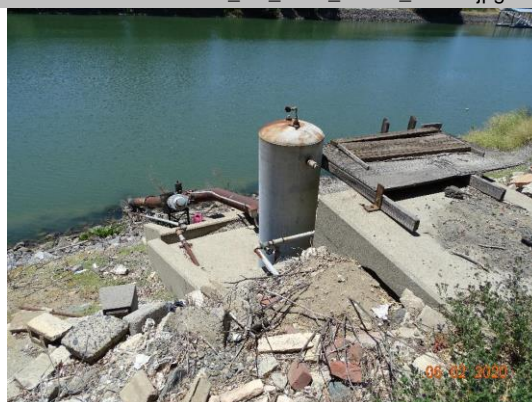
Photo 2 of 3 : UCIP\_SP\_2021\_60696\_87975.jpg

Water-Side: View of levee slope looking from crown

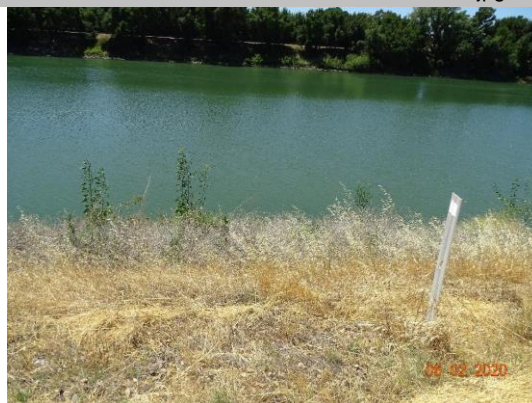
Photo 3 of 3 : UCIP\_SP\_2021\_60698\_87986.jpg

Water-Side: View of levee slope looking from crown

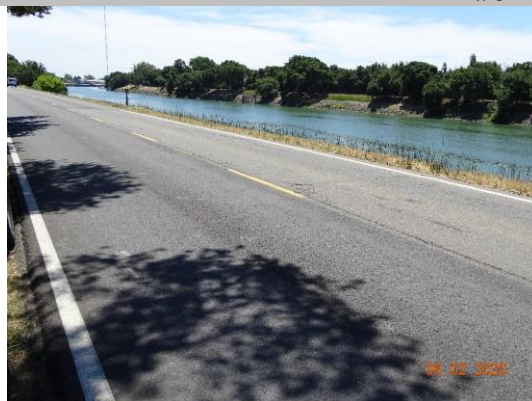
Photo 1 of 3 : UCIP\_SP\_2021\_60701\_87995.jpg

Comment Code					
Inspector Comment					
FS_ID:60701 DS_ID:22030 EP_NO: 11126 Repair Type: Non-Urgent Crossing Status: Found UCIP Comments: 06/02/2020 Record updated from No Action Needed to Non-Urgent. Field measured 8-inch pipe sleeved through 12-inch pipe. Appears that annular space between pipes has been grouted through a plugged hole at landside shoulder. Concrete standpipe and distribution box at landside toe look abandoned. Water is designed to go around concrete box to either underground pipe of screen filter. Unable to find a permit for modifications. Pipe is running - no leaks detected. No permit has been identified authorizing pipe through the levee. Need to have CVFPB review ABO and determine current owner. (O.Yakimov - DWR UCIP) FIELD_STRUCT_DESC: 8-inch irrigation pipe sleeved through the 12-inch steel pipe through the levee, 3 feet below crown. Water pump, filler pump and pressure tank on a concrete pad on the waterside (WS) slope. Butterfly valves at pump and at the landside (LS) toe. Abandoned concrete standpipe and concrete distribution box at landside toe. Screen filter at landside levee toe, service pole a 1.5-inch galvanized electrical conduit at the same location. (12-inch pipe [HLM 6.74] authorized under Automatic Board Order (ABO) issued as Permit No. 11126, 1975 - Alma K. Fletcher). [Additional Reference(s): DWR Levee Log, 2005 (HLM 6.74), listed as 12-inch pipe. USACE Sacramento O&M Manual, Unit 111, May 1959, Revised 29 December 2016, (RM 28.06), listed as 6-inch pipe. USACE As-Built Drawing No. 06-13-1100, Sheet 14, upstream of 'L' 1652+65, January 1933, listed as 6-inch pipe]. FS Date: 6/2/2020 3:17:35 PM

Top of Levee: View of levee crown looking downstream
