**Flood Control Project Maintenance
Levee Inspections
LMA District Cover Sheet**

Reclamation District No. 0551 Pearson

**Flood Control Project Maintenance
Levee Inspections
Unit Cover Sheet**

Waterway			Bank	Unit Miles
Unit No. 01 Sacramento River			Left	6.78
	Spring (March - May)	Summer (June - August)	(September - November) Fall	Winter (December - February)
Unit Maintenance Rating (Fall Only)				
Date of Inspection	3/10/2022 - 3/10/2022			
DWR Inspector	David Julian			
Accompanied By	Topper van Loben Sels RD 551

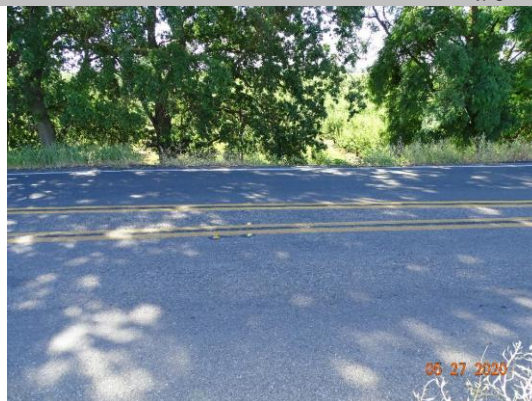
Photo 2 of 3 : UCIP_SP_2022_57695_85471.jpg

Top of Levee: View of levee crown at the crossing

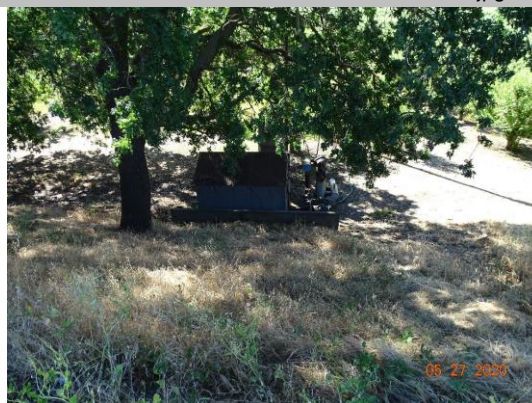
Photo 3 of 3 : UCIP_SP_2022_57695_85474.jpg

Land-Side: View of levee slope looking from crown

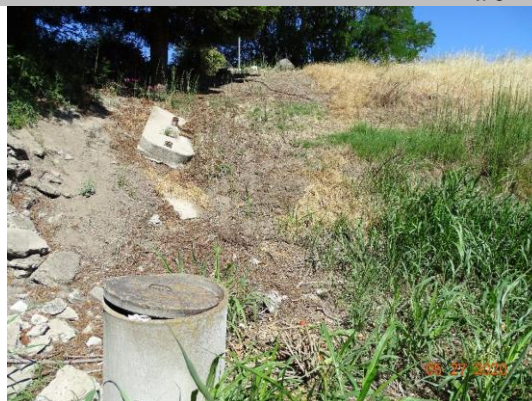
Photo 3 of 3 : UCIP_SP_2022_60001_87294.jpg

Land-Side: View of levee slope looking from toe

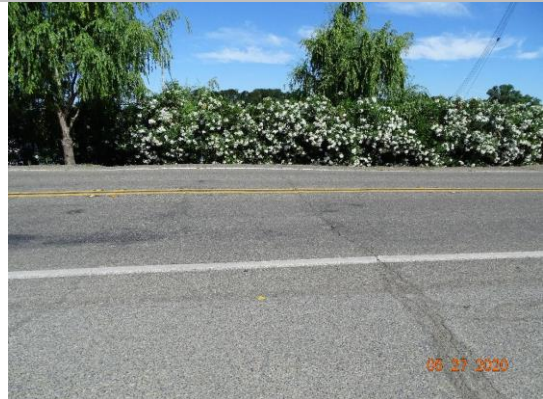
Photo 1 of 3 : UCIP_SP_2022_60032_87319.jpg

Comment Code						
Inspector Comment						
FS_ID:60032 DS_ID:21982 EP_NO: 2759 Repair Type: Non-Urgent Crossing Status: Found UCIP Comments: 05/27/2020 Record remains Non-Urgent. Unauthorized encroachment recorded in Levee Log prior to 2011. Unable to determine pipe material through the levee. PVC pipe is visible in a plastic box on waterside. (O.Yakimov - DWR UCIP) 04/1-/2013 Unclear where exact crossing is located (W.Wylie - DWR UCIP) FIELD_STRUCT_DESC: [Courtland Boating Facilities] 1-inch steel water line through the levee, at an unknown depth. Ramp and boating facilities on the waterside (WS). Pipe visible under buildings at concrete foundation on the landside (LS). Water service connections for irrigation located on the WS slope. (Reference to existing 1-inch water pipe to be connected to the trailer made in Permit No. 2759, 1958 - Jack and Belva Swisley and Ed Hathaway). FS Date: 5/27/2020 3:05:40 PM

Top of Levee: View of levee crown looking towards waterside

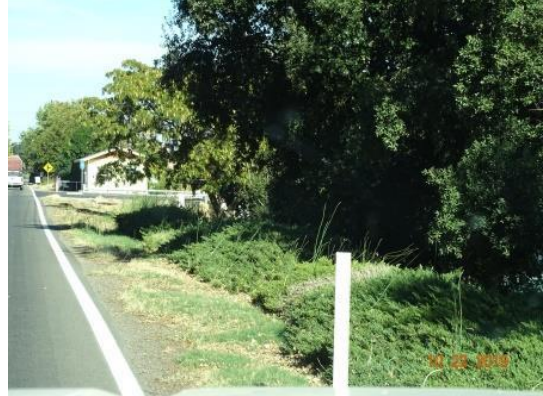
Photo 1 of 1 : SP_2022_RD0551_175_69_20220307_00030.jpg

LM Start	0.56	Rating **	M	Issue No.	69
LM End	0.59	Issue Type +	En	Location *	LS
Category	Earthen Levee			GPS Latitude/Longitude	
				Start	End
Item	Vegetation			38.330242 °	38.329830 °
				-121.571405 °	-121.571725 °
DWR ID	DWR_RD0551_01_f _ 2019_69				
Comment Code					
V6 : Landscaping					
Inspector Comment

View looking downstream at landscaping on the landside slope (Fall 2019).

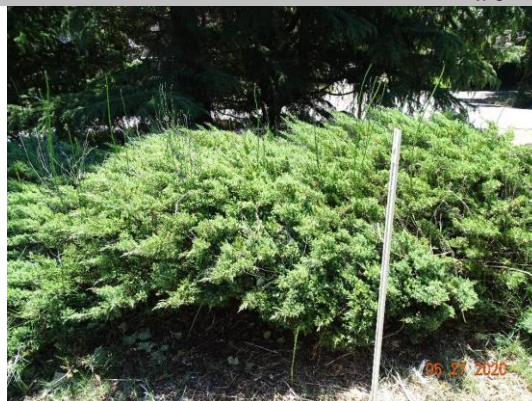
Photo 2 of 3 : UCIP_SP_2022_60080_87334.jpg

Comment Code						
Inspector Comment						
FS_ID:60080 DS_ID:21984 EP_NO: 3673 Repair Type: Non-Urgent Crossing Status: Not Found UCIP Comments: 05/27/2020 Record updated from No Action Needed to Non-Urgent. Crossing not found. A sign noticed during last inspection on opposite side of river is gone. Recommend owner to install communication line markers. (O.Yakimov - DWR UCIP) 04/10/2013 Sign on opposite side of river is a good indication of communication line location. (W.Wylie - DWR UCIP) FIELD_STRUCT_DESC: 2.5-inch steel telephone conduit through the levee and across the channel, 3 feet below the crown. (Armored submarine 2.5-inch steel conduit telephone cable authorized under Permit No. 3673, 1961 - Delta Telephone and Telegraph Company). [Additional Reference(s): DWR Levee Log, 2005 (HLM 0.60)]. FS Date: 5/27/2020 8:25:53 AM

Land-Side: View of landside at potential crossing

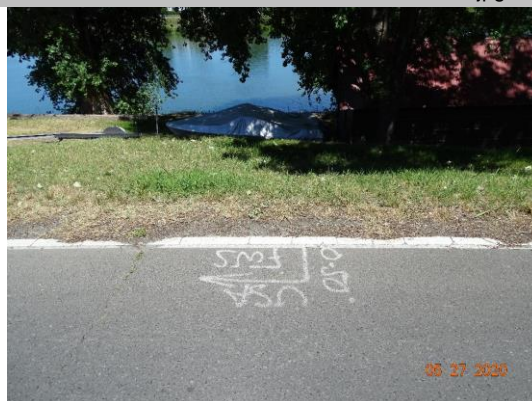
Photo 3 of 3 : UCIP_SP_2022_60080_87335.jpg

Water-Side: View of levee slope looking from crown

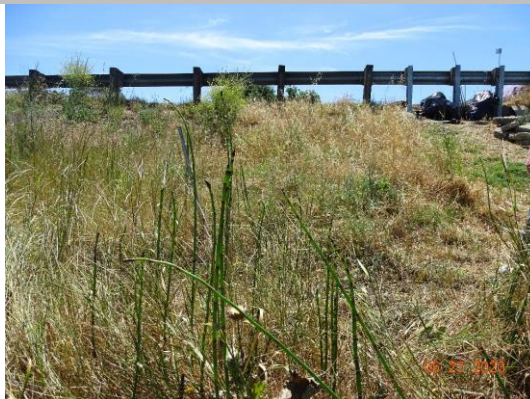
Photo 3 of 3 : UCIP_SP_2022_60085_87349.jpg

Comment Code						
Inspector Comment						
FS_ID:60085 DS_ID:21985 EP_NO: 6220 Repair Type: Non-Urgent Crossing Status: Found UCIP Comments: 05/27/2020 Record remains Non-Urgent. Two sinkholes on waterside levee slope that measure 18"x 12"x 6" deep found in pipe alignment. Crossing appears abandoned. Pipe is heavily rusted at riverbank. From conversation with adjacent property owner found out that pipe is located on easement to the property just across from the crossing and used to serve water for orchard on landside. (O.Yakimov - DWR UCIP) 04/10/2013 Pipe abandoned and should be removed. (W.Wylie - DWR UCIP) FIELD_STRUCT_DESC: 8-inch coated steel irrigation pipe through the levee, 6.1 feet below the crown. Pump on the waterside (WS) with slide gate and air vent. (8-inch pipe authorized under Permit No. 6220, 1968 - Robert U. Grant). [Additional Reference(s): DWR Levee Log, 2005 (HLM 0.71)]. FS Date: 5/27/2020 8:59:30 AM

Water-Side: View of levee slope looking towards crown

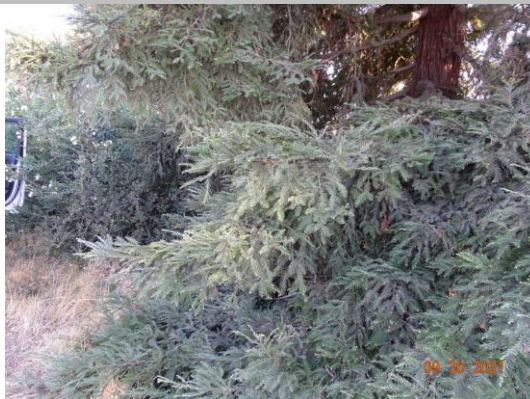
Photo 1 of 1 : SP_2022_RD0551_175_57_20220307_00021.jpg

LM Start	0.73	Rating **	U	Issue No.	57
LM End	0.76	Issue Type +	En	Location *	LS
Category	Earthen Levee			GPS Latitude/Longitude	
				Start	End
Item	Vegetation			38.328122 °	38.327783 °
				-121.573130 °	-121.573362 °
DWR ID	DWR_RD0551_01_f_2018_57				
Comment Code					
V6 : Landscaping					
Inspector Comment

View of thick landscaping on the landside slope (Fall 2021).

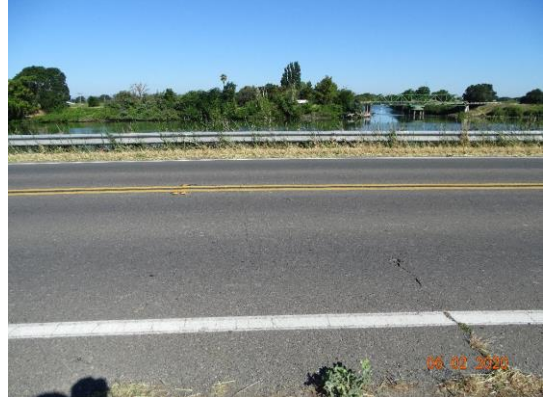
Photo 1 of 3 : UCIP_SP_2022_60086_87355.jpg

Comment Code					
Inspector Comment					
FS_ID:60086 DS_ID:21986 EP_NO: 701 Repair Type: Urgent Crossing Status: Found UCIP Comments: 06/02/2020 Record updated from Non-Urgent to Urgent. Through hole in pipe visible on landside slope, missing wall of pipe at riverbank. 2-foot diameter scour hole present around a hole in pipe on landside slope. 3-foot diameter and 3-inch deep depression of levee slope just above this hole. Crossing appears abandoned. (O.Yakimov - DWR UCIP) 04/10/2013 Pipe appears abandoned and should be done so properly. Good candidate for video inspection. (W.Wylie - DWR UCIP) FIELD_STRUCT_DESC: 14-inch steel irrigation pipe through the levee, 7.2 feet below the crown. Pump in pump house on the waterside (WS) slope. Service pole on the landside (LS) slope. 1-inch galvanized filler pipe, and a 2-inch electrical conduit at the same location. (16-inch pipe authorized under Permit No. 701, 1937 - American Trust Company). [Additional Reference(s): DWR Levee Log, 2005 (HLM 0.89). USACE Sacramento O&M Manual, Unit 111, May 1959, Revised 29 December 2016, (RM 33.91), listed as 14-inch pipe. USACE As-Built Drawing No. 06-13-1100, Sheet 12, upstream of 'L' 1348+33, January 1933]. FS Date: 6/2/2020 10:38:50 AM

Top of Levee: View of levee crown looking towards waterside

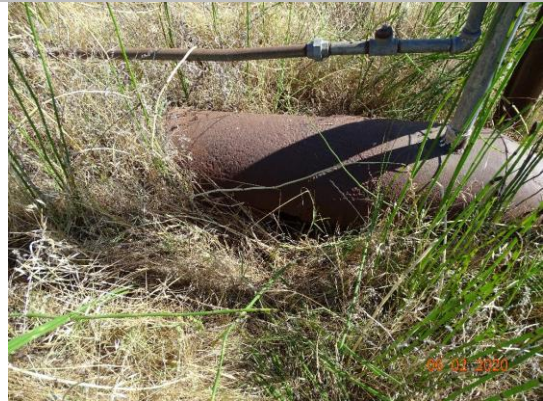
Photo 3 of 3 : UCIP_SP_2022_60086_87358.jpg

Land-Side: 1-inch filler line through levee connected to the pipe

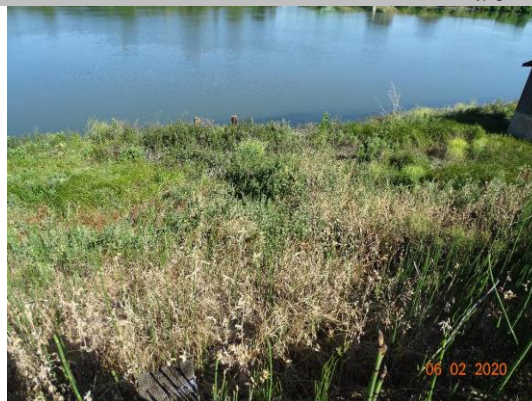
Photo 2 of 3 : UCIP_SP_2022_60092_87361.jpg

FS_ID:60092
DS_ID:21987
EP_NO: 793A
Repair Type: Non-Urgent
Crossing Status: Found
UCIP Comments: 06/02/2020 Record updated from No Action Needed to Non-Urgent. Pump and screen filters installed on landside, capped old 12-inch pipe on landside slope next to the standpipe. Unable to find a permit authorizing modifications to this crossing. Two abandoned concrete standpipes on the landside slope and at the toe, abandoned pump piles at riverbank. Minor runoff erosion on waterside shoulder in pipe alignment. Pipe debris at riverbank. (O.Yakimov - DWR UCIP)
FIELD_STRUCT_DESC: 8-inch steel irrigation pipe sleeved through a 12-inch pipe with annular space grouted 7.8 feet below the crown. Pump and pressure booster at the landside (LS) toe with switch panel and power pole. (12-inch pipe authorized under Permit No. 793, 1939 - Margaret H. Smith Estate). (Sleeving 8-inch pipe through existing 10-inch pipe and grouting annular space authorized under Permit No. 793A, 1974 - George W.G. Smith). [Additional Reference(s): DWR Levee Log, 2005 (HLM 0.90). USACE Sacramento O&M Manual, Unit 111, May 1959, Revised 29 December 2016, (RM 33.90), listed as 12-inch pipe].

Water-Side: View of levee slope looking from crown

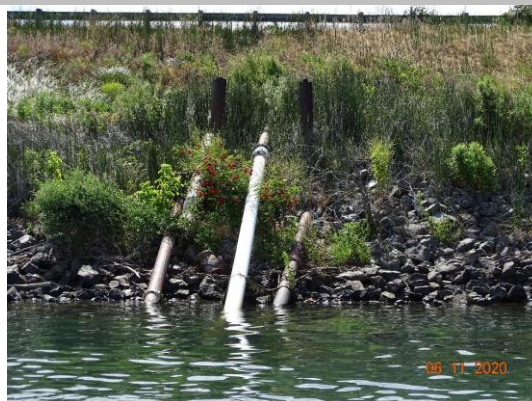
Photo 3 of 3 : UCIP_SP_2022_60092_87363.jpg

Water-Side: Pipe intake and pipe debris around. View from river

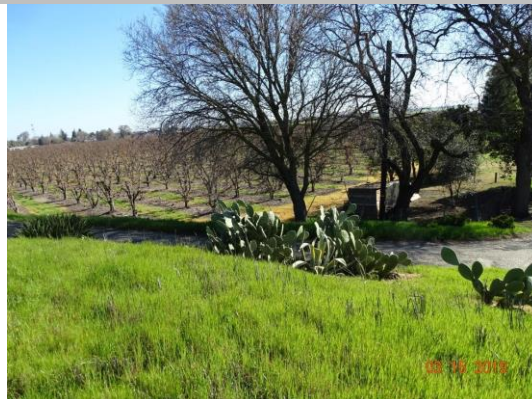
Photo 1 of 1 : SP_2022_RD0551_175_63_20220307_00027.jpg

LM Start	1.28	Rating **	M	Issue No.	63
LM End	1.28	Issue Type +	En	Location *	LS
Category	Earthen Levee			GPS Latitude/Longitude	
				Start	End
Item	Vegetation			38.320707 °	38.320707 °
				-121.576335 °	-121.576335 °
DWR ID	DWR_RD0551_01_s_2019_63				
Comment Code					
V6 : Landscaping					
Inspector Comment					
Cactus is located on landside slope.

View of cactus at the bottom of the landside slope (Spring 2019).

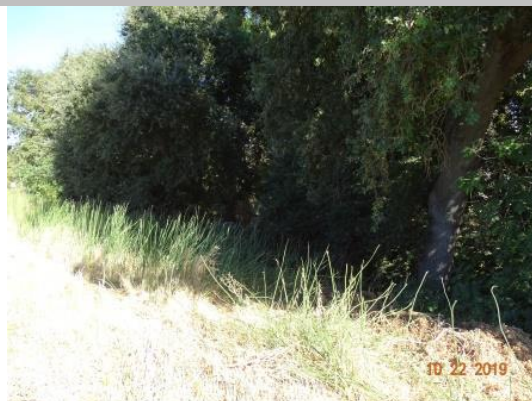
Photo 1 of 1 : SP_2022_RD0551_175_46_20220307_00012.jpg

View looking upstream at landscaping on the landside slope (Fall 2019).

LM Start	1.36	Rating **	U	Issue No.	46
LM End	1.36	Issue Type +	En	Location *	LS
Category	Earthen Levee			GPS Latitude/Longitude	
				Start	End
Item	Vegetation			38.319621 °	38.319621 °
				-121.576531 °	-121.576531 °
DWR ID	DWR_RD0551_01_f_2017_46				
Comment Code					
V6 : Landscaping					
Inspector Comment					
Landscaping should be maintained to allow inspection and access to landside slope and toe.

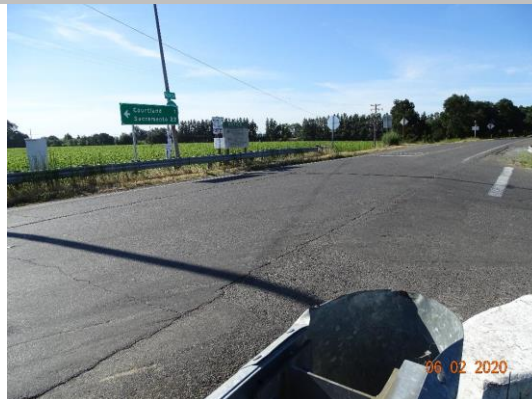
Photo 1 of 3 : UCIP_SP_2022_60099_87395.jpg

LM Start	1.43	Rating **	M	Issue No.	12	
LM End	1.43	Issue Type +	En	Location *		
Category	Supplemental			GPS Latitude/Longitude		
				Start		End
Item	DWR UCIP Field Study			38.318582 °	38.318582 °	
				-121.576498 °	-121.576498 °	
DWR ID	22972					
Comment Code						
Inspector Comment						
FS_ID:60099 DS_ID:22972 EP_NO: N/A Repair Type: Non-Urgent Crossing Status: Found UCIP Comments: 06/02/2020 Record updated from No Action Needed to Non-Urgent. No permit has been found authorizing this crossing through the levee. Conduit seems to cross intersection diagonally. (O.Yakimov - DWR UCIP) FIELD_STRUCT_DESC: 3-inch polyvinyl chloride (PVC) electrical conduit through the levee, 5 feet below the crown. Joint pole (JP) on the landside (LS) toe with a utility box on the LS shoulder. 2.5-inch steel conduit visible under bridge. FS Date: 6/2/2020 2:30:34 PM

Top of Levee: View of intersection where conduit crossing levee

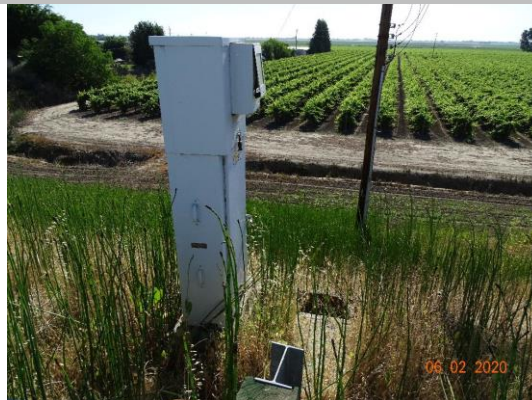
Photo 2 of 3 : UCIP_SP_2022_60099_87396.jpg

Land-Side: Service box and underground christy box on levee shoulder. Junction pole at the toe

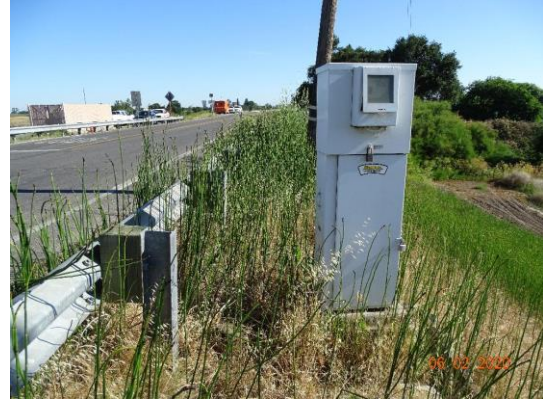
Photo 3 of 3 : UCIP_SP_2022_60099_87397.jpg

Land-Side: View of levee shoulder at the crossing

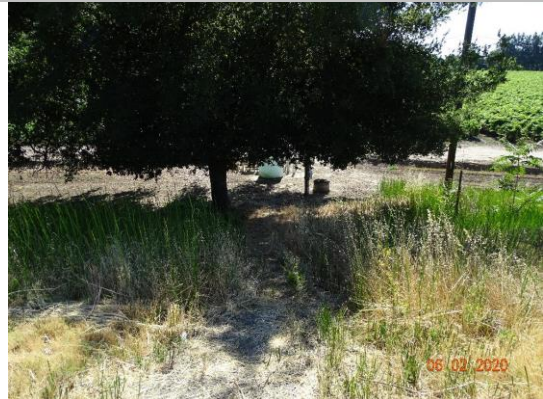
Photo 2 of 3 : UCIP_SP_2022_60100_87401.jpg

FS_ID:60100
DS_ID:21988
EP_NO: 11148
Repair Type: Non-Urgent
Crossing Status: Found
UCIP Comments: 06/02/2020 Record updated from No Action Needed to Non-Urgent. No permit has been identified authorizing pipe. Need to have CVFPB review ABO and determine current owner. No permit found authorizing sleeving 6-inch pipe through 10-inch pipe. Pump is running - minor leaks through pump sealing. (O.Yakimov - DWR UCIP)
FIELD_STRUCT_DESC: 6-inch steel irrigation pipe sleeved through a 10-inch pipe, 6.8 feet below the crown. Pump in pump house on the waterside (WS) slope. Service pole on the landside (LS) slope. Filtration system installed on the LS toe. (10-inch pipe [HLM 1.51] authorized under Automatic Board Order (ABO) issued as Permit No. 11148, 1975 - M.C.C. Van Loben Sells). [Additional Reference(s): DWR Levee Log, 2005 (HLM 1.51). USACE Sacramento O&M Manual, Unit 111, May 1959, Revised 29 December 2016, (RM 33.29), listed as 10-inch pipe. USACE As-Built Drawing No. 06-13-1100, Sheet 12, near 'L' 1370+00, January 1933, listed as 10-inch pipe].

Land-Side: View of levee slope looking from crown

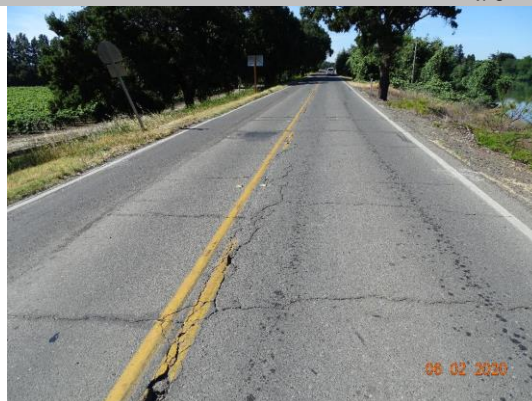
Photo 1 of 3 : UCIP_SP_2022_60128_87408.jpg

Comment Code						
Inspector Comment						
FS_ID:60128 DS_ID:22007 EP_NO: 16640 Repair Type: Non-Urgent Crossing Status: Found UCIP Comments: 06/02/2020 Record updated from No Action Needed to Non-Urgent. Unable to locate a permit authorizing to sleeve 10-inch pipe through 12-inch pipe. (O.Yakimov - DWR UCIP) FIELD_STRUCT_DESC: 10-inch coated steel irrigation pipe sleeved through a 12-inch pipe, 2 feet below the crown. Pump in pump house on the waterside (WS). Pipe discharges into a 6-foot by 10-foot concrete distribution box on the landside (LS) slope. (12-inch pipe authorized under Permit No. 16640, 1996 - Carel D. Van Loben Sels). FS Date: 6/2/2020 9:21:00 AM

Top of Levee: View of levee crown looking downstream

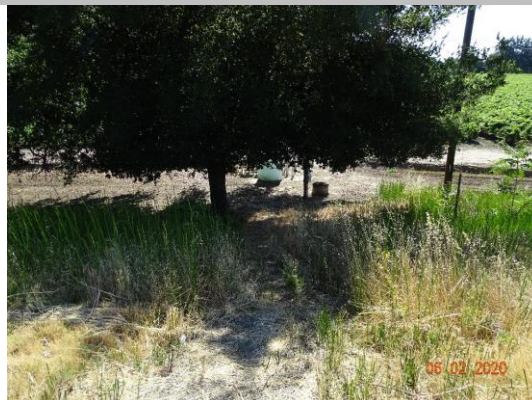
Photo 2 of 3 : UCIP_SP_2022_60128_87410.jpg

Land-Side: View of levee slope looking from crown

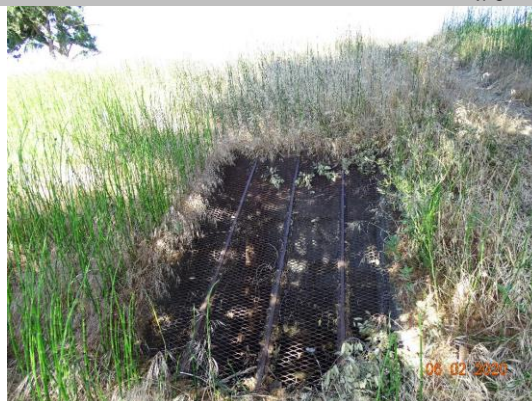
Photo 3 of 3 : UCIP_SP_2022_60128_87411.jpg

Land-Side: Concrete distribution box at levee toe covered with metal grate

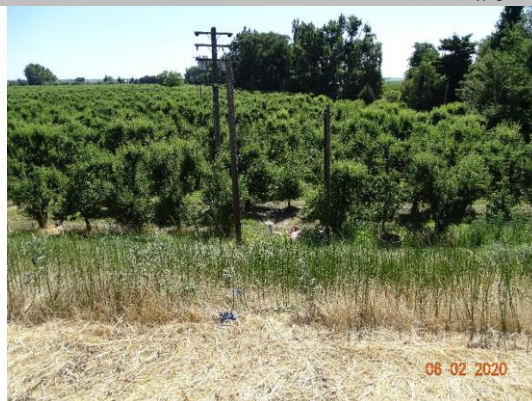
Photo 2 of 3 : UCIP_SP_2022_60145_87425.jpg

Land-Side: View of levee slope looking from crown

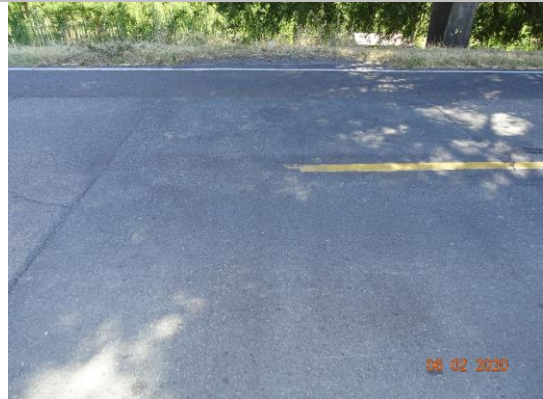
Photo 1 of 3 : UCIP_SP_2022_60156_87427.jpg

Top of Levee: View of levee crown looking towards landside. Cut in road pavement visible

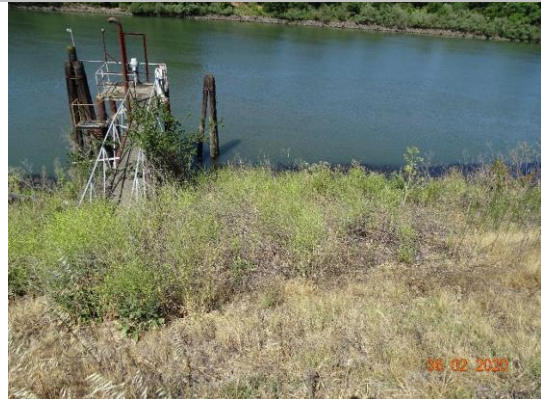
Photo 3 of 3 : UCIP_SP_2022_60156_87429.jpg

Water-Side: View of levee slope looking from crown

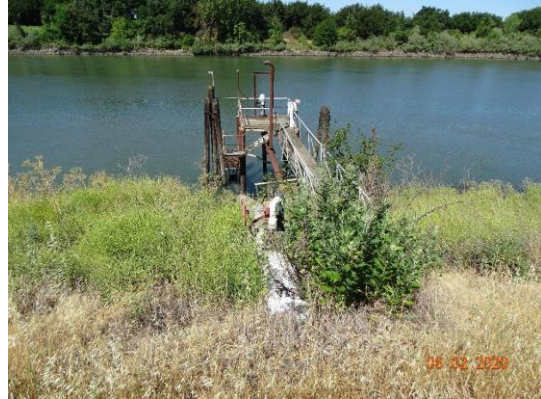
Photo 2 of 3 : UCIP_SP_2022_60178_87495.jpg

Water-Side: View of levee slope looking from crown

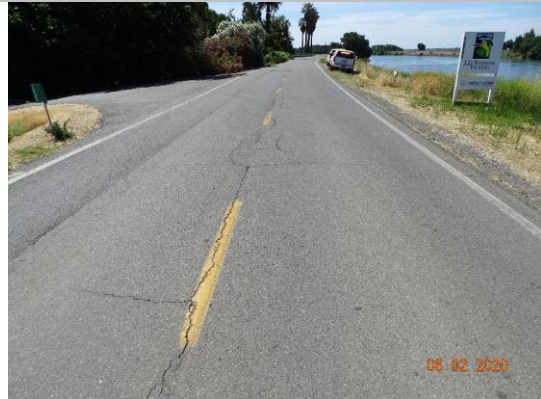
Photo 1 of 3 : UCIP_SP_2022_60214_87501.jpg

Top of Levee: View of levee crown looking downstream

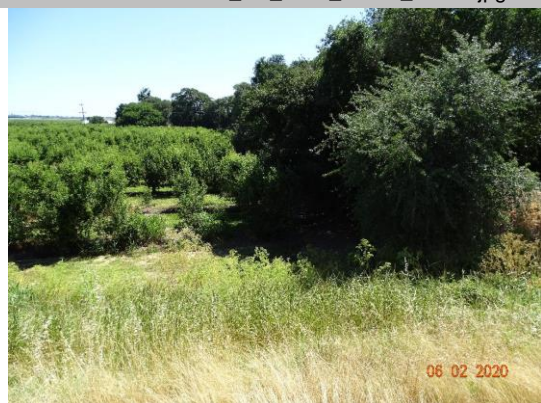
Photo 2 of 3 : UCIP_SP_2022_60214_87502.jpg

Land-Side: View of levee slope looking from crown

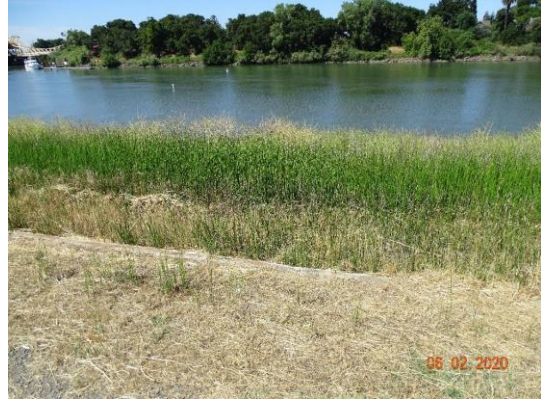
Photo 3 of 3 : UCIP_SP_2022_60214_87503.jpg

Water-Side: View of levee slope looking from crown

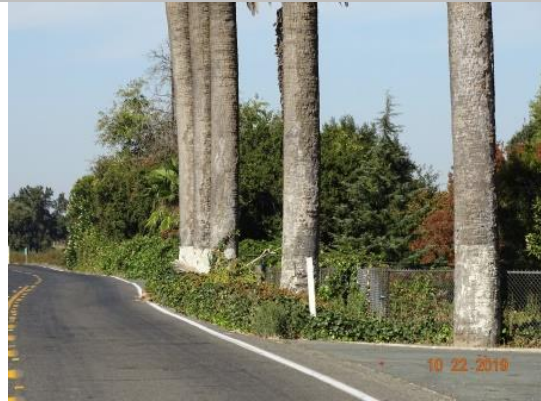
Photo 1 of 1 : SP_2022_RD0551_175_47_20220307_00013.jpg

LM Start	2.25	Rating **	U	Issue No.	47
LM End	2.35	Issue Type +	En	Location *	LS
Category	Earthen Levee			GPS Latitude/Longitude	
				Start	End
Item	Vegetation			38.307283 °	38.306025 °
				-121.573182 °	-121.572387 °
DWR ID	DWR_RD0551_01_f_2017_47				
Comment Code					
V6 : Landscaping					
Inspector Comment					
Landscaping hides levee slope. Toe is mostly visible. Landscaping should be maintained to allow inspection and access to landside slope and toe.

View looking upstream at landscaping on the landside slope (Fall 2019).

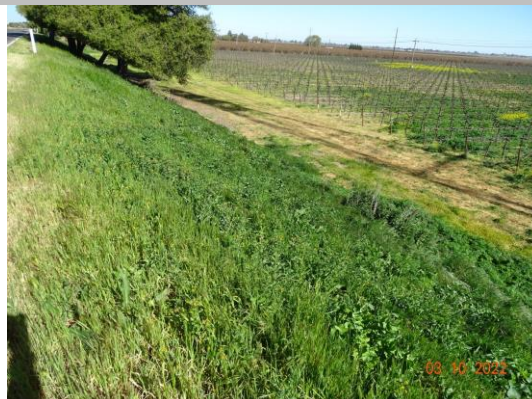
Photo 1 of 1 : SP_2022_RD0551_175_99_20220311_00185.jpg

LM Start	2.37	Rating **	M	Issue No.	99
LM End	3.39	Issue Type +	Ma	Location *	LS
Category	Earthen Levee			GPS Latitude/Longitude	
				Start	End
Item	Vegetation			38.305807 °	38.293317 °
				-121.572278 °	-121.562110 °
DWR ID	DWR_RD0551_01_s_2022_99				
Comment Code					
V1 : Control annual grass and weeds on the levee slopes and easements.					
Inspector Comment

View looking upstream at annual vegetation on the landside slope (Spring 2022).

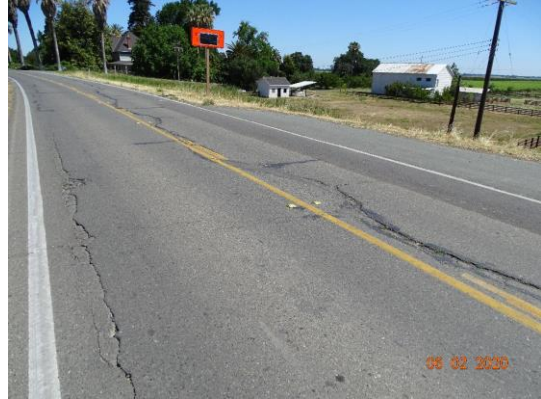
Photo 2 of 3 : UCIP_SP_2022_60216_87506.jpg

FS_ID:60216
DS_ID:21993
EP_NO: 1248
Repair Type: Non-Urgent
Crossing Status: Indicator Found
UCIP Comments: 06/02/2020 Record updated from No Action Needed to Non-Urgent. Crossing appears abandoned. Unable to locate a permit and confirm proper pipe abandonment. (O.Yakimov - DWR UCIP)

FIELD_STRUCT_DESC: 10-inch irrigation pipe of an unknown material through the levee, 5 feet below the crown. Concrete plug on the waterside (WS) end. Concrete headwall, electrical connection box, concrete abutment on WS slope. Steel pile pumping platform remains at the WS toe. No pump or other appurtenances found. (12-inch pipe authorized under Permit No. 1248, 1947 - Estate of Laura R. Dorsey). [Additional Reference(s): DWR Levee Log, 2005 (HLM 2.42). USACE As-Built Drawing No. 50-04-2983, Sheet 9, STA 1+45, March 1954, listed as 8-inch pipe].
FS Date: 6/2/2020 8:36:51 AM

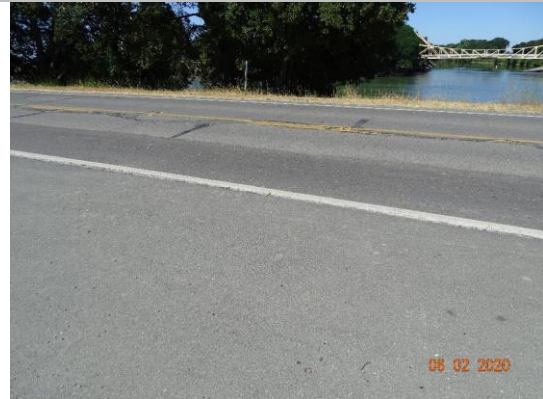
Photo 1 of 3 : UCIP_SP_2022_60233_87514.jpg

Comment Code					
Inspector Comment					
FS_ID:60233 DS_ID:21994 EP_NO: 11141 Repair Type: Non-Urgent Crossing Status: Found UCIP Comments: 06/02/2020 Record remains Non-Urgent. Field measured pipe through the levee to be 11-inch in diameter. 8-inch pipe sleeved through 11-inch pipe. Annular space between pipes seems to be grouted. Concrete standpipe at landside levee toe has been removed. Unable to locate a permit for modifications. No permit has been identified authorizing original pipe. Need to have CVFPB review ABO and determine current owner. (O.Yakimov - DWR UCIP) 04/10/2013 Records indicate this pipe was abandoned, but it appears to be active. Verify status. (W.Wylie - DWR UCIP) FIELD_STRUCT_DESC: 8-inch steel irrigation pipe sleeved through 11-inch pipe through the levee, 8 feet below the crown. Slant pump on the waterside (WS) slope. Service pole on the landside (LS) slope with a 1.5-inch galvanized iron electrical conduit through the levee at the same location. This crossing replaces 12-inch pipe (see DSID 25637). (12-inch pipe authorized under Permit No. 747, 1938 - Runyon And Stephenson). (12-inch pipe [HLM 2.32] authorized under Automatic Board Order (ABO) issued as Permit No. 1975, 1975 - Adele Runyon, Et Al). [Additional Reference(s): DWR Levee Log, 2005 (HLM 2.42), listed as 12-inch pipe. USACE Sacramento O&M Manual, Unit 111, May 1959, Revised 29 December 2016, (RM 32.38), listed as 12-inch pipe. USACE As-Built Drawing No. 06-13-1100, Sheet 13, 'L' 1422+78, January 1933, listed as 12-inch pipe. USACE As-Built Drawing No. 50-04-2983, Sheet 9, STA 1+50, March 1954]. FS Date: 6/2/2020 9:53:01 AM

Top of Levee: View of levee crown looking towards waterside

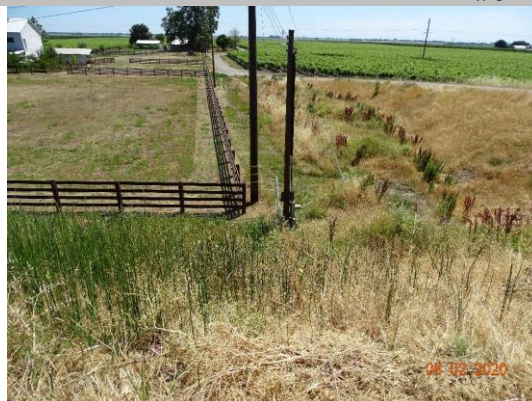
Photo 2 of 3 : UCIP_SP_2022_60233_87513.jpg

Land-Side: View of levee slope looking from crown

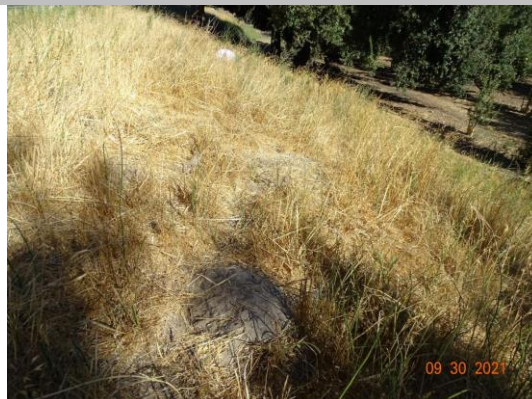
Photo 1 of 1 : SP_2022_RD0551_175_88_20220307_00031.jpg

LM Start	2.62	Rating **	M	Issue No.	88
LM End	2.62	Issue Type +	Ma	Location *	LS
Category	Earthen Levee			GPS Latitude/Longitude	
				Start	End
Item	Animal Control			38.302511 °	38.302511 °
				-121.570354 °	-121.570354 °
DWR ID	DWR_RD0551_01_f_2021_88				
Comment Code					
A1 : Exterminate rodents and backfill and compact or grout burrows.					
Inspector Comment

View looking multiple animal holes in the landside slope (Fall 2021).

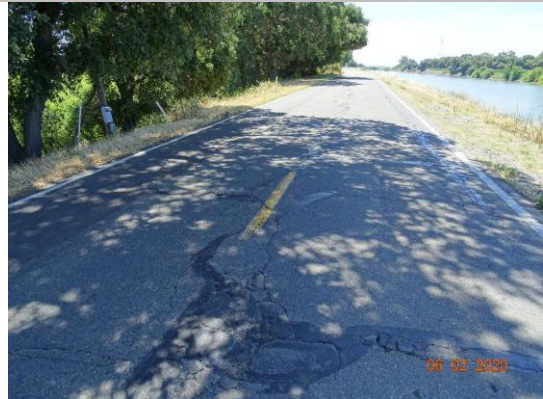
Photo 1 of 3 : UCIP_SP_2022_60293_87552.jpg

Comment Code					
Inspector Comment					
FS_ID:60293 DS_ID:22032 EP_NO: 1204 Repair Type: Non-Urgent Crossing Status: Found UCIP Comments: 06/02/2020 Record remains Non-Urgent. Unable to locate a permit authorizing to sleeve 10-inch pipe through 12-inch pipe. Wet spot on the ground observed at concrete standpipe. (O.Yakimov - DWR UCIP) 04/10/2013 Gap between sleeved pipes does not appear to be grouted on LS slope. (W.Wylie - DWR UCIP) FIELD_STRUCT_DESC: 12-inch steel irrigation conduit through the levee, 6 feet below the crown. 10-inch irrigation pipe sleeved through the 12-inch conduit. Pump on pile structure on the waterside (WS) toe. 48-inch concrete riser on the landside (LS) toe. (12-inch pipe authorized under Permit No. 1204, 1947 - M. J. Barry Estate). [Additional Reference(s): USACE Sacramento O&M Manual, Unit 111, May 1959, Revised 29 December 2016, (RM 31.82), listed as 12-inch pipe]. USACE As-Built Drawing No. 06-13-1100, Sheet 13, upstream of 'L' 1460+20, January 1933. USACE As-Built Drawing No. 50-04-2983, Sheet 8, STA 30+80, March 1954]. FS Date: 6/2/2020 1:26:54 PM

Top of Levee: View of levee crown looking downstream

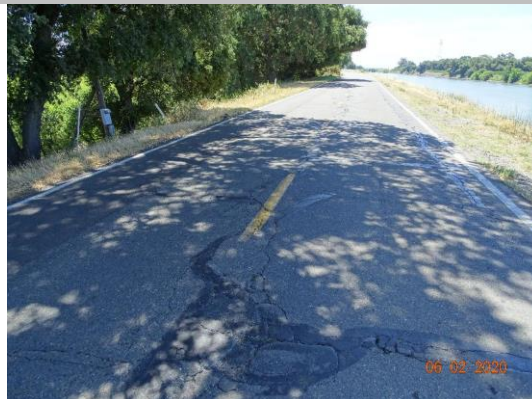
Photo 1 of 3 : UCIP_SP_2022_60300_87565.jpg

LM Start	2.96	Rating **	M	Issue No.	30
LM End	2.96	Issue Type +	En	Location *	
Category	Supplemental			GPS Latitude/Longitude	
				Start	End
Item	DWR UCIP Field Study			38.298311 °	38.298311 °
				-121.566950 °	-121.566950 °
DWR ID	22042				
Comment Code					
Inspector Comment					
FS_ID:60300 DS_ID:22042 EP_NO: N/A Repair Type: Non-Urgent Crossing Status: Found UCIP Comments: 06/02/2020 Record updated from No Action Needed to Non-Urgent. No permit has been found authorizing this pipe through the levee. (O.Yakimov - DWR UCIP) FIELD_STRUCT_DESC: 1.5-inch steel electrical conduit through the levee, 3 feet below the crown. Service pole, connection box, and electric meter at landside toe. Provides power to a pump on pile structure in river channel. On waterside attached to the walkway. FS Date: 6/2/2020 3:24:24 PM

Top of Levee: View of levee crown looking downstream

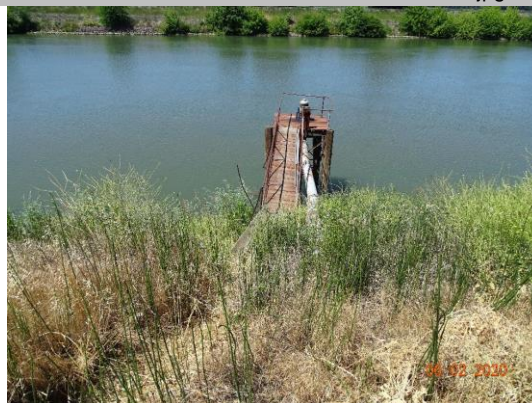
Photo 2 of 3 : UCIP_SP_2022_60300_87566.jpg

Water-Side: View of levee slope looking from crown

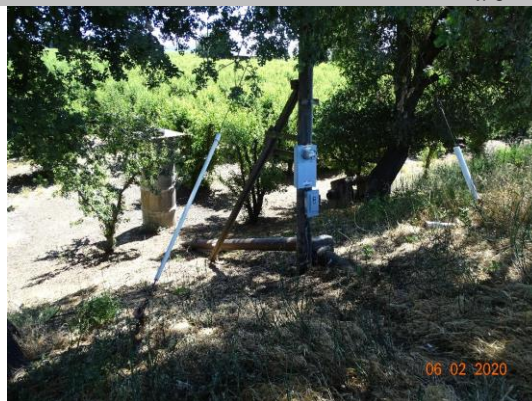
Photo 3 of 3 : UCIP_SP_2022_60300_87567.jpg

Land-Side: View of levee slope looking from crown

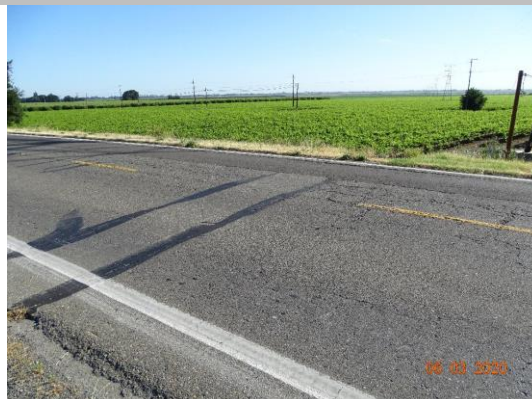
Photo 1 of 3 : UCIP_SP_2022_60354_87569.jpg

Comment Code						
Inspector Comment						
FS_ID:60354 DS_ID:22041 EP_NO: N/A Repair Type: Non-Urgent Crossing Status: Found UCIP Comments: 06/03/2020 Record updated from No Action Needed to Non-Urgent. Damaged CMP riser on landside slope missing cover - safety issue. Pump on waterside slope is removed and replaced with submersible pump. Unable to find a permit for modification. No permit has been identified authorizing pipe through levee. (O.Yakimov - DWR UCIP)						
FIELD_STRUCT_DESC: 12-inch steel irrigation pipe through the levee, 6 feet below the crown. Pipe measures 10 inches in diameter at the slopes of the levee. Metal steps to pump on concrete pad on the waterside (WS). Vent in a 36-inch corrugated metal pipe (CMP) riser on the landside (LS) shoulder. 1-inch electrical conduit at the same location with an electrical panel on a pole at the LS toe. [Additional Reference(s): USACE Sacramento O&M Manual, Unit 111, May 1959, Revised 29 December 2016, (RM 31.38), listed as 12-inch pipe. USACE As-Built Drawing No. 06-13-1100, Sheet 13, upstream of 'L' 1482+00, January 1933]. FS Date: 6/3/2020 11:25:42 AM

Top of Levee: View of levee crown looking towards landside. Cut in pavement in pipe alignment is visible

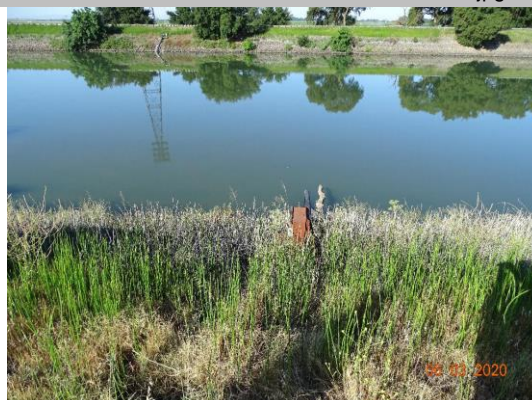
Photo 2 of 3 : UCIP_SP_2022_60354_87570.jpg

Water-Side: View of levee slope looking from crown

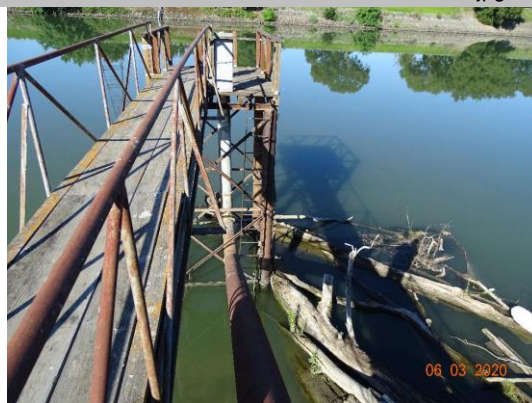
Photo 3 of 3 : UCIP_SP_2022_60363_87585.jpg

Water-Side: Pump on pile structure in the stream, walkway bridge

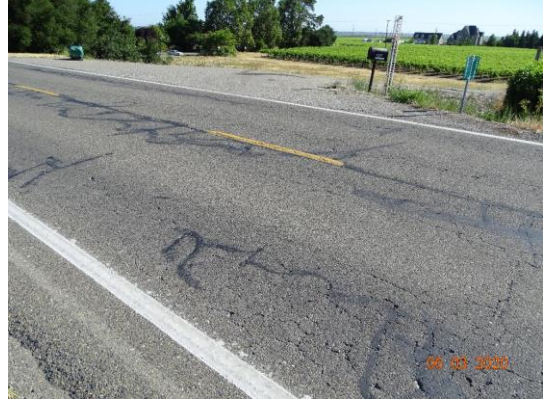
Photo 1 of 3 : UCIP_SP_2022_60380_87590.jpg

Comment Code						
Inspector Comment						
FS_ID:60380 DS_ID:22033 EP_NO: N/A Repair Type: Non-Urgent Crossing Status: Not Found UCIP Comments: 06/03/2020 Record updated from No Action Needed in place by grouting with concrete authorized under Permit No. 2276. No permit has been identified authorizing pipe installation. Pipe was abandoned in place and grouted with concrete under Permit No. 2276. (O.Yakimov - DWR UCIP) FIELD_STRUCT_DESC: 8-inch steel irrigation pipe through the levee, 6.7 feet below the crown. Pump on the waterside (WS). (Abandonment in place by grouting with concrete authorized under Permit No. 2276, 1956 - Paul V. Amick Sr.). [Additional Reference(s): USACE Sacramento O&M Manual, Unit 111, May 1959, Revised 29 December 2016, (RM 31.26), listed as 8-inch pipe. USACE As-Built Drawing No. 06-13-1100, Sheet 13, downstream of 'L' 1482+00, January 1933]. FS Date: 6/3/2020 2:29:58 PM

Top of Levee: View of levee crown looking towards landside

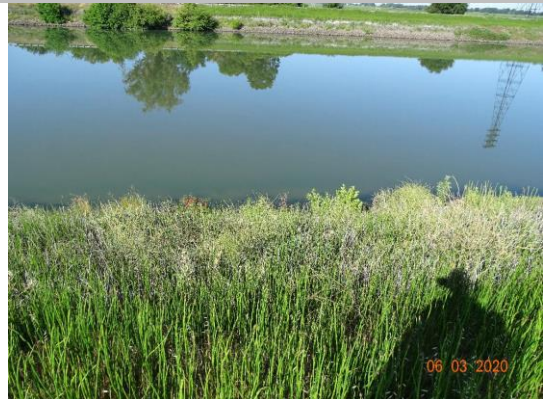
Photo 2 of 3 : UCIP_SP_2022_60380_87591.jpg

Water-Side: View of levee slope looking from crown

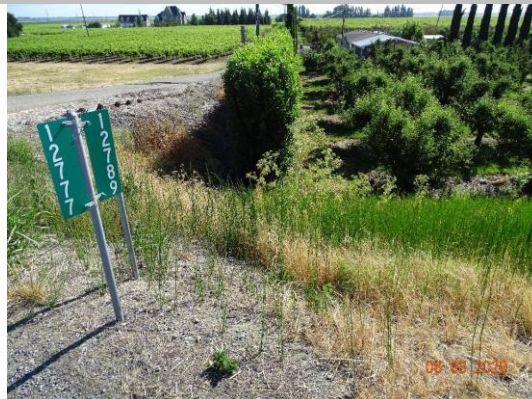
Photo 3 of 3 : UCIP_SP_2022_60380_87592.jpg

Land-Side: View of levee slope looking from crown

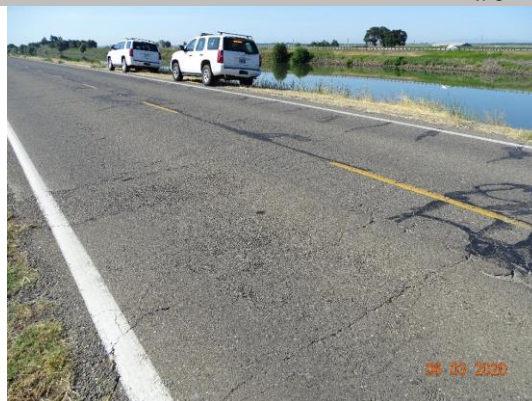
Photo 1 of 3 : UCIP_SP_2022_60384_87594.jpg

UCIP Comments: 06/03/2020 Record updated from No Action Needed to Non-Urgent. Crossing not found. No permit has been identified authorizing pipe. Need to have CVFPB review ABO and determine current owner. (O.Yakimov - DWR UCIP)

FIELD_STRUCT_DESC: 10-inch steel irrigation pipe through the levee, 3.8 feet below the crown. Thin plates tack welded on ends. (10-inch pipe [HLM 3.55] authorized under Automatic Board Order (ABO) issued as Permit No. 11153, 1975 - Wilcox Fruit Company). [Additional Reference(s): DWR Levee Log, 2005 (HLM 3.55)].
FS Date: 6/3/2020 3:23:30 PM

Top of Levee: View of levee crown looking downstream

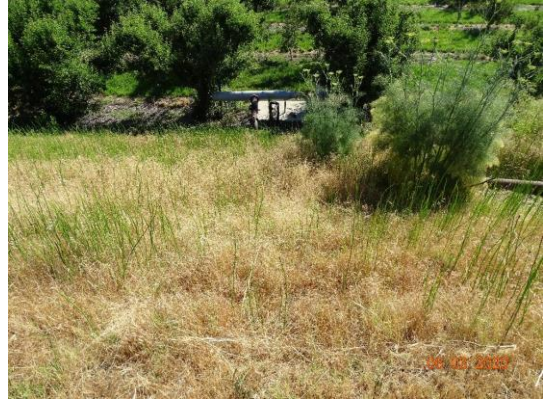
Photo 2 of 3 : UCIP_SP_2022_60384_87593.jpg

Land-Side: View of levee slope looking from crown

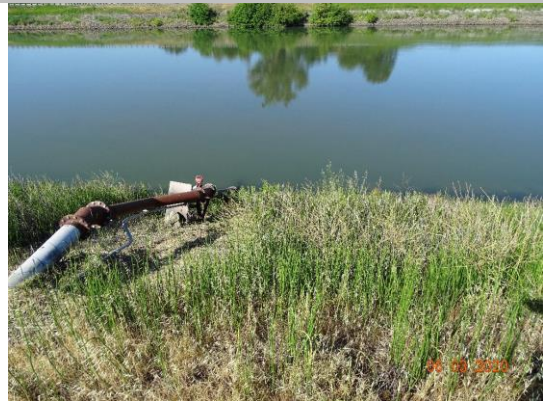
Photo 3 of 3 : UCIP_SP_2022_60384_87595.jpg

Water-Side: View of levee slope looking from crown

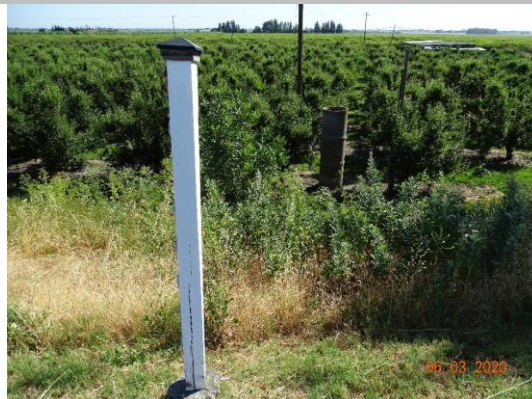
Photo 3 of 3 : UCIP_SP_2022_60391_87603.jpg

Comment Code					
Inspector Comment					
FS_ID:60391 DS_ID:22013 EP_NO: 2276 Repair Type: Non-Urgent Crossing Status: Found UCIP Comments: 06/03/2020 Record updated from No Action Needed to Non-Urgent. Unable to inspect landside levee slope due to overgrown vegetation. (O.Yakimov - DWR UCIP) FIELD_STRUCT_DESC: 12-inch pipe through levee, 5.8-feet below crown. Slant pump on waterward slope. 48-inch concrete riser on LS toe and a 1-inch galvanized steel electrical conduit at same location. (Installation of a pipe through levee authorized under Permit No. 2276, 1956 - Paul V. Amick Sr.). [Additional Reference(s): DWR Levee Log, 2005 (HLM 3.72)]. FS Date: 6/3/2020 7:49:50 AM

Land-Side: View of levee slope looking from crown

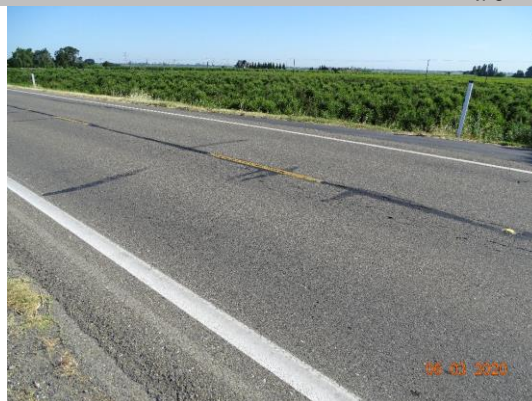
Photo 1 of 3 : UCIP_SP_2022_60439_87729.jpg

FS_ID:60439
DS_ID:22014
EP_NO: 11153
Repair Type: Non-Urgent
Crossing Status: Not Found
UCIP Comments: 06/03/2020 Record updated from No Action Needed to Non-Urgent. Crossing not found. Unauthorized encroachment recorded in Levee Log prior to 2011. Need to have CVFPB review ABO and determine current owner. (O.Yakimov - DWR UCIP)

Top of Levee: View of levee crown looking towards landside

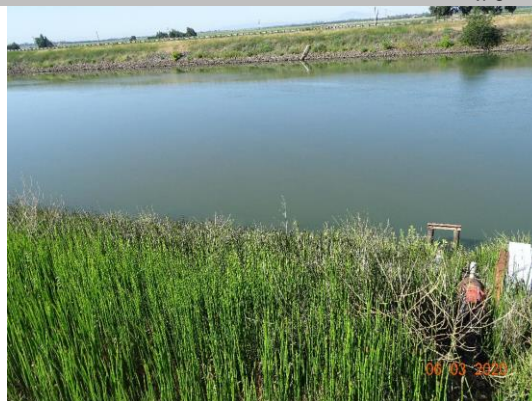
Photo 2 of 3 : UCIP_SP_2022_60439_87724.jpg

Water-Side: View of levee slope looking from crown

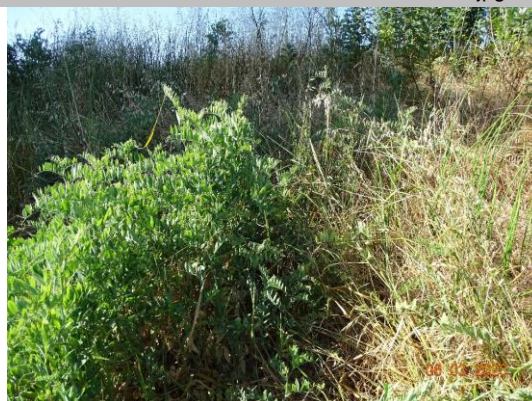
Photo 3 of 3 : UCIP_SP_2022_60439_87725.jpg

Land-Side: View of levee slope looking from crown. Overgrown vegetation prevents slope evaluation

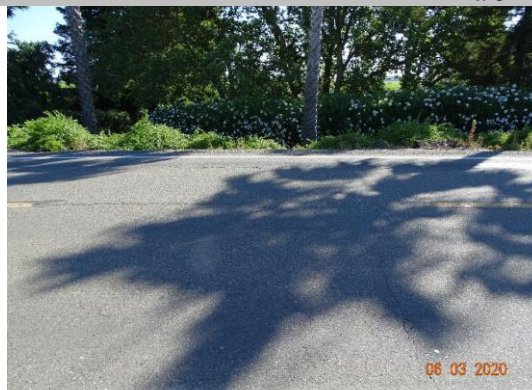
Photo 1 of 3 : UCIP_SP_2022_60441_87726.jpg

LM Start	3.72	Rating **	M	Issue No.	38	
LM End	3.72	Issue Type +	En	Location *		
Category	Supplemental			GPS Latitude/Longitude		
				Start		End
Item	DWR UCIP Field Study			38.289783 °		38.289783 °
				-121.558252 °		-121.558252 °
DWR ID	22015					
Comment Code						
Inspector Comment						
FS_ID:60441 DS_ID:22015 EP_NO: 5916 Repair Type: Non-Urgent Crossing Status: Not Found UCIP Comments: 06/03/2020 Record updated from No Action Needed to Non-Urgent. Crossing not found. (O.Yakimov - DWR UCIP)						
FIELD_STRUCT_DESC: 2-inch pipe of an unknown material or purpose through the levee, 3 feet below the crown. Landside (LS) end capped. (1-inch pipe (STA 120+50) authorized under Permit No. 5916, 1967 - Wilcox Fruit Company). [Additional Reference(s): DWR Levee Log, 2005 (HLM 3.75)]. FS Date: 6/3/2020 1:54:41 PM

Top of Levee: View of levee crown looking towards landside

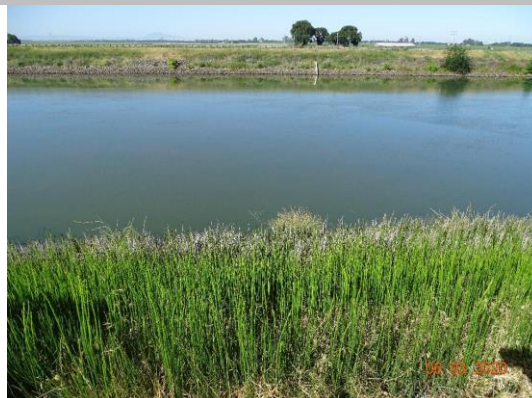
Photo 2 of 3 : UCIP_SP_2022_60441_87727.jpg

Water-Side: View of levee slope looking from crown

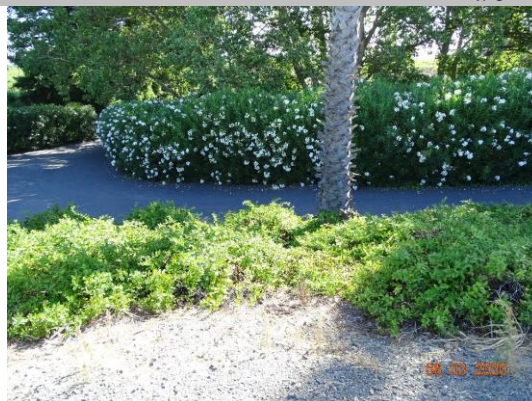
Photo 3 of 3 : UCIP_SP_2022_60441_87728.jpg

Land-Side: View of levee slope looking from crown

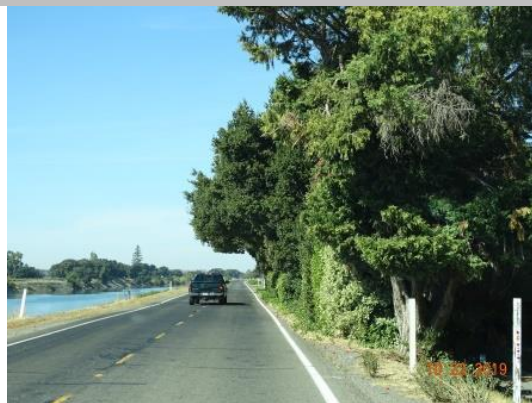
Photo 1 of 1 : SP_2022_RD0551_175_48_20220307_00014.jpg

LM Start	3.78	Rating **	U	Issue No.	48
LM End	3.85	Issue Type +	En	Location *	LS
Category	Earthen Levee			GPS Latitude/Longitude	
				Start	End
Item	Vegetation			38.289067 °	38.288394 °
				-121.557423 °	-121.556591 °
DWR ID	DWR_RD0551_01_f_2017_48				
Comment Code					
V6 : Landscaping					
Inspector Comment					
Landscaping should be maintained to allow inspection and access to landside slope and toe.

View looking upstream at landscaping on the landside slope (Fall 2019).

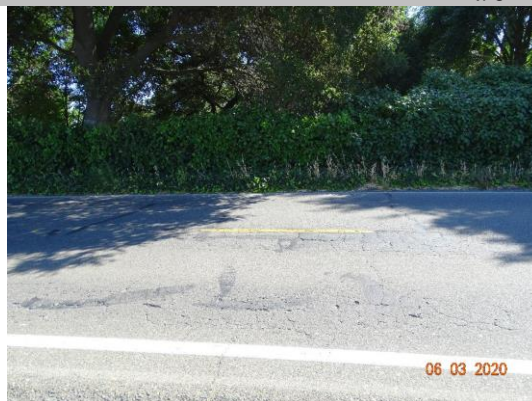
Photo 1 of 3 : UCIP_SP_2022_60444_87731.jpg

Comment Code					
Inspector Comment					
FS_ID:60444 DS_ID:22016 EP_NO: 11133 Repair Type: Non-Urgent Crossing Status: Found UCIP Comments: 06/03/2020 Record updated from No Action Needed to Non-Urgent. Crossing appears abandoned. 2-inch PVC pipe is connected to the pipe through the levee, pipe is open on waterside slope. Disconnected cable is coming out of PVC pipe. Unauthorized encroachment recorded in Levee Log prior to 2011. Need to have CVFPB review ABO and determine current owner. (O.Yakimov - DWR UCIP) FIELD_STRUCT_DESC: 2-inch galvanized steel pipe of unknown purpose through the levee, 2 feet below the crown. (2-inch pipe [HLM 3.83] authorized under Automatic Board Order (ABO) issued as Permit No. 11133, 1975 - Warren G. & Margie Mara). [Additional Reference(s): DWR Levee Log, 2005 (HLM 3.83)]. FS Date: 6/3/2020 2:00:44 PM

Top of Levee: View of levee crown looking towards landside

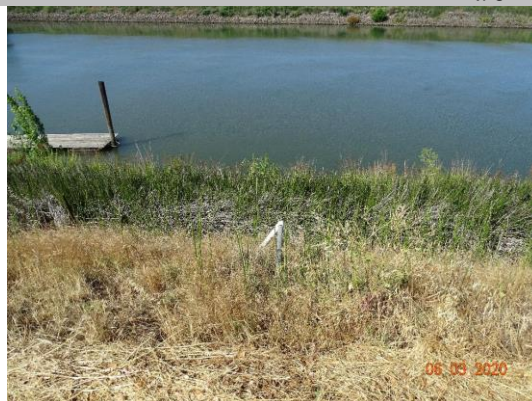
Photo 3 of 3 : UCIP_SP_2022_60444_87733.jpg

Water-Side: View of levee slope looking from crown

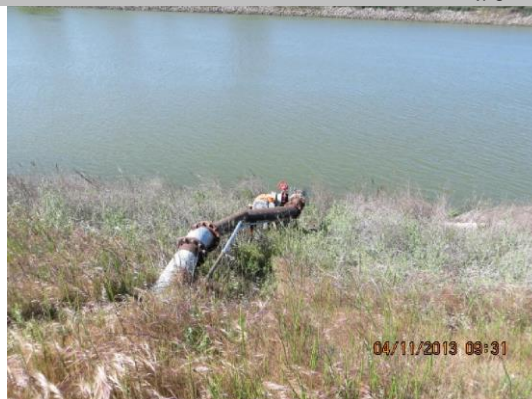
Photo 1 of 3 : UCIP_SP_2022_60445_19285.jpg

Comment Code					
Inspector Comment					
FS_ID:60445 DS_ID:22017 EP_NO: 11153 Repair Type: Non-Urgent Crossing Status: Found UCIP Comments: 06/03/2020 Record updated from No Action Needed to Non-Urgent. Unauthorized encroachment recorded in Levee Log prior to 2011. Need to have CVFPB review ABO and determine current owner. Burrow hole under pipe on landside slope. (O.Yakimov - DWR UCIP) FIELD_STRUCT_DESC: 10-inch pipe through the levee 4.0 feet below the crown. Siphon breaker on LS shoulder. Screen filter, concrete standpipe, service pole with electric meter and connection box at LS toe. 1.5-inch galvanized iron electrical conduit through the levee at same alignment. (10-inch pipe [HLM 3.93] authorized under Automatic Board Order (ABO) issued as Permit No. 11153, 1975 - Wilcox Fruit Company). [Additional Reference(s): DWR Levee Log, 2005 (HLM 3.93)]. FS Date: 6/3/2020 2:22:09 PM

Slant pump, butterfly valve, electrical conduit and pipe on WS slope.

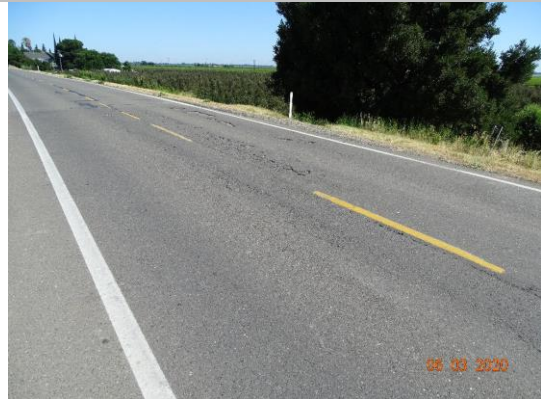
Photo 1 of 3 : UCIP_SP_2022_60450_87746.jpg

Comment Code						
Inspector Comment						
FS_ID:60450 DS_ID:22034 EP_NO: N/A Repair Type: Non-Urgent Crossing Status: Not Found UCIP Comments: 06/03/2020 Record remains Non-Urgent. Crossing not found. Metal and pipe debris on waterside slope. No pipe evidence found on landside. No permit has been identified authorizing pipe. (O.Yakimov - DWR UCIP) 04/11/2013 Abandoned. Determine if pipe was removed or abandoned in place. W.Wylie - DWR UCIP) FIELD_STRUCT_DESC: 8-inch irrigation pipe through the levee 6.7-feet below the crown. [Additional Reference(s): USACE Sacramento O&M Manual, Unit 111, May 1959, Revised 29 December 2016, (RM 30.76), listed as 8-inch pipe. USACE As-Built Drawing No. 06-13-1100, Sheet 13, downstream of 'L' 1504+00, January 1933]. FS Date: 6/3/2020

Top of Levee: View of levee crown looking upstream

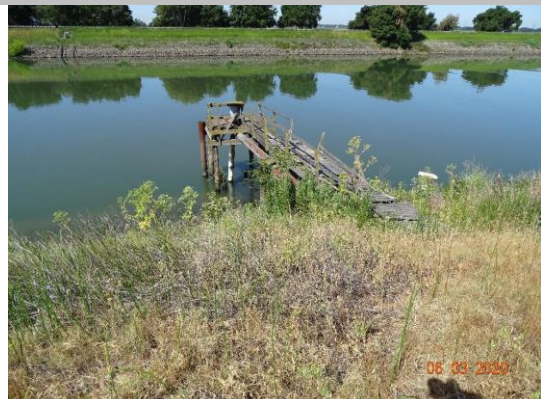
Photo 2 of 3 : UCIP_SP_2022_60450_87747.jpg

Water-Side: View of levee slope looking from crown

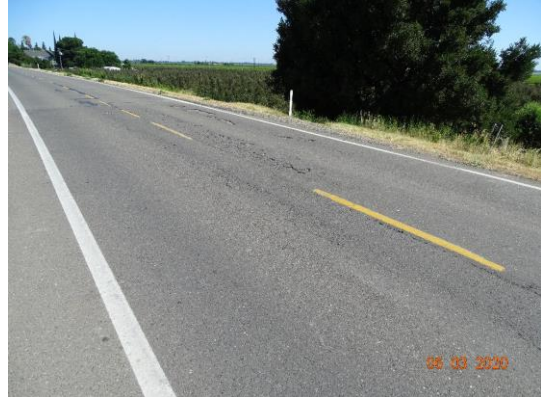
Photo 1 of 3 : UCIP_SP_2022_60460_87782.jpg

Comment Code					
Inspector Comment					
<p>FS_ID:60460 DS_ID:22018 EP_NO: 11146 Repair Type: Non-Urgent Crossing Status: Found UCIP Comments: 06/03/2020 Record remains Non-Urgent. Pipe is exposed on landside due to 7.0' x 4.5' excavation 16 feet from levee toe. Pipe is running. Water is supplied to orchard through a hose connected to a pipe at excavation. Pipe inflow from standpipe is plugged with concrete as seen on photo. Drainage from hose connection gets into open concrete pipe at excavation that goes towards the orchard. No permit has been identified authorizing pipe. Need to have CVFPB review ABO and determine current owner. (O.Yakimov - DWR UCIP) 04/11/2013 Wooden walkway in bad repair and presents a hazard to the public. (W.Wylie - DWR UCIP) FIELD_STRUCT_DESC: 14-inch irrigation pipe of an unknown material through the levee, 10.4 feet below the crown. Pump on pile structure in stream with wooden walkway. 48-inch concrete standpipe on the landside (LS) toe with booster pump and electrical panel, media filtration facility on landside. Siphon breaker in a 24-inch corrugated metal pipe (CMP) riser on the LS slope. 1.5-inch electrical conduit at the same location. (14-inch pipe [HLM 4.04] authorized under Automatic Board Order (ABO) issued as Permit No. 11146, 1975 - Edgar D. Turner III). [Additional Reference(s): DWR Levee Log, 2005 (HLM 4.04). USACE Sacramento O&M Manual, Unit 111, May 1959, Revised 29 December 2016, (RM 30.75), listed as 14-inch pipe. USACE As-Built Drawing No. 06-13-1100, Sheet 13, downstream of 'L' 1504+00, January 1933]. FS Date: 6/3/2020 3:44:18 PM</p>

Top of Levee: View of levee crown looking upstream

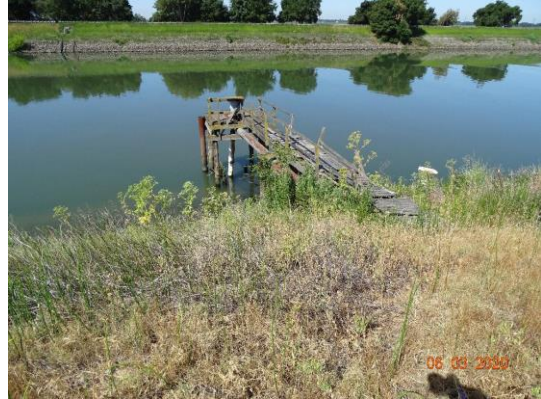
Photo 2 of 3 : UCIP_SP_2022_60460_87783.jpg

Water-Side: View of levee slope looking from crown
