**Flood Control Project Maintenance
Levee Inspections
LMA District Cover Sheet**

Reclamation District No. 0551 Pearson

**Flood Control Project Maintenance
Levee Inspections
Unit Cover Sheet**

Waterway			Bank	Unit Miles
Unit No. 01 Sacramento River			Left	6.78
	Spring (March - May)	Summer (June - August)	(September - November) Fall	Winter (December - February)
Unit Maintenance Rating (Fall Only)				
Date of Inspection	3/10/2022 - 3/10/2022			
DWR Inspector	David Julian			
Accompanied By	Topper van Loben Sels RD 551

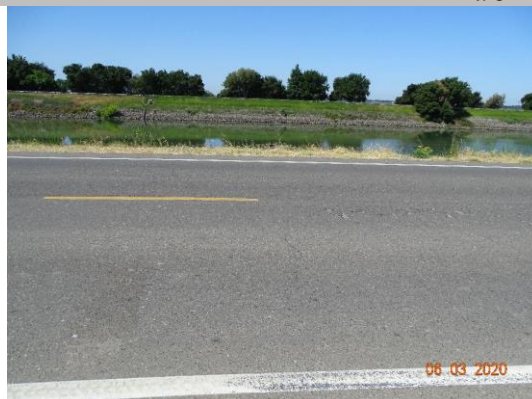
Photo 1 of 3 : UCIP_SP_2022_60557_87842.jpg

Comment Code						
Inspector Comment						
FS_ID:60557 DS_ID:22035 EP_NO: N/A Repair Type: Non-Urgent Crossing Status: Not Found UCIP Comments: 06/03/2020 Record updated from No Action Needed to Non-Urgent. Crossing not found. No permit has been identified authorizing pipe. (O.Yakimov - DWR UCIP)						
FIELD_STRUCT_DESC: 10-inch irrigation pipe of an unknown material through the levee, 7.8 feet below the crown. Pump on the waterside (WS). [Additional Reference(s): USACE Sacramento O&M Manual, Unit 111, May 1959, Revised 29 December 2016, (RM 30.75), listed as 10-inch pipe. USACE As-Built Drawing No. 06-13-1100, Sheet 13, downstream of 'L' 1504+00, January 1933]. FS Date: 6/3/2020 10:29:31 AM

Top of Levee: View of levee crown looking towards waterside

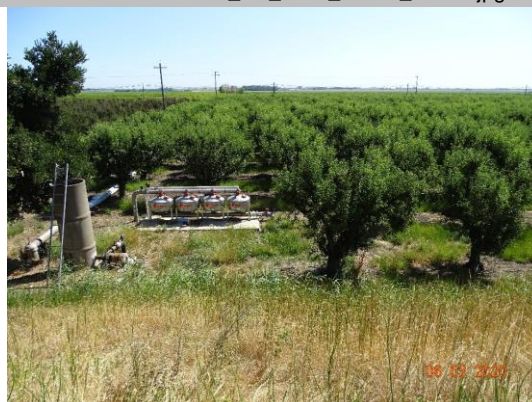
Photo 2 of 3 : UCIP_SP_2022_60557_87841.jpg

Land-Side: View of levee slope looking from crown

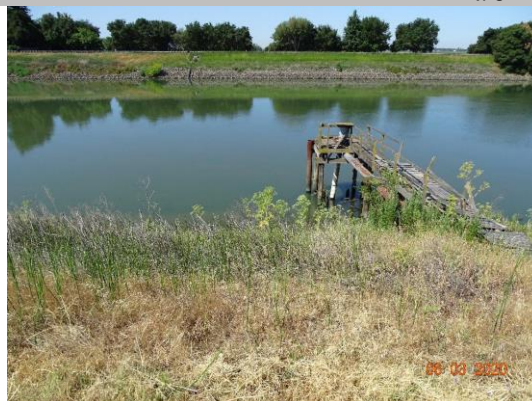
Photo 3 of 3 : UCIP_SP_2022_60557_87843.jpg

Water-Side: View of levee slope looking from crown

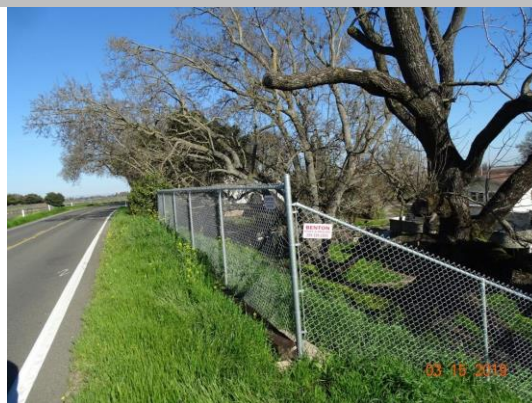
Photo 1 of 1 : SP_2022_RD0551_175_60_20220307_00024.jpg

LM Start	4.18	Rating **	M	Issue No.	60
LM End	4.23	Issue Type +	En	Location *	LS
Category	Earthen Levee			GPS Latitude/Longitude	
				Start	End
Item	Encroachments			38.284795 °	38.284318 °
				-121.552597 °	-121.551830 °
DWR ID	DWR_RD0551_01_s_2019_60				
Comment Code					
FE : Fence					
Inspector Comment					
A chainlink fence is located on landside.

View looking upstream at chainlink fence on the landside slope and shoulder (Spring 2019).

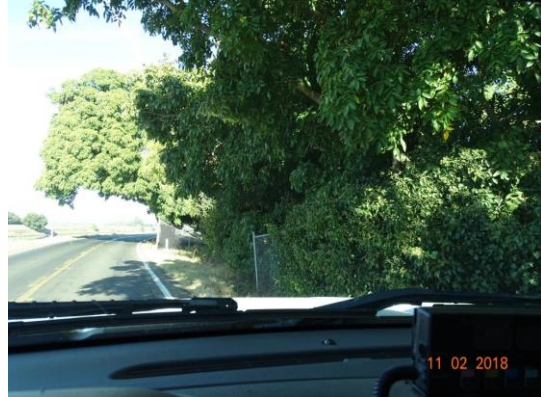
Photo 1 of 1 : SP_2022_RD0551_175_52_20220307_00017.jpg

LM Start	4.22	Rating **	U	Issue No.	52
LM End	4.22	Issue Type +	En	Location *	LS
Category	Earthen Levee			GPS Latitude/Longitude	
				Start	End
Item	Vegetation			38.284400 °	38.284400 °
				-121.552035 °	-121.552035 °
DWR ID	DWR_RD0551_01_f _ 2018_52				
Comment Code					
V6 : Landscaping					
Inspector Comment

View looking upstream at landscaping on the landside slope (November 2018).

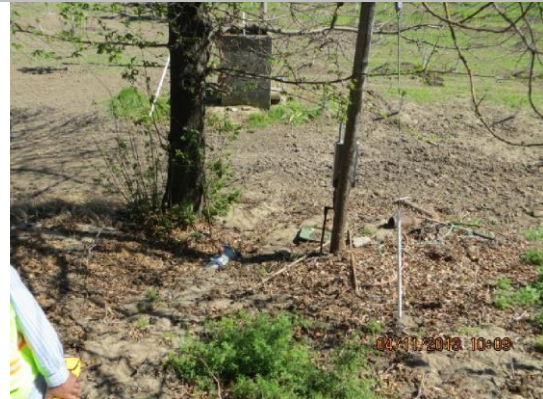
Photo 2 of 2 : UCIP_SP_2022_60558_19535.jpg

Comment Code					
Inspector Comment					
FS_ID:60558 DS_ID:22009 EP_NO: 11142 Repair Type: Non-Urgent Crossing Status: Not Found UCIP Comments: 06/03/2020 Record is Non-Urgent. Crossing not found. No permit has been identified authorizing pipe. (O.Yakimov - DWR UCIP) FIELD_STRUCT_DESC: 6-inch irrigation pipe of an unknown material through the levee, 6.5 feet below the crown. Pump on concrete pad on the waterside (WS) slope. [Additional Reference(s): USACE Sacramento O&M Manual, Unit 111, May 1959, Revised 29 December 2016, (RM 30.31), listed as 6-inch pipe. USACE As-Built Drawing No. 06-13-1100, Sheet 14, near 'L' 1530+00, January 1933]. FS Date: 6/3/2020 10:46:37 AM

Siphon breaker and vent on pipe at LS toe.

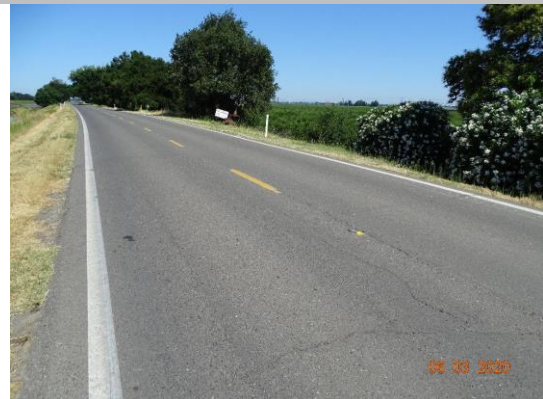
Photo 1 of 3 : UCIP_SP_2022_60578_87846.jpg

FS_ID:60578
DS_ID:22019
EP_NO: 11142
Repair Type: Non-Urgent
Crossing Status: Found
UCIP Comments: 06/03/2020 Record updated from No Action Needed to Non-Urgent. No permit has been identified authorizing original pipe. Unable to locate a permit for sleeving 6-inch pipe through 10-inch pipe. Need to have CVFPB review ABO and determine current owner. (O.Yakimov - DWR UCIP)
FIELD_STRUCT_DESC: 6-inch irrigation pipe sleeved through the 10-inch irrigation pipe of an unknown material through the levee, 6.5 feet below the crown. Pump and butterfly valve on a concrete pad on the waterside (WS) slope. Air vent on pipe at landside toe. Electrical panel, and meter on a service pole at landside toe. 1-inch galvanized steel electrical conduit at the same location. (10-inch pipe [HLM 4.49] authorized under Automatic Board Order (ABO) issued as Permit No. 11142, 1975 - Tadashi Kimiye & Saburo Hirose). [Additional Reference(s): DWR Levee Log, 2005 (HLM 4.49). USACE Sacramento O&M Manual, Unit 111, May 1959, Revised 29 December 2016, (RM 30.31), listed as 10-inch pipe. USACE As-Built Drawing No. 06-13-1100, Sheet 14, near 'L' 1530+00, January 1933].

Top of Levee: View of levee crown looking upstream

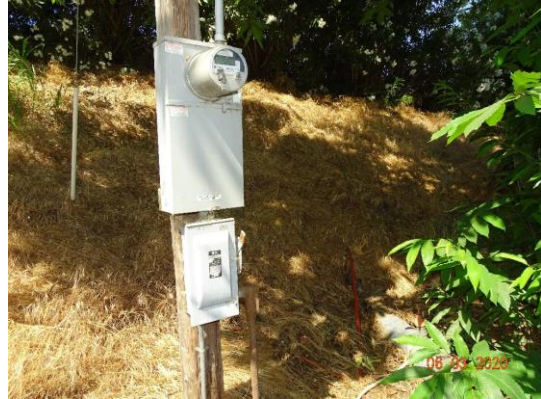
Photo 2 of 3 : UCIP_SP_2022_60578_87850.jpg

Land-Side: Service pole at levee toe

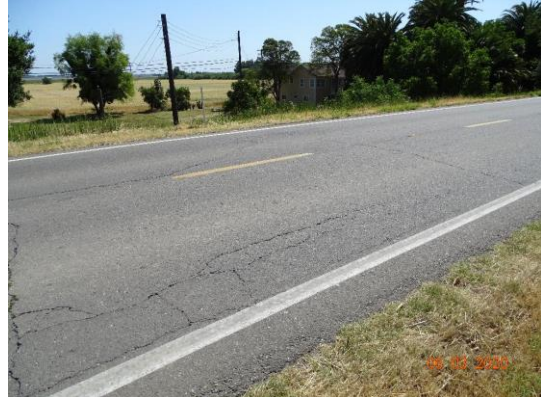
Photo 1 of 3 : UCIP_SP_2022_60620_87852.jpg

FS_ID:60620
DS_ID:22020
EP_NO: 11152
Repair Type: Urgent
Crossing Status: Found
UCIP Comments: 06/03/2020 Record updated from Non-Urgent to Urgent. Pipe is in failed condition. Pipe segment on waterside levee slope is removed. Through holes in pipe visible on waterside slope. Pump and intake pipe are removed from piled structure in the stream. 8' x 9' x 2'- deep depression on landside slope in pipe alignment. Crossing appears abandoned. (O.Yakimov - DWR UCIP)
10/24/2016 Per Mr. Topper Van Loben, LMA contact, new owner is working with DCC Engineering to obtain CVFPB permit for pipe rehabilitation. Work rehabilitation for existing pipe includes sleeving an 8-inch steel pipe through existing pipe and grouting space between pipes. Crossing has been downgraded to Non-Urgent since walkway has been repaired and pipe in the process of being rehabilitated. UCIP staff is waiting for permit authorizing pipe rehabilitation. (O. Magana - DWR UCIP) (Olivia) As of 09/21/2015 owner is working with Gilbert Labrie, LMA consultant, to resolve issue. (T. Van Loben - LMA representative / G. Labrie - LMA Engineer - DCC Engineering)As of 12/17/2013 District submitted letter to landowner explaining UCIP report details including photos of the pipe problems. (T. Van Loben - LMA representative / G. Labrie - LMA Engineer - DCC Engineering)As of 12/13/2013 the District has contacted the tenant farmer who is in the process of contacting the owner to update on condition of pipe. (T. Van Loben - LMA representative / G. Labrie - LMA Engineer - DCC Engineering) 04/11/2013 Pier for pump is falling apart and is a hazard to the public. Some settlement along pipe on LS slope. (W. Wylie - DWR UCIP)

Top of Levee: View of levee crown looking towards landside

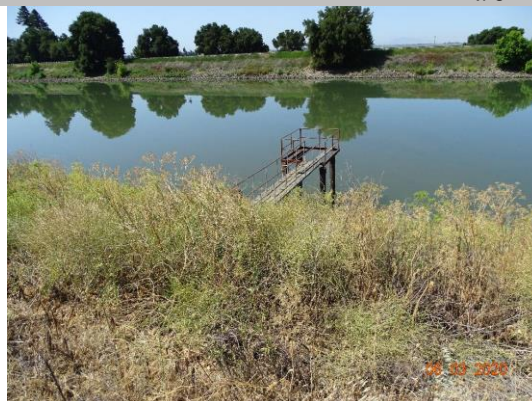
Photo 2 of 3 : UCIP_SP_2022_60620_87851.jpg

Water-Side: View of levee slope looking from crown

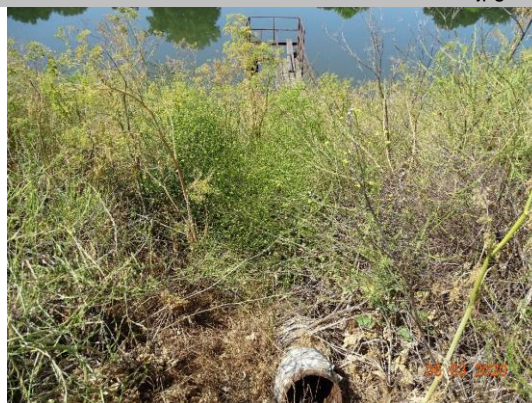
Photo 3 of 3 : UCIP_SP_2022_60620_87853.jpg

Water-Side: Pipe cut on levee slope

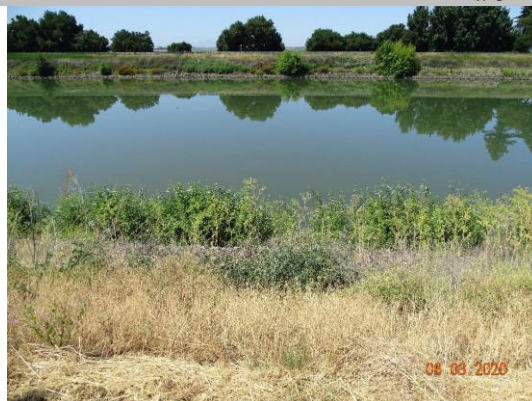
Photo 2 of 3 : UCIP_SP_2022_60621_87859.jpg

Water-Side: View of levee slope looking from crown

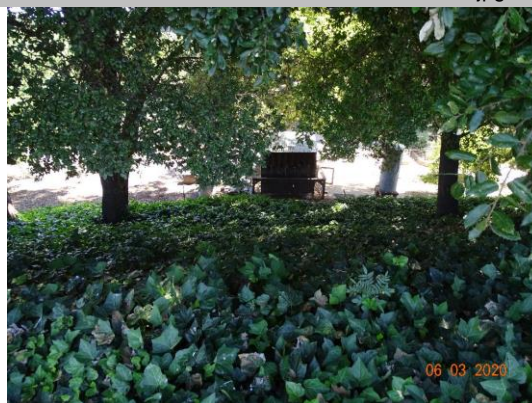
Photo 3 of 3 : UCIP_SP_2022_60621_87860.jpg

Comment Code					
Inspector Comment					
FS_ID:60621 DS_ID:22036 EP_NO: N/A Repair Type: Non-Urgent Crossing Status: Not Found UCIP Comments: 06/03/2020 Record updated from No Action Needed to Non-Urgent. Crossing not found. No permit has been identified authorizing pipe. (O.Yakimov - DWR UCIP)					
FIELD_STRUCT_DESC: 12-inch steel irrigation pipe through the levee, 4 feet below the crown. Pump and motor on a concrete slab on the waterside (WS) slope. [Additional Reference(s): USACE Sacramento O&M Manual, Unit 111, May 1959, Revised 29 December 2016, (RM 29.95), listed as 12-inch pipe. USACE As-Built Drawing No. 06-13-1100, Sheet 14, near 'L' 1543+45, January 1933. USACE As-Built Drawing No. 50-04-2983, Sheet 5, downstream of STA 125+70, March 1954]. FS Date: 6/3/2020 10:51:39 AM

Land-Side: View of levee slope looking from crown. Water well and facility at levee toe

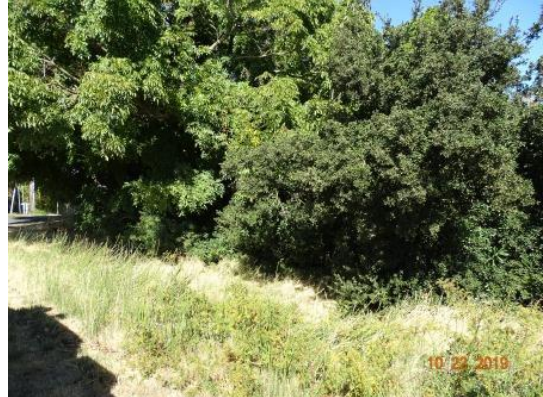
Photo 1 of 1 : SP_2022_RD0551_175_44_20220307_00011.jpg

LM Start	5.00	Rating **	U	Issue No.	44
LM End	5.00	Issue Type +	En	Location *	LS
Category	Earthen Levee			GPS Latitude/Longitude	
				Start	End
Item	Vegetation			38.276870 °	38.276870 °
				-121.541463 °	-121.541463 °
DWR ID	DWR_RD0551_01_f_2019_44				
Comment Code					
V6 : Landscaping					
Inspector Comment

View looking slightly upstream at landscaping on the landside slope (Fall 2019).

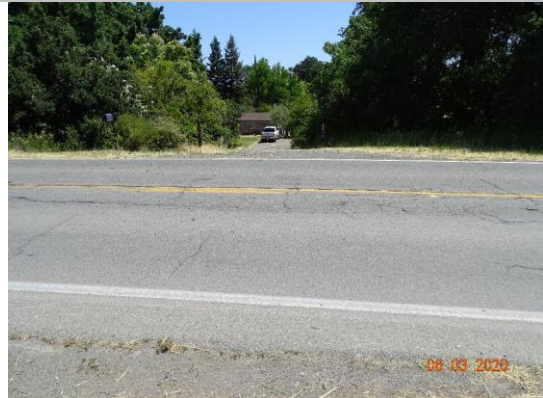
Photo 1 of 3 : UCIP_SP_2022_56199_87883.jpg

Comment Code						
Inspector Comment						
FS_ID:56199						
DS_ID:25122						
EP_NO: N/A						
Repair Type: Non-Urgent						
Crossing Status: Found						
UCIP Comments: 06/03/2020 Record is Non-Urgent. Five conduits are visible under bridge to boat launching two of which are open ended.						
Recommend capping conduits under bridge to prevent water backflow.						
(O.Yakimov - DWR UCIP)						
FIELD_STRUCT_DESC: 6-inch wrapped and soil proofed galvanized iron conduit through the levee 2-feet below the crown. Electric, water, and other utility pipes sleeved through conduit with welded steel caps and annular space grouted. (6-inch steel utility chase authorized under Permit No. 18769, 2013 - Michael & Jill Steinbacher).						
FS Date: 6/3/2020

Top of Levee: View of levee crown looking towards landside

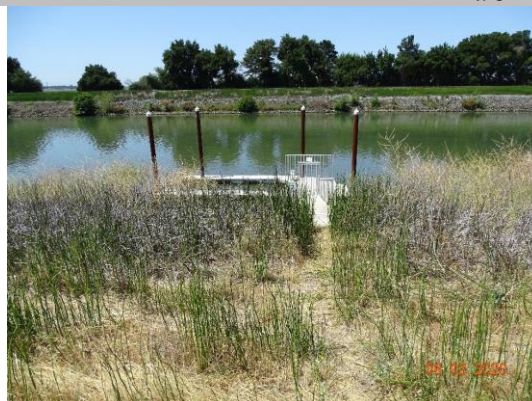
Photo 2 of 3 : UCIP_SP_2022_56199_87884.jpg

Water-Side: View of levee slope looking from crown

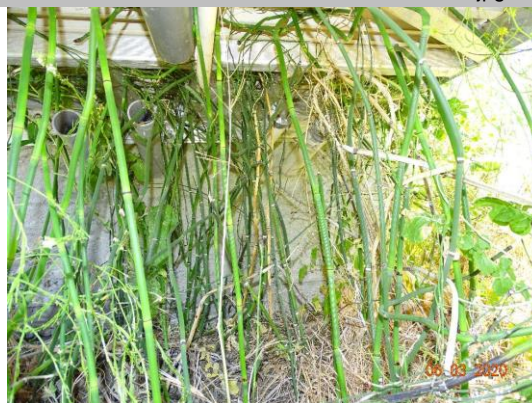
Photo 3 of 3 : UCIP_SP_2022_56199_87885.jpg

Water-Side: Conduits under walkway

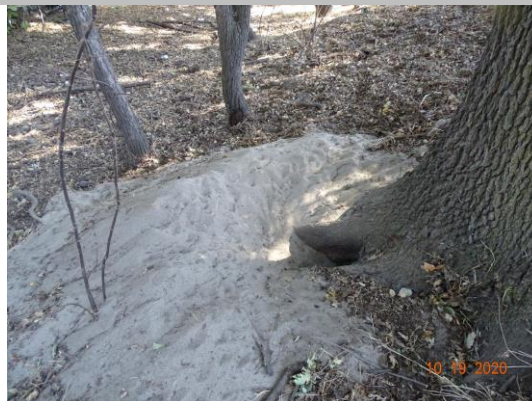
Photo 1 of 1 : SP_2022_RD0551_175_89_20220307_00032.jpg

LM Start	5.02	Rating **	U	Issue No.	89
LM End	5.02	Issue Type +	Ma	Location *	LS
Category	Earthen Levee			GPS Latitude/Longitude	
				Start	End
Item	Animal Control			38.276577 °	38.276577 °
				-121.541148 °	-121.541148 °
DWR ID	DWR_RD0551_01_f_2020_89				
Comment Code					
A1 : Exterminate rodents and backfill and compact or grout burrows.					
Inspector Comment					
Multiple large rodent holes burrowed under trees in the landside slope.

View large animal hole in the landside slope (Fall 2020).

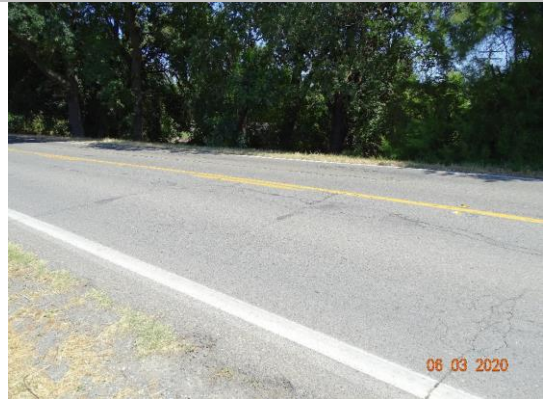
Photo 1 of 3 : UCIP_SP_2022_60628_87889.jpg

Comment Code						
Inspector Comment						
FS_ID:60628 DS_ID:22022 EP_NO: 11125 Repair Type: Non-Urgent Crossing Status: Found UCIP Comments: 06/03/2020 Record remains Non-Urgent. Crossing appears abandoned. Service pole at landside toe with electric panel and meter is broken down. Unable to evaluate waterside slope due to overgrown vegetation. Unauthorized encroachment recorded in Levee Log prior to 2011. Need to have CVFPB review ABO and determine current owner. (O.Yakimov - DWR UCIP) 04/11/2013 Pumphouse has been removed from pump and pump is in disrepair. Pipe at LS toe is sleeved or has been replaced with a 6-inch PVC pipe. This pump appears abandoned and should be done so properly. (W.Wylie - DWR UCIP) FIELD_STRUCT_DESC: 6-inch irrigation pipe of an unknown material through the levee, 6.5 feet below the crown. Pump and slide gate on the waterside (WS) slope. 1-inch electrical conduit at the same location with service pole at the landside (LS) toe. 4-foot by 6-foot concrete distribution box at the LS toe. (6-inch pipe [HLM 5.09] authorized under Automatic Board Order (ABO) issued as Permit No. 11125, 1975 - William H. And Evelyn J. Cortopassi). [Additional Reference(s): DWR Levee Log, 2005 (HLM 5.09). USACE Sacramento O&M Manual, Unit 111, May 1959, Revised 29 December 2016, (RM 29.71), listed as 6-inch pipe. USACE As-Built Drawing No. 06-13-1100, Sheet 14, downstream of 'L' 1560+12, January 1933]. FS Date: 6/3/2020 4:46:04 PM

Top of Levee: View of levee crown looking towards landside

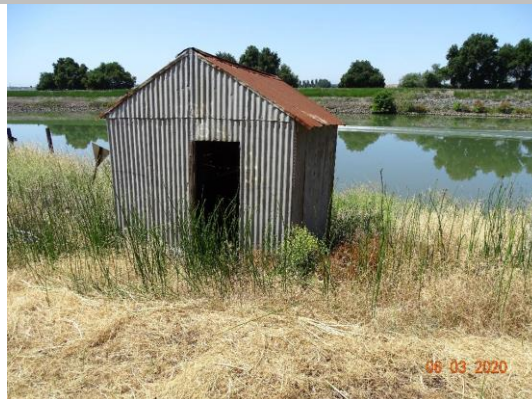
Photo 2 of 3 : UCIP_SP_2022_60628_87890.jpg

Water-Side: View of levee slope looking from crown. Abandoned pumphouse on levee slope

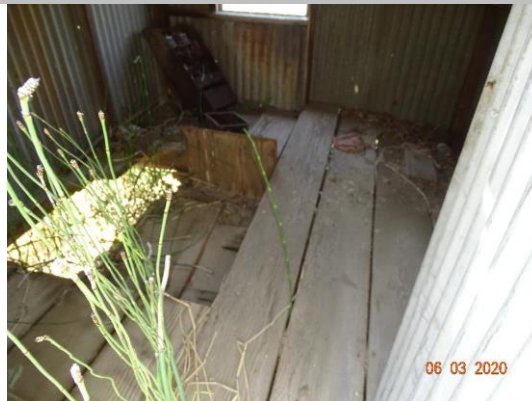
Photo 3 of 3 : UCIP_SP_2022_60628_87891.jpg

Water-Side: View inside of abandoned pumphouse

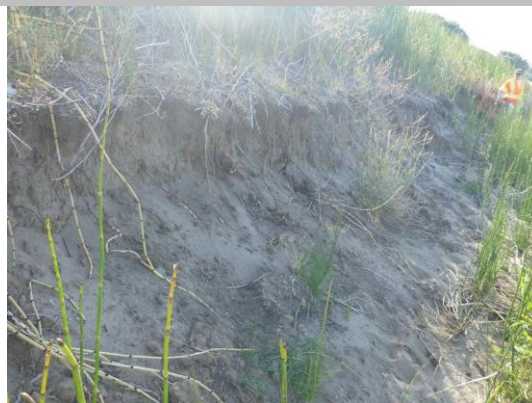
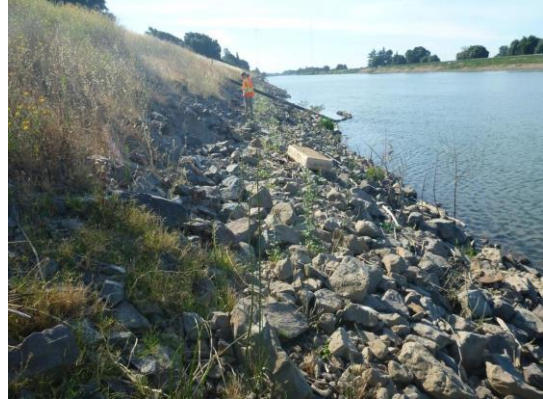
LM Start	5.20	Rating **	A/W	Issue No.	34
LM End	5.28	Issue Type +	Ob	Location *	N/A
Category	Supplemental			GPS Latitude/Longitude	
				Start	End
Item	2017 Storm Damage			38.274592 °	38.273800 °
				-121.538958 °	-121.537869 °
DWR ID	LMA-169

Comment Code					
Inspector Comment					
Repair not complete as of September 2021.					
Levee Evaluation Comments					
Description:District Station 273+82 to 278+08, Sec. 21 and 22, T. 5 N. R. 4 E., M.D.M. Approximately 426 linear-feet of erosion exists along the waterside slope of the Sacramento River. The erosion commences approximately halfway down the slope and extends to the rip rap.					
Some existing rip rap has been pulled off in this section.					
Site ID No:342					
Site Designation:LMA-169					
Repair Type: Erosion					
Rating:Serious					
Field Date:7/14/2017					
Notes: there is a 7 ft scarp that extends for 40-60 ft in very sandy soil, scarps are 2-4 ft the rest of the length. Worst site in this RD so far.					
Serious because of the length of this deeper scarp and the weak soil here. Crown is a paved road.

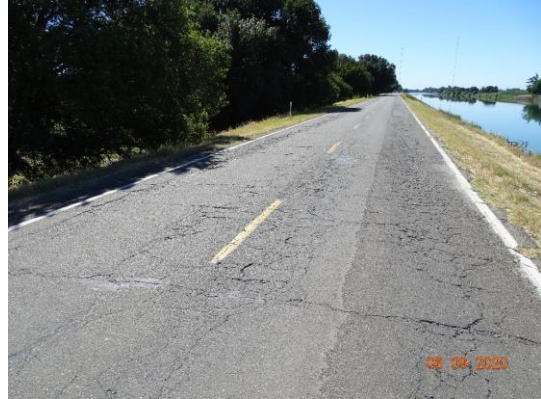
Photo 1 of 3 : UCIP_SP_2022_60630_87898.jpg

FS_ID:60630
DS_ID:22023
EP_NO: 11131
Repair Type: Urgent
Crossing Status: Found
UCIP Comments: 06/09/2020 Record updated from Non-Urgent to Urgent. 7-foot diameter 1-foot deep unauthorized excavation found at landside levee toe next to the concrete standpipe. Excavation is apparently made to expose and fix leaking pipe. Abandoned closure device and concrete standpipe at landside toe. 2.5-inch PVC connected to pipe end at landside toe. Pipe is running - no leaks detected. CMP riser on landside slope missing cover - fall hazard. No permit has been identified authorizing pipe. Need to have CVFPB review ABO and determine current owner. (O.Yakimov - DWR UCIP)
01/15/2014 Based on District notes from January 15, 2014, pump discharge pipe has been repaired. Corrosion holes in pipe at LS toe good indicator that pipe is failing internally. Pipe should be examined internally for damage (video inspect).: As of 12/12/2013 the District discussed with farmer tenant what needed to be done, and the tenant informed the District that they would address the repairs.: As of 12/17/2013 District submitted letter to landowner explaining UCIP report details including photos of the pipe problems

FIELD_STRUCT_DESC: 10-inch steel exterior coated irrigation pipe through the levee, 7.7 feet below the crown. Pump and slide gate on a concrete pad on the waterside (WS) slope. Siphon breaker in a 24-inch corrugated metal pipe (CMP) riser on the landside (LS) slope. 36-inch concrete standpipe, shut off device, and power pole with panel box on the LS toe. 1.5-inch galvanized steel electrical conduit at the same location. (10-inch pipe [HLM 5.3] authorized under Automatic Board Order (ABO) issued as Permit No. 11131, 1975 - Helen Crofton Sloane Latimer). [Additional Reference(s): DWR Levee Log, 2005 (HLM 5.30). USACE Sacramento O&M Manual, Unit 111, May 1959, Revised 29 December 2016, (RM 29.52), listed as 9-inch pipe. USACE As-Built Drawing No. 06-13-1100, Sheet 14, 'L' 1571+85, January 1933, listed as 9-inch pipe].
FS Date: 6/9/2020 10:52:00 AM

Top of Levee: View of levee crown looking downstream

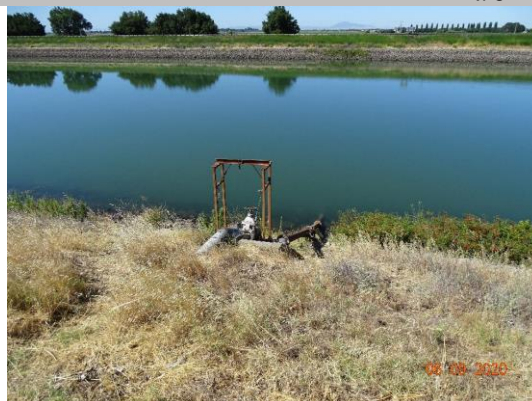
Photo 2 of 3 : UCIP_SP_2022_60630_87899.jpg

Water-Side: View of levee slope looking from crown

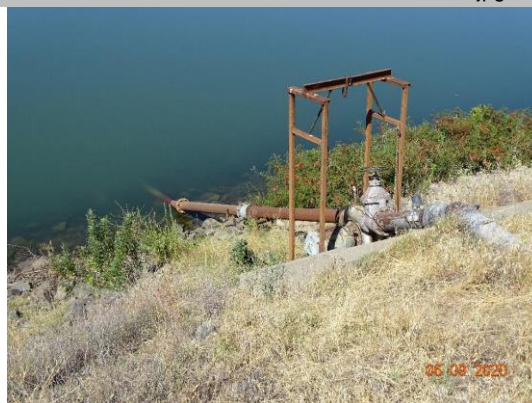
Photo 3 of 3 : UCIP_SP_2022_60630_87896.jpg

Water-Side: Pump, slide gate valve, and intake pipe on levee slope

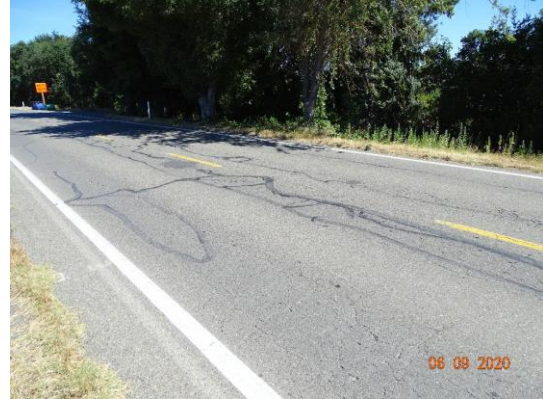
Photo 1 of 3 : UCIP_SP_2022_60635_87911.jpg

Comment Code						
Inspector Comment						
FS_ID:60635 DS_ID:22024 EP_NO: 11131 Repair Type: Non-Urgent Crossing Status: Found UCIP Comments: 06/09/2020 Record updated from No Action Needed to Non-Urgent. Unable to evaluate levee slopes due to overgrown vegetation on waterside and landscaping on landside. No permit has been identified authorizing pipe. Need to have CVFPB review ABO and determine current owner. (O.Yakimov - DWR UCIP) 04/11/2013 Good candidate for video inspection. (W.Wylie - DWR UCIP) FIELD_STRUCT_DESC: 8-inch irrigation pipe of an unknown material through the levee, 7.7 feet below the crown. Pump house, pump, and slide gate on a concrete pad on the waterside (WS) slope. 5-foot by 6-foot concrete distribution box at the landside (LS) toe. Service pole on the LS slope, electrical conduit of unknown diameter at this location. (8-inch pipe [HLM 5.6] authorized under Automatic Board Order (ABO) issued as Permit No. 11131, 1975 - Helen Crofton Sloane Latimer). [Additional Reference(s): DWR Levee Log, 2005 (HLM 5.60). USACE Sacramento O&M Manual, Unit 111, May 1959, Revised 29 December 2016, (RM 29.20), listed as 6-inch pipe. USACE As-Built Drawing No. 06-13-1100, Sheet 14, downstream of 'L' 1588+00, January 1933, listed as 6-inch pipe]. FS Date: 6/9/2020 2:08:08 PM

Top of Levee: View of levee crown looking upstream

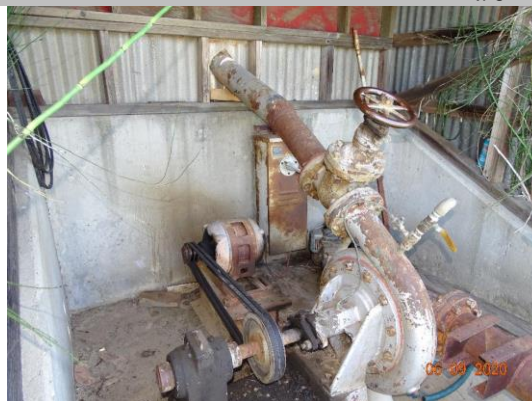
Photo 3 of 3 : UCIP_SP_2022_60635_87913.jpg

Water-Side: Pump in pumphouse on levee slope

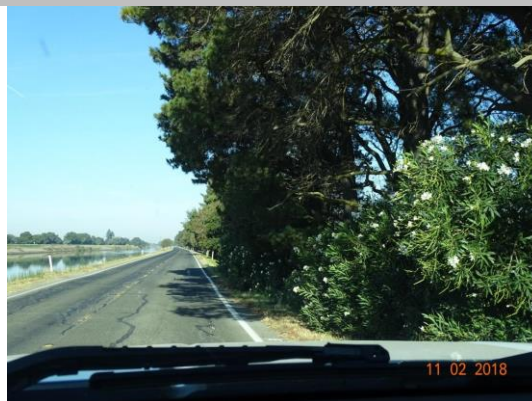
Photo 1 of 1 : SP_2022_RD0551_175_24_20220307_00007.jpg

LM Start	5.59	Rating **	U	Issue No.	24
LM End	5.62	Issue Type +	En	Location *	LS
Category	Earthen Levee			GPS Latitude/Longitude	
				Start	End
Item	Vegetation			38.270840 °	38.270574 °
				-121.533577 °	-121.533281 °
DWR ID	DWR_RD0551_01_f_2018_24				
Comment Code					
V6 : Landscaping					
Inspector Comment

View looking upstream at landscaping on the landside slope (November 2018).

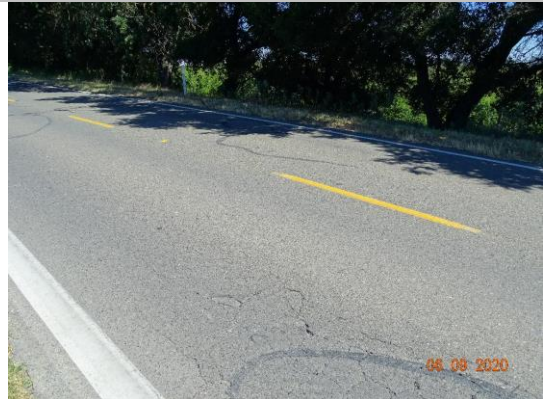
Photo 1 of 3 : UCIP_SP_2022_60636_87917.jpg

FS_ID:60636
DS_ID:22025
EP_NO: 11134
Repair Type: Non-Urgent
Crossing Status: Found
UCIP Comments: 06/09/2020 Record updated from No Action Needed to Non-Urgent. CMP riser on landside slope needs a cover - fall hazard. Pipe is running - minor leak through siphon breaker on the top of standpipe and landside toe. No permit has been identified authorizing pipe. Need to have CVFPB review ABO and determine current owner. (O.Yakimov - DWR UCIP)

Top of Levee: View of levee crown looking towards landside

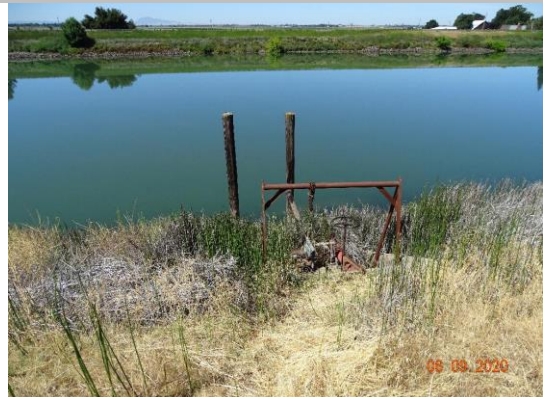
Photo 2 of 3 : UCIP_SP_2022_60636_87918.jpg

Water-Side: View of levee slope looking from crown

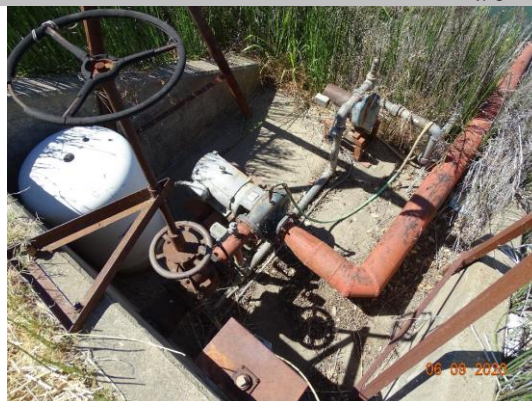
Photo 3 of 3 : UCIP_SP_2022_60636_87919.jpg

Water-Side: Concrete pad on levee slope with pumps, valve, pressure tank

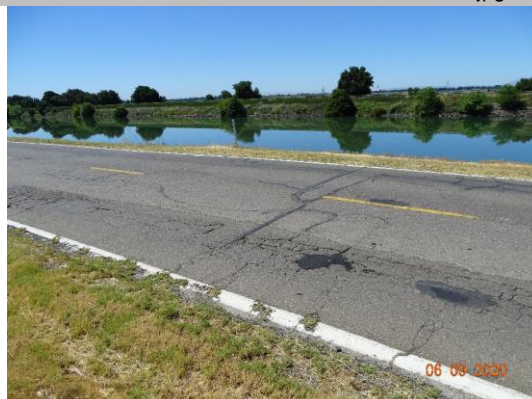
Photo 1 of 3 : UCIP_SP_2022_60639_88019.jpg

UCIP Comments: 06/09/2020 Record updated from No Action Needed to Non-Urgent. Crossing appears abandoned. Pipe is plugged with concrete as visible inside of concrete distribution box at landside toe. Unable to locate a permit and confirm proper pipe abandonment. Pipe not found on waterside. No permit has been identified authorizing pipe through the levee. (O.Yakimov - DWR UCIP)

Top of Levee: View of levee crown looking downstream

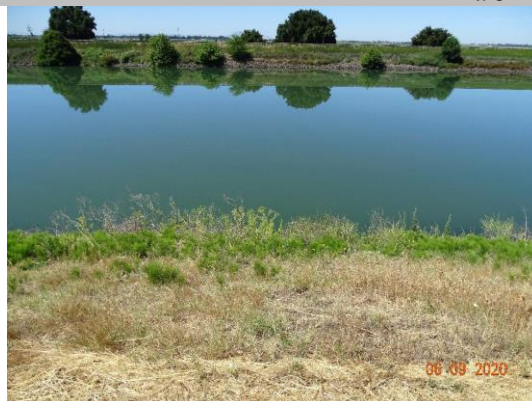
Photo 2 of 3 : UCIP_SP_2022_60639_88020.jpg

Water-Side: View of levee slope looking from crown

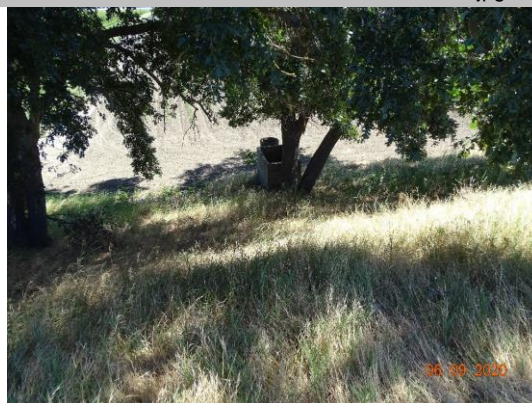
Photo 3 of 3 : UCIP_SP_2022_60639_88018.jpg

Land-Side: View of levee slope looking from crown

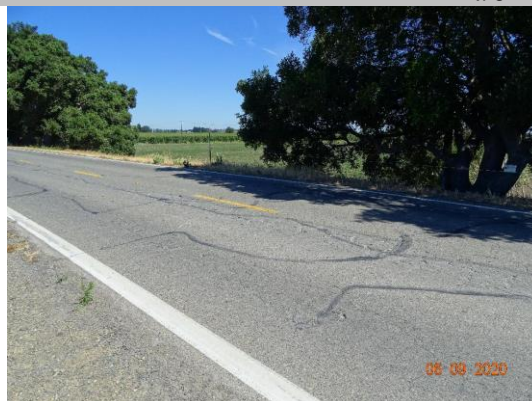
Photo 1 of 3 : UCIP_SP_2022_60640_88021.jpg

LM Start	5.88	Rating **	M	Issue No.	76	
LM End	5.88	Issue Type +	En	Location *		
Category	Supplemental			GPS Latitude/Longitude		
				Start		End
Item	DWR UCIP Field Study			38.268033	°	38.268033
				-121.529660	°	-121.529660
DWR ID	21997					
Comment Code						
Inspector Comment						
FS_ID:60640 DS_ID:21997 EP_NO: N/A Repair Type: Non-Urgent Crossing Status: Found UCIP Comments: 06/09/2020 Record updated from No Action Needed to Non-Urgent. No permit has been identified authorizing pipe. (O.Yakimov - DWR UCIP)						
FIELD_STRUCT_DESC: 2-inch steel domestic water line through the levee, 3 feet below the crown. Pump house on the waterside. Air vent on landside shoulder. [Additional Reference(s): USACE Sacramento O&M Manual, Unit 111, May 1959, Revised 29 December 2016, (RM 28.87), listed as 2-inch pipe]. FS Date: 6/9/2020 3:51:38 PM

Top of Levee: View of levee crown looking upstream

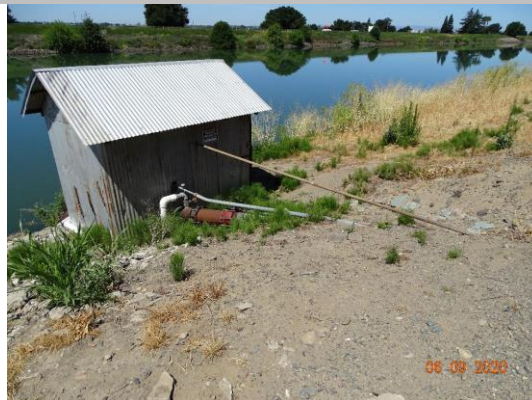
Photo 2 of 3 : UCIP_SP_2022_60640_88022.jpg

Water-Side: Levee slope, pumphouse on the slope

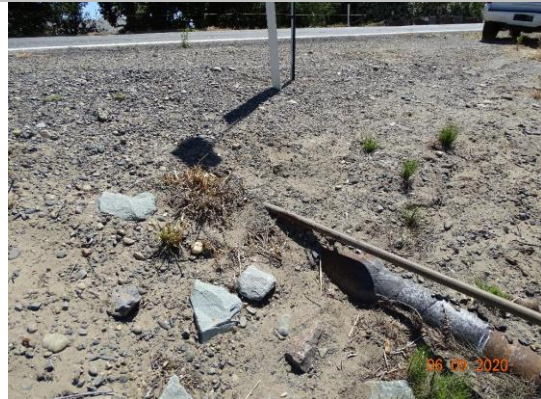
Photo 3 of 3 : UCIP_SP_2022_60640_88023.jpg

Water-Side: Pipe daylights on levee slope

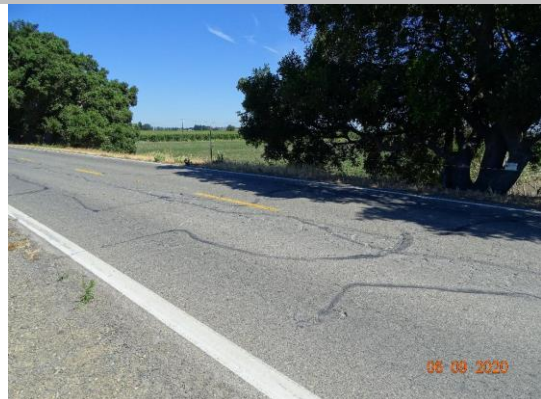
Photo 1 of 3 : UCIP_SP_2022_60641_88027.jpg

FS_ID:60641
 DS_ID:22026
 EP_NO: 11123
 Repair Type: Non-Urgent
 Crossing Status: Found
 UCIP Comments: 06/09/2020 Record updated from No Action Needed to Non-Urgent. Unable to find a permit authorizing to sleeve 10-inch through 12-inch pipe. (O.Yakimov - DWR UCIP)
 FIELD_STRUCT_DESC: 10-inch steel irrigation pipe sleeved through the 12-inch steel pipe through the levee, 3.8 feet below the crown. Pump and butterfly valve in pump house on the waterside (WS) slope. 48-inch concrete standpipe on the landside (LS) toe, and a 1.5-inch galvanized iron electrical conduit at the same location with a service pole on the LS slope. (12-inch pipe authorized under Permit No. 1656, 1952 - Alexander Johnson). (10-inch pipe [HLM 5.93] authorized under Automatic Board Order (ABO) issued as Permit No. 11123, 1975 - Anthony & Leonilia Castanho). [Additional Reference(s): DWR Levee Log, 2005 (HLM 5.87), listed as 10-inch pipe. USACE Sacramento O&M Manual, Unit 111, May 1959, Revised 29 December 2016, (RM 28.87), listed as 10-inch pipe].

Top of Levee: View of levee crown looking upstream

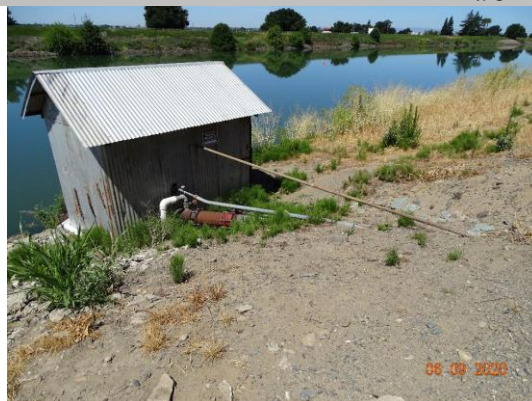
Photo 2 of 3 : UCIP_SP_2022_60641_88028.jpg

Water-Side: View of levee slope looking from crown. Pump house on levee slope

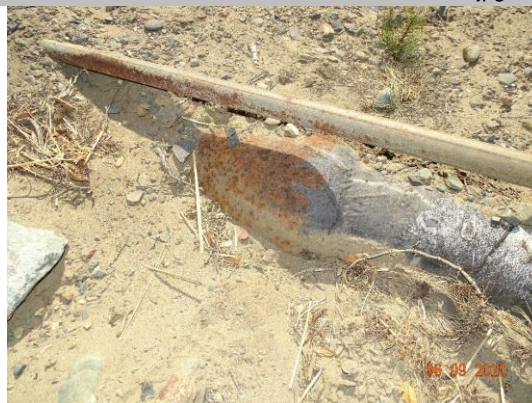
Photo 3 of 3 : UCIP_SP_2022_60641_88029.jpg

Water-Side: Sleeve point on levee slope

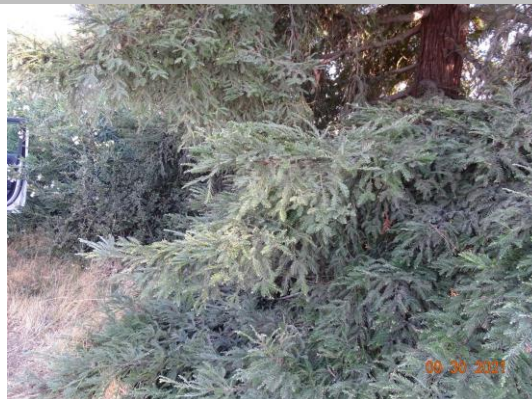
Photo 1 of 1 : SP_2022_RD0551_175_91_20220307_00034.jpg

LM Start	5.91	Rating **	U	Issue No.	91
LM End	5.91	Issue Type +	En	Location *	LS
Category	Earthen Levee			GPS Latitude/Longitude	
				Start	End
Item	Vegetation			38.267738 °	38.267738 °
				-121.529175 °	-121.529175 °
DWR ID	DWR_RD0551_01_f_2021_91				
Comment Code					
V6 : Landscaping					
Inspector Comment

View of landscaping on the landside slope (Fall 2021).

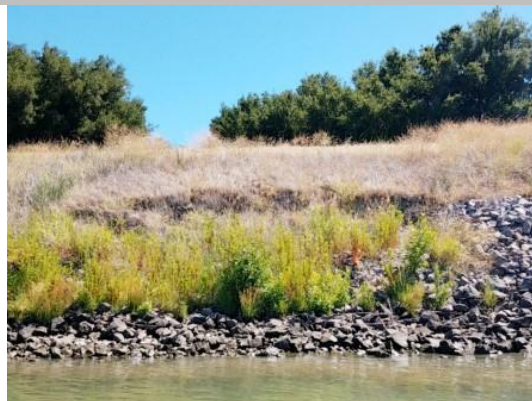
Photo 1 of 1 : SP_2022_RD0551_175_2_20220307_00002.jpg

LM Start	6.07	Rating **	U	Issue No.	2
LM End	6.07	Issue Type +	Ma	Location *	WS
Category	Earthen Levee			GPS Latitude/Longitude	
				Start	End
Item	Erosion / Bank Caving			38.265890 °	38.265890 °
				-121.527360 °	-121.527360 °
DWR ID	DWR_RD0551_01_s_2020_2				
Comment Code					
E2 : Schedule repair of erosion site prior to the next inspection.					
Inspector Comment					
Two foot vertical erosion into the midslope of the waterside prism.

View from the channel of erosion into the waterside prism (Summer 2020).

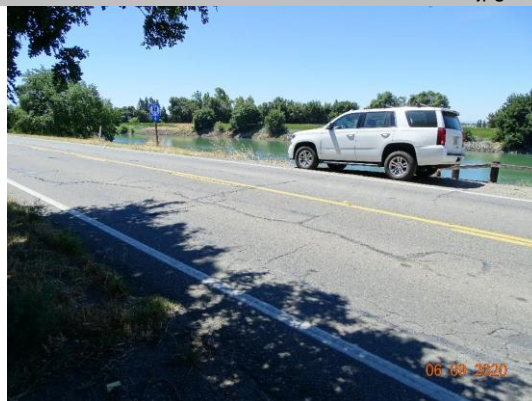
Photo 1 of 3 : UCIP_SP_2022_60643_87950.jpg

LM Start	6.16	Rating **	M	Issue No.	78
LM End	6.16	Issue Type +	En	Location *	
Category	Supplemental			GPS Latitude/Longitude	
				Start	End
Item	DWR UCIP Field Study			38.265182 °	38.265182 °
				-121.526136 °	-121.526136 °
DWR ID	21999				
Comment Code					
Inspector Comment					
FS_ID:60643 DS_ID:21999 EP_NO: N/A Repair Type: Non-Urgent Crossing Status: Not Found UCIP Comments: 06/09/2020 Record updated from No Action Needed to Non-Urgent. Crossing not found. No permit has been identified authorizing pipe. (O.Yakimov - DWR UCIP) FIELD_STRUCT_DESC: 3.5-inch conduit of unknown purpose of an unknown material through the levee, 5.8 feet below the crown. [Additional Reference(s): USACE Sacramento O&M Manual, Unit 111, May 1959, Revised 29 December 2016, (RM 28.59), listed as 3.5-inch pipe]. FS Date: 6/9/2020 4:31:25 PM

Top of Levee: View of levee crown looking downstream

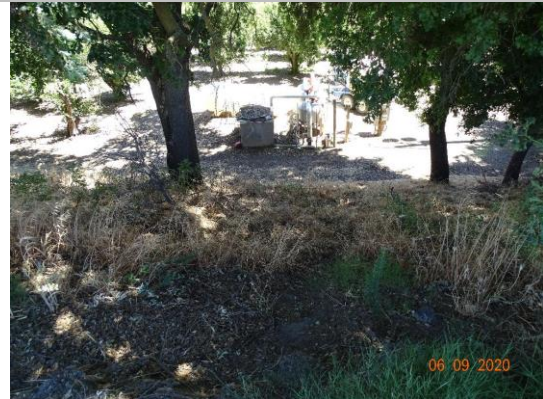
Photo 3 of 3 : UCIP_SP_2022_60643_87951.jpg

Land-Side: View of levee slope looking from crown

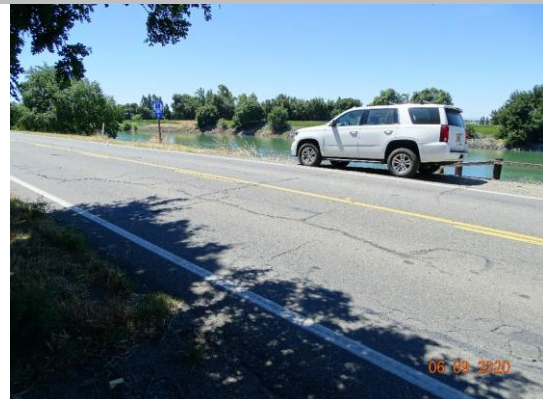
Photo 1 of 3 : UCIP_SP_2022_60650_87927.jpg

FS_ID:60650
DS_ID:22027
EP_NO: 11122
Repair Type: Non-Urgent
Crossing Status: Indicator Found
UCIP Comments: 06/09/2020 Record updated from No Action Needed to Non-Urgent. Pump is moved downstream to a separate piled steel pad and connected to existing 10-inch pipe through the levee. Concrete distribution box at landside toe seems abandoned. Fine media filtration system installed on landside and connected to this crossing. Unable to find permit for system modifications. Pipe is running - minor water leak through pump sealing on waterside slope. (O.Yakimov - DWR UCIP)
FIELD_STRUCT_DESC: 10-inch steel exterior coated irrigation pipe through the levee, 8 feet below the crown. Abandoned pile structure on waterside slope and in stream. Pump and butterfly valve on steel piled pad on waterside slope downstream of abandoned structure. Service pole with electrical panel and meter, media filters off landside toe. Abandoned 4-foot by 6-foot concrete distribution box at landside levee toe. This crossing replaces 8-inch pipe (see DSID 21998). (10-inch pipe authorized under Permit No. 4303, 1963 - Robert M. Carmany). (10-inch pipe [HLM 6.21] authorized under Automatic Board Order (ABO) issued as Permit No. 11122, 1975 - Robert M. And Francis Carmany). [Additional Reference(s): DWR Levee Log, 2005 (HLM 6.21)].

Top of Levee: View of levee crown looking towards waterside

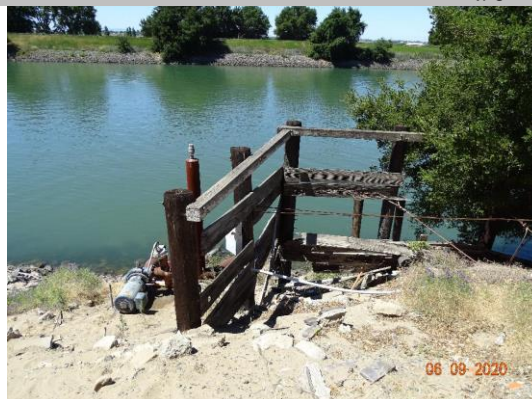
Photo 2 of 3 : UCIP_SP_2022_60650_87923.jpg

Water-Side: Abandoned pile structure on levee slope and in channel

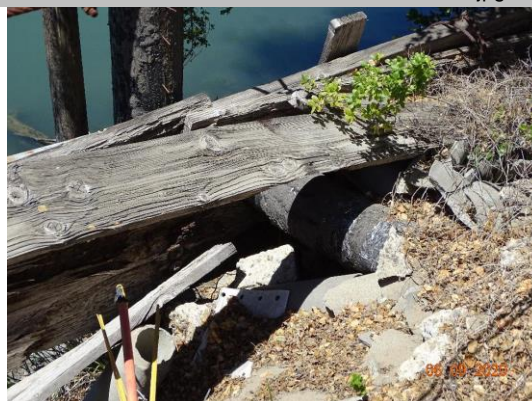
Photo 3 of 3 : UCIP_SP_2022_60650_87930.jpg

Water-Side: 10-inch pipe at abandoned structure on levee slope

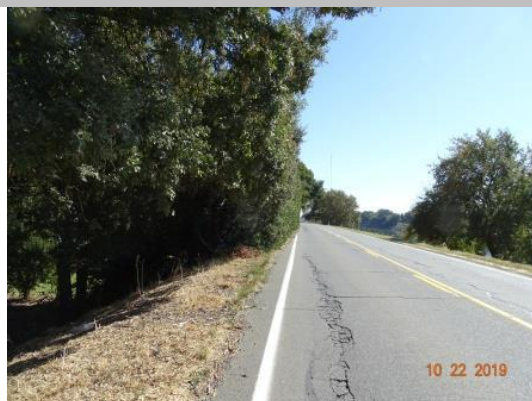
Photo 1 of 1 : SP_2022_RD0551_175_51_20220307_00016.jpg

LM Start	6.19	Rating **	U	Issue No.	51
LM End	6.26	Issue Type +	En	Location *	LS
Category	Earthen Levee			GPS Latitude/Longitude	
				Start	End
Item	Vegetation			38.264814 °	38.264112 °
				-121.525728 °	-121.524845 °
DWR ID	DWR_RD0551_01_f_2017_51				
Comment Code					
V6 : Landscaping					
Inspector Comment					
Landscaping should be maintained to allow inspection and access to landside slope and toe.

View looking downstream at landscaping on the landside slope (Fall 2019).

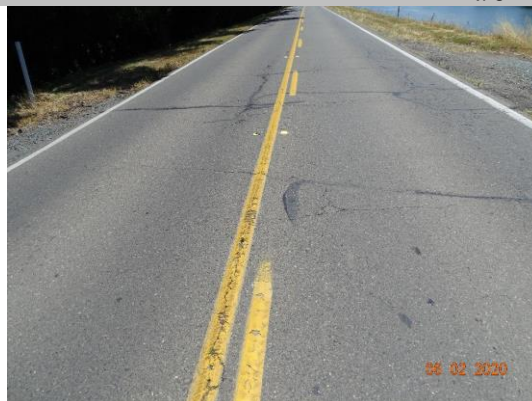
Photo 1 of 3 : UCIP_SP_2022_60684_87960.jpg

Comment Code						
Inspector Comment						
FS_ID:60684 DS_ID:21977 EP_NO: N/A Repair Type: Non-Urgent Crossing Status: Found UCIP Comments: 06/02/2020 Record updated from No Action Needed to Non-Urgent. No permit has been identified authorizing crossing. (O.Yakimov - DWR UCIP) FIELD_STRUCT_DESC: 1.5-inch galvanized steel electrical conduit through the levee, 6.3 feet below the crown. Slant pump on the waterside (WS) slope. [Additional Reference(s): DWR Levee Log, 2005 (HLM 6.36), listed as 3.5-inch pipe. USACE Sacramento O&M Manual, Unit 111, May 1959, Revised 29 December 2016, (RM 28.44), listed as 3.5-inch pipe. FS Date: 6/2/2020 1:59:48 PM

Top of Levee: View of levee crown looking downstream

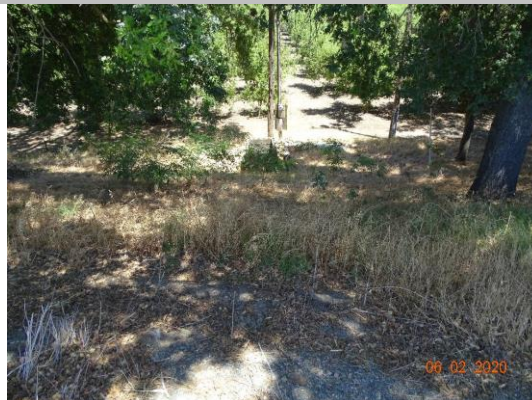
Photo 2 of 3 : UCIP_SP_2022_60684_87961.jpg

Land-Side: View of levee slope looking from crown

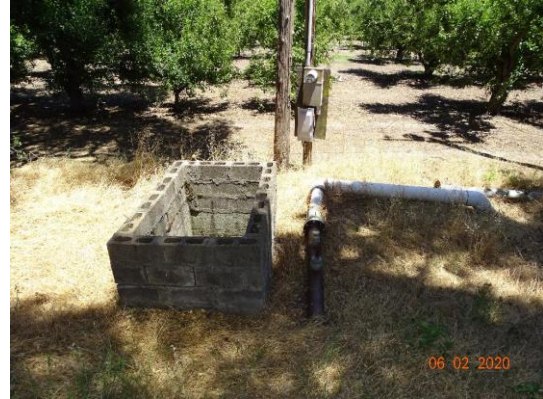
Photo 3 of 3 : UCIP_SP_2022_60684_87962.jpg

Land-Side: Service pole at levee toe

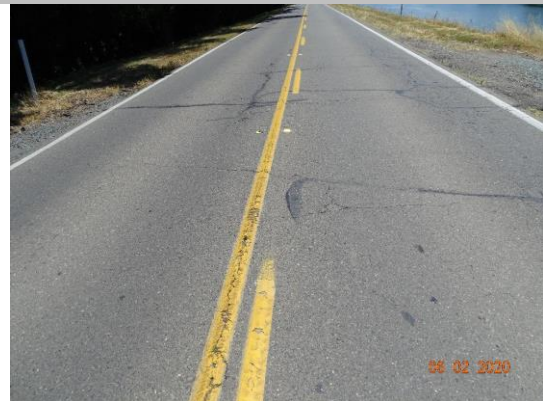
Photo 1 of 3 : UCIP_SP_2022_60690_87970.jpg

FS_ID:60690
DS_ID:22028
EP_NO: N/A
Repair Type: Non-Urgent
Crossing Status: Found
UCIP Comments: 06/02/2020 Record updated from No Action Needed to Non-Urgent. Pipe is capped with steel plate inside of concrete distribution box at landside toe. 6-inch steel pipe going around the concrete box apparently connected underground at levee toe to the pipe through the levee. Unable to find a permit for modifications. No permit has been identified authorizing pipe through the levee. (O.Yakimov - DWR UCIP)
FIELD_STRUCT_DESC: 12-inch welded steel irrigation pipe through the levee, 6.3 feet below the crown. Slant pump and slide gate on the waterside (WS) slope. 4-foot by 6-foot concrete distribution box, siphon breaker and vent on 6-inch pipe next to the concrete box at landside toe. [Additional Reference(s): DWR Levee Log, 2005 (HLM 6.36). USACE Sacramento O&M Manual, Unit 111, May 1959, Revised 29 December 2016, (RM 28.44), listed as 8-inch pipe. USACE As-Built Drawing No. 06-13-1100, Sheet 14, downstream of 'L' 1627+05, January 1933, listed as 8-inch pipe. USACE As-Built Drawing No. 50-04-2983, Sheet 3, STA 35+09.5, March 1954, listed as 8-inch pipe].

Top of Levee: View of levee crown looking downstream

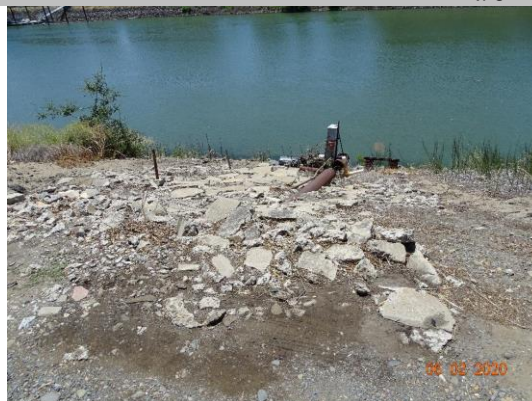
Photo 2 of 3 : UCIP_SP_2022_60690_87968.jpg

Water-Side: View of levee slope looking from crown

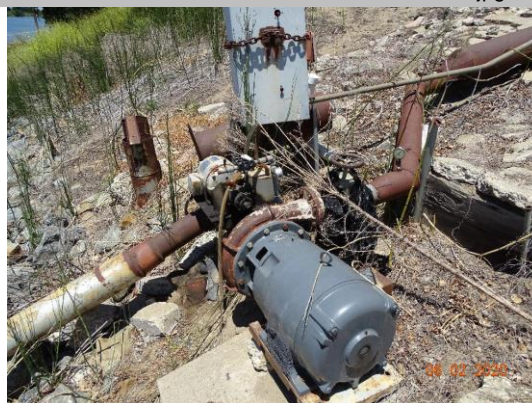
Photo 3 of 3 : UCIP_SP_2022_60690_87969.jpg

Water-Side: Pump on concrete pad on levee slope

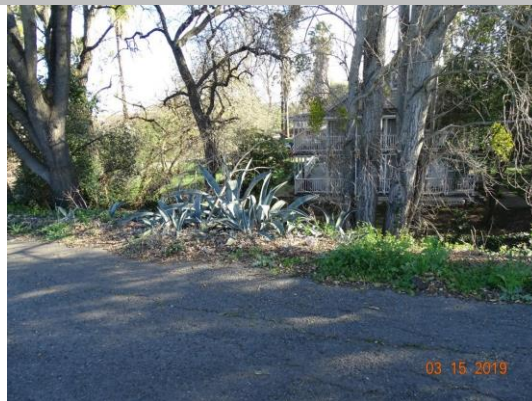
Photo 1 of 1 : SP_2022_RD0551_175_20_20220307_00005.jpg

LM Start	6.44	Rating **	M	Issue No.	20
LM End	6.44	Issue Type +	En	Location *	LS
Category	Earthen Levee			GPS Latitude/Longitude	
				Start	End
Item	Vegetation			38.262388 °	38.262388 °
				-121.522368 °	-121.522368 °
DWR ID	DWR_RD0551_01_s_ 2019_20				
Comment Code					
V6 : Landscaping					
Inspector Comment					
Cactus on the landside slope should be removed.

View of cactus on the landside shoulder (Spring 2019).

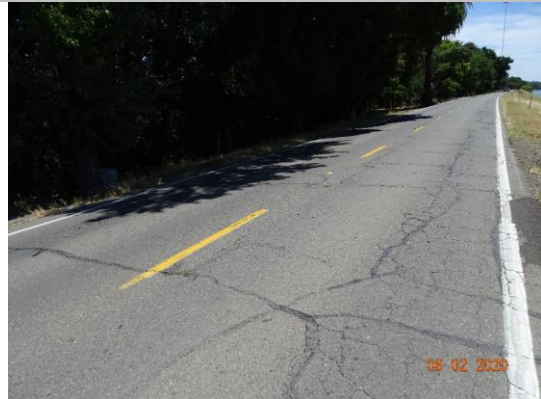
Photo 1 of 3 : UCIP_SP_2022_60696_87974.jpg

Comment Code						
Inspector Comment						
FS_ID:60696 DS_ID:22029 EP_NO: 3354 Repair Type: Non-Urgent Crossing Status: Found UCIP Comments: 06/02/2020 Record updated from No Action Needed to Non-Urgent. 12-inch pipe sleeved through 14-inch pipe through the levee. Unable to find a permit for modification. Pipe is running - leaks not detected. (O.Yakimov - DWR UCIP) FIELD_STRUCT_DESC: 12-inch steel irrigation pipe sleeved through 14-inch coated steel pipe through the levee, 3.5 feet below the crown. Slant pump on a concrete slab on the waterside (WS) slope. Siphon breaker in a 24-inch corrugated metal pipe (CMP) riser on the landside (LS) shoulder. Slide gate in a 48-inch concrete riser on the LS toe. 1.5-inch electrical conduit at the same location. This crossing replaces 12-inch pipe (see DSID 22000). (14-inch pipe authorized under Permit No. 3354, 1960 - F.I. Christie). [Additional Reference(s): DWR Levee Log, 2005 (HLM 6.53), listed as 14-inch pipe. USACE As-Built Drawing No. 06-13-1100, Sheet 14, 'L' 1640+00, January 1933, , listed as 14-inch pipe]. FS Date: 6/2/2020 2:31:53 PM

Top of Levee: View of levee crown looking downstream

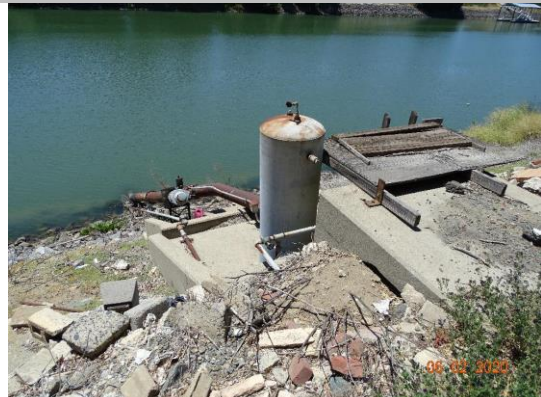
Photo 2 of 3 : UCIP_SP_2022_60696_87975.jpg

Water-Side: View of levee slope looking from crown

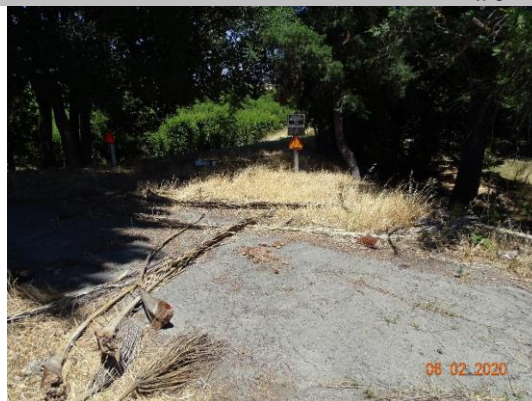
Photo 2 of 3 : UCIP_SP_2022_60698_87985.jpg

Land-Side: View of landside looking from crown

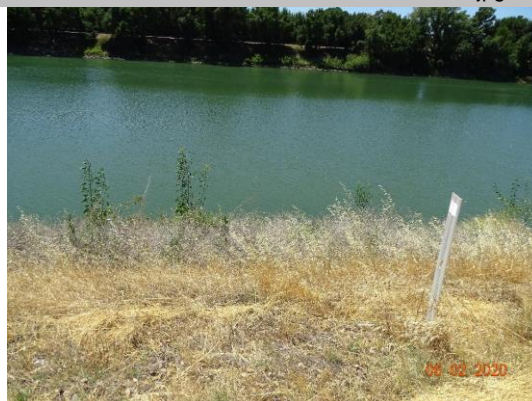
Photo 3 of 3 : UCIP_SP_2022_60698_87986.jpg

Water-Side: View of levee slope looking from crown

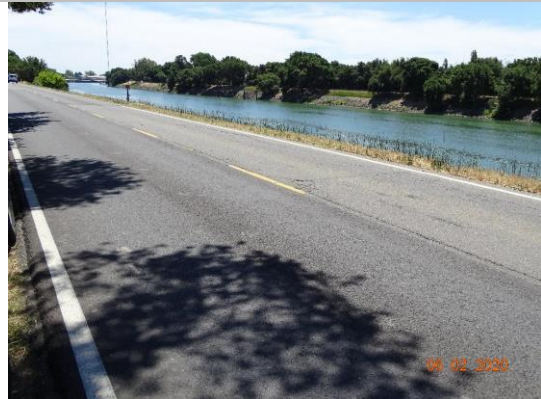
Photo 1 of 3 : UCIP_SP_2022_60701_87995.jpg

Comment Code					
Inspector Comment					
FS_ID:60701					
DS_ID:22030					
EP_NO: 11126					
Repair Type: Non-Urgent					
Crossing Status: Found					
UCIP Comments: 06/02/2020 Record updated from No Action Needed to Non-Urgent. Field measured 8-inch pipe sleeved through 12-inch pipe. Appears that annular space between pipes has been grouted through a plugged hole at landside shoulder. Concrete standpipe and distribution box at landside toe look abandoned. Water is designed to go around concrete box to either underground pipe of screen filter. Unable to find a permit for modifications. Pipe is running - no leaks detected. No permit has been identified authorizing pipe through the levee. Need to have CVFPB review ABO and determine current owner. (O.Yakimov - DWR UCIP)					
FIELD_STRUCT_DESC: 8-inch irrigation pipe sleeved through the 12-inch steel pipe through the levee, 3 feet below crown. Water pump, filler pump and pressure tank on a concrete pad on the waterside (WS) slope. Butterfly valves at pump and at the landside (LS) toe. Abandoned concrete standpipe and concrete distribution box at landside toe. Screen filter at landside levee toe, service pole a 1.5-inch galvanized electrical conduit at the same location. (12-inch pipe [HLM 6.74] authorized under Automatic Board Order (ABO) issued as Permit No. 11126, 1975 - Alma K. Fletcher). [Additional Reference(s): DWR Levee Log, 2005 (HLM 6.74), listed as 12-inch pipe. USACE Sacramento O&M Manual, Unit 111, May 1959, Revised 29 December 2016, (RM 28.06), listed as 6-inch pipe. USACE As-Built Drawing No. 06-13-1100, Sheet 14, upstream of 'L' 1652+65, January 1933, listed as 6-inch pipe].

Top of Levee: View of levee crown looking downstream

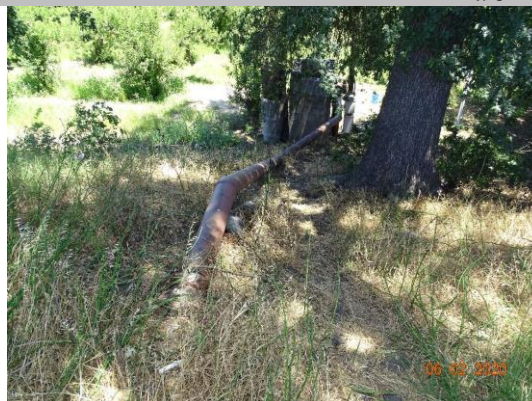
Photo 2 of 3 : UCIP_SP_2022_60701_87996.jpg

Land-Side: View of levee slope looking from crown
