**Flood Control Project Maintenance
Levee Inspections
LMA District Cover Sheet**

Reclamation District No. 0551 Pearson

**Flood Control Project Maintenance
Levee Inspections**

Levee Inspection Report By Mile - Spring 2023

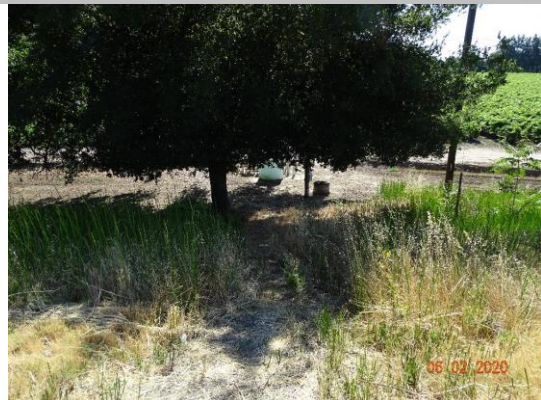
Photo 2 of 3 : UCIP_SP_2023_60128_87410.jpg

Land-Side: View of levee slope looking from crown

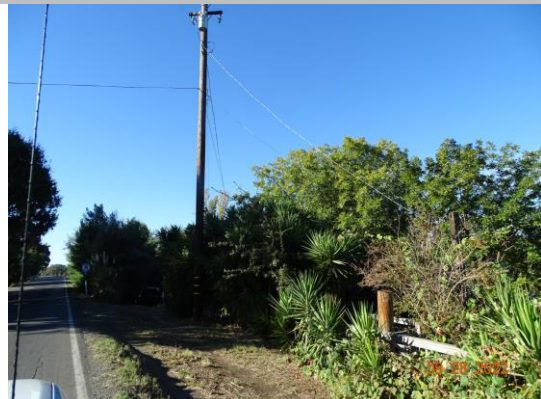
Photo 1 of 1 : SP_2023_RD0551_175_6_20230206_00003.jpg

LM Start	1.53	Rating **	M	Issue No.	6
LM End	1.60	Issue Type +	En	Location *	WS
Category	Earthen Levee			GPS Latitude/Longitude	
				Start	End
Item	Vegetation			38.317138°	38.316060°
				-121.576567°	-121.576688°
DWR ID	DWR_RD0551_01_s_2012_6				
Comment Code					
V6 : Landscaping					
Inspector Comment					
Thin landscaping to allow visibility and access down waterside slope.

View of the landscaping on the WS shoulder and slope (Fall 2022).

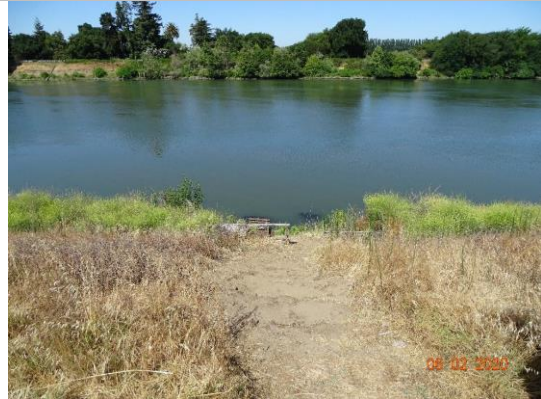
Photo 1 of 3 : UCIP_SP_2023_60145_87424.jpg

DS_ID:21990
FS_ID:60145
EP_NO: 11145
Repair Type: Non-Urgent
EVAL Issue: 10, Unauthorized Modification or Non-Compliant Permit
Crossing Status: Found
UCIP Comments: 06/02/2020 Record remains Non-Urgent. A portion on pipe on landside slope was replaced. Due to overgrown vegetation unable to locate connection of a replaced pipe segment to a pipe through the levee and evaluate levee slope condition. Pump house on waterside has been removed. Intake pipe at riverbank to the pump has been replaced, pipe debris left at riverbank. Unable to locate a permit for replacing the pipe segment on landside slope. No permit has been identified authorizing pipe through the levee. Need to have CVFPB review ABO and determine current owner. (O.Yakimov - DWR UCIP) Based on District notes from January 14, 2014, pump discharge pipe has been repaired. Pipe failing on LS slope causing erosion along pipe alignment. Pipe debris on both slopes should be removed as well.: As of 12/13/2013 District President noted that the landowner had made repairs to the LS slope leaks.: As of 12/17/2013 District submitted letter to landowner explaining UCIP report details including photos of the pipe problems

FIELD_STRUCT_DESC: 10-inch irrigation pipe of an unknown material through the levee, 4.7 feet below the crown. Pump on concrete pad, butterfly valve, and U-shaped headwall on the waterside (WS) slope. 36-inch concrete riser on the landside (LS) toe. 1-inch electrical conduit at the same location. Service pole at the LS toe. (10-inch pipe [HLM 1.78] authorized under Automatic Board Order (ABO) issued as Permit No. 11145, 1975 - Horace D. & Lucile Towne). [Additional Reference(s): DWR Levee Log, 2005 (HLM 1.78). USACE Sacramento O&M Manual, Unit 111, May 1959, Revised 29 December 2016, (RM 33.02), listed as 8-inch pipe. USACE As-Built Drawing No. 06-13-1100, Sheet 13, RM 33, upstream of 'L' 1396+35, January 1933].
FS Date: 6/2/2020 11:15:34 AM

Water-Side: View of levee slope looking from crown

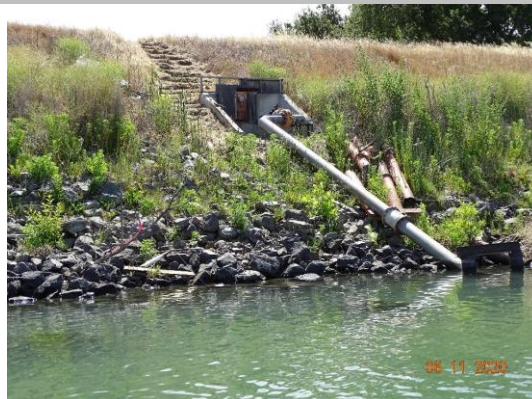
Photo 2 of 3 : UCIP_SP_2023_60145_87422.jpg

Water-Side: Overview of waterside looking from river

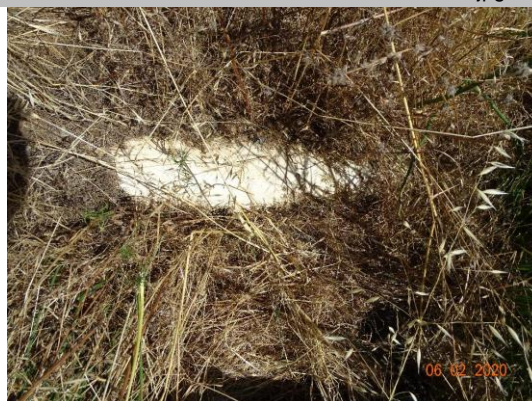
Photo 3 of 3 : UCIP_SP_2023_60145_87420.jpg

Land-Side: New pipe visible on levee slope

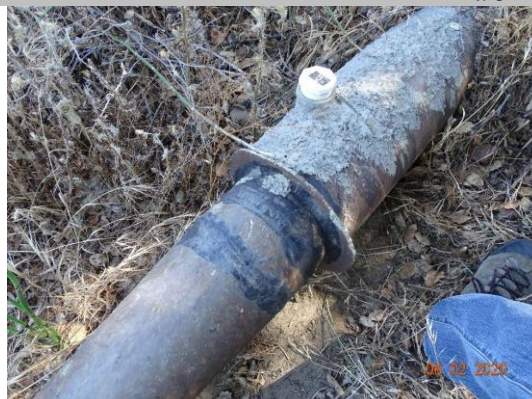
Photo 2 of 3 : UCIP_SP_2023_60233_87515.jpg

Comment Code					
Inspector Comment					
DS_ID:21994 FS_ID:60233 EP_NO: 11141 Repair Type: Non-Urgent EVAL Issue: 10, Unauthorized Modification or Non-Compliant Permit Crossing Status: Found UCIP Comments: 06/02/2020 Record remains Non-Urgent. Field measured pipe through the levee to be 11-inch in diameter. 8-inch pipe sleeved through 11-inch pipe. Annular space between pipes seems to be grouted. Concrete standpipe at landside levee toe has been removed. Unable to locate a permit for modifications. No permit has been identified authorizing original pipe. Need to have CVFPB review ABO and determine current owner. (O.Yakimov - DWR UCIP) 04/10/2013 Records indicate this pipe was abandoned, but it appears to be active. Verify status. (W.Wylie - DWR UCIP) FIELD_STRUCT_DESC: 8-inch steel irrigation pipe sleeved through 11-inch pipe through the levee, 8 feet below the crown. Slant pump on the waterside (WS) slope. Service pole on the landside (LS) slope with a 1.5-inch galvanized iron electrical conduit through the levee at the same location. This crossing replaces 12-inch pipe (see DSID 25637). (12-inch pipe authorized under Permit No. 747, 1938 - Runyon And Stephenson). (12-inch pipe [HLM 2.32] authorized under Automatic Board Order (ABO) issued as Permit No. 1975, 1975 - Adele Runyon, Et Al). [Additional Reference(s): DWR Levee Log, 2005 (HLM 2.42), listed as 12-inch pipe. USACE Sacramento O&M Manual, Unit 111, May 1959, Revised 29 December 2016, (RM 32.38), listed as 12-inch pipe. USACE As-Built Drawing No. 06-13-1100, Sheet 13, 'L' 1422+78, January 1933, listed as 12-inch pipe. USACE As-Built Drawing No. 50-04-2983, Sheet 9, STA 1+50, March 1954]. FS Date: 6/2/2020 9:53:01 AM

Water-Side: 8-inch pipe sleeved through 11-inch pipe. Annular space filler plug with grout spilled on pipe

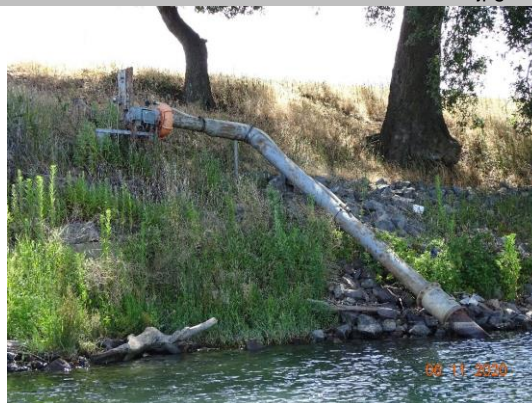
Photo 3 of 3 : UCIP_SP_2023_60233_87519.jpg

Water-Side: View of levee slope and pipe looking from river

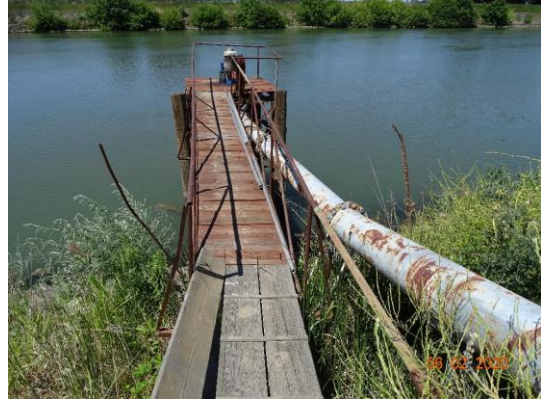
Photo 1 of 3 : UCIP_SP_2023_60293_87554.jpg

Comment Code					
Inspector Comment					
DS_ID:22032 FS_ID:60293 EP_NO: 1204 Repair Type: Non-Urgent EVAL Issue: 10, Unauthorized Modification or Non-Compliant Permit Crossing Status: Found UCIP Comments: 06/02/2020 Record remains Non-Urgent. Unable to locate a permit authorizing to sleeve 10-inch pipe through 12-inch pipe. Wet spot on the ground observed at concrete standpipe. (O.Yakimov - DWR UCIP) 04/10/2013 Gap between sleeved pipes does not appear to be grouted on LS slope. (W.Wylie - DWR UCIP) FIELD_STRUCT_DESC: 12-inch steel irrigation conduit through the levee, 6 feet below the crown. 10-inch irrigation pipe sleeved through the 12-inch conduit. Pump on pile structure on the waterside (WS) toe. 48-inch concrete riser on the landside (LS) toe. (12-inch pipe authorized under Permit No. 1204, 1947 - M. J. Barry Estate). [Additional Reference(s): USACE Sacramento O&M Manual, Unit 111, May 1959, Revised 29 December 2016, (RM 31.82), listed as 12-inch pipe]. USACE As-Built Drawing No. 06-13-1100, Sheet 13, upstream of 'L' 1460+20, January 1933. USACE As-Built Drawing No. 50-04-2983, Sheet 8, STA 30+80, March 1954]. FS Date: 6/2/2020 1:26:54 PM

Water-Side: Pump on pile structure and timber walkway to the pump

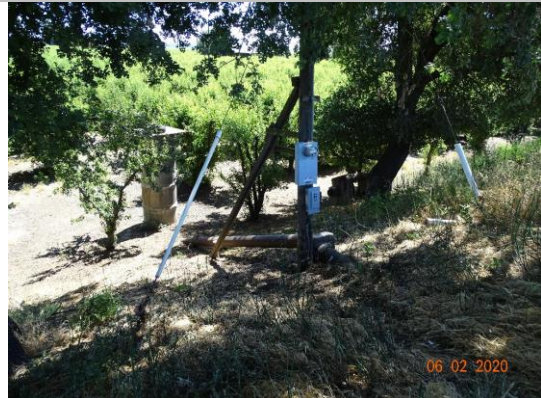
Photo 2 of 3 : UCIP_SP_2023_60293_87556.jpg

Land-Side: View of levee slope looking from crown

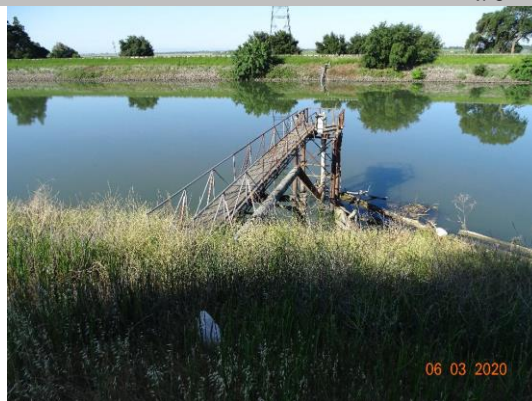
Photo 2 of 3 : UCIP_SP_2023_60363_87584.jpg

Water-Side: View of levee slope looking from crown

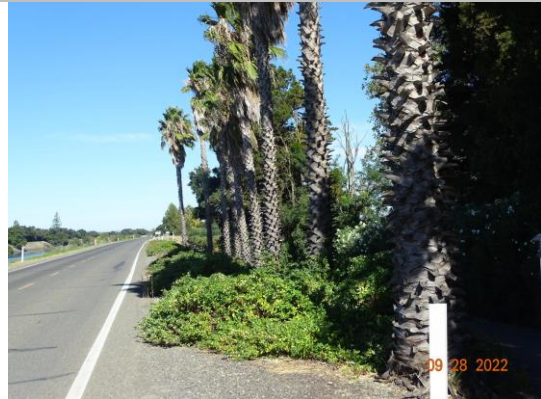
Photo 1 of 1 : SP_2023_RD0551_175_54_20230206_00019.jpg

LM Start	3.71	Rating **	M	Issue No.	54
LM End	3.74	Issue Type +	En	Location *	LS
Category	Earthen Levee			GPS Latitude/Longitude	
				Start	End
Item	Vegetation			38.289920°	38.289544°
				-121.558357°	-121.557956°
DWR ID	DWR_RD0551_01_f _ 2018_54				
Comment Code					
V6 : Landscaping					
Inspector Comment

View of the landscaping on the LS slope (Fall 2022).

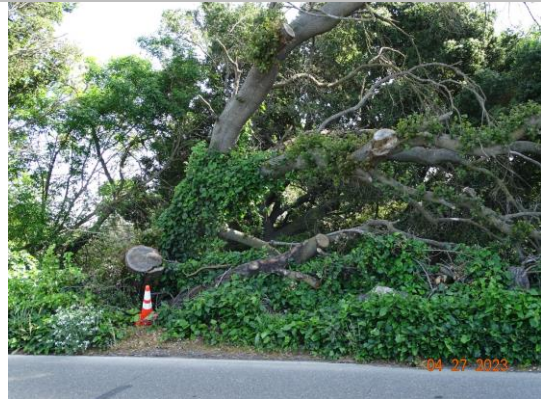
Photo 1 of 1 : SP_2023_RD0551_175_35_20230515_00107.jpg

LM Start	3.81	Rating **	M	Issue No.	35
LM End	3.81	Issue Type +	Ma	Location *	LS
Category	Earthen Levee			GPS Latitude/Longitude	
				Start	End
Item	Trim / Thin Trees			38.288805°	38.288805°
				-121.557125°	-121.557125°
DWR ID	DWR_RD0551_01_s_2023_35				
Comment Code					
T2 : Tree or limb.					
Inspector Comment

View of the fallen tree on the LS shoulder and slope (Spring 2023).

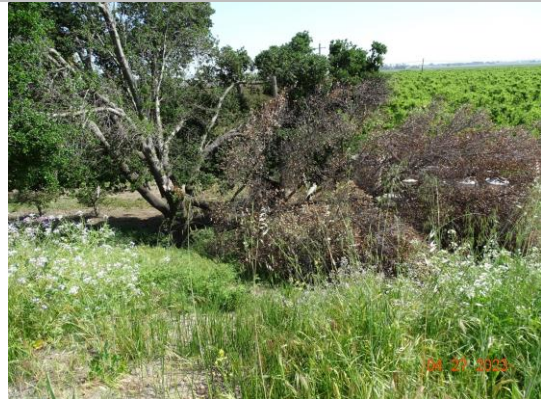
Photo 1 of 1 : SP_2023_RD0551_175_39_20230515_00111.jpg

LM Start	4.01	Rating **	M	Issue No.	39
LM End	4.01	Issue Type +	Ma	Location *	LS
Category	Earthen Levee			GPS Latitude/Longitude	
				Start	End
Item	Trim / Thin Trees			38.286591°	38.286591°
				-121.554545°	-121.554545°
DWR ID	DWR_RD0551_01_s_2023_39				
Comment Code					
T2 : Tree or limb.					
Inspector Comment

View of the tree limb and branches on the LS slope (Spring 2023).

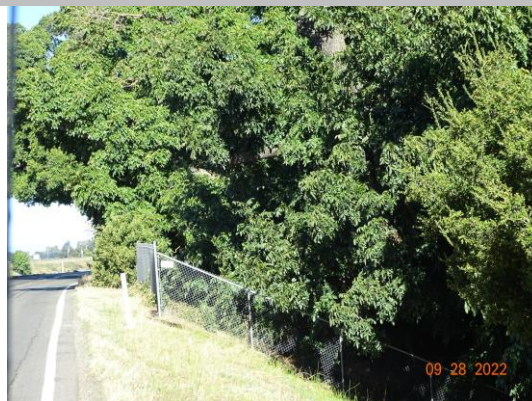
Photo 1 of 1 : SP_2023_RD0551_175_52_20230206_00017.jpg

LM Start	4.22	Rating **	U	Issue No.	52
LM End	4.22	Issue Type +	En	Location *	LS
Category	Earthen Levee			GPS Latitude/Longitude	
				Start	End
Item	Vegetation			38.284400°	38.284400°
				-121.552035°	-121.552035°
DWR ID	DWR_RD0551_01_f_2018_52				
Comment Code					
V6 : Landscaping					
Inspector Comment

View of the landscaping on the LS slope (Fall 2022).

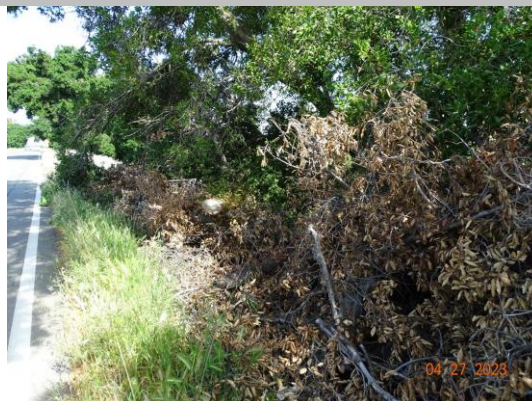
Photo 1 of 1 : SP_2023_RD0551_175_38_20230515_00110.jpg

LM Start	4.40	Rating **	M	Issue No.	38
LM End	4.40	Issue Type +	Ma	Location *	LS
Category	Earthen Levee			GPS Latitude/Longitude	
				Start	End
Item	Trim / Thin Trees			38.282903°	38.282903°
				-121.549398°	-121.549398°
DWR ID	DWR_RD0551_01_s_2023_38				
Comment Code					
T2 : Tree or limb.					
Inspector Comment

View of the tree limbs and branches on the LS slope (Spring 2023).

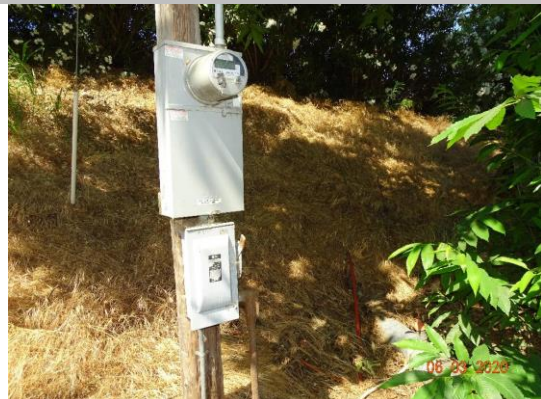
Photo 2 of 3 : UCIP_SP_2023_60578_87850.jpg

Land-Side: Service pole at levee toe

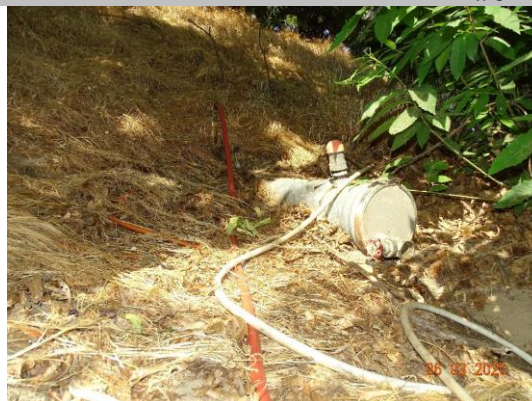
Photo 3 of 3 : UCIP_SP_2023_60578_87844.jpg

Land-Side: Pipe end with air vent at levee toe

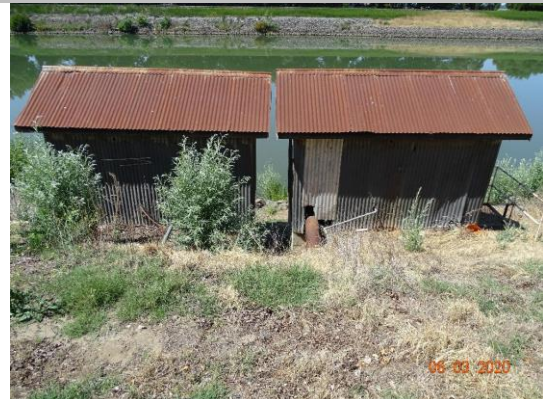
Photo 2 of 3 : UCIP_SP_2023_60623_87870.jpg

Comment Code						
Inspector Comment						
DS_ID:22043 FS_ID:60623 EP_NO: 16800 Repair Type: Urgent EVAL Issue: 1, Pipe Integrity Crossing Status: Found UCIP Comments: 07/21/2022 Record updated from No Action Needed to Urgent. Pipe failed near the landside concrete standpipe. Pipe discovered to have significant wear, pitting, and holes. Enforcement Case No. 2022-15616 issued for this crossing. (O.Yakimov - DWR UCIP) 06/03/2020 Record remains No Action Needed. No issues observed during inspection. (O.Yakimov - DWR UCIP) FIELD_STRUCT_DESC: 16-inch coated steel irrigation pipe through the levee, 4.71 feet below the crown. Pump and butterfly valve in pump house on the waterside (WS) slope. Service poles on the landside (LS) slope. 48-inch concrete riser off the LS toe. 1-inch galvanized iron filler pipe at the same location. This crossing replaces 16-inch pipe (see DSID 25622). (16-inch pipe authorized under Permit No. 16773, 1997 - Joe Green Ranch). [Additional Reference(s) of original crossing: DWR Levee Log, 2005 (HLM 5.01). USACE Sacramento O&M Manual, Unit 111, May 1959, Revised 29 December 2016, (RM 29.79), listed as 16-inch pipe. USACE As-Built Drawing No. 06-13-1100, Sheet 14, 'L' 1560+12, January 1933]. FS Date: 6/3/2020 11:27:14 AM

Water-Side: Pump house on levee slope

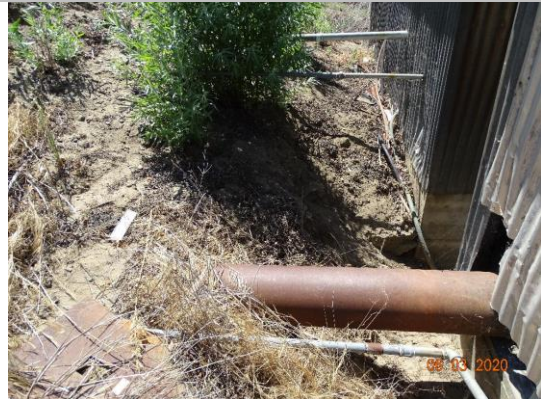
Photo 3 of 3 : UCIP_SP_2023_60623_87871.jpg

Water-Side: Water supply pipe and filler pile at pumphouse on levee slope

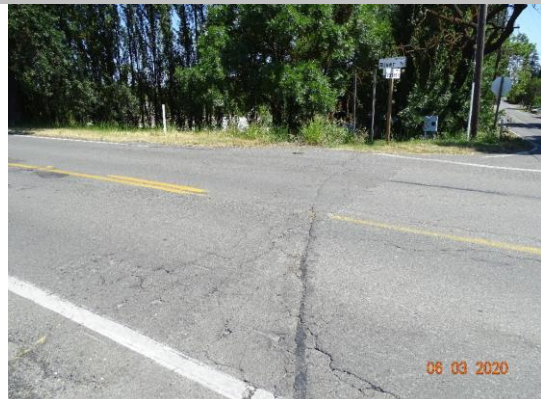
Photo 1 of 3 : UCIP_SP_2023_77178_87875.jpg

DS_ID:22021
FS_ID:77178
EP_NO: 16800
Repair Type: Urgent
EVAL Issue: 1, Pipe Integrity
Crossing Status: Found
UCIP Comments: 08/15/2022 Record updated from No Action Needed to Urgent. Enforcement case 2022-15620 was open for this crossing. Pipe is leaking near landside concrete standpipe and may be damaged by tree roots. (O.Yakimov - DWR UCIP)
06/03/2020 Record remains No Action Needed. No issues observed during inspection. (O.Yakimov - DWR UCIP)
FIELD_STRUCT_DESC: 16-inch coated steel irrigation pipe through the levee, 4.67 feet below the crown. Pump and slide gate in pump house on the waterside (WS) slope. Service poles on the landside (LS) slope. 1-inch galvanized iron filler pipe at the same location. This crossing replaces 16-inch pipe (see DSID 25621). (16-inch pipe authorized under Permit No. 16800, 1997 - William Schultz). [Additional Reference(s) of original crossing: DWR Levee Log, 2005 (HLM 5.01), listed as 14-inch pipe. USACE Sacramento O&M Manual, Unit 111, May 1959, Revised 29 December 2016, (RM 29.79), listed as 16-inch pipe. USACE As-Built Drawing No. 06-13-1100, Sheet 14, 'L' 1560+12, January 1933].

Top of Levee: View of levee crown looking towards landside

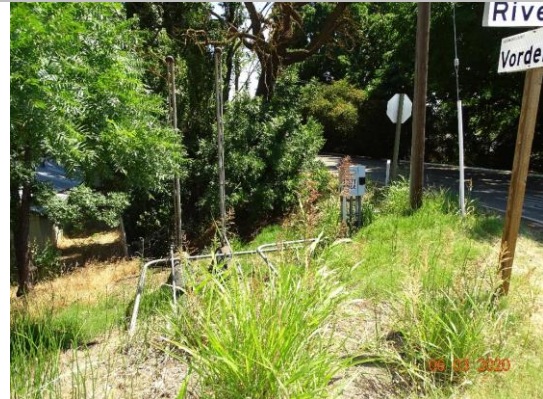
Photo 2 of 3 : UCIP_SP_2023_77178_87878.jpg

Land-Side: View of levee slope looking from crown

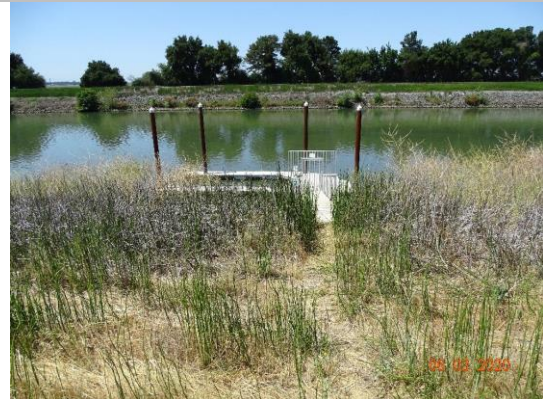
Photo 1 of 3 : UCIP_SP_2023_56199_87884.jpg

Comment Code						
Inspector Comment						
DS_ID:25122 FS_ID:56199 EP_NO: N/A Repair Type: Non-Urgent EVAL Issue: 10, Unauthorized Modification or Non-Compliant Permit Crossing Status: Found UCIP Comments: 06/03/2020 Record is Non-Urgent. Five conduits are visible under bridge to boat launching two of which are open ended. Recommend capping conduits under bridge to prevent water backflow. (O.Yakimov - DWR UCIP) FIELD_STRUCT_DESC: 6-inch wrapped and soil proofed galvanized iron conduit through the levee 2-feet below the crown. Electric, water, and other utility pipes sleeved through conduit with welded steel caps and annular space grouted. (6-inch steel utility chase authorized under Permit No. 18769, 2013 - Michael & Jill Steinbacher). FS Date: 6/3/2020

Water-Side: View of levee slope looking from crown

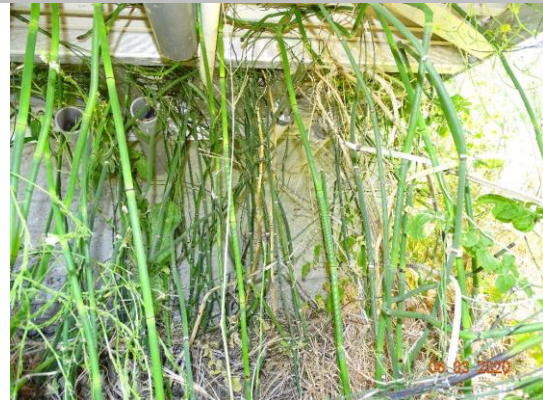
Photo 2 of 3 : UCIP_SP_2023_56199_87885.jpg

Water-Side: Conduits under walkway

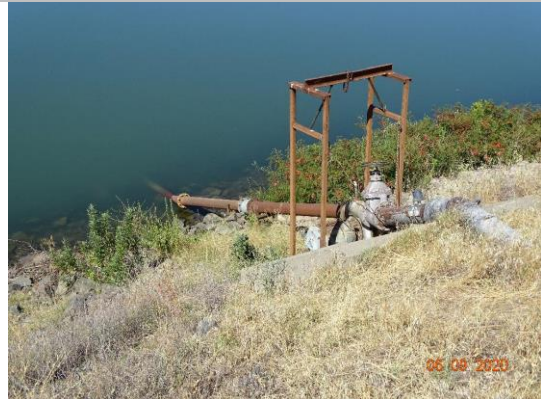
Photo 1 of 3 : UCIP_SP_2023_60630_87896.jpg

Comment Code					
Inspector Comment					
DS_ID:22023 FS_ID:60630 EP_NO: 11131 Repair Type: Urgent EVAL Issue: 2a, Levee Integrity Crossing Status: Found UCIP Comments: 06/09/2020 Record updated from Non-Urgent to Urgent. 7-foot diameter 1-foot deep unauthorized excavation found at landside levee toe next to the concrete standpipe. Excavation is apparently made to expose and fix leaking pipe. Abandoned closure device and concrete standpipe at landside toe. 2.5-inch PVC connected to pipe end at landside toe. Pipe is running - no leaks detected. CMP riser on landside slope missing cover - fall hazard. No permit has been identified authorizing pipe. Need to have CVFPB review ABO and determine current owner. (O.Yakimov - DWR UCIP) 01/15/2014 Based on District notes from January 15, 2014, pump discharge pipe has been repaired. Corrosion holes in pipe at LS toe good indicator that pipe is failing internally. Pipe should be examined internally for damage (video inspect).: As of 12/12/2013 the District discussed with farmer tenant what needed to be done, and the tenant informed the District that they would address the repairs.: As of 12/17/2013 District submitted letter to landowner explaining UCIP report details including photos of the pipe problems FIELD_STRUCT_DESC: 10-inch steel exterior coated irrigation pipe through the levee, 7.7 feet below the crown. Pump and slide gate on a concrete pad on the waterside (WS) slope. Siphon breaker in a 24-inch corrugated metal pipe (CMP) riser on the landside (LS) slope. 36-inch concrete standpipe, shut off device, and power pole with panel box on the LS toe. 1.5-inch galvanized steel electrical conduit at the same location. (10-inch pipe [HLM 5.3] authorized under Automatic Board Order (ABO) issued as Permit No. 11131, 1975 - Helen Crofton Sloane Latimer). [Additional Reference(s): DWR Levee Log, 2005 (HLM 5.30). USACE Sacramento O&M Manual, Unit 111, May 1959, Revised 29 December 2016, (RM 29.52), listed as 9-inch pipe. USACE As-Built Drawing No. 06-13-1100, Sheet 14, 'L' 1571+85, January 1933, listed as 9-inch pipe]. FS Date: 6/9/2020 10:52:00 AM

Water-Side: Pump, slide gate valve, and intake pipe on levee slope

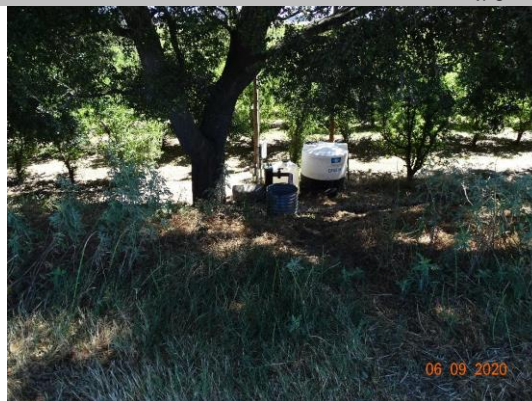
Photo 2 of 3 : UCIP_SP_2023_60636_87920.jpg

Comment Code					
Inspector Comment					
DS_ID:22025 FS_ID:60636 EP_NO: 11134 Repair Type: Non-Urgent EVAL Issue: 4b, Safety Issue Crossing Status: Found UCIP Comments: 06/09/2020 Record updated from No Action Needed to Non-Urgent. CMP riser on landside slope needs a cover - fall hazard. Pipe is running - minor leak through siphon breaker on the top of standpipe and landside toe. No permit has been identified authorizing pipe. Need to have CVFPB review ABO and determine current owner. (O.Yakimov - DWR UCIP) FIELD_STRUCT_DESC: 8-inch irrigation pipe of an unknown material through the levee, 8 feet below the crown. Water pump, gate valve, pressure tank, filler pump on a concrete pad on the waterside (WS) slope. Siphon breaker in a 24-inch CMP riser on the landside (LS) slope. Service pole with electrical panel and meter at landside levee toe. 14-inch steel standpipe with siphon breaker on top at landside toe. 2-inch galvanized steel electrical conduit through the levee at this location. (8-inch pipe [HLM 5.77] authorized under Automatic Board Order (ABO) issued as Permit No. 11134, 1975 - John & Voine B. Molino, et al). [Additional Reference(s): DWR Levee Log, 2005 (HLM 5.77). USACE Sacramento O&M Manual, Unit 111, May 1959, Revised 29 December 2016, (RM 29.03), listed as 6-inch pipe. USACE As-Built Drawing No. 06-13-1100, Sheet 14, upstream of 'L' 1600+60, January 1933, listed as 6-inch pipe]. FS Date: 6/9/2020 2:22:02 PM

Land-Side: View of levee slope looking from crown

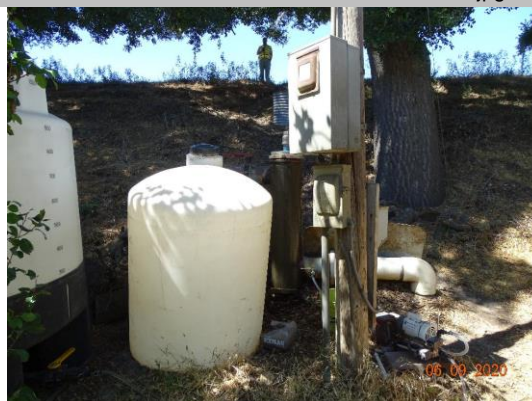
Photo 3 of 3 : UCIP_SP_2023_60636_87922.jpg

Land-Side: Service pole with electrical panels at the toe

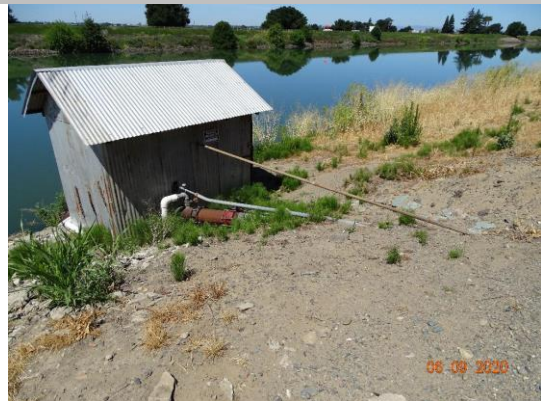
Photo 1 of 3 : UCIP_SP_2023_60641_88028.jpg

Comment Code					
Inspector Comment					
DS_ID:22026 FS_ID:60641 EP_NO: 11123 Repair Type: Non-Urgent EVAL Issue: 10, Unauthorized Modification or Non-Compliant Permit Crossing Status: Found UCIP Comments: 06/09/2020 Record updated from No Action Needed to Non-Urgent. Unable to find a permit authorizing to sleeve 10-inch through 12-inch pipe. (O.Yakimov - DWR UCIP) FIELD_STRUCT_DESC: 10-inch steel irrigation pipe sleeved through the 12-inch steel pipe through the levee, 3.8 feet below the crown. Pump and butterfly valve in pump house on the waterside (WS) slope. 48-inch concrete standpipe on the landside (LS) toe, and a 1.5-inch galvanized iron electrical conduit at the same location with a service pole on the LS slope. (12-inch pipe authorized under Permit No. 1656, 1952 - Alexander Johnson). (10-inch pipe [HLM 5.93] authorized under Automatic Board Order (ABO) issued as Permit No. 11123, 1975 - Anthony & Leonilia Castanho). [Additional Reference(s): DWR Levee Log, 2005 (HLM 5.87), listed as 10-inch pipe. USACE Sacramento O&M Manual, Unit 111, May 1959, Revised 29 December 2016, (RM 28.87), listed as 10-inch pipe]. FS Date: 6/9/2020 3:52:11 PM

Water-Side: View of levee slope looking from crown. Pumphouse on levee slope

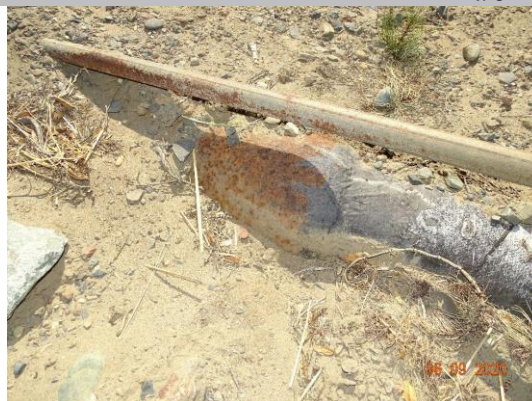
Photo 2 of 3 : UCIP_SP_2023_60641_88029.jpg

Water-Side: Sleeving point on levee slope

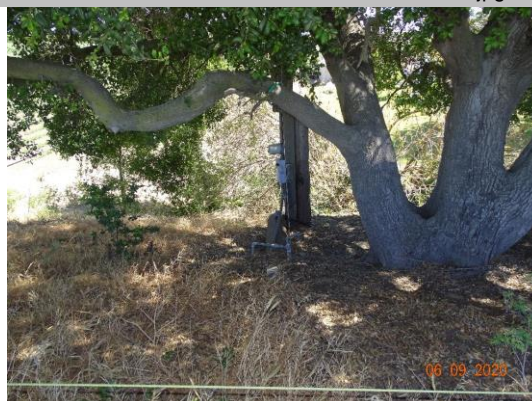
Photo 3 of 3 : UCIP_SP_2023_60641_88032.jpg

Land-Side: View of levee slope looking from crown

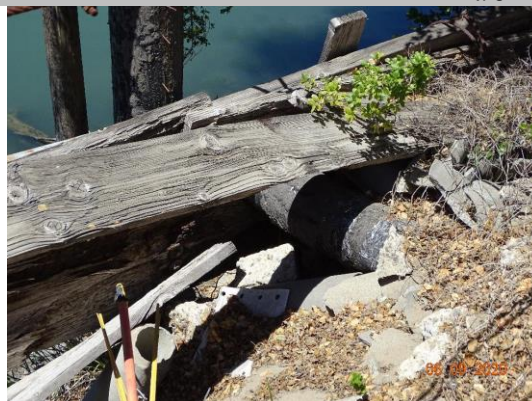
Photo 3 of 3 : UCIP_SP_2023_60650_87930.jpg

Comment Code						
Inspector Comment						
DS_ID:22027 FS_ID:60650 EP_NO: 11122 Repair Type: Non-Urgent EVAL Issue: 10, Unauthorized Modification or Non-Compliant Permit Crossing Status: Indicator Found UCIP Comments: 06/09/2020 Record updated from No Action Needed to Non-Urgent. Pump is moved downstream to a separate piled steel pad and connected to existing 10-inch pipe through the levee. Concrete distribution box at landside toe seems abandoned. Fine media filtration system installed on landside and connected to this crossing. Unable to find permit for system modifications. Pipe is running - minor water leak through pump sealing on waterside slope. (O.Yakimov - DWR UCIP) FIELD_STRUCT_DESC: 10-inch steel exterior coated irrigation pipe through the levee, 8 feet below the crown. Abandoned pile structure on waterside slope and in stream. Pump and butterfly valve on steel piled pad on waterside slope downstream of abandoned structure. Service pole with electrical panel and meter, media filters off landside toe. Abandoned 4-foot by 6-foot concrete distribution box at landside levee toe. This crossing replaces 8-inch pipe (see DSID 21998). (10-inch pipe authorized under Permit No. 4303, 1963 - Robert M. Carmany). (10-inch pipe [HLM 6.21] authorized under Automatic Board Order (ABO) issued as Permit No. 11122, 1975 - Robert M. And Francis Carmany). [Additional Reference(s): DWR Levee Log, 2005 (HLM 6.21)]. FS Date: 6/9/2020 8:33:40 AM

Water-Side: 10-inch pipe at abandoned structure on levee slope

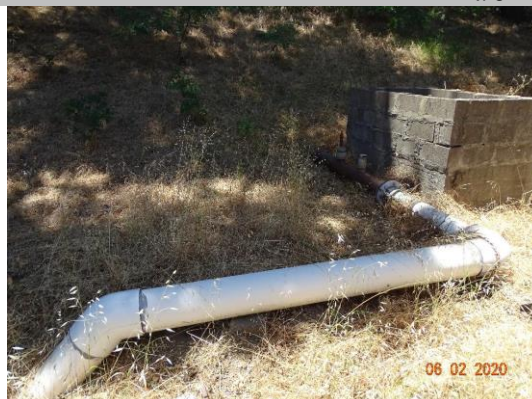
Photo 3 of 3 : UCIP_SP_2023_60690_87965.jpg

Land-Side: 6-inch steel pipe continued with a PVC pipe at the concrete box

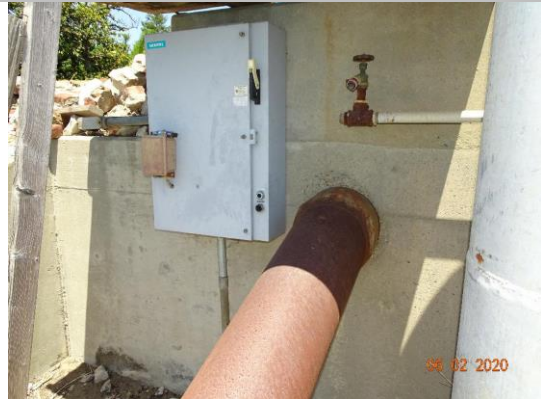
Photo 1 of 3 : UCIP_SP_2023_60696_87977.jpg

Comment Code					
Inspector Comment					
DS_ID:22029 FS_ID:60696 EP_NO: 3354 Repair Type: Non-Urgent EVAL Issue: 10, Unauthorized Modification or Non-Compliant Permit Crossing Status: Found UCIP Comments: 06/02/2020 Record updated from No Action Needed to Non-Urgent. 12-inch pipe sleeved through 14-inch pipe through the levee. Unable to find a permit for modification. Pipe is running - leaks not detected. (O.Yakimov - DWR UCIP) FIELD_STRUCT_DESC: 12-inch steel irrigation pipe sleeved through 14-inch coated steel pipe through the levee, 3.5 feet below the crown. Slant pump on a concrete slab on the waterside (WS) slope. Siphon breaker in a 24-inch corrugated metal pipe (CMP) riser on the landside (LS) shoulder. Slide gate in a 48-inch concrete riser on the LS toe. 1.5-inch electrical conduit at the same location. This crossing replaces 12-inch pipe (see DSID 22000). (14-inch pipe authorized under Permit No. 3354, 1960 - F.I. Christie). [Additional Reference(s): DWR Levee Log, 2005 (HLM 6.53), listed as 14-inch pipe. USACE As-Built Drawing No. 06-13-1100, Sheet 14, 'L' 1640+00, January 1933, , listed as 14-inch pipe]. FS Date: 6/2/2020 2:31:53 PM

Water-Side: 12-inch pipe through 14-inch pipe enter headwall

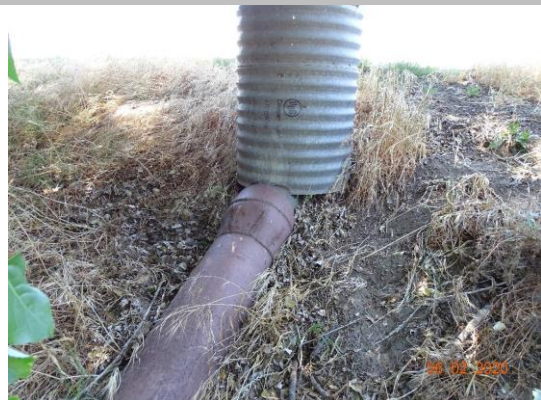
Photo 2 of 3 : UCIP_SP_2023_60696_87979.jpg

Land-Side: Sleeved pipe is visible on levee shoulder

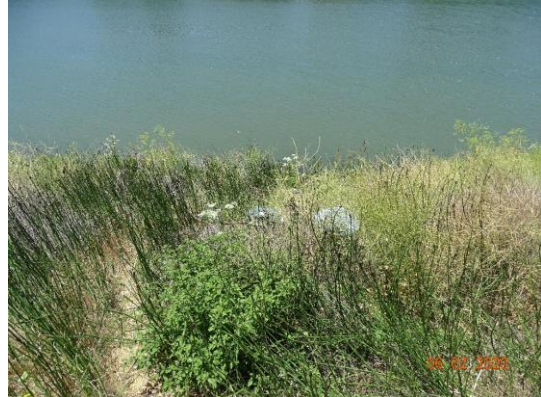
Photo 2 of 3 : UCIP_SP_2023_60701_87987.jpg

Comment Code						
Inspector Comment						
DS_ID:22030 FS_ID:60701 EP_NO: 11126 Repair Type: Non-Urgent EVAL Issue: 10, Unauthorized Modification or Non-Compliant Permit Crossing Status: Found UCIP Comments: 06/02/2020 Record updated from No Action Needed to Non-Urgent. Field measured 8-inch pipe sleeved through 12-inch pipe. Appears that annular space between pipes has been grouted through a plugged hole at landside shoulder. Concrete standpipe and distribution box at landside toe look abandoned. Water is designed to go around concrete box to either underground pipe of screen filter. Unable to find a permit for modifications. Pipe is running - no leaks detected. No permit has been identified authorizing pipe through the levee. Need to have CVFPB review ABO and determine current owner. (O.Yakimov - DWR UCIP) FIELD_STRUCT_DESC: 8-inch irrigation pipe sleeved through the 12-inch steel pipe through the levee, 3 feet below crown. Water pump, filler pump and pressure tank on a concrete pad on the waterside (WS) slope. Butterfly valves at pump and at the landside (LS) toe. Abandoned concrete standpipe and concrete distribution box at landside toe. Screen filter at landside levee toe, service pole a 1.5-inch galvanized electrical conduit at the same location. (12-inch pipe [HLM 6.74] authorized under Automatic Board Order (ABO) issued as Permit No. 11126, 1975 - Alma K. Fletcher). [Additional Reference(s): DWR Levee Log, 2005 (HLM 6.74), listed as 12-inch pipe. USACE Sacramento O&M Manual, Unit 111, May 1959, Revised 29 December 2016, (RM 28.06), listed as 6-inch pipe. USACE As-Built Drawing No. 06-13-1100, Sheet 14, upstream of 'L' 1652+65, January 1933, listed as 6-inch pipe]. FS Date: 6/2/2020 3:17:35 PM

Water-Side: View of levee slope looking from crown

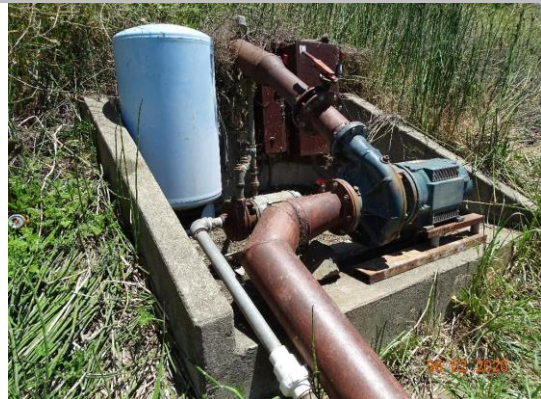
Photo 3 of 3 : UCIP_SP_2023_60701_87994.jpg

Water-Side: View of water pump, filler pump and pressure tank on concrete pad on levee slope
