Flood Control Project Maintenance
Levee Inspections
LMA District Cover Sheet

Reclamation District No. 0551 Pearson

Levee Inspection Report By Mile - Spring 2024

Waterway	Bank	Unit Miles	Inspection Start/End	Inspector
Unit No. 01 Sacramento River	Left	1.83	03/11/2024 03/11/2024	Gregg McMillon

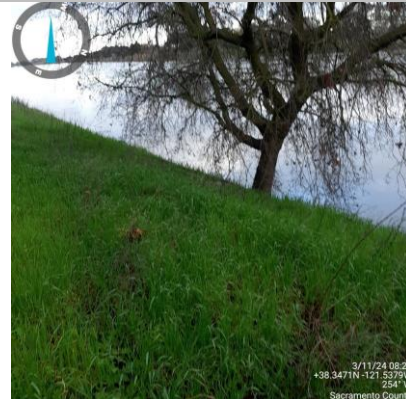
Photo 1 of 1 : SP_2024_RD0755_177_1_20240311_00021.jpg

LM Start	0.10	Rating **	U	Issue No.	1
LM End	0.15	Issue Type +	Ma	Location *	WS
Category	Earthen Levee			GPS Latitude/Longitude	
				Start	End
Item	Vegetation			38.347139°	38.346853°
				-121.537538°	-121.538382°
DWR ID	DWR_RD0755_01_s_2024_1				
Comment Code					
V1 : Control annual grass and weeds on the levee slopes and easements.					
Inspector Comment

View of vegetation on WS slope. (Spring 2024)

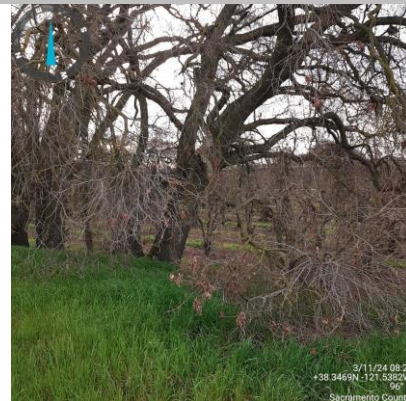
Photo 1 of 1 : SP_2024_RD0755_177_17_20240311_00022.jpg

LM Start	0.10	Rating **	U	Issue No.	17
LM End	0.15	Issue Type +	Ma	Location *	LS
Category	Earthen Levee			GPS Latitude/Longitude	
				Start	End
Item	Vegetation			38.347139°	38.346853°
				-121.537538°	-121.538382°
DWR ID	DWR_RD0755_01_s_2024_17				
Comment Code					
V1 : Control annual grass and weeds on the levee slopes and easements.					
Inspector Comment

View of tall vegetation on LS slope. (Spring 2024)

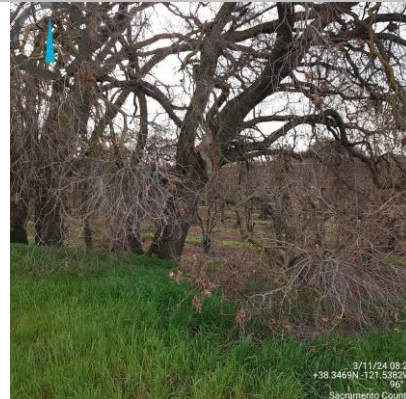
Photo 1 of 1 : SP_2024_RD0755_177_19_20240311_00023.jpg

LM Start	0.14	Rating **	U	Issue No.	19
LM End	0.14	Issue Type +	Ma	Location *	LS
Category	Earthen Levee			GPS Latitude/Longitude	
				Start	End
Item	Trim / Thin Trees			38.347139°	38.347139°
				-121.537538°	-121.537538°
DWR ID	DWR_RD0755_01_s_2024_19				
Comment Code					
T1 : Trim and thin trees to at least five feet above ground level to allow visibility of the ground and room to flood fight.					
Inspector Comment					
Remove tree limbs on LS slope.

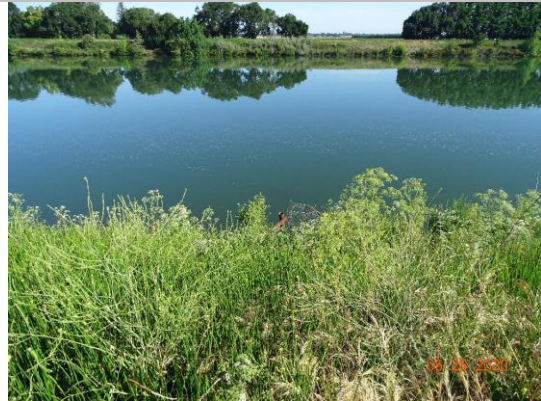
Photo 2 of 3 : UCIP_SP_2024_57010_84336.jpg

Comment Code						
Inspector Comment						
DS_ID:18848 FS_ID:57010 EP_NO: 11221 Repair Type: Urgent EVAL Issue: 1, Pipe Integrity Crossing Status: Found UCIP Comments: 05/26/2020 Record updated to Urgent. Through holes in pipe on LS slope. Open end of electrical conduit without wires at LS toe next to abandoned service pole. These two could pose flood risk to landside. 14-inch to 12-inch pipe welded connection on LS shoulder. Ruined pile structure at riverbank, missing pump. Abandoned service pole at LS toe. Crossing appears abandoned. Need to have CVFPB review ABO and determine current owner. Coordinates of crossing have been updated. (O.Yakimov - DWR UCIP) FIELD_STRUCT_DESC: 14-inch irrigation discharge pipe of an unknown material through the levee, invert elevation 4.2 feet below the crown, 2-inch steel electrical conduit at same location. Pump on a pile structure in the river. Wooden stairs and walkway to the pump. 42-inch concrete standpipe and service pole at landside toe. (14-inch pipe [HLM 0.18] authorized under Automatic Board Order (ABO) issued as Permit No. 11221, 1975 - Greene and Hemly, Inc). [Additional Reference(s): DWR Levee Log, 2005 (HLM 0.18). USACE As-Built Drawing No. 50-04-2983, Sheet 14, RM 36.5, March 1954, listed as 12-inch pipe]. FS Date: 5/26/2020 9:45:18 AM

Water-Side: View of levee slope looking from crown

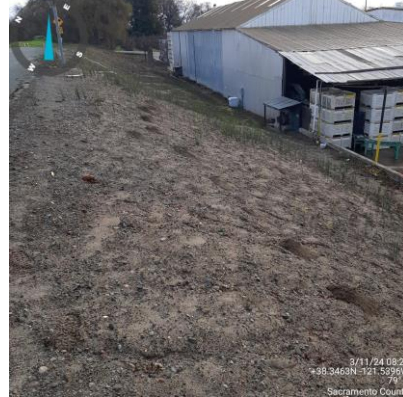
Photo 1 of 1 : SP_2024_RD0755_177_2_20240311_00011.jpg

LM Start	0.23	Rating **	M	Issue No.	2
LM End	0.23	Issue Type +	Ma	Location *	LS
Category	Earthen Levee			GPS Latitude/Longitude	
				Start	End
Item	Animal Control			38.346341°	38.346341°
				-121.539618°	-121.539618°
DWR ID	DWR_RD0755_01_s_2024_2				
Comment Code					
A3 : No rodents visible, but rodent burrows visible; need to backfill and compact or grout burrows.					
Inspector Comment

View of rodent burrow mounds. (Spring 2024)

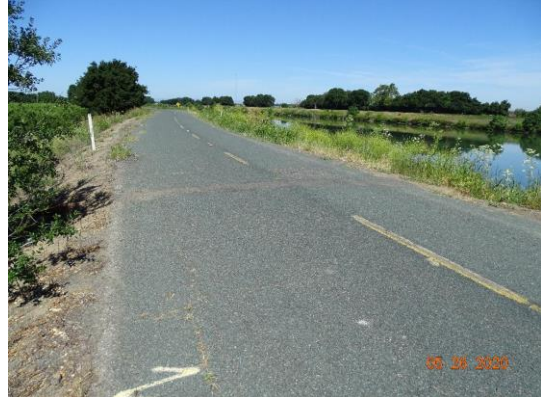
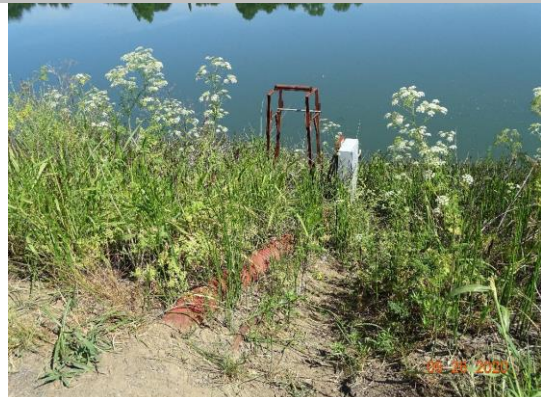
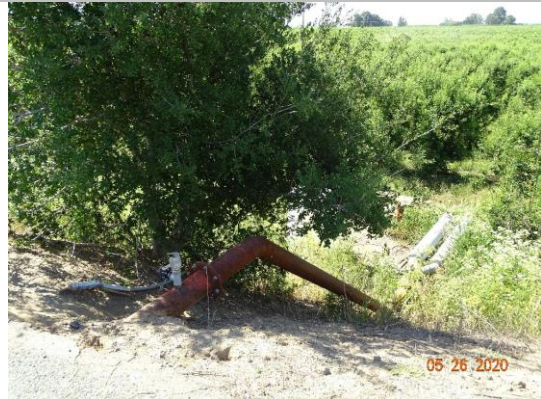
Comment Code						
Inspector Comment						
DS_ID:18849						
FS_ID:57013						
EP_NO: 4302						
Repair Type: Non-Urgent						
EVAL Issue: 11, Maintenance Compliance Issue						
Crossing Status: Found						
UCIP Comments: 05/26/2020 Record remains Non-Urgent. Pump is running, minor leak through pump sealing on WS slope observed. (O.Yakimov - DWR UCIP)						
08/06/2013 FBC about 2 feet.Power conduit also through the levee.Wet ground on pump site/location. May need investigation about wet ground.						
FIELD_STRUCT_DESC: 8-inch coated steel irrigation discharge pipe through the levee, 2 feet below the crown. 2-inch electrical conduit through the levee at same location. Pump, electrical box, and control valve on the waterside (WS) slope. Siphon breaker on the landside (LS) shoulder. Pipe connected to two screen filters on LS. Service pole at the LS toe. (8-inch pipe [HLM 0.43] authorized under Permit No. 4302, 1963 - E. C. Hemly). [Additional Reference(s): DWR Levee Log, 2005 (HLM 0.44)].

Top of Levee: View on levee crown at the crossing looking downstream

Water-Side: View of levee slope looking from crown

Land-Side: View of levee slope looking from crown

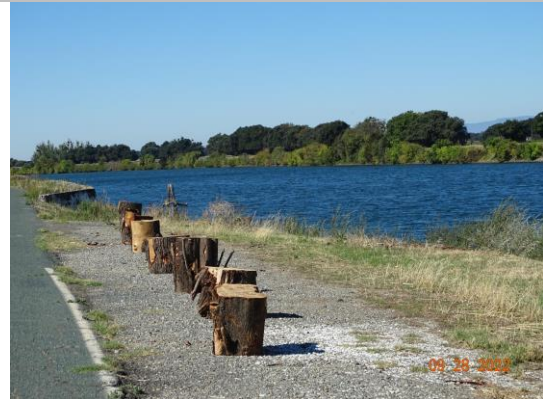
Photo 1 of 1 : SP_2024_RD0755_177_38_20240301_00009.jpg

LM Start	0.59	Rating **	A/W	Issue No.	38
LM End	0.59	Issue Type +	En	Location *	WS
Category	Earthen Levee			GPS Latitude/Longitude	
				Start	End
Item	Encroachments			38.345490°	38.345490°
				-121.546098°	-121.546098°
DWR ID	DWR_RD0755_01_f _ 2022_38				
Comment Code					
MISC : Miscellaneous					
Inspector Comment					
There are tree logs on the WS shoulder to prevent parking.

View of the logs on the WS shoulder (Fall 2022).

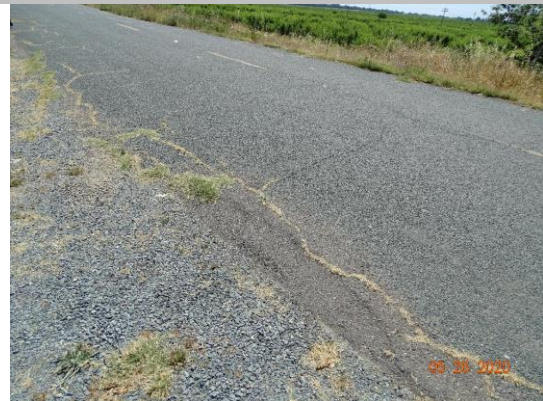
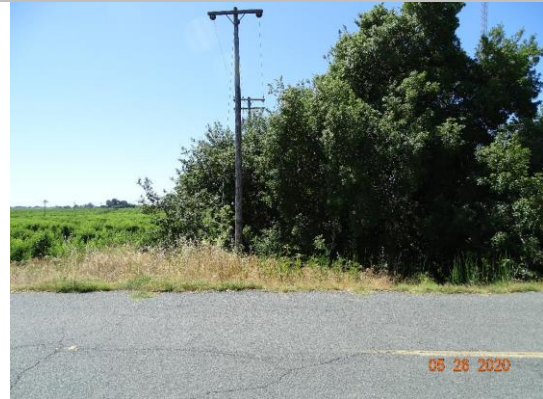
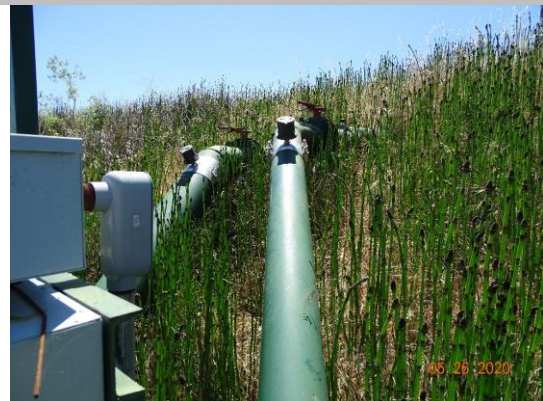
Comment Code						
Inspector Comment						
DS_ID:18850 FS_ID:57034 EP_NO: 4637 Repair Type: Non-Urgent EVAL Issue: 10, Unauthorized Modification or Non-Compliant Permit Crossing Status: Found UCIP Comments: 05/26/2020 Record updated from No Action Needed to Non-Urgent. Pumping platform on pile structure in the river has been removed. Unable to find permit authorizing modifications to this crossing to sleeve 12-inch pipe through 16-inch pipe. (O.Yakimov - DWR UCIP) 08/06/2013 12-inch steel pipe sleeved through 16 in steel pipe. Pump was running during field survey. FIELD_STRUCT_DESC: 12-inch pipe sleeved through a 16-inch coated steel irrigation discharge pipe through the levee, 5 feet below the crown. Pump on pumping platform of WS slope with stairs to the pump. Flow meter installed on 12-inch pipe. This crossing replaces 16-inch pipe (see DSID 25613). (Replacement of a portion of 16-inch pipe through the levee section authorized under Permit No. 4637, 1964 - Green and McKeown Farms, Inc). [Additional Reference(s): DWR Levee Log, 2005 (HLM 0.70). USACE Sacramento O&M Manual, Unit 111, May 1959, Revised 29 December 2016, (RM 35.90), listed as 14-inch pipe]. FS Date: 5/26/2020 8:27:31 AM

Top of Levee: View of levee crown at the crossing looking upstream

Land-Side: View of landside looking from crown

Water-Side: View of levee slope looking towards crown

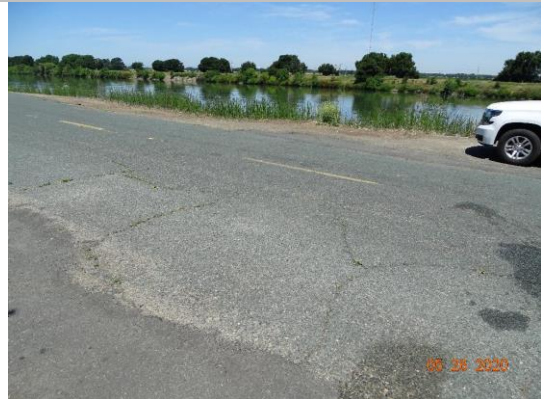
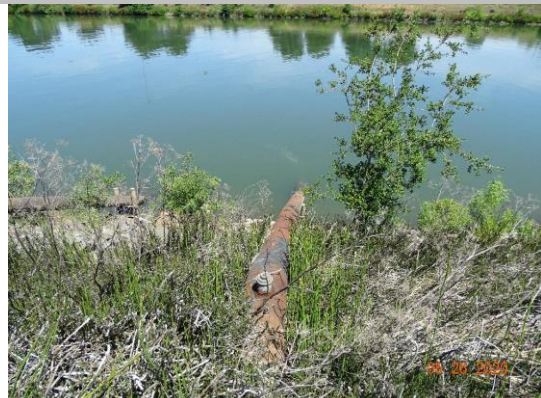
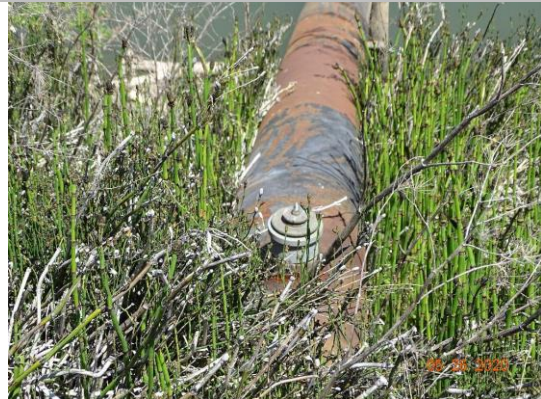
Comment Code					
Inspector Comment					
DS_ID:18852 FS_ID:57038 EP_NO: 11222 Repair Type: Non-Urgent EVAL Issue: Crossing Status: Found UCIP Comments: 05/26/2020 Record updated from No Action Needed to Non-Urgent. No permit has been identified authorizing pipe. Pipe was running during site visit pumping water to the waterside. (O.Yakimov - DWR UCIP) 08/06/2013 It was working during field survey. A pump found 150 ft from the levee. Not sure whether the pump belong to this drainage system. FIELD_STRUCT_DESC: 16-inch steel drainage pipe sleeved through a 24-inch steel drainage pipe through the levee, invert elevation 8 feet below the crown. Air vent installed on the pipe on WS slope. Concrete headwall on LS. (12-inch pipe sleeved through 24-inch pipe-inch pipe [HLM 0.71] authorized under Automatic Board Order (ABO) issued as Permit No. 11222, 1975 - Green McKeown, Inc). [Additional Reference(s): DWR Levee Log, 2005 (HLM 0.71), referenced as 12-inch pipe through 24-inch pipe. USACE Sacramento O&M Manual, Unit 111, May 1959, Revised 29 December 2016, (RM 35.89), listed as 24-inch pipe]. FS Date: 5/26/2020 3:00:07 PM

Top of Levee: View of levee crown looking downstream

Water-Side: View of levee slope looking from crown

Water-Side: Pipe and air release valve on levee slope

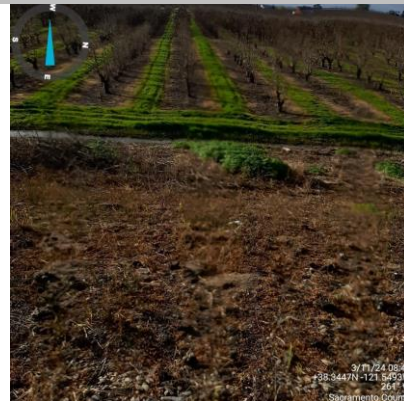
Photo 1 of 1 : SP_2024_RD0755_177_7_20240311_00015.jpg

LM Start	0.80	Rating **	M	Issue No.	7
LM End	0.80	Issue Type +	En	Location *	LS
Category	Earthen Levee			GPS Latitude/Longitude	
				Start	End
Item	Encroachments			38.344650°	38.344650°
				-121.549875°	-121.549875°
DWR ID	DWR_RD0755_01_s_2024_7				
Comment Code					
PR : Prunings					
Inspector Comment					
Pruning pile to be removed on the LS slope.

View of pruning pile on the LS slope. (Spring 2024)

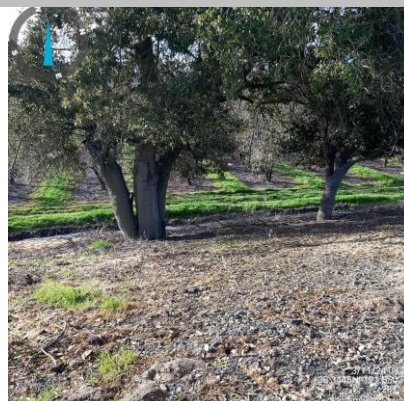
Photo 1 of 1 : SP_2024_RD0755_177_8_20240311_00016.jpg

LM Start	0.82	Rating **	M	Issue No.	8
LM End	0.82	Issue Type +	Ma	Location *	LS
Category	Earthen Levee			GPS Latitude/Longitude	
				Start	End
Item	Trim / Thin Trees			38.344544°	38.344544°
				-121.550270°	-121.550270°
DWR ID	DWR_RD0755_01_s_2024_8				
Comment Code					
T2 : Tree or limb.					
Inspector Comment					
Remove tree limbs on LS slope.

View of tree limbs on the LS slope. (Spring 2024)

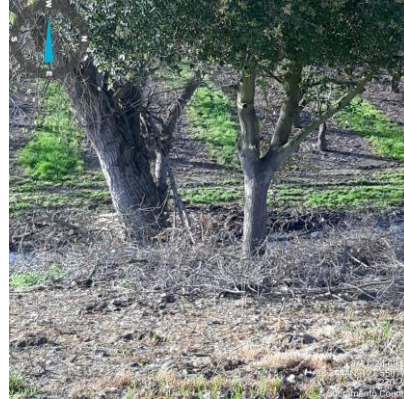
Photo 1 of 1 : SP_2024_RD0755_177_9_20240311_00017.jpg

LM Start	0.85	Rating **	M	Issue No.	9
LM End	0.85	Issue Type +	Ma	Location *	LS
Category	Earthen Levee			GPS Latitude/Longitude	
				Start	End
Item	Trim / Thin Trees			38.344413°	38.344413°
				-121.550772°	-121.550772°
DWR ID	DWR_RD0755_01_s_2024_9				
Comment Code					
T2 : Tree or limb.					
Inspector Comment					
Remove tree limbs on LS slope.

View of tree limbs on the LS slope. (Spring 2024)

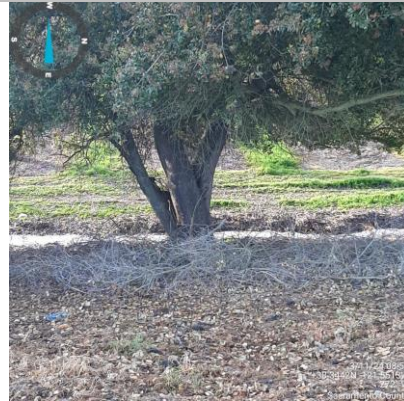
Photo 1 of 1 : SP_2024_RD0755_177_11_20240311_00018.jpg

LM Start	0.89	Rating **	M	Issue No.	11
LM End	0.89	Issue Type +	Ma	Location *	LS
Category	Earthen Levee			GPS Latitude/Longitude	
				Start	End
Item	Trim / Thin Trees			38.344260°	38.344260°
				-121.551376°	-121.551376°
DWR ID	DWR_RD0755_01_s_2024_11				
Comment Code					
T2 : Tree or limb.					
Inspector Comment					
Remove tree limbs on LS slope.

View of tree limbs on the LS slope. (Spring 2024)

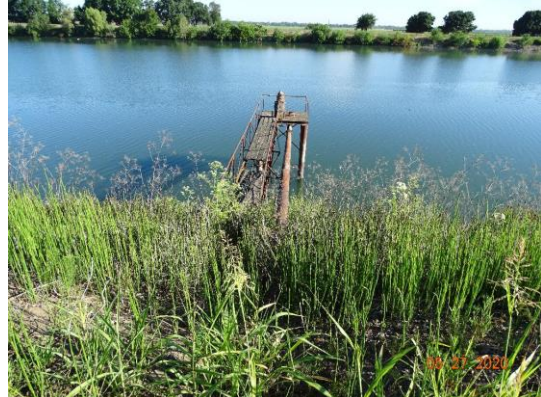
Photo 3 of 3 : UCIP_SP_2024_57080_84495.jpg

DS_ID:18855
FS_ID:57080
EP_NO: 11225
Repair Type: Urgent
EVAL Issue: 1, Pipe Integrity
Crossing Status: Found
UCIP Comments: 05/27/2020 Record updated from Non-Urgent to Urgent. Through holes in pipe on waterside slope, sinkhole on WS shoulder measures 3'x3'x1'. Erosion continues to levee crown - road pavement. Asphalt patch repair on the crown. Knocked down service pole with electric box on LS slope. Crossing appears abandoned. Need to have CVFPB review ABO and determine current owner. (O.Yakimov - DWR UCIP)
08/06/2013 Abandoned pipe and pump. Service pole, power box lying on LS slope.
FIELD_STRUCT_DESC: 10-inch irrigation discharge pipe of an unknown material and a 1-inch electrical conduit through the levee, invert elevation 5.6 feet below the crown. Pump on a pile structure with a walkway to the pump. Abandoned service pole on the landside (LS) slope. (10-inch pipe [HLM 0.94] authorized under Automatic Board Order (ABO) issued as Permit No. 11225, 1975 - Helen D. Wilson). [Additional Reference(s): DWR Levee Log, 2005 (HLM 0.94). USACE Sacramento O&M Manual, Unit 111, May 1959, Revised 29 December 2016, (RM 35.66), listed as 10-inch pipe. USACE As-Built Drawing No. 50-04-2983, Sheet 13, downstream of Station 515+00, March 1954].

Water-Side: View of levee slope looking from crown

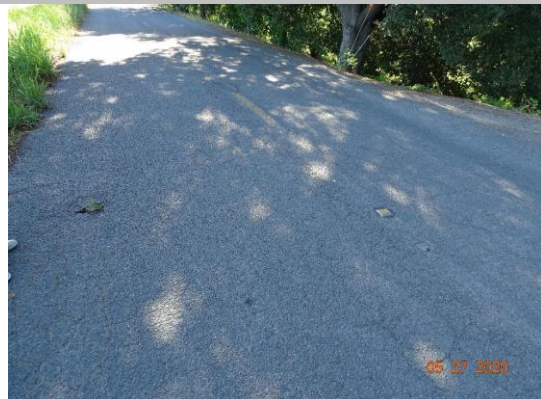
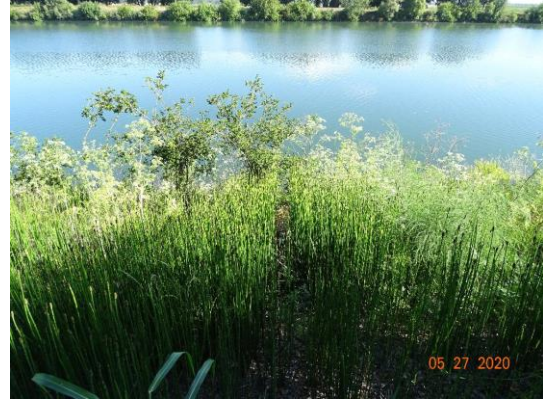
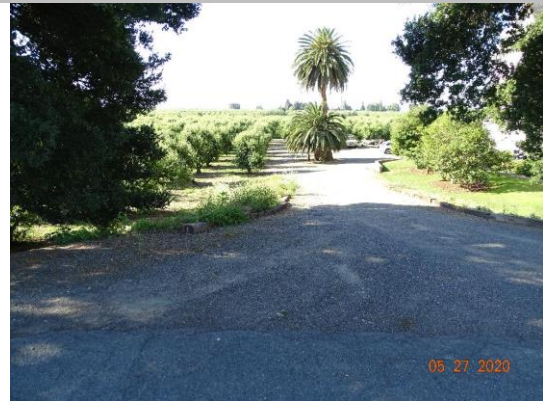
DS_ID:18856
FS_ID:57081
EP_NO: N/A
Repair Type: Non-Urgent
EVAL Issue: 6, Levee Damage or Threat for Levee Damage
Crossing Status: Found
UCIP Comments: 05/27/2020 Record remains Non-Urgent. A sinkhole is developing on levee crown closer to waterside hinge. The sinkhole is currently measuring 12"x18" in size. Was unable to locate pipe on landside slope. Crossing appears abandoned. No permit has been identified authorizing pipe. (O.Yakimov - DWR UCIP)
08/06/2013 Needs to be properly abandoned.
FIELD_STRUCT_DESC: 12-inch pipe of an unknown material or purpose through the levee, invert elevation 5 feet below the crown. Siphon breaker on the waterside (WS). Pipe not found on the landside (LS). [Additional Reference(s): DWR Levee Log, 2005 (HLM 1.05). USACE Sacramento O&M Manual, Unit 111, May 1959, Revised 29 December 2016, (RM 35.55), listed as 12-inch pipe].
FS Date: 5/27/2020 7:33:53 AM

Top of Levee: View of levee crown looking upstream

Water-Side: View of levee slope looking from crown

Land-Side: View of levee slope looking from crown

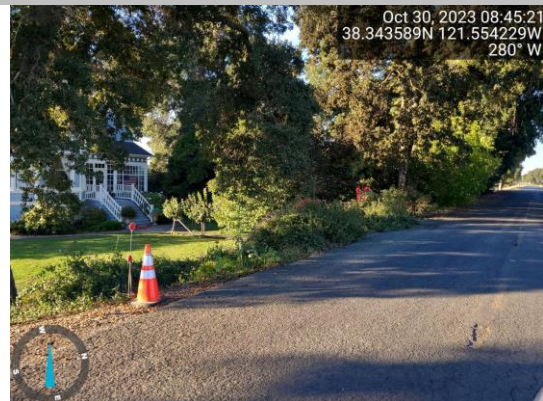
Photo 1 of 1 : SP_2024_RD0755_177_23_20240301_00005.jpg

LM Start	1.05	Rating **	M	Issue No.	23
LM End	1.08	Issue Type +	En	Location *	LS
Category	Earthen Levee			GPS Latitude/Longitude	
				Start	End
Item	Vegetation			38.343595°	38.343487°
				-121.554238°	-121.554768°
DWR ID	DWR_RD0755_01_s_2017_23				
Comment Code					
V6 : Landscaping					
Inspector Comment					
Ground vegetation, shrubs and trees should be maintained to allow inspection and access to landside slope and toe.

View of the landscaping on the LS slope (Fall 2023).

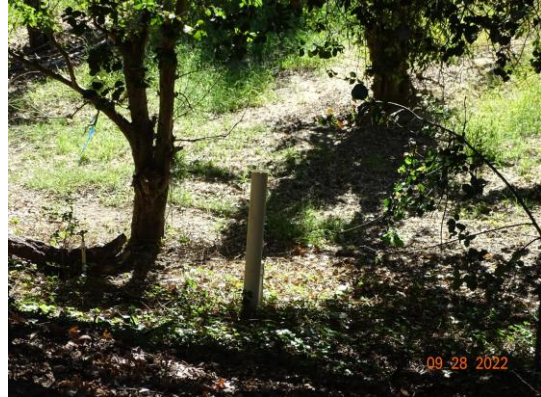
Photo 1 of 1 : SP_2024_RD0755_177_44_20240301_00010.jpg

LM Start	1.08	Rating **	M	Issue No.	44
LM End	1.08	Issue Type +	En	Location *	LS
Category	Earthen Levee			GPS Latitude/Longitude	
				Start	End
Item	Encroachments			38.343470°	38.343470°
				-121.554775°	-121.554775°
DWR ID	DWR_RD0755_01_f_2019_44				
Comment Code					
LI : Landscape Irrigation					
Inspector Comment					
Landscape valve and sprinkler are on the landside slope.

View of the valve and sprinkler on the LS slope (Fall 2022).

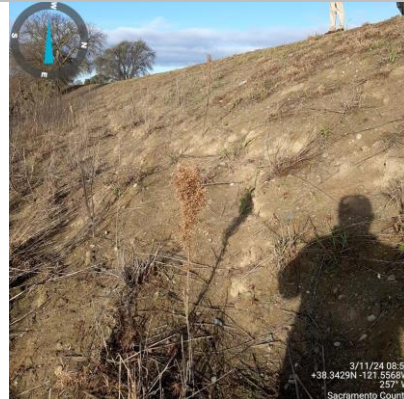
Photo 1 of 1 : SP_2024_RD0755_177_12_20240311_00019.jpg

LM Start	1.20	Rating **	A/W	Issue No.	12
LM End	1.20	Issue Type +	Ma	Location *	LS
Category	Earthen Levee			GPS Latitude/Longitude	
				Start	End
Item	Erosion / Bank Caving			38.342957°	38.342957°
				-121.557019°	-121.557019°
DWR ID	DWR_RD0755_01_s_2024_12				
Comment Code					
E1 : Note and monitor erosion site.					
Inspector Comment					
Monitor erosion on LS slope.

View of erosion on LS slope. (Spring 2024)

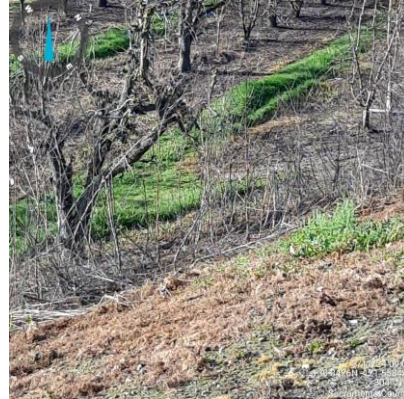
Photo 1 of 1 : SP_2024_RD0755_177_13_20240311_00020.jpg

LM Start	1.30	Rating **	M	Issue No.	13
LM End	1.31	Issue Type +	Ma	Location *	LS
Category	Earthen Levee			GPS Latitude/Longitude	
				Start	End
Item	Vegetation			38.342426°	38.342415°
				-121.558813°	-121.558843°
DWR ID	DWR_RD0755_01_s_2024_13				
Comment Code					
V2 : Remove the wild growth and woody vegetation other than native grasses from the levee slopes.					
Inspector Comment

View of woody vegetation on the LS slope. (Spring 2024)

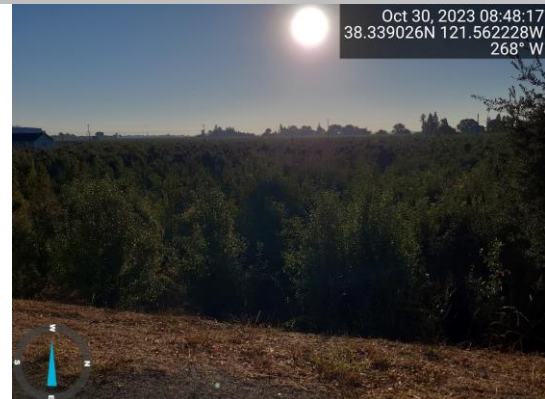
Photo 1 of 1 : SP_2024_RD0755_177_33_20240301_00008.jpg

LM Start	1.58	Rating **	M	Issue No.	33
LM End	1.72	Issue Type +	En	Location *	LS
Category	Earthen Levee			GPS Latitude/Longitude	
				Start	End
Item	Encroachments			38.339360°	38.337767°
				-121.561855°	-121.563602°
DWR ID	DWR_RD0755_01_s_2019_33				
Comment Code					
CR : Crops					
Inspector Comment					
Pear trees are on the landside slope.

View of the trees along the LS toe (Fall 2023).

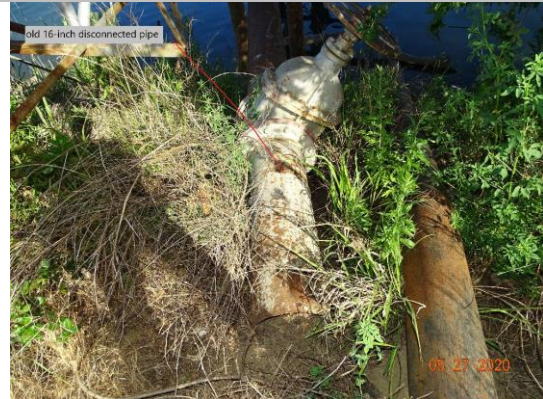
Photo 2 of 3 : UCIP_SP_2024_57084_84538.jpg

DS_ID:18858
FS_ID:57084
EP_NO: 11219
Repair Type: Non-Urgent
EVAL Issue: 10, Unauthorized Modification or Non-Compliant Permit
Crossing Status: Found
UCIP Comments: 05/27/2020 Record remains Non-Urgent. 14-inch supply pipe segment on waterside cut off between closure device and levee shoulder and replaced with 12-inch pipe from WS shoulder to riverbank. Pump house with a pump at LS toe was built. 8-inch pipe daylights in this pump house. Pump on pile structure in the river and walkway to the pump have been abandoned. 2-inch electrical conduit through the levee has open end with no wires on LS shoulder - should be abandoned properly. Need to have CVFPB review ABO and determine current owner. (O.Yakimov - DWR UCIP)
08/06/2013 Pump and walkway seem abandoned.- Power line is not connected with pump.- A pump house like structure found on LS levee toe.
FIELD_STRUCT_DESC: 14-inch irrigation discharge pipe of an unknown material through the levee, invert elevation 8.5 feet below the crown. Pump house at landside levee toe. Siphon breaker and power pole on the landside (LS) slope. 2-inch electrical conduit through the levee at the same location. Pump on pile structure in the river and walkway to the pump have been abandoned. (14-inch pipe [HLM 1.65] authorized under Automatic Board Order (ABO) issued as Permit No. 11219, 1975 - David J. Jr and Bonnie Elliott). [Additional Reference(s): DWR Levee Log, 2005 (HLM 1.65). USACE Sacramento O&M Manual, Unit 111, May 1959, Revised 29 December 2016, (RM35.02), 14-inch pipe referenced in RD0551. USACE As-Built Drawing No. 50-4-2983, Sheet 11, page 15, March 1954. USACE As-Built Drawing No. 06-13-1100, Sheet 12, near 'L' 1283+75, January 1933].

LM Start	1.64	Rating **	M	Issue No.	52 (cont)
LM End	1.64	Issue Type +	En	Location *	
Category	Supplemental		GPS Latitude/Longitude		
			Start	End	
Item	DWR UCIP Field Study		38.338715°	38.338715°	
			-121.562560°	-121.562560°	
DWR ID	18858

Water-Side: 16-inch supply pipe has been cut off between levee slope and shut off device

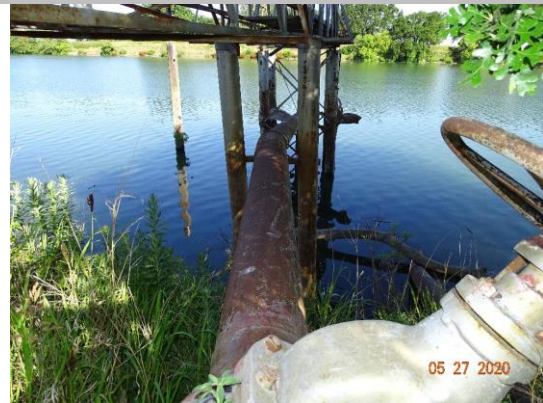
Photo 3 of 3 : UCIP_SP_2024_57084_84539.jpg

Water-Side: Abandoned 16-inch supply pipe under walkway and pumping pier on riverbank

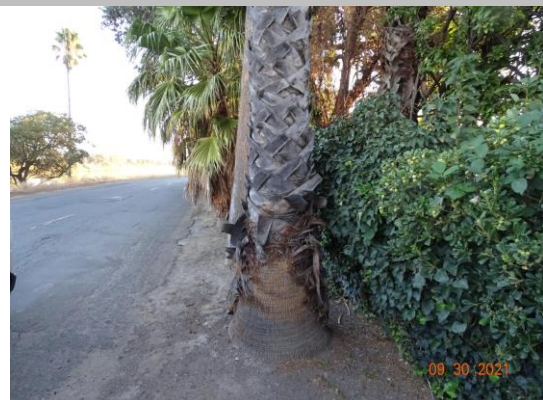
Photo 1 of 1 : SP_2024_RD0755_177_25_20240301_00006.jpg

LM Start	1.73	Rating **	U	Issue No.	25
LM End	1.84	Issue Type +	En	Location *	LS
Category	Earthen Levee			GPS Latitude/Longitude	
				Start	End
Item	Vegetation			38.337688°	38.336437°
				-121.563738°	-121.564800°
DWR ID	DWR_RD0755_01_f_2017_25				
Comment Code					
V6 : Landscaping					
Inspector Comment					
Landscaping on the landside should be maintained to allow inspection and access to levee slope and toe.

View looking upstream at landscaping on the landside slope (Fall 2021).

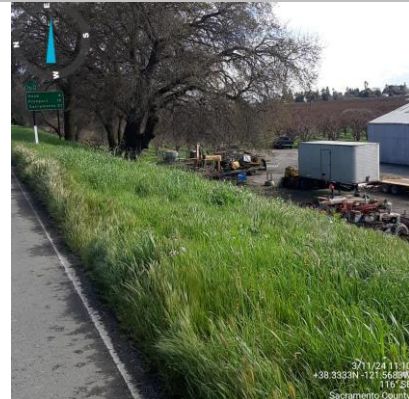
Photo 1 of 1 : SP_2024_RD0551_175_81_20240318_00126.jpg

LM Start	0.04	Rating **	U	Issue No.	81
LM End	0.32	Issue Type +	Ma	Location *	LS
Category	Earthen Levee			GPS Latitude/Longitude	
				Start	End
Item	Vegetation			38.335814°	38.332974°
				-121.565075°	-121.568568°
DWR ID	DWR_RD0551_01_s_2024_81				
Comment Code					
V1 : Control annual grass and weeds on the levee slopes and easements.					
Inspector Comment

View of tall grass on the LS slope. (Spring 2024)

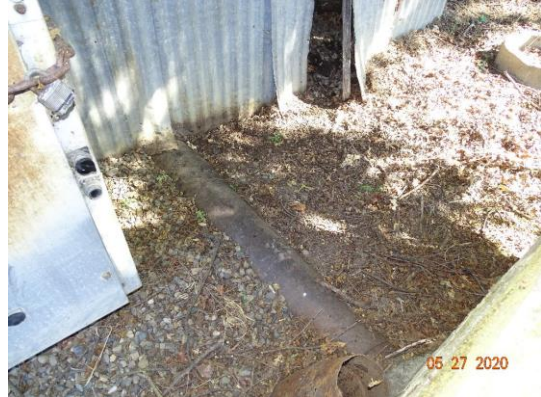
Photo 3 of 3 : UCIP_SP_2024_57695_85477.jpg

Comment Code					
Inspector Comment					
DS_ID:21971 FS_ID:57695 EP_NO: 8664 Repair Type: Non-Urgent EVAL Issue: 10, Unauthorized Modification or Non-Compliant Permit Crossing Status: Found UCIP Comments: 05/27/2020 Record updated from No Action Needed to Non-Urgent. 8-inch pipe sleeved through 10-inch pipe. Installed new pump with gate valve and pressure booster, service pole with electric panel next to pumphouse. Abandoned pump and gate valve in pump house, abandoned 48-inch and 24-inch concrete standpipes at pump house on the LS toe. Unable to locate a permit authorizing modification. Need to have CVFPB review ABO and determine current owner. (O.Yakimov - DWR UCIP) FIELD_STRUCT_DESC: 8-inch pipe sleeved through 10-inch coated steel irrigation pipe through the levee, 5 feet below the crown. Pump with gate valve and pressure booster, service pole with electrical panel next to pumphouse on the landside slope. (Retention of irrigation pumping plant, centrifugal pump and gate valve in pump house, landside toe of the levee [HLM 0.05] authorized under Automatic Board Order (ABO) issued as Permit No. 8664, 1972 - Lincoln Chan). [Additional Reference(s): DWR Levee Log, 2005 (HLM 0.05). USACE Sacramento O&M Manual, Unit 111, May 1959, Revised 29 December 2016, (RM 34.75), listed as 10-inch pipe]. FS Date: 5/27/2020 10:13:34 AM

LM Start	0.07	Rating **	M	Issue No.	94 (cont)
LM End	0.07	Issue Type +	En	Location *	
Category	Supplemental			GPS Latitude/Longitude	
				Start	End
Item	DWR UCIP Field Study			38.335670 °	38.335670 °
				-121.565490 °	-121.565490 °
DWR ID	21971

Land-Side: Abandoned 10-inch pipe between pumphouse and concrete standpipe

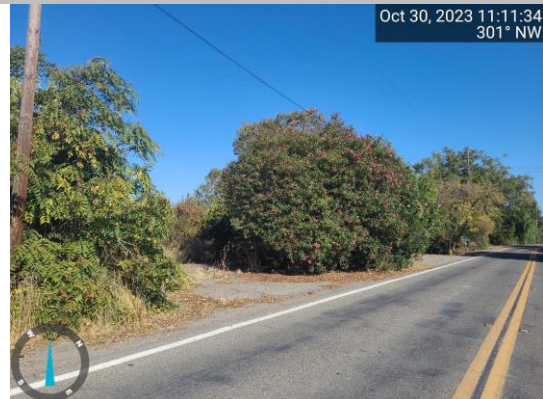
Photo 1 of 1 : SP_2024_RD0551_175_17_20240301_00004.jpg

LM Start	0.40	Rating **	U	Issue No.	17
LM End	0.51	Issue Type +	En	Location *	WS
Category	Earthen Levee			GPS Latitude/Longitude	
				Start	End
Item	Vegetation			38.332115°	38.330818°
				-121.569658°	-121.570980°
DWR ID	DWR_RD0551_01_f_2018_17				
Comment Code					
V6 : Landscaping					
Inspector Comment					
Trim oleanders on waterside hinge.

View looking upstream of landscaping blocking view down waterside slope (Fall 2023).

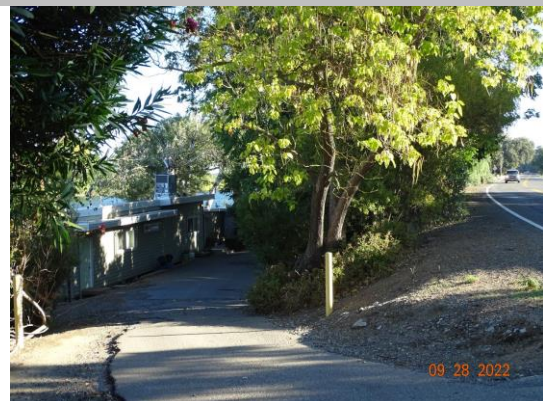
Photo 1 of 1 : SP_2024_RD0551_175_21_20240301_00006.jpg

LM Start	0.49	Rating **	M	Issue No.	21
LM End	0.49	Issue Type +	En	Location *	WS
Category	Earthen Levee			GPS Latitude/Longitude	
				Start	End
Item	Encroachments			38.331063°	38.331063°
				-121.570634°	-121.570634°
DWR ID	DWR_RD0551_01_s_2014_21				
Comment Code					
BU : Building					
Inspector Comment					
11750 River Road - The new land owner is working with the LMA trying to get CVFPB Permits for this project. No other work at this site. Waiting to hear from Enforcements.

View of the building on the WS toe (Fall 2022).

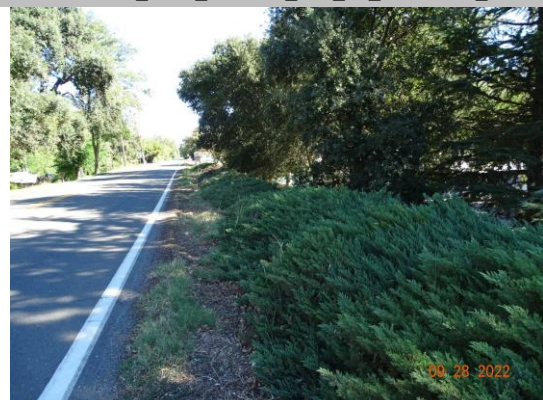
Photo 1 of 1 : SP_2024_RD0551_175_69_20240301_00029.jpg

LM Start	0.56	Rating **	M	Issue No.	69
LM End	0.59	Issue Type +	En	Location *	LS
Category	Earthen Levee			GPS Latitude/Longitude	
				Start	End
Item	Vegetation			38.330242°	38.329830°
				-121.571405°	-121.571725°
DWR ID	DWR_RD0551_01_f_2019_69				
Comment Code					
V6 : Landscaping					
Inspector Comment

View of the landscaping on the LS slope (Fall 2022).

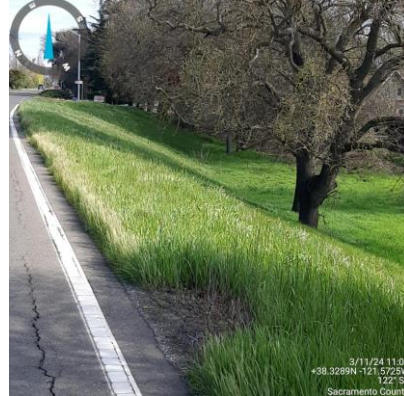
Photo 1 of 1 : SP_2024_RD0551_175_80_20240318_00128.jpg

LM Start	0.60	Rating **	U	Issue No.	80
LM End	0.72	Issue Type +	Ma	Location *	LS
Category	Earthen Levee			GPS Latitude/Longitude	
				Start	End
Item	Vegetation			38.329786°	38.328317°
				-121.571850°	-121.573030°
DWR ID	DWR_RD0551_01_s_2024_80				
Comment Code					
V1 : Control annual grass and weeds on the levee slopes and easements.					
Inspector Comment

View of tall grass on the LS slope. (Spring 2024)

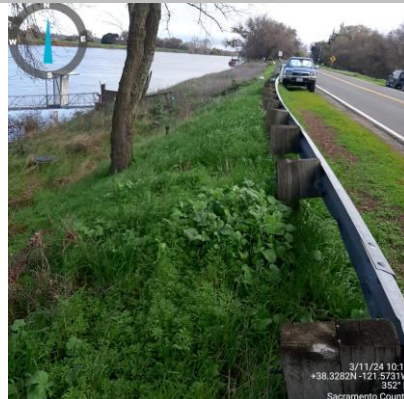
Photo 1 of 1 : SP_2024_RD0551_175_39_20240311_00102.jpg

LM Start	0.60	Rating **	U	Issue No.	39
LM End	1.40	Issue Type +	Ma	Location *	WS
Category	Earthen Levee			GPS Latitude/Longitude	
				Start	End
Item	Vegetation			38.329786°	38.318979°
				-121.571850°	-121.576508°
DWR ID	DWR_RD0551_01_s_2024_39				
Comment Code					
V1 : Control annual grass and weeds on the levee slopes and easements.					
Inspector Comment

View of tall grass on WS slope. (Spring 2024)

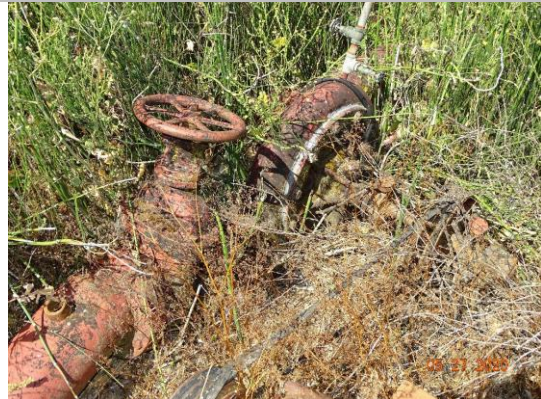
Photo 1 of 3 : UCIP_SP_2024_60085_87347.jpg

Comment Code						
Inspector Comment						
DS_ID:21985 FS_ID:60085 EP_NO: 6220 Repair Type: Non-Urgent EVAL Issue: 6, Levee Damage or Threat for Levee Damage Crossing Status: Found UCIP Comments: 05/27/2020 Record remains Non-Urgent. Two sinkholes on waterside levee slope that measure 18"x 12"x 6" deep found in pipe alignment. Crossing appears abandoned. Pipe is heavily rusted at riverbank. From conversation with adjacent property owner found out that pipe is located on easement to the property just across from the crossing and used to serve water for orchard on landside. (O.Yakimov - DWR UCIP) 04/10/2013 Pipe abandoned and should be removed. (W.Wylie - DWR UCIP) FIELD_STRUCT_DESC: 8-inch coated steel irrigation pipe through the levee, 6.1 feet below the crown. Pump on the waterside (WS) with slide gate and air vent. (8-inch pipe authorized under Permit No. 6220, 1968 - Robert U. Grant). [Additional Reference(s): DWR Levee Log, 2005 (HLM 0.71)]. FS Date: 5/27/2020 8:59:30 AM

LM Start	0.71	Rating **	M	Issue No.	95 (cont)
LM End	0.71	Issue Type +	En	Location *

Water-Side: Abandoned pipe, pump, and gate valve

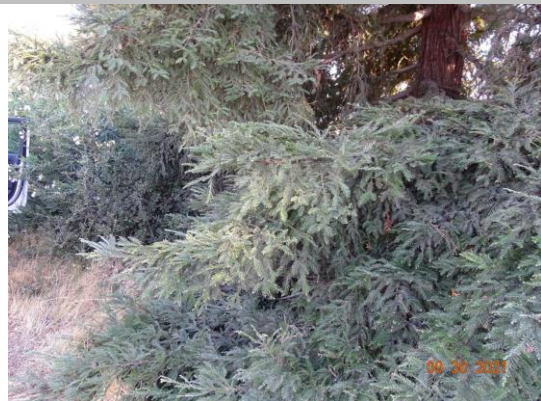
Photo 1 of 1 : SP_2024_RD0551_175_57_20240301_00022.jpg

LM Start	0.73	Rating **	U	Issue No.	57
LM End	0.76	Issue Type +	En	Location *	LS
Category	Earthen Levee			GPS Latitude/Longitude	
				Start	End
Item	Vegetation			38.328122°	38.327783°
				-121.573130°	-121.573362°
DWR ID	DWR_RD0551_01_f _ 2018_57				
Comment Code					
V6 : Landscaping					
Inspector Comment

View of thick landscaping on the landside slope (Fall 2021).

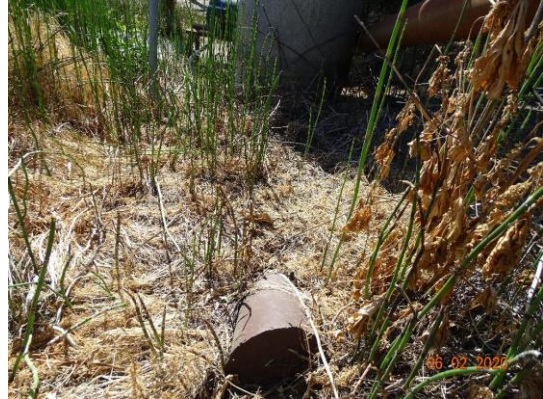
Photo 2 of 3 : UCIP_SP_2024_60092_87367.jpg

DS_ID:21987
FS_ID:60092
EP_NO: 793A
Repair Type: Non-Urgent
EVAL Issue: 10, Unauthorized Modification or Non-Compliant Permit Crossing Status: Found
UCIP Comments: 06/02/2020 Record updated from No Action Needed to Non-Urgent. Pump and screen filters installed on landside, capped old 12-inch pipe on landside slope next to the standpipe. Unable to find a permit authorizing modifications to this crossing. Two abandoned concrete standpipes on the landside slope and at the toe, abandoned pump piles at riverbank. Minor runoff erosion on waterside shoulder in pipe alignment. Pipe debris at riverbank. (O.Yakimov - DWR UCIP)
FIELD_STRUCT_DESC: 8-inch steel irrigation pipe sleeved through a 12-inch pipe with annular space grouted 7.8 feet below the crown. Pump and pressure booster at the landside (LS) toe with switch panel and power pole. (12-inch pipe authorized under Permit No. 793, 1939 - Margaret H. Smith Estate). (Sleeving 8-inch pipe through existing 10-inch pipe and grouting annular space authorized under Permit No. 793A, 1974 - George W.G. Smith). [Additional Reference(s): DWR Levee Log, 2005 (HLM 0.90). USACE Sacramento O&M Manual, Unit 111, May 1959, Revised 29 December 2016, (RM 33.90), listed as 12-inch pipe].

LM Start	0.90	Rating **	M	Issue No.	97 (cont)
LM End	0.90	Issue Type +	En	Location *	
Category	Supplemental			GPS Latitude/Longitude	
				Start	End
Item	DWR UCIP Field Study			38.325955°	38.325955°
				-121.574608°	-121.574608°
DWR ID	21987

Land-Side: Capped old 12-inch pipe on levee slope

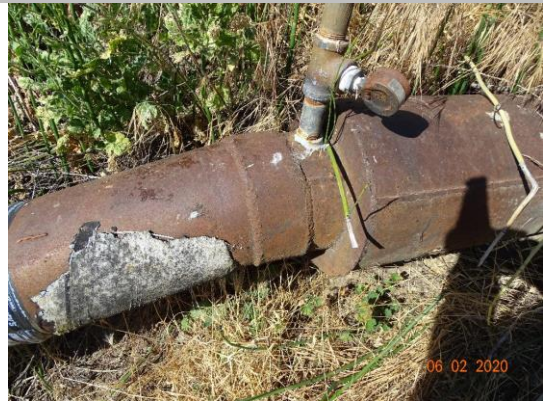
Photo 3 of 3 : UCIP_SP_2024_60092_87365.jpg

Land-Side: 8-inch pipe comes out of 12-inch pipe on levee slope

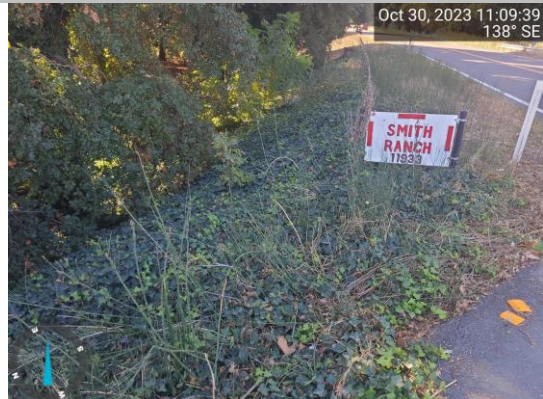
Photo 1 of 1 : SP_2024_RD0551_175_45_20240301_00012.jpg

LM Start	0.93	Rating **	M	Issue No.	45
LM End	0.93	Issue Type +	En	Location *	LS
Category	Earthen Levee			GPS Latitude/Longitude	
				Start	End
Item	Vegetation			38.325577°	38.325577°
				-121.574800°	-121.574800°
DWR ID	DWR_RD0551_01_s_2020_45				
Comment Code					
V6 : Landscaping					
Inspector Comment					
There is ivy covering the LS slope.

View of ivy on the landside slope (Fall 2023).

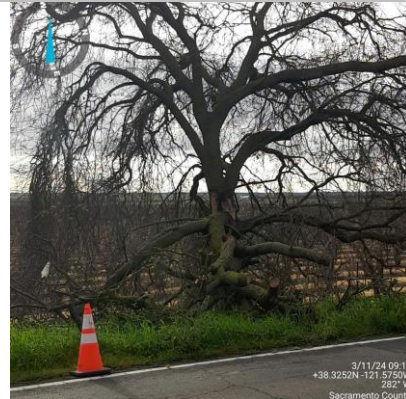
Photo 1 of 1 : SP_2024_RD0551_175_35_20240311_00099.jpg

LM Start	0.96	Rating **	U	Issue No.	35
LM End	0.96	Issue Type +	Ma	Location *	LS
Category	Earthen Levee			GPS Latitude/Longitude	
				Start	End
Item	Trim / Thin Trees			38.325202°	38.325202°
				-121.574985°	-121.574985°
DWR ID	DWR_RD0551_02_s_2024_35				
Comment Code					
T2 : Tree or limb.					
Inspector Comment					
Remove the broken tree limbs from the LS slope.

View of tree limbs on the LS slope. (Spring 2024)

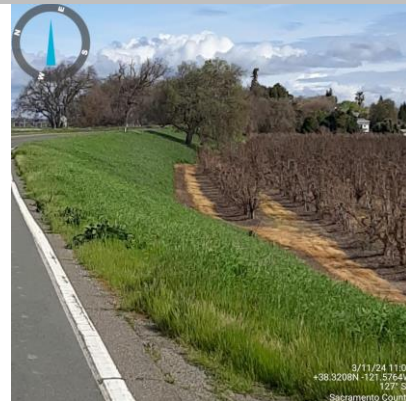
Photo 1 of 1 : SP_2024_RD0551_175_78_20240314_00109.jpg

LM Start	0.97	Rating **	U	Issue No.	78
LM End	1.27	Issue Type +	Ma	Location *	LS
Category	Earthen Levee			GPS Latitude/Longitude	
				Start	End
Item	Vegetation			38.325030°	38.320801°
				-121.575043°	-121.576329°
DWR ID	DWR_RD0551_01_s_2024_78				
Comment Code					
V1 : Control annual grass and weeds on the levee slopes and easements.					
Inspector Comment

View of tall grass on the LS slope. (Spring 2024)

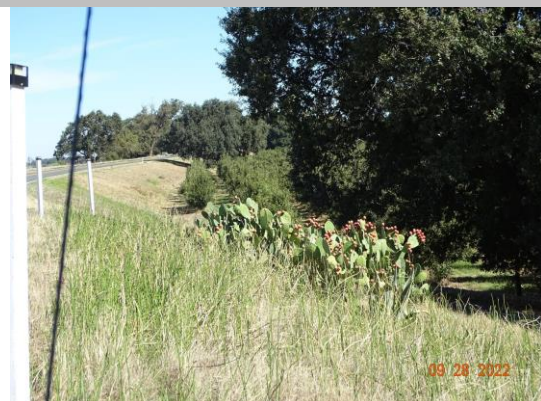
Photo 1 of 1 : SP_2024_RD0551_175_63_20240301_00028.jpg

LM Start	1.28	Rating **	M	Issue No.	63
LM End	1.28	Issue Type +	En	Location *	LS
Category	Earthen Levee			GPS Latitude/Longitude	
				Start	End
Item	Vegetation			38.320707°	38.320707°
				-121.576335°	-121.576335°
DWR ID	DWR_RD0551_01_s_2019_63				
Comment Code					
V6 : Landscaping					
Inspector Comment					
Cactus is located on landside slope.

View of the cactus on the LS slope (Fall 2022).

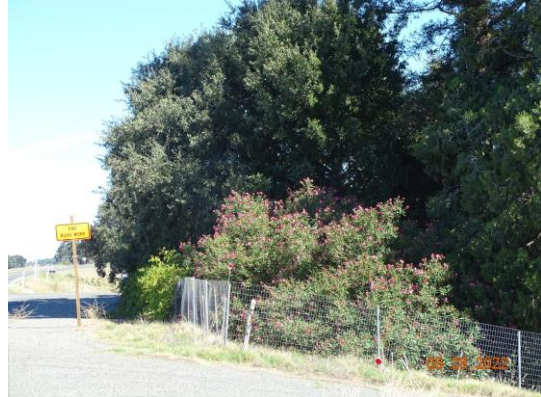
Photo 1 of 1 : SP_2024_RD0551_175_46_20240301_00013.jpg

LM Start	1.36	Rating **	U	Issue No.	46
LM End	1.36	Issue Type +	En	Location *	LS
Category	Earthen Levee			GPS Latitude/Longitude	
				Start	End
Item	Vegetation			38.319621°	38.319621°
				-121.576531°	-121.576531°
DWR ID	DWR_RD0551_01_f_2017_46				
Comment Code					
V6 : Landscaping					
Inspector Comment					
Landscaping should be maintained to allow inspection and access to landside slope and toe.

View of the landscaping on the LS slope (Fall 2022).

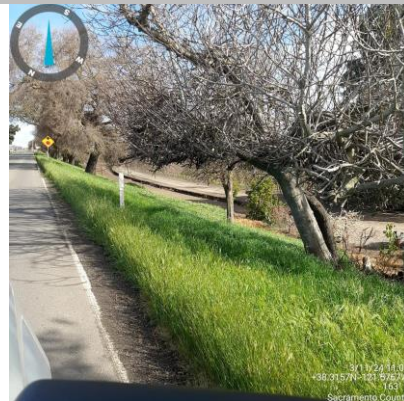
Photo 1 of 1 : SP_2024_RD0551_175_77_20240314_00110.jpg

LM Start	1.40	Rating **	U	Issue No.	77
LM End	1.69	Issue Type +	Ma	Location *	LS
Category	Earthen Levee			GPS Latitude/Longitude	
				Start	End
Item	Vegetation			38.318979°	38.314780°
				-121.576508°	-121.576755°
DWR ID	DWR_RD0551_01_s_2024_77				
Comment Code					
V1 : Control annual grass and weeds on the levee slopes and easements.					
Inspector Comment

View of tall grass on the LS slope. (Spring 2024)

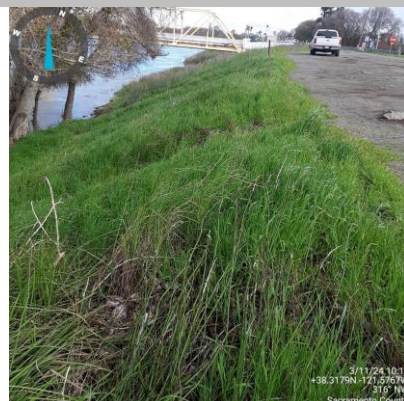
Photo 1 of 1 : SP_2024_RD0551_175_41_20240311_00103.jpg

LM Start	1.48	Rating **	U	Issue No.	41
LM End	1.53	Issue Type +	Ma	Location *	WS
Category	Earthen Levee			GPS Latitude/Longitude	
				Start	End
Item	Vegetation			38.317802°	38.317138°
				-121.576677°	-121.576567°
DWR ID	DWR_RD0551_01_s_2024_41				
Comment Code					
V1 : Control annual grass and weeds on the levee slopes and easements.					
Inspector Comment

View of tall grass on WS slope. (Spring 2024)

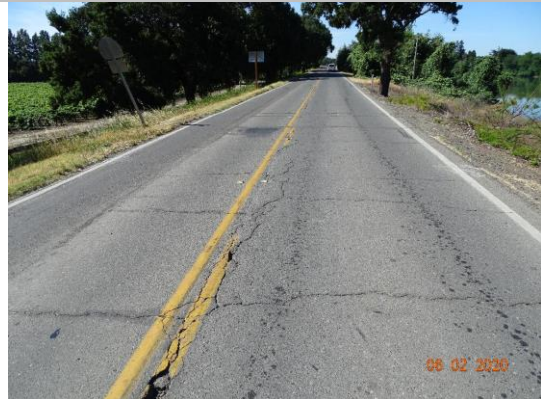
Photo 1 of 3 : UCIP_SP_2024_60128_87408.jpg

Comment Code						
Inspector Comment						
DS_ID:22007 FS_ID:60128 EP_NO: 16640 Repair Type: Non-Urgent EVAL Issue: 10, Unauthorized Modification or Non-Compliant Permit Crossing Status: Found UCIP Comments: 06/02/2020 Record updated from No Action Needed to Non-Urgent. Unable to locate a permit authorizing to sleeve 10-inch pipe through 12-inch pipe. (O.Yakimov - DWR UCIP) FIELD_STRUCT_DESC: 10-inch coated steel irrigation pipe sleeved through a 12-inch pipe, 2 feet below the crown. Pump in pump house on the waterside (WS). Pipe discharges into a 6-foot by 10-foot concrete distribution box on the landside (LS) slope. (12-inch pipe authorized under Permit No. 16640, 1996 - Carel D. Van Loben Sels). FS Date: 6/2/2020 9:21:00 AM

Top of Levee: View of levee crown looking downstream

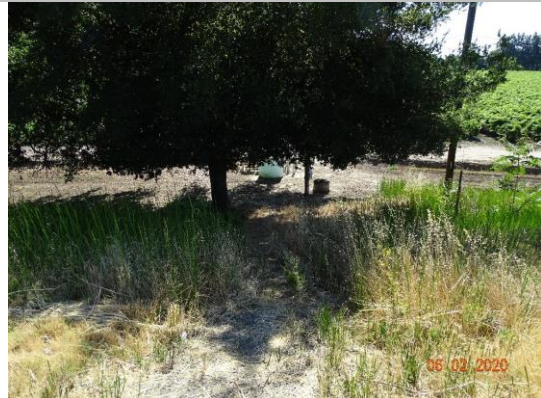
Photo 2 of 3 : UCIP_SP_2024_60128_87410.jpg

Land-Side: View of levee slope looking from crown

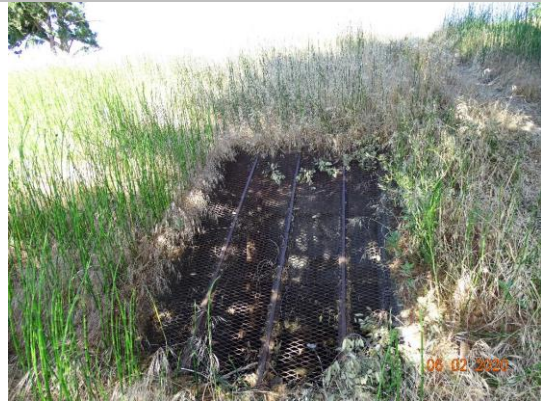
Photo 3 of 3 : UCIP_SP_2024_60128_87411.jpg

Land-Side: Concrete distribution box at levee toe covered with metal grate

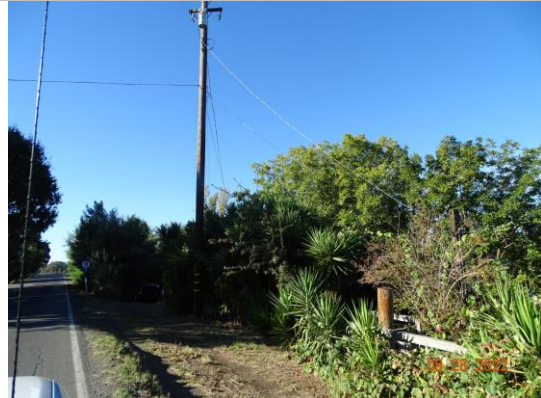
Photo 1 of 1 : SP_2024_RD0551_175_6_20240301_00003.jpg

LM Start	1.53	Rating **	M	Issue No.	6
LM End	1.60	Issue Type +	En	Location *	WS
Category	Earthen Levee			GPS Latitude/Longitude	
				Start	End
Item	Vegetation			38.317138°	38.316060°
				-121.576567°	-121.576688°
DWR ID	DWR_RD0551_01_s_2012_6				
Comment Code					
V6 : Landscaping					
Inspector Comment					
Thin landscaping to allow visibility and access down waterside slope.

View of the landscaping on the WS shoulder and slope (Fall 2022).

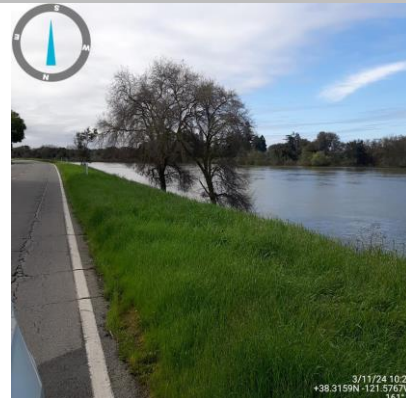
Photo 1 of 1 : SP_2024_RD0551_175_42_20240311_00105.jpg

LM Start	1.64	Rating **	U	Issue No.	42
LM End	2.33	Issue Type +	Ma	Location *	WS
Category	Earthen Levee			GPS Latitude/Longitude	
				Start	End
Item	Vegetation			38.315527°	38.306243°
				-121.576804°	-121.572640°
DWR ID	DWR_RD0551_01_s_2024_42				
Comment Code					
V1 : Control annual grass and weeds on the levee slopes and easements.					
Inspector Comment

View of tall grass on WS slope. (Spring 2024)

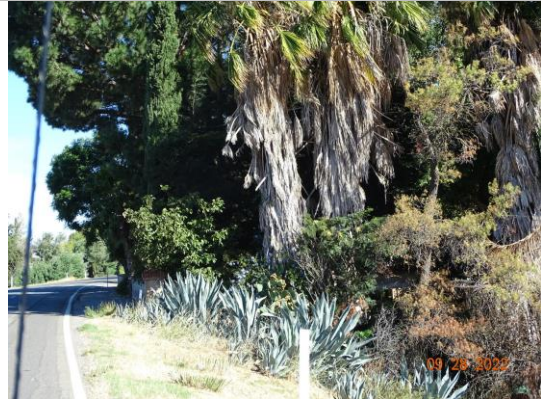
Photo 1 of 1 : SP_2024_RD0551_175_62_20240301_00027.jpg

LM Start	1.70	Rating **	U	Issue No.	62
LM End	1.70	Issue Type +	En	Location *	LS
Category	Earthen Levee			GPS Latitude/Longitude	
				Start	End
Item	Vegetation			38.314687°	38.314687°
				-121.576727°	-121.576727°
DWR ID	DWR_RD0551_01_s_2019_62				
Comment Code					
V6 : Landscaping					
Inspector Comment					
Landscaping is blocking the view down the landside slope.

View of the landscaping on the LS slope (Fall 2022).

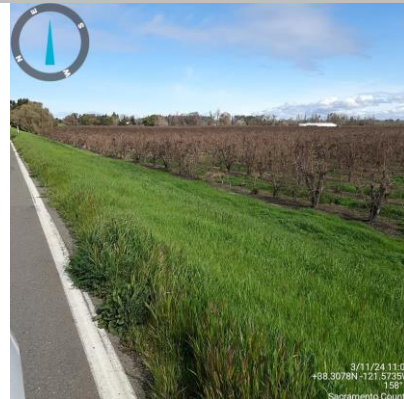
Photo 1 of 1 : SP_2024_RD0551_175_76_20240314_00111.jpg

LM Start	1.73	Rating **	U	Issue No.	76
LM End	2.24	Issue Type +	Ma	Location *	LS
Category	Earthen Levee			GPS Latitude/Longitude	
				Start	End
Item	Vegetation			38.314223°	38.307483°
				-121.576655°	-121.573341°
DWR ID	DWR_RD0551_01_s_2024_76				
Comment Code					
V1 : Control annual grass and weeds on the levee slopes and easements.					
Inspector Comment

View of tall grass on the LS slope. (Spring 2024)

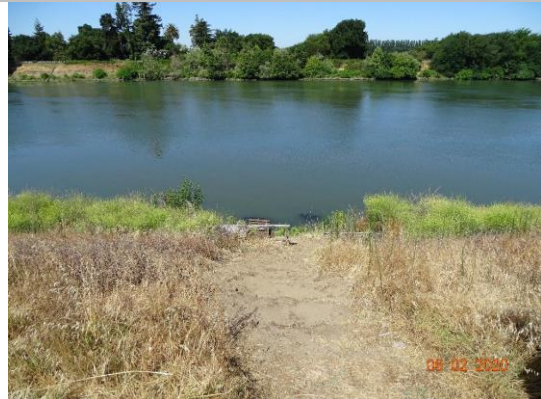
Photo 1 of 3 : UCIP_SP_2024_60145_87424.jpg

DS_ID:21990
FS_ID:60145
EP_NO: 11145
Repair Type: Non-Urgent
EVAL Issue: 10, Unauthorized Modification or Non-Compliant Permit
Crossing Status: Found
UCIP Comments: 06/02/2020 Record remains Non-Urgent. A portion on pipe on landside slope was replaced. Due to overgrown vegetation unable to locate connection of a replaced pipe segment to a pipe through the levee and evaluate levee slope condition. Pumphouse on waterside has been removed. Intake pipe at riverbank to the pump has been replaced, pipe debris left at riverbank. Unable to locate a permit for replacing the pipe segment on landside slope. No permit has been identified authorizing pipe through the levee. Need to have CVFPB review ABO and determine current owner. (O.Yakimov - DWR UCIP)
Based on District notes from January 14, 2014, pump discharge pipe has been repaired. Pipe failing on LS slope causing erosion along pipe alignment. Pipe debris on both slopes should be removed as well.: As of 12/13/2013 District President noted that the landowner had made repairs to the LS slope leaks.: As of 12/17/2013 District submitted letter to landowner explaining UCIP report details including photos of the pipe problems

FIELD_STRUCT_DESC: 10-inch irrigation pipe of an unknown material through the levee, 4.7 feet below the crown. Pump on concrete pad, butterfly valve, and U-shaped headwall on the waterside (WS) slope. 36-inch concrete riser on the landside (LS) toe. 1-inch electrical conduit at the same location. Service pole at the LS toe. (10-inch pipe [HLM 1.78] authorized under Automatic Board Order (ABO) issued as Permit No. 11145, 1975 - Horace D. & Lucile Towne). [Additional Reference(s): DWR Levee Log, 2005 (HLM 1.78). USACE Sacramento O&M Manual, Unit 111, May 1959, Revised 29 December 2016, (RM 33.02), listed as 8-inch pipe. USACE As-Built Drawing No. 06-13-1100, Sheet 13, RM 33, upstream of 'L' 1396+35, January 1933].
FS Date: 6/2/2020 11:15:34 AM

Water-Side: View of levee slope looking from crown

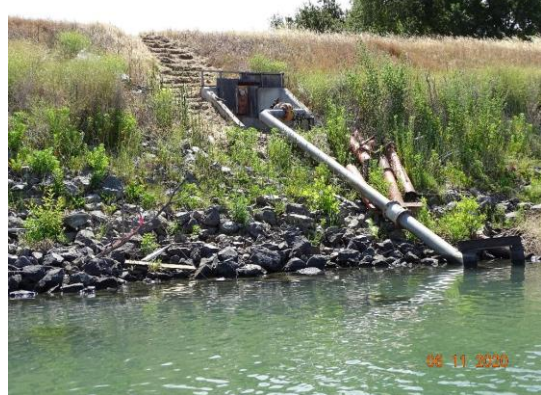
Photo 2 of 3 : UCIP_SP_2024_60145_87422.jpg

Water-Side: Overview of waterside looking from river

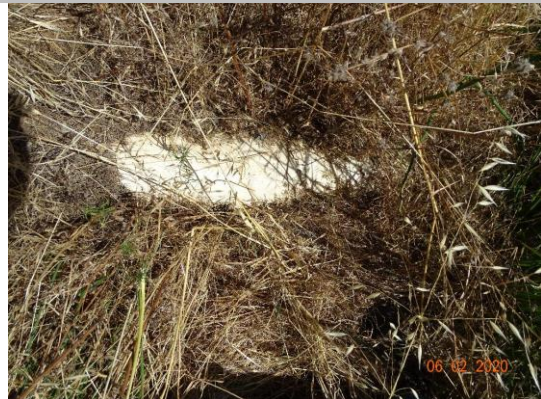
Photo 3 of 3 : UCIP_SP_2024_60145_87420.jpg

Land-Side: New pipe visible on levee slope

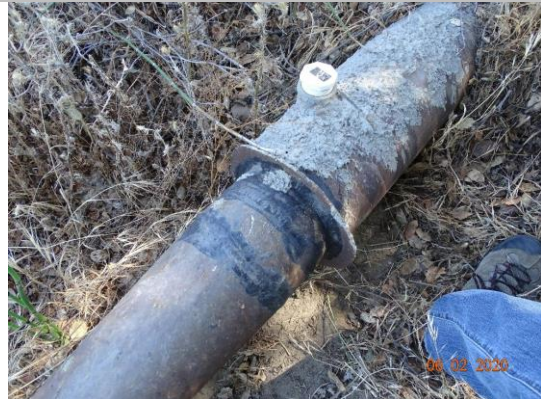
Photo 2 of 3 : UCIP_SP_2024_60233_87515.jpg

Comment Code					
Inspector Comment					
DS_ID:21994 FS_ID:60233 EP_NO: 11141 Repair Type: Non-Urgent EVAL Issue: 10, Unauthorized Modification or Non-Compliant Permit Crossing Status: Found UCIP Comments: 06/02/2020 Record remains Non-Urgent. Field measured pipe through the levee to be 11-inch in diameter. 8-inch pipe sleeved through 11-inch pipe. Annular space between pipes seems to be grouted. Concrete standpipe at landside levee toe has been removed. Unable to locate a permit for modifications. No permit has been identified authorizing original pipe. Need to have CVFPB review ABO and determine current owner. (O.Yakimov - DWR UCIP) 04/10/2013 Records indicate this pipe was abandoned, but it appears to be active. Verify status. (W.Wylie - DWR UCIP) FIELD_STRUCT_DESC: 8-inch steel irrigation pipe sleeved through 11-inch pipe through the levee, 8 feet below the crown. Slant pump on the waterside (WS) slope. Service pole on the landside (LS) slope with a 1.5-inch galvanized iron electrical conduit through the levee at the same location. This crossing replaces 12-inch pipe (see DSID 25637). (12-inch pipe authorized under Permit No. 747, 1938 - Runyon And Stephenson). (12-inch pipe [HLM 2.32] authorized under Automatic Board Order (ABO) issued as Permit No. 1975, 1975 - Adele Runyon, Et Al). [Additional Reference(s): DWR Levee Log, 2005 (HLM 2.42), listed as 12-inch pipe. USACE Sacramento O&M Manual, Unit 111, May 1959, Revised 29 December 2016, (RM 32.38), listed as 12-inch pipe. USACE As-Built Drawing No. 06-13-1100, Sheet 13, 'L' 1422+78, January 1933, listed as 12-inch pipe. USACE As-Built Drawing No. 50-04-2983, Sheet 9, STA 1+50, March 1954]. FS Date: 6/2/2020 9:53:01 AM

Water-Side: 8-inch pipe sleeved through 11-inch pipe. Annular space filler plug with grout spilled on pipe

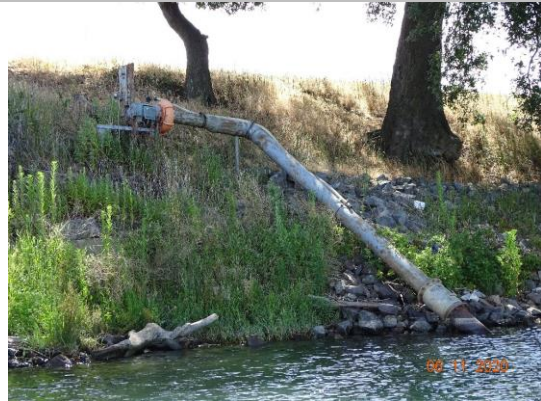
Photo 3 of 3 : UCIP_SP_2024_60233_87519.jpg

Water-Side: View of levee slope and pipe looking from river
