Flood Control Project Maintenance
Levee Inspections
LMA District Cover Sheet

Reclamation District No. 0551 Pearson

Levee Inspection Report By Mile - Spring 2024

Waterway	Bank	Unit Miles	Inspection Start/End	Inspector
Unit No. 01 Sacramento River	Left	1.83	03/11/2024 03/11/2024	Gregg McMillon

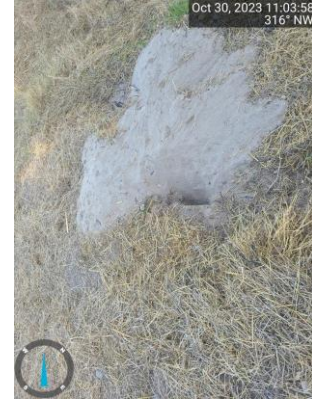
Photo 1 of 1 : SP_2024_RD0551_175_88_20240301_00030.jpg

LM Start	2.62	Rating **	M	Issue No.	88
LM End	2.62	Issue Type +	Ma	Location *	LS
Category	Earthen Levee			GPS Latitude/Longitude	
				Start	End
Item	Animal Control			38.302511°	38.302511°
				-121.570354°	-121.570354°
DWR ID	DWR_RD0551_01_f_2021_88				
Comment Code					
A1 : Exterminate rodents and backfill and compact or grout burrows.					
Inspector Comment					
Rodent holes need to be backfilled and compacted.

View looking at multiple animal holes in the landside slope (Fall 2023).

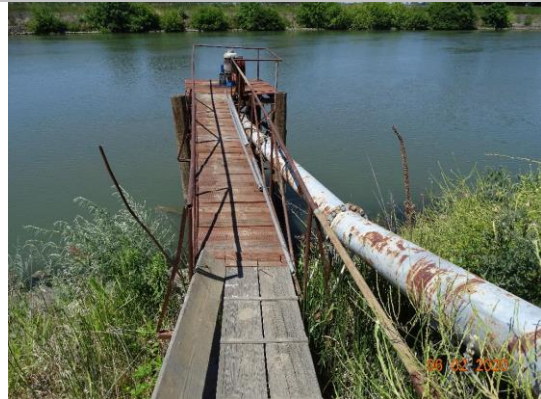
Photo 1 of 3 : UCIP_SP_2024_60293_87554.jpg

Comment Code					
Inspector Comment					
DS_ID:22032 FS_ID:60293 EP_NO: 1204 Repair Type: Non-Urgent EVAL Issue: 10, Unauthorized Modification or Non-Compliant Permit Crossing Status: Found UCIP Comments: 06/02/2020 Record remains Non-Urgent. Unable to locate a permit authorizing to sleeve 10-inch pipe through 12-inch pipe. Wet spot on the ground observed at concrete standpipe. (O.Yakimov - DWR UCIP) 04/10/2013 Gap between sleeved pipes does not appear to be grouted on LS slope. (W.Wylie - DWR UCIP) FIELD_STRUCT_DESC: 12-inch steel irrigation conduit through the levee, 6 feet below the crown. 10-inch irrigation pipe sleeved through the 12-inch conduit. Pump on pile structure on the waterside (WS) toe. 48-inch concrete riser on the landside (LS) toe. (12-inch pipe authorized under Permit No. 1204, 1947 - M. J. Barry Estate). [Additional Reference(s): USACE Sacramento O&M Manual, Unit 111, May 1959, Revised 29 December 2016, (RM 31.82), listed as 12-inch pipe]. USACE As-Built Drawing No. 06-13-1100, Sheet 13, upstream of 'L' 1460+20, January 1933. USACE As-Built Drawing No. 50-04-2983, Sheet 8, STA 30+80, March 1954]. FS Date: 6/2/2020 1:26:54 PM

Water-Side: Pump on pile structure and timber walkway to the pump

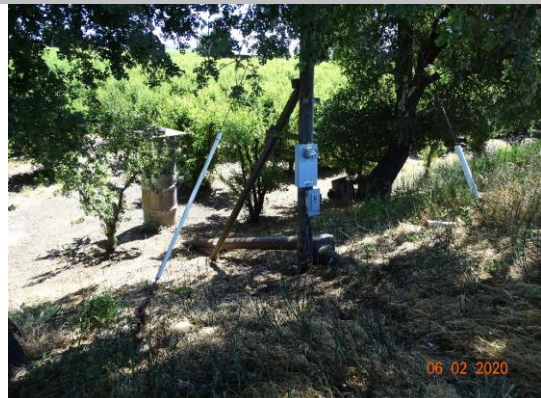
Photo 2 of 3 : UCIP_SP_2024_60293_87556.jpg

Land-Side: View of levee slope looking from crown

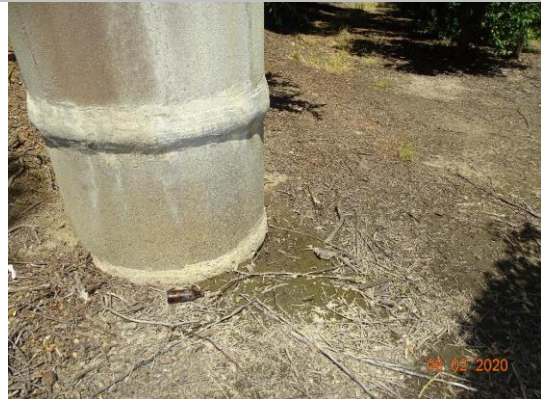
Photo 3 of 3 : UCIP_SP_2024_60293_87559.jpg

Land-Side: 48-inch concrete standpipe at levee toe. Wet spot on the ground next to it

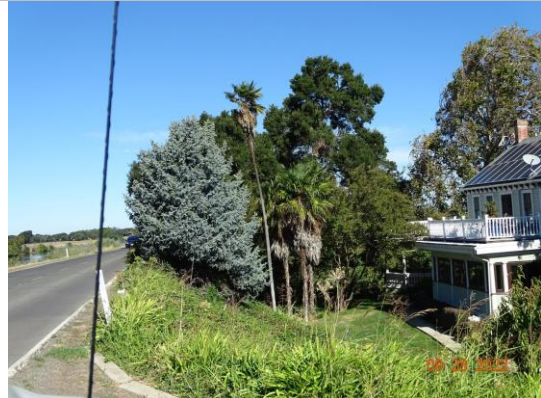
Photo 1 of 1 : SP_2024_RD0551_175_56_20240301_00021.jpg

LM Start	3.01	Rating **	U	Issue No.	56
LM End	3.03	Issue Type +	En	Location *	LS
Category	Earthen Levee			GPS Latitude/Longitude	
				Start	End
Item	Vegetation			38.297744°	38.297527°
				-121.566446°	-121.566225°
DWR ID	DWR_RD0551_01_f_2018_56				
Comment Code					
V6 : Landscaping					
Inspector Comment

View of the landscaping on the LS slope (Fall 2022).

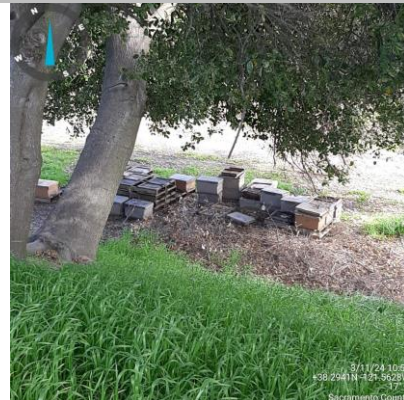
Photo 1 of 1 : SP_2024_RD0551_175_74_20240314_00114.jpg

LM Start	3.33	Rating **	M	Issue No.	74
LM End	3.33	Issue Type +	En	Location *	LS
Category	Earthen Levee			GPS Latitude/Longitude	
				Start	End
Item	Encroachments			38.294053°	38.294053°
				-121.562894°	-121.562894°
DWR ID	DWR_RD0551_01_s_2024_74				
Comment Code					
MISC : Miscellaneous					
Inspector Comment					
Move bee boxes off levee toe.

View of bee boxes located at the levee toe road. (Spring 2024)

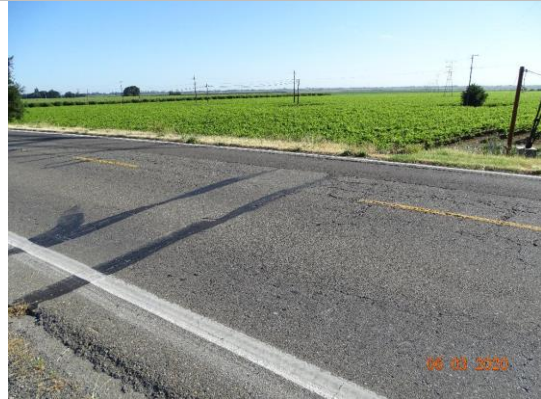
Photo 1 of 3 : UCIP_SP_2024_60354_87569.jpg

Comment Code					
Inspector Comment					
DS_ID:22041 FS_ID:60354 EP_NO: N/A Repair Type: Non-Urgent EVAL Issue: 4b, Safety Issue Crossing Status: Found UCIP Comments: 06/03/2020 Record updated from No Action Needed to Non-Urgent. Damaged CMP riser on landside slope missing cover - safety issue. Pump on waterside slope is removed and replaced with submersible pump. Unable to find a permit for modification. No permit has been identified authorizing pipe through levee. (O.Yakimov - DWR UCIP) FIELD_STRUCT_DESC: 12-inch steel irrigation pipe through the levee, 6 feet below the crown. Pipe measures 10 inches in diameter at the slopes of the levee. Metal steps to pump on concrete pad on the waterside (WS). Vent in a 36-inch corrugated metal pipe (CMP) riser on the landside (LS) shoulder. 1-inch electrical conduit at the same location with an electrical panel on a pole at the LS toe. [Additional Reference(s): USACE Sacramento O&M Manual, Unit 111, May 1959, Revised 29 December 2016, (RM 31.38), listed as 12-inch pipe. USACE As-Built Drawing No. 06-13-1100, Sheet 13, upstream of 'L' 1482+00, January 1933]. FS Date: 6/3/2020 11:25:42 AM

Top of Levee: View of levee crown looking towards landside. Cut in pavement in pipe alignment is visible

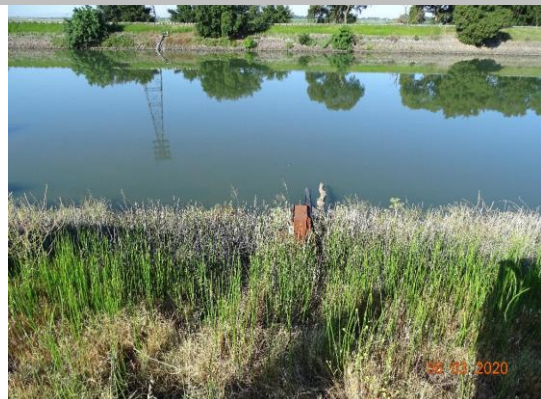
Photo 2 of 3 : UCIP_SP_2024_60354_87570.jpg

Water-Side: View of levee slope looking from crown

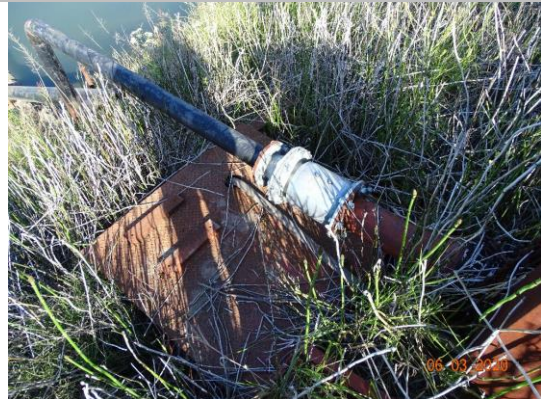
Photo 3 of 3 : UCIP_SP_2024_60354_87571.jpg

Water-Side: A pad where pump was installed on levee slope

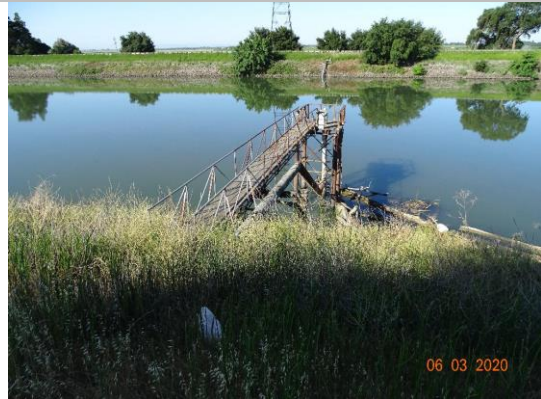
Photo 2 of 3 : UCIP_SP_2024_60363_87584.jpg

Water-Side: View of levee slope looking from crown

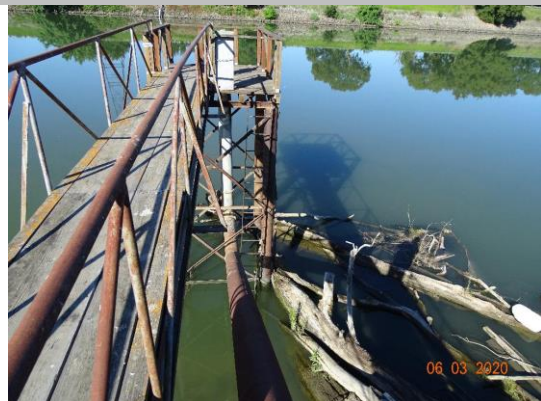
Photo 3 of 3 : UCIP_SP_2024_60363_87585.jpg

Water-Side: Pump on pile structure in the stream, walkway bridge

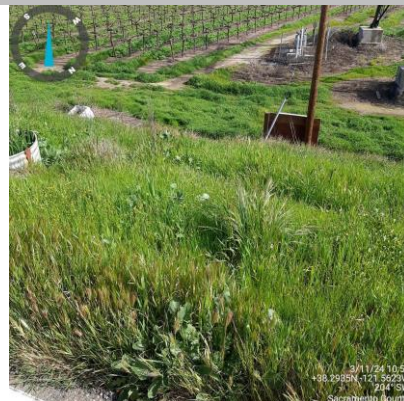
Photo 1 of 1 : SP_2024_RD0551_175_73_20240314_00115.jpg

LM Start	3.40	Rating **	U	Issue No.	73
LM End	3.40	Issue Type +	Ma	Location *	LS
Category	Earthen Levee			GPS Latitude/Longitude	
				Start	End
Item	Vegetation			38.293305°	38.293305°
				-121.562103°	-121.562103°
DWR ID	DWR_RD0551_01_s_2024_73				
Comment Code					
V1 : Control annual grass and weeds on the levee slopes and easements.					
Inspector Comment

View of tall grass on the LS slope. (Spring 2024)

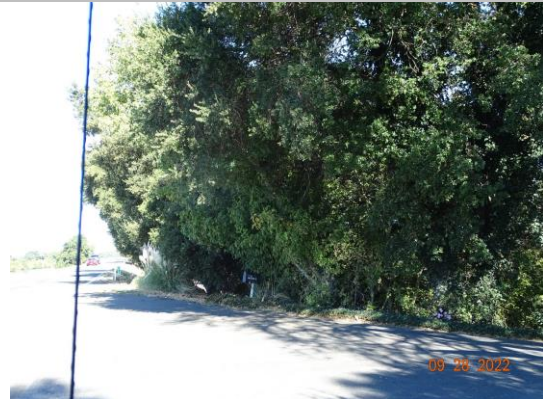
Photo 1 of 1 : SP_2024_RD0551_175_55_20240301_00020.jpg

LM Start	3.45	Rating **	U	Issue No.	55
LM End	3.45	Issue Type +	En	Location *	LS
Category	Earthen Levee			GPS Latitude/Longitude	
				Start	End
Item	Vegetation			38.292710°	38.292710°
				-121.561440°	-121.561440°
DWR ID	DWR_RD0551_01_f_2018_55				
Comment Code					
V6 : Landscaping					
Inspector Comment

View of the landscaping on the LS slope (Fall 2022).

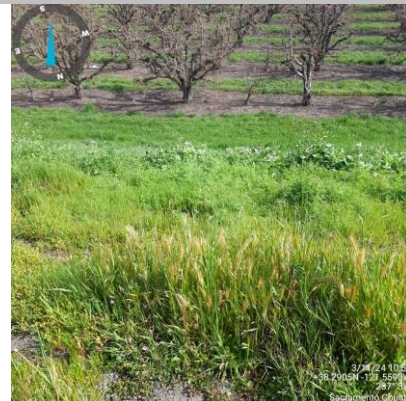
Photo 1 of 1 : SP_2024_RD0551_175_72_20240314_00116.jpg

LM Start	3.48	Rating **	U	Issue No.	72
LM End	3.67	Issue Type +	Ma	Location *	LS
Category	Earthen Levee			GPS Latitude/Longitude	
				Start	End
Item	Vegetation			38.292376°	38.290278°
				-121.561127°	-121.558787°
DWR ID	DWR_RD0551_01_s_2024_72				
Comment Code					
V1 : Control annual grass and weeds on the levee slopes and easements.					
Inspector Comment

View of tall grass on the LS slope. (Spring 2024)

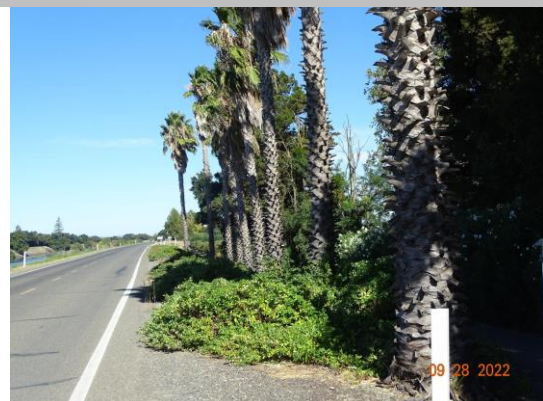
Photo 1 of 1 : SP_2024_RD0551_175_54_20240301_00019.jpg

LM Start	3.71	Rating **	M	Issue No.	54
LM End	3.74	Issue Type +	En	Location *	LS
Category	Earthen Levee			GPS Latitude/Longitude	
				Start	End
Item	Vegetation			38.289920°	38.289544°
				-121.558357°	-121.557956°
DWR ID	DWR_RD0551_01_f_2018_54				
Comment Code					
V6 : Landscaping					
Inspector Comment

View of the landscaping on the LS slope (Fall 2022).

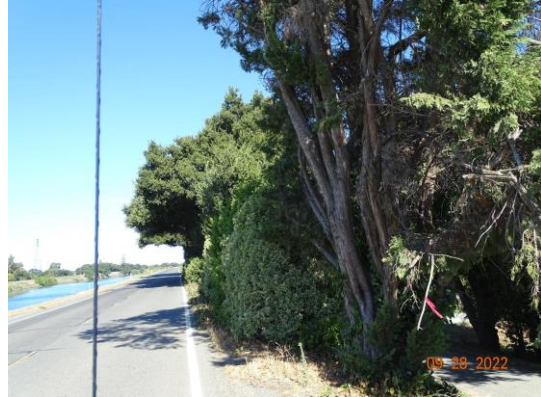
Photo 1 of 1 : SP_2024_RD0551_175_48_20240301_00015.jpg

LM Start	3.78	Rating **	U	Issue No.	48
LM End	3.85	Issue Type +	En	Location *	LS
Category	Earthen Levee			GPS Latitude/Longitude	
				Start	End
Item	Vegetation			38.289067°	38.288394°
				-121.557423°	-121.556591°
DWR ID	DWR_RD0551_01_f_2017_48				
Comment Code					
V6 : Landscaping					
Inspector Comment					
Landscaping should be maintained to allow inspection and access to landside slope and toe.

View of the landscaping on the LS slope (Fall 2022).

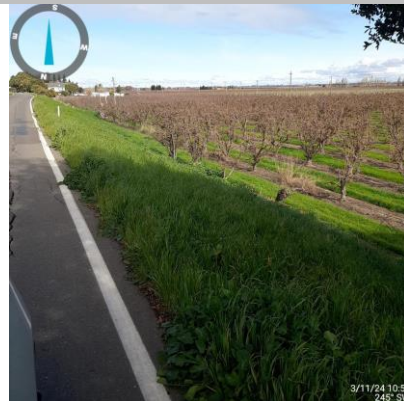
Photo 1 of 1 : SP_2024_RD0551_175_71_20240314_00117.jpg

LM Start	3.86	Rating **	U	Issue No.	71
LM End	4.17	Issue Type +	Ma	Location *	LS
Category	Earthen Levee			GPS Latitude/Longitude	
				Start	End
Item	Vegetation			38.288249°	38.284847°
				-121.556454°	-121.552726°
DWR ID	DWR_RD0551_01_s_2024_71				
Comment Code					
V1 : Control annual grass and weeds on the levee slopes and easements.					
Inspector Comment

View of tall grass on the LS slope. (Spring 2024)

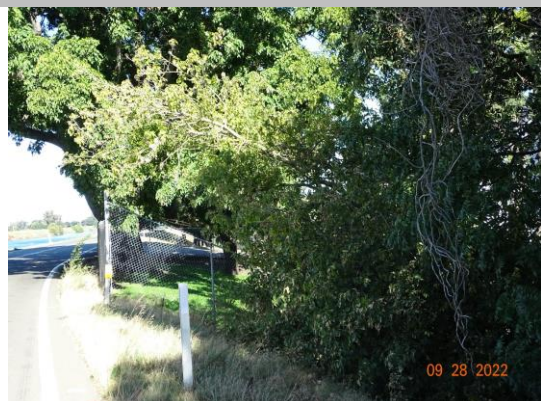
Photo 1 of 1 : SP_2024_RD0551_175_60_20240301_00025.jpg

LM Start	4.18	Rating **	M	Issue No.	60
LM End	4.23	Issue Type +	En	Location *	LS
Category	Earthen Levee			GPS Latitude/Longitude	
				Start	End
Item	Encroachments			38.284795°	38.284318°
				-121.552597°	-121.551830°
DWR ID	DWR_RD0551_01_s_2019_60				
Comment Code					
FE : Fence					
Inspector Comment					
A chainlink fence is located on landside.

View of the fence on the LS shoulder and slope (Fall 2022).

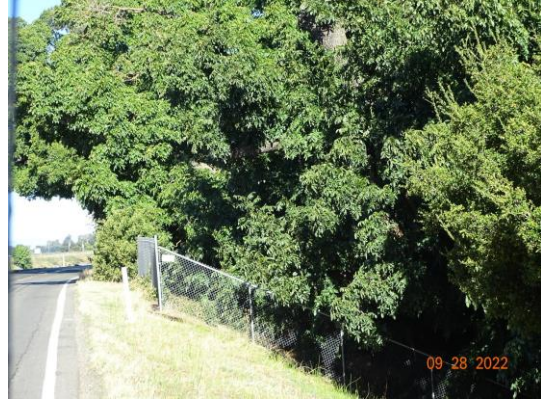
Photo 1 of 1 : SP_2024_RD0551_175_52_20240301_00018.jpg

LM Start	4.22	Rating **	U	Issue No.	52
LM End	4.22	Issue Type +	En	Location *	LS
Category	Earthen Levee			GPS Latitude/Longitude	
				Start	End
Item	Vegetation			38.284400°	38.284400°
				-121.552035°	-121.552035°
DWR ID	DWR_RD0551_01_f_2018_52				
Comment Code					
V6 : Landscaping					
Inspector Comment

View of the landscaping on the LS slope (Fall 2022).

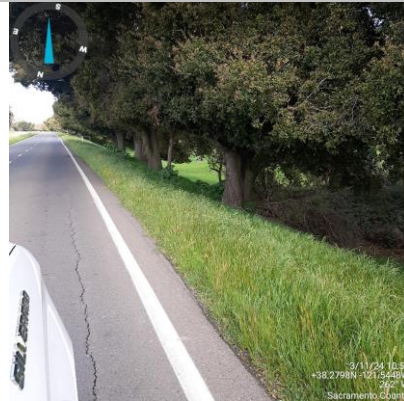
Photo 1 of 1 : SP_2024_RD0551_175_70_20240314_00118.jpg

LM Start	4.24	Rating **	U	Issue No.	70
LM End	4.80	Issue Type +	Ma	Location *	LS
Category	Earthen Levee			GPS Latitude/Longitude	
				Start	End
Item	Vegetation			38.284295°	38.278987°
				-121.551735°	-121.543927°
DWR ID	DWR_RD0551_01_s_2024_70				
Comment Code					
V1 : Control annual grass and weeds on the levee slopes and easements.					
Inspector Comment

View of tall grass on the LS slope. (Spring 2024)

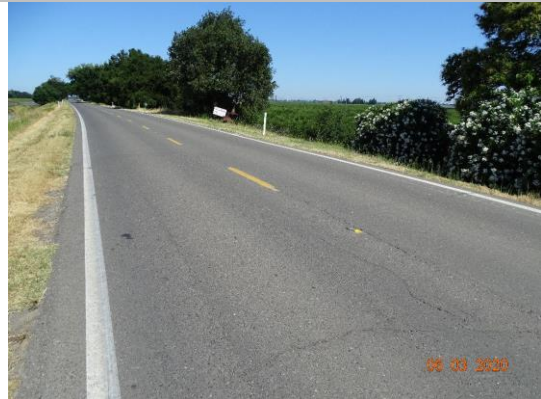
Photo 1 of 3 : UCIP_SP_2024_60578_87846.jpg

Comment Code					
Inspector Comment					
DS_ID:22019 FS_ID:60578 EP_NO: 11142 Repair Type: Non-Urgent EVAL Issue: 10, Unauthorized Modification or Non-Compliant Permit Crossing Status: Found UCIP Comments: 06/03/2020 Record updated from No Action Needed to Non-Urgent. No permit has been identified authorizing original pipe. Unable to locate a permit for sleeving 6-inch pipe through 10-inch pipe. Need to have CVFPB review ABO and determine current owner. (O.Yakimov - DWR UCIP) FIELD_STRUCT_DESC: 6-inch irrigation pipe sleeved through the 10-inch irrigation pipe of an unknown material through the levee, 6.5 feet below the crown. Pump and butterfly valve on a concrete pad on the waterside (WS) slope. Air vent on pipe at landside toe. Electrical panel, and meter on a service pole at landside toe. 1-inch galvanized steel electrical conduit at the same location. (10-inch pipe [HLM 4.49] authorized under Automatic Board Order (ABO) issued as Permit No. 11142, 1975 - Tadashi Kimiye & Saburo Hirose). [Additional Reference(s): DWR Levee Log, 2005 (HLM 4.49). USACE Sacramento O&M Manual, Unit 111, May 1959, Revised 29 December 2016, (RM 30.31), listed as 10-inch pipe. USACE As-Built Drawing No. 06-13-1100, Sheet 14, near 'L' 1530+00, January 1933]. FS Date: 6/3/2020 1:28:59 PM

Top of Levee: View of levee crown looking upstream

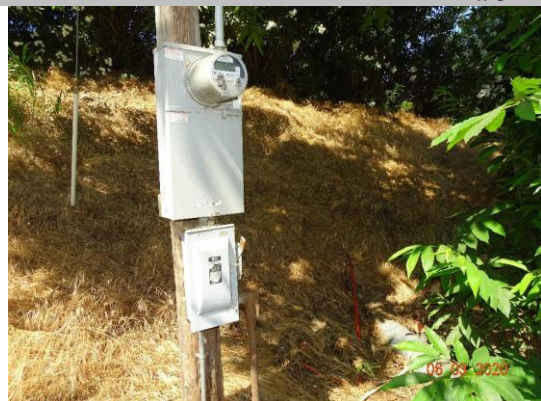
Photo 2 of 3 : UCIP_SP_2024_60578_87850.jpg

Land-Side: Service pole at levee toe

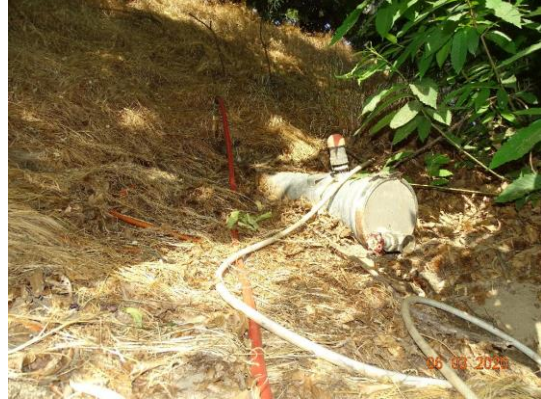
Photo 3 of 3 : UCIP_SP_2024_60578_87844.jpg

Land-Side: Pipe end with air vent at levee toe

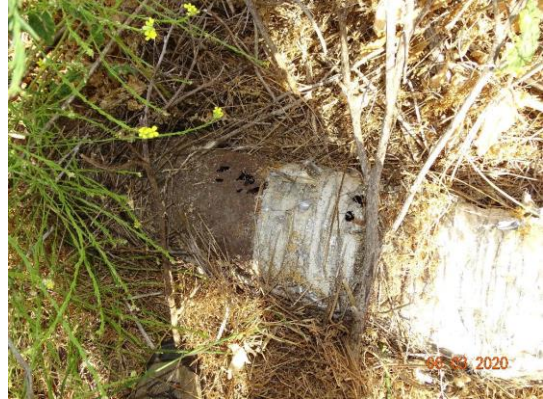
Photo 2 of 3 : UCIP_SP_2024_60620_87854.jpg

DS_ID:22020
FS_ID:60620
EP_NO: 11152
Repair Type: Urgent
EVAL Issue: 1, Pipe Integrity
Crossing Status: Found
UCIP Comments: 06/03/2020 Record updated from Non-Urgent to Urgent. Pipe is in failed condition. Pipe segment on waterside levee slope is removed. Through holes in pipe visible on waterside slope. Pump and intake pipe are removed from piled structure in the stream. 8' x 9' x 2'- deep depression on landside slope in pipe alignment. Crossing appears abandoned. (O.Yakimov - DWR UCIP)
10/24/2016 Per Mr. Topper Van Loben, LMA contact, new owner is working with DCC Engineering to obtain CVFPB permit for pipe rehabilitation. Work rehabilitation for existing pipe includes sleeving an 8-inch steel pipe through existing pipe and grouting space between pipes. Crossing has been downgraded to Non-Urgent since walkway has been repaired and pipe in the process of being rehabilitated. UCIP staff is waiting for permit authorizing pipe rehabilitation. (O. Magana - DWR UCIP) (Olivia) As of 09/21/2015 owner is working with Gilbert Labrie, LMA consultant, to resolve issue. (T. Van Loben - LMA representative / G. Labrie - LMA Engineer - DCC Engineering)As of 12/17/2013 District submitted letter to landowner explaining UCIP report details including photos of the pipe problems. (T. Van Loben - LMA representative / G. Labrie - LMA Engineer - DCC Engineering)As of 12/13/2013 the District has contacted the tenant farmer who is in the process of contacting the owner to update on condition of pipe. (T. Van Loben - LMA representative / G. Labrie - LMA Engineer - DCC Engineering) 04/11/2013 Pier for pump is falling apart and is a hazard to the public. Some settlement along pipe on LS slope. (W. Wylie - DWR UCIP)

Water-Side: Through holes in pipe on levee slope

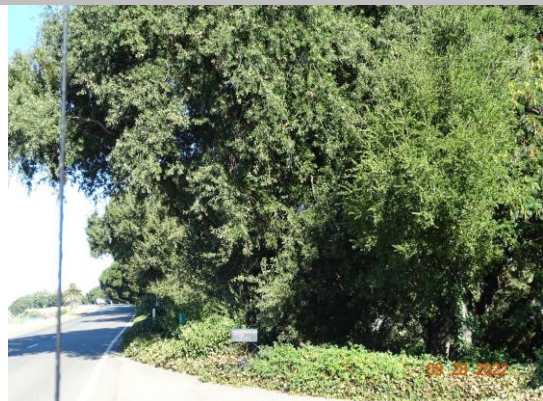
Photo 1 of 1 : SP_2024_RD0551_175_25_20240301_00008.jpg

LM Start	4.82	Rating **	U	Issue No.	25
LM End	4.86	Issue Type +	En	Location *	LS
Category	Earthen Levee			GPS Latitude/Longitude	
				Start	End
Item	Vegetation			38.278760°	38.278287°
				-121.543608°	-121.543132°
DWR ID	DWR_RD0551_01_f_2018_25				
Comment Code					
V6 : Landscaping					
Inspector Comment

View of the landscaping on the LS slope (Fall 2022).

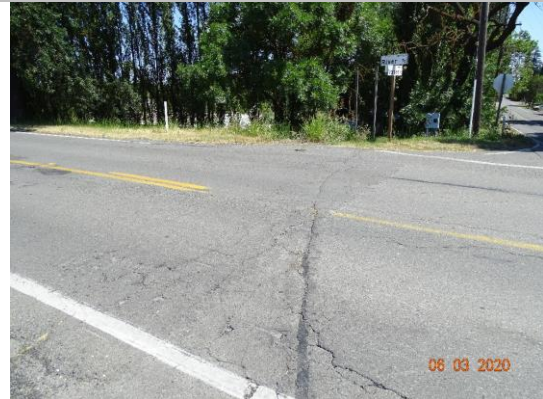
Photo 1 of 3 : UCIP_SP_2024_60623_87869.jpg

Comment Code						
Inspector Comment						
DS_ID:22043 FS_ID:60623 EP_NO: 16800 Repair Type: Urgent EVAL Issue: 1, Pipe Integrity Crossing Status: Found UCIP Comments: 07/21/2022 Record updated from No Action Needed to Urgent. Pipe failed near the landside concrete standpipe. Pipe discovered to have significant wear, pitting, and holes. Enforcement Case No. 2022-15616 issued for this crossing. (O.Yakimov - DWR UCIP) 06/03/2020 Record remains No Action Needed. No issues observed during inspection. (O.Yakimov - DWR UCIP) FIELD_STRUCT_DESC: 16-inch coated steel irrigation pipe through the levee, 4.71 feet below the crown. Pump and butterfly valve in pump house on the waterside (WS) slope. Service poles on the landside (LS) slope. 48-inch concrete riser off the LS toe. 1-inch galvanized iron filler pipe and 2-inch electrical conduit at the same location. This crossing replaces 16-inch pipe (see DSID 25622). (16-inch pipe authorized under Permit No. 16773, 1997 - Joe Green Ranch). (In-kind replacement of the of the existing 16-inch diameter steel pipe and the 2-inch electrical conduit from the landside hinge to the landside levee toe approved under Project Authorization No. WC2023007, 2023 - MBK Engineers, on behalf of Umer Malik). [Additional Reference(s) of original crossing: DWR Levee Log, 2005 (HLM 5.01). USACE Sacramento O&M Manual, Unit 111, May 1959, Revised 29 December 2016, (RM 29.79), listed as 16-inch pipe. USACE As-Built Drawing No. 06-13-1100, Sheet 14, 'L' 1560+12, January 1933]. FS Date: 6/3/2020 11:27:14 AM

Top of Levee: View of levee crown looking towards landside

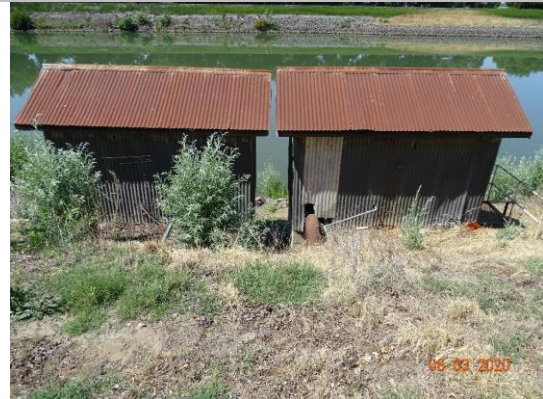
Photo 2 of 3 : UCIP_SP_2024_60623_87870.jpg

Water-Side: Pumphouse on levee slope

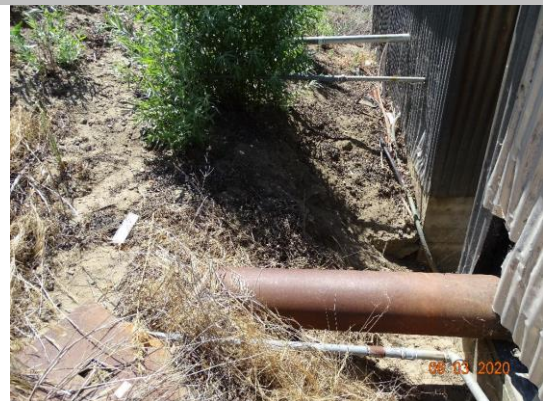
Photo 3 of 3 : UCIP_SP_2024_60623_87871.jpg

Water-Side: Water supply pipe and filler pile at pumphouse on levee slope

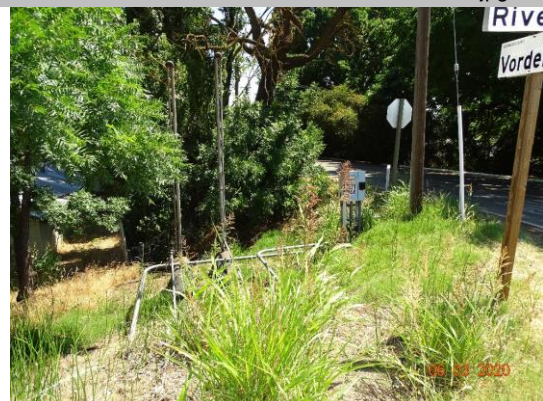
Photo 2 of 3 : UCIP_SP_2024_77178_87878.jpg

Comment Code					
Inspector Comment					
DS_ID:22021 FS_ID:77178 EP_NO: 16800 Repair Type: Urgent EVAL Issue: 1, Pipe Integrity Crossing Status: Found UCIP Comments: 08/15/2022 Record updated from No Action Needed to Urgent. Enforcement case 2022-15620 was open for this crossing. Pipe is leaking near landside concrete standpipe and may be damaged by tree roots. (O.Yakimov - DWR UCIP) 06/03/2020 Record remains No Action Needed. No issues observed during inspection. (O.Yakimov - DWR UCIP) FIELD_STRUCT_DESC: 16-inch coated steel irrigation pipe through the levee, 4.67 feet below the crown. Pump and slide gate in pump house on the waterside (WS) slope. Service poles on the landside (LS) slope. 1-inch galvanized iron filler pipe at the same location. This crossing replaces 16-inch pipe (see DSID 25621). (16-inch pipe authorized under Permit No. 16800, 1997 - William Schultz). (Replacement portions of the pipe within waterside and landside slopes approved under Project Authorization No. WA2023173, 2023 - Michael Moncrief on behalf of James Hardesty). [Additional Reference(s) of original crossing: DWR Levee Log, 2005 (HLM 5.01), listed as 14-inch pipe. USACE Sacramento O&M Manual, Unit 111, May 1959, Revised 29 December 2016, (RM 29.79), listed as 16-inch pipe. USACE As-Built Drawing No. 06-13-1100, Sheet 14, 'L' 1560+12, January 1933]. FS Date: 6/3/2020

Land-Side: View of levee slope looking from crown

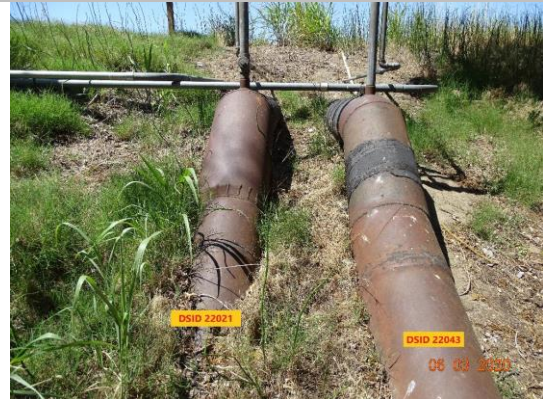
Photo 3 of 3 : UCIP_SP_2024_77178_87879.jpg

Land-Side: View of pipe at levee toe

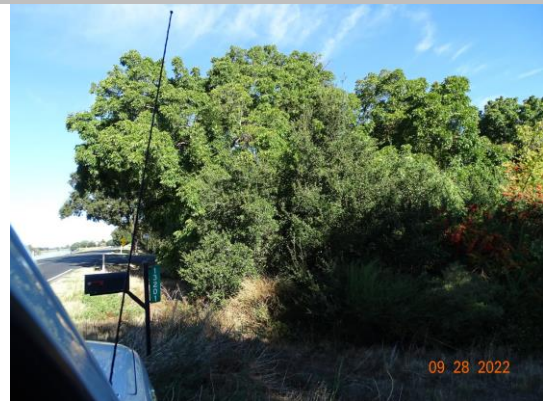
Photo 1 of 1 : SP_2024_RD0551_175_44_20240301_00011.jpg

LM Start	5.00	Rating **	U	Issue No.	44
LM End	5.00	Issue Type +	En	Location *	LS
Category	Earthen Levee			GPS Latitude/Longitude	
				Start	End
Item	Vegetation			38.276870°	38.276870°
				-121.541463°	-121.541463°
DWR ID	DWR_RD0551_01_f_2019_44				
Comment Code					
V6 : Landscaping					
Inspector Comment

View of the landscaping on the LS slope (Fall 2022).

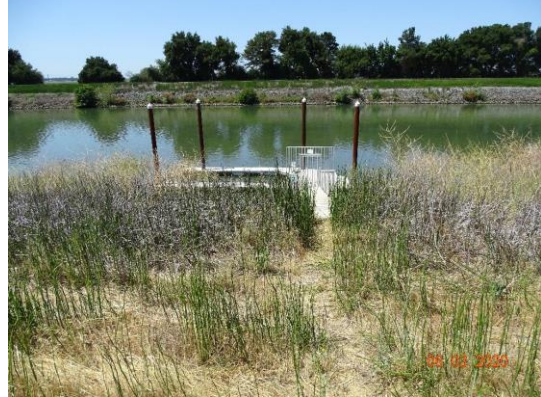
Photo 1 of 3 : UCIP_SP_2024_56199_87884.jpg

Comment Code					
Inspector Comment					
DS_ID:25122					
FS_ID:56199					
EP_NO: N/A					
Repair Type: Non-Urgent					
EVAL Issue: 10, Unauthorized Modification or Non-Compliant Permit					
Crossing Status: Found					
UCIP Comments: 06/03/2020 Record is Non-Urgent. Five conduits are visible under bridge to boat launching two of which are open ended.					
Recommend capping conduits under bridge to prevent water backflow.					
(O.Yakimov - DWR UCIP)					
FIELD_STRUCT_DESC: 6-inch wrapped and soil proofed galvanized iron conduit through the levee 2-feet below the crown. Electric, water, and other utility pipes sleeved through conduit with welded steel caps and annular space grouted. (6-inch steel utility chase authorized under Permit No. 18769, 2013 - Michael & Jill Steinbacher).					
FS Date: 6/3/2020

Water-Side: View of levee slope looking from crown

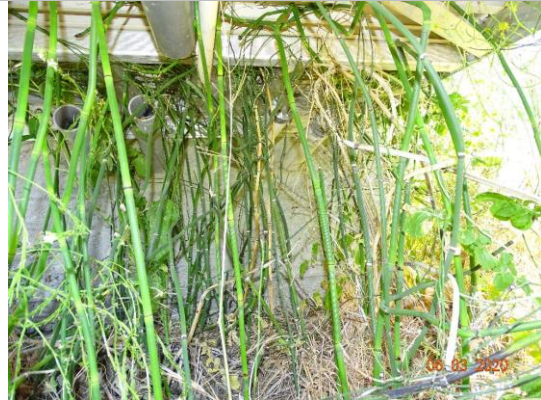
Photo 2 of 3 : UCIP_SP_2024_56199_87885.jpg

Water-Side: Conduits under walkway

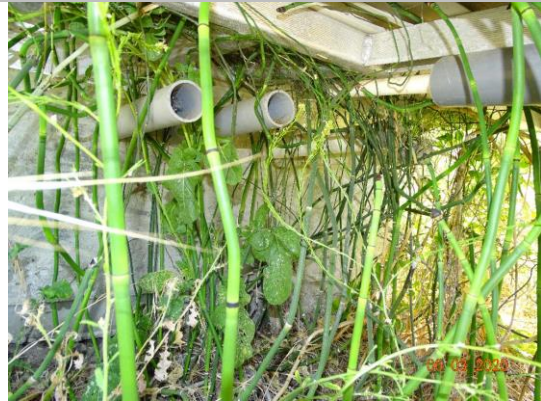
Photo 3 of 3 : UCIP_SP_2024_56199_87886.jpg

Water-Side: Another view of conduits under walkway

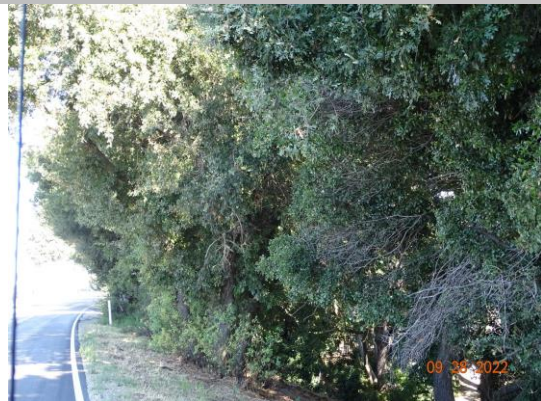
Photo 1 of 1 : SP_2024_RD0551_175_49_20240301_00016.jpg

LM Start	5.08	Rating **	U	Issue No.	49
LM End	5.08	Issue Type +	En	Location *	LS
Category	Earthen Levee		GPS Latitude/Longitude		
			Start	End	
Item	Vegetation		38.275865 °	38.275865 °	
			-121.540461 °	-121.540461 °	
DWR ID	DWR_RD0551_01_f_2017_49

View of the landscaping on the LS slope (Fall 2022).

Landscaping should be maintained to allow inspection and access to landside slope and toe.

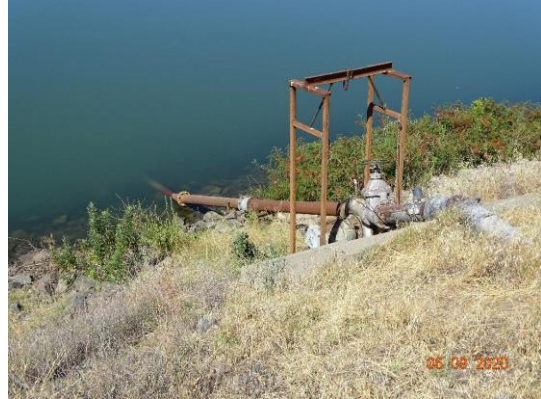
Photo 1 of 3 : UCIP_SP_2024_60630_87896.jpg

Comment Code					
Inspector Comment					
DS_ID:22023 FS_ID:60630 EP_NO: 11131 Repair Type: Urgent EVAL Issue: 2a, Levee Integrity Crossing Status: Found UCIP Comments: 06/09/2020 Record updated from Non-Urgent to Urgent. 7-foot diameter 1-foot deep unauthorized excavation found at landside levee toe next to the concrete standpipe. Excavation is apparently made to expose and fix leaking pipe. Abandoned closure device and concrete standpipe at landside toe. 2.5-inch PVC connected to pipe end at landside toe. Pipe is running - no leaks detected. CMP riser on landside slope missing cover - fall hazard. No permit has been identified authorizing pipe. Need to have CVFPB review ABO and determine current owner. (O.Yakimov - DWR UCIP) 01/15/2014 Based on District notes from January 15, 2014, pump discharge pipe has been repaired. Corrosion holes in pipe at LS toe good indicator that pipe is failing internally. Pipe should be examined internally for damage (video inspect).: As of 12/12/2013 the District discussed with farmer tenant what needed to be done, and the tenant informed the District that they would address the repairs.: As of 12/17/2013 District submitted letter to landowner explaining UCIP report details including photos of the pipe problems FIELD_STRUCT_DESC: 10-inch steel exterior coated irrigation pipe through the levee, 7.7 feet below the crown. Pump and slide gate on a concrete pad on the waterside (WS) slope. Siphon breaker in a 24-inch corrugated metal pipe (CMP) riser on the landside (LS) slope. 36-inch concrete standpipe, shut off device, and power pole with panel box on the LS toe. 1.5-inch galvanized steel electrical conduit at the same location. (10-inch pipe [HLM 5.3] authorized under Automatic Board Order (ABO) issued as Permit No. 11131, 1975 - Helen Crofton Sloane Latimer). [Additional Reference(s): DWR Levee Log, 2005 (HLM 5.30). USACE Sacramento O&M Manual, Unit 111, May 1959, Revised 29 December 2016, (RM 29.52), listed as 9-inch pipe. USACE As-Built Drawing No. 06-13-1100, Sheet 14, 'L' 1571+85, January 1933, listed as 9-inch pipe]. FS Date: 6/9/2020 10:52:00 AM

Water-Side: Pump, slide gate valve, and intake pipe on levee slope

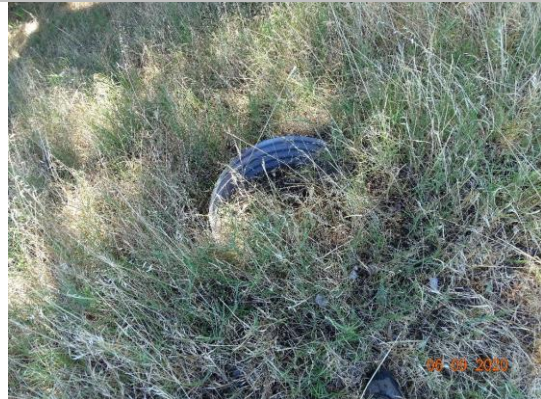
Photo 2 of 3 : UCIP_SP_2024_60630_87901.jpg

Land-Side: Uncovered 24-inch CMP riser on levee slope

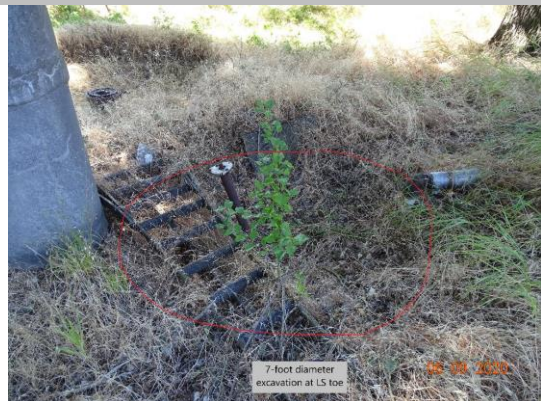
Photo 3 of 3 : UCIP_SP_2024_60630_87904.jpg

Land-Side: 7-foot diameter and 1-foot deep excavation at levee toe

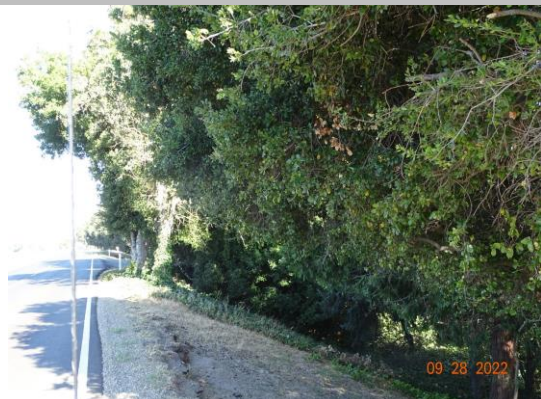
Photo 1 of 1 : SP_2024_RD0551_175_58_20240301_00023.jpg

LM Start	5.54	Rating **	M	Issue No.	58
LM End	5.54	Issue Type +	En	Location *	LS
Category	Earthen Levee			GPS Latitude/Longitude	
				Start	End
Item	Vegetation			38.271415°	38.271415°
				-121.534307°	-121.534307°
DWR ID	DWR_RD0551_01_s_2019_58				
Comment Code					
V6 : Landscaping					
Inspector Comment					
Thin landscaping to allow visibility and access down landside slope.

View of the landscaping on the LS slope (Fall 2022).

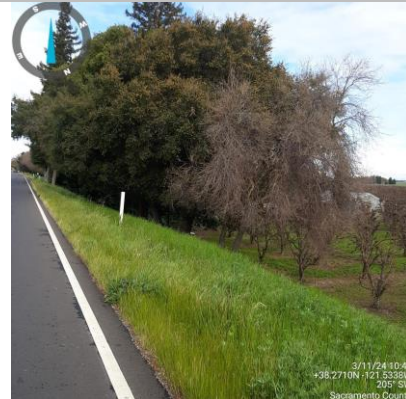
Photo 1 of 1 : SP_2024_RD0551_175_66_20240314_00120.jpg

LM Start	5.57	Rating **	U	Issue No.	66
LM End	5.57	Issue Type +	Ma	Location *	LS
Category	Earthen Levee			GPS Latitude/Longitude	
				Start	End
Item	Vegetation			38.271049°	38.271049°
				-121.533857°	-121.533857°
DWR ID	DWR_RD0551_01_s_2024_66				
Comment Code					
V1 : Control annual grass and weeds on the levee slopes and easements.					
Inspector Comment

View of tall grass on the LS slope. (Spring 2024)

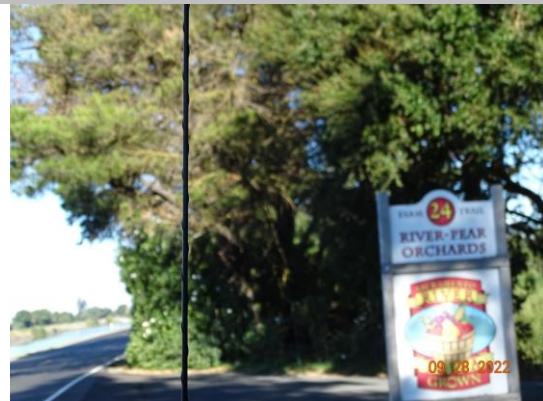
Photo 1 of 1 : SP_2024_RD0551_175_24_20240301_00007.jpg

LM Start	5.59	Rating **	U	Issue No.	24
LM End	5.62	Issue Type +	En	Location *	LS
Category	Earthen Levee			GPS Latitude/Longitude	
				Start	End
Item	Vegetation			38.270840°	38.270574°
				-121.533577°	-121.533281°
DWR ID	DWR_RD0551_01_f_2018_24				
Comment Code					
V6 : Landscaping					
Inspector Comment

View of the landscaping on the LS slope (Fall 2022).

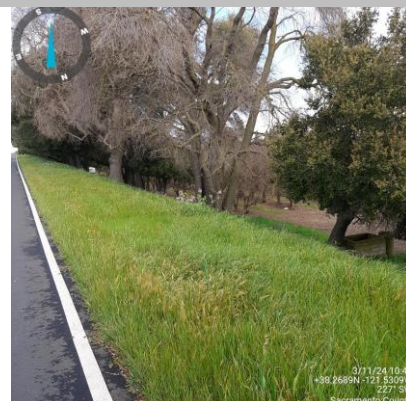
Photo 1 of 1 : SP_2024_RD0551_175_65_20240314_00121.jpg

LM Start	5.62	Rating **	U	Issue No.	65
LM End	5.89	Issue Type +	Ma	Location *	LS
Category	Earthen Levee			GPS Latitude/Longitude	
				Start	End
Item	Vegetation			38.270574°	38.267938°
				-121.533280°	-121.529556°
DWR ID	DWR_RD0551_01_s_2024_65				
Comment Code					
V1 : Control annual grass and weeds on the levee slopes and easements.					
Inspector Comment

View of tall grass on the LS slope. (Spring 2024)

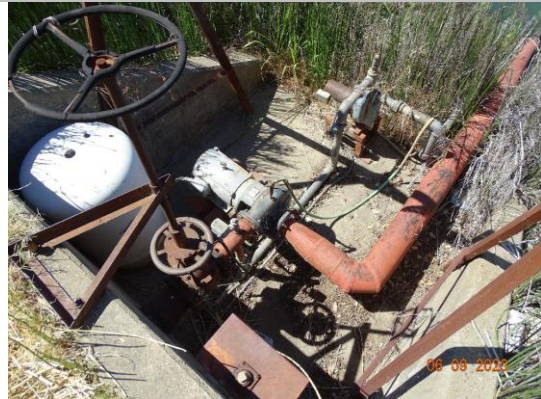
Photo 1 of 3 : UCIP_SP_2024_60636_87919.jpg

Comment Code					
Inspector Comment					
DS_ID:22025 FS_ID:60636 EP_NO: 11134 Repair Type: Non-Urgent EVAL Issue: 4b, Safety Issue Crossing Status: Found UCIP Comments: 06/09/2020 Record updated from No Action Needed to Non-Urgent. CMP riser on landside slope needs a cover - fall hazard. Pipe is running - minor leak through siphon breaker on the top of standpipe and landside toe. No permit has been identified authorizing pipe. Need to have CVFPB review ABO and determine current owner. (O.Yakimov - DWR UCIP) FIELD_STRUCT_DESC: 8-inch irrigation pipe of an unknown material through the levee, 8 feet below the crown. Water pump, gate valve, pressure tank, filler pump on a concrete pad on the waterside (WS) slope. Siphon breaker in a 24-inch CMP riser on the landside (LS) slope. Service pole with electrical panel and meter at landside levee toe. 14-inch steel standpipe with siphon breaker on top at landside toe. 2-inch galvanized steel electrical conduit through the levee at this location. (8-inch pipe [HLM 5.77] authorized under Automatic Board Order (ABO) issued as Permit No. 11134, 1975 - John & Voine B. Molino, et al). [Additional Reference(s): DWR Levee Log, 2005 (HLM 5.77). USACE Sacramento O&M Manual, Unit 111, May 1959, Revised 29 December 2016, (RM 29.03), listed as 6-inch pipe. USACE As-Built Drawing No. 06-13-1100, Sheet 14, upstream of 'L' 1600+60, January 1933, listed as 6-inch pipe]. FS Date: 6/9/2020 2:22:02 PM

Water-Side: Concrete pad on levee slope with pumps, valve, pressure tank

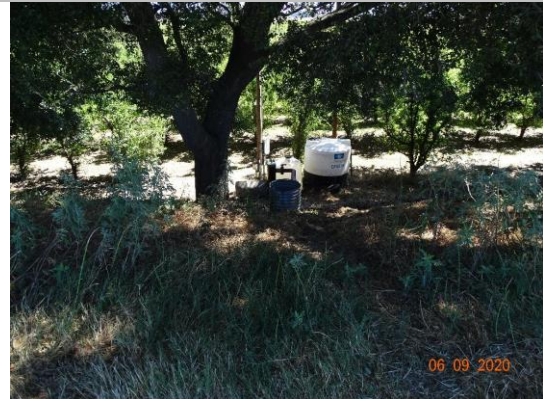
Photo 2 of 3 : UCIP_SP_2024_60636_87920.jpg

Land-Side: View of levee slope looking from crown

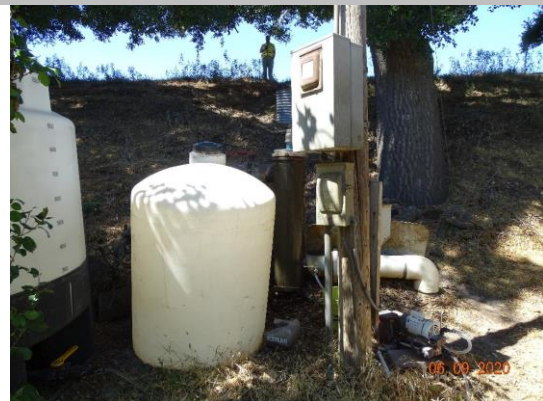
Photo 3 of 3 : UCIP_SP_2024_60636_87922.jpg

Land-Side: Service pole with electrical panels at the toe

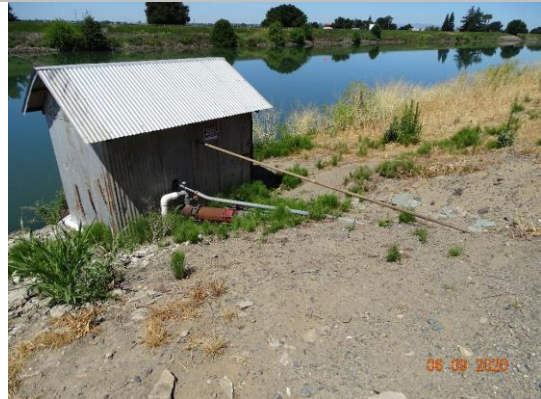
Photo 1 of 3 : UCIP_SP_2024_60641_88028.jpg

Comment Code						
Inspector Comment						
DS_ID:22026 FS_ID:60641 EP_NO: 11123 Repair Type: Non-Urgent EVAL Issue: 10, Unauthorized Modification or Non-Compliant Permit Crossing Status: Found UCIP Comments: 06/09/2020 Record updated from No Action Needed to Non-Urgent. Unable to find a permit authorizing to sleeve 10-inch through 12-inch pipe. (O.Yakimov - DWR UCIP) FIELD_STRUCT_DESC: 10-inch steel irrigation pipe sleeved through the 12-inch steel pipe through the levee, 3.8 feet below the crown. Pump and butterfly valve in pump house on the waterside (WS) slope. 48-inch concrete standpipe on the landside (LS) toe, and a 1.5-inch galvanized iron electrical conduit at the same location with a service pole on the LS slope. (12-inch pipe authorized under Permit No. 1656, 1952 - Alexander Johnson). (10-inch pipe [HLM 5.93] authorized under Automatic Board Order (ABO) issued as Permit No. 11123, 1975 - Anthony & Leonilia Castanho). [Additional Reference(s): DWR Levee Log, 2005 (HLM 5.87), listed as 10-inch pipe. USACE Sacramento O&M Manual, Unit 111, May 1959, Revised 29 December 2016, (RM 28.87), listed as 10-inch pipe]. FS Date: 6/9/2020 3:52:11 PM

Water-Side: View of levee slope looking from crown. Pump house on levee slope

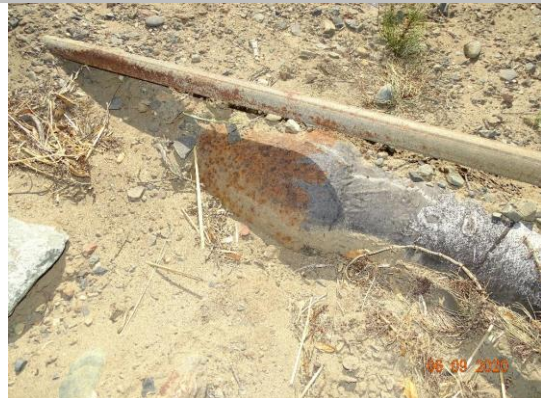
Photo 2 of 3 : UCIP_SP_2024_60641_88029.jpg

Water-Side: Sleeving point on levee slope

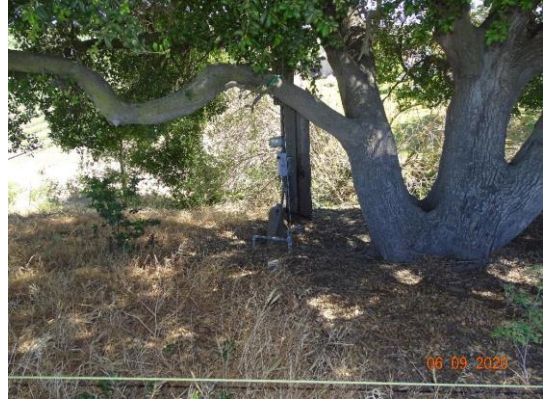
Photo 3 of 3 : UCIP_SP_2024_60641_88032.jpg

Land-Side: View of levee slope looking from crown

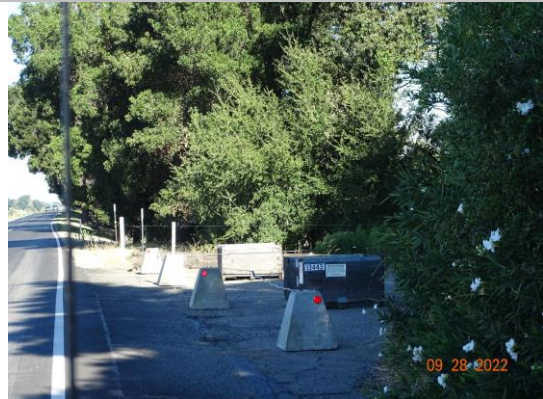
Photo 1 of 1 : SP_2024_RD0551_175_59_20240301_00024.jpg

LM Start	5.90	Rating **	A/W	Issue No.	59
LM End	5.90	Issue Type +	En	Location *	LS
Category	Earthen Levee			GPS Latitude/Longitude	
				Start	End
Item	Encroachments			38.267757°	38.267757°
				-121.529443°	-121.529443°
DWR ID	DWR_RD0551_01_f_2018_59				
Comment Code					
MA : Material					
Inspector Comment					
Boxes were placed on the landside shoulder inhibiting parking and access down the levee.

View of the concrete blocks on the LS shoulder (Fall 2022).

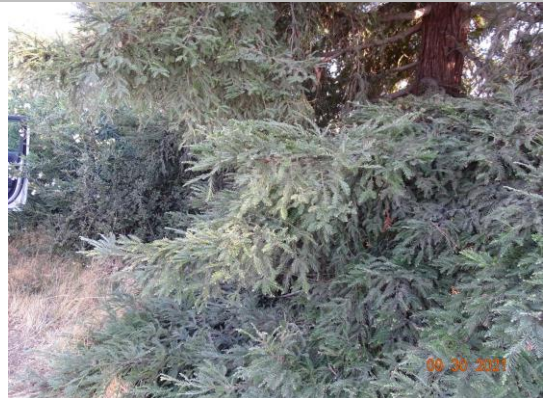
Photo 1 of 1 : SP_2024_RD0551_175_91_20240301_00031.jpg

LM Start	5.91	Rating **	U	Issue No.	91
LM End	5.91	Issue Type +	En	Location *	LS
Category	Earthen Levee			GPS Latitude/Longitude	
				Start	End
Item	Vegetation			38.267738°	38.267738°
				-121.529175°	-121.529175°
DWR ID	DWR_RD0551_01_f_2021_91				
Comment Code					
V6 : Landscaping					
Inspector Comment

View of landscaping on the landside slope (Fall 2021).

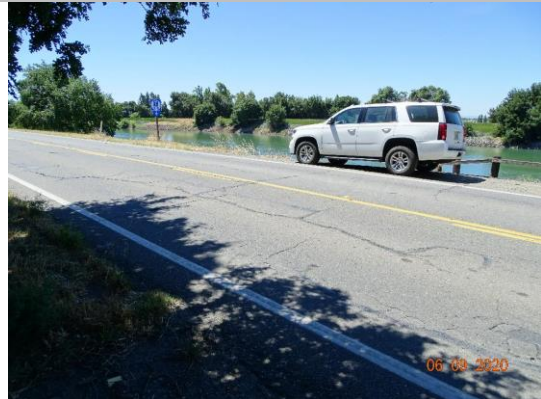
Photo 1 of 3 : UCIP_SP_2024_60650_87927.jpg

Comment Code					
Inspector Comment					
DS_ID:22027 FS_ID:60650 EP_NO: 11122 Repair Type: Non-Urgent EVAL Issue: 10, Unauthorized Modification or Non-Compliant Permit Crossing Status: Indicator Found UCIP Comments: 06/09/2020 Record updated from No Action Needed to Non-Urgent. Pump is moved downstream to a separate piled steel pad and connected to existing 10-inch pipe through the levee. Concrete distribution box at landside toe seems abandoned. Fine media filtration system installed on landside and connected to this crossing. Unable to find permit for system modifications. Pipe is running - minor water leak through pump sealing on waterside slope. (O.Yakimov - DWR UCIP) FIELD_STRUCT_DESC: 10-inch steel exterior coated irrigation pipe through the levee, 8 feet below the crown. Abandoned pile structure on waterside slope and in stream. Pump and butterfly valve on steel piled pad on waterside slope downstream of abandoned structure. Service pole with electrical panel and meter, media filters off landside toe. Abandoned 4-foot by 6-foot concrete distribution box at landside levee toe. This crossing replaces 8-inch pipe (see DSID 21998). (10-inch pipe authorized under Permit No. 4303, 1963 - Robert M. Carmany). (10-inch pipe [HLM 6.21] authorized under Automatic Board Order (ABO) issued as Permit No. 11122, 1975 - Robert M. And Francis Carmany). [Additional Reference(s): DWR Levee Log, 2005 (HLM 6.21)]. FS Date: 6/9/2020 8:33:40 AM

Top of Levee: View of levee crown looking towards waterside

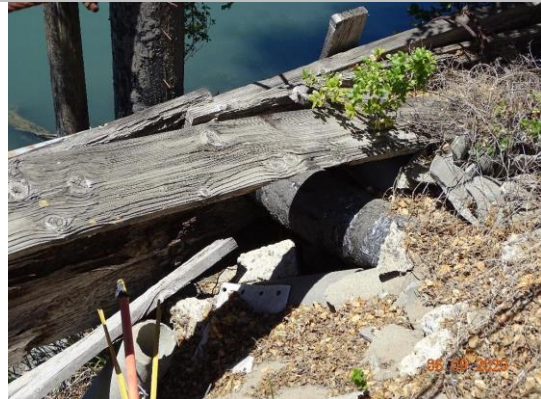
Photo 3 of 3 : UCIP_SP_2024_60650_87930.jpg

Water-Side: 10-inch pipe at abandoned structure on levee slope

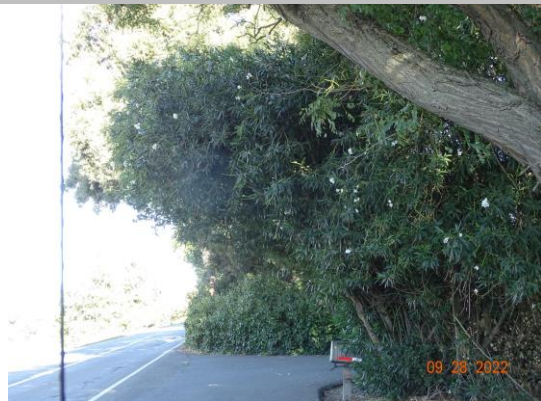
Photo 1 of 1 : SP_2024_RD0551_175_51_20240301_00017.jpg

LM Start	6.19	Rating **	U	Issue No.	51
LM End	6.26	Issue Type +	En	Location *	LS
Category	Earthen Levee			GPS Latitude/Longitude	
				Start	End
Item	Vegetation			38.264814°	38.264112°
				-121.525728°	-121.524845°
DWR ID	DWR_RD0551_01_f_2017_51				
Comment Code					
V6 : Landscaping					
Inspector Comment					
Landscaping should be maintained to allow inspection and access to landside slope and toe.

View of the landscaping on the LS shoulder and slope (Fall 2022).

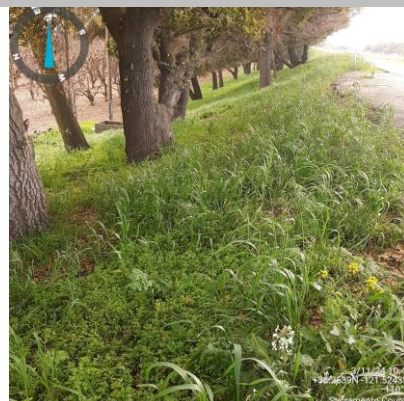
Photo 1 of 1 : SP_2024_RD0551_175_53_20240314_00123.jpg

LM Start	6.29	Rating **	U	Issue No.	53
LM End	6.43	Issue Type +	Ma	Location *	LS
Category	Earthen Levee			GPS Latitude/Longitude	
				Start	End
Item	Vegetation			38.263877°	38.262418°
				-121.524389°	-121.522522°
DWR ID	DWR_RD0551_01_s_2024_53				
Comment Code					
V1 : Control annual grass and weeds on the levee slopes and easements.					
Inspector Comment

View of tall grass on the LS slope. (Spring 2024)

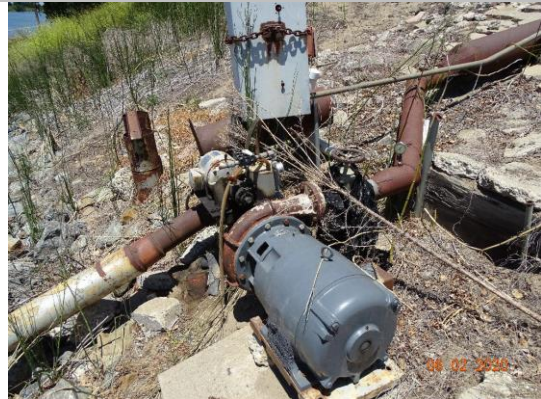
Photo 1 of 3 : UCIP_SP_2024_60690_87969.jpg

Comment Code						
Inspector Comment						
DS_ID:22028						
FS_ID:60690						
EP_NO: N/A						
Repair Type: Non-Urgent						
EVAL Issue: 10, Unauthorized Modification or Non-Compliant Permit						
Crossing Status: Found						
UCIP Comments: 06/02/2020 Record updated from No Action Needed						
to Non-Urgent. Pipe is capped with steel plate inside of concrete						
distribution box at landside toe. 6-inch steel pipe going around the						
concrete box apparently connected underground at levee toe to the pipe						
through the levee. Unable to find a permit for modifications. No permit						
has been identified authorizing pipe through the levee. (O.Yakimov -						
DWR UCIP)						
FIELD_STRUCT_DESC: 12-inch welded steel irrigation pipe through						
the levee, 6.3 feet below the crown. Slant pump and slide gate on the						
waterside (WS) slope. 4-foot by 6-foot concrete distribution box, siphon						
breaker and vent on 6-inch pipe next to the concrete box at landside

Water-Side: Pump on concrete pad on levee slope

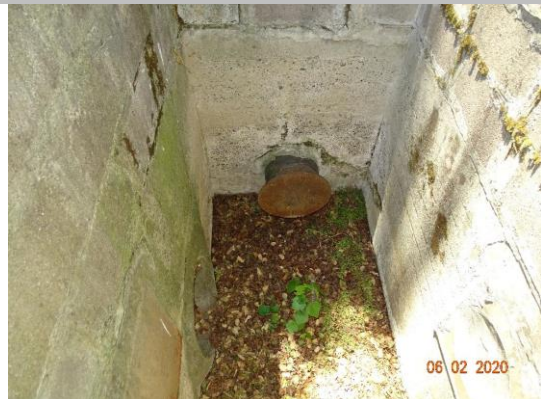
Photo 2 of 3 : UCIP_SP_2024_60690_87964.jpg

Land-Side: View inside of concrete distribution box. Pipe is capped

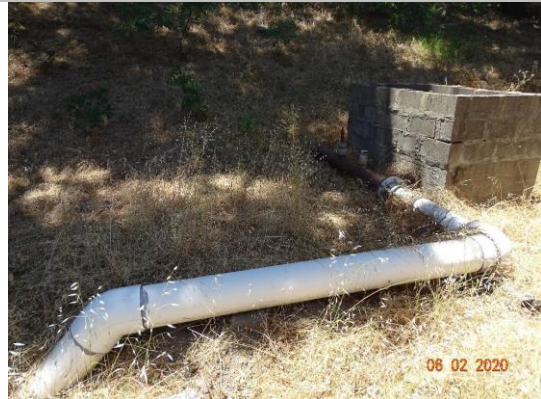
Photo 3 of 3 : UCIP_SP_2024_60690_87965.jpg

Land-Side: 6-inch steel pipe continued with a PVC pipe at the concrete box

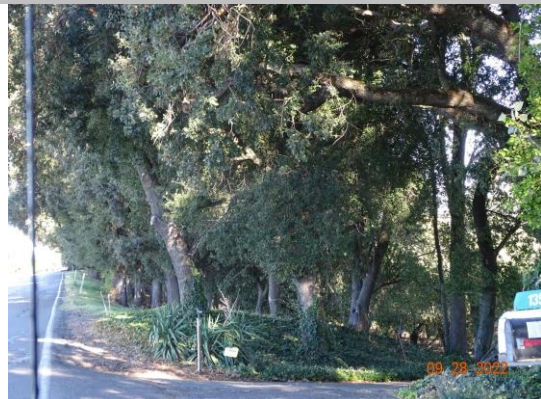
Photo 1 of 1 : SP_2024_RD0551_175_20_20240301_00005.jpg

LM Start	6.44	Rating **	M	Issue No.	20
LM End	6.44	Issue Type +	En	Location *	LS
Category	Earthen Levee			GPS Latitude/Longitude	
				Start	End
Item	Vegetation			38.262388 °	38.262388 °
				-121.522368 °	-121.522368 °
DWR ID	DWR_RD0551_01_s_2019_20				
Comment Code					
V6 : Landscaping					
Inspector Comment					
Cactus on the landside slope should be removed.

View of the cactus and other landscaping on the LS slope (Fall 2022).

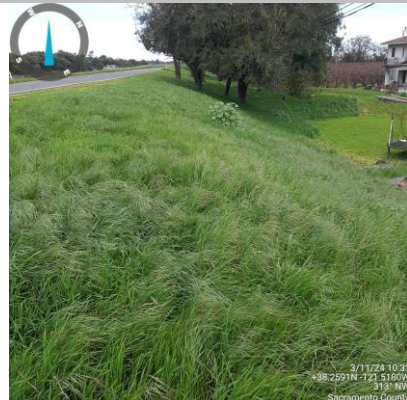
Photo 1 of 1 : SP_2024_RD0551_175_50_20240314_00124.jpg

LM Start	6.45	Rating **	U	Issue No.	50
LM End	6.78	Issue Type +	Ma	Location *	LS
Category	Earthen Levee			GPS Latitude/Longitude	
				Start	End
Item	Vegetation			38.262236°	38.258975°
				-121.522174°	-121.517882°
DWR ID	DWR_RD0551_01_s_2024_50				
Comment Code					
V1 : Control annual grass and weeds on the levee slopes and easements.					
Inspector Comment

View of tall grass on the LS slope. (Spring 2024)

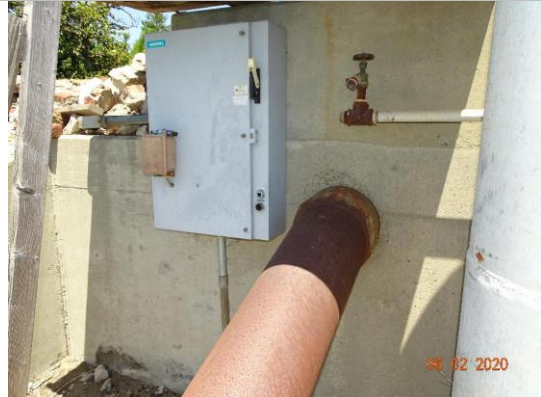
Photo 1 of 3 : UCIP_SP_2024_60696_87977.jpg

Comment Code					
Inspector Comment					
DS_ID:22029					
FS_ID:60696					
EP_NO: 3354					
Repair Type: Non-Urgent					
EVAL Issue: 10, Unauthorized Modification or Non-Compliant Permit					
Crossing Status: Found					
UCIP Comments: 06/02/2020 Record updated from No Action Needed to Non-Urgent. 12-inch pipe sleeved through 14-inch pipe through the levee. Unable to find a permit for modification. Pipe is running - leaks not detected. (O.Yakimov - DWR UCIP)					
FIELD_STRUCT_DESC: 12-inch steel irrigation pipe sleeved through 14-inch coated steel pipe through the levee, 3.5 feet below the crown. Slant pump on a concrete slab on the waterside (WS) slope. Siphon breaker in a 24-inch corrugated metal pipe (CMP) riser on the landside (LS) shoulder. Slide gate in a 48-inch concrete riser on the LS toe. 1.5-inch electrical conduit at the same location. This crossing replaces 12-inch pipe (see DSID 22000). (14-inch pipe authorized under Permit No. 3354, 1960 - F.I. Christie). [Additional Reference(s): DWR Levee Log, 2005 (HLM 6.53), listed as 14-inch pipe. USACE As-Built Drawing No. 06-13-1100, Sheet 14, 'L' 1640+00, January 1933, , listed as 14-inch pipe].

Water-Side: 12-inch pipe through 14-inch pipe enter headwall

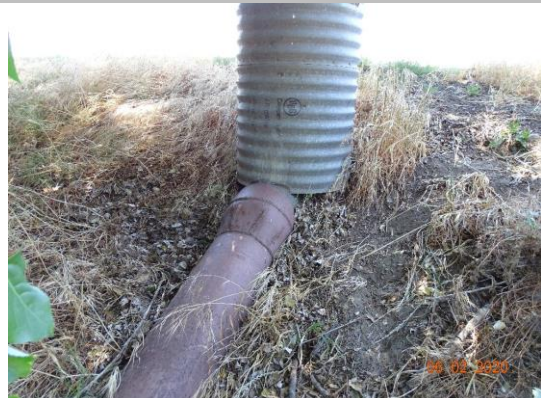
Photo 2 of 3 : UCIP_SP_2024_60696_87979.jpg

Land-Side: Sleeved pipe is visible on levee shoulder
