Flood Control Project Maintenance
Levee Inspections
LMA District Cover Sheet

Reclamation District No. 0551 Pearson

Levee Inspection Report By Mile - Spring 2024

Waterway	Bank	Unit Miles	Inspection Start/End	Inspector
Unit No. 01 Sacramento River	Left	1.83	03/11/2024 03/11/2024	Gregg McMillon

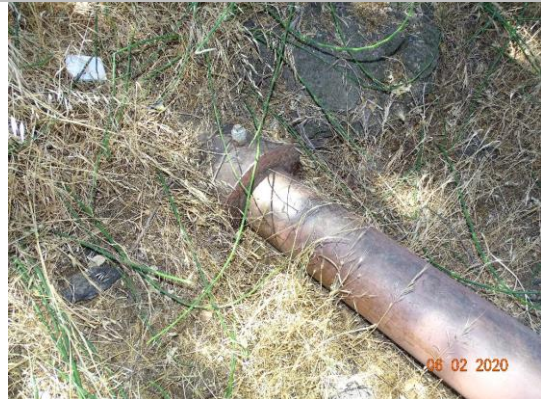
Photo 1 of 3 : UCIP_SP_2024_60701_87997.jpg

Comment Code						
Inspector Comment						
DS_ID:22030 FS_ID:60701 EP_NO: 11126 Repair Type: Non-Urgent EVAL Issue: 10, Unauthorized Modification or Non-Compliant Permit Crossing Status: Found UCIP Comments: 06/02/2020 Record updated from No Action Needed to Non-Urgent. Field measured 8-inch pipe sleeved through 12-inch pipe. Appears that annular space between pipes has been grouted through a plugged hole at landside shoulder. Concrete standpipe and distribution box at landside toe look abandoned. Water is designed to go around concrete box to either underground pipe of screen filter. Unable to find a permit for modifications. Pipe is running - no leaks detected. No permit has been identified authorizing pipe through the levee. Need to have CVFPB review ABO and determine current owner. (O.Yakimov - DWR UCIP) FIELD_STRUCT_DESC: 8-inch irrigation pipe sleeved through the 12-inch steel pipe through the levee, 3 feet below crown. Water pump, filler pump and pressure tank on a concrete pad on the waterside (WS) slope. Butterfly valves at pump and at the landside (LS) toe. Abandoned concrete standpipe and concrete distribution box at landside toe. Screen filter at landside levee toe, service pole a 1.5-inch galvanized electrical conduit at the same location. (12-inch pipe [HLM 6.74] authorized under Automatic Board Order (ABO) issued as Permit No. 11126, 1975 - Alma K. Fletcher). [Additional Reference(s): DWR Levee Log, 2005 (HLM 6.74), listed as 12-inch pipe. USACE Sacramento O&M Manual, Unit 111, May 1959, Revised 29 December 2016, (RM 28.06), listed as 6-inch pipe. USACE As-Built Drawing No. 06-13-1100, Sheet 14, upstream of 'L' 1652+65, January 1933, listed as 6-inch pipe]. FS Date: 6/2/2020 3:17:35 PM

Land-Side: Pipe sleeved through 12-inch pipe visible on levee shoulder.
Grout filler plug on top of pipe

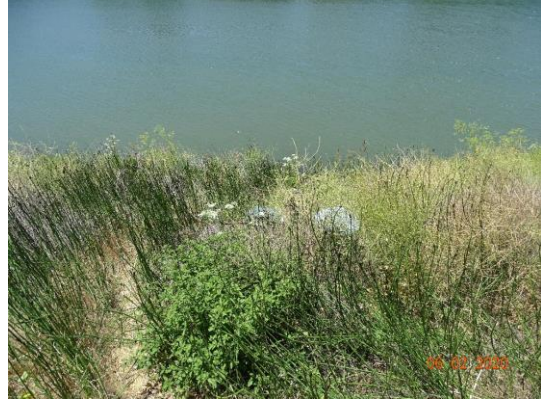
Photo 2 of 3 : UCIP_SP_2024_60701_87987.jpg

Water-Side: View of levee slope looking from crown

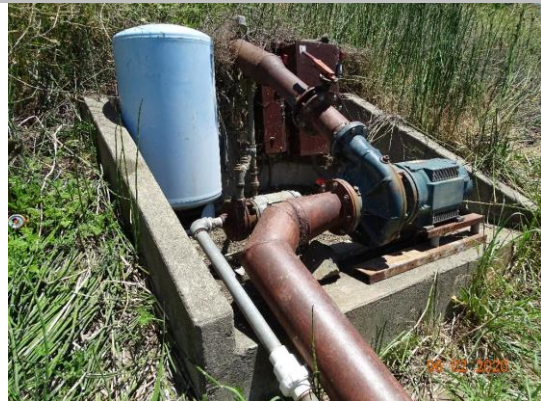
Photo 3 of 3 : UCIP_SP_2024_60701_87994.jpg

Water-Side: View of water pump, filler pump and pressure tank on concrete pad on levee slope
