**Flood Control Project Maintenance  
Levee Inspections**

**Fall 2011 Levee Maintenance Deficiency Summary Report**

**Sacramento River Basin**

**Reclamation District No. 0556 Upper Andrus**

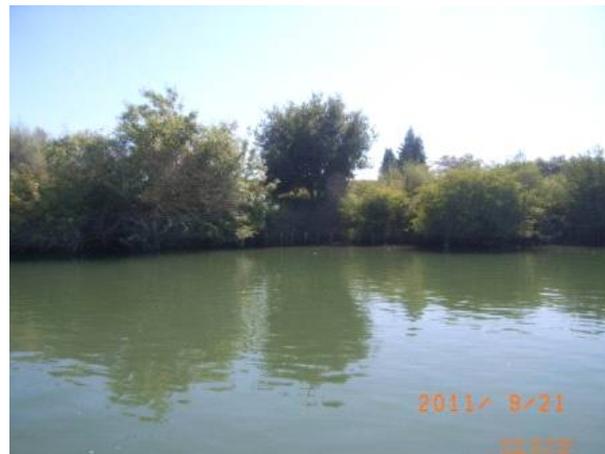
Levee Mile Report Line	5
Start Levee Mile	1.08
End Levee Mile	1.11
Location	Water Side
Category	Supplemental
Item	USACE Erosion Survey
USACE 2011 Photo #1	
USACE2011_SAC_25-2_L_1.jpg

4	1.03	1.04	Earthen Levee	Vegetation	WS	U	Remove the wild growth other than native grasses from the levee slopes.	38.238524 ° -121.536808 °	38.238566 ° -121.536984 °	24 Y
5	1.08	1.11	Supplemental	USACE Erosion Survey	WS	M	Inspector Comments: 1997 - Rock is in poor condition and has failed in many places. Scallops in berm with remnants of old rock in the toe area. 2005 - Brush boxes present. 2011: No observed change. [2011 Site ID: SAC_25-2_L]	38.239006 ° -121.537765 °	38.239265 ° -121.538845 °	26 Y
6	1.45	1.45	Earthen Levee	Vegetation	WS	U	Remove the wild growth other than native grasses from the levee slopes.	38.240118 ° -121.544255 °	38.240118 ° -121.544255 °	19 Y
7	1.45	1.53	Supplemental	USACE Erosion Survey	WS	M	Inspector Comments: 1997 - Slow erosion of the berm at the waterline; bench below water. 2005 - Brush boxes present. 2010 - Minor new erosion. 2011: No observed change. [2011 Site ID: SAC_24-8_L]	38.240401 ° -121.544106 °	38.240772 ° -121.546791 °	27 Y
