**Flood Control Project Maintenance
Levee Inspections**

Fall 2012 Levee Maintenance Deficiency Summary Report

Reclamation District No. 0556 Upper Andrus

Levee Inspection Report By Mile - Fall 2012

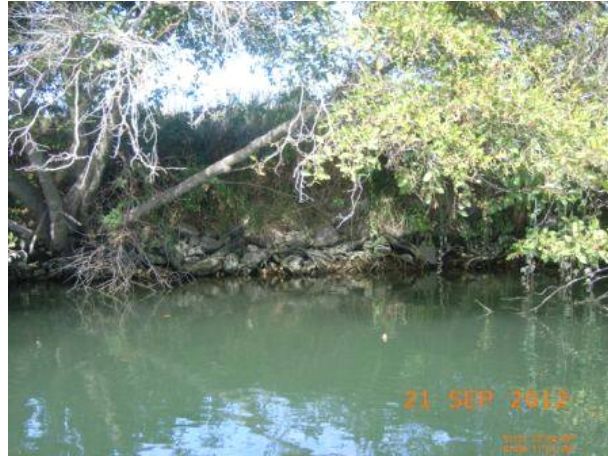
USACE 2012 Photo #2

Levee Mile Report Line	60
Start Levee Mile	5.11
End Levee Mile	5.26
Location	Water Side
Category	Supplemental
Item	USACE Erosion Survey

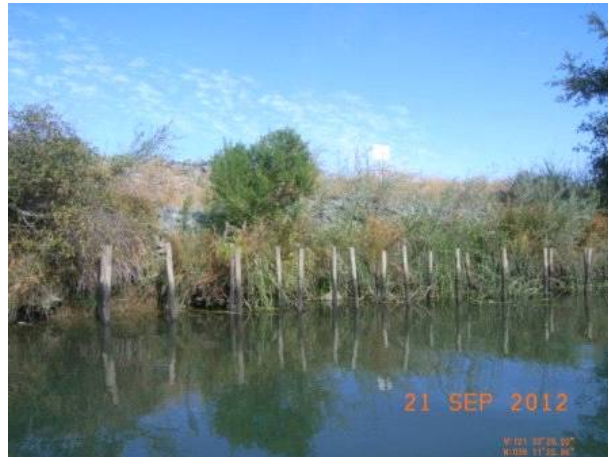
USACE 2012 Photo #3

Levee Mile Report Line	60
Start Levee Mile	5.11
End Levee Mile	5.26
Location	Water Side
Category	Supplemental
Item	USACE Erosion Survey

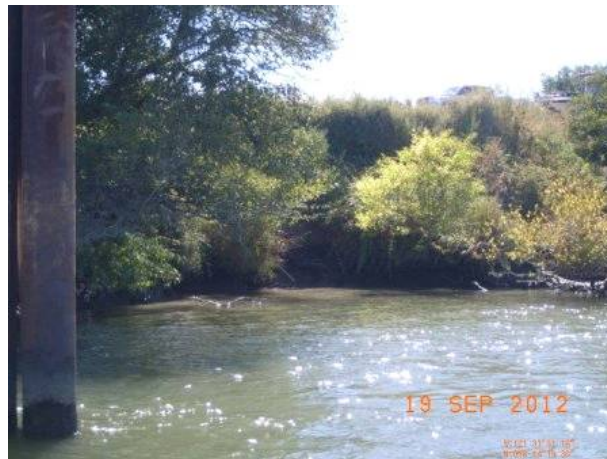
USACE 2012 Photo #2

Levee Mile Report Line	5
Start Levee Mile	0.31
End Levee Mile	0.60
Location	Water Side
Category	Supplemental
Item	USACE Erosion Survey

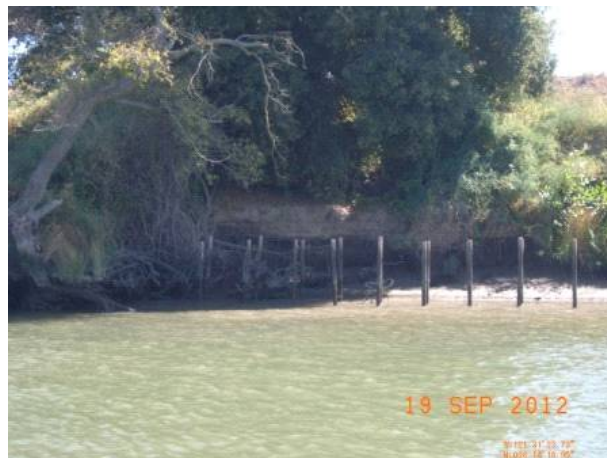
USACE 2012 Photo #3

Levee Mile Report Line	5
Start Levee Mile	0.31
End Levee Mile	0.60
Location	Water Side
Category	Supplemental
Item	USACE Erosion Survey

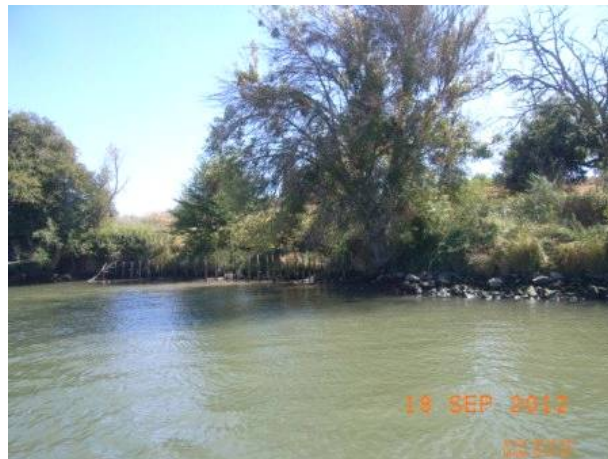
USACE 2012 Photo #3

Levee Mile Report Line	10
Start Levee Mile	1.08
End Levee Mile	1.16
Location	Water Side
Category	Supplemental
Item	USACE Erosion Survey

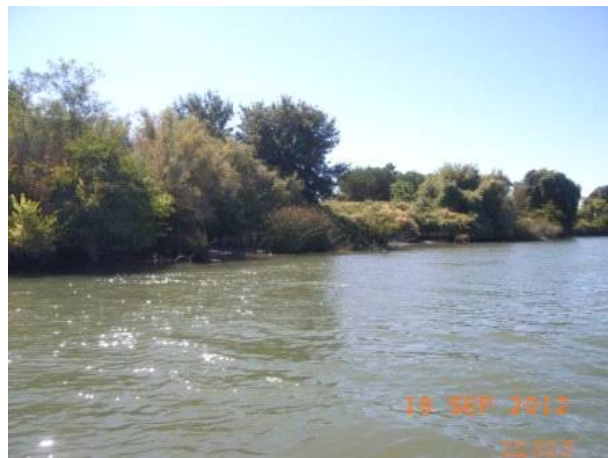
USACE 2012 Photo #1

Levee Mile Report Line	12
Start Levee Mile	1.45
End Levee Mile	1.59
Location	Water Side
Category	Supplemental
Item	USACE Erosion Survey

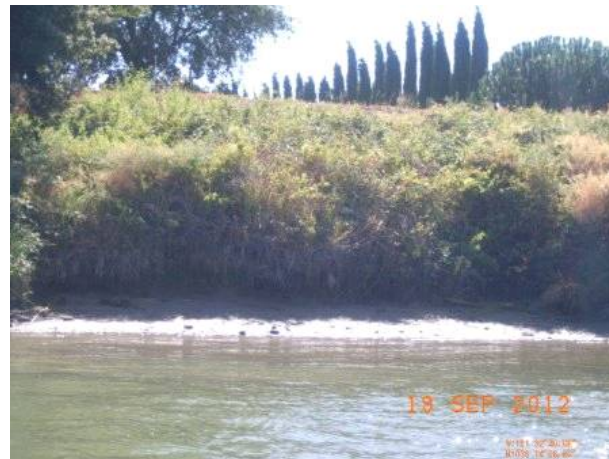
USACE 2012 Photo #3

Levee Mile Report Line	12
Start Levee Mile	1.45
End Levee Mile	1.59
Location	Water Side
Category	Supplemental
Item	USACE Erosion Survey

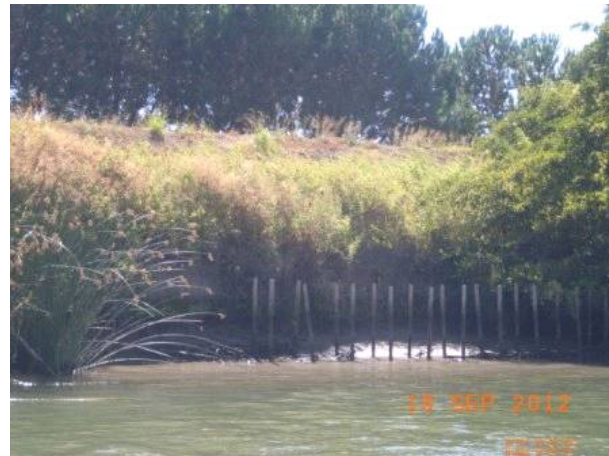
USACE 2012 Photo #4

Levee Mile Report Line	12
Start Levee Mile	1.45
End Levee Mile	1.59
Location	Water Side
Category	Supplemental
Item	USACE Erosion Survey

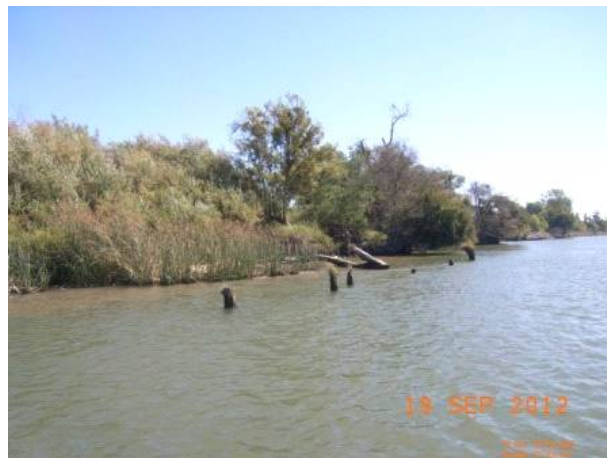
USACE 2012 Photo #1

Levee Mile Report Line	23
Start Levee Mile	3.16
End Levee Mile	3.28
Location	Water Side
Category	Supplemental
Item	USACE Erosion Survey

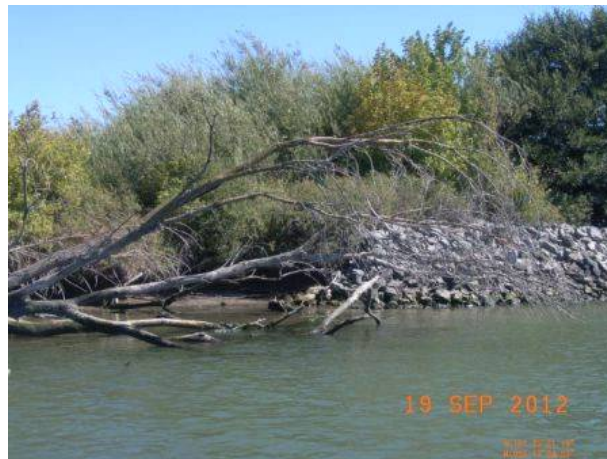
USACE 2012 Photo #3

Levee Mile Report Line	23
Start Levee Mile	3.16
End Levee Mile	3.28
Location	Water Side
Category	Supplemental
Item	USACE Erosion Survey

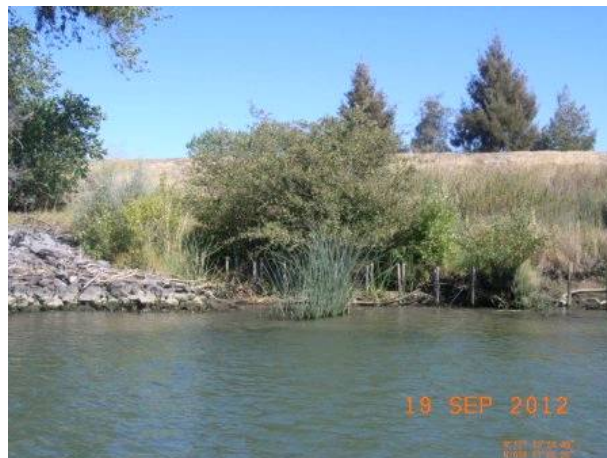
USACE 2012 Photo #1

Levee Mile Report Line	27
Start Levee Mile	3.58
End Levee Mile	3.63
Location	Water Side
Category	Supplemental
Item	USACE Erosion Survey

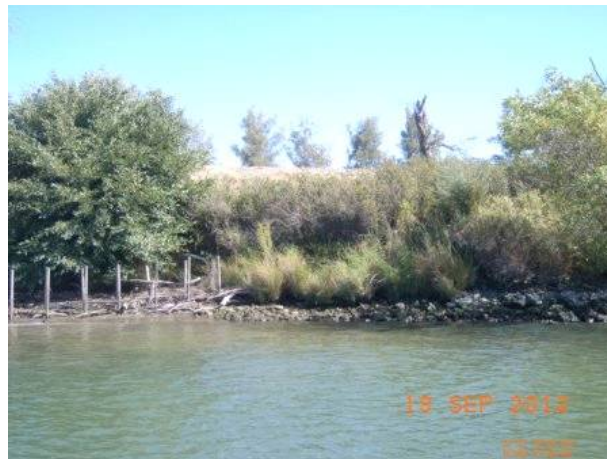
USACE 2012 Photo #3

Levee Mile Report Line	27
Start Levee Mile	3.58
End Levee Mile	3.63
Location	Water Side
Category	Supplemental
Item	USACE Erosion Survey

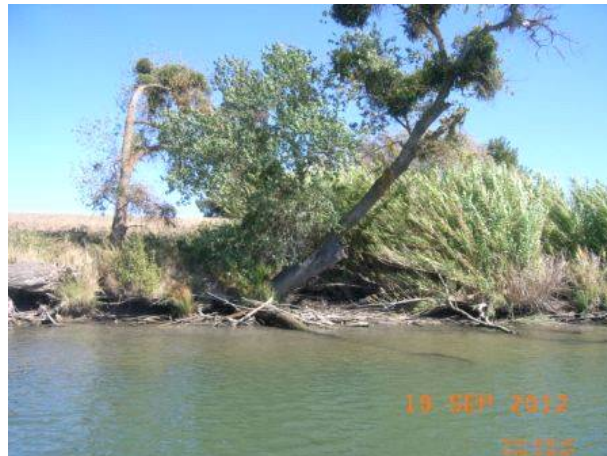
USACE 2012 Photo #1

Levee Mile Report Line	31
Start Levee Mile	3.95
End Levee Mile	4.12
Location	Water Side
Category	Supplemental
Item	USACE Erosion Survey

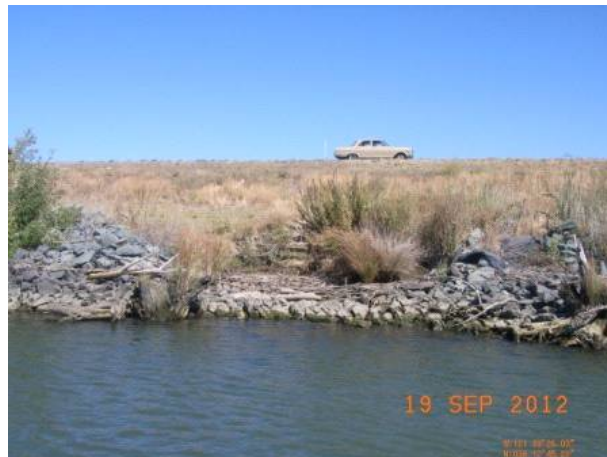
USACE 2012 Photo #3

Levee Mile Report Line	31
Start Levee Mile	3.95
End Levee Mile	4.12
Location	Water Side
Category	Supplemental
Item	USACE Erosion Survey

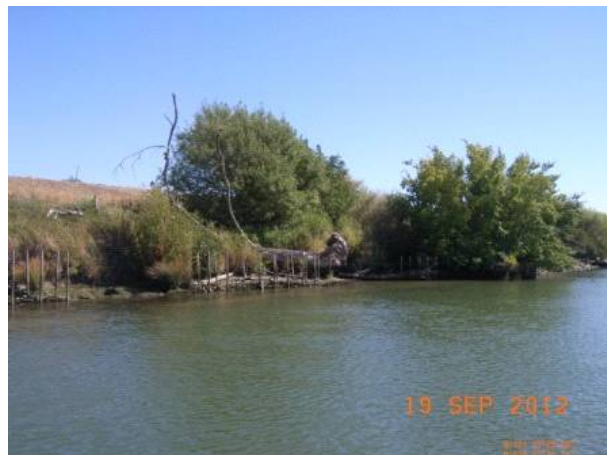
USACE 2012 Photo #4

Levee Mile Report Line	31
Start Levee Mile	3.95
End Levee Mile	4.12
Location	Water Side
Category	Supplemental
Item	USACE Erosion Survey

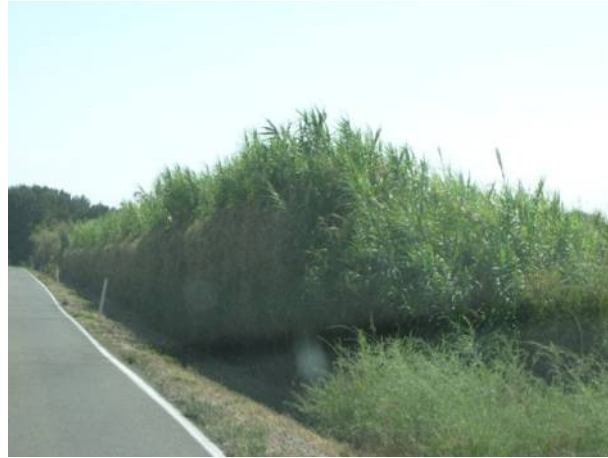
phillips_f_20121205_448.jpg

RD556, wild growth of bamboo on waterward slope. Unable to see levee section. Photo taken 10-02-2012.

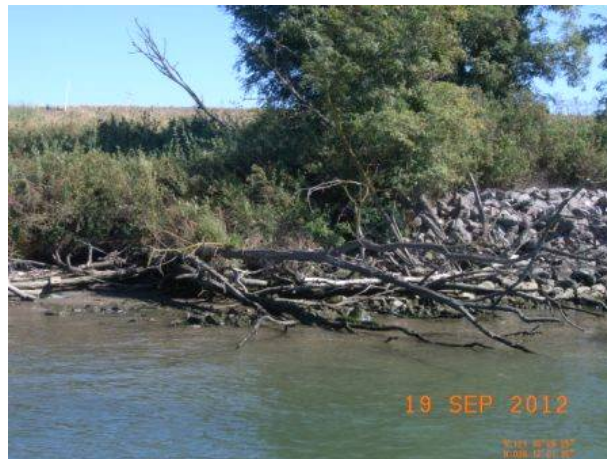
USACE 2012 Photo #2

Levee Mile Report Line	46
Start Levee Mile	4.85
End Levee Mile	4.88
Location	Water Side
Category	Supplemental
Item	USACE Erosion Survey

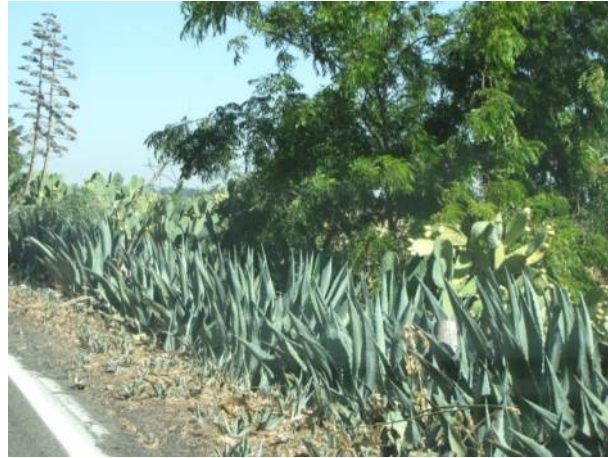
phillips_f_20121205_451.jpg

RD 556, unsatisfactory growth on L/S levee shoulder and slope. Photo taken 10-02-2012.
