**Flood Control Project Maintenance
Levee Inspections**

Fall 2013 Levee Maintenance Deficiency Summary Report

Reclamation District No. 0556 Upper Andrus

Levee Inspection Report By Mile - Fall 2013

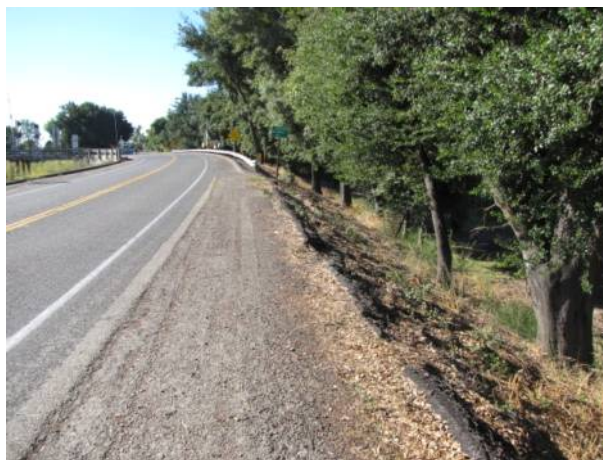
RD 556 Unit 1 looking downstream from levee mile 0.05 landside slope. Photo taken 9-27-2013

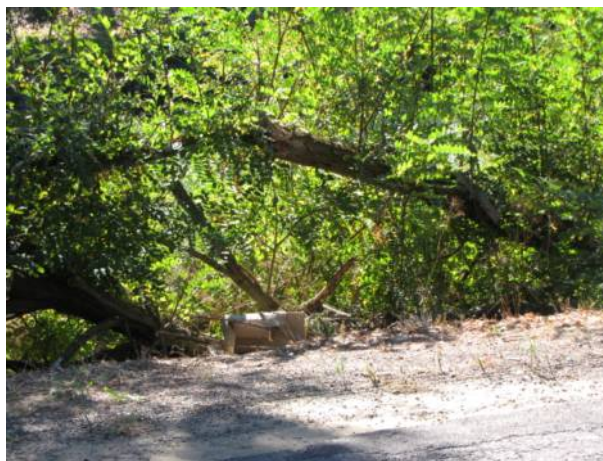
Levee Mile Report Line	6
Start Levee Mile	0.42
End Levee Mile	0.42
Location	Water Side
Category	Earthen Levee
Item	Encroachments

This tree was listed in the last two reports, remove it from levee section. Photo taken 9-27-2013.

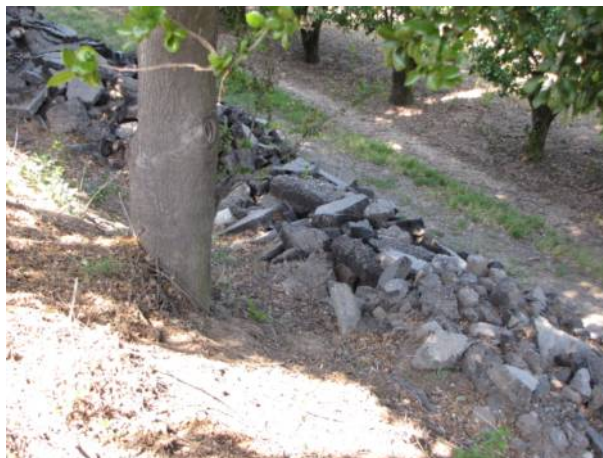
Levee Mile Report Line	21
Start Levee Mile	1.34
End Levee Mile	1.36
Location	Land Side
Category	Earthen Levee
Item	Encroachments

Unauthorized asphalt dumping on toe of levee section. Photo taken 4-25-2013.

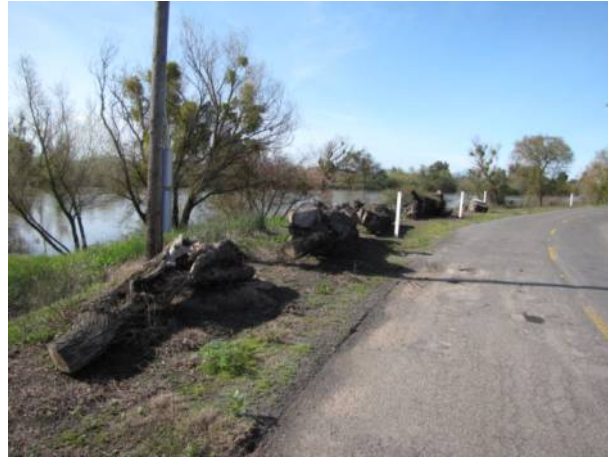
The landowner stated that he would have these trees removed from levee section next month (April). Photo taken 3-29-2011. 10-02-2012 The cut up tree has not been removed from waterward levee shoulder. No change 4-25-2013.

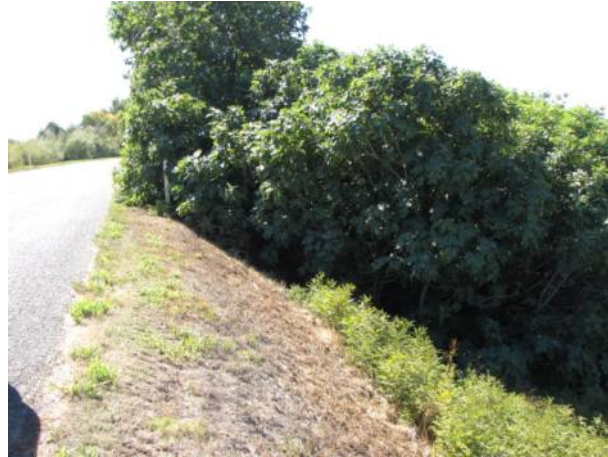
Levee Mile Report Line	37
Start Levee Mile	2.32
End Levee Mile	2.34
Location	Land Side
Category	Earthen Levee
Item	Trim / Thin Trees

Unit 1 levee miles 2.32 -2.34 this dense growth of fig trees complete block visibility of the levee slope. Status: Unsatisfactory.

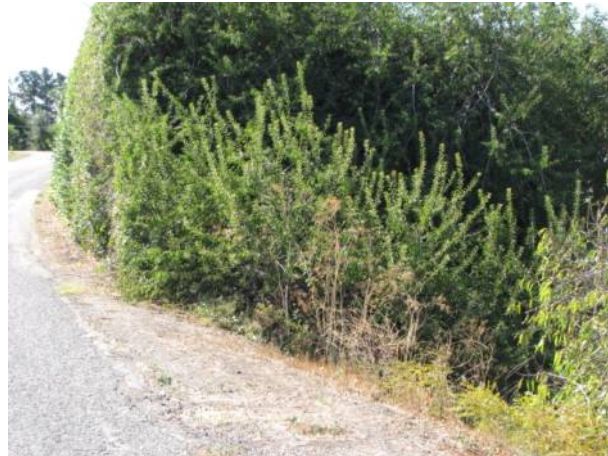
Levee Mile Report Line	39
Start Levee Mile	2.42
End Levee Mile	2.46
Location	Land Side
Category	Earthen Levee
Item	Vegetation

Not able to inspect this section, unsatisfactory growth of trees. Photo taken 9-27-2013.

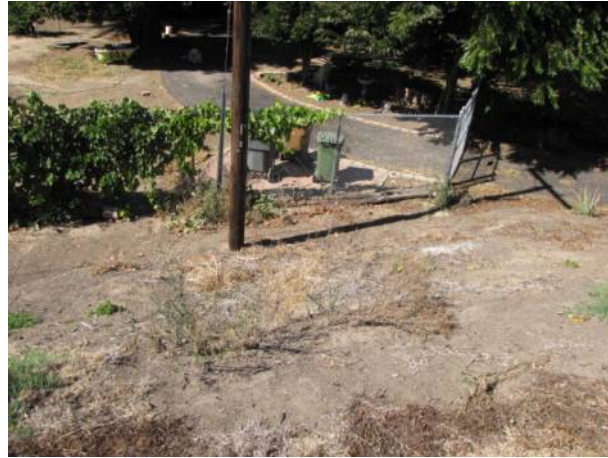
A section of this fence is within the 10-foot of levee toe easement. Photo taken 9-27-2013.

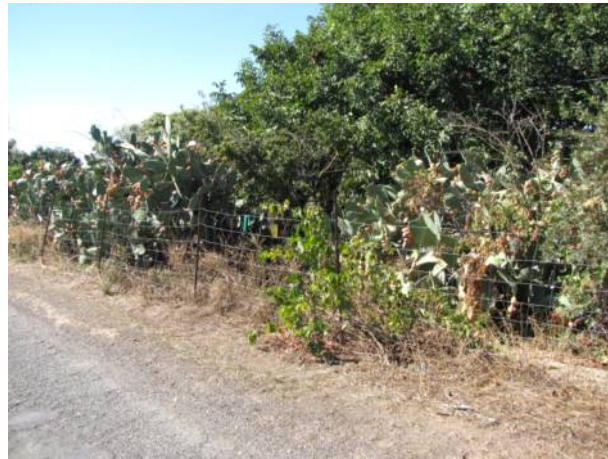
Levee Mile Report Line	65
Start Levee Mile	3.24
End Levee Mile	3.35
Location	Land Side
Category	Earthen Levee
Item	Vegetation

Unsatisfactory wild cactus growth completely blocks visibility. Photo taken 9-27-2013.

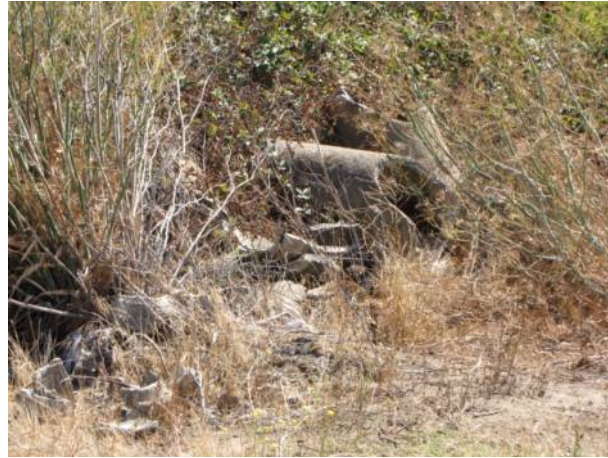
This concrete remains to be on levee section water ward, the district needs to remove it. It has appeared on the last two inspections and beyond. Photo taken 9-27-2013.

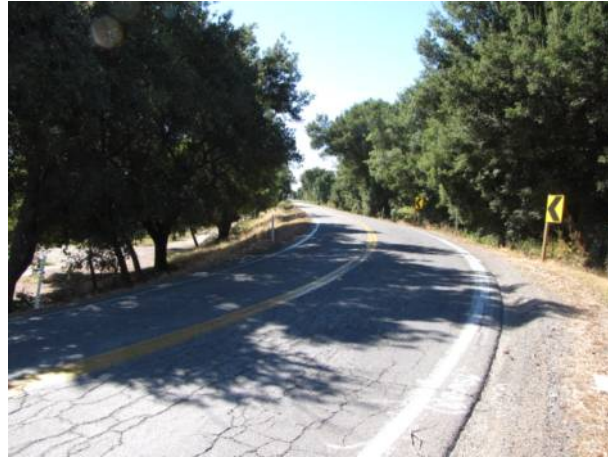
RD 556 Unit 2 looking upstream from the water side slope levee mile 0.00. Photo taken 9-27-2013. Both slopes can be seen from this location.

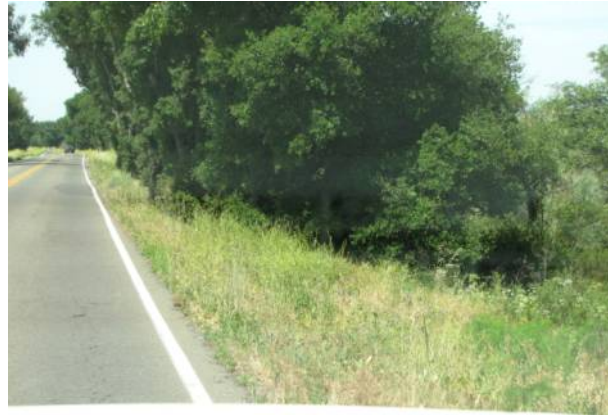
Levee Mile Report Line	5
Start Levee Mile	0.08
End Levee Mile	0.14
Location	Water Side
Category	Earthen Levee
Item	Vegetation

RD 556 Water side wild growth on slope and shoulder. Photo taken 4-25-2013. No new photo taken 9-27-2013.

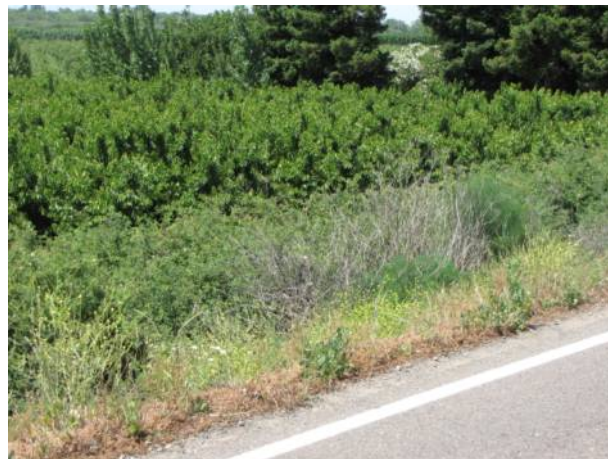
Levee Mile Report Line	17
Start Levee Mile	1.03
End Levee Mile	1.07
Location	Land Side
Category	Earthen Levee
Item	Vegetation

Unsatisfactory growth on landward slope and toe of landward levee section. Photo taken 4-25-2013.

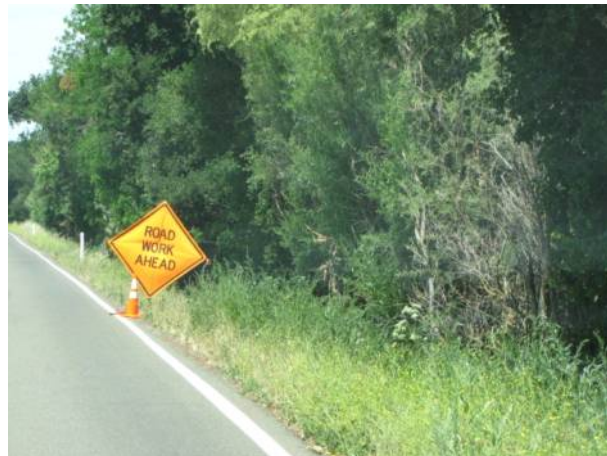
Levee Mile Report Line	20
Start Levee Mile	1.17
End Levee Mile	1.37
Location	Water Side
Category	Earthen Levee
Item	Trim / Thin Trees

Unsatisfactory wild growth on landward slope blocking view of levee section. Photo taken 4-25-2013. No new photo taken 9-27-2013.

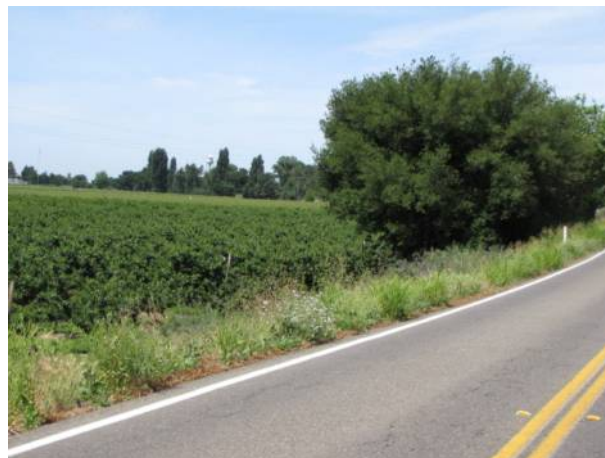
Levee Mile Report Line	27
Start Levee Mile	1.53
End Levee Mile	1.71
Location	Land Side
Category	Earthen Levee
Item	Vegetation

Wild growth on landward levee section greater than 4 feet tall covering levee slope. Photo taken 4-25-2013. No new photo taken 9-27-2013.

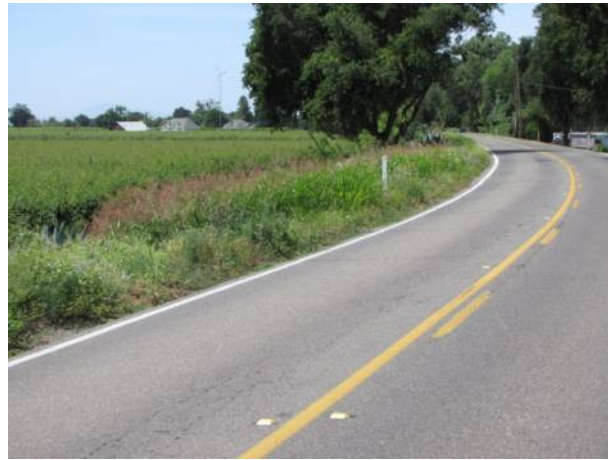
This photo captures some of the wild growth on the landward slope and shoulder that stretches for several miles. Only one photo was taken at the beginning of the run. Photo taken 4-25-2013. No new photo taken 9-27-2013.

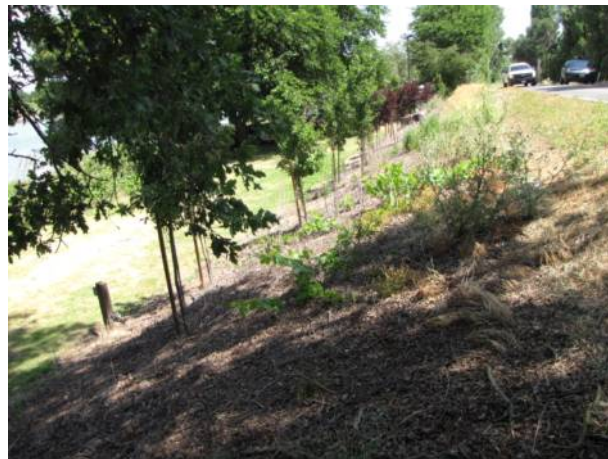
Levee Mile Report Line	34
Start Levee Mile	2.10
End Levee Mile	2.16
Location	Water Side
Category	Earthen Levee
Item	Encroachments

Unauthorized tree plantings along the toe waterward levee section looking downstream. Photo taken 4-25-2013. no new photo was taken during Fall inspection. 9-27-2013.

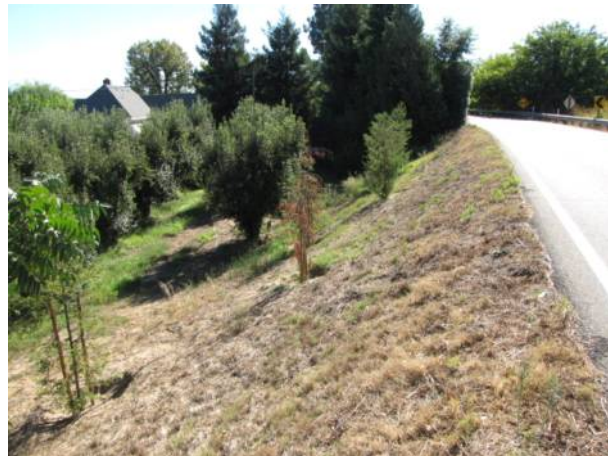
Levee Mile Report Line	35
Start Levee Mile	2.31
End Levee Mile	2.33
Location	Land Side
Category	Earthen Levee
Item	Encroachments

Unauthorized tree planting along landward slope by land owner. Photo retaken in 9-27-2013.

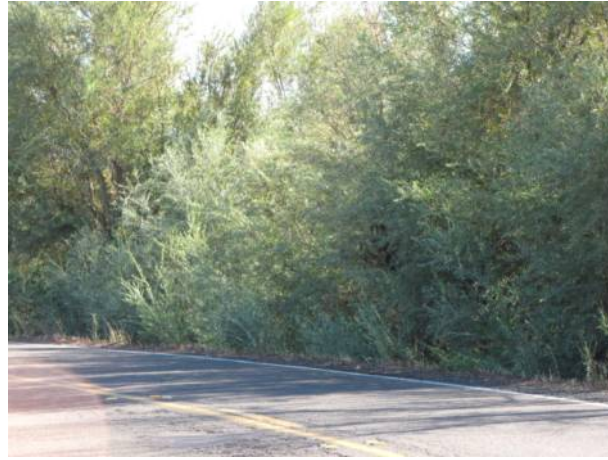
Unwanted wild growth on waterside blocking visibility. Photo taken 9-27-2013.

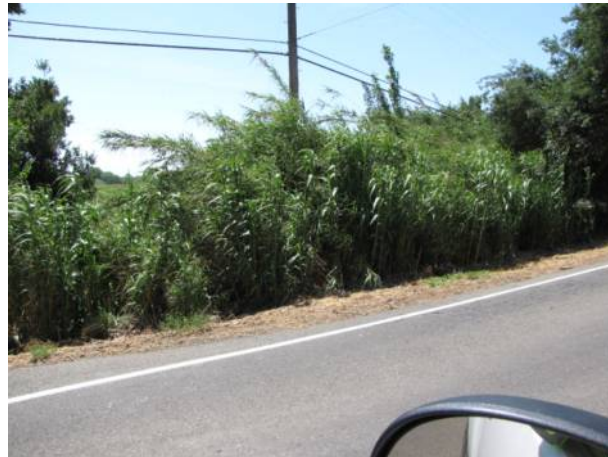
Levee Mile Report Line	37
Start Levee Mile	2.38
End Levee Mile	2.73
Location	Land Side
Category	Earthen Levee
Item	Vegetation

RD 556 Unit 2 Bambo taking over the levee section landward. Photo taken 4-25-2013. No new photo taken 9-27-2013.

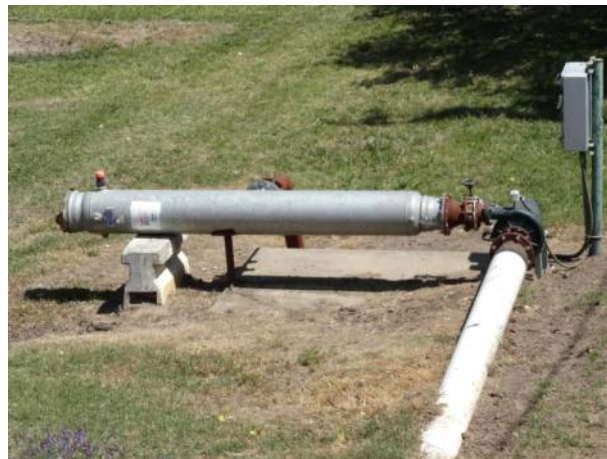
Levee Mile Report Line	52
Start Levee Mile	3.51
End Levee Mile	3.51
Location	Water Side
Category	Supplemental
Item	DWR UCIP Field Study

LS- concrete box beneath steel pipe.

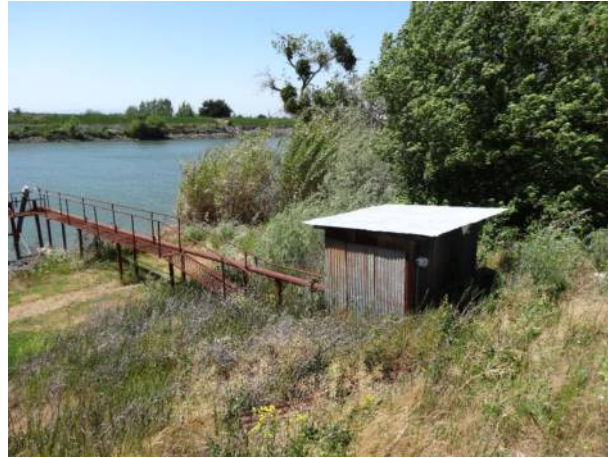
WS- pipe and pump on steel pile structure. Steel walkway from pump house to the pump on steel structure.

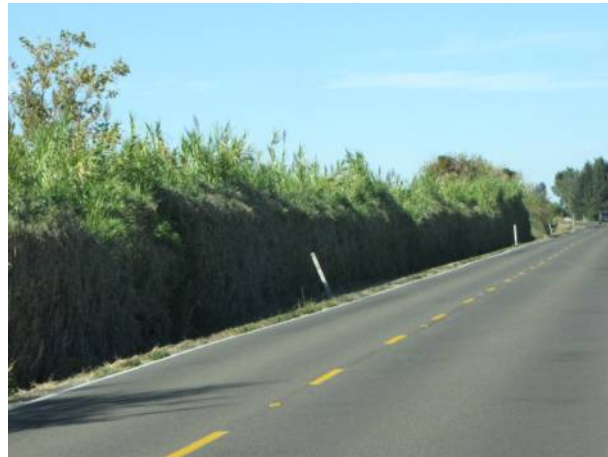
Levee Mile Report Line	60
Start Levee Mile	3.98
End Levee Mile	4.58
Location	Water Side
Category	Earthen Levee
Item	Vegetation

Waterside unwanted bambo on waterside slope completely blocking visibility of levee section. Photo taken 9-27-2013.

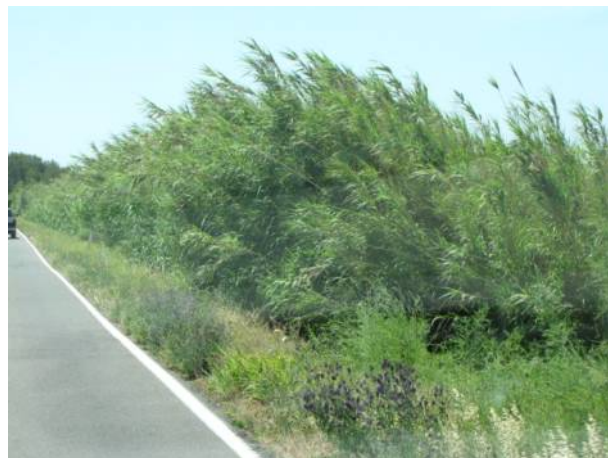
Levee Mile Report Line	62
Start Levee Mile	4.22
End Levee Mile	4.60
Location	Water Side
Category	Earthen Levee
Item	Vegetation

Unsatisfactory wild growth of bamboo blocking view of levee section waterward slope. Photo taken 4-25-2013. No new photo taken 9-27-2013.

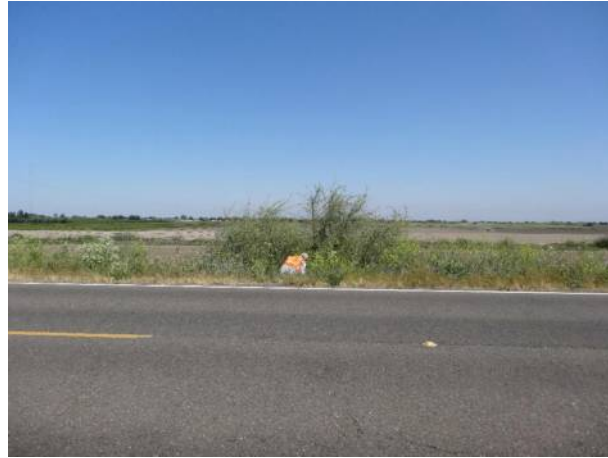
LS- levee crown and overview of landside.

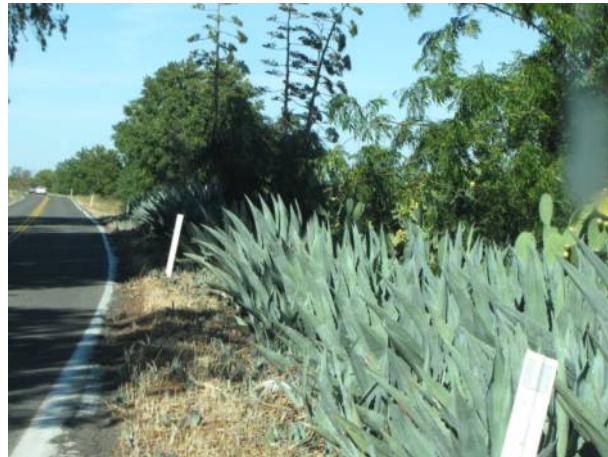
Levee Mile Report Line	69
Start Levee Mile	4.53
End Levee Mile	4.89
Location	Land Side
Category	Earthen Levee
Item	Encroachments

Unsatisfactory, this landscape blocks visibility to levee section. Photo taken 9-27-2013.

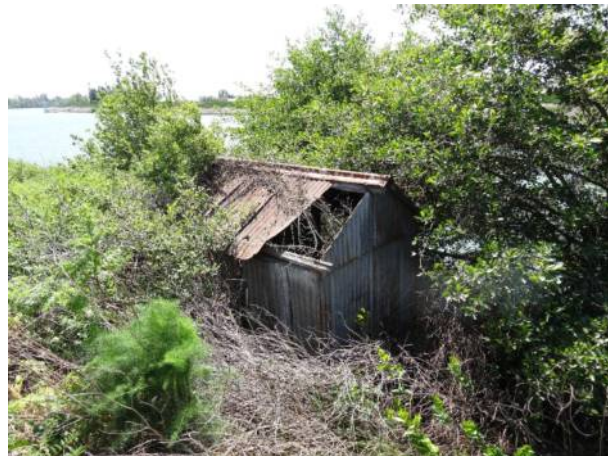
Levee Mile Report Line	70
Start Levee Mile	4.53
End Levee Mile	4.53
Location	Land Side
Category	Supplemental
Item	DWR UCIP Field Study

WS- abandoned pump house on levee slope. Dense vegetation on levee slope.

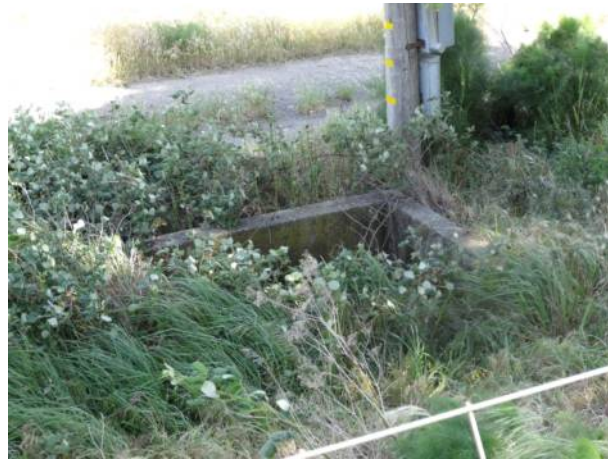
LS- power pole and a concrete distribution box near levee toe.

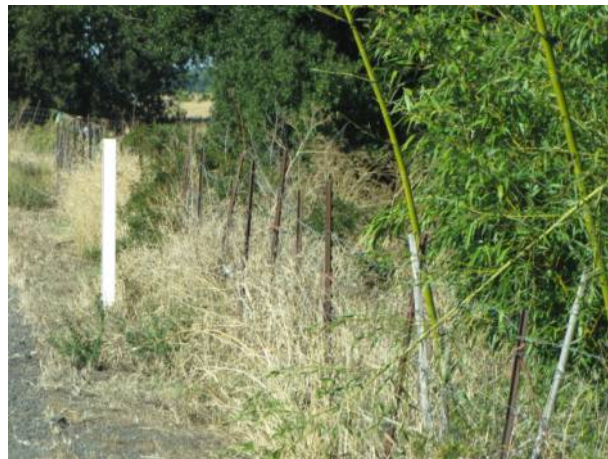
Levee Mile Report Line	74
Start Levee Mile	4.72
End Levee Mile	4.90
Location	Land Side
Category	Earthen Levee
Item	Vegetation

Unsatisfactory wild growth along the landward levee section. Photo taken 9-27-2013.

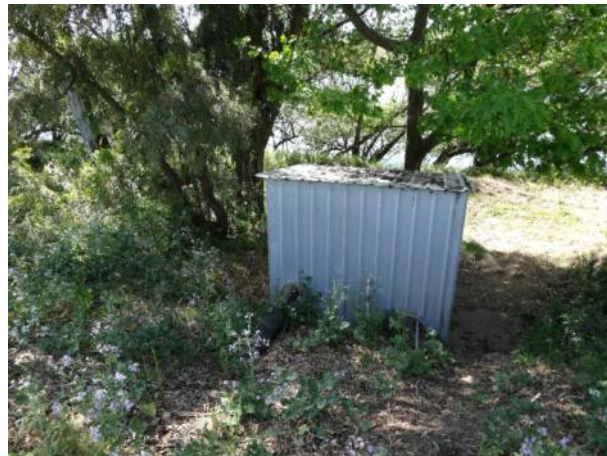
Levee Mile Report Line	84
Start Levee Mile	5.21
End Levee Mile	5.21
Location	Water Side
Category	Supplemental
Item	DWR UCIP Field Study

WS- pump house on levee slope
