**Flood Control Project Maintenance
Levee Inspections**

Fall 2014 Levee Maintenance Deficiency Summary Report

Sacramento River Basin

Reclamation District No. 0556 Upper Andrus

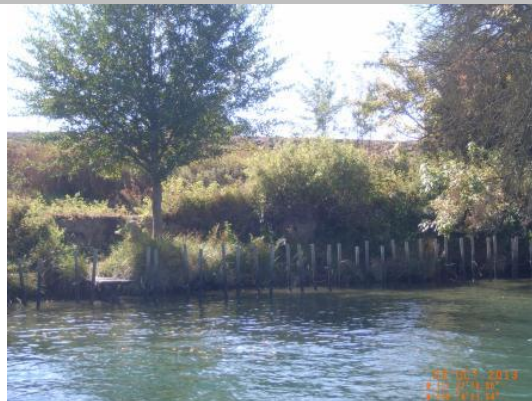
Photo 1 of 1 : FA_2014_RD0556_19_27_20141030_00009.jpg

LM Start	1.03	Rating **	M	Issue No.	27
LM End	1.16	Issue Type +	Ma	Location *	WS
Category	Supplemental			GPS Latitude/Longitude	
				Start	End
Item	USACE Erosion Survey			38.238772 °	38.239265 °
				-121.536788 °	-121.538845 °
DWR ID	DWR_RD0556_02_f_2014_27				
Action/Comments					
Inspector Comments: 1997 - Rock is in poor condition and has failed in many places. Scallops in berm with remnants of old rock in the toe area. 2005 - Brush boxes present. 2013: Site extended upstream approximately 300 ft to include new erosion pockets. [2013 Site ID: SAC_25-2_L]

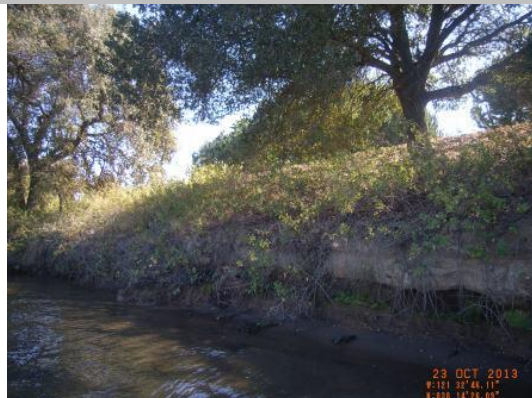
Photo 1 of 1 : FA_2014_RD0556_19_26_20141030_00008.jpg

LM Start	1.45	Rating **	M	Issue No.	26
LM End	1.59	Issue Type +	Ma	Location *	WS
Category	Supplemental			GPS Latitude/Longitude	
				Start	End
Item	USACE Erosion Survey			38.240401 °	38.240772 °
				-121.544106 °	-121.546791 °
DWR ID	DWR_RD0556_02_f_2014_26				
Action/Comments					
Inspector Comments: 1997 - Slow erosion of the berm at the waterline; bench below water. 2005 - Brush boxes present. 2010 - Minor new erosion. 2013: There is little to no berm remaining at downstream end of this site. [2013 Site ID: SAC_24-8_L]

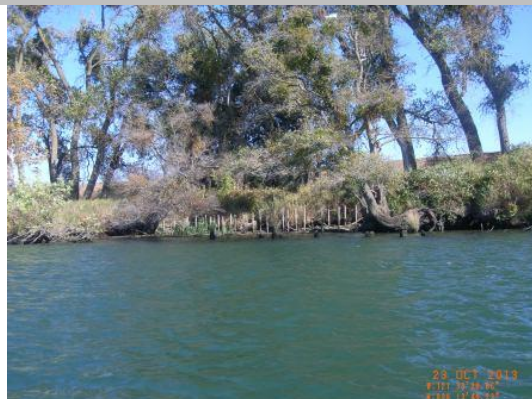
Photo 1 of 1 : FA_2014_RD0556_19_25_20141030_00007.jpg

LM Start	2.96	Rating **	M	Issue No.	25
LM End	3.02	Issue Type +	Ma	Location *	WS
Category	Supplemental			GPS Latitude/Longitude	
				Start	End
Item	USACE Erosion Survey			38.228202 °	38.226601 °
				-121.555502 °	-121.555605 °
DWR ID	DWR_RD0556_02_f_2014_25				
Action/Comments					
Inspector Comments: 1997 - Few scallops in berm, some getting close to levee toe. 2005 - Brush boxes present. 2012 - More erosion of the toe since last year. 2013: No observed changes. [2013 Site ID: SAC_23-3_L]

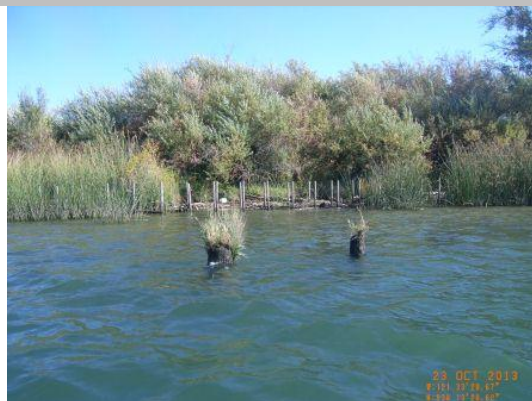
Photo 1 of 1 : FA_2014_RD0556_19_23_20141030_00005.jpg

LM Start	3.16	Rating **	M	Issue No.	23
LM End	3.25	Issue Type +	Ma	Location *	WS
Category	Supplemental			GPS Latitude/Longitude	
				Start	End
Item	USACE Erosion Survey			38.224850 °	38.223233 °
				-121.555641 °	-121.555687 °
DWR ID	DWR_RD0556_02_f_2014_23				
Action/Comments					
Inspector Comments: 2000 - Recently fallen cottonwood at the downstream end. 2005 - Empty brush boxes. 2011 - A few trees have fallen since last year. 2012 - Potential new tree popout since last year. 2013: New erosion at downstream end of site and a recent tree pop-out observed. [2013 Site ID: SAC_23-2_L]

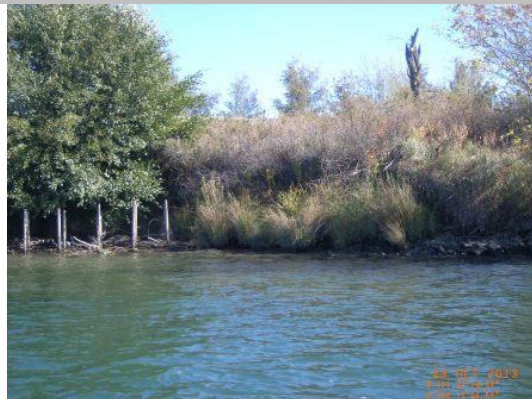
Photo 1 of 1 : FA_2014_RD0556_19_22_20141030_00004.jpg

LM Start	3.58	Rating **	M	Issue No.	22
LM End	3.63	Issue Type +	Ma	Location *	WS
Category	Supplemental			GPS Latitude/Longitude	
				Start	End
Item	USACE Erosion Survey			38.218951 °	38.218104 °
				-121.556689 °	-121.556819 °
DWR ID	DWR_RD0556_02_f_2014_22				
Action/Comments					
Inspector Comments: 1997 - Scallops into berm and very close to levee toe. 2005 - Brush boxes present. 2011 - New toe scour and freshly fallen tree. 2012 - New tree popout has taken significant portion of soil out of the levee. 2013: No observed changes. [2013 Site ID: SAC_22-7_L]

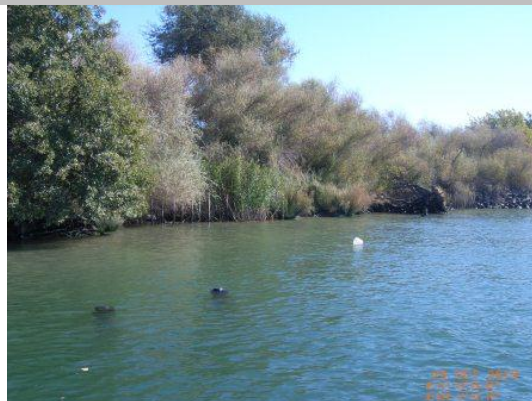
Photo 1 of 1 : FA_2014_RD0556_19_19_20141030_00002.jpg

LM Start	4.44	Rating **	M	Issue No.	19
LM End	4.48	Issue Type +	Ma	Location *	WS
Category	Supplemental			GPS Latitude/Longitude	
				Start	End
Item	USACE Erosion Survey			38.206379 °	38.205733 °
				-121.557089 °	-121.556999 °
DWR ID	DWR_RD0556_02_f_2014_19				
Action/Comments					
Inspector Comments: 2013: Erosion pockets encroaching on levee foundation. [2013 Site ID: SAC_21-9_L]

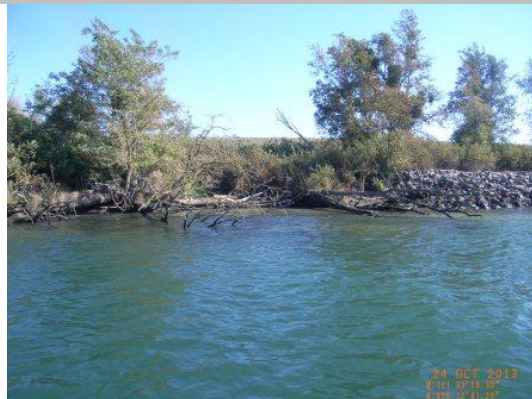
Photo 1 of 1 : FA_2014_RD0556_19_3_20141030_00001.jpg

LM Start	4.87	Rating **	M	Issue No.	3
LM End	4.88	Issue Type +	Ma	Location *	WS
Category	Supplemental			GPS Latitude/Longitude	
				Start	End
Item	USACE Erosion Survey			38.200646 °	38.200225 °
				-121.557606 °	-121.557749 °
DWR ID	DWR_RD0556_02_f_2014_3				
Action/Comments					
Inspector Comments: 1999 - Downstream 140 ft repaired with rock. 2010 - Lots of woody debris, but no changes to site. 2013: No observed changes. [2013 Site ID: SAC_21-5_L]
