**Flood Control Project Maintenance
Levee Inspections**

Fall 2015 Levee Maintenance Deficiency Summary Report

Sacramento River Basin

Reclamation District No. 0556 Upper Andrus

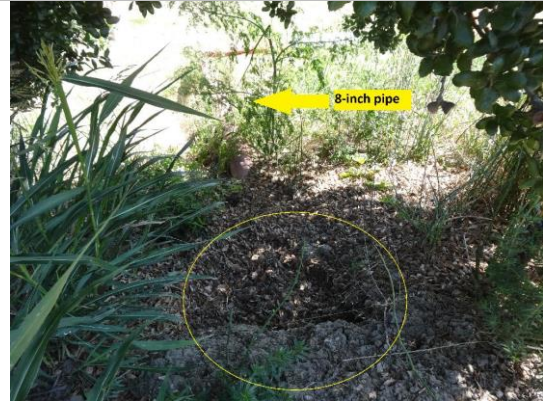
Photo 1 of 3 : UCIP_FA_2015_4404.jpg

LS view: 8-inch pipe off LS slope with possible erosion above pipe (circled).

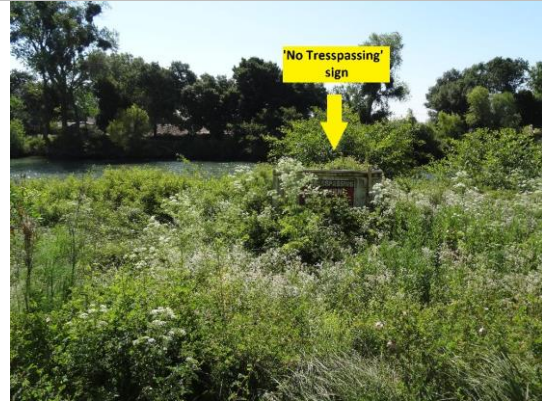
Photo 2 of 4 : UCIP_FA_2015_5799.jpg

Inspector Comments: FS_ID:45564
 DS_ID:20820
 EP_NO: 3448
 FS_HLM: 0.43
 Repair Type: Non-Urgent
 Crossing Status: Indicator Found
 UCIP Comments: Dense vegetation inhibited visibility of gasline marker on WS. Need to contact owner to determine status of crossing.
 FIELD_STRUCT_DESC: 4-1/2-inch steel pipe gas line through levee, 4.0 feet below the crown. Location marker on waterward shoulder.
 (App. 3448-PG&E pipe not located 2/91). Cut in pavement visible at crossing. Gasline marker on LS and opposite bank at RD 263.
 FS Date: 05/27/2015

View of WS. Dense vegetation limited visibility of 'No Trespassing' sign.

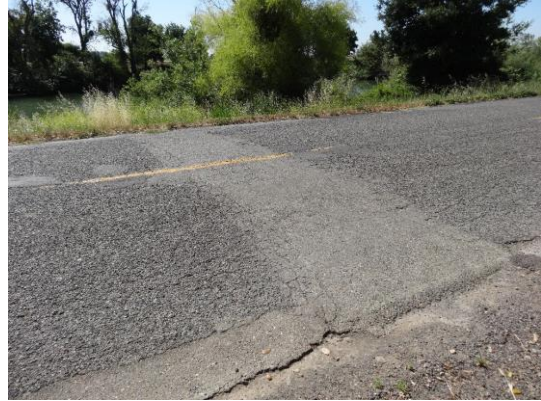
Photo 2 of 3 : UCIP_FA_2015_6325.jpg

Inspector Comments: FS_ID:45663
 DS_ID:20821
 EP_NO: 5548
 FS_HLM: 0.53
 Repair Type: Non-Urgent
 Crossing Status: Found
 UCIP Comments: Dense vegetation prevents inspection of WS slope.
 FIELD_STRUCT_DESC: 12-inch steel pipe through levee, 5.0 feet below crown. 1-1/4-inch electrical conduit through the levee. Concrete steps on landward slope. Pump off landward toe. Cuts visible on pavement. (App. 5548).
 FS Date: 05/13/2015

View of WS with cuts visible on pavement.

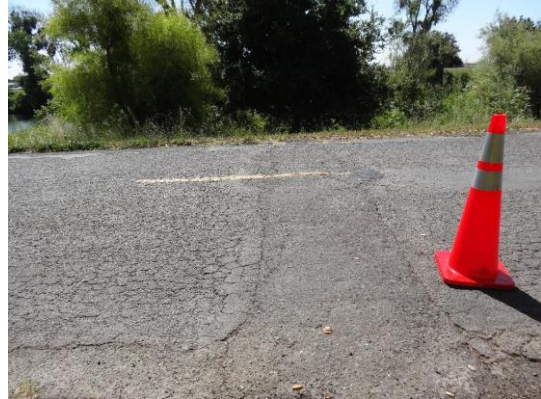
Photo 1 of 2 : UCIP_FA_2015_6324.jpg

View of WS with cuts visible on pavement.

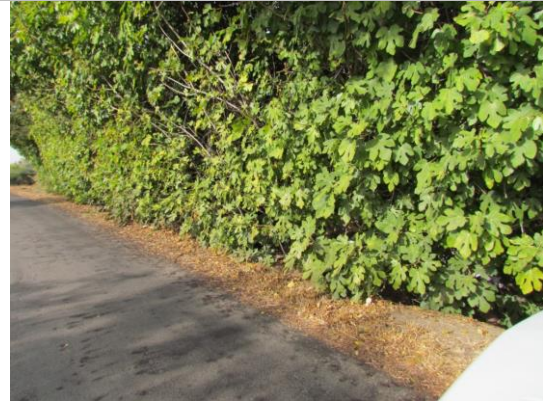
Photo 1 of 1 : FA_2015_RD0556_18_376_20150915_00018.jpg

LM Start	0.68	Rating **	U	Issue No.	376
LM End	0.90	Issue Type +	Ma	Location *	LS
Category	Earthen Levee			GPS Latitude/Longitude	
				Start	End
Item	Vegetation			38.230785 °	38.228602 °
				-121.523470 °	-121.526289 °
DWR ID	DWR_RD0556_01_s _ 2014_376				
Action/Comments					
Trees / Woody Vegetation					
Inspector Comments: District should remove these unwanted fig trees from the landside slope, unable to see ground.

Remove unwanted fig trees present on the landside slope.

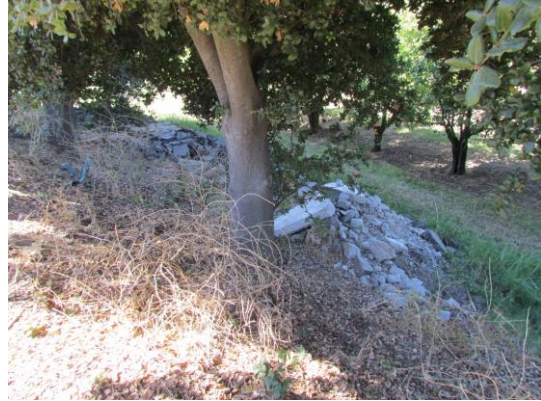
Photo 1 of 1 : FA_2015_RD0556_18_27_20151006_00024.jpg

LM Start	1.34	Rating **	U	Issue No.	27
LM End	1.37	Issue Type +	En	Location *	LS
Category	Earthen Levee			GPS Latitude/Longitude	
				Start	End
Item	Encroachments			38.227521 °	38.227320 °
				-121.532393 °	-121.532710 °
DWR ID	DWR_RD0556_01_s _ 2013_27				
Action/Comments					
Debris					
Inspector Comments: Remove the pile of asphalt and concrete from the toe of levee.

Unauthorized pile of asphalt and concrete dumped on the landside levee toe.

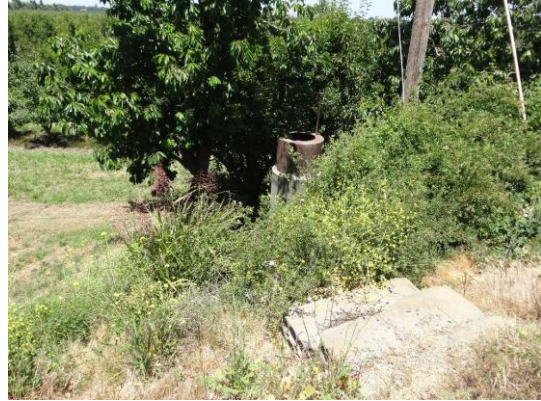
Photo 1 of 2 : UCIP_FA_2015_5800.jpg

Action/Comments					
Inspector Comments: FS_ID:45743 DS_ID:20827 EP_NO: 11169 FS_HLM: 1.56 Repair Type: Non-Urgent Crossing Status: Found UCIP Comments: Dense vegetation on LS and WS limited accessibility. FIELD_STRUCT_DESC: 8-inch steel pipe through levee, 3.5 feet below crown. Pump and gate valve on WS berm. 2-inch electrical conduit into WS slope. A 36-inch concrete standpipe and concrete block step on Landward Slope. (Listed as 10-inch in ABO 11169 - Mealer). O&M Manual Sac 103, June 1954 FS Date: 05/27/2015

Concrete standpipe and steps off LS toe.

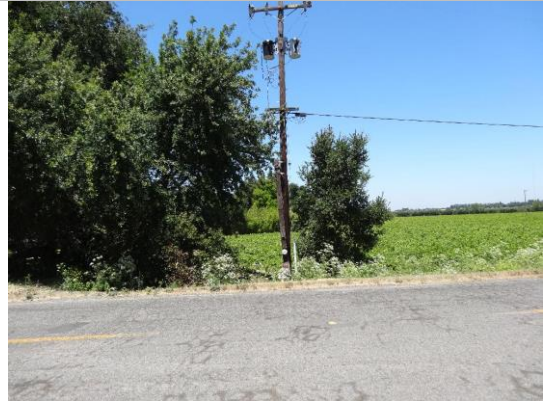
Photo 1 of 3 : UCIP_FA_2015_5849.jpg

LS view: service pole on LW slope. Standpipe not visible in photo.

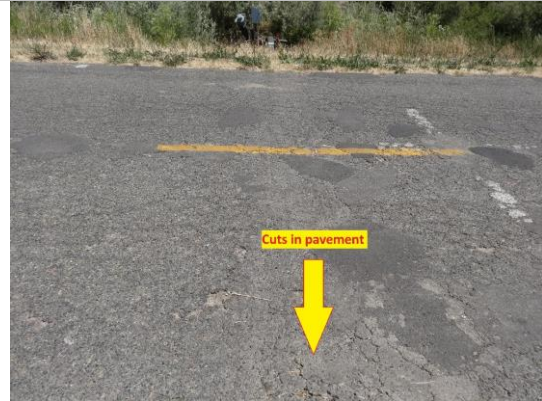
Photo 2 of 3 : UCIP_FA_2015_5859.jpg

View toward WS with cuts in pavement in alignment with pipe on WS

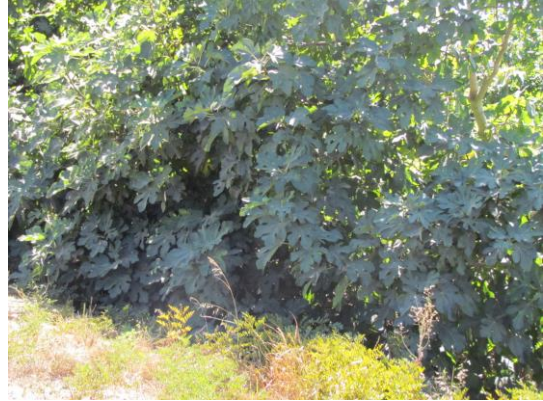
Photo 1 of 1 : FA_2015_RD0556_18_24_20151007_00028.jpg

LM Start	2.32	Rating **	U	Issue No.	24
LM End	2.34	Issue Type +	Ma	Location *	LS
Category	Earthen Levee			GPS Latitude/Longitude	
				Start	End
Item	Vegetation			38.219822 °	38.219592 °
				-121.544000 °	-121.543927 °
DWR ID	DWR_RD0556_01_s _ 2012_24				
Action/Comments					
Trees / Woody Vegetation					
Inspector Comments: Unable to see the levee section for heavy growth of trees. Remove them or thin them out so the ground can be seen.

Unsatisfactory woody tree growth of Fig trees blocking the view of both the shoulder and slope landward.

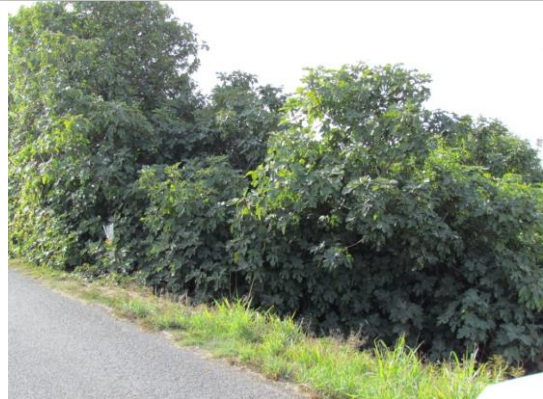
Photo 1 of 1 : FA_2015_RD0556_18_47_20150915_00009.jpg

LM Start	2.42	Rating **	U	Issue No.	47
LM End	2.46	Issue Type +	Ma	Location *	LS
Category	Earthen Levee			GPS Latitude/Longitude	
				Start	End
Item	Vegetation			38.218426 °	38.217846 °
				-121.543800 °	-121.543796 °
DWR ID	DWR_RD0556_01_f _ 2012_47				
Action/Comments					
Trees / Woody Vegetation					
Inspector Comments: This section of trees need to be removed from levee section, visibility completely blocked.

Unsatisfactory tree growth completely blocking visibility of the levee section at this location.

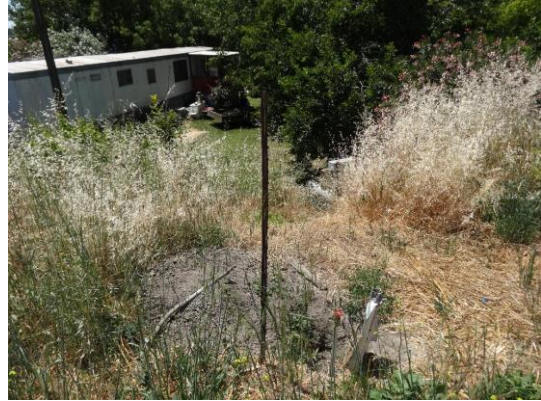
Photo 1 of 2 : UCIP_FA_2015_6380.jpg

Pipe, pump @LS toe. 2'x2' hole off shoulder. Spigot in hole possibly for irrigation. House and service pole in background.

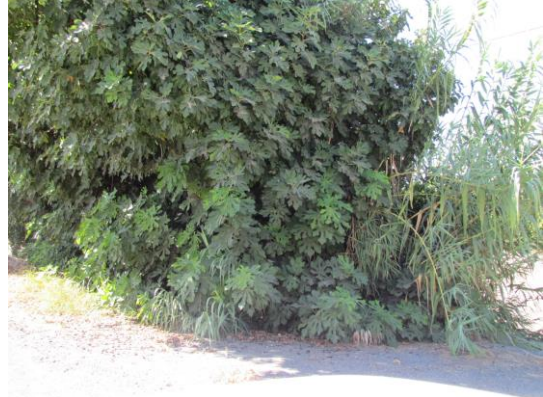
Photo 1 of 1 : FA_2015_RD0556_18_79_20151007_00038.jpg

LM Start	3.17	Rating **	U	Issue No.	79
LM End	3.28	Issue Type +	Ma	Location *	LS
Category	Earthen Levee			GPS Latitude/Longitude	
				Start	End
Item	Vegetation			38.210823 °	38.209983 °
				-121.538813 °	-121.540533 °
DWR ID	DWR_RD0556_01_f_2015_79				
Action/Comments					
Remove the wild growth other than native grasses from the levee slopes.					
Inspector Comments: Remove the unsatisfactory growth of vegetation from the levee section.

Unsatisfactory woody tree growth and arundo blocking view of landside levee shoulder and slope.

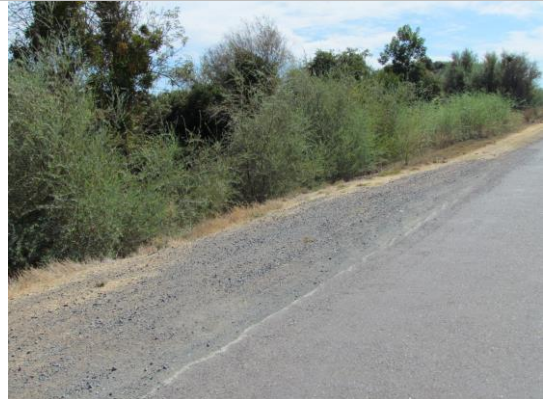
Photo 1 of 1 : FA_2015_RD0556_18_80_20151007_00037.jpg

LM Start	3.32	Rating **	U	Issue No.	80
LM End	3.92	Issue Type +	Ma	Location *	WS
Category	Earthen Levee			GPS Latitude/Longitude	
				Start	End
Item	Vegetation			38.209497 °	38.201645 °
				-121.540917 °	-121.542198 °
DWR ID	DWR_RD0556_01_f_2015_80				
Action/Comments					
Remove the wild growth other than native grasses from the levee slopes.					
Inspector Comments: Remove this unsatisfactory growth from the waterside so the slope can be inspected.

Looking downstream from levee mile 3.32-3.92 waterside unsatisfactory growth of willows blocks the view of the slope.

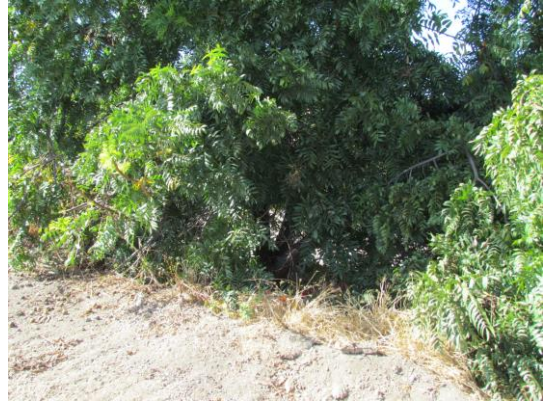
Photo 1 of 1 : FA_2015_RD0556_18_83_20151007_00034.jpg

LM Start	3.53	Rating **	U	Issue No.	83
LM End	4.07	Issue Type +	Ma	Location *	LS
Category	Earthen Levee			GPS Latitude/Longitude	
				Start	End
Item	Vegetation			38.206568 °	38.200653 °
				-121.541810 °	-121.544667 °
DWR ID	DWR_RD0556_01_f_2015_83				
Action/Comments					
Remove the wild growth other than native grasses from the levee slopes. Inspector Comments: Thin out this growth of trees to allow viewing the levee slope and shoulder.

Looking downstream from the landside slope unsatisfactory woody tree growth blocking view of levee section.

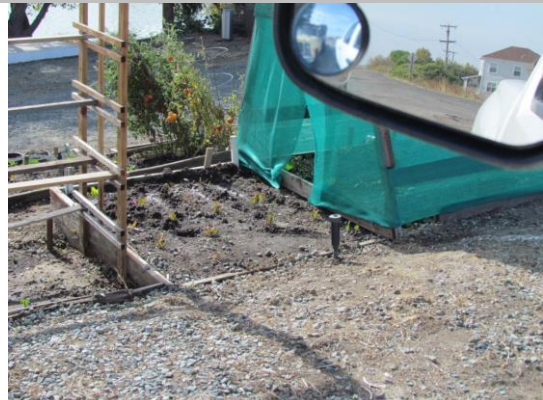
Photo 1 of 2 : FA_2015_RD0556_18_70_20150915_00016.jpg

LM Start	3.94	Rating **	U	Issue No.	70
LM End	4.01	Issue Type +	En	Location *	WS
Category	Earthen Levee			GPS Latitude/Longitude	
				Start	End
Item	Encroachments			38.201515 °	38.201105 °
				-121.542573 °	-121.543720 °
DWR ID	DWR_RD0556_01_f_2014_70				
Action/Comments					
Crops					
Inspector Comments: Remove the unauthorized planter boxes repack earth materials back on slope.

Continue placement of unauthorized planter boxes into levee slope waterside.

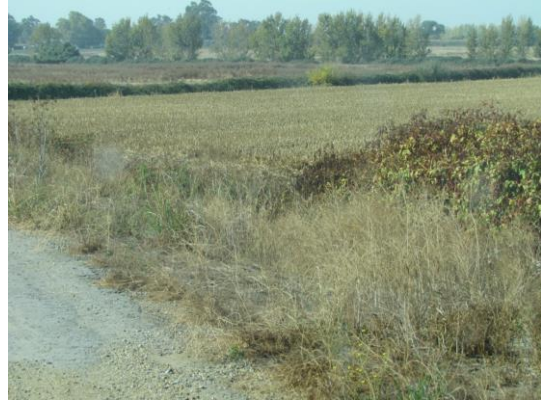
Photo 1 of 1 : FA_2015_RD0556_18_66_20150915_00012.jpg

LM Start	4.07	Rating **	U	Issue No.	66
LM End	5.47	Issue Type +	Ma	Location *	LS
Category	Earthen Levee			GPS Latitude/Longitude	
				Start	End
Item	Vegetation			38.200659 °	38.186542 °
				-121.544711 °	-121.562411 °
DWR ID	DWR_RD0556_01_s_2013_66				
Action/Comments					
Remove the wild growth other than native grasses from the levee slopes. Inspector Comments: Remove the wild berries from the slope and toe of the levee section along with the tall weeds.

Unwanted tall weeds and berries growing on the landside slope and toe.

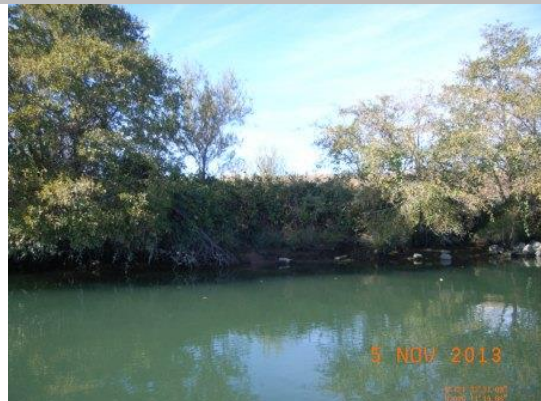
Photo 1 of 1 : USACE2013A_GEO_7-0_R_7.jpg

LM Start	5.12	Rating **	M	Issue No.	1
LM End	5.27	Issue Type +	Ma	Location *	WS
Category	Supplemental			GPS Latitude/Longitude	
				Start	End
Item	2015 USACE Erosion Survey, DRAFT			38.189775 °	38.188121 °
				-121.557729 °	-121.559413 °
DWR ID					
Action/Comments					
Inspector Comments: 1997 - Toe damaged rock. 1999 - One pocket filled with gravel. 2000 - Eroding beach with some biotech rolls and stakes; some gravel on slope. 2001 - Staked, low fascine walls at bankline. 2005 - Stone revetment in between pockets. 2006 - New rock on upper slope behind brush boxes at the upstream end, Stone is sliding off the hard toe. 2015: Last observed in 2013. [2015 Site ID: GEO 7-0 R]

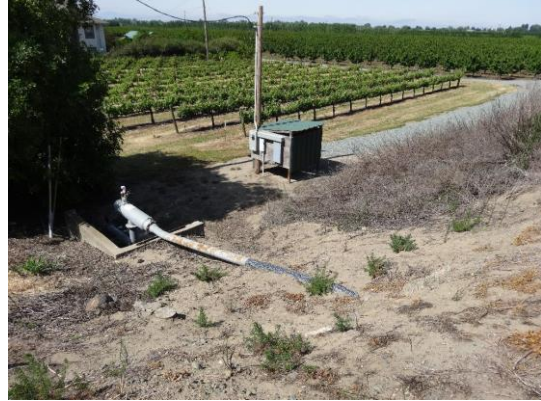
Photo 2 of 3 : UCIP_FA_2015_0904.jpg

LS- steel pipe on a concrete box

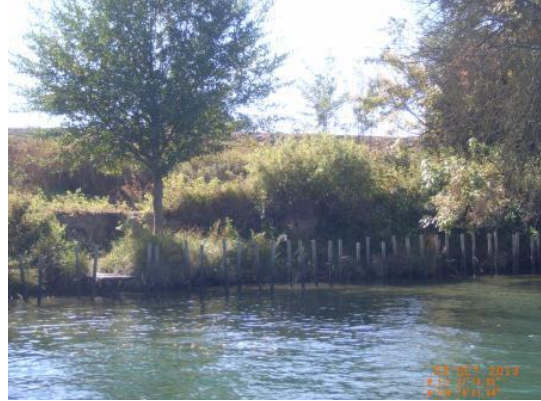
Photo 1 of 1 : USACE2013A_SAC_25-2_L_9.jpg

LM Start	1.03	Rating **	M	Issue No.	2
LM End	1.15	Issue Type +	Ma	Location *	WS
Category	Supplemental			GPS Latitude/Longitude	
				Start	End
Item	2015 USACE Erosion Survey, DRAFT			38.238772 °	38.239265 °
				-121.536788 °	-121.538845 °
DWR ID					
Action/Comments					
Inspector Comments: 1997 - Rock is in poor condition and has failed in many places. Scallops in berm with remnants of old rock in the toe area. 2005 - Brush boxes present. 2013 - Site extended upstream approximately 300 ft to include new erosion pockets. 2015: Minor new erosion at toe. [2015 Site ID: SAC_25-2_L]

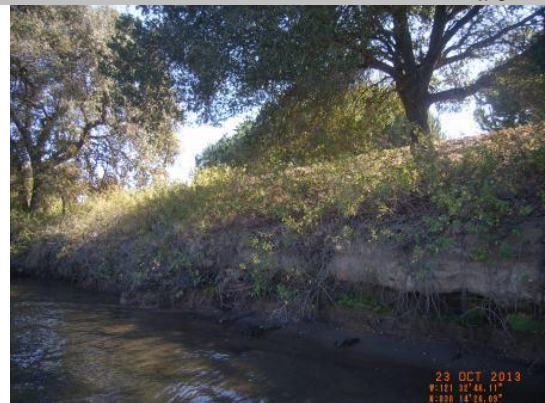
Photo 1 of 1 : USACE2013A_SAC_24-8_L_9.jpg

LM Start	1.45	Rating **	M	Issue No.	5
LM End	1.59	Issue Type +	Ma	Location *	WS
Category	Supplemental			GPS Latitude/Longitude	
				Start	End
Item	2015 USACE Erosion Survey, DRAFT			38.240401 °	38.240772 °
				-121.544106 °	-121.546791 °
DWR ID					
Action/Comments					
Inspector Comments: 1997 - Slow erosion of the berm at the waterline; bench below water. 2005 - Brush boxes present. 2010 - Minor new erosion. 2013 - There is little to no berm remaining at downstream end of this site. 2015: No observed changes. [2015 Site ID: SAC_24-8_L]

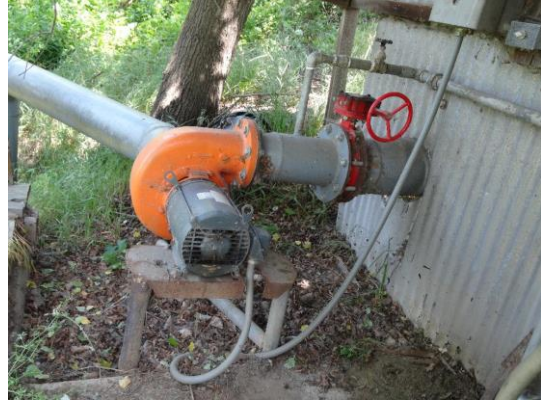
Photo 2 of 3 : UCIP_FA_2015_0647.jpg

WS- pump, and gate valve in pump house.

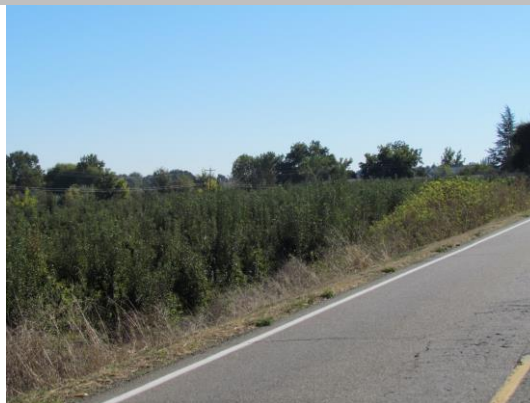
Photo 1 of 1 : FA_2015_RD0556_19_80_20151106_00033.jpg

LM Start	2.61	Rating **	U	Issue No.	80
LM End	3.40	Issue Type +	Ma	Location *	LS
Category	Earthen Levee			GPS Latitude/Longitude	
				Start	End
Item	Vegetation			38.232545 °	38.221512 °
				-121.557112 °	-121.555715 °
DWR ID	DWR_RD0556_02_f_2015_80				
Action/Comments					
Control annual grass and weeds on the levee slopes and easements. Inspector Comments: Remove the wild growth from the landside levee slope.

Looking downstream landside at wild roses bamboo and other growth covering the slope.

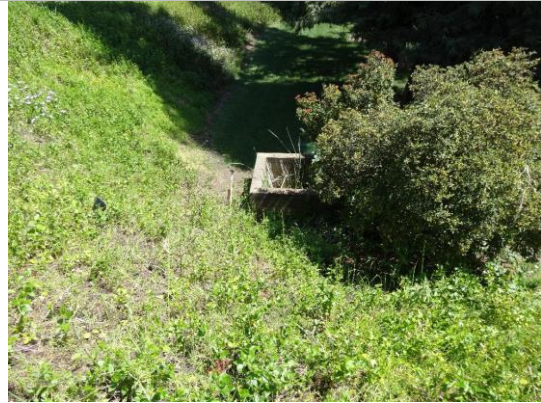
Photo 1 of 3 : UCIP_FA_2015_0637.jpg

LS- concrete distribution box near toe of the levee

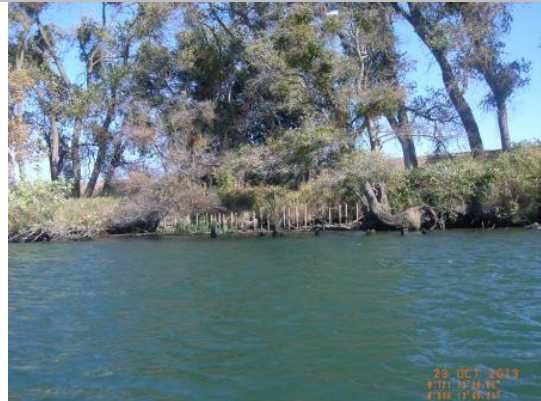
Photo 1 of 1 : USACE2013A_SAC_23-3_L_2.jpg

LM Start	2.93	Rating **	M	Issue No.	11
LM End	3.04	Issue Type +	Ma	Location *	WS
Category	Supplemental			GPS Latitude/Longitude	
				Start	End
Item	2015 USACE Erosion Survey, DRAFT			38.228202 °	38.226601 °
				-121.555502 °	-121.555605 °
DWR ID					
Action/Comments					
Inspector Comments: 1997 - Few scallops in berm, some getting close to levee toe. 2005 - Brush boxes present. 2012 - More erosion of the toe since last year. 2015: No observed changes. [2015 Site ID: SAC_23-3_L]

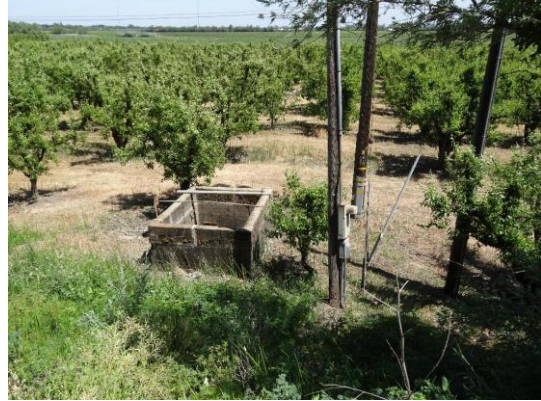
Photo 1 of 3 : UCIP_FA_2015_0640.jpg

LM Start	3.07	Rating **	M	Issue No.	94 (cont)
LM End	3.07	Issue Type +	En	Location *	WS

LS- a concrete spill box on landside of the levee.

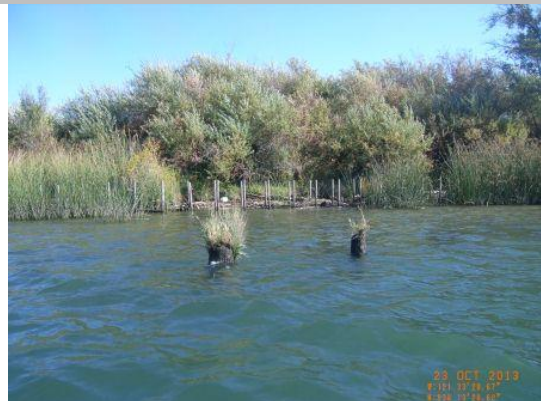
Photo 1 of 1 : USACE2013A_SAC_23-2_L_4.jpg

LM Start	3.17	Rating **	M	Issue No.	10
LM End	3.28	Issue Type +	Ma	Location *	WS
Category	Supplemental			GPS Latitude/Longitude	
				Start	End
Item	2015 USACE Erosion Survey, DRAFT			38.224850 °	38.223233 °
				-121.555641 °	-121.555687 °
DWR ID					
Action/Comments					
Inspector Comments: 2000 - Recently fallen cottonwood at the downstream end. 2005 - Empty brush boxes. 2011 - A few trees have fallen since last year. 2012 - Potential new tree popout since last year. 2013 - New erosion at downstream end of site and a recent tree pop-out observed. 2015: No observed changes. [2015 Site ID: SAC_23-2_L]

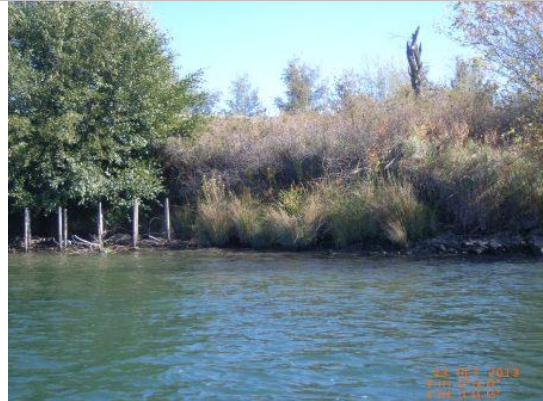
Photo 1 of 1 : USACE2013A_SAC_22-7_L_5.jpg

LM Start	3.58	Rating **	M	Issue No.	8
LM End	3.64	Issue Type +	Ma	Location *	WS
Category	Supplemental			GPS Latitude/Longitude	
				Start	End
Item	2015 USACE Erosion Survey, DRAFT			38.218951 °	38.218104 °
				-121.556689 °	-121.556819 °
DWR ID					
Action/Comments					
Inspector Comments: 1997 - Scallops into berm and very close to levee toe. 2005 - Brush boxes present. 2011 - New toe scour and freshly fallen tree. 2012 - New tree popout has taken significant portion of soil out of the levee. 2015: No observed changes. [2015 Site ID: SAC_22-7_L]

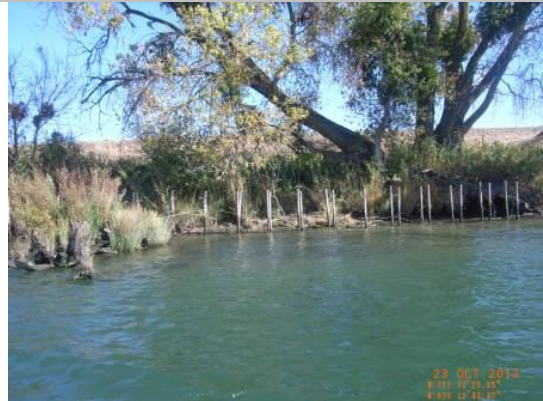
Photo 1 of 1 : USACE2013A_SAC_22-5_L_13.jpg

LM Start	3.95	Rating **	M	Issue No.	4
LM End	4.12	Issue Type +	Ma	Location *	WS
Category	Supplemental			GPS Latitude/Longitude	
				Start	End
Item	2015 USACE Erosion Survey, DRAFT			38.213581 °	38.211112 °
				-121.557197 °	-121.557042 °
DWR ID					
Action/Comments					
Inspector Comments: 2002 - Spot rock along berm, but not in the erosion pockets. 2005 - Some new minor stone revetment at the upstream end. Brush boxes present. 2006 - Currently installing new brush in downstream brush boxes. 2007 - Rock in middle portion for about 150 ft. 2010 - Some attempt at repairs but still has pockets of erosion. 2012 - More erosion along the toe. 2015: No observed changes. [2015 Site ID: SAC_22-5_L]

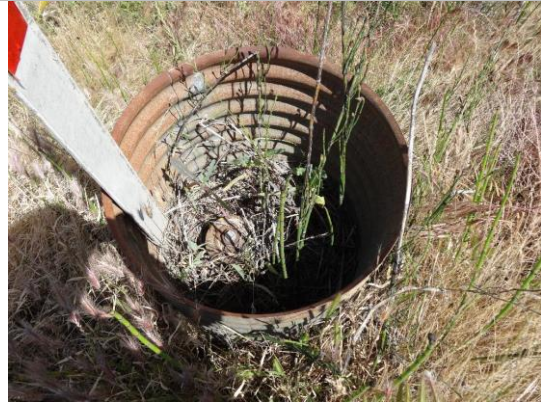
Photo 1 of 3 : UCIP_FA_2015_0757.jpg

Inspector Comments: FS_ID:12543
 DS_ID:20864
 EP_NO: 11197
 FS_HLM: 3.9792
 Repair Type: Non-Urgent
 Crossing Status: Found
 UCIP Comments: Electric control panel in pump house. Needs cleaning of CMP riser on landside.
 FIELD_STRUCT_DESC: A 6-inch steel irrigation pipe through levee 6.5 feet below crown. Slanted pump on steel pile structure in the stream, walkway to the pump, and gate valve in pump house on waterward slope. Siphon breaker and service poles on landward slope. Concrete standpipe on landside. (ABO #11197- Souza.). O&M Manual Sac 103, June 1954.
 FS Date: 04/25/2013

LS- siphon breaker in CMP riser. It needs cleaning.

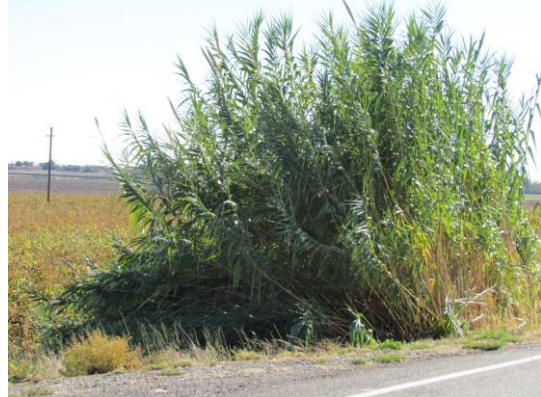
Photo 1 of 1 : FA_2015_RD0556_19_86_20151110_00034.jpg

LM Start	3.99	Rating **	U	Issue No.	86
LM End	3.99	Issue Type +	Ma	Location *	LS
Category	Earthen Levee			GPS Latitude/Longitude	
				Start	End
Item	Vegetation			38.212918 °	38.212918 °
				-121.556848 °	-121.556848 °
DWR ID	DWR_RD0556_02_f_2015_86				
Action/Comments					
Remove the wild growth other than native grasses from the levee slopes.					
Inspector Comments: Remove the patch of bamboo from the landside shoulder.

Landside levee shoulder levee mile 3.99 RD 556 Unit 2.

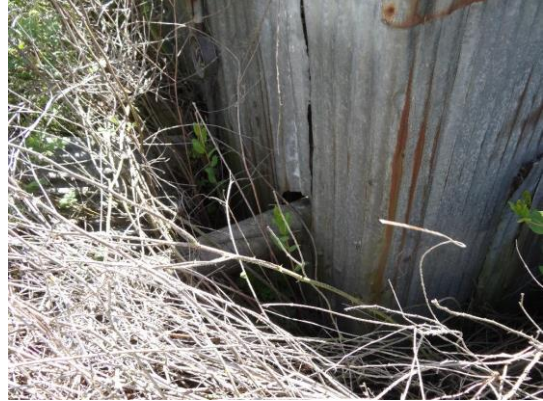
Photo 1 of 3 : UCIP_FA_2015_0802.jpg

Inspector Comments: FS_ID:12546
 DS_ID:20866
 EP_NO: 11940
 FS_HLM: 4.5341
 Repair Type: Non-Urgent
 Crossing Status: Found
 UCIP Comments: - Abandoned crossing.- Siphon breaker on LS not found due to dense vegetation, - An abandoned CMP riser and service pole found on LS.- It may need to be properly abandoned.
 FIELD_STRUCT_DESC: Abandoned 6-inch pipe through levee, 6.7 feet below crown. Pump and gate valve in pumphouse on waterward slope. Siphon breaker and service pole on landward slope. (ABO # 11940-Robinson.). O&M Manual Sac 103, June 1954.
 FS Date: 04/25/2013

WS- pipe daylight from levee slope to pump house.

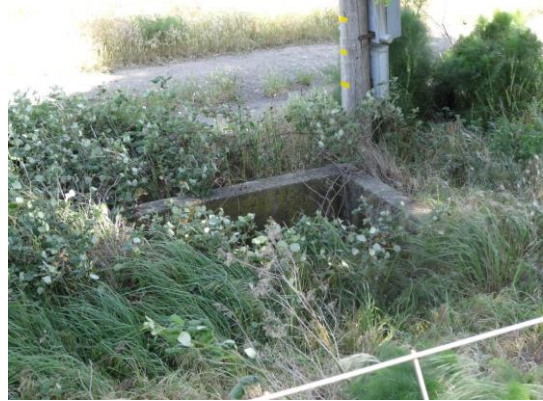
Photo 1 of 3 : UCIP_FA_2015_0805.jpg

LS- power pole and a concrete distribution box near levee toe.

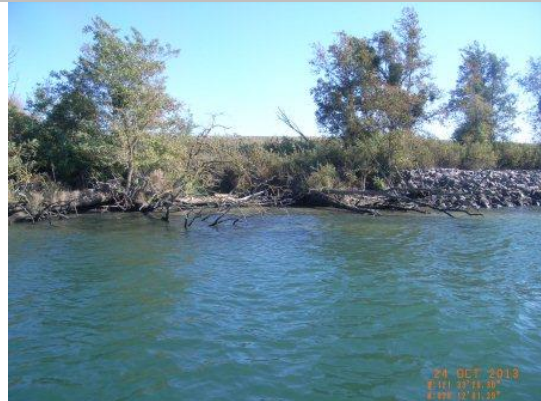
Photo 1 of 1 : USACE2013A_SAC_21-5_L_2.jpg

LM Start	4.77	Rating **	M	Issue No.	3
LM End	4.88	Issue Type +	Ma	Location *	WS
Category	Supplemental			GPS Latitude/Longitude	
				Start	End
Item	2015 USACE Erosion Survey, DRAFT			38.201687 °	38.200225 °
				-121.557305 °	-121.557749 °
DWR ID					
Action/Comments					
Inspector Comments: 1999 - Downstream 140 ft repaired with rock. 2010 - Lots of woody debris, but no changes to site. 2015: Site extended upstream due to erosion pockets. [2015 Site ID: SAC_21-5_L]

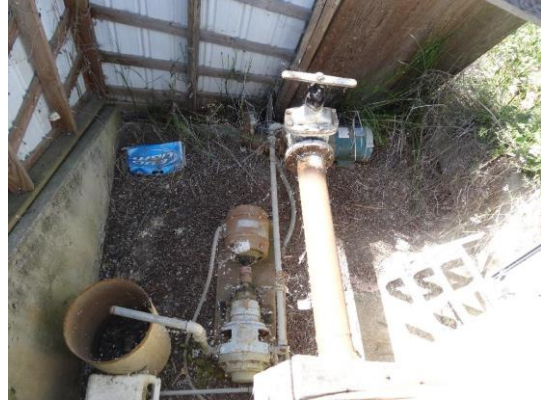
Photo 1 of 2 : UCIP_FA_2015_0808.jpg

WS- pump, pipe and gate valve in pump house.
